I-40 Crossing I-40 E.B. / WOLF RIVER

90 - LAST INSPECTION DATE 10/02/2024

IDENTIFICATION	
(1) State Names	47 - Tennessee
(8) Structure Number	79I00400059
(5) Inventory Route	1
(2) Highway Agency District	Region 4
(3) County Code	79 - Shelby

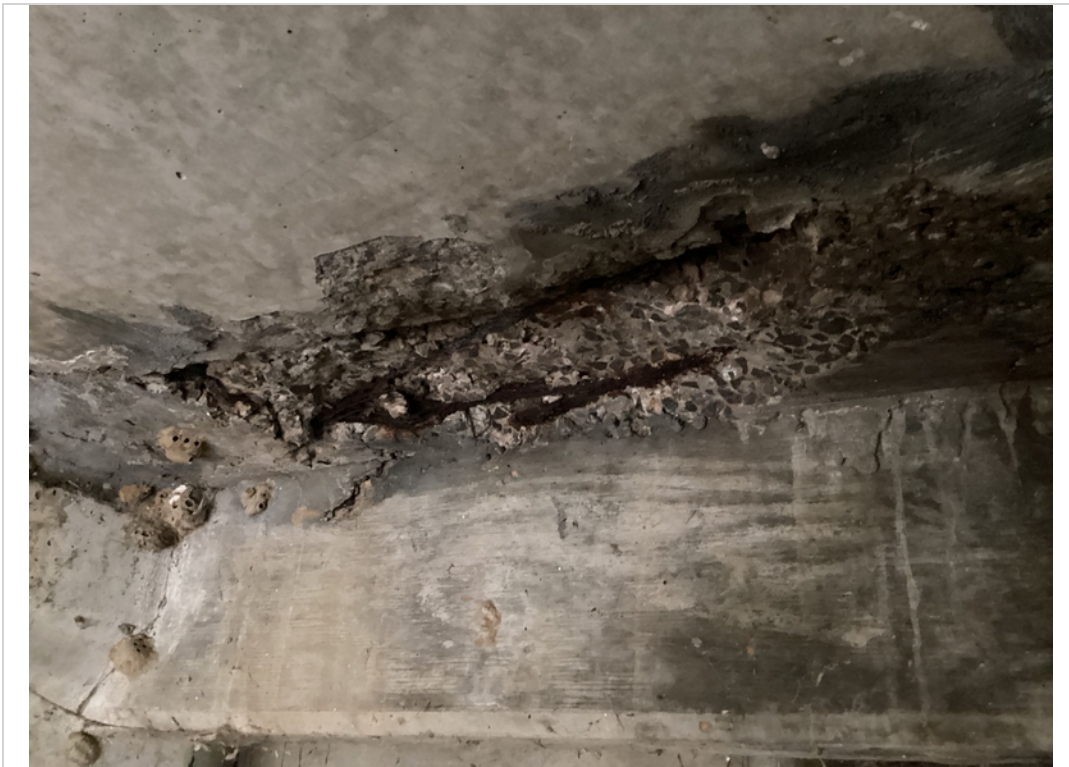
Bottom deck span 11A spalling to steel

① spalling to steel 30" wide 12" long 2" deep

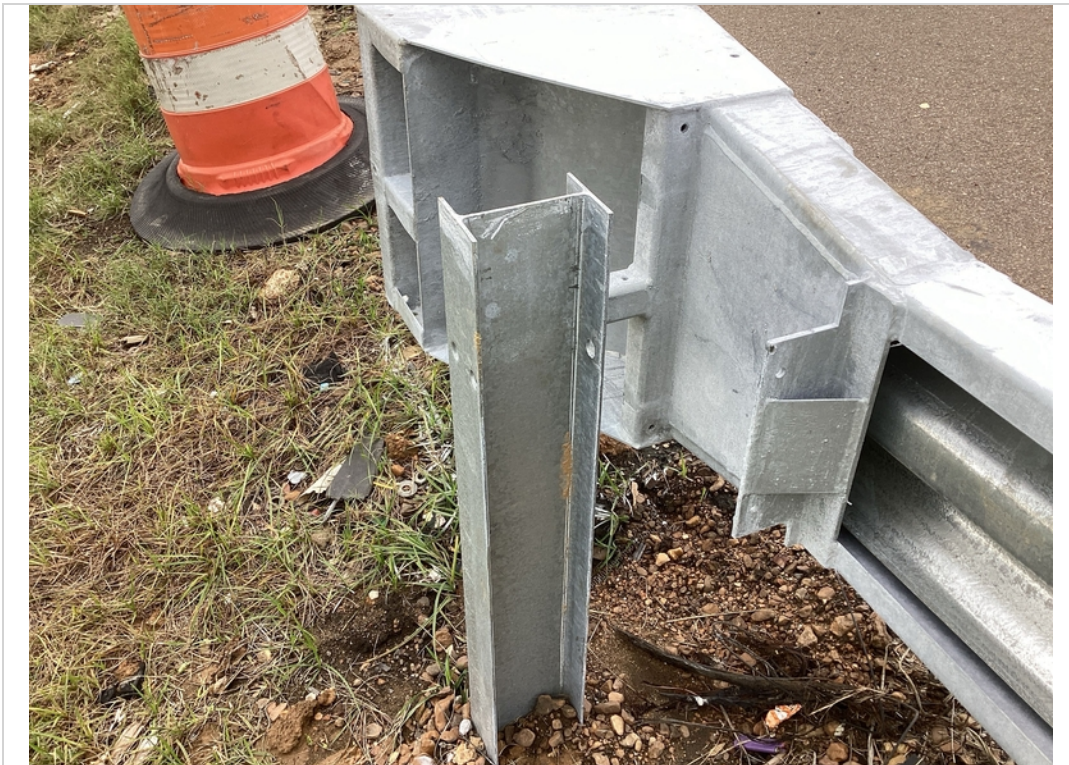
Approach 1 right has damage

This is an eleven span Concrete I Beam Bridge. Safety features include metal approach rails & concrete parapet. Approach 1 & 2 asphalt has 1/8" cracks & patched areas. Approach 1 right terminal has heavy damage. Approach 1 & 2 right drains are full of debris. Asphalt wearing surface has cracks up to 1/8", patched areas, and potholes. Span 1, 11A, & 11B joints have missing/torn material, debris present, and broken header. All deck drains are full of debris. The bottom deck has spalling & cracks up to 1/32" with efflorescence. The superstructure has damage areas & hairline cracks. The substructure has spalling & hairline efflorescence cracks. Vegetation has tree growth under the bridge. Scour is within 5' of the footing.

Approach 1 right terminal damage

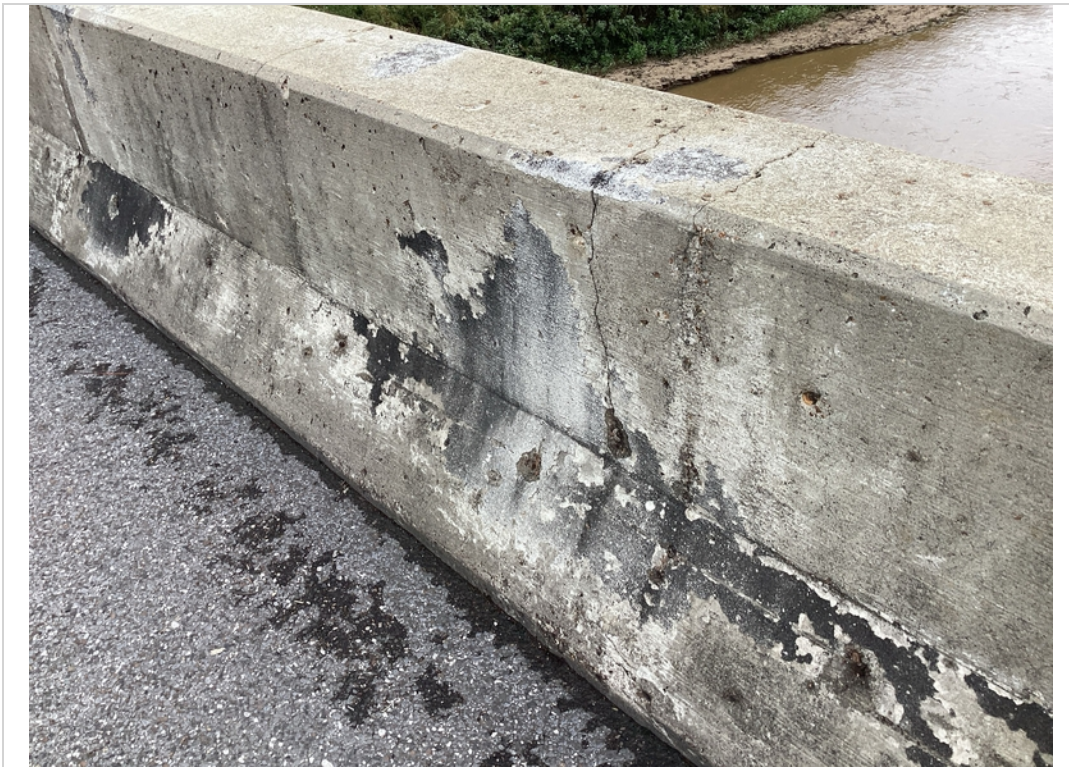
Span 3 , typical of parapet , cracks

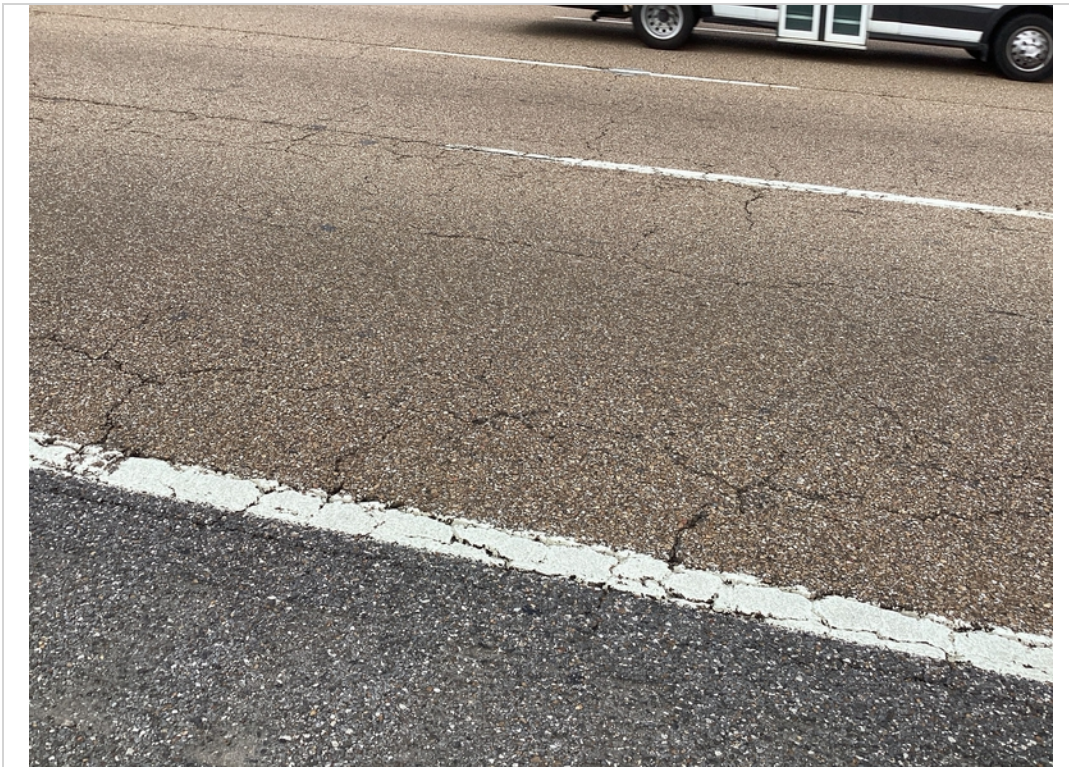
Span 3 cracks

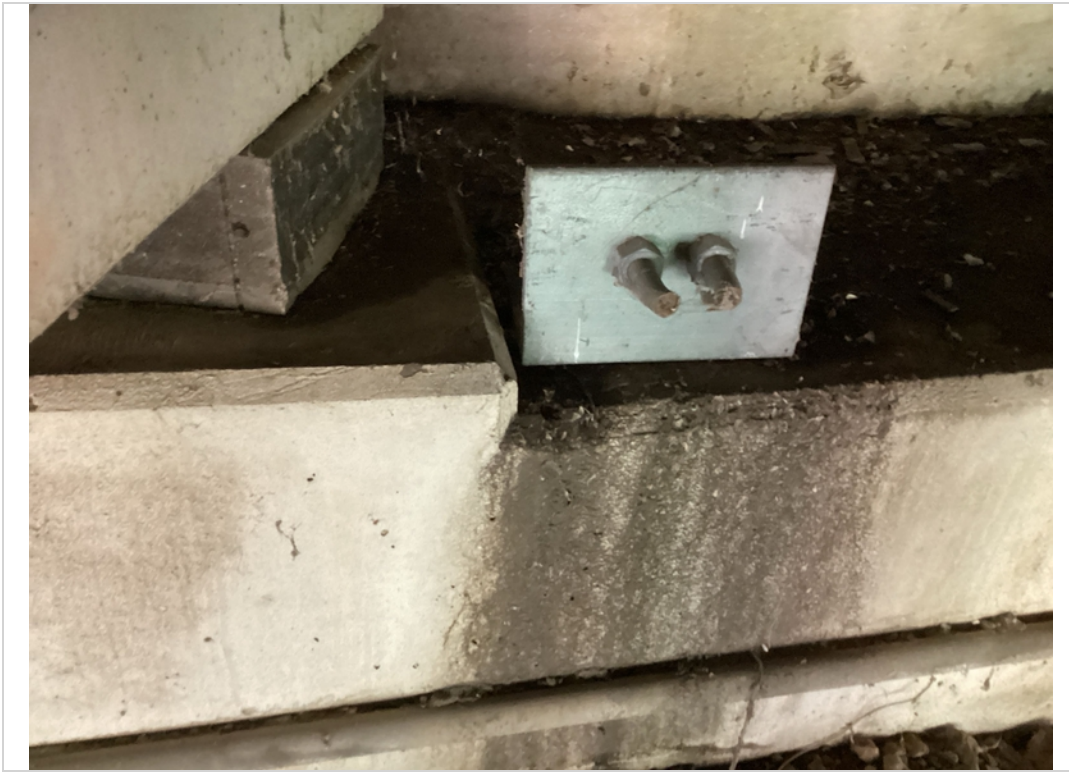
Abutment 1 broken earthquake at beam "D"

1 connection at beam "D" broken

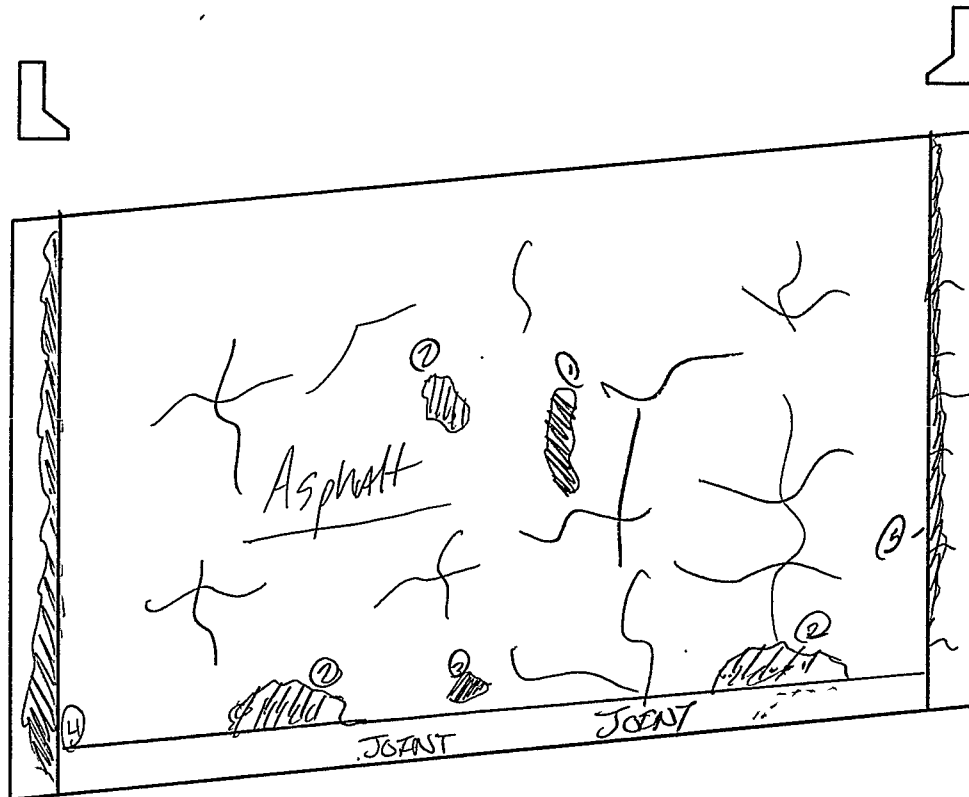
SPAN. NO. 1

ELEMENT	RATING	COMMENT
TOP DECK	G (F) P C	1/8" cracks, See ①②③
PARAPET	G (F) P C	Pop out spall, 1/16" cracks See ④⑤
DRAINS	G F P C	N/A
JOINTS	G F (P) C	Missing Material
	G F P C

- ① Pot hole (Spec 1)  
Cup se)  
2' L x 3" W x 1" D
- ② Patch Area
- ③ Pot Holes  
4' L x 1' W
- ④ Collision Damage  
Length of Span x 2' H  
x 1/8" D
- ⑤ Scaling (Cup se)  
1/2" D x Length of  
Span x 2' H

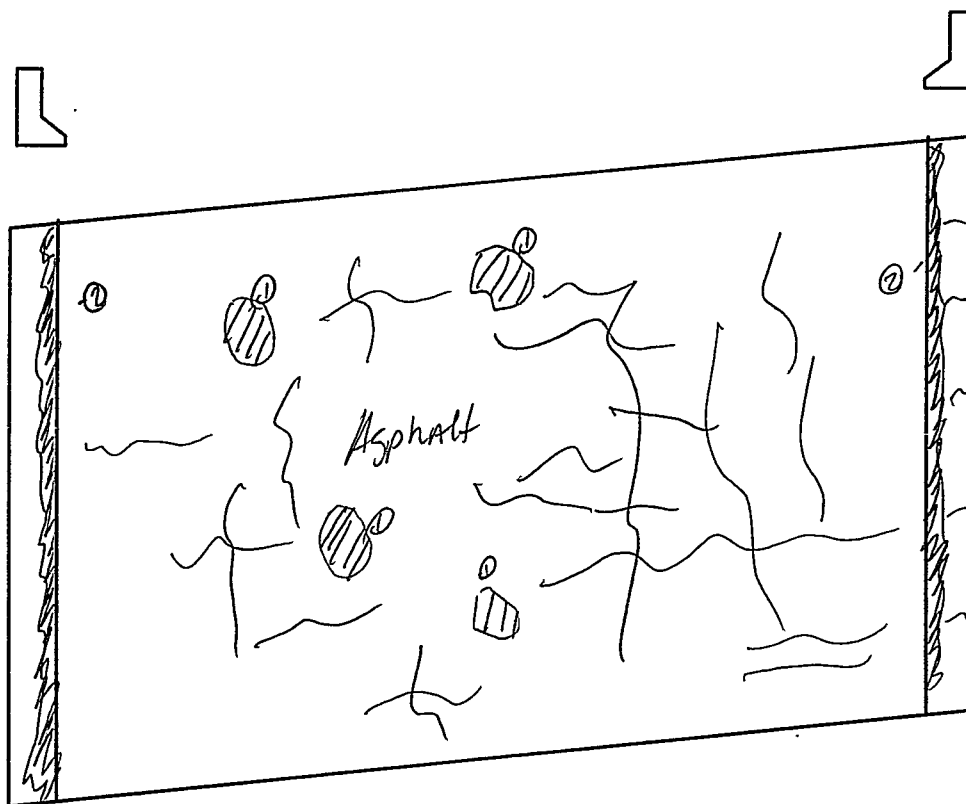
SPAN. NO. 2

ELEMENT	RATING	COMMENT
TOP DECK	G (F) P C	1/8" cracks, See ①
PARAPET	G (F) P C	pop-out spall, 1/16" cracks
DRAINS	G F (P) C	100% full
JOINTS	G F P C	N/A
	G F P C

① Patch Area  
② Sealing (up to)  
Length of Span  
x 2" H x 1/2" Dp

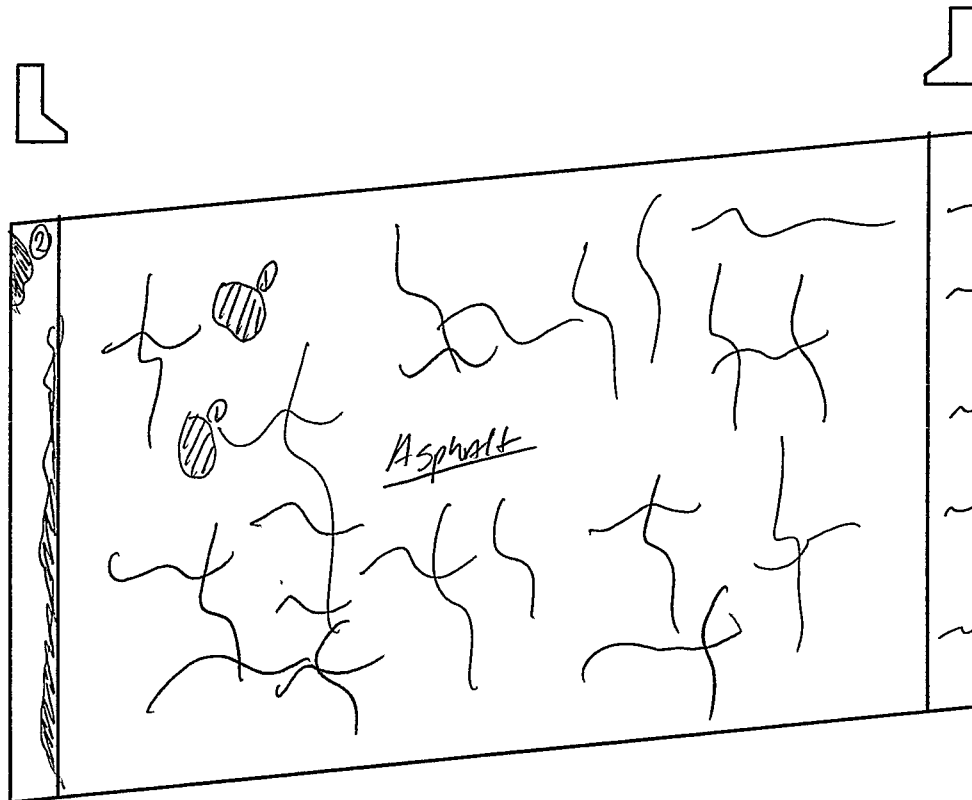
SPAN. NO. 3

ELEMENT	RATING	COMMENT
TOP DECK	G (F) P C	upto) 1/8" cracks
PARAPET	G (F) P C	pop-out spall, see (2) (2)
DRAINS	G F (P) C	100% full
JOINTS	G F (P) C	N/A : "
	G F P C

① Patch 1A/19  
 ② Damage Cap etc)  
 1.5' L x 8" H x 1" D  
 ③ Sealing upto)  
 length of span  
 x 2' H x 1/8" D

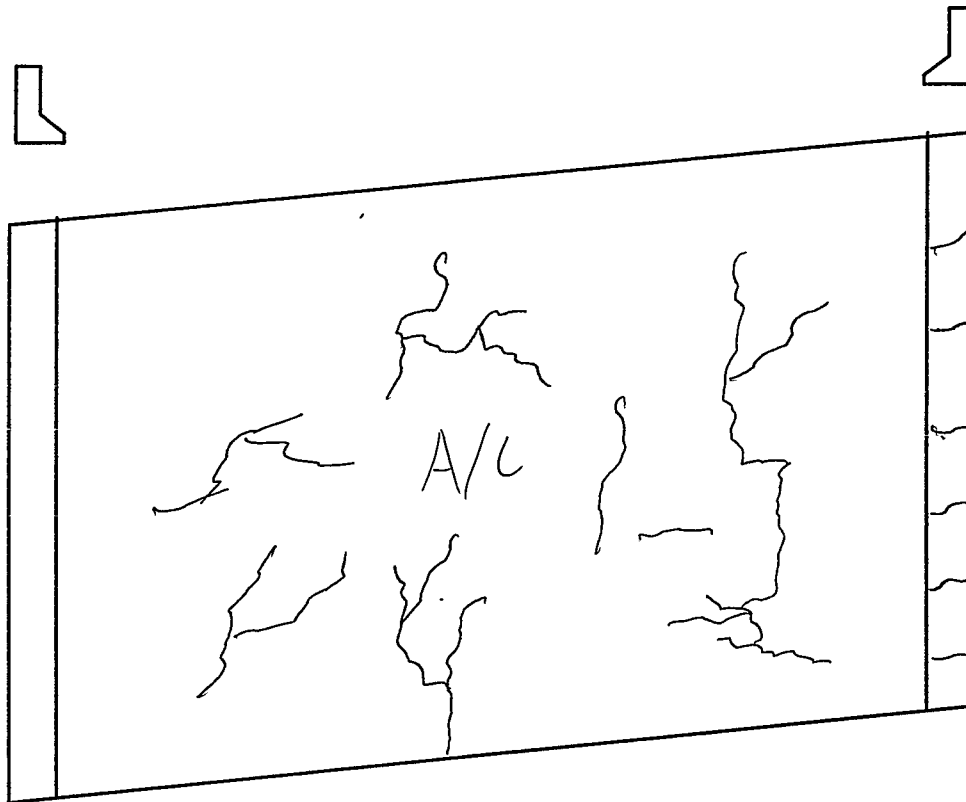
SPAN. NO. 7

ELEMENT	RATING	COMMENT
TOP DECK	G (F) P C	up to $\frac{1}{8}$ "
PARAPET	G (F) P C	$\frac{1}{8}$ " crack
DRAINS	G F P C	
JOINTS	G F P C	
	G F P C

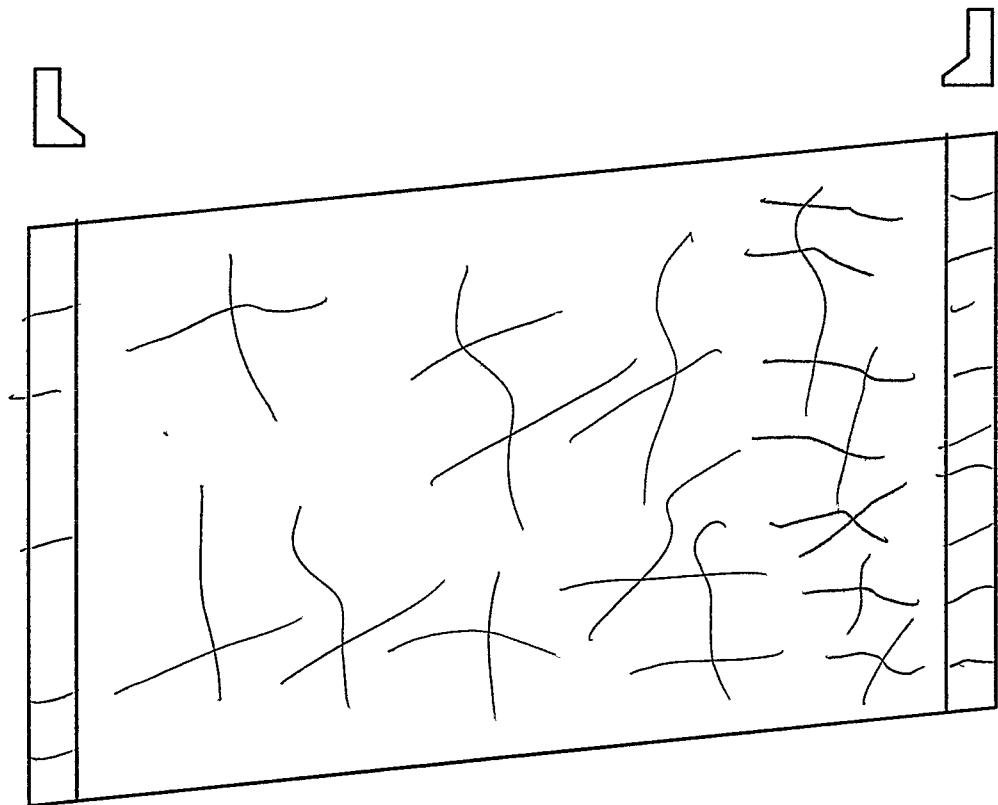
SPAN. NO. 9A

ELEMENT	RATING	COMMENT
TOP DECK	G (F) P C	upto 1/8" cracks
PARAPET	G (F) P C	upto 1/32" cracks
DRAINS	G F (P) C	100 % Filled
<del>JOINTS</del>	<del>G F P C</del>	
	G F P C

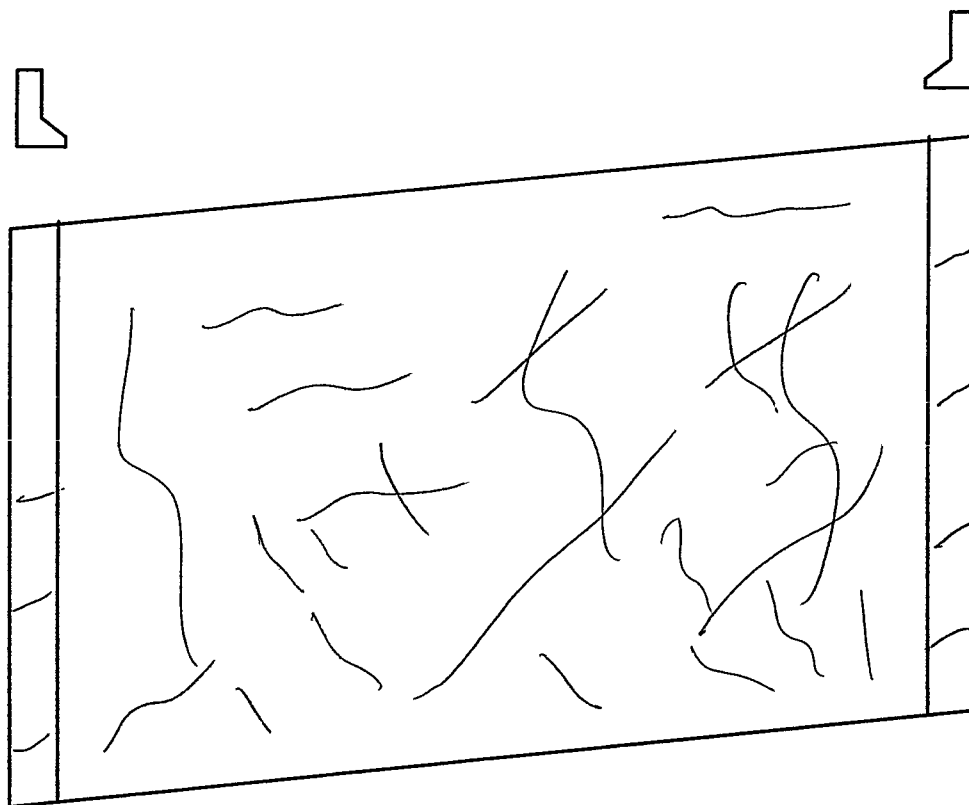
SPAN. NO. 98

ELEMENT	RATING	COMMENT
TOP DECK	G <del>F</del> P C	upto 1/8" cracking
PARAPET	G <del>F</del> P C	upto 1/32" cracking
DRAINS	G F <del>P</del> C	100 % Filled
JOINTS	<del>G F P C</del>	
	G F P C

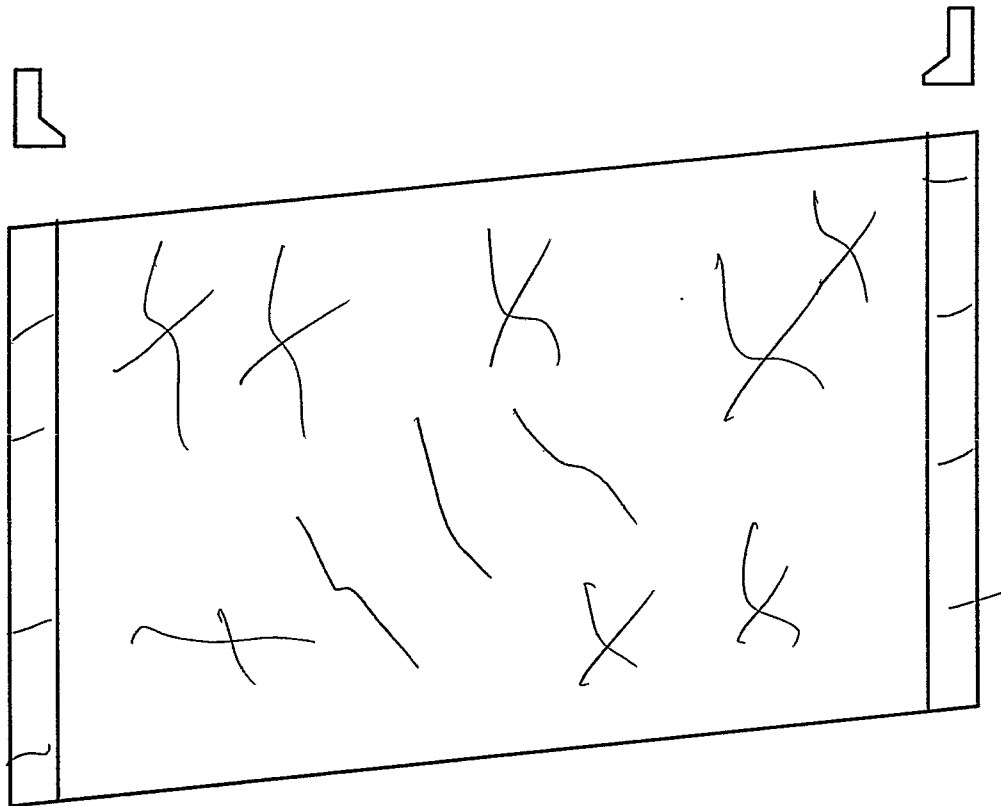
SPAN. NO. 10A

ELEMENT	RATING	COMMENT
TOP DECK	G <u>F</u> P C	up to 1/8" cracking
PARAPET	G <u>F</u> P C	up to 1/32" cracks
DRAINS	G F <u>P</u> C	100% Filled
JOINTS	<del>G F P C</del>	
	G F P C

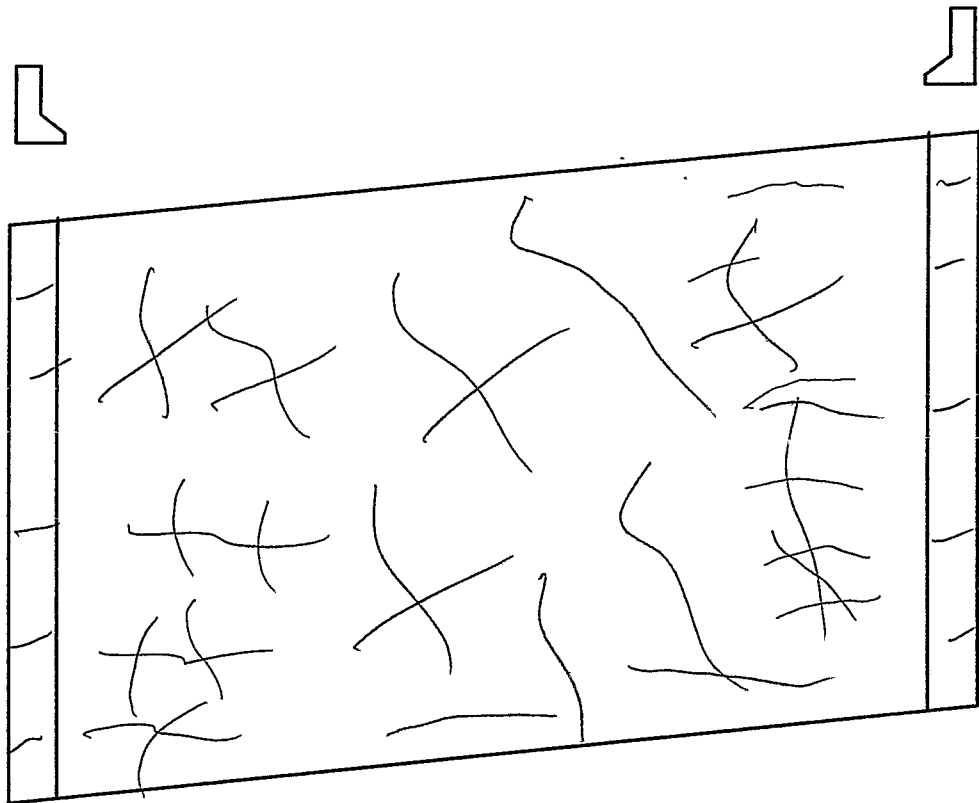
SPAN. NO. 103

ELEMENT	RATING	COMMENT
TOP DECK	G <u>F</u> P C	up to 1/8" cracks
PARAPET	G <u>F</u> P C	up to 1/16" cracks
DRAINS	G F <u>P</u> C	100 % Filled
<del>JOINTS</del>	<del>G F P C</del>	
	G F P C

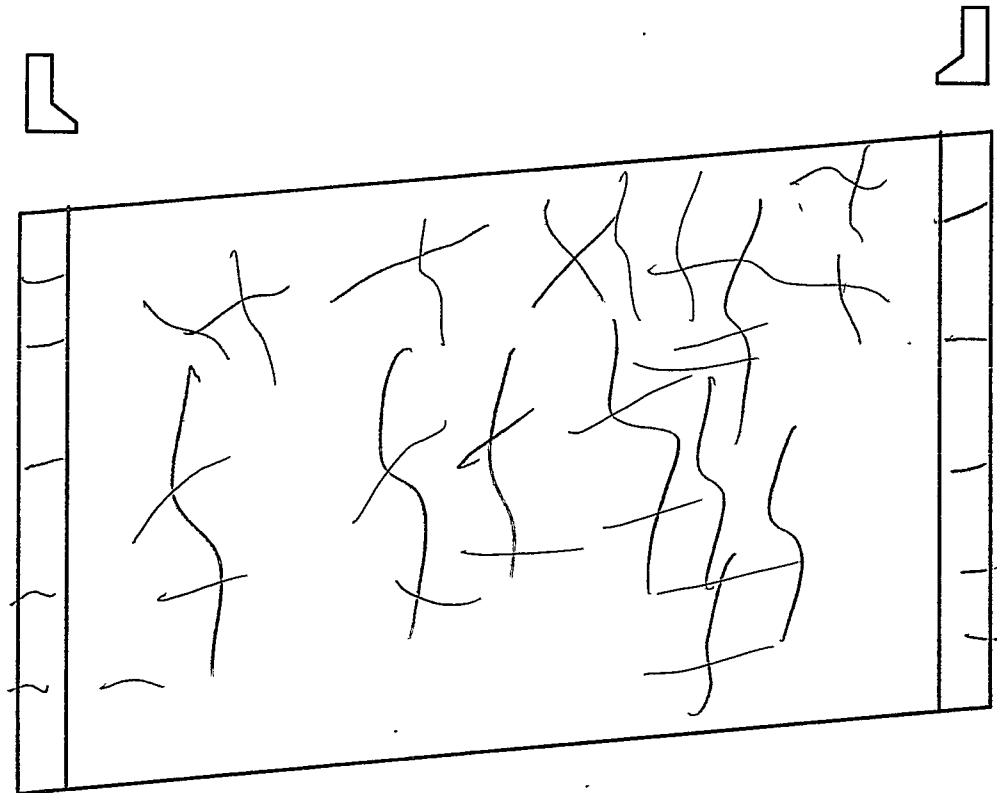
SPAN. NO. 11A

ELEMENT	RATING	COMMENT
TOP DECK	G (F) P C	Up to 1/8" cracks
PARAPET	G (F) P C	1/32" cracks
DRAINS	G F (P) C	100 % Filled
JOINTS	G F (P) C	Spalling around joint
	G F P C

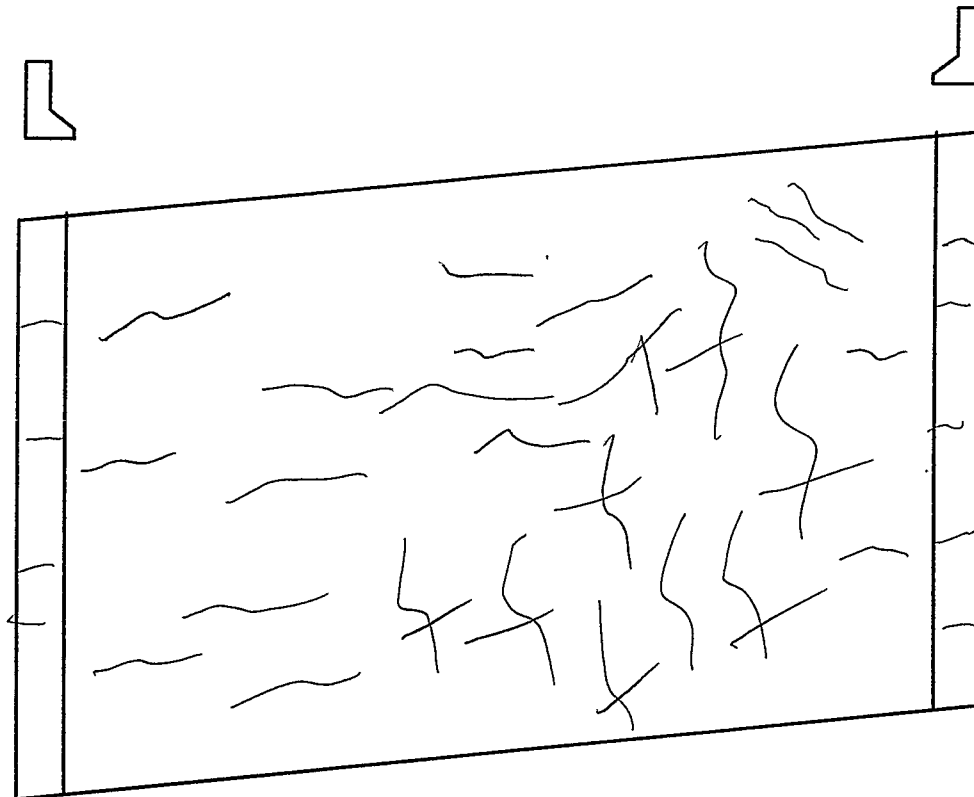
SPAN. NO. 11B

ELEMENT	RATING	COMMENT
TOP DECK	G (F) P C	up to 1/8" cracking
PARAPET	G (F) P C	up to 1/32" cracks
DRAINS	G F (P) C	100% Filled
JOINTS	G F (P) C	Filled with debris
	G F P C

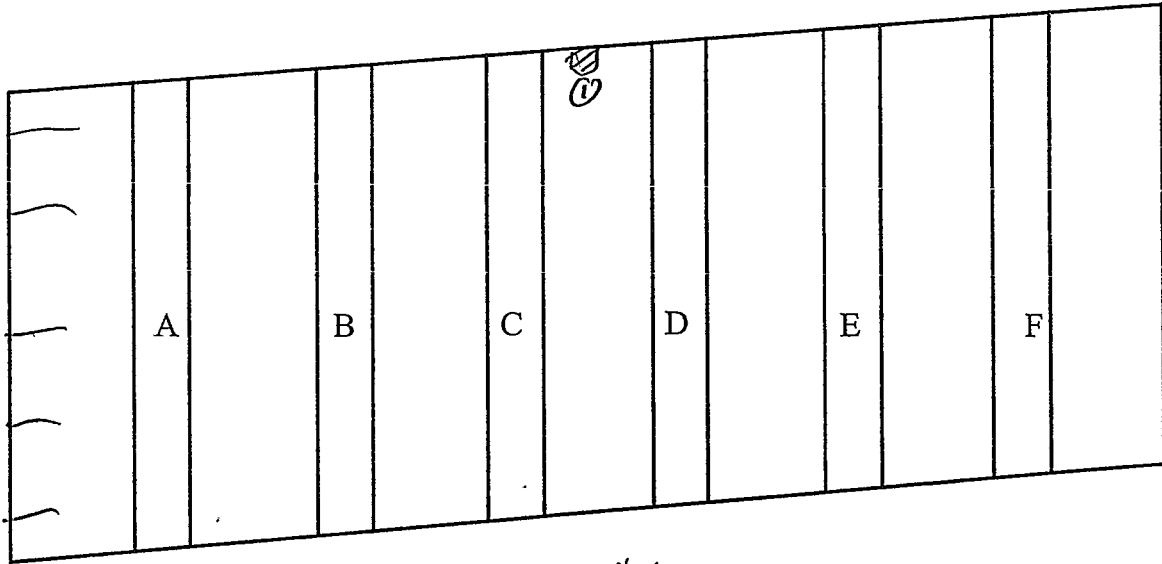
60° RT SPAN NO. 11-A

ELEMENT	RATING	COMMENT
BOTTOM DECK	G <u>F</u> P C	
IBeam A - F	<u>G</u> F P C G F P C G F P C	
BACKWALLS	<u>G</u> F P C	hairline cracks
DIA.	<u>G</u> F P C
