Region 04, 79 - Shelby County

I-40 Crossing I-40 W.B. / WOLF RIVER

90 - LAST INSPECTION DATE 10/02/2024

IDENTIFICATION	
(1) State Names	47 - Tennessee
(8) Structure Number	79I00400060
(5) Inventory Route	1
(2) Highway Agency District	Region 4
(3) County Code	79 - Shelby

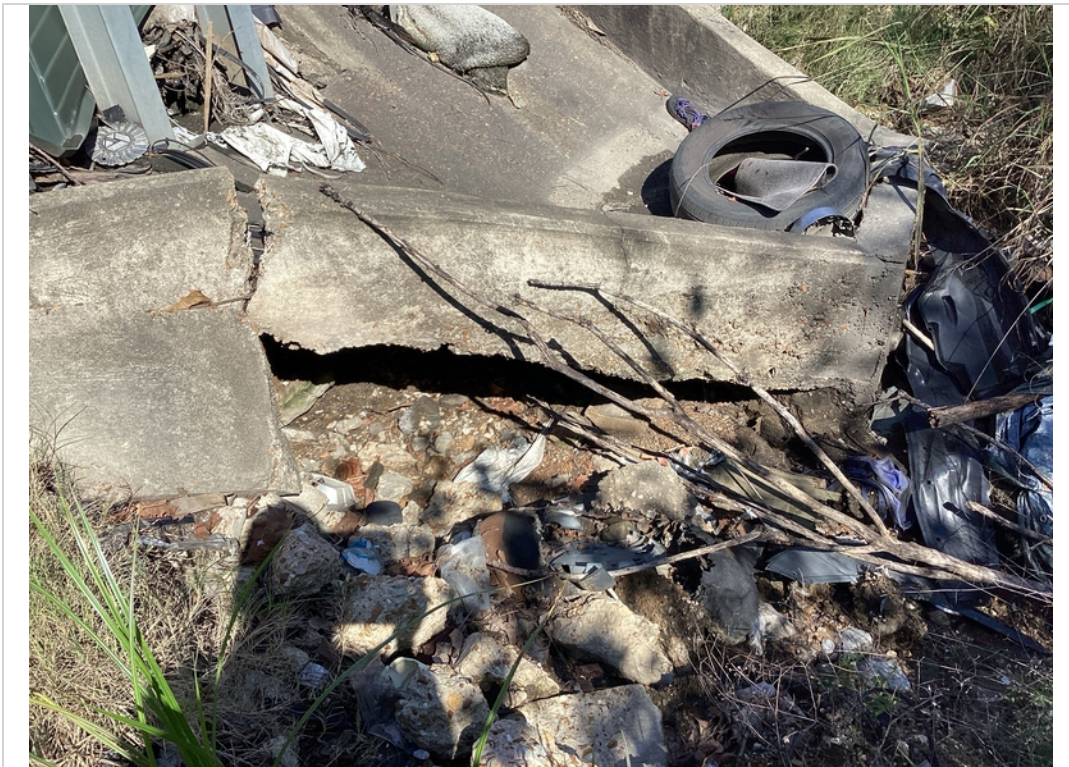
Approach 2 right side embankment

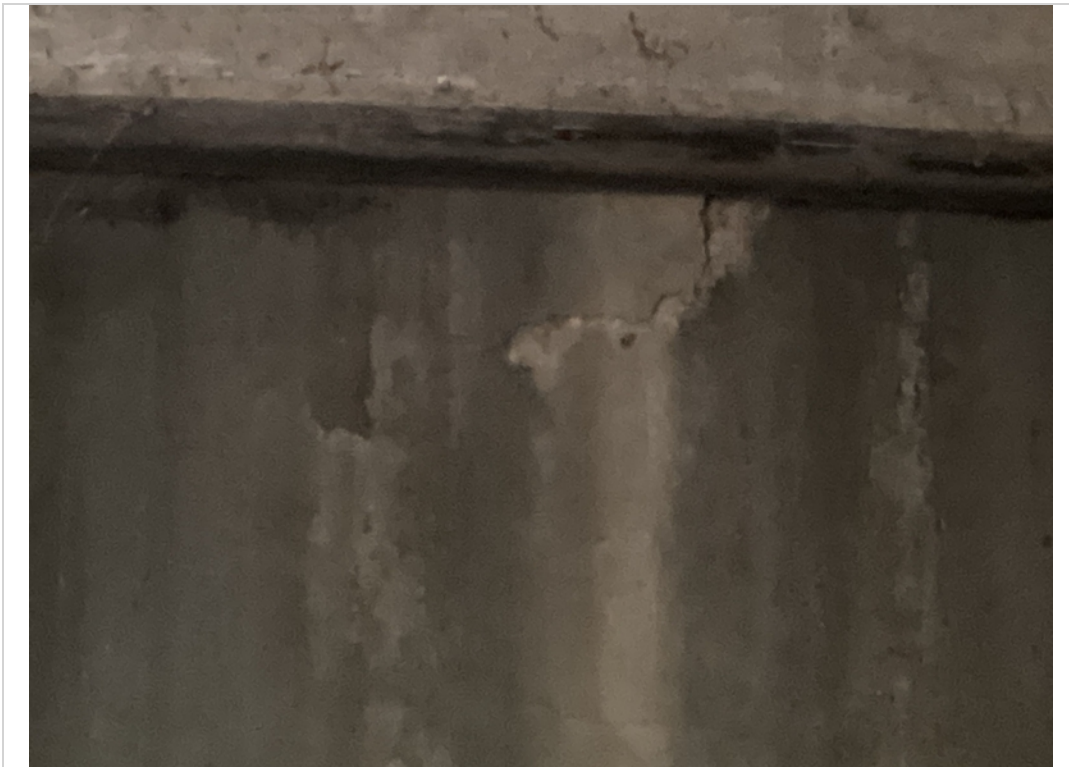
Abutment 2 backwall spall

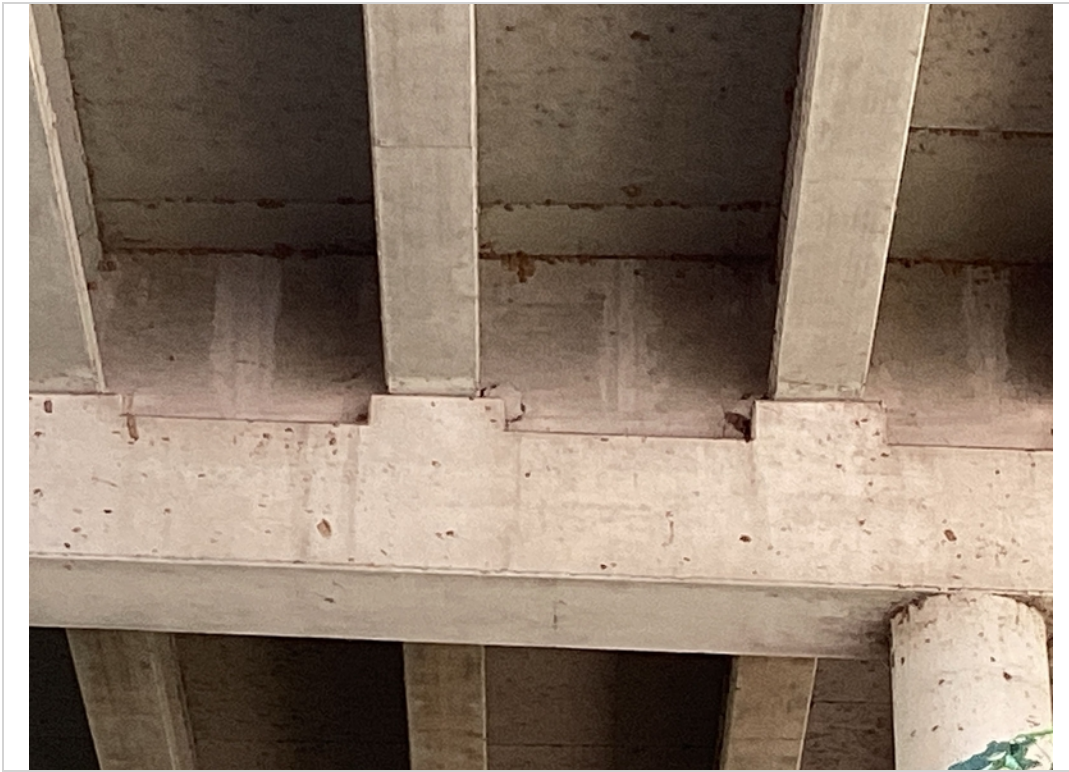
Span 7 diaphragm spall

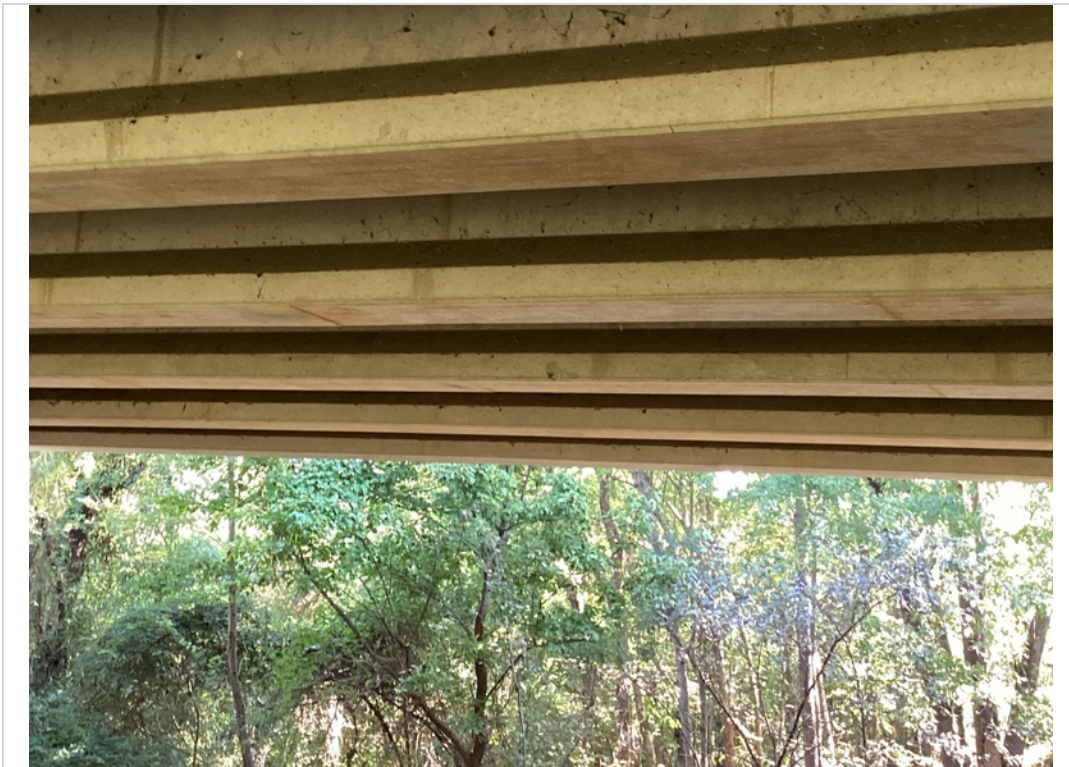
Span 1, beam G , spalling

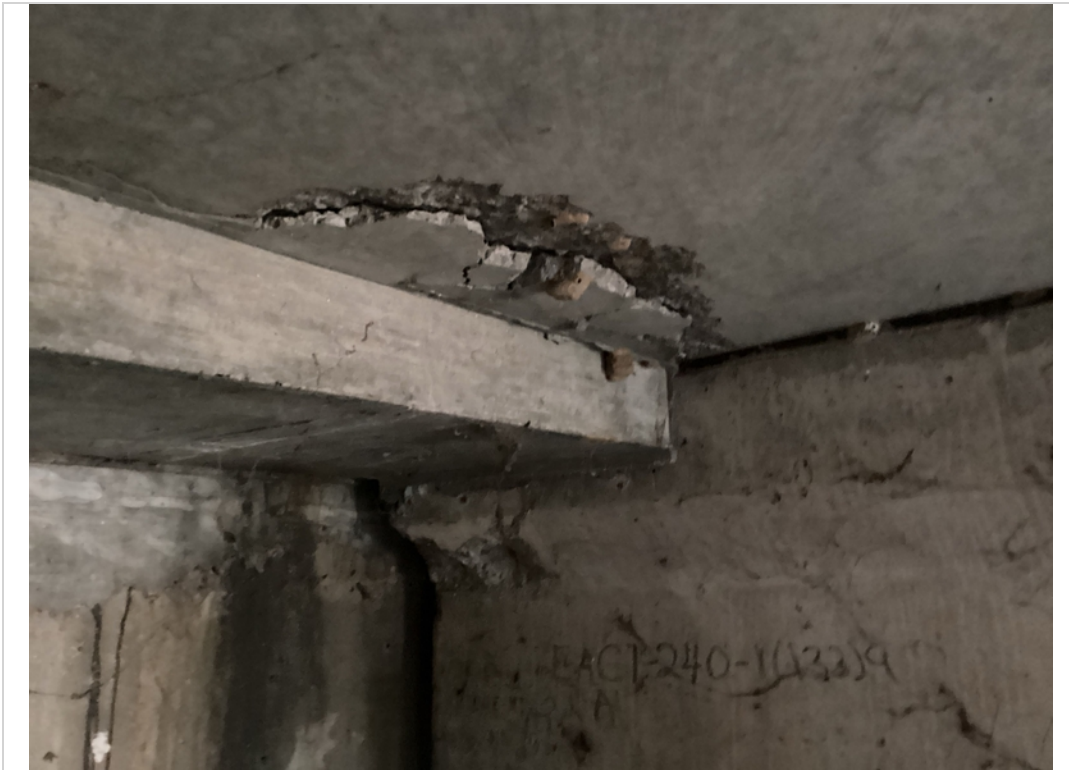
Span 1 , beam H, spall to steel ,bottom deck , impending spall

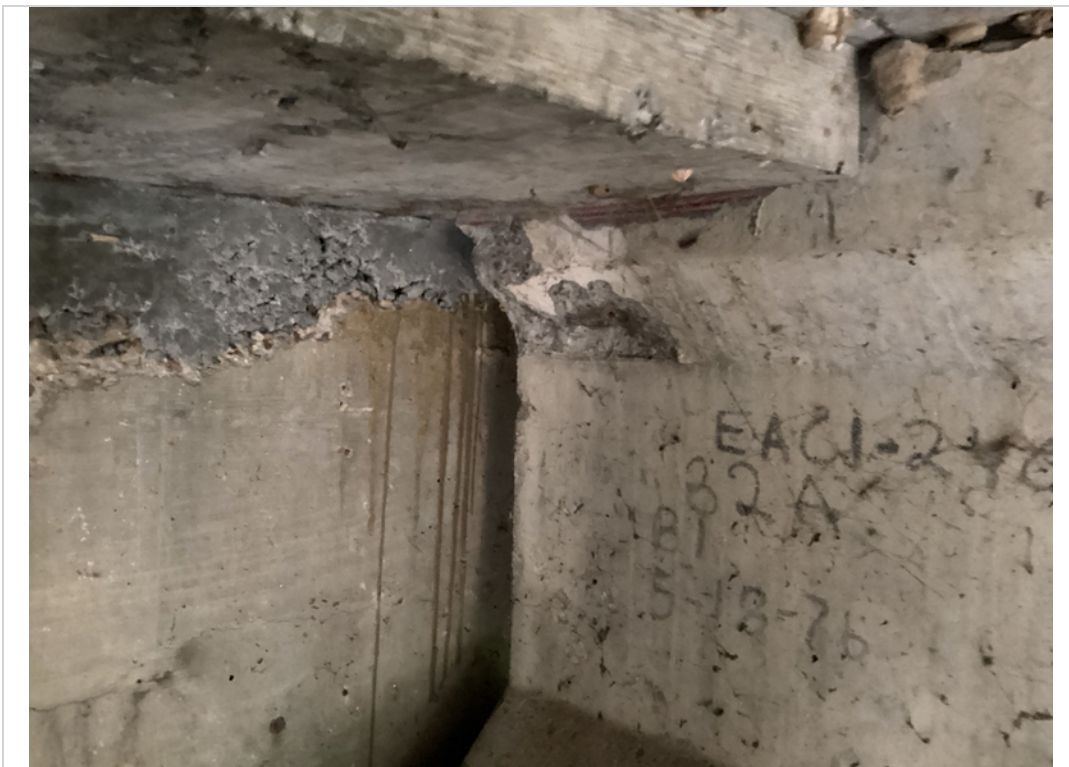
Span 1, beam I, spalling

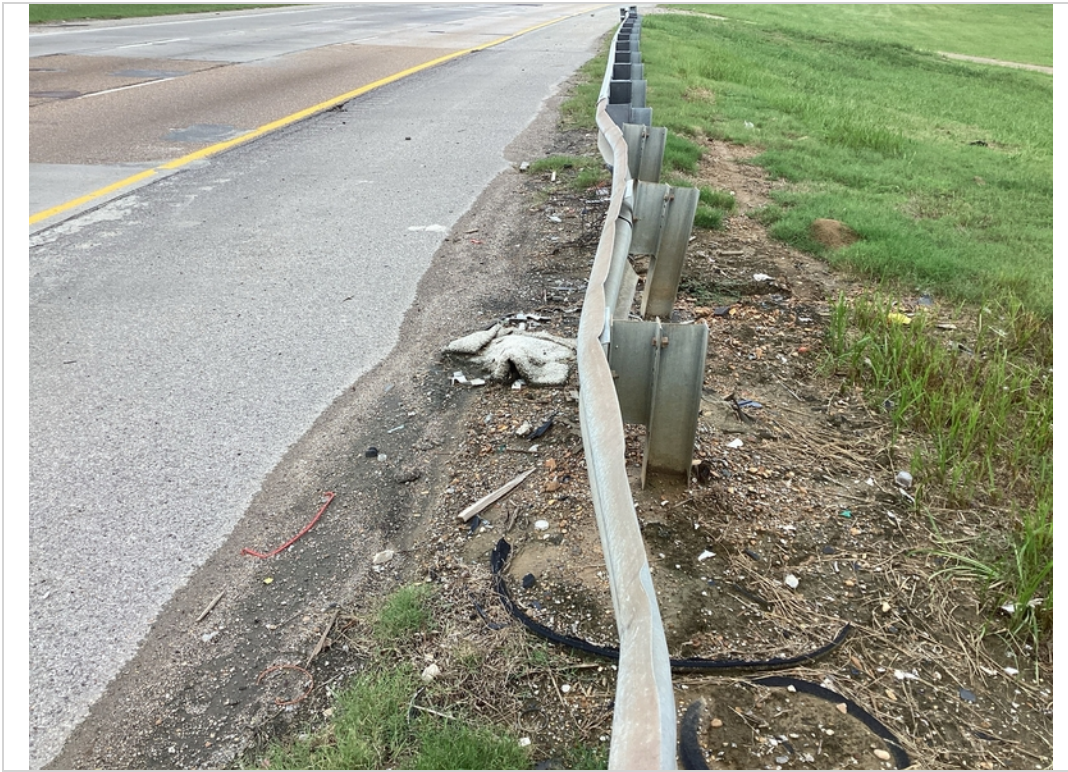
Approach 2 right has damage

Approach 2 right guardrail damage

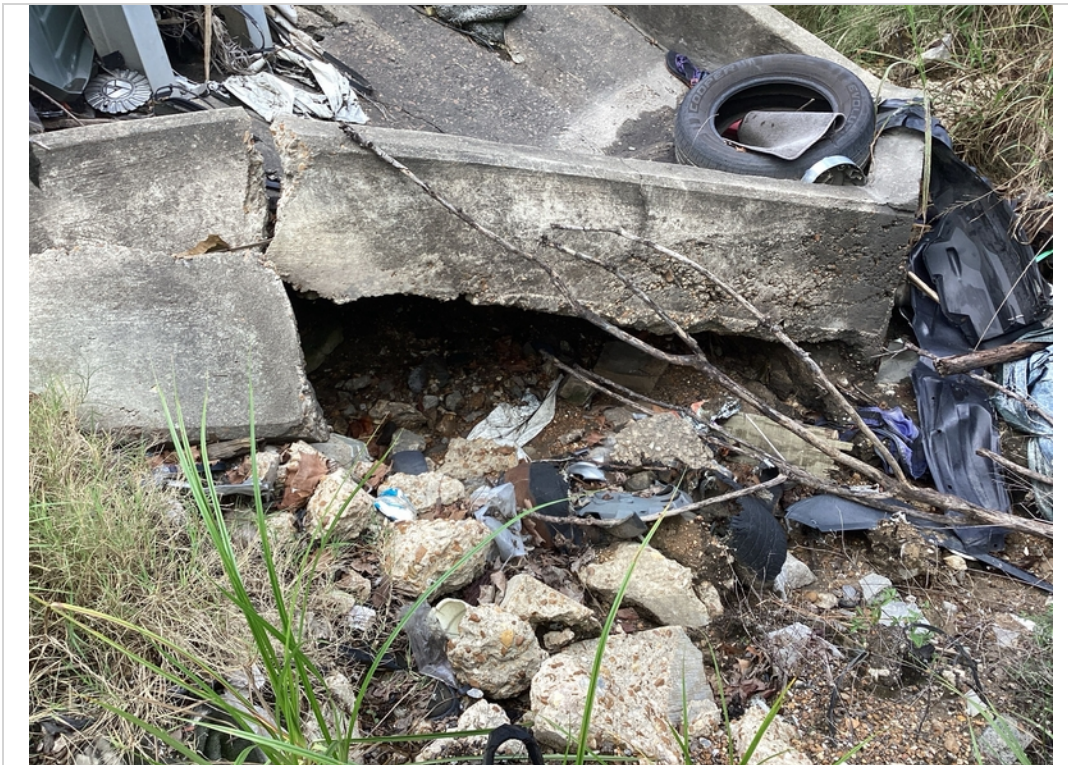
Washing at approach 2 right

Approach 2 right embankment washing

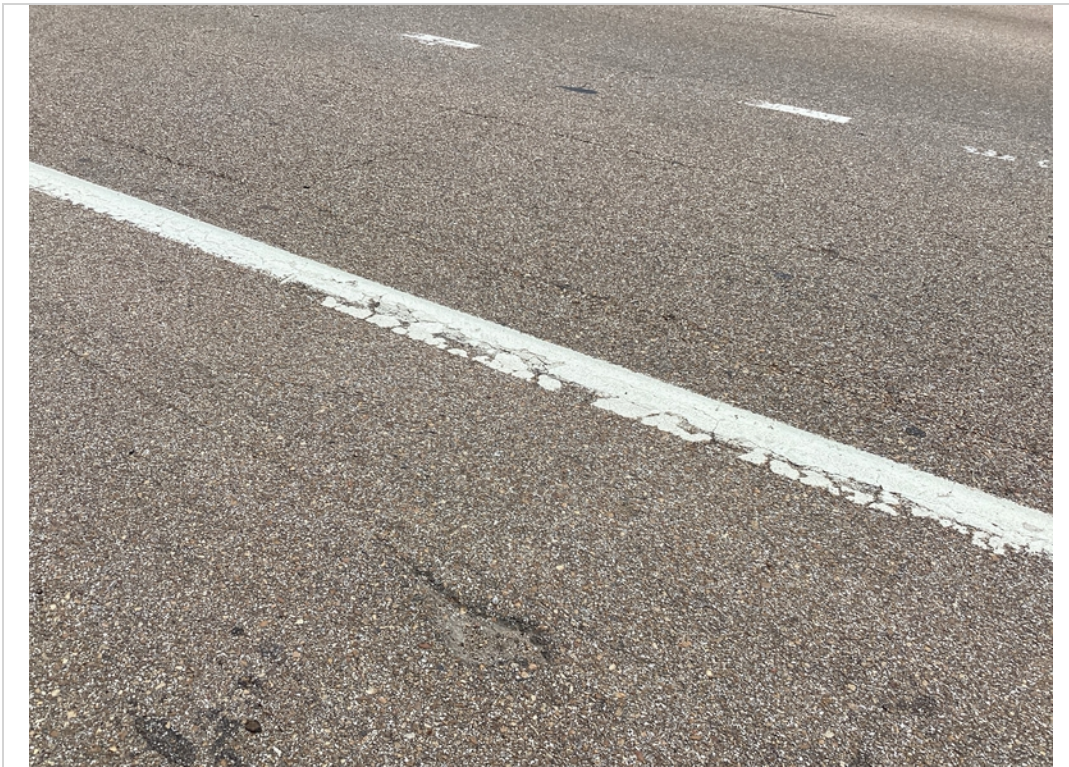
Span 1 damage & cracks

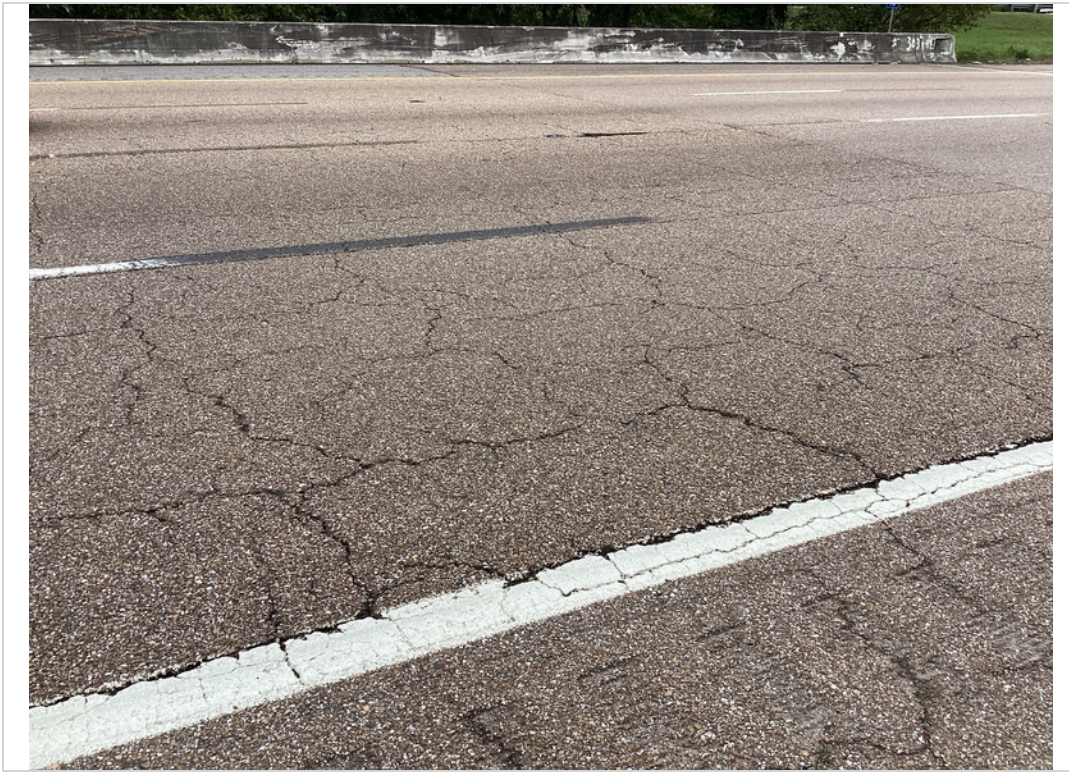
Span 1 cracks & pot holes

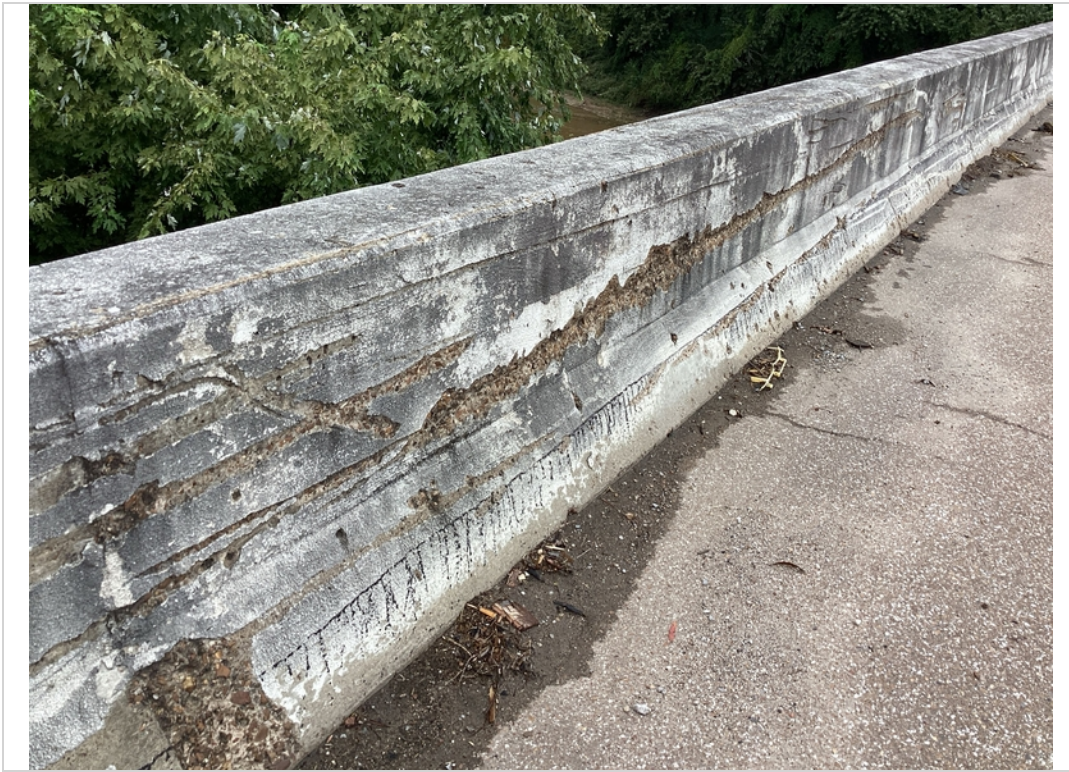
Span 3 parapet , collision damage

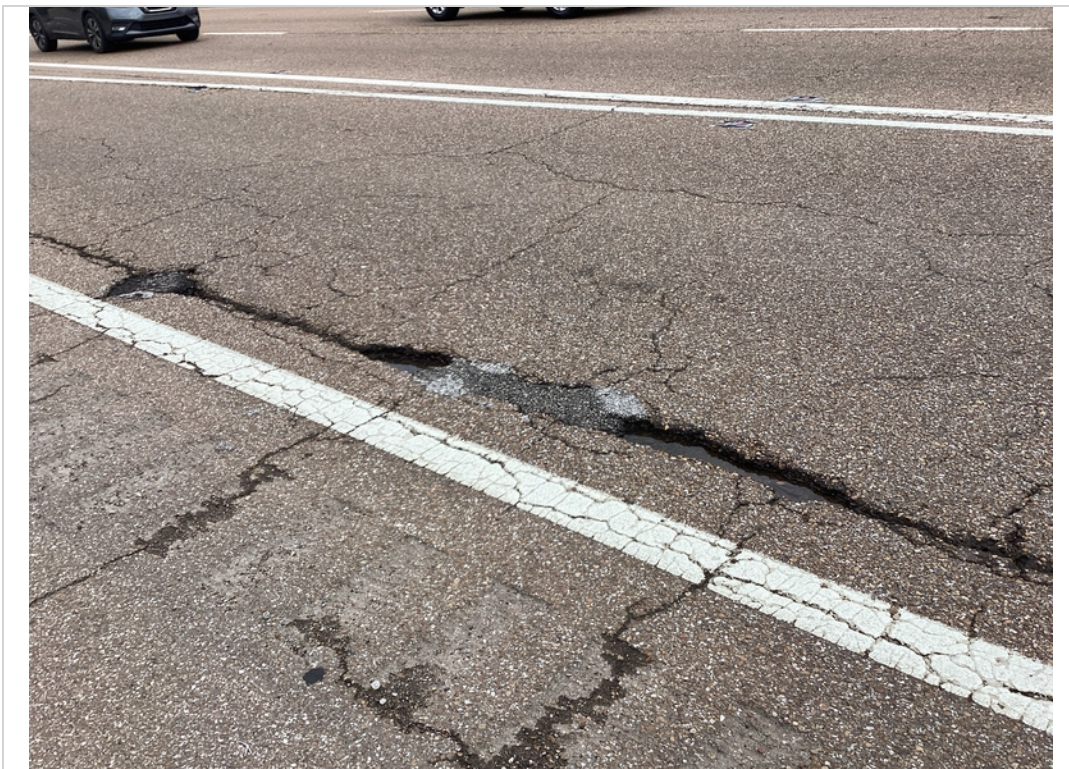
Span 7 top deck spalling/pothole

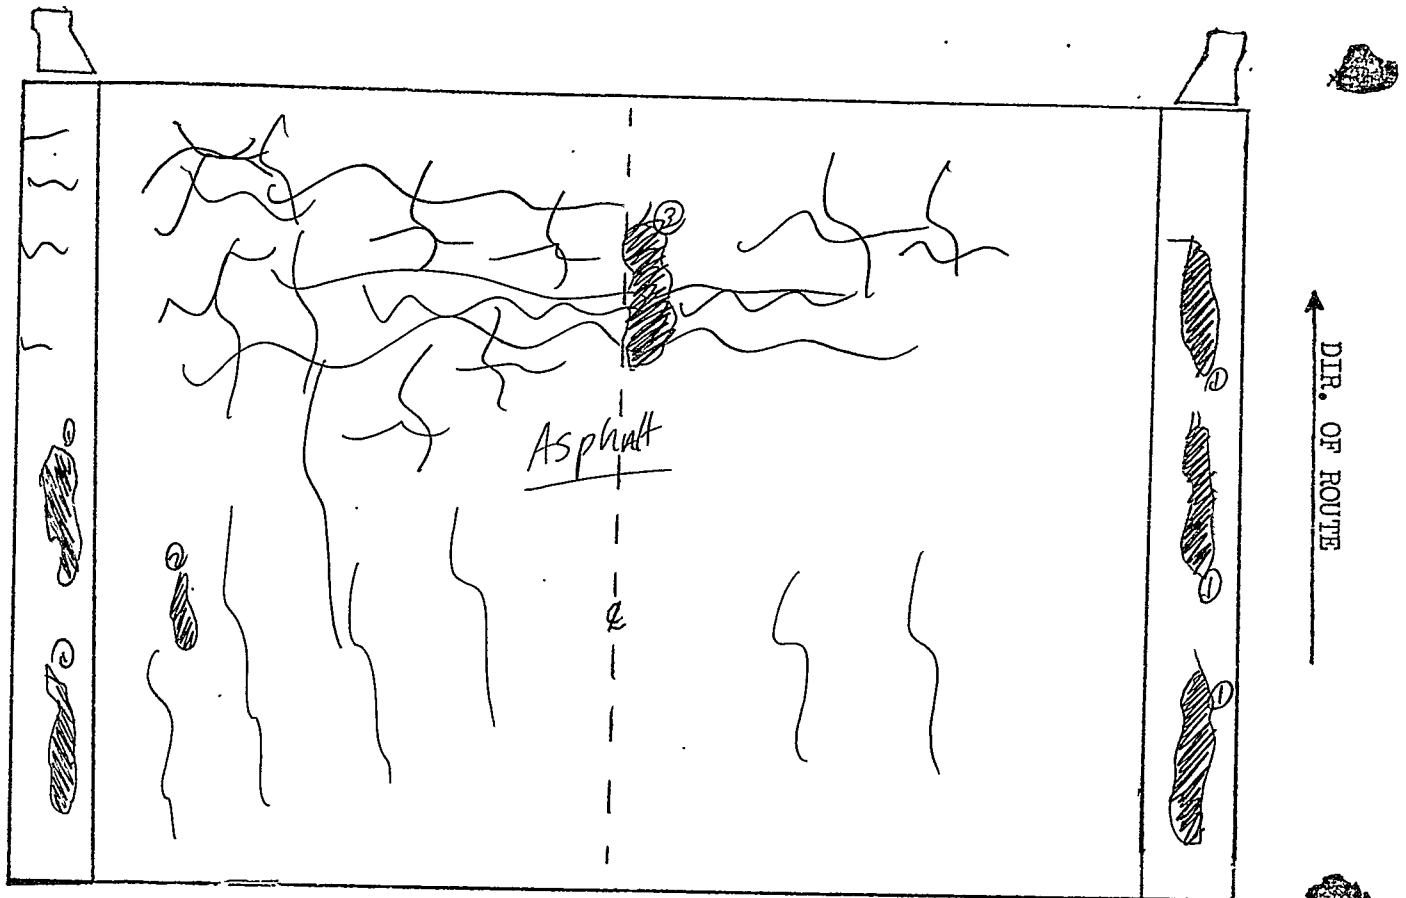
BR. NO. 79 I-40 5.01 LT.SPAN NO. 1

ELEMENT	RATING	COMMENT
TOP DECK	G <u>F</u> P C	up to 1/8" cracks, See ② ③
PARAPET	G <u>F</u> P C	pop-out spall, See ①
RAILS & POST	G F P C	N/A
DRAINS	G F P C	N/A
EXP. JOINTS	G F <u>P</u> C	Full of debris
	G F P C

① Collision Damage
(up to)

2' L x 1' H x 1/8" D

② Damage (up to)

1' L x 5" W x 1/2" D

③ Pot hole (up to)

1.5' L x 8" W x 1" D

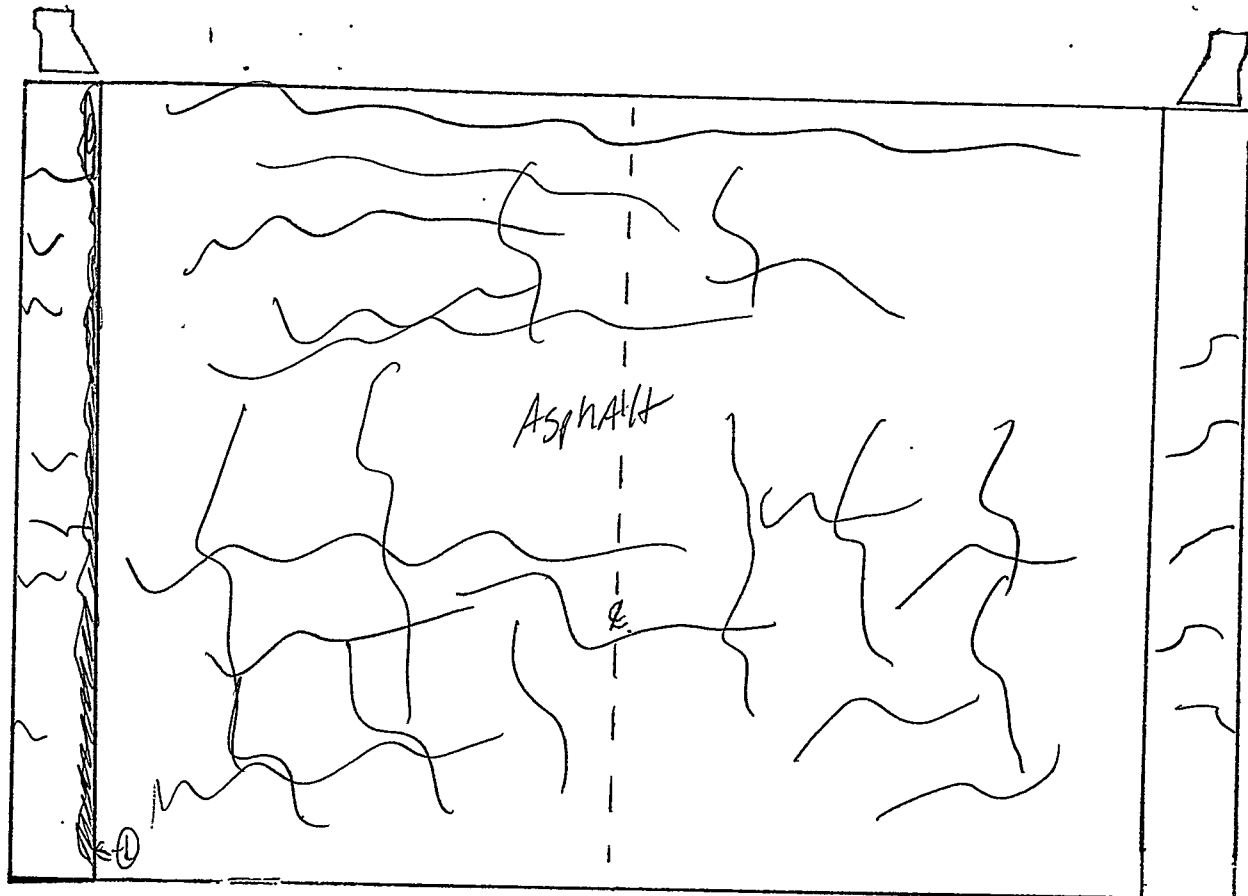
BR. NO. 79 T-40 5.01 LT.SPAN NO. 2

ELEMENT	RATING	COMMENT
TOP DECK	G <u>F</u> P C	1/8" cracks
PARAPET	G <u>F</u> P C	pop out spall, ①
RAILS & POST	G F P C	
DRAINS	G F <u>P</u> C	100% full of debris
EXP. JOINTS	G F P C	
	G F P C

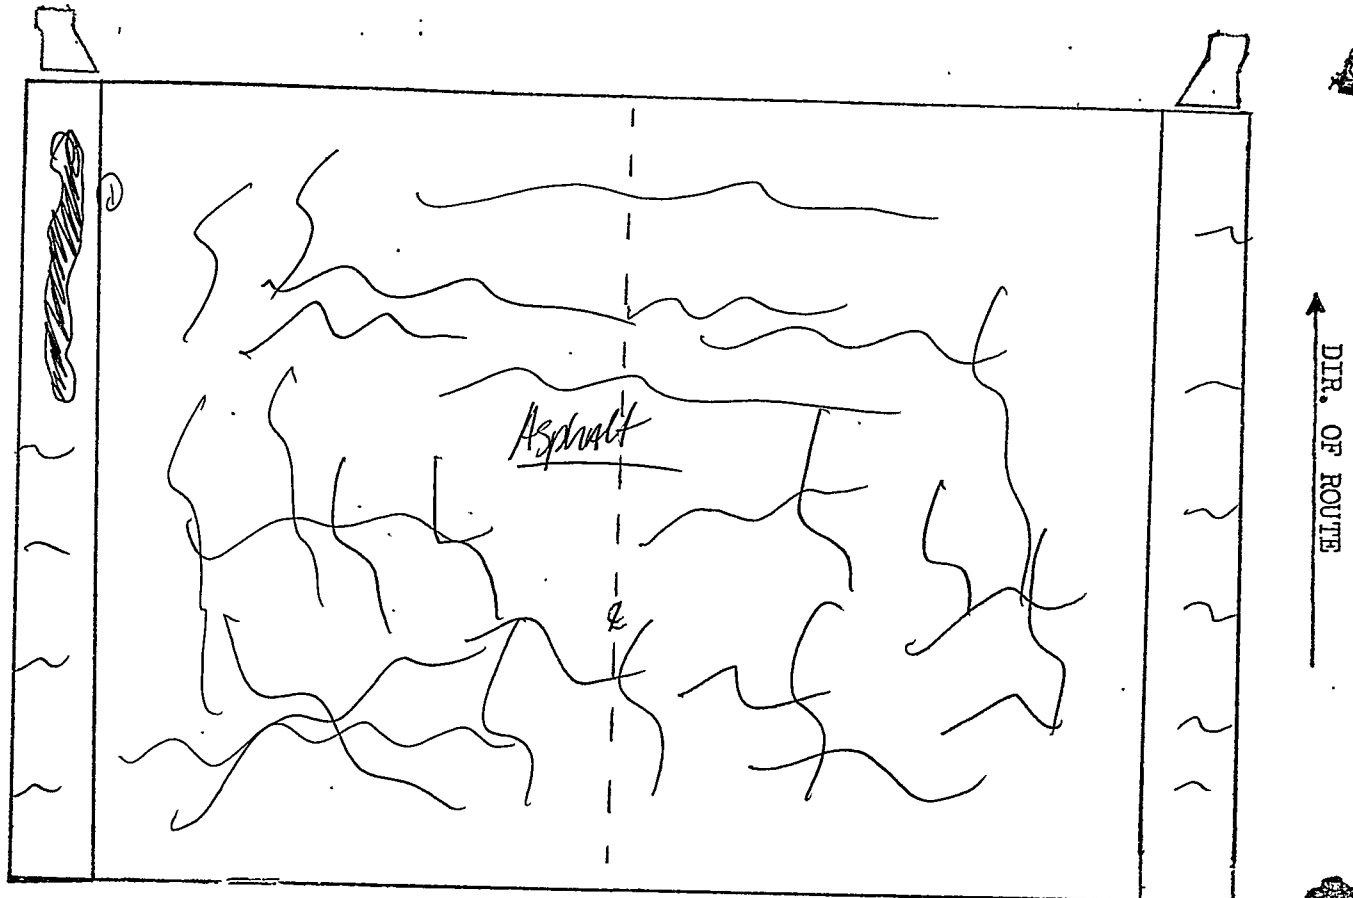
SPAN NO. 3

ELEMENT	RATING	COMMENT
TOP DECK	G <u>F</u> P C	up to 1/8" cracks
PARAPET	G <u>F</u> P C	pop-out spall, See ①
RAILS & POST	G F P C	
DRAINS	G F <u>P</u> C	100% full of debris
EXP. JOINTS	G F P C	
	G F P C

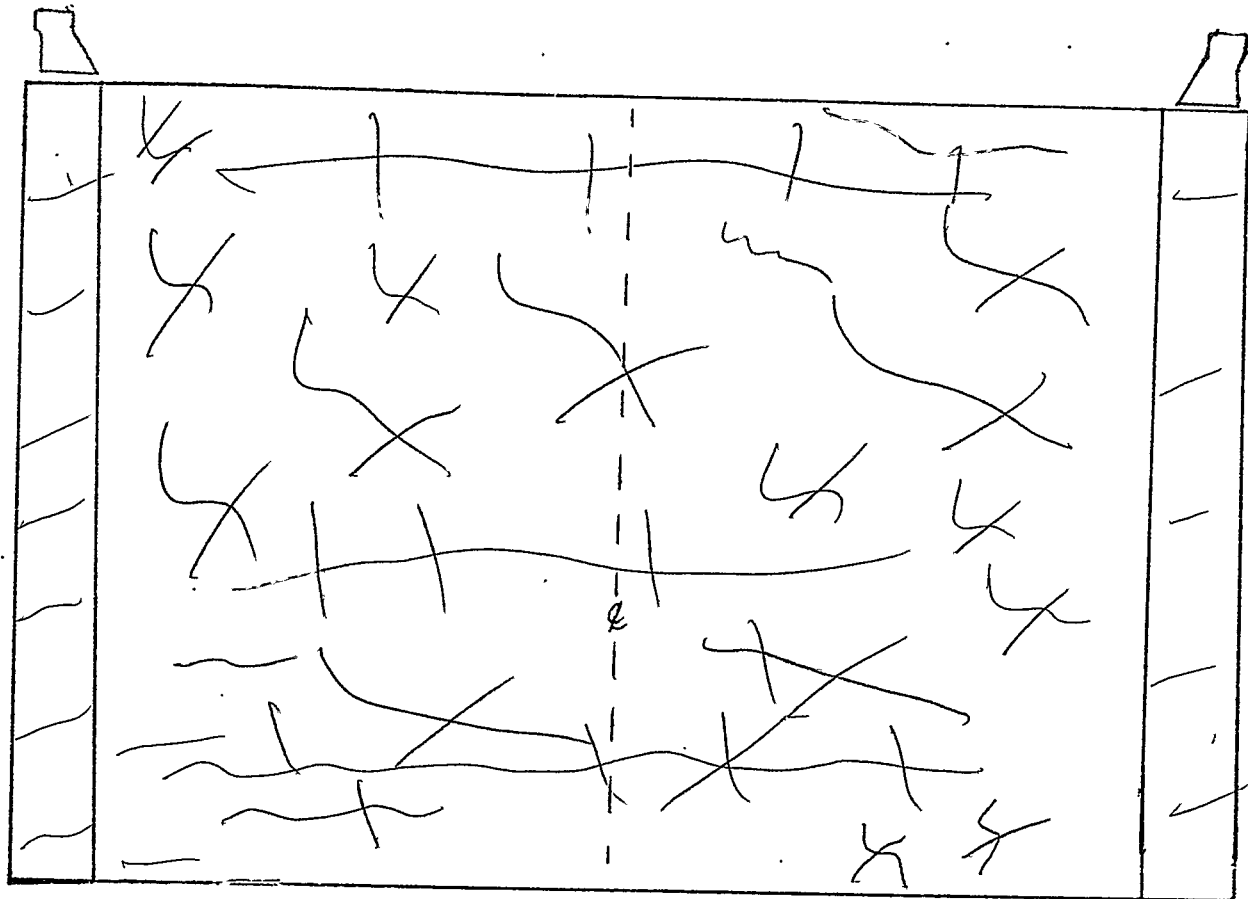
BR. NO. 79 I-40 5.01 LT.SPAN NO. 4

ELEMENT	RATING	COMMENT
TOP DECK	G F P C	up to 1/8" cracking
PARAPET	G F P C	up to 1/32" cracking
RAILS & POST	G F P C	
DRAINS	G F P C	100% Filled
EXP. JOINTS	G F P C	
	G F P C

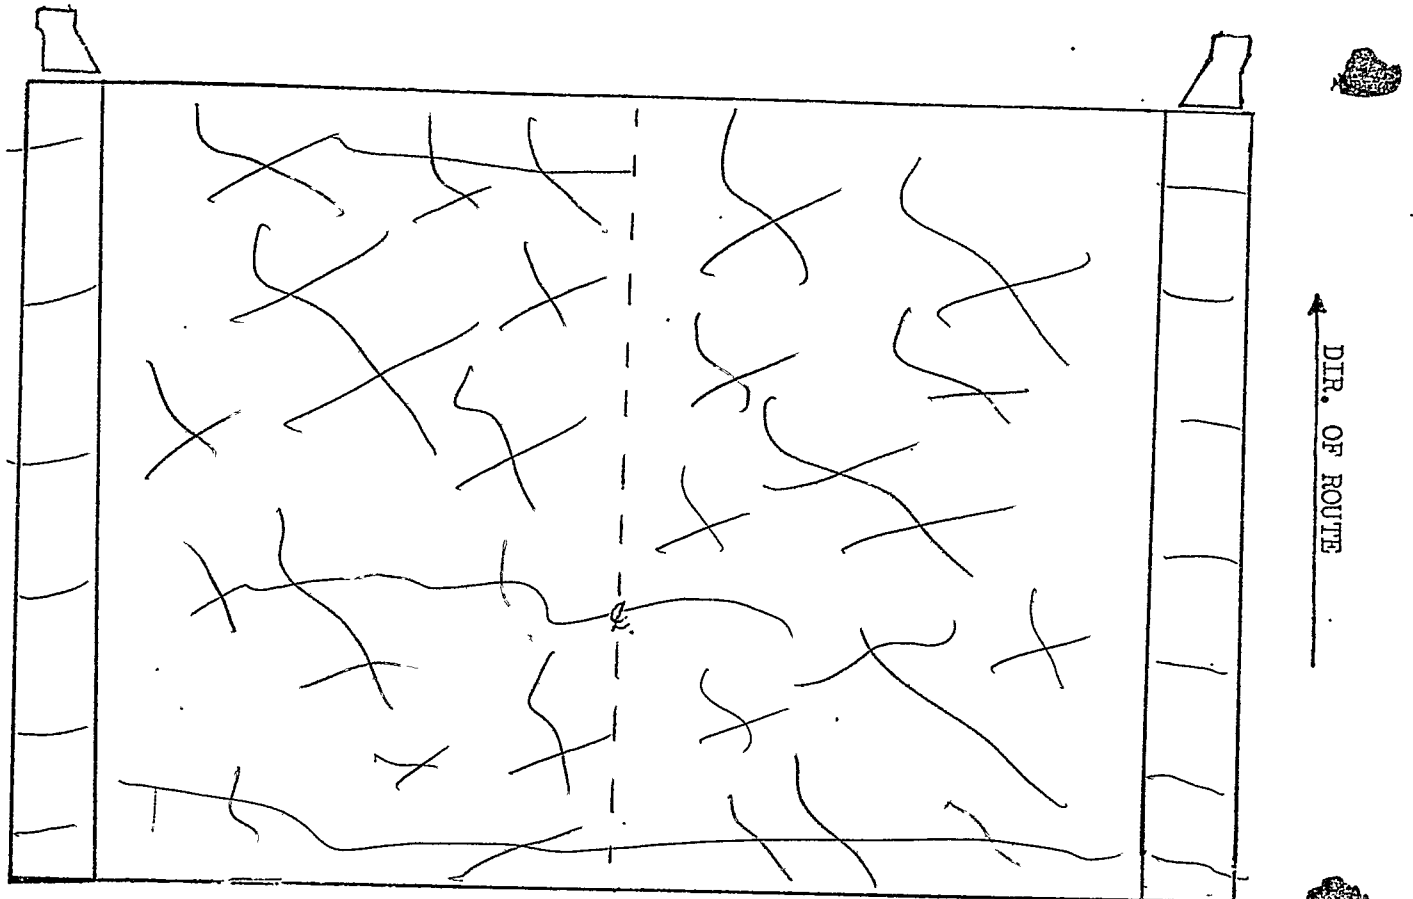
BR. NO. 79 T-40 S.01SPAN NO. 5

ELEMENT	RATING	COMMENT
TOP DECK	G F P C	up to 1/8" cracking
PARAPET	G F P C	up to 1/32" cracks
RAILS & POST	G F P C	
DRAINS	G F P C	100% Filled
EXP. JOINTS	G F P C	
	G F P C

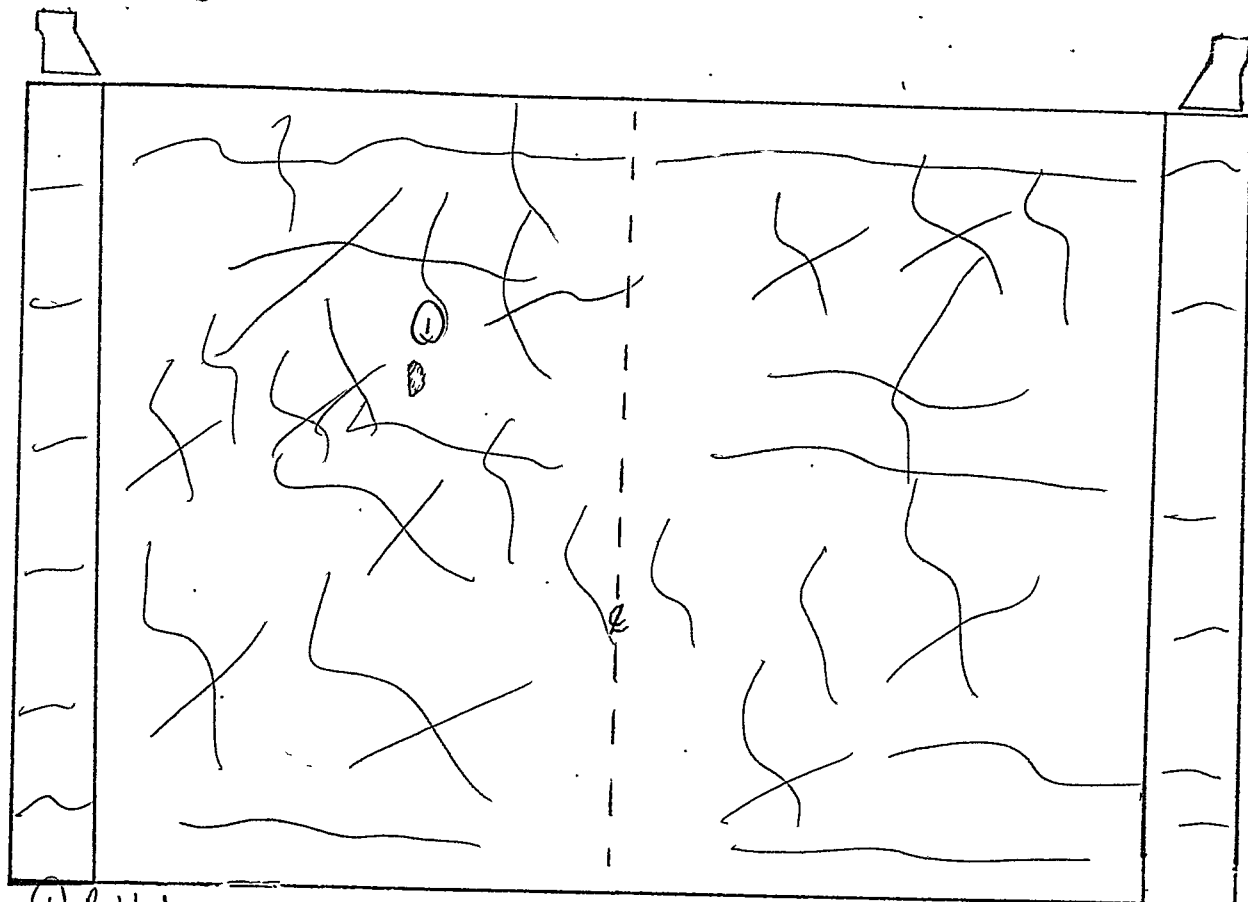
BR. NO. 79 I-40 501SPAN NO. 06

① Pothole
1' L X 1.5' D

ELEMENT	RATING	COMMENT
TOP DECK	G F P C	see ① + upto 1/8" cracking
PARAPET	G F P C	upto 1/32" cracks,
RAILS & POST	G F P C	
DRAINS	G F P C	100 % Filled
EXP. JOINTS	G F P C	
	G F P C

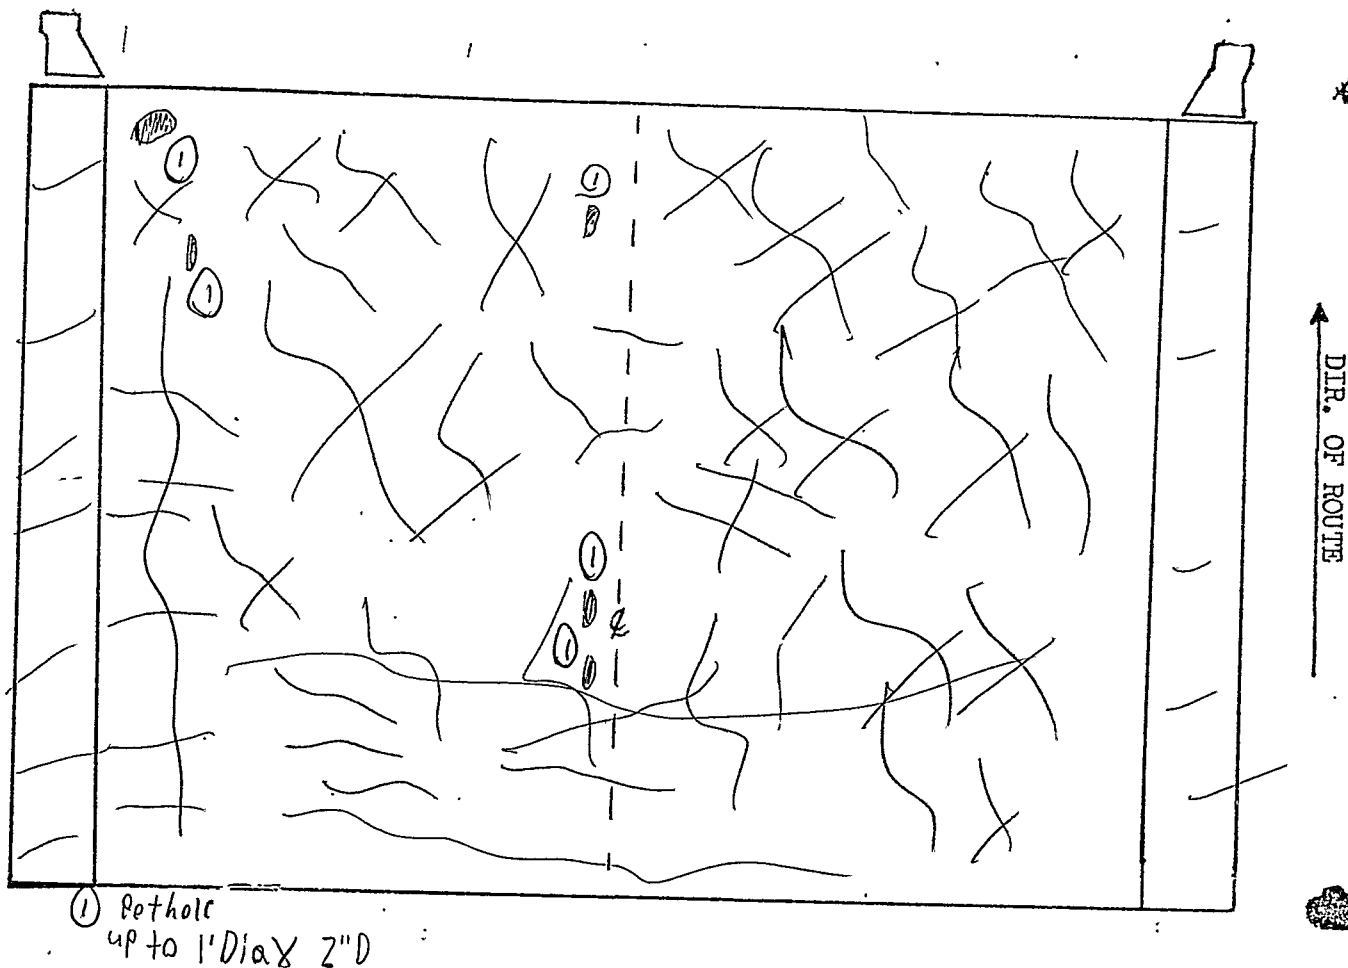
BR. NO. 79 I-40 5.01SPAN NO. 7

ELEMENT	RATING	COMMENT
TOP DECK	G F <u>P</u> C	see 1 up to 1/4" cracks
PARAPET	G <u>F</u> P C	up to 1/32" cracks
RAILS & POST	G F P C	
DRAINS	G F P C	100% full
EXP. JOINTS	G F P C	
	G F P C

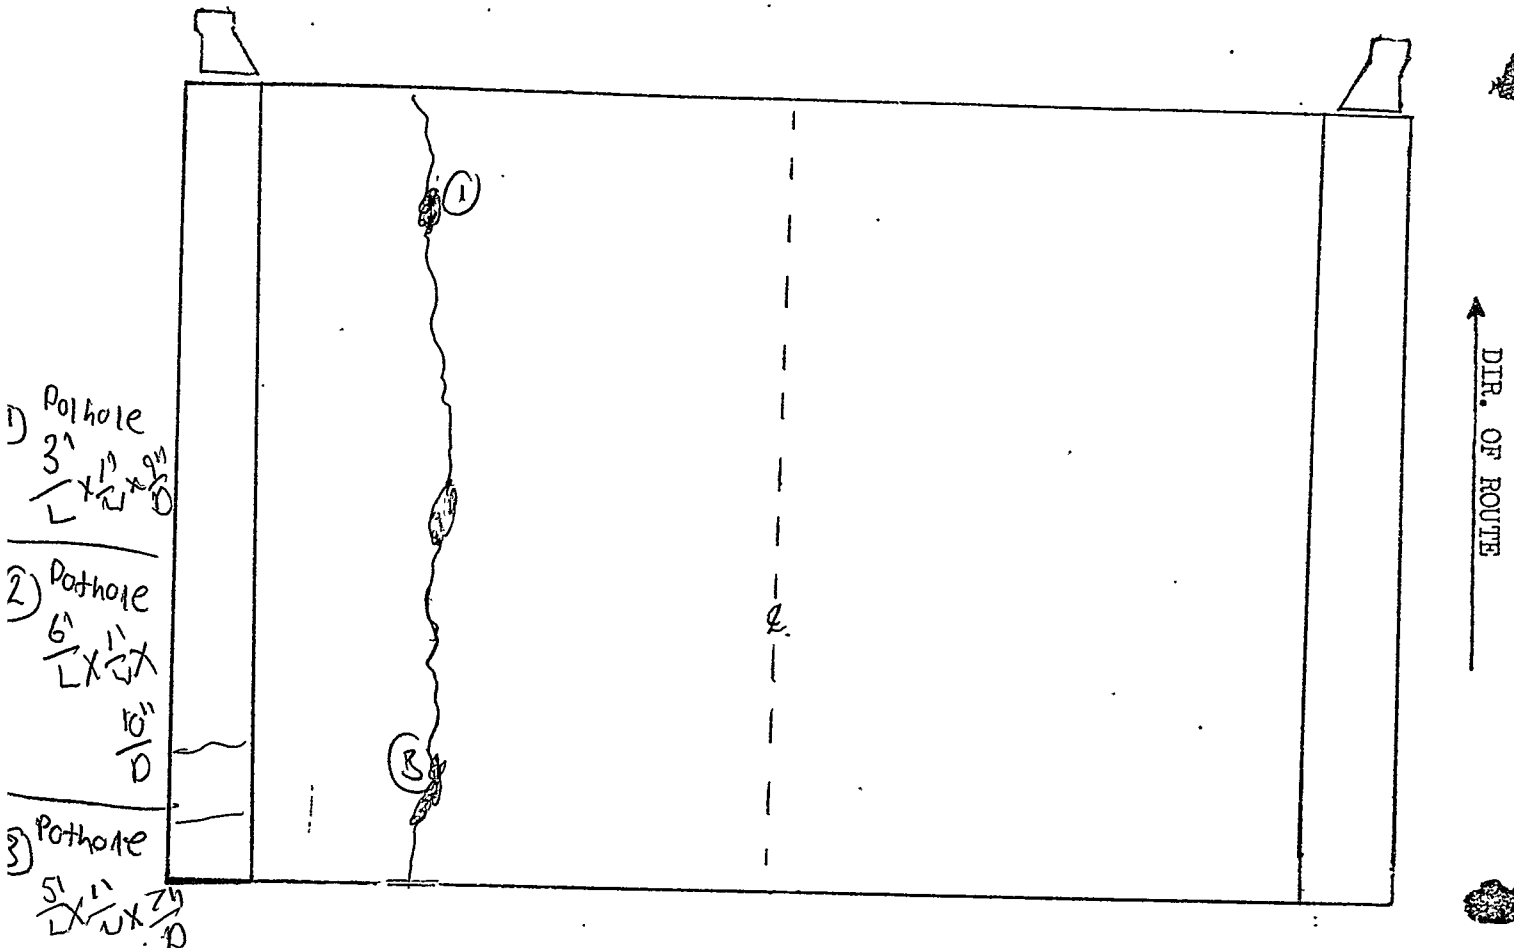
BR. NO. 79. I-40 5.01SPAN NO. 8

ELEMENT	RATING	COMMENT
TOP DECK	G F <u>P</u> C	See ①, ②, ③ 1" cracks
PARAPET	<u>G</u> F P C	hL
RAILS & POSTS	G F P C	
DRAINS	G F P C	
EXP. JOINTS	G F P C	
	G F P C

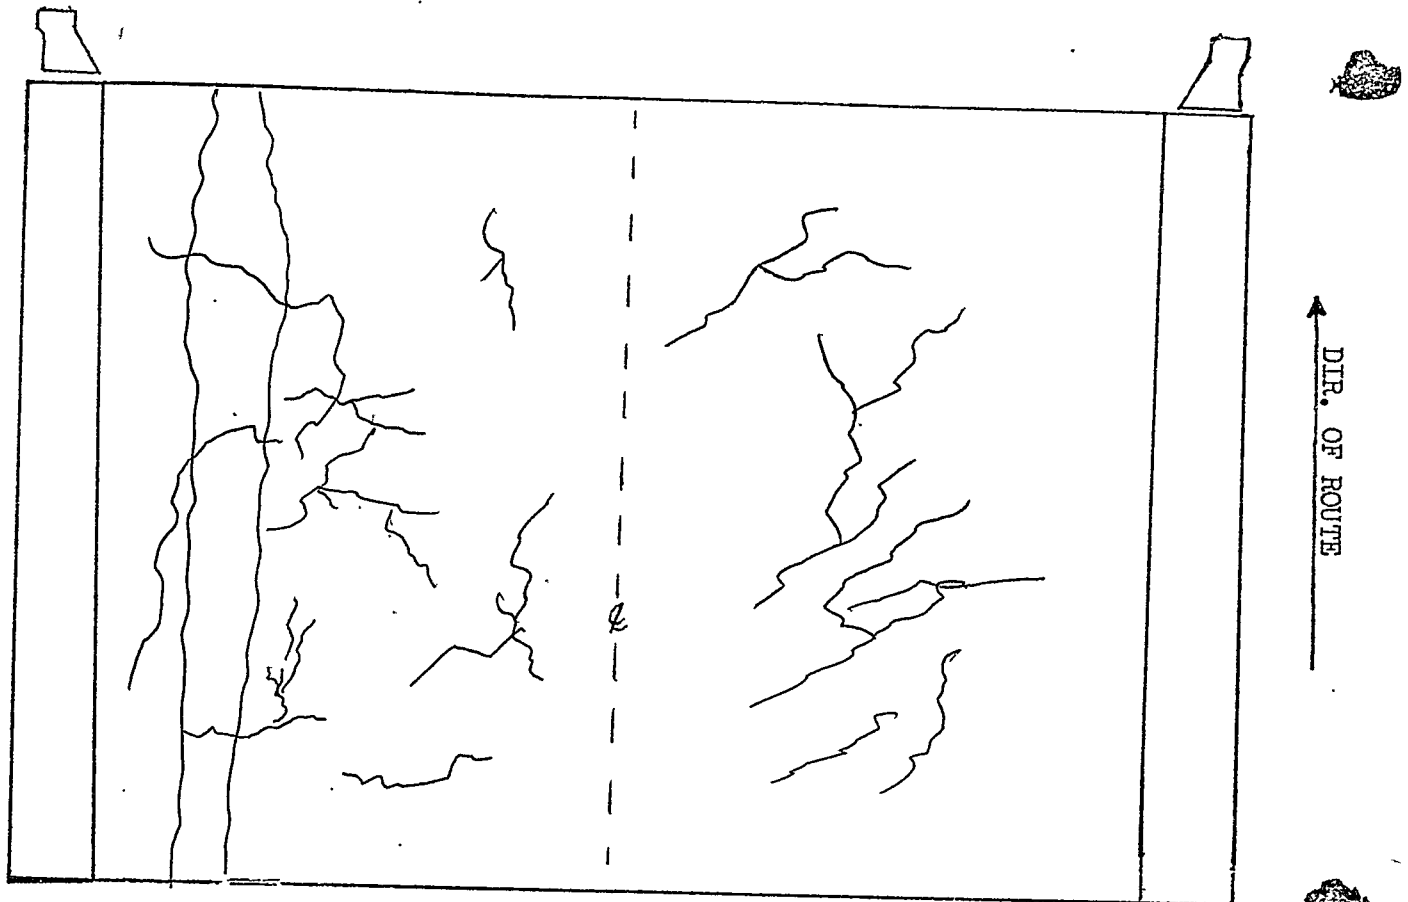
SPAN NO. 9

ELEMENT	RATING	COMMENT
TOP DECK	G F P C	$\frac{1}{2}$ " crack
PARAPET	G F P C	
RAILS & POST	G F P C	
DRAINS	G F P C	
EXP. JOINTS	G F P C	
	G F P C

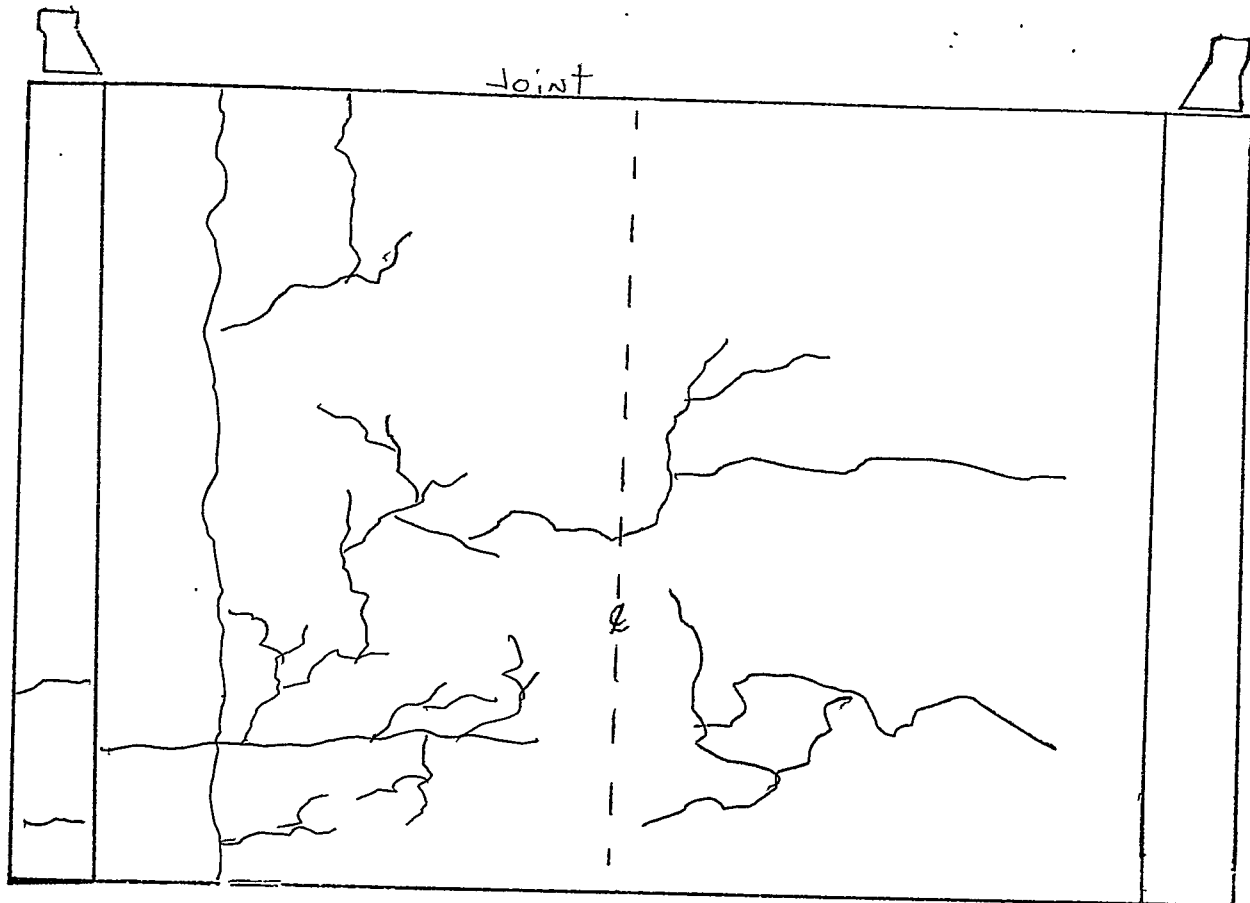
BR. NO. 79 I-40 5.01SPAN NO. 10

ELEMENT	RATING	COMMENT
TOP DECK	G (F) P C	$\frac{1}{2}$ " crack
PARAPET	(G) F P C	hl
RAILS & POST	G F P C	
DRAINS	G F P C	
EXP. JOINTS	G F P C	
	G F P C
