Region 04, 79 - Shelby County

I-40 Crossing I-40 W.B. / WOLF RIVER

90 - LAST INSPECTION DATE 10/02/2024

IDENTIFICATION	
(1) State Names	47 - Tennessee
(8) Structure Number	79I00400060
(5) Inventory Route	1
(2) Highway Agency District	Region 4
(3) County Code	79 - Shelby

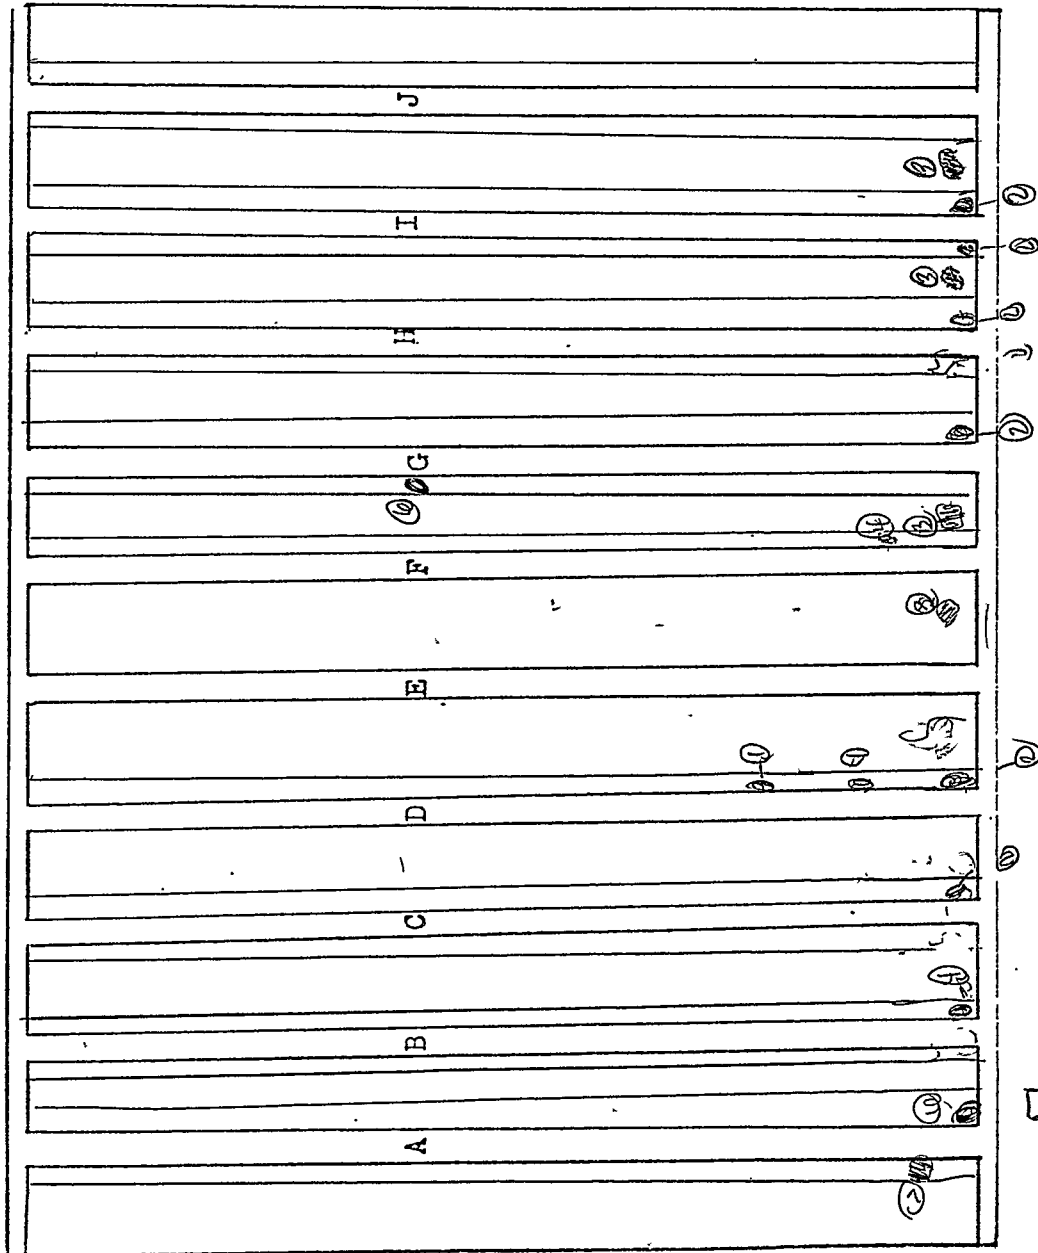
BENT NO. _____ SPAN NO. 1 ABT. NO. _____ PIER NO. _____

ELEMENT	RATING	COMMENTS
BOTTOM DECK	G F P C	See ③, 1/32" cracks ① Spall Cup de. 4'0" x 1'0" ② Spall to Steel cup Joist 1'0" x 1'0"
CONC. I. BEAMS	G F P C	③ Imp Spall 2'6" x 1'6"
A	G F P C	See ①, ② ④ Spall to Steel 4'0" x 1'0"
B	G F P C	See ④ ⑤ Spall 10'0" x 3'4" x 7/8" dia
C	G F P C	See ② ⑥ Spall 1'0" x 1'2" dia
D	G F P C	See ①, ② ⑦ Imp Spall 1'0" x 3'0"
E	G F P C	
F	G F P C	See ③, ④
G	G F P C	See ②
H	G F P C	See ②, Hairline cracks
I	G F P C	See ②
J	G F P C	
K		
L		
M		
N		
O		
P		
Q		
R		
S		
T		
U		
V		
W		
X		
Y		
Z		
DIA.	G F P C	
BACKWALLS	G F P C	See ①, ⑤, ⑥, 1/16" cracks
EQ	Good

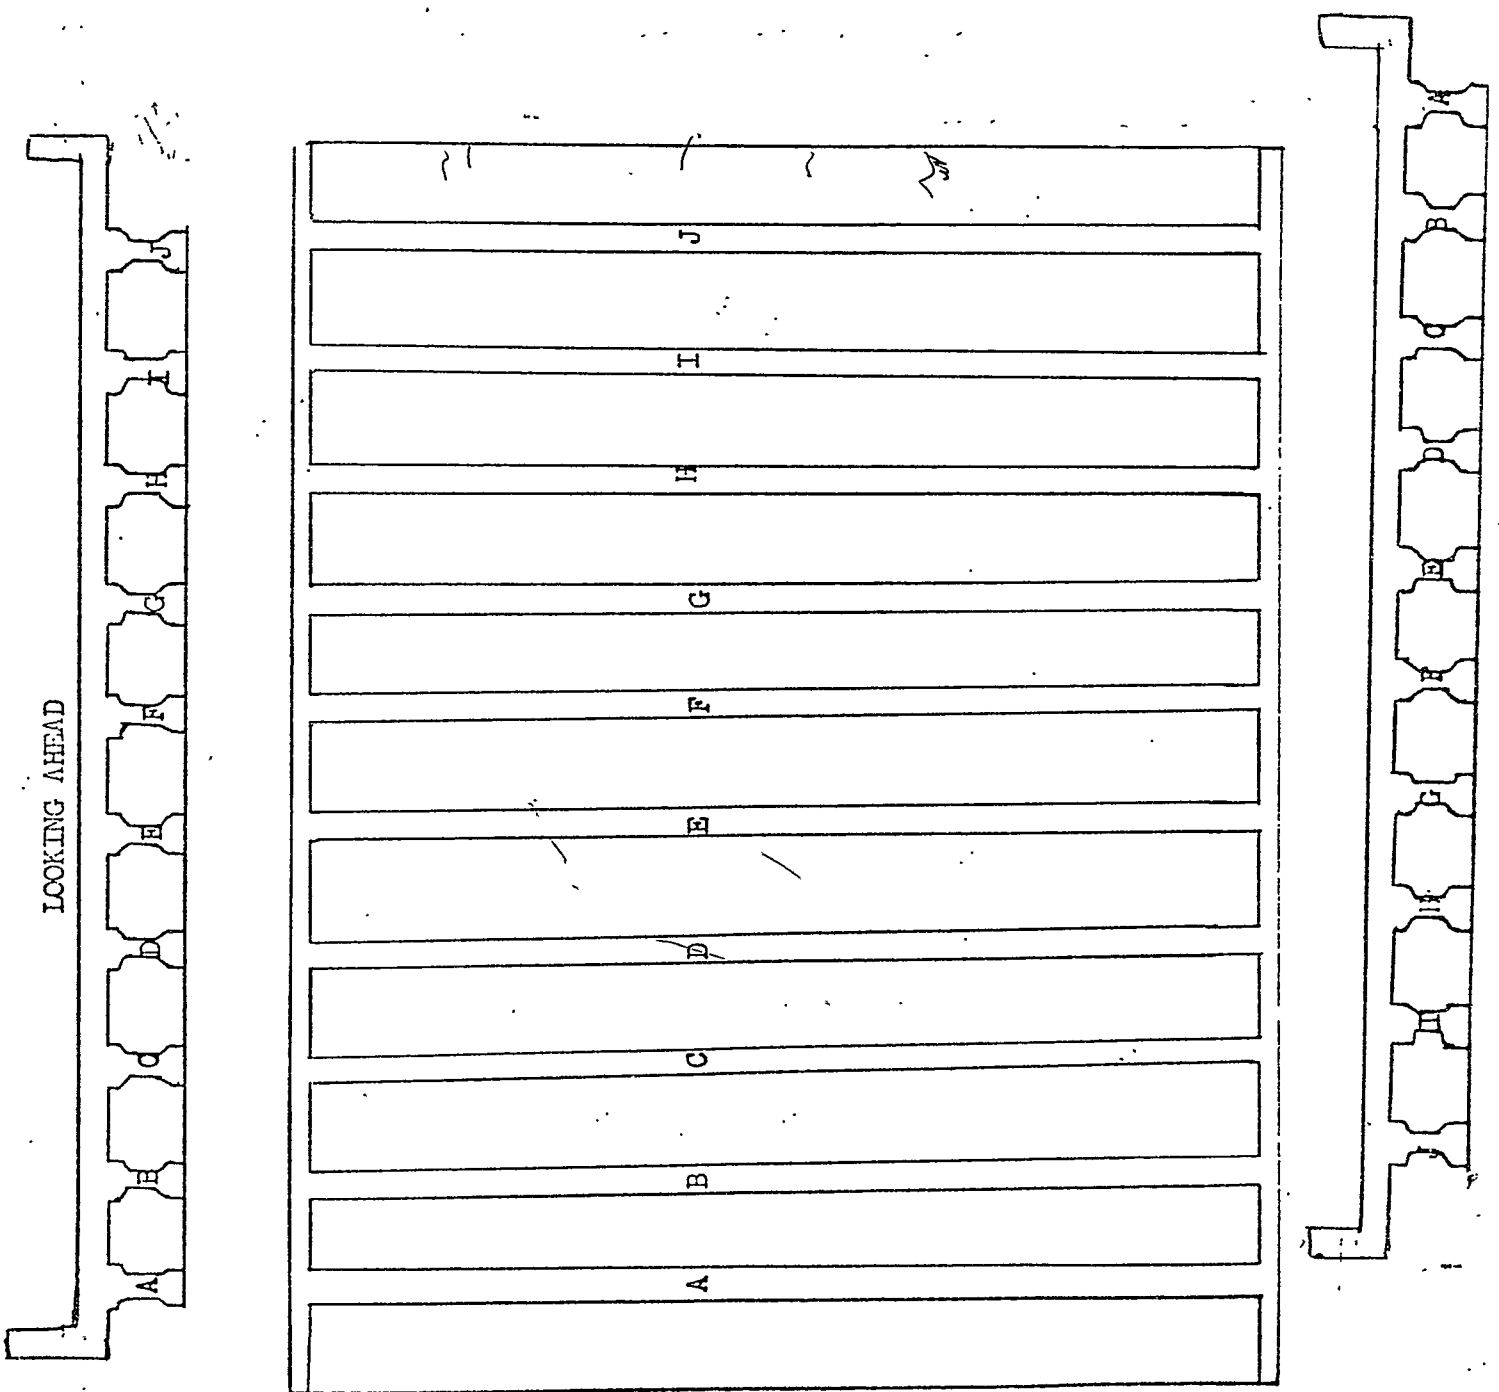
BENT NO. _____ SPAN NO. 2 ABT. NO. _____ PIER NO. _____

ELEMENT	RATING	COMMENTS
BOTTOM DECK	<u>G</u> F P C	Mainline Cracks w/ off in deck hang
CONC. I. BEAMS	<u>G</u> F P C	
A	G F P C	
B	G F P C	
C	G F P C	
D	G F P C	
E	G F P C	
F	G F P C	
G	G F P C	
H	G F P C	
I	G F P C	
J	G F P C	
DIA.	<u>G</u> F P C	
BACKWALLS	G F P C	N/A

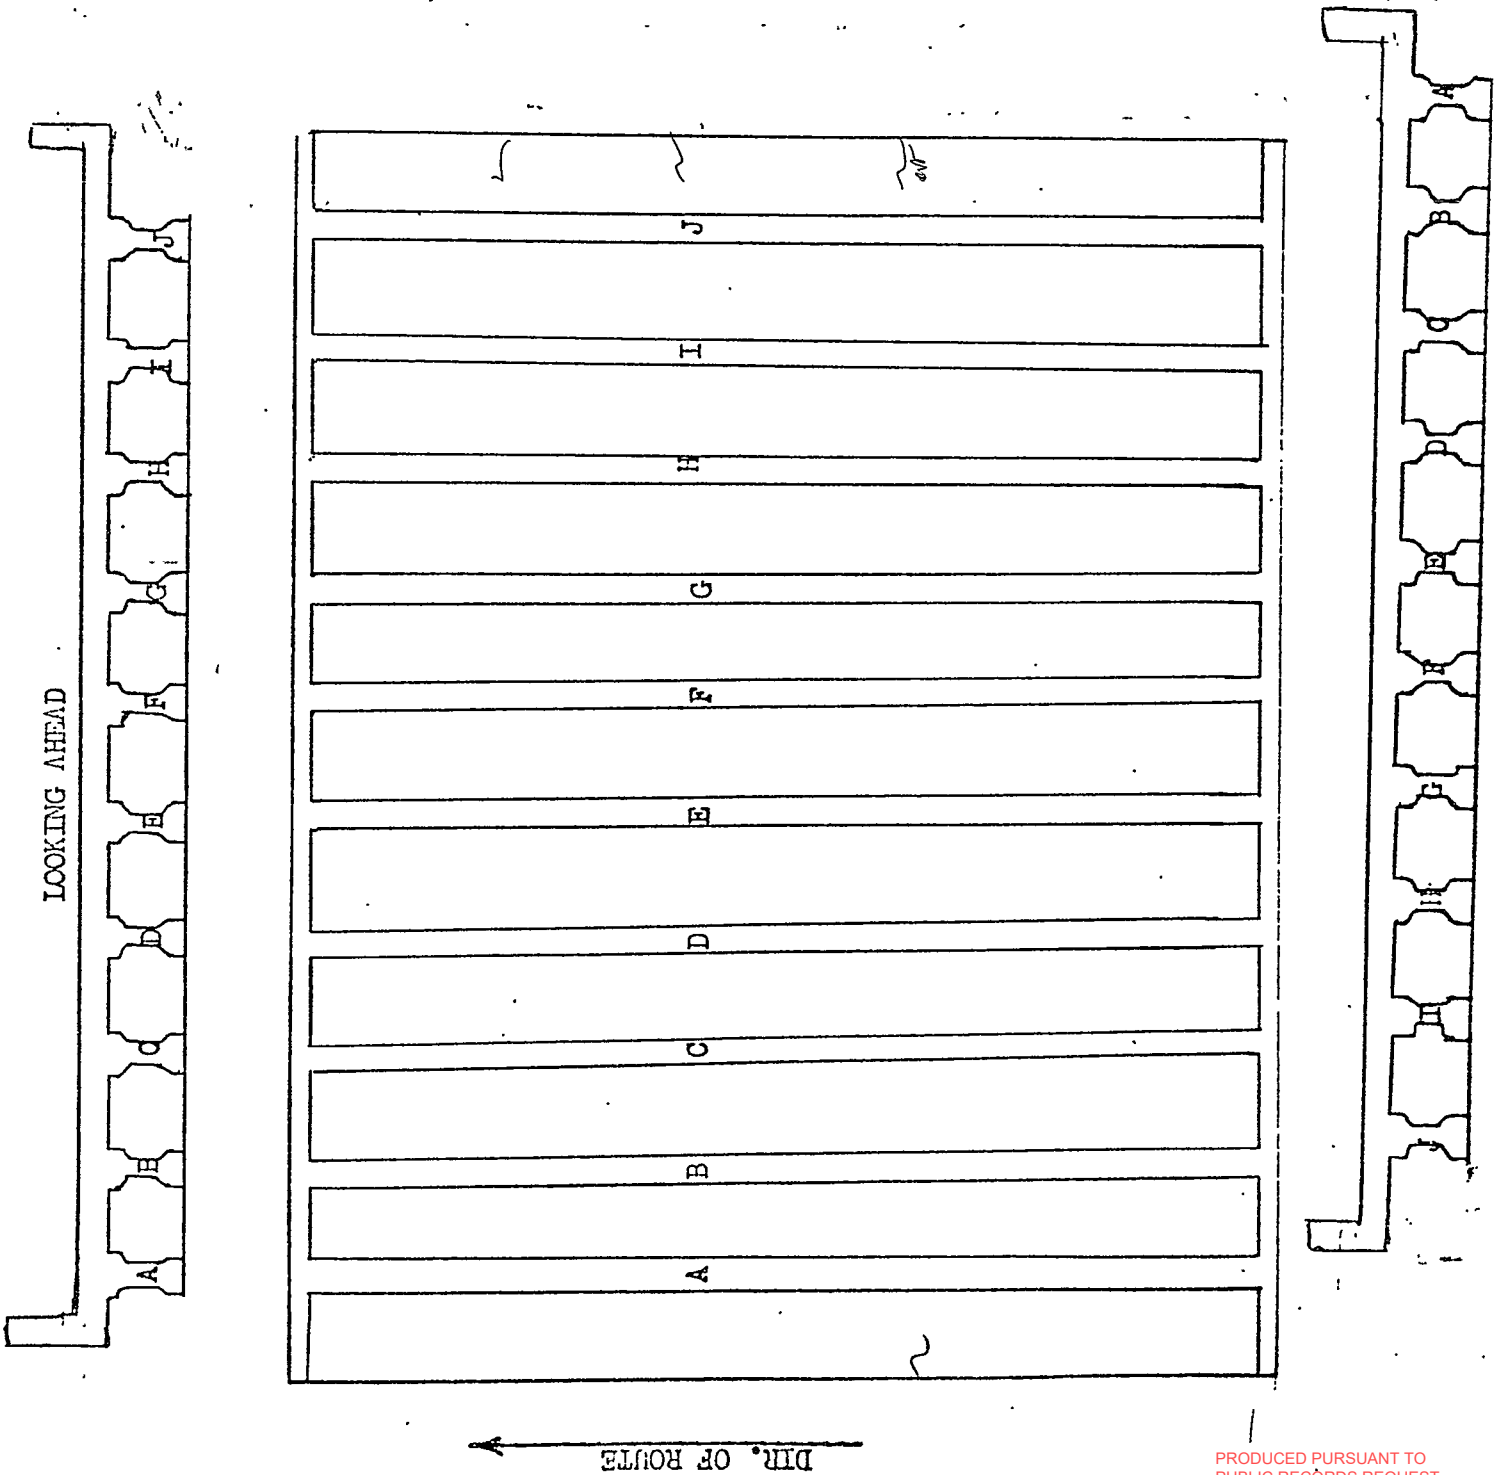
BENT NO. _____ SPAN NO. 3 ABT. NO. _____ PIER NO. _____

ELEMENT	RATING	COMMENTS
BOTTOM DECK	G F P C	Horizontal cracks at all in crosshairs
CONC. I. BEAMS	G F P C	
A	G F P C	
B	G F P C	
C	G F P C	
D	G F P C	
E	G F P C	
F	G F P C	
G	G F P C	
H	G F P C	
I	G F P C	
J	G F P C	
DIA.	G F P C	
BACKWALLS	G F P C	N/A

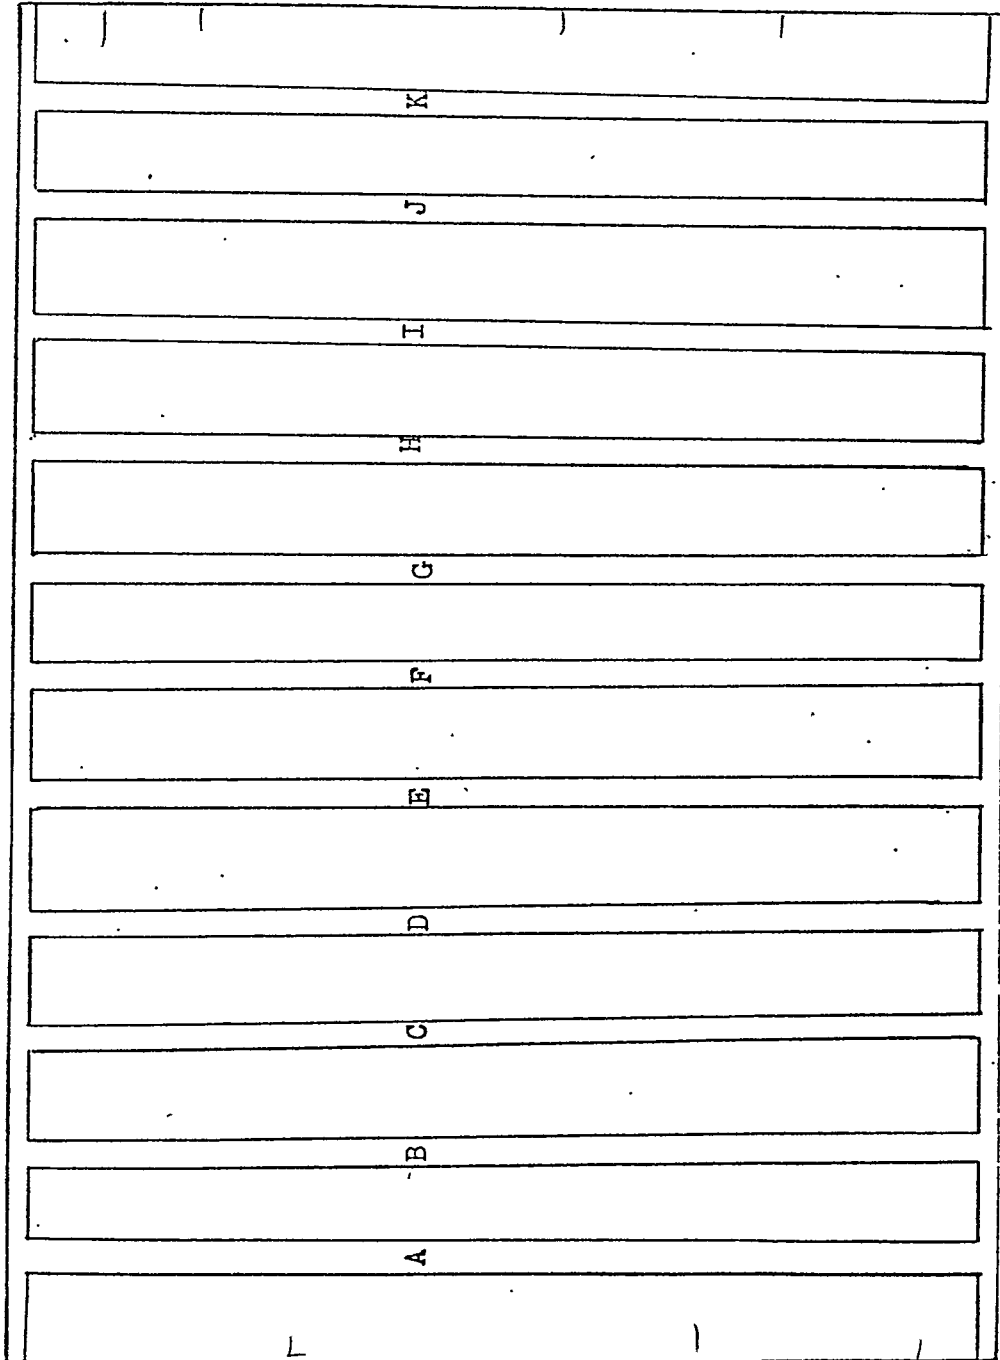
① Spacing 8" dia 1/2" deep

ELEMENT	RATING	COMMENTS
BOTTOM DECK	(G) F P C	Hairline cracks eff
CONC. I. BEAMS	(G) F P C	
A	(G) F P C	
B	(G) F P C	
C	(G) F P C	
D	(G) F P C	
E	(G) F P C	
F	(G) F P C	
G	(G) F P C	
H	(G) F P C	
I	(G) F P C	
J	(G) F P C	
K	(G) F P C	
DIA.	G (F) P C	(1)
BACKFILLS	G F P C

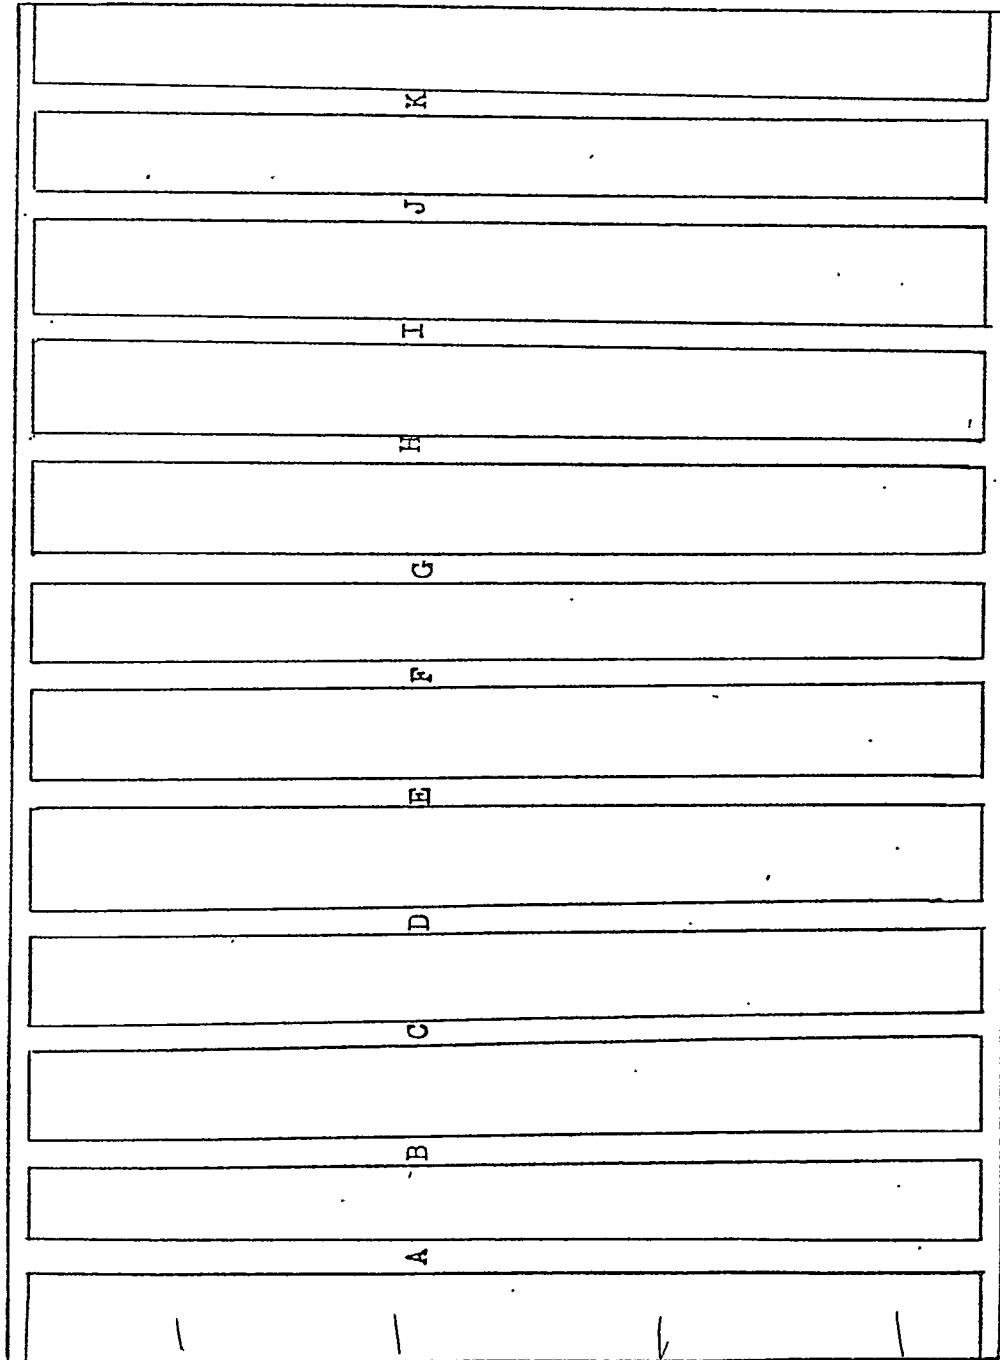
ELEMENT	RATING	COMMENTS
BOTTOM DECK	G F P C	Main line cracks with eff
CONC. I. BEAMS	G F P C	
A	G F P C	
B	G F P C	
C	G F P C	
D	G F P C	
E	G F P C	
F	G F P C	
G	G F P C	
H	G F P C	
I	G F P C	
J	G F P C	
K	G F P C	
DIA.	G F P C	
BACKFILLS	G F P C

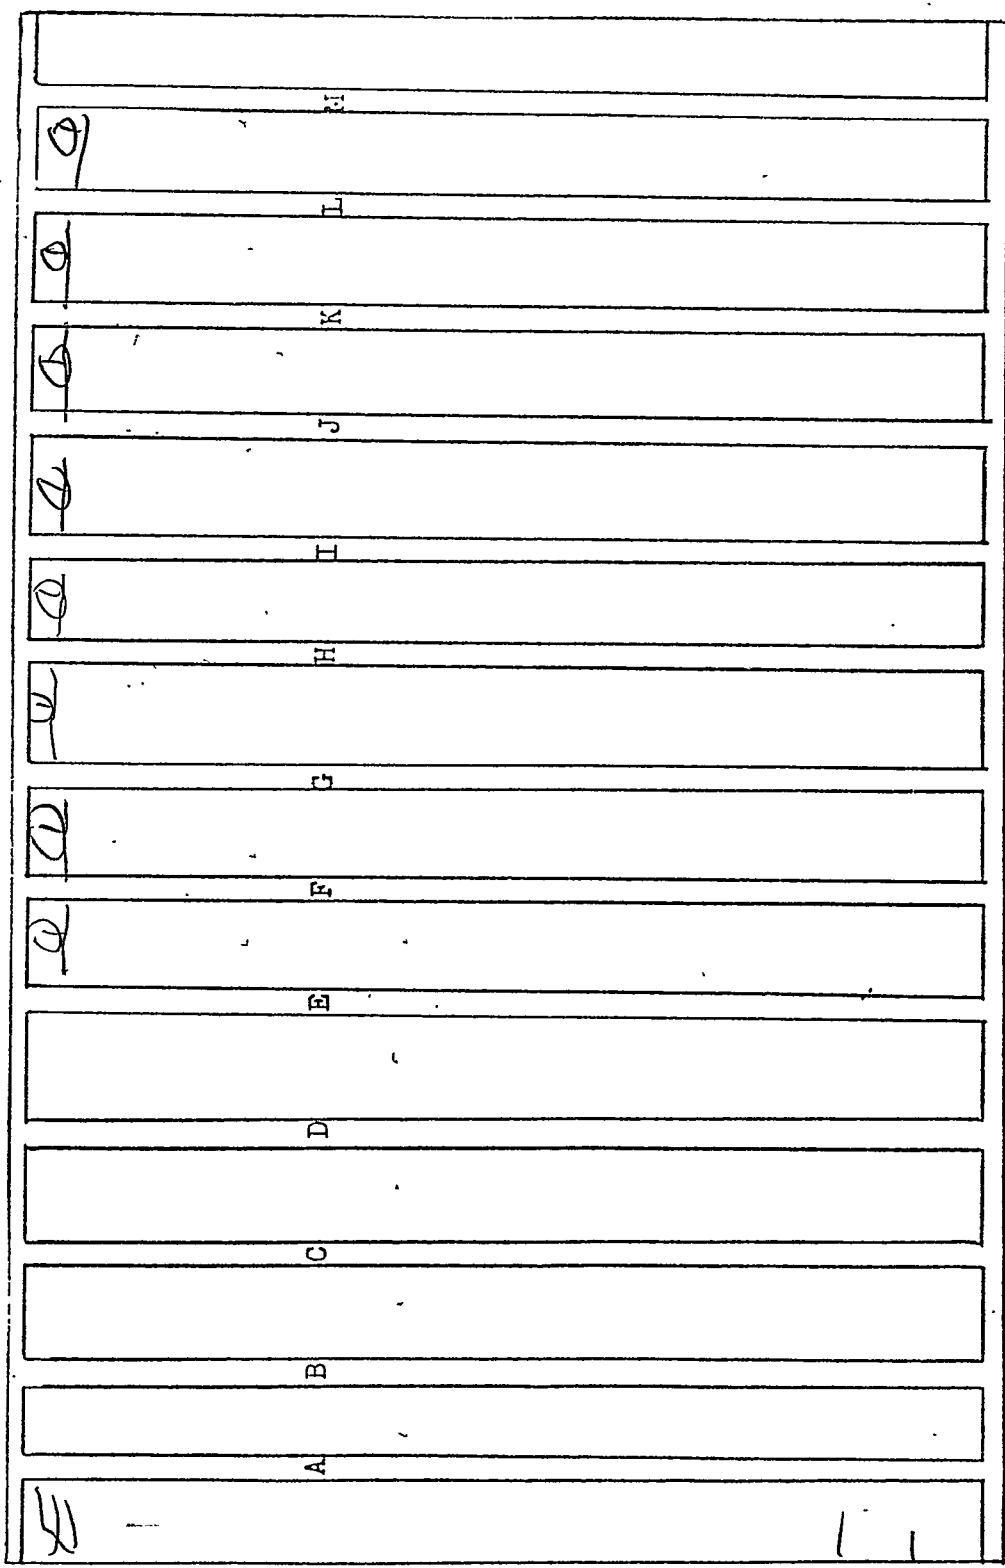
BENT NO. _____ SPAN NO. 10 ABT. NO. _____ PIER NO. _____

ELEMENT	RATING	COMMENTS
BOTTOM DECK	G(F) P C	Hairline cracks with egg ①
CONC. I. BEAMS	(G) F P C	
A	(G) F P C	
B	(G) F P C	
C	(G) F P C	
D	(G) F P C	
E	(G) F P C -	- - -
F	(G) F P C	
G	(G) F P C	
H	(G) F P C	
I	(G) F P C	
J	(G) F P C	
K	(G) F P C	
L	(G) F P C	
M	(G) F P C	
DIA.	(G) F P C	
BACKWALLS	G(F) P C	Up to 1/32" cracks ②

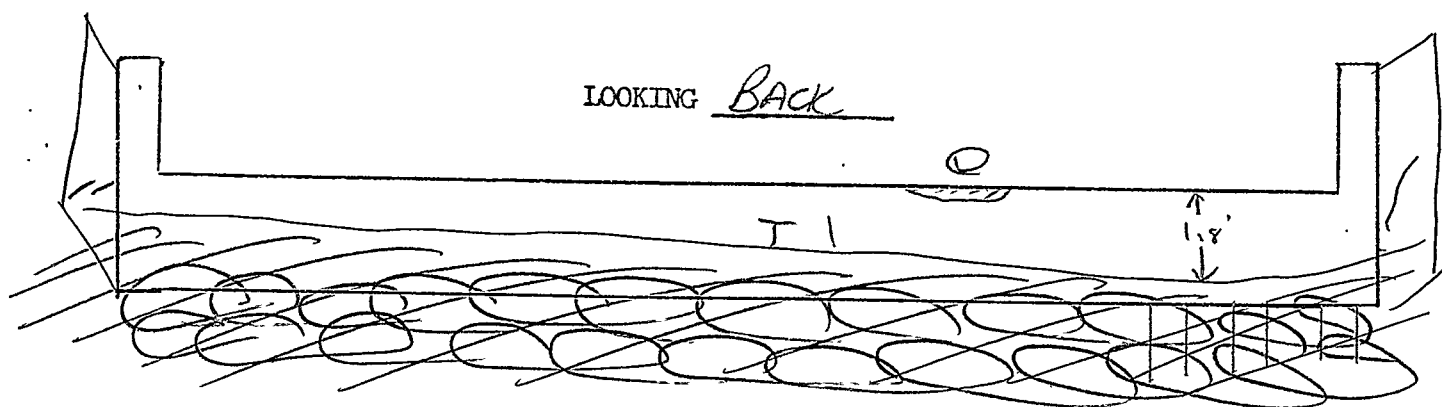
ABUT. NO. 1

① Impending Spall 4' w x 4" H x 6" L

ELEMENT	RATING	COMMENT
BEARING	(G) F P C	
CAP	G (F) P C	HL cracks, see ①
WINGS	G (F) P C	up to 1/32" cracks v/eff
MBANKMENT	(G) F P C	
GRAVELMENT R. & R. P	(G) F P C	
VEG.	G F (P) C	Tree growth
B-a.	(G) F P C

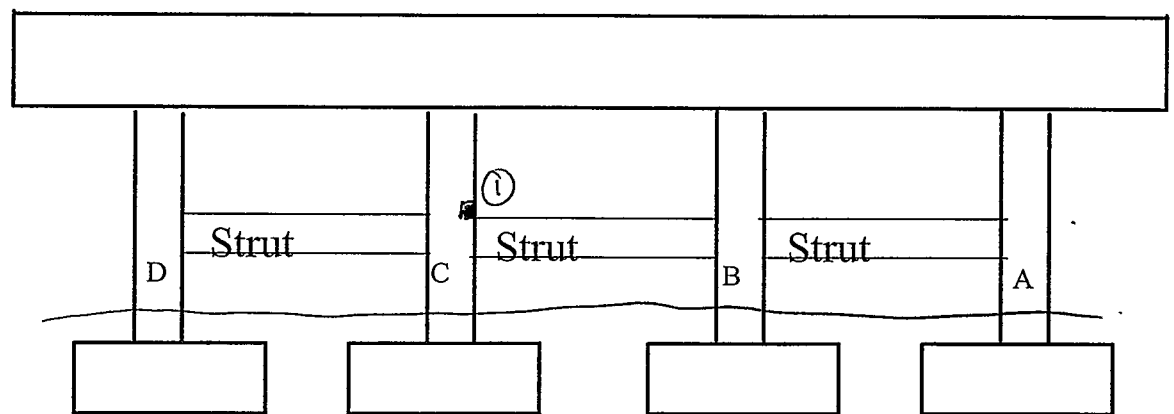
① Impending Spall
1' Dia X 3' / D

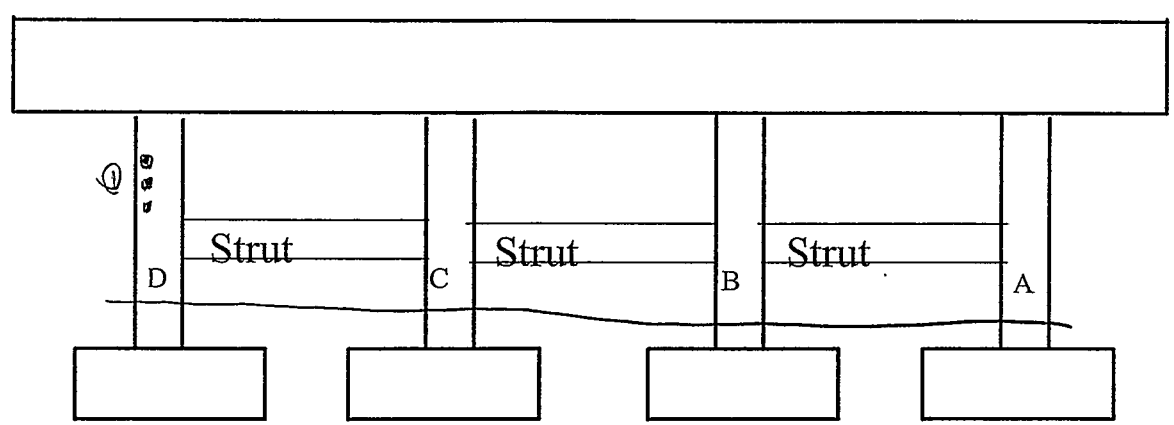
① Spall
up to 4" Dia x 0.5' / D.
