IDENTIFICATION	
(1) State Names	47 - Tennessee
(8) Structure Number	79I00400061
(5) Inventory Route	1
(2) Highway Agency District	Region 4
(3) County Code	79 - Shelby

(4) Place Code	48000
(6) Features Intersected	I-40 W.B.
(7) Facility Carried	FAP 300 RP TOI40EB
(9) Location	IN MEMPHIS
(11) Mile Point	1.210 mi
(12) Base Highway Network	Yes

BOTTOM BRIDGE

79-SR300-0121

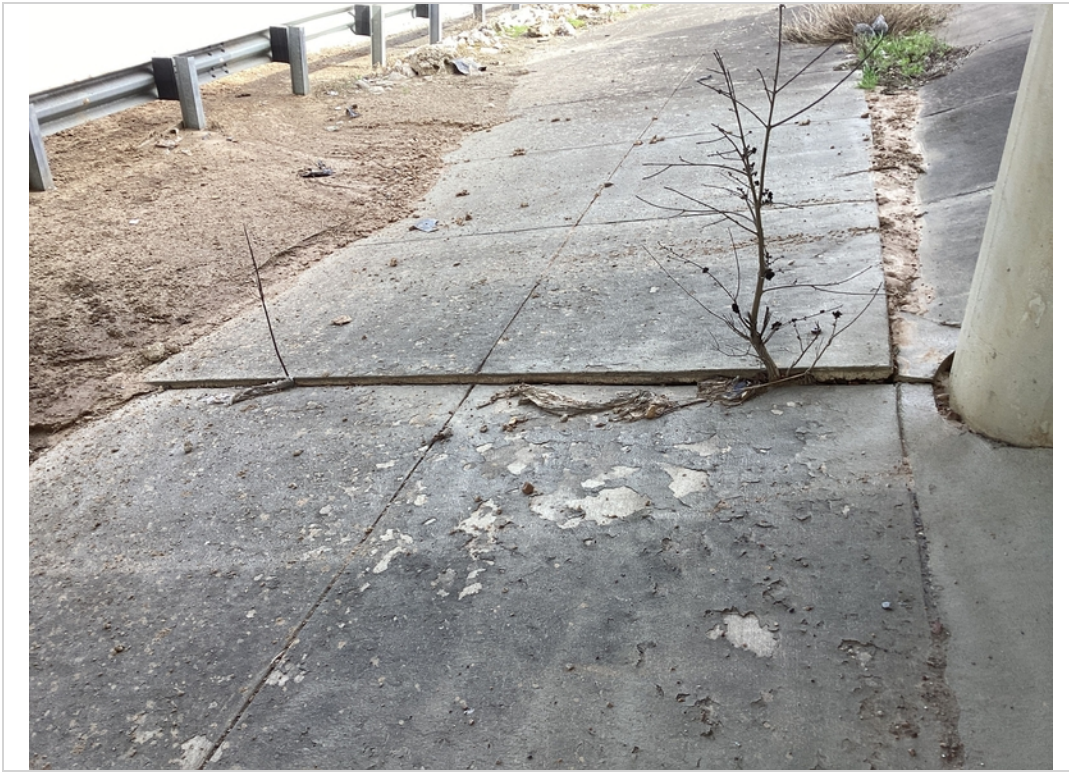
Tree growth between slope paving

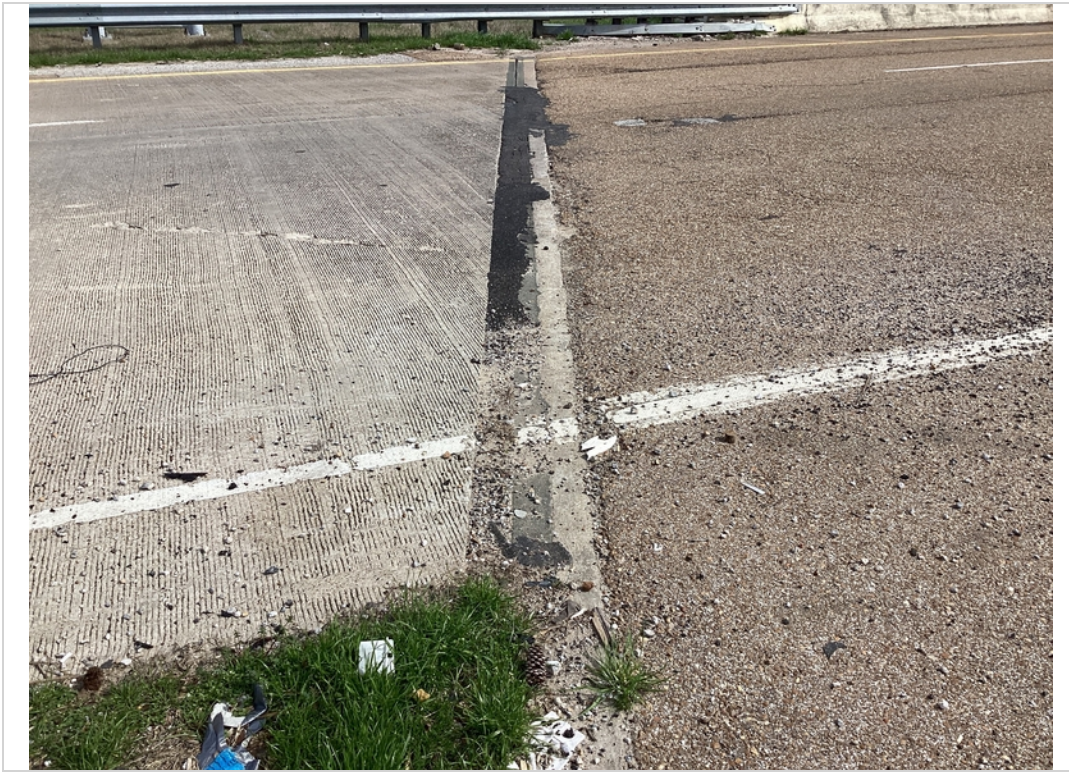
Approach #1 joint

Spalling, filled with asphalt and debris

Date Added	Recommendation	Priority
03/06/2023	CLEAN AND SEAL ROADWAY EXPANSION JOINTS.	
03/06/2023	Repair potholes in span #2 top deck

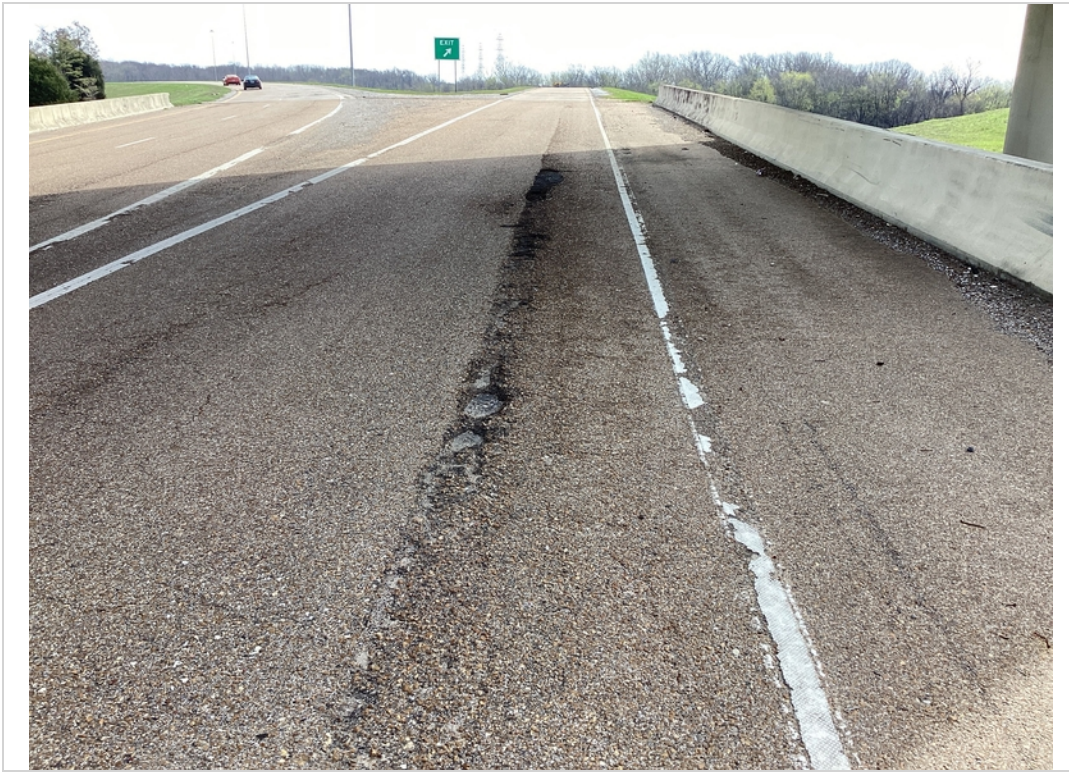
Wearing Surface	(Poor)	Cracks up to 1/4", span #2 spalling
------------------------	--------	-------------------------------------

Top deck span #2 spalling

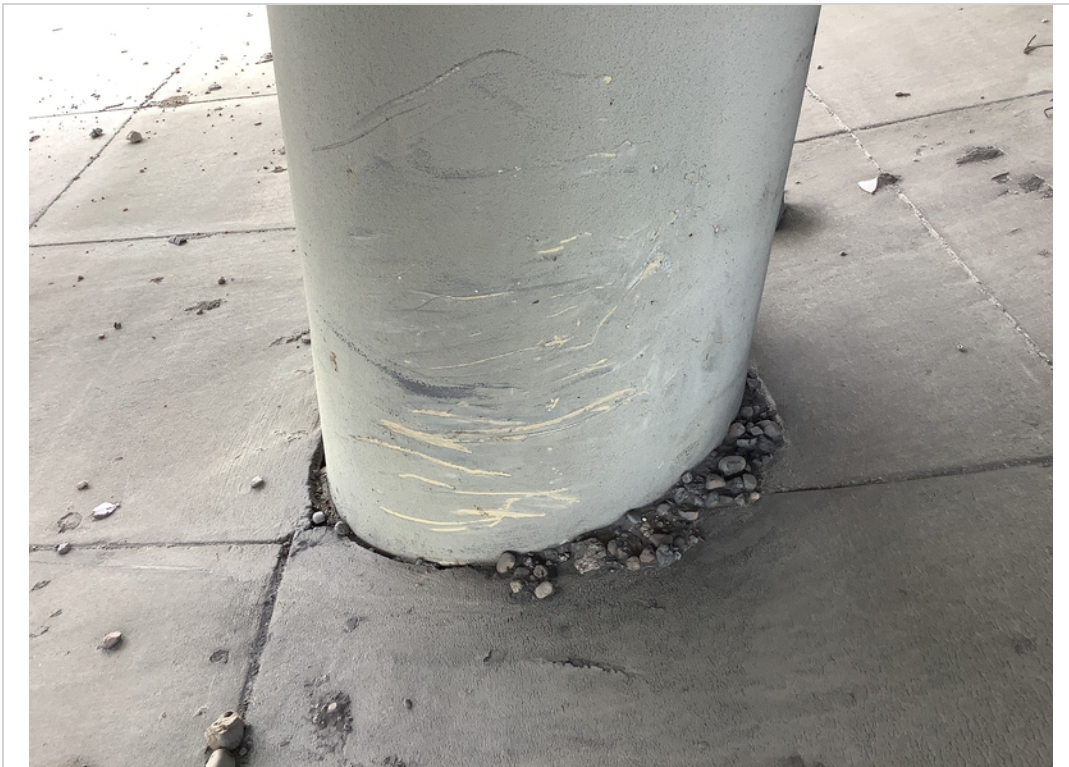
Bent Columns	(Fair)	Scuffing and hairline cracking.
Bent Plumb	(Good)

Column B scuffing

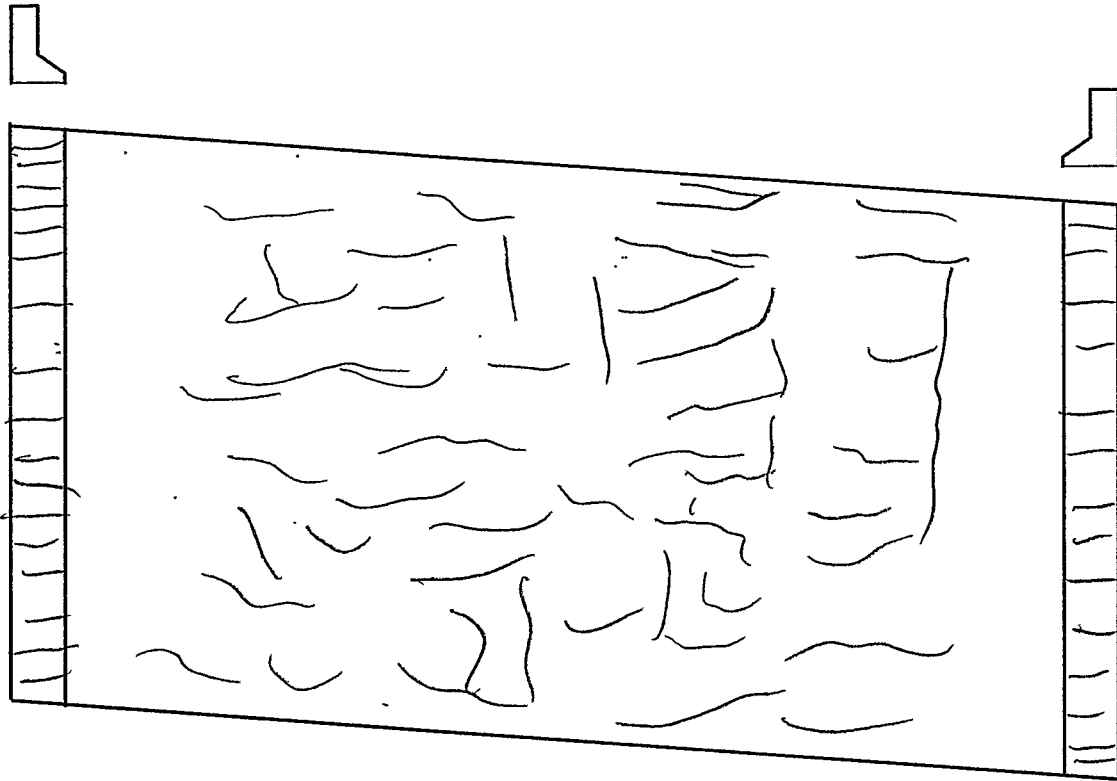
SPAN. NO. 1

ELEMENT	RATING	COMMENT
TOP DECK	G <u>F</u> P C	Cracks up to 1/4"
PARAPET	G <u>F</u> P C	Cracks up to 1/16"
	G F P C	
	G F P C	
	G F P C

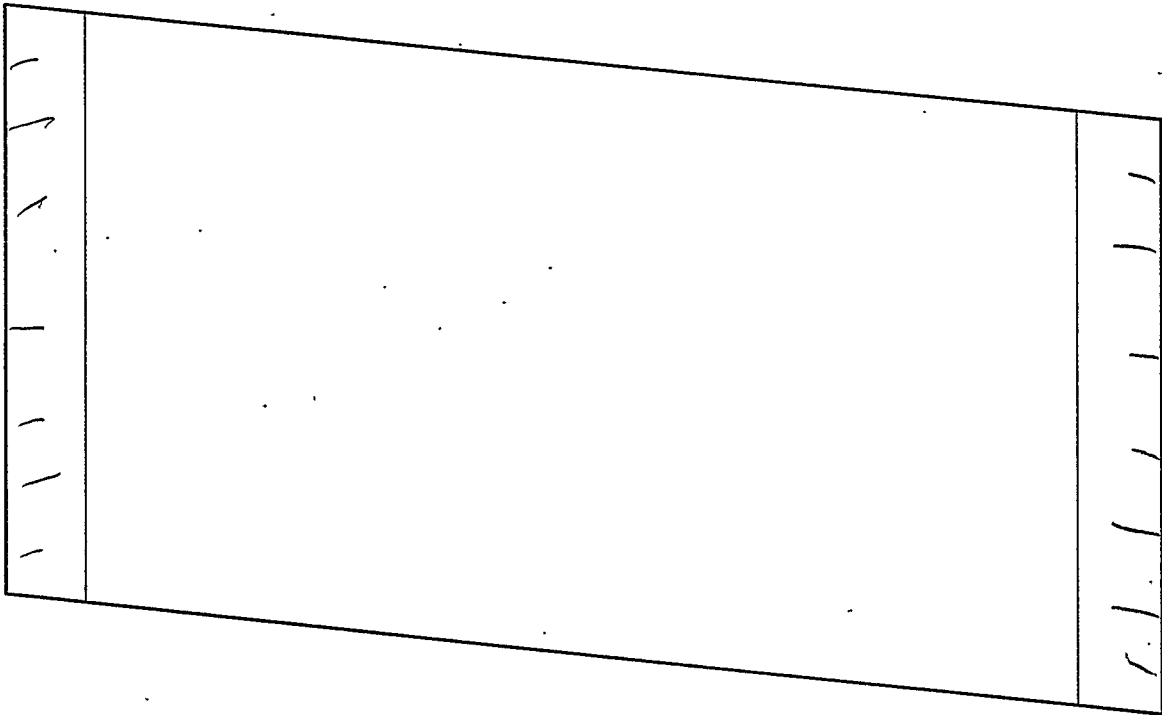
ELEMENT	RATING	COMMENT
BOTTOM DECK	G (F) P C	Hairline cracks w/eff in overhang
BOX BEAM	G F P C	
	G F P C	
	G F P C	
BACKWALLS	G F P C	
	G F P C

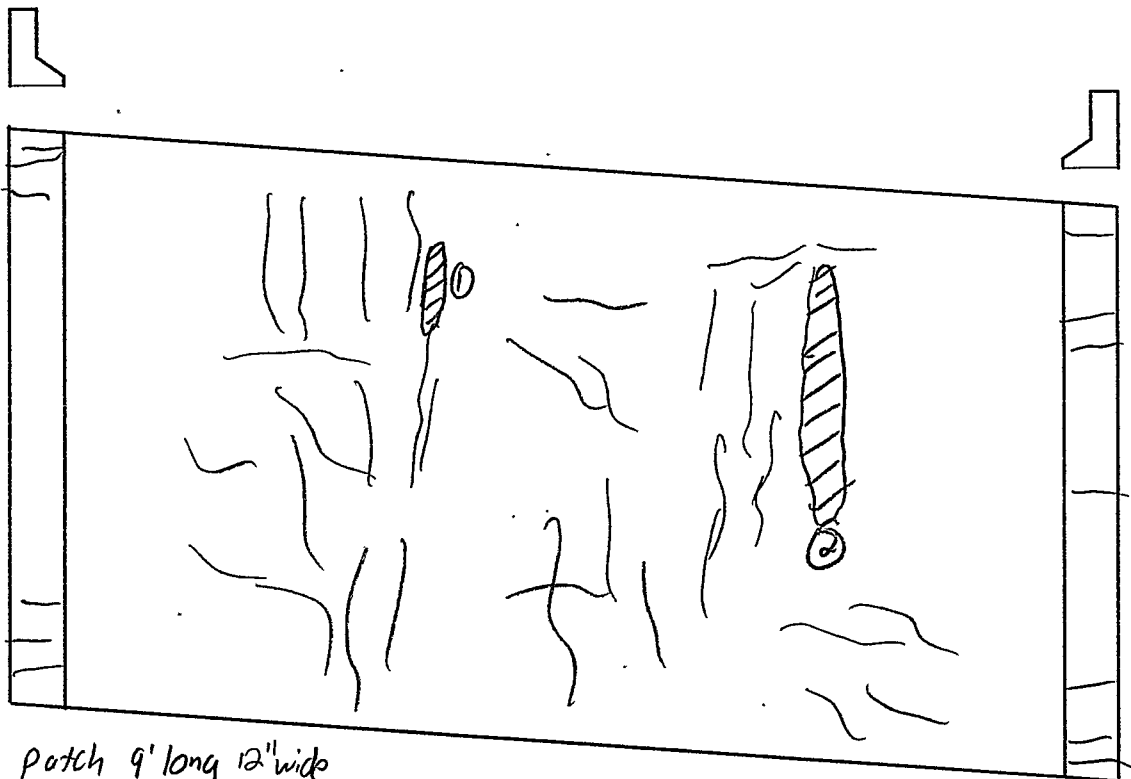
① rough patch 9' long 12" wide

② Spalling 45' long 12" wide 1 1/2" deep

ELEMENT	RATING	COMMENT
TOP DECK	G F <u>P</u> C	①② cracks up to 1/4"
PARAPET	G <u>F</u> P C	cracks up to 1/16"
	G F P C	
	G F P C	
	G F P C

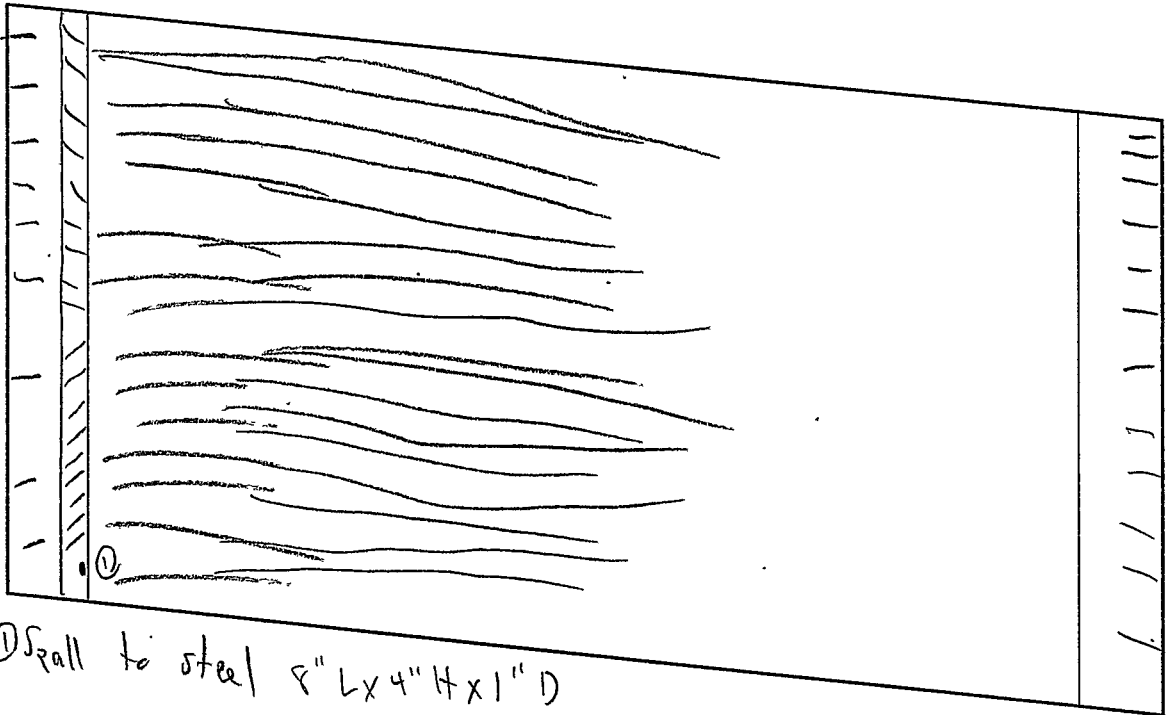
ELEMENT	RATING	COMMENT
BOTTOM DECK	G (F) P C	Hairline cracks w/eff in overhang
BOX BEAM	G (F) P C	Hairline cracks
	G F P C	
	G F P C	
	G F P C	
	G F P C

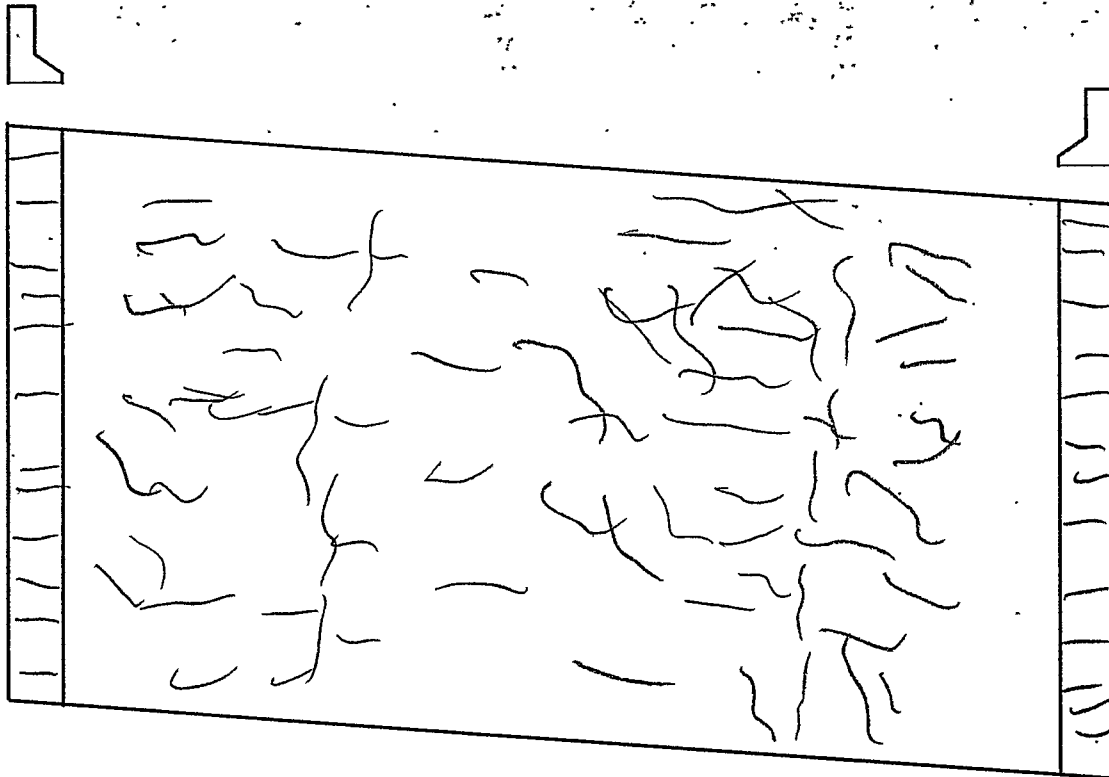
SPAN NO. 3

ELEMENT	RATING	COMMENT
TOP DECK	G \textcircled{F} P C	Cracks up to 1/4"
PARAPET	G \textcircled{F} P C	Cracks up to 1/16"
	G F P C	
	G F P C	
	G F P C

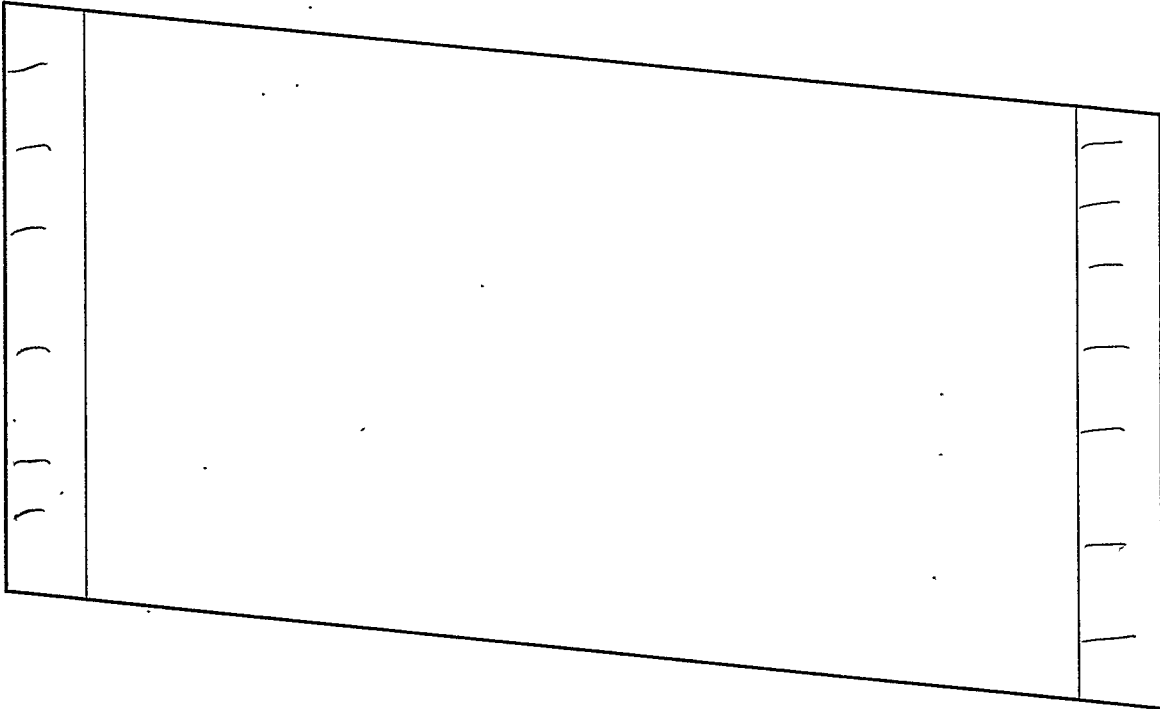
ELEMENT	RATING	COMMENT
BOTTOM DECK	G (F) P C	Hairline cracks v/eff
BOX BEAM	G (F) F P C G F P C G F P C	
BACKWALLS	G (F) P C G F P C	Hairline cracks v/eff

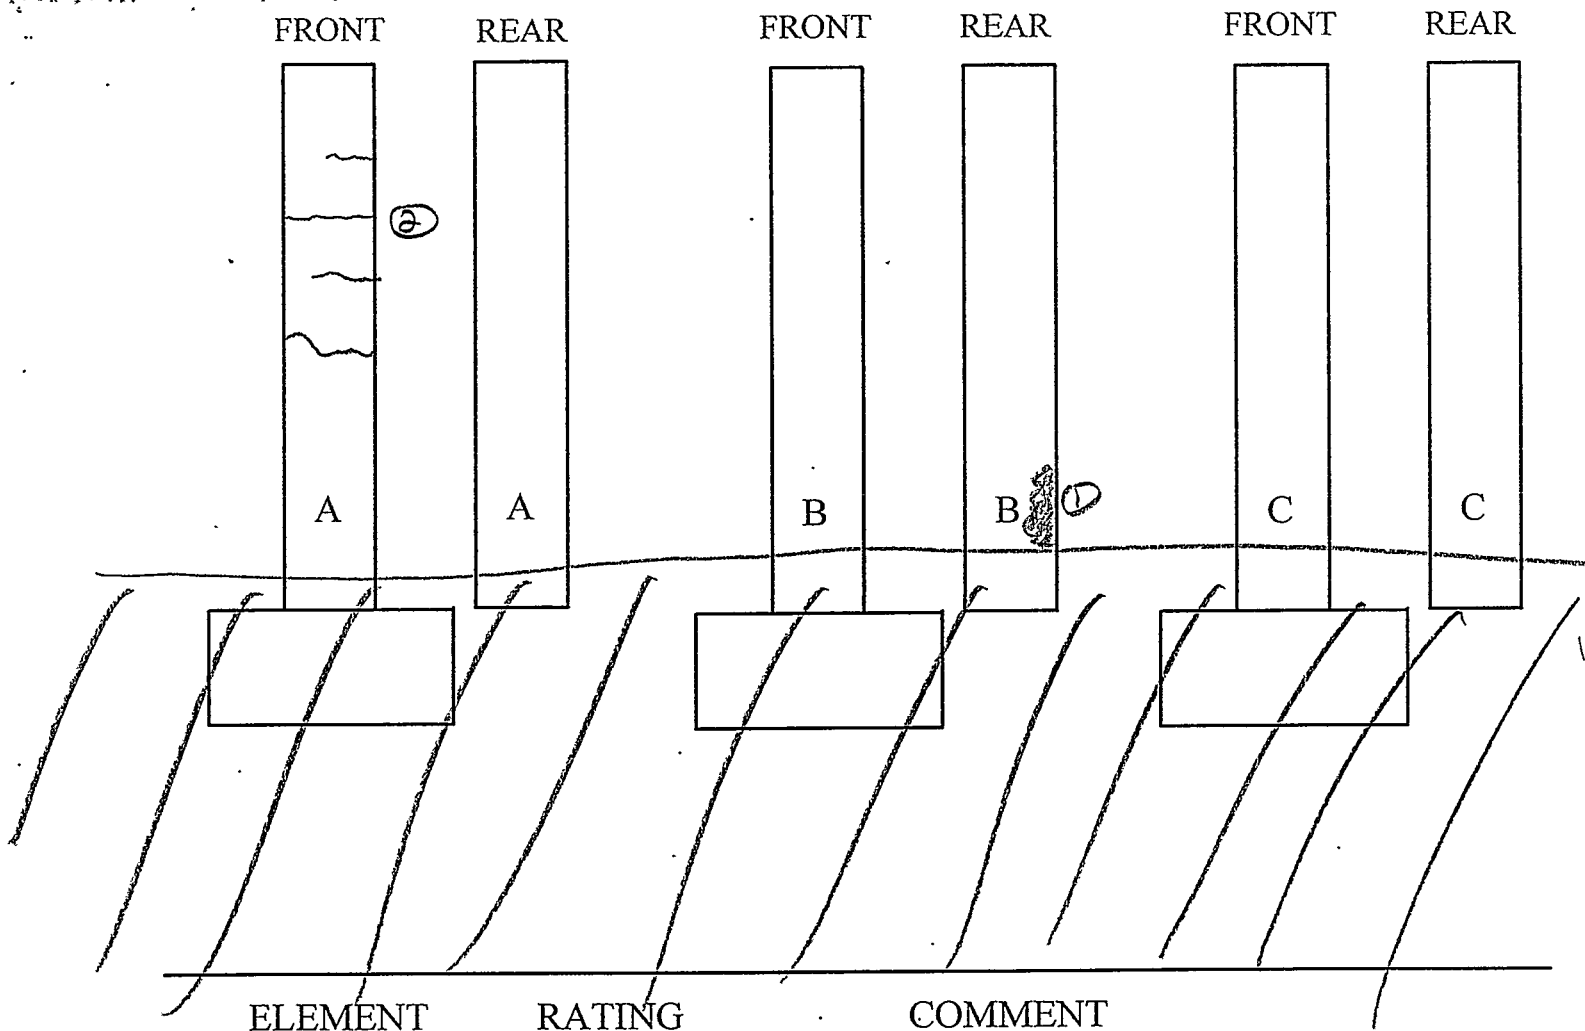
ELEMENT		RATING	COMMENT
COLUMN	A	G <u>F</u> P C	② ①
COLUMN	B	G <u>F</u> P C	
COLUMN	C	G <u>F</u> P C	
FOOTING		G F P C	① slight Damage 36" H x 36" L x 1/16' See photo D
SLOPE PAVING		G <u>F</u> P C G <u>F</u> P C	
BRM Columns			② Hairline Cracking
1130 - 10

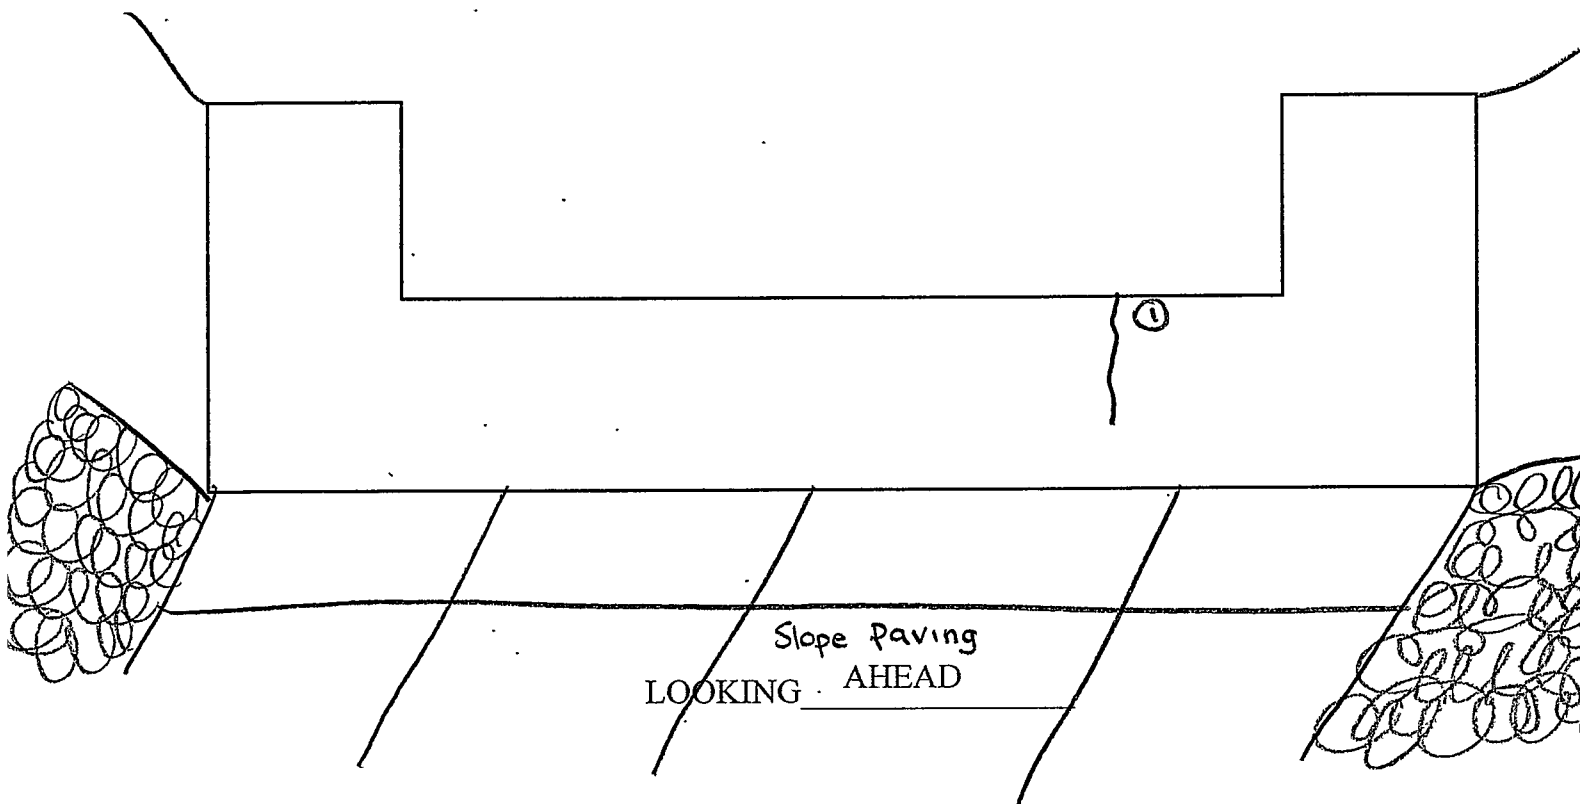
ABUT. NO. 2

ELEMENT	RATING	COMMENT
BEARING	(G) F P C	① hairline w / EFF
CAP	(G) F P C	- see ①
WINGS	(G) F P C	- texture coat peeling
PILES	G F P C	
EMBANKMENT	(G) F P C	
VEGETATION	G (F) P C	
RIP-RAP	(G) F P C	
SLOPE PAVING	(G) F P C
