IDENTIFICATION	
(1) State Names	47 - Tennessee
(8) Structure Number	79I00400065
(5) Inventory Route	1
(2) Highway Agency District	Region 4
(3) County Code	79 - Shelby

(4) Place Code	48000
(6) Features Intersected	I-40 E.B.
(7) Facility Carried	FAP 300 EXIT RP
(9) Location	SR-300 RAMP / I-40 EBL
(11) Mile Point	1.500 mi
(12) Base Highway Network	Yes

79-SR300-0150

Road Name: SR 300 RAMP TO N. WATKINS

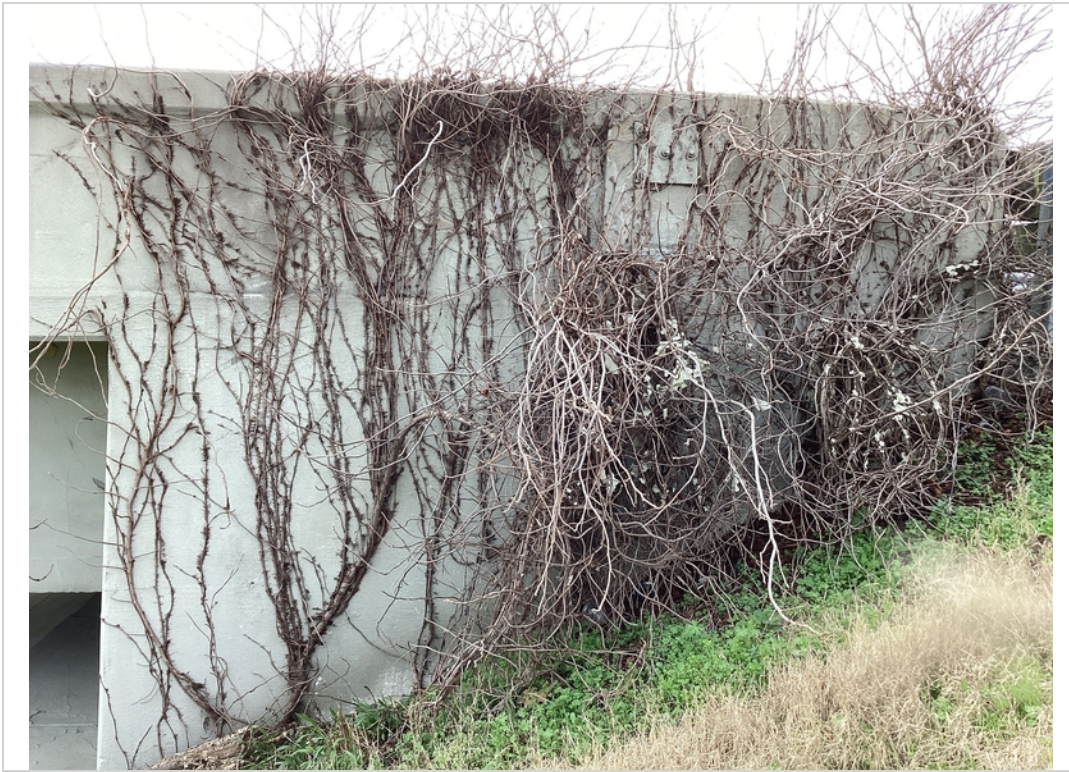
Heavy veg growth at wings

Date Added	Recommendation	Priority
03/06/2023	CLEAN AND SEAL ROADWAY EXPANSION JOINTS.	
03/06/2023	REPAIR THE WEARING SURFACE AT APPROACH NO.2	
03/06/2023	Cut vegetation

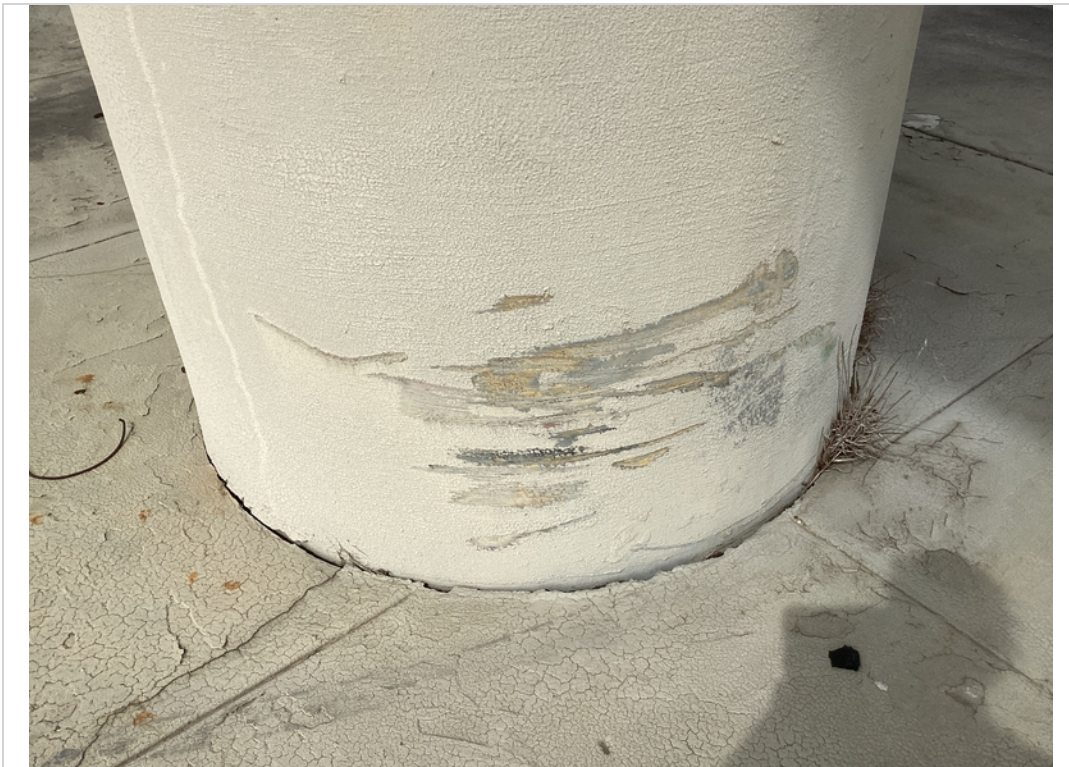
Bent Columns	(Good)	Light abrasion on bent 1 column
Bent Plumb	(Good)

Abrasion on column. Bent 1

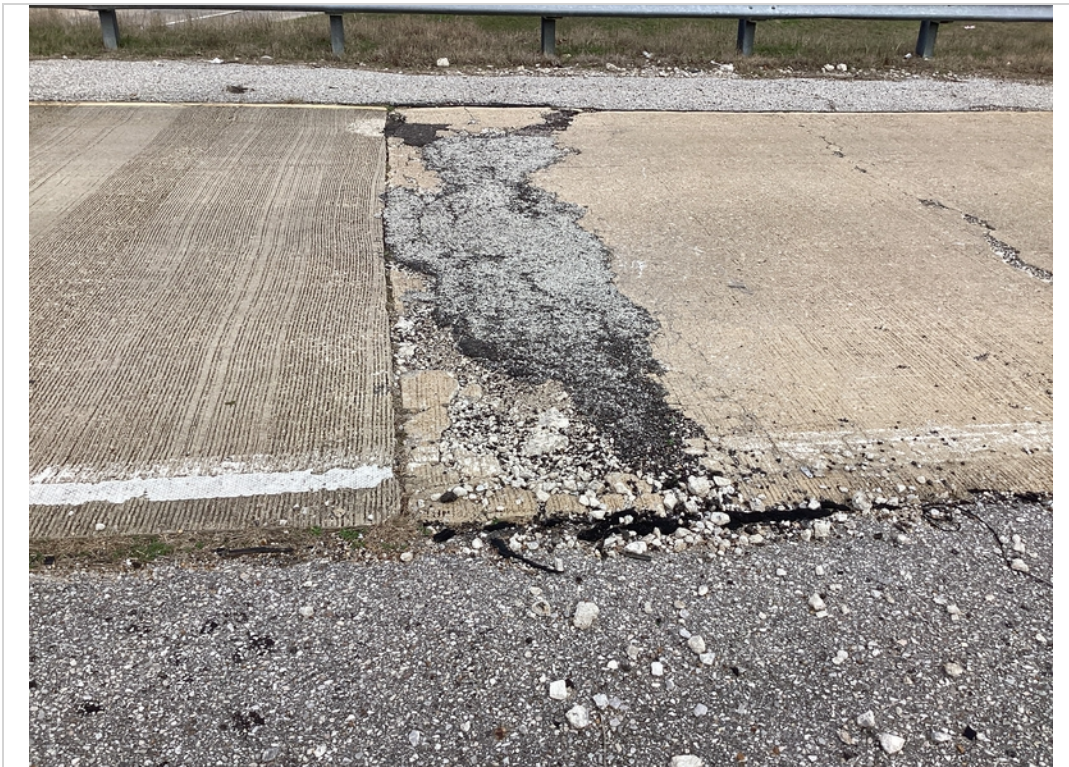
Cracks up to 1/4", failing asphalt patch

Approach #2 pavement failing patch

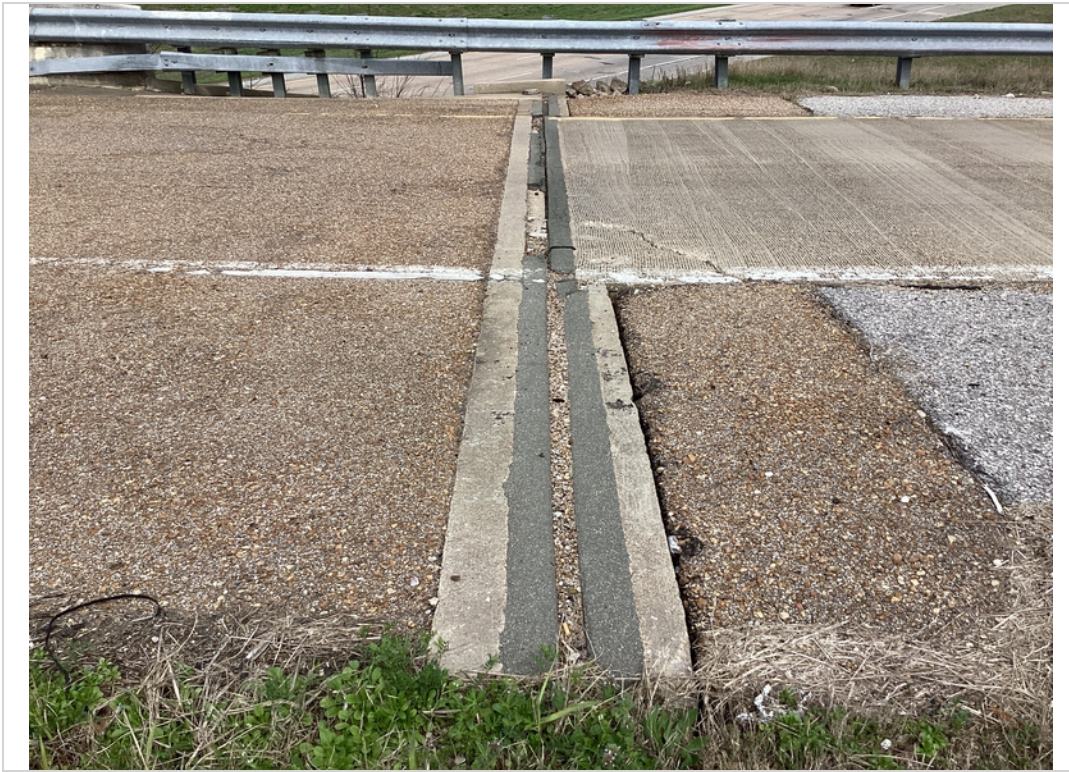
Spalling headers and debris impaction

Approach #2 joint

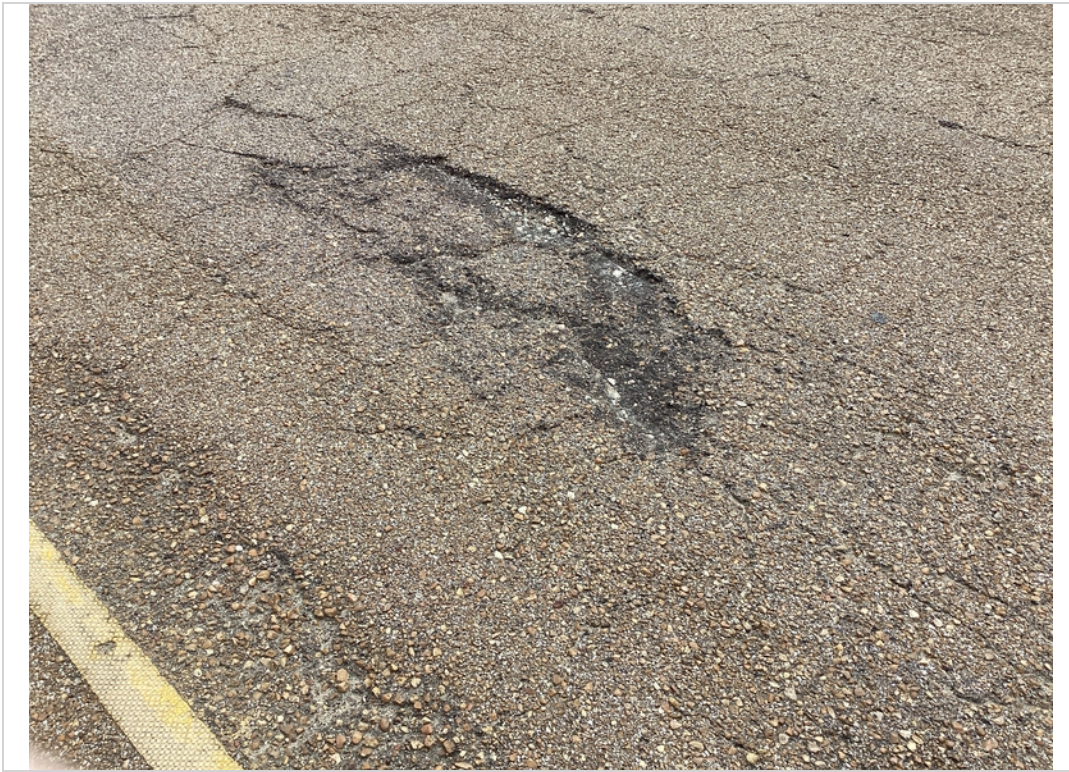
Top deck span #3 spalling

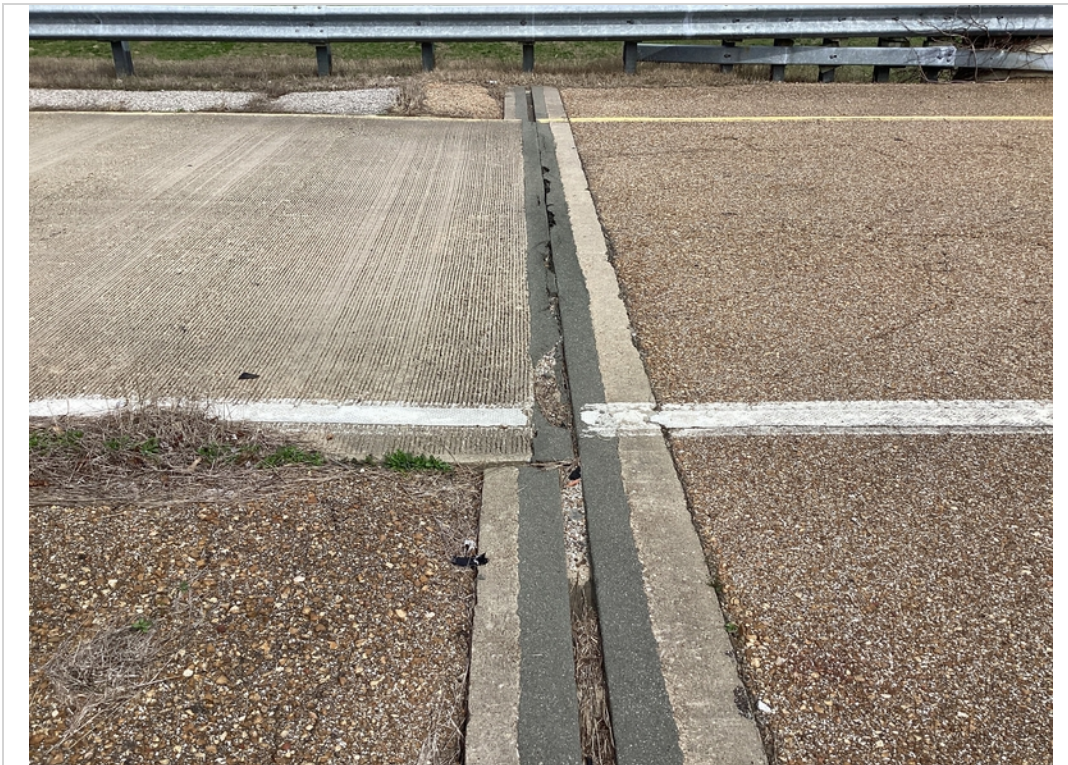
Approach #1 joint

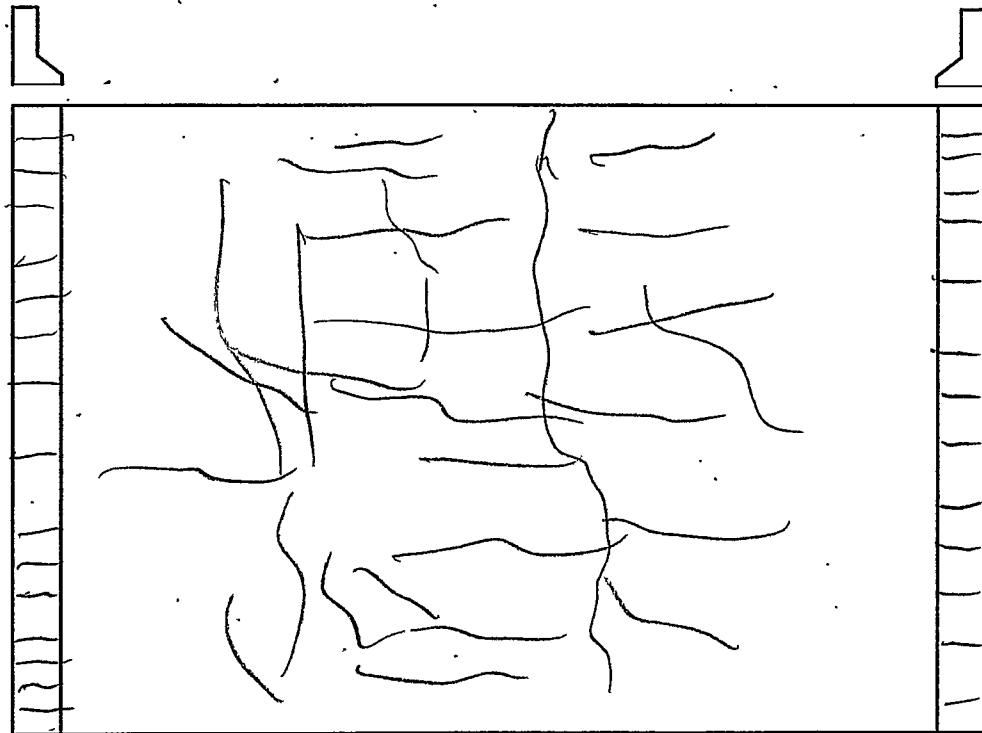
SPAN. NO. 1

ELEMENT	RATING	COMMENT
TOP DECK	G (F) P C	cracks up to 1/4"
PARAPET	G (F) P C	cracks up to 1/16"
	G F P C	
	G F P C	
	G F P C	
	G F P C	
	G F P C

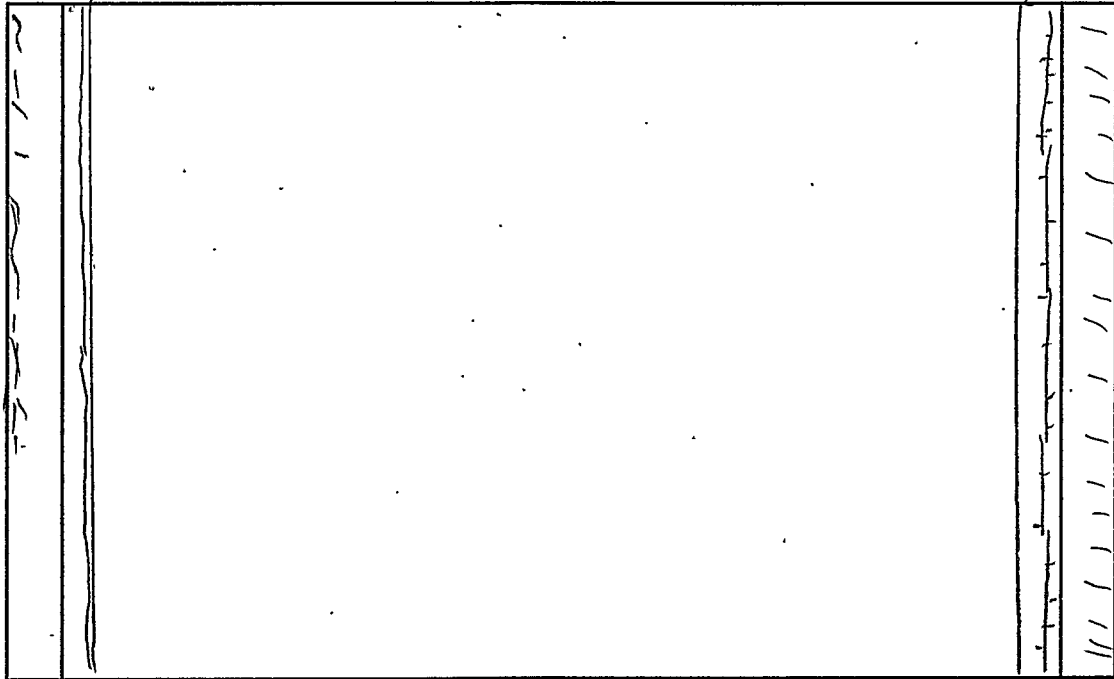
ELEMENT	RATING	COMMENT
BOTTOM DECK	G (F) P C	Hair line cracks w/eff
BOX BEAM	G (F) P C	Hair line cracks w/eff
	G F P C	
	G F P C	
BACKWALLS	(G) F P C	
	G F P C

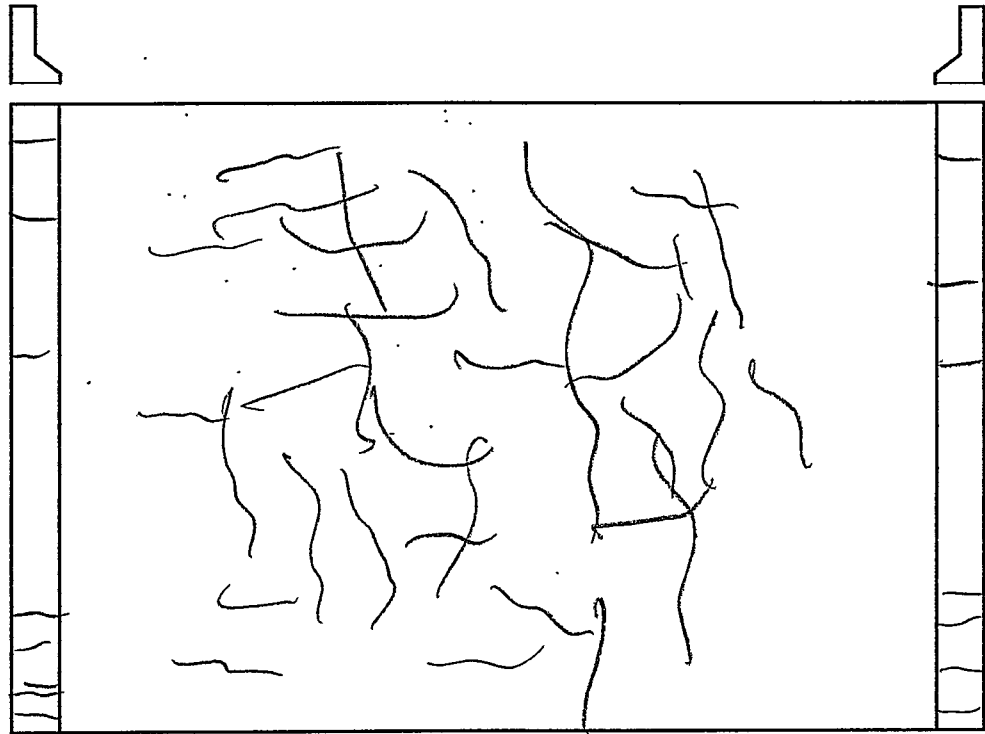
SPAN. NO. 2

ELEMENT	RATING	COMMENT
TOP DECK	G <u>F</u> P C	cracks up to 1/4"
PARAPET	G <u>F</u> P C	cracks up to 1/16"
	G F P C	
	G F P C	
	G F P C	
	G F P C	
	G F P C

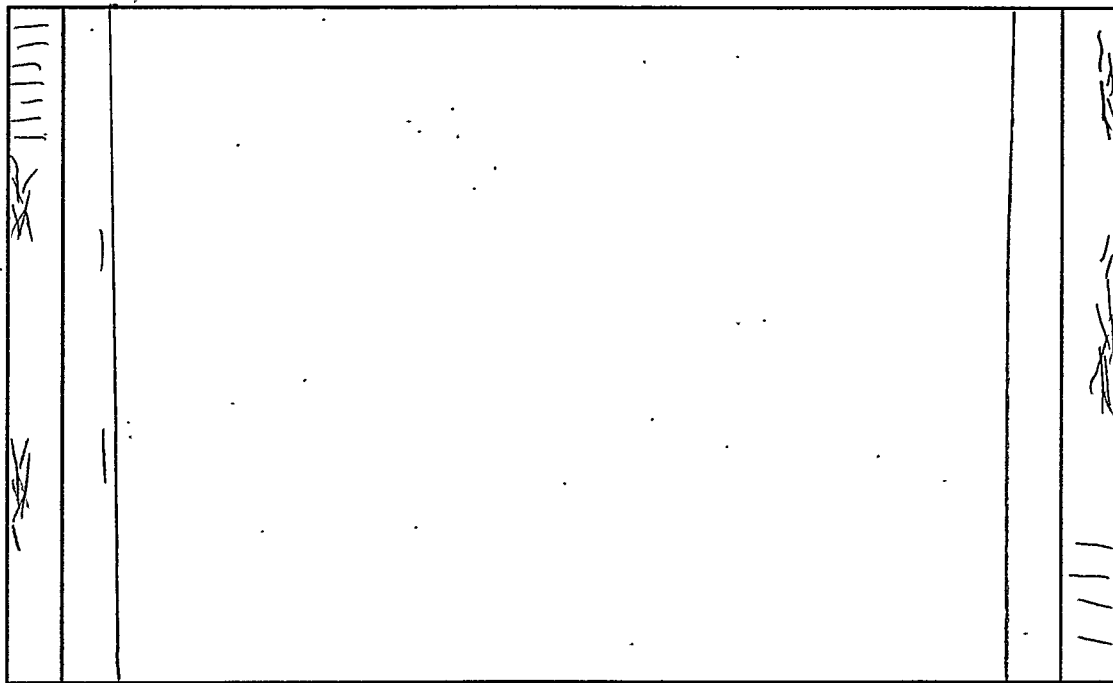
ELEMENT	RATING	COMMENT
BOTTOM DECK	G (F) P C	Hairline cracks v/e #4
BOX BEAM	(G) F P C	Hairline cracks
	G F P C	
	G F P C	
	G F P C	
	G F P C

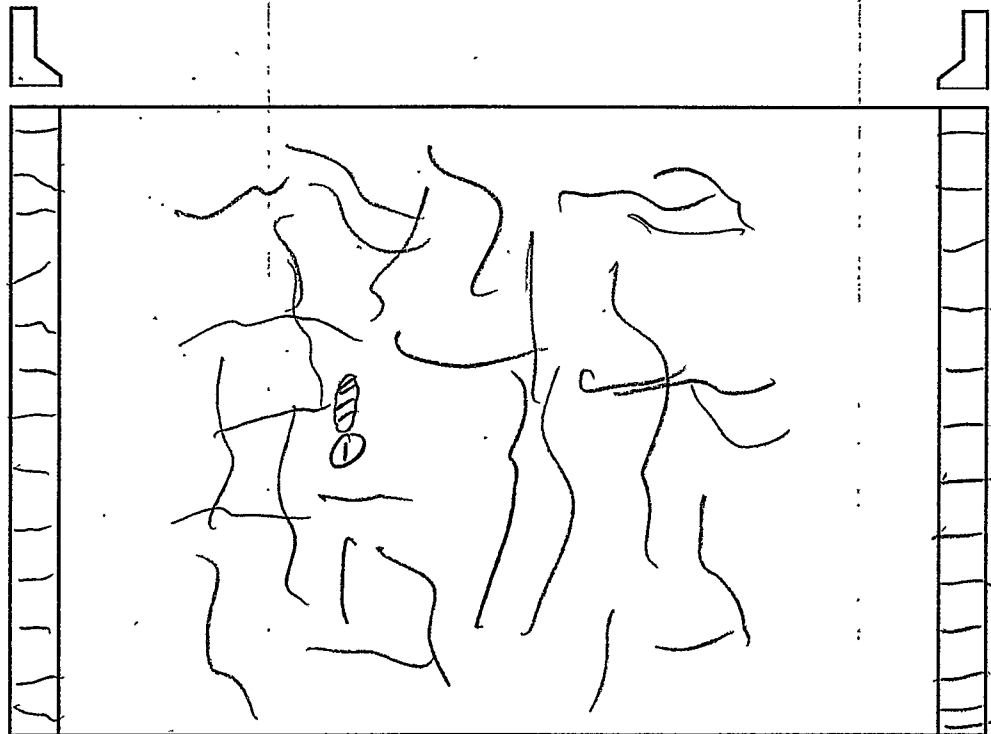
① spall 5' long 12" wide 1" deep

ELEMENT	RATING	COMMENT
TOP DECK	G (F) P C	cracks up to 1/4" ①
PARAPET	G (F) P C	cracks up to 1/16"
	G F P C	
	G F P C	
	G F P C	
	G F P C	
	G F P C

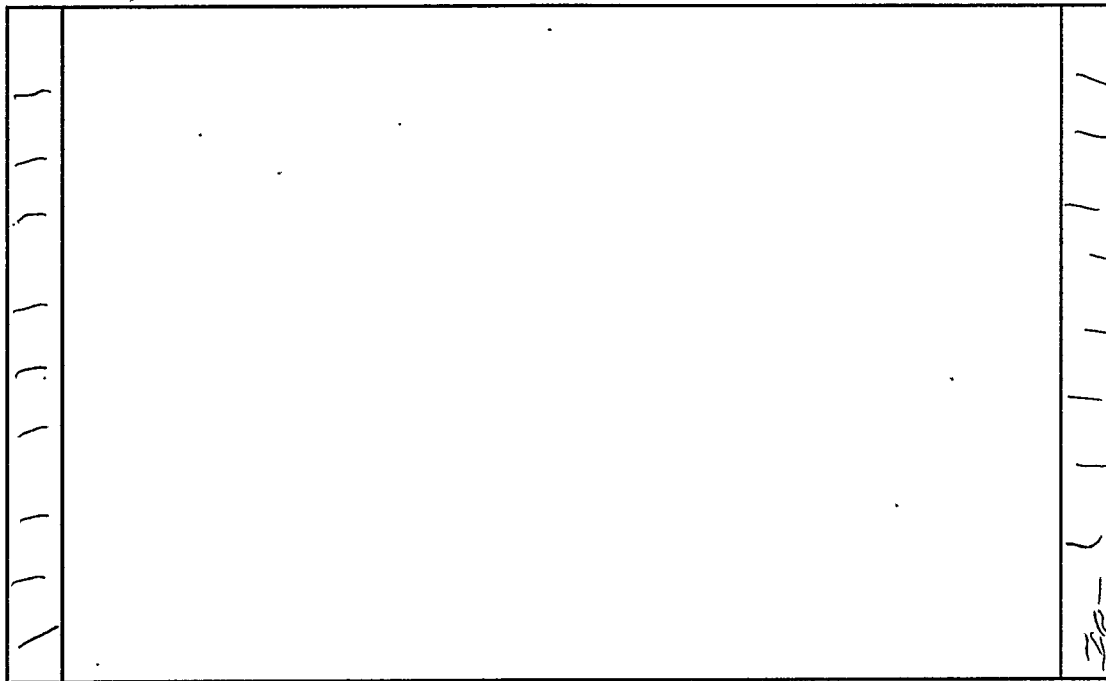
ELEMENT	RATING	COMMENT
BOTTOM DECK	G (F) P C	Hairlike cracks w/e ft
BOX BEAM	G (G) F P C G F P C G F P C	
BACKWALLS	G (G) F P C G F P C

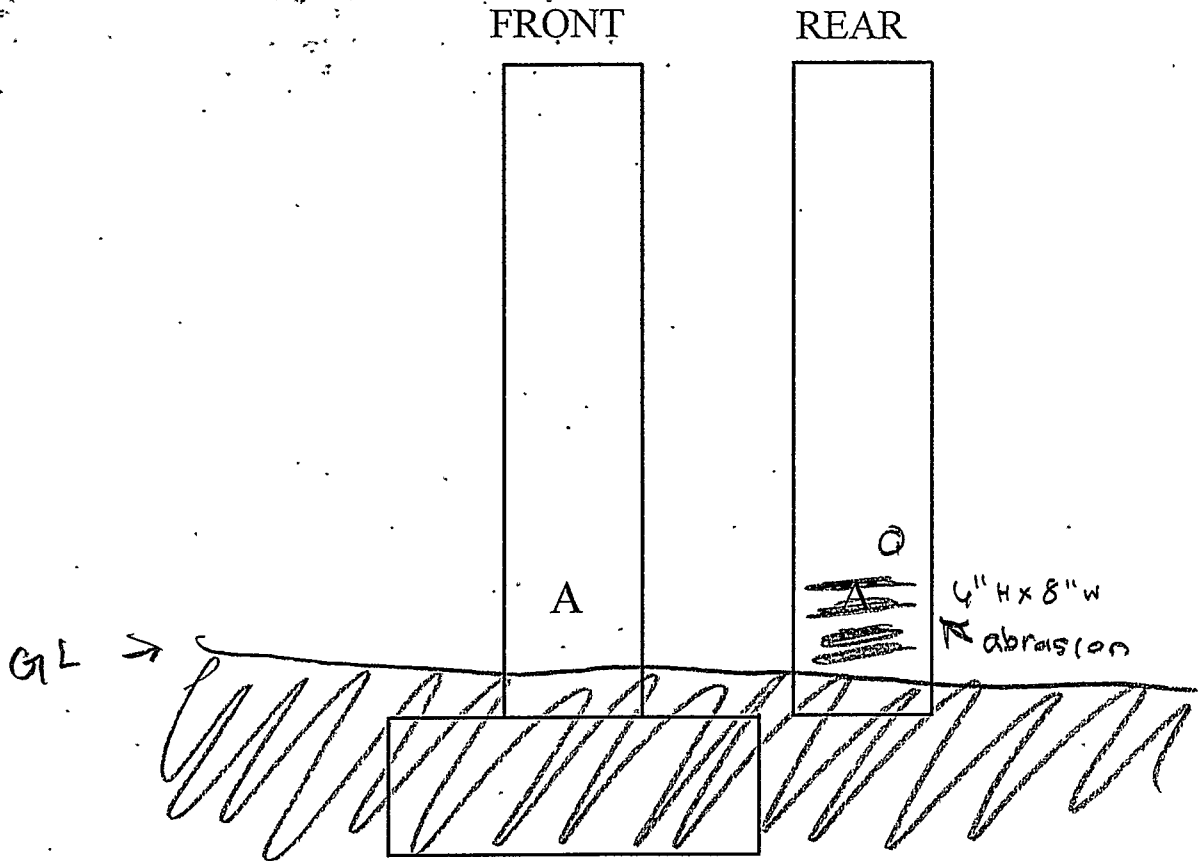
ELEMENT	RATING	COMMENT
BEARING	(G) F P C	
CAP	(G) F P C	- texture coat peeling
WINGS	(G) F P C	- texture coat peeling
PILES	G F P C	N/V
EMBANKMENT	(G) F P C	
VEGETATION	G (F) P C	- tree/vine overgrowth
RIP-RAP	G F P C	N/A
SLOPE PAVING	(G) F P C

ELEMENT	RATING	COMMENT
COLUMN	Ⓒ F P C	- See ①
FOOTING	G F P C	N/V
SLOPE PAVING	Ⓒ F P C	
	G F P C	
	G F P C	
	G F P C

light
① abrasion

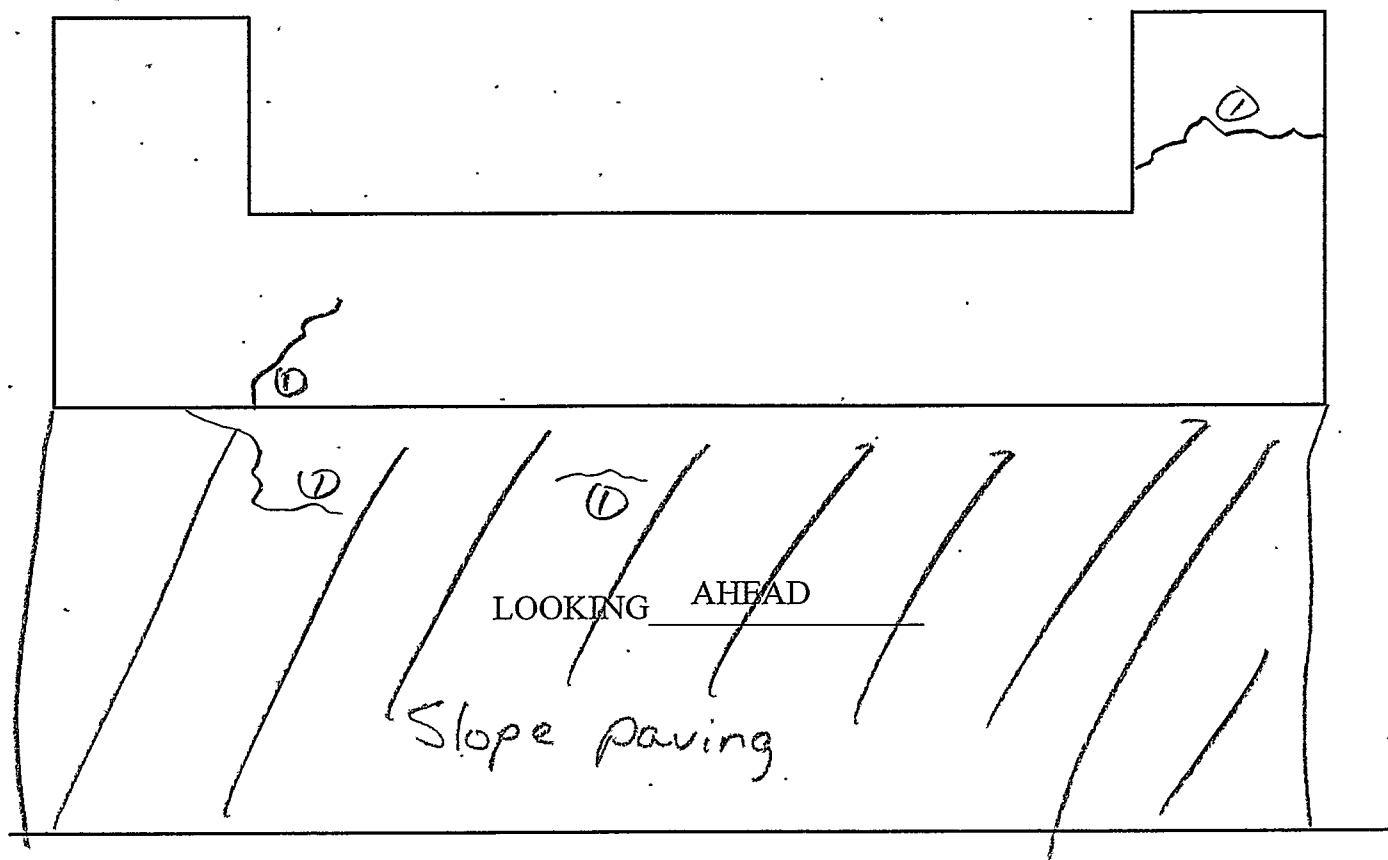
ABUT. NO. 2

ELEMENT	RATING	COMMENT
BEARING	G F P C	① Hairline Crack
CAP	(G) F P C	(1)
WINGS	(G) F P C	(1)
PILES	G F P C	
EMBANKMENT	(G) F P C	
VEGETATION	G F (P) C	Tree growth
RIP-RAP	G F P C	
SLOPE PAVING	(G) F P C	(1) Note: Texture coat peeling slightly
