Region 04, 79 - Shelby County

I-40 Crossing I-40 E.B. / N WATKINS ST

90 - LAST INSPECTION DATE 11/04/2024

| IDENTIFICATION | |
|---|--|
| (8) Structure Number | 79I00400069 |

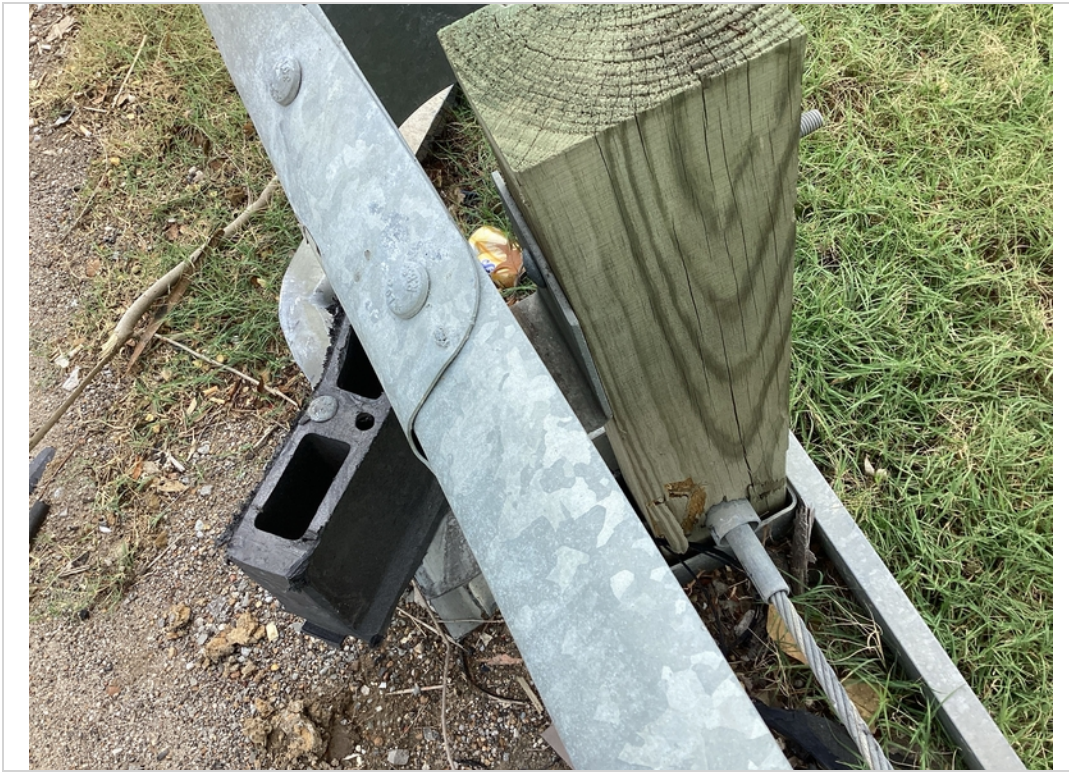
Approach 2 right is not attached

Approach 2 right terminal not attached

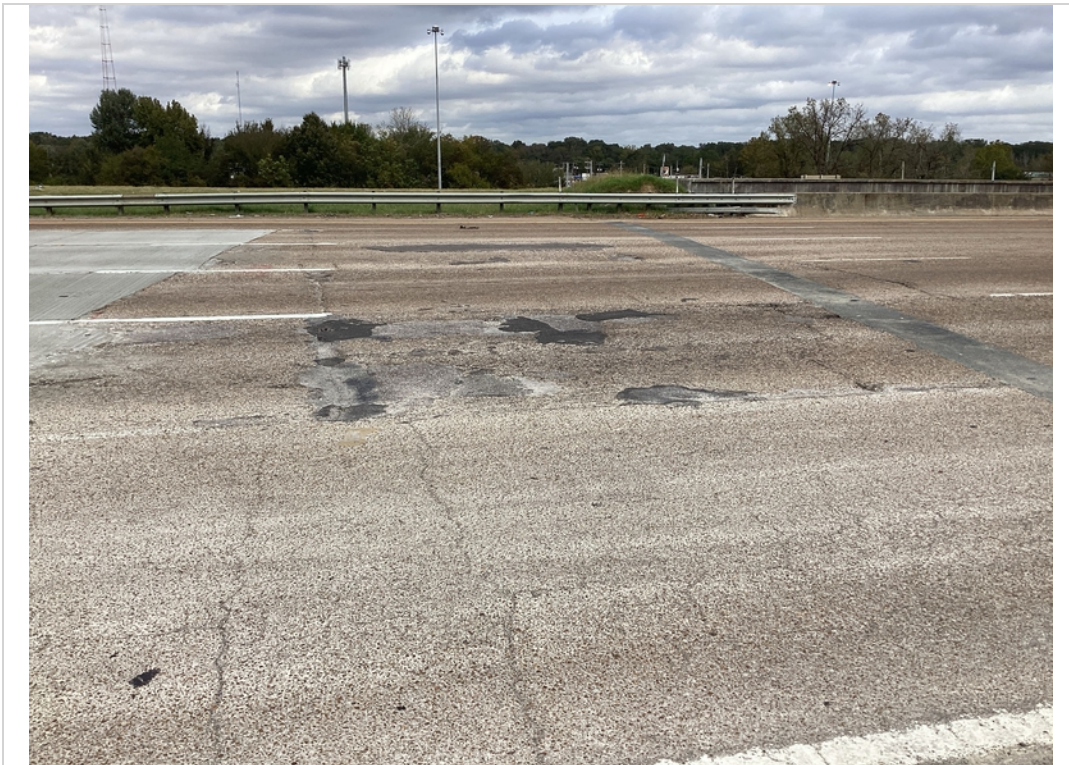
Approach 1&2 have 1/2" cracks,spall,and rough patching

Approach 1 asphalt

| Date Added | Recommendation | Priority |
|---|---|---|
| 09/30/2020 | LEVEL THE WEARING SURFACE AT BOTH APPROACHES. | |

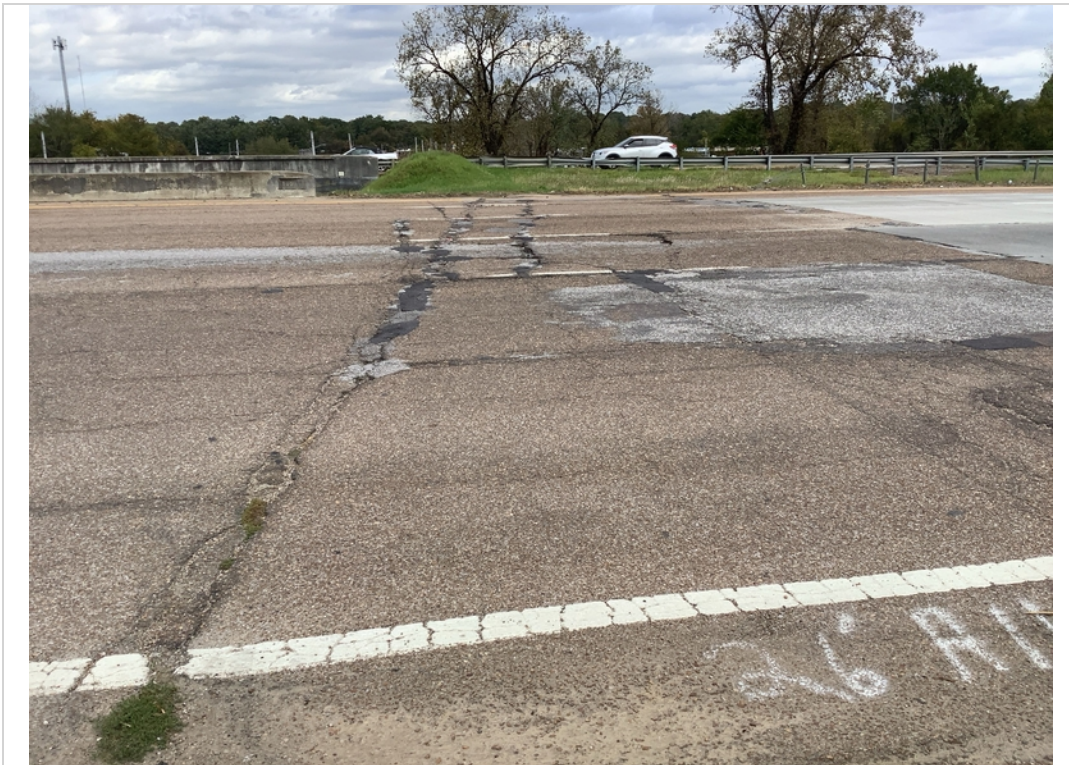
Approach 2 pavement

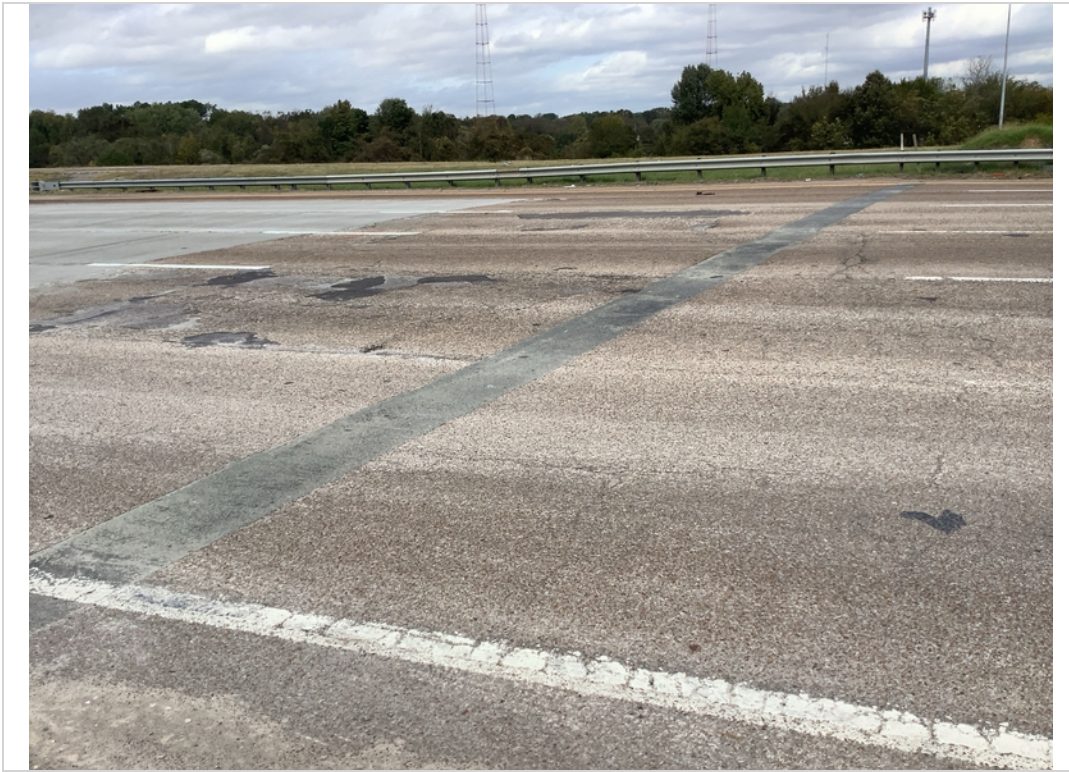
Approach 1 pavement

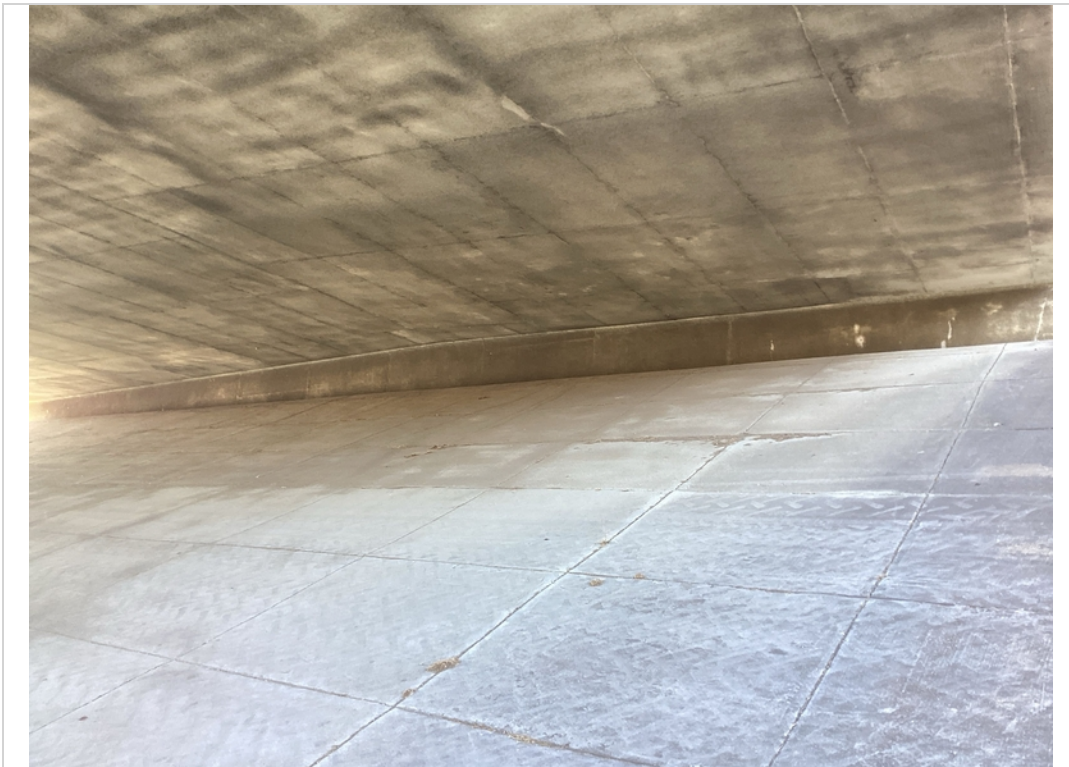
Abutment 1 cap

| ELEMENT | RATING | COMMENTS |
|---|---|---|
| CAP | G [Ⓢ] F P C | up to 1/16" cracks with eff. |

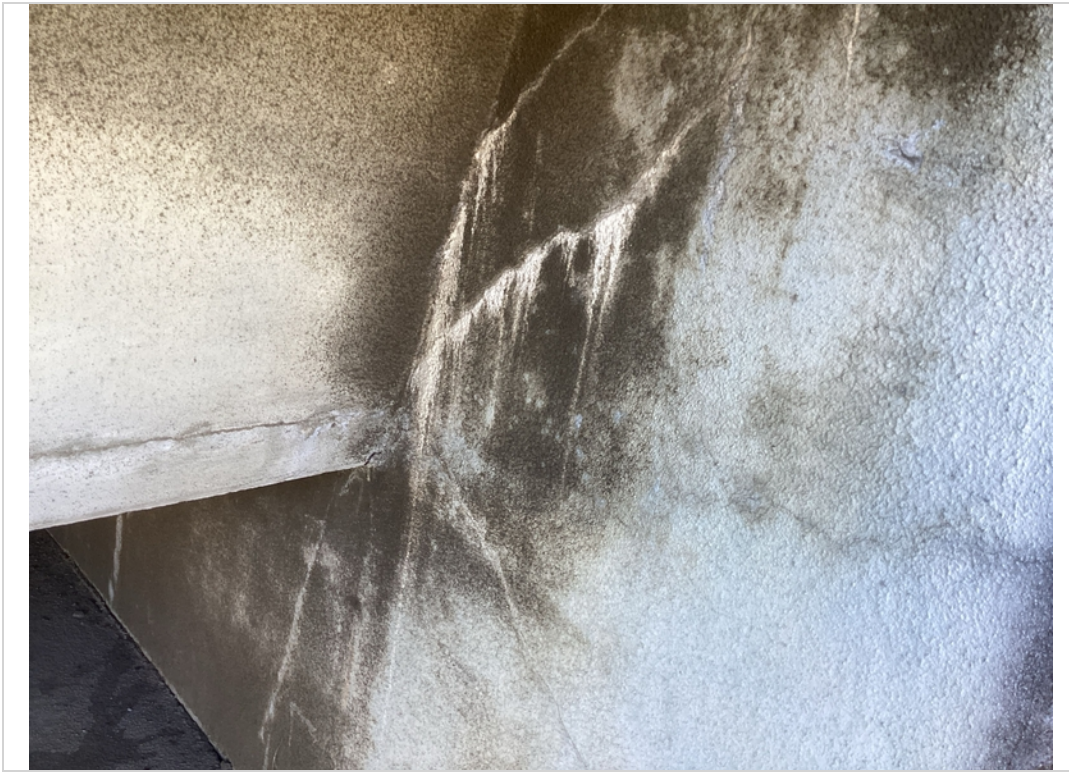
| Abutment Caps | (Fair) | 1/8" cracks with efflorescence |

Abutment 1 crack

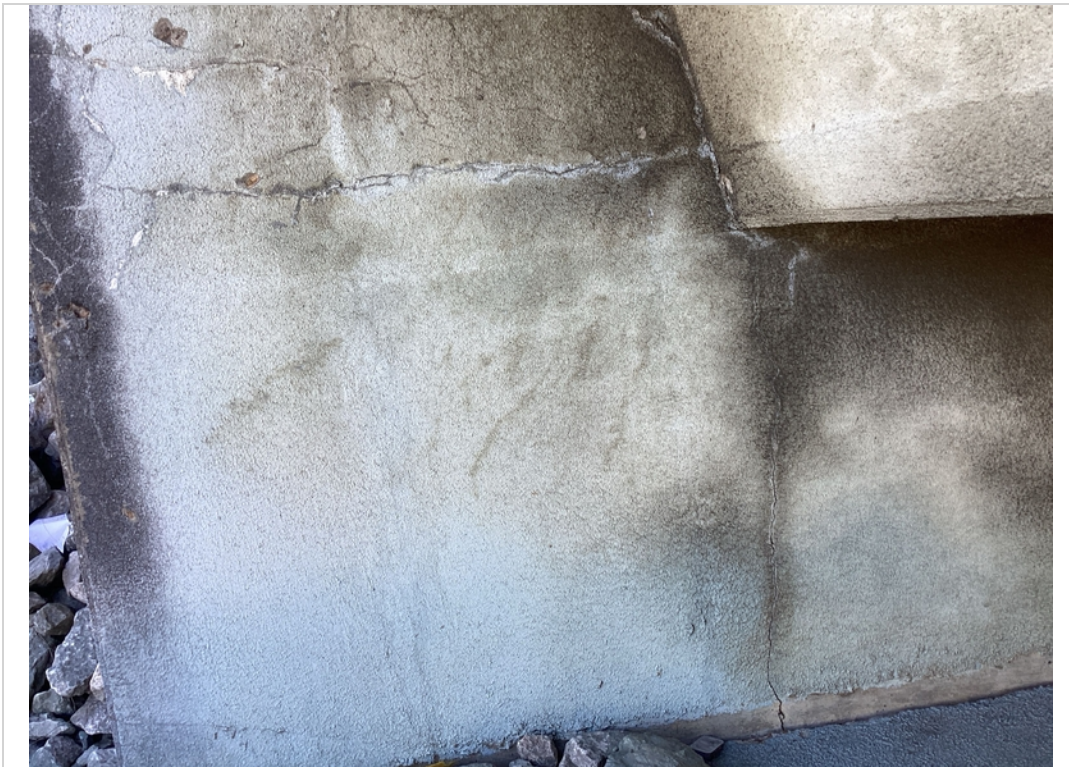
Abutment 2 , 1/8" cracks

| CAP | G (F) P C | 1/8" cracks w/eff |

| WINGS | G (F) P C | 1/8" cracks w/eff |

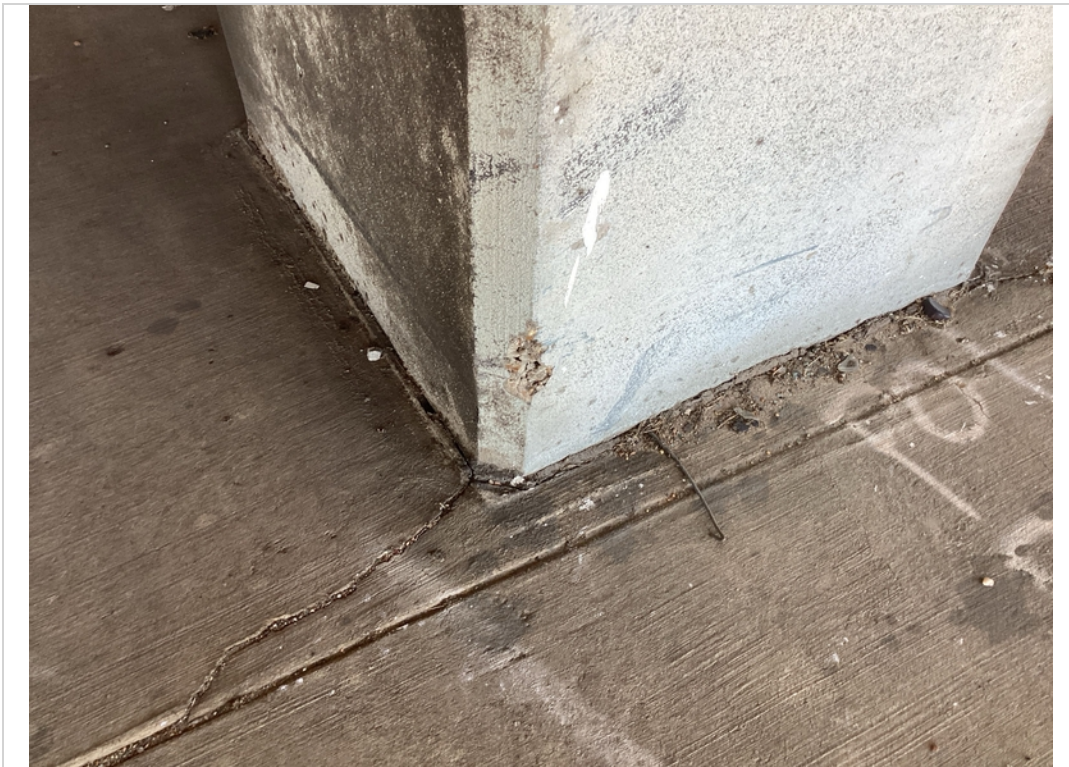
Bent 1 , stem C , damage

D Damage

7"4x3" W x 1/8" D

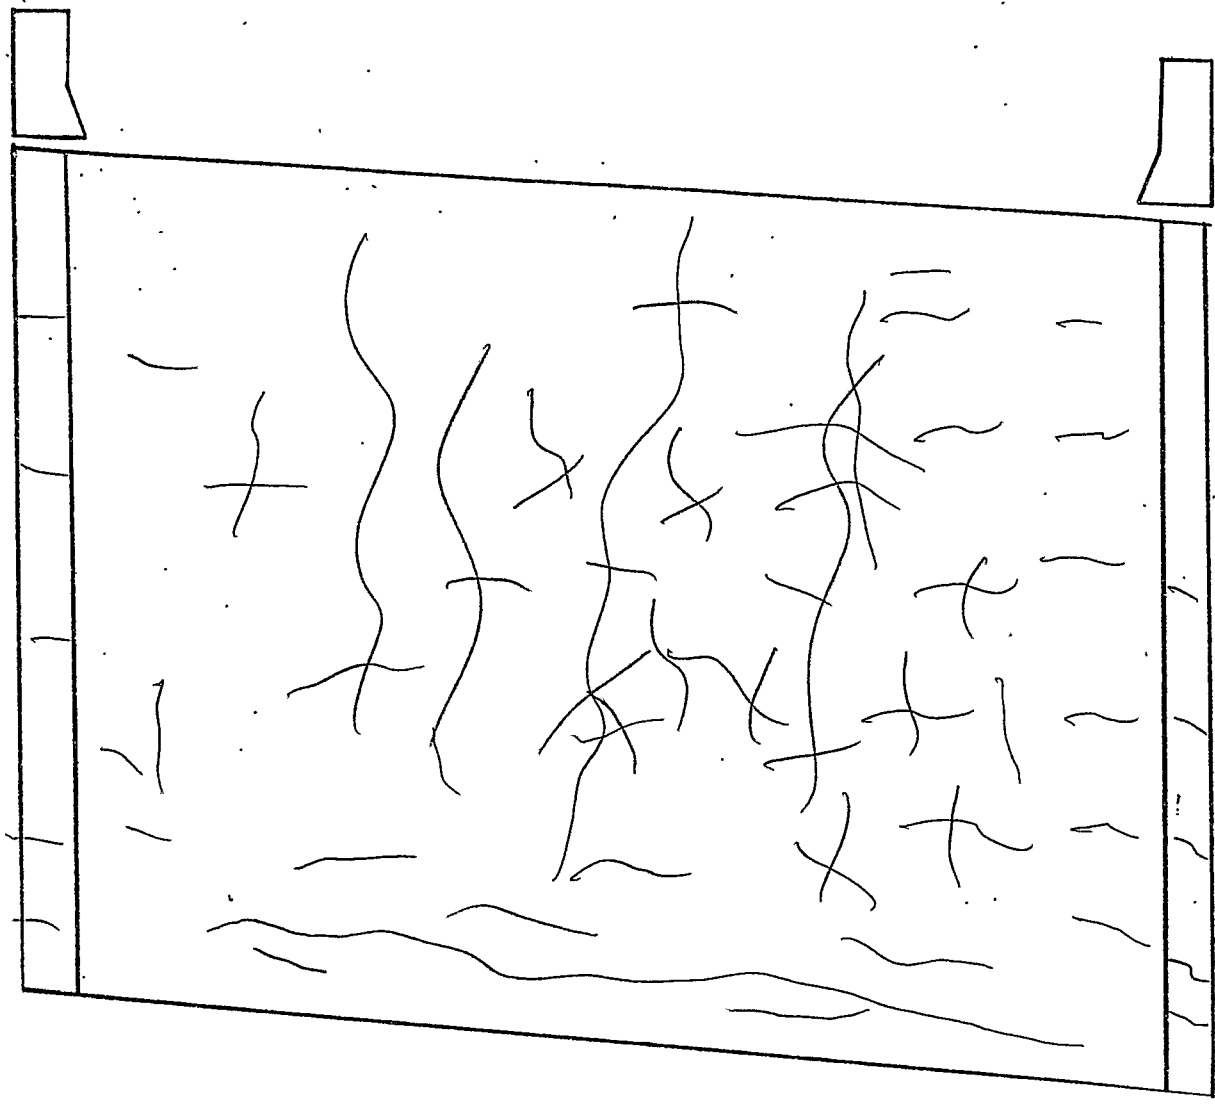
SPAN NO 1

upto. 1/8" cracking
Hairline cracks

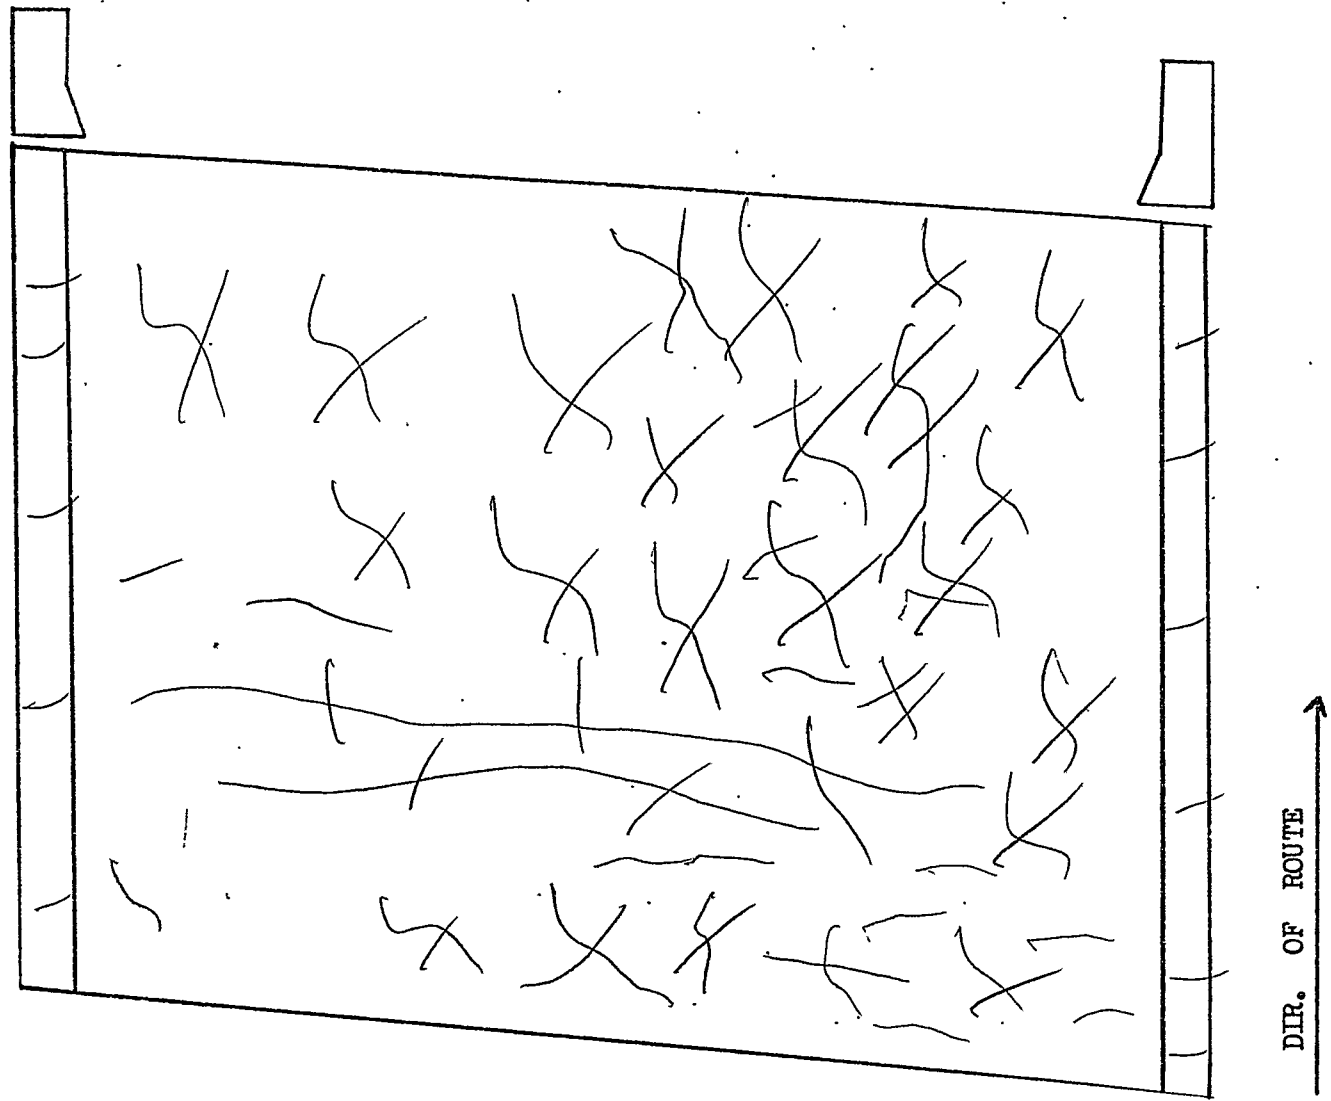
SPAN NO. 2

upto 1/8" cracks
upto 1/32" cracks

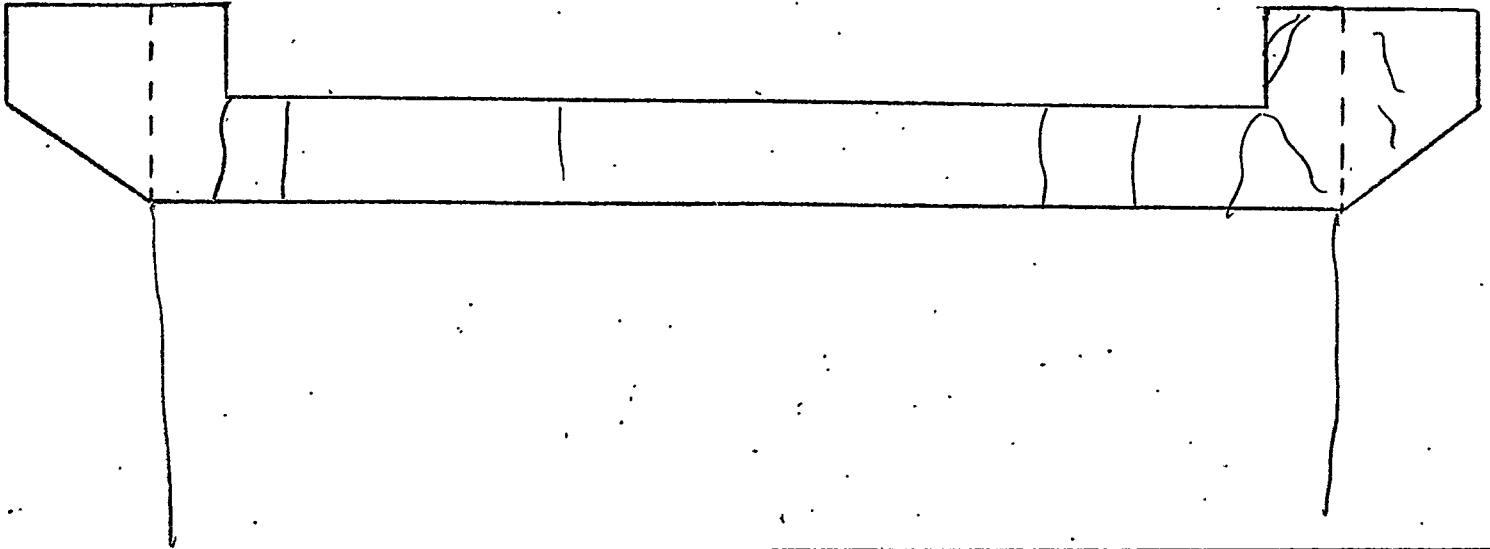
ABUT. NO. 1

| ELEMENT | RATING | COMMENTS |
|---|---|---|
| WINGS | (G) F P C | horizontal crack with eff |
