I-40 Crossing I-40 W.B. / N WATKINS ST

90 - LAST INSPECTION DATE 11/04/2024

IDENTIFICATION	
(1) State Names	47 - Tennessee
(8) Structure Number	79I00400070
(5) Inventory Route	1
(2) Highway Agency District	Region 4
(3) County Code	79 - Shelby

Inspection Team's Summary

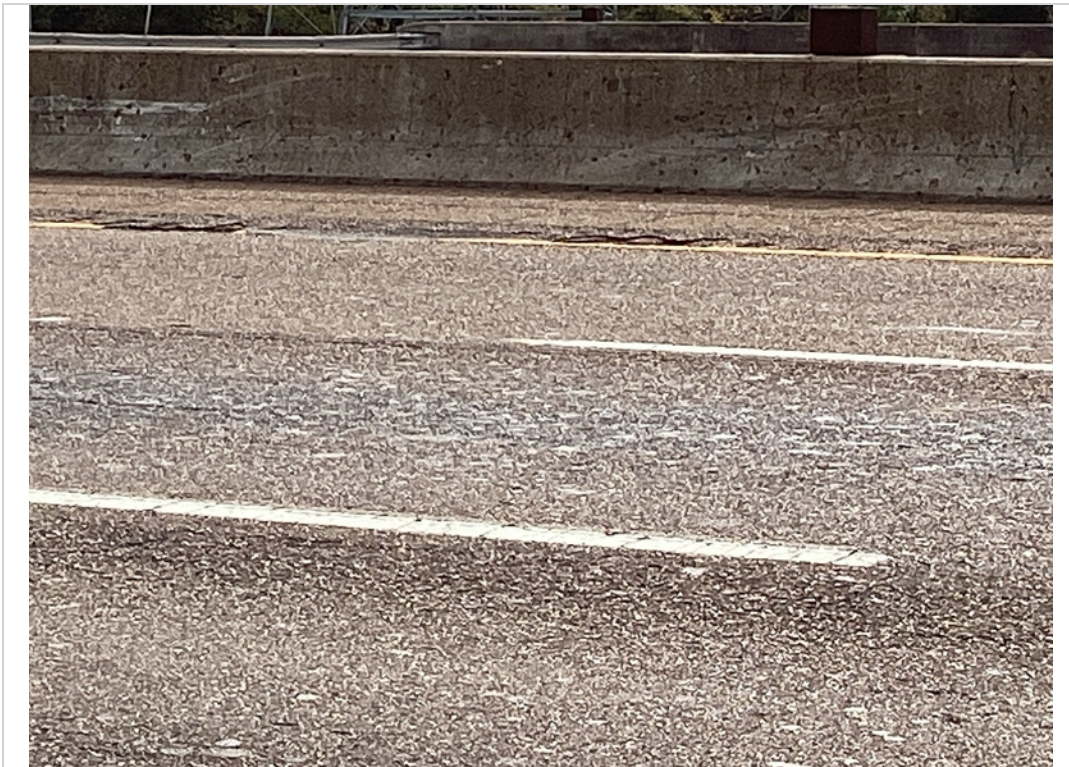
Wearing Surface Type		Asphalt	Wearing Surface Depth	4
Wearing Surface	(Fair)	Up to 1/16" cracks and potholes		
Deck - Structural Condition	(Good)			
Parapet	(Fair)	Hairline cracks

Span 1 potholes

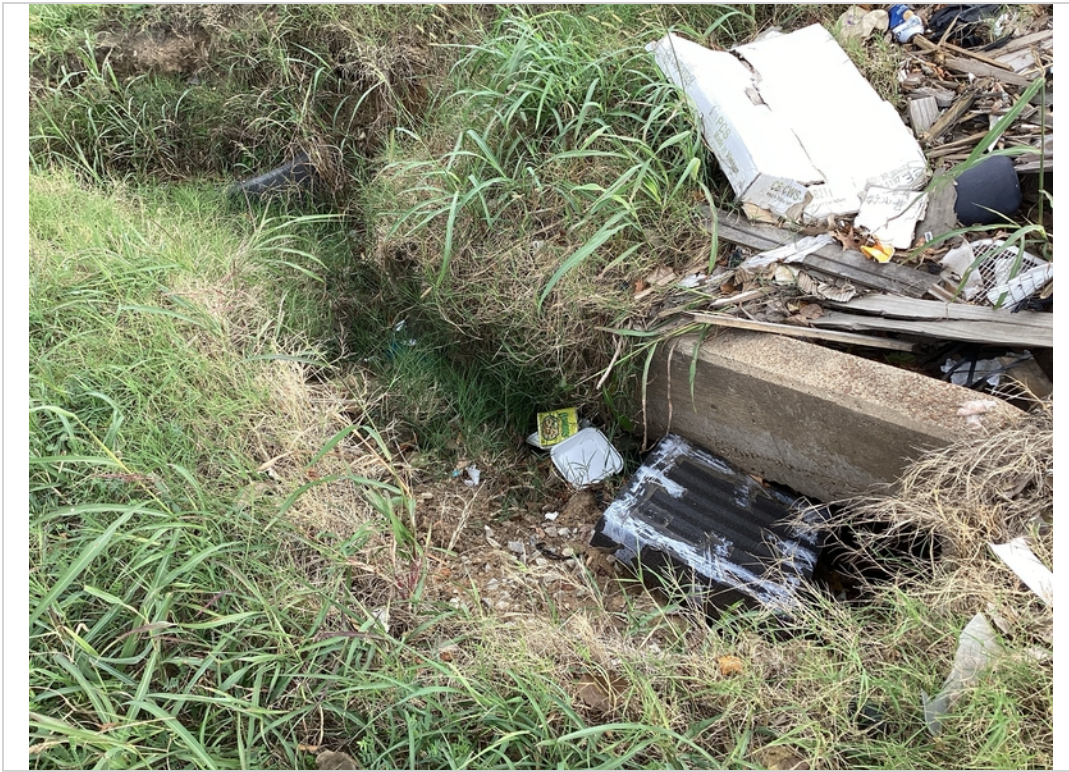
Approach 1 left embankment has heavy washing

Approach 1 left embankment washing

Date Added	Recommendation	Priority
01/15/2015	APPROACH GUARDRAILS ARE SUBSTANDARD	
09/30/2020	LEVEL THE WEARING SURFACE AT APPROACH NO.2	
09/28/2022	REPAIR EMBANKMENT EROSION ON LEFT SIDE OF APPROACH NO.1	
09/28/2022	UNDERPASS SUBSTRUCTURE PROTECTION GUARDRAILS ARE NON-EXISTENT	
09/28/2022	CLEAR APPROACH DRAINS.	
09/28/2022	CUT VEGETATION

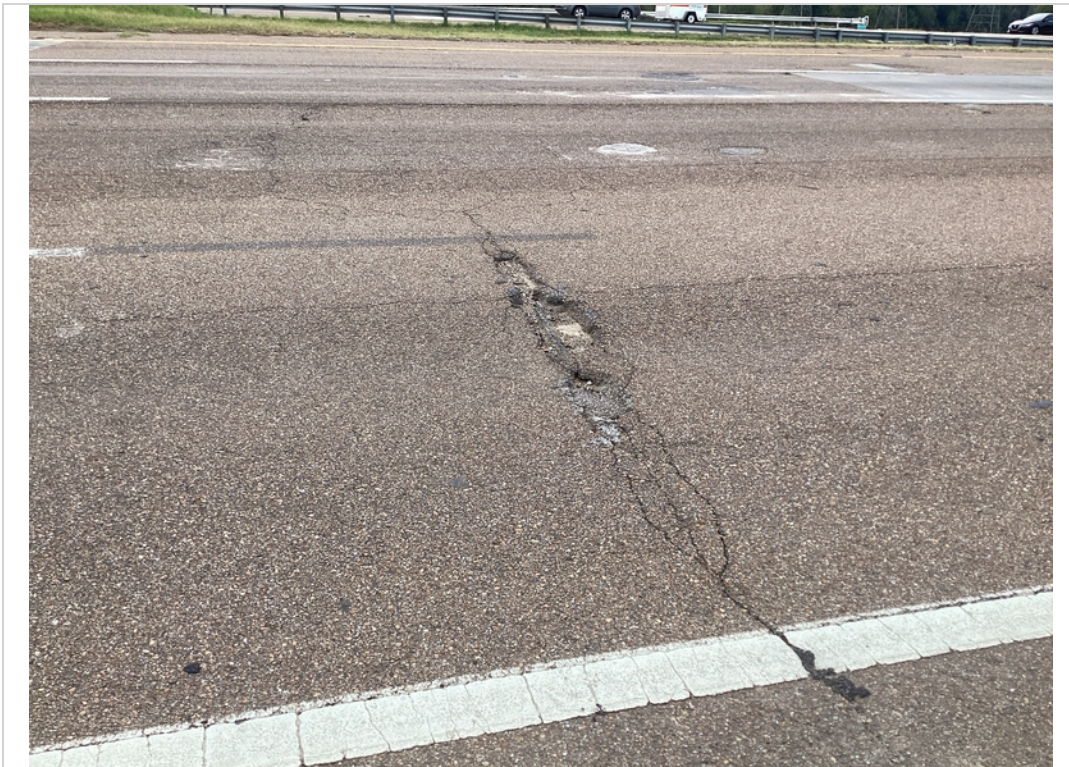
Approach 1&2 have 1/2" cracks and spall

Approach 1 asphalt

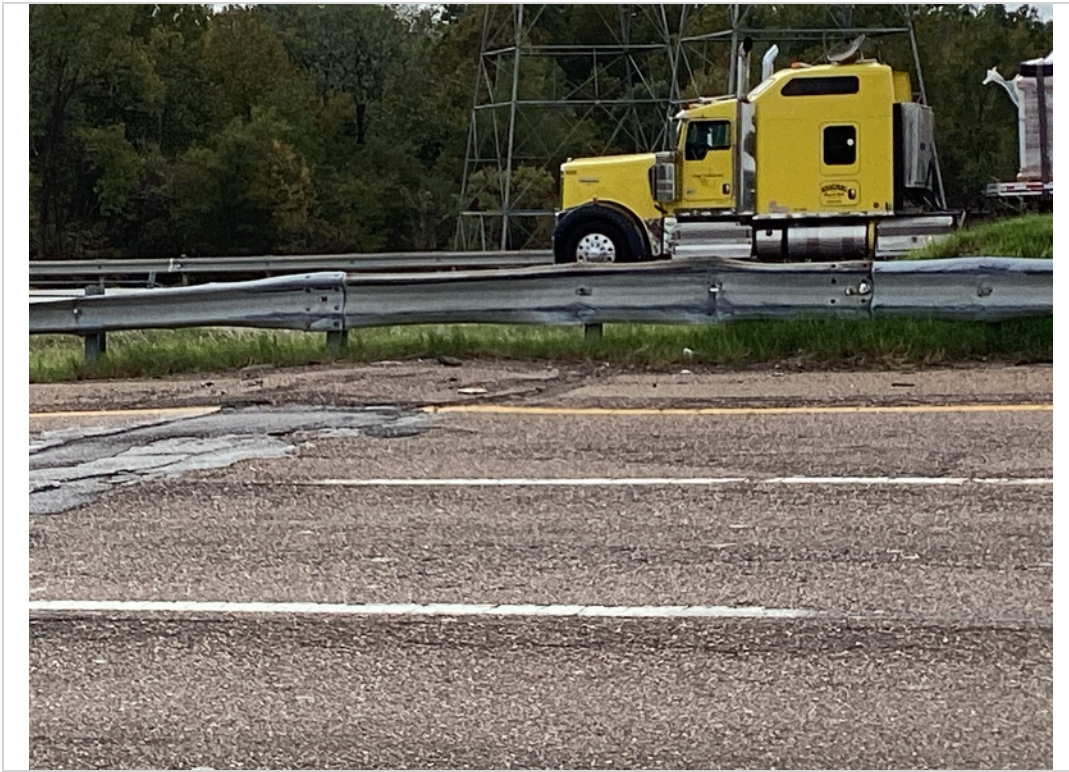
Approach 2 right transition damage

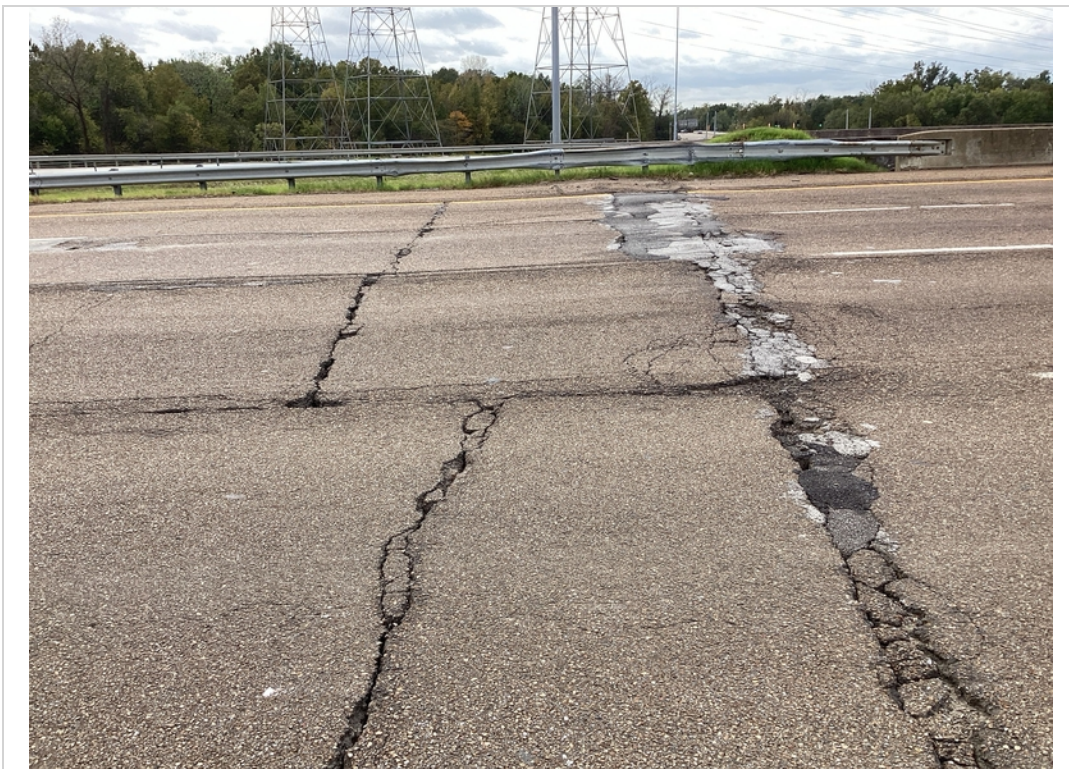
Approach 2 asphalt

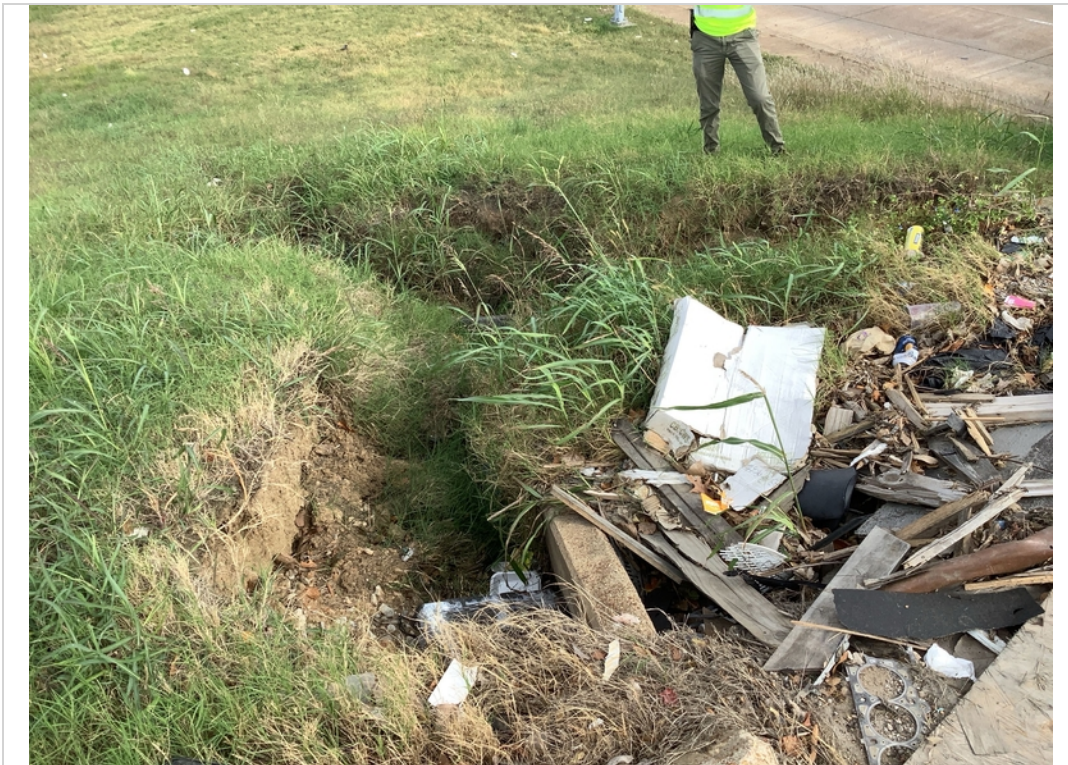
Approach 1 left embankment washing

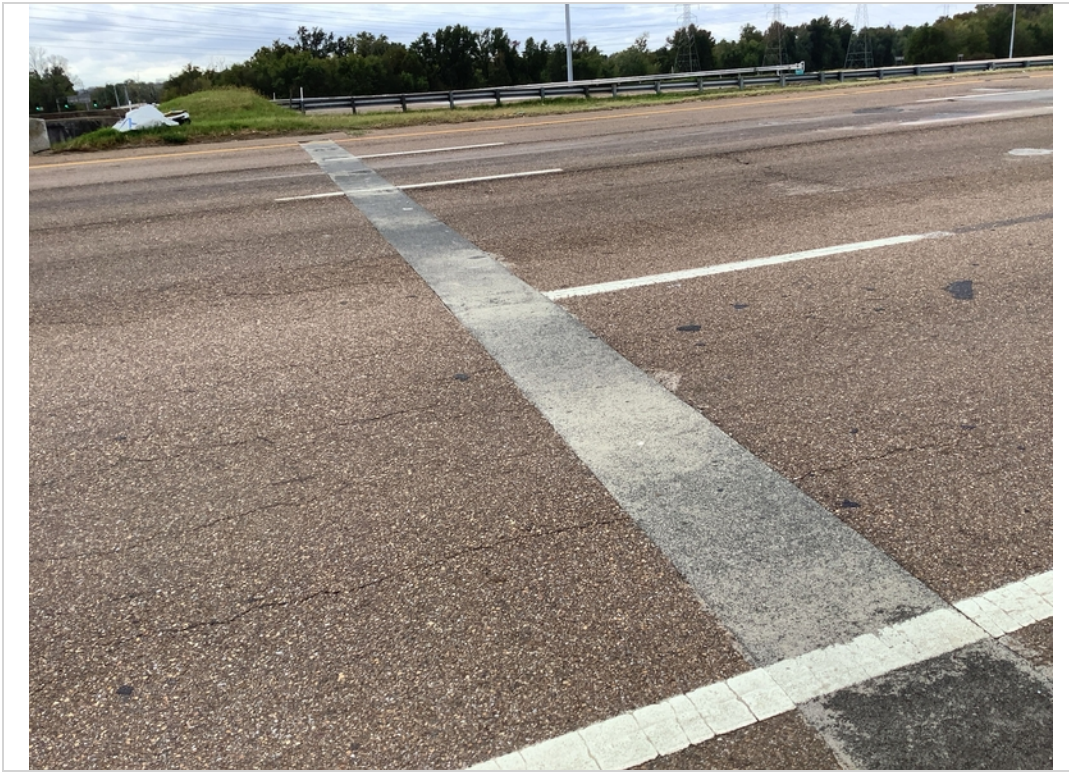
Approach 1 pavement

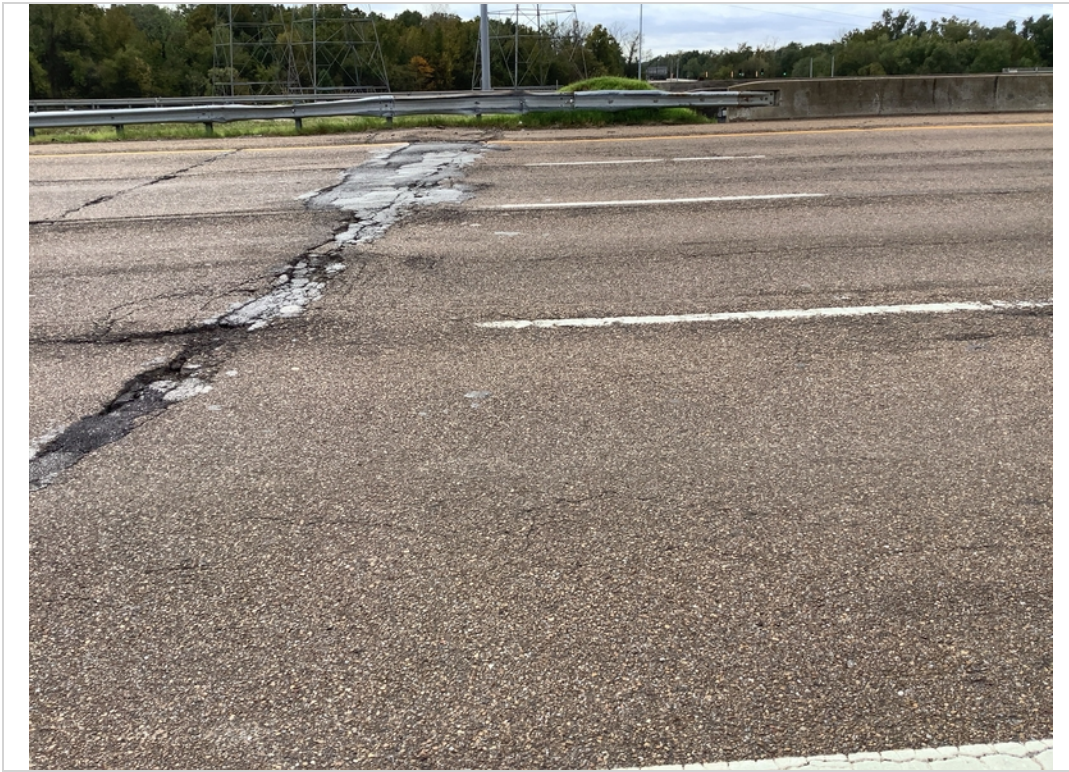
Approach 2 pavement

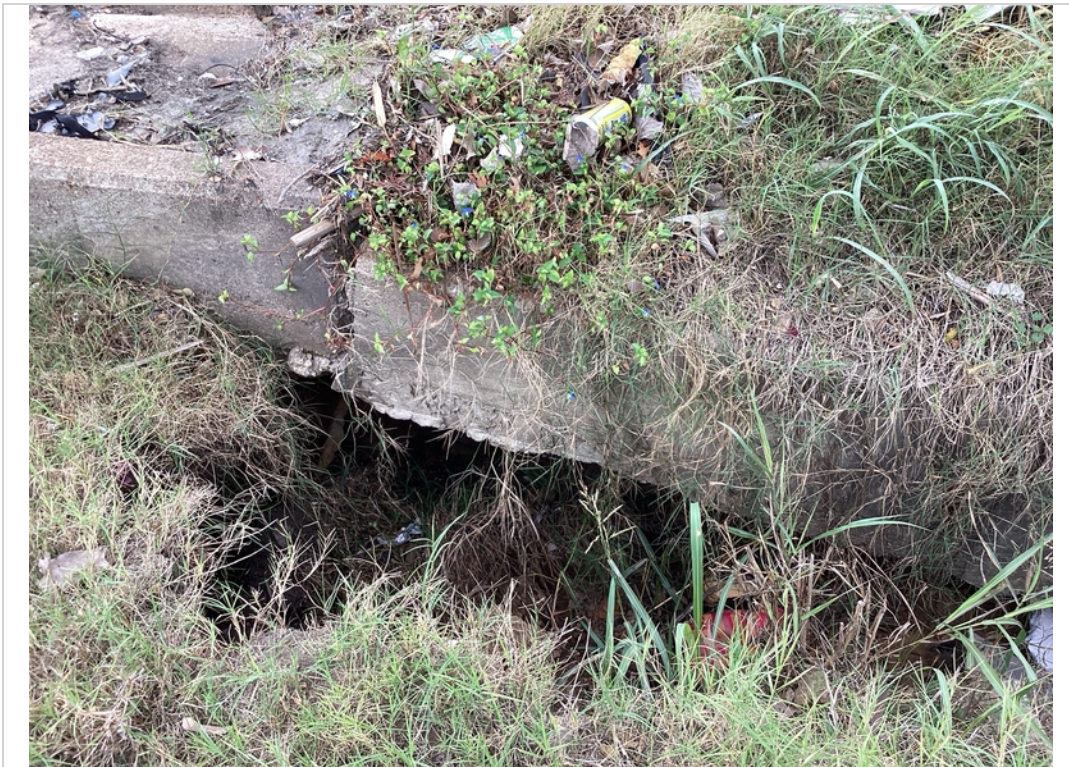
Approach 1 left embankment washing below and under drain

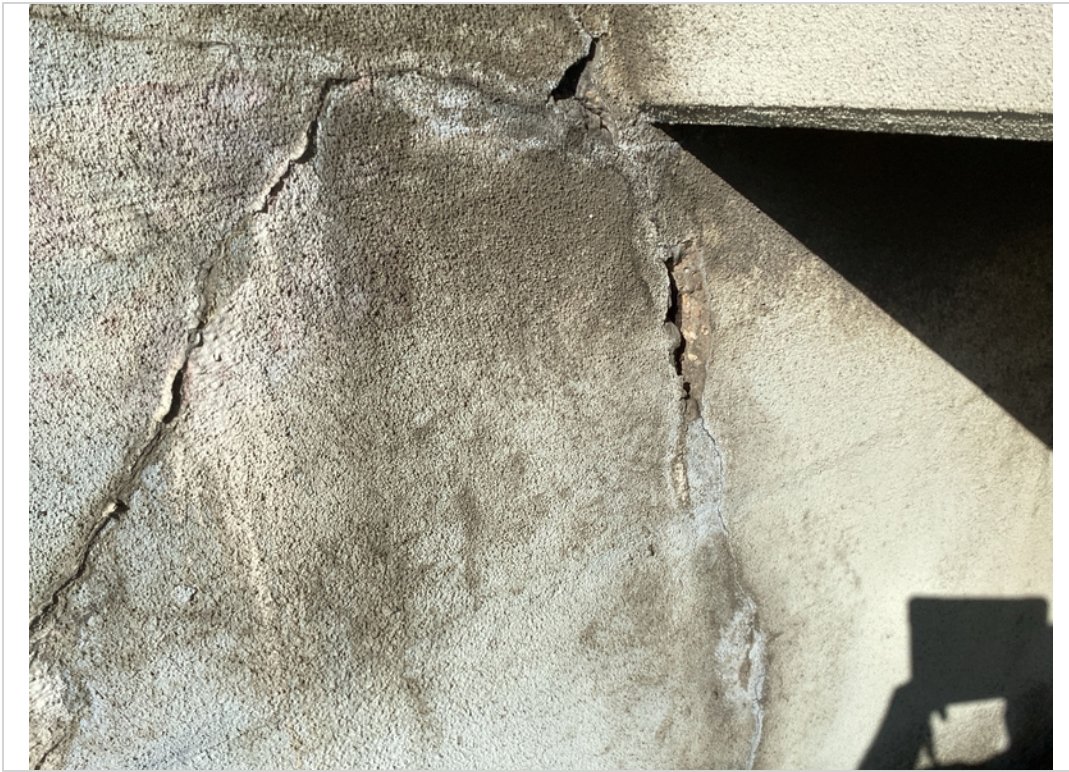
Abutment Caps	(Fair)	1/4" cracks with efflorescence , spalling
Abutment Wings	(Fair)	1/4" cracks
Abutment Backwall	(Good)	
Abutment Plumb	(Good)	
Abutment Piles	(Not Visible)	
Abutment Embankment	(Good)	
Abutment Bearing Surface	(Good)	
Abutment Slope Paving	(Good)

Abutment 1 spall to steel

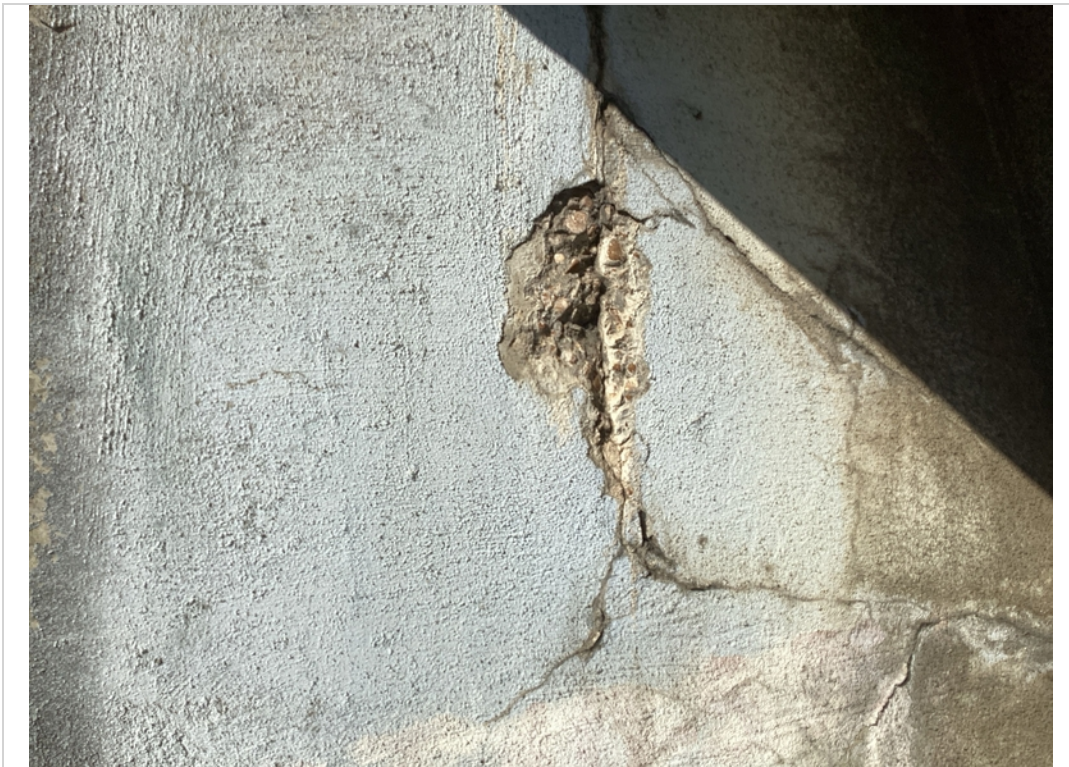
Abutment 1 spall

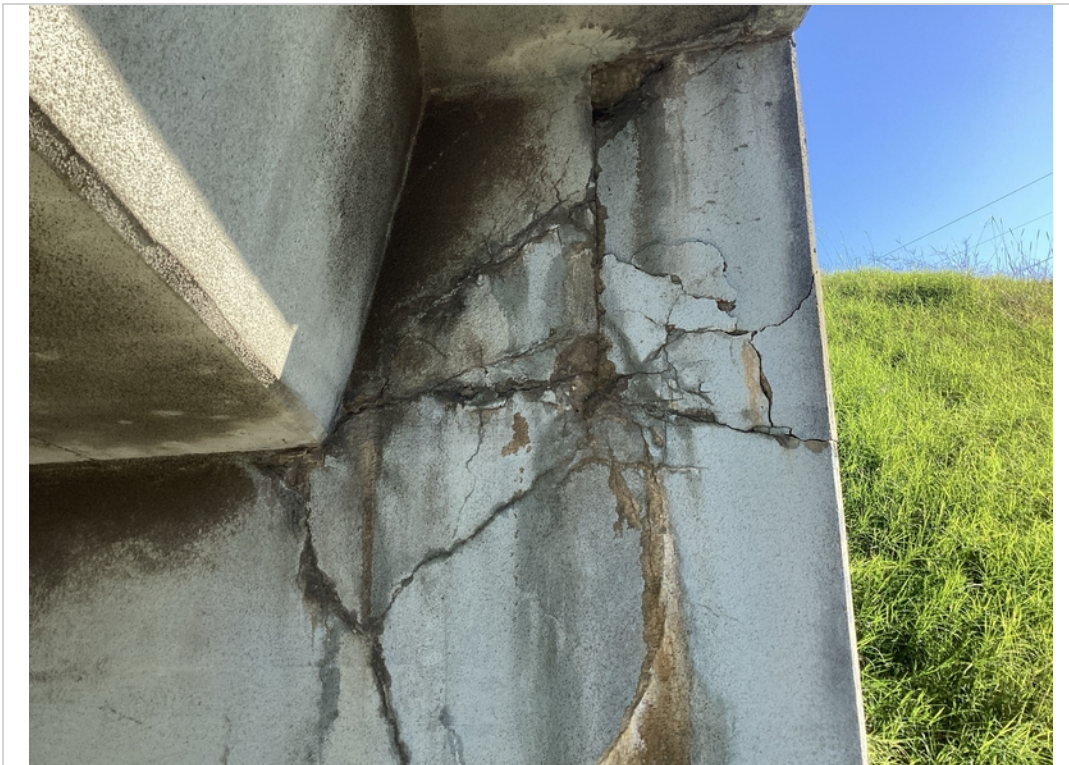
Abutment 2 , impending spall , spalling , 1/4" cracks

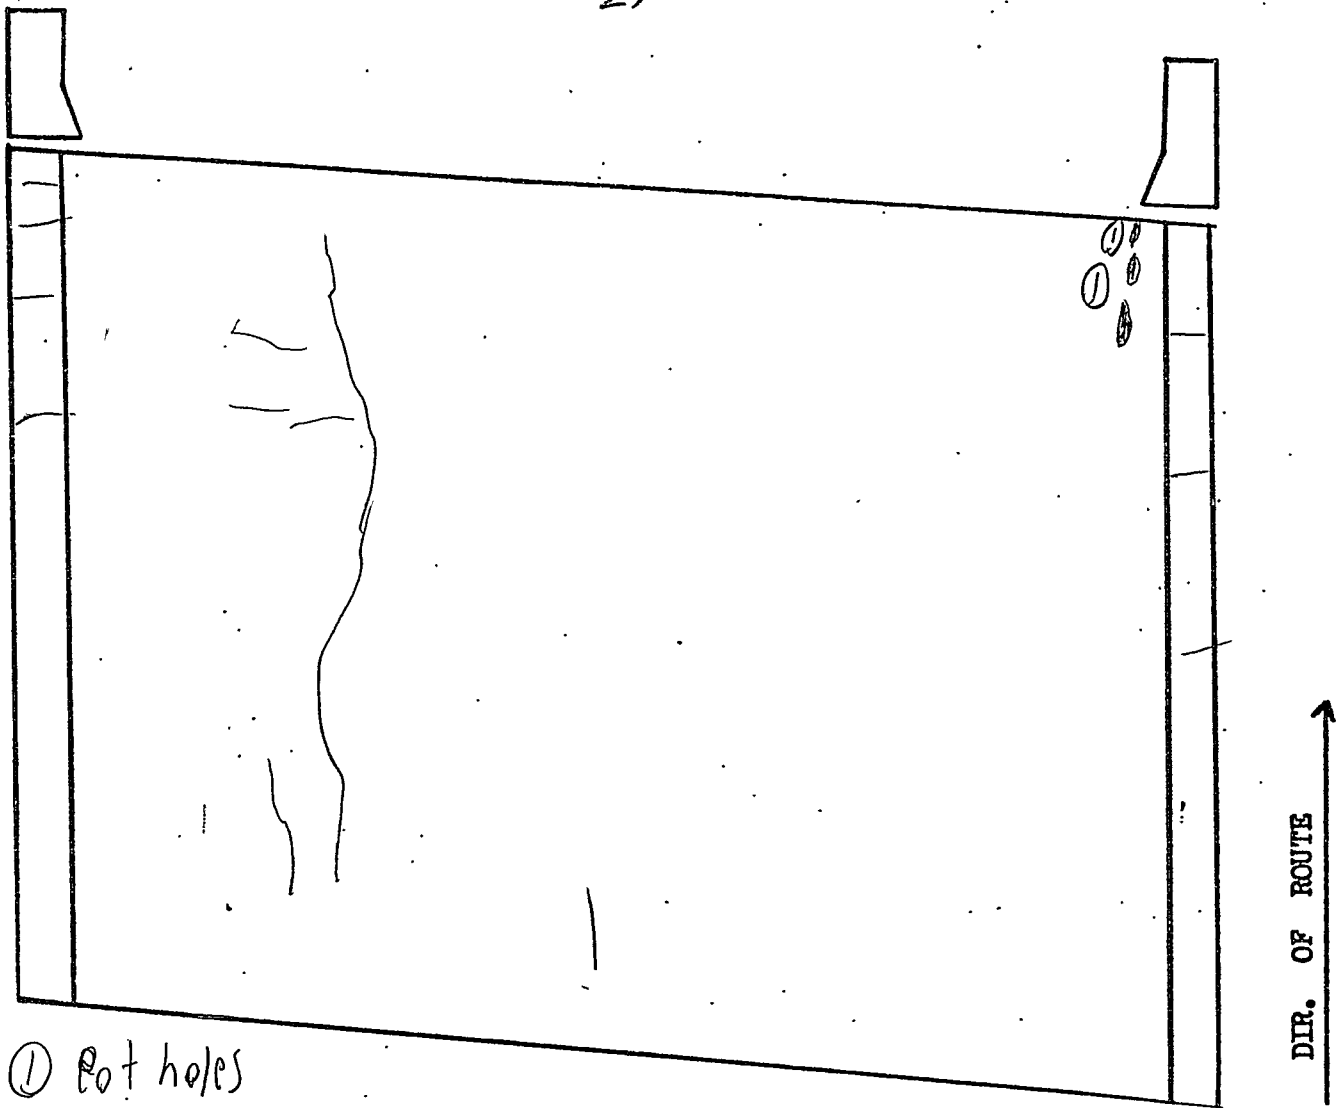
① Pot holes
upto 2' L x 1' W x 1" D

DECK	G	F	P	C	See ① & upto 1/16" cracks Hairline cracks
PARAPET	G	F	P	C	
DRAINS	G	F	P	C	
JOINTS	G	F	P	C	
RAILS	G	F	P	C

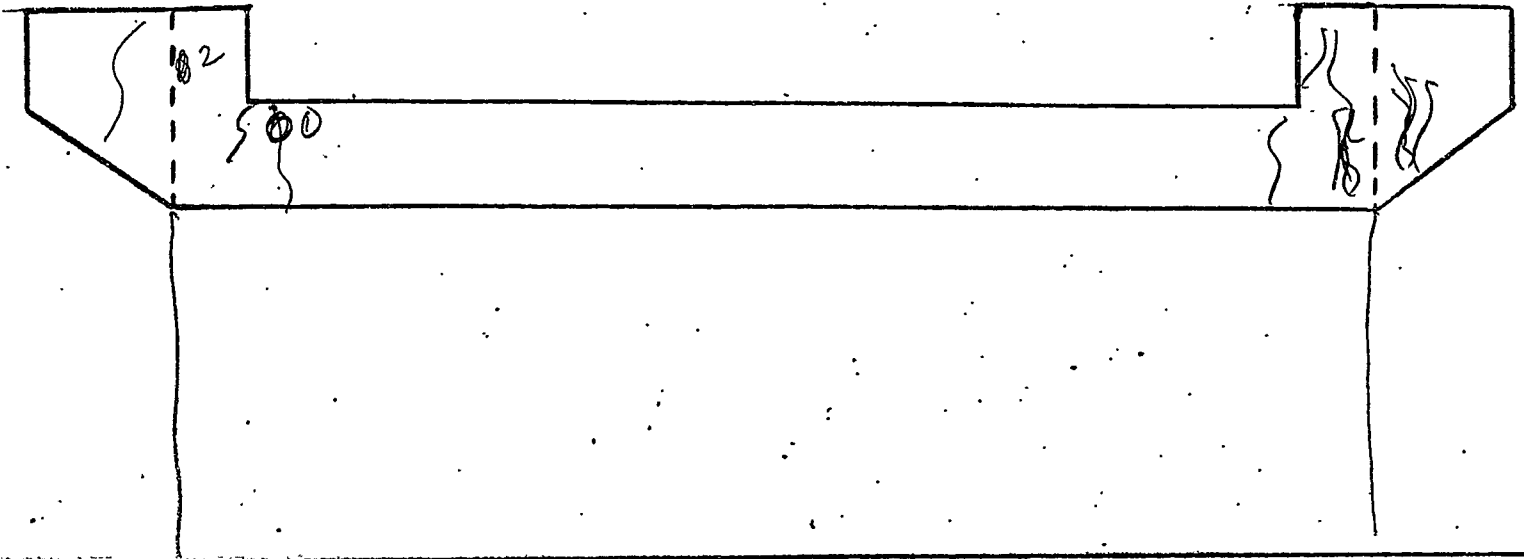
ABUT. NO. 1

② Spall 10' x 10' x 1/2' deep
5" w 1/2" deep

① Spall to steel 2" w 1" deep
6" w 1/2" deep
LOOKING BACK

MENT	RATING	COMMENTS
BEARING	G F P C	NIV
PAINT	G F P C	N/A
CAP	G F P C	① ② Hairline cracks with eff.
WINGS	G F P C	Hairline cracks with eff.
EMB.	G F P C	
VEG.	G F P C	
RIP-RAP	G F P C	
SLOPE PAV.	G F P C	
BACKWALL	G F P C

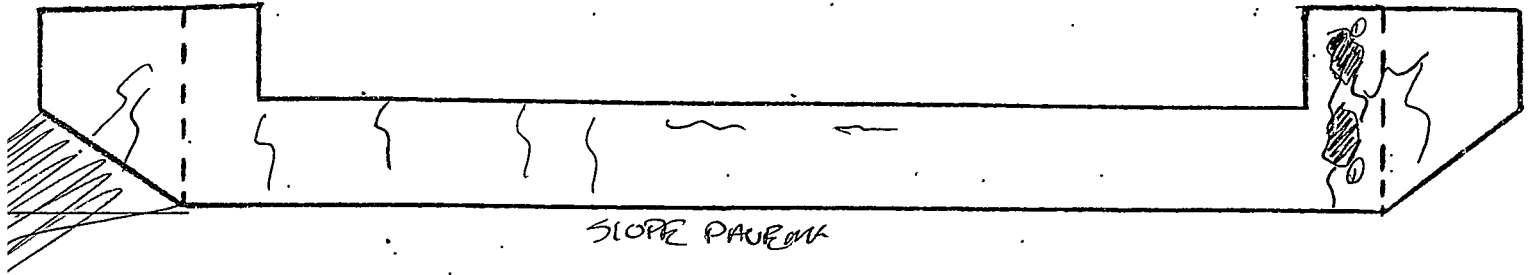
ABUT. NO. 2

MENT	RATING	COMMENTS
BEARING	G F P C	N/V
PAINT	G F <u>P</u> C	75% missing
CAP	G <u>F</u> P C	See (1), 1/4" cracks
WINGS	G <u>F</u> P C	1/4" cracks
EMB.	<u>G</u> F P C	
VEG.	<u>G</u> F P C	
RIP-RAP	<u>G</u> F P C	N/A
SLOPE PAV.	<u>G</u> F P C	
BACKWALL	G F P C

① Spalling
(up to)
1' Ø x 1" Dp
