Region 04, 79 - Shelby County

N. MCLEAN BLVD. Crossing N. MCLEAN BLVD. / I-40

11/04/2024

Inspection Team's Summary

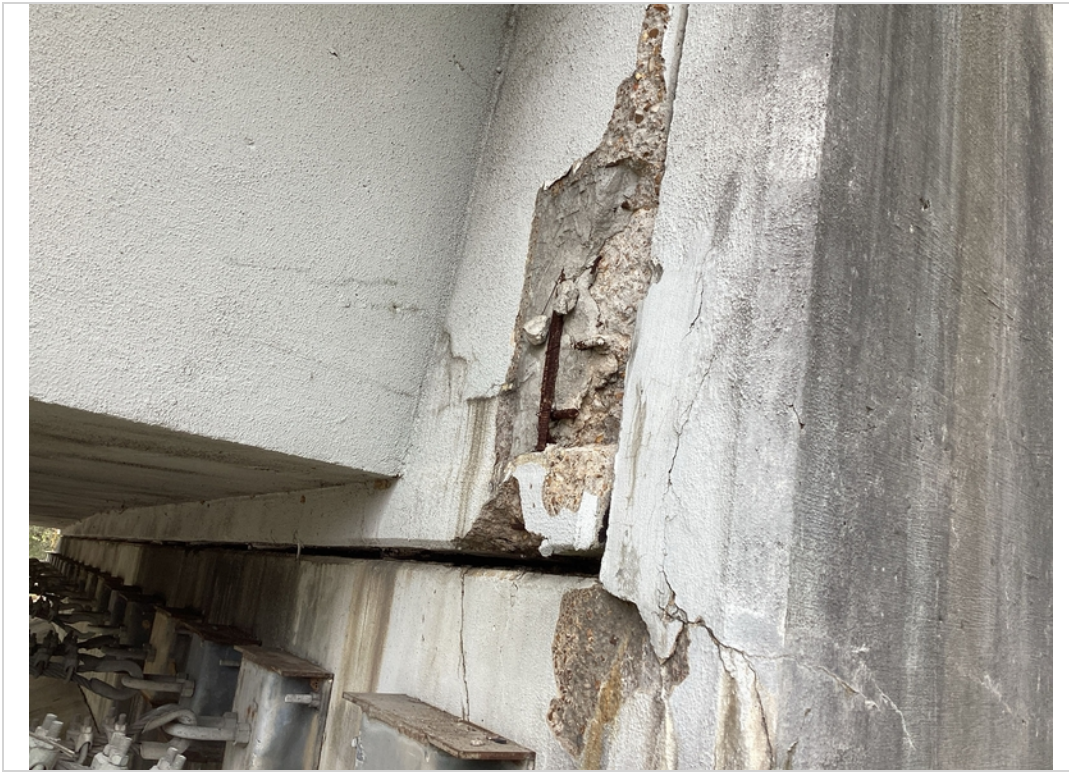
Abutment Caps	(Fair)	Spall to steel & hairline efflorescence cracks
Abutment Wings	(Poor)	Abutment 2 is poor due to heavy spall to steel
Abutment Backwall	(Poor)	Abutment 2 has a large spall to steel area
Abutment Plumb	(Good)	
Abutment Piles	(Good)	
Abutment Embankment	(Poor)	Abutment 2 washing below and under slope paving
Abutment Bearing Surface	(Good)	
Abutment Slope Paving	(Poor)	Abutment 2 washing below and under slope paving

Abutment 2 backwall spall to steel

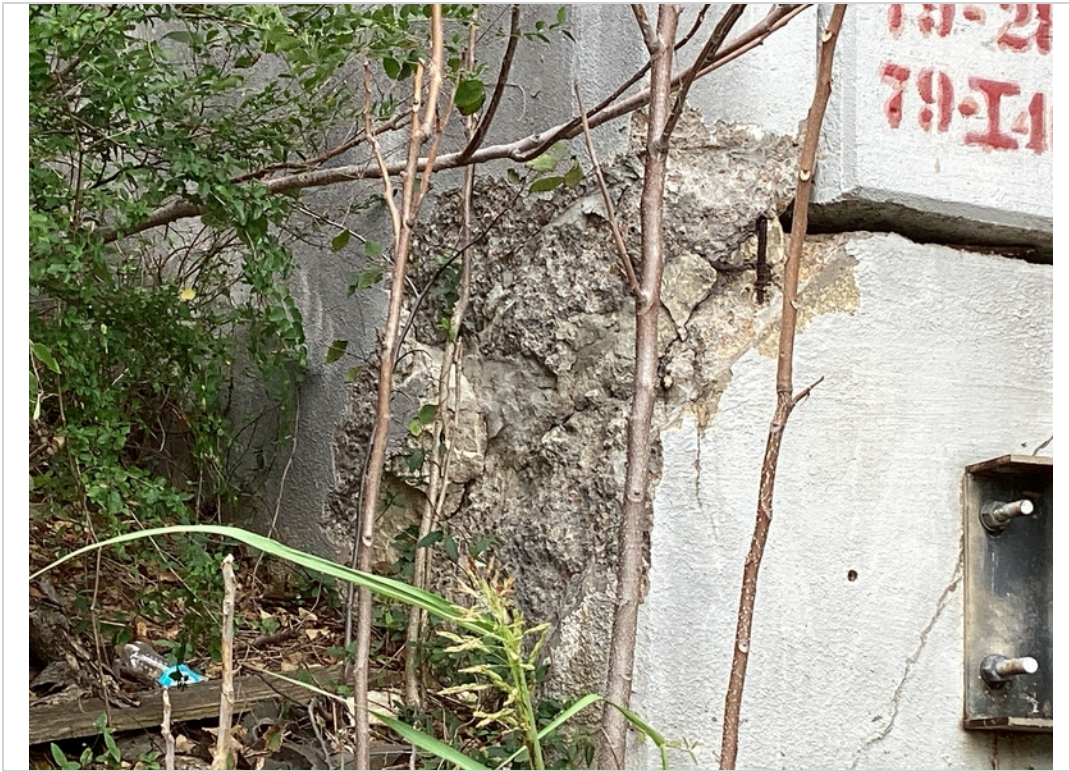
Abutment 1 spall to steel

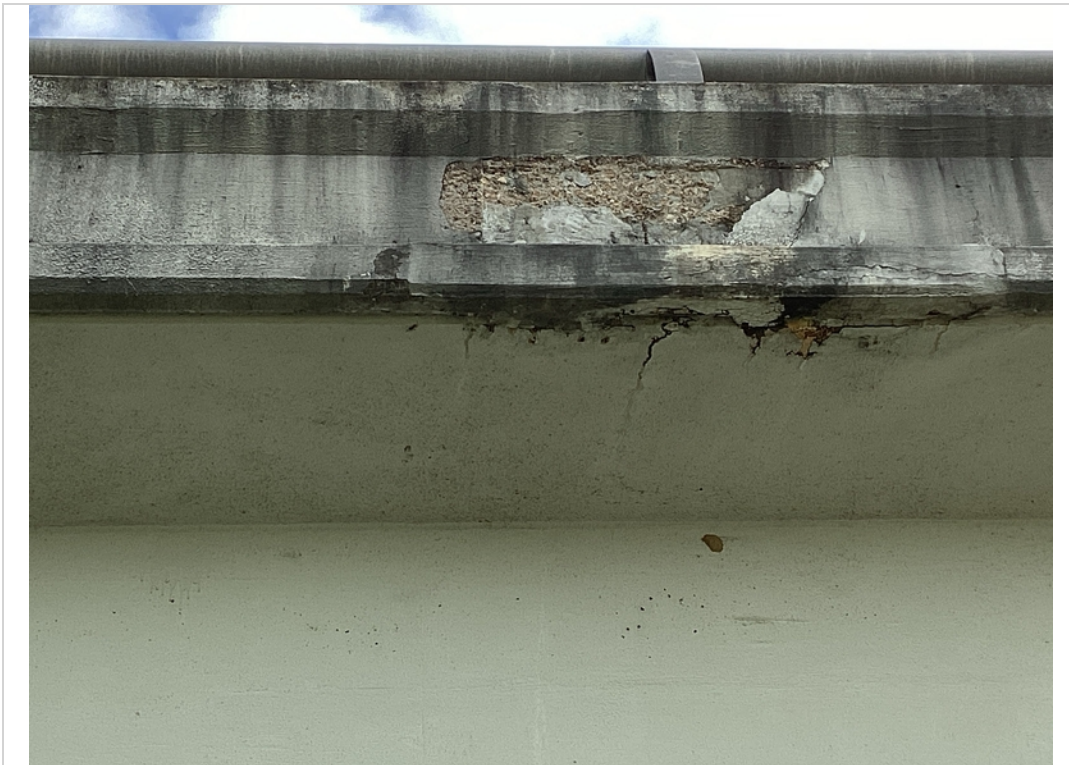
Span 1 overhang spall

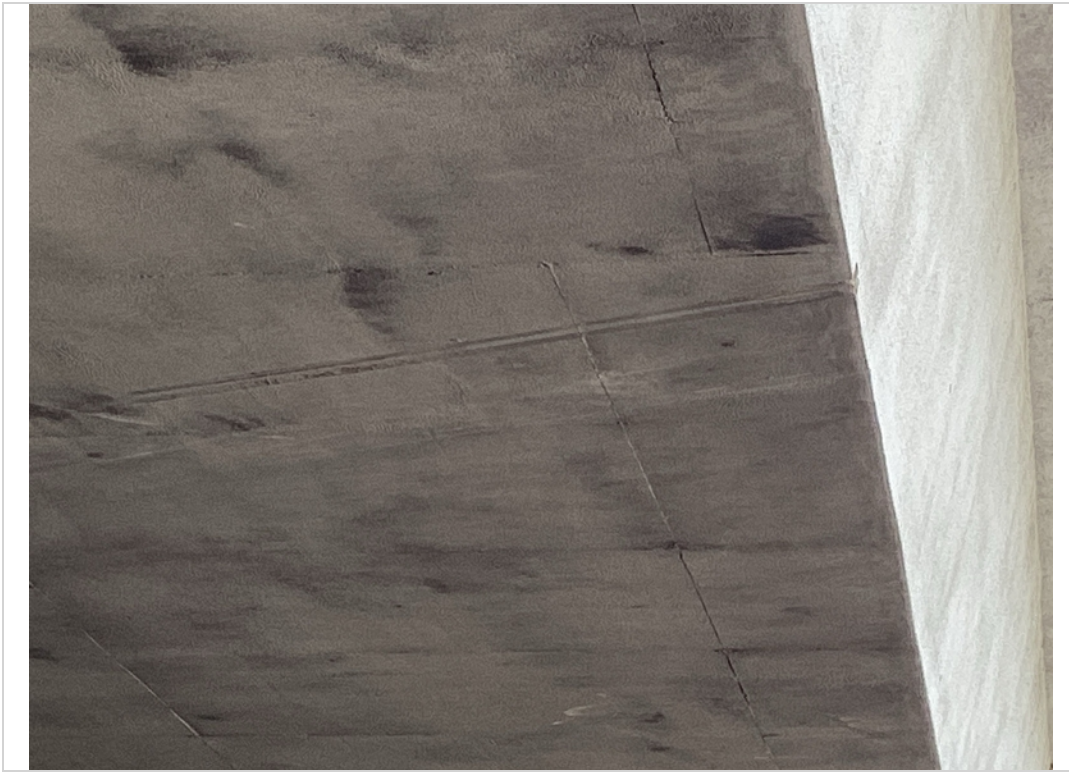
Bearing Devices	(Good)	
Girders	(Fair)	Span 1 has light damage
Alignment of Members	(Good)

Span 1 damage

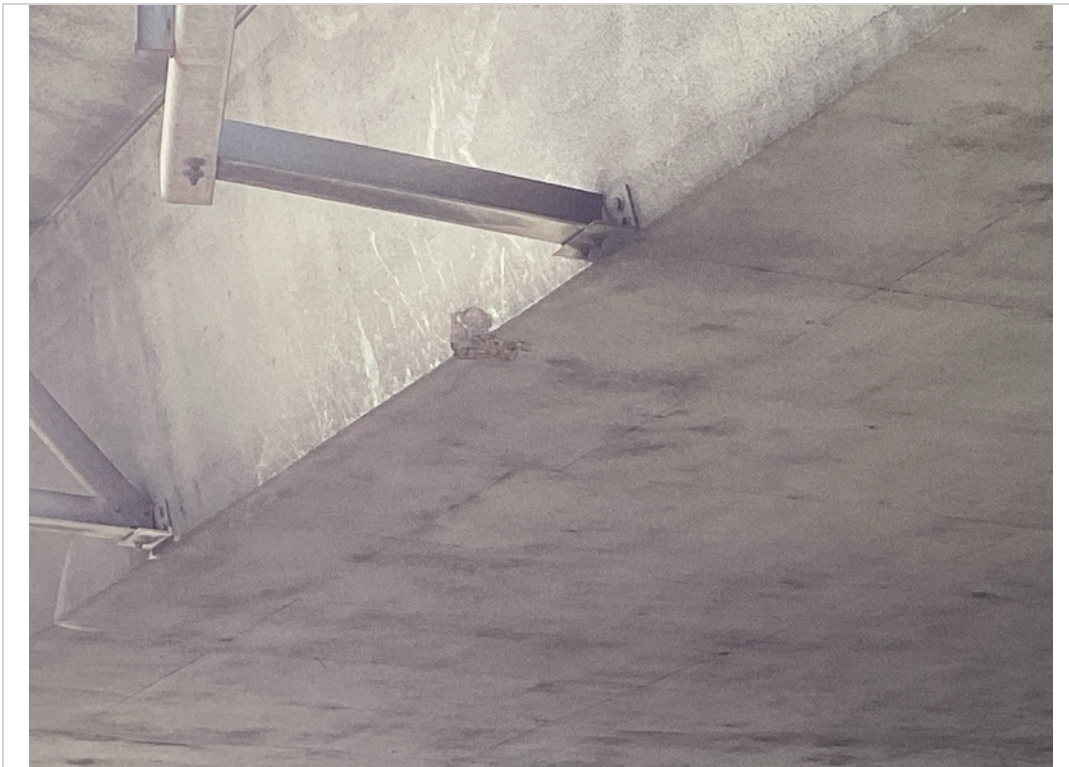
Span 1 damage

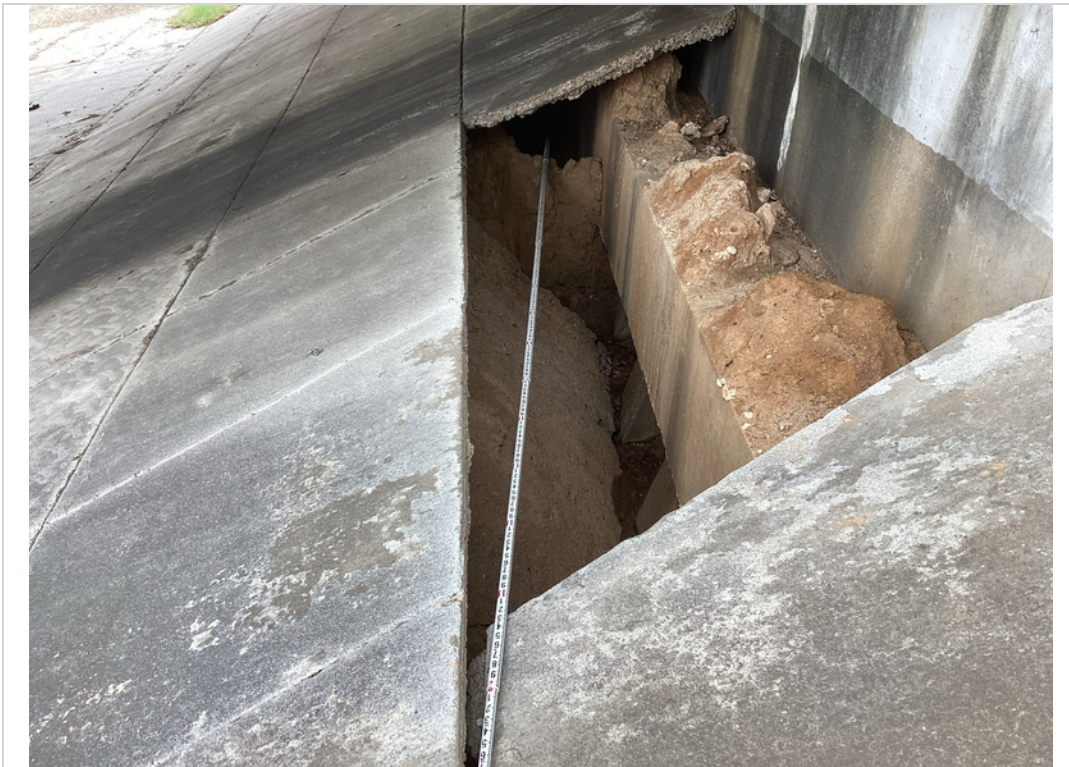
Washing below slope paving at abutment 2

Date Added	Recommendation	Priority
11/04/2024	REPAIR WINGWALL AT ABUTMENT NO.1 RT & 2 LT	
11/04/2024	LEVEL THE WEARING SURFACE AT APPROACH NO.1 and 2	
04/16/2009	APPROACH GUARDRAILS ARE SUBSTANDARD	
04/16/2009	BRIDGERAILS ARE SUBSTANDARD	
04/16/2009	APPROACH GUARDRAIL TERMINALS ARE SUBSTANDARD	
12/07/2018	UNDERPASS SUBSTRUCTURE PROTECTION GUARDRAILS ARE SUBSTANDARD	
11/04/2024	CLEAN AND SEAL ROADWAY EXPANSION JOINTS AT APPROACH NO.1 and 2	
11/04/2024	REPAIR BACKWALL AT ABUTMENT NO.2	
11/04/2024	PATCH SIDEWALK IN SPAN NO.1 LT	
11/04/2024	REPAIR EMBANKMENT EROSION AT ABUTMENT NO.2	
11/04/2024	REPAIR SLOPE PAVEMENT AT ABUTMENT NO.2	
09/28/2022	CUT VEGETATION	
10/30/2024	Repair approach 1 right guardrail

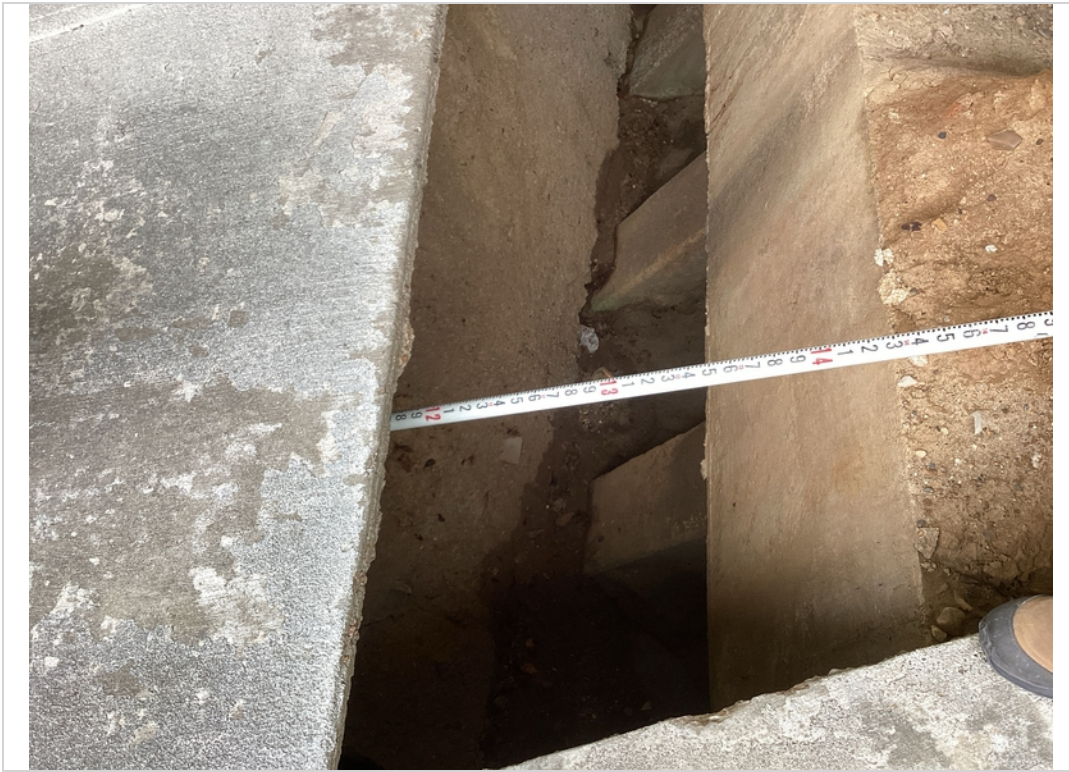
Washing below slope paving at abutment 2

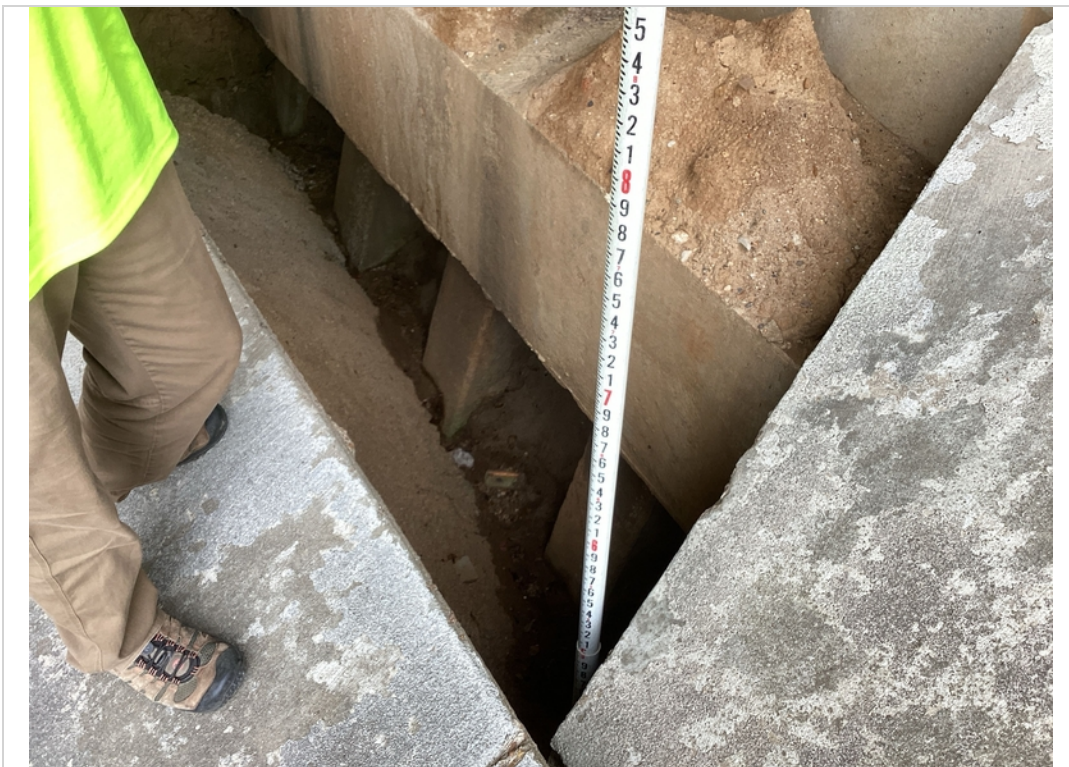
Washing below slope paving at abutment 2

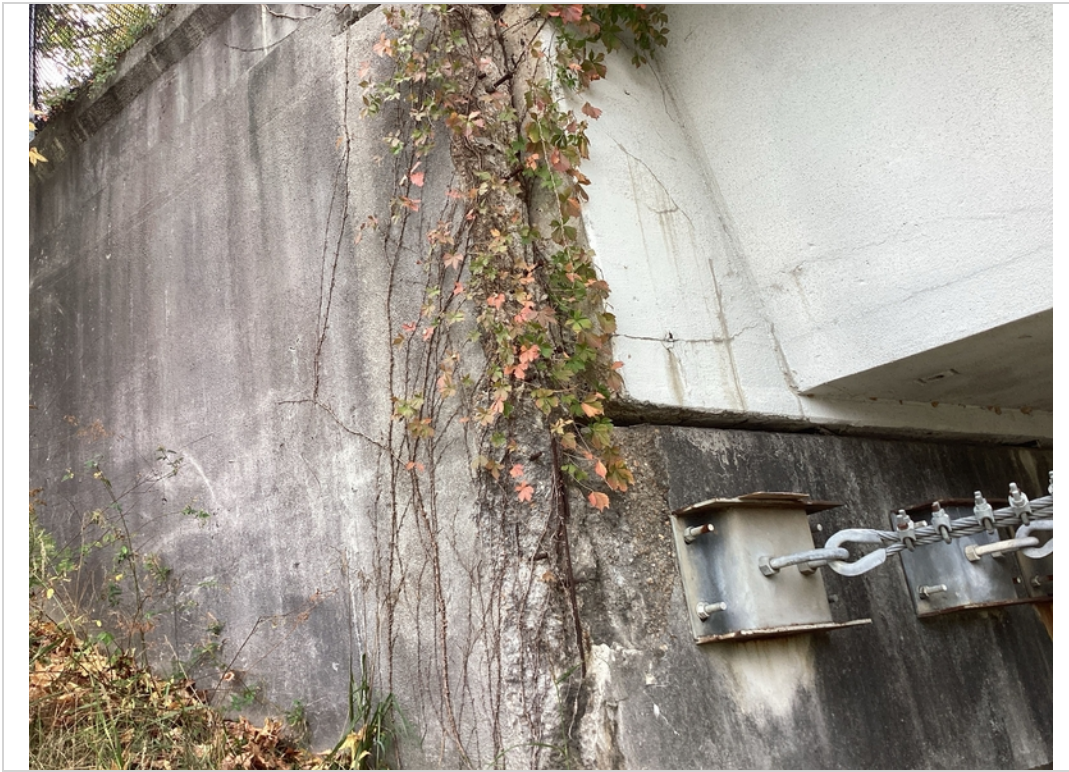
Abutment 2/left wing spall to steel

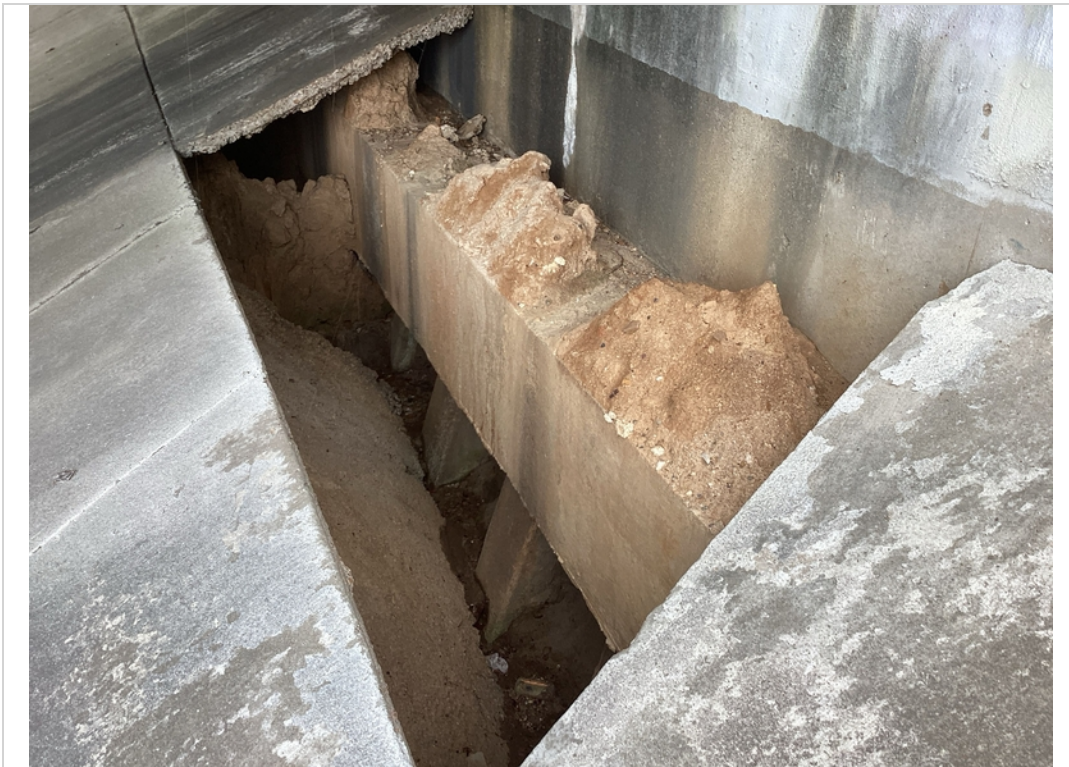
Abutment 2 right side of embankment/slope paving

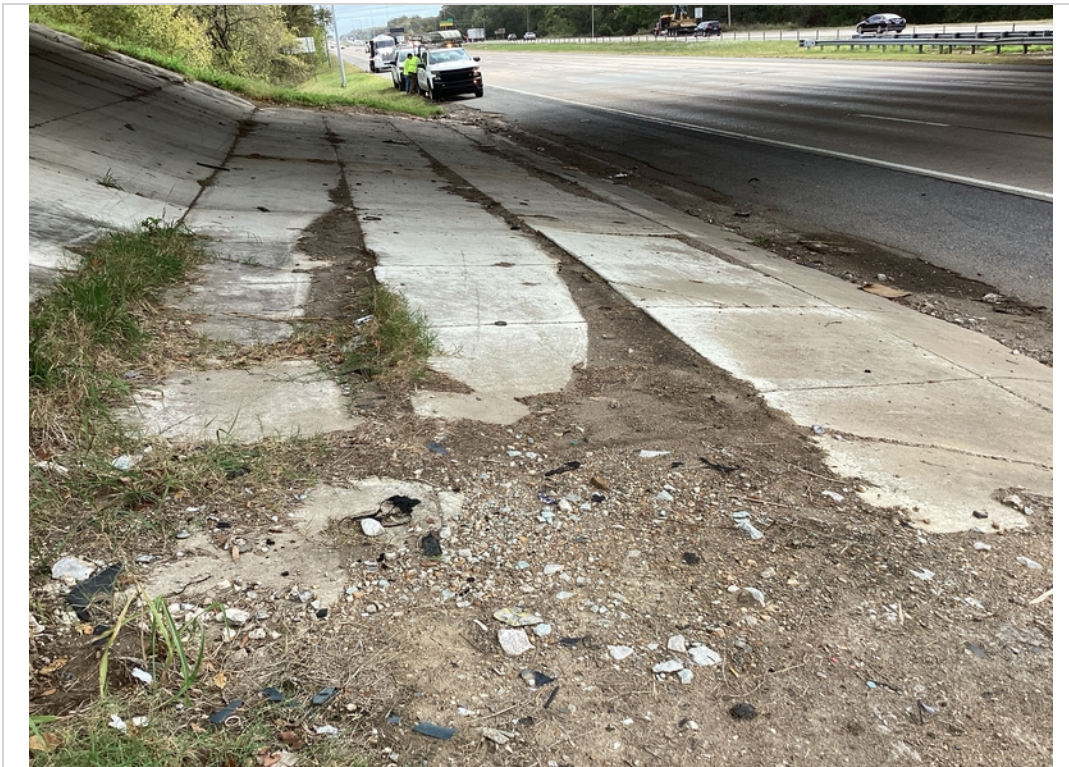
Abutment 1 slope paving sinking/bucking

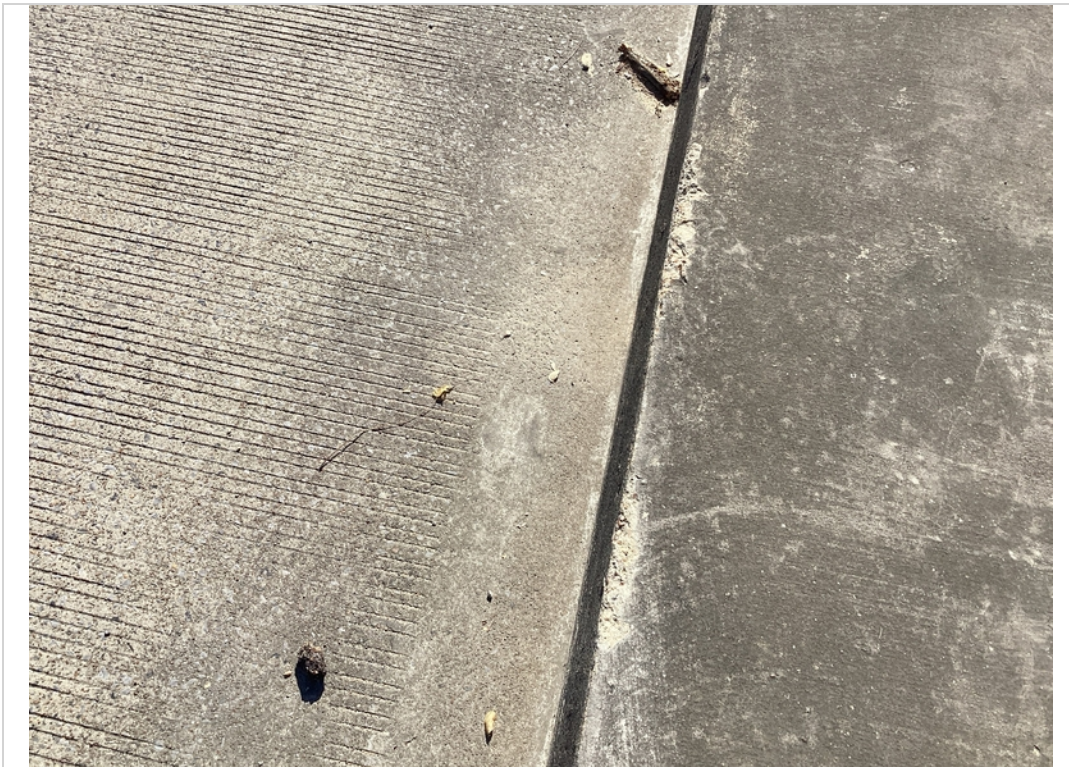
Span 1 , damage

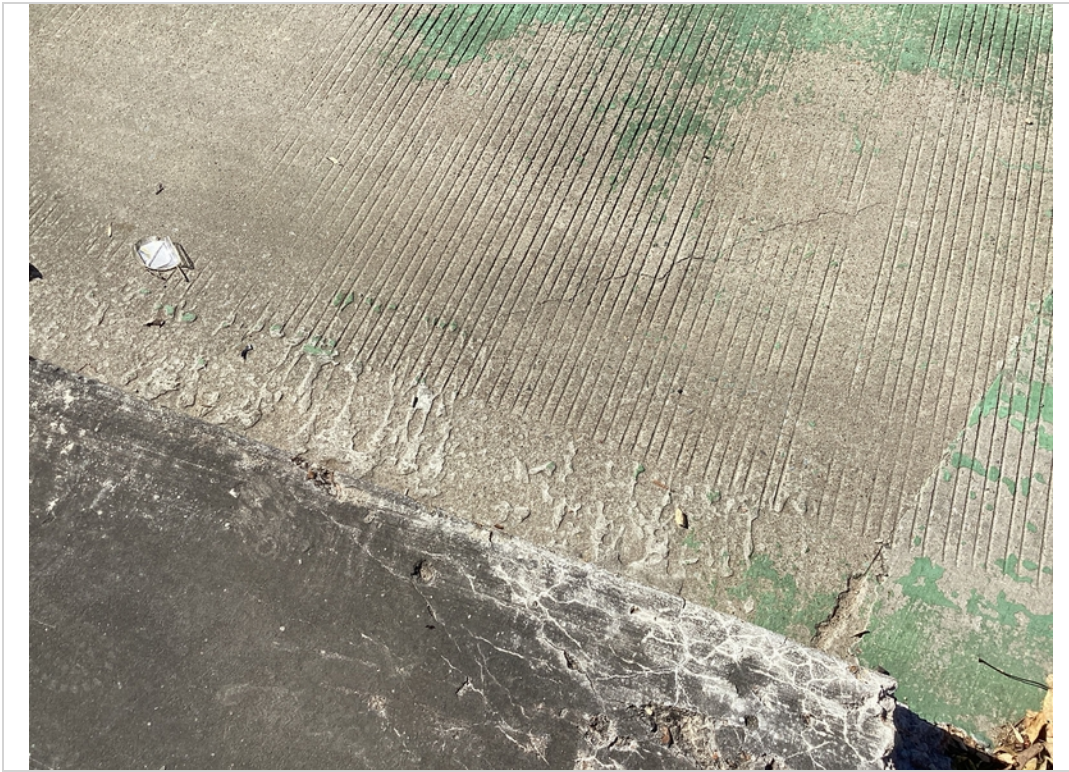
Span 1 , cracks & sidewalk light scaling

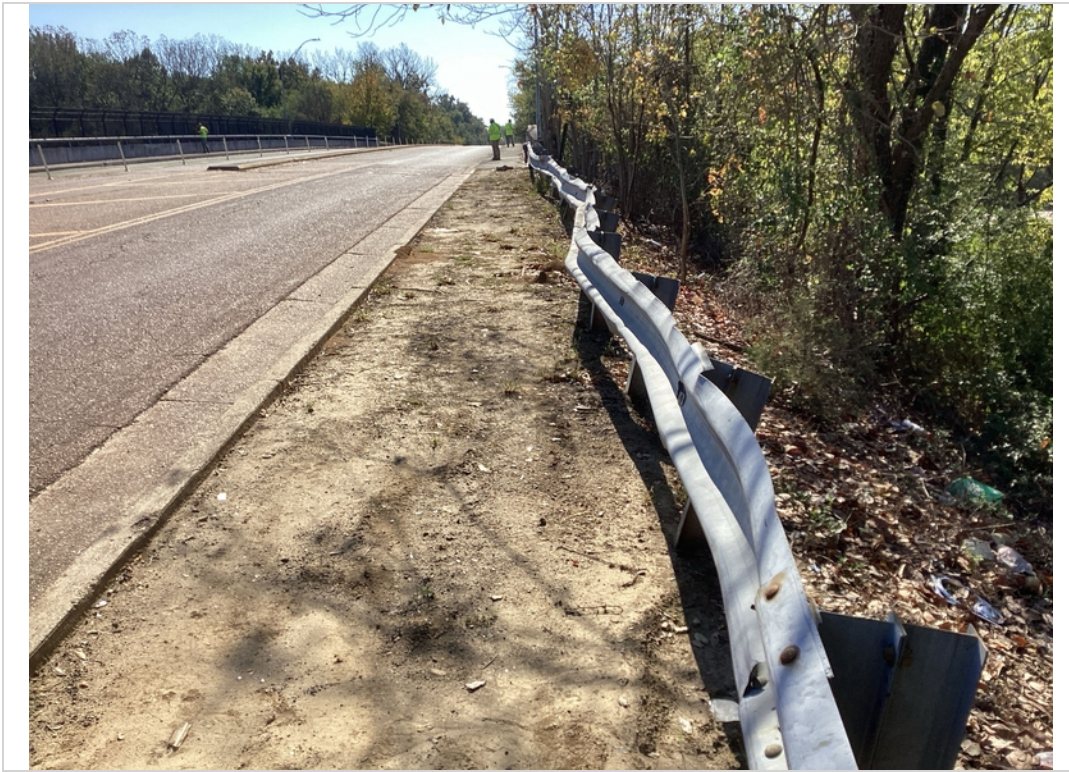
Damage at approach 1 right

Approach 1 right guardrail

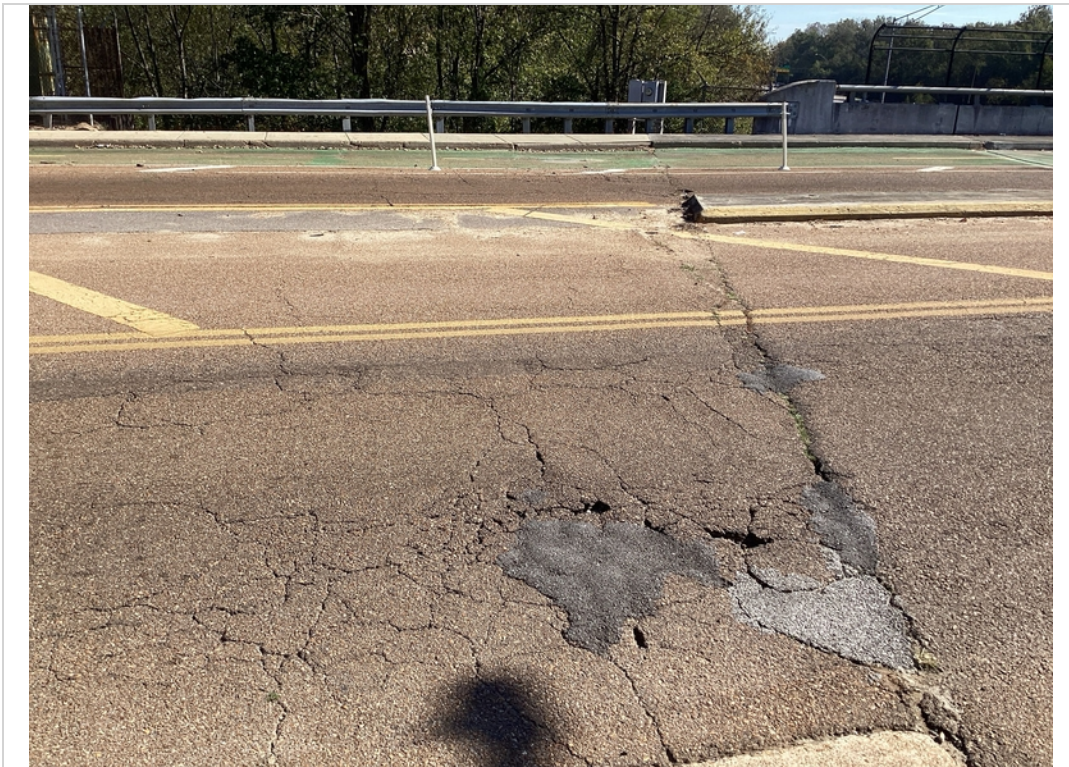
Potholes, rough patch work and 1/8" cracks

Approach 1 asphalt

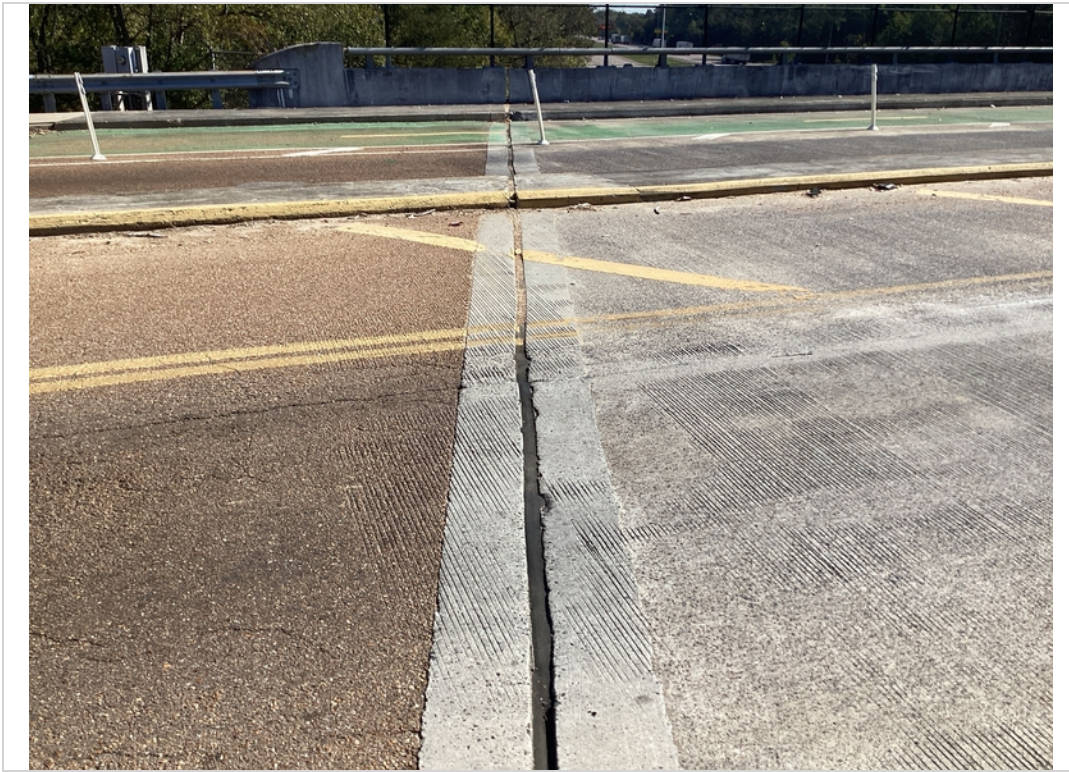
Debris impaction and torn material

Approach 1 joint

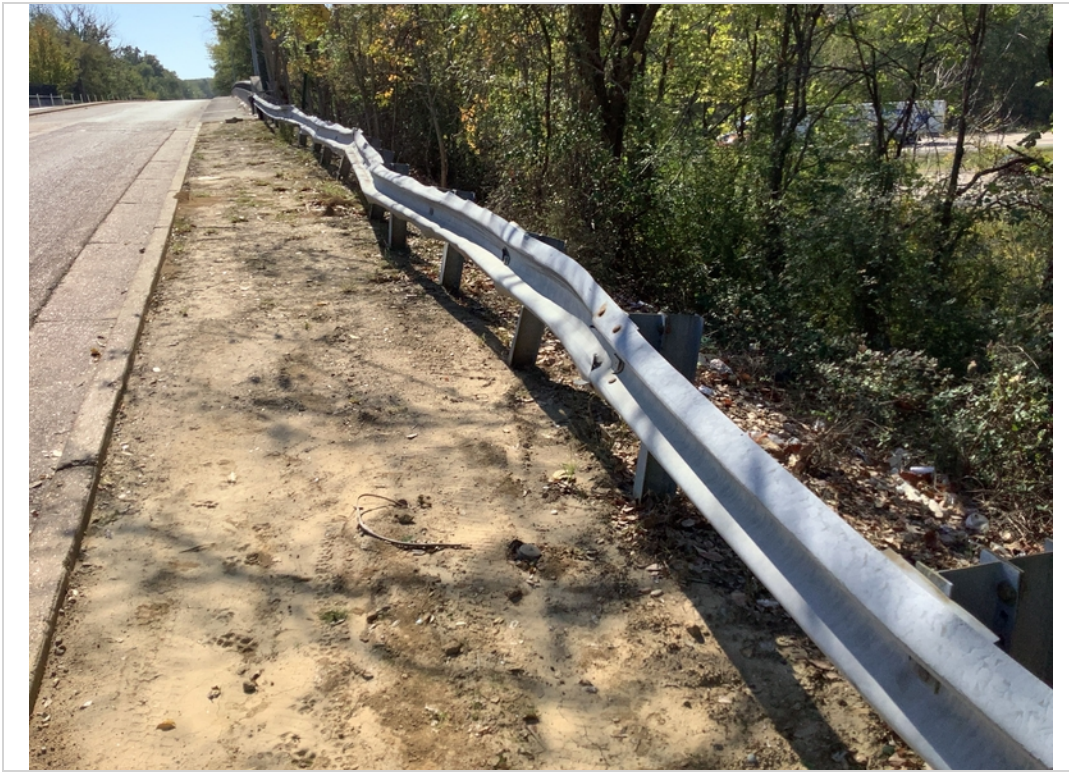
Approach 1 right guard rail collision damage

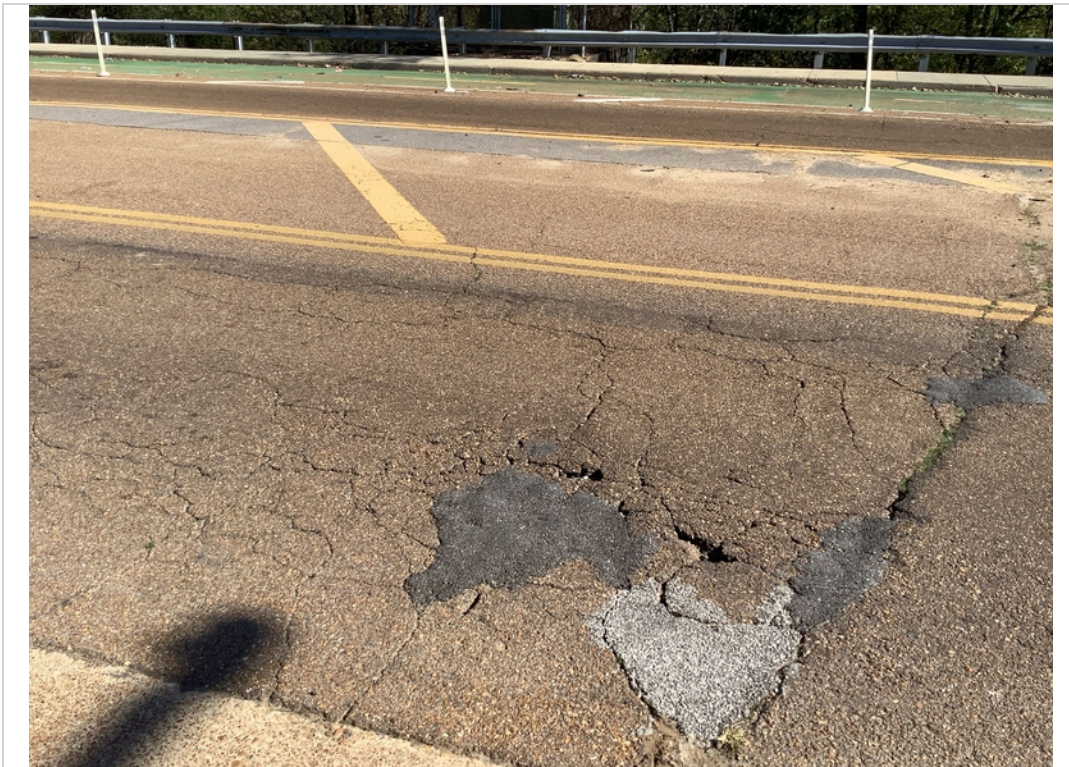
Approach 1 pavement
