I-40 Crossing I-40 EB / N HOLLYWOOD ST

90 - LAST INSPECTION DATE 11/04/2024

IDENTIFICATION	
(1) State Names	47 - Tennessee
(8) Structure Number	79I00400073
(5) Inventory Route	1
(2) Highway Agency District	Region 4
(3) County Code	79 - Shelby

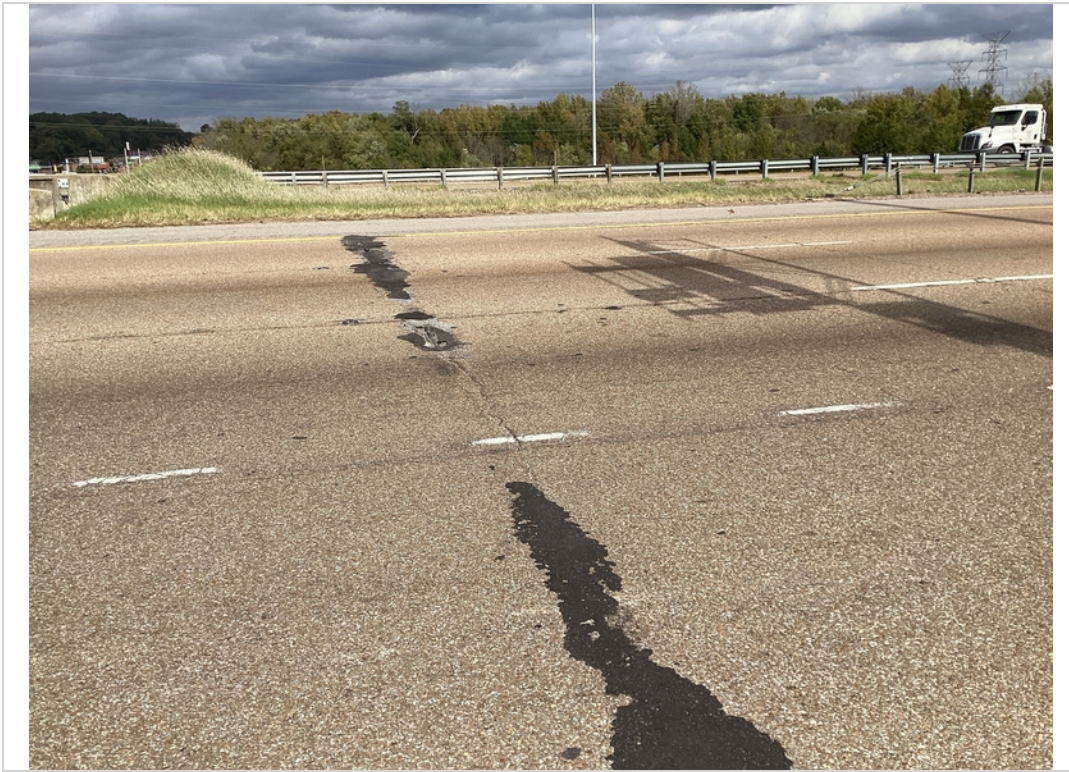
Approach 2 has a large pothole

Approach 2 asphalt

Date Added	Recommendation	Priority
06/05/2007	APPROACH GUARDRAILS ARE SUBSTANDARD	
06/05/2007	UNDERPASS SUBSTRUCTURE PROTECTION GUARDRAILS ARE NON-EXISTENT	
09/28/2022	REPAIR APPROACH GUARDRAILS AT APPROACH NO.1 RT	
11/04/2024	LEVEL THE WEARING SURFACE AT BOTH APPROACHES.	
11/04/2024	CLEAR APPROACH DRAINS.	
11/04/2024	REPAIR BACKWALL AT ABUTMENT NO.2

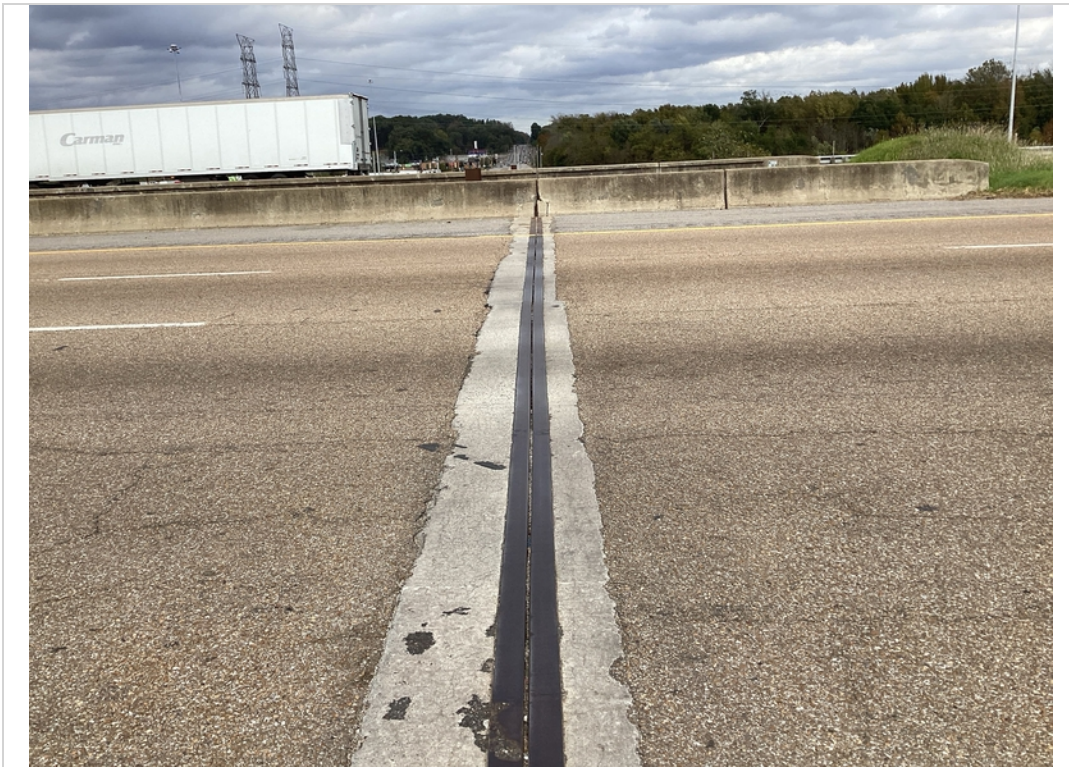
Approach 2 full of debris

Approach 2 joint

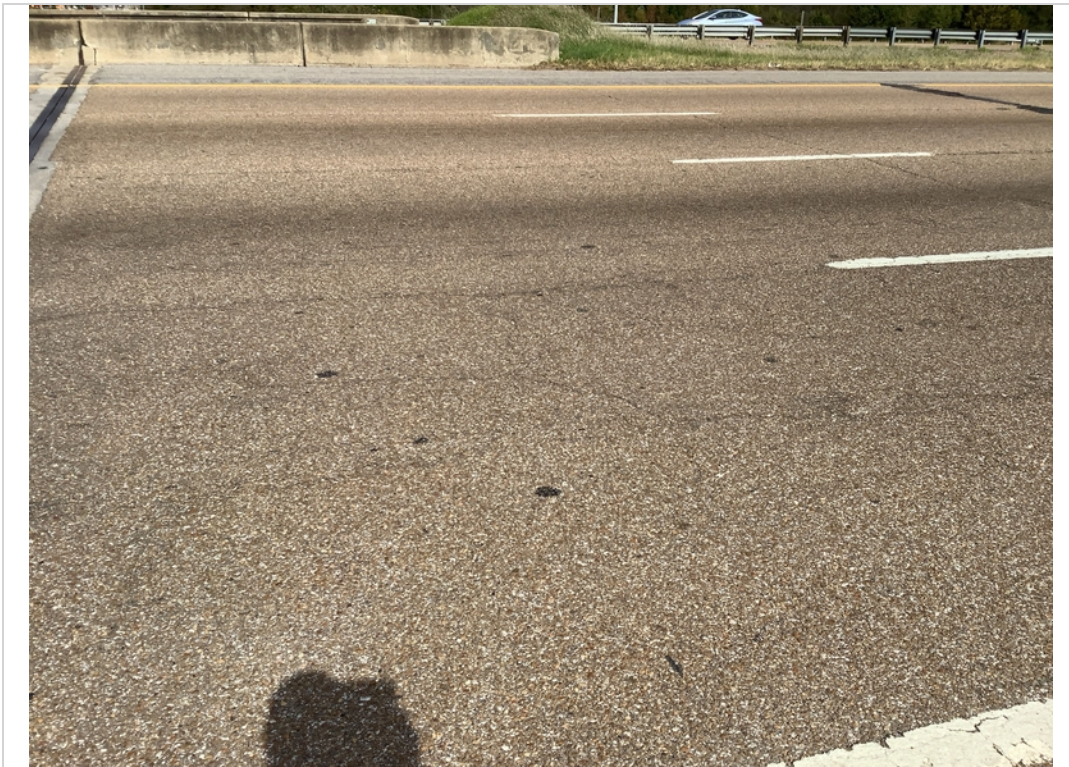
Approach 2 pavement

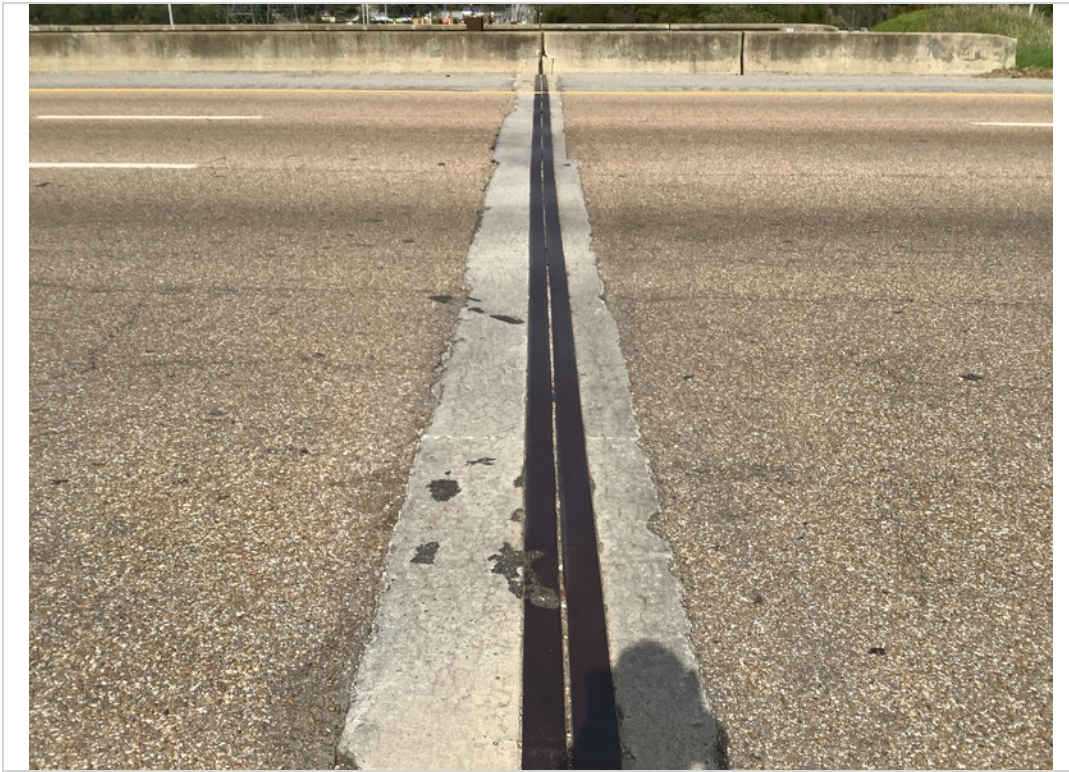
Approach 2 joint

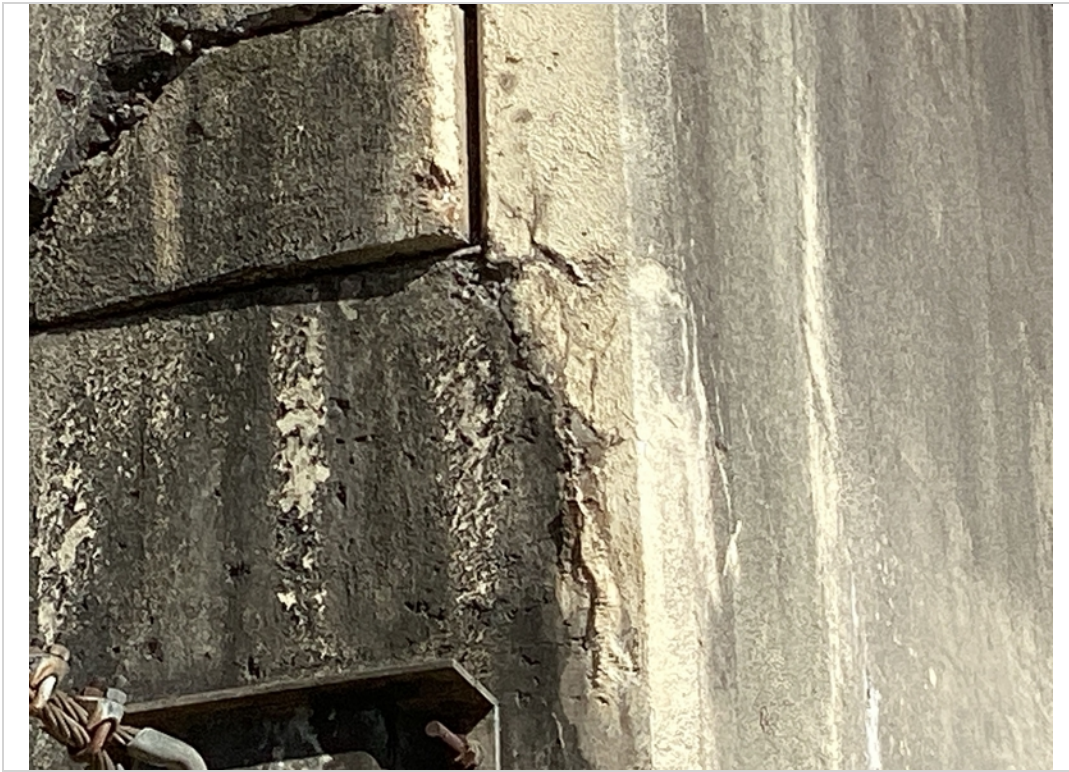
Abutment 2 crack

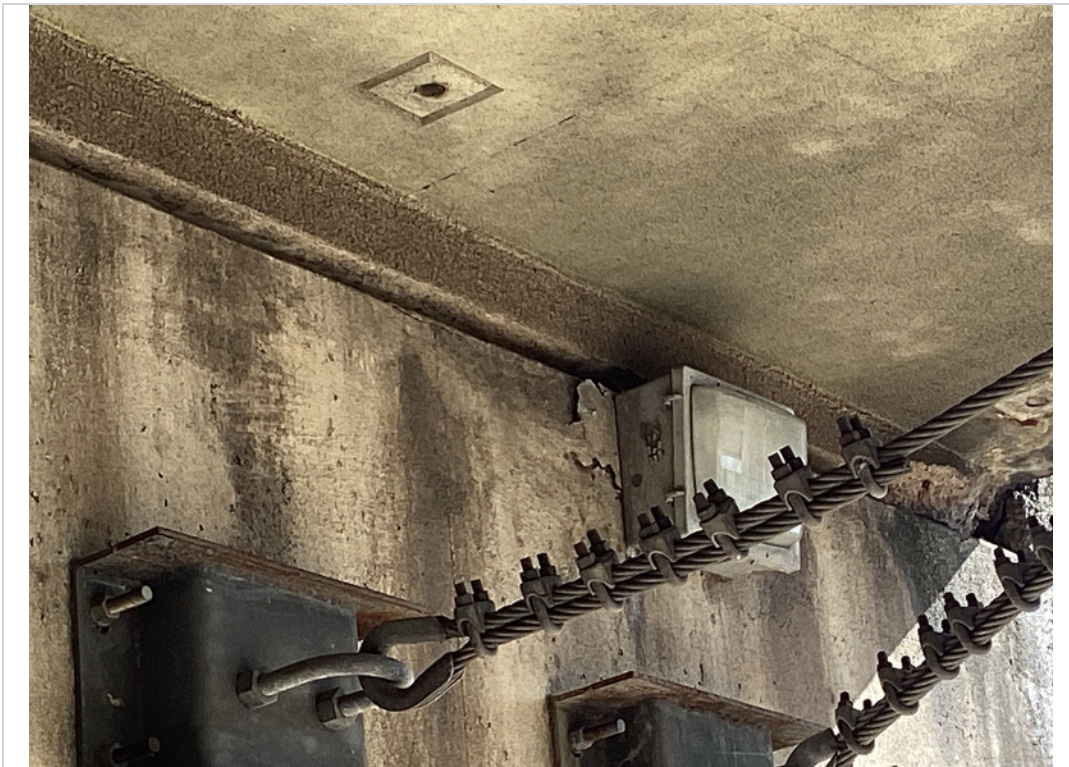
Abutment 2 impending spall

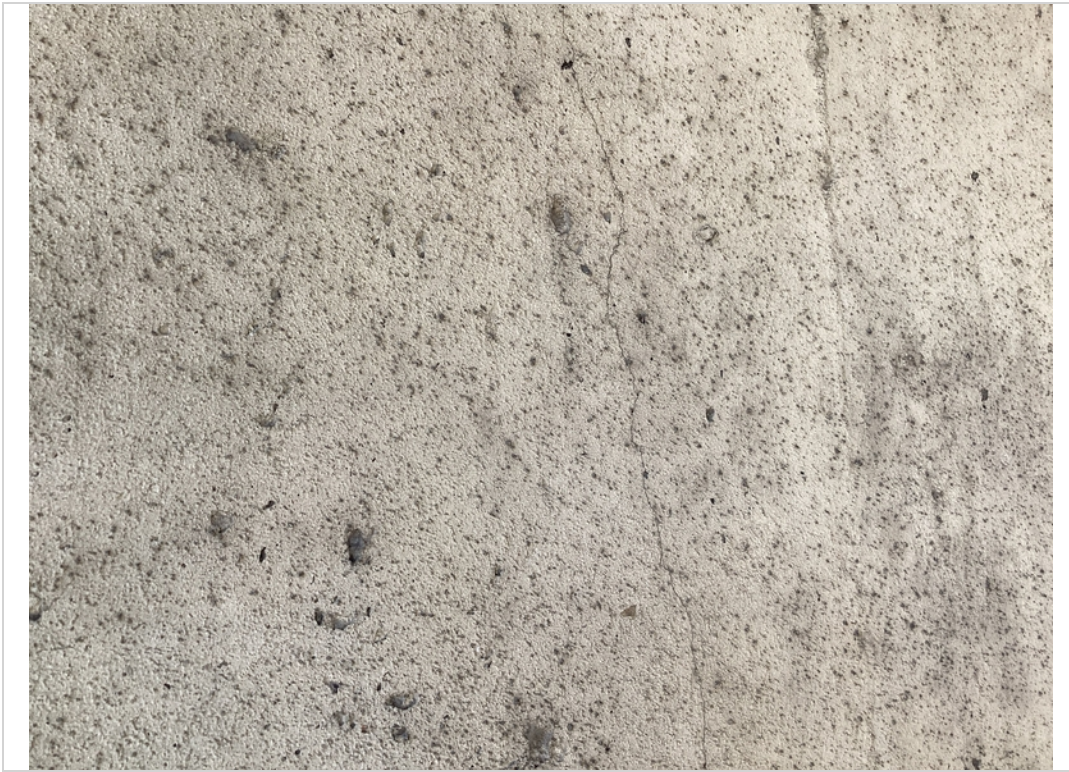
Abutment 1, hairline crack

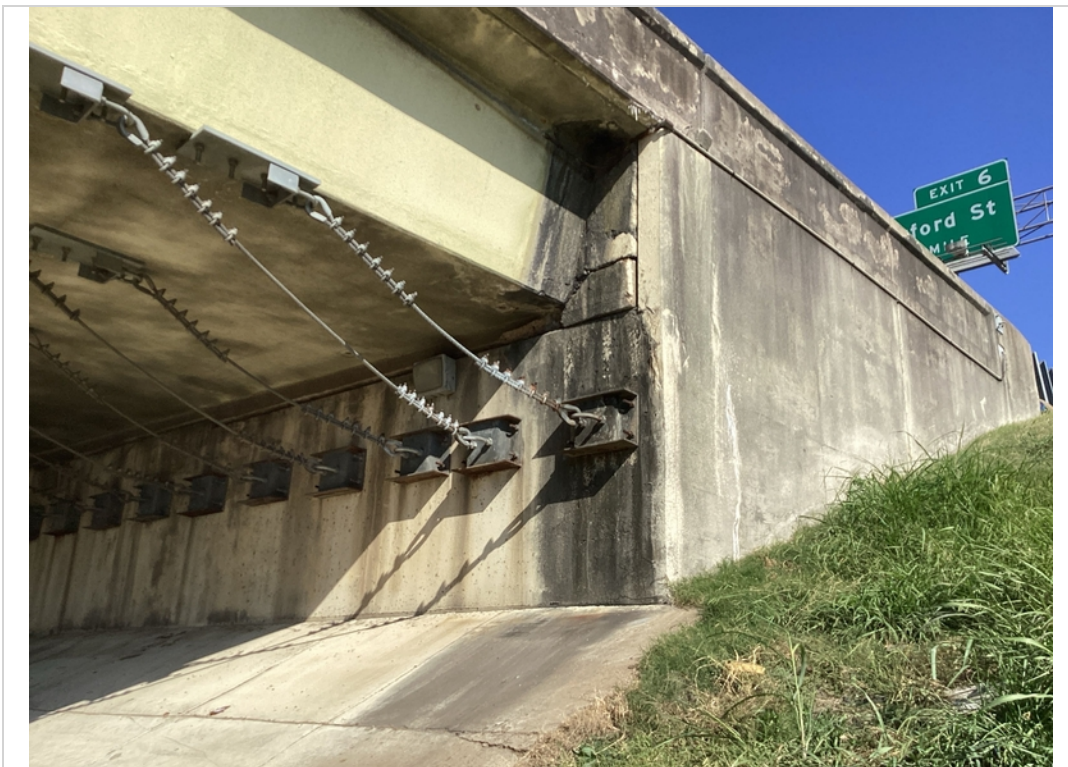
Abutment Caps	(Fair)	1/16" cracks with efflorescence , spalling
Abutment Wings	(Fair)	Spalling , impending spall , 1/8" cracks with efflorescence
Abutment Backwall	(Poor)	Spall steel abut 2 back wall
Abutment Plumb	(Good)	
Abutment Piles	(Not Visible)	
Abutment Embankment	(Good)	
Abutment Bearing Surface	(Good)	
Abutment Slope Paving	(Good)

Spall about 2 backwall

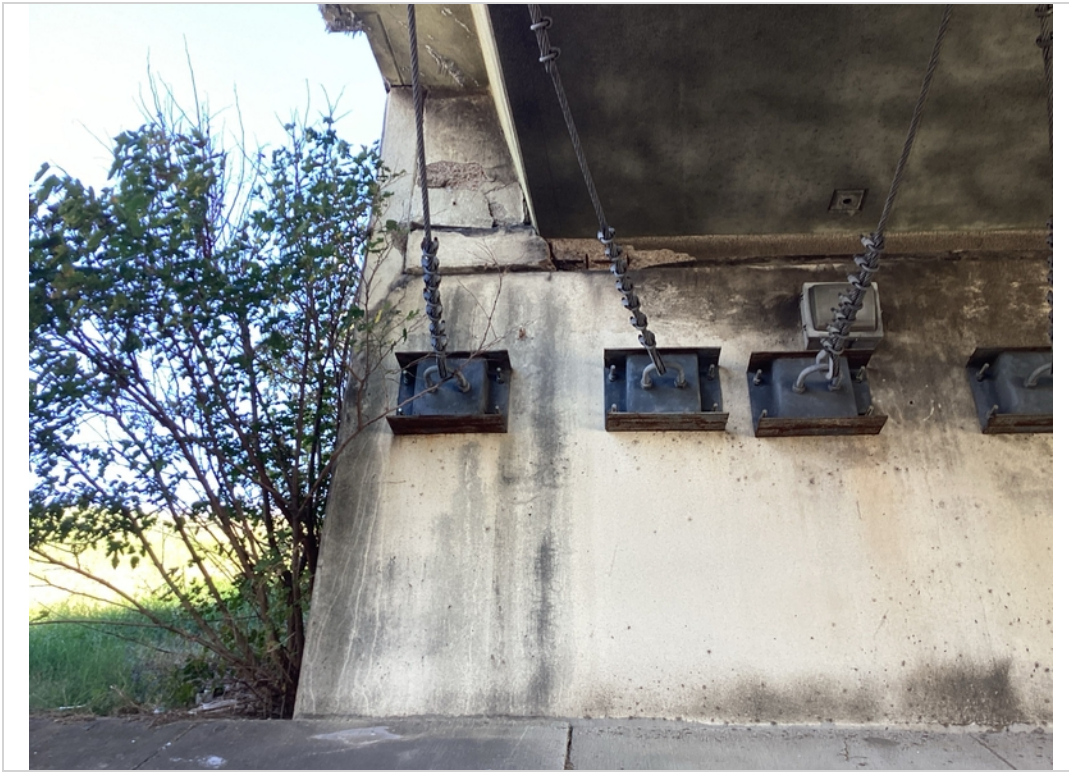
Spall abut 2 back wall

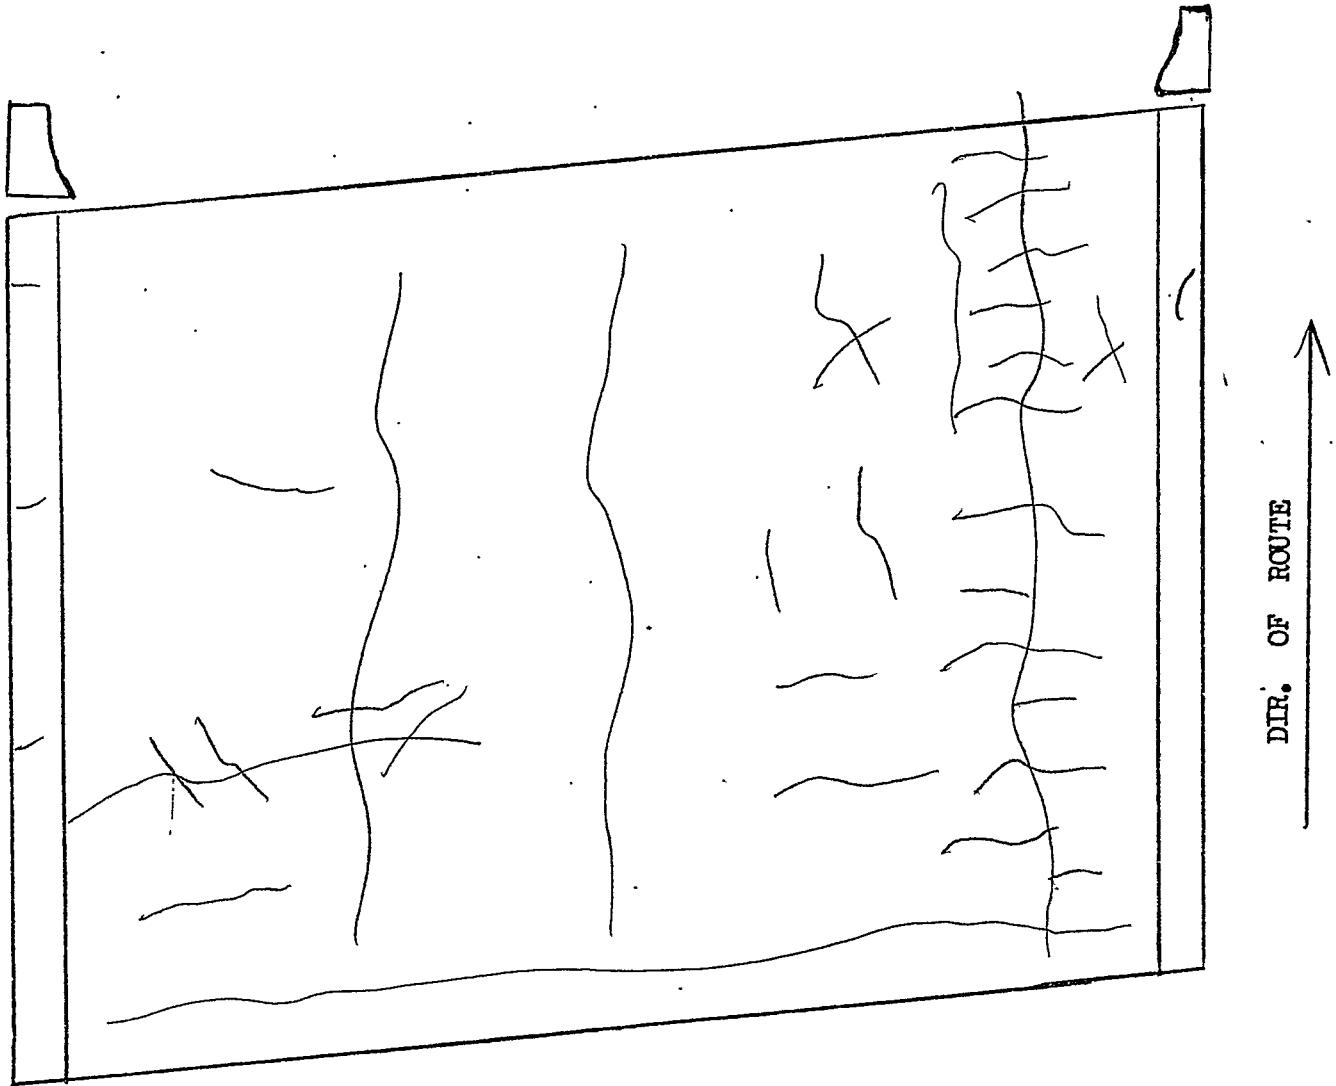
BRIDGE NO. 79

DECK	G (F) P C	upto 1/16" cracks
PARAPET	G (F) P C	Surface steel upto 1/32" cracks
DRAINS	G F P C	
JOINT	G F P C

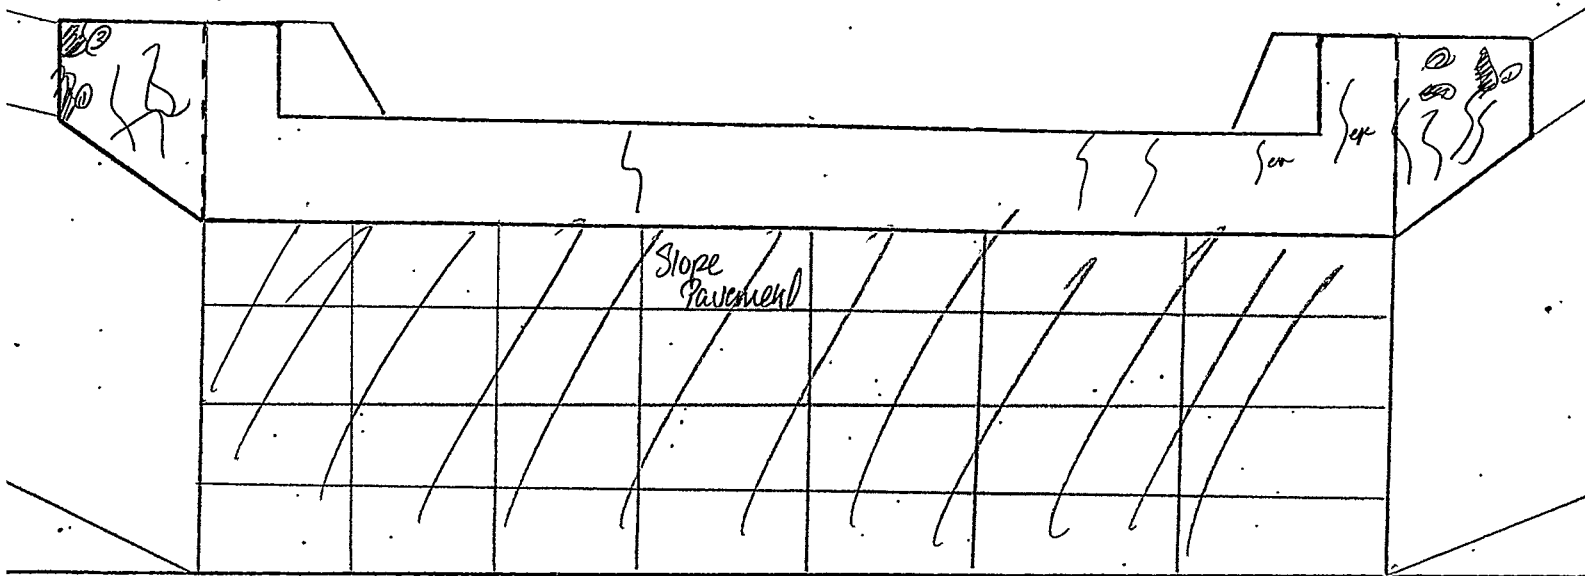
BRIDGE NO. 79 7-40-75 E.B.L. ABUT. NO. 2

ELEMENT	RATING	COMMENTS
BEARING	G F P C	N/A
PAINT	G F (P) C	
CAP	(G) F P C	Handline cracks w/eff
WINGS	G (F) P C	See (1), (2), 1/8" cracks w/eff
EMB.	(G) F P C	
VEG.	(G) F P C	
RIP-RAP	G F P C	N/A
SLOPE PAV.	(G) F P C	
BACKWALL	G F P C	N/A

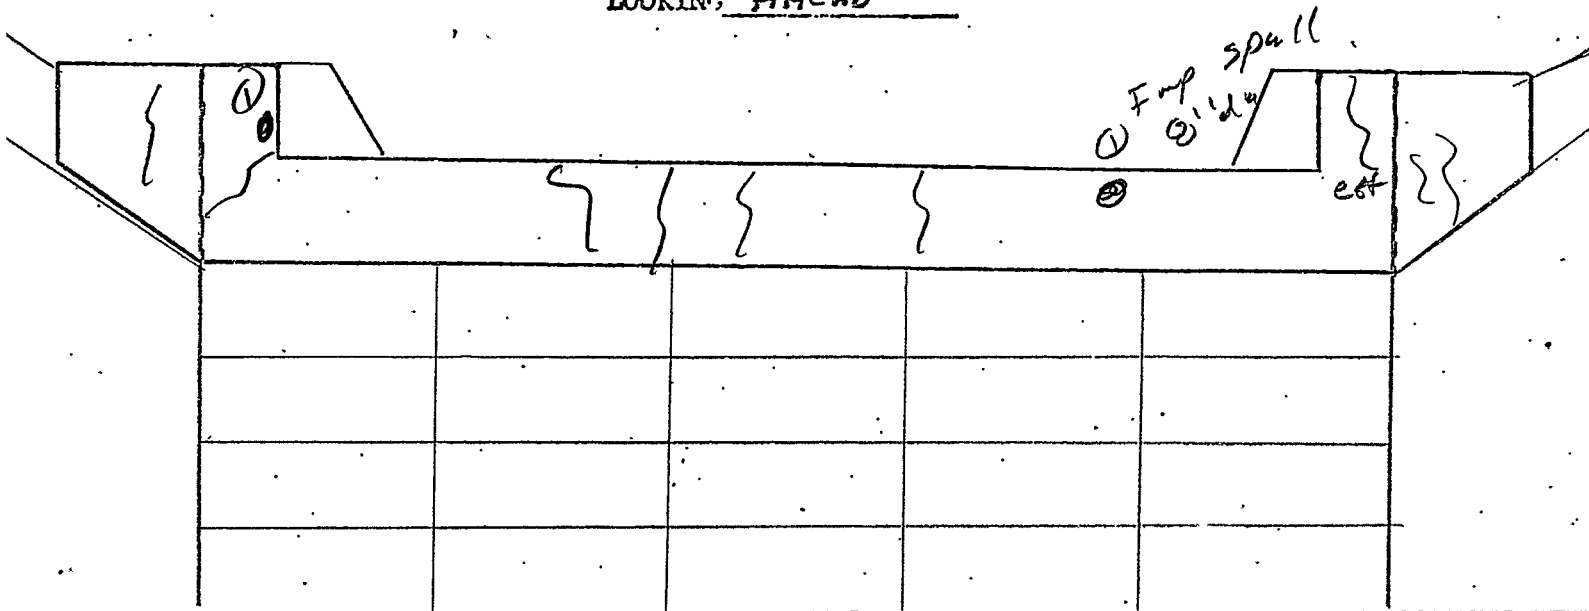
LEMENT	RATING	COMMENTS
BEARING	(D) F P C	
PAINT	G F P C	N/A
CAP	G F P C	① Up to 1/16" cracks with chf
WINGS	(G) F P C	Horizontal cracks e&f
EMB.	(G) F P C	
VEG.	(G) F P C	
RIP-RAP	G F P C	
SLOPE PAV	(G) F P C	
BACKWALL	(G) F P C	Medi corrosion
EQ
