Region 04, 79 - Shelby County

I-40 Crossing I-40 WB / N HOLLYWOOD ST

IDENTIFICATION	
(1) State Names	47 - Tennessee
(8) Structure Number	79I00400074
(5) Inventory Route	1
(2) Highway Agency District	Region 4
(3) County Code	79 - Shelby

Inspection Team's Summary

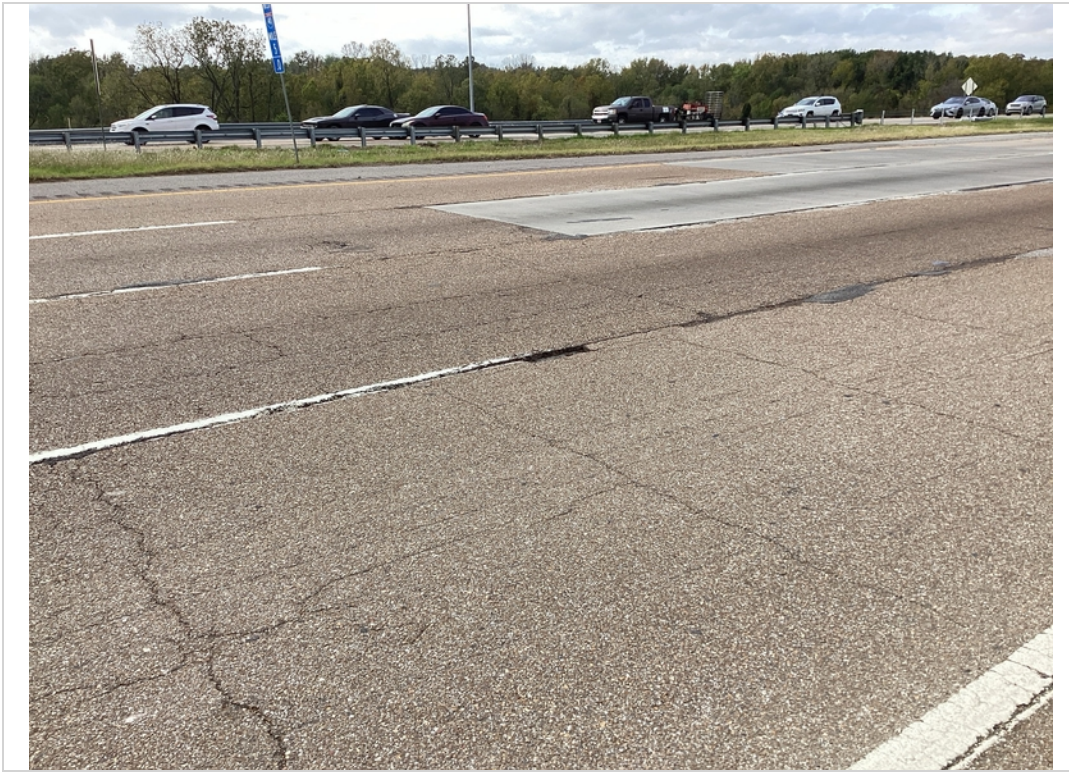
Approach 1&2 have 1/2" cracks and spall

Approach 2 asphalt

Date Added	Recommendation	Priority
11/04/2024	REPAIR CONCRETE PARAPET IN SPAN NO.1 LT	
08/10/2005	APPROACH GUARDRAILS ARE SUBSTANDARD	
09/28/2022	UNDERPASS SUBSTRUCTURE PROTECTION GUARDRAILS ARE NON-EXISTENT	
11/04/2024	LEVEL THE WEARING SURFACE AT BOTH APPROACHES.	
11/04/2024	CLEAR APPROACH DRAINS.	
10/30/2024	REPAIR BACKWALL AT ABUTMENT NO.2	
11/04/2024	CLEAN AND SEAL APPROACH 2 JOINT

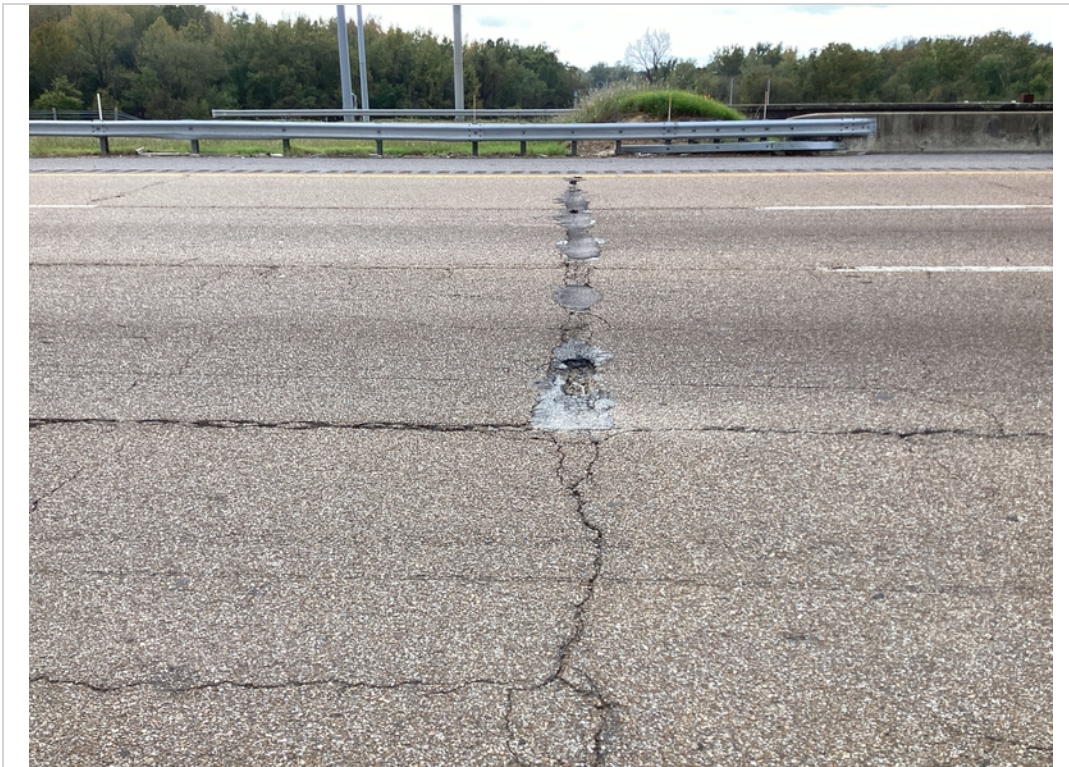
Approach 2 asphalt

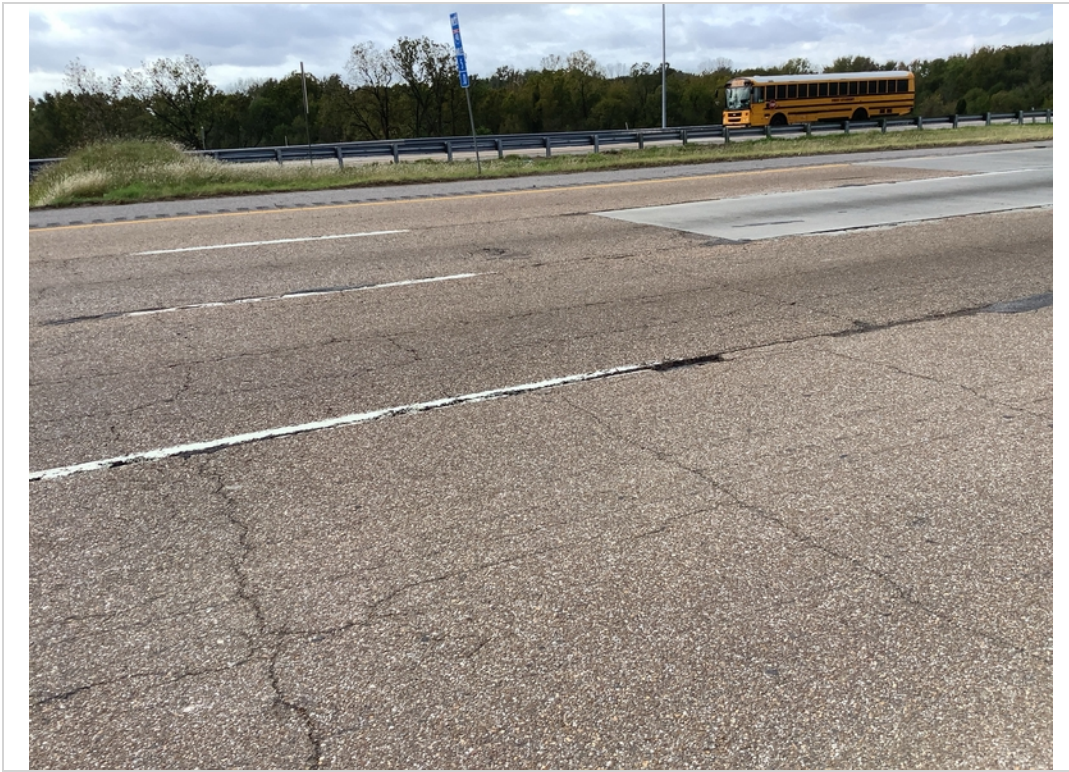
Approach 1 pavement

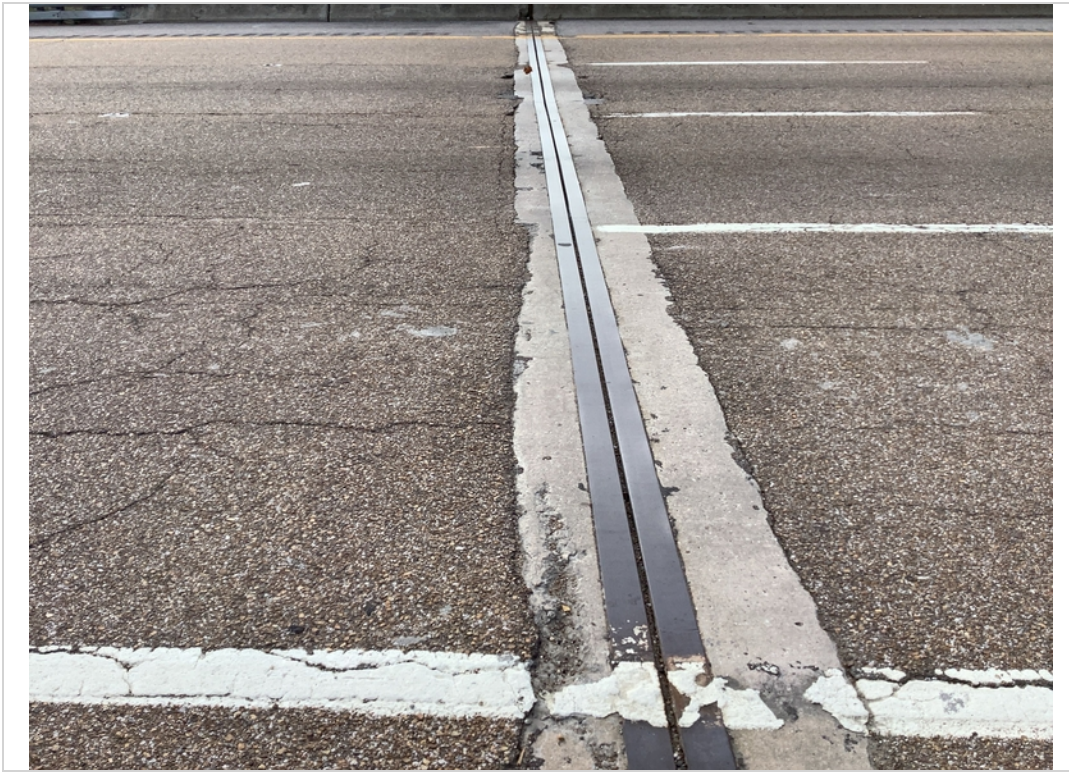
Approach 2 full of debris

Approach 2 joint

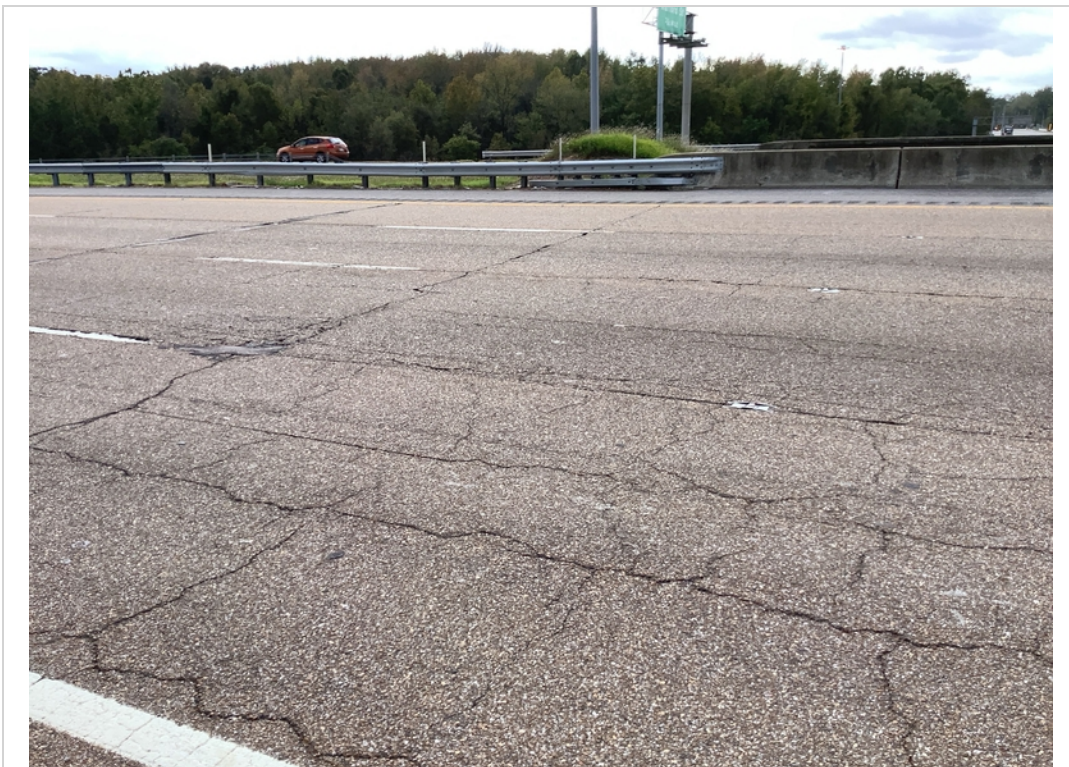
Approach 2 pavement

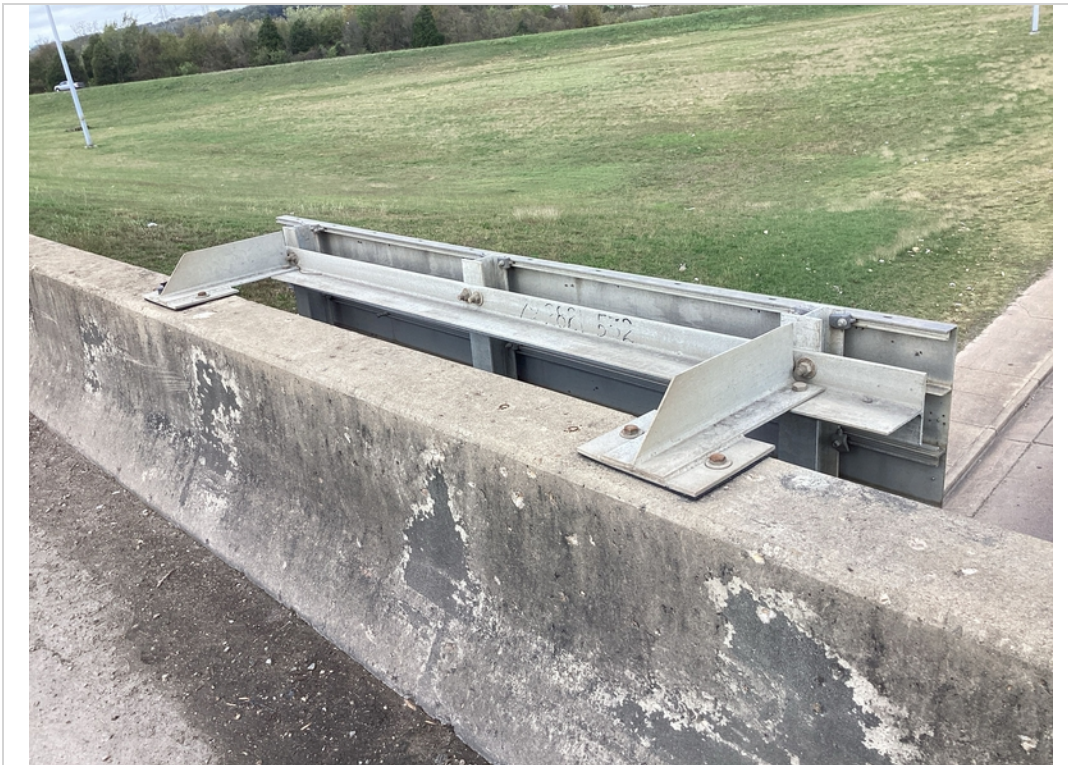
Bridge mounted sign upper connection

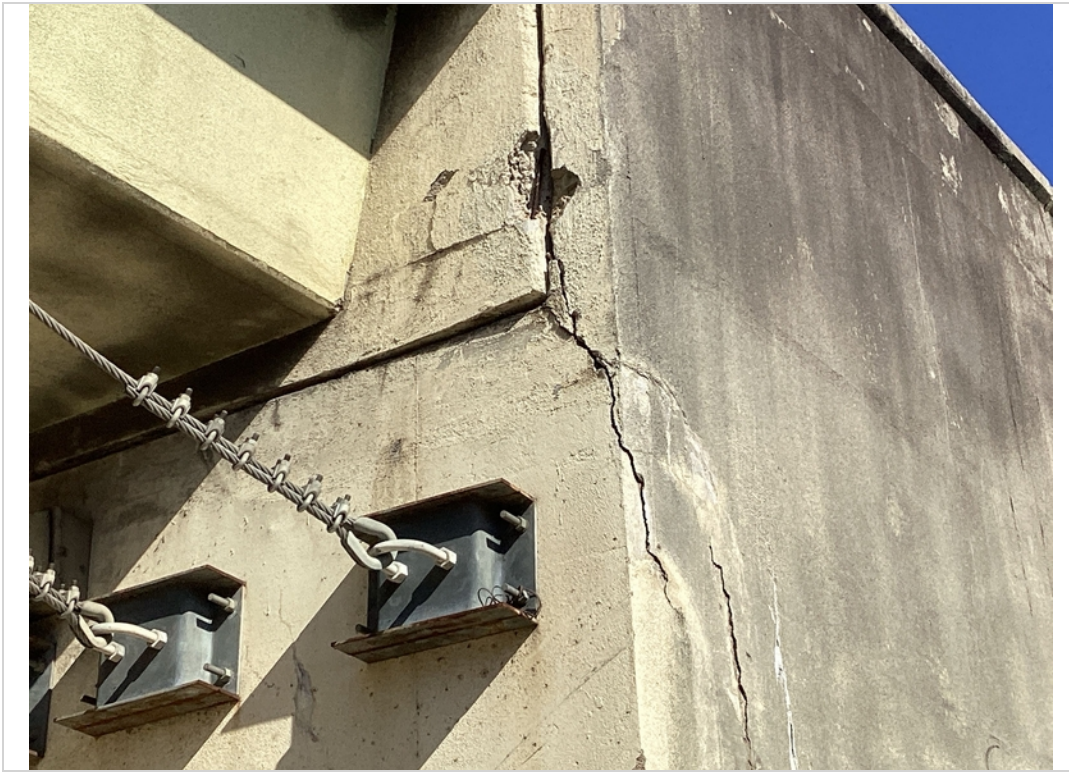
Abutment 2 spall

① Spall
6" dia
1' x 1' deep

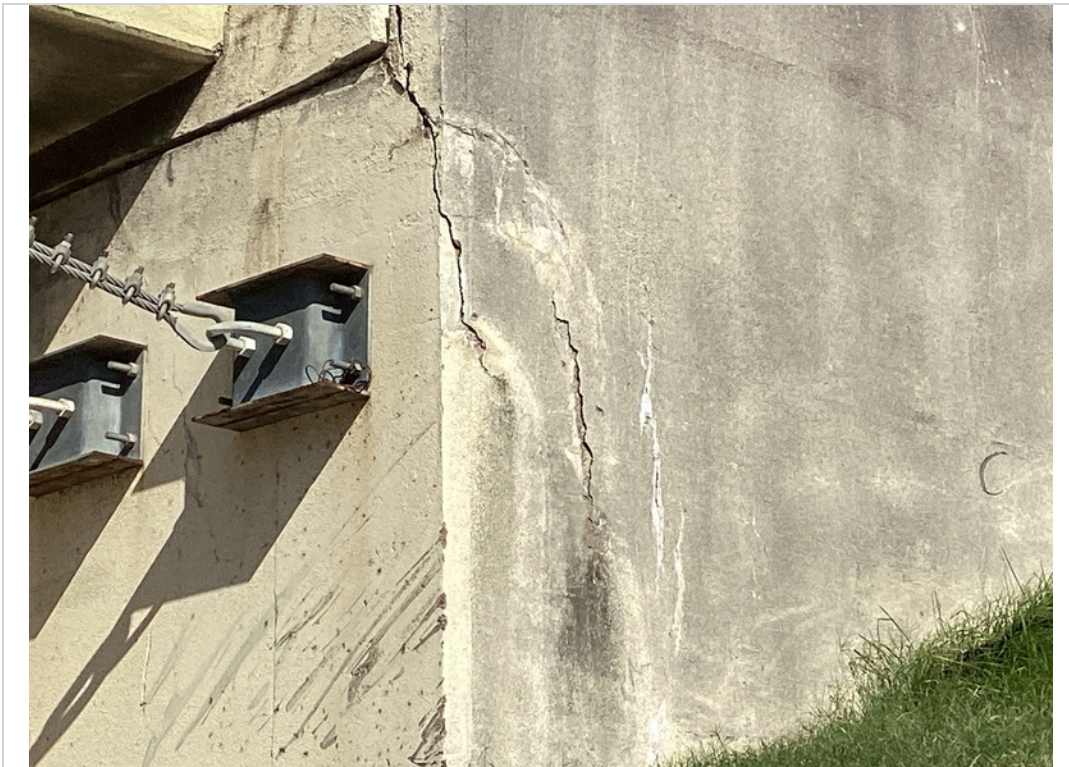
Abutment 2 impending spall

② Imp
spall 3' by
2' L

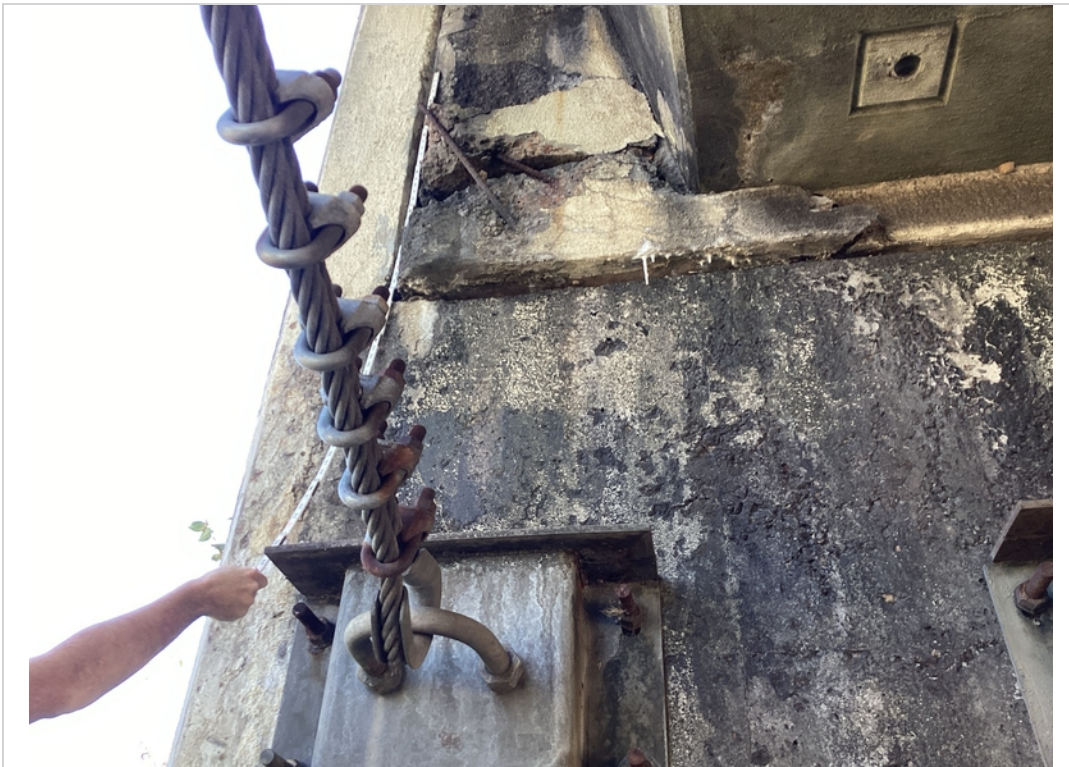
Abutment Caps	(Fair)	Hairline cracks with efflorescence , impending spall
Abutment Wings	(Fair)	1/8" cracks with efflorescence , impending spall , spalling
Abutment Backwall	(Poor)	Spall steel abut 2 back wall
Abutment Plumb	(Good)	
Abutment Piles	(Not Visible)	
Abutment Embankment	(Good)	
Abutment Bearing Surface	(Good)	
Abutment Slope Paving	(Good)

Spall steel back wall span 1

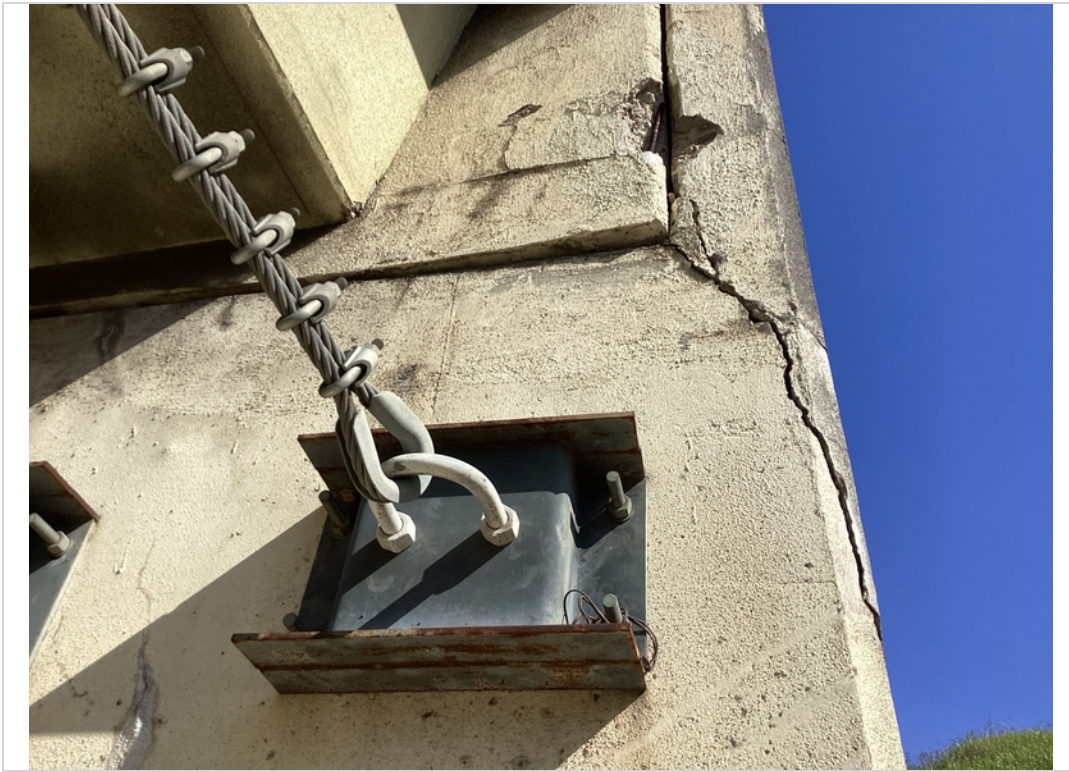
Spall steel back wall span 1

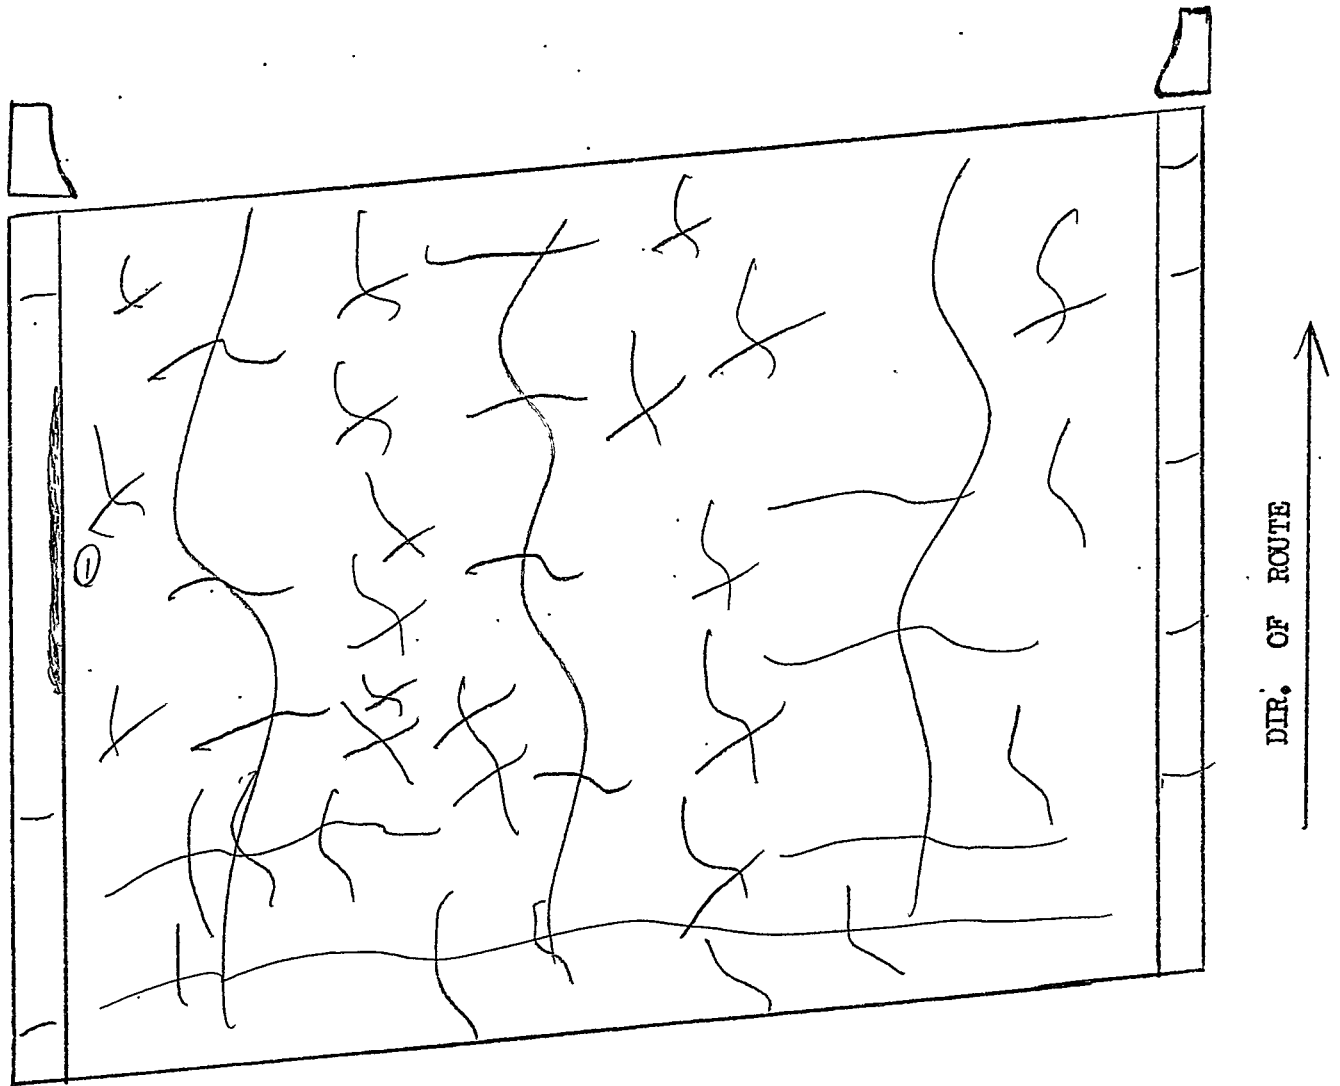
BRIDGE NO. 79 I-240 7.51 E W.B.L. SK. RT. SPAN NO. 1

DECK	G (F) P C	up to $\sqrt{8}$ " cracking	① Scaling
PARAPET	G (F) P C	Hairline cracks & see ①	$10' / L \times 0.5" \times \frac{5"}{H}$
DRAINS	G F P C		
JOINT	G F P C

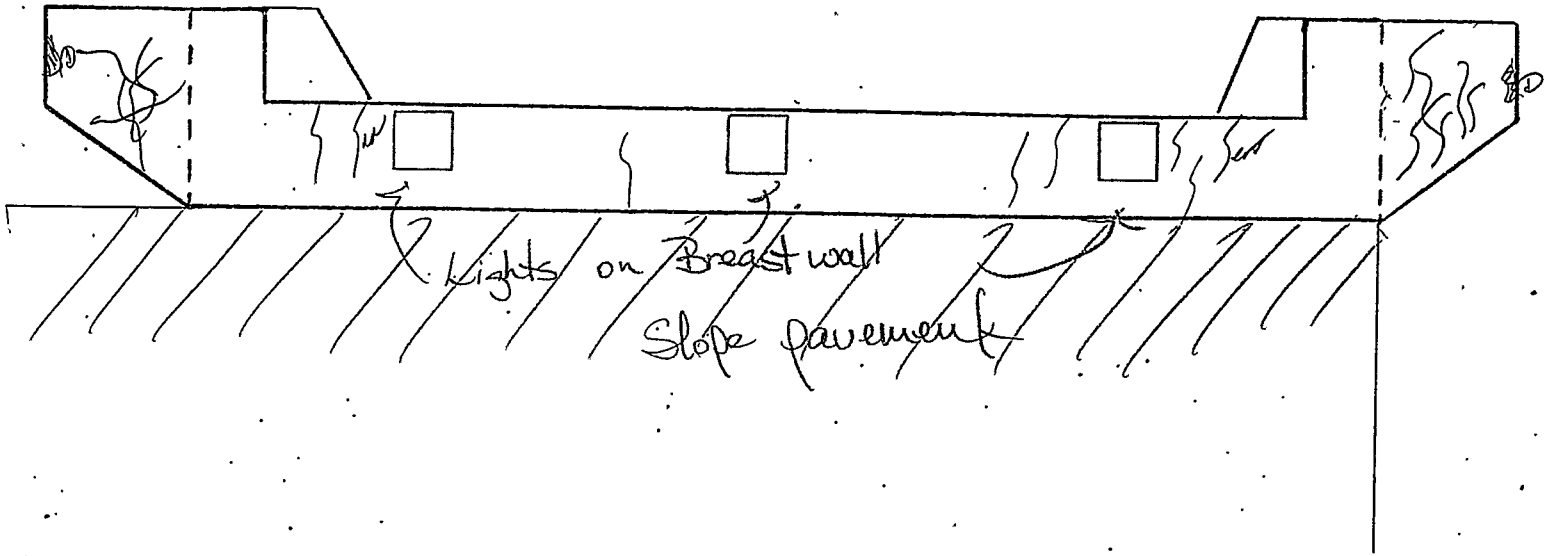
BRIDGE NO. 79 I-240 7515L W.B.L. ABUT. NO. 2

LEMENT	RATING	COMMENTS
BEARING	G F P C	N/A
PAINT	G F (P) C	Dirty, peeling
CAP	G (F) P C	Horizontal cracks w/alt
WINGS	G (F) P C	1/8" cracks w/alt
EMB.	(G) F P C	
VEG.	(G) F P C	
RIP-RAP	G F P C	N/A
SLOPE PAV.	(G) F P C	
BACKWALL	(G) F P C	N/A

① Spall cap to
1' H x 4' W x 1/2" D

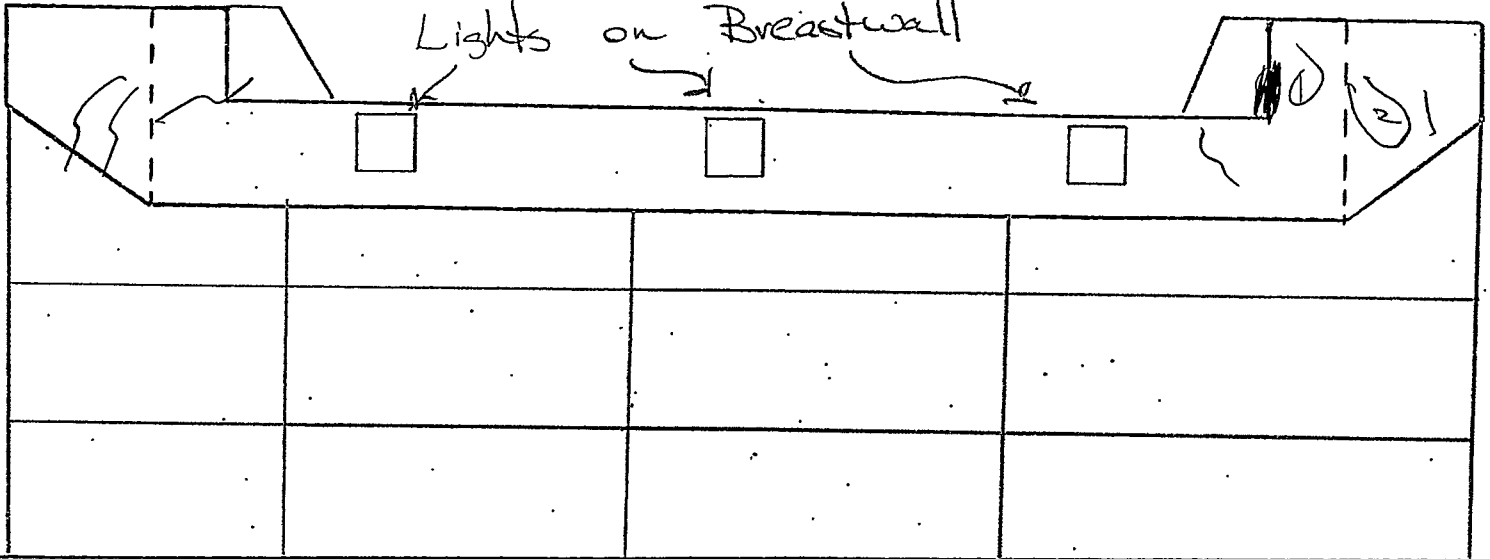
ELEMENT	RATING	COMMENTS
BEARING	Ⓒ F P C	
PAINT	G F P C	N/A
CAP	Ⓒ F P C	① Hairline cracks effr
WINGS	Ⓒ F P C	② Hairline cracks effr
EMB.	Ⓒ F P C	
VEG.	Ⓒ F P C	
RIP-RAP	G F P C	
SLOPE PAV	Ⓒ F P C	
BACKWALL	G F P C
