Inspection Report

80I00400035

Regular Inspection Report

I40 / CANEY FORK RIVER & NFA A43

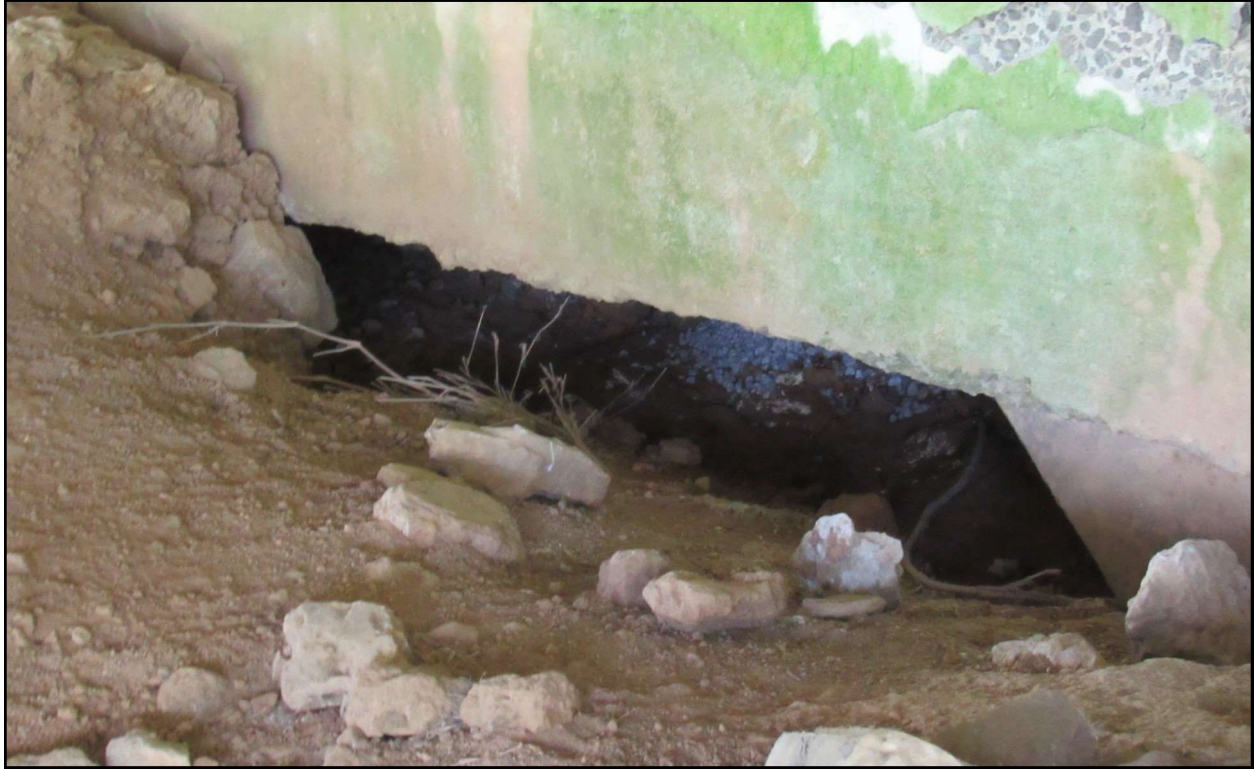
VOID AT ABUTMENT #2

Rating	Comments
Caps	GOOD	CRACK W/DELAM @ ABUT-2
Breastwall	NA	
Wings	GOOD	
Backwall	GOOD	
Plumb	GOOD	
Footing	NV	
Piles	NV	
Embankment	GOOD	
Bearing Surface	GOOD	
Slope Paving	GOOD	
Rip Rap	NA

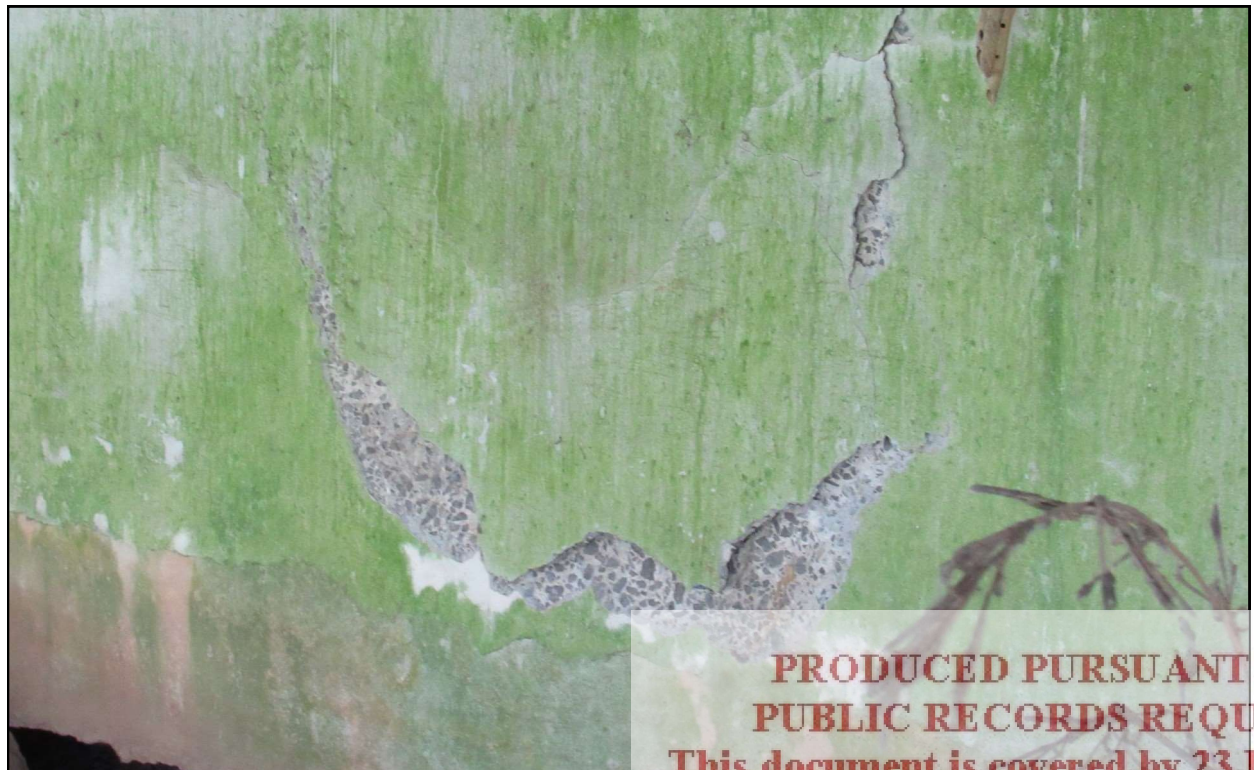
DELAM AT ABUTMENT #2

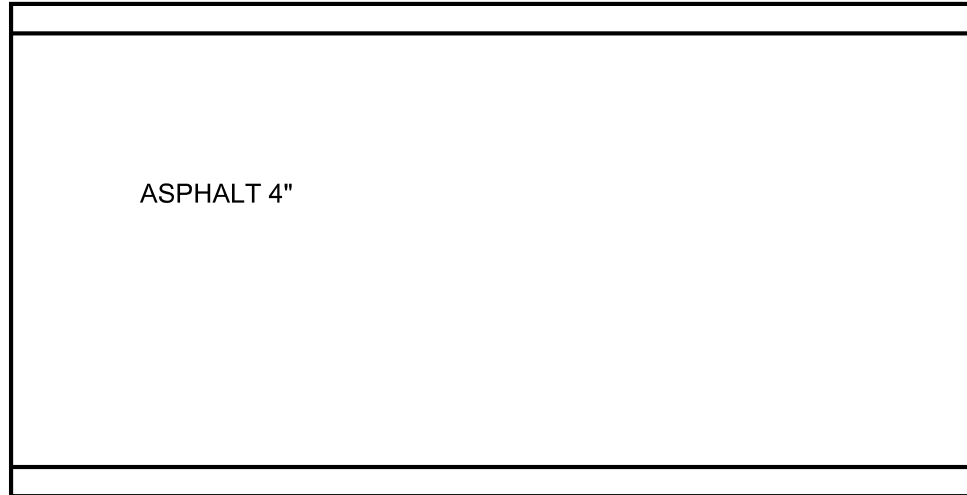
Top of Deck Span No. 4

DECK	NV	AC OVERLAY IS GOOD
		(1) SINKHOLE AT APPROACH B LT SIDE
CURBS	NA	
RAILS	G	RANDOM HAIR LINE CRACKS
JOINTS	P	PAVED OVER
SIDEWALK	NA	
JOINTS	NA	
DRAINS	NA

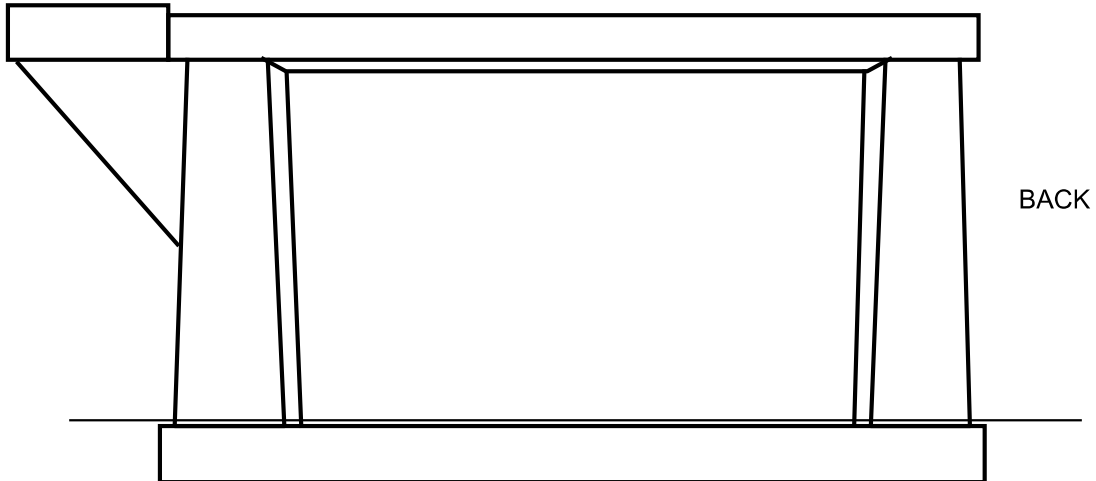
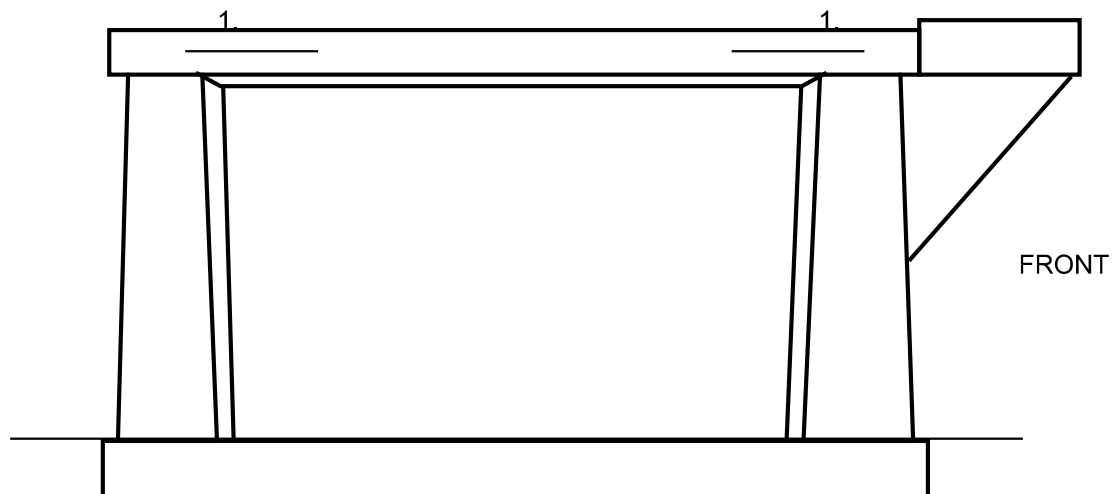
CAP	G	1.) 1/16" CRACKS 2'L
WALL	G	
FOOTING	NV	
BEARINGS	G

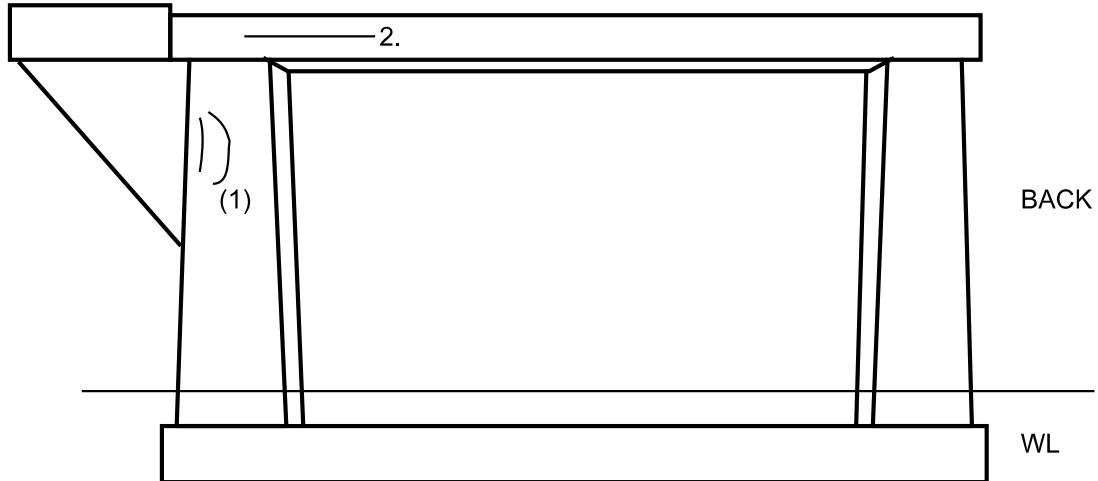
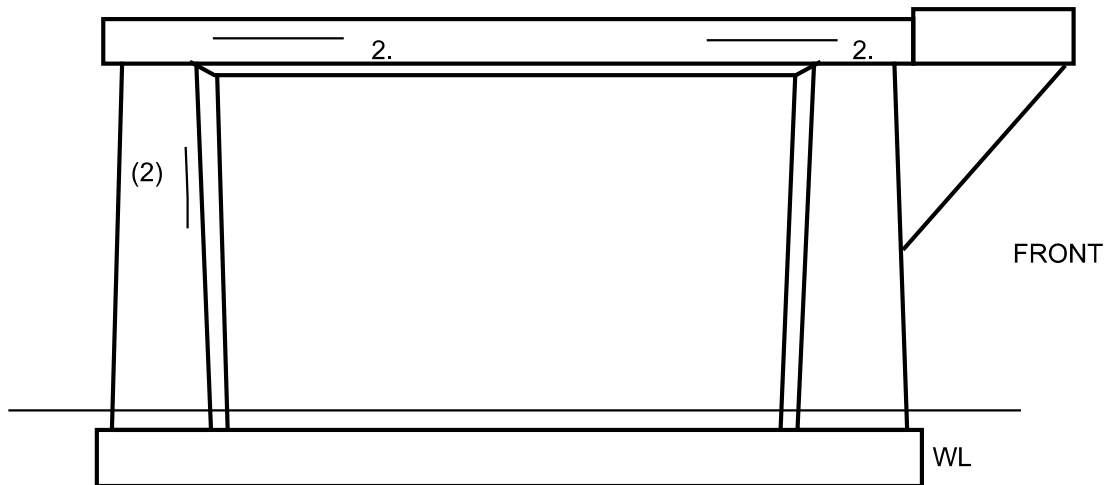
CAP	G	(1) 1/8" VERTICAL CRACKS 2' LONG
		2.) 1/16" CRACKS 2'L
WALL	G	
FOOTING	NV	
BEARINGS	G

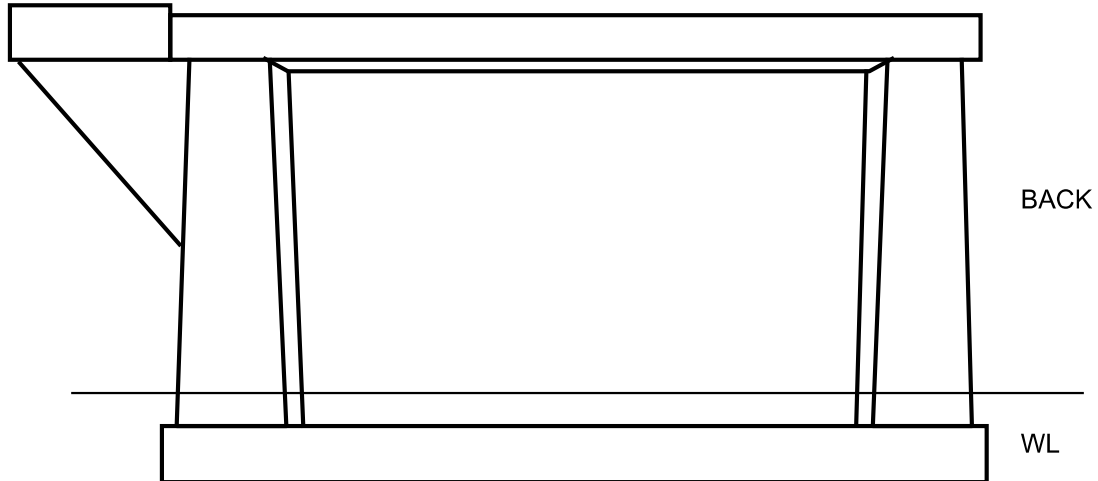
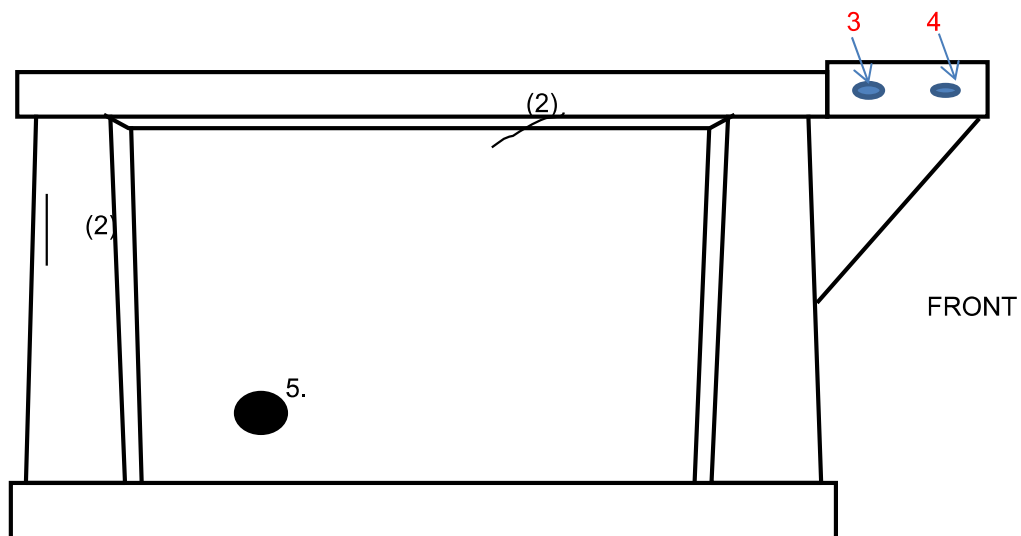
CAP	G	(1) 1/8" VERTICAL CRACK 1' LONG
		(2) 1/8" HORIZONTAL CRACK 2' LONG
		[3] 1' DIAMETER INPLACE SPALLS 4. SPALL 1'DIA UP TO 2"DP
WALL	G	5.) 1' DIAM DELAM
FOOTING	NV	
BEARINGS	G

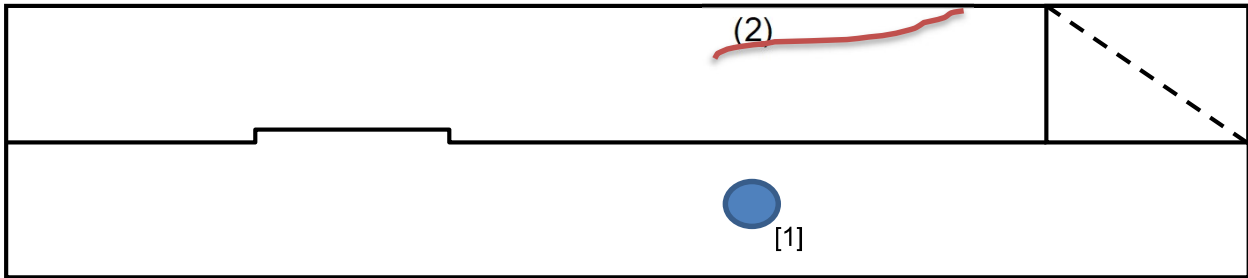
BACKWALL	G	
CAP	G	[1] INPLACE SPALL 4' X 3'
		(2) 1/8" CRACK 2'L
WINGS	G	
BEARINGS	NV	
		SPILL THROUGH ABUT W MINOR EROSION
