Inspection Report

80I00400036

Bridge Key: 80I00400036
NBI Number: -1
Structure Name: -1
Location (9): 0.03 MI W. PUTNAM CO. LN
Carries (7): I40
Type of Service (42A): 1 Highway
Feature Crossed (6): CANEY FORK RIV & NFA A43
Type of Service (42B): 6 Highway-waterway
Placecode (4): Unknown
County (3): Smith
State (1): 47 Tennessee
Station: 32 Nashville B
Region (2): Region 3
Latitude (16): 36.14
Longitude (17): -85.80
Owner (22): State Highway Agency
Custodian (21): State Highway Agency
Year Built (27): 1971
Year Recon (106): 1991
Historical (37): 4 Hist sign not determin

Regular Inspection Report

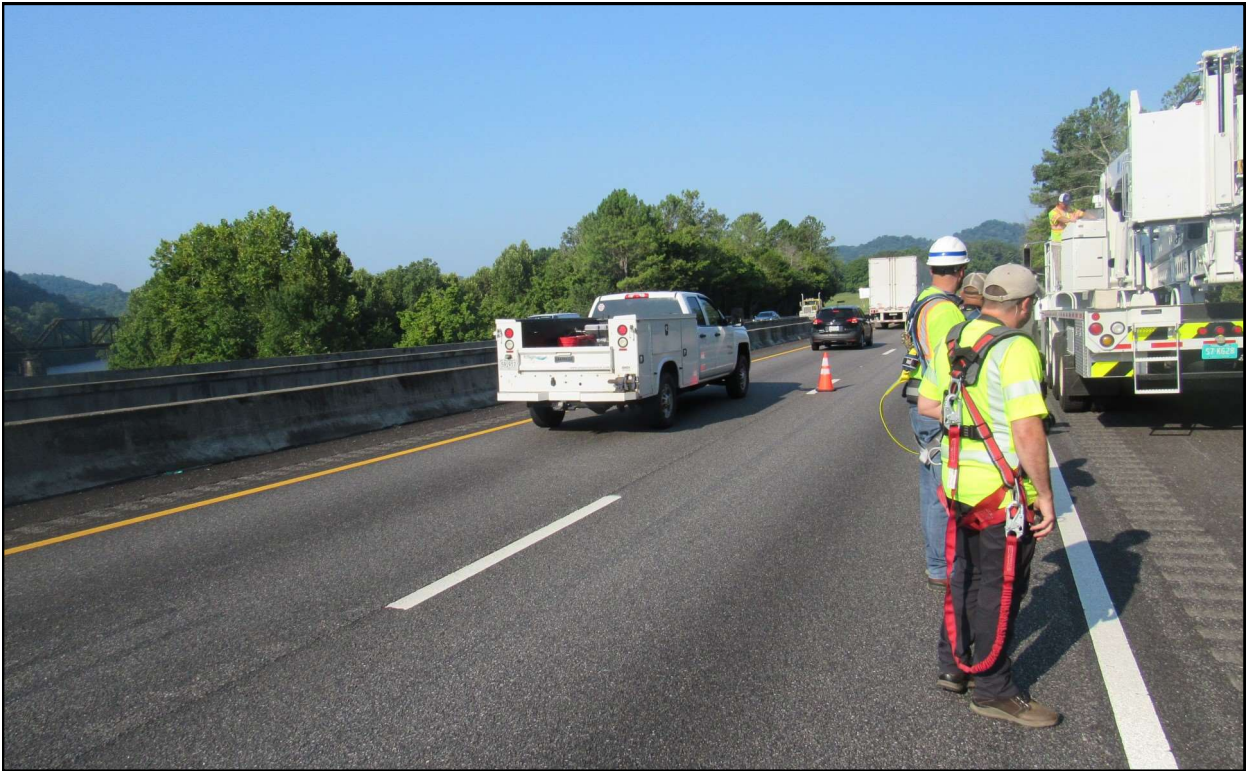
"A" APPROACH VIEW

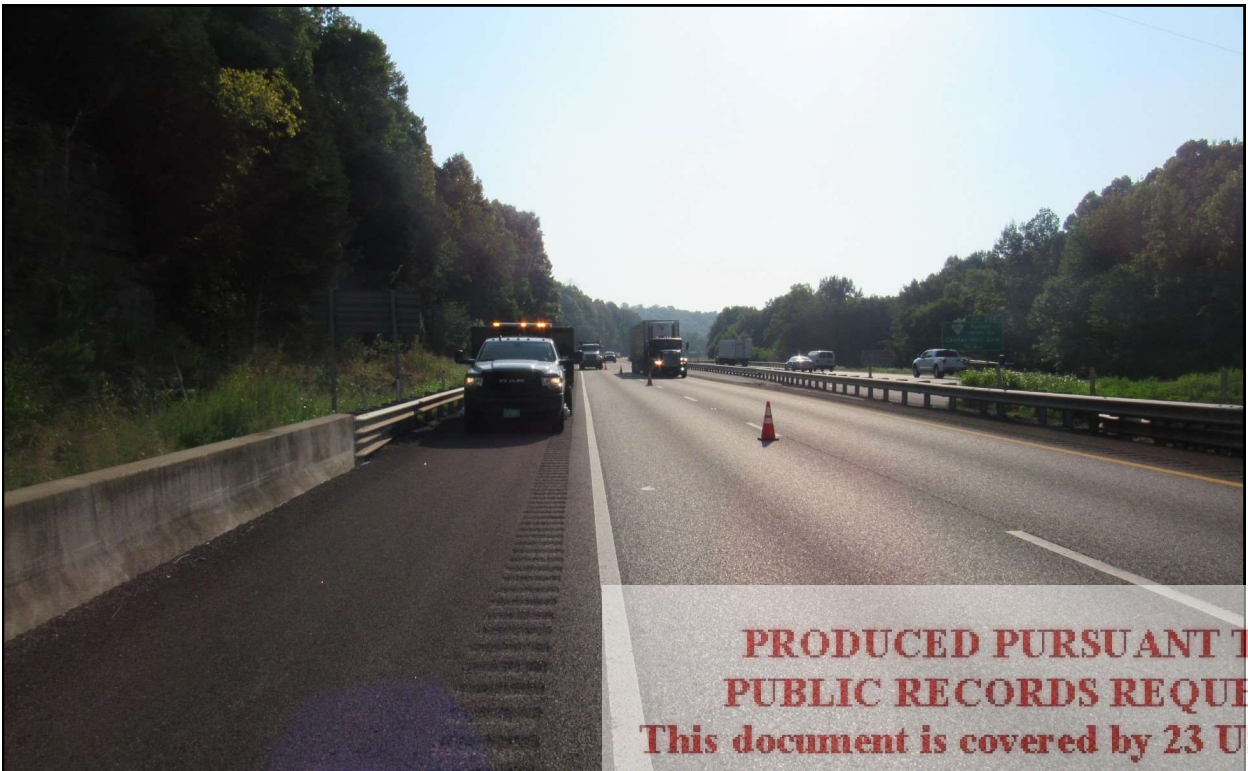
"B" APPROACH VIEW

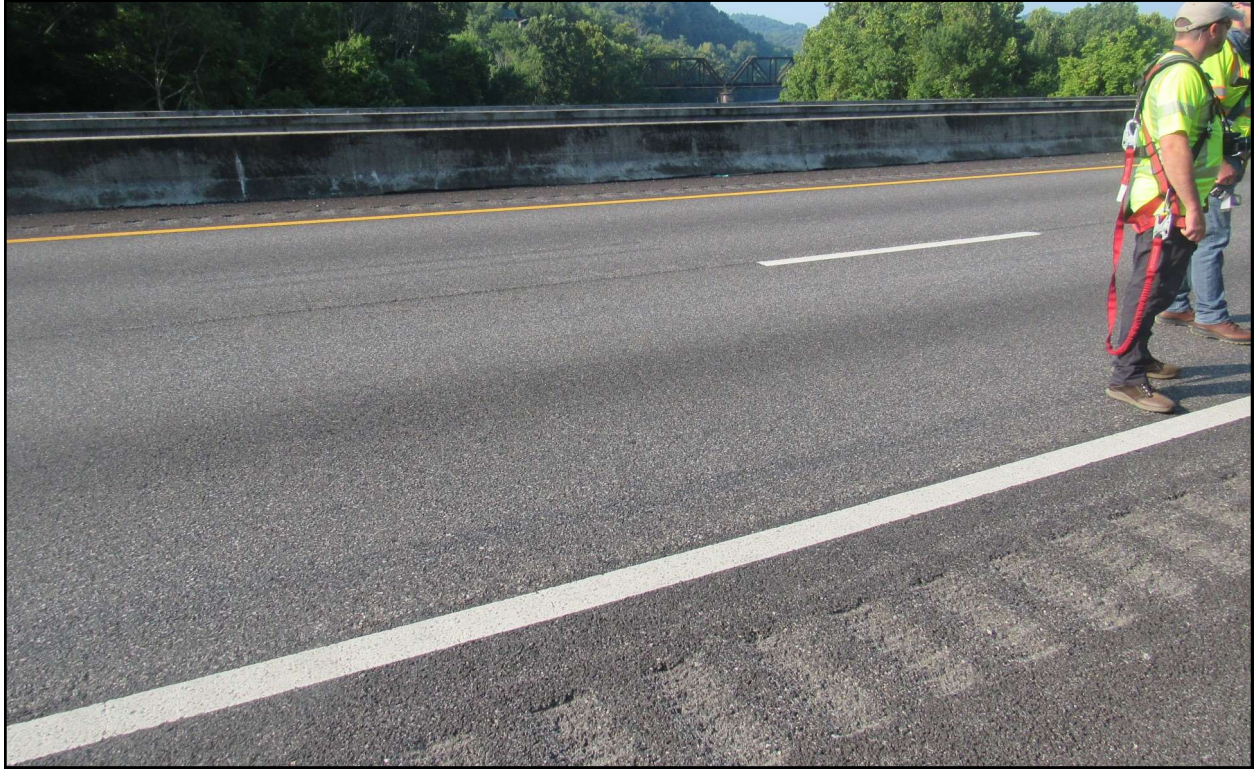
VIEW ACROSS DECK

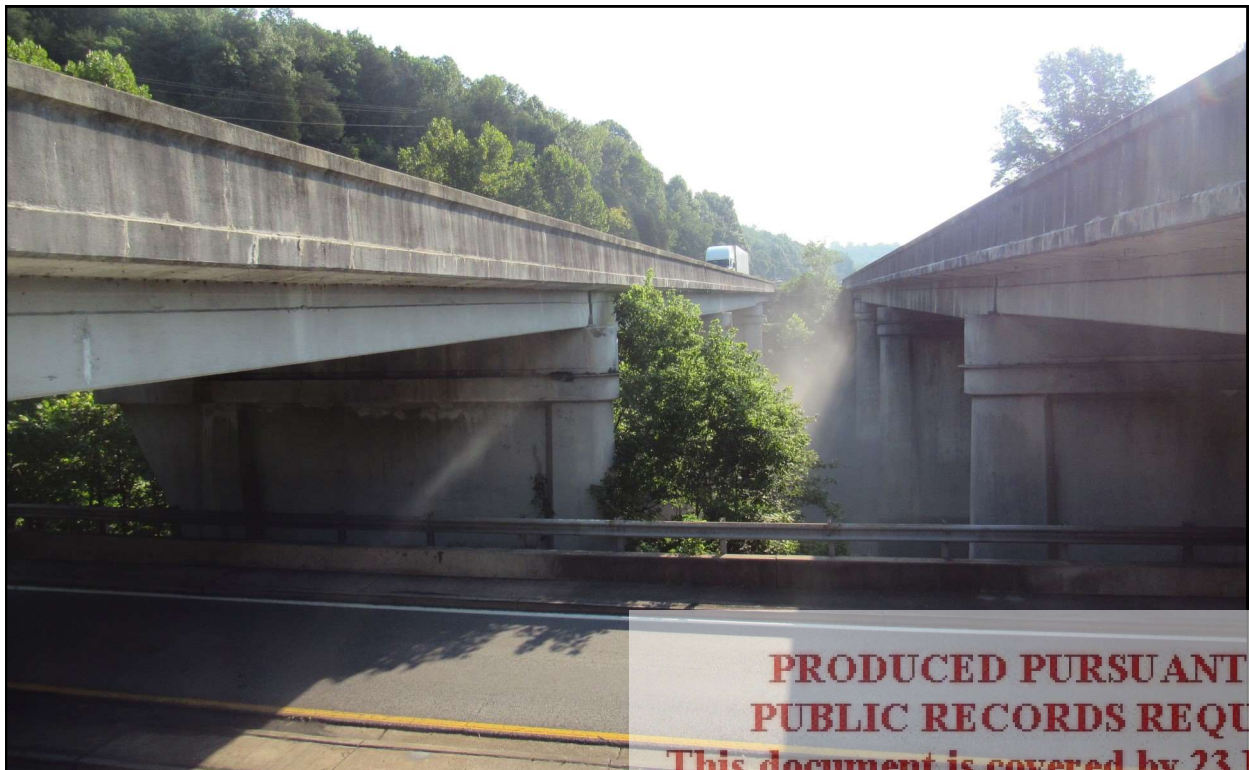
INLET ELEVATION

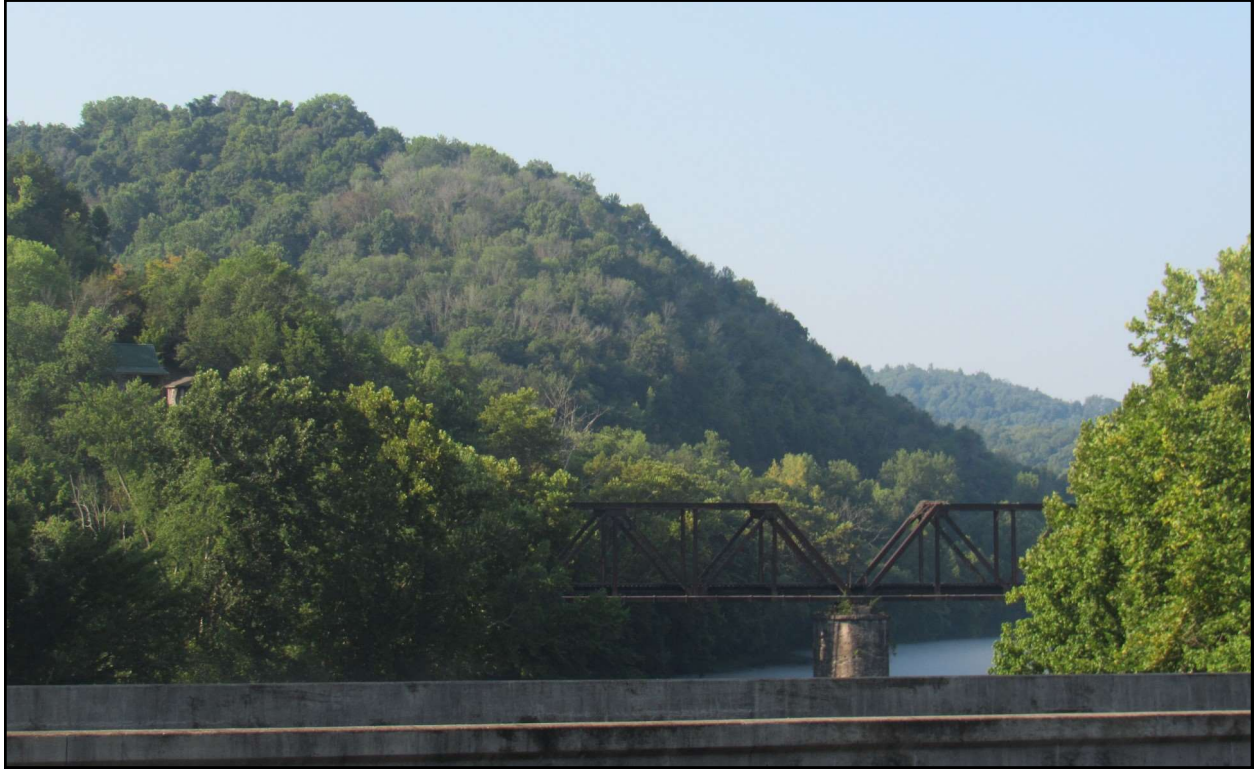
UPSTREAM VIEW

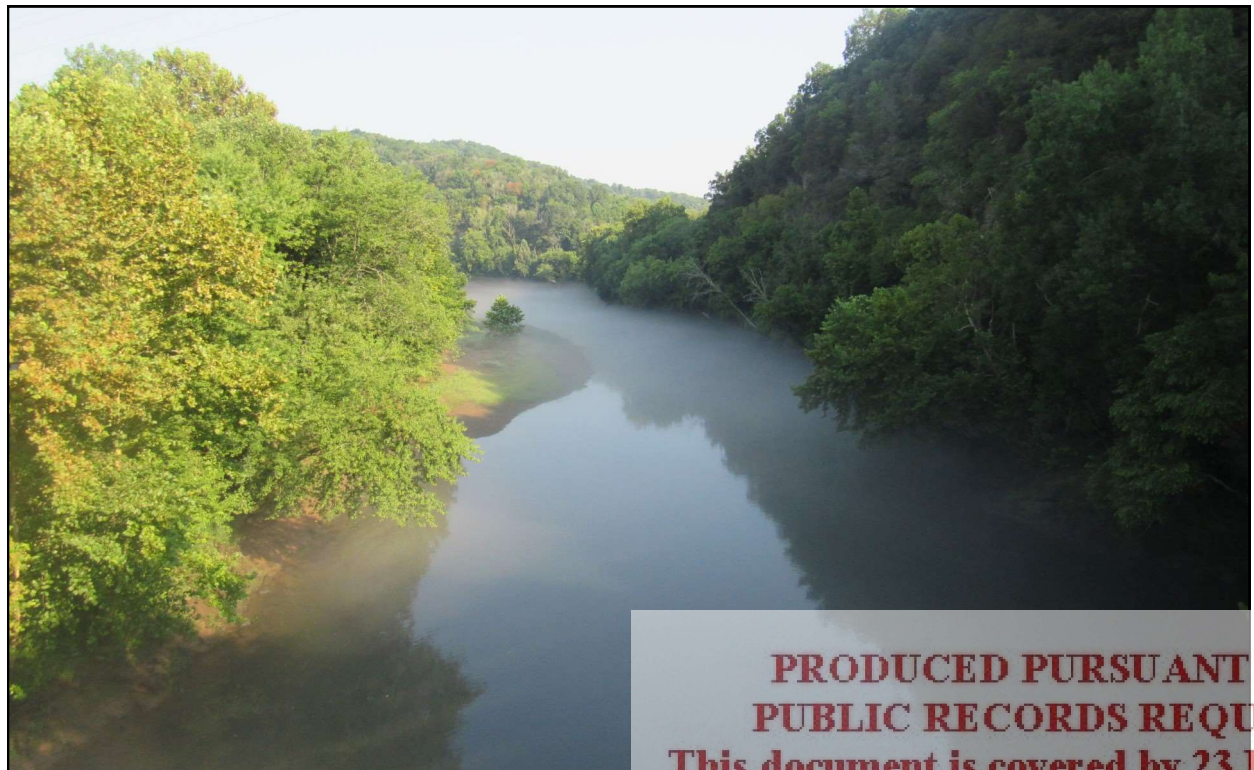
DOWNSTREAM VIEW

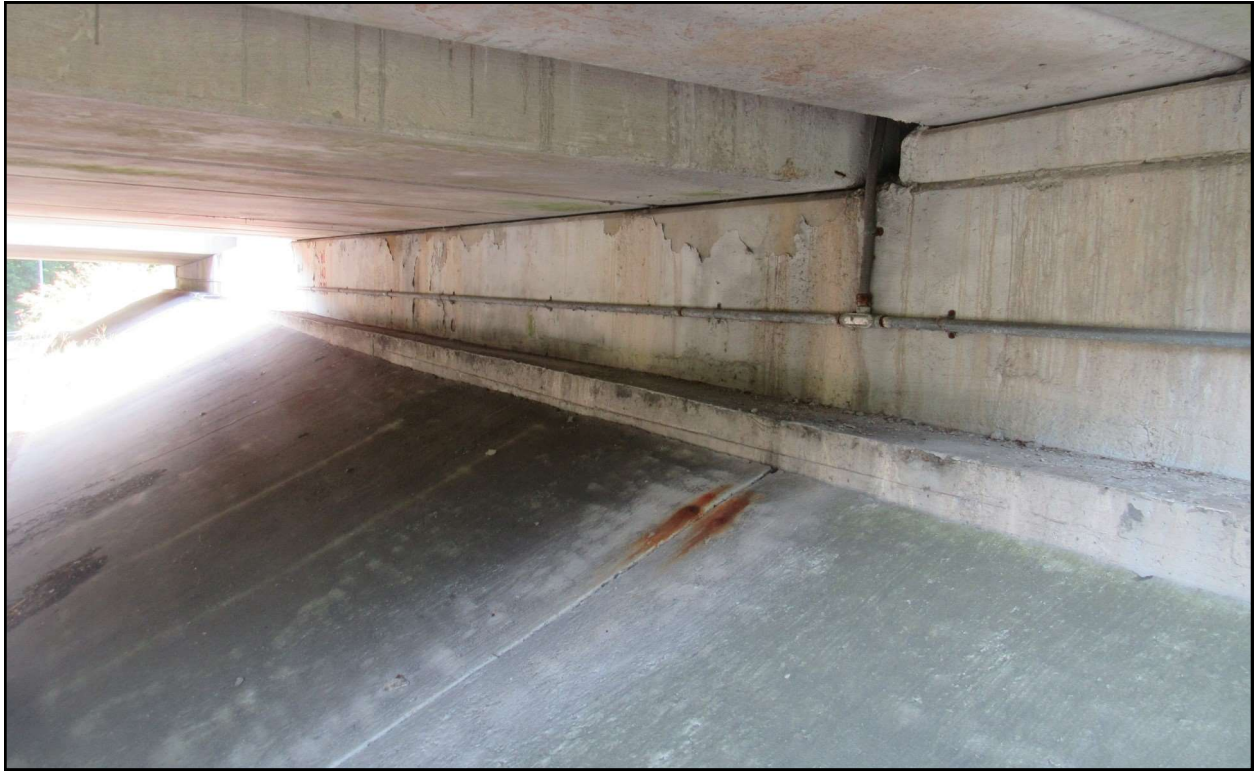
ABUTMENT TYPICAL

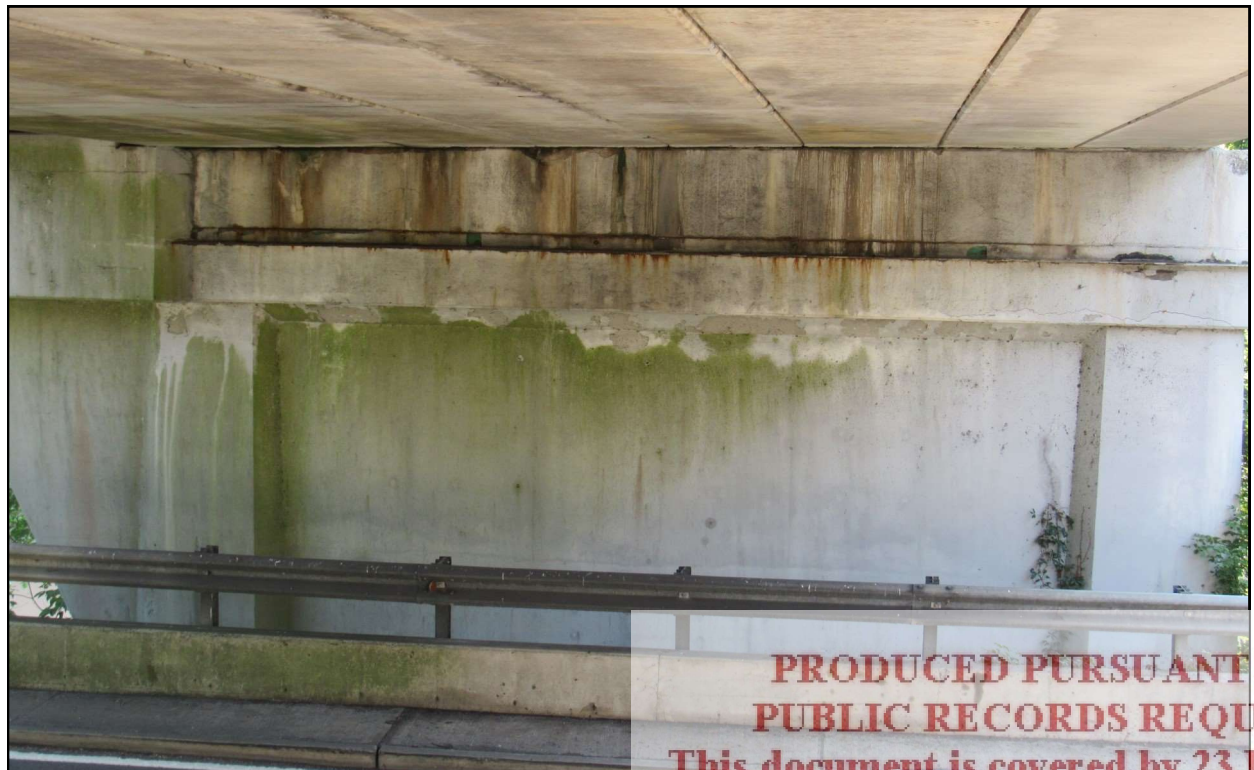
PIER TYPICAL

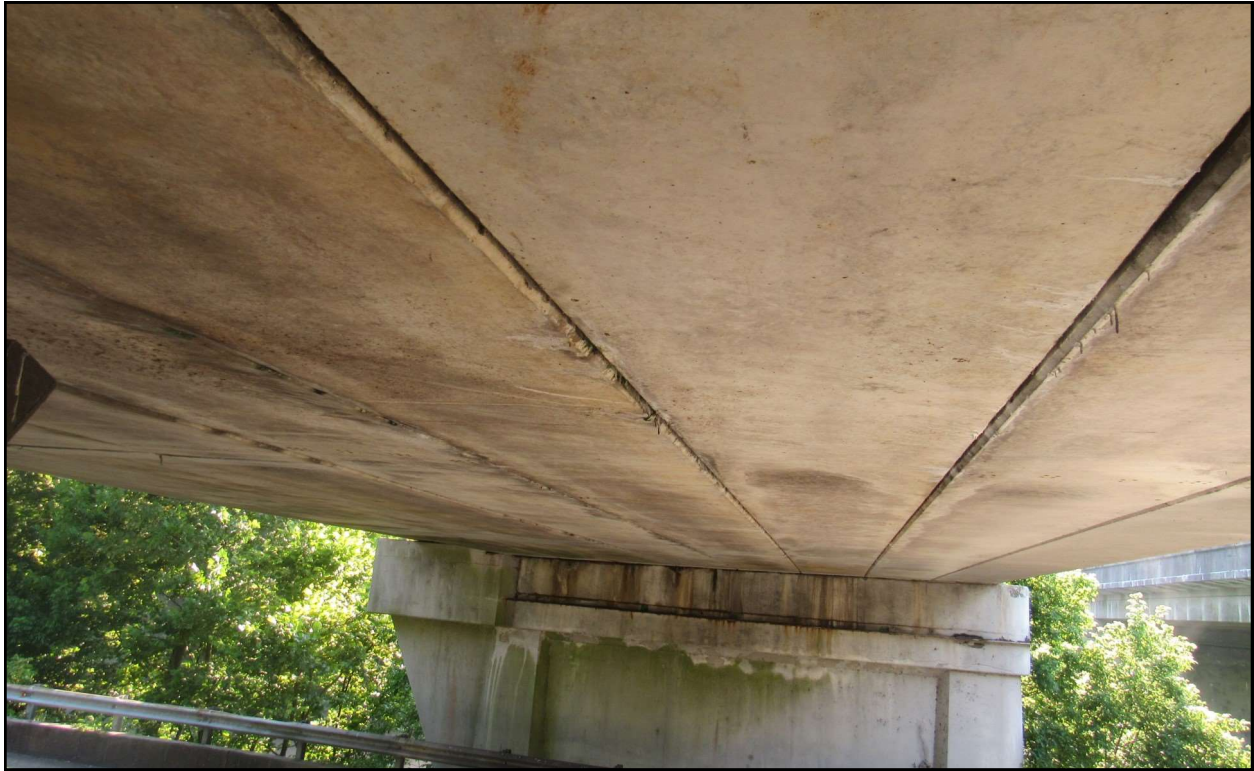
BOTTOM DECK VIEW

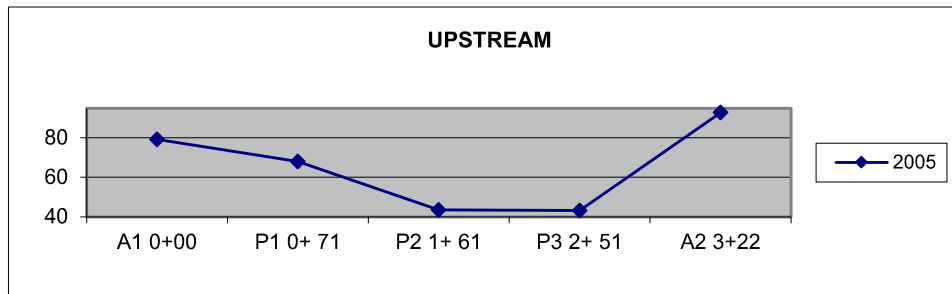
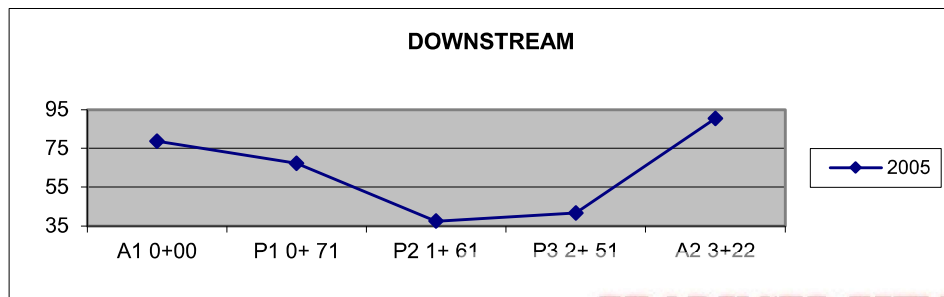
Stream Profile

A1 0+00	79.2
P1 0+ 71	68
P2 1+ 61	43.5
P3 2+ 51	43.2
A2 3+22	92.7

A1 0+00	78.7
P1 0+ 71	67.2
P2 1+ 61	37.5
P3 2+ 51	41.7
A2 3+22	90.4

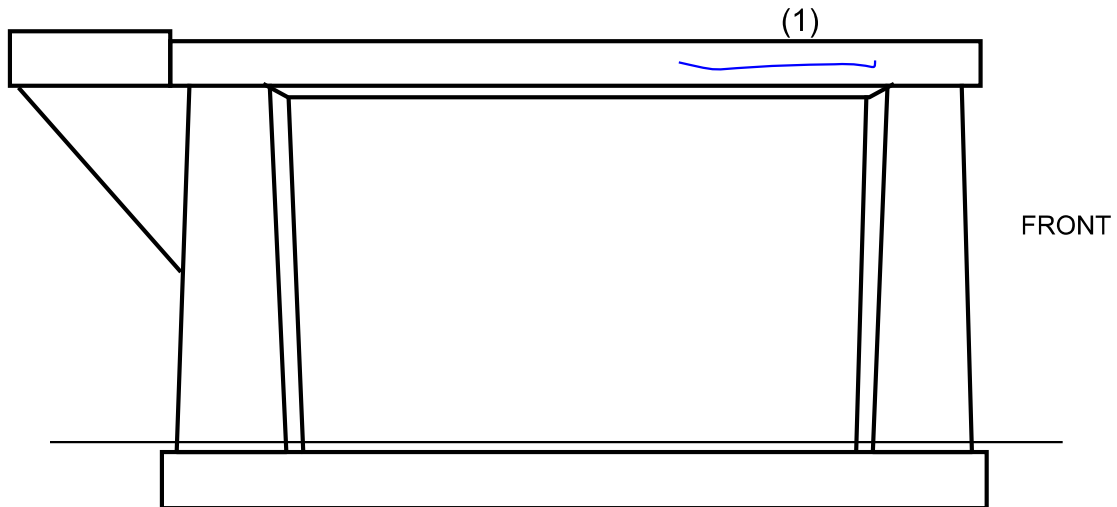
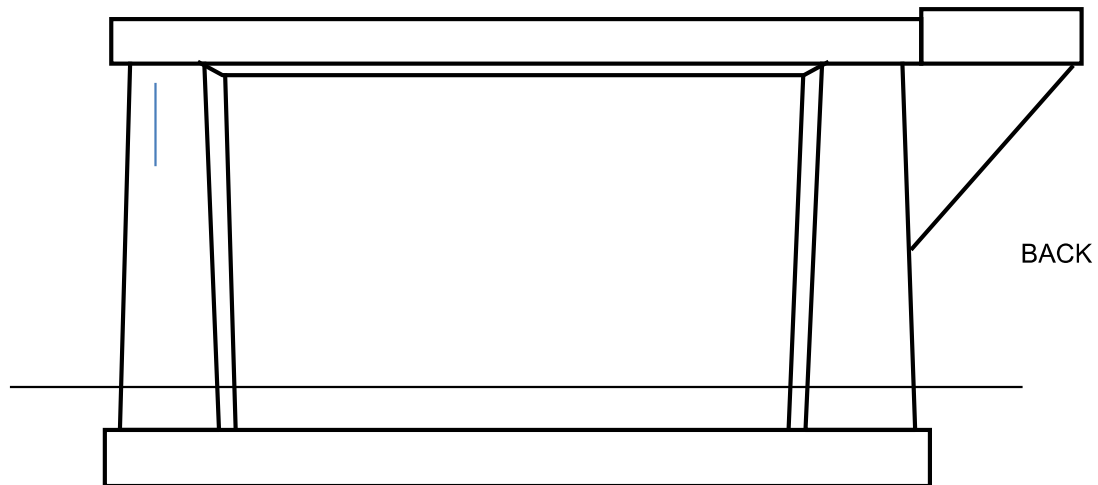
CAP	G	(1) 1/8" HORIZONTAL CRACK 8' LONG
		AREAS OF MAP CRACKING
WALL	G	FEW HAIR CRACKS
FOOTING	NV	
BEARINGS	P

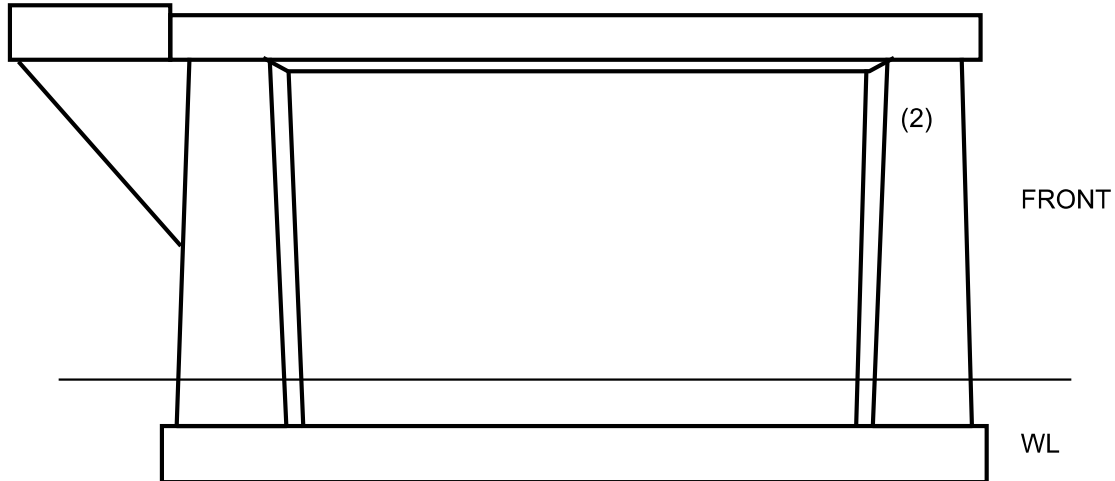
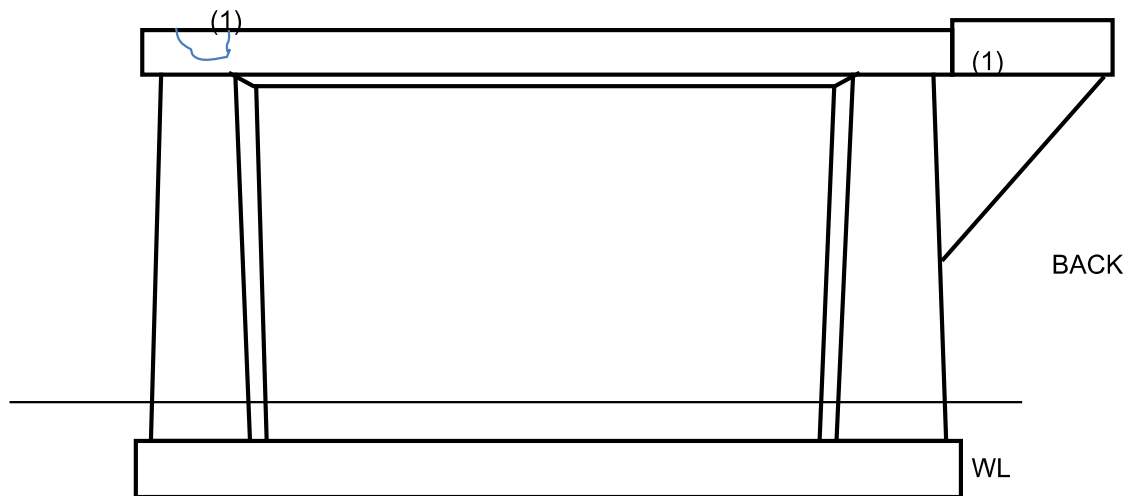
CAP	G	(1) HAIR CRACK W EFF
		(2) VERTICAL CRACKS ON OUTSIDE OF PIER
WALL	G	
FOOTING	NV	
BEARINGS	P

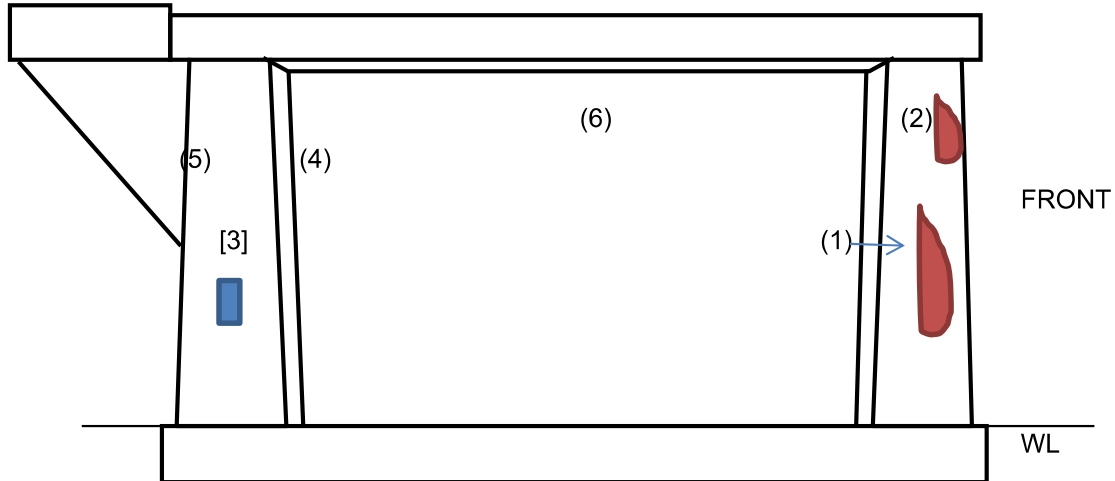
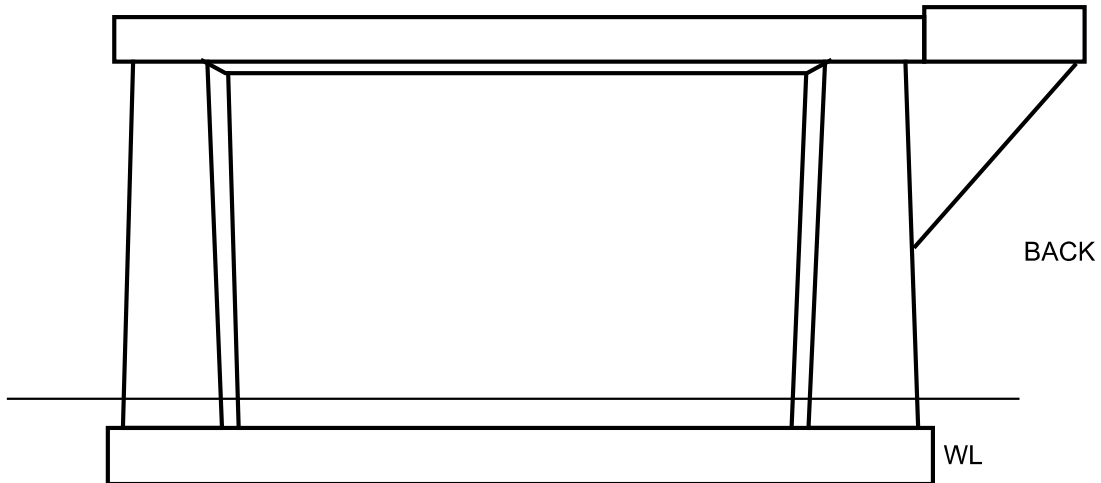
CAP	G	AREAS OF MAP CRACKING; (6) 1/16" CRACK 3'L
		RANDOM HAIR CRACKS WITH LEACHING
WALL	G	(1) AREA OF DELAM 4' H X 1' W; (4) DELAM 3'H x 2'W
		(2) AREA OF DELAM 5'H X 2'W; (5) 1/16" CRACK, 3'L
		[3] AREA OF DELAM 4' H X 1' W
FOOTING	NV	
BEARINGS	NV
