TENNESSEE DEPARTMENT OF TRANSPORTATION ASBESTOS SURVEY REPORT

Bridge 80I00400035 (80-I0040-17.13R)
I-40 East Bound Over Caney Fork River, LM 17.16
Smith County
TDOT Project No.: 80I040-S1-006, PIN: 131552.01

TriAD Project No. PROJ-042759 TDOT W021

08/16/24

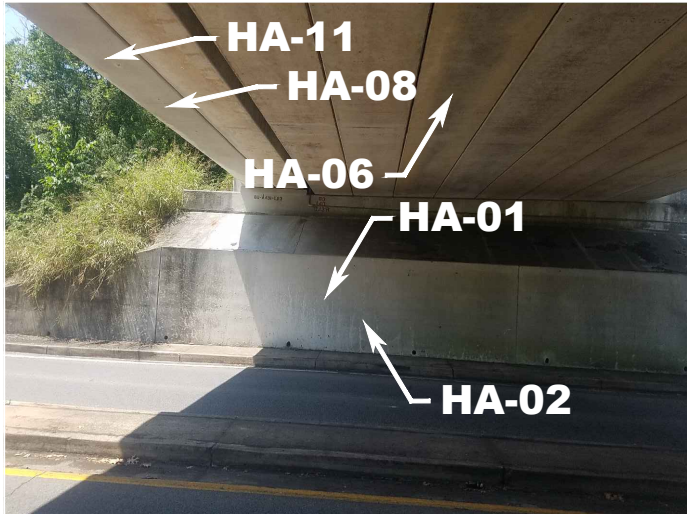
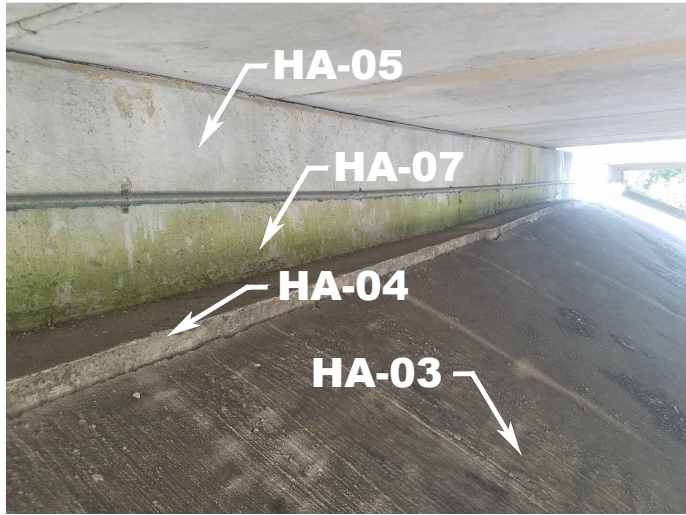
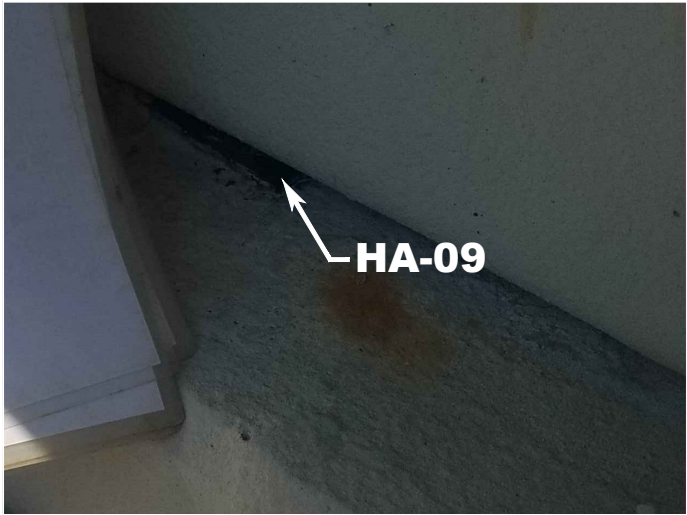
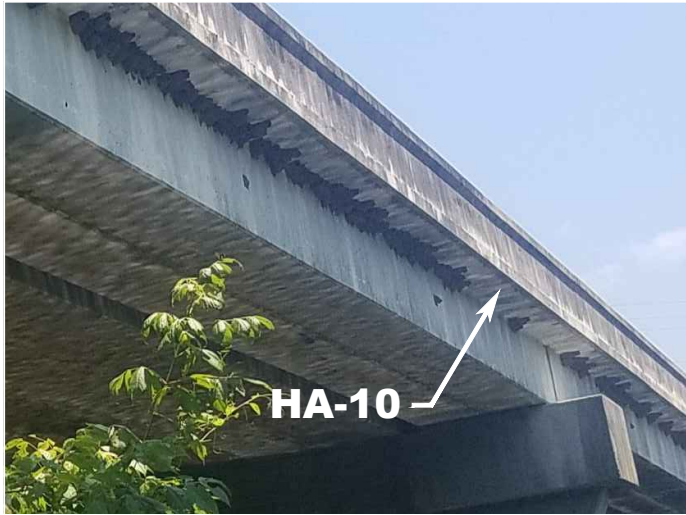
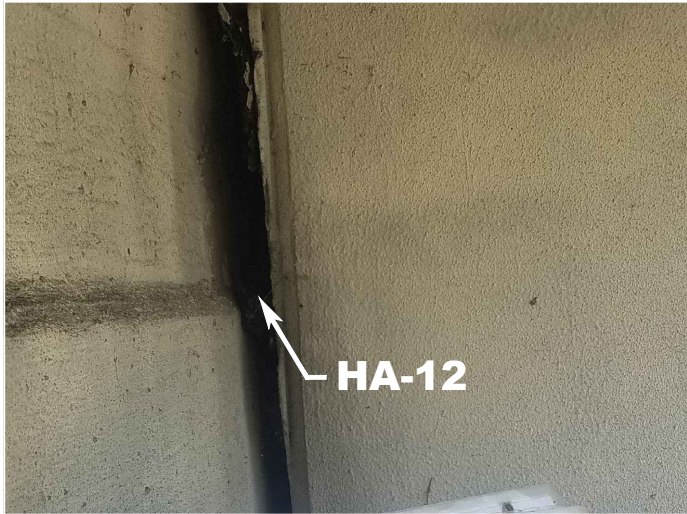
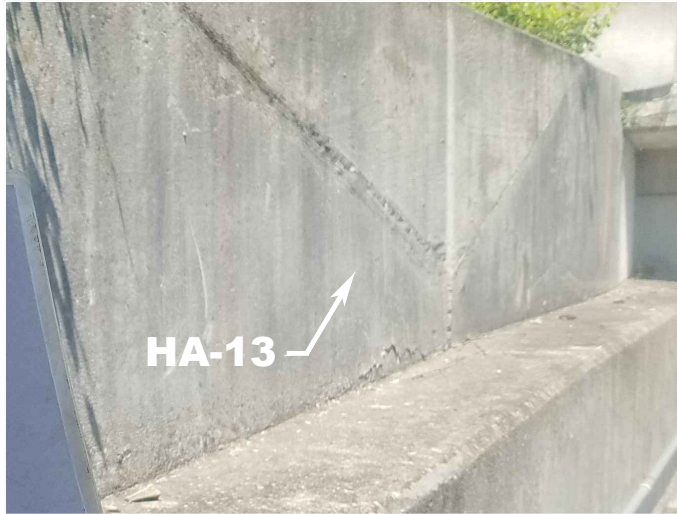
FIGURE 2 HOMOGENEOUS AREAS

Based on the analytical results, none of the sampled materials contained asbestos. The analytical results of all the samples collected, along with the chain-of-custody records, are included in Appendix A. Photographs of examples of the HAs are included in Appendix B. A Bridge Vicinity Map is provided as Figure 1. A profile of the bridge with homogenous area sample locations is depicted on Figure 2.

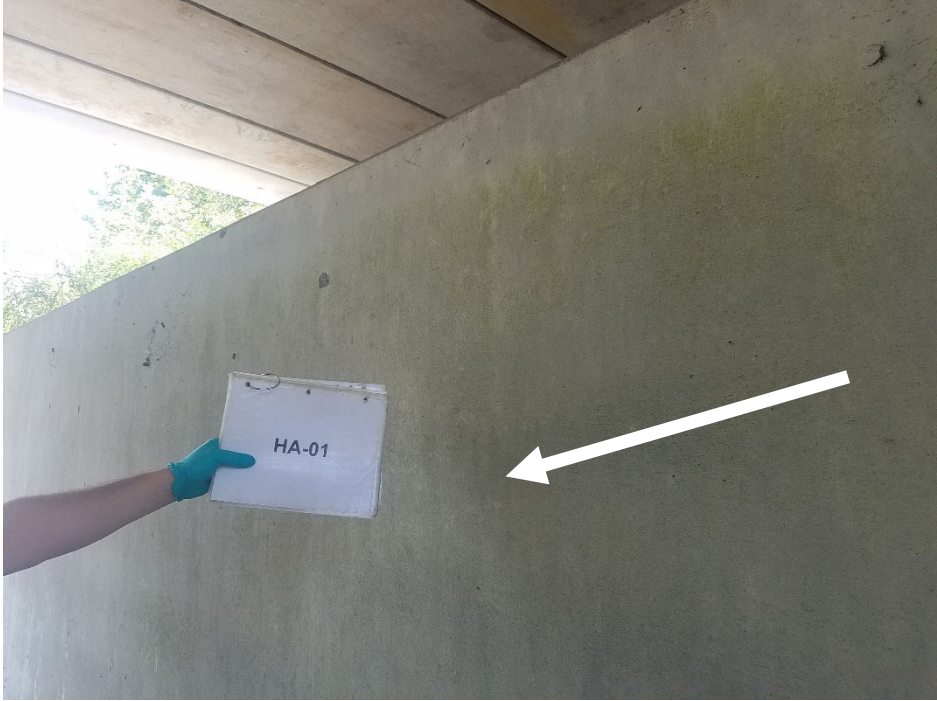
The retaining wall is made of concrete. Three samples were collected from this HA. A hammer and chisel were used to collect these samples.

Date: 08/05/2024	
Description: Photograph 3 – HA-01 Retaining Wall

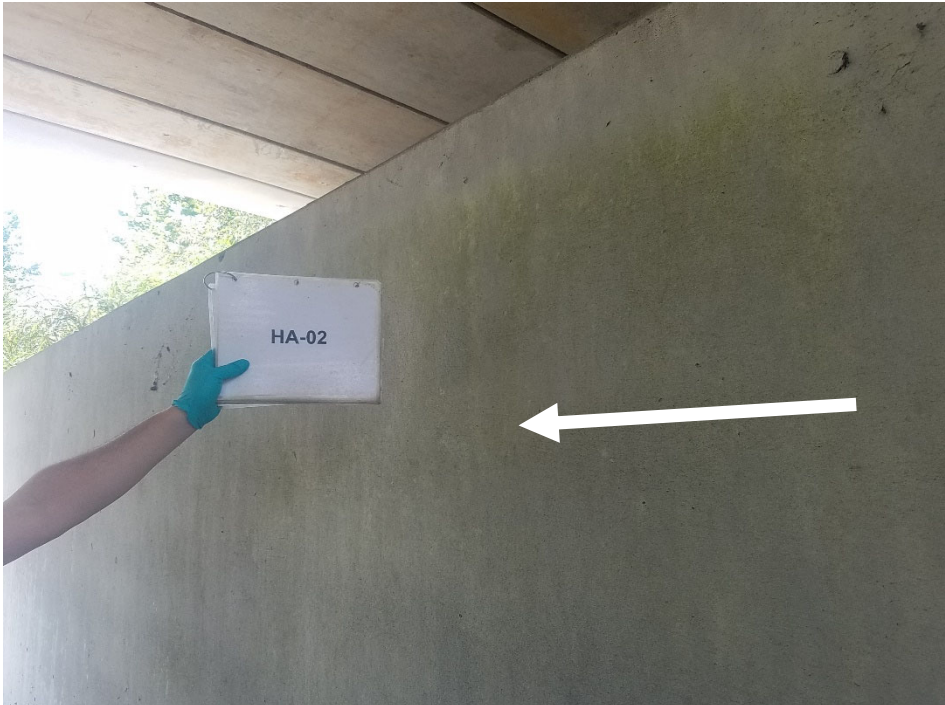
The retaining wall is coated with a thin gray textured material. Three samples of the coating were collected from this HA. A utility knife was used to collect these samples.

Date: 08/05/2024	
Description: Photograph 4 – HA-02 Retaining Wall Coating

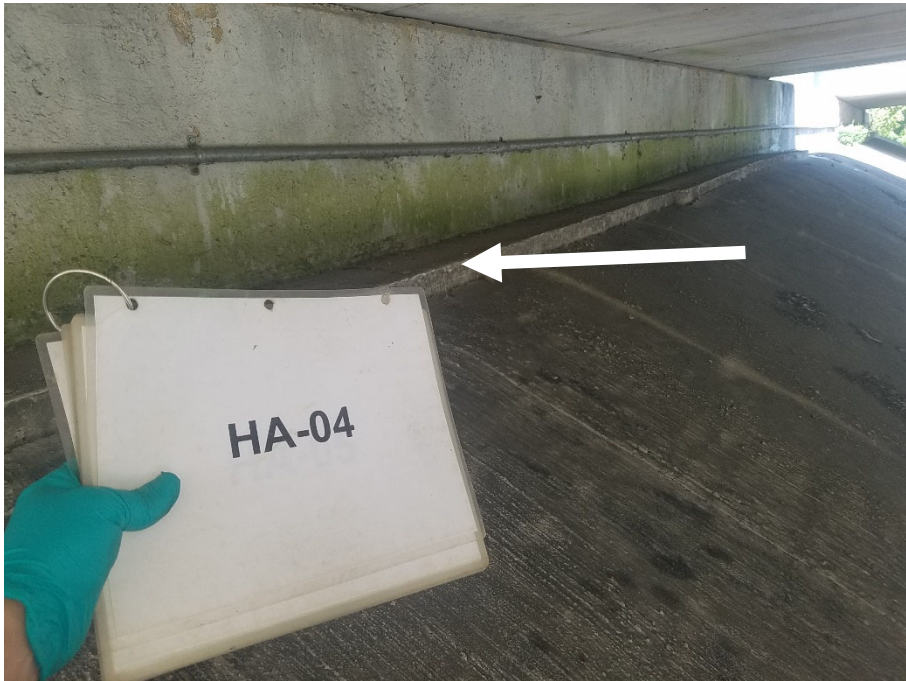
The abutment base is made of concrete. Three samples were collected from this HA. A hammer and chisel were used to collect these samples.

Date: 08/05/2024	
Description: Photograph 6 – HA-04 Abutment Base

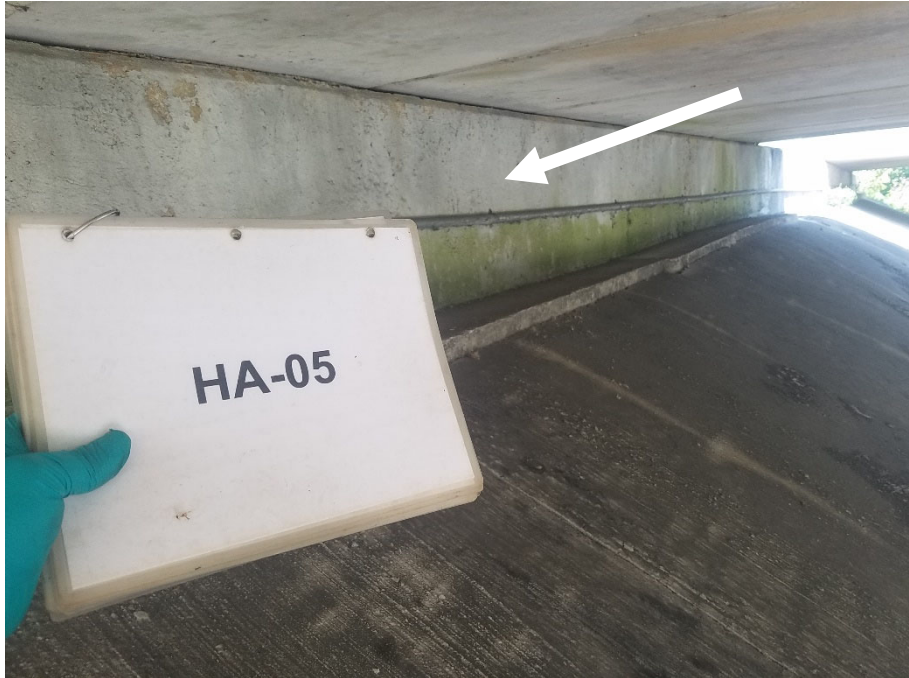
The abutments are made of concrete. Three samples were collected from this HA. A hammer and chisel were used to collect these samples.

Date: 08/05/2024	
Description: Photograph 7 – HA-05 Abutment

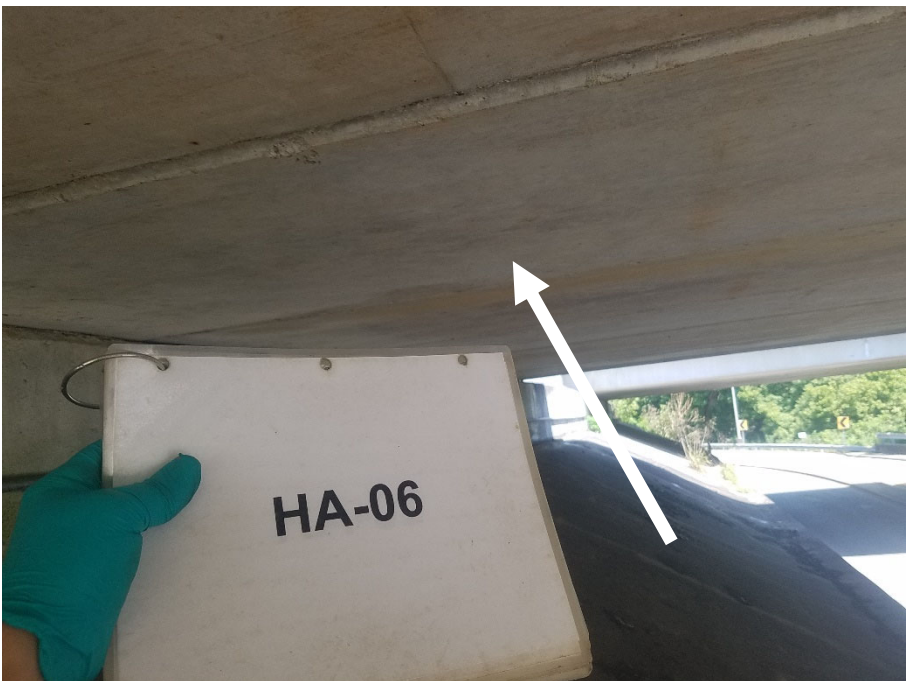
The bottom of the decking is made of concrete. Three samples were collected from this HA. A hammer and chisel were used to collect these samples.

Date: 08/05/2024	
Description: Photograph 8 – HA-06 Bottom of Decking

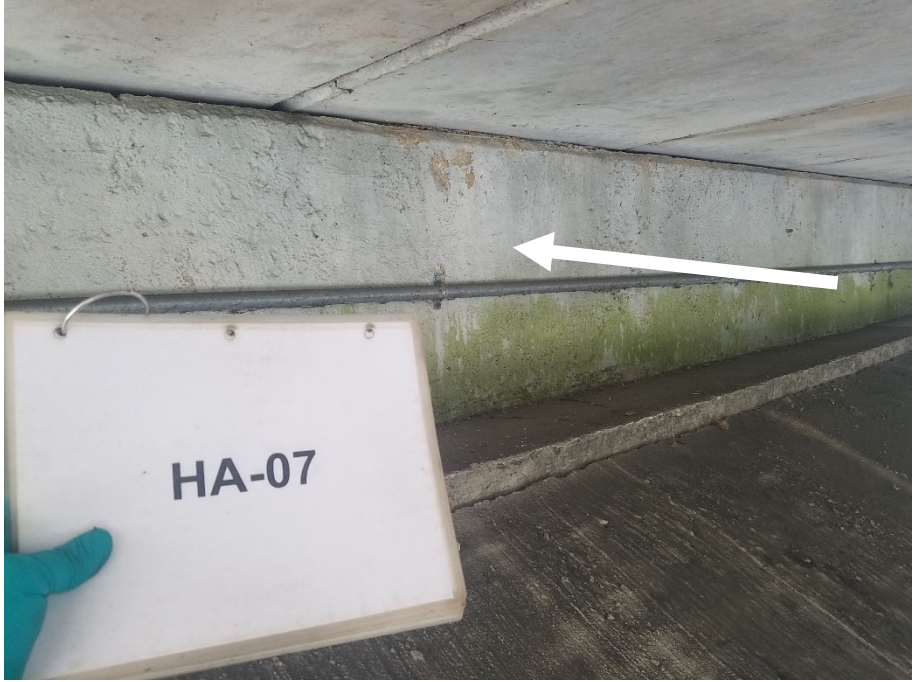
The abutments are coated with a thin gray textured material. Three samples of the coating were collected from this HA. A utility knife was used to collect these samples.

Date: 08/05/2024	
Description: Photograph 9 – HA-07 Abutment Coating

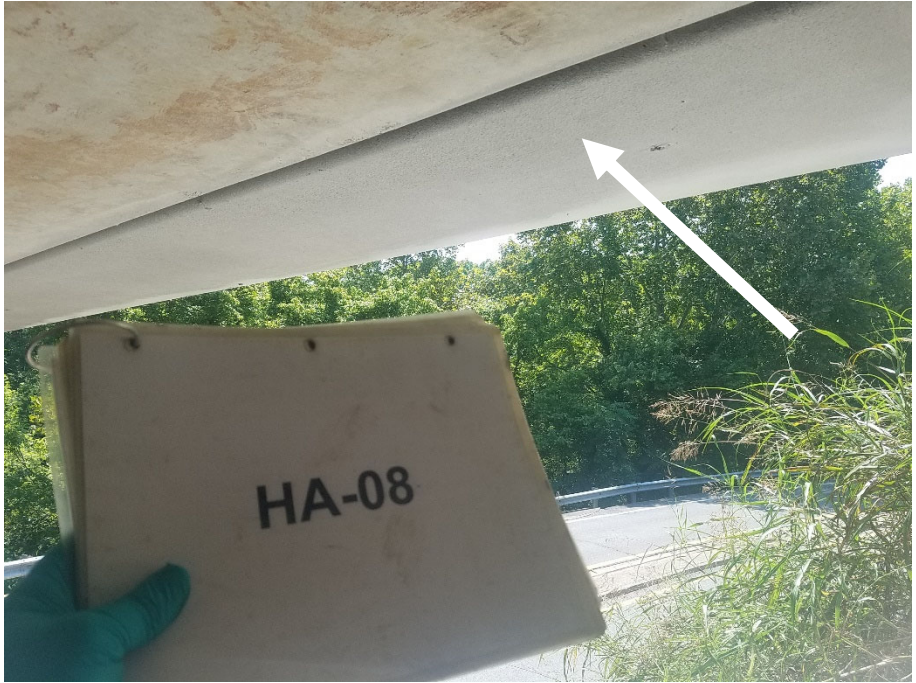
The outer longitudinal girders are made of concrete. Three samples were collected from this HA. A hammer and chisel were used to collect these samples.

Date: 08/05/2024	
Description: Photograph 10 – HA-08 Outer Longitudinal Girder

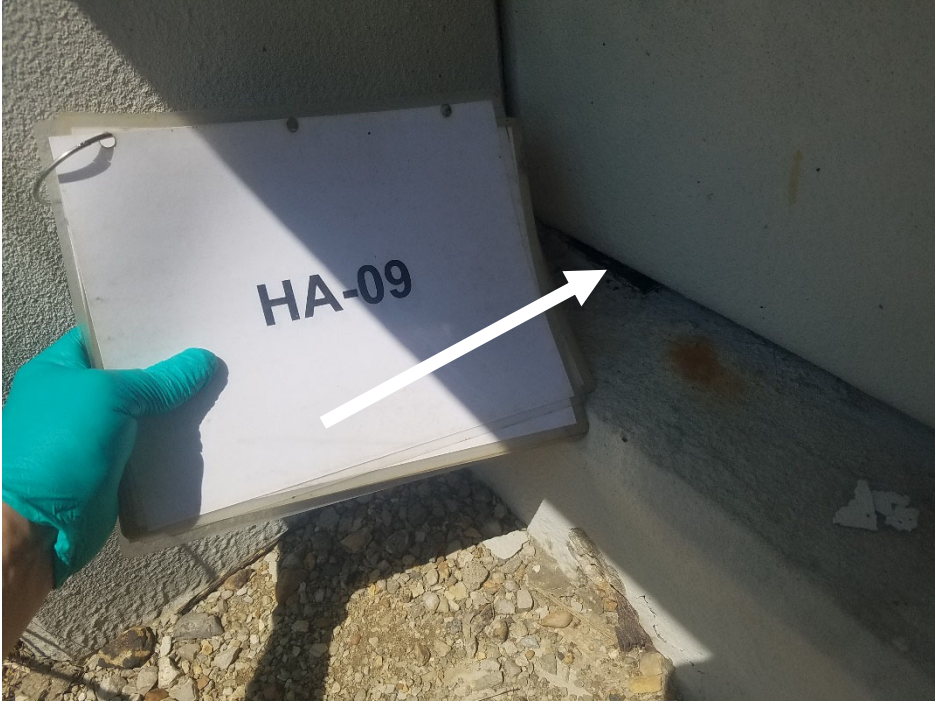
Flexible bearing pads are present between the longitudinal girders and the abutment. Three samples were collected from this HA. A utility knife was used to collect these samples.

Date: 08/05/2024	
Description: Photograph 11 – HA-09 Bearing Pad

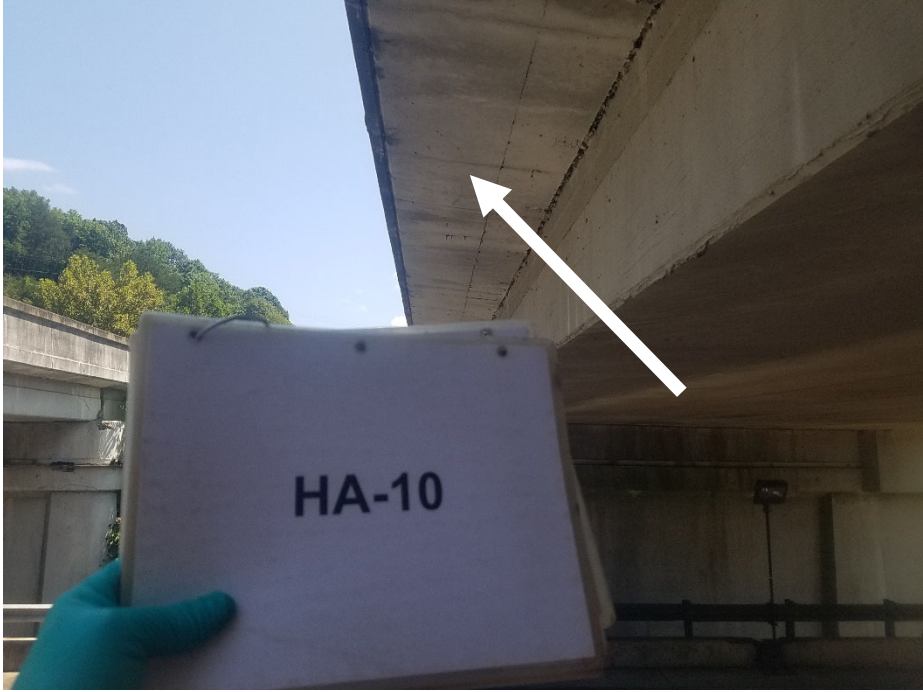
The bottom of the decking outer strips are made of concrete. Three samples were collected from this HA. A hammer and chisel were used to collect these samples.

Date: 08/05/2024	
Description: Photograph 12 – HA-10 Bottom of Decking Outer Strip

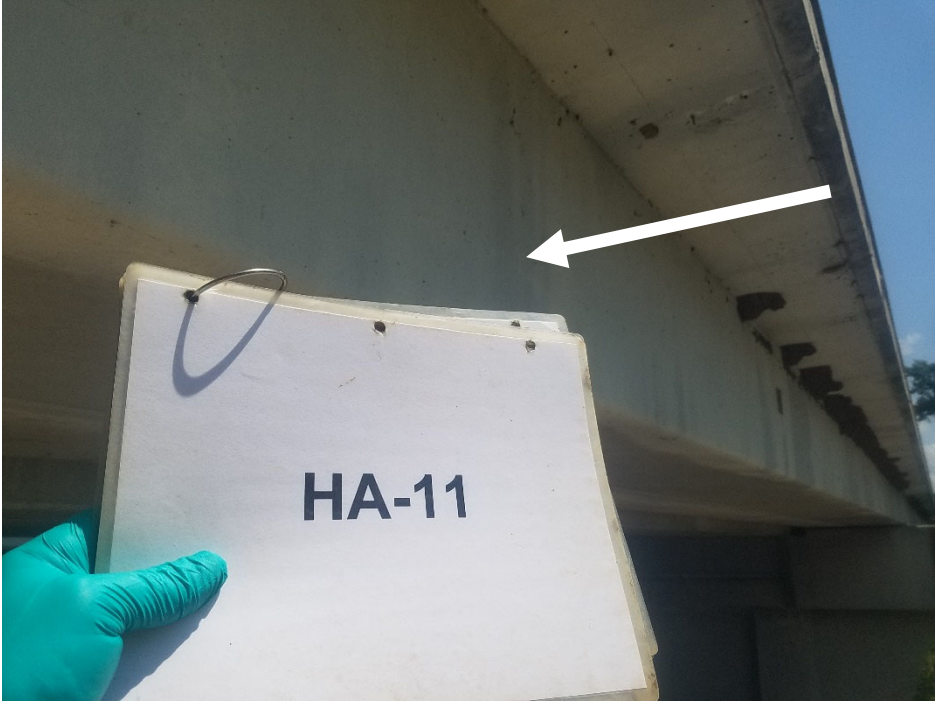
The outer longitudinal girders are coated with a thin gray textured material. Three samples of the coating were collected from this HA. A utility knife was used to collect these samples.

Date: 08/05/2024	
Description: Photograph 13 – HA-11 Outer Longitudinal Girder Coating

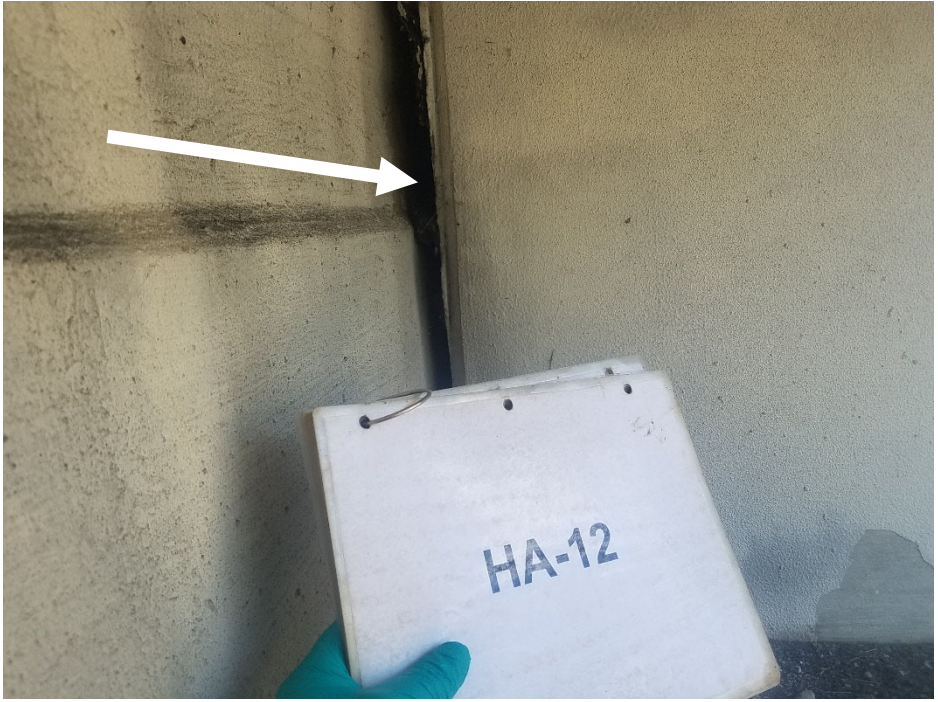
Padding is present between the end walls and the decking. Three samples were collected from this HA. A utility knife was used to collect these samples.

Date: 08/05/2024	
Description: Photograph 14 – HA-12 Padding Between End Wall and Decking

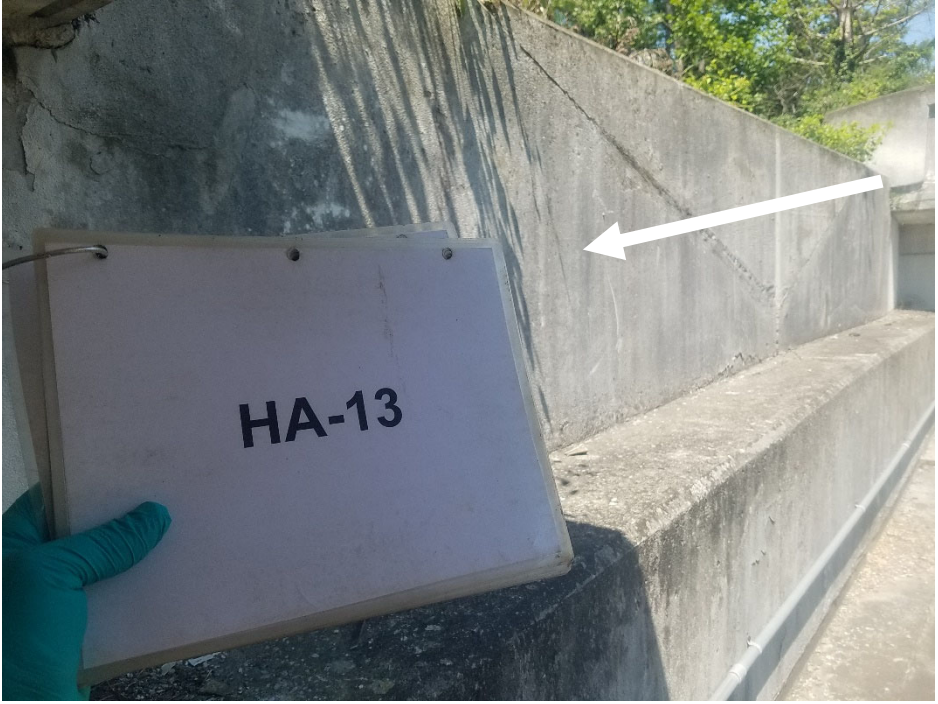
The end walls are made of concrete. Three samples were collected from this HA. A hammer and chisel were used to collect these samples.

Date: 08/05/2024	
Description: Photograph 15 – HA-13 End Wall

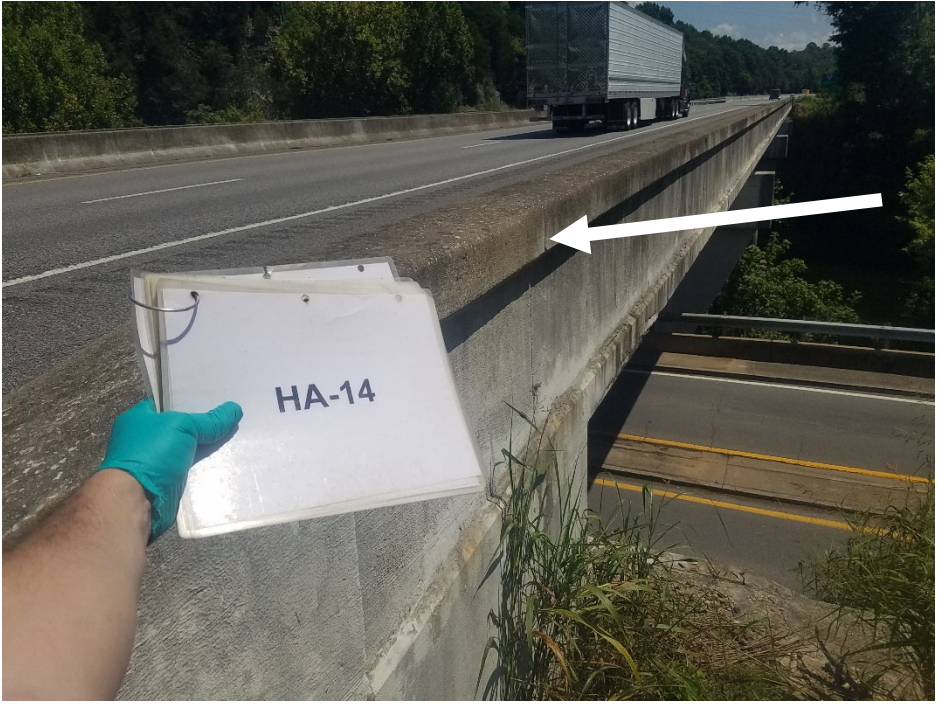
The parapets are made of concrete. Three samples were collected from this HA. A hammer and chisel were used to collect these samples.

Date: 08/05/2024	
Description: Photograph 16 – HA-14 Parapet

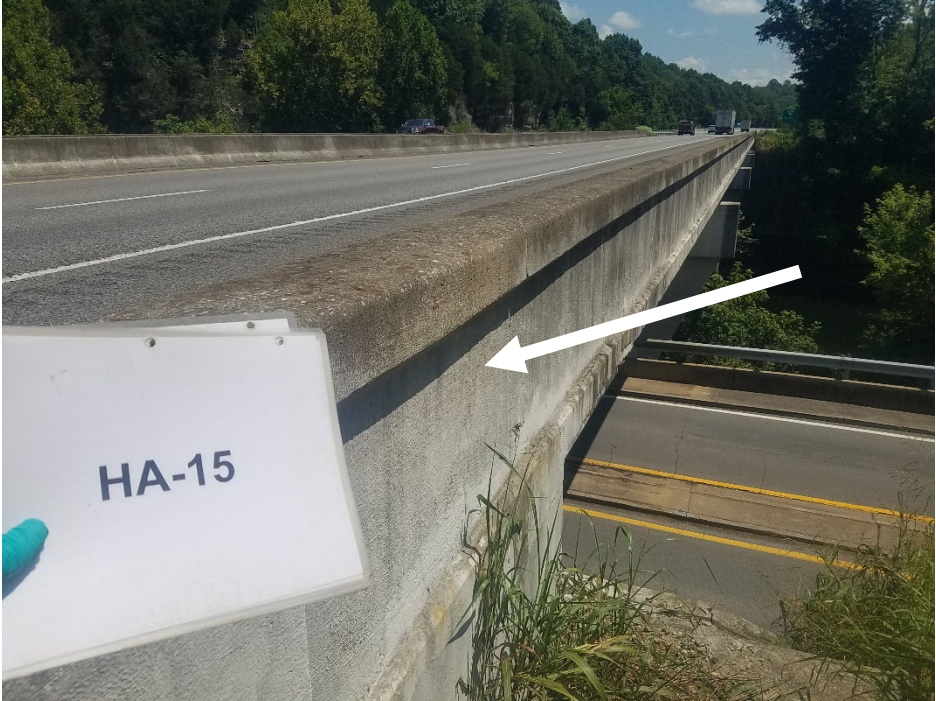
The parapets are coated with a thin gray textured material. Three samples of the coating were collected from this HA. A utility knife was used to collect these samples.

Date: 08/05/2024	
Description: Photograph 17 – HA-15 Parapet Coating

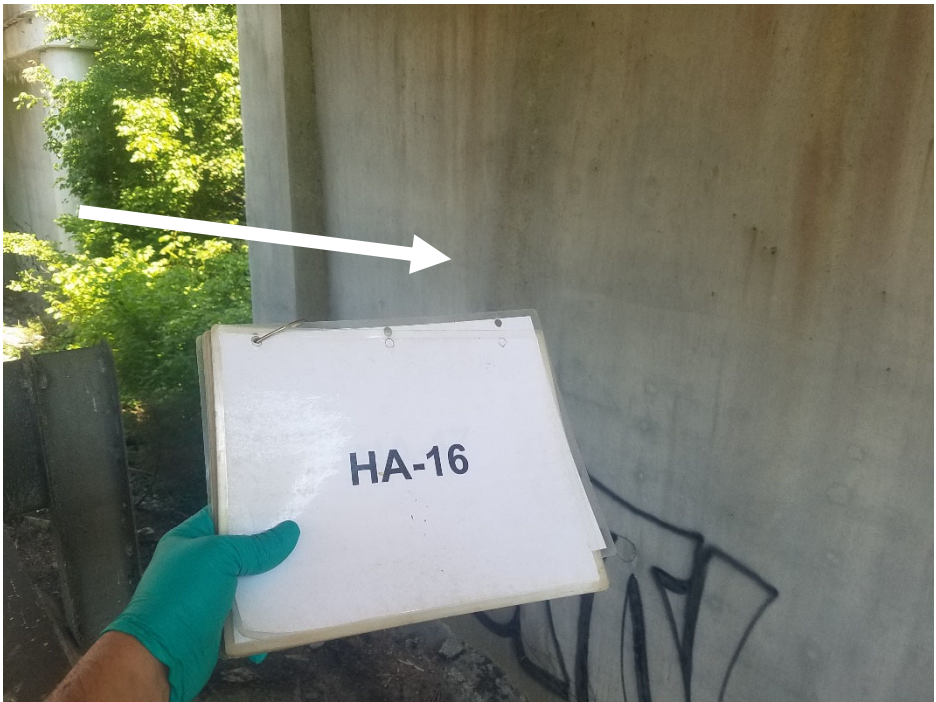
The piers are made of concrete. Three samples were collected from this HA. A hammer and chisel were used to collect these samples.

Date: 08/05/2024	
Description: Photograph 18 – HA-16 Pier

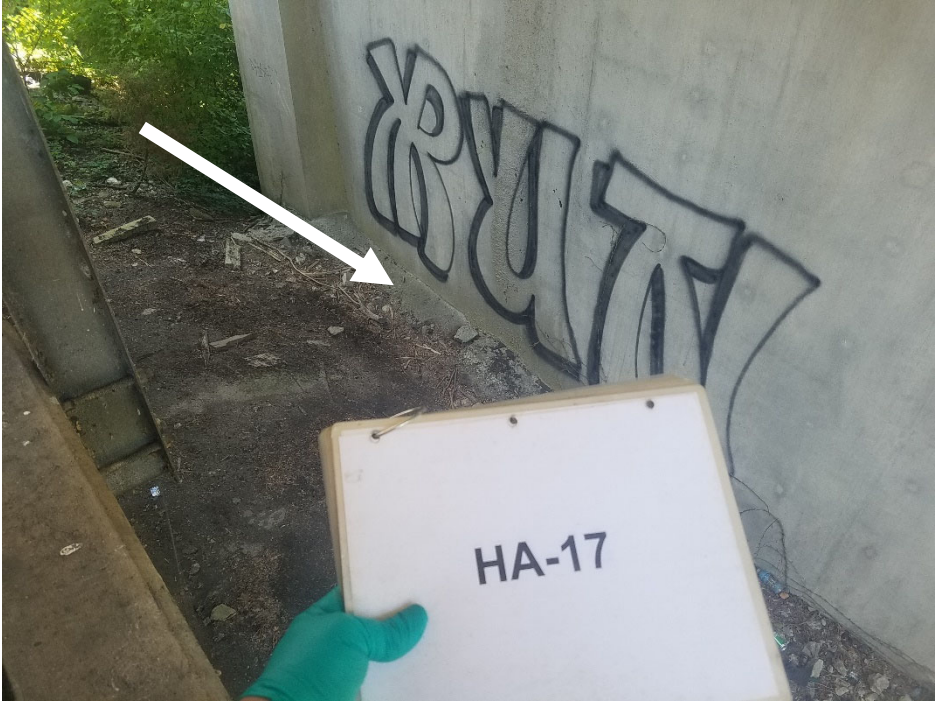
Concrete was present at the base of the piers. Three samples were collected from this HA. A hammer and chisel were used to collect these samples.

Date: 08/05/2024	
Description: Photograph 19 – HA-17 Concrete at Pier Base
