Asset #58I00240069(Routine)

I-24 Crossing I-24 WB / SHELLMOUND RD.

# Routine Bridge Inspection Report

Federal ID	58I00240069
Location	58-I0024-22.65
Description	Interstate 24 Westbound Lanes over Shellmound Road, I-24 Milepost 157.16
GPS Coordinates	35.043983, -85.602900
Date	7/16/2024
Overall Condition	Fair

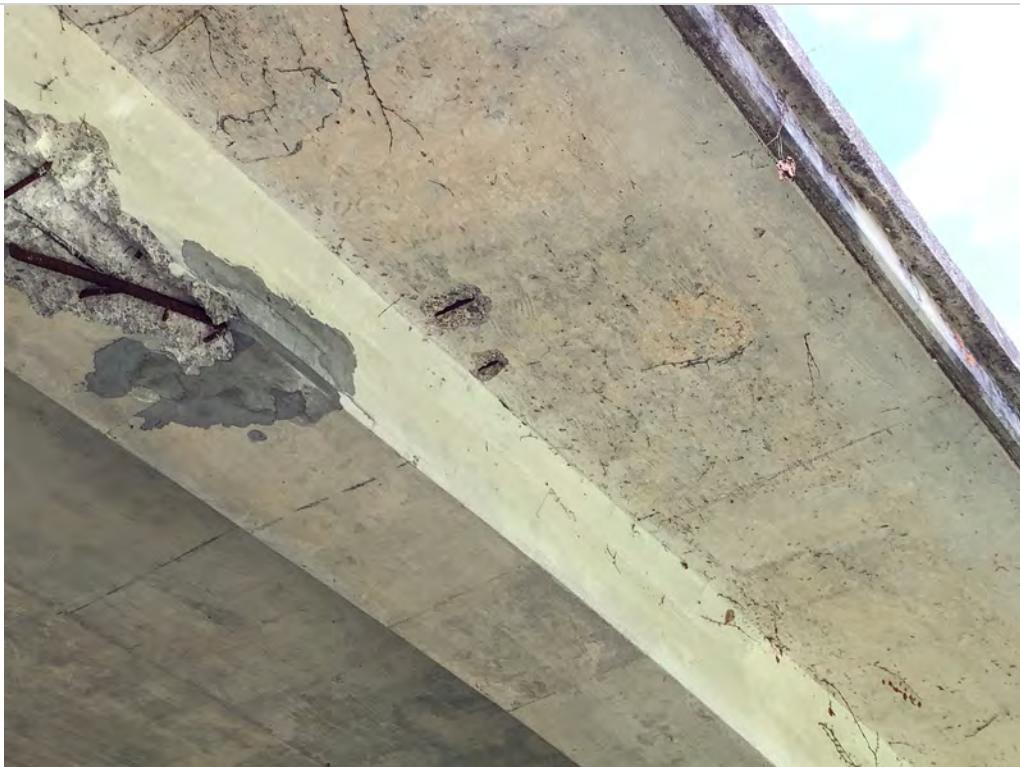
Typical spall in overhang

Wearing Surface Type	Asphalt	Wearing Surface Depth	6
Wearing Surface	(Good)		
Deck - Structural Condition	(Fair)	Isolated minor and moderate spalls with exposed rebar in overhangs	
Curbs	(NA)		
Median	(NA)		
Sidewalks	(NA)		
Parapet	(Good)	Some minor cracks	
Railing	(NA)		
Rail Paint	(NA)		
Deck Drains	(NA)		
Lighting Standards	(NA)		
Utilities	(NA)		
Expansion Joints	(NA)

The deck is rated fair. The top of the deck is not visible due to the asphalt wearing surface. The bottom of the deck has isolated minor and moderate spalls in the overhangs. The concrete parapets are rated good and meet the current safety standards.

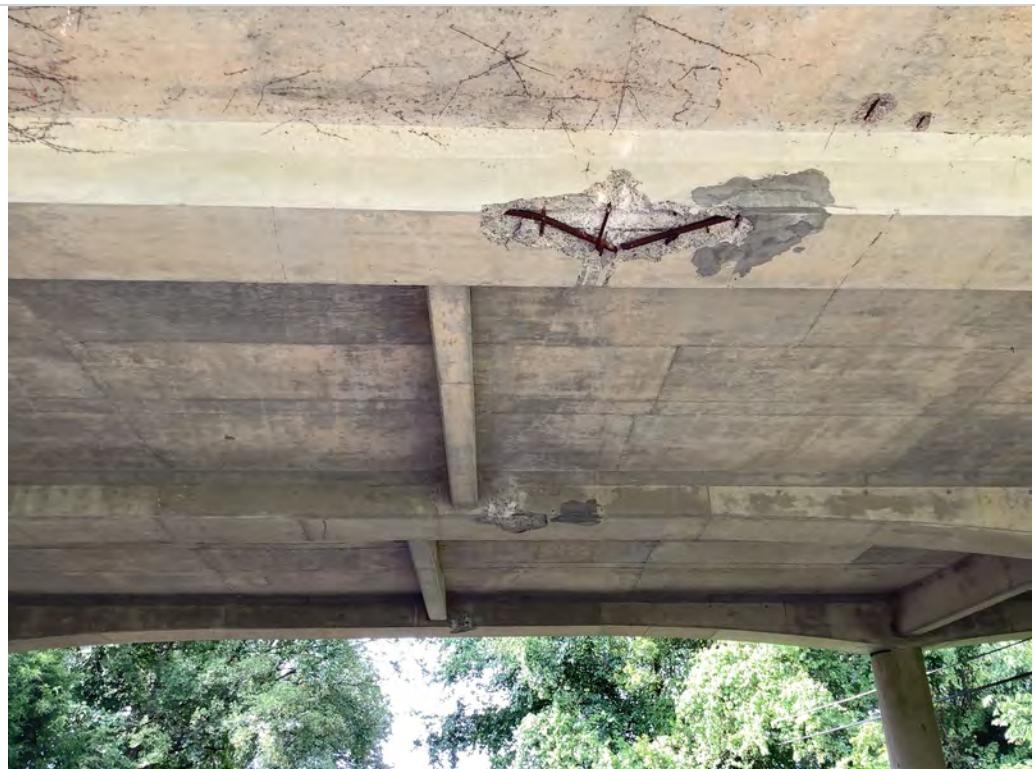
Collision damage to beams in span #2

Bearing Devices	(Good)	
Girders	(Fair)	Beams "A", "B", and "C" in span #2 have moderate collision damage; beam "A" in span #2 has severed reinforcing steel due to collision damage
Beams	(NA)	
Floor Beams	(NA)	
Stringers	(NA)	
Diaphragms	(Good)	Isolated minor cracks and delaminated areas
Superstructure Bracing	(NA)	
Trusses - General	(NA)	
Trusses - Portals	(NA)	
Trusses - Bracing	(NA)	
Superstructure Paint	(Good)	
Alignment of Members	(Good)

The superstructure is rated fair. All three concrete girders in span #2 have moderate spalled areas. Beam "A" has one severed reinforcing bar due to collision damage.

Date Added	Recommendation	Priority
08/26/2008	APPROACH GUARDRAILS ARE SUBSTANDARD	
08/26/2008	APPROACH GUARDRAIL TERMINALS ARE SUBSTANDARD	
09/17/2002	UNDERPASS SUBSTRUCTURE PROTECTION GUARDRAILS ARE NON-EXISTENT	
07/13/2022	REPAIR CONCRETE GIRDERS "A", "B" AND "C" IN SPAN #2	2

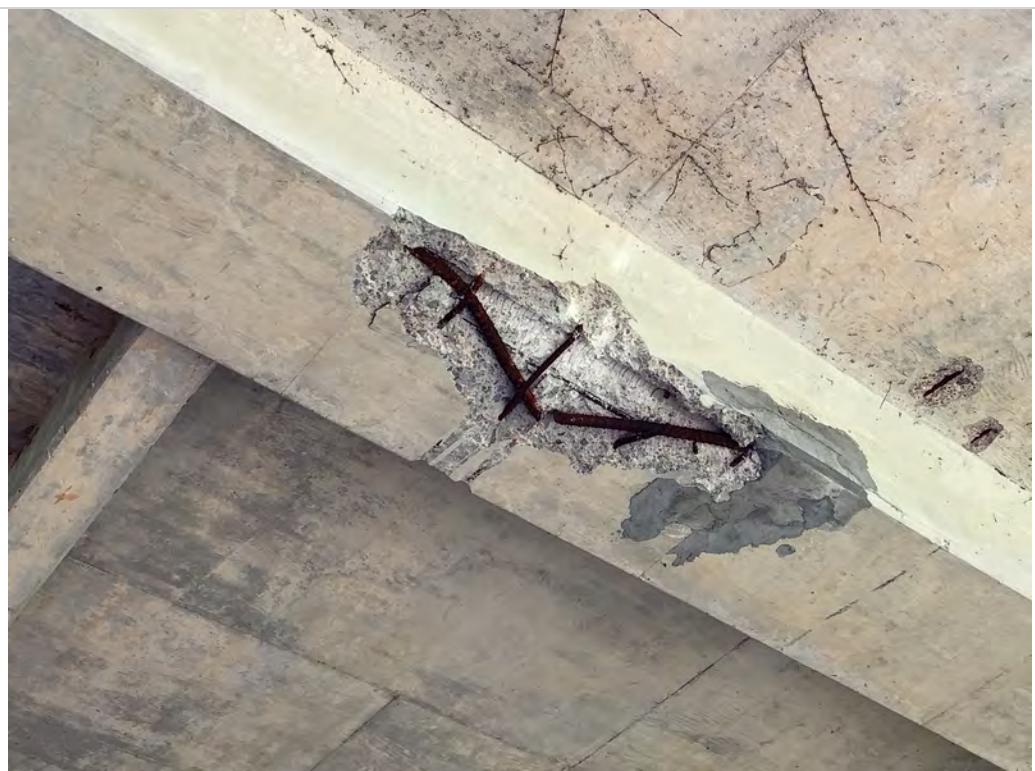
Broken steel reinforcing in beam "A" in span #2

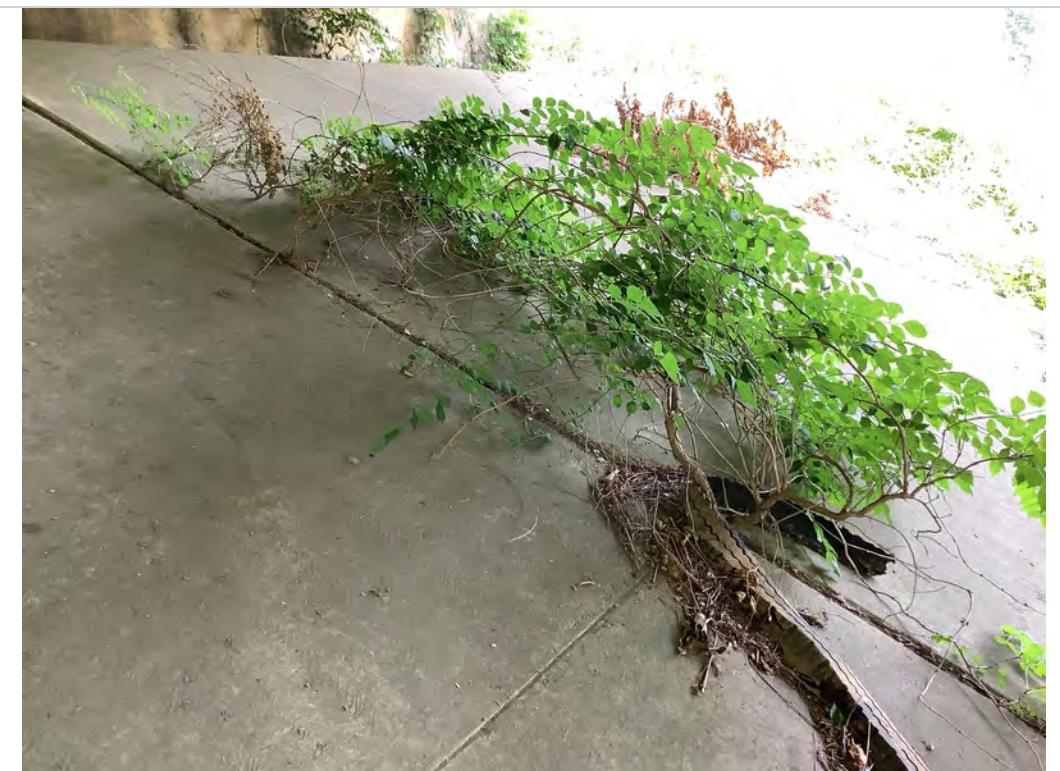
Vegetation growth between cracks in slope paving

<b>Abutment Caps</b>	(Good)	Some minor cracking
<b>Abutment Breastwall</b>	(NA)	
<b>Abutment Wings</b>	(Good)	Minor spall at #2 right
<b>Abutment Backwall</b>	(Good)	
<b>Abutment Plumb</b>	(Good)	
<b>Abutment Footing</b>	(NA)	
<b>Abutment Piles</b>	(Not Visible)	
<b>Abutment Embankment</b>	(Good)	
<b>Abutment Bearing Surface</b>	(Good)	
<b>Abutment Slope Paving</b>	(Good)	Vegetation growing between slabs
<b>Abutment Rip Rap</b>	(NA)

The substructure is rated good. The abutment caps have some minor cracking. The backwall of abutment #1 and a few bent columns have minor delaminated areas. The concrete slope pavement is rated good but has vegetation growth between the slabs. The bent columns have some minor rebar pop-outs and delaminated areas.

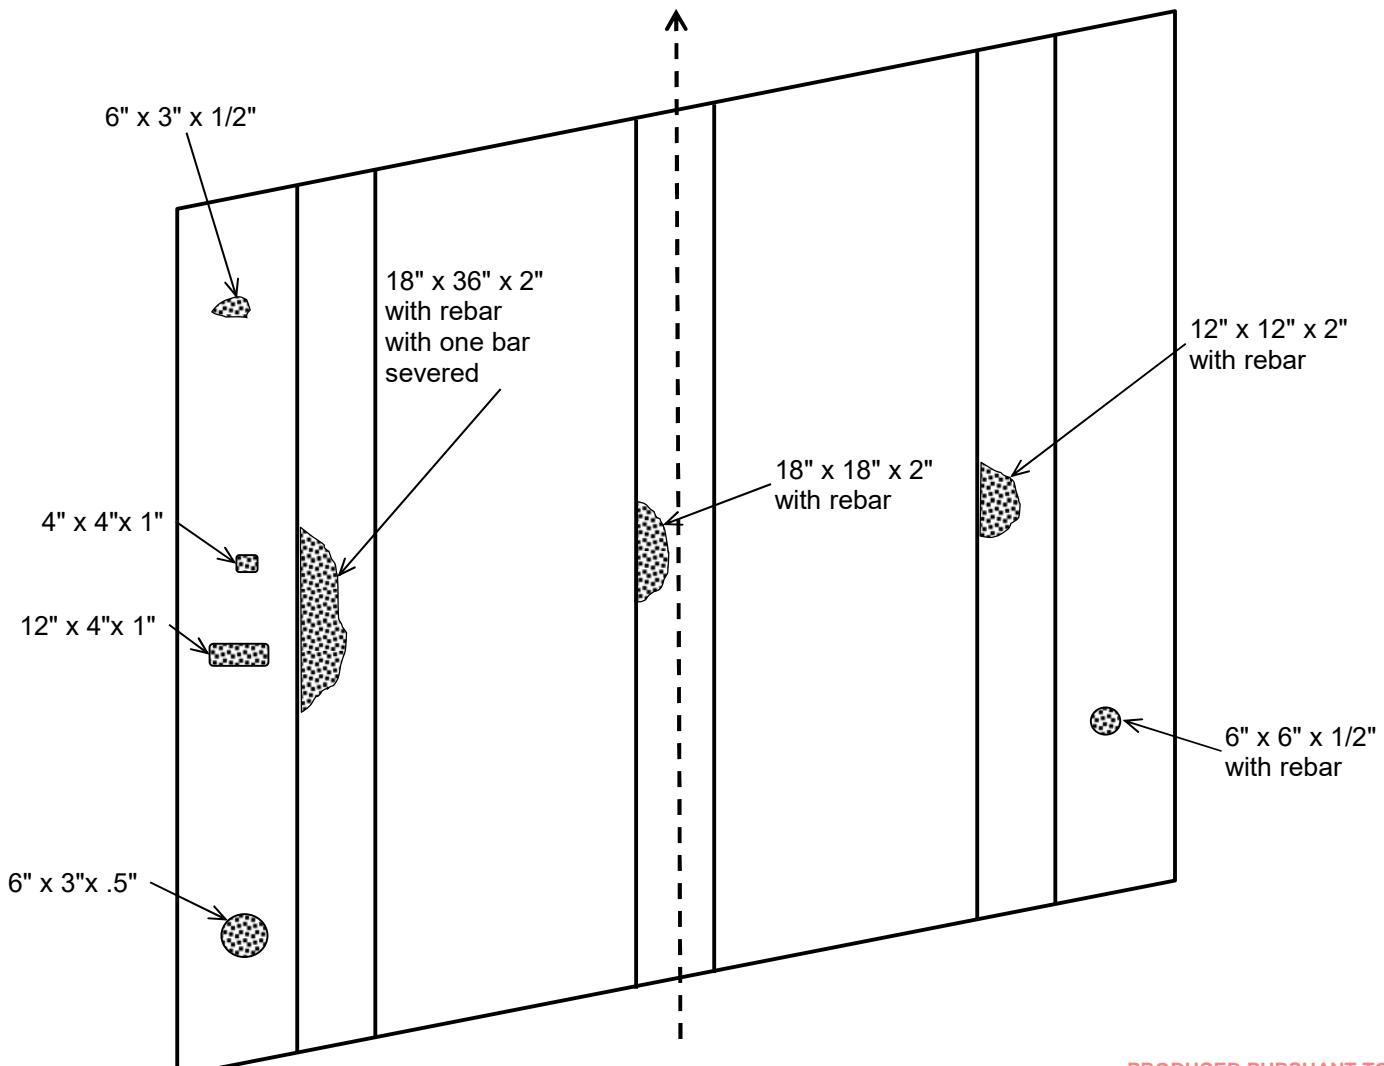
# Bottom of Deck Span No. 2

cracks are small

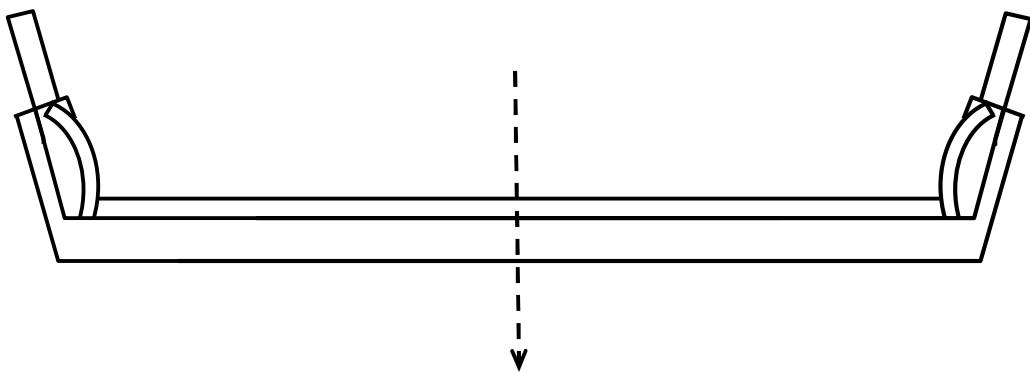
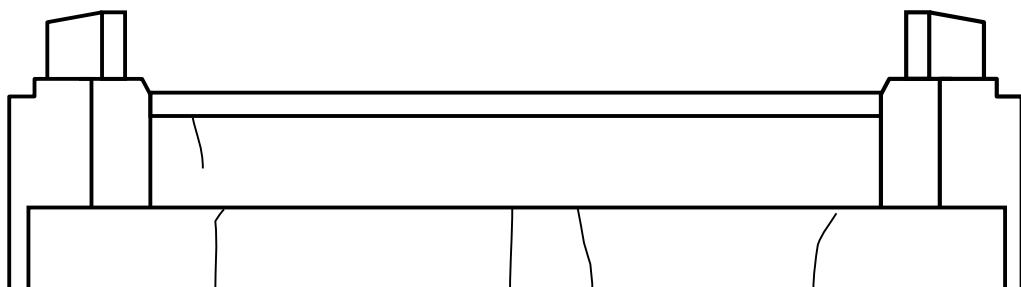
## Abutment No. 1

cracks are hairline

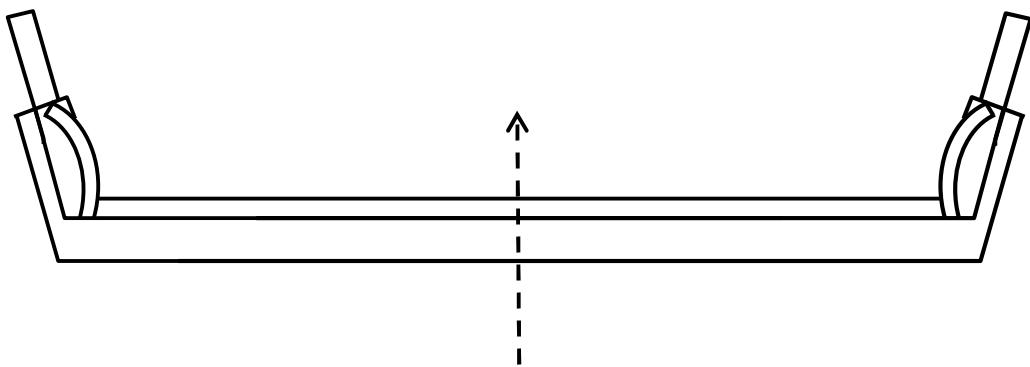
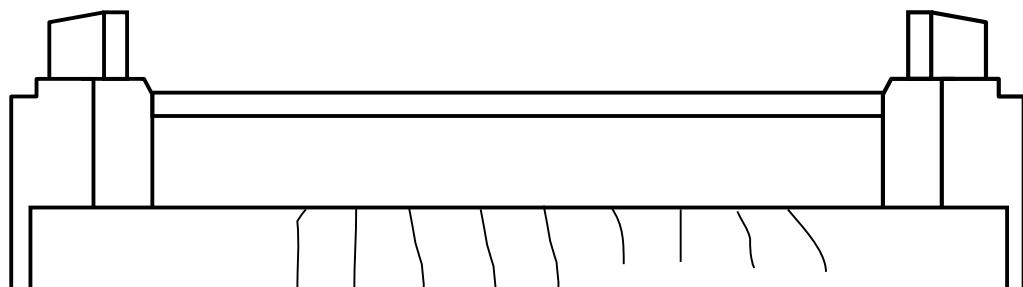
## Abutment No. 2

cracks are hairline
