SHELLMOUND RD. Crossing SHELLMOUND RD. / I-24 EB

# Routine Bridge Inspection Report

Federal ID	58I00240039
Location	58-02161-01.36
Description	Shellmound Road over Interstate 24 Eastbound Lanes, I-24 Milepost 157.29
GPS Coordinates	35.040683, -85.603533
Date	7/17/2024
Overall Condition	Fair

Asset #58I00240039(Routine)

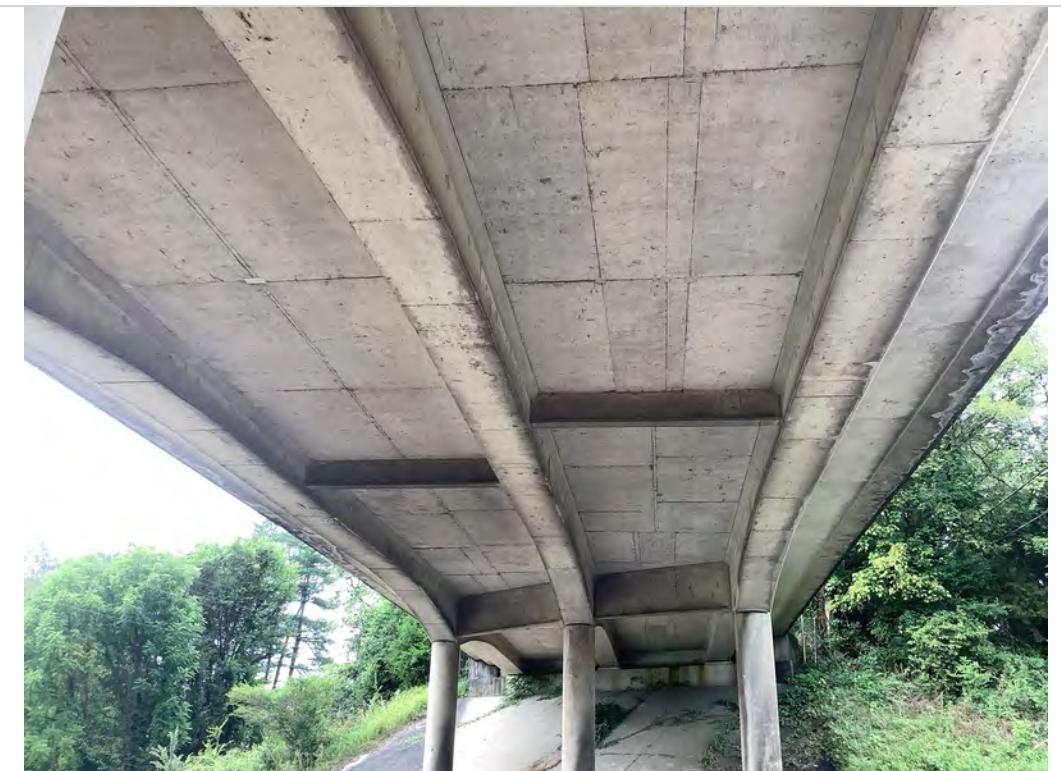
Typical bottom of deck

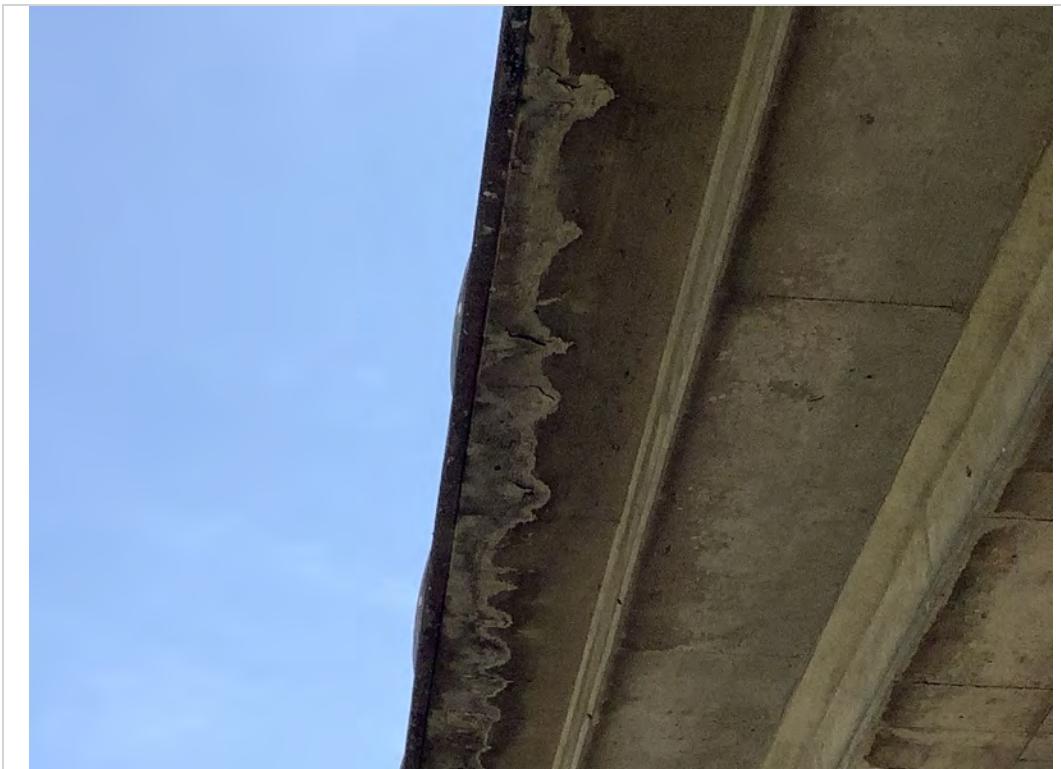
Typical delaminated areas in overhang

The underpass is rated good. There are delaminated areas in overhangs in span #2 which could fall onto the roadway beneath.

Date Added	Recommendation	Priority
09/17/2002	INSTALL OBJECT MARKER SIGNS AT APPROPRIATE LOCATIONS	
09/22/2004	APPROACH GUARDRAILS ARE SUBSTANDARD	
07/25/2016	CLEAR DRAINS AT APPROACH #1 AND #2	
09/22/2004	BRIDGERAILS ARE SUBSTANDARD	
07/13/2022	REPAIR APPROACH GUARDRAIL ON RIGHT SIDE OF BOTH APPROACHES	
08/27/2018	UNDERPASS SUBSTRUCTURE PROTECTION GUARDRAILS ARE SUBSTANDARD	
07/13/2022	REMOVE DELAMINATED CONCRETE IN BOTTOM OF DECK SPAN #2	1

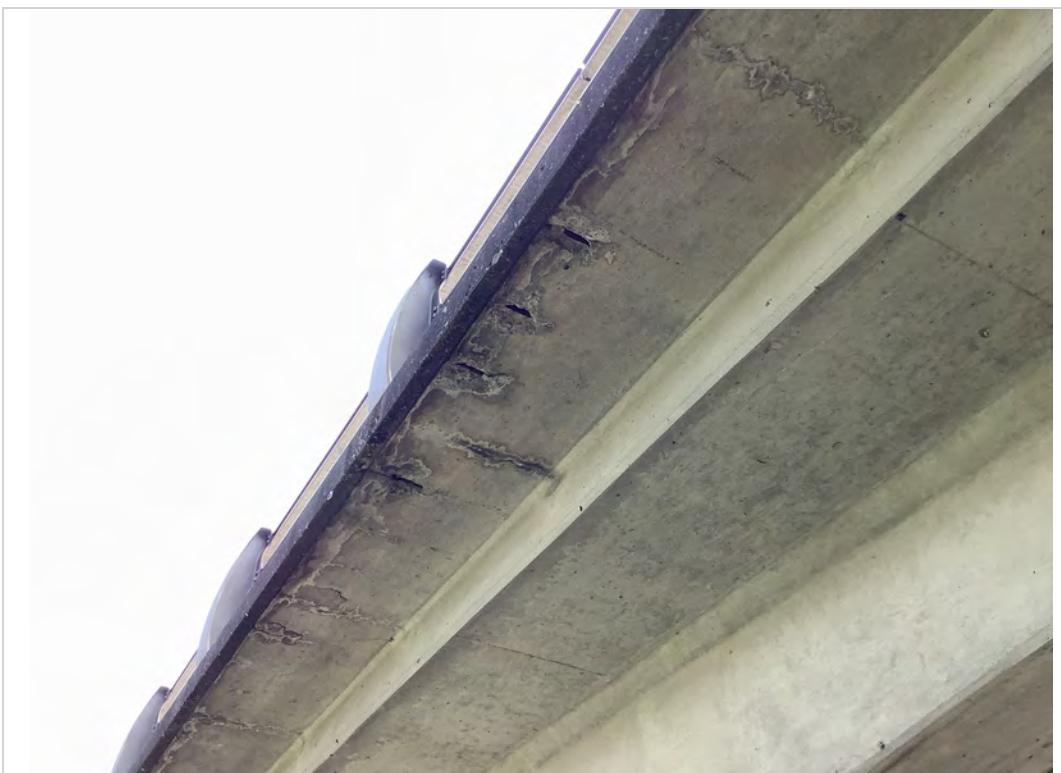
Typical spall with exposed rebar

The deck is rated fair. The top of the concrete deck is not visible due to the asphalt wearing surface. There is heavy vegetation at the curblines and cracking. The bottom of the concrete deck some minor cracking, delaminated areas, repaired areas, and isolated minor and moderate spalls. The curbs are rated fair due to widespread minor transverse cracks, dirt, and vegetation in the curblines. The substandard deck railing is rated good. There is slight to moderate joint leakage on the abutments.

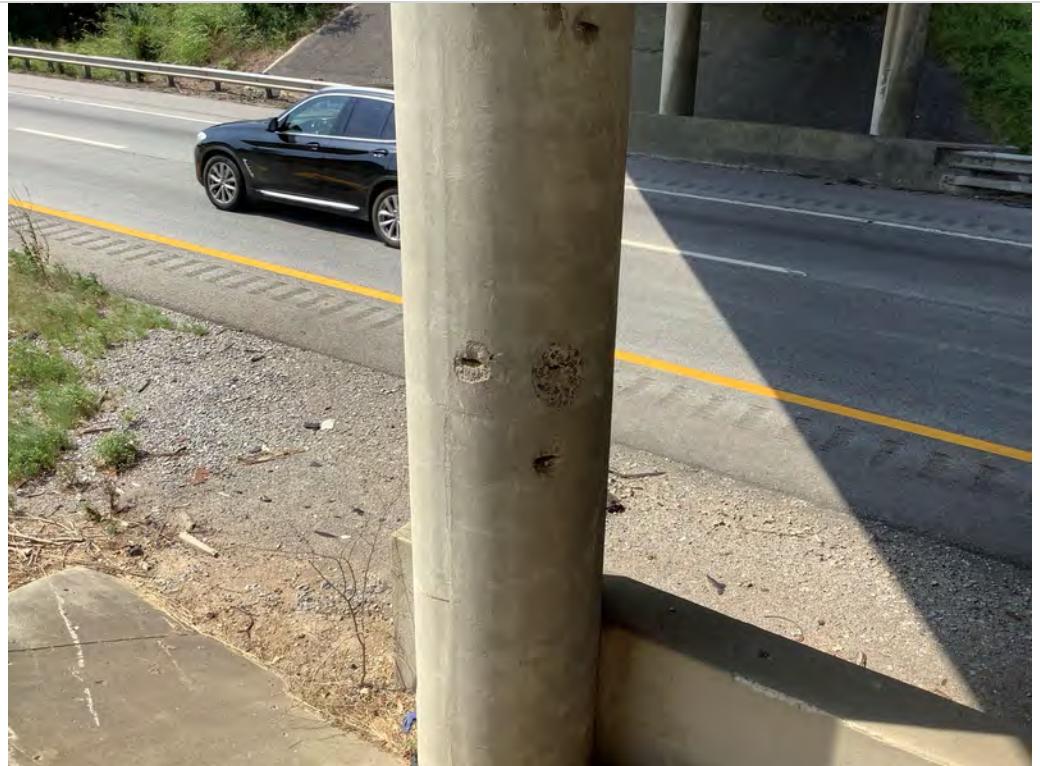
Typical spall on bents

The substructure is rated good. The columns are have some minor rebar pop-outs and delaminated areas.

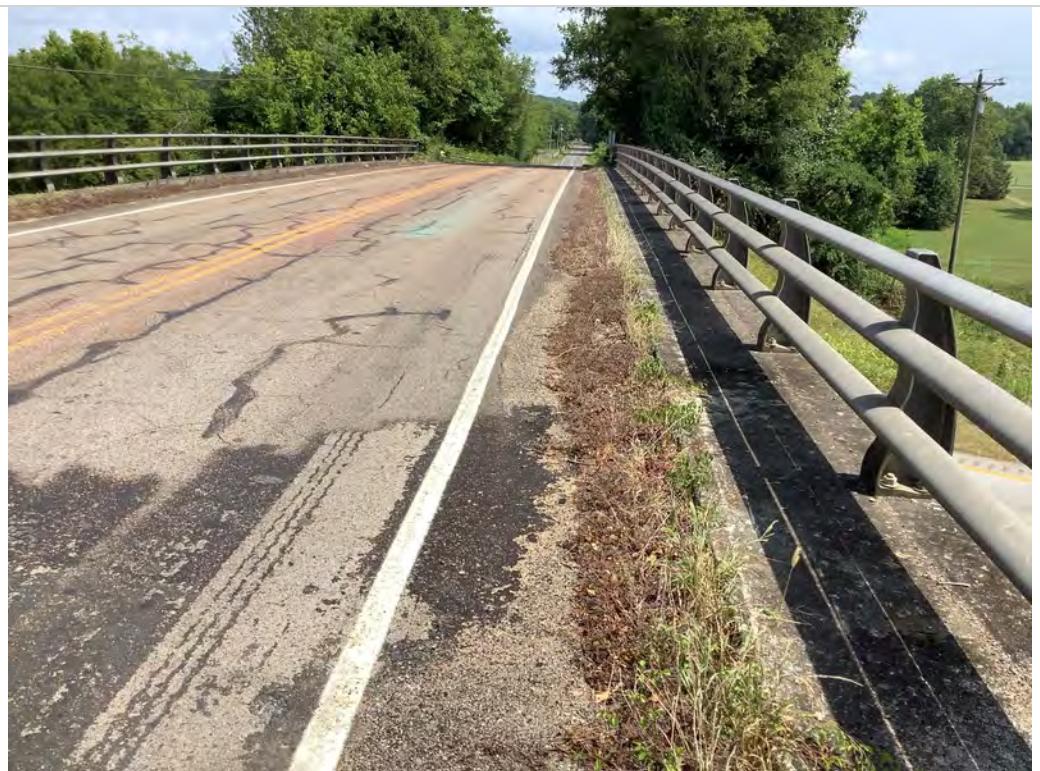
Debris on top of deck

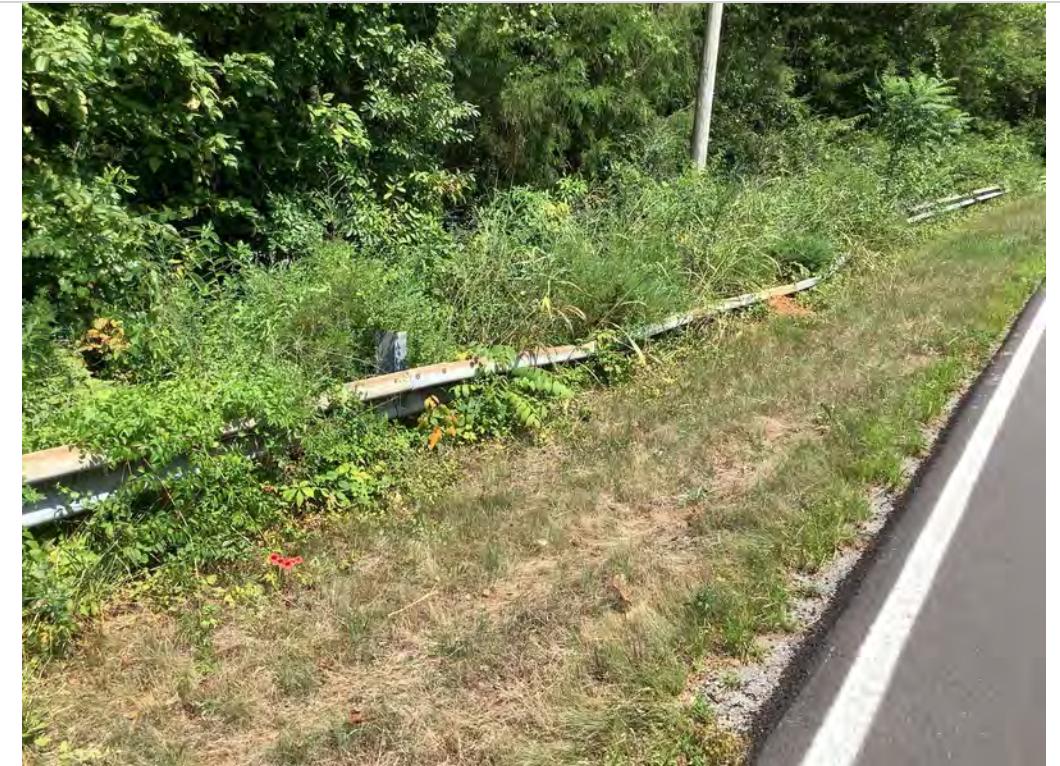
Damaged guardrail at approach #2 right

**Bridge Railing Rating** (Good) \_\_\_\_\_  
**Transitions Rating** (NA) Approach guardrail not attached to bridge railing  
**Guardrail Rating** (Poor) Collision damage; set too low  
**Guardrail Terminal Rating** (Poor) Collision damage; set too low

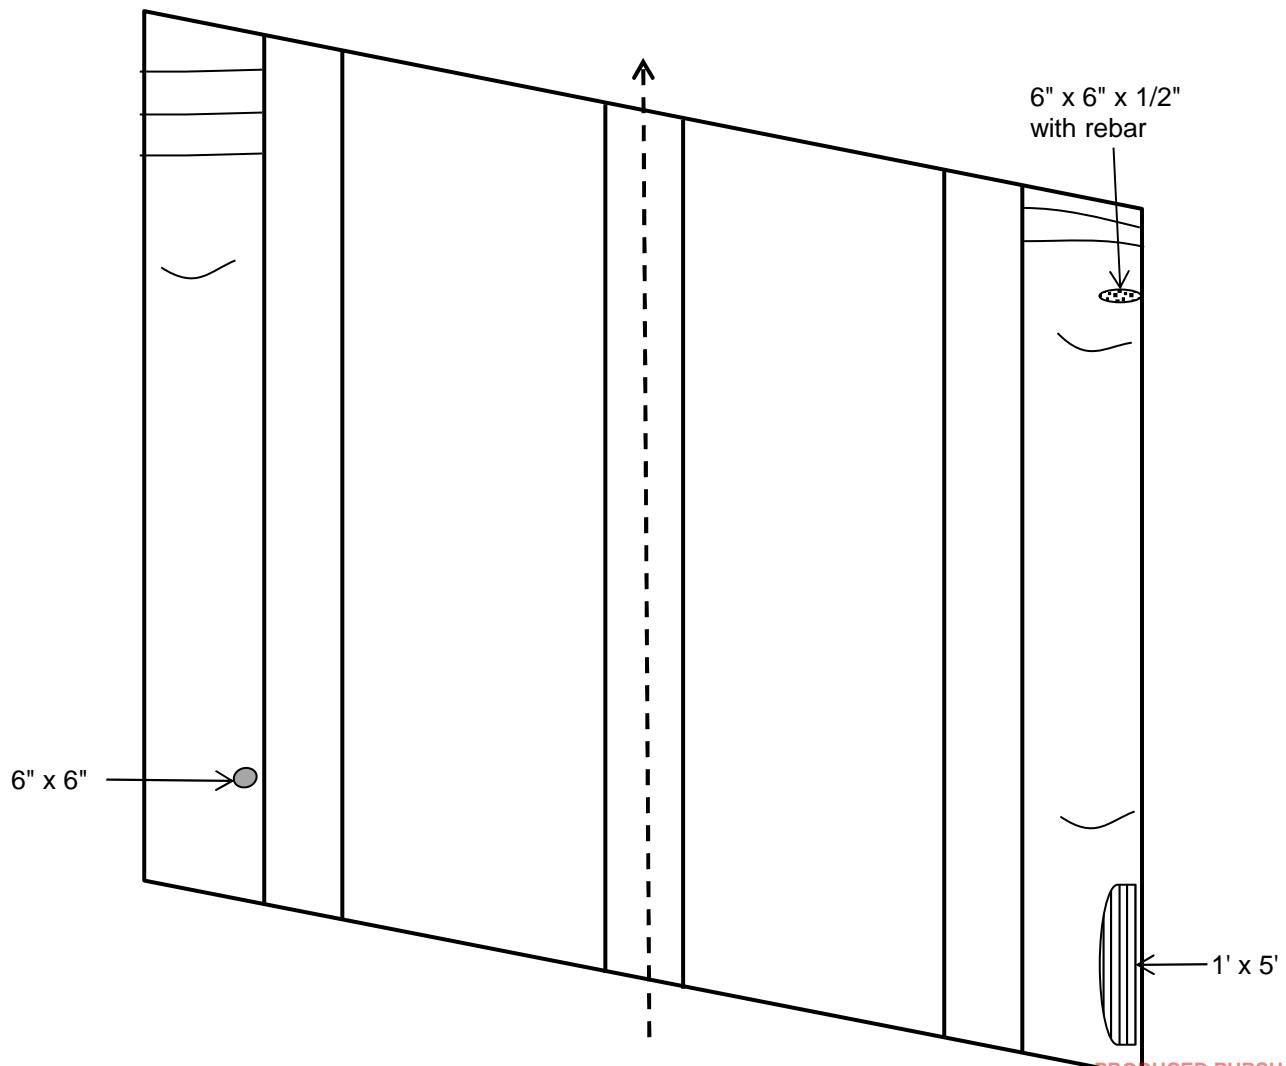
Bottom of Deck Span No. 1

-Cracks are hairline with efflorescence

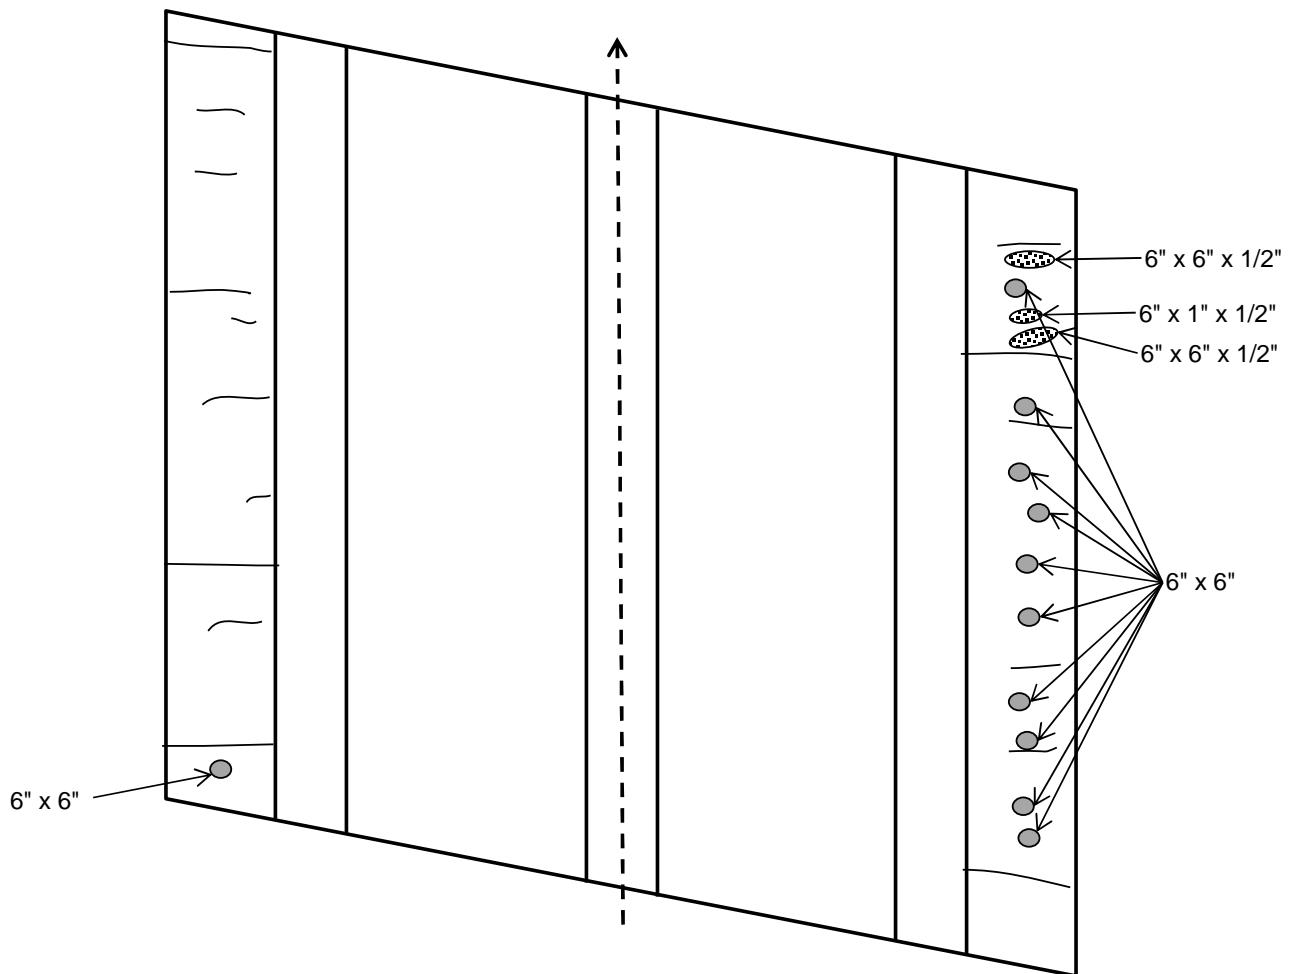
Bottom of Deck Span No. 2

-Cracks are hairline with efflorescence

-All spalls have rebar

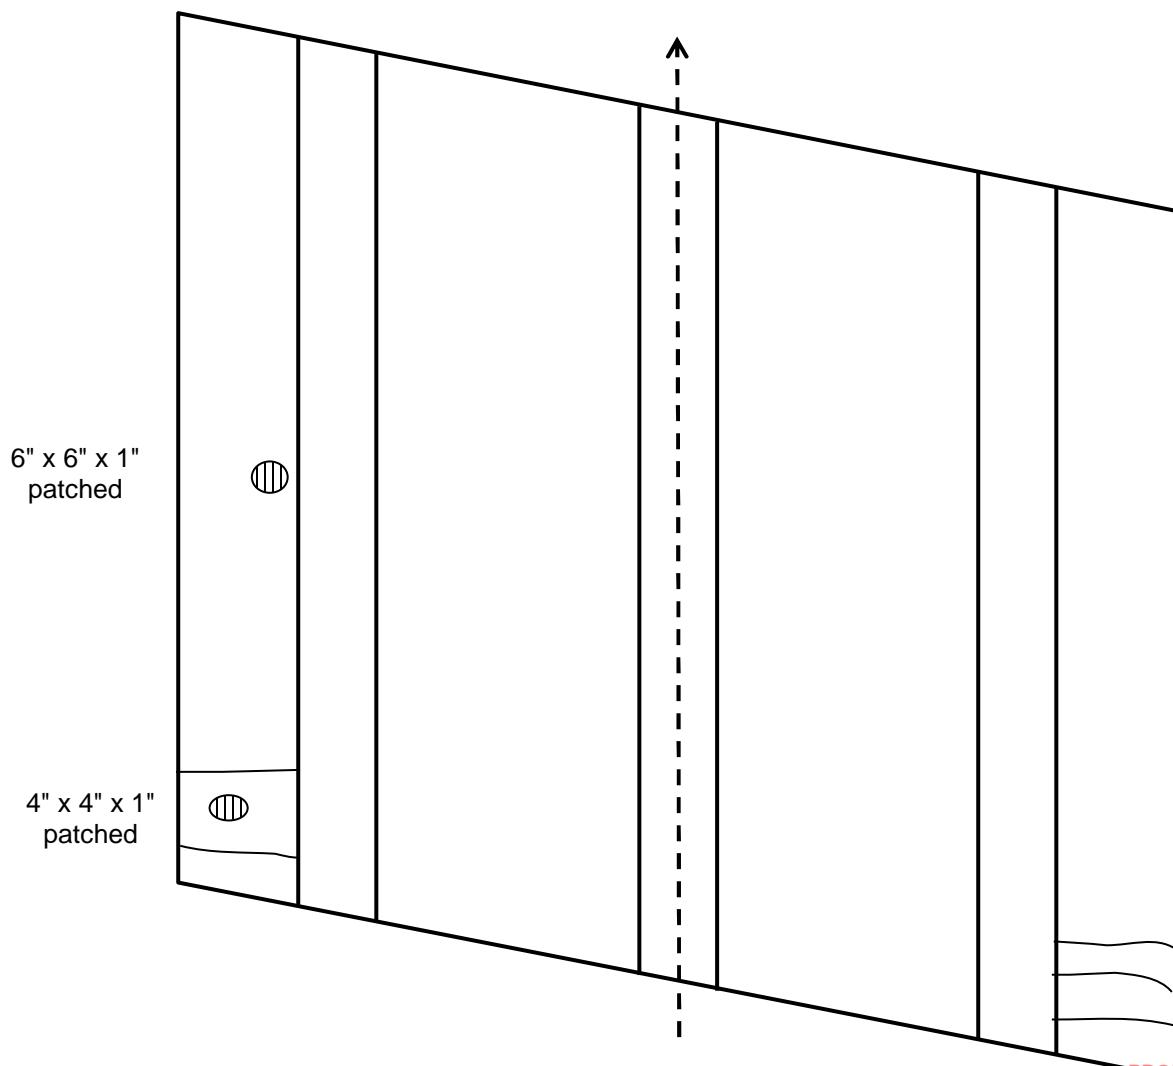
Bottom of Deck Span No. 3

cracks are hairline with efflorescence
