I-24 Crossing I-24 WB / SHELLMOUND RD.

# Routine Bridge Inspection Report

| Marion County | |
|---|---|
| Description | Interstate 24 Westbound Lanes over Shellmound Road, I-24 Milepost 157.16 |
| Date | 7/16/2024 |

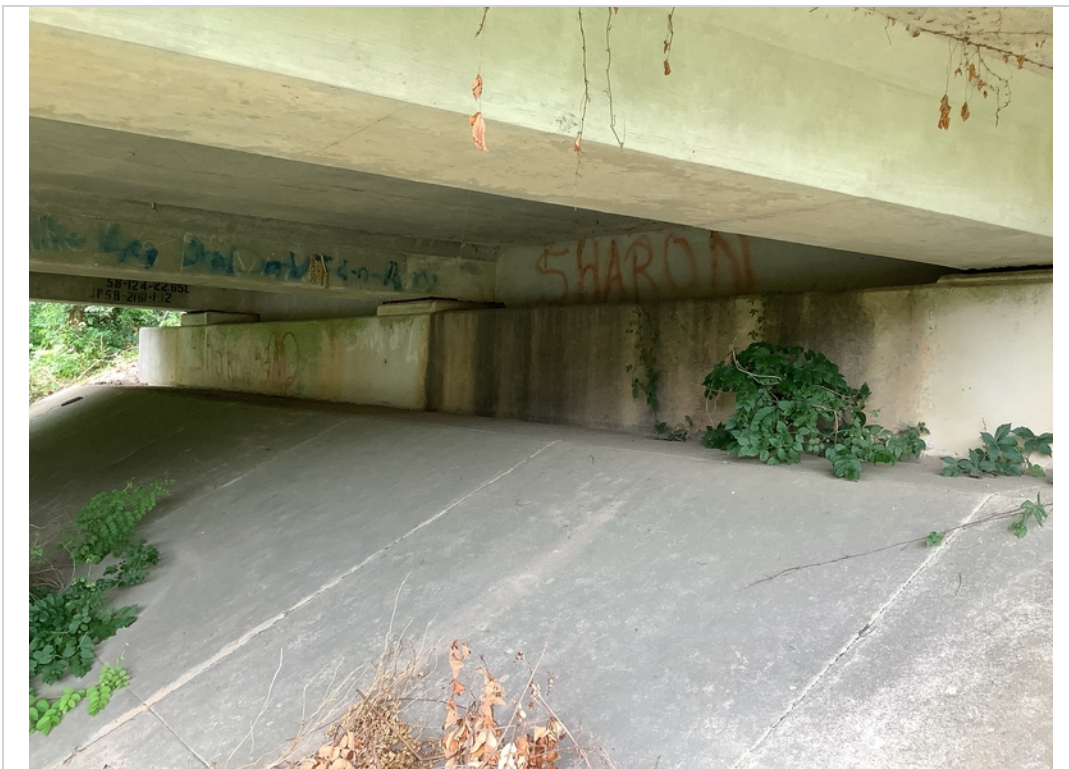
Typical abutment

| Abutment Caps | (Good) | Some minor cracking |

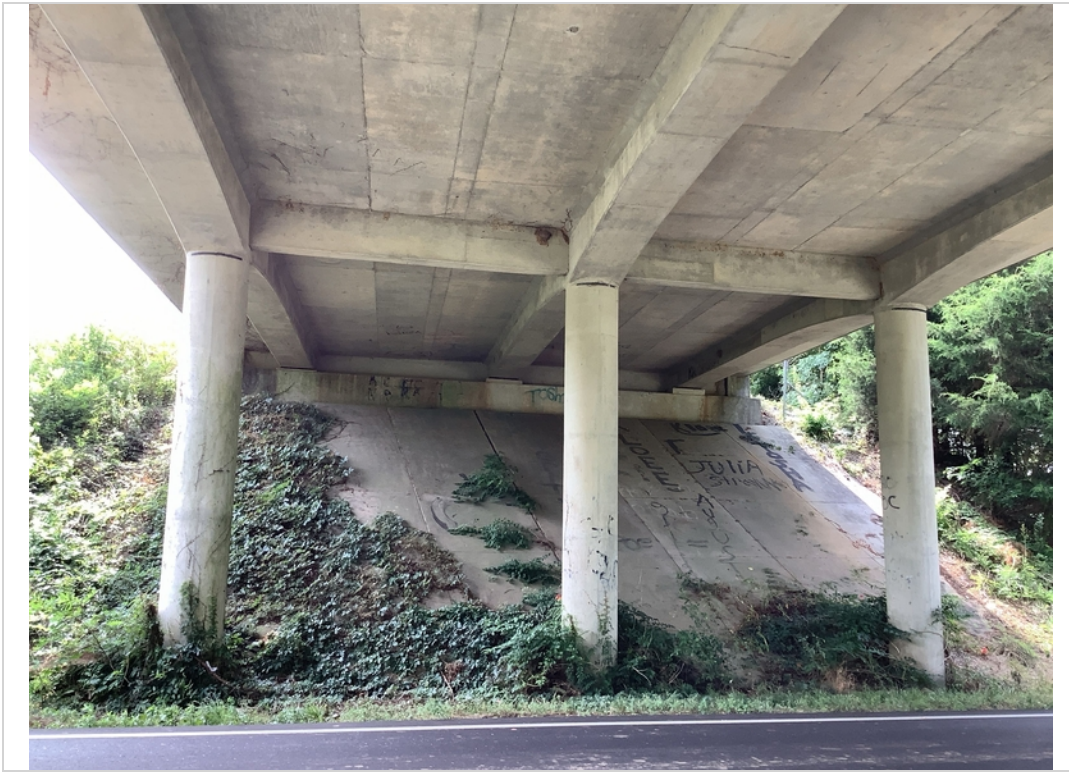
Typical bent

| Bent Columns | (Good) | Some minor rebar pop-outs and delaminated areas |

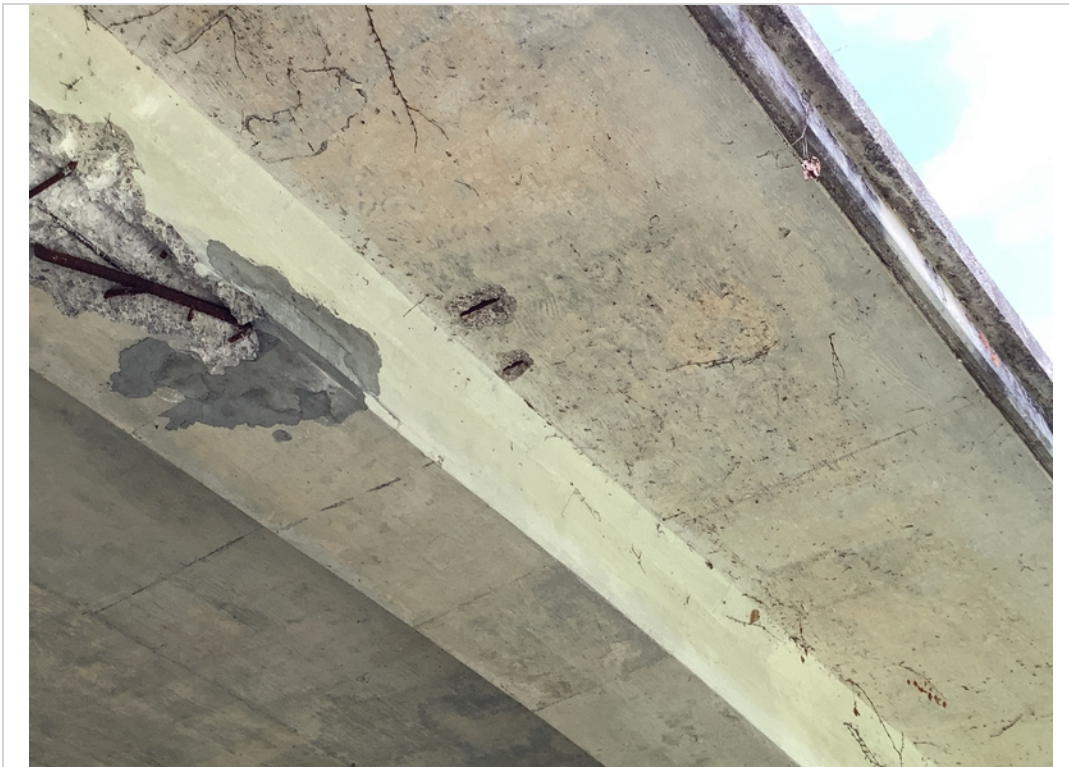
Typical spall in overhang

| Wearing Surface Type | | Asphalt | Wearing Surface Depth | 6 |
|---|---|---|---|---|
| Deck - Structural Condition | (Fair) | Isolated minor and moderate spalls with exposed rebar in overhangs | | |

The deck is rated fair. The top of the deck is not visible due to the asphalt wearing surface. The bottom of the deck has isolated minor and moderate spalls in the overhangs. The concrete parapets are rated good and meet the current safety standards.

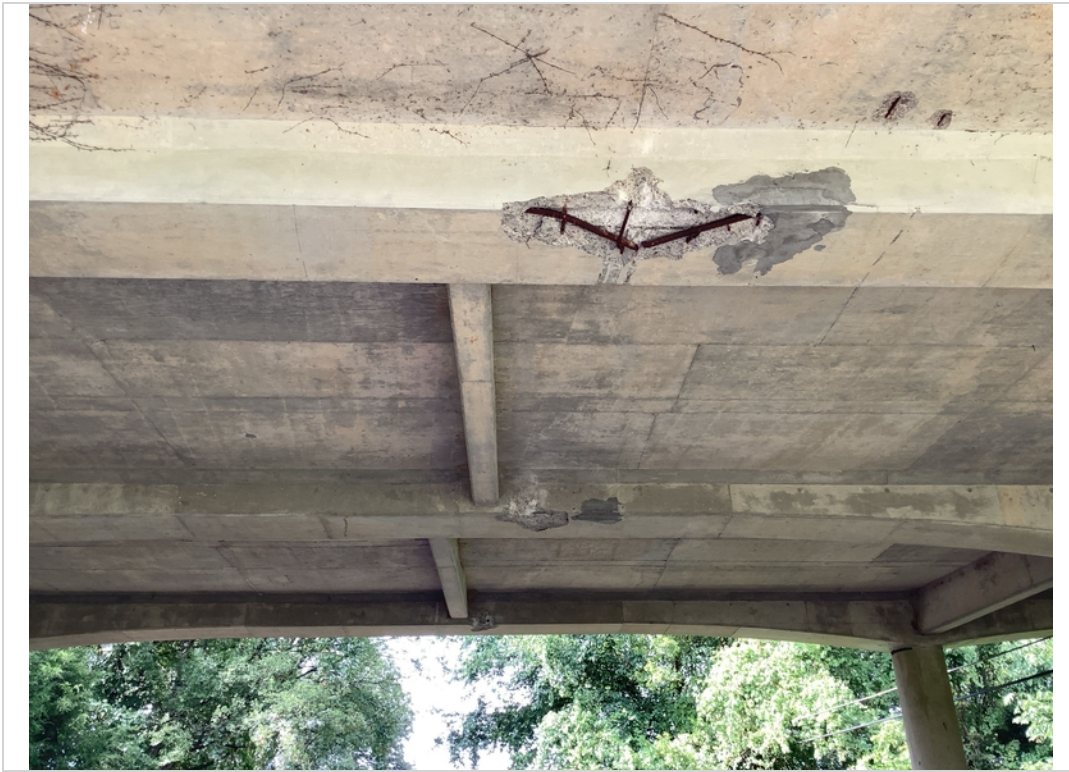
Collision damage to beams in span #2

| Girders | (Fair) | Beams "A", "B", and "C" in span #2 have moderate collision damage; beam "A" in span #2 has severed reinforcing steel due to collision damage | | |

The superstructure is rated fair. All three concrete girders in span #2 have moderate spalled areas. Beam "A" has one severed reinforcing bar due to collision damage.

| Date Added | Recommendation | Priority |
|---|---|---|
| 07/13/2022 | REPAIR CONCRETE GIRDERS "A", "B" AND "C" IN SPAN #2 | 2 |

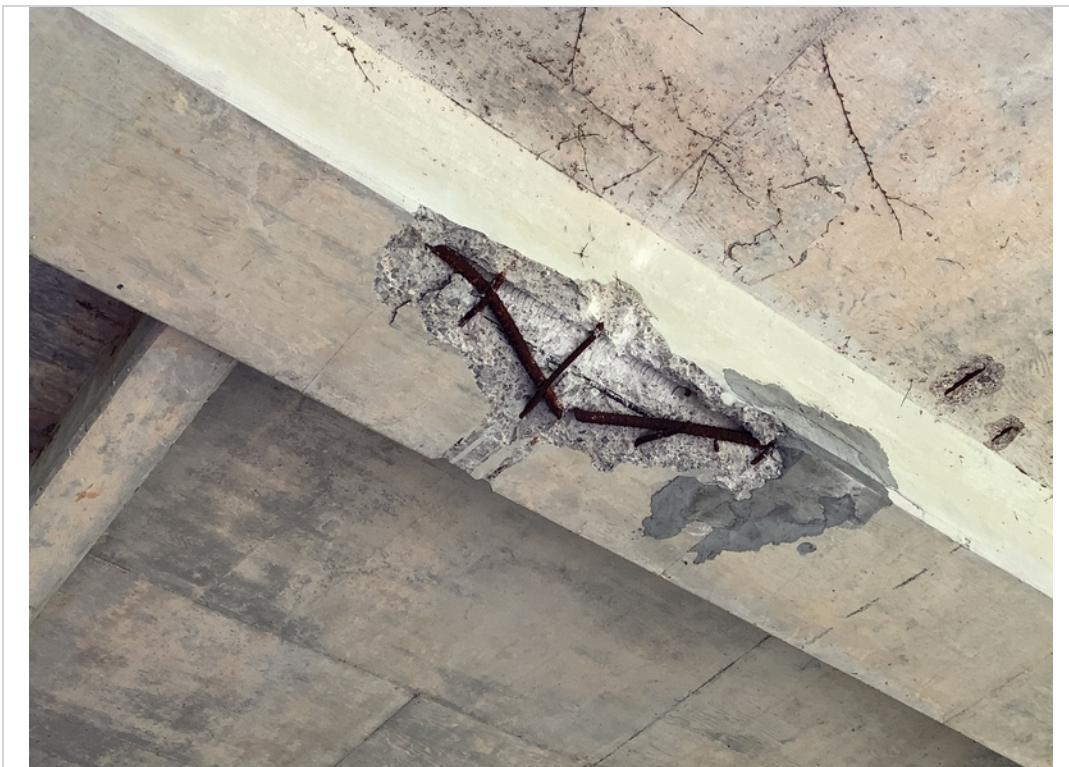
Broken steel reinforcing in beam "A" in span #2

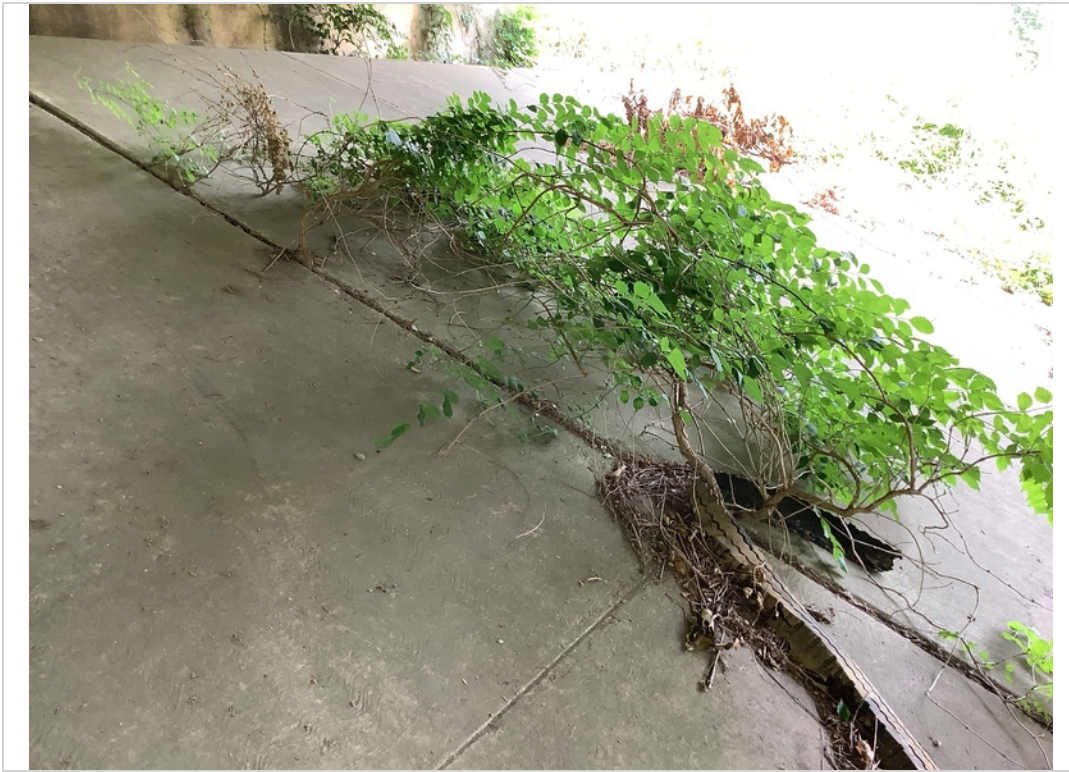
Vegetation growth between cracks in slope paving

| Abutment Slope Paving | (Good) | Vegetation growing between slabs |

The substructure is rated good. The abutment caps have some minor cracking. The backwall of abutment #1 and a few bent columns have minor delaminated areas. The concrete slope pavement is rated good but has vegetation growth between the slabs. The bent columns have some minor rebar pop-outs and delaminated areas.

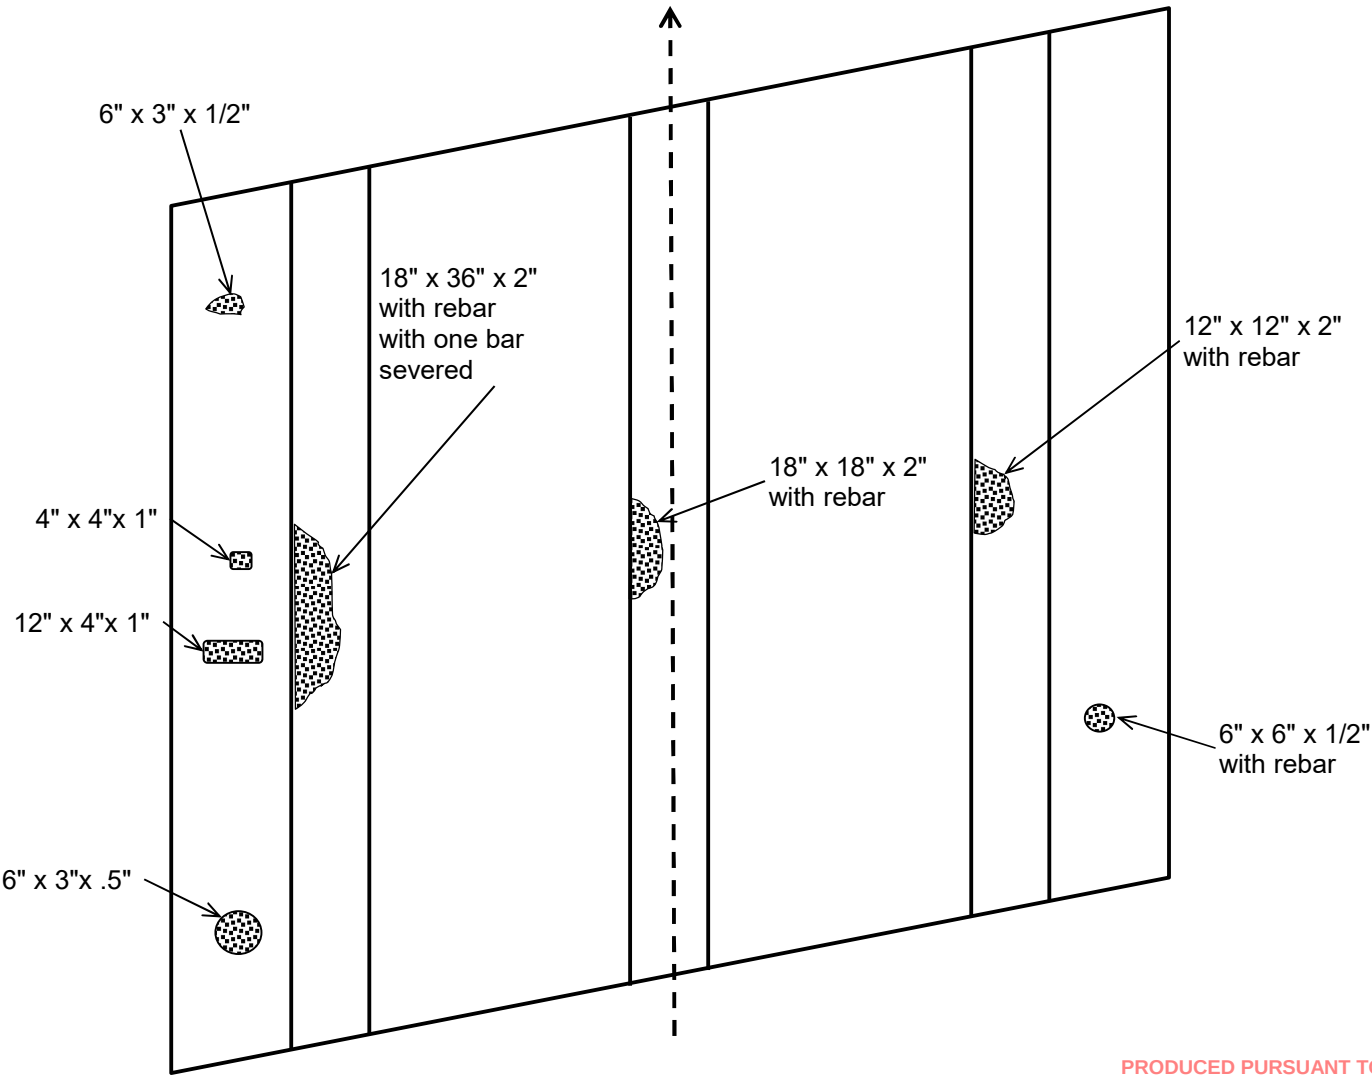
Bottom of Deck Span No. 2

cracks are small

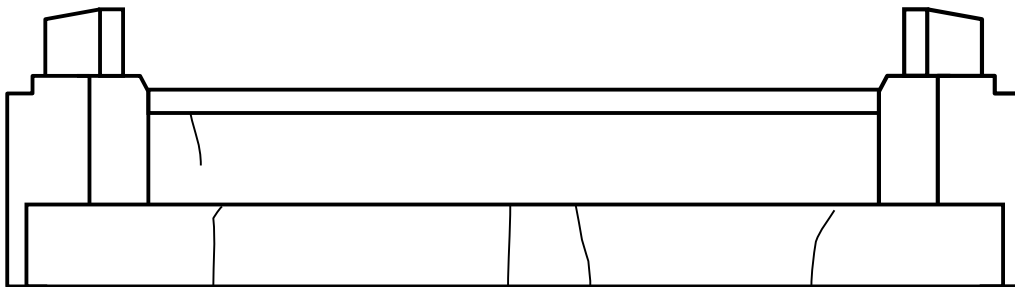
# Abutment No. 1

cracks are hairline

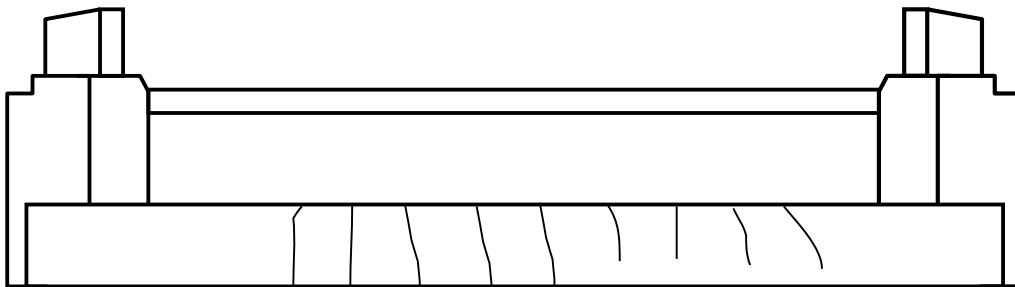
# Abutment No. 2

cracks are hairline
