SHELLMOUND RD. Crossing SHELLMOUND RD. / I-24 EB

# Routine Bridge Inspection Report

| Marion County | |
|---|---|
| Description | Shellmound Road over Interstate 24 Eastbound Lanes, I-24 Milepost 157.29 |
| Date | 7/17/2024 |

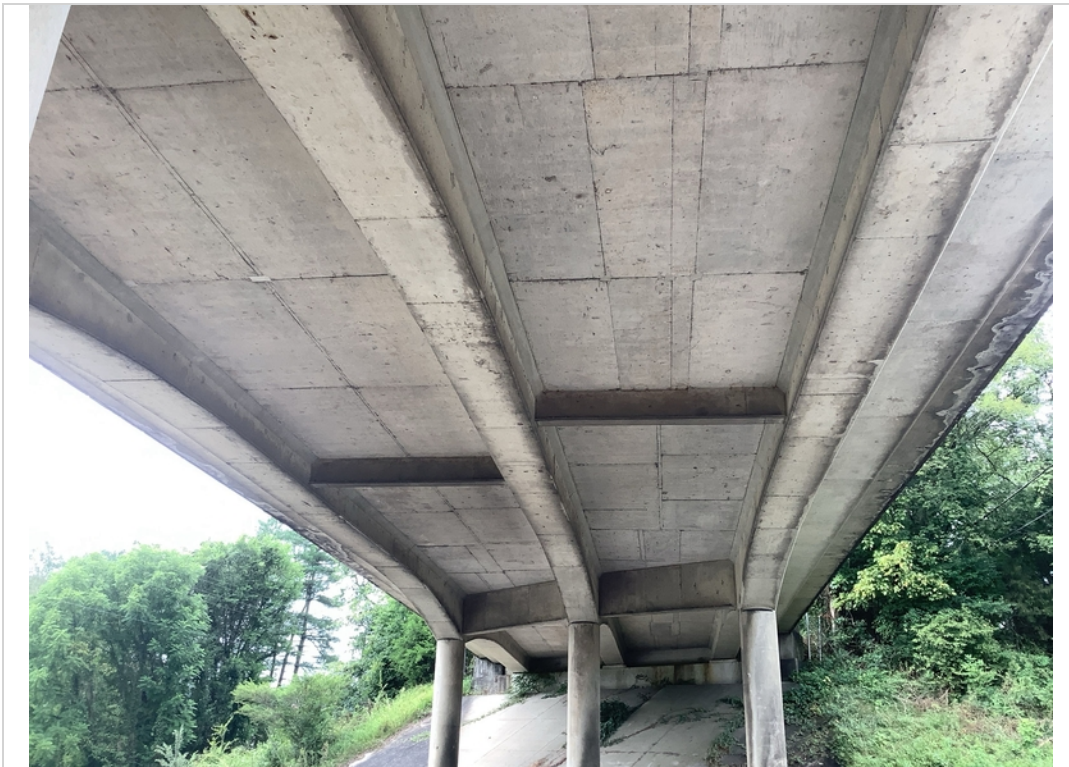
Typical bottom of deck

| Wearing Surface Type | | Asphalt | Wearing Surface Depth | 4 |
|---|---|---|---|---|
| Deck - Structural Condition | (Fair) | Some minor cracking, delaminated areas, and repaired areas; isolated minor and moderate spalls | | |

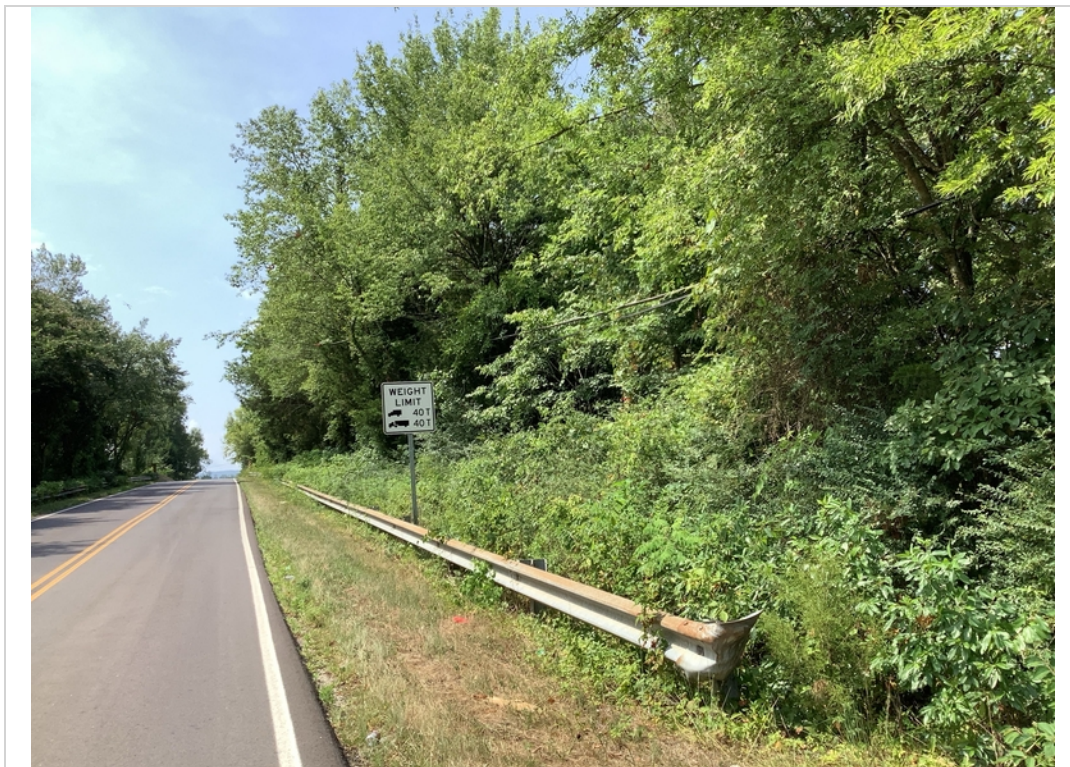
Weight posting for Approach #1

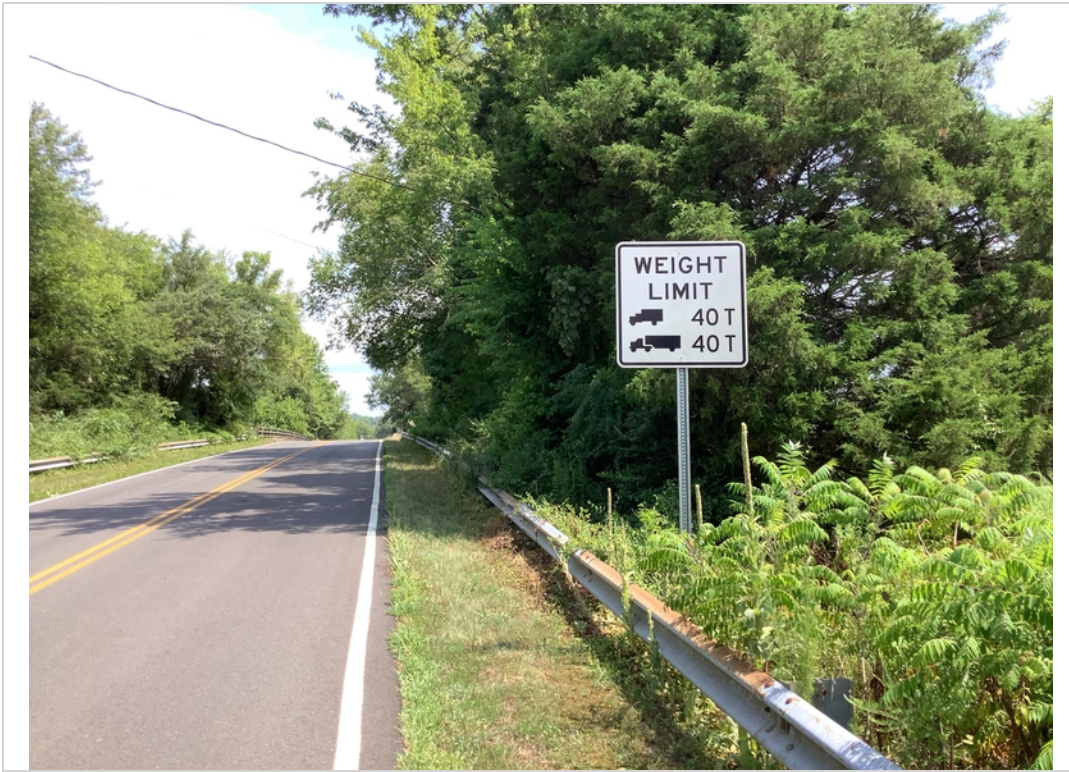
Weight posting for approach #2

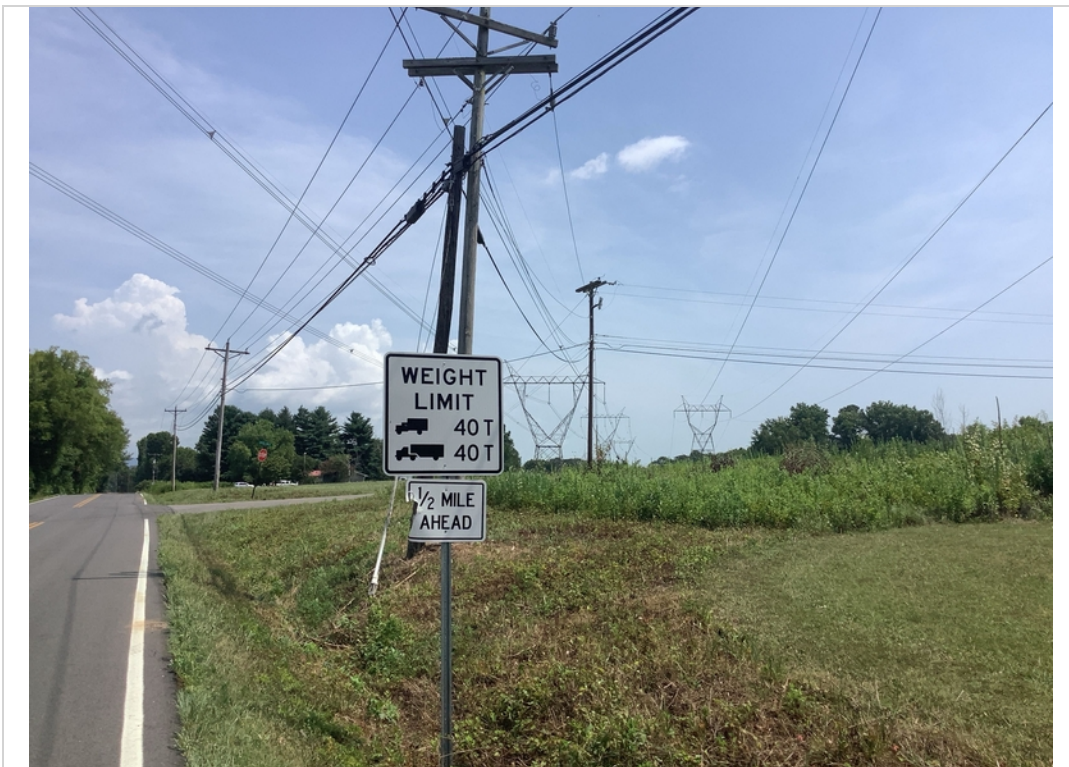
Advanced weight posting sign for approach #2

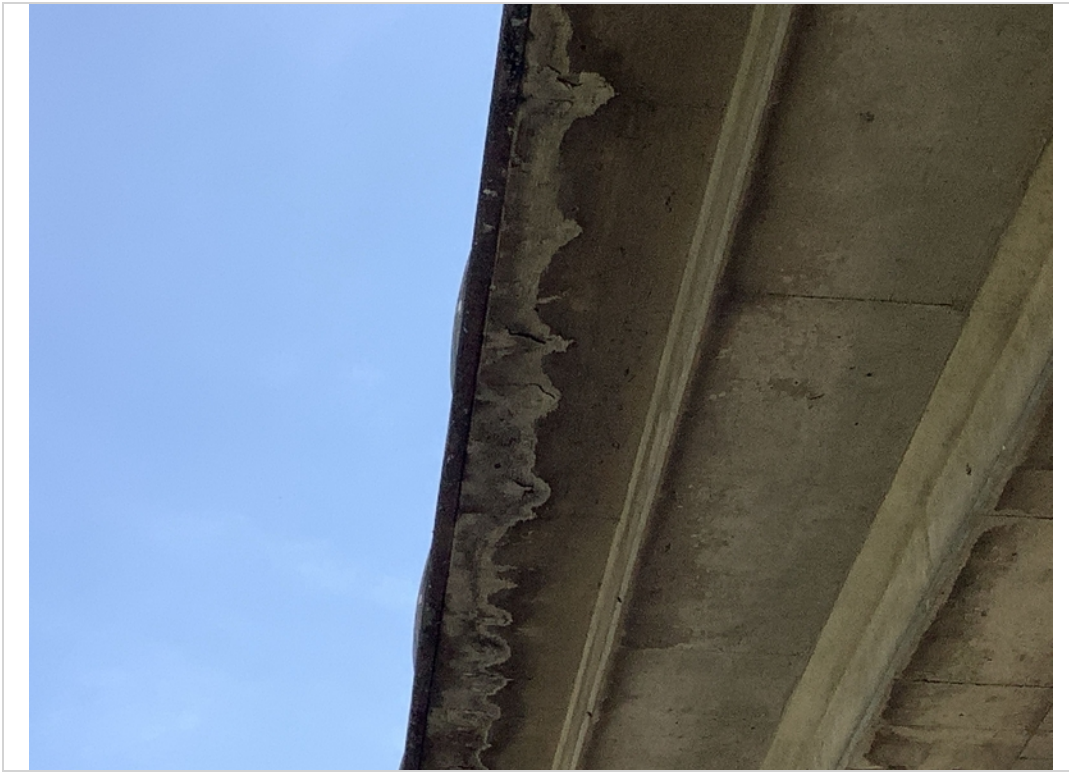
Typical delaminated areas in overhang

The underpass is rated good. There are delaminated areas in overhangs in span #2 which could fall onto the roadway beneath.

| Date Added | Recommendation | Priority |
|---|---|---|
| 07/13/2022 | REMOVE DELAMINATED CONCRETE IN BOTTOM OF DECK SPAN #2 | 1 |

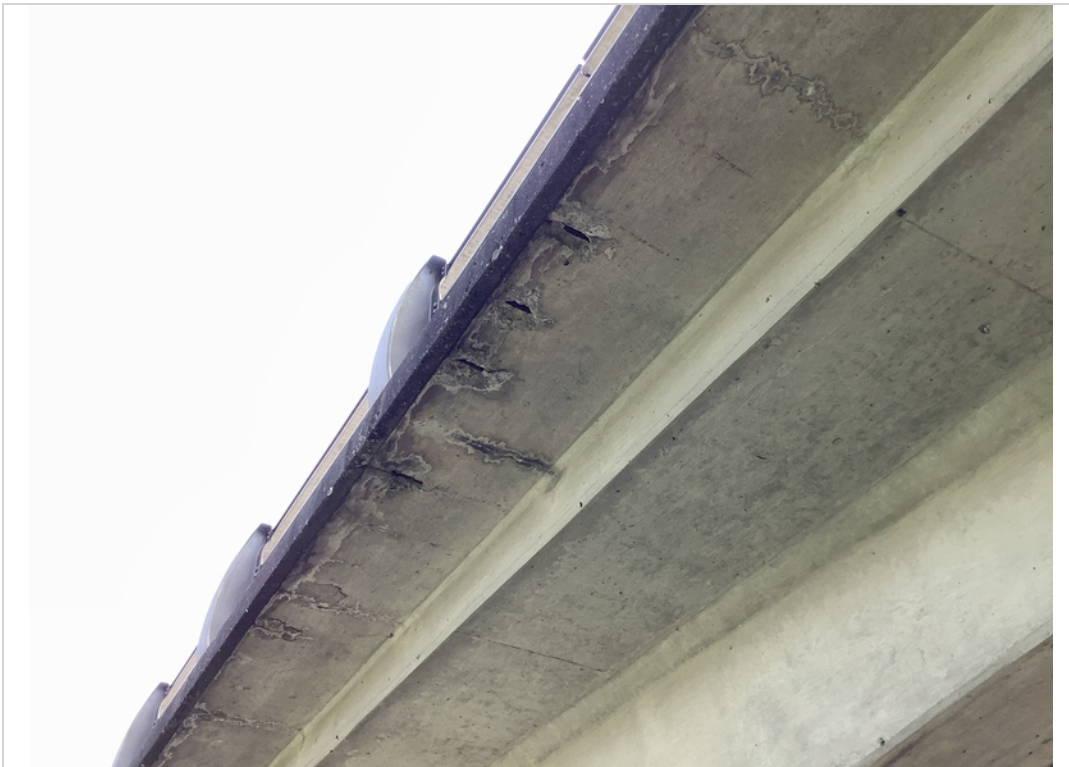
Typical spall with exposed rebar

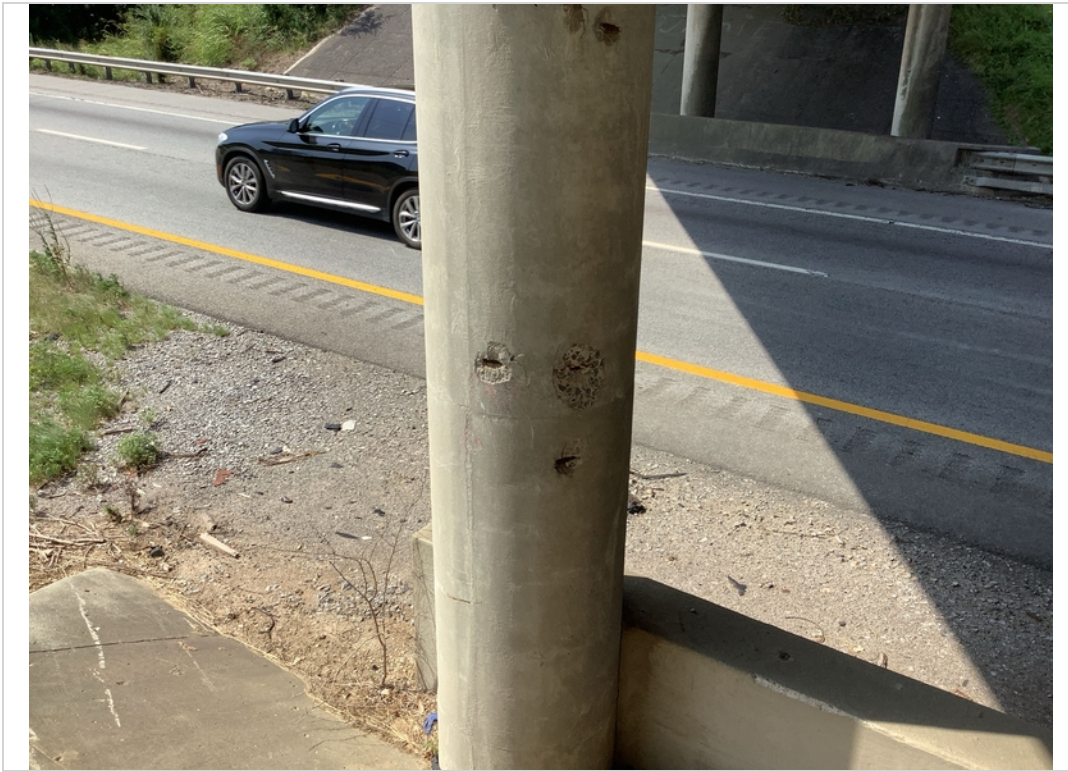
Typical spall on bents

| Bent Columns | (Good) | Some minor rebar pop-outs and delaminated areas |

The substructure is rated good. The columns are have some minor rebar pop-outs and delaminated areas.

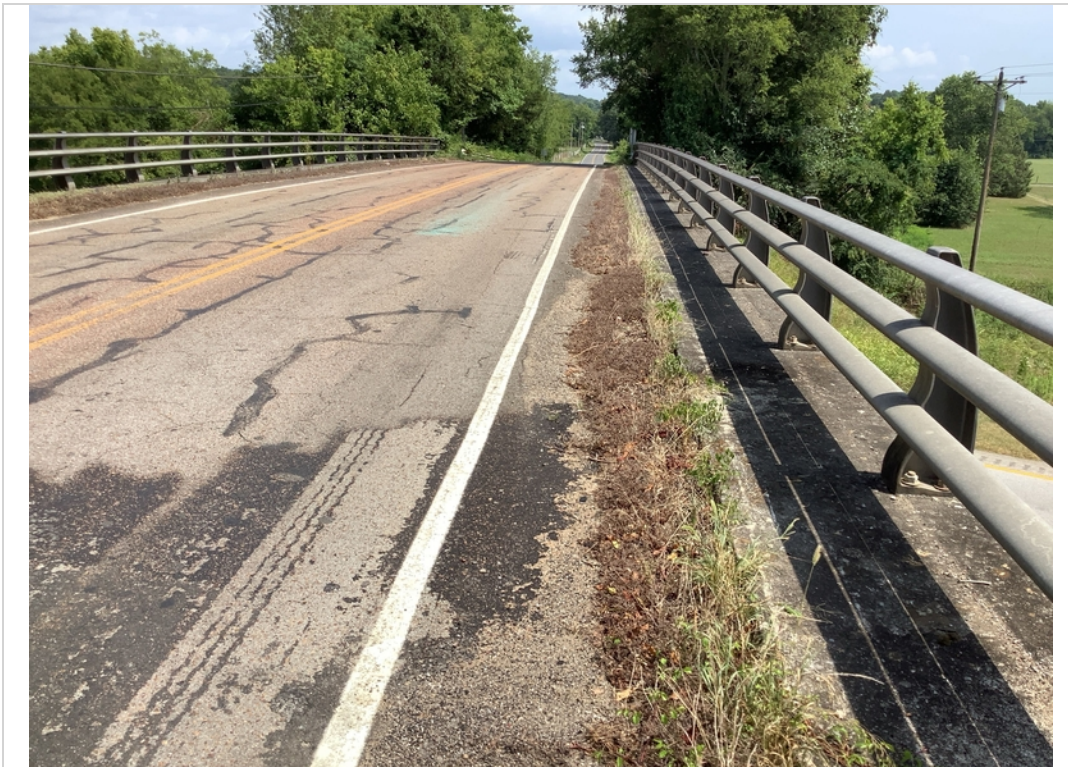
Debris on top of deck

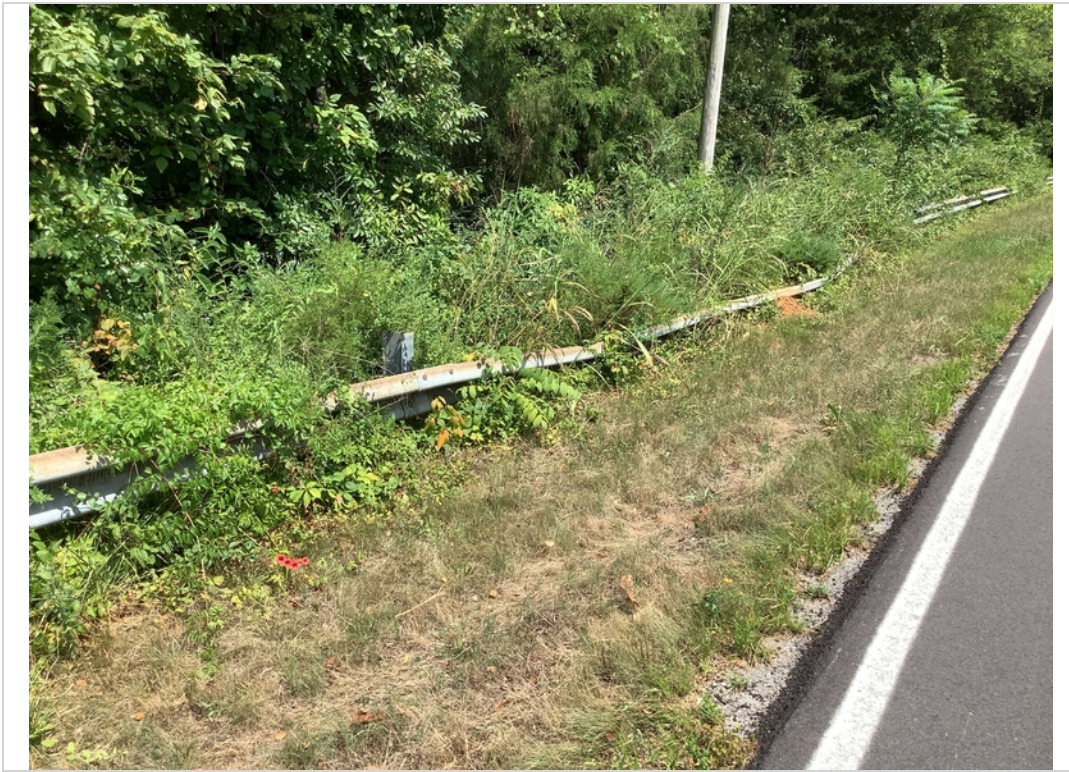
Damaged guardrail at approach #2 right

Guardrail Rating (Poor) Collision damage; set too low

Guardrail Terminal Rating (Poor) Collision damage; set too low

| Date Added | Recommendation | Priority |
|---|---|---|
| 07/13/2022 | REPAIR APPROACH GUARDRAIL ON RIGHT SIDE OF BOTH APPROACHES | |

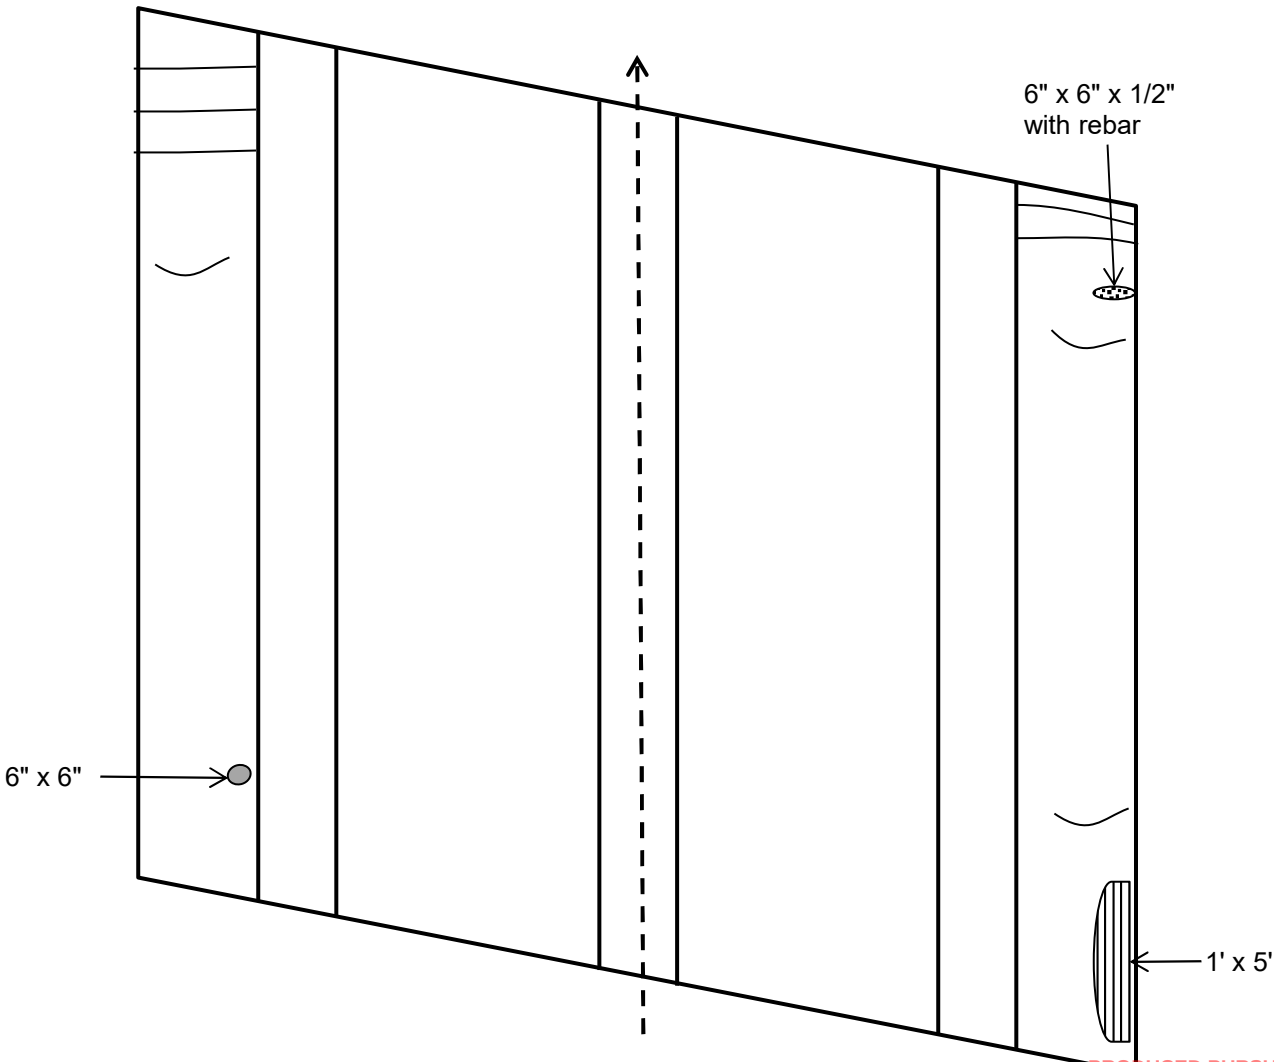
Bottom of Deck Span No. 1

-Cracks are hairline with efflorescence

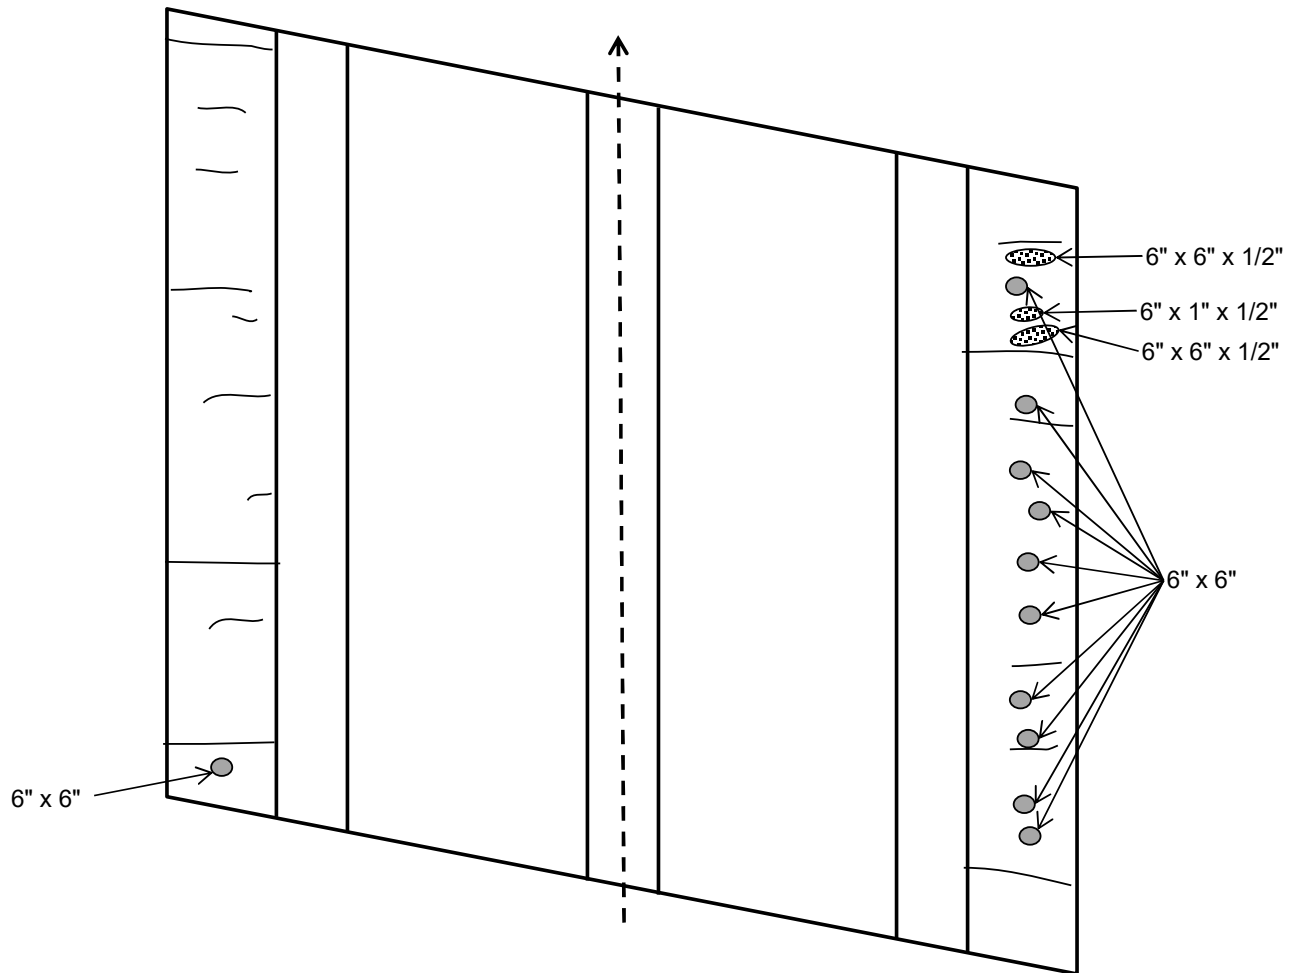
# Bottom of Deck Span No. 2

-Cracks are hairline with efflorescence

-All spalls have rebar

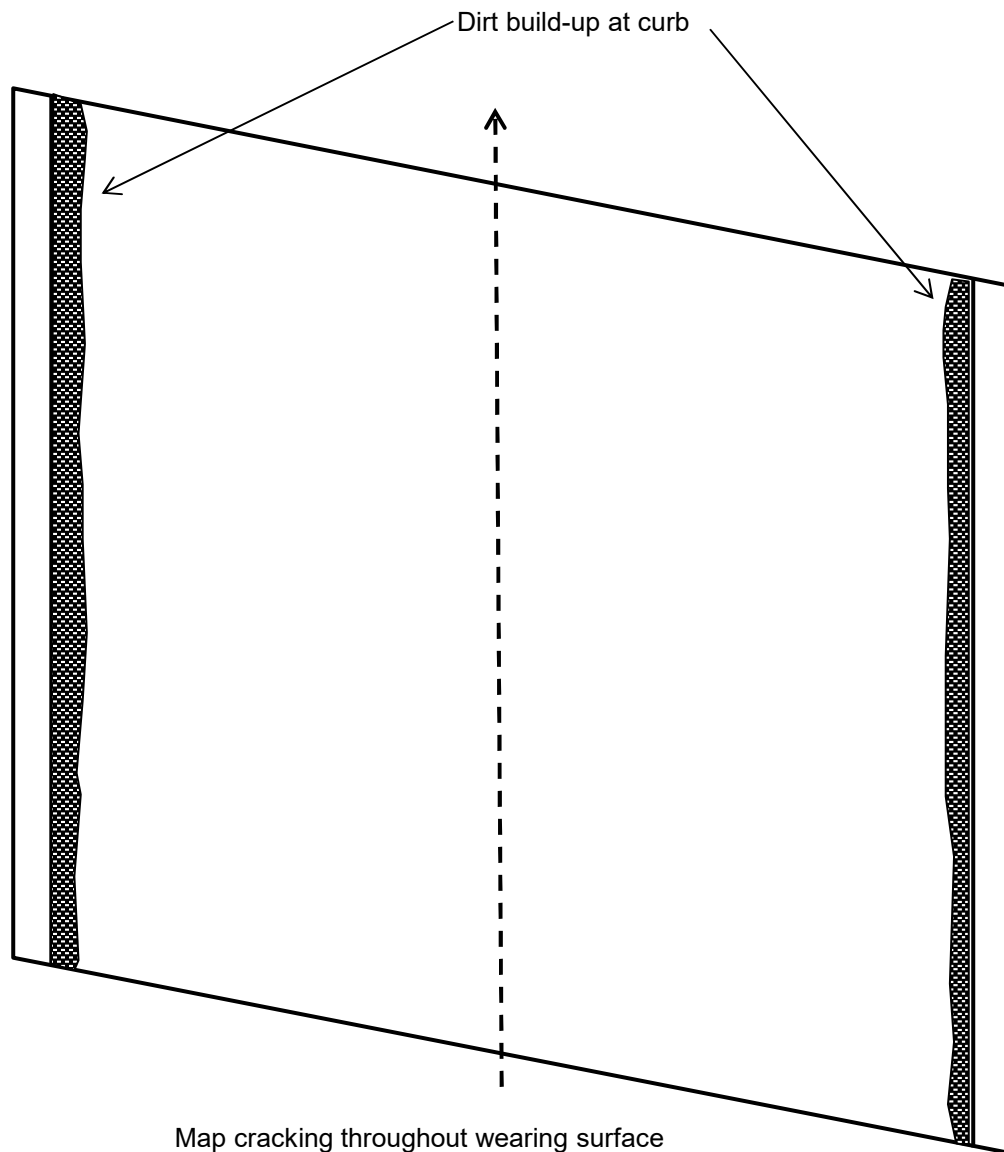
# Top of Deck Span No. 3

Map cracking throughout wearing surface

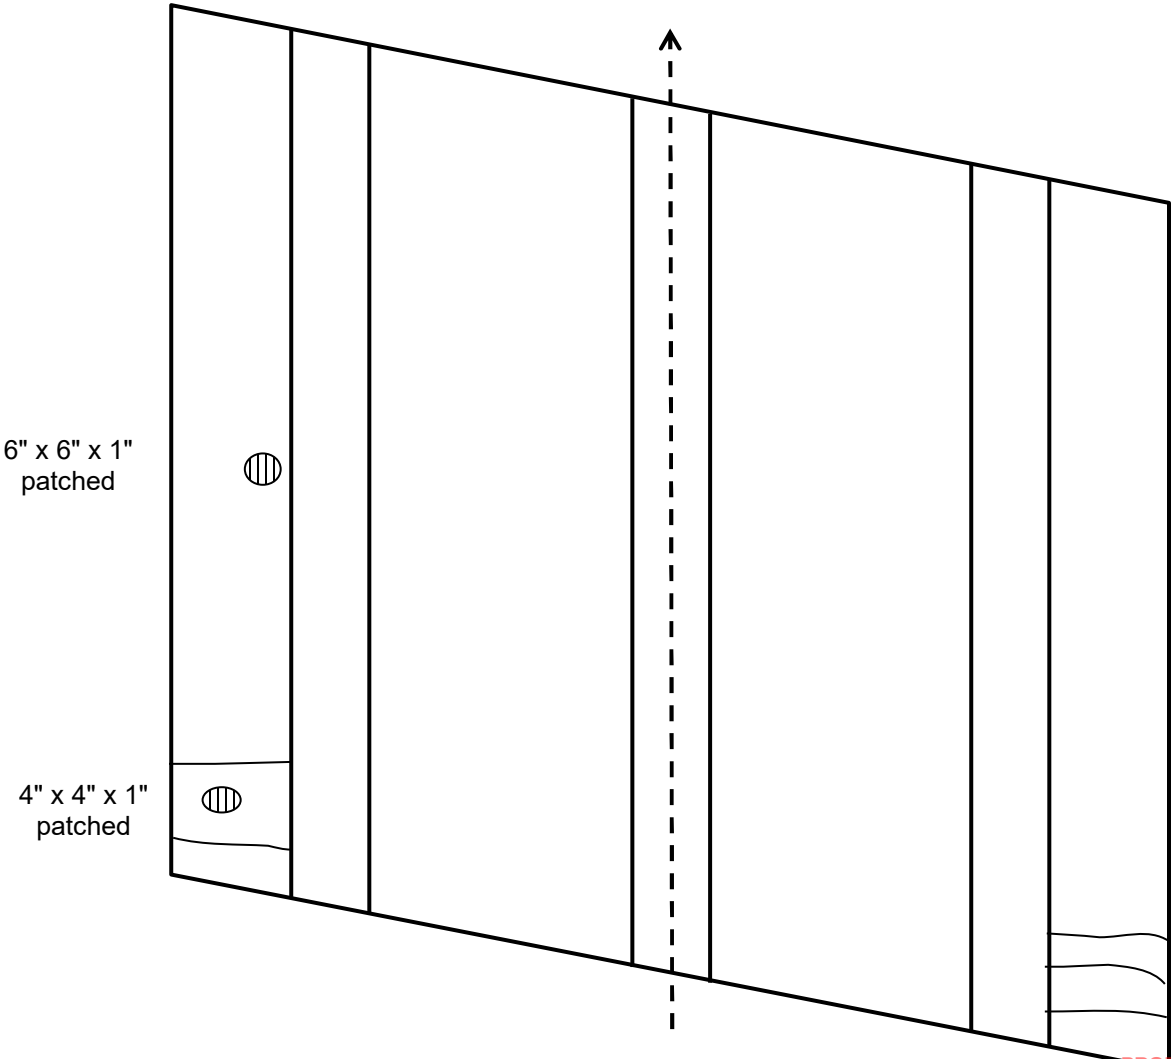
Bottom of Deck Span No. 3

cracks are hairline with efflorescence
