County: 75 - Rutherford, Route: 01044, Log mile: 0.480

Team Lead: Carlos Goncalves, **Inspection Date:** 06/14/2024

EPPS MILL RD. Crossing I24 35.72240, -86.32037

Inspection Team's Summary

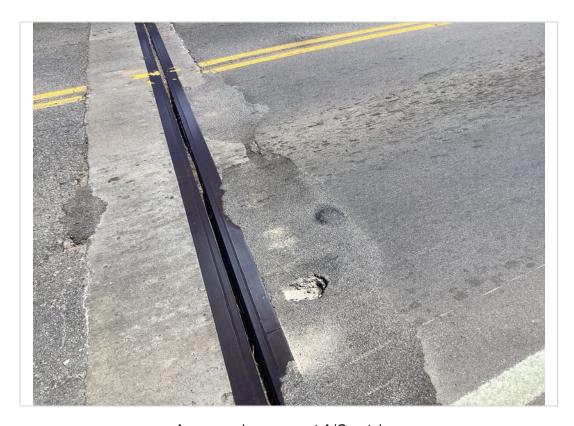
A approach pavement A/C patches

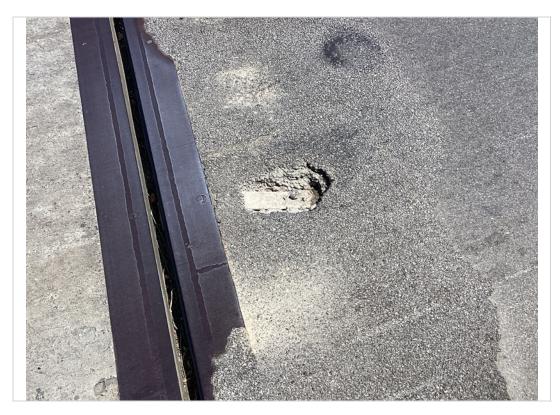
A approach pavement pothole

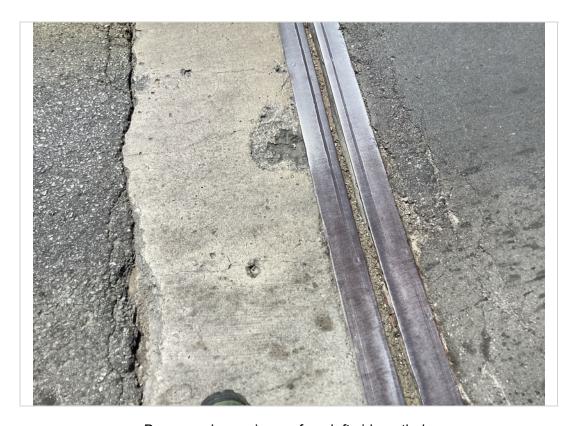
B approach wearing surface left side pothole

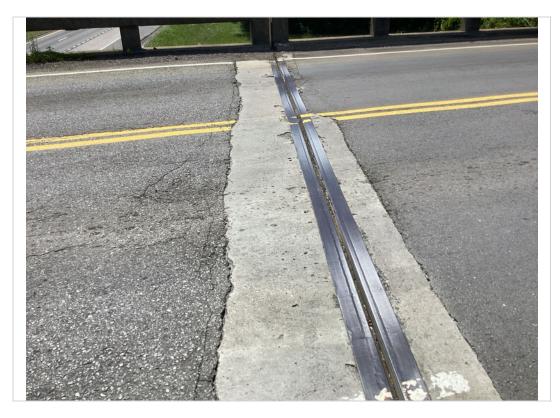
B approach wearing surface area of map cracking full length

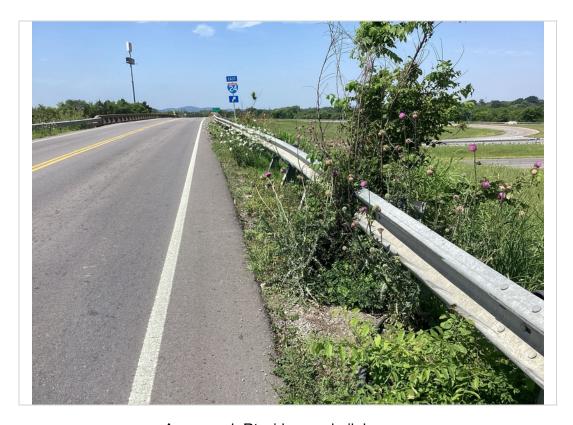
A approach Rt. side guardrail damage

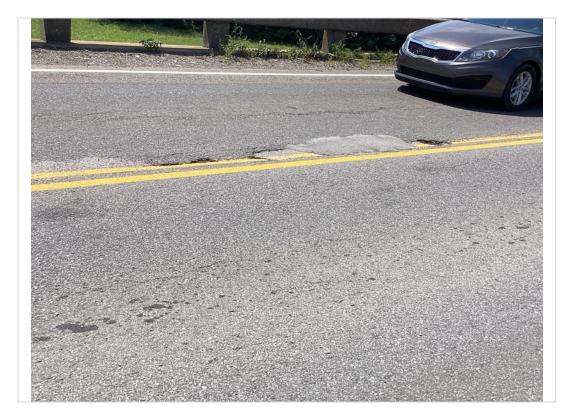
Span 2 near B approach area of small potholes over A/C patches

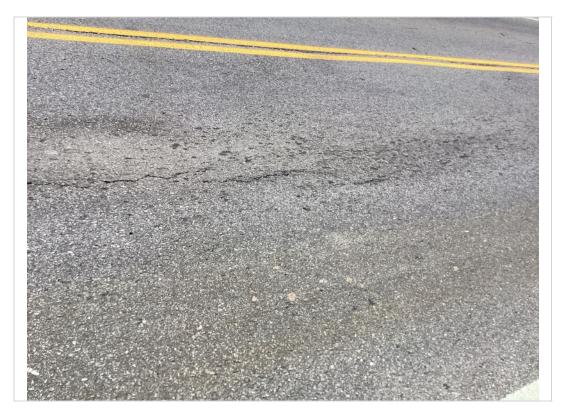
Span 1 near A approach 1/8" open longitudinal crack

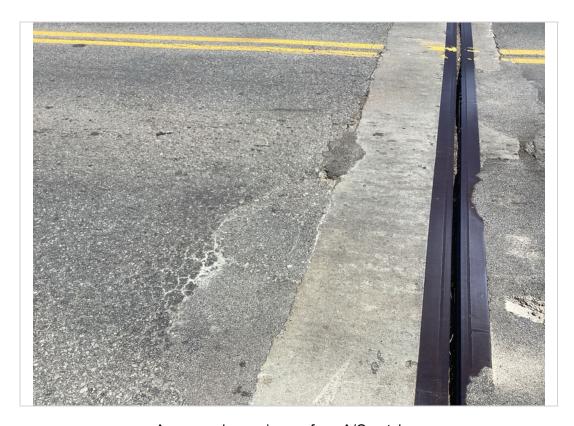
A approach wearing surface A/C patches

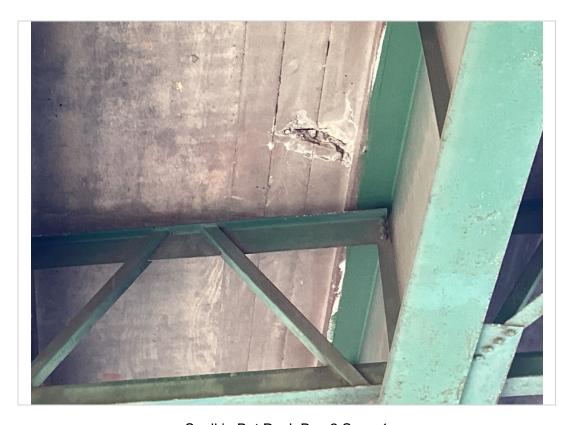
Spall in Bot Deck Bay 2 Span 1

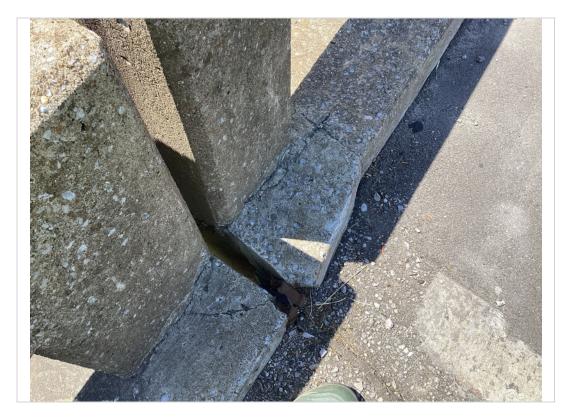
Bridge parapet right side near B approach joint area of delamination

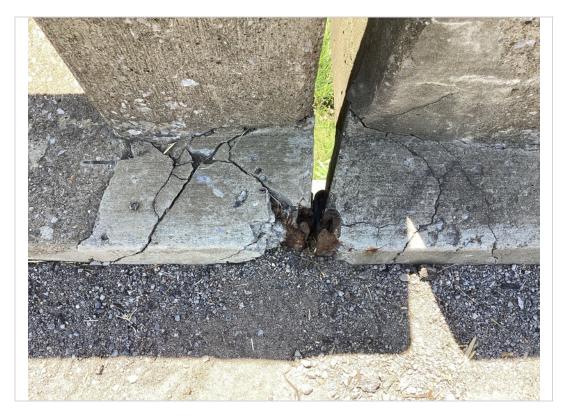
Bridge parapet left side near A approach joint area of delamination

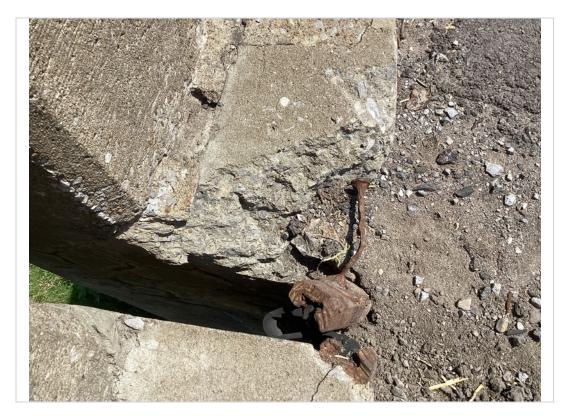
Bridge parapet right side near A approach joint spall with exposed steel

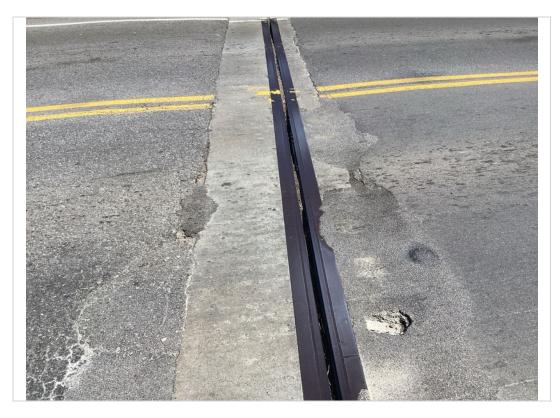
The asphalt-wearing surface is fair with a/c patches in span #2. The strip seal joints are poor with moderate-heavy debris, corrosion and light section loss. Joints are angled up 90 degrees at ends which is trapping debris in joint. The underside of the deck is fair with numerous map cracks with efflorescence. The bridge rails are good. The current Deck condition rating is Fair (6).

A approach joint filled with light debris

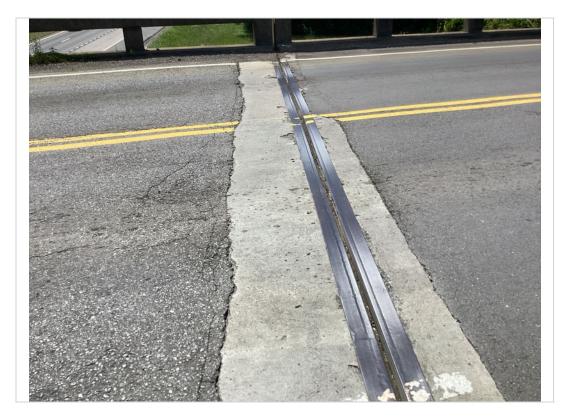
B approach joint filled with light debris

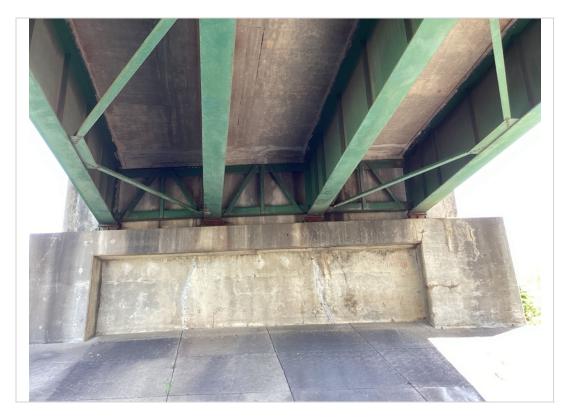
Girders are fair due to light corrosion and pitting on bottom flanges, and impact damage repairs on beam 'D' span #2. Bearings are fair at abutment #1 and #2 with moderate corrosion and 2" to 2.5" of tilt up station. The current Superstructure condition rating is Fair (6).

Abutment 1 moderate corrosion on bearings

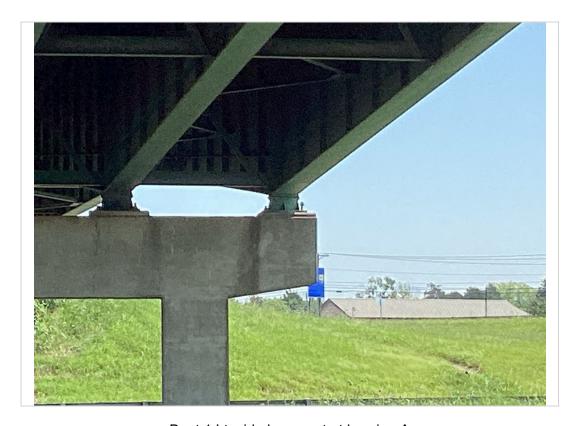
Bent 1 Lt. side loose nut at bearing A

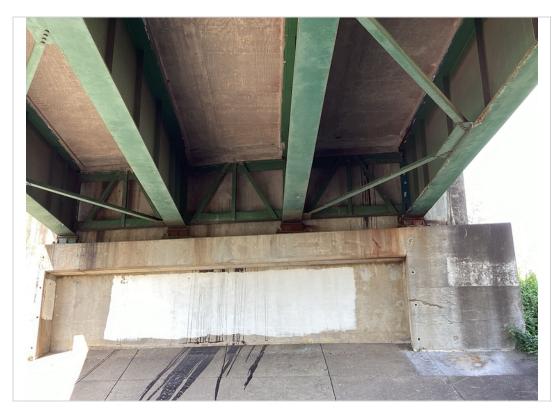
Abutment 2 bearings B - D moderate corrosion

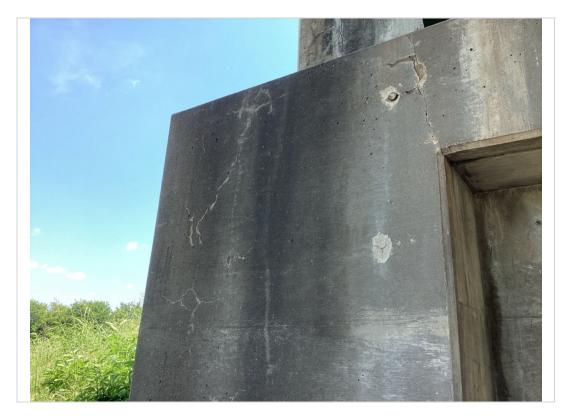
Abutment 1 cap random hairline cracks w/EFF. throughout

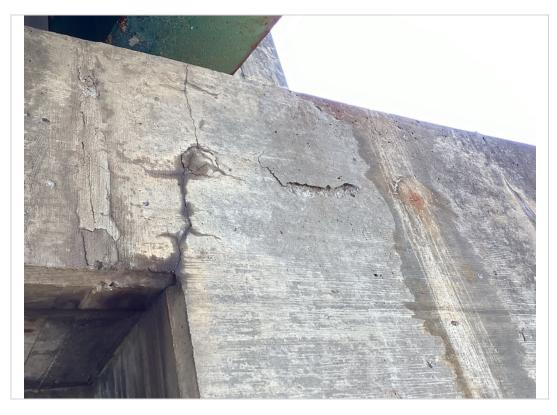
Abutment 1 cap Lt. side area of delamination

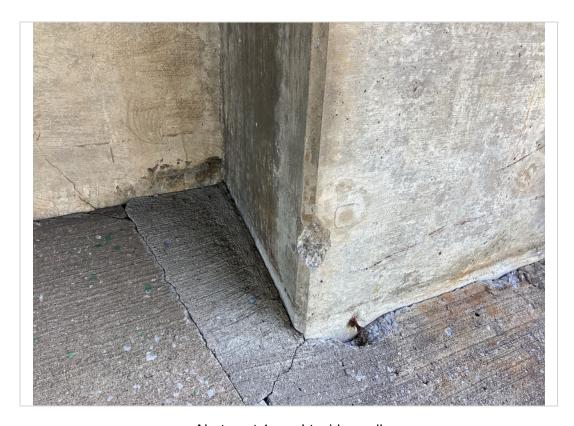
Abutment 1 cap Lt. side spall

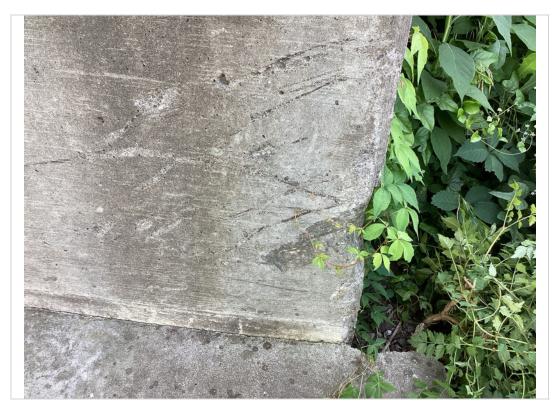
Abutment 2 cap Rt. Side spall

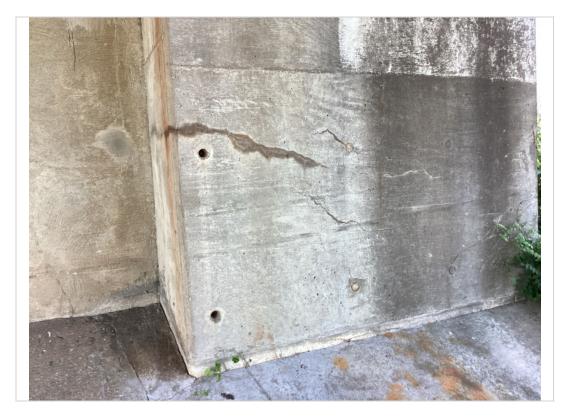
Abutment 2 cap random hairline cracks throughout

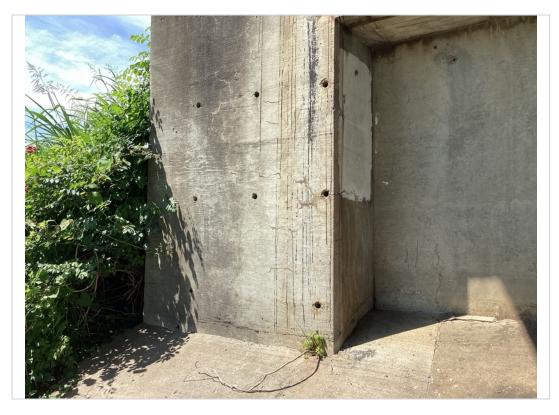
Abutment 2 cap map cracking

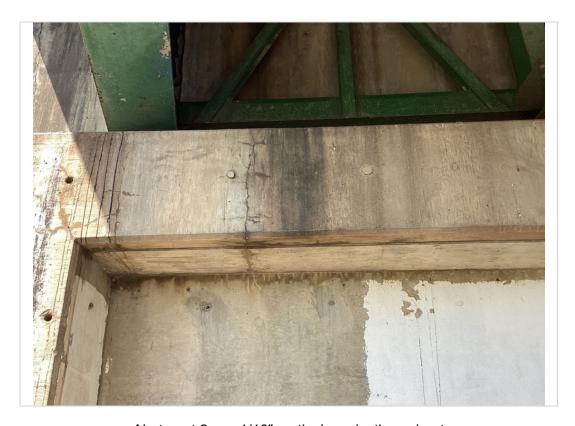
Abutment 2 cap 1/16" vertical cracks throughout

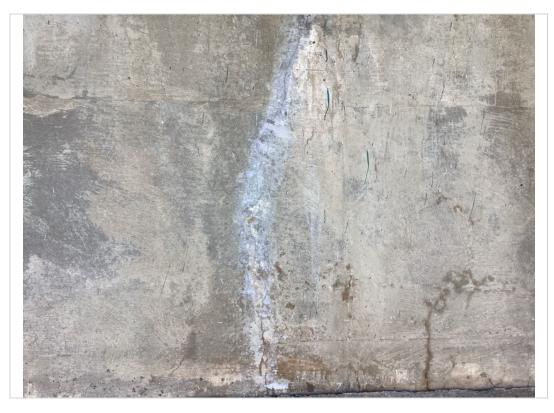
Abutment 1 breastwall Random hairline cracks w/EFF. Throughout

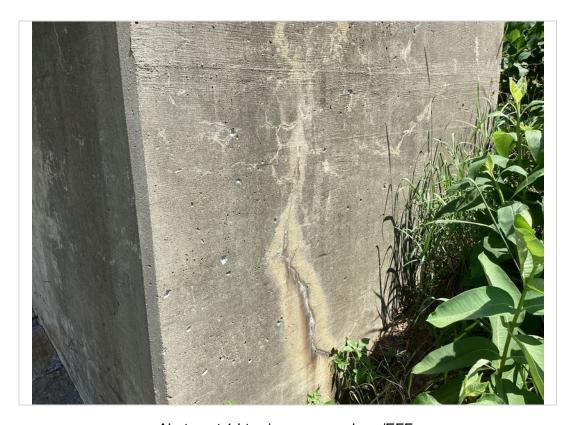
Abutment 1 Lt. wing map cracks w/EFF.

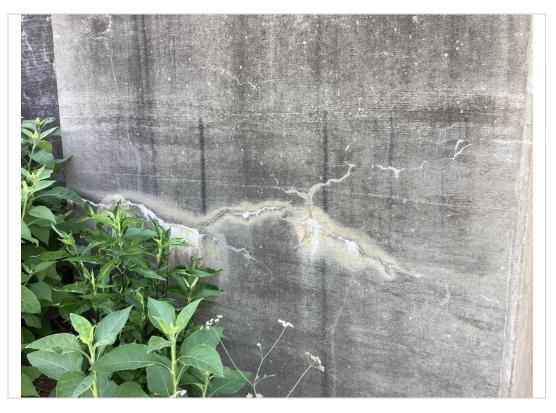
Abutment 1 Rt. Wing map cracks w/EFF.

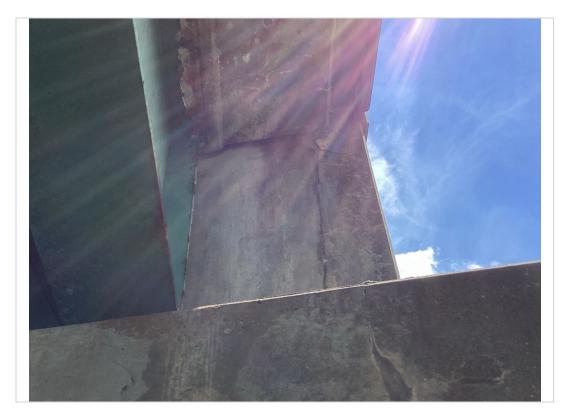
Abutment 1 backwall Lt. side 1/16" vertical crack

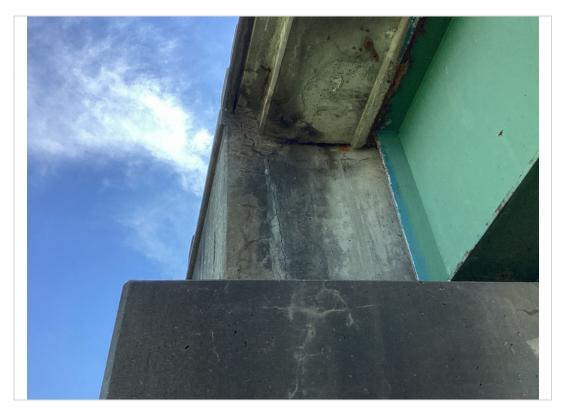
Abutment 1 backwall Rt. Side 1/16" vertical crack

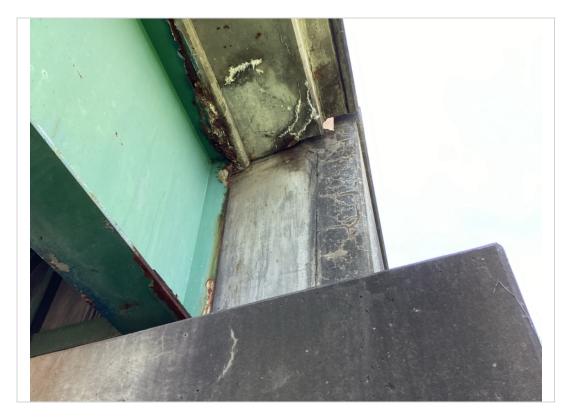
Abutment 2 Rt. Side backwall map cracking w/EFF

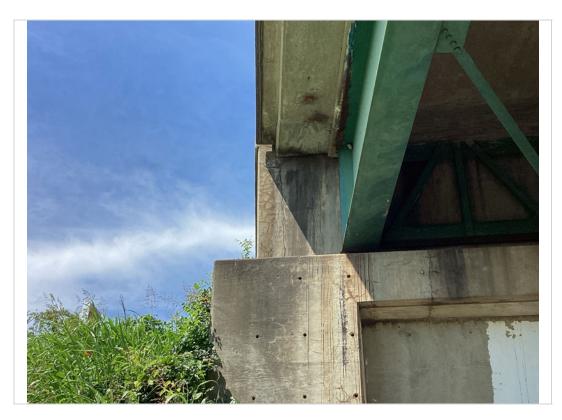
Abutment 2 backwall Lt. side 1/16" vertical crack

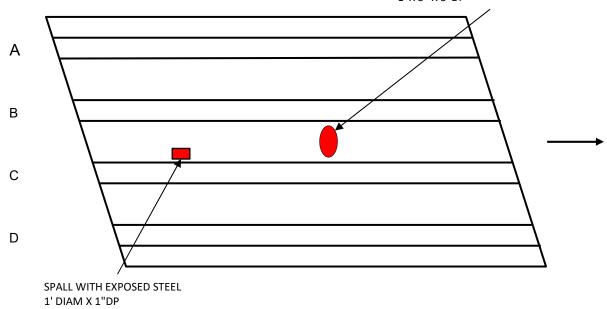
Bottom of Slab Span No. 1

HEAVY SPALL WITH EXPOSED STEEL 1' X 5" X 5"DP

DECK	FAIR	SPALL /EXP STL 1'DIA X 1"D,
		CONC. REPAIR @ ABUT. #1 AT ALL BAYS
BRACING	GOOD	INTERMEDIATE
DIAPH.	GOOD	
GIRDER A	GOOD	MOD CORR TOP FLANG 3' FROM ABUT #1
GIRDER B	FAIR	MOD CORR BTM FLANGE OVER ROAD
GIRDER C	FAIR	MOD CORR BOTTOM FLANGE- OVER ROAD
GIRDER D	FAIR	MOD. CORRO. TOP FLANGE 3' FROM ABUT. # 1, MOD CORR
		BOTT FLANGE-OVER ROAD
OVERHANGS	GOOD	RDM. H.C.'S W/EFF., RUST STAINS
PAINT	POOR	PEELING BM'S "B"-"D", FADING ALL BMS & DIAPHRAMS

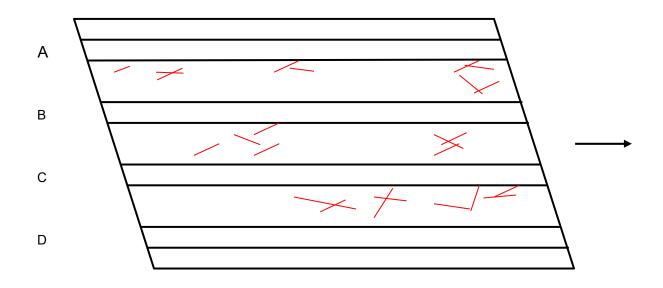
Bottom of Slab Span No. 2

FAIR	H.L. MAP CRACKS W/EFF, CONC.
	REPAIRS AT ABUT #2 AT ALL BAYS
GOD	INTERMEDIATE
GOOD	
FAIR	LIGHT CORRBOT FLANGE, TOP FLANGE AT ABUT 2
GOOD	LIGHT CORROSION
GOOD	LIGHT CORROSION
FAIR	REPAIRED SECTION FROM IMPACT DAMAGE, LGT. CORR.
	OUTSIDE OF TOP & BTM. FLANGE 3'L, LGH CORR. BOTT
	FLANGE 25'L OVER RD, TOP FLANGE AT ABUT 2
FAIR	MAP CRACKS W/EFF, H.C.'S W/EFF
FAIR	FADING, PEELING ON ALL BEAMS
	GOOD FAIR GOOD FAIR FAIR

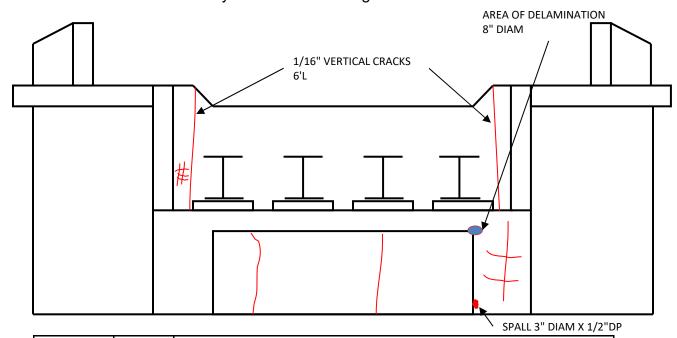
WALL	GOOD	OPEN CRACK UP TO 1/16" OPEN- 6'L W/ H.L. PATTERN CRACKS
CAP	GOOD	HORIZ/VERT H.C.'S W/EFFL
		LGT RUST STAINS; IMPACT DMG; AREA OF DELAM. 8"DIA
BEARING	FAIR	MOD. CORROSION ON ALL - PAINTED W/ MOD.RUST STAINS
LT. WING	GOOD	RDM MAP CRACK W/EFF
RT. WING	GOOD	RDM MAP CRACKS W/EFF
EMBANKMNT	GOOD

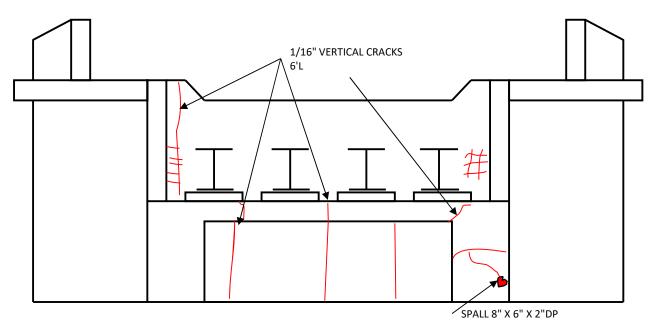
Abutment No. 2

\\/\\	GOOD	DATTERN HICKS VERT CRACK LIR TO 1/16" OREN
WALL	GOOD	PATTERN H.C.'S, VERT CRACK UP TO 1/16" OPEN,
		FULL HEIGHT
CAP	GOOD	VERT CRACKS UP TO 1/16" OPEN-UP TO FULL HEIGHT,
		RANDOM DIAG/HORIZ H.C.'S, SPALL
BEARING	FAIR	MOD. CORROSION AT "B, C, & D"
LT. WING	GOOD	RANDOM H.L. PATTERN CRACKS
RT. WING	GOOD
