BRIDGE MAINTENANCE RECOMMENDATIONS

Tennessee Department
of Transportation

CROSSING: EPPS MILL RD / I24

BRIDGE INSPECTION REPORT

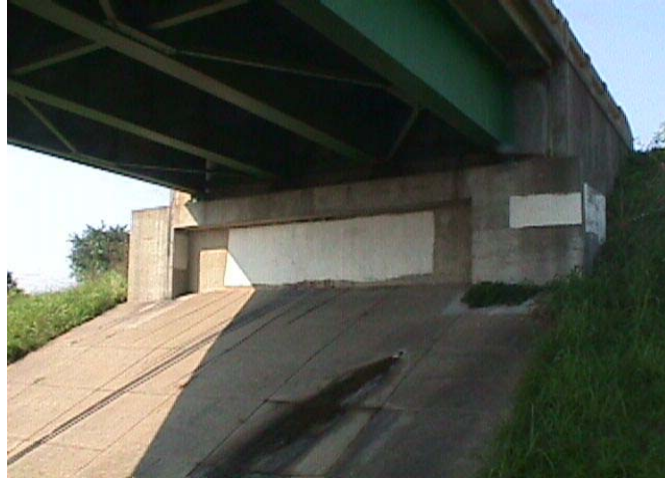
PIC1

[ABUTMENT TYPICAL](#)

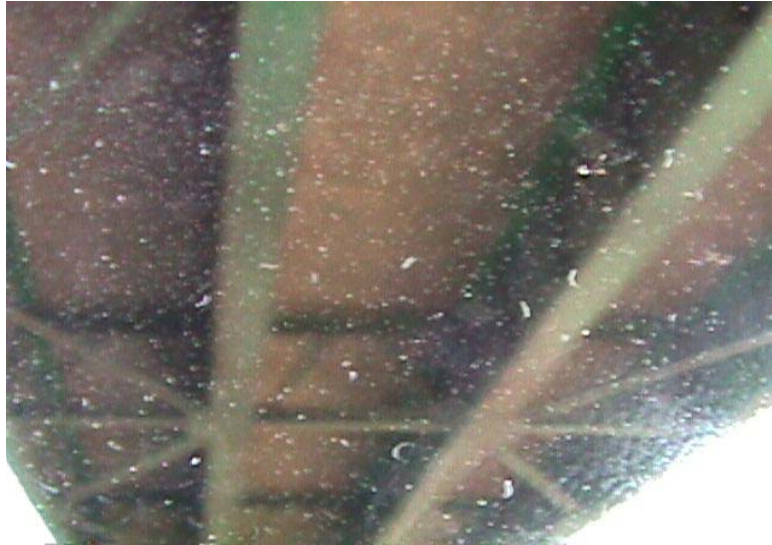
PIC2

[BOTTOM OF DECK TYPICAL](#)

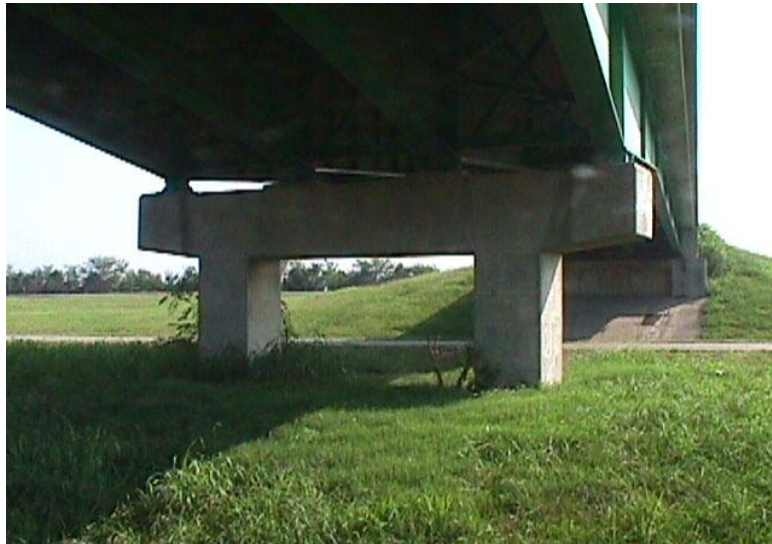
PIC3

[BENT TYPICAL](#)

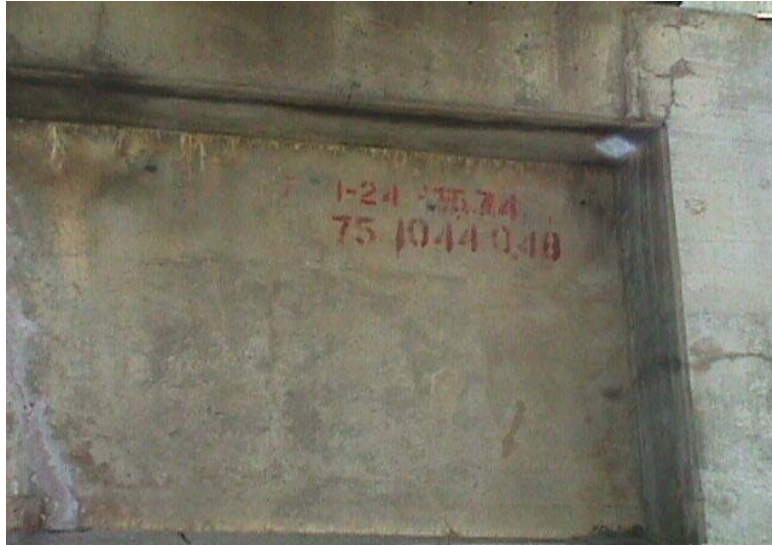
PIC4

BRIDGE NO. AT ABUTMENT # 1

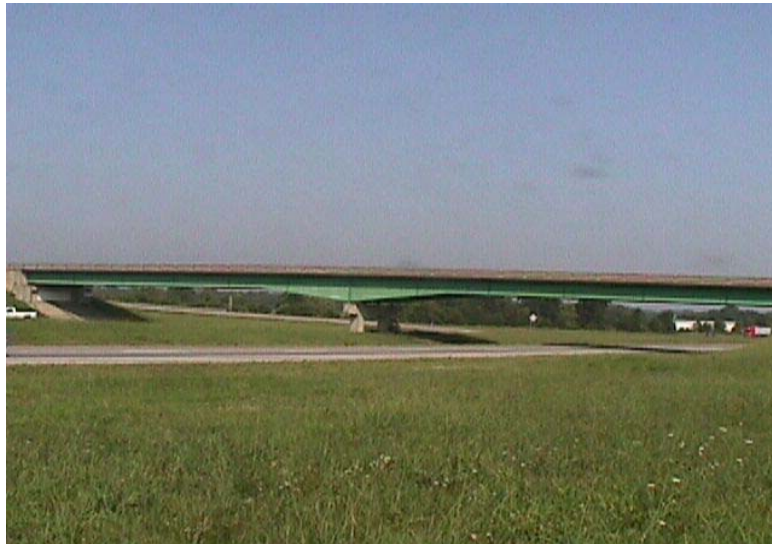
PIC5

ELEVATION VIEW, EAST SIDE

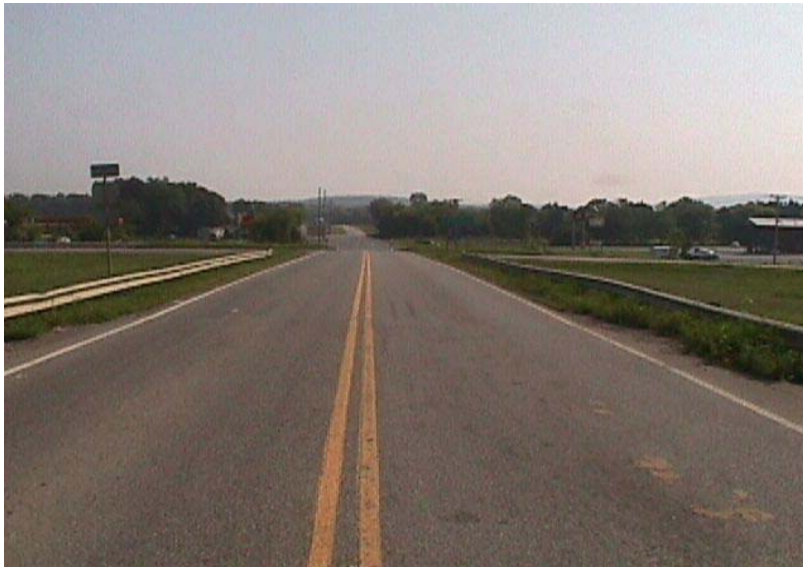
PIC6

["A" APPROACH](#)

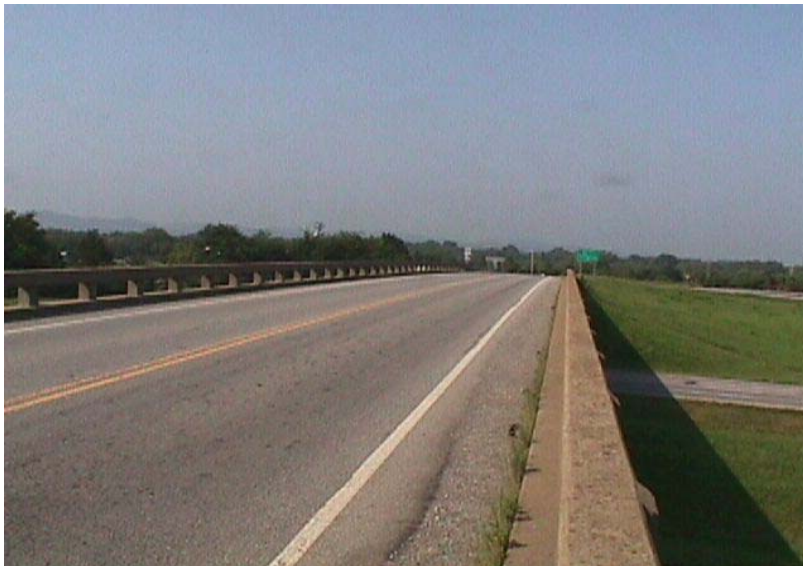
PIC7

[VIEW ACROSS DECK](#)

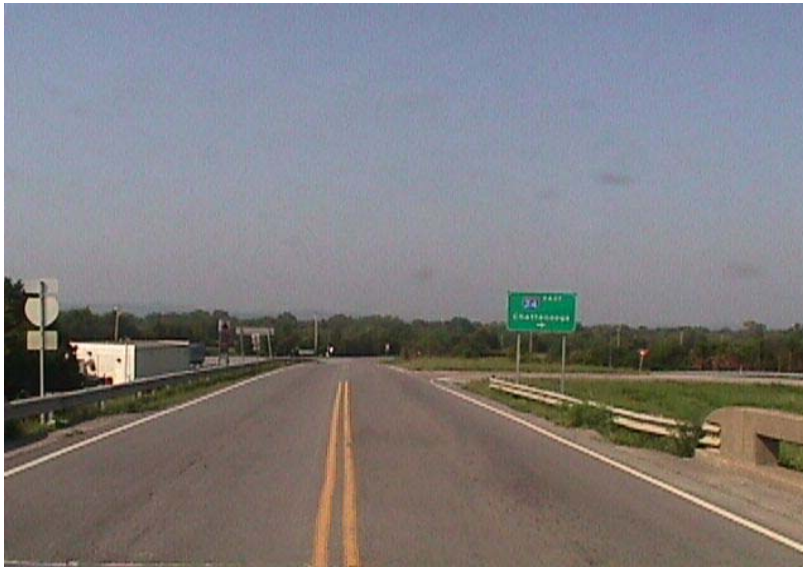
PIC8

"B" APPROACH

No.	RECOMMENDATIONS	REPAIR DATE	REPAIRED BY
1.	REPAIR APPROACH ROADWAY @ EXPANSION JOINT A END		
2.	LEVEL APPROACH B

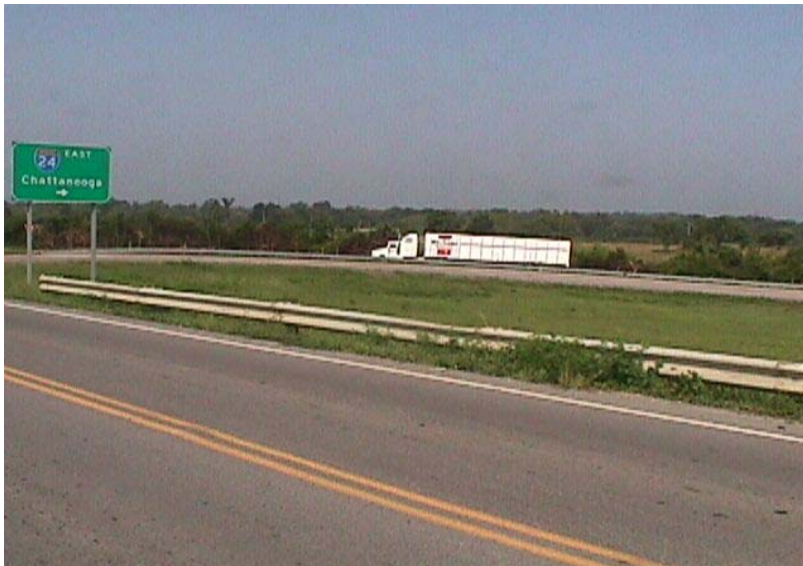
PIC9

APPROACH RAIL B END LT SIDE

Rating	Standard/ SubStandard	Comments
Bridgerailing	GOOD	SUBSTANDARD	
Transitions	FAIR	SUBSTANDARD	RUB-RAIL NON-EXISTANT
Guardrail	FAIR	SUBSTANDARD	MOD COLL DMG "A" & "B" ENDS. TOO LOW
Guardrail Terminal	FAIR	SUBSTANDARD	LGT COLL DMG

REPAIR APPROACH GUARDRAILS AT APPROACH NO. 0001

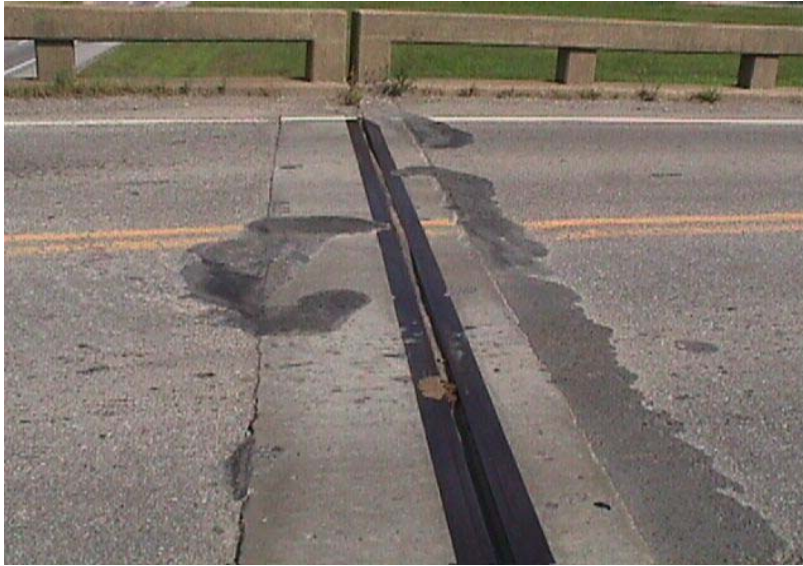
PIC10

JOINT A END PATCHES & DEPRESSIONS

Rating	Comments
Alignment	GOOD	
Slab	N/A	
Joints	FAIR	MOD DEBRIS BUILD-UP "A" & "B"
Pavement	POOR	DEPRESSION & A/C PATCHES "A" END
Embankment	GOOD	
Drains	N/A

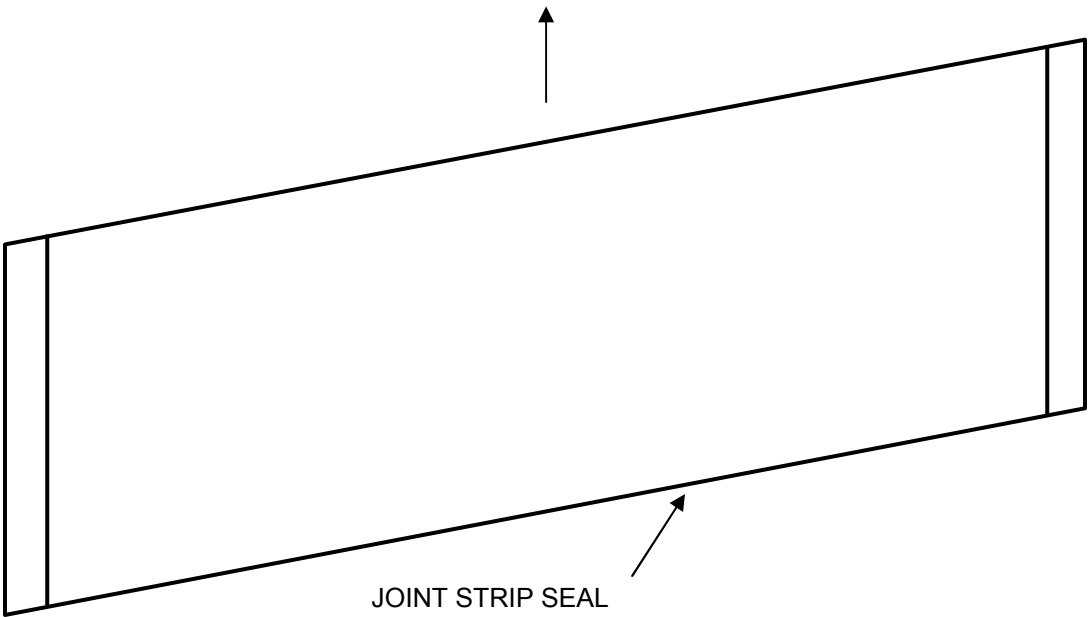
Top of Deck Span No. 1

SURFACE	F	
CURB	G	
RAIL	G	SUBSTANDARD
JOINTS	F	PARTIAL PAVED OVER, DEBRIS BUILD UP AND LIGHT SECT. LOSS

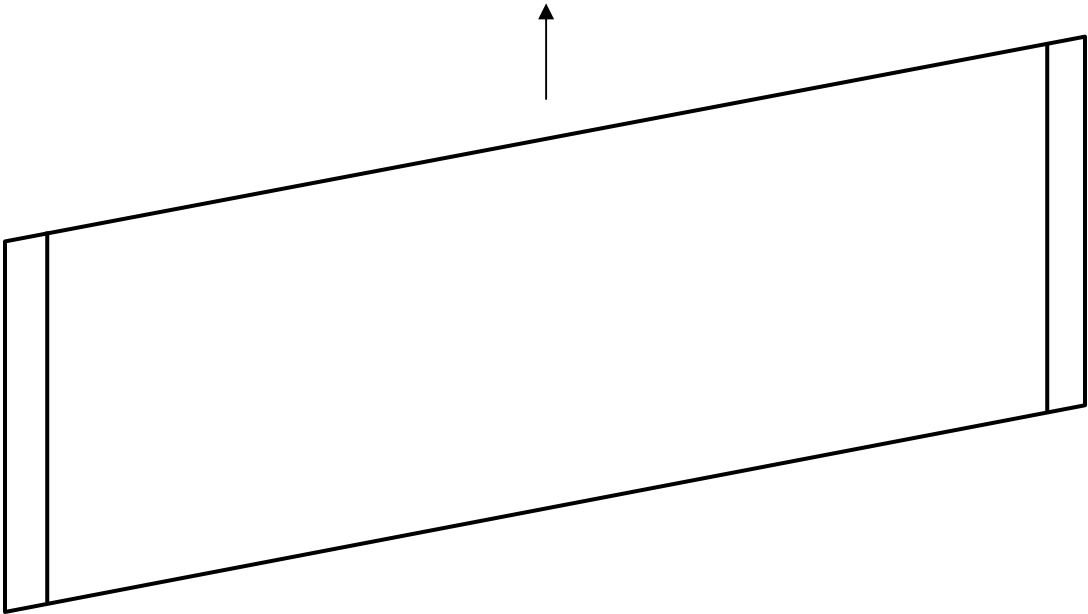
Top of Deck Span No.2

SURFACE	F	
CURB	G	
RAIL	G	SUBSTANDARD
JOINTS	F	PARTIAL PAVED OVER, DEBRIS BUILD UP AND LIGHT SECT. LOSS

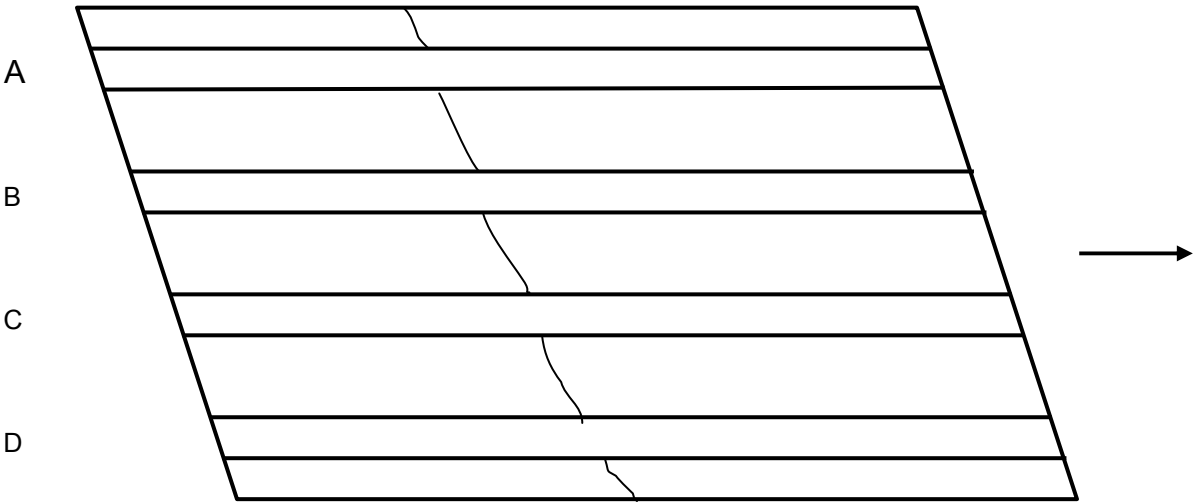
Bottom of Slab Span No. 1

DECK	G	LIGHT RANDOM MAP CRACKS
BRACING		
DIAPH.	G	
ALIGN.	G	
BEAM A	G	
BEAM B	G	
BEAM C	G	
BEAM D	G	
OVERHANG	G	LIGHT PATTERN CRACK AND H.S. POP OUTS

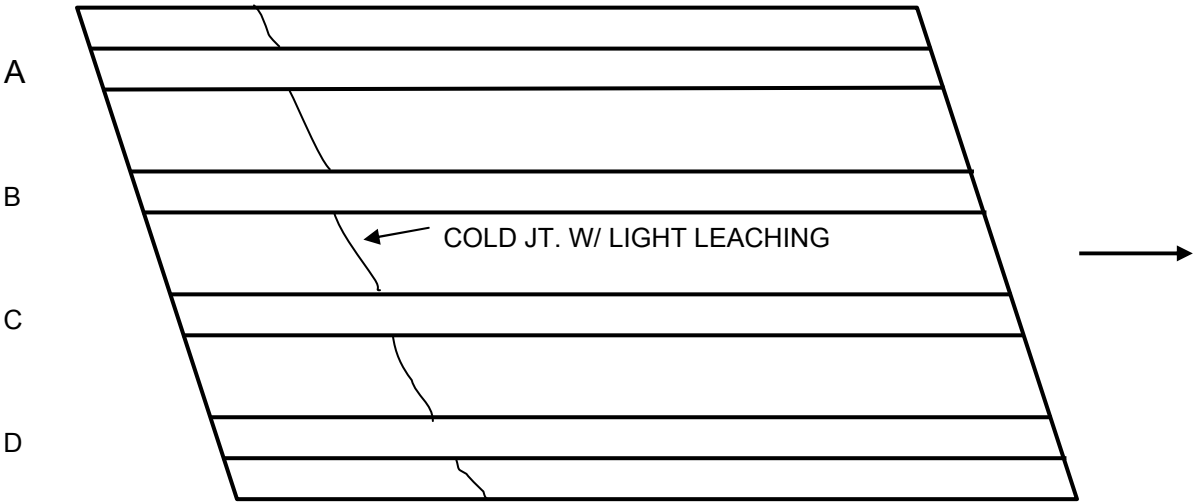
Bottom of Slab Span No. 2

DECK	G	LIGHT RANDOM MAP CRACKS
BRACING		
DIAPH.	G	
ALIGN.	G	
BEAM A	G	
BEAM B	G	
BEAM C	G	
BEAM D	G	
OVERHANG	G	LIGHT PATTERN CRACK AND H.S. POP OUTS

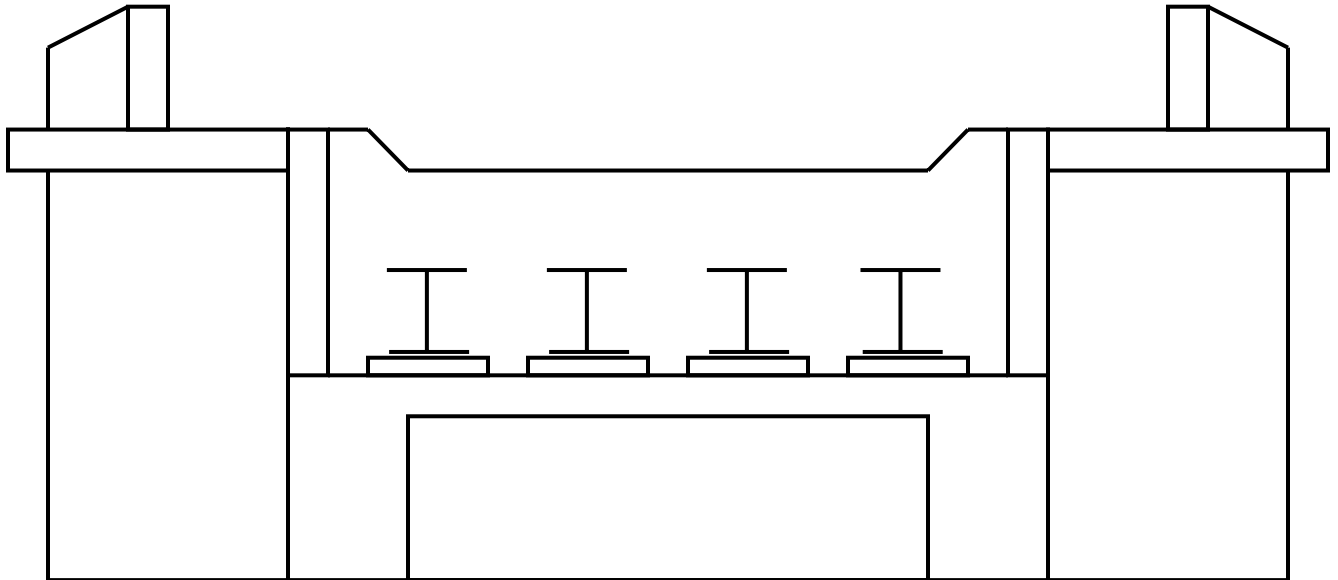
Abutment No. 1

WALL	G	
CAP	G	
BEARING	F	MOD. CORROSION
LT. WING	G	
RT. WING	G	
FOOTING	NV

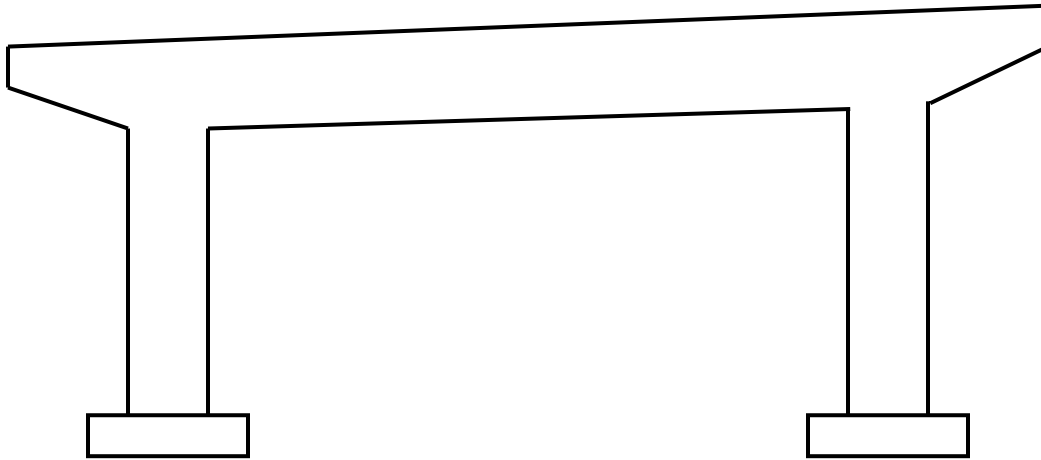
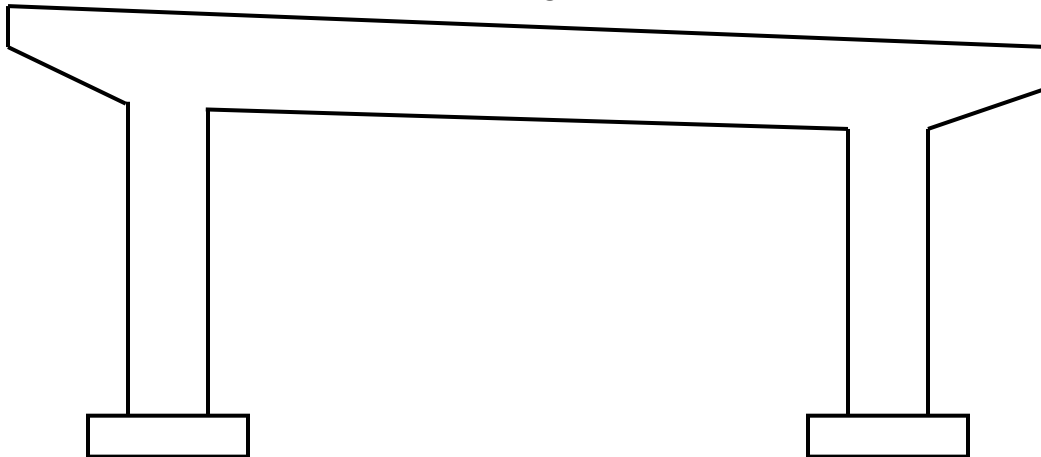
BENT # 1

CAP	G	
COLUMN	G	
BEARINGS	G	LIGHT RUST
FOOTING	NV	
PLUMB	G	
SCOUR	G

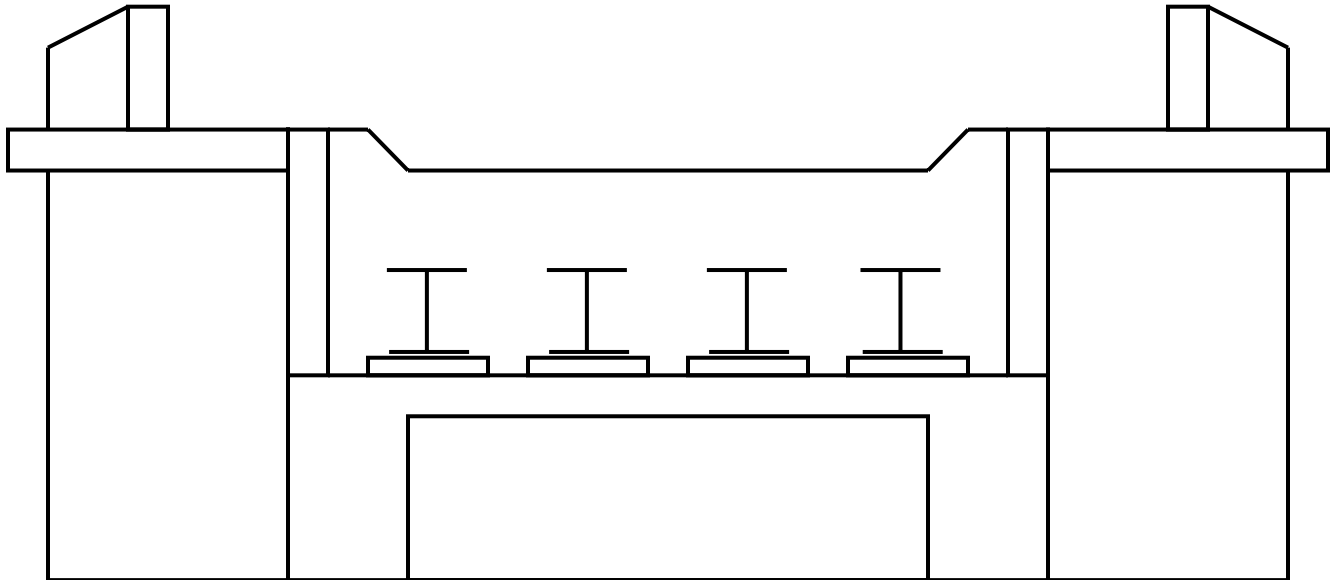
Abutment No. 2

WALL	G	
CAP	G	
BEARING	F	MOD. CORROSION
LT. WING	G	
RT. WING	G	
FOOTING	NV
