HAYWOOD COUNTY

38-SR087-0361

Crossing: LAGOON CREEK

Bridge Maintenance Recommendations

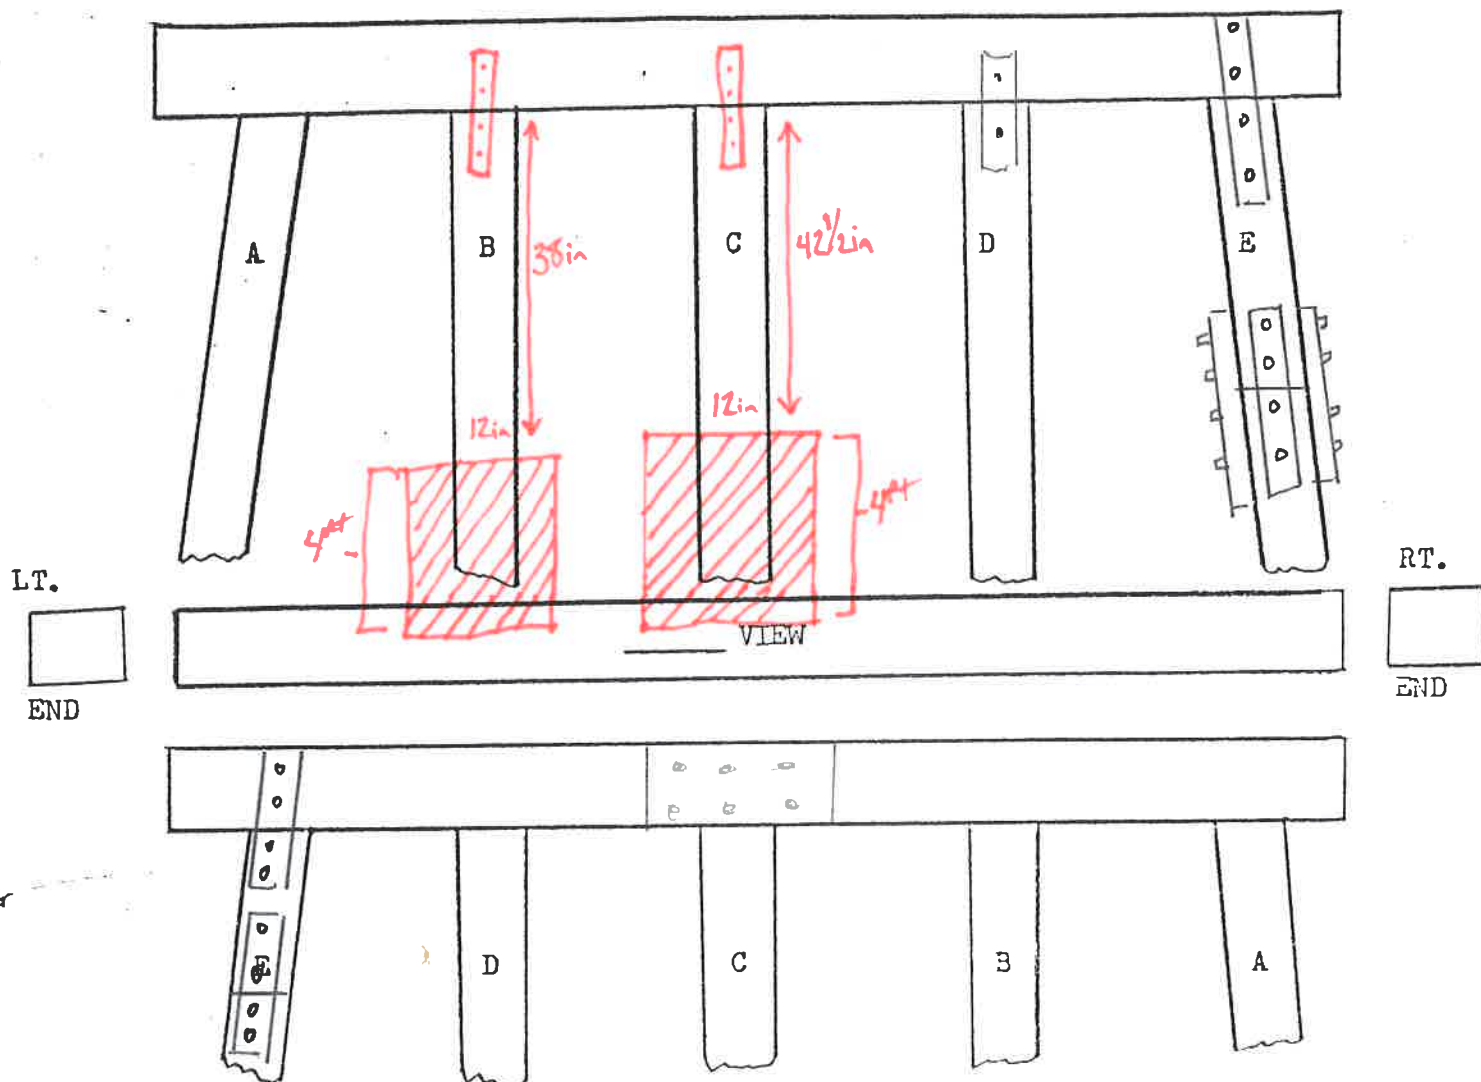
BENT NO. 1

- Spliced piling at 76in from bottom of cap
- Spliced piling at 80 in from bottom of cap

140	REPLACE _TIMBER _PILES _B, C _ AT BENT NO. _1 (08-26-21 Bridge Repair spliced piles "B" & "C" and poured concrete barrel around them)
140	REPLACE _TIMBER _PILES _C, D _ AT BENT NO. _2 (08-26-21 Bridge Repair added piles "B", "D", "F" & "H")

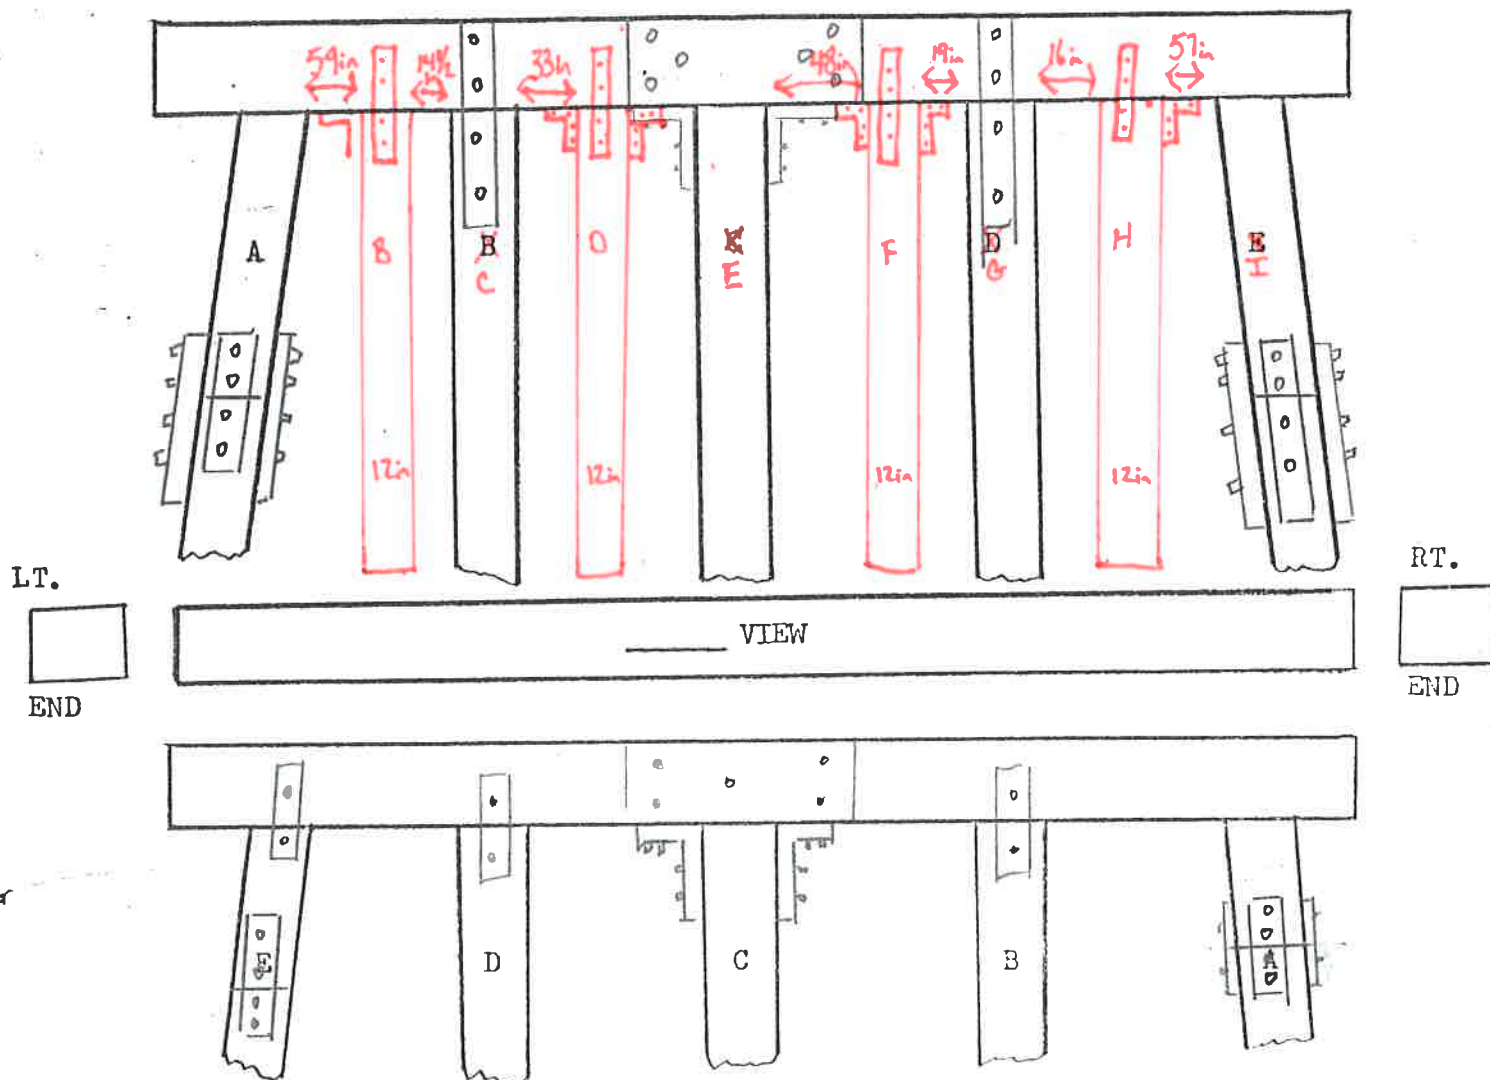
BENT NO. 2

Added pilings B, D, F, and H in Bent #2

-17ft in ground and 8ft 4in above ground
-18ft in ground and 8ft 4in above ground
-19ft in ground and 8ft 10in above ground
-20ft in ground and 7ft 10in above ground
