HAYWOOD COUNTY

38-SR087-0347

BRIDGE MAINTENANCE RECOMMENDATIONS

BRIDGE INSPECTION REPORT

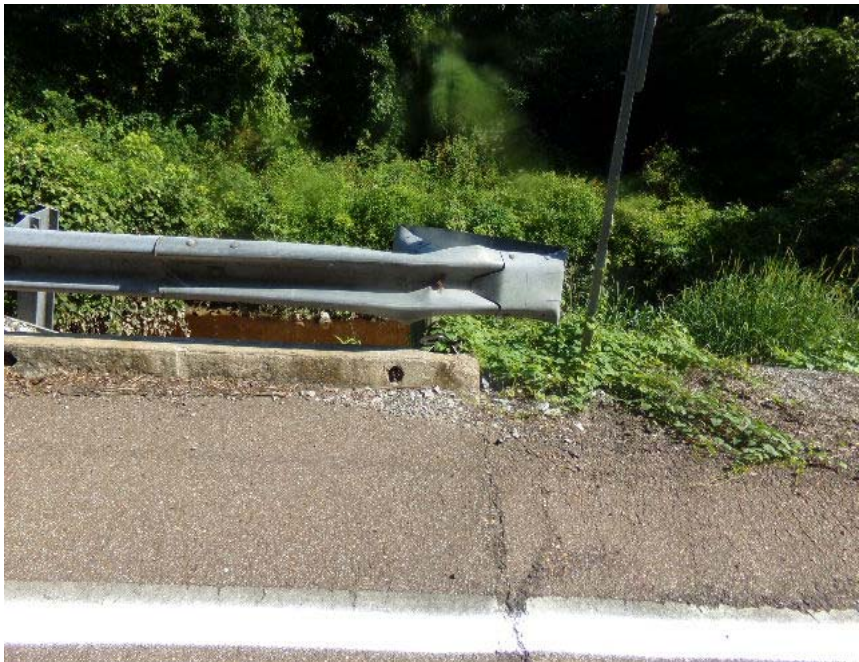
APPROACH # 2 LEFT TERMINAL

Rating	STANDARD/ SUB-STANDARD	Comments
Bridgerailing	G F (P) C	() (X)	See 3.2
Transitions	G F P C	() ()	—
Guardrail	G F P C	() ()	—
Guardrail Terminal	G (E) P C	() (X)

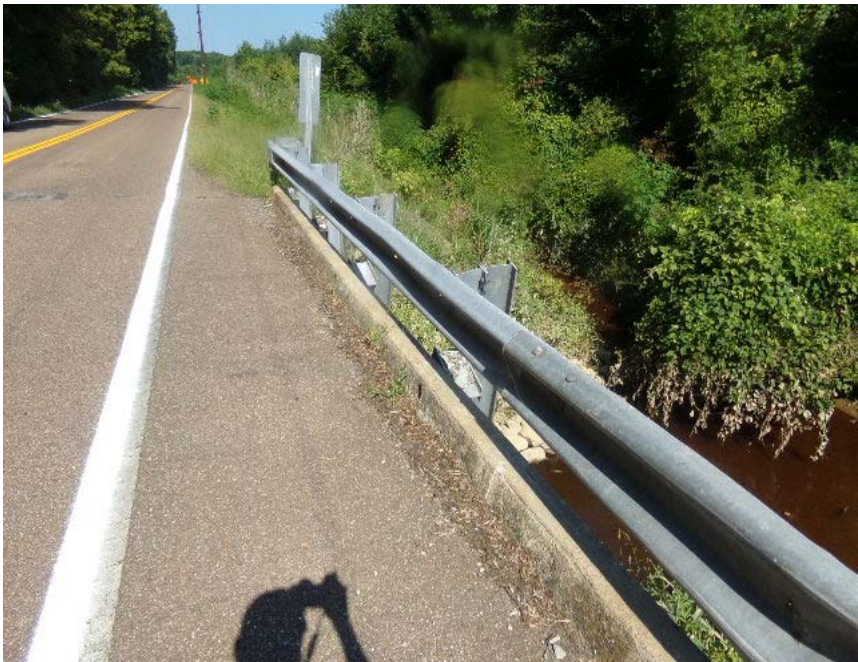
LEFT RAIL

The rail on span # 1 left side has heavy collision damage.

CLEAR DRAINS
APPROACH GUARDRAIL TERMINALS ARE SUBSTANDARD
APPROACH GUARDRAILS ARE NON-EXISTENT
BRIDGERAILS ARE SUBSTANDARD
REPAIR BRIDGERAIL ON LEFT SIDE OF SPAN NO.1

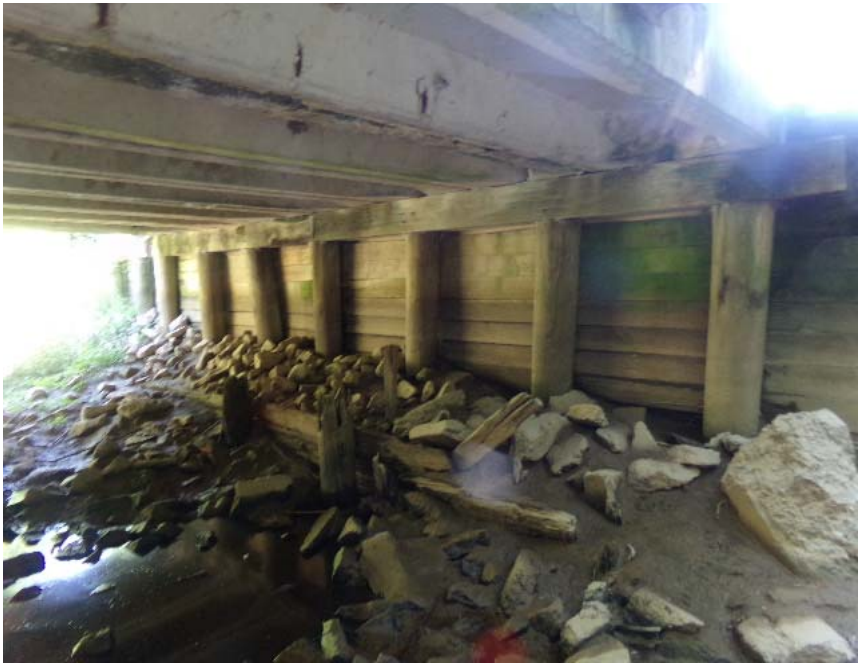
ABUTMENT # 2

The timber substructure has light to medium weathering, splintered areas & decay.

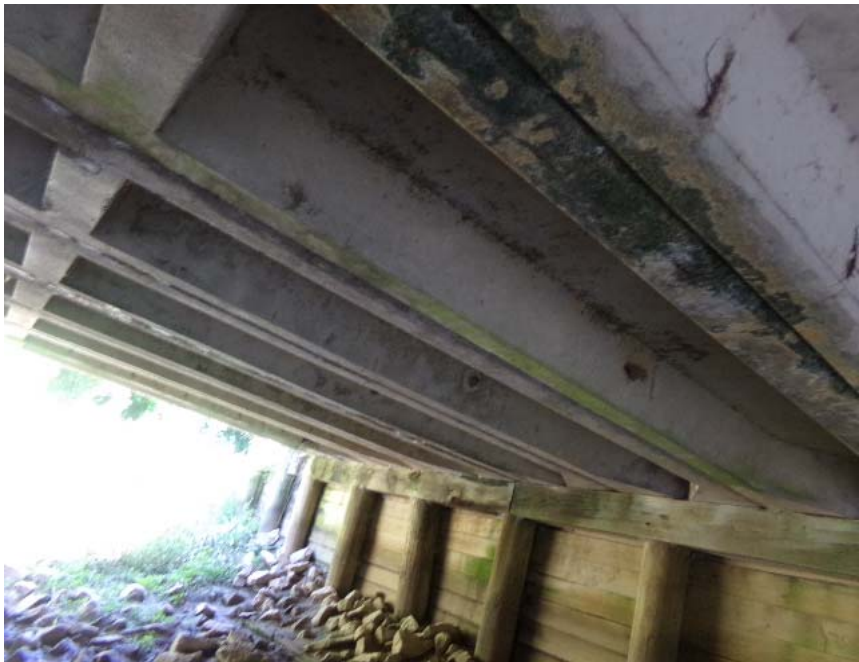
BOTTOM DECK

The p.c.c.s. have up to 1/8" cracks, efflorescence stains & spalling.

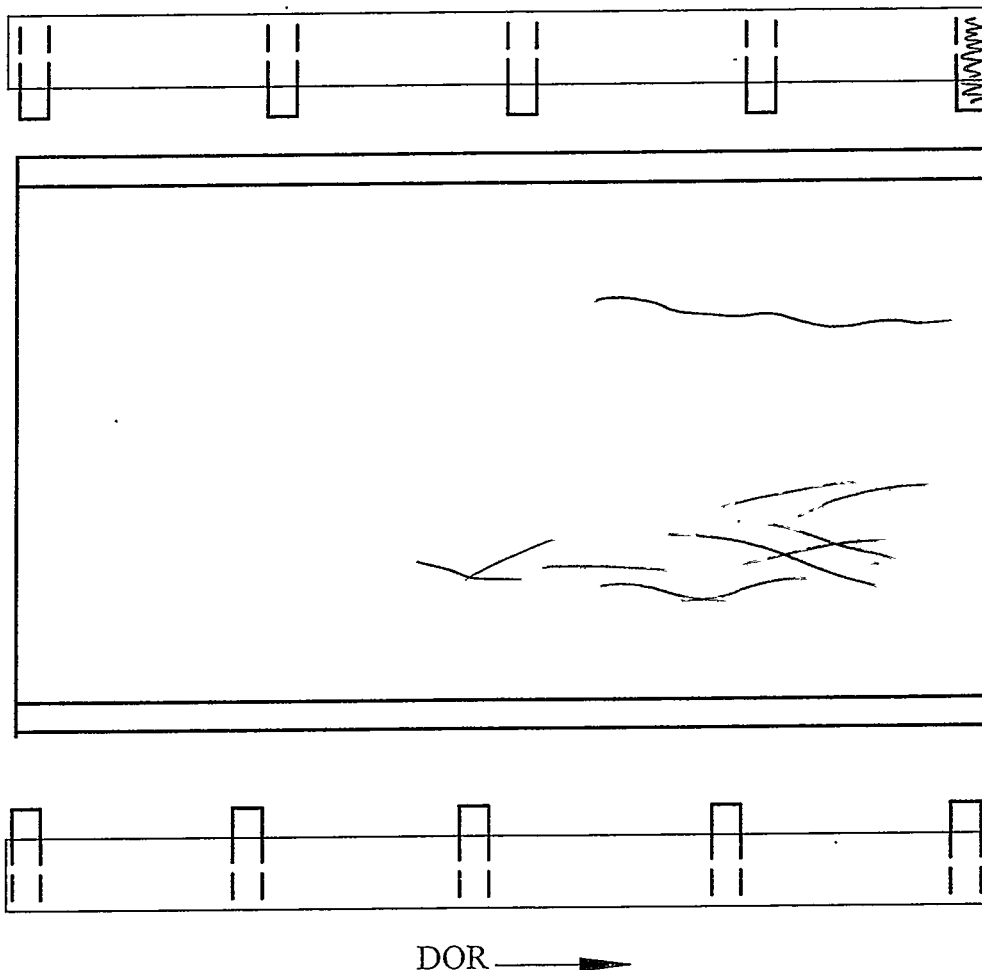
SPAN. NO. 1

ELEMENT	RATING	COMMENT
TOP DECK	G (F) P C	Cracks up to 1/16"
CURBS	(G) F P C	
RAIL & POST	G F (P) C	Damage, missing post
PAINT	G F P C	
DRAINS	G F (P) C	Filled w/debris
JOINT	G F P C	
	G F P C

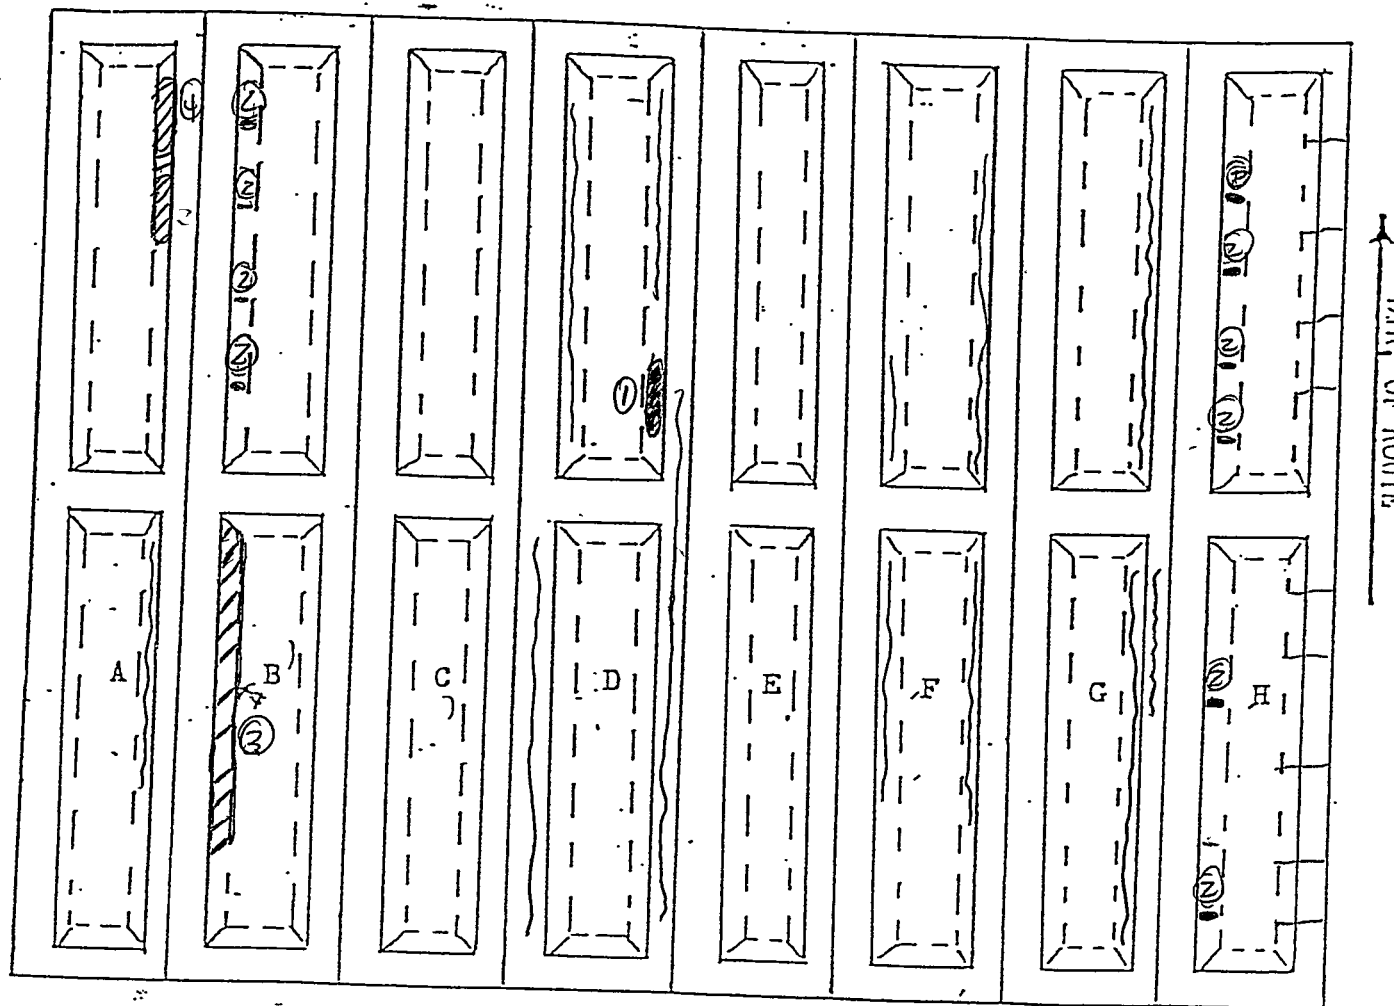
SPAN NO. 1

ELEMENT		RATING	COMMENT
BOTTOM DECK SLAB	A	(G) F P C	See 4, fine cracks See 2, 3
	B	(G) F P C	
	C	(G) F P C	
	D	(G) F P C	
	E	(G) F P C	See ① 1/8" crack
	F	(G) F P C	fine cracks
	G	(G) F P C	fine cracks
	H	(G) F P C	See ②, hairline cracks
BOLTS		(G) F P C

- ① 2' L x 4" H x ? D
Impending Spall
- ② upto 4" in dia x 1/2" D
Surface steel
- ③ 8' L x 7" H x 1 1/2" D
Spall to steel
- ④ 2 1/2' L x 4" H x 1 1/2" D
Spall to steel

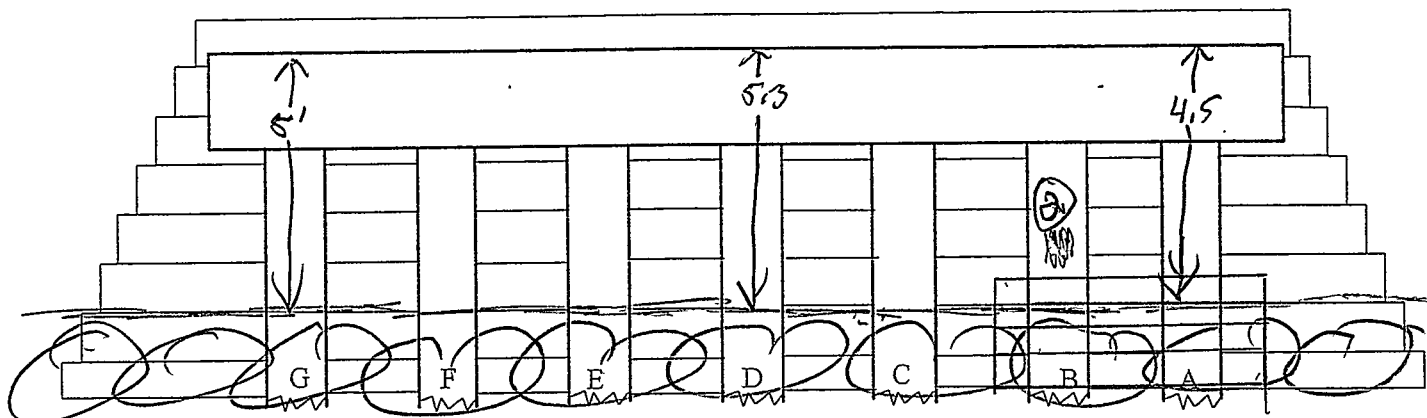
AUG 11 2021
ABUT. NO.

ELEMENT	RATING	COMMENT
CAP	G (F) P C	light to med weathering see ① Decay Area 1/4 x 4 1/2 x 1/8
WINGS	G (F) P C	② Splitter 1/4 x 8 1/2 x 1/8
PILES A	G (F) P C	
B	G (F) P C	
C	G (F) P C	
D	G (F) P C	
E	G (F) P C	
F	G (F) P C	see ②
G	G (F) P C	
RIP - RAP	G (F) P C	
EMB.	G (F) P C	
VEG.	G (F) P C	Med
BREASTWALL	G (F) P C	light to med weathering
Ret. Wall —	G (F) P C	1 1 1
	G F P C

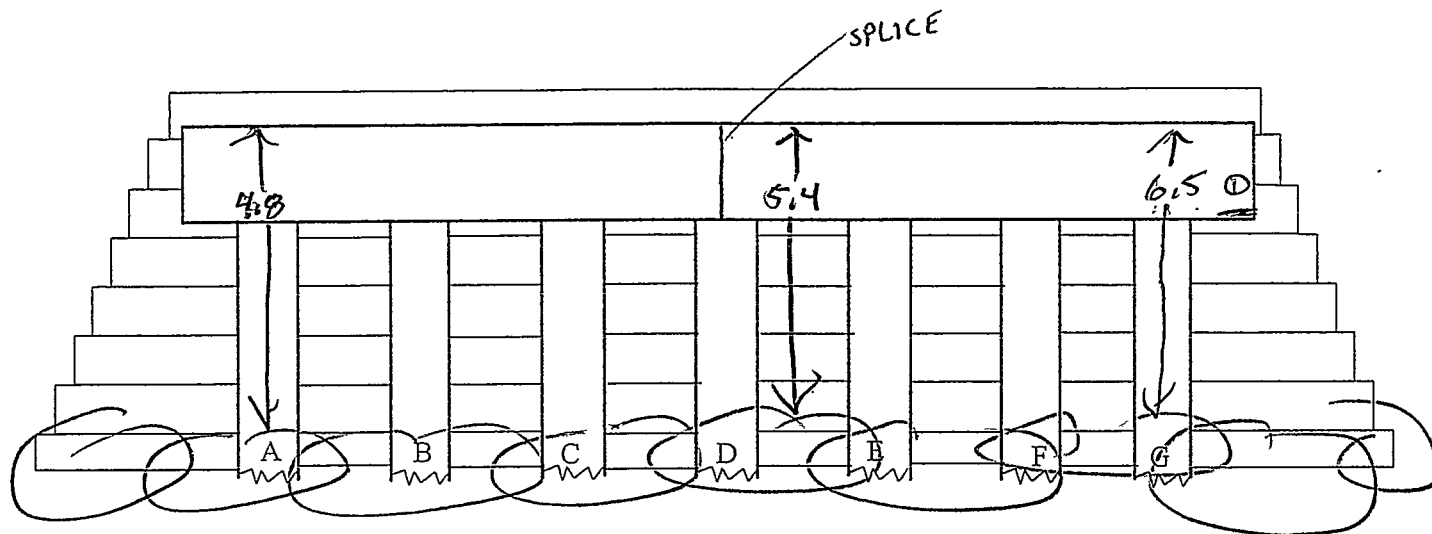
AUG 11 2021
ABUT. NO. 2

ELEMENT	RATING	COMMENT
CAP	G <u>F</u> P C	light to med weathering seen \rightarrow \textcircled{D} splinter 7" \times 2" 10' \times 10' 5"
WINGS	G <u>F</u> P C	
PILES A	G <u>F</u> P C	
B	G <u>F</u> P C	
C	G <u>F</u> P C	
D	G <u>F</u> P C	
E	G <u>F</u> P C	
F	G <u>F</u> P C	
G	G <u>F</u> P C	
RIP - RAP	G <u>F</u> P C	med light to med weathering
EMB.	G <u>F</u> P C	
VEG.	G <u>F</u> P C	
BREASTWALL	G <u>F</u> P C G F P C G F P C
