BRIDGE MAINTENANCE RECOMMENDATIONS

LOCATION: 38-SR180-02.61-

CROSSING: OFFER CREEK

BRIDGE INSPECTION REPORT

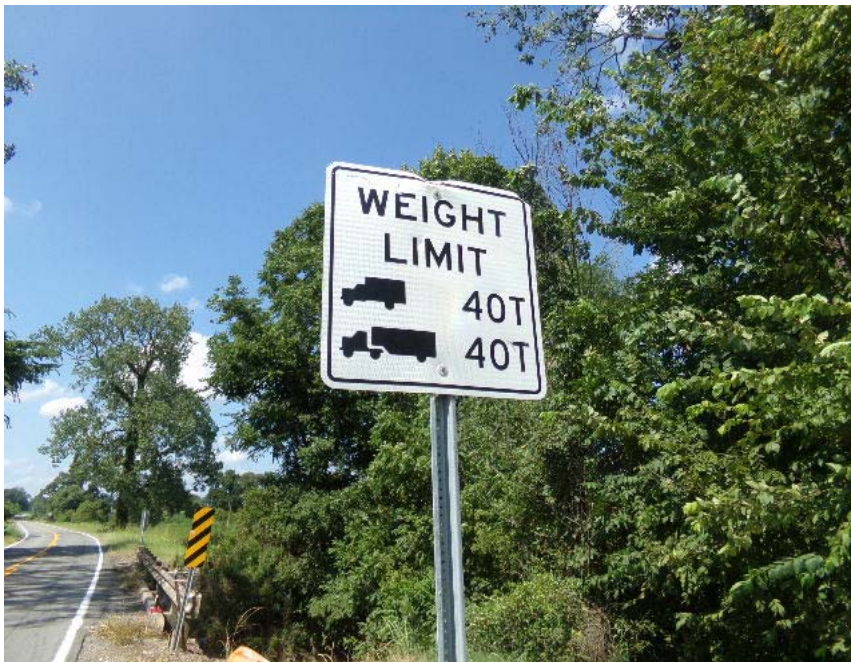
APPROACH # 1 WEIGHT LIMIT

REPLACE MISSING WEIGHT POSTING SIGN APPROACH NO 2

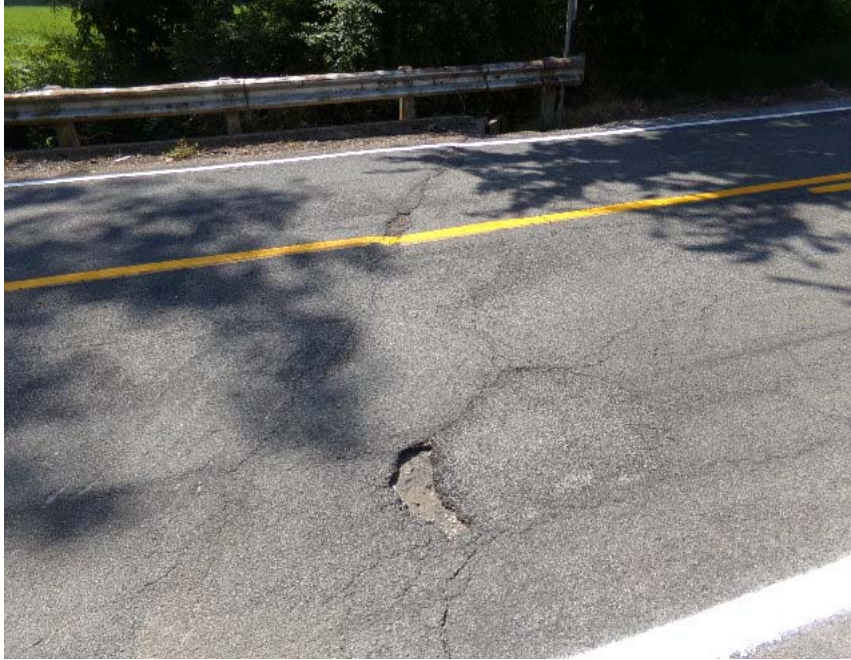
APPROACH # 2

Approach # 2 asphalt has up to 1" settlement & a large pothole.

LEVEL THE WEARING SURFACE AT APPROACH NO.2

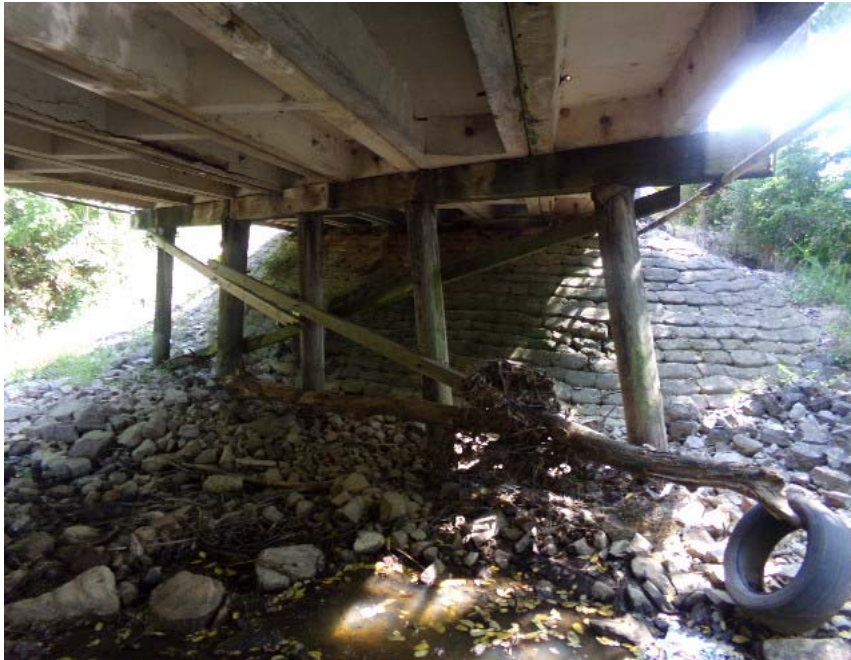
BENT # 1 DRIFT

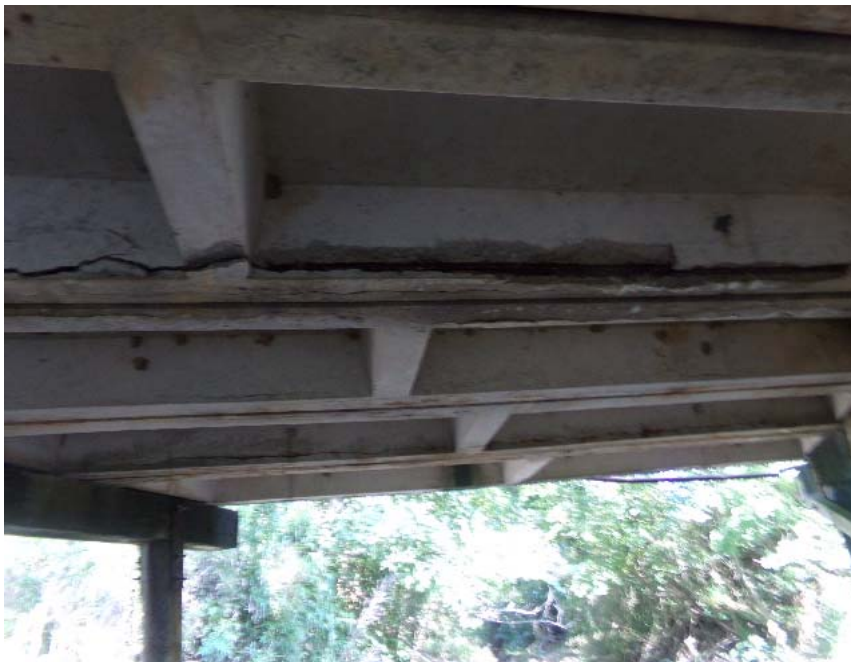
SPAN # 2 SLAB "D"

Span # 1 slabs "a & b" & span # 2 slab "d" have heavy spall to steel areas.

REPAIR OR REPLACE PRECAST CONCRETE CHANNEL SLAB "D" IN SPAN NO.2

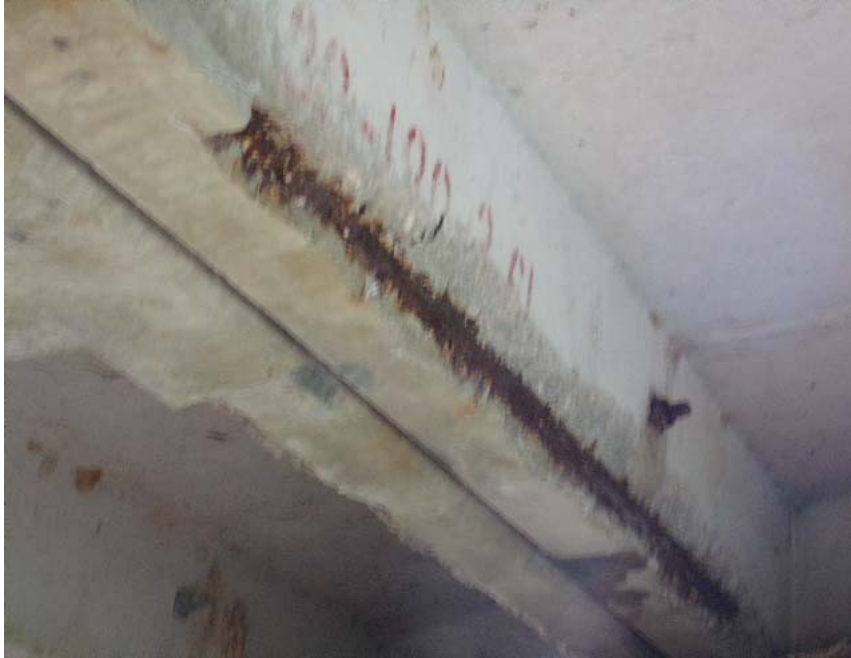
SPAN # 1 SLAB "A"

REPAIR OR REPLACE PRECAST CONCRETE CHANNEL SLAB "A, B" IN SPAN NO.1

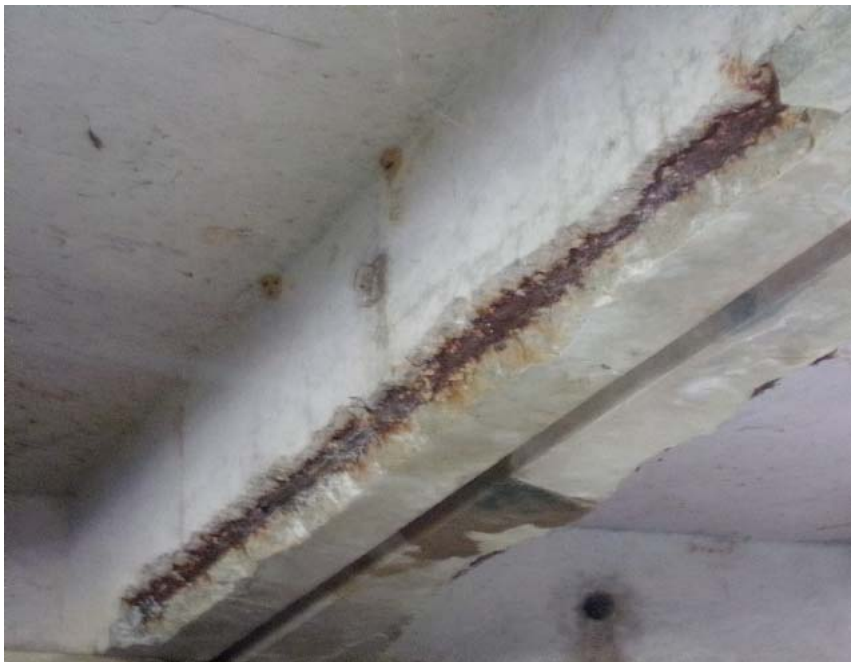
SPAN # 1 SLAB "B"

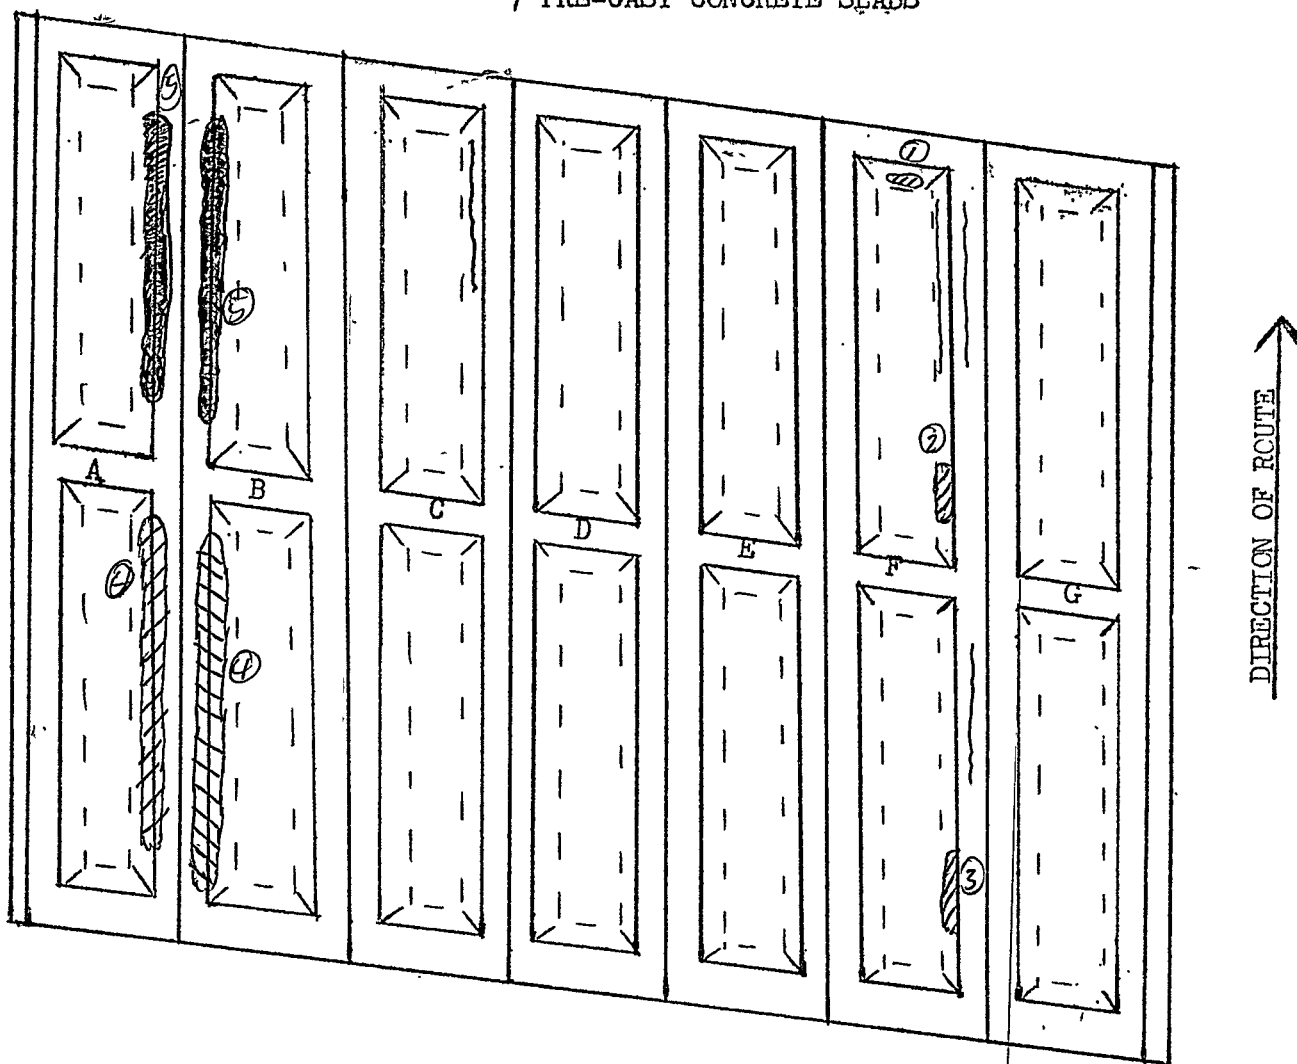
SPAN NO. 1
AUG 11 2021

ELEMENT	RATING				COMMENT
SLAB	A	G	F	(P) C	see 4,5
	B	G	F	(P) C	see 4,5
	C	G	(F)	P C	fine crack
	D	(G)	F	P C	
	E	(G)	F	P C	
	F	G	(F)	P C	fine cracks, see 1,2,3
	G	(G)	F	P C	
BOLTS	(G)	F	P	C

- ① 1' W x 5" H x 1 1/2" D
Spall to steel
- ② 1 1/2' L x 4" H x 1 1/2" D
Spall to steel
- ③ 2 1/2' L x 5" H x 2" D
Spall to steel
- ④ 6' L x 3" H x 4" W x 2" D
Spall to steel
- ⑤ 6' L x 3" H x 3" W x ? D
Impending spall

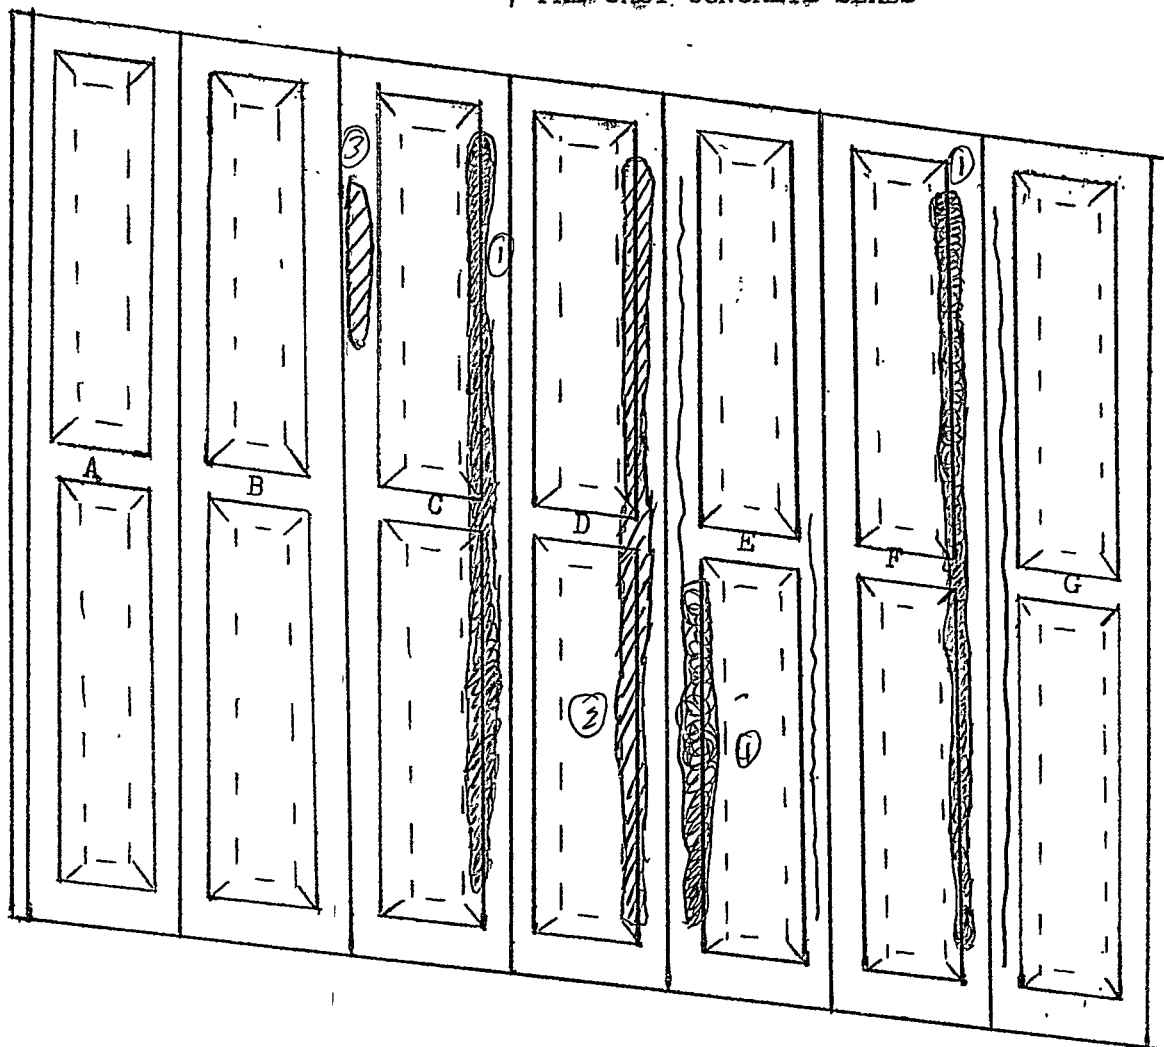
SPAN NO. 2

ELEMENT		RATING				COMMENT
SLAB	A	(G)	F	P	C	
	B	(G)	F	P	C	
	C	G	(F)	P	C	see 1,3
	D	G	F	(P)	C	see 2
	E	G	(F)	P	C	1/16" crack, see 4
	F	G	(F)	P	C	see 1
	G	G	(F)	P	C	1/16" crack
BOLTS		(G)	F	P	C

- ① 19'2x3"Hx4'Wx?D
Impending Spall
- ② 19'2x5"Hx4'Wx2"D
Spall to steel
- ③ 6'2x4'Wx2"Hx2"D
Spall to steel
- ④ 12'2x4'Wx3"Hx?D
Impending Spall

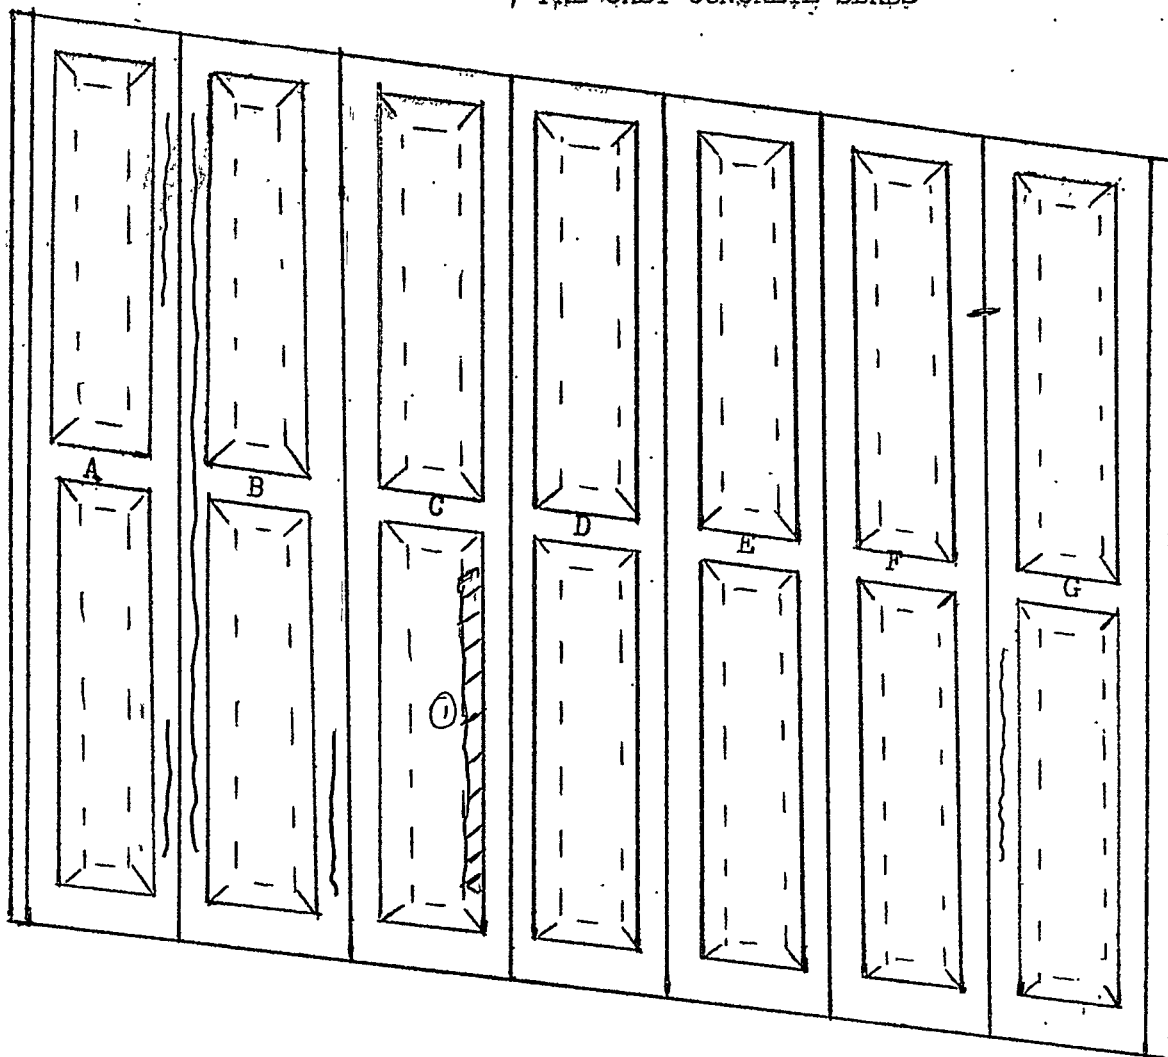
SPAN NO. 3

ELEMENT		RATING			COMMENT
SLAB	A	G	(F)	P C	1/16" cracks
	B	G	(F)	P C	1/16" cracks
	C	G	(F)	P C	see 1
	D	(G)	F	P C	
	E	(G)	F	P C	
	F	(G)	F	P C	
	G	G	(F)	P C	fine crack
BOLTS	G	(F)	P C		MISSING

1 8'0" x 3'0" x 3'0" x 2'
Spall to steel

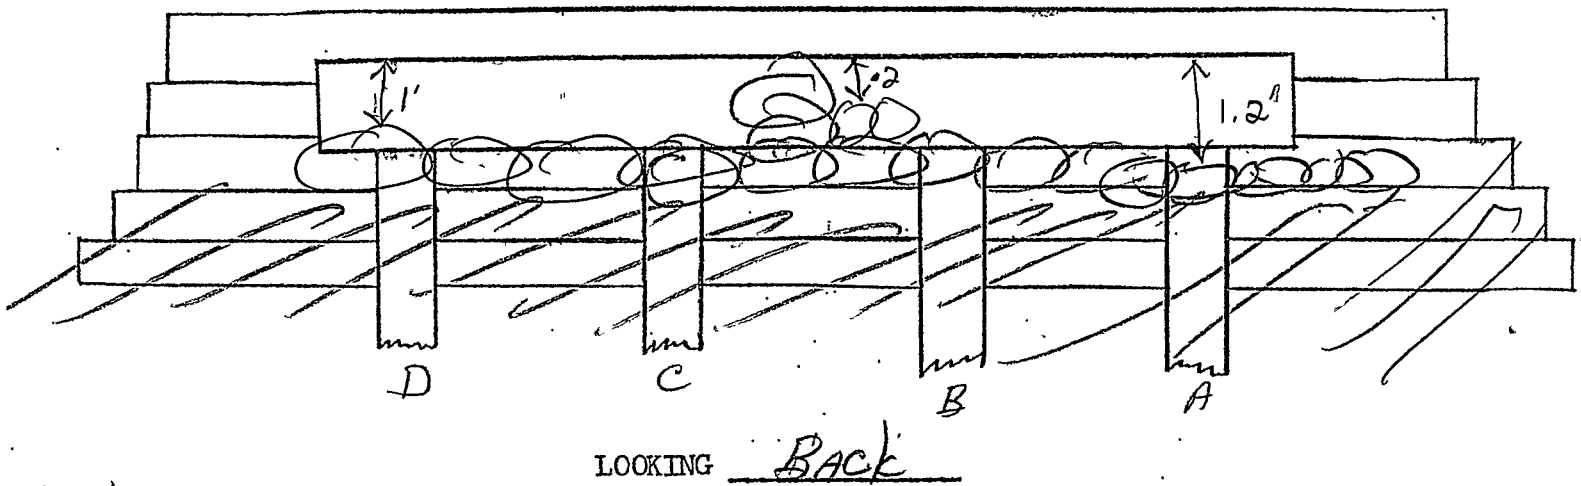
ABUT. NO. 1 AUG 11 2021

ELEMENT	RATING	COMMENT
CAP	G <u>F</u> P C	light to med weathering
BREASTWALL	G F P C	NV
WINGS	G F P C	NV
PILING	A G F P C B G F P C C G F P C D G F P C	NV
RIP RAP	G <u>F</u> P C	
EMB.	G <u>F</u> P C	
VEG.	G <u>F</u> P C

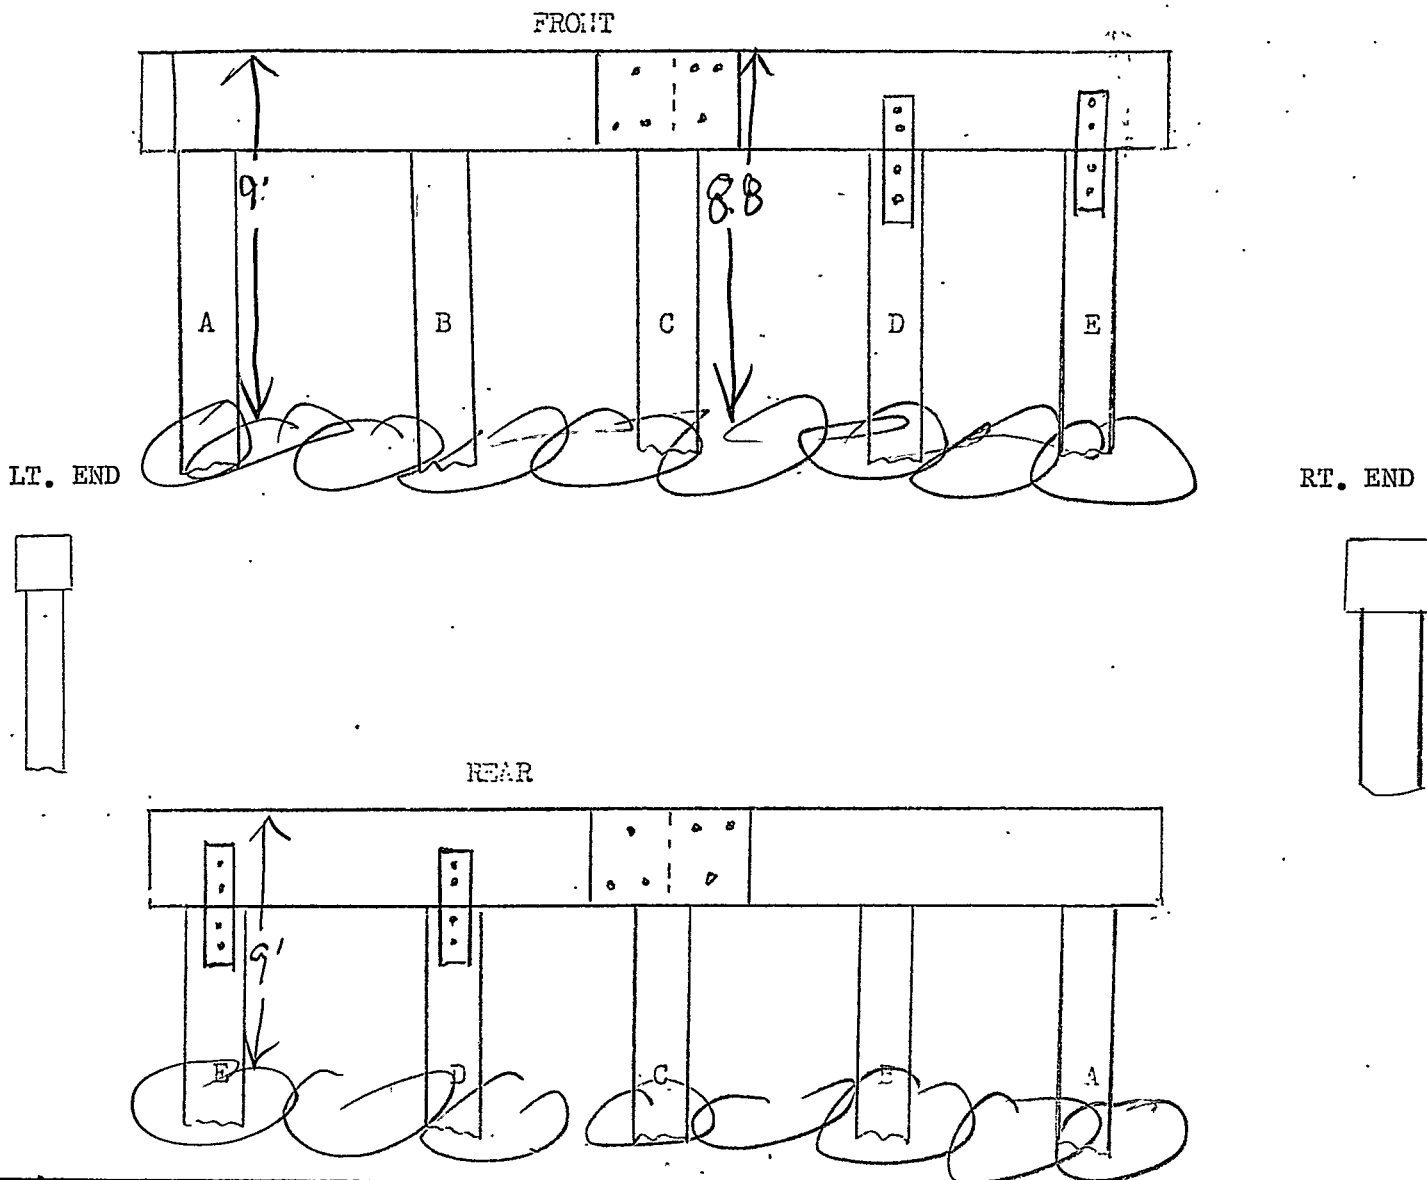
BENT NO. 1

ELEMENT		RATING	COMMENT
BEARINGS		G F P C	
CAP		G (F) P C	light to med weathering
PILE	A	G (F) P C	
	B	G F P C	
	C	G F P C	
	D	G F P C	
	E	G F P C	
BRACING		G (F) P C	BROKEN light to med weathering

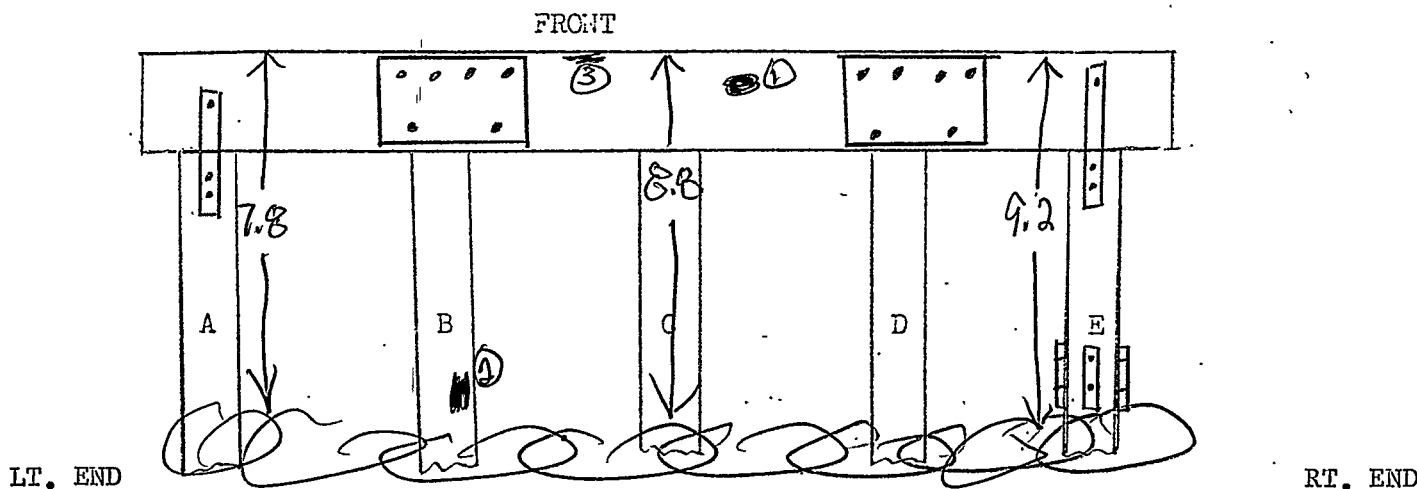
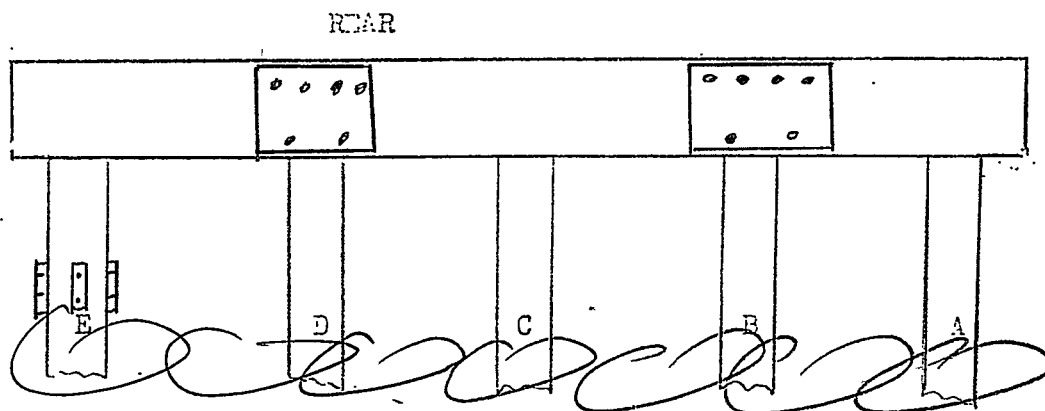
AUG. 11 2021
BENT NO. 2

- ① Decay Area $5\frac{1}{4} \times 1\frac{1}{2} \times 2\frac{1}{2}$
② " " $1\frac{1}{4} \times 3\frac{3}{4} \times 2\frac{1}{2}$
③ Sp. Water $4\frac{1}{4} \times 1\frac{1}{2} \times 1\frac{1}{2}$

ELEMENT		RATING	COMMENT
BEARINGS		G F P C	
CAP		G <u>F</u> P C	light to med weathering see 1+3
PILE	A	G <u>F</u> P C	 see 2
	B	G F P C	
	C	G F P C	
	D	G F P C	
	E	G <u>F</u> P C	
BRACING		G F P C

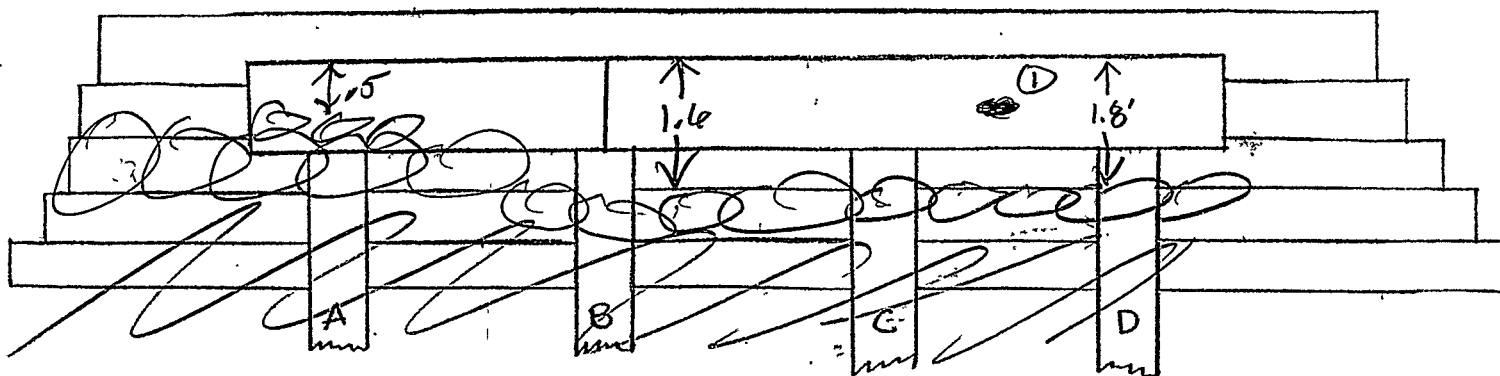
BR. NO. 38 180 261 ABUT. NO. 2

LOOKING Ahead ① Decay 2/3 X 1/4 X 1/10

ELEMENT	RATING	COMMENT
CAP	G (F) P C	light to med weathering see ①
BREASTWALL	G F P C	NV
WINGS	G (F) P C	light to med weathering
PILING	A G F P C B G (F) P C C G (F) P C D G F P C	NV light to med weathering
RIP RAP	G (F) P C	Scattered
EMB.	(G) F P C	
VEG.	(G) F P C
