HAYWOOD COUNTY

38-SR180-0274

BRIDGE MAINTENANCE RECOMMENDATIONS

BRIDGE INSPECTION REPORT

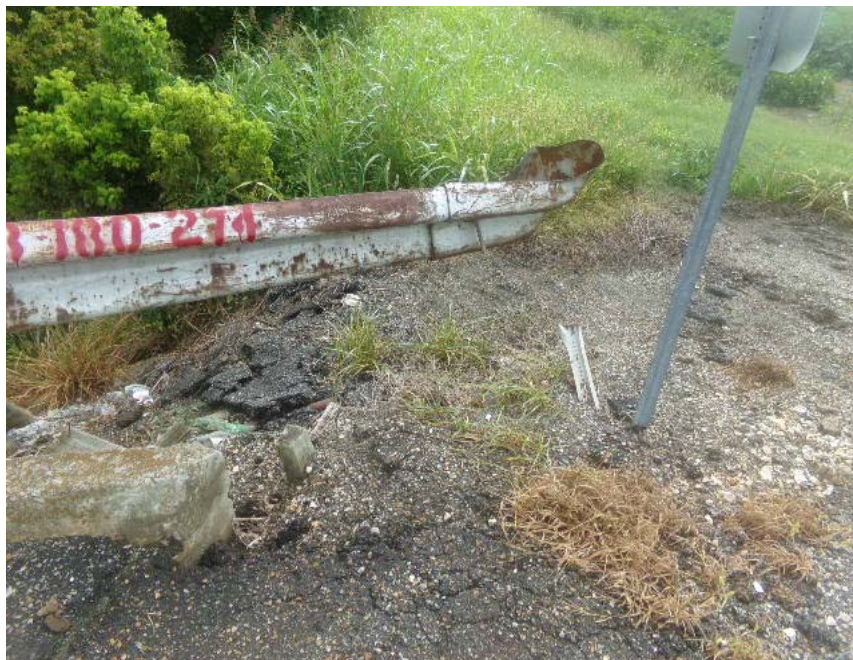
APPROACH # 1 RIGHT RAIL COLLISION DAMAGE

REPAIR _METAL_ RAILING IN SPAN NO. _1 RT

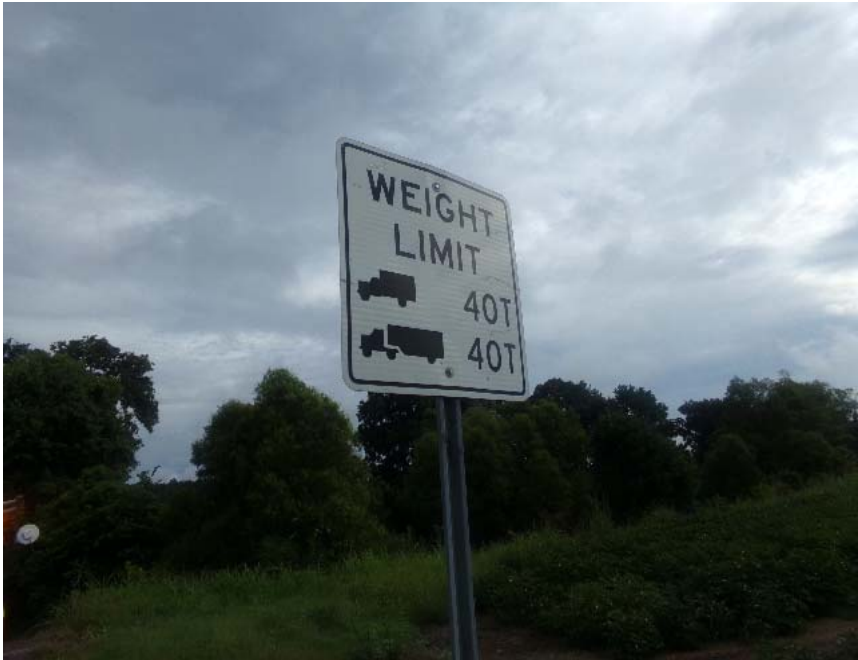
APPROACH # 1 WEIGHT LIMIT SIGN 40 TON

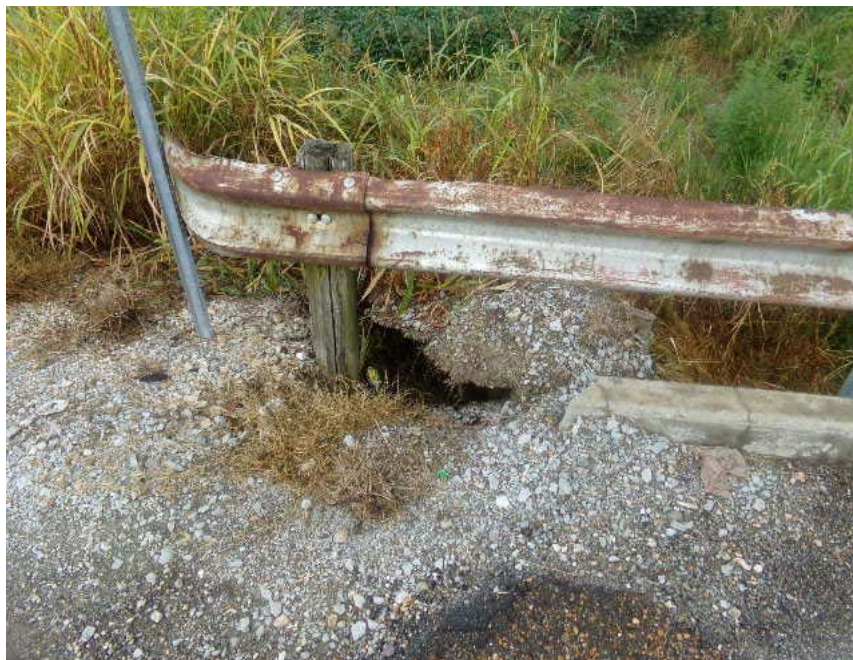
APPROACH # 1 LEFT EMBANKMENT

Rating	Comments
Alignment	G F P C	
Slab	G F P C	
Joints	G F P C	
Pavement	G F P C	
Embankment	G F P C	<u>A₂₉ #1 Lt (004)</u>
Drains	G F P C

REPAIR EMBANKMENT AT APPROACH NO. _1 RT

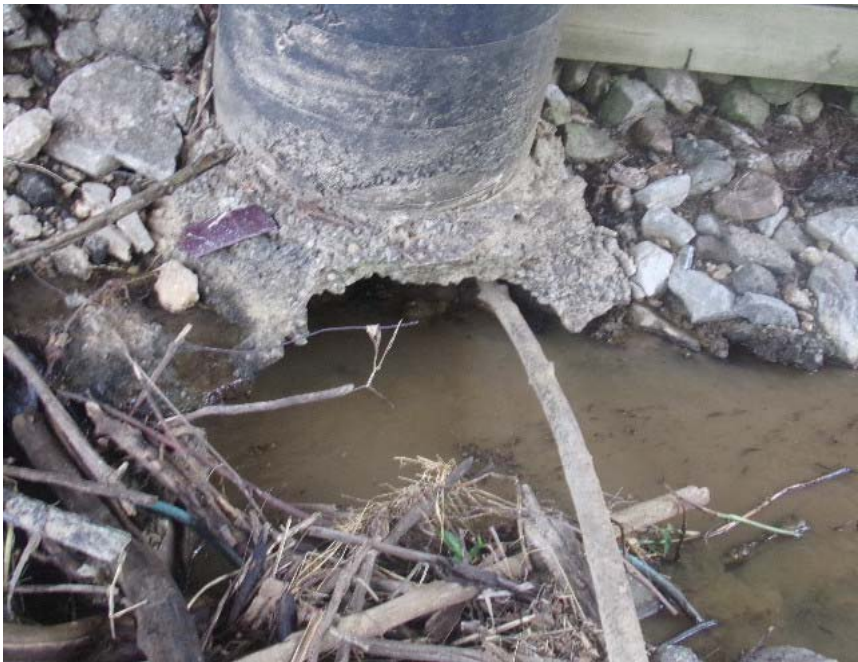
WASH BENT # 2 PILE "D" UNDER CASING

This is a four span PCCS bridge with timber substructure, metal bridge rails, and four paddleboards. This bridge is posted at Approach #1 only at 40/40 Tons. Approach #2 weight limit sign is missing. The asphalt approaches have settlement up to 1/2" and cracks up to 1/8". Approach #1 left embankment is washing behind wingwall. The asphalt wearing surface has cracks up to 1/16". Span #1 right bridge rail has heavy collision damage. Span #1 PCCS 'F' and 'G' have heavy spall to steel. Slab 'F' on span #3 has heavy cracking. The timber substructure has light to medium weathering and decay. Bent #1 pile 'A' has heavy decay. Bent #3 pile 'D' splice connection is broken. Bent #2 pile 'D' embankment is washing below concrete casing. Scour is fair

PROTECT FROM SCOUR AT BENT NO. _2

Repaired pile D Bent No 3 with new splice at top 9-14-21
of pile and place rock around scour at pile in Bent No 2.

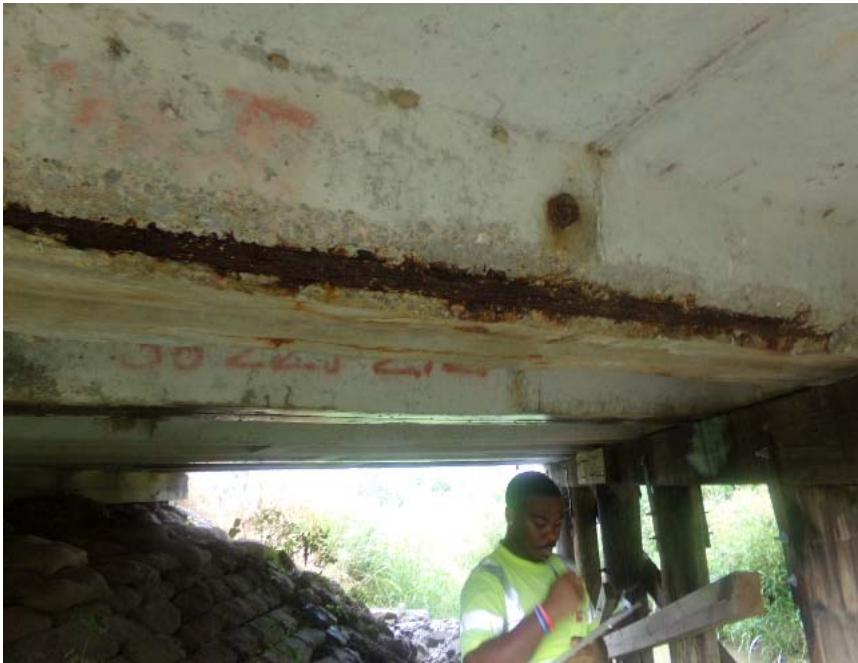
SPAN # 1 SLAB "G"

ELEMENT	RATING				COMMENT
SLAB	A	(G)	F	P C	
	B	G	(F)	P C	See ④
	C	G	(F)	P C	See ③
	D	(G)	F	P C	
	E	G	(F)	P C	1/16" cracks
	F	G	F	(P) C	See 1, 2
	G	G	F	(P) C	See 1
BOLTS		(G)	F	P C

- ① 9'Lx6"Hx2"D
Spall to Steel
- ② 6'Lx5"Hx?D
- Impending Spall
- ③ 3'Lx8"Wx2"D
Spall to Steel
- ④ 2' in dia x 1"D
Spalling

REPLACE PRECAST CONCRETE CHANNEL SLAB _F, G_ IN SPAN NO. _1

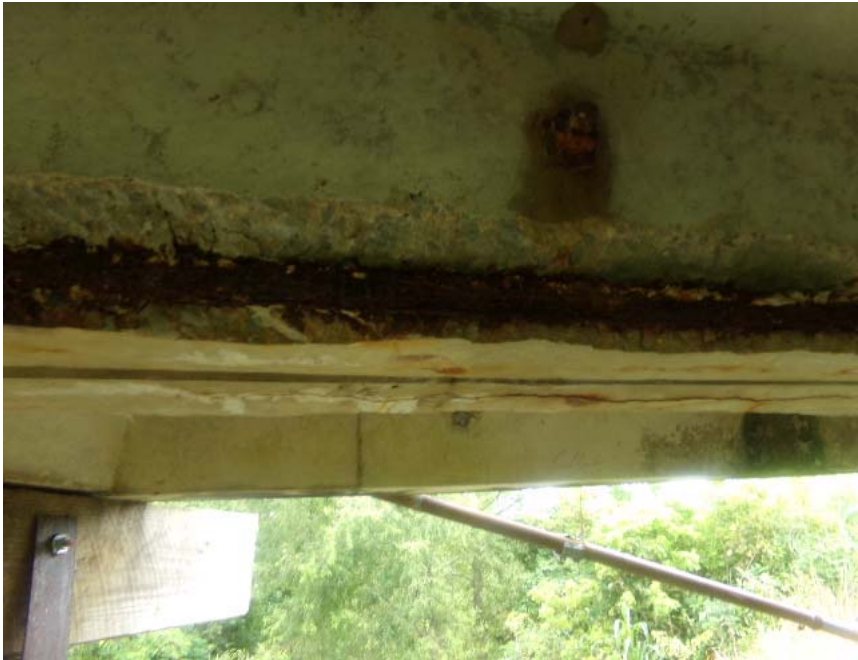
SPAN # 1 SLAB "F"

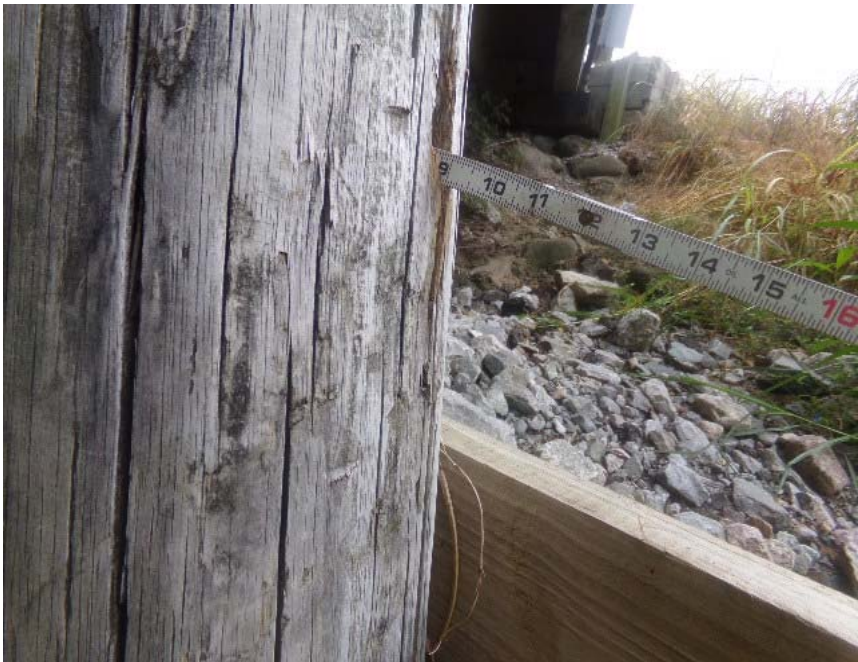
BENT # 1 PILE "A"

ELEMENT	RATING	COMMENTS
CAP	G F P C	① Heavy Decay 3" x 1" x 9" / 12" pile
Piling	12' A G F P C	SEC ①
	12' B G F P C	light to med weathering
	12' C G F P C	
	12' D G F P C	
	14' E G F P C	
	12' F G F P C	
BRACING	G F P C	
Conc. Casing	G F P C

REPAIR OR REPLACE _TIMBER_ PILE _A_ AT BENT NO. _1

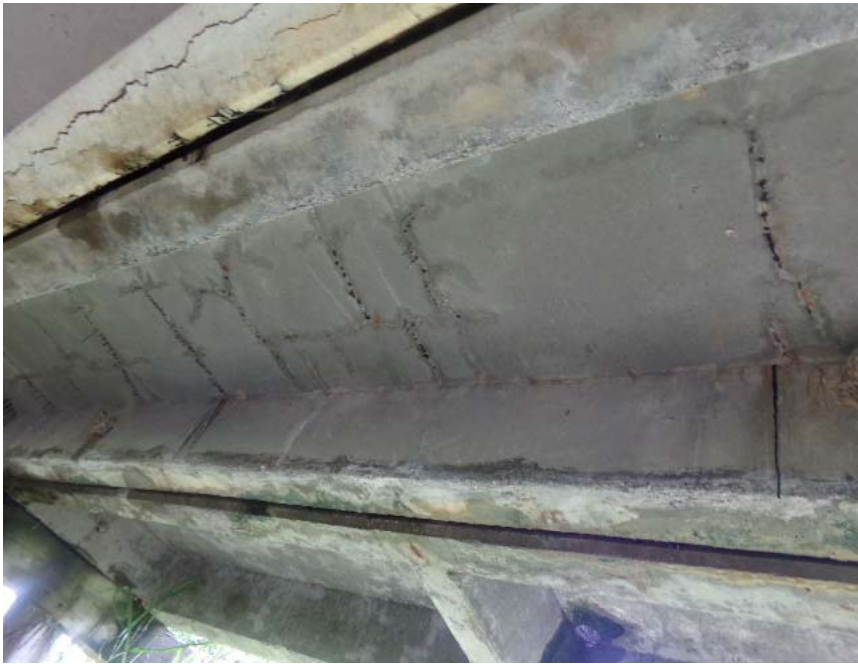
SPAN # 3 SLAB "F"

ELEMENT	RATING	COMMENT
SLAB	A <u>G</u> F P C	
	B <u>G</u> F P C	
	C <u>G</u> <u>F</u> P C	① Spill tested 2.5' L 6" W 1" deep 1/16" crack
	D <u>G</u> <u>F</u> P C	Imp spill 3' L 6" W ②
	E <u>G</u> <u>F</u> P C	Imp spill 18' L 6" W
	F <u>G</u> <u>F</u> <u>P</u> C	Fine cracks with eff in valley
	G <u>G</u> F P C	
BOLTS	G <u>F</u> P C	2 missing

REPLACE PRECAST CONCRETE CHANNEL SLAB _F_ IN SPAN NO. _3

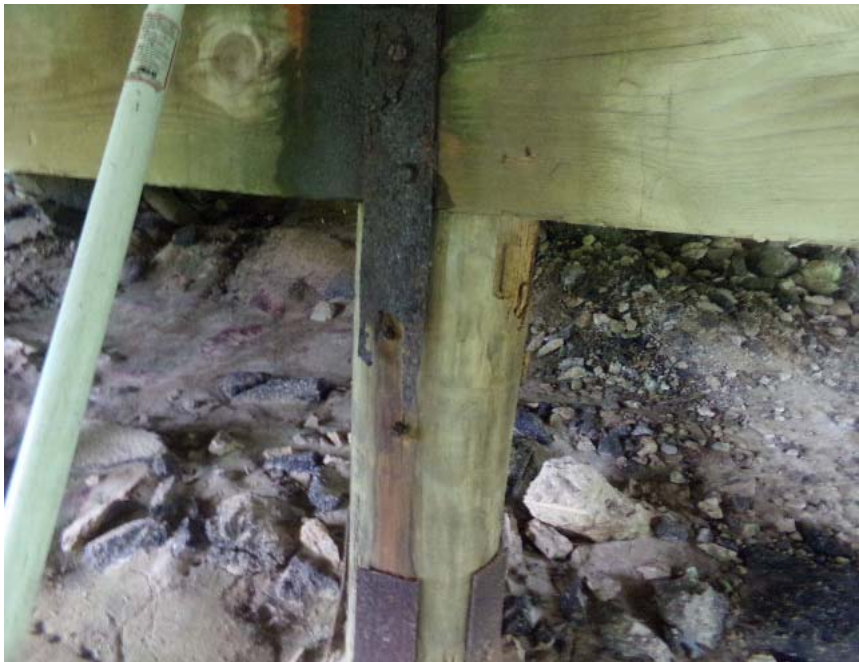
BENT # 3 PILE "D" GRADER BLADE

PROPERLY SPLICE PILE _D_ AT BENT NO. _3

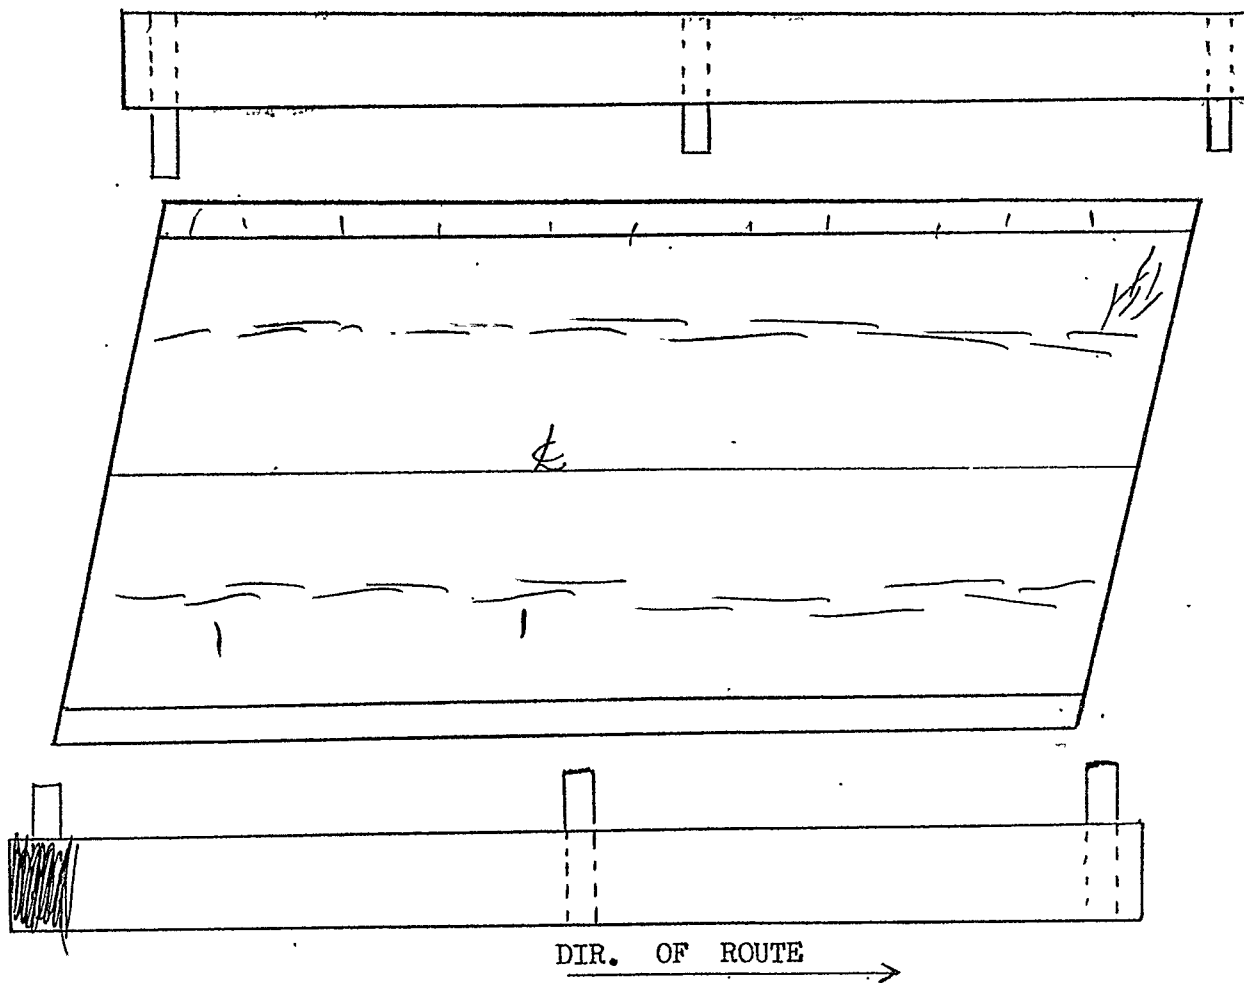
SKEW 60 SPAN NO. 1

ELEMENT	RATING	COMMENTS
TOP DECK	G (F) P C	up to 1/16" cracks
CURB	G (F) P C	Hair like cracks
RAIL&POST	G (F) (P) C	Heavy collision damage, surface rust
PAINT	G F P C	
DRAINS	(G) F P C	
EXP. JOINT	G F P C

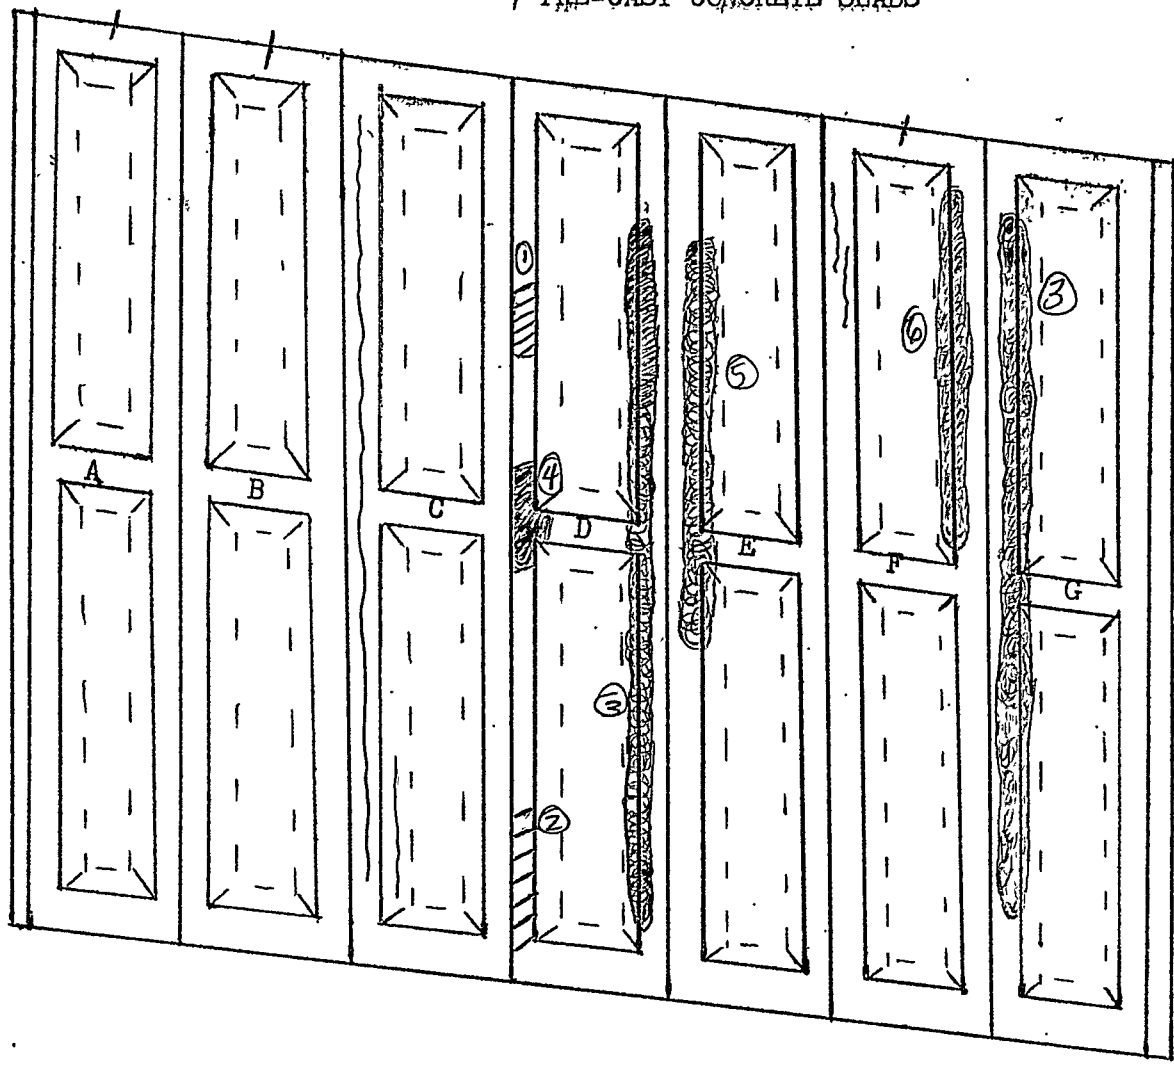
ELEMENT	RATING				COMMENT
SLAB	A	(G)	F	P C	
	B	(G)	F	P C	
	C	G	(F)	P C	1/16" crack
	D	G	(F)	P C	see 1, 2, 3, 4
	E	G	(F)	P C	see 5
	F	G	(F)	P C	see 6, fine crack
	G	G	(F)	P C	see 3
BOLTS	G	(F)	P C		MISSING 3

- ① 2' L x 8" W x 2" D
Spall to Steel
- ② 3 1/2' L x 4" H x 2" D
Spall to Steel
- ③ 19' L x 6" W x 4" H x ? D
Impending Spall
- ④ 4' L x 7" W x 4" H x ? D
Impending Spall
- ⑤ 8' L x 6" W x 3" H x ? D
Impending Spall
- ⑥ 9' L x 4" W x 4" H x ? D
Impending Spall

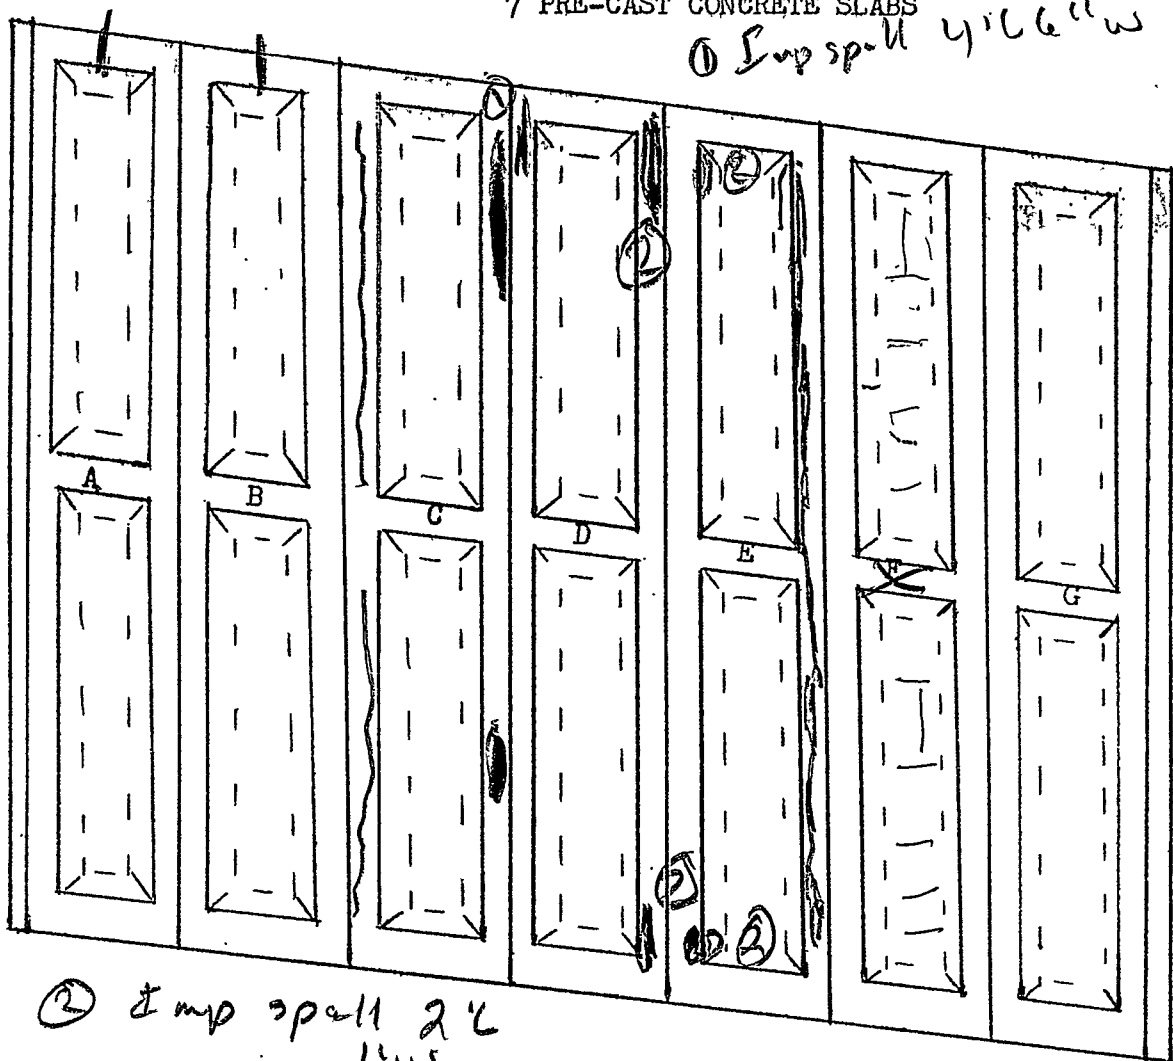
AUGSPAN NO. 2021 3

① Imp spill 4' L 6" W

② Imp spill 2' L 1' W

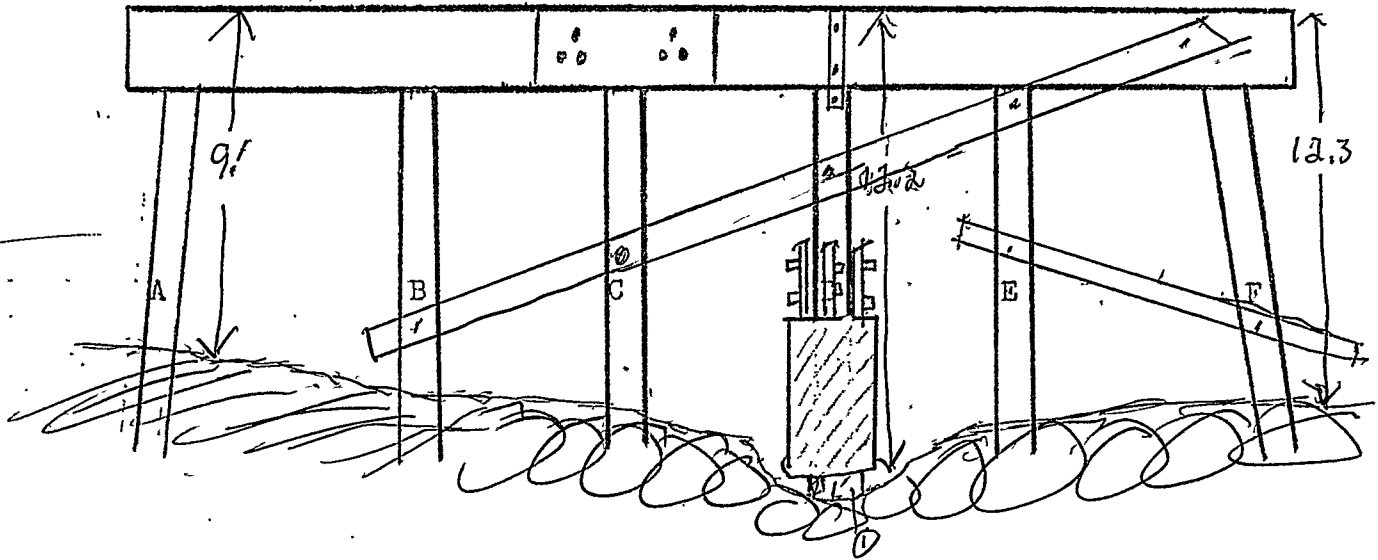
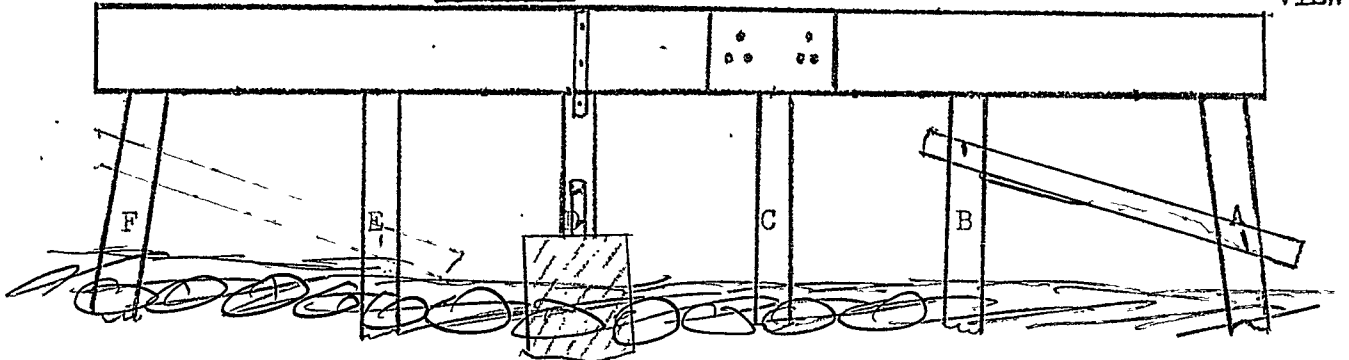
AUG 18 2021
BENT NO. 2

ELEMENT	RATING	COMMENTS
CAP	G <u>F</u> P C	light to med WEATHERING. ① Embankment washing 1" below casing x 1 5/8" x 7 5/8"
Piling	A G <u>F</u> P C	
	B G <u>F</u> P C	
	C G <u>F</u> P C	
	D G <u>F</u> P C	
	E G <u>F</u> P C	
	F G <u>F</u> P C	
BRACING	G <u>F</u> P C	
Conc. Casing	G <u>F</u> P C	
Embankment	②	SEE ①

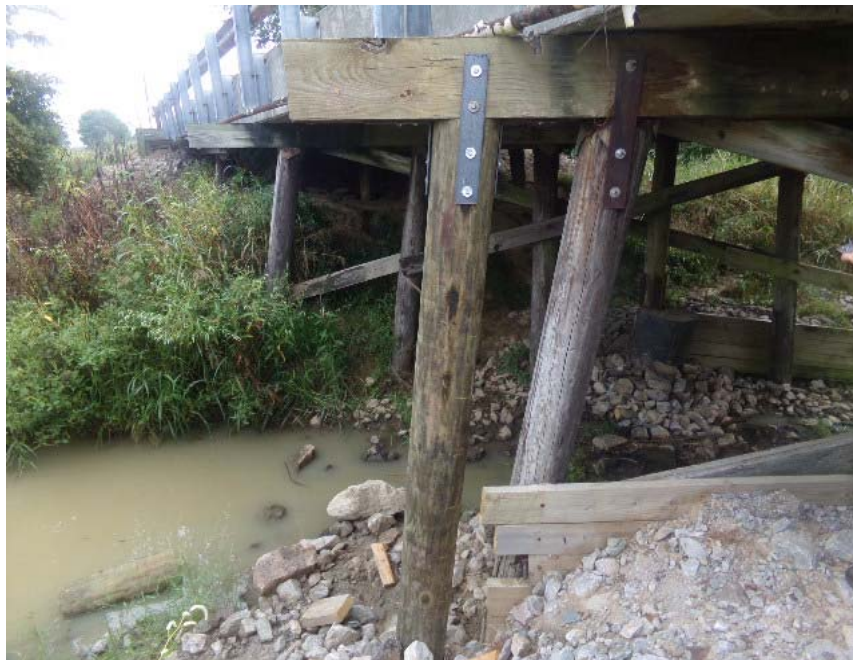
BENT # 1 PILE "A"

1. Bridge is open to traffic.
2. New pile "A" at bent #1 has been added.
3. No change to slabs.
4. Rip-rap has been added around casing of bent #2, pile "D".
5. No change in bolts.
6. No change in embankment erosion.
7. No change in approaches.
8. No change in rail.

According to bridge repair, pile "A" was driven 18' in ground.

COMMENTS: ON MONDAY AUGUST 30, 2021, A NEW PILING WAS DRIVEN OUTSIDE EXIST. PILE A @ BENT 1,
ON WEDNESDAY SEPTEMBER 1, 2021 THE NEW PILING WAS PULLED UNDER THE CAP.

18 ft in ground 10 ft From ground to cap From center to center
pile old & new 26" at top of pile and at the ground center of
Both pile 21' center of each piling

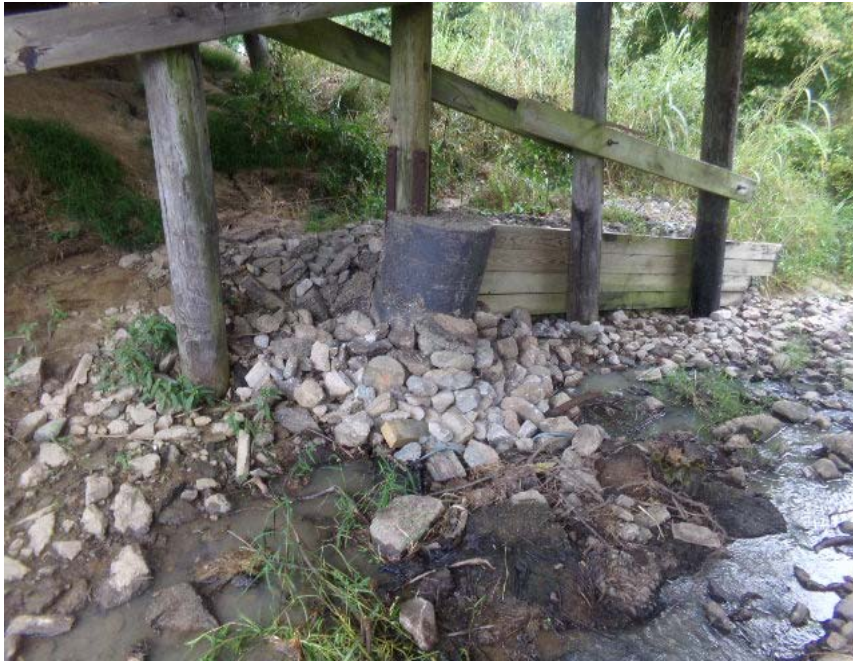
BENT # 2 PILE "C" RIP RAP

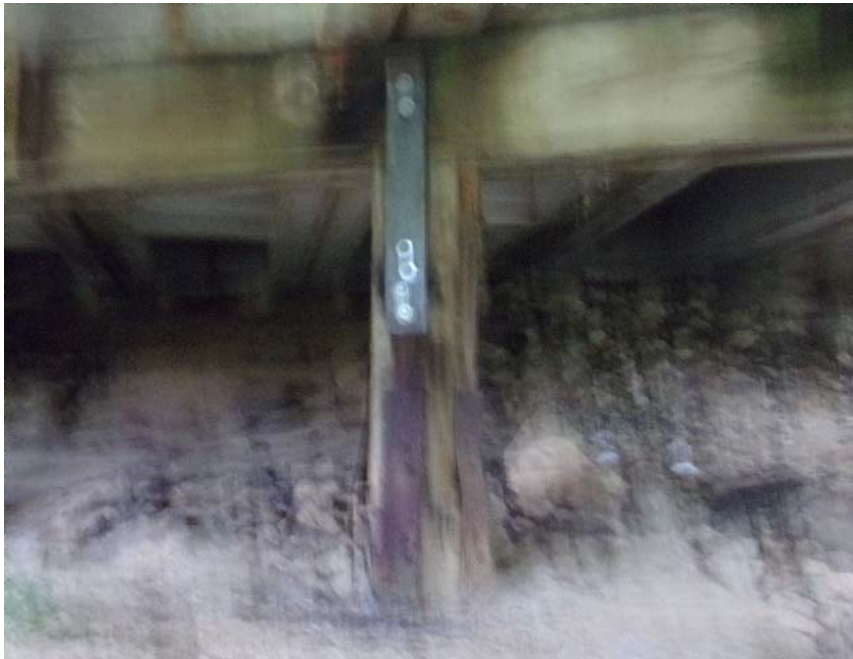
BENT # 3 PILE "D"

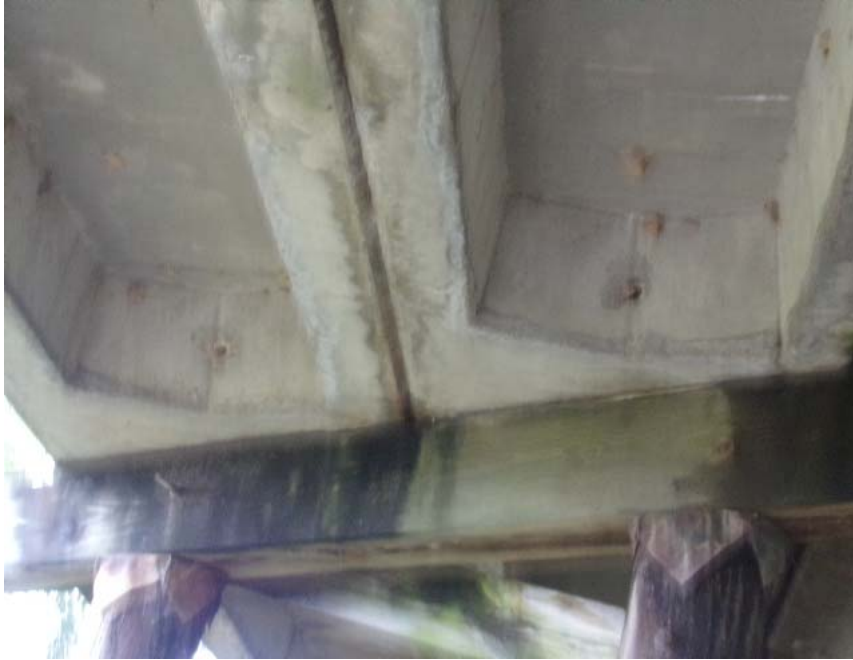
SPAN # 2 MISSING BOLTS
