BRIDGE MAINTENANCE RECOMMENDATIONS

Tennessee Department
of Transportation

COUNTY: HAYWOOD
LOCATION: 38-SR087-02.30-
CO. SEQ.: 1 SPEC. CASE: 0

BRIDGE INSPECTION REPORT

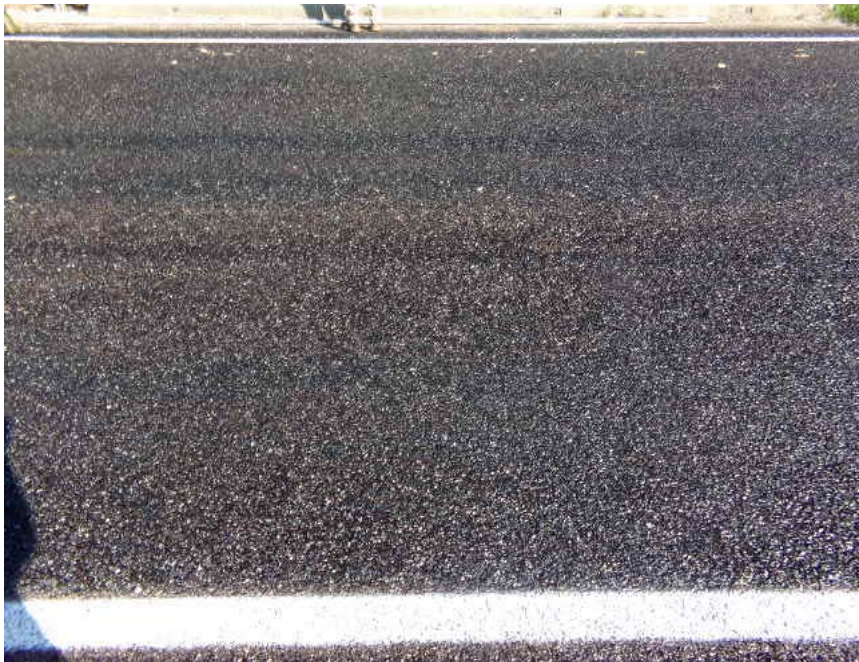
VIEW ACROSS TOP OF DECK

The asphalt roadway has no issues.

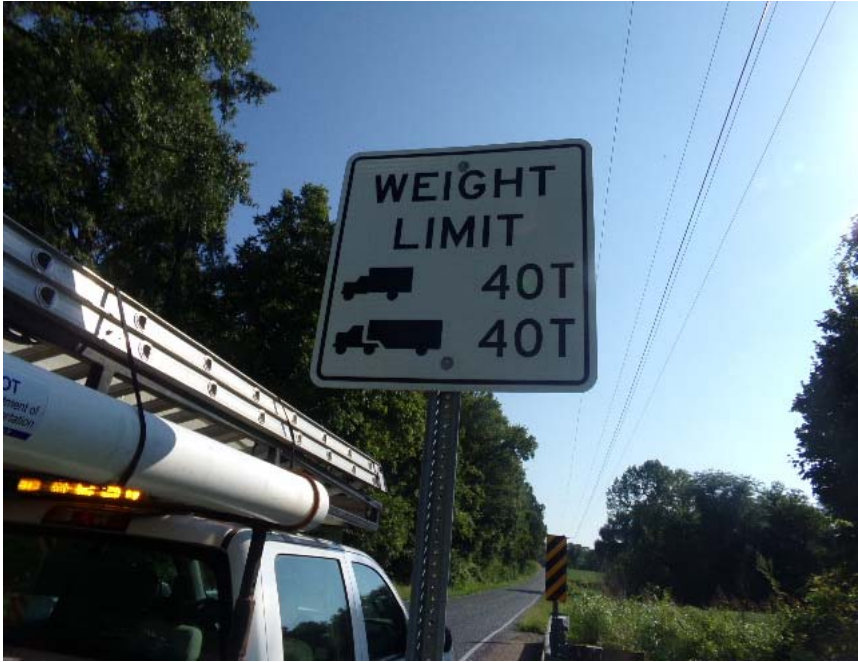
APPROACH # 1 WEIGHT LIMIT

The bridge is posted @ 40/40 ton on each approach.

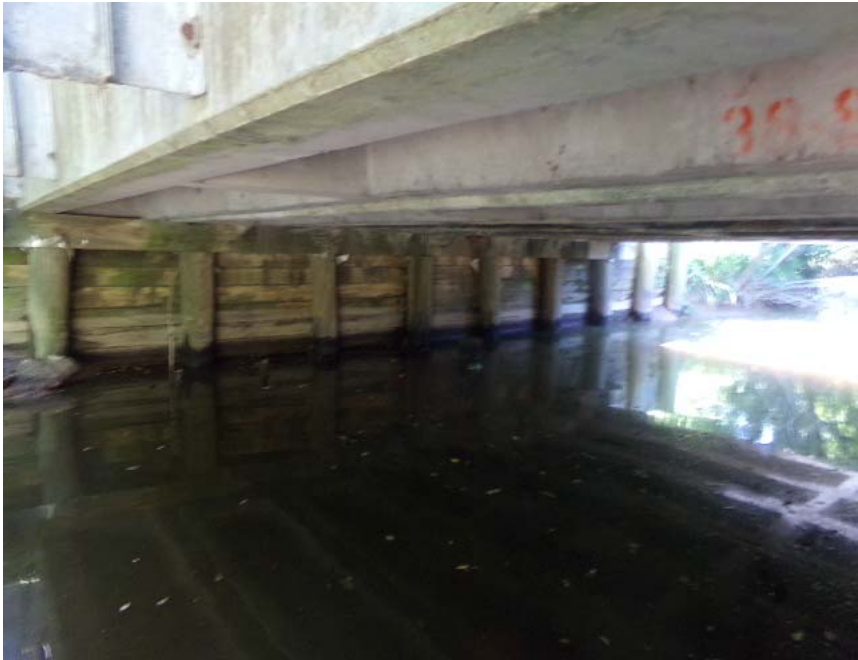
ABUTMENT # 2

The scour is fair due to abutment # 2 being in the channel.

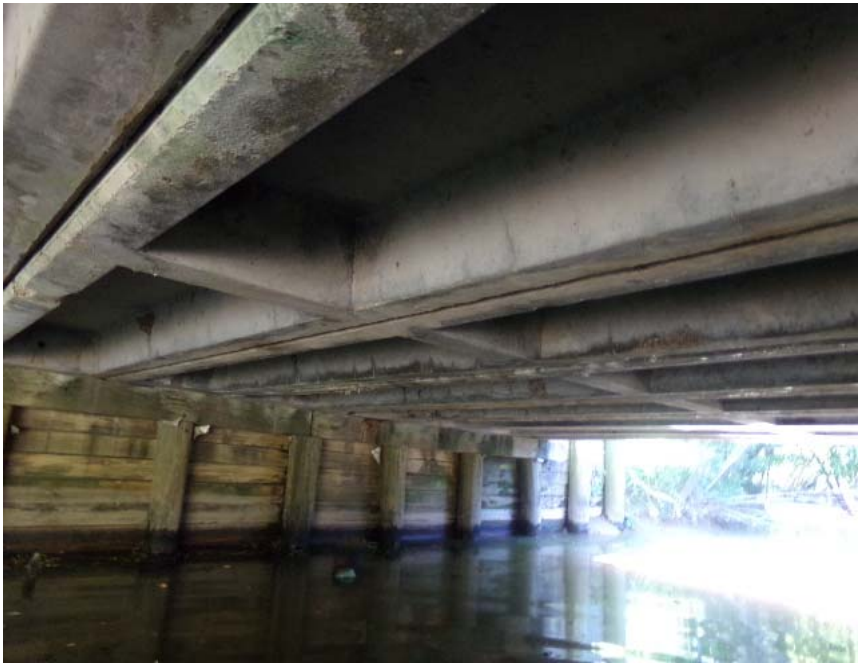
BOTTOM DECK

The p.c.c.s. have up to 1/16" cracks with efflorescence & spalling.

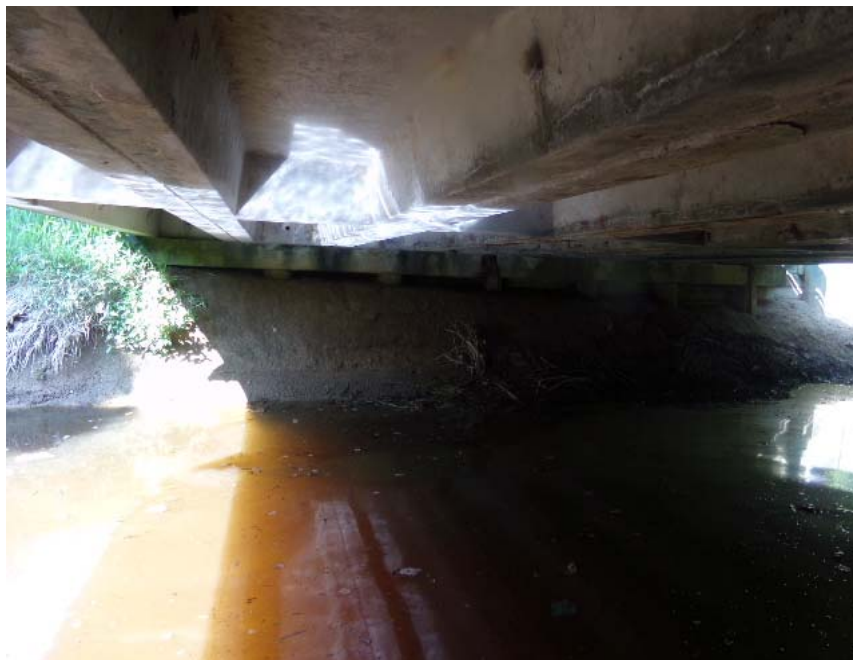
ABUTMENT # 1

The timber substructure has light to medium weathering & decay.

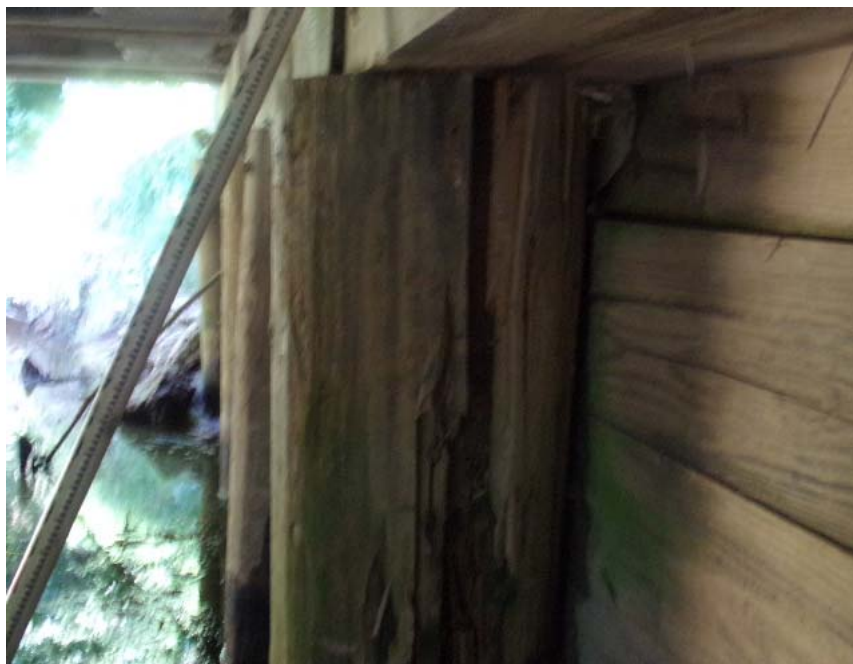
ABUTMENT # 2 PILE "D"

ELEMENT	RATING	COMMENT
CAP	G (E) P C	light to med weathering
WINGS	G (E) P C	
PILES A	G (E) P C	
B	G (E) P C	
C	G (E) P C	
D	G (E) P C	see (1) light to med weathering
E	G (E) P C	
F	G (E) P C	
G	G (E) P C	
RIP RAP	G F P C	
EMB.	G (E) P C	In Channel
VEG.	G F (E) C	Heavy
BREASTWALL	G (E) P C	light to med weathering
	G F P C	
	G F P C

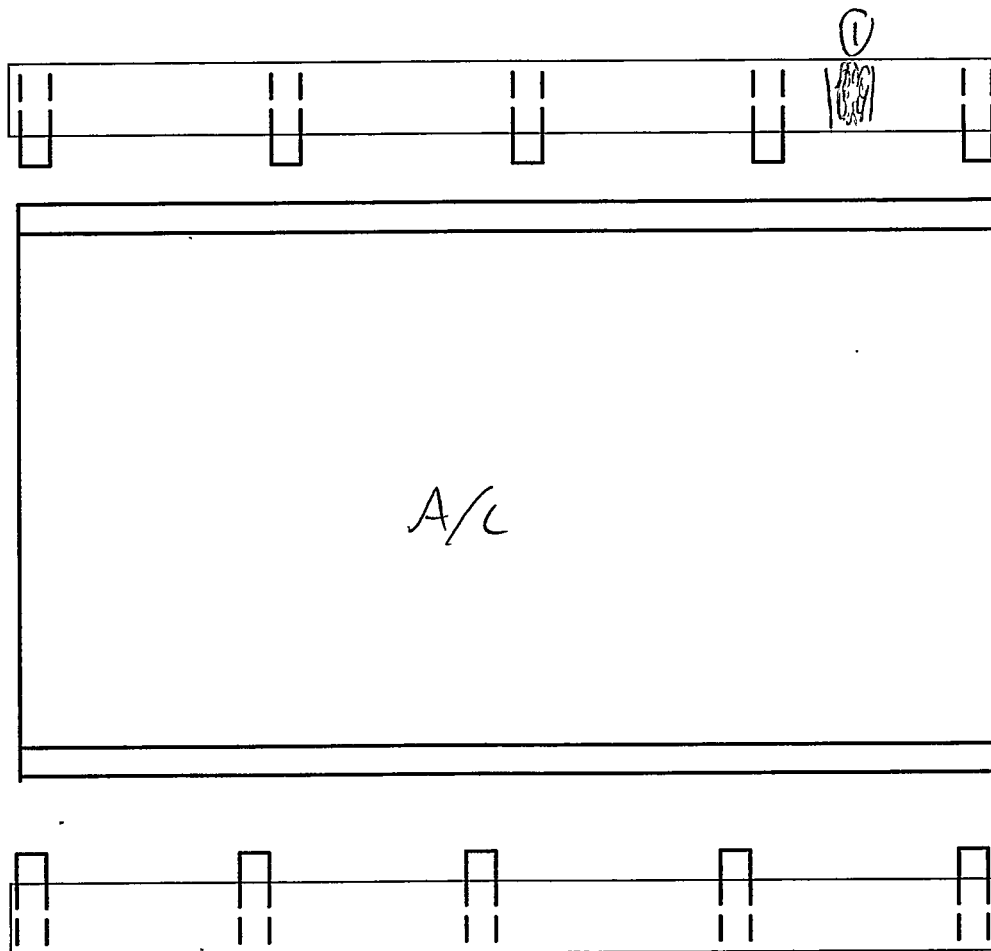
SPAN. NO. 11 ^{AUG 11 2021}

① Damage 4' L

ELEMENT	RATING	COMMENT
TOP DECK	(G) F P C	
CURBS	(G) F P C	
RAIL & POST	G (F) P C	See ①
PAINT	G F P C	
DRAINS	G F (P) C	Filled with debris
JOINT	G F P C	
	G F P C

CLEAR DRAINS

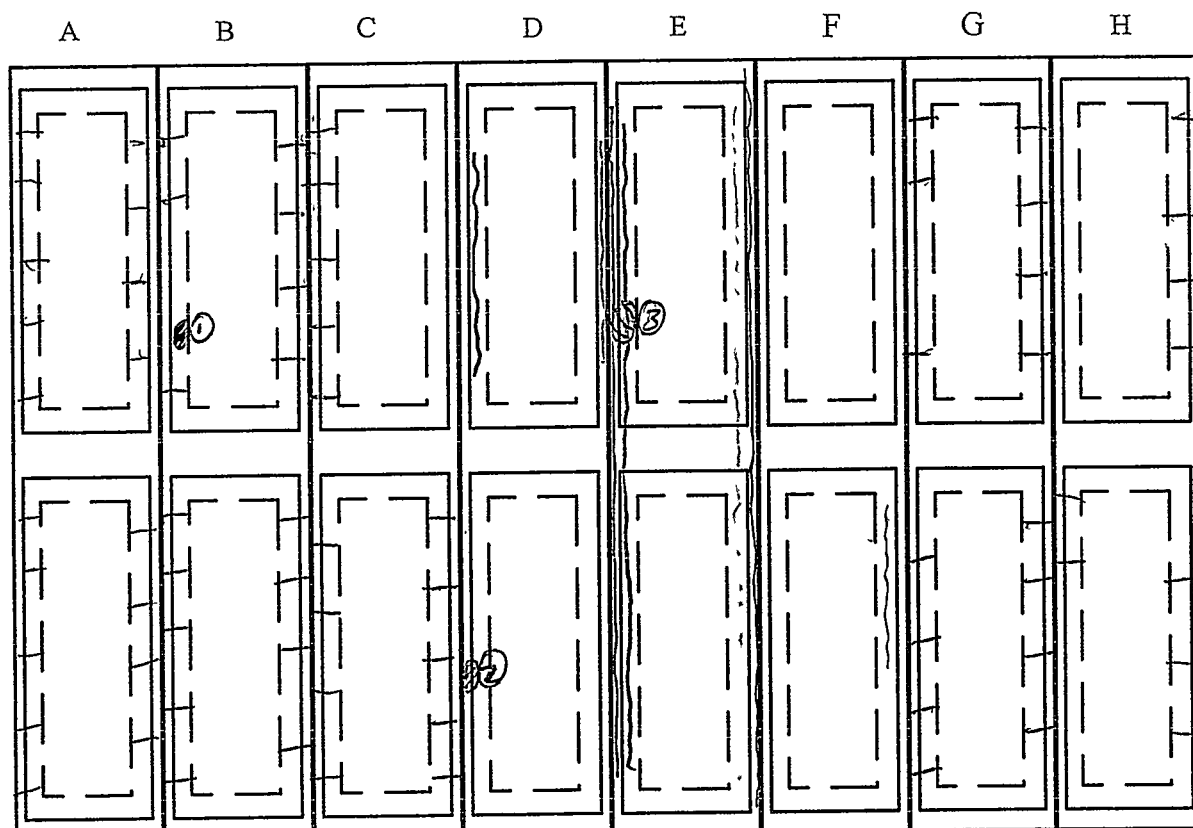
SPAN. NO. 1

① 1' in dia x 3/4" D Spalling
② 5" in dia x 1" D Spall to steel
③ 1' x 6" H x 1" D Spall to steel

ELEMENT	RATING	COMMENT
SLABS A	G (F) P C	hairline cracks w/eff
B	G (F) P C	hairline cracks w/eff, see ①
C	G (F) P C	hairline cracks w/eff
D	G (F) P C	1/16" cracks, see ②
E	G (F) P C	1/16" cracks w/eff see ③
F	G (F) P C	hairline cracks w/eff
G	G (F) P C	hairline cracks w/eff
H	G (F) P C	hairline cracks w/eff
BOLTS	G (F) P C

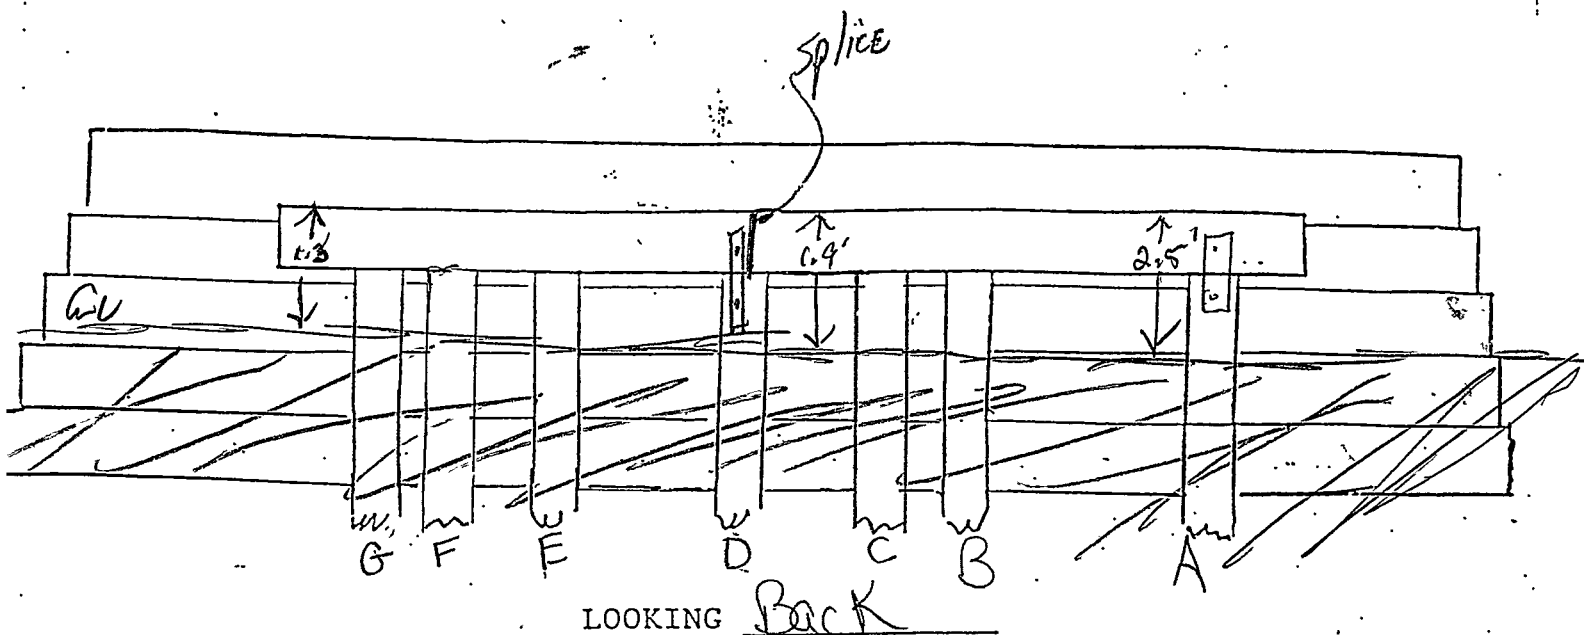
ABUT. NO. 1

ELEMENT	RATING	COMMENT
CAP.	G F P C	light to med weathering
BREASTWALL	G F P C	
WINGS	G F P C	
PILING A	G F P C	
B	G F P C	
C	G F P C	
D	G F P C	
E	G F P C	
F	G F P C	
G	G F P C	
RIP RAP	G F P C	
VEG.	G F P C	Heavy
Embankment	G F P C

CUT AND REMOVE VEGETATION FROM CHANNEL
