LAUDERDALE COUNTY

**49-SR087-2076**

# BRIDGE MAINTENANCE RECOMMENDATIONS

## BRIDGE INSPECTION REPORT

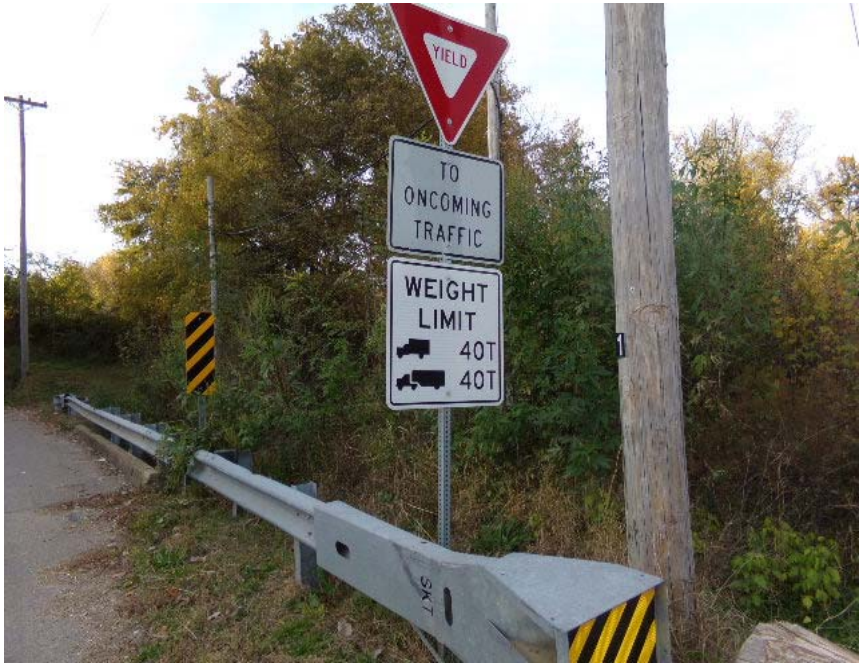
**APPROACH # 2 WEIGHT LIMIT SIGN**

Comments Regarding any Problems with Signing: 2 Paddleboards on App #2 only

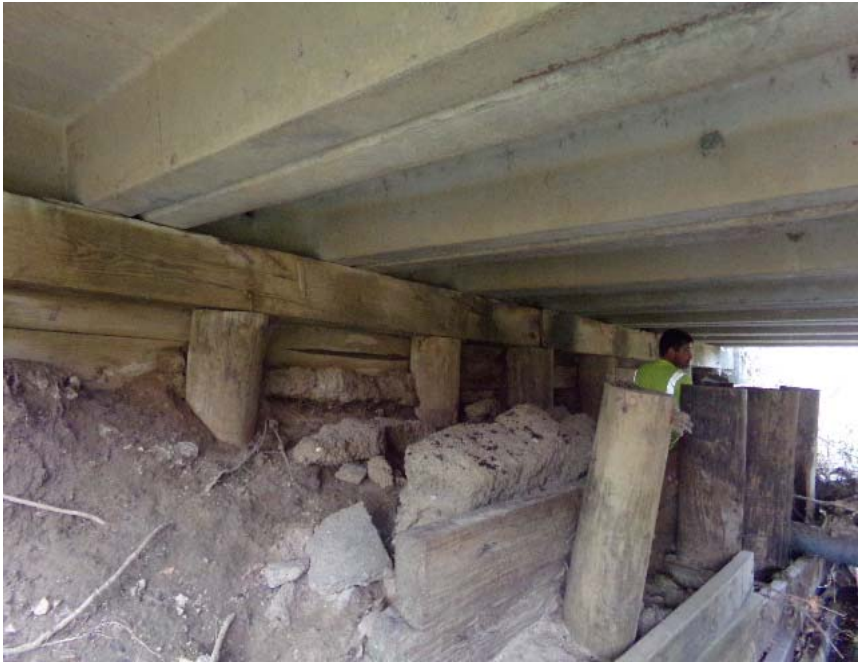
**ABUTMENT # 1**

ELEMENT	RATING	COMMENT
CAP	G F P C	Med. weathering
PILING	G F P C	Med. weathering
BREASTWALL	G F P C	Med. weathering
WINGS & PILE	G F P C	Med. weathering
EMB.	G F P C	Light growth
VEG.	G F P C	
	G F P C	
	G F P C

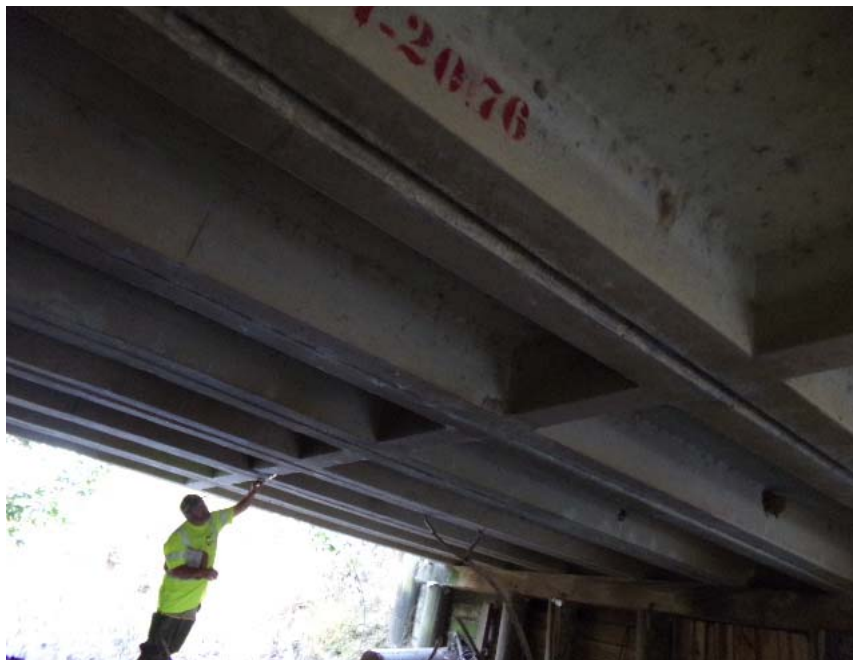
**BOTTOM DECK OF SPAN # 1**

The superstructure has up to 1/16" cracks & spalling.

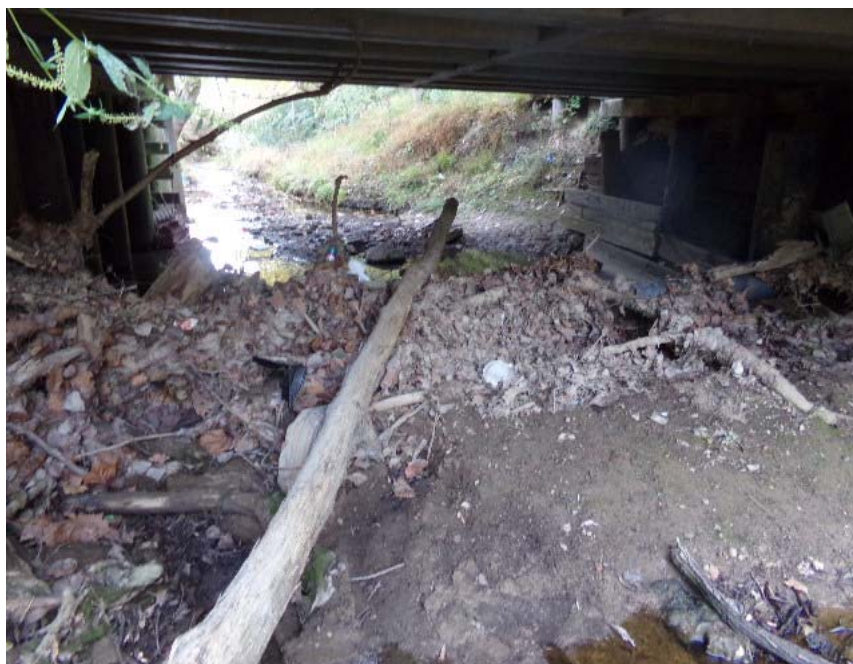
**DIRFT CAUGHT ON PIPE IN MIDDLE OF CHANNEL**

4. Indications that flood waters overtop bridge:  
NO (X) YES ( ) OCCASIONALLY ( ) FREQUENTLY ( ) UNKNOWN ( )
5. Debris characteristics:
- a. debris/drift present YES (X) NO ( )

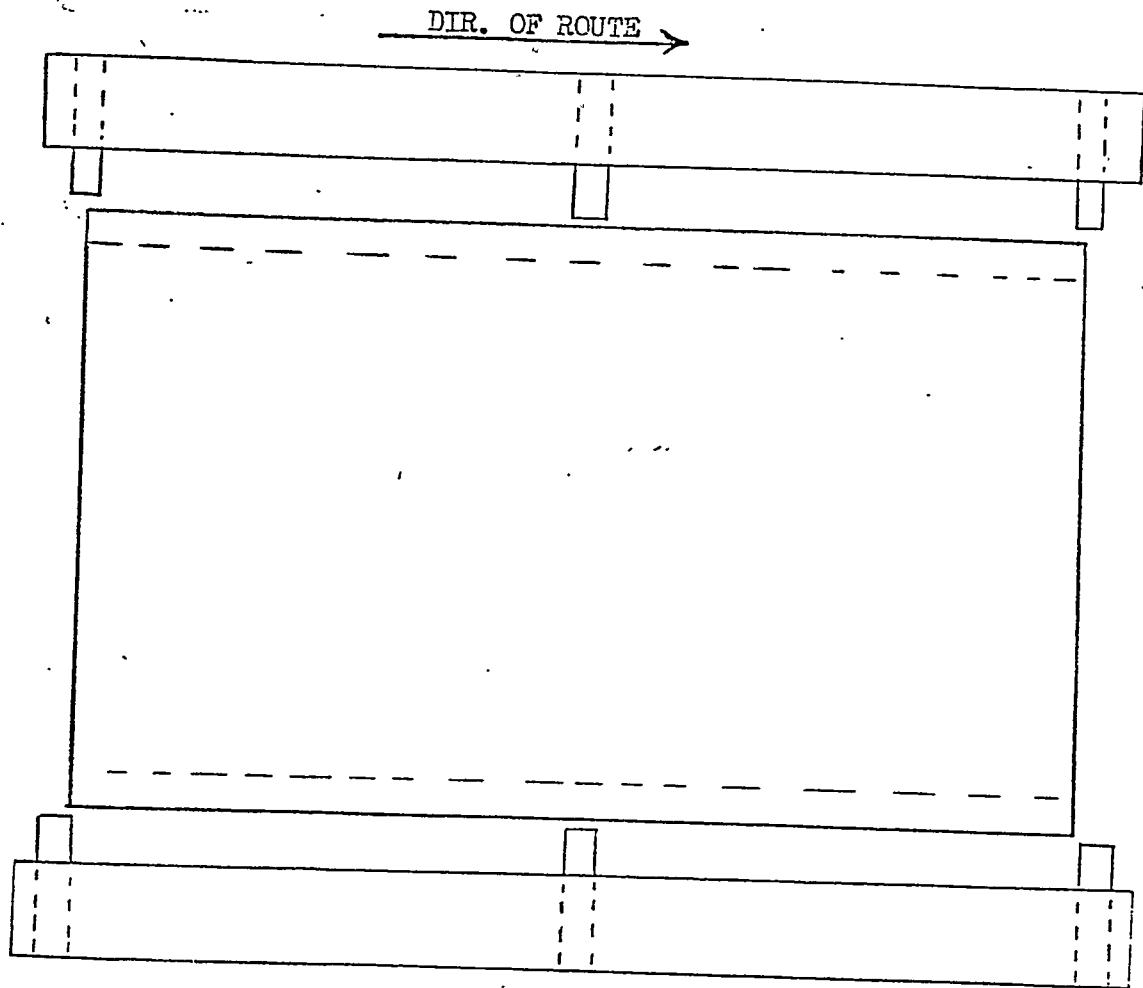
SPAN NO. 1

Drains are filled with debris.

ELEMENT	RATING	COMMENT
TOP DECK	(G) F P C	
RAILS & POST	(G) F P C	
PAINT	G F P C	
DRAINS	G F (P) C	filled w/debris
JOINTS	G F P C	
CURBS	(G) F P C

CLEAR DRAINS

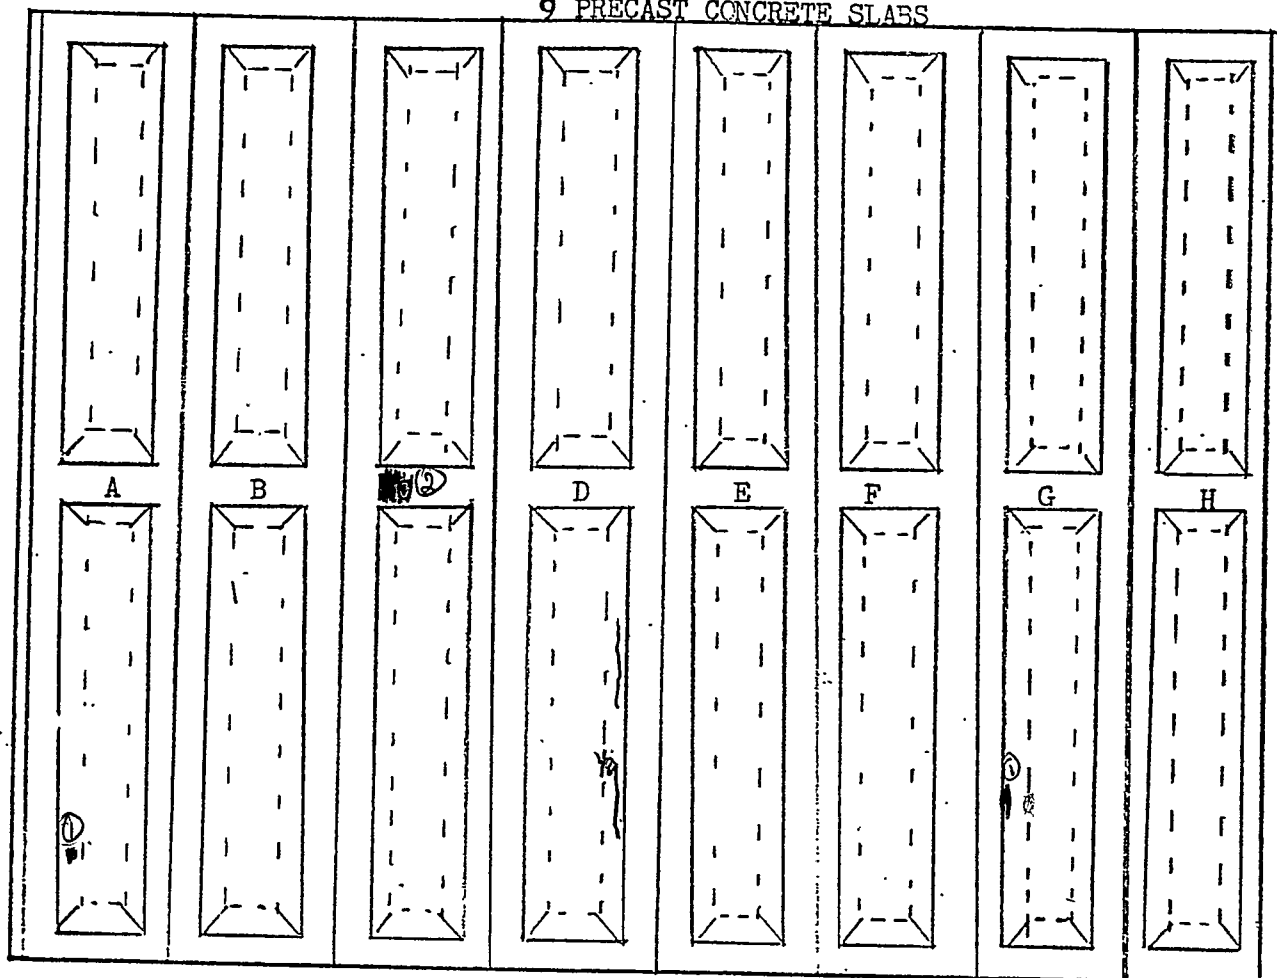
9 PRECAST CONCRETE SLABS

Element	Rating	Comment
SLAB	A <u>G</u> F P C	See ①
	B <u>G</u> F P C	
	C <u>G</u> <u>F</u> P C	See ②
	D <u>G</u> <u>F</u> P C	upto 1/8" cracks
	E <u>G</u> F P C	
	F <u>G</u> F P C	
	G <u>G</u> F P C	See ①
	H <u>G</u> F P C	
BOLTS	<u>G</u> F P C	
Btm Deck

① Spalling 5" dia x 1/8" d  
② Spalling 1" w x 1/2" x 3/4" d

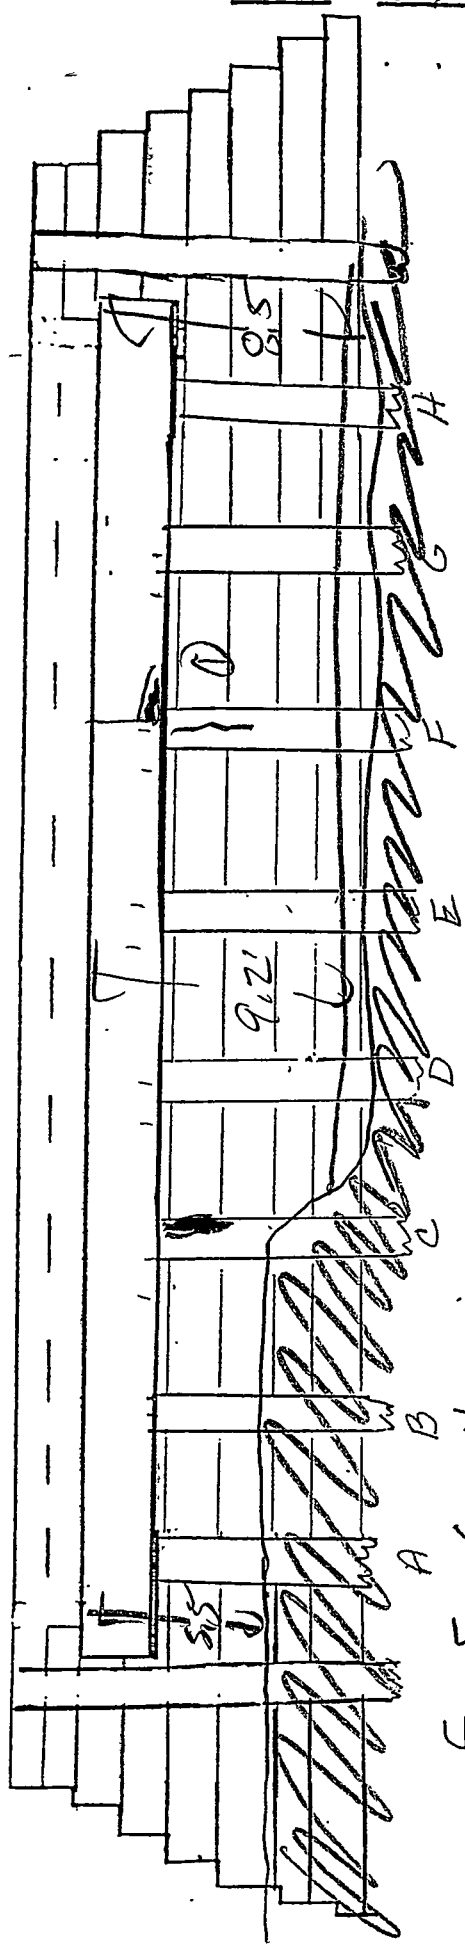
ABUT. NO. 2

① Splinter 1' w 3" tail

ELEMENT	RATING	COMMENT
CAP	G F P C	① Light to med event bearing
PILING	G F P C	med. weathering
BREASTWALL	G F P C	light weathering
WINGS & PILE	G F P C	E-17 piles up to 4' out under ②
FLUMES	G F P C	about in channel cap
VEG.	G F P C	light to med. event bearing
CH	G F P C	splinter 2.5 high 6' w 1/2" tail
C	G F P C	1/4" ch/c/2
F	F
