Bridge Maintenance Recommendations

Bridge Location No.: **49 - SR087 - 0518**

BRIDGE INSPECTION REPORT

Inspection Team's Summary

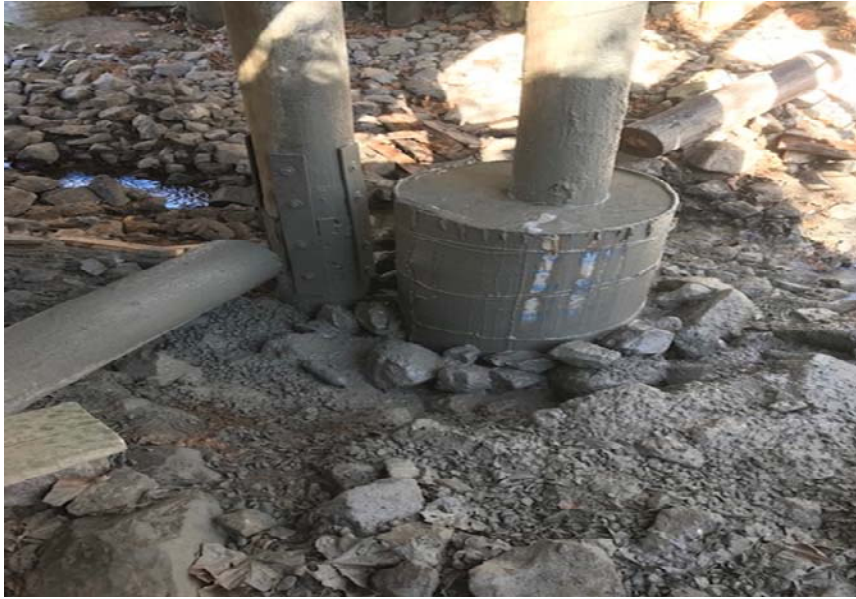
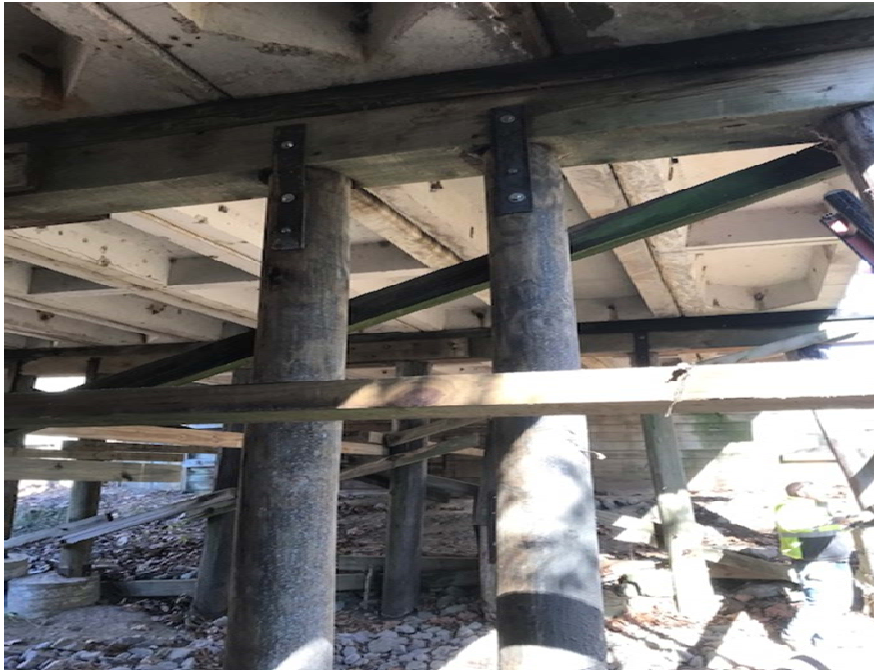
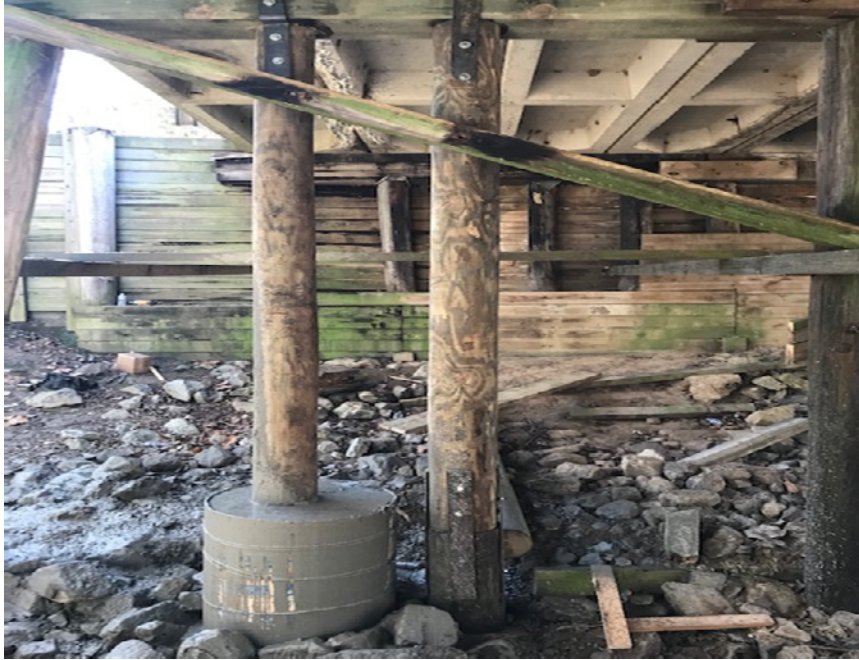
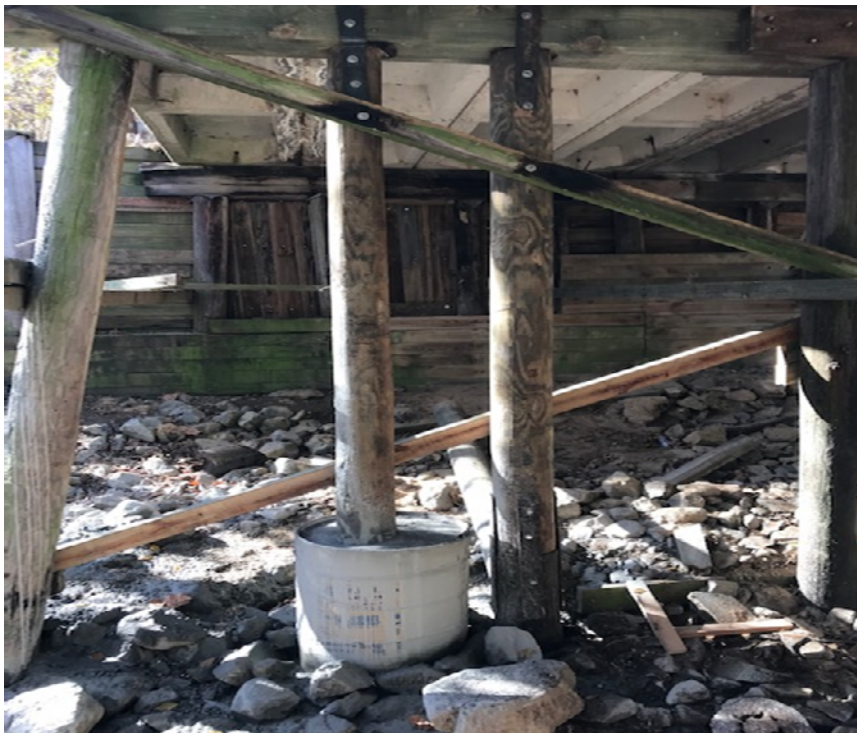
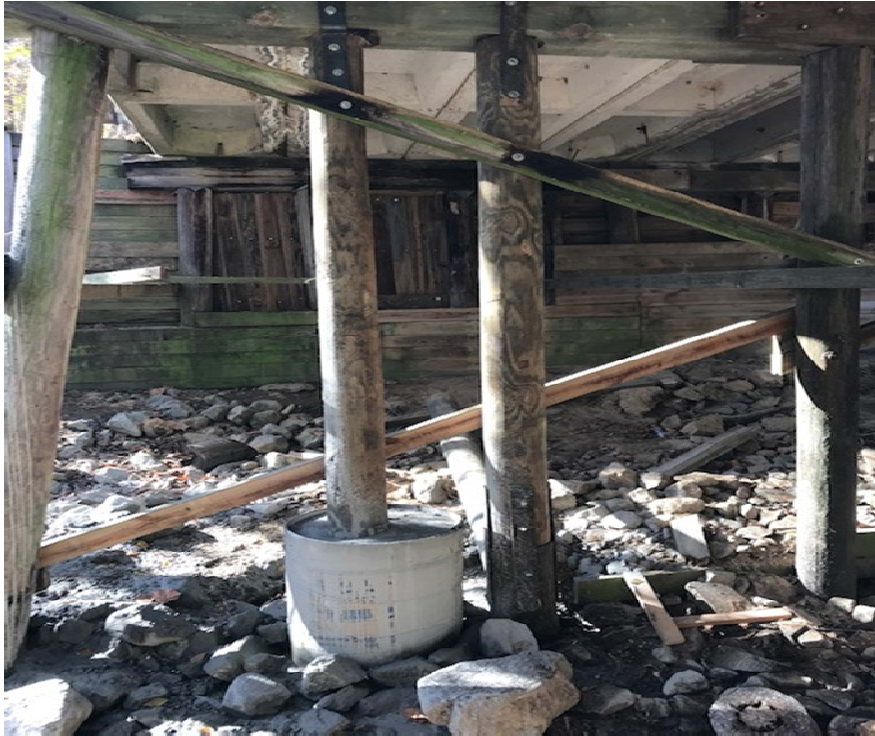
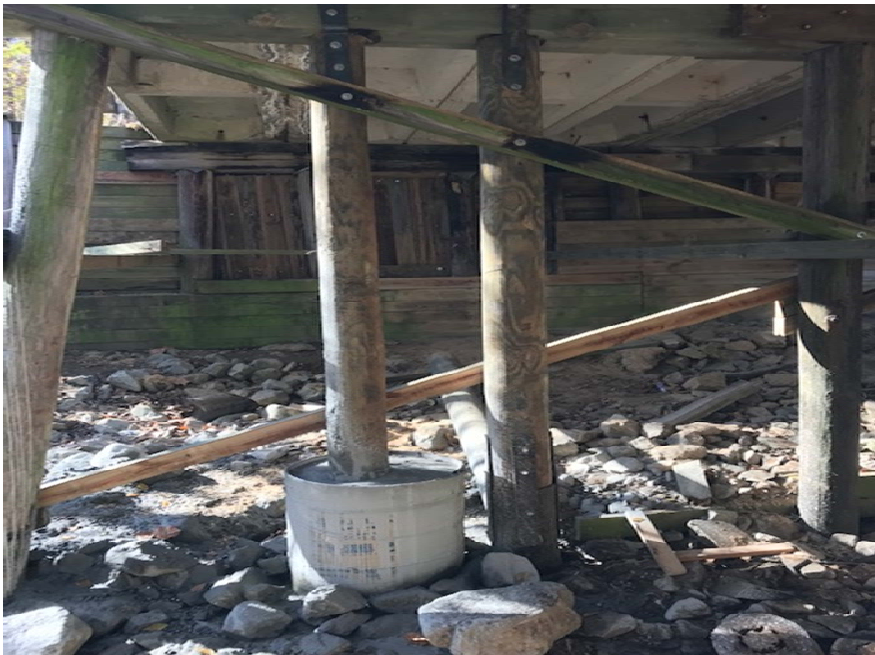
REPAIRED PILES "G" & "H" IN BENT #1

Bent # 1 piles "g & h" are decayed.

11-22-21 REPAIRED PILES G & H AT BENT 1, BREASTWALL AT BOTH ABUTMENTS AND WINGWALL
AT ABUTMENT 1 (HB)

COMMENTS: 1. Repaired piles G & H in Bent #1.
2. Repaired breastwall at abutment #1 & 2
3. Repaired wingwall at abutment #1 Completed 11/22/21
H.B.

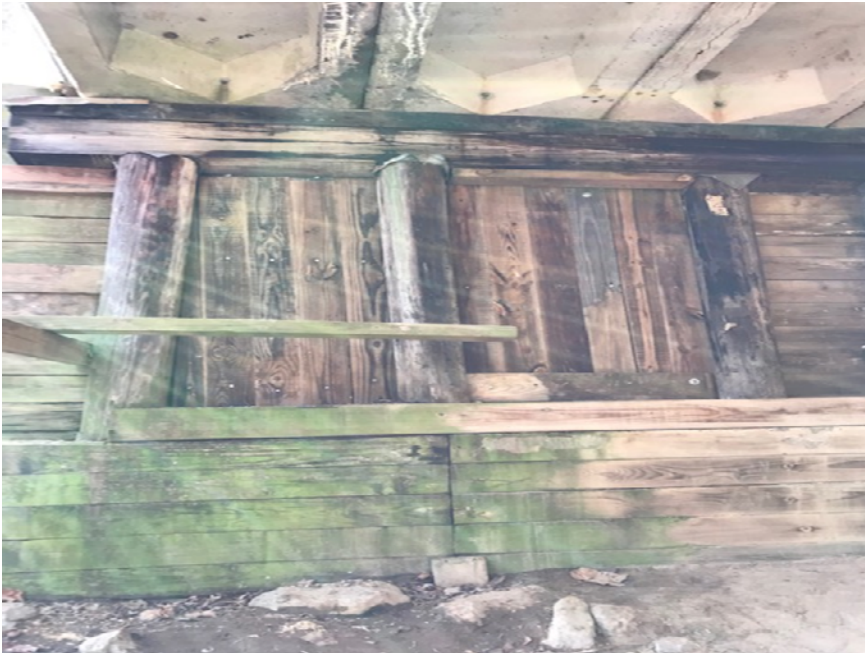
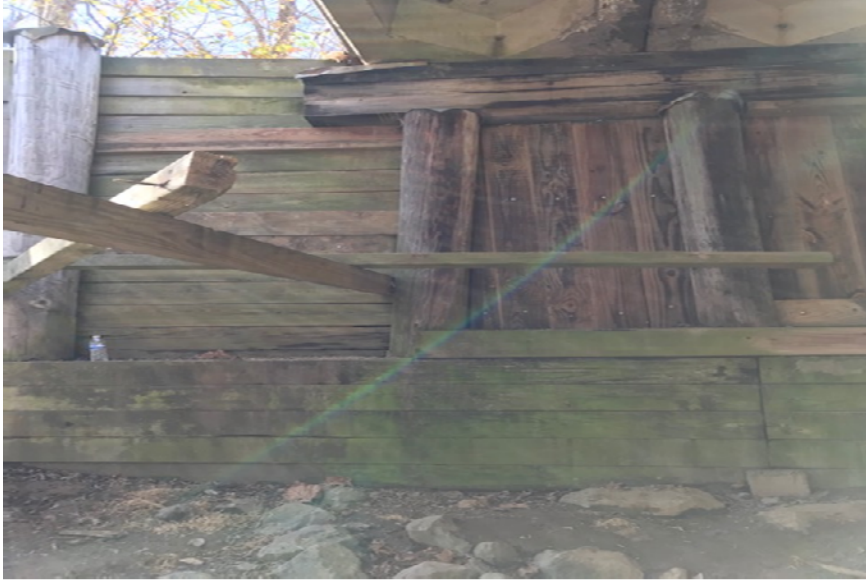
REPAIRED BREASTWALL & WING AT ABUTMENT #1 & BREASTWALL AT ABUTMENT #2

Abutments # 1 & 2 breast walls & abutment # 1 left wing are
decayed.

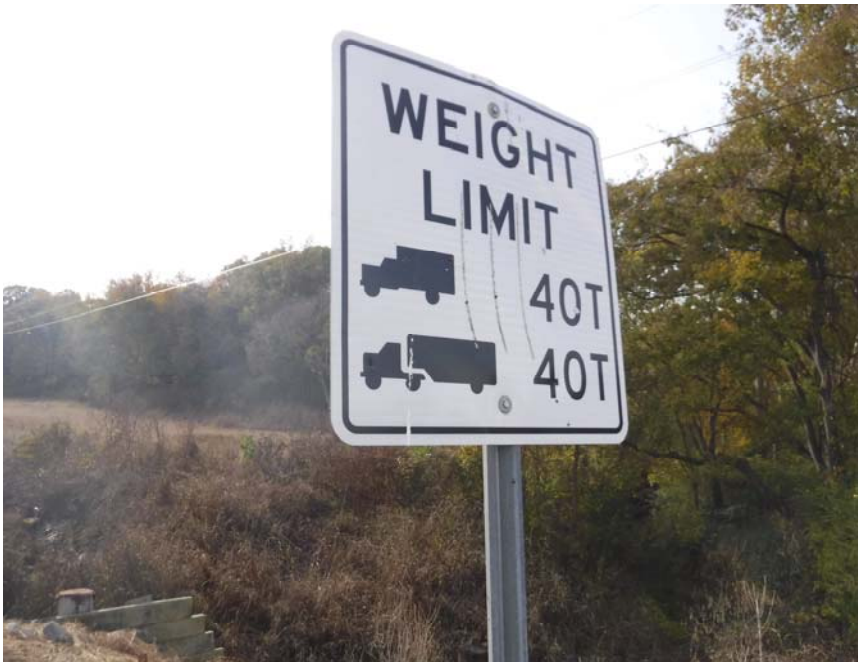
APPROACH # 2 WEIGHT LIMIT SIGN

This is a 3 span p.c.c.s. & timber bridge in poor condition.
There are metal rails, 4 paddle board signs & a 40 ton weight
limit sign on approach # 2 left.

023	REPLACE MISSING LOAD-LIMIT SIGN AT APPROACH NO. _1
141	REPAIR OR REPLACE _TIMBER_ PILES _G & H_ AT BENT NO. _1 (repaired 11-22-21)

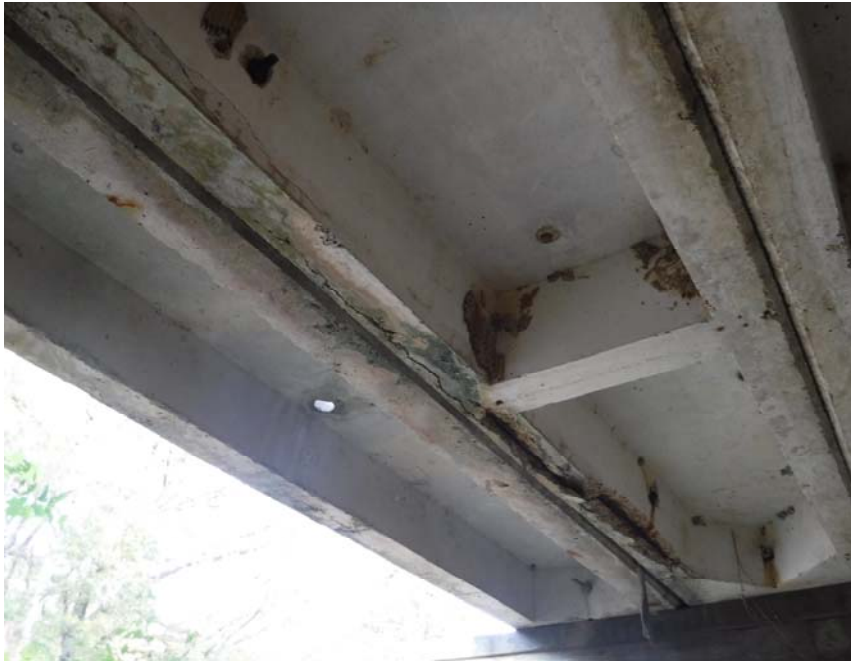
SPAN # 1 SLAB "B" SPALL TO STEEL

Span # 1 p.c.c.s. "b" is spalled to steel.

238	BRIDGERAILS ARE SUBSTANDARD
229	APPROACH GUARDRAILS ARE NON-EXISTENT
241	REPLACE PRECAST CONCRETE CHANNEL SLAB _B_ IN SPAN NO. _1
167	REPAIR _TIMBER_ BREASTWALL AT ABUTMENT NO. _1 & 2 (repaired 11-22-21)
154	REPAIR WINGS AT ABUTMENT NO. _1 (repaired 11-22-21)
204	CUT VEGETATION

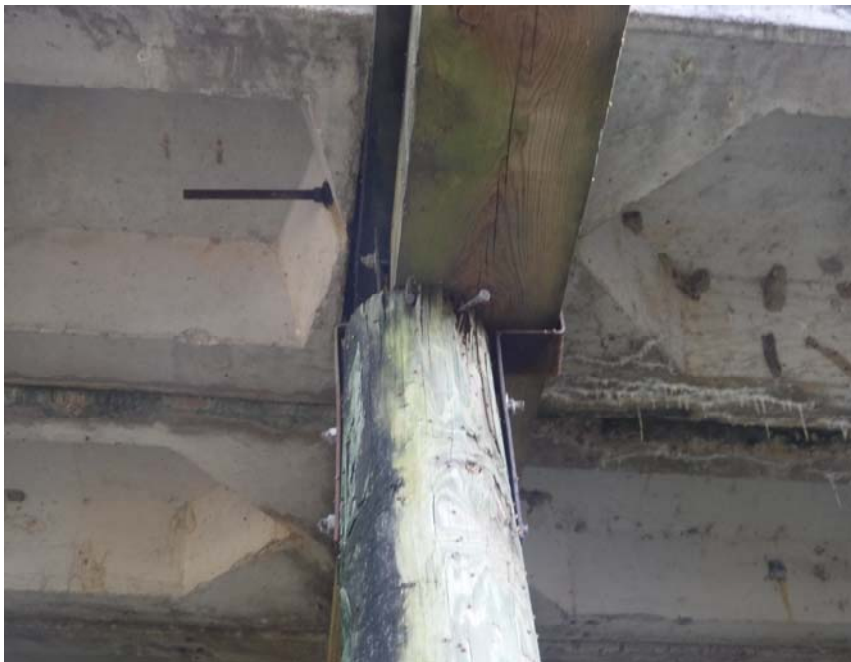
BENT # 2 PILE "A" ALIGNMENT

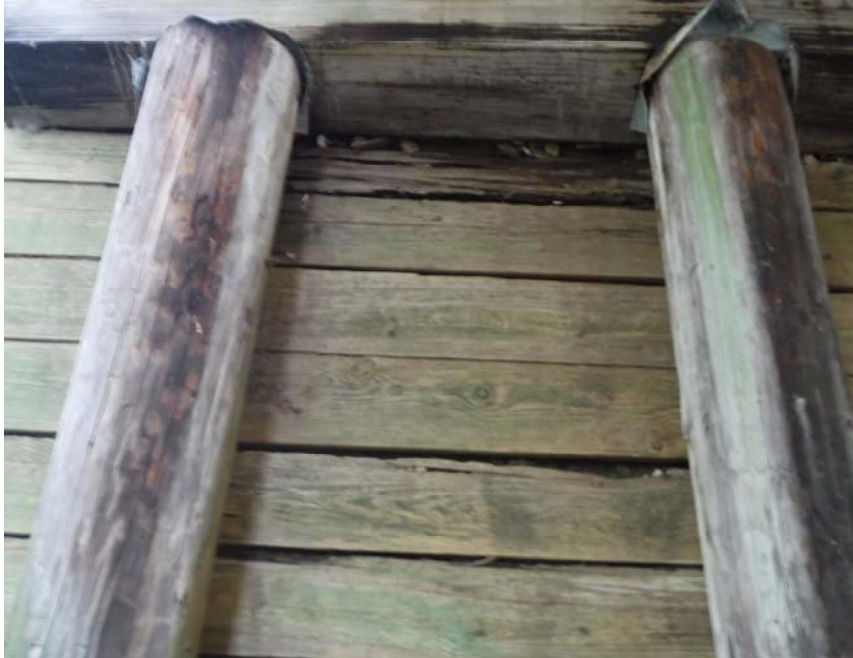
ABUTMENT # 1 BREAST BOARD DECAYED

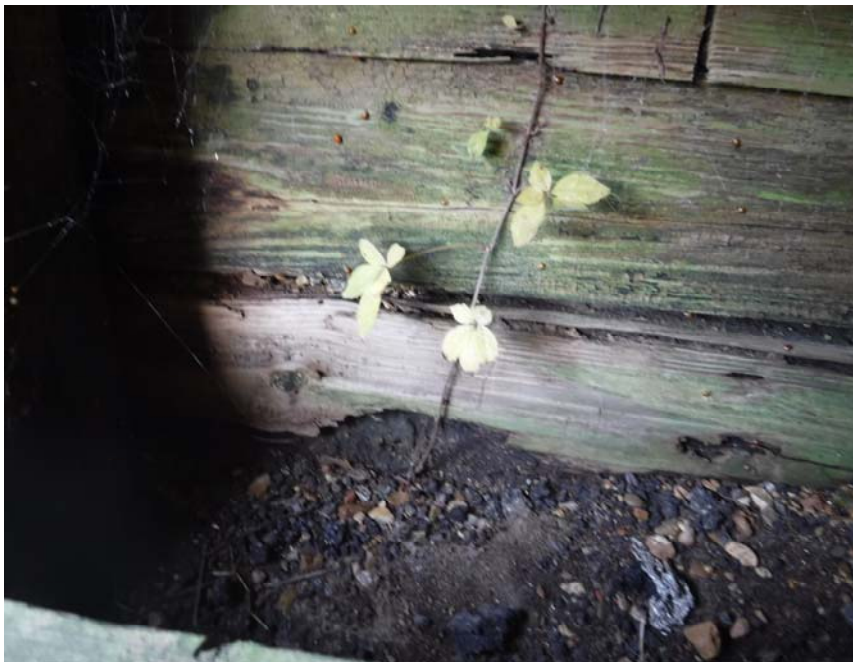
ABUTMENT # 2 BREAST BOARD DECAYED

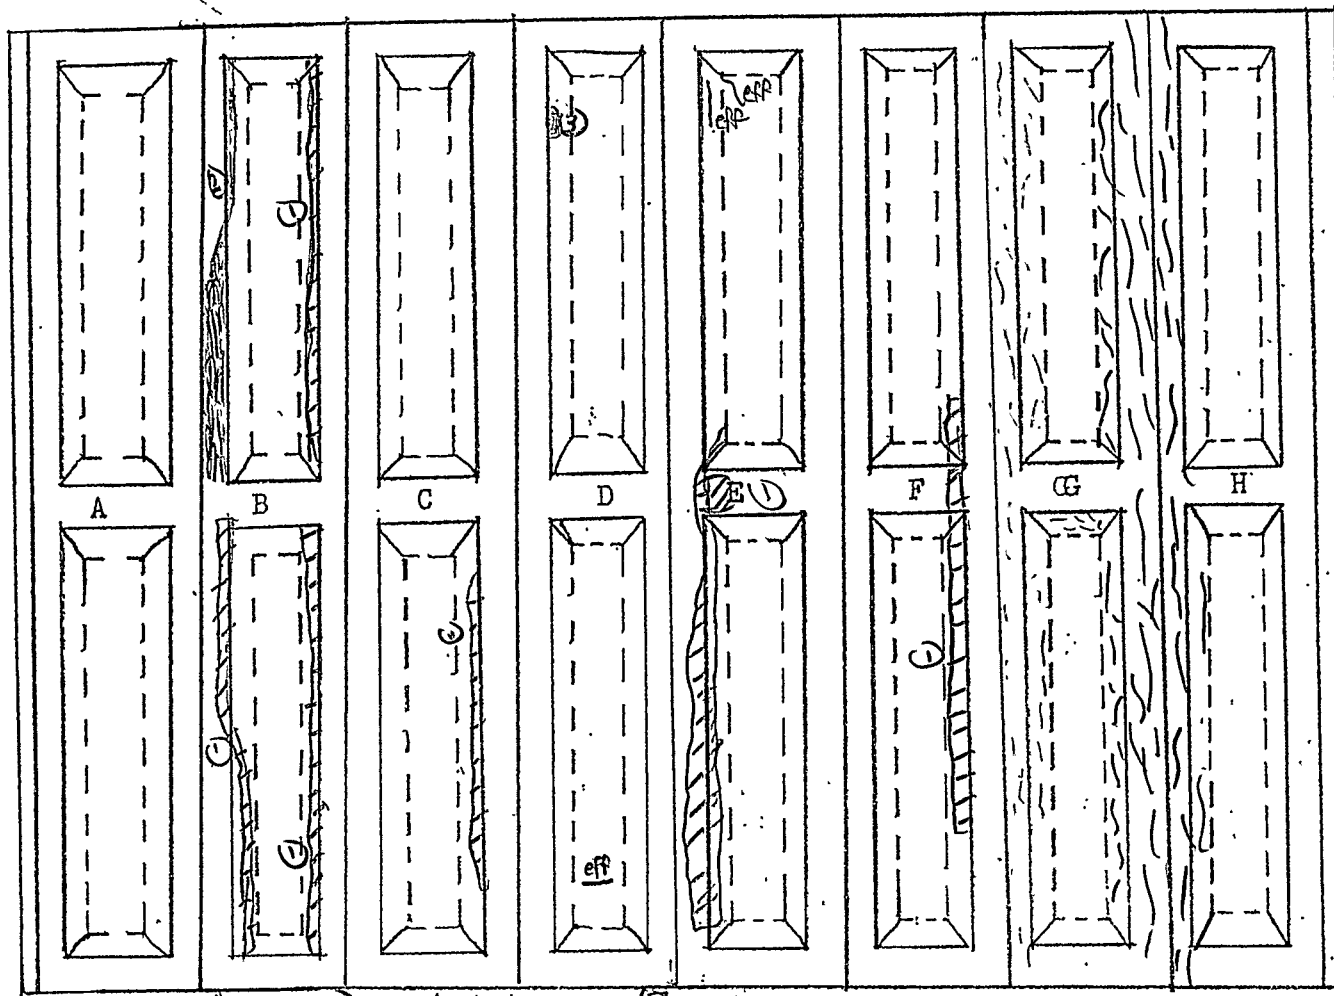
8 PRE-CAST CONC. SLABS

① up to impending spall 7' L x 2" H x 6" W
② Spalled steel w/ 6' L x 4" W x 2" D
③ Spall in 4" H x 3" L x 1/16" D
6-1090 42-1080
410-1122

ELEMENT	RATING	COMMENT
SLAB A	G F P C	
B	G F P C	Spall in see ①②
C	G F P C	Spall in see ①
D	G F P C	Spall in see ③ + hairline crack w/eff
E	G F P C	Spall in see ① + hairline cracks w/eff
F	G F P C	Spall in see ①
G	G F P C	hairline cracks w/eff
H	G F P C	" " "
BOLTS	G F P C	Some bolts have medium corrosion

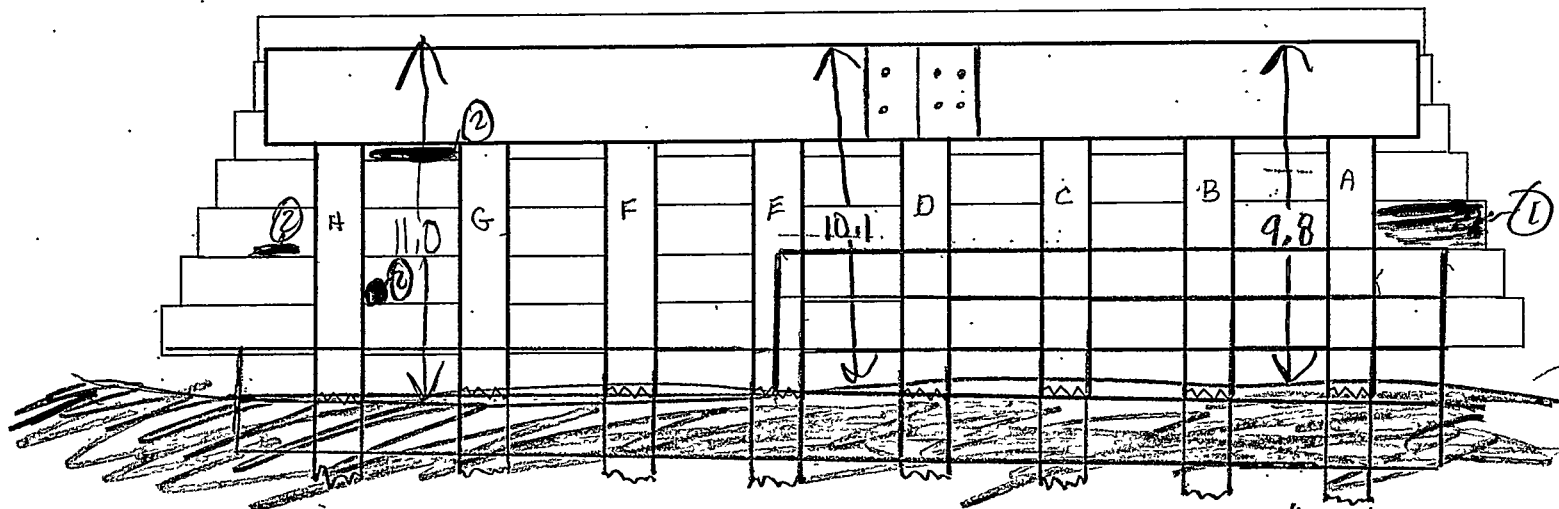
ABUT. NO. 1

① broken section on
wing 3' x 8" high

② detected
broken
Area $2' \times 6" \times 4"$

ELEMENT	RATING	COMMENT
CAP A	G F P C	light to medium weathering
B	G F P C	
WINGS	G F (P) C	See ① + light to medium weathering
PILES A-H	G F P C	light to medium weathering
B	G F P C	
C	G F P C	
D	G F P C	
E	G F P C	
F	G F P C	
G	G F P C	
H	G F P C	
BREASTWALL	G F (P) C	See ②
EMB.	G F P C	light washing
VEG.	G F (P) C	heavy growth
RIP - RAP	G F P C	
Ret. Wall	G F P C	light to medium weathering

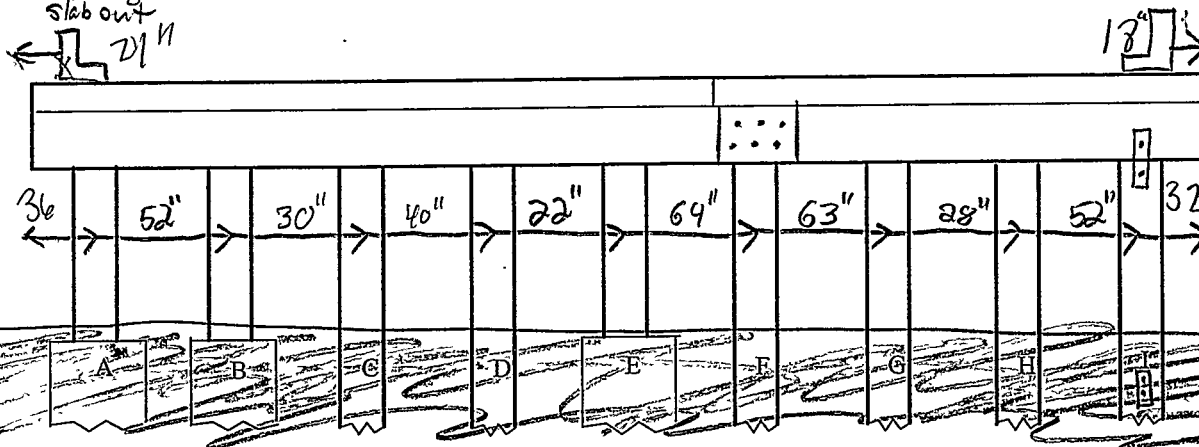
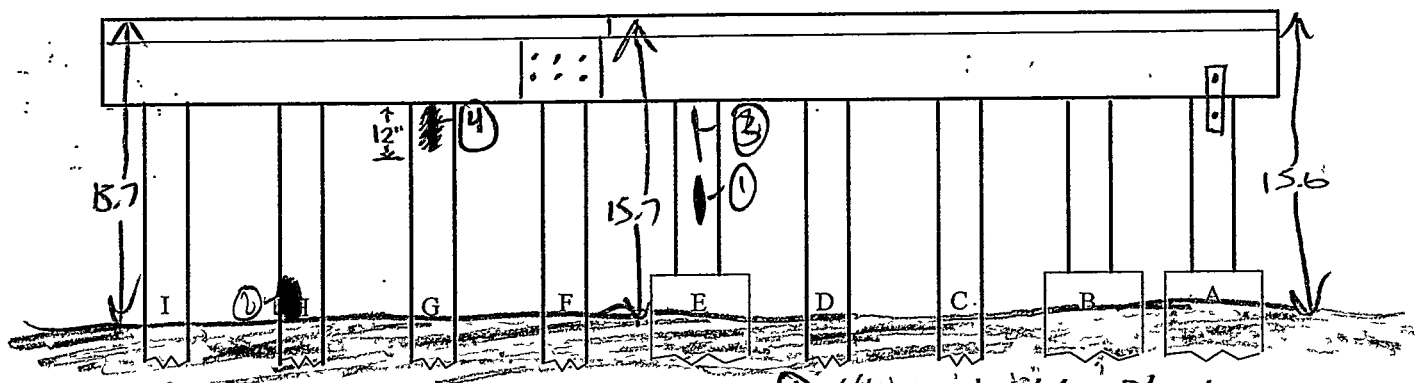
BENT. NO. 1

① Spattered Area
 $\frac{1'}{H} \times \frac{4''}{W} \times \frac{2''}{D}$

② Decay
 $\frac{1'}{H} \times \frac{8''}{W} \times \frac{4''}{D}$

③ Spattered Area
 $\frac{2'}{H} \times \frac{12''}{W} \times \frac{1''}{D}$

④ 4 inch outside shell

ELEMENT	RATING	COMMENT
CAP A	G (F) P C	light to medium weathering
B	G (F) P C	
PILES A 10"	G (F) P C	light to medium weathering
B 12"	G (F) P C	
C 12"	G (F) P C	
D 11"	G (F) P C	
E 11"	G (F) P C	see ① & ③
F 11"	G (F) P C	light to medium weathering
G 12"	G (F) P C	see ④
H 11"	G (F) P C	see ②
I 11"	G (F) P C	light to medium weathering
CONC. CASING	G (F) P C	
BRACING	G (F) P C	light to medium weathering
Rip-Rap	G (F) P C	Scattered

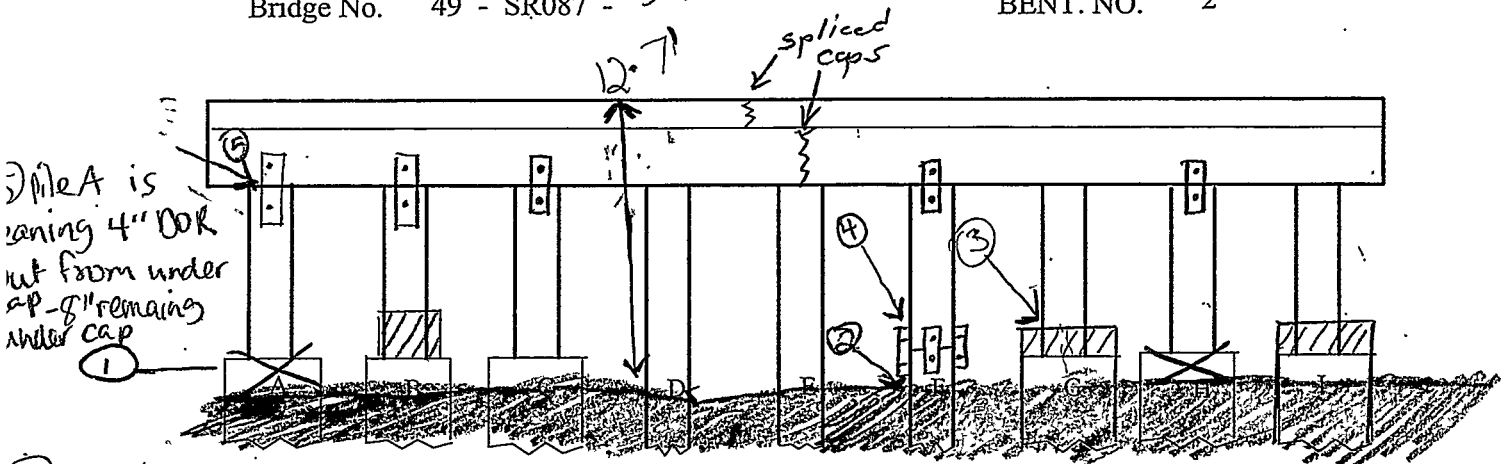
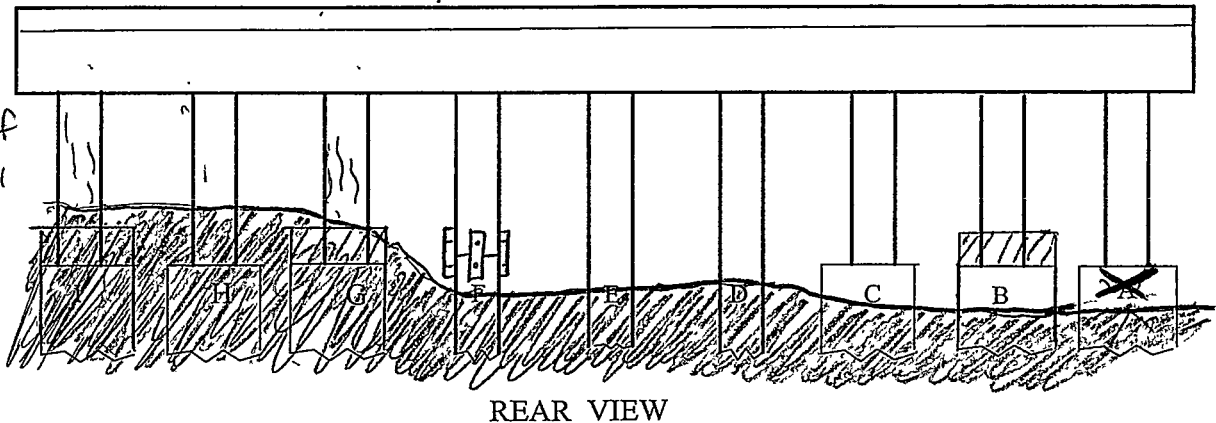
BENT. NO. 2

① No conc. casing @ Pile 'A' or 'H'

② up to 1/2' deep decay around bottom 5" of pile

③ 5" center core remaining
top bottom of pile up to 6" off center

ELEMENT		RATING	COMMENT
CAP	A	G (E) P C	light to med. weathering
	B	G (E) P C	" " "
PILES	A	G (E) P C	see ① & ⑤ light to med. weathering
	B	G (E) P C	light to med weathering
	C	G (E) P C	
	D	G (E) P C	
	E	G (E) P C	
	F	G (E) P C	see ② & ④ + med weathering
	G	G (F) P C	see ③ + up to 1/8" grain cracks + med weathering
	H	G (E) P C	light to med weathering
	I	G (E) P C	up to 1/8" grain cracks + med weathering
CONC. CASING		G (E) F P C	
BRACING		G (E) F P C	
Steel grader blades		(fair)	med corrosion

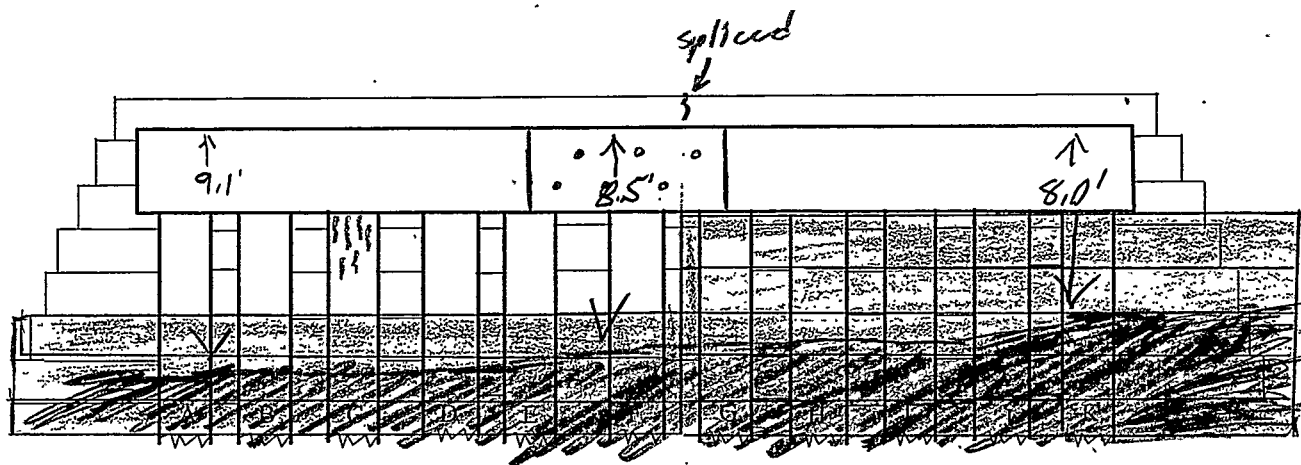
ABUT. NO. 2

ELEMENT	RATING	COMMENT
CAP	G F P C	light to med weathering
WINGS	G F P C	" "
PILES A	G F P C	med weathering
B	G F P C	
C	G F P C	Heavy weathering + Decay + Replaced by 'D'
D	G F P C	med weathering
E	G F P C	med weathering
F	G F P C	med weathering
G	G F P C	N/V
H	G F P C	
I	G F P C	
J	G F P C	
K	G F P C	
BREASTWALL	G F P C	Heavy decayed + missing areas
EMB.	G F P C	
VEG.	G F P C	med growth
RIP RAP	G F P C	none
Ret. Wall	G F P C	med weathering
