LAUDERDALE COUNTY

Bridge Loc. No: 49-SR087-06.44

BRIDGE MAINTENANCE RECOMMENDATIONS

BRIDGE INSPECTION REPORT

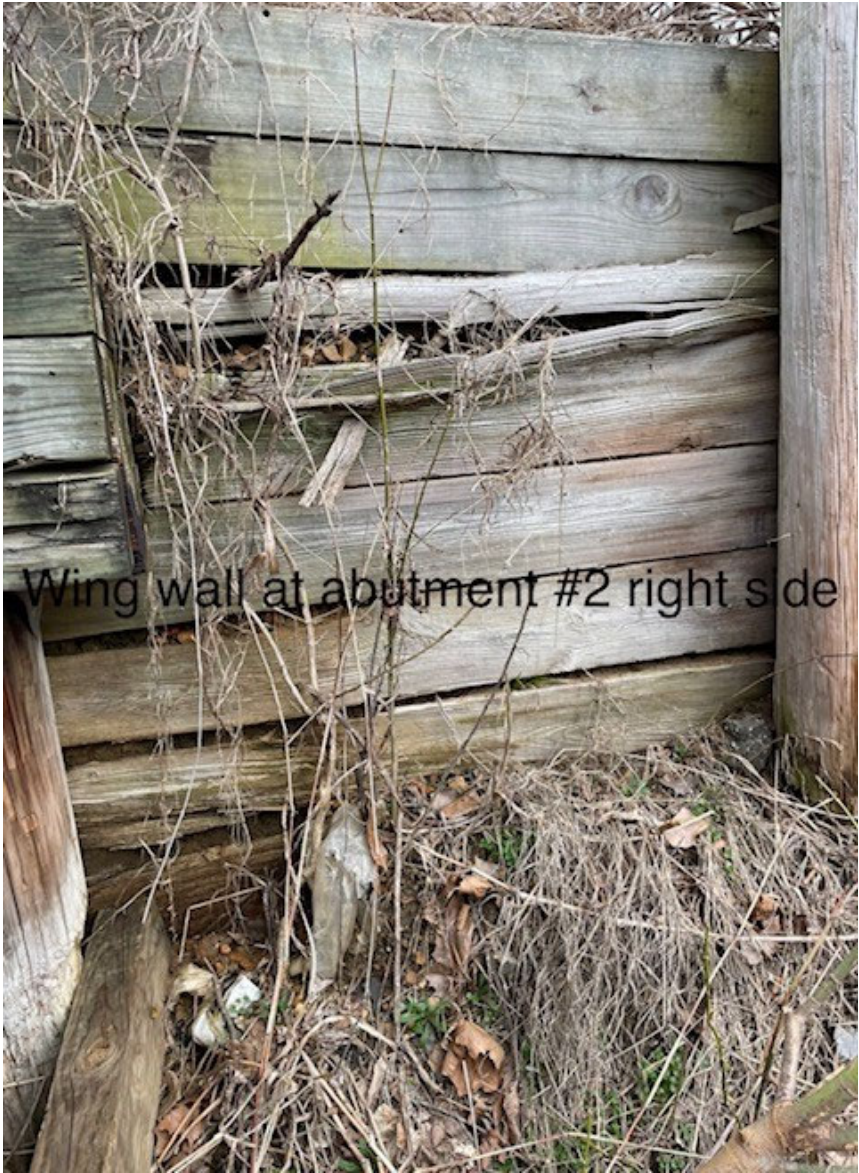
Wing wall at abutment #2 right side

ABUTMENT #2 Right wingwall

204	CUT VEGETATION				
COMMENTS: 1. Replaced channel slab A & C in span #3					
2. Repaired timber breastwall at abutment #2					
3. Repaired wingwall at abutment #2 right side. Completed					
H.B 02/21/23

REPAIR RIGHT WINGWALL AT ABUTMENT NO.2

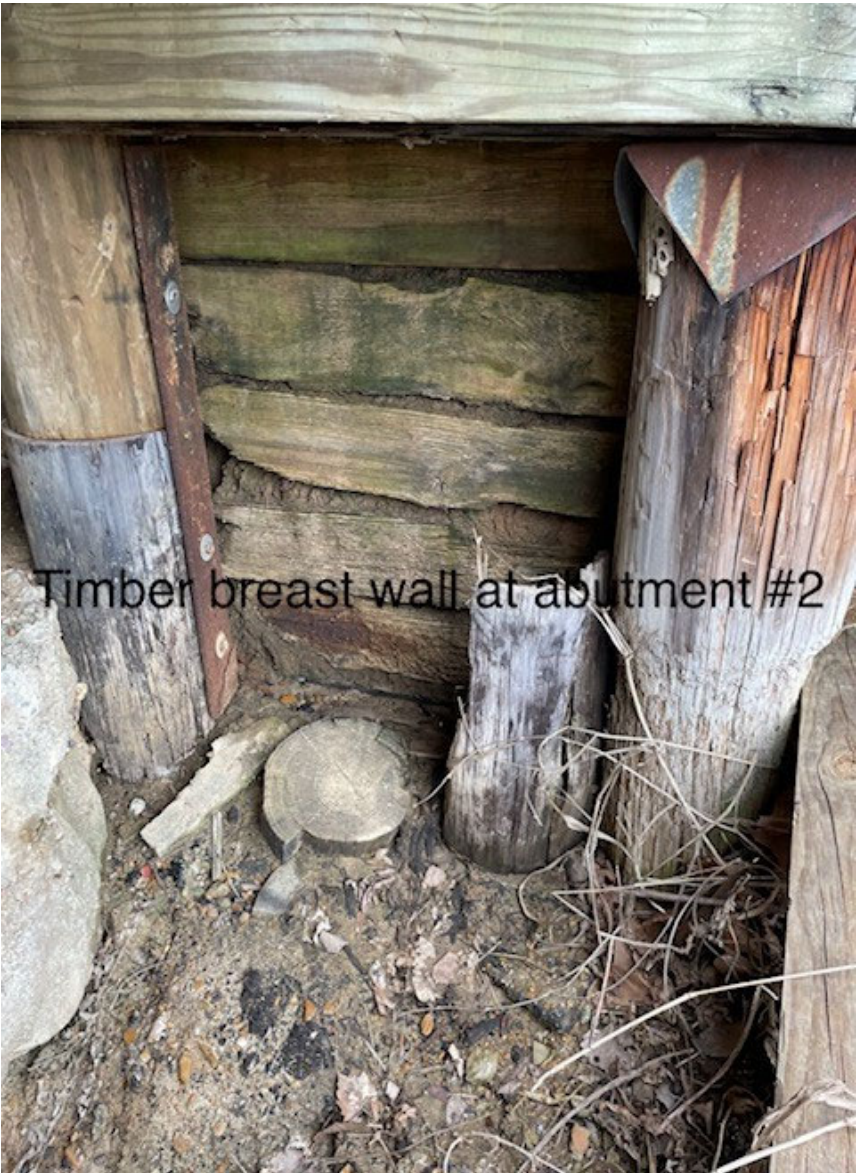
ABUTMENT #2 Breastwall

REPLACE BREASTWALL AT ABUTMENT NO.2

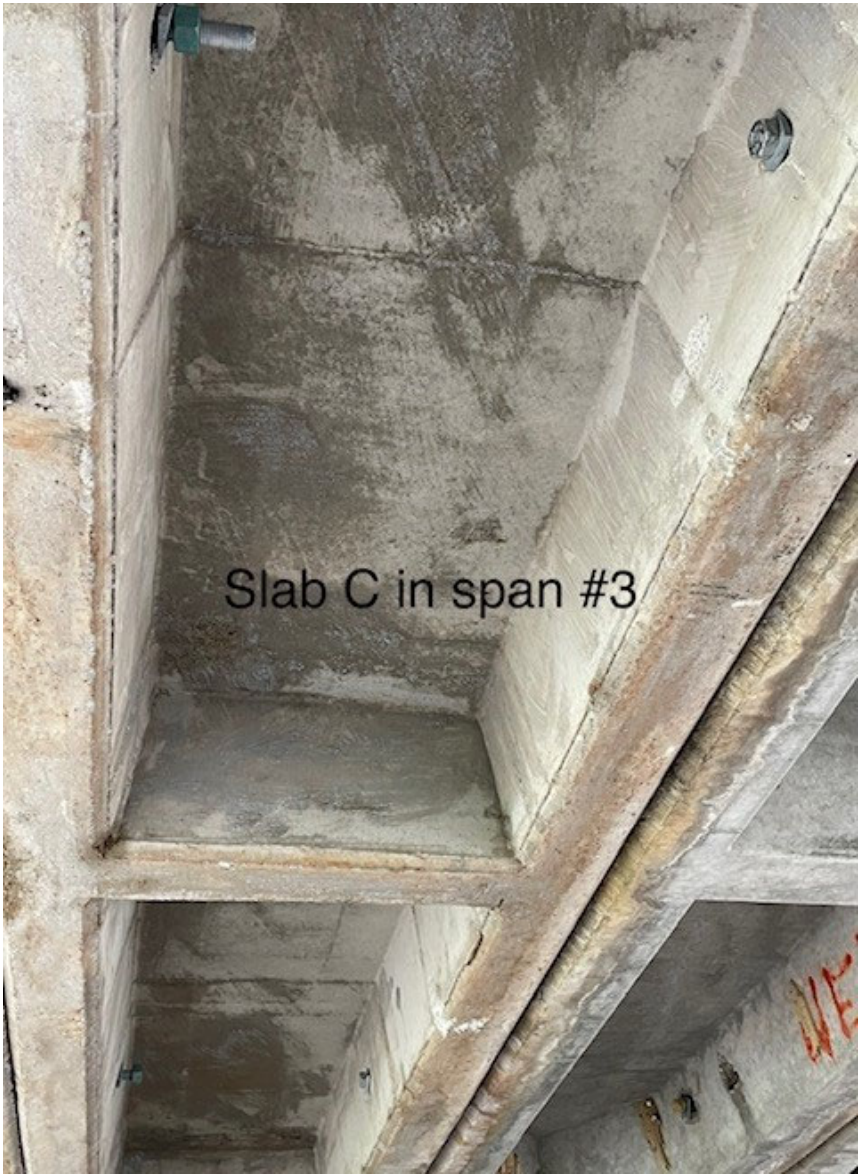
Span #3 Slab 'C' replaced

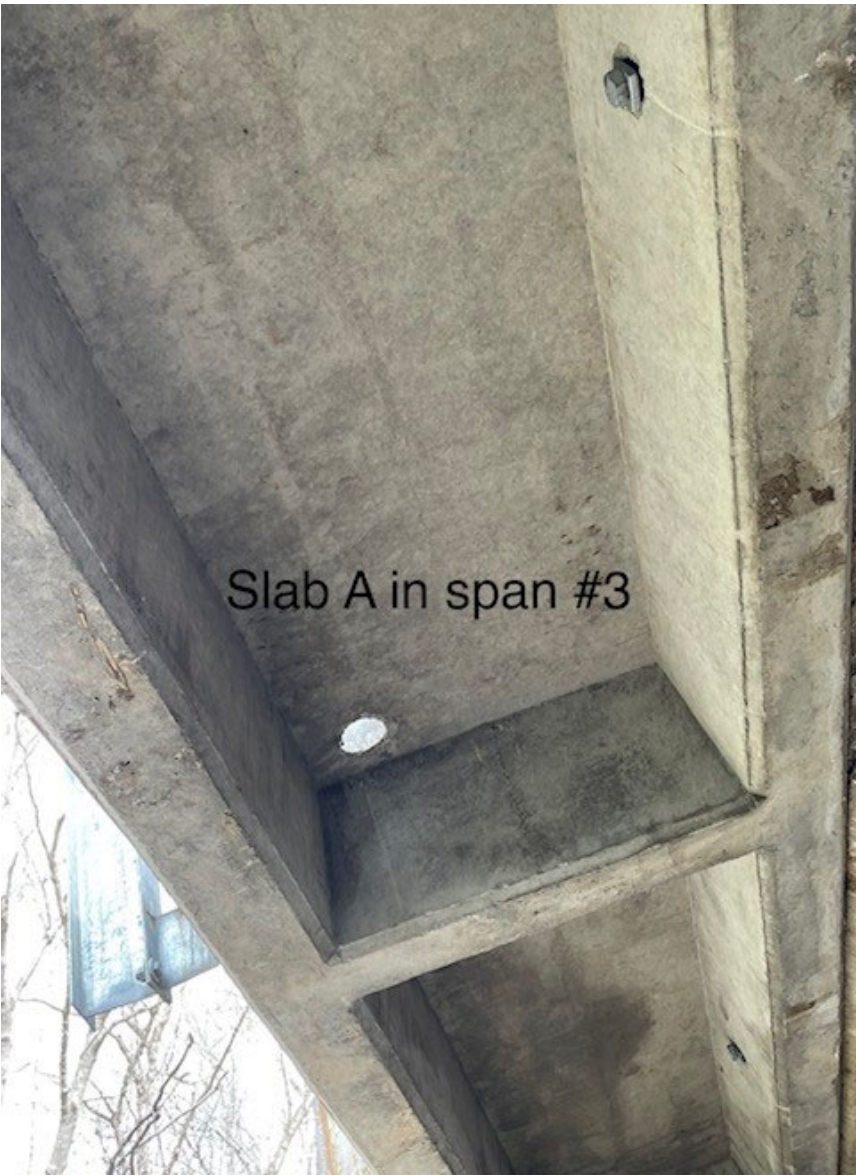
Span #3 Slab 'A' replaced

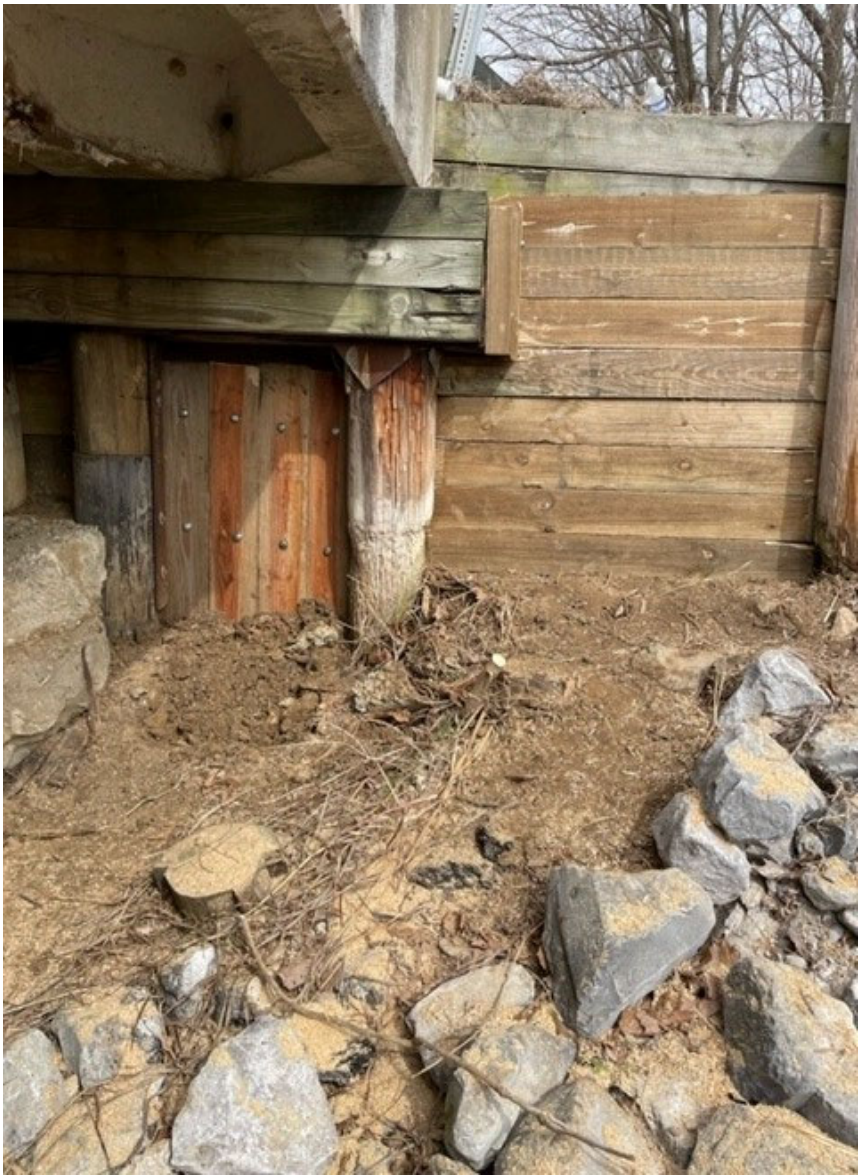
ABUTMENT #2 Right wingwall and Breastwall Repaired

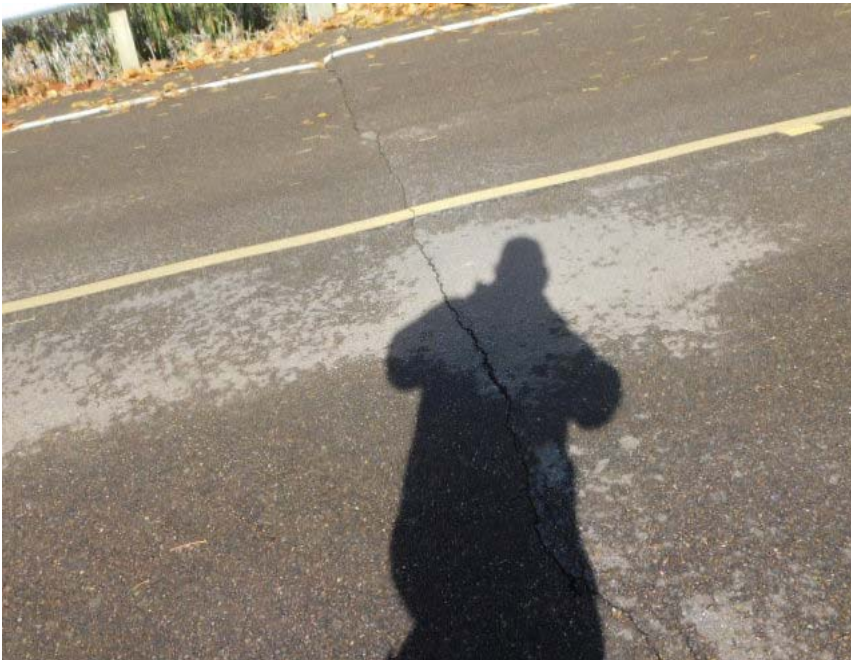
APPROACH #1 ASPHALT SETTLED

Approach A/c settled up to 2 1/2" (001)

Approach #1 asphalt is settled up to 2 1/2".

LEVEL THE WEARING SURFACE AT APPROACH NO.1

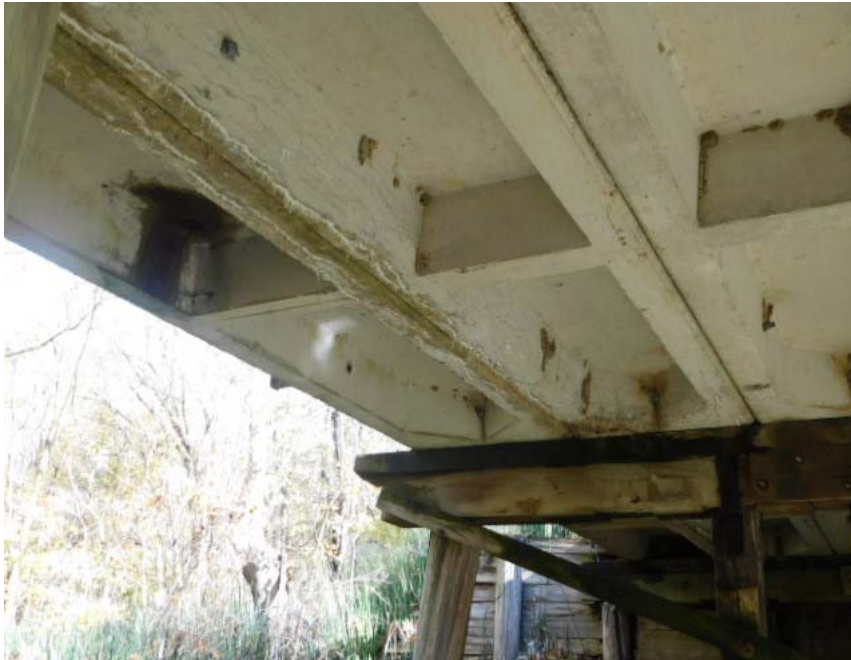
SPAN #2, SLAB "B" CRACKED

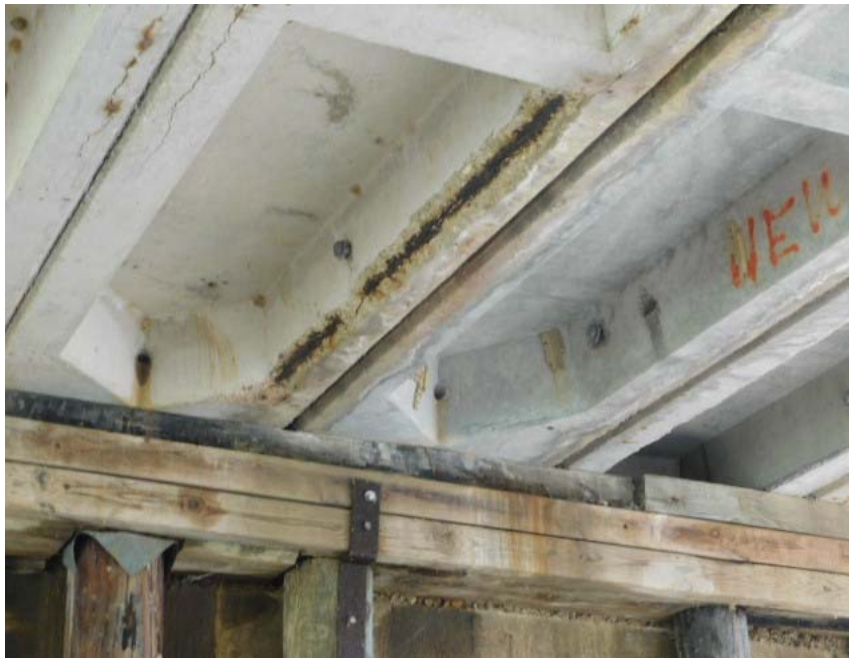
SPAN #3, SLAB "C" SPALLED TO STEEL

REPAIR OR REPLACE PRECAST CONCRETE CHANNEL SLAB "A & C" IN SPAN NO.3

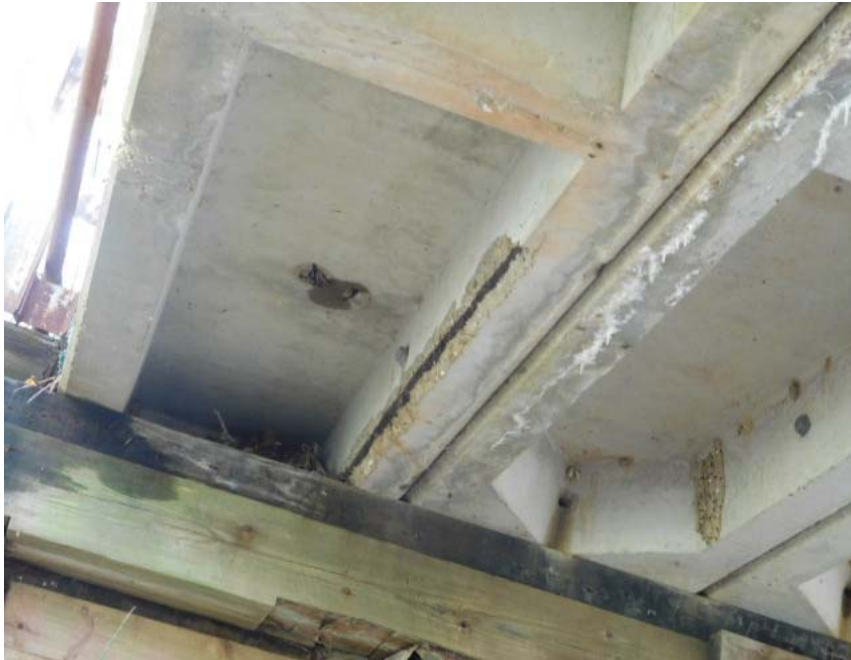
SPAN #3, SLAB "A" SPALLED TO STEEL

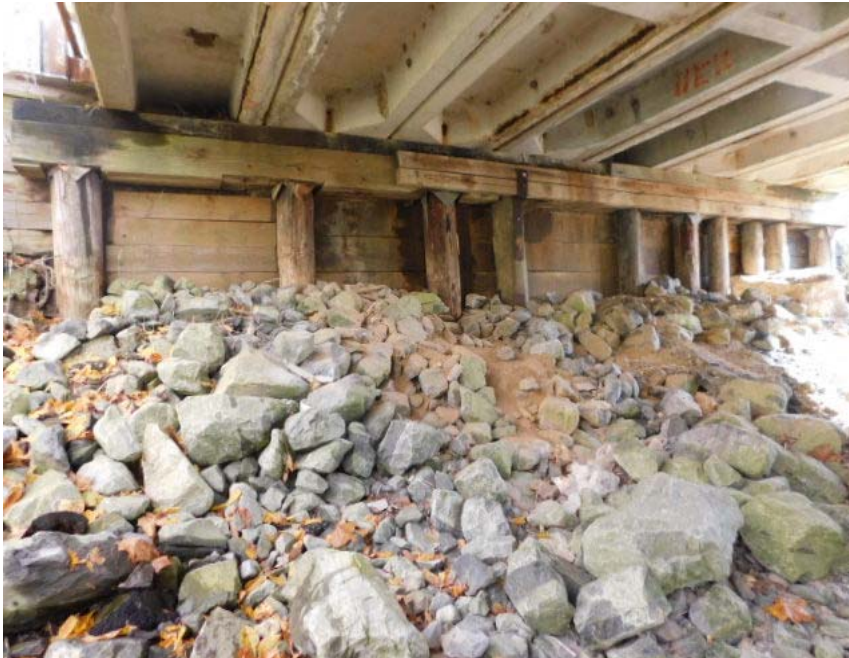
ABUTMENT #2

Abutment #2 breast wall & right wing is poor, decayed

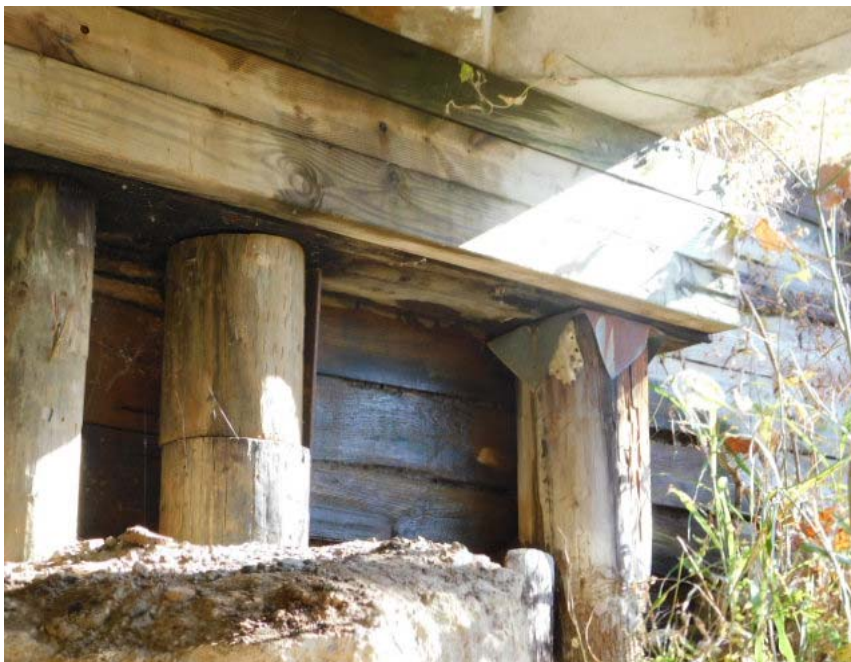
ABUTMENT #1, PILE "I" SPLICED

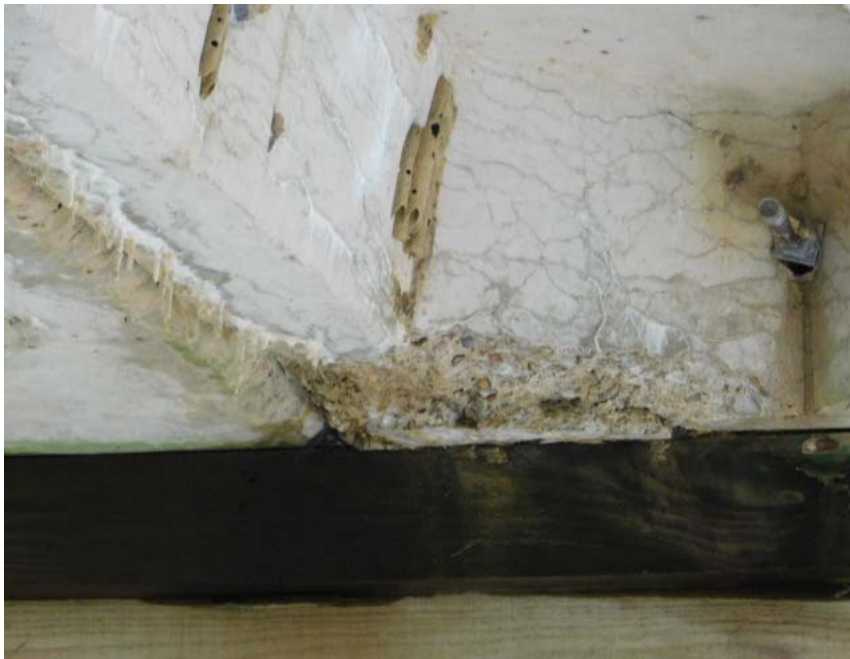
SPAN #2, SLAB "B" SPALLING

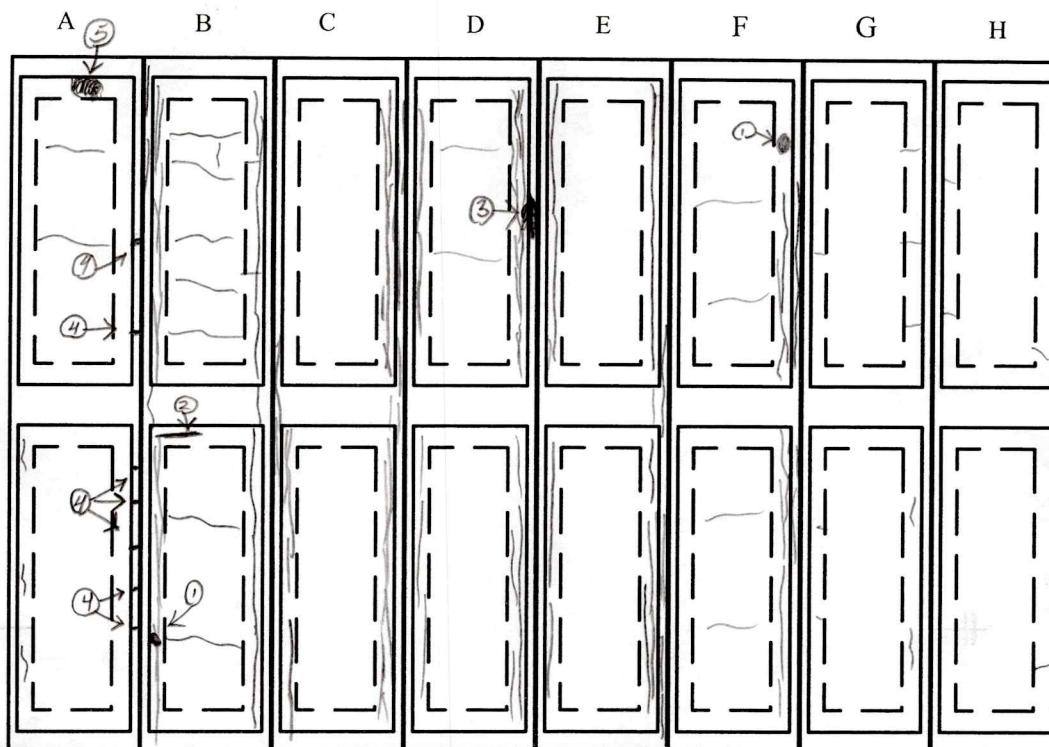
SPAN. NO. 1

⑤ spalling up to 12" dia x 2" deep

① spalling areas up to 14" dia x 1" deep

③ spalling up to 7" dia x 1" deep

② surface steel up to 16" w x 3" h x 1/2" deep

ELEMENT	RATING	COMMENT
SLABS A	G (F) P C	see (4+5) + Fine cracks
B	G (F) P C	see (1+2) + up to 1/16" cracks + light EFF
C	G (F) P C	Fine cracks + light EFF
D	G (F) P C	see (3) + Fine cracks + light EFF
E	G (F) P C	up to 1/16" cracks
F	G (F) P C	see (1) + Fine cracks + light EFF
G	G (F) P C	HL cracks
H	G (F) P C	HL cracks
BOLTS	(C) F P C

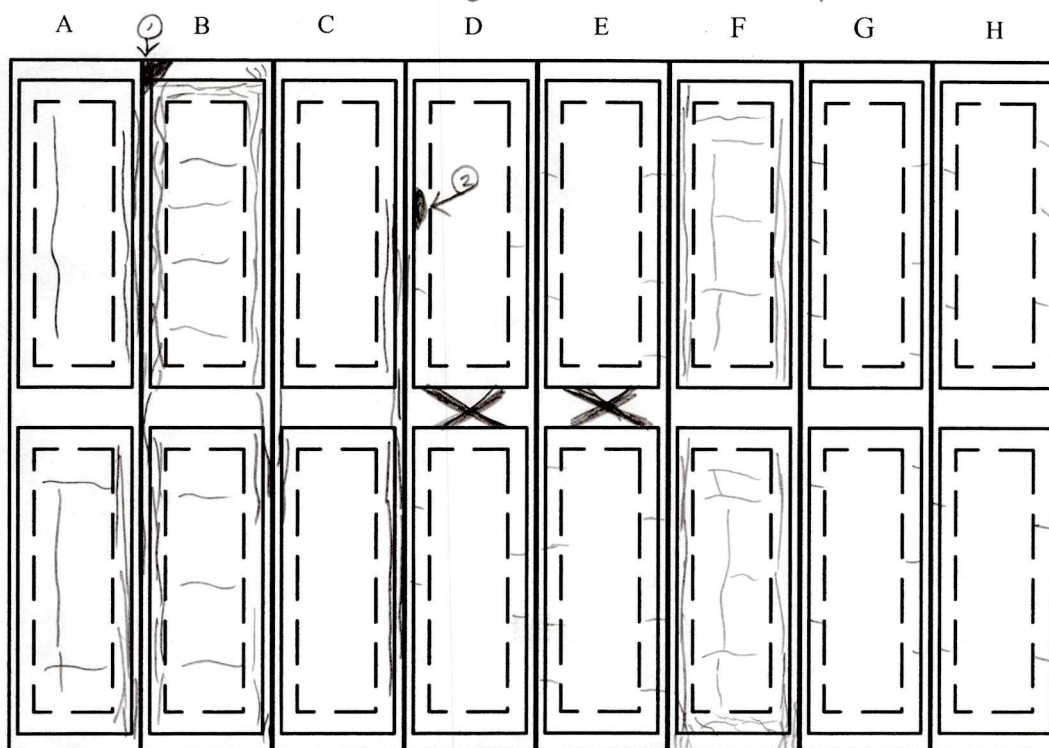
SPAN. NO. 2

① spalling area up to 16" L x 24" W x 2" deep

② spalling area up to 9" dia x 1/2" deep

ELEMENT	RATING	COMMENT
SLABS A	G F P C	
B	G F P C	see ① + fine cracks w/ EFF
C	G F P C	up to 1/16" cracks
D	G F P C	see ② + HL cracks
E	G F P C	HL cracks
F	G F P C	up to 1/16" cracks w/ EFF
G	G F P C	HL cracks
H	G F P C	HL cracks
BOLTS	G F P C

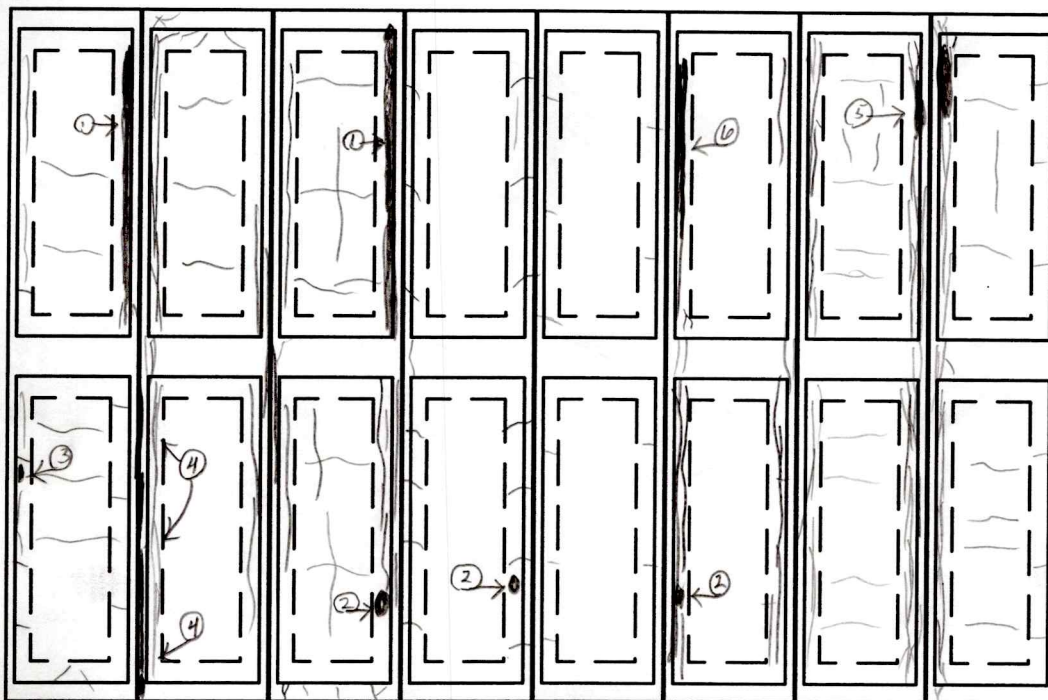
SPAN. NO. 3

④ spalling up to 8'2" x 6" w x 1" deep ⑤ spalling to steel up to 20'2" x 6" h x 3" deep + up to 1/8" section loss on steel

① spalling to steel areas up to 8'2" x 6" h x 3" deep + up to 1/8" section loss on steel

② spalling up to 14" dia x 1" deep

③ Shipped area up to 4" dia x 1/2" deep

ELEMENT	RATING	COMMENT
SLABS A	G F P C	see (1+3) + HL cracks
B	G F P C	see (4) + fine cracks w/ EFF
C	G F P C	see (1+2) + up to 1/8" cracks
D	G F P C	see (2) + HL cracks
E	G F P C	HL cracks
F	G F P C	see (2+6) + 1/8" cracks
G	G F P C	see (5) + up to 1/8" cracks + light EFF
H	G F P C	see (5) + fine cracks w/ EFF
BOLTS	G F P C

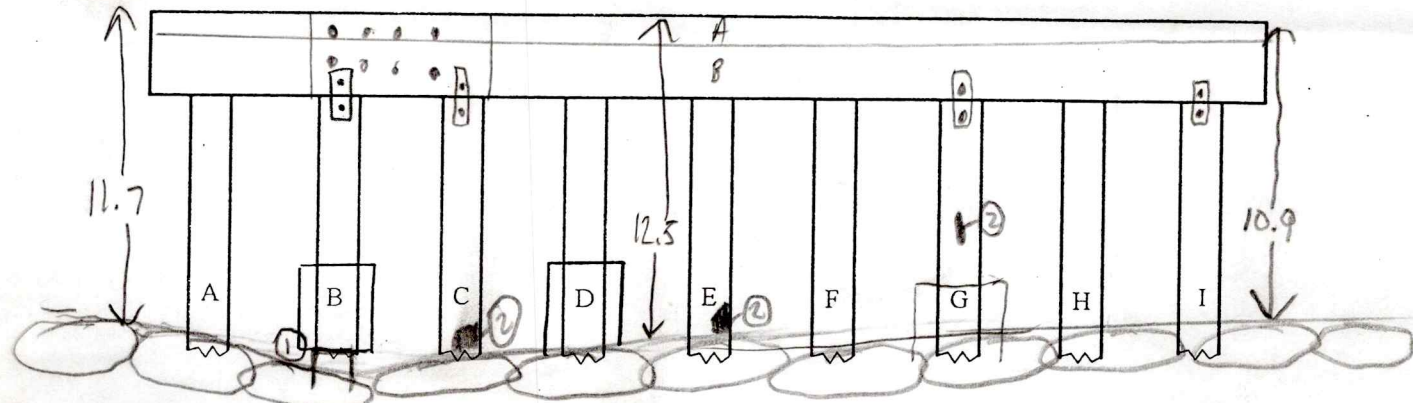
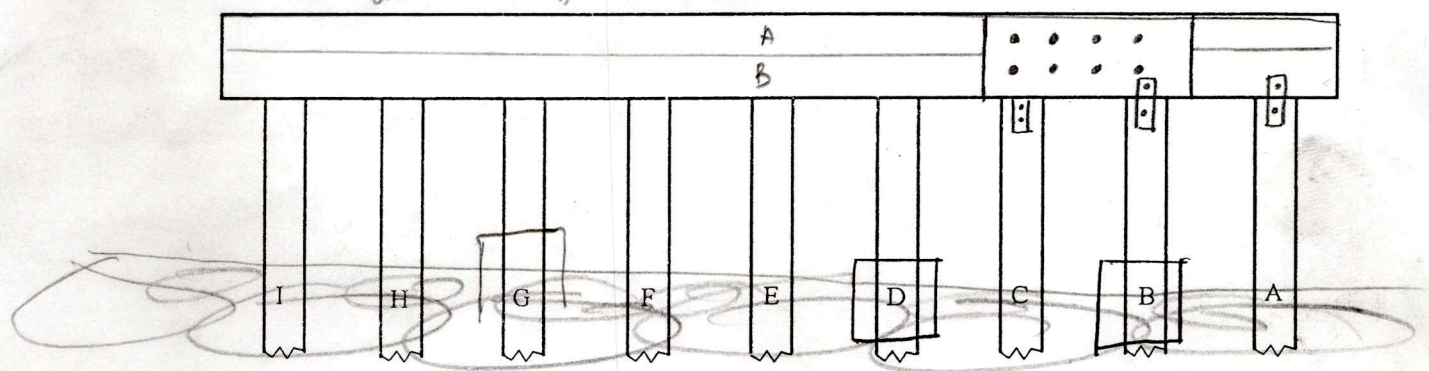
NOV 18 2021
BENT. NO. 2

① Embankment washing below
conc. casing B $\frac{6''}{\text{below}} \times \frac{3''}{\text{back}} \times \frac{1''}{\text{under}}$
② decay $\frac{6''}{H} \times \frac{6''}{W} \times \frac{1''}{D}$

ELEMENT	RATING	COMMENT
BEARINGS	G F P C	NV
CAP A+B	G (F) P C	light to medium weathering
PILES A	G (F) P C	light to medium weathering
B	G (F) P C	
C	G (F) P C	see ②
D	G (F) P C	light to medium weathering
E	G (F) P C	see ②
F	G (F) P C	light to medium weathering
G	G (F) P C	
H	G (F) P C	
I	G (F) P C	
bracing	G (F) P C	medium weathering
rip rap	(G) (F) P C	
emb.	(F)	see ①

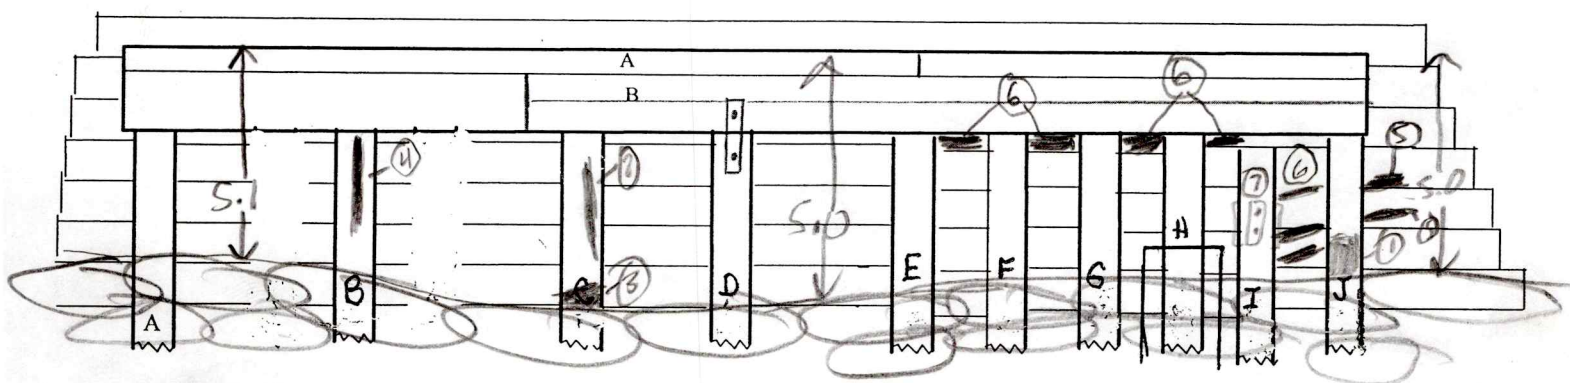
ABUT. NO. 2

② decay
 $\frac{2'}{H} \times \frac{6''}{W} \times \frac{1''}{D}$

③ 1/2" decay and
pile

⑥ broken Areas on
breast wall $\frac{2'}{W} \times \frac{6''}{H} \times \frac{4''}{D}$
Cap B covered by
(2) 3"x6" boards

④ decay $\frac{1'}{H} \times \frac{6''}{W} \times \frac{1''}{D}$

⑤ broken Area on wing
 $\frac{1'}{L} \times \frac{6''}{H} \times \frac{4''}{D}$

① decay and
pile
 $\frac{1'}{H}$
pile size is $\frac{12''}{Diameter} \times \frac{12''}{D}$

⑦ splice on
pile I, new piece
 $\frac{16''}{Diameter} \times \frac{16''}{H}$

ELEMENT	RATING	COMMENT
CAP A+B	G F P C	light to medium weathering
WINGS	G F P C	see ⑤
PILES A-	G F P C	light to medium weathering
B	G F P C	see ④
C	G F P C	see ② & ③
D-I	G F P C	light to medium weathering
J	G F P C	see ①
BREASTWALL	G F P C	see ⑥
EMB.	G F P C	
VEG.	G F P C	heavy growth
RIP-RAP	G F P C	scattered
CONCRETE CASING	G F P C	
bracing	F	medium weathering
