Region 04, 49 - Lauderdale County

SR-87 Crossing BRANCH

90 - LAST INSPECTION DATE 06/13/2024

| IDENTIFICATION | |
|---|---|
| (8) Structure Number | 49SR0870025 |

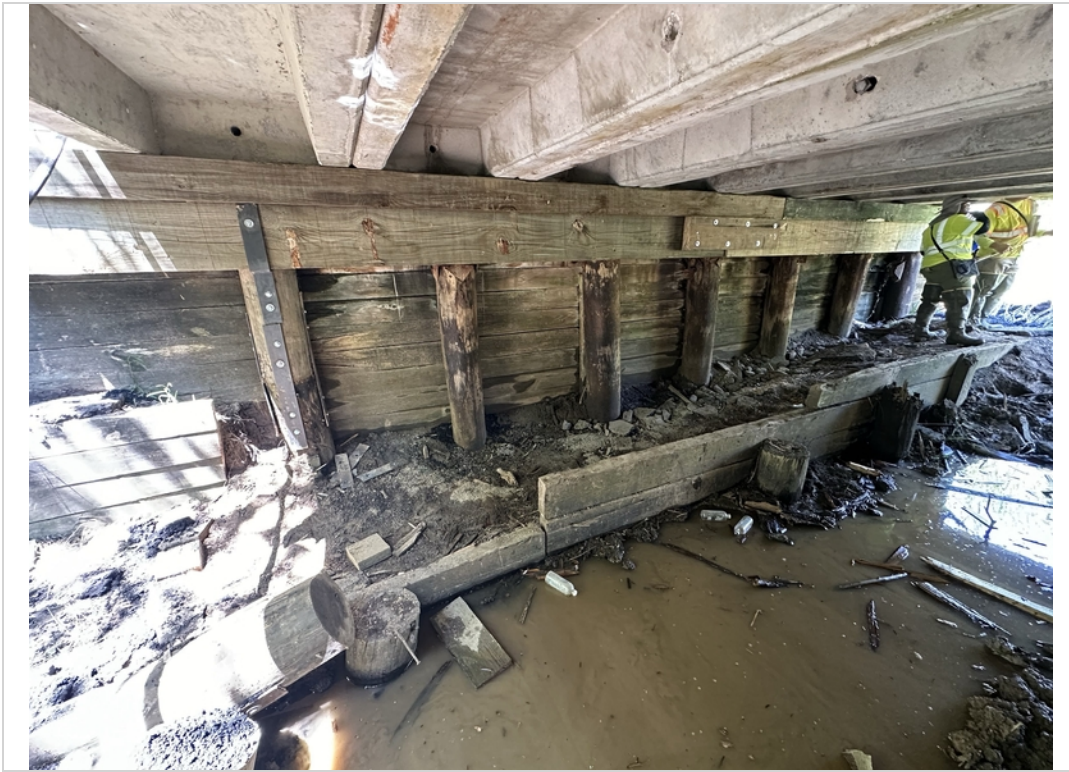
| <b>Abutment Breastwall</b> | (Poor) | Decay at abutment 2 |

This is a BER inspection. This is now a one span PCCS bridge with timber substructure. The safety features are metal approach rails, metal bridge rails, and paddle boards. There is a weight limit posting at Approach 1 and 2(3T/3T). The asphalt roadway has cracks up to 1/4". The PCCSs have hairline cracks and damage. The timber substructure has light to medium weathering and up to 1/8" checks. Abutment 2 breastwall has heavy decay. The scour has no problems.

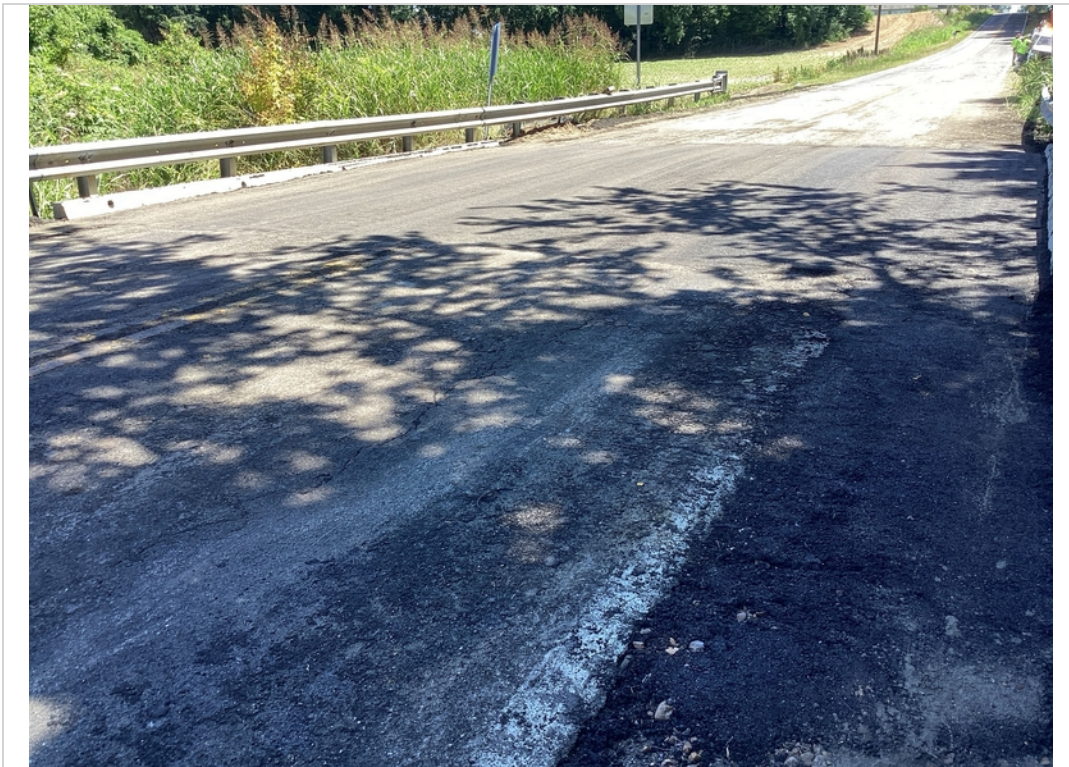
Approach 2 asphalt spalled and settled

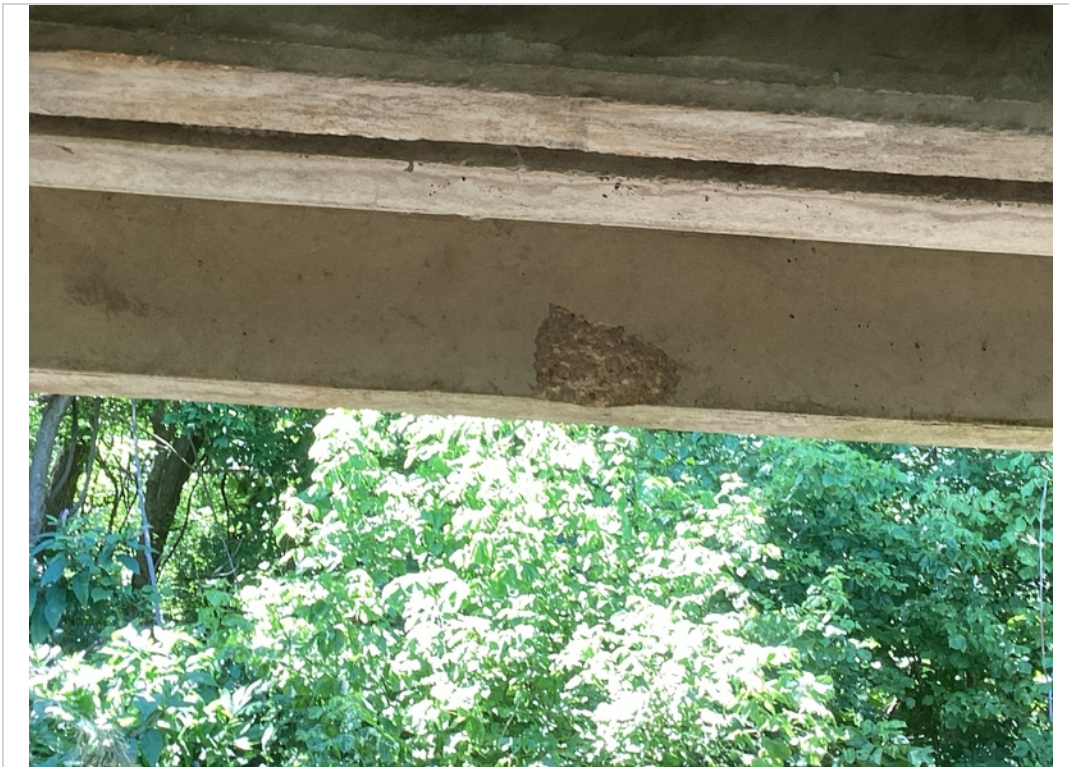
Span 1 slab A, damage

| ELEMENT | | RATING | COMMENT |
|---|---|---|---|
| | C | G F P C | (3) Damage<br>6" L x 3" H x 1/8" D |

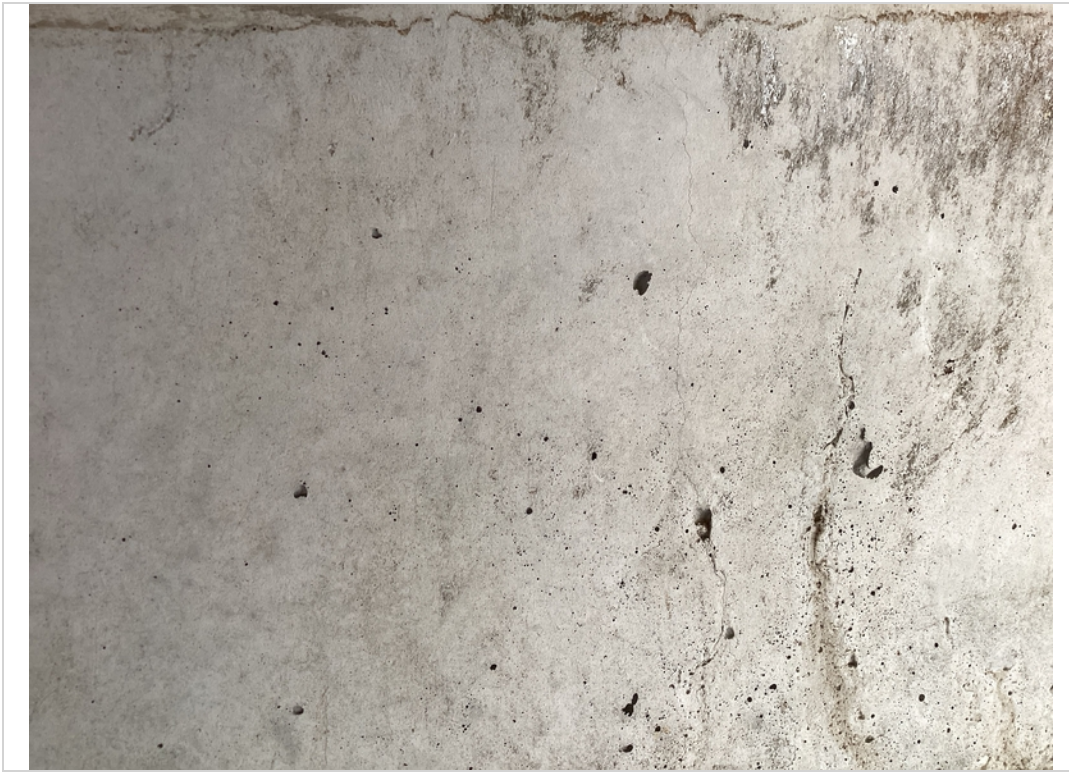
Span 1 slab H, hairline cracks

| ELEMENT | | RATING | COMMENT |
|---|---|---|---|
| | H | G F P C | Horizontal Cracks |

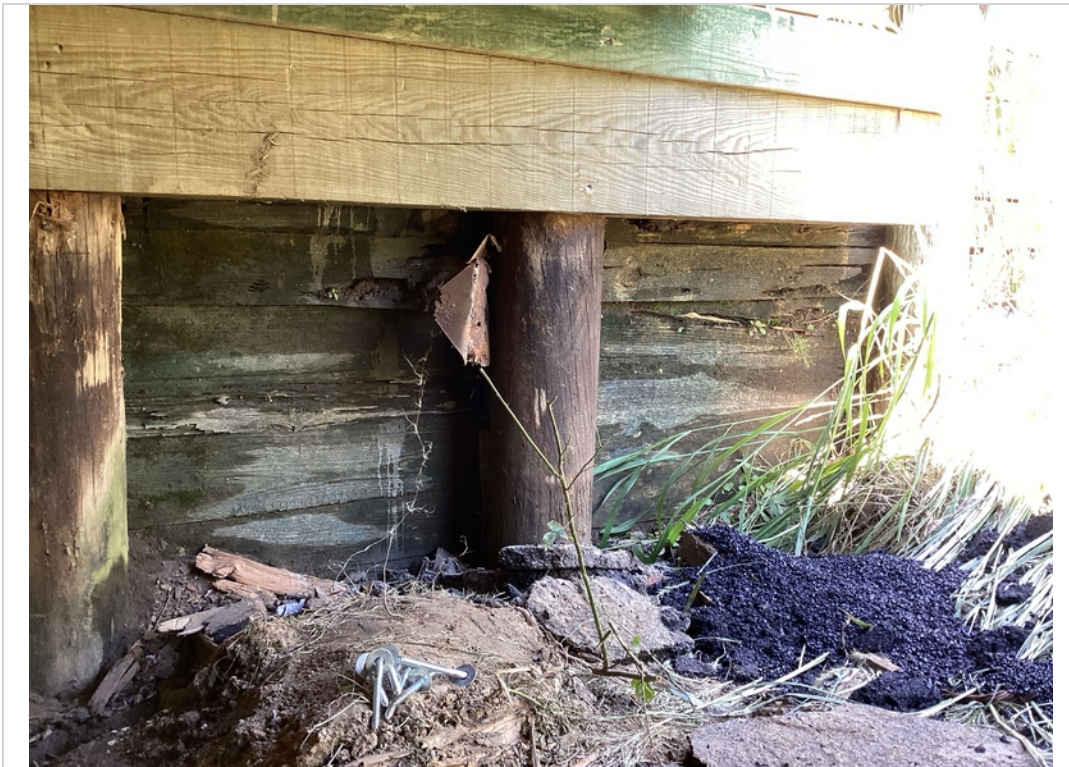
Breast wall at abutment 2 decay

| ELEMENT | RATING | COMMENT |
|---|---|---|
| BREASTWALL | G (F) P C | Decay Areas |
