LAUDERDALE COUNTY

BRIDGE MAINTENANCE RECOMMENDATIONS

LOCATION: 49-SR087-11.75-

BRIDGE INSPECTION REPORT

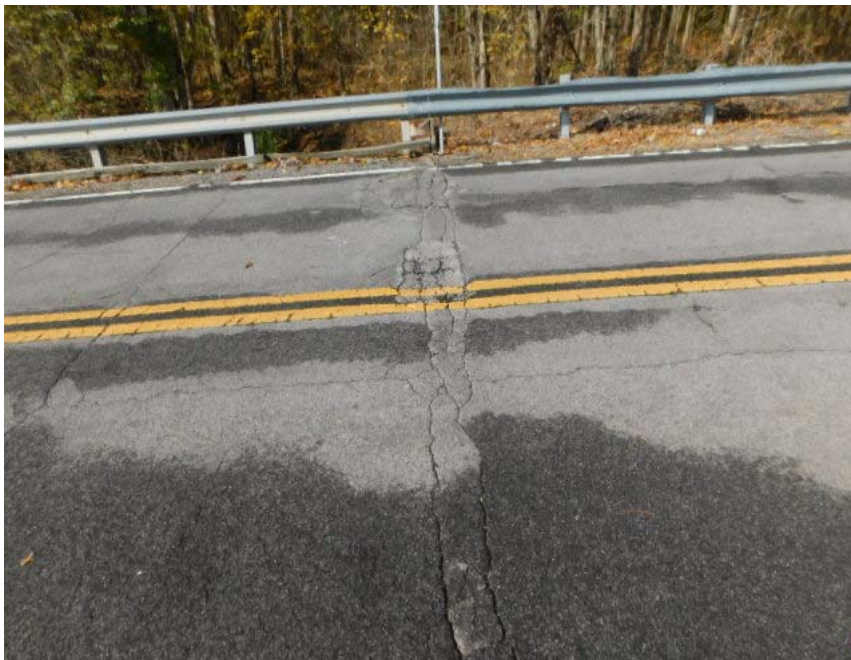
APPROACH #2 ASPHALT PATCHED & SETTLED

Approach #2 asphalt is poor, cracked, patched and settled.

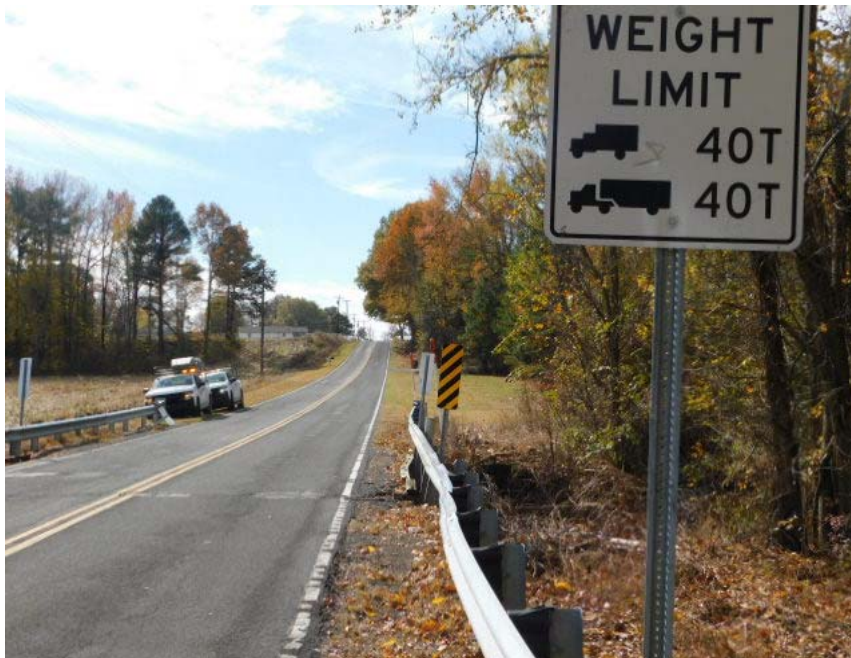
APPROACH #2 WITH 40 TON/40 TON WEIGHT LIMIT SIGN

Approach #1 weight limit sign has been knocked down.

No.	RECOMMENDATIONS	REPAIR DATE	REPAIRED BY
1.	REPLACE MISSING WEIGHT POSTING SIGN(S) (APPROACH #1

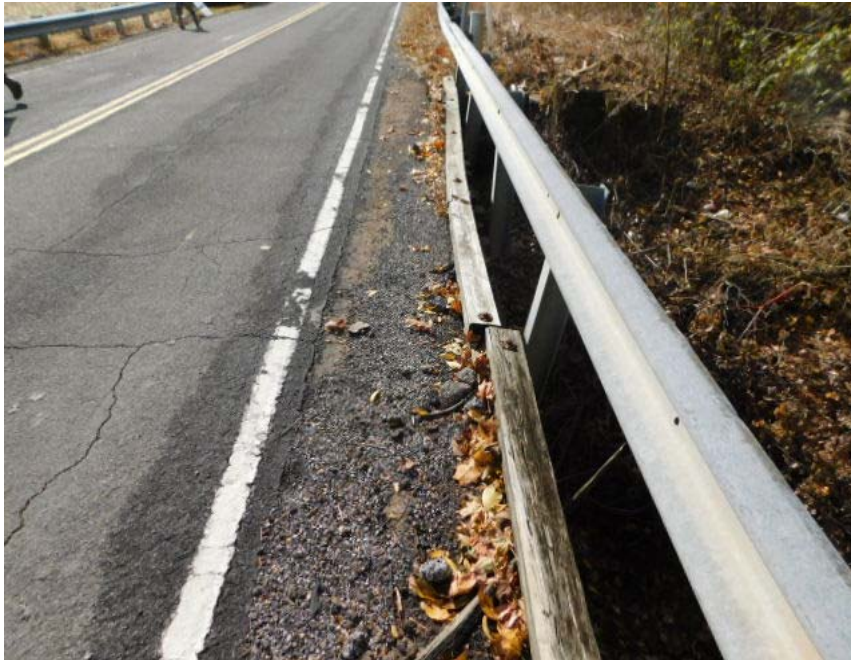
SPAN #1, LEFT SIDE WITH WHEELGUARDS BROKEN

Span #1, left wheel guard is poor.

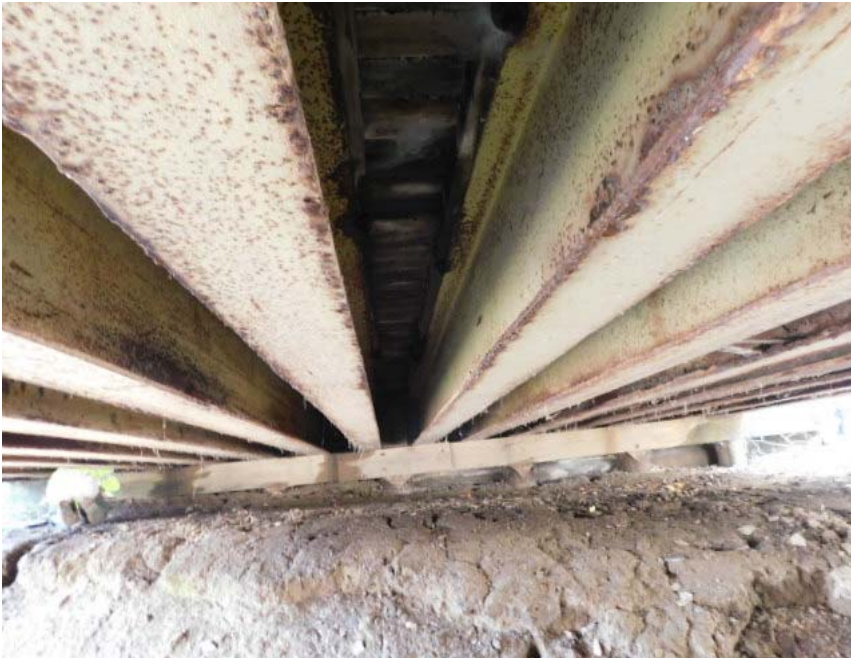
SPAN #1, BOTTOM OF DECK

The bottom deck has medium weathering and decay.

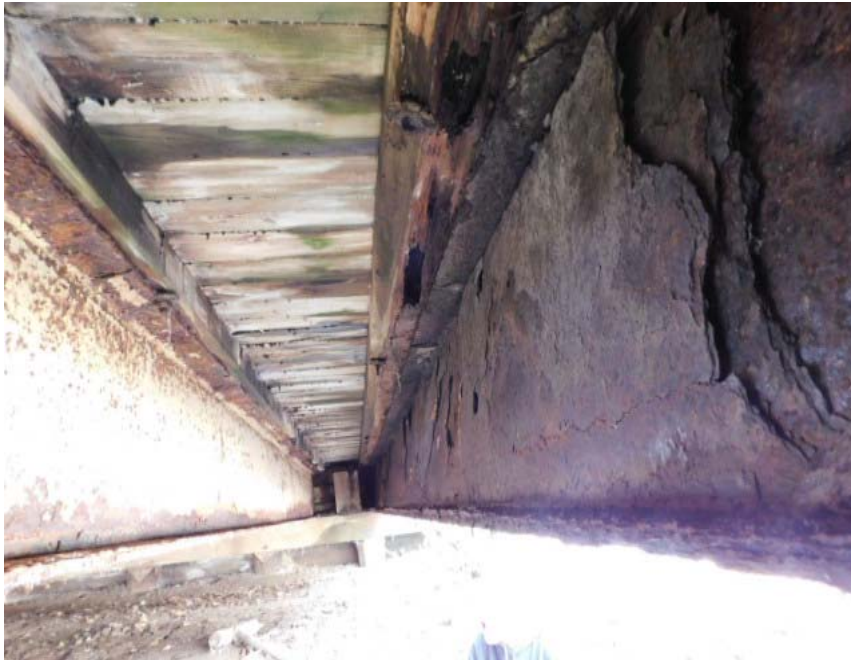
SPAN #1, STEEL "I" BEAM "A" WITH COLLISION DAMAGE

Alignment is poor on steel "I" beam "A" out of alignment 3".

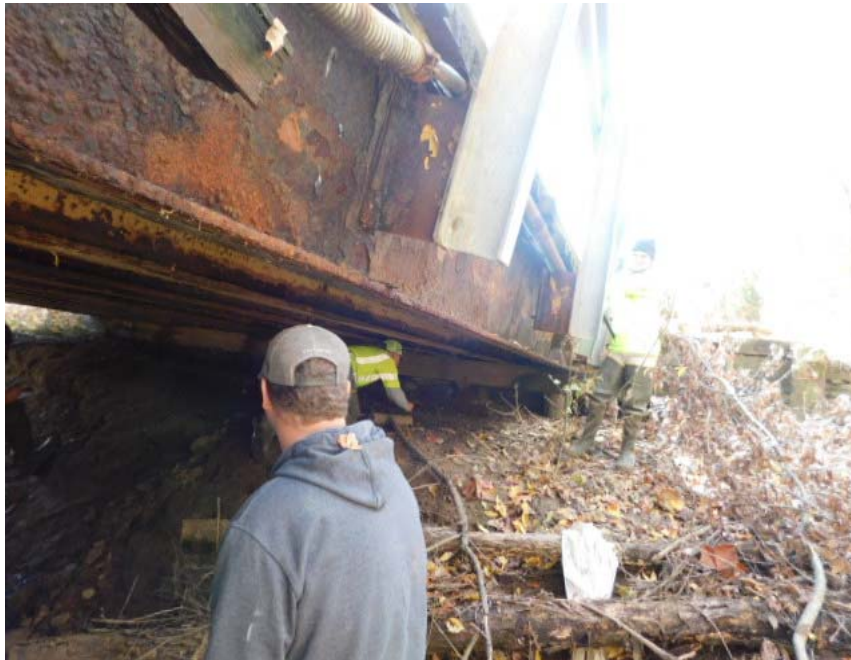
SPAN #1, STEEL "I" BEAM "A" WITH COLLISION DAMAGE

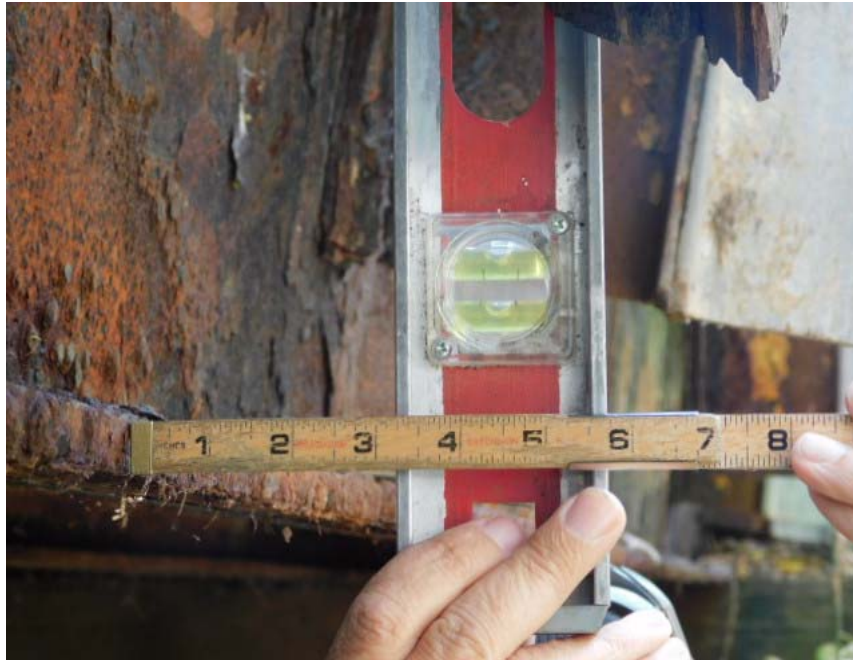
SPAN #1, STEEL "I" BEAM "A" WITH COLLISION DAMAGE

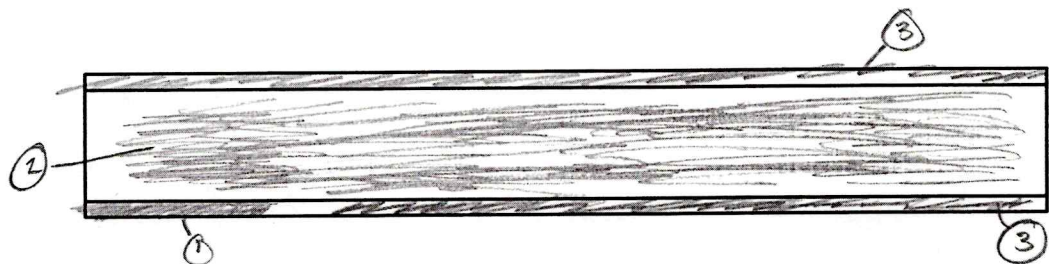
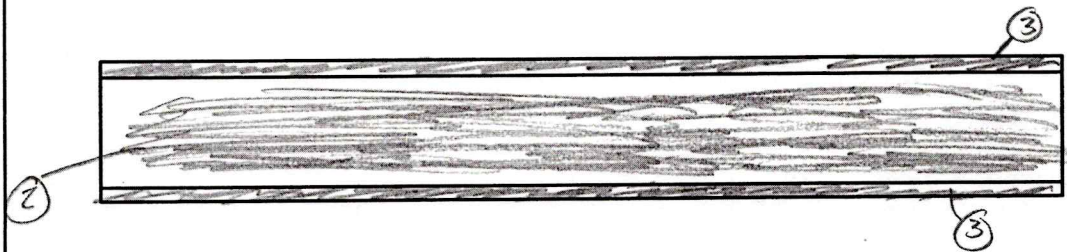
S. I. B. 'A'

① 7/16" Section loss on Bottom flange
5'6" x 2 1/2" wide

② 1/16" Section loss length of Beam

③ 1/8" Section loss on top flange length of Beam

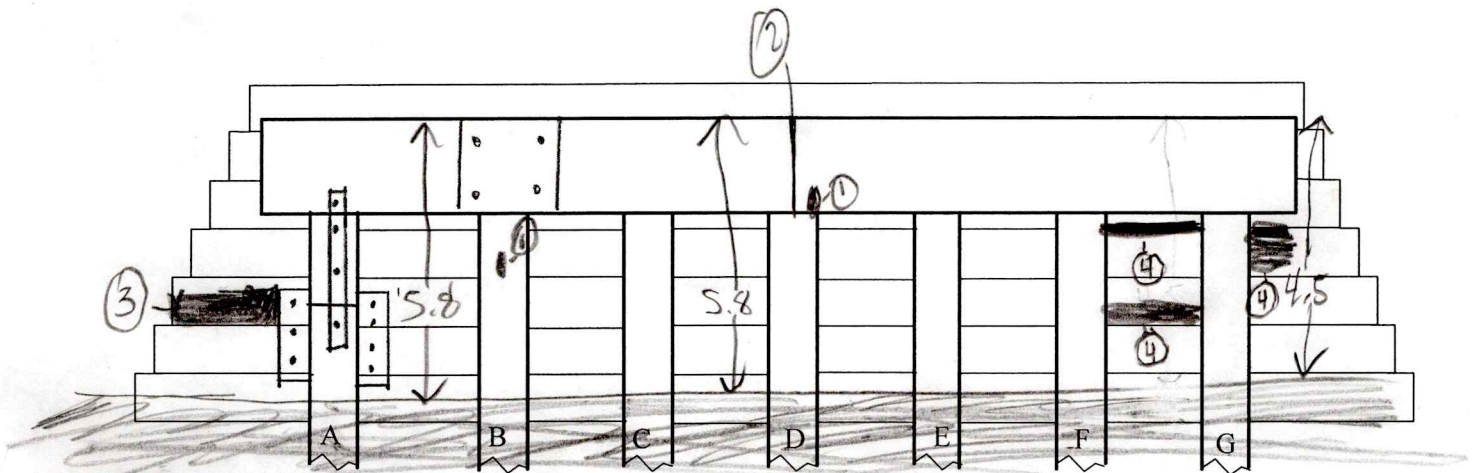
ABUT. NO. NOV 18 2021 2

- ① Decayed Area
4" diameter x $\frac{1}{8}$ "
- ② Spliced Cap
- ③ broken Area on wing
 $2' \times \frac{1}{4} \times \frac{1}{8}$
- ④ broken Area on breastwall
 $2' \times 10' \times \frac{1}{4} \times \frac{1}{8}$

ELEMENT	RATING	COMMENT
CAP	G (F) P C	See ① + medium weathering
WINGS	G F (P) C	See ③
PILES A	G (F) P C	right to medium weathering
B	G (F) P C	See ① + right to medium weathering
C	G (F) P C	right to medium weathering
D	G (F) P C	
E	G (F) P C	
F	G (F) P C	
G	G (F) P C	
BREASTWALL	G F (P) C	See ④
EMB.	(G) F P C	
VEG.	(G) F P C	
RIP RAP	G F P C	
	G F P C	
	G F P C
