## LAUDERDALE COUNTY

# Bridge Maintenance Recommendations

Bridge Location No.: **49 - SR087 - 1911**

Bridge Number: **49SR0870033**

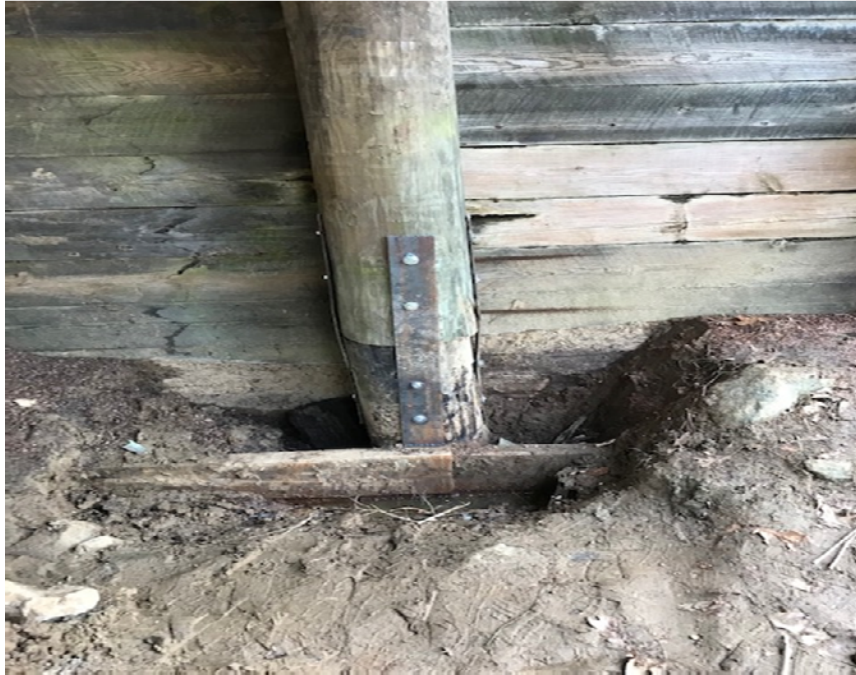
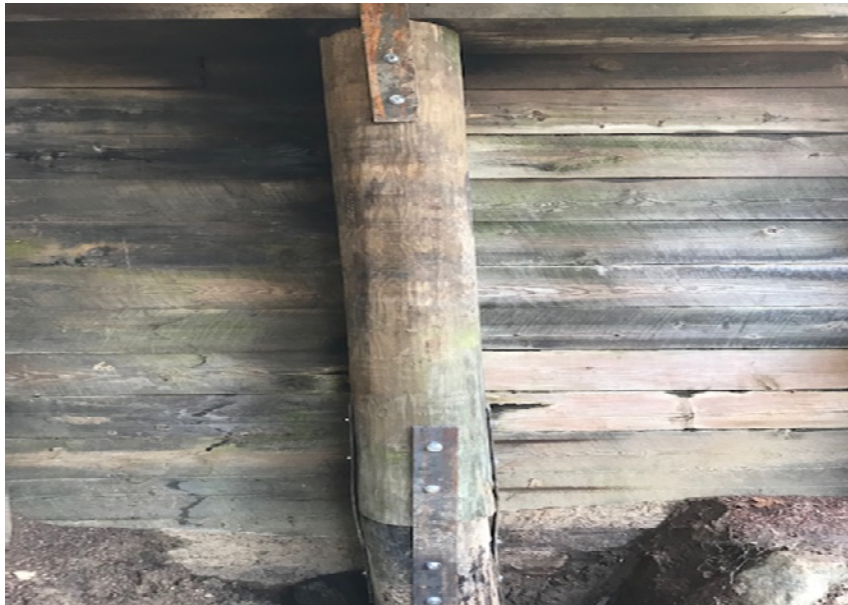
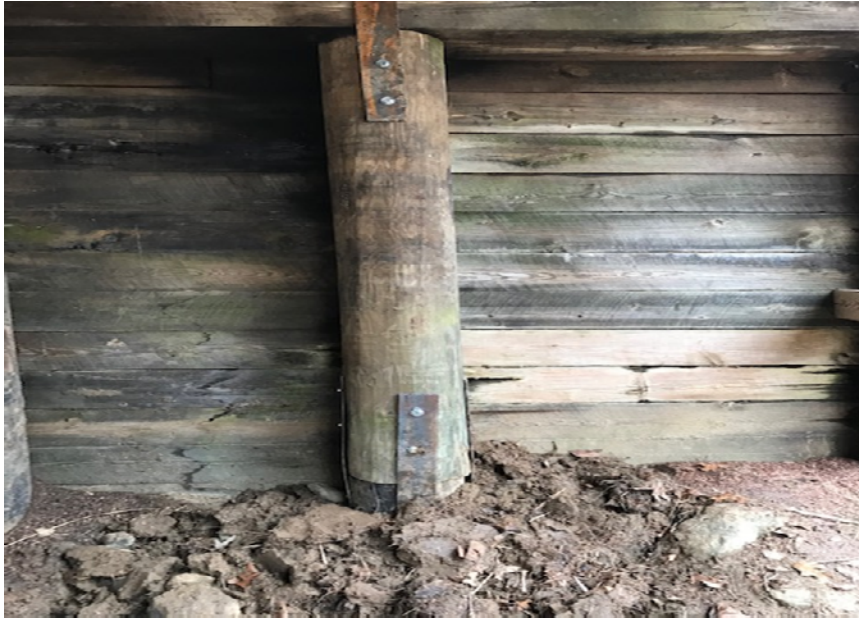
**STUBBED PILING "G" AT ABUTMENT #2 7 FT. FROM CAP**

The substructure has light to medium weathering, decay & 2" shakes with decay on pile "g" on abutment # 2.

238	BRIDGERAILS ARE SUBSTANDARD
228	APPROACH GUARDRAILS ARE SUBSTANDARD
185	REPAIR_TIMBER_PILE _G_ AT ABUTMENT NO. _2 (12-13-21 REPAIRED BY BRIDGE REPAIR)
043	CLEAN DRAINS IN SPAN NO. _1 & 2 (12-13-21 CLEANED BY BRIDGE REPAIR)
135	REPAIR_TIMBER_CAP "A" AT _BENT_ NO. _1 (12-13-21 CAPS "A" & "B" REPAIRED BY BRIDGE REPAIR)

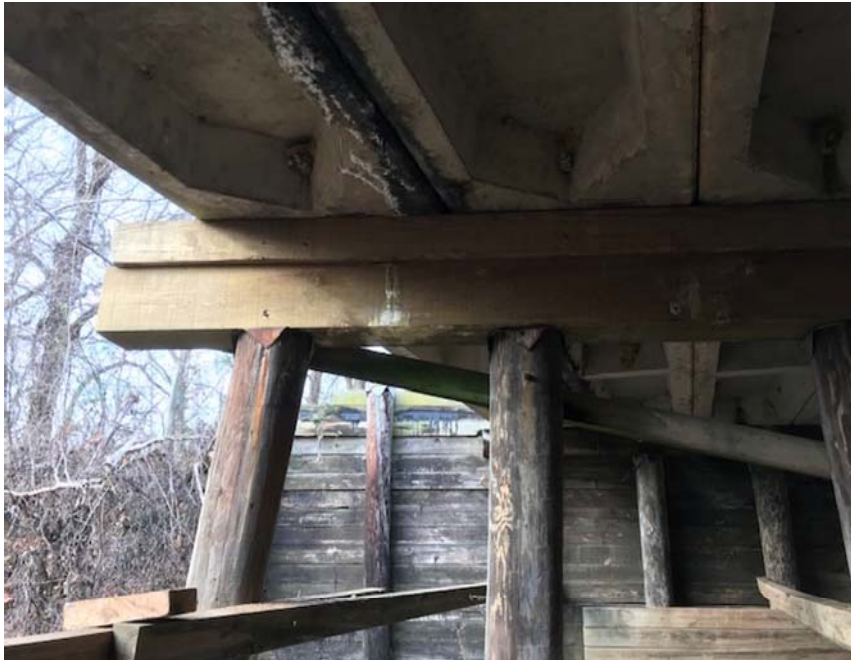
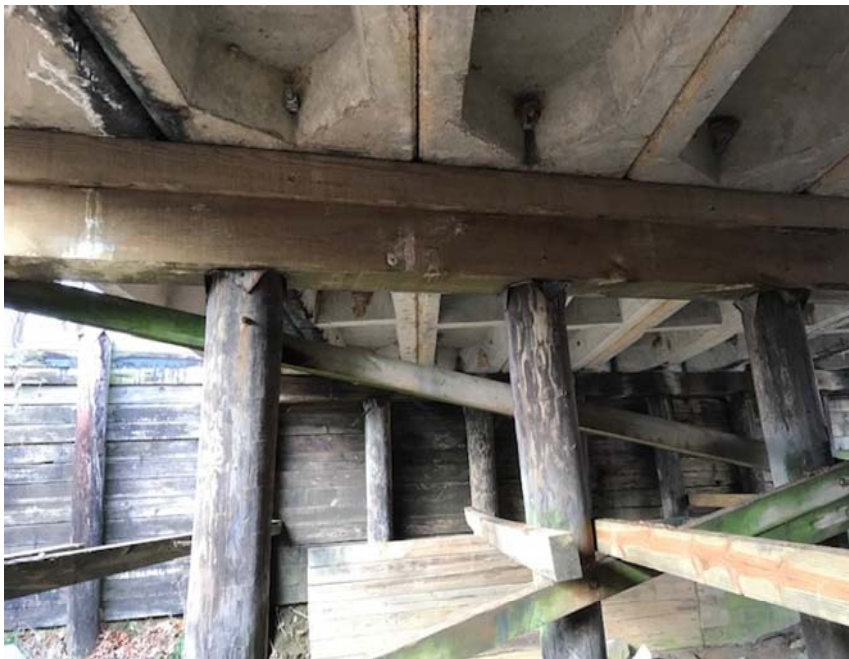
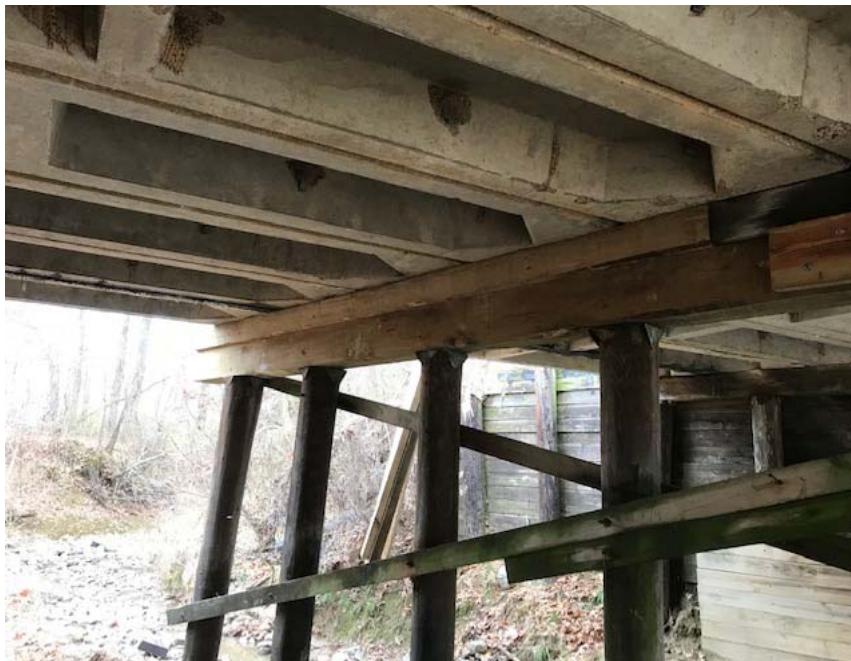
**REPLACED TIMBER CAP "A" & "B" AT BENT #1, RT. SIDE**

Bent # 1 cap "a" has heavy decay.

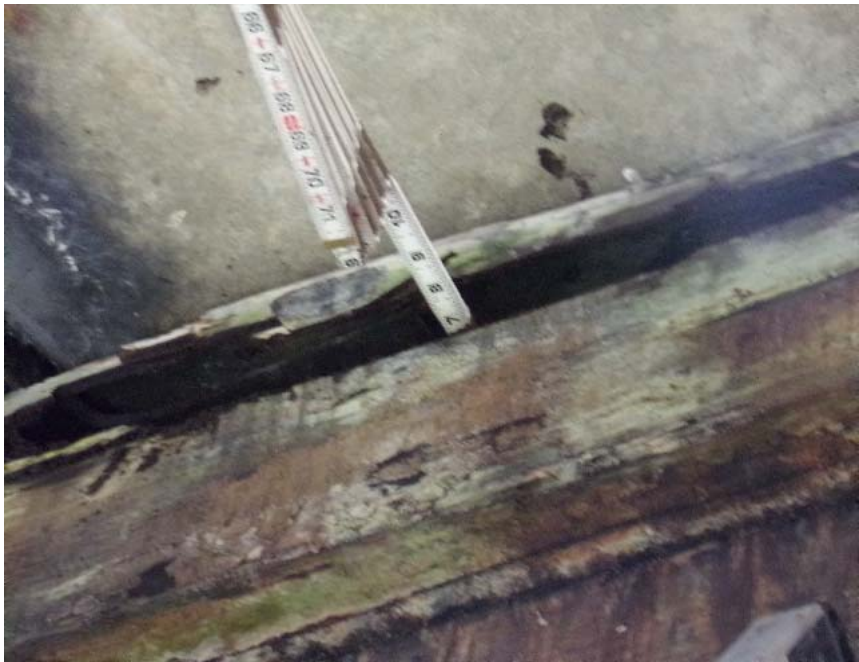
**CAP "A" BENT # 1**

Rating	Comments	PILE(S)	BENT
Caps	G F <u>(P)</u> C	Bent #1 cap "A" (135)		
Columns	G F P C			
Plumb	<u>(G)</u> F P C			
Footings	G F P C			
Piles	G <u>(F)</u> P C			
Bearing R.R. Rag	<u>(G)</u> F P C			
Bracing	G <u>(F)</u> P C			
Earthquake Devices	G F P C

REPAIR OR REPLACE PILE "G" AT ABUTMENT NO.2  
REPAIR CAPBEAM "A" AT BENT NO.1  
CLEAR DRAINS  
APPROACH GUARDRAILS ARE SUBSTANDARD  
BRIDGERAILS ARE SUBSTANDARD

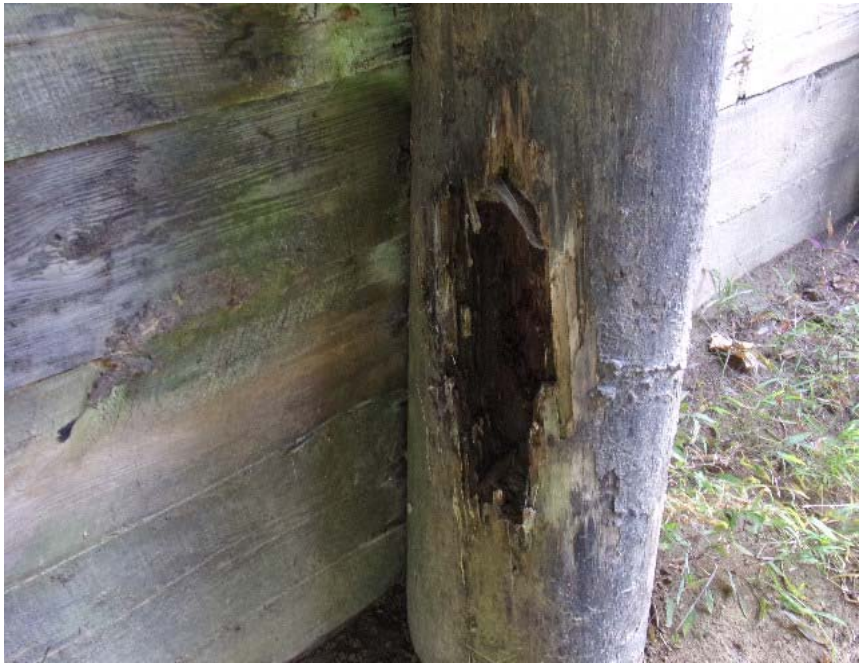
**PILE "G" ON ABUTMENT # 2**

Rating	Comments	PILE(S)	ABUTMENT
Caps	G <u>(F)</u> P C			
Breastwall	G <u>(F)</u> P C			
Wings	G <u>(F)</u> P C			
Backwall	G F P C			
Plumb	G <u>(F)</u> P C			
Footing	G F P C			
Piles	G F <u>(P)</u> C	Abut #2 Pile "C" (185)		
Embankment	<u>(G)</u> F P C			
Bearing	G F P C			
Slope Paving Ret. wall	G <u>(F)</u> P C			
Rip Rap	G <u>(F)</u> P C			
Earthquake Devices	G F P C

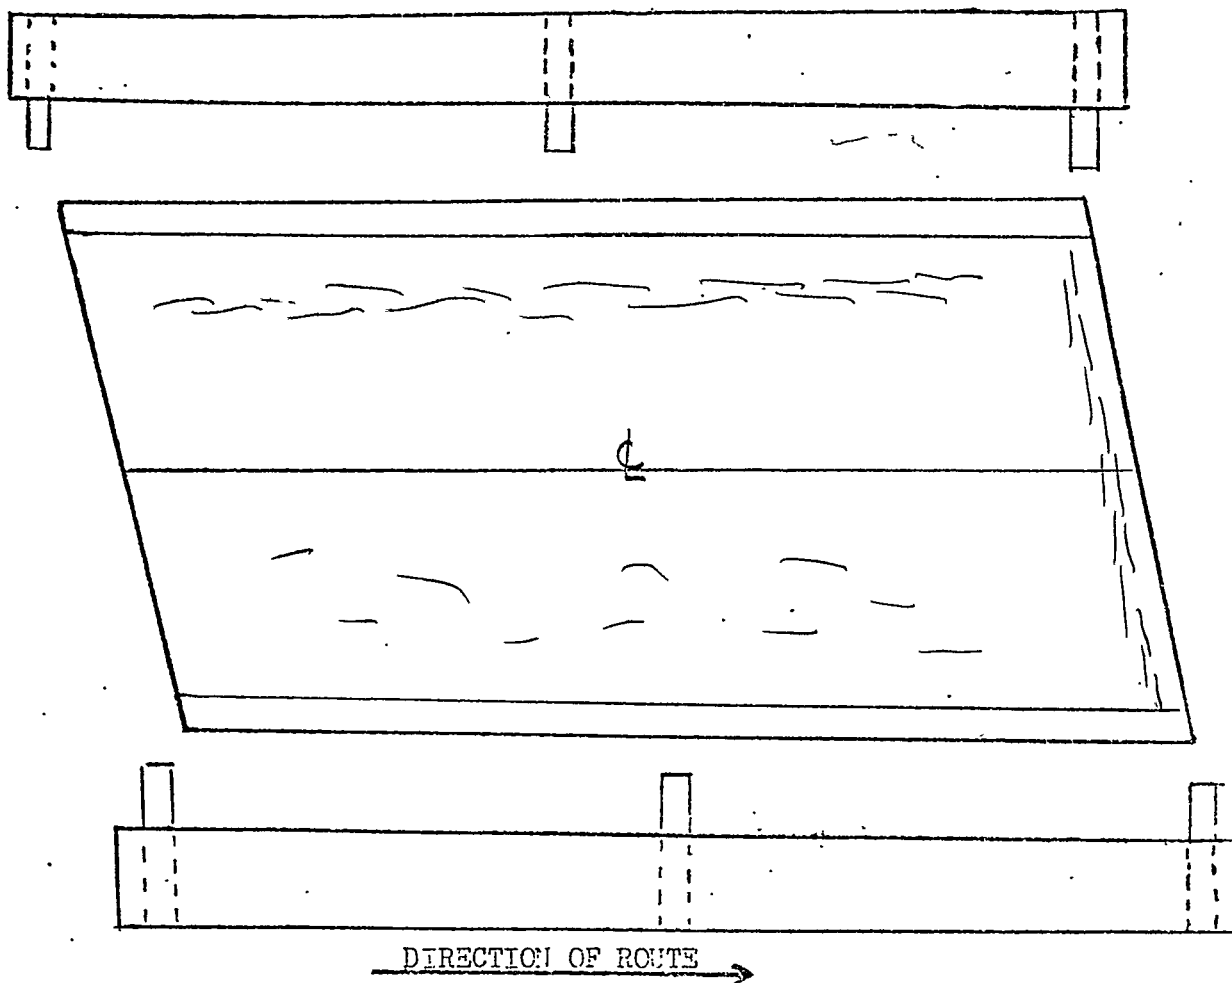
SKEW 75 RT. SPAN NO. 1

ELEMENT	RATING	COMMENT
TOP DECK	G <u>F</u> P C	Cracks up to 1/8"
CURBS	G <u>F</u> P C	
RAILS & POSTS	G <u>F</u> P C	
PAINT	G F P C	
DRAINS	G F <u>P</u> C	100% filled w/ debris
JOINTS	G F P C

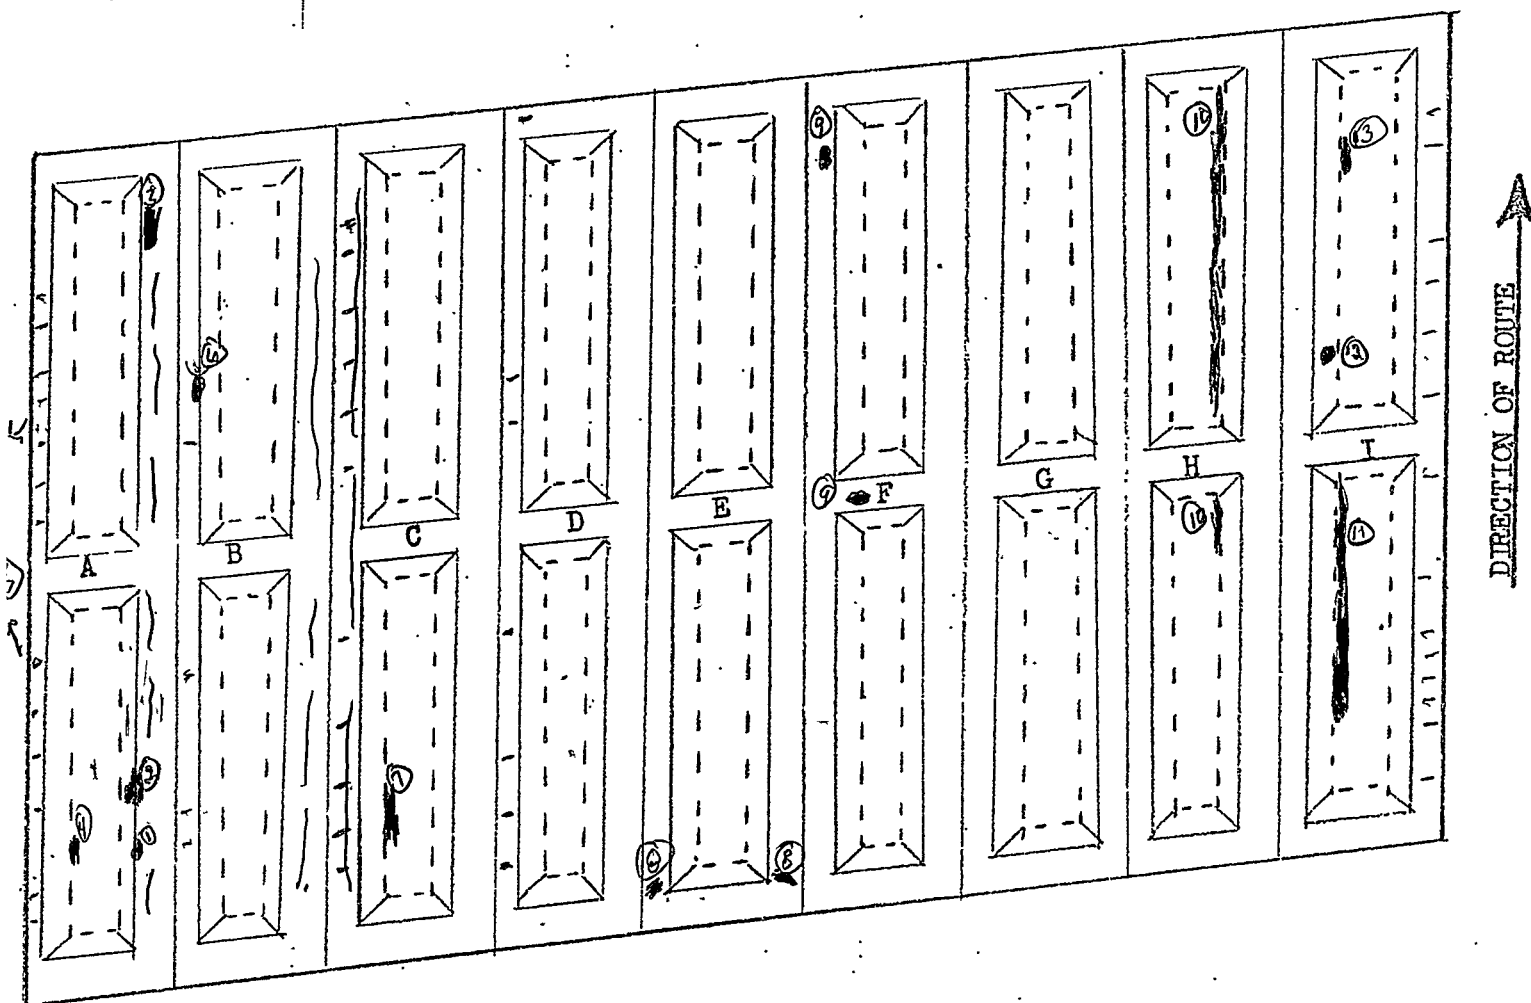
9 PRECAST CONCRETE SLABS

Element	Rating	Comment
SLAB	A G (F) P C	HAIRLINE CRACKS WITH EFF + SEE 1-5
	B G (F) P C	SEE 6 + SURFACE STEEL
	C G (F) P C	SEE 7 + FINE CRACKS + SURFACE RUST
	D G (F) P C	SURFACE RUST
	E G (F) P C	SEE 8
	F G (F) P C	SEE 9
	G (G) F P C	
	H G (F) P C	SEE 10
	I G (F) P C	SEE 11, 12, 13 + SURFACE RUST
BOLTS	(G) F P C

- ① Spall to steel  $4\frac{1}{2}'' \times 1\frac{1}{2}''$
- ② Impending Spall  $1\frac{1}{2}'' \times 4\frac{1}{2}'' \times 3\frac{1}{2}''$
- ③ Spall to steel  $1\frac{1}{2}'' \times 6\frac{1}{2}'' \times 3\frac{1}{2}''$
- ④ Spalling  $1\frac{1}{2}'' \times 4\frac{1}{2}'' \times 1\frac{1}{2}''$
- ⑤ SURFACE STEEL
- ⑥ Spall to steel  $1\frac{1}{2}'' \times 6\frac{1}{2}'' \times 1\frac{1}{2}''$
- ⑦ | | |  $1\frac{1}{2}'' \times 6\frac{1}{2}'' \times 3\frac{1}{2}''$
- ⑧ Spalling  $1\frac{1}{2}'' \times 6\frac{1}{2}'' \times 3\frac{1}{2}''$
- ⑨ |  $6\frac{1}{2}'' \times 3\frac{1}{2}''$
- ⑩ Spall to steel  $8\frac{1}{2}'' \times 4\frac{1}{2}'' \times 5\frac{1}{2}''$
- ⑪ | | |  $6\frac{1}{2}'' \times 4\frac{1}{2}'' \times 5\frac{1}{2}''$
- ⑫ Spalling  $6\frac{1}{2}'' \times 2\frac{1}{2}''$
- ⑬ Spall to steel  $1\frac{1}{2}'' \times 3\frac{1}{2}'' \times 1\frac{1}{2}''$

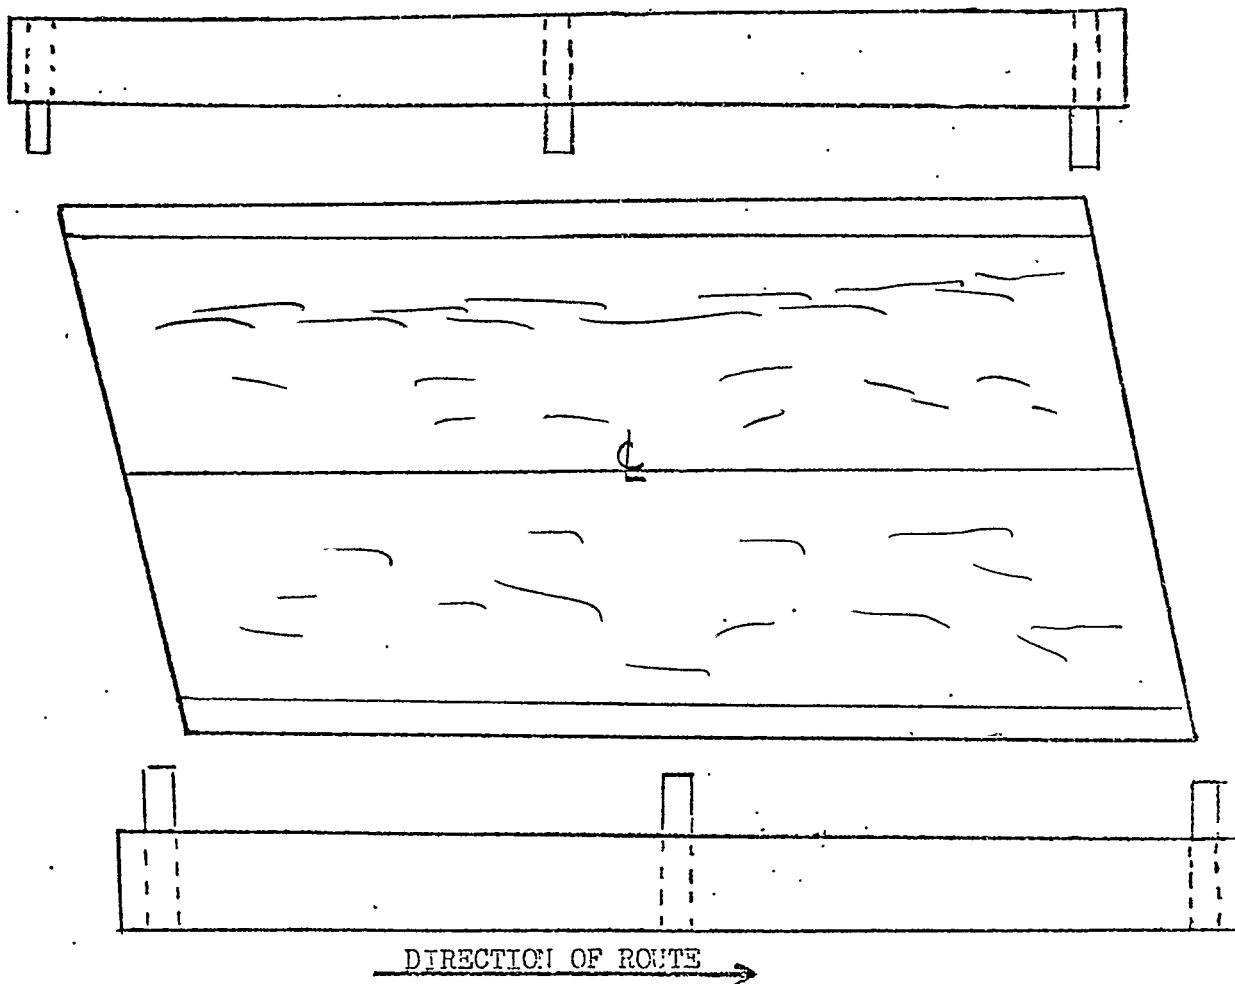
SKEW 75 RT. SPAN NO. 2

ELEMENT	RATING	COMMENT
TOP DECK	G <u>F</u> P C	Cracks up to 1/8"
CURBS	<u>G</u> F P C	
RAILS & POSTS	<u>G</u> F P C	
PAINT	G F P C	
DRAINS	G F <u>P</u> C	100% filled w/ debris
JOINTS	G F P C

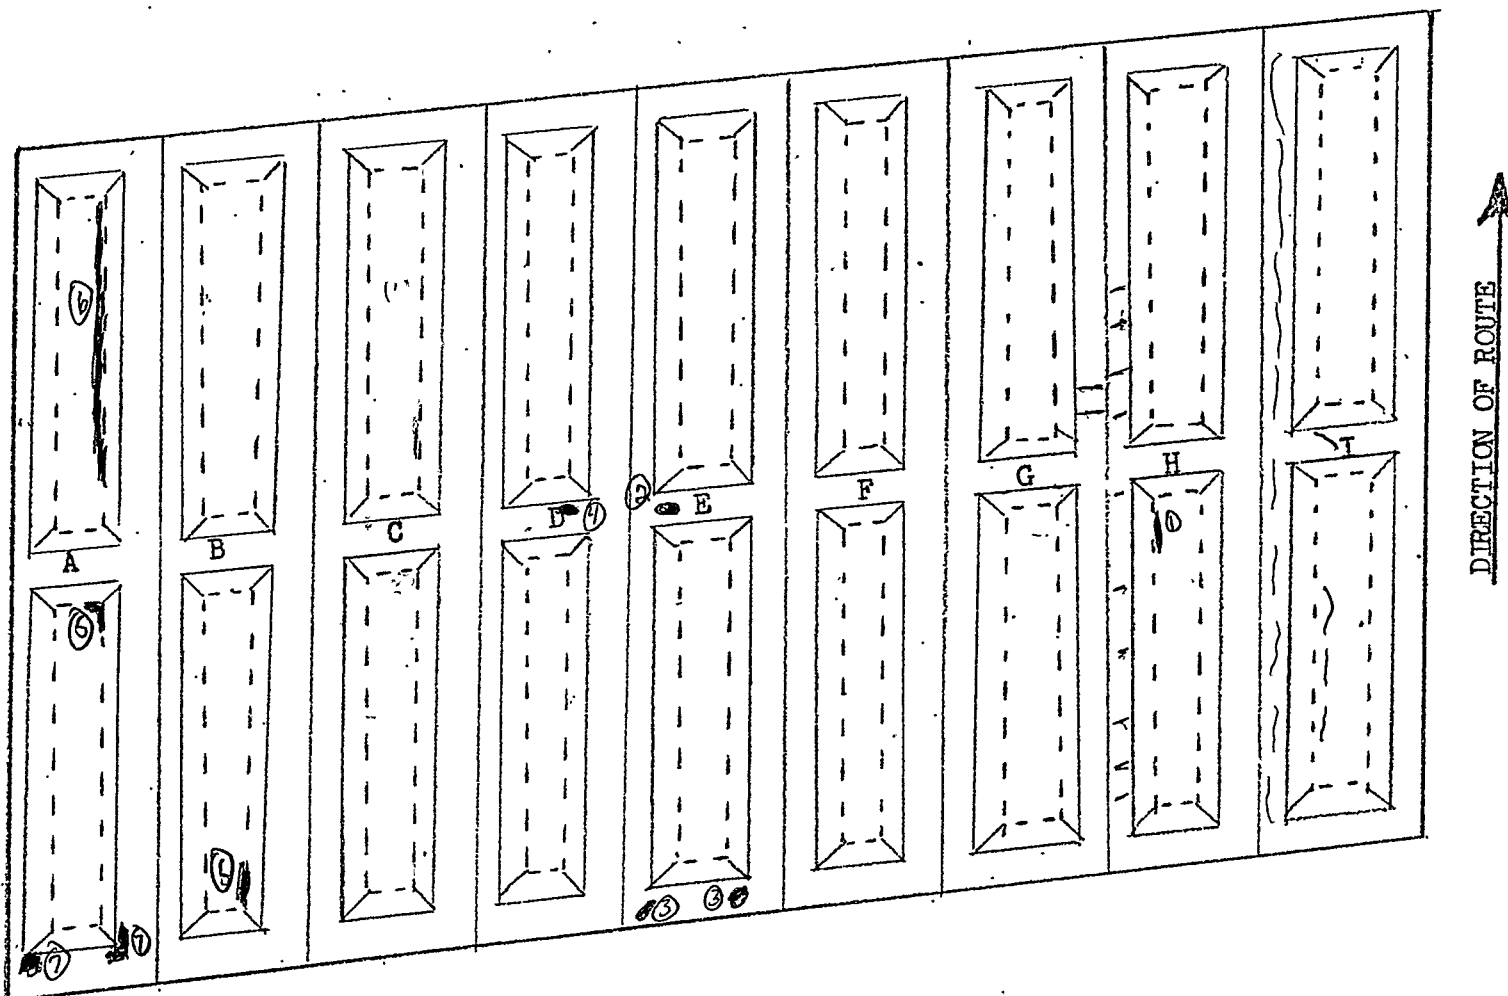
SPAN NO. 2

Element	Rating	Comment
SLAB	A G (F) P C	SEE 5, 6, 7
	B G (F) P C	SEE 5
	C (G) F P C	
	D G (F) P C	SEE 4
	E G (F) P C	SEE 2, 3
	F (G) F P C	
	G (G) (F) P C	Hairline Cracks with Eff
	H G (F) P C	SEE 1 + Surface Rust
	I G (F) P C	Hairline Cracks with Eff
BOLTS	(G) F P C

- ① Impending Spall  $1\frac{1}{2} \times 3\frac{1}{4} \times \frac{3}{8}$
- ② Spalling  $6\frac{1}{2} \times 4\frac{1}{2} \times 1\frac{1}{2}$
- ③  $4\frac{1}{2} \times 1\frac{1}{2} \times \frac{1}{2}$
- ④  $6\frac{1}{2} \times 3\frac{1}{2} \times 1\frac{1}{2}$
- ⑤ Spall to Steel  $1\frac{1}{2} \times 6\frac{1}{2} \times 4\frac{1}{2}$
- ⑥  $6\frac{1}{2} \times 6\frac{1}{2} \times 5\frac{1}{2}$
- ⑦ Spalling  $1\frac{1}{2} \times 1\frac{1}{2}$
