# BRIDGE MAINTENANCE RECOMMENDATIONS

Tennessee Department  
of Transportation

LOCATION: 49-SR371-01.39-

FED. BRIDGE NO.: 49SR0872003

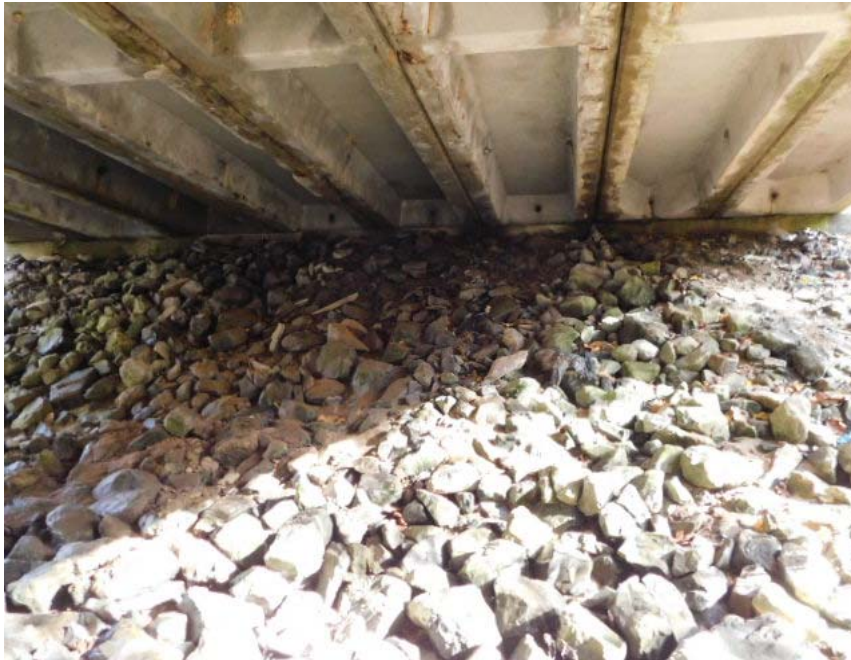
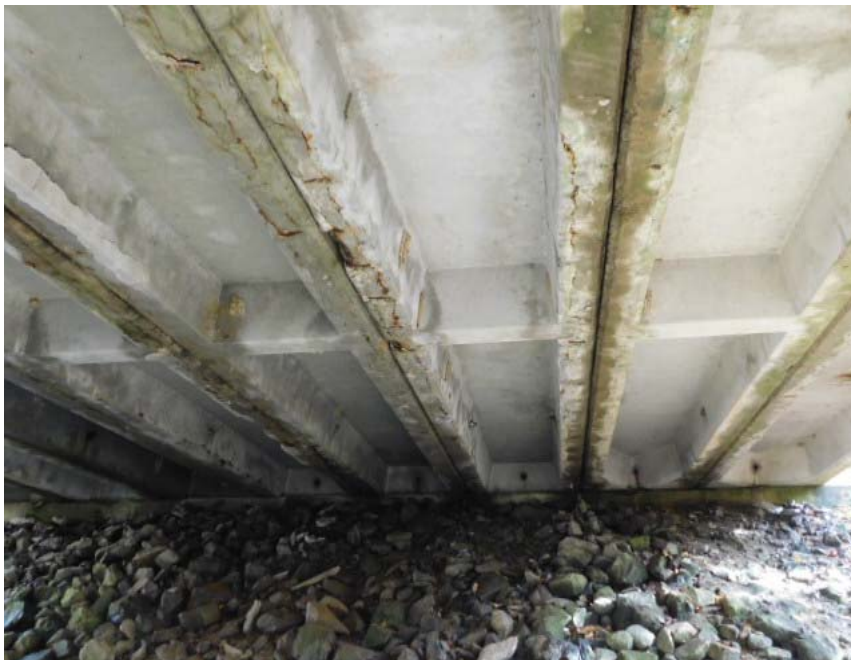
**BOTTOM DECK SPAN # 2**

The superstructure has spalling to steel areas, beginning to spall  
areas & up to 1/16" cracks,

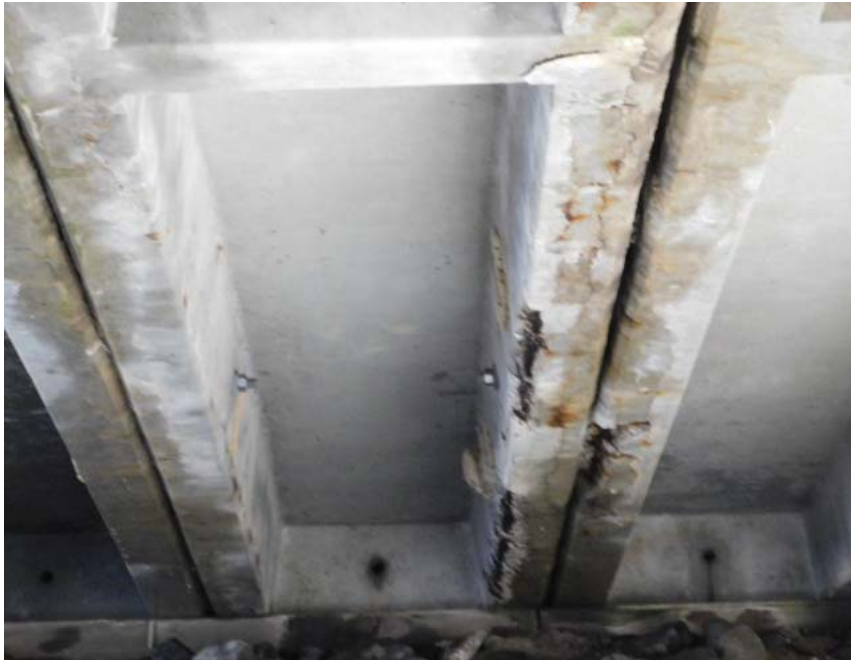
**SLAB "D" SPAN # 2 SPALLED TO STEEL**

Span # 2 p.c.c.s. "d, e & f" slabs are poor.

REPAIR OR REPLACE PRECAST CONCRETE CHANNEL SLAB "D, E, F" IN SPAN NO.2

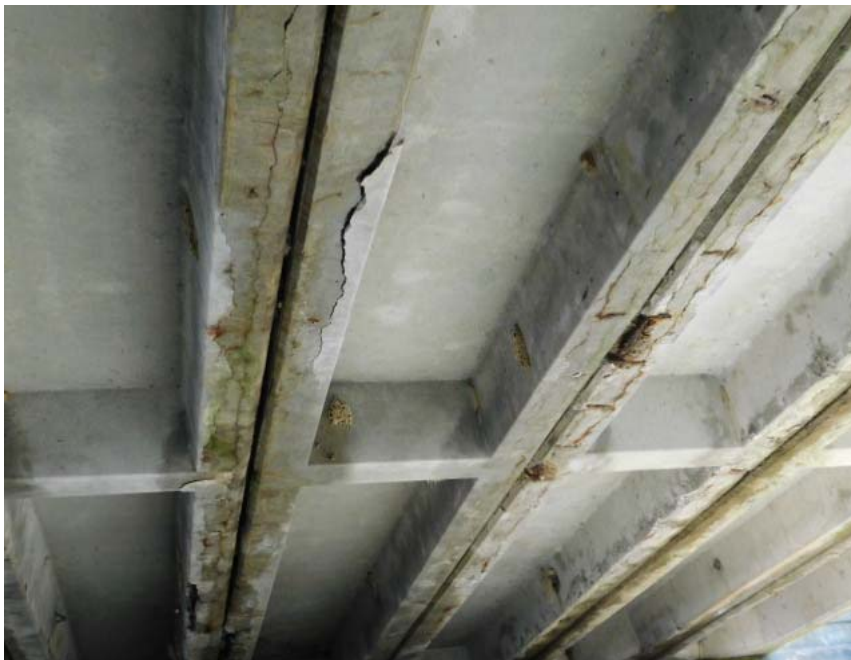
**SLAB "E" SPAN # 2 SPALLED TO STEEL**

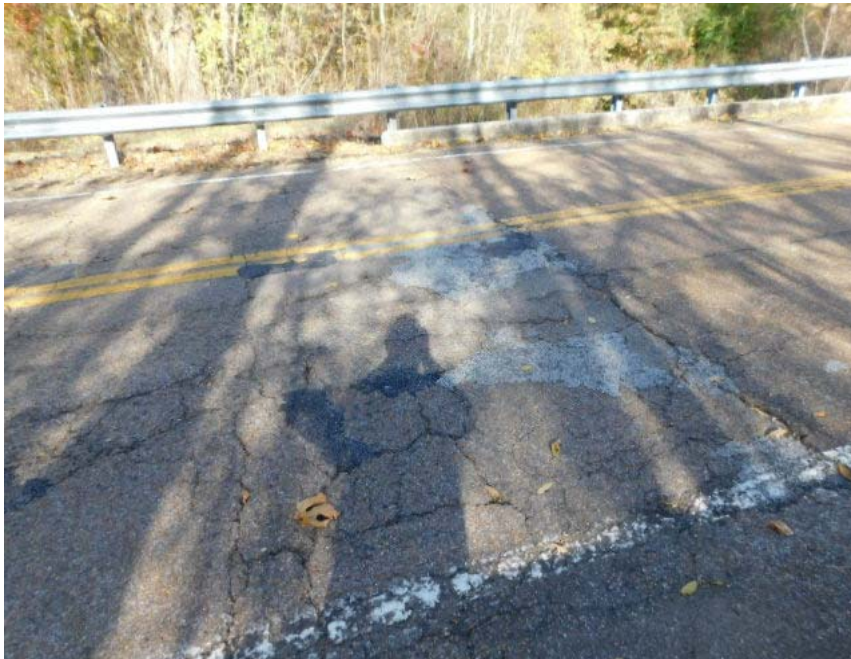
**APPROACH # 1 A/C PATCHED, CRACKED & SPALLED**

Approaches # 1 & 2 a/c have cracking, patching, spalling &  
settlement.

LEVEL THE WEARING SURFACE AT BOTH APPROACHES.

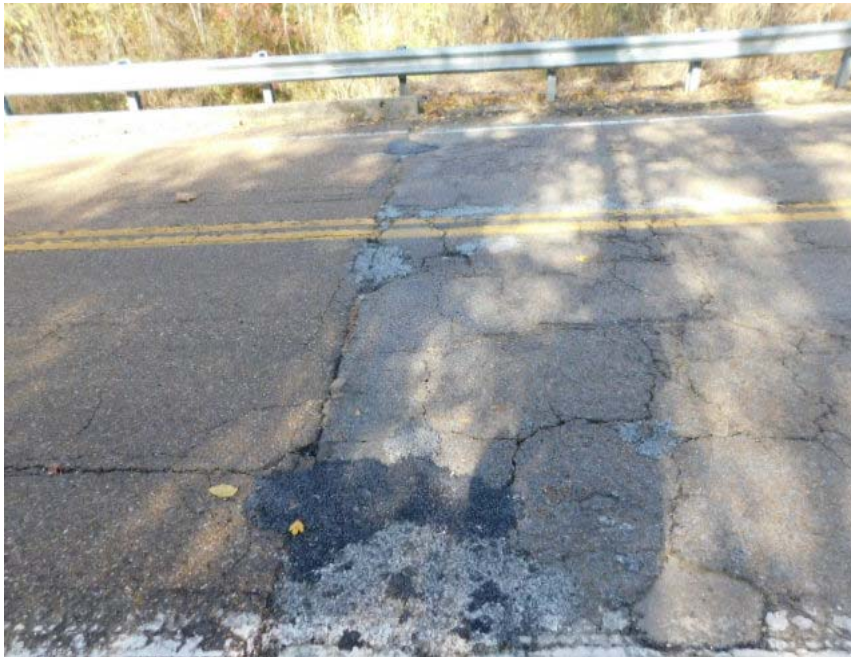
**APPROACH # 2 A/C SPALLED, PATCHED & SETTLED**

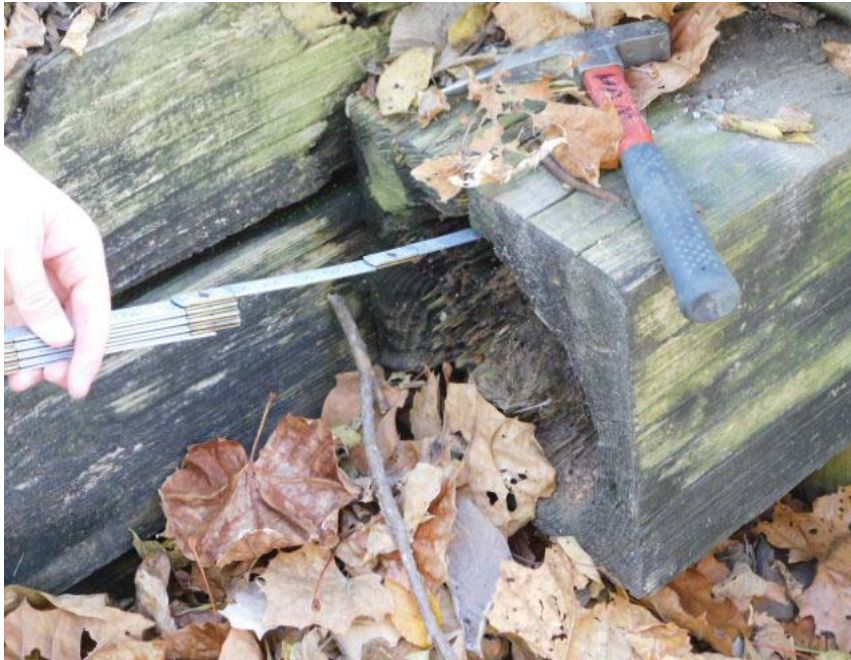
**LEFT SIDE END OF CAP ABUTMENT # 1 DECAYED**

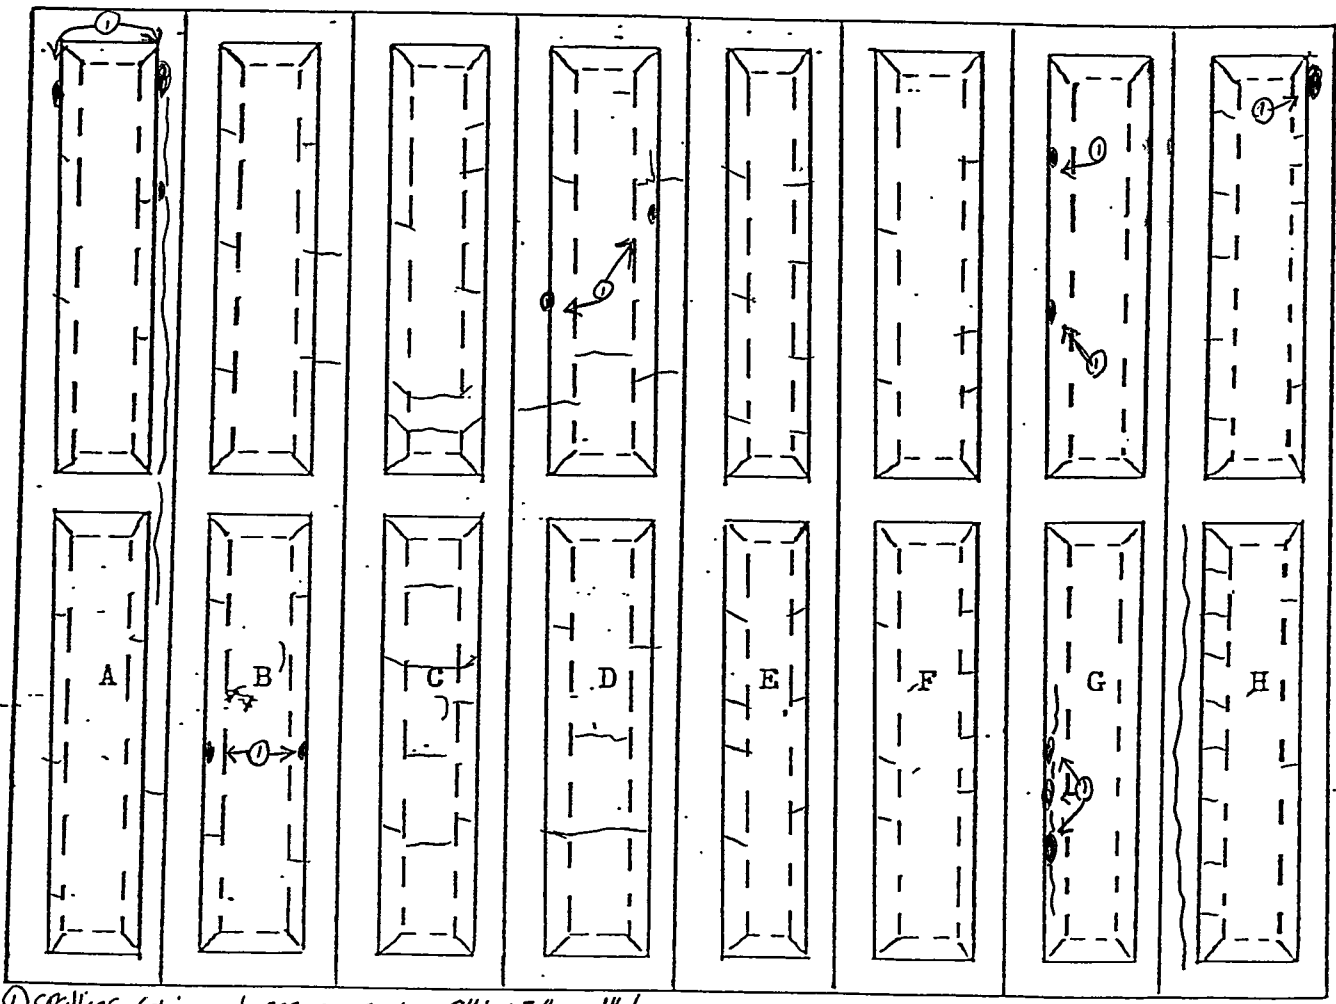
SPAN NO. 1

① Spalling/chipped areas up to 9" L x 5" W x 1" deep

ELEMENT		RATING	COMMENT
BOTTOM DECK SLAB	A	G F P C	
	B	G <u>F</u> P C	see ① + up to 1/16" crack
	C	G <u>F</u> P C	see ① + HL cracks
	D	G <u>F</u> P C	HL to fine cracks light EFF
	E	G <u>F</u> P C	see ① + HL to fine cracks light EFF
	F	G <u>F</u> P C	HL cracks light EFF
	G	G <u>F</u> P C	HL cracks light EFF
	H	G <u>F</u> P C	see ① + HL cracks
BOLTS		<u>G</u> F P C	see ① + up to 1/16" cracks

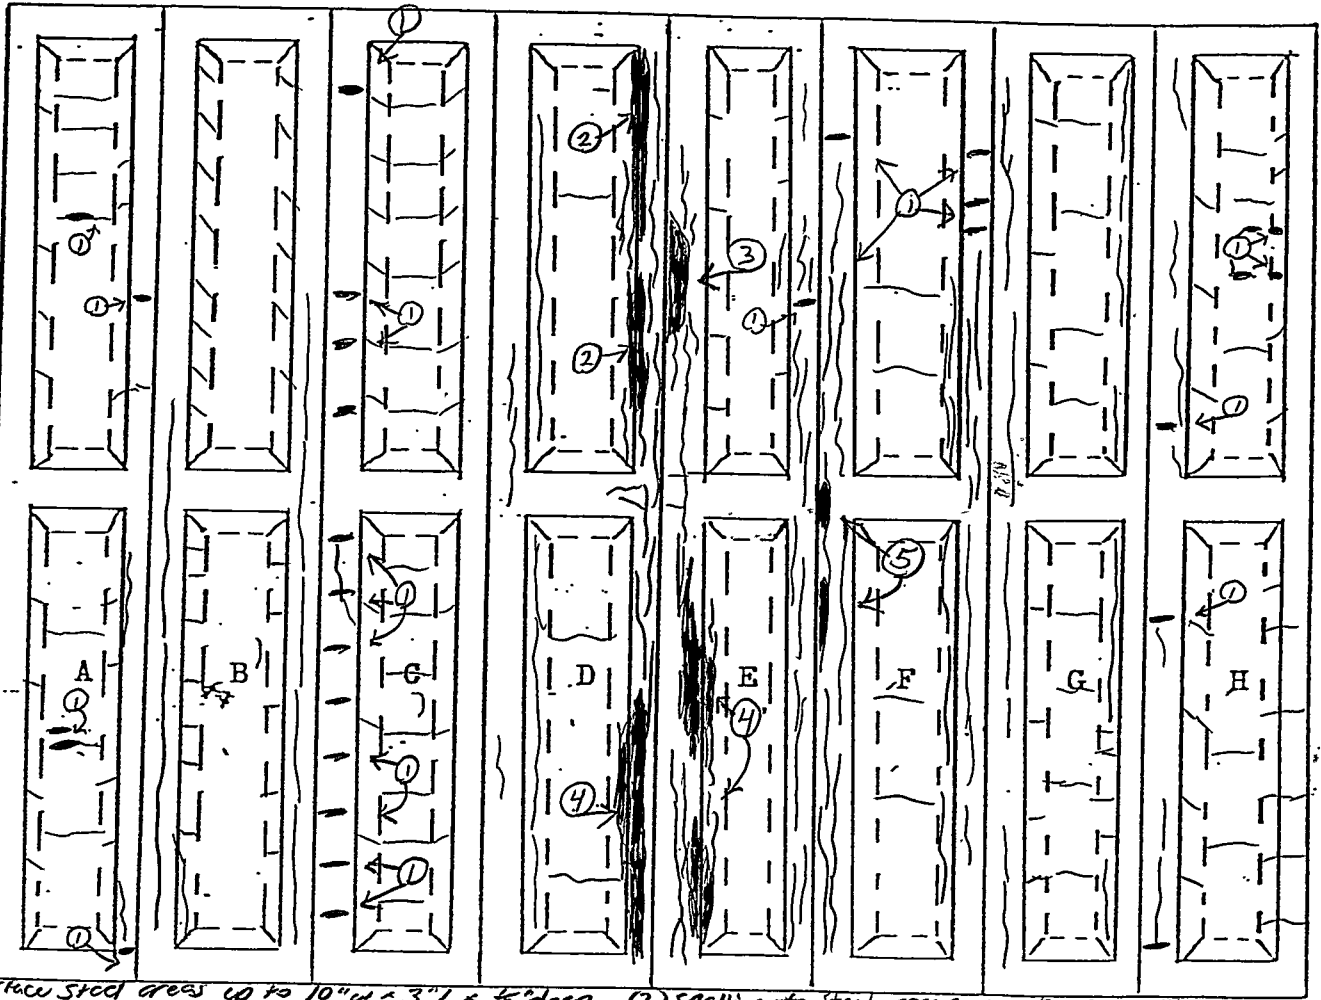
BR. NO. 49 371 1.39 SK. 90°

- ③ Spalling to steel up to 4' L x 5' W x 3" deep + up to  $\frac{1}{16}$ " section loss on steel  
④ Impending spalling up to 5' L x 5' W x 5" h  
⑤ spalling to steel

① Surface steel areas up to 10" W x 3' L x  $\frac{1}{2}$ " deep ② Spalling to steel areas up to 5' L x 8' W x 3" deep + up to  $\frac{1}{16}$ " section loss on steel

see ① + HL to Fine cracks  
up to  $\frac{1}{16}$ " cracks  
see ① + up to  $\frac{1}{16}$ " cracks + EFF  
see ②+④ + up to  $\frac{1}{16}$ " cracks + EFF  
see ①+②+④ + up to  $\frac{1}{16}$ " cracks  
see ①+⑤ + up to  $\frac{1}{16}$ " cracks  
up to  $\frac{1}{16}$ " cracks  
see ① + up to  $\frac{1}{16}$ " cracks

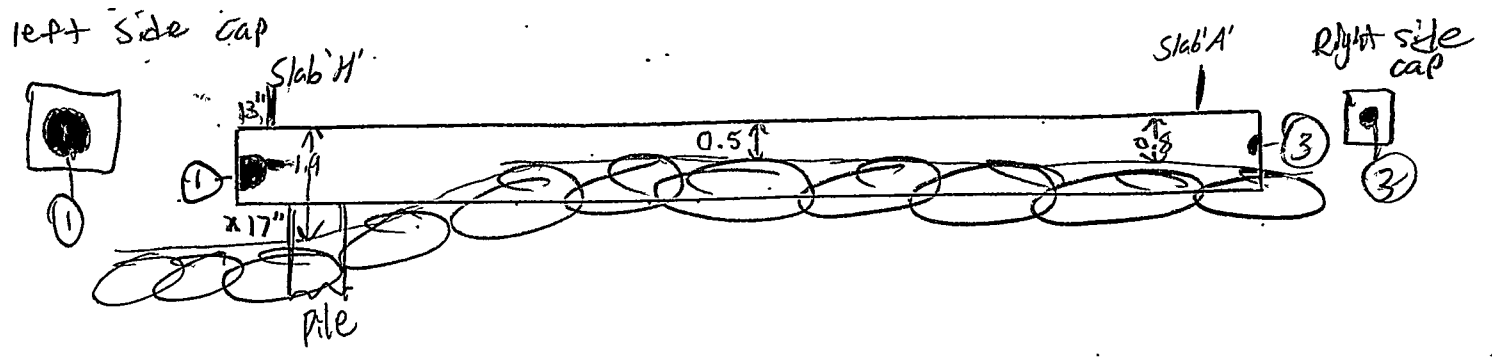
① Decayed Area

$$\frac{10''}{H} \times \frac{10''}{W} \times \frac{4''}{D}$$

③ Decayed Area

$$\frac{5''}{H} \times \frac{5''}{W} \times \frac{5''}{D}$$

② Decayed 2" DIA x 16" Deep

ELEMENT	RATING	COMMENT
BEARINGS	G F P C	NV
CAP	G (F) P C	SEE ① ②
PILING <u>A</u>	G (F) P C	medium weathering
	G F P C	
	G F P C	
<u>WINGS</u>	G (F) P C	medium weathering
<u>RIDGEO</u>	(G) F P C

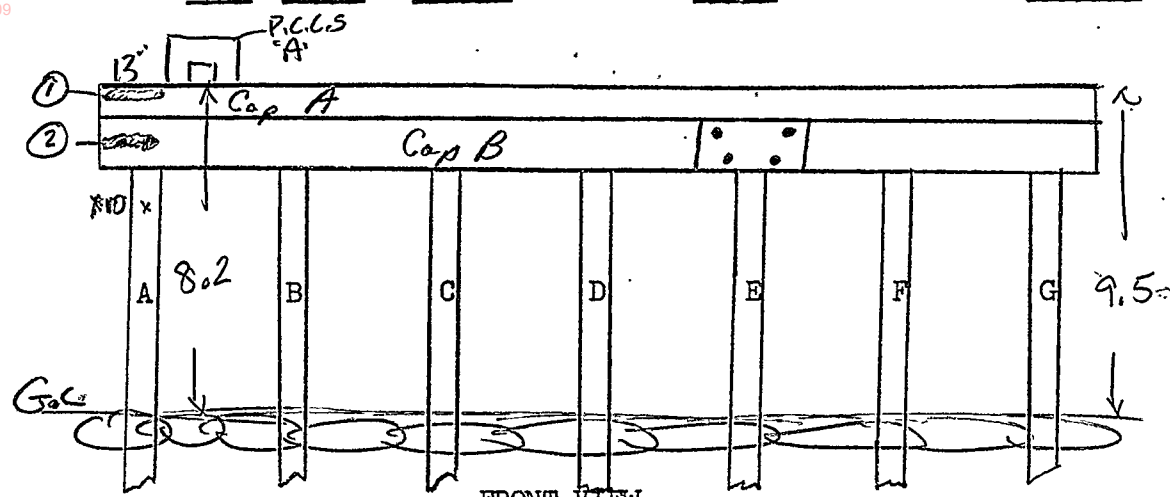
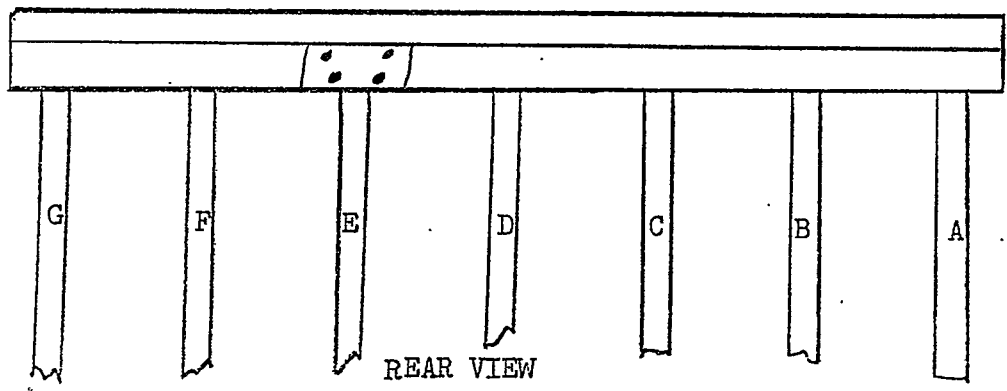
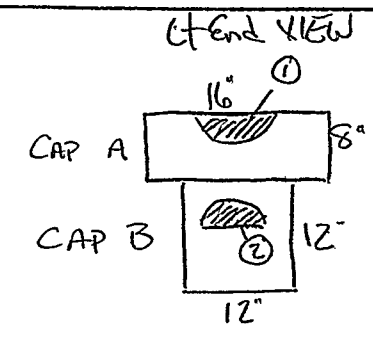
BENT NO. 1

ELEMENT	RATING	COMMENT
BEARINGS	G F P C	N/A
CAP	G <u>F</u> P C	See ①, ② & Medium weathering
PILING A-G	G <u>F</u> P C	Medium weathering
PILING _____	G F P C	
PILING _____	G F P C	
Rip RAP	G <u>F</u> P C	
BRACING	G F P C	None

① Decayed  
5" W x 3 1/4" H x 14" D  
② Decayed  
6 1/4" W x 3" H x 12" Deep

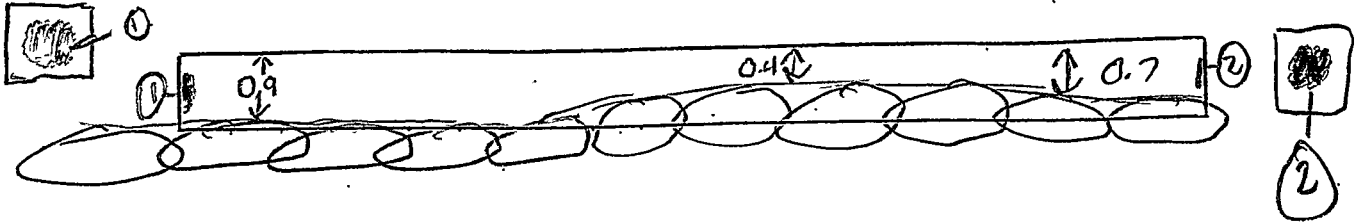
NOV 16 2021  
AEUT\_NO. 2

① Delay  $\frac{10''}{\text{Diameter}} \times \frac{4''}{D}$

② Decay  
 $\frac{8''}{\text{Diameter}} \times \frac{1''}{D}$

ELEMENT	RATING	COMMENT
BEARINGS	G F P C	NV
CAP	G <del>F</del> P C	see ① ② light to medium weathering
PILING	G F P C	NV
	G F P C	
	G F P C	
<u>WINGS</u>	G <del>F</del> P C	light to medium weathering
	G F P C
