Region 04, 38 - Haywood County

CHARLESTON RD. Crossing OVERFLOW

Inspection Date(s): 07/08/2025 - 07/09/2025

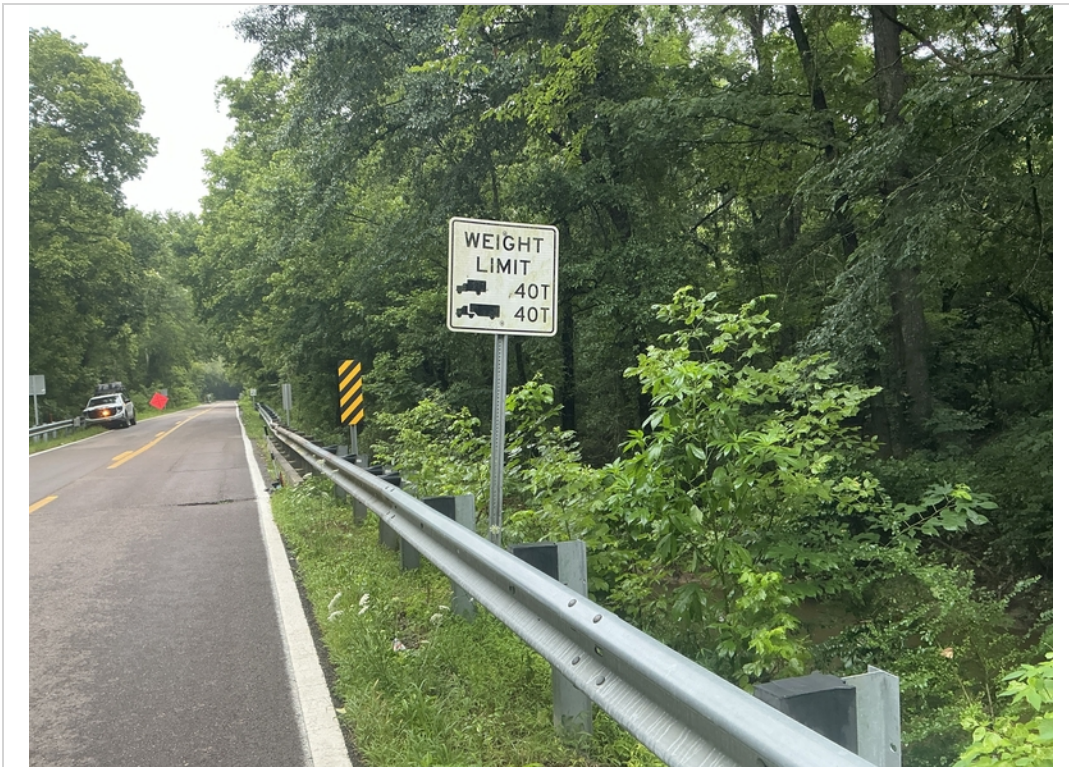
APP 1 RT Weight Limit Sign

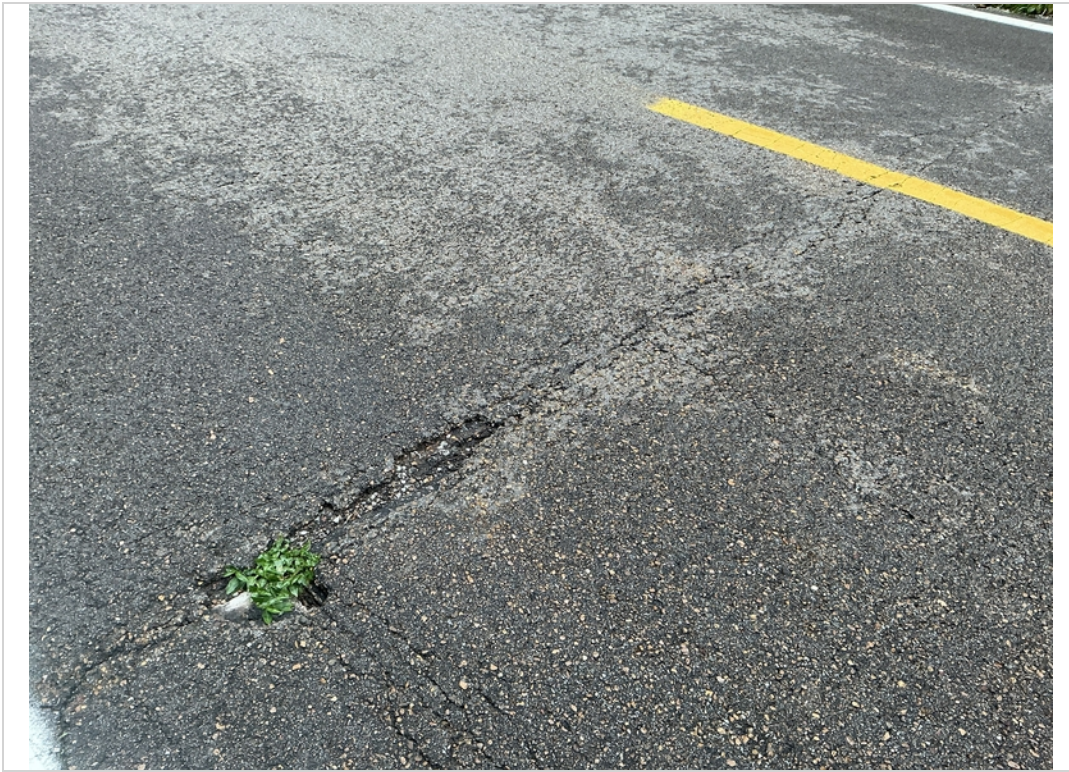
APP 1 Minor Settlement

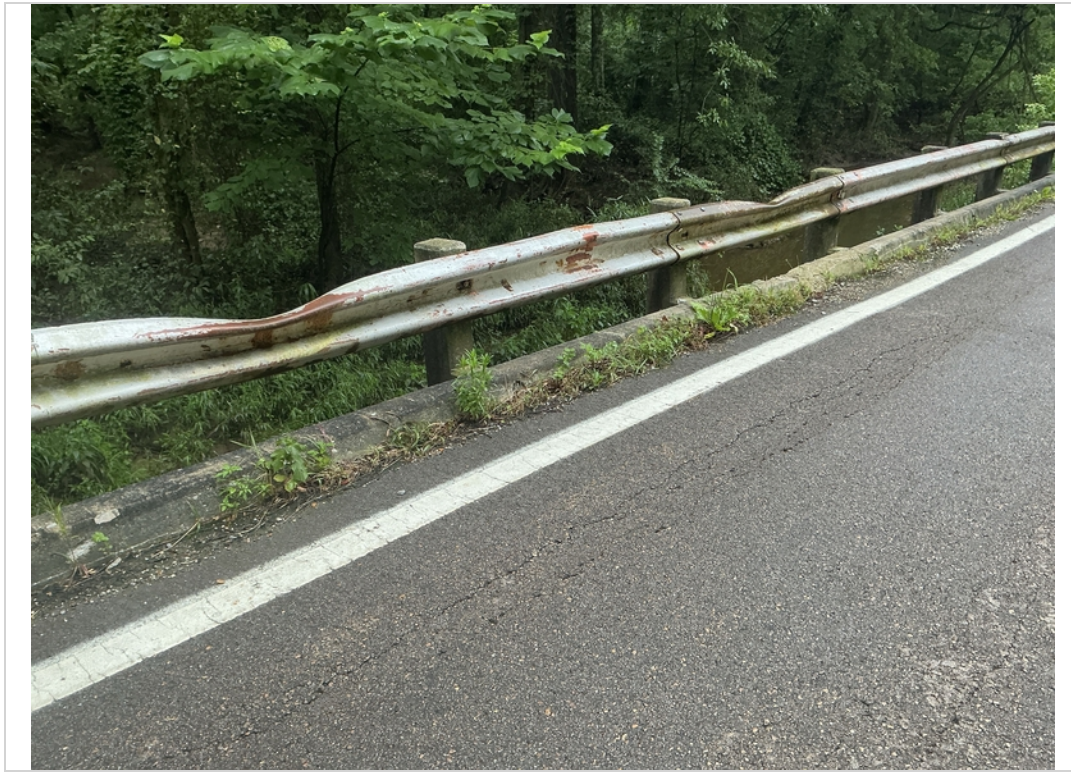
RT Rail Minor Impact Damage

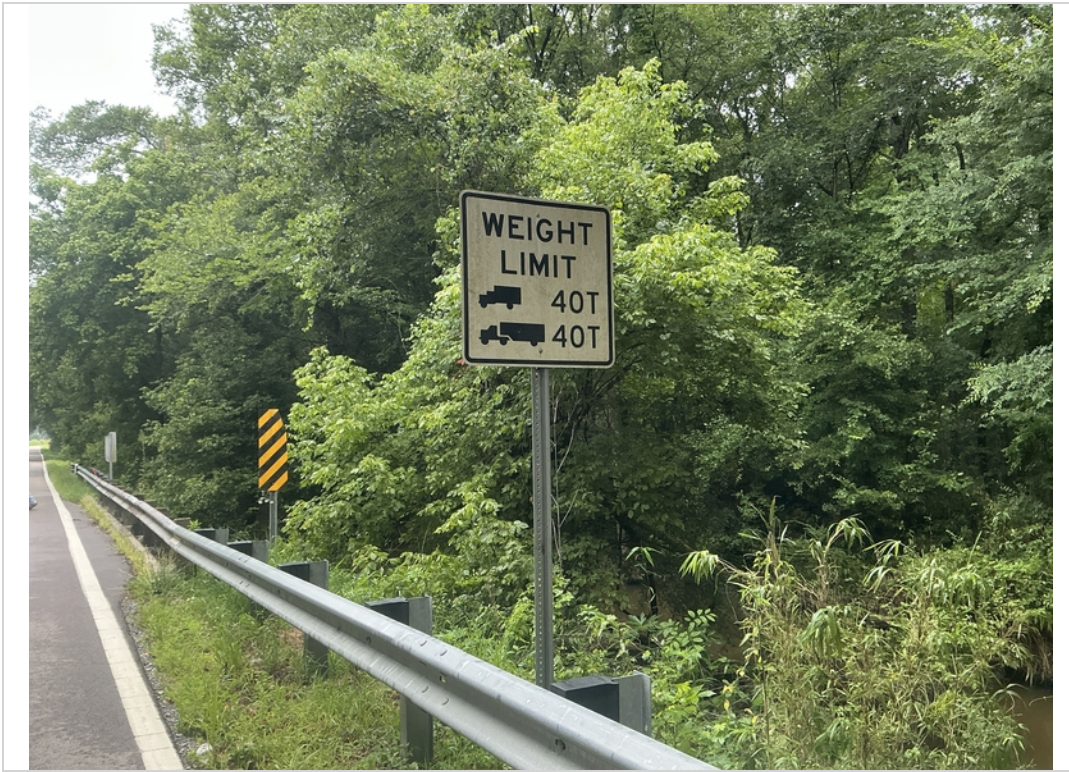
APP 2 LT Weight Limit Sign

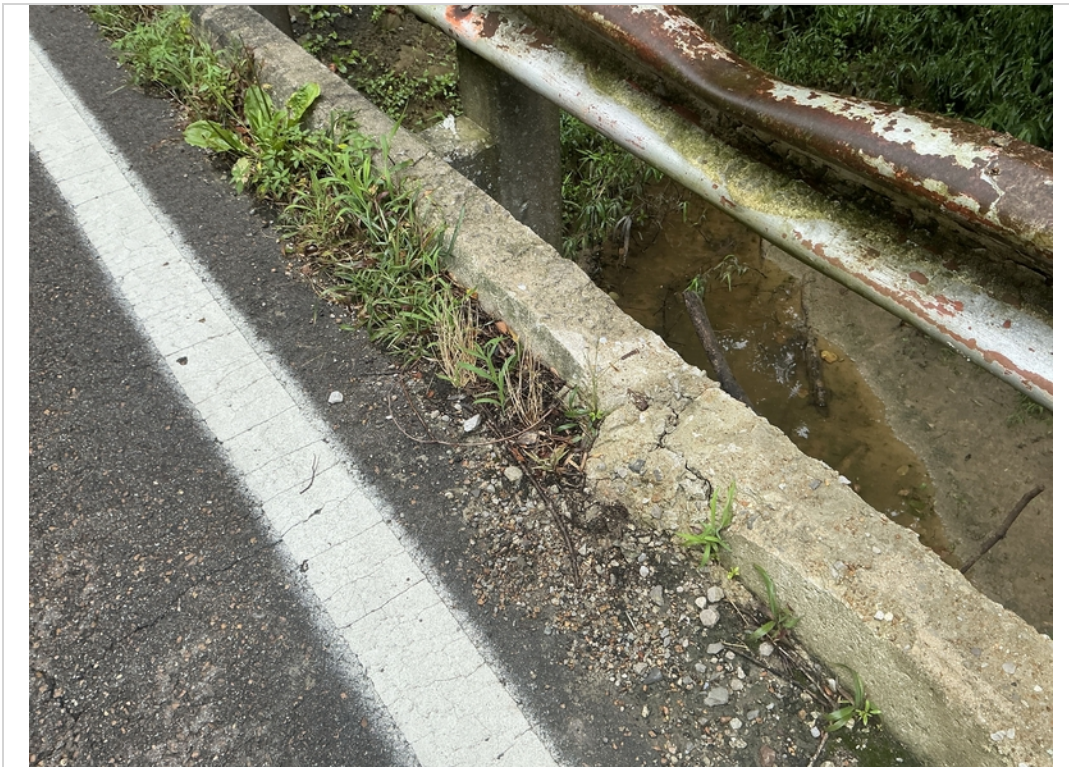
| Wearing Surface Type | | Asphalt | Wearing Surface Depth | 2in. |
|---|---|---|---|---|
| Curbs | (Fair) | Spalls with exposed Rebar in span 3 | | |

Span 2/3 RT Curb Spall with exposed Rebar

| Date Added | Recommendation | Priority |
|---|---|---|
| 08/16/2023 | REPAIR CONCRETE CURB ON RIGHT SIDE OF SPAN NO.2 & 3 | |

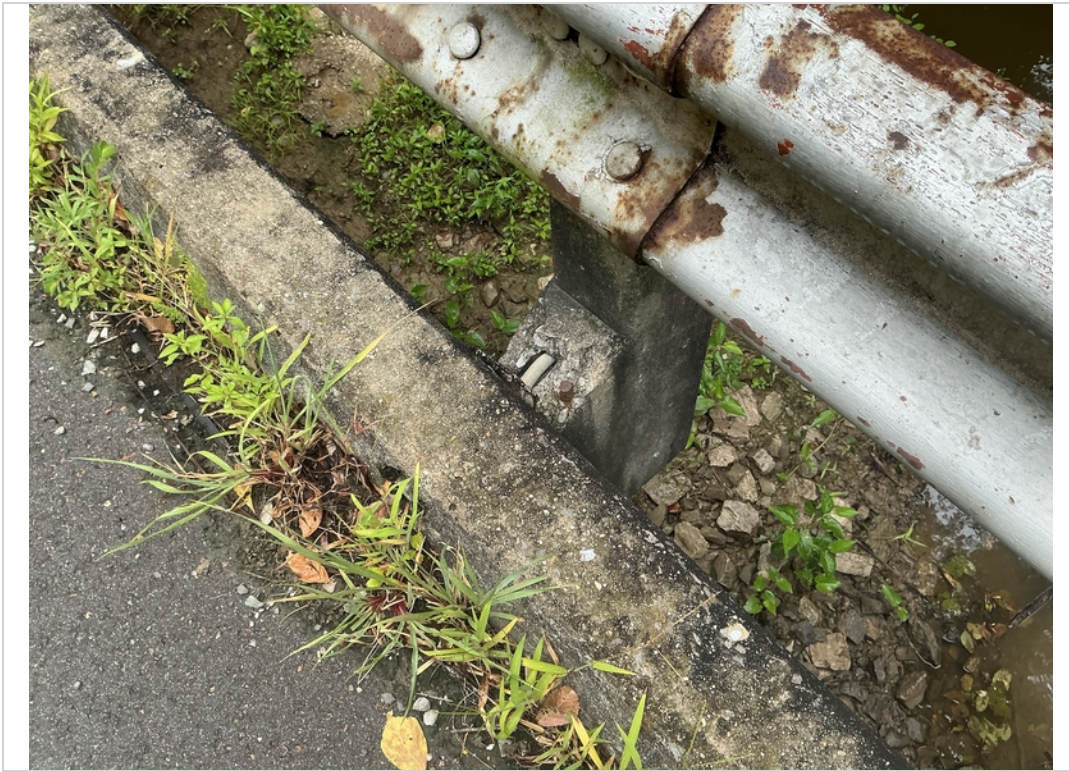
| Wearing Surface Type | | Asphalt | Wearing Surface Depth | 2in. |
|---|---|---|---|---|
| Railing | (Fair) | Minor Impact Damage<br>Concrete Rail Post Spalls with Exposed Steel at Connections | | |

Concrete Rail Post Spalls at Anchor  
Typical

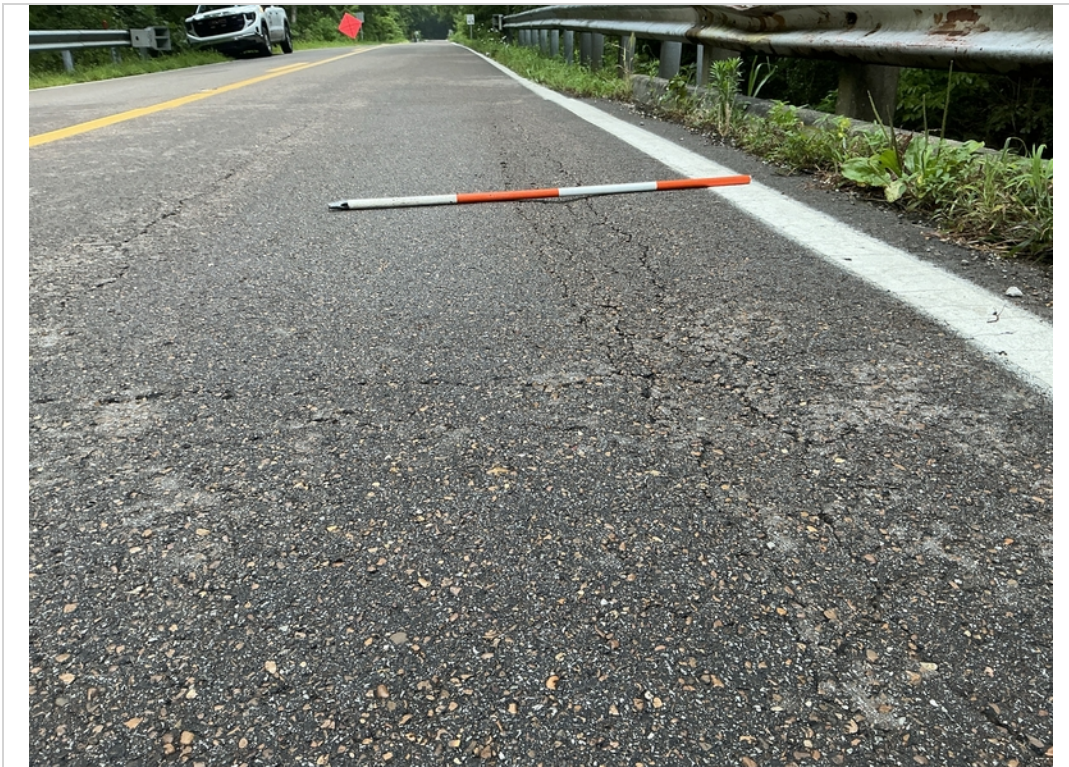
| Wearing Surface Type | | Asphalt | Wearing Surface Depth | 2in. |
|---|---|---|---|---|
| Wearing Surface | (Fair) | Settlement/Raveling between beam edges in spans 2 and 3 | | |

Spans 2 & 3 Settlement Between Beam Edges

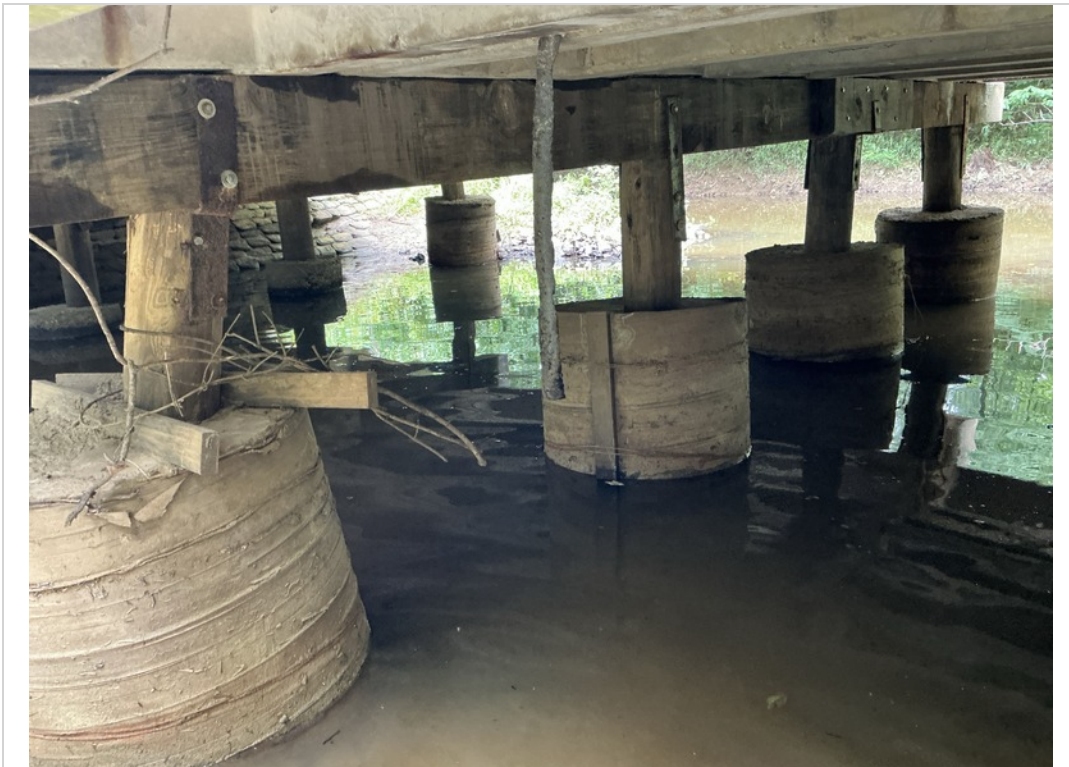
Bent 2 Replacement Looking Back  
Spliced Piles and New Cap

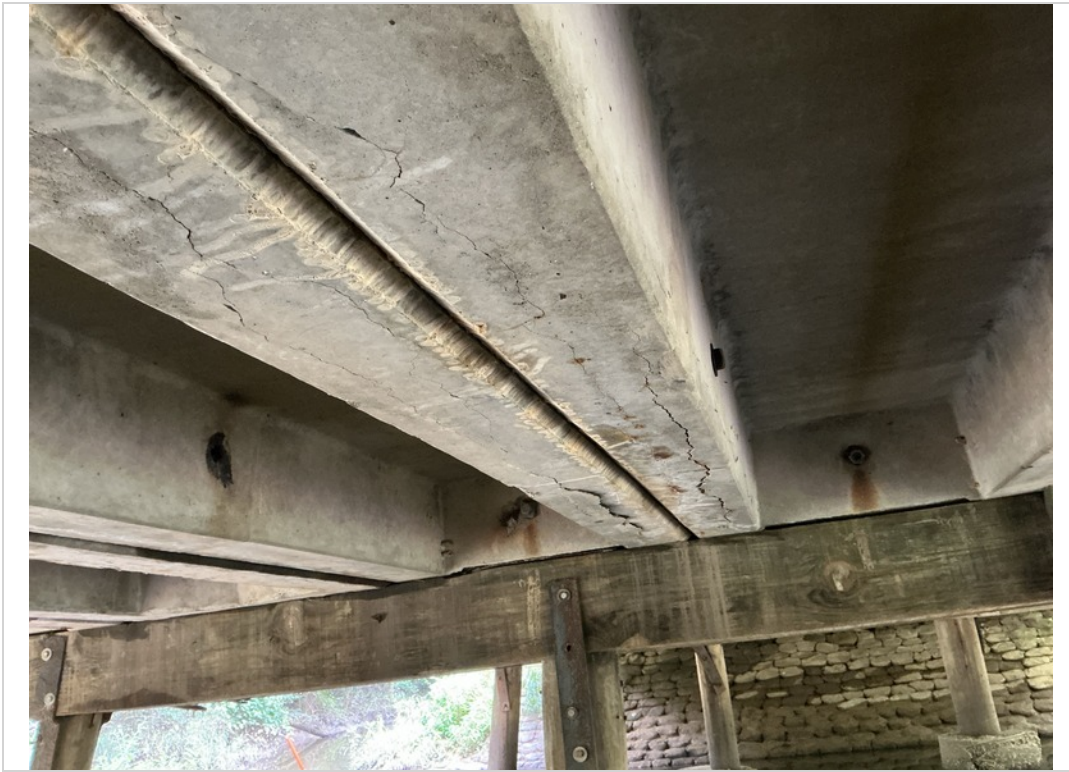
Span 3 Beams D & E Delaminations

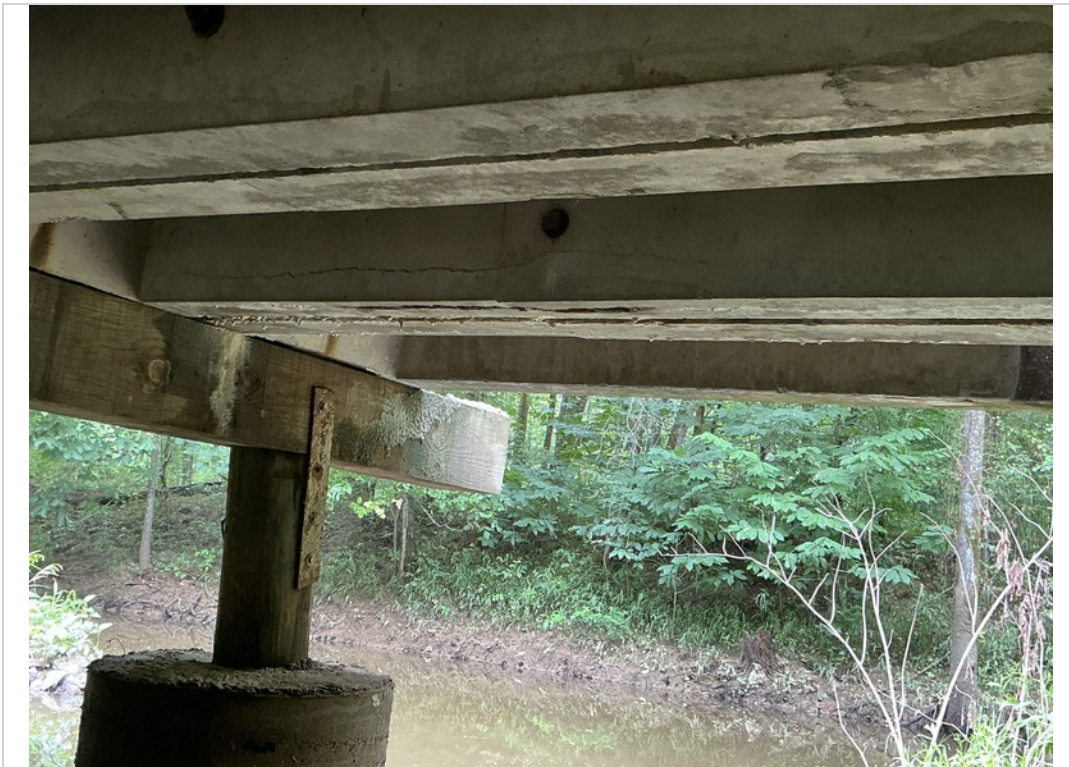
Span 3 Beam B Delamination

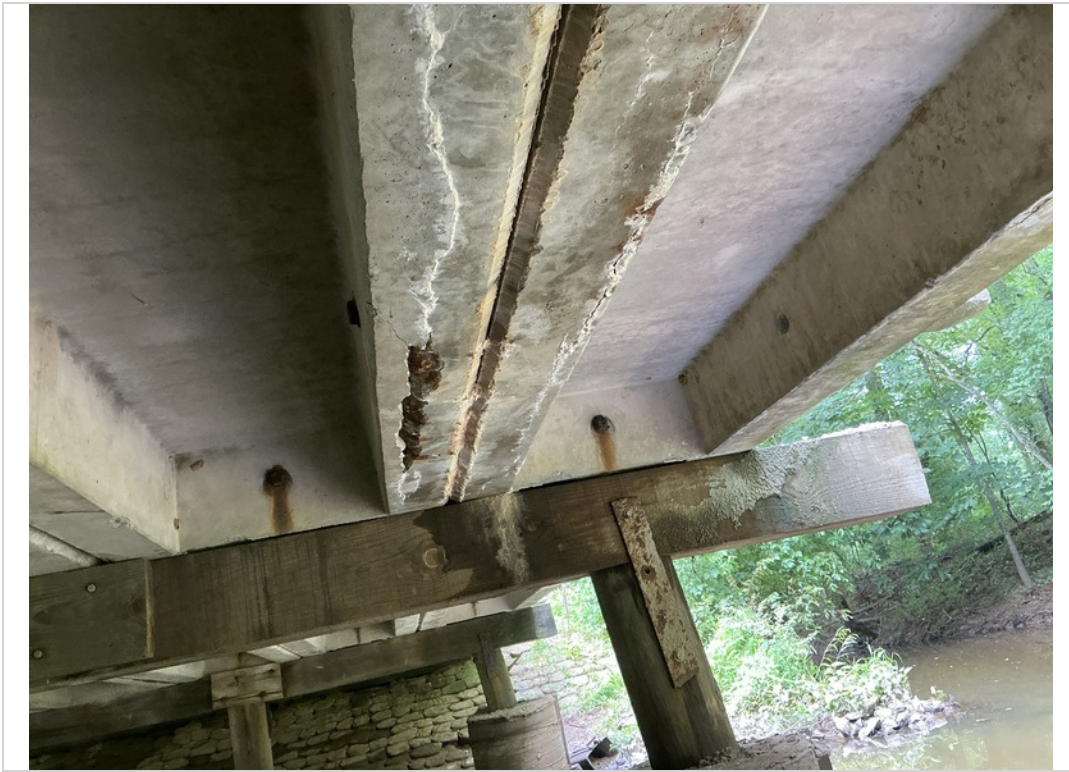
Span 3 Beam B spall and Hairline Cracks w/EFF

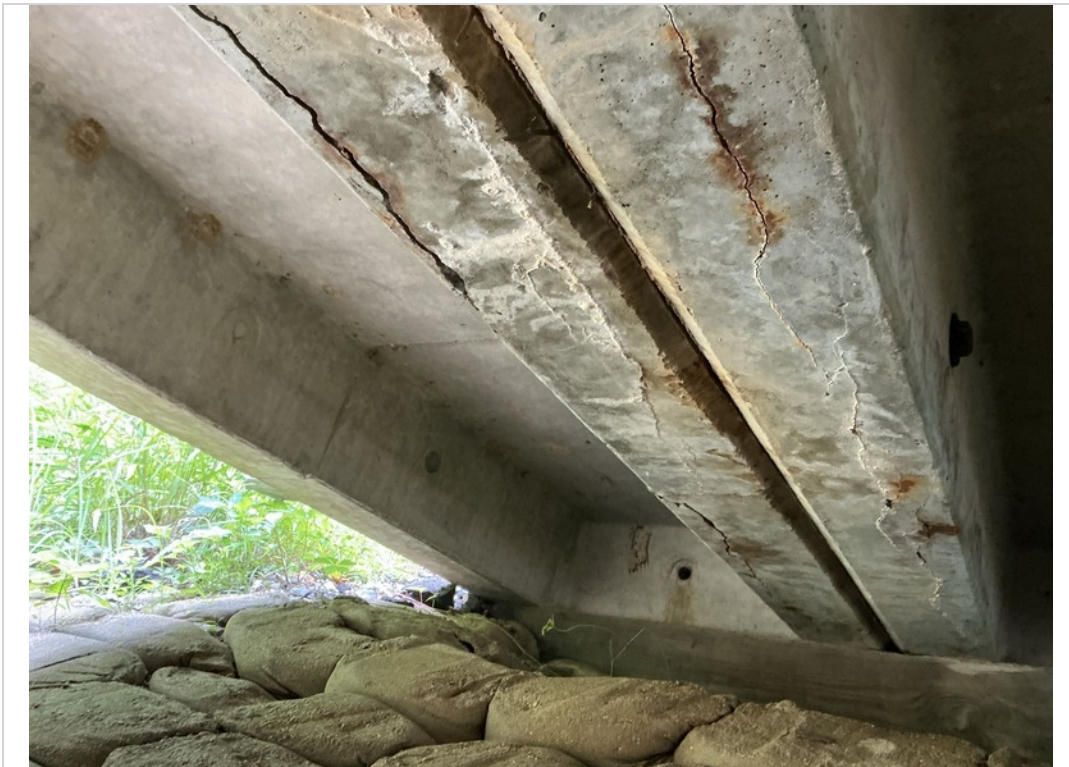
Span 3 Beams A & B Hairline Cracks w/EFF

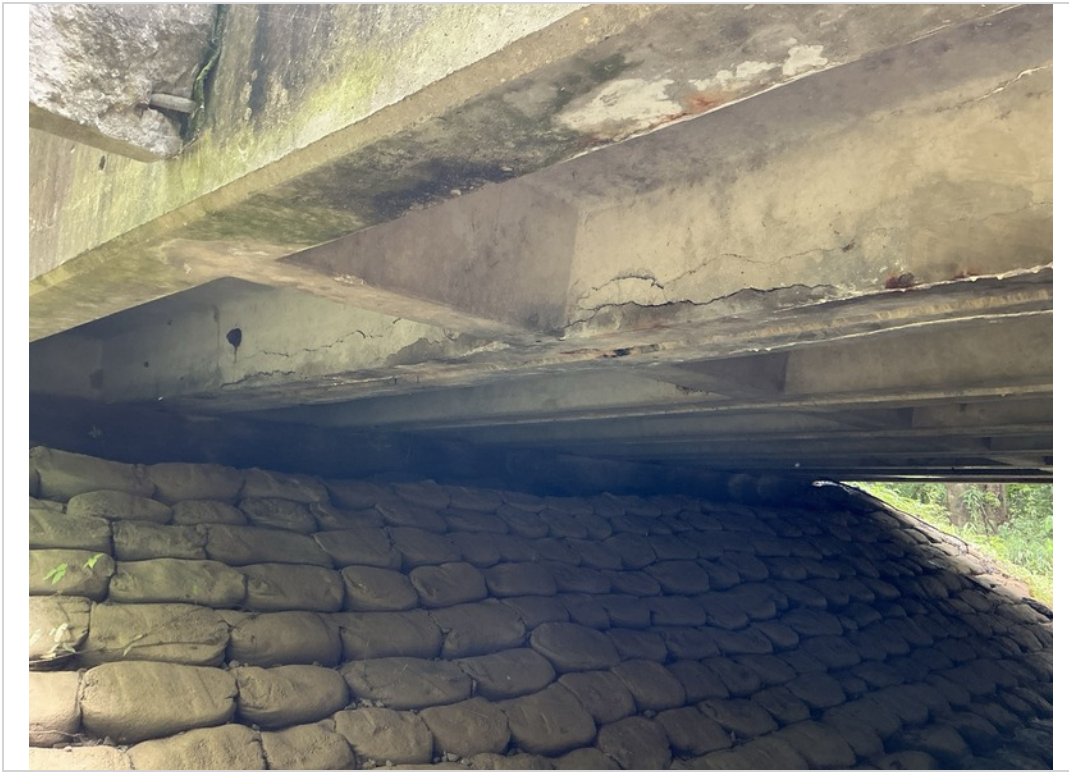
Span 3 Beam A Delamination

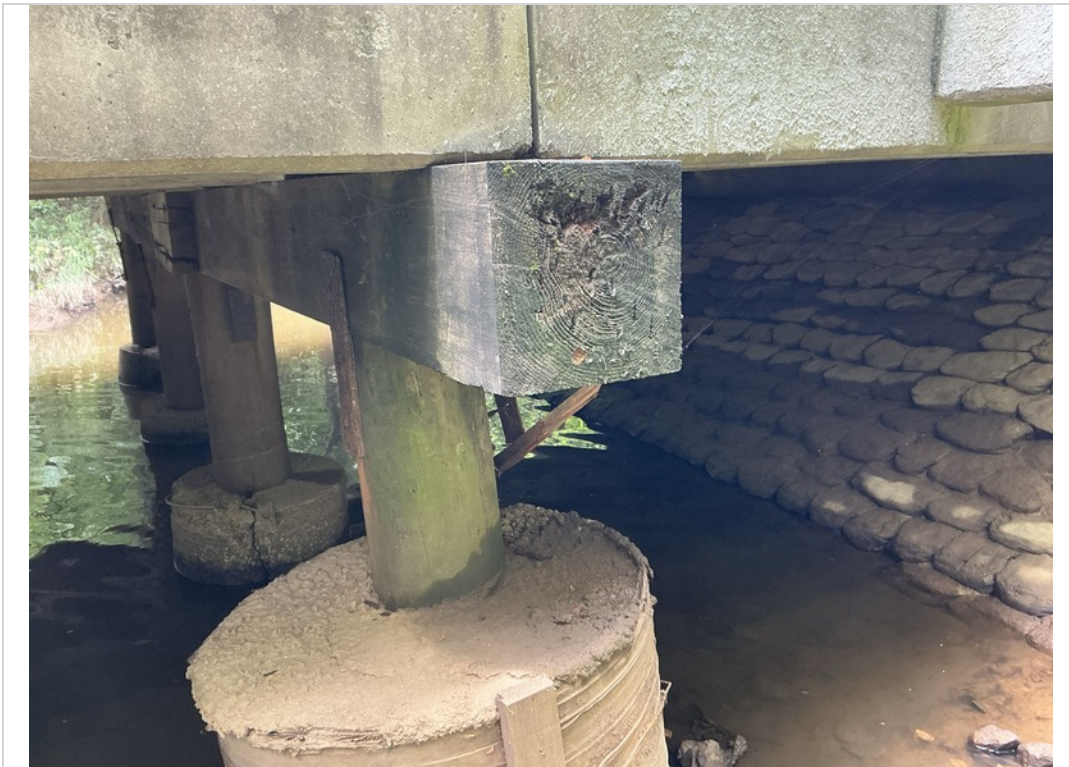
Bent 1 Cap LT Minor Decay/Weathering

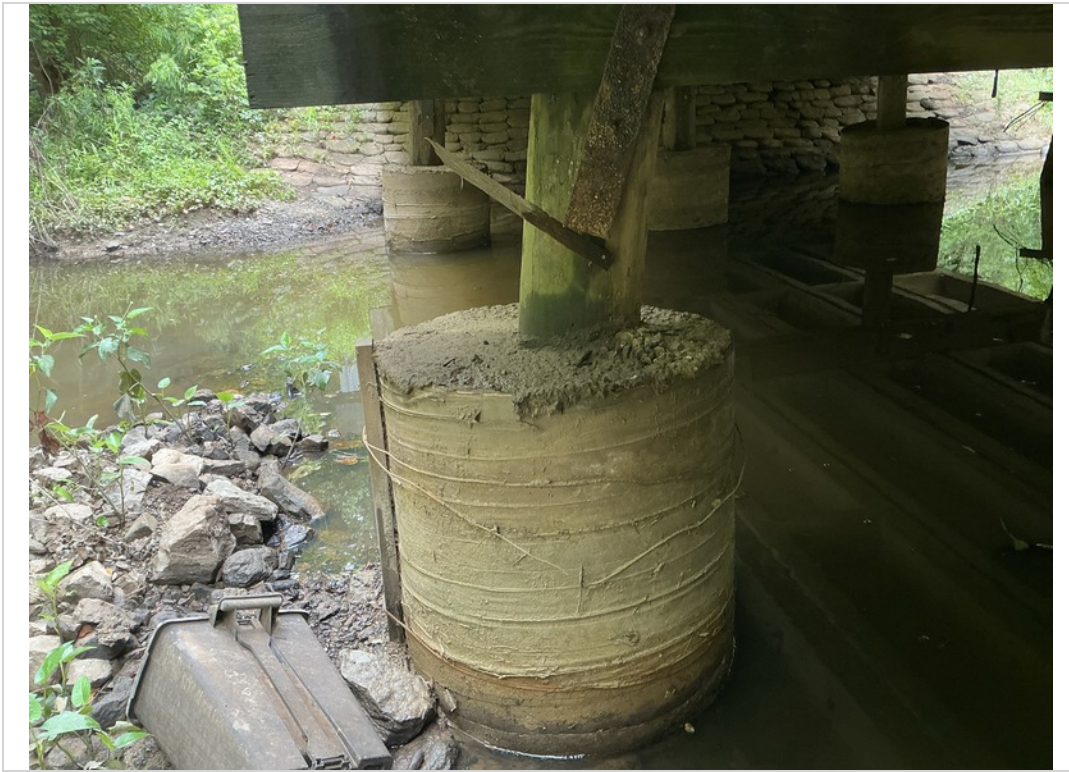
Bent 1 Pile A Replacement

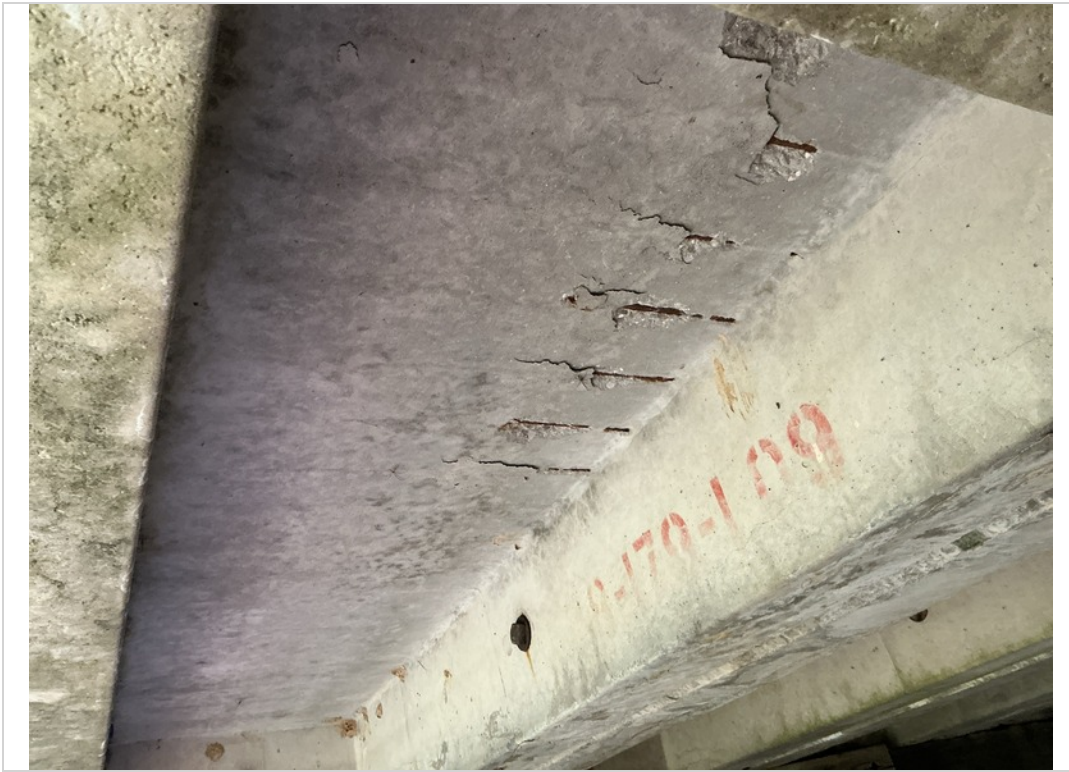
Span 1 Beam A Cover Spalls in Soffit

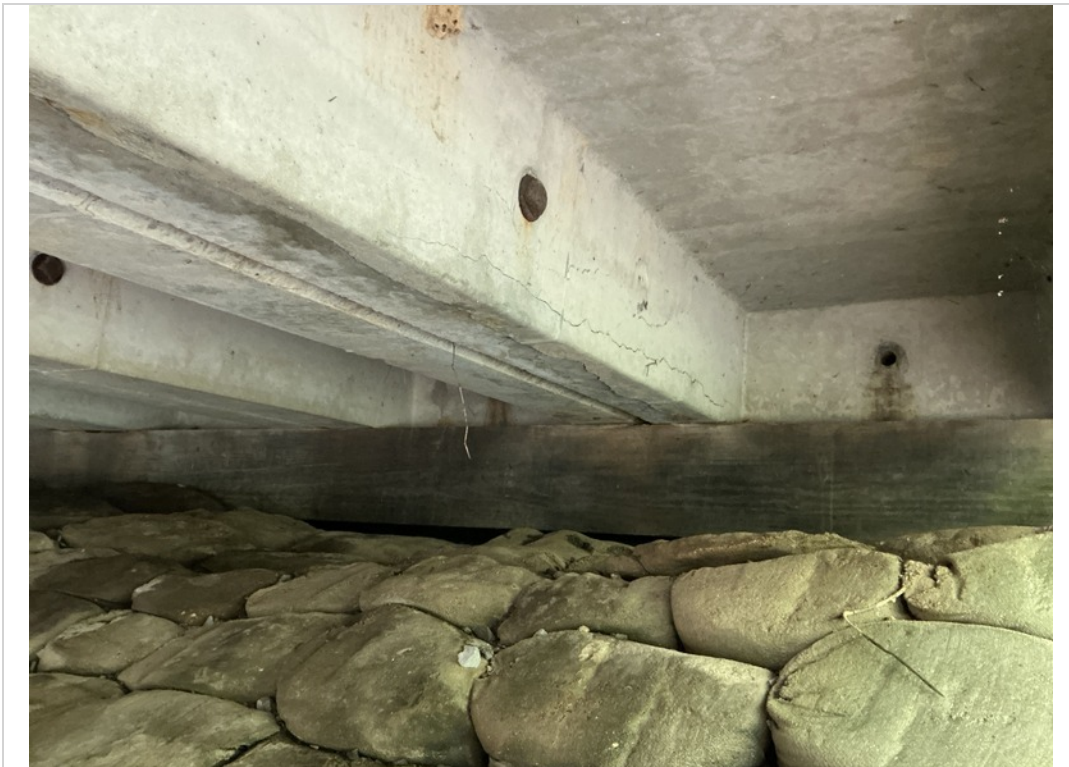
Span 1 Beam A Delamination

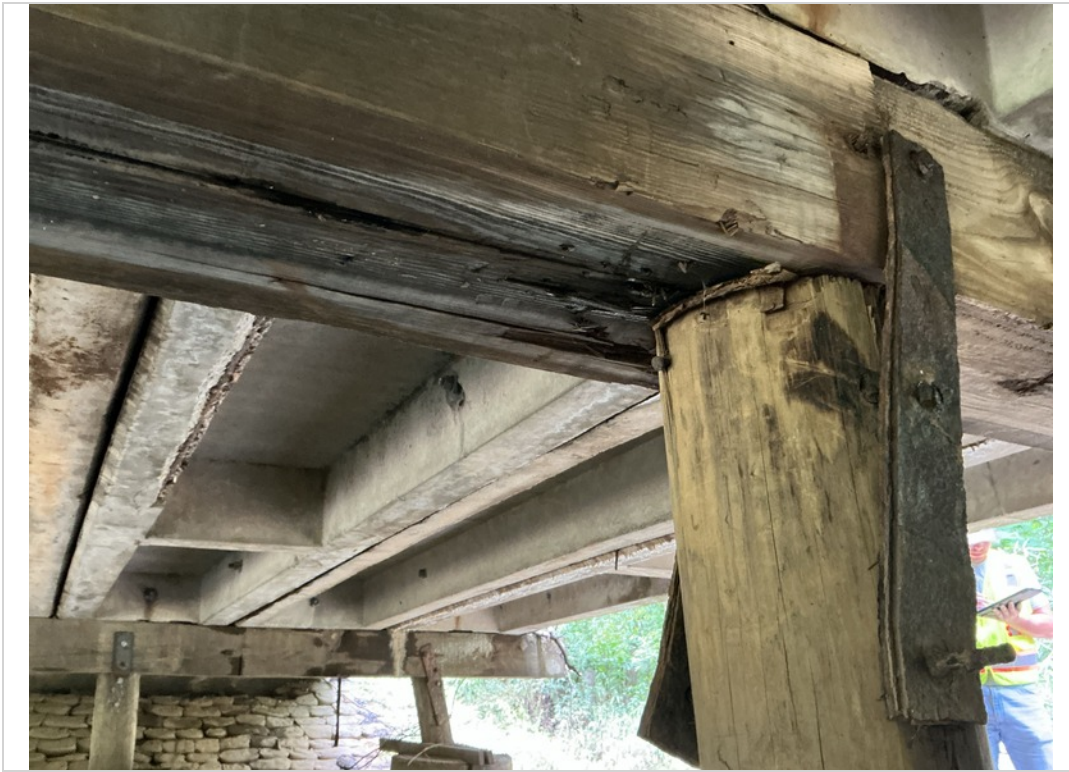
| Bent Caps | (Fair) | Decay, splintering, checks up to 1/16"<br>Bent 1 cap section split/shake at bearing on Pile C<br>Bent 2 Cap has been Replaced |

Bent 1 at Pile C  
Minor Decay, Splitting/Shake at Cap Section End at Bearing Point

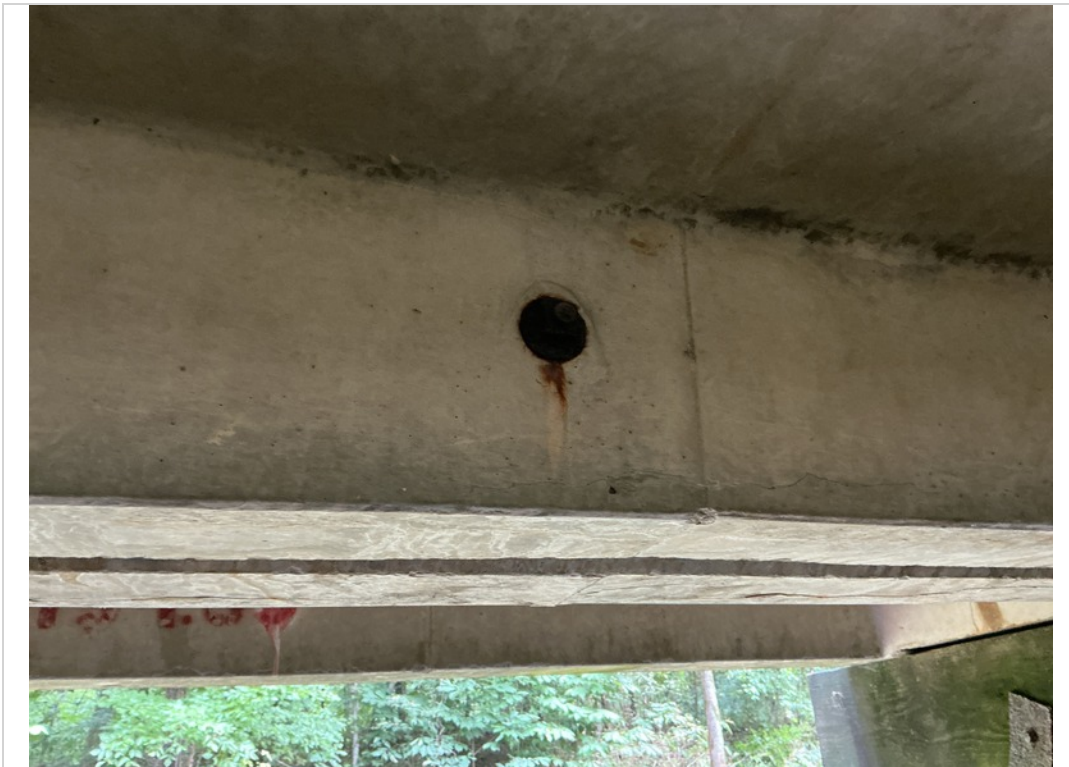
| PCCS/CBB Bolts | (Poor) | Span connectors in spans 1 and 2 corroded with missing nuts |

PCCS Bolt Corrosion  
Typical

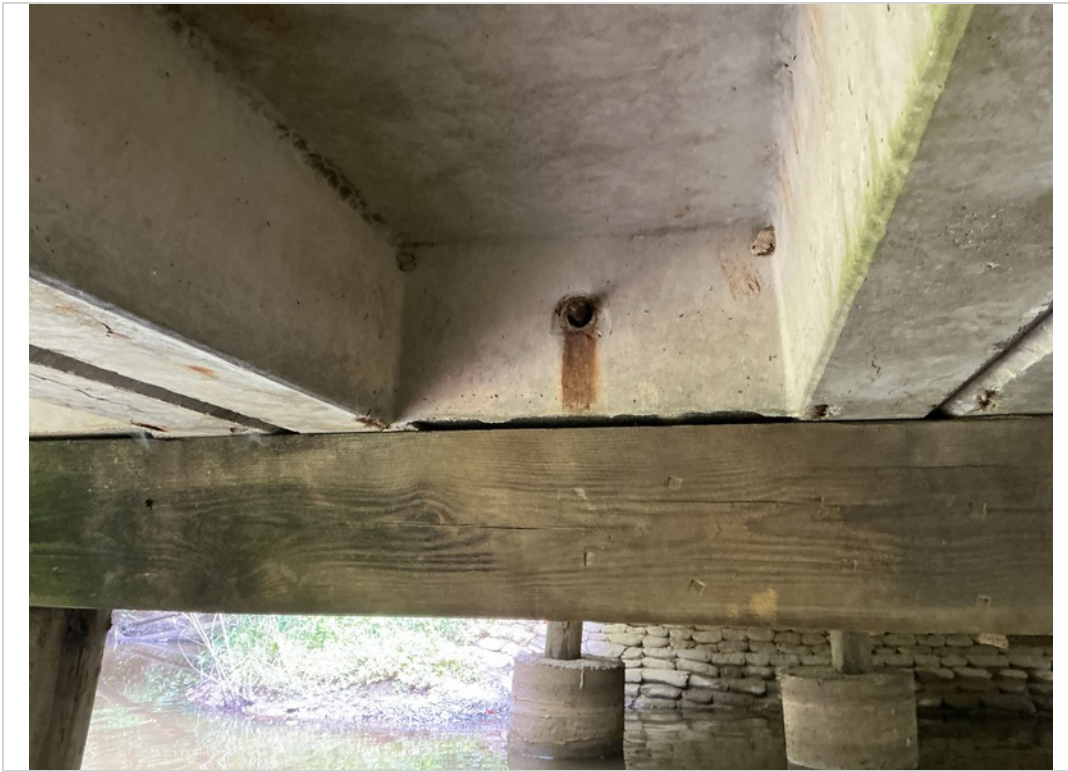
PCCS Missing Bolts  
Typical

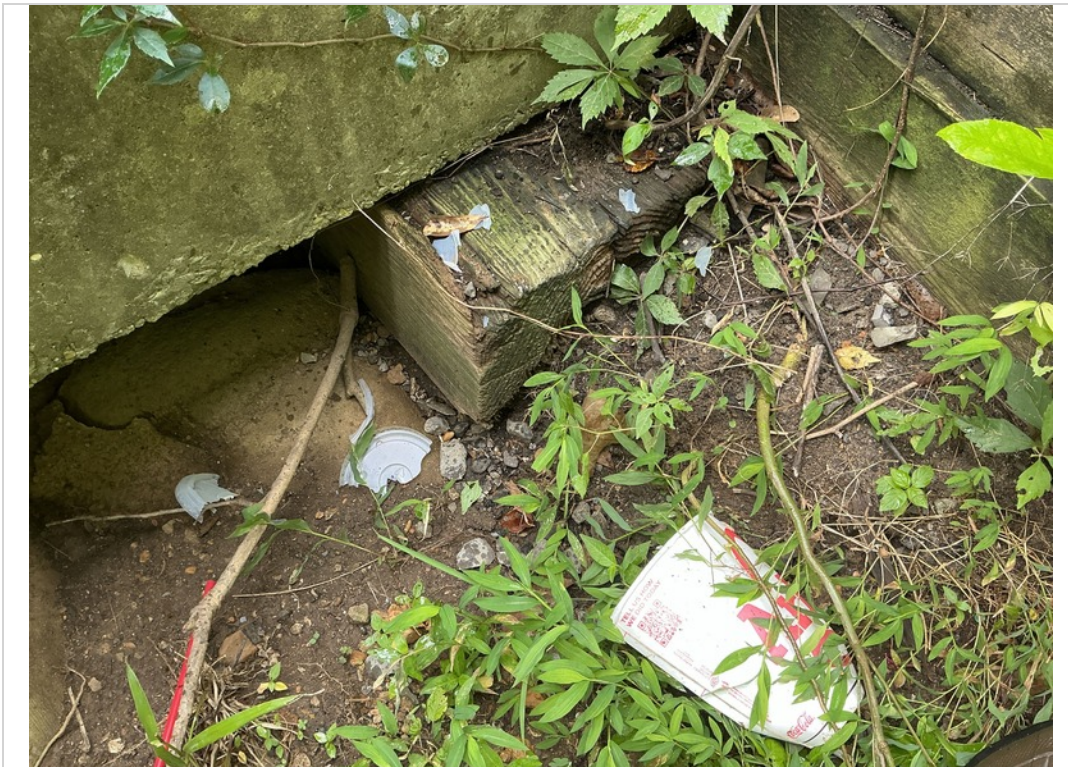
| Abutment Caps | (Fair) | Minor decay at cap ends, checks up to 1/16" |

ABT 1 Cap LT Decay

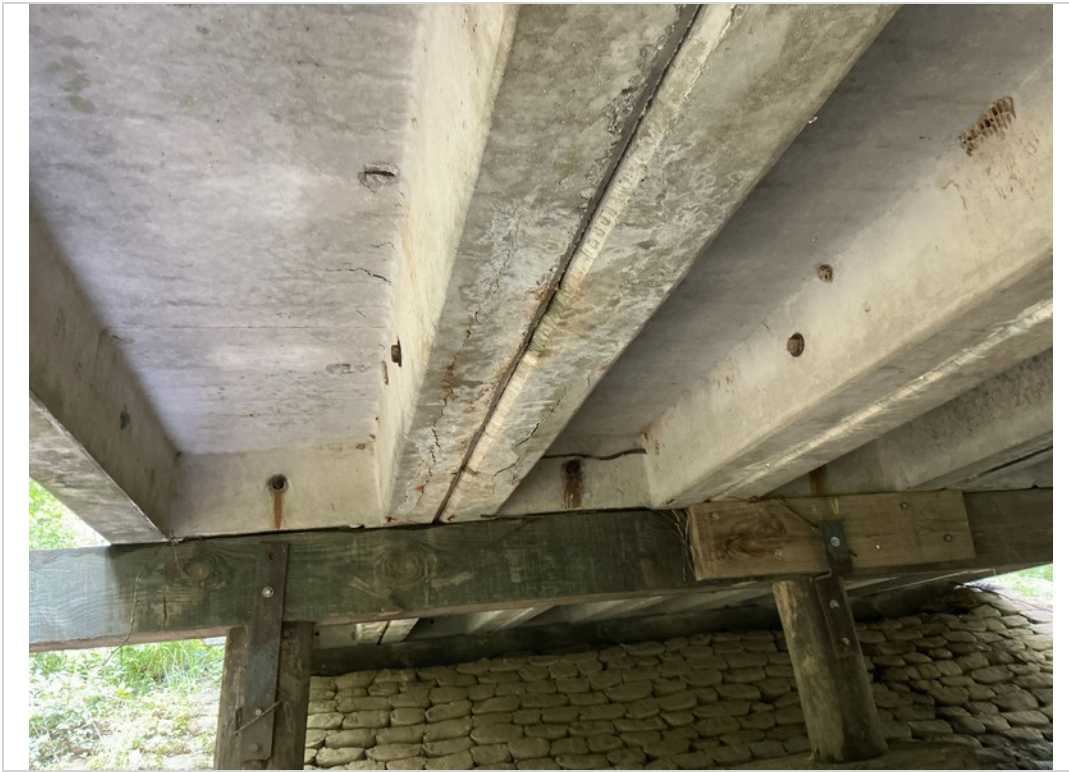
Span 2 Beams A & B Delamination

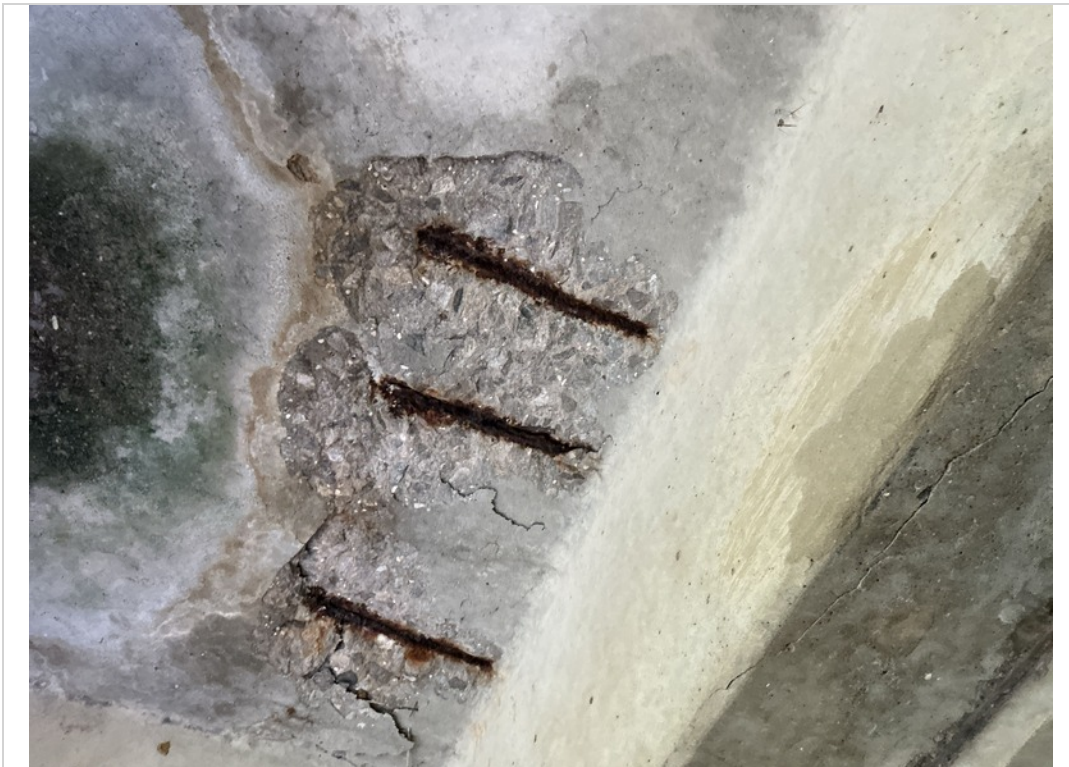
Span 2 Beam A Cover Spalls in Soffit

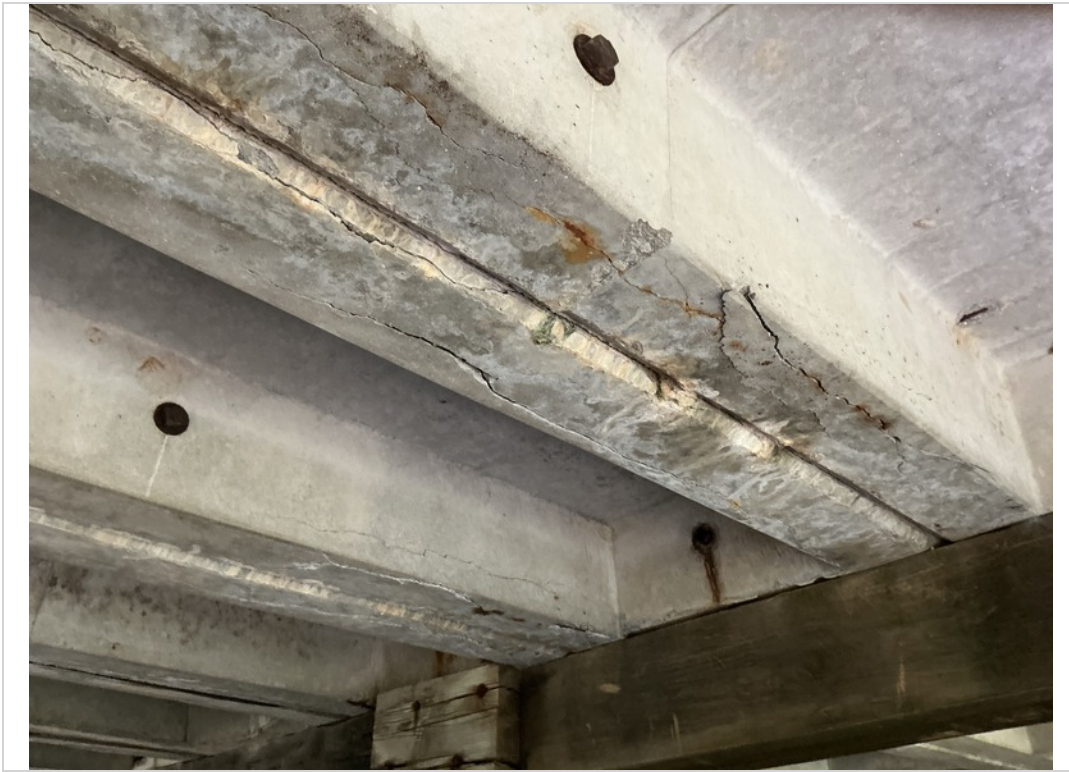
Span 2 Beams A & B Delamination

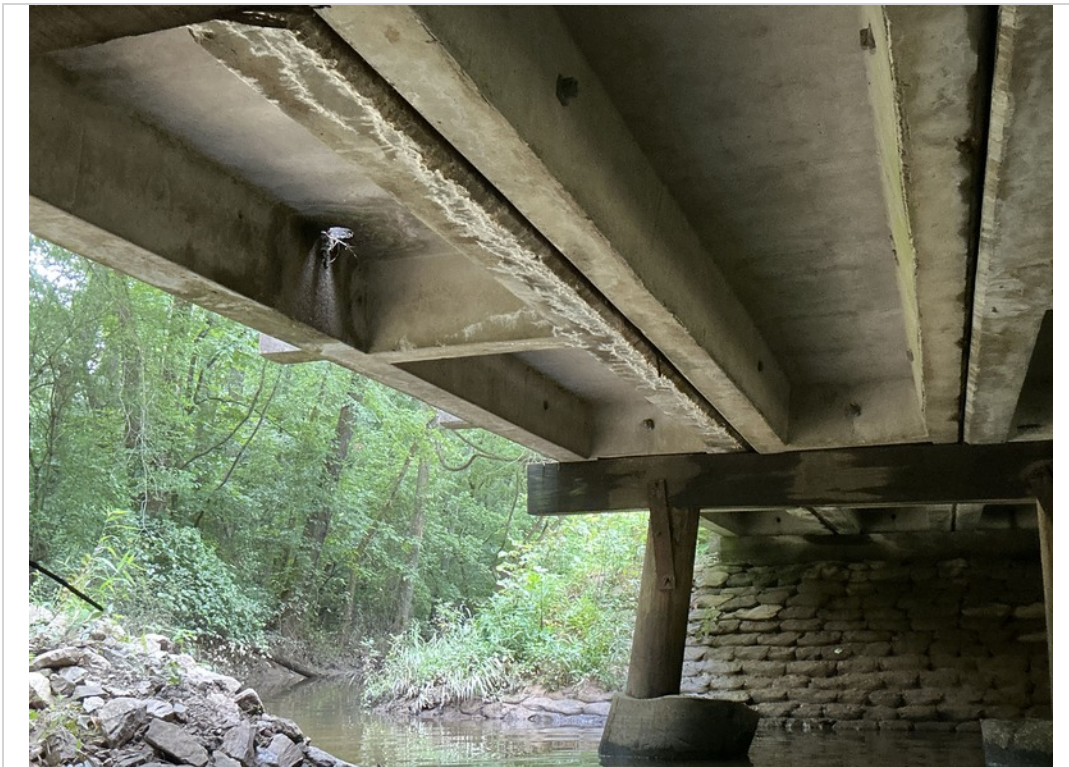
Span 2 Beam G Hairline Cracks w/EFF

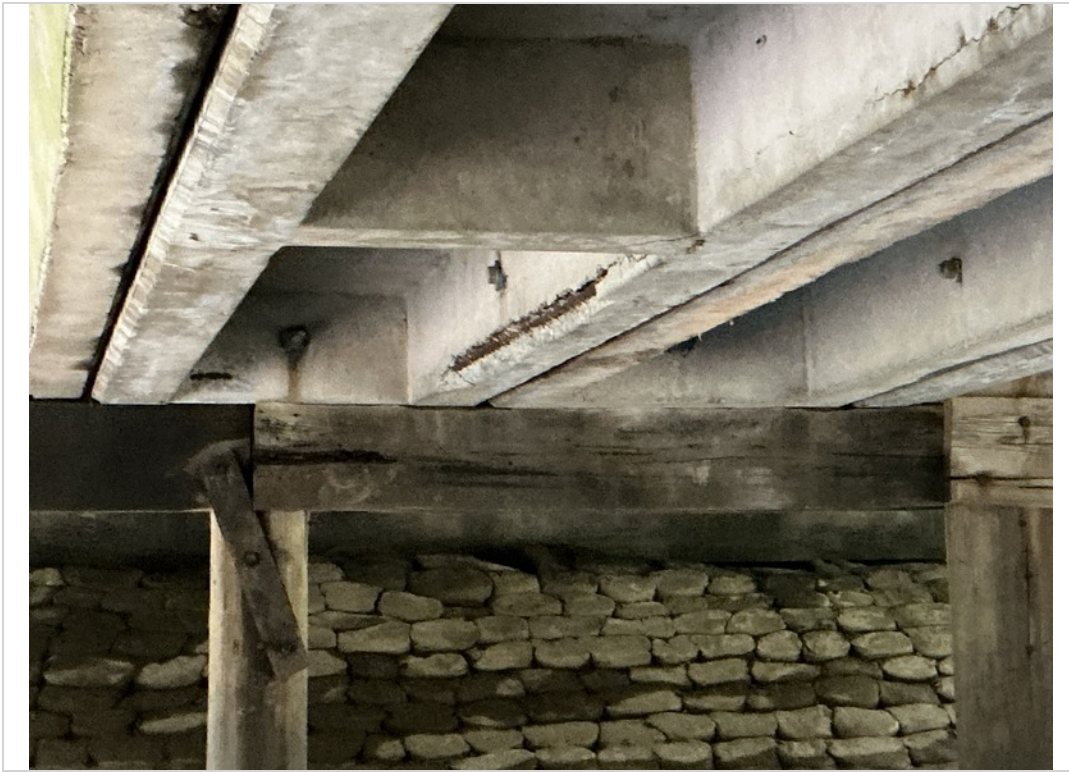
Span 2 Beam E Spall w/Exposed Rebar

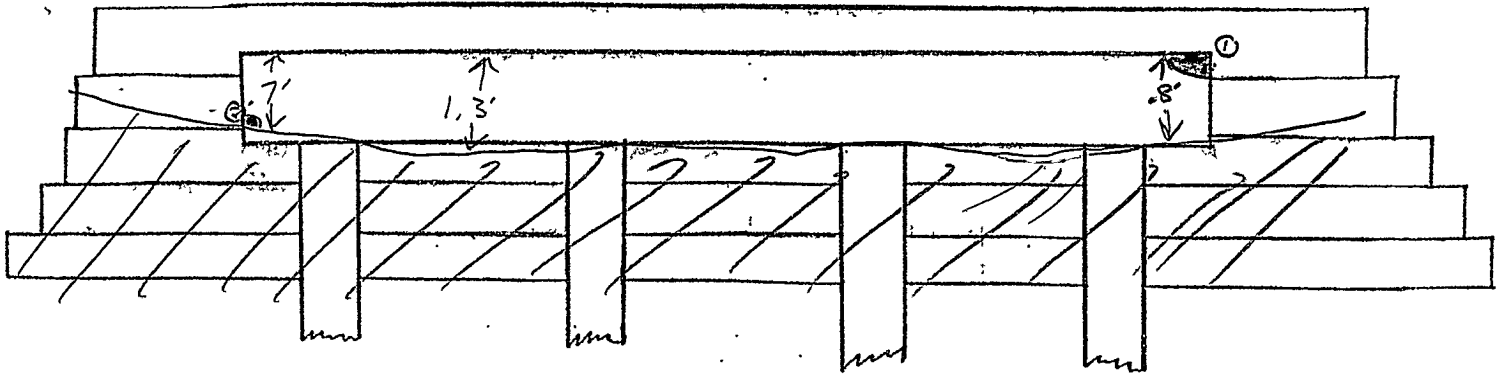
BR, NO, 38 779 109ABUT. NO. 1

LOOKING BACK① Decay  
6" W X 2" L X 1/4" D② Decay  
10" W X 3" T X 1/4" D
