Region 04, 38 - Haywood County

CHARLESTON RD. Crossing OVERFLOW

Inspection Date(s): 07/08/2025 - 07/09/2025

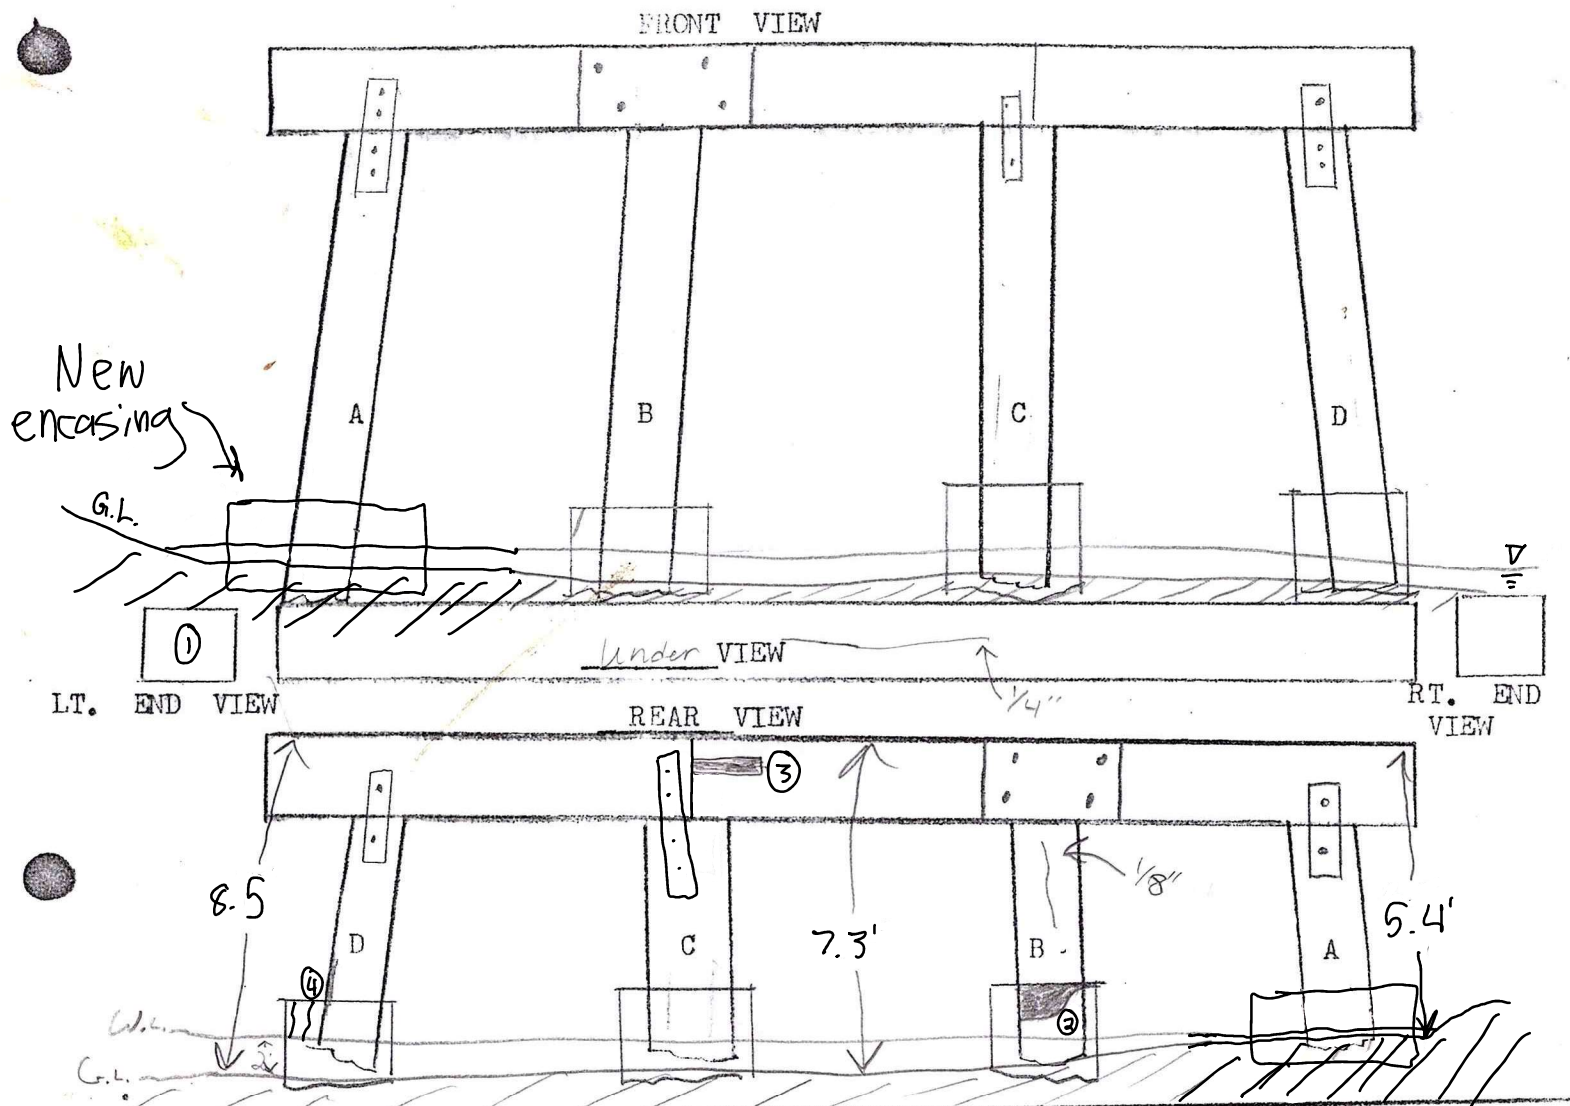
BENT NO. 1

| ELEMENT | RATING | COMMENTS |
|---|---|---|
| CAP | G F P C | Up to 1/4" checks, see ① and ③ |
| CASING | G F P C | up to 1/16" cracks, see ③, Water abrasion |

- ① Decay  
12" L x 11" T x 1/4" W
- ② Spall to steel  
18" T x 2" W x 2" D
- ③ Decay/splitting  
18" x 2" x 2" D  
at end of cap  
section above pile
