I-24 Crossing I24 / NORTH FIRST ST

90 - LAST INSPECTION DATE 09/21/2021

IDENTIFICATION	
(1) State Names	47 - Tennessee
(8) Structure Number	19I00240107
(5) Inventory Route	1
(2) Highway Agency District	Region 3
(3) County Code	19 - Davidson

4 span Bridge / Cont. S.I.B
I-24 / North First Street

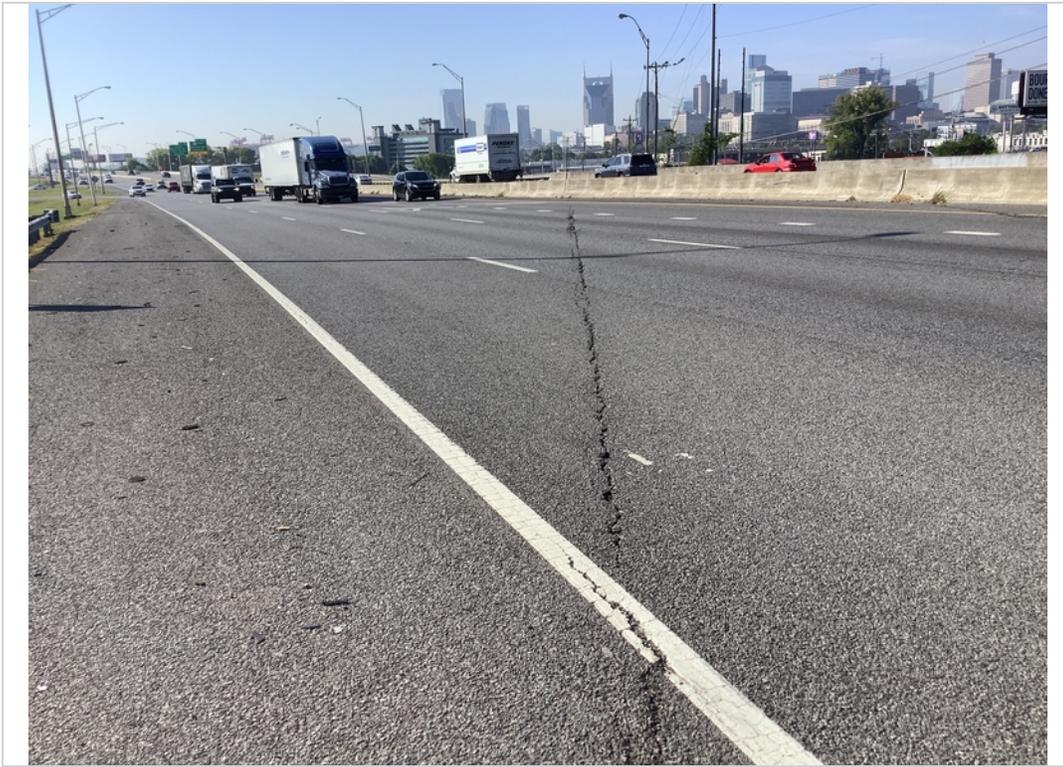
Expansion joint span #4, transverse crack upto 1" open, westbound

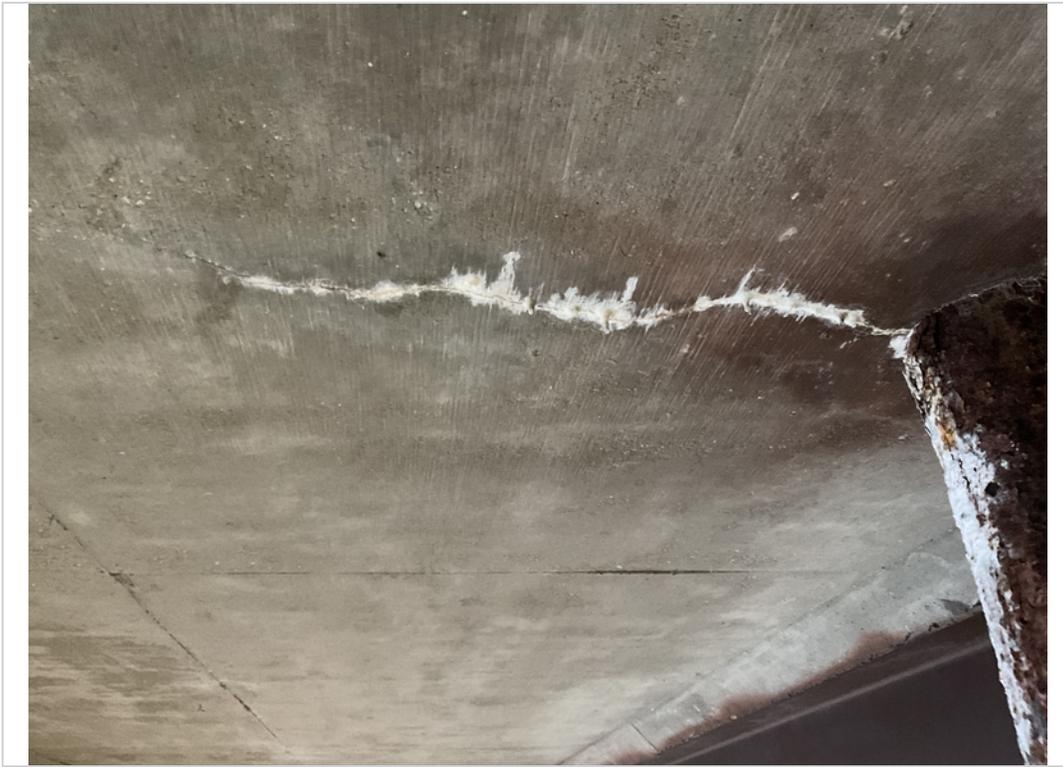
Span 4 bay J trans cracks with eff

Span 4 bay I trans crack with eff

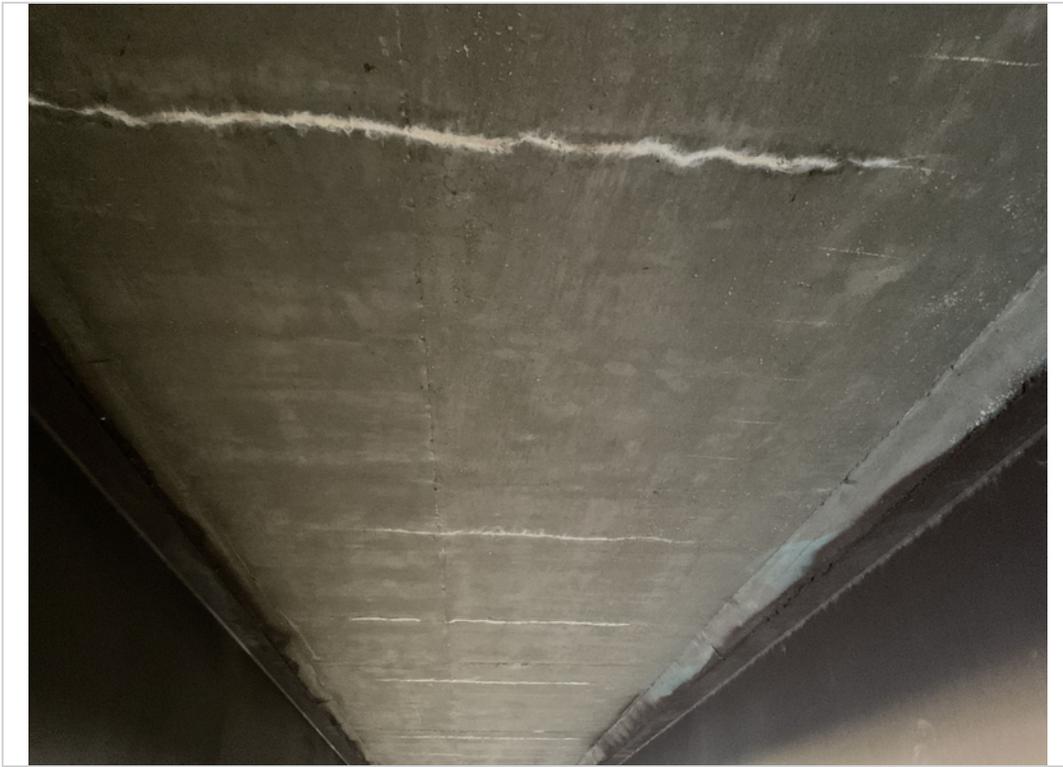
Span 4 bay H trans cracks with eff

Span 4 bay G trans cracks with eff

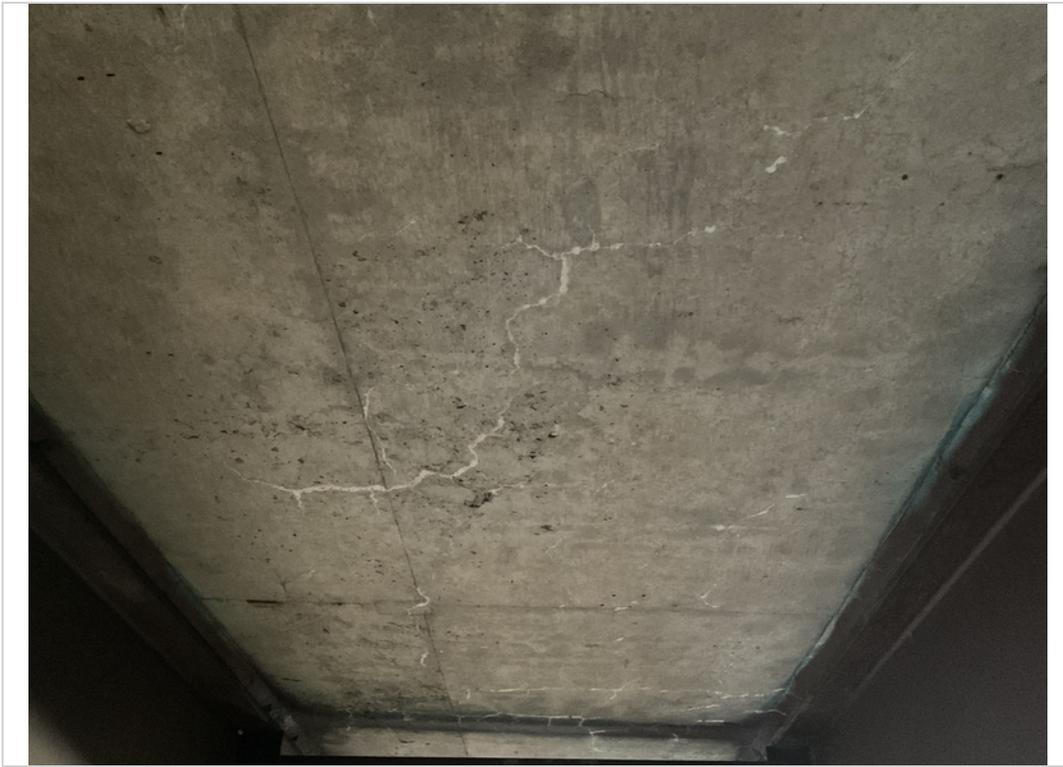
Span 4 bay F map cracks with eff

Span 4 bay E map cracks with eff

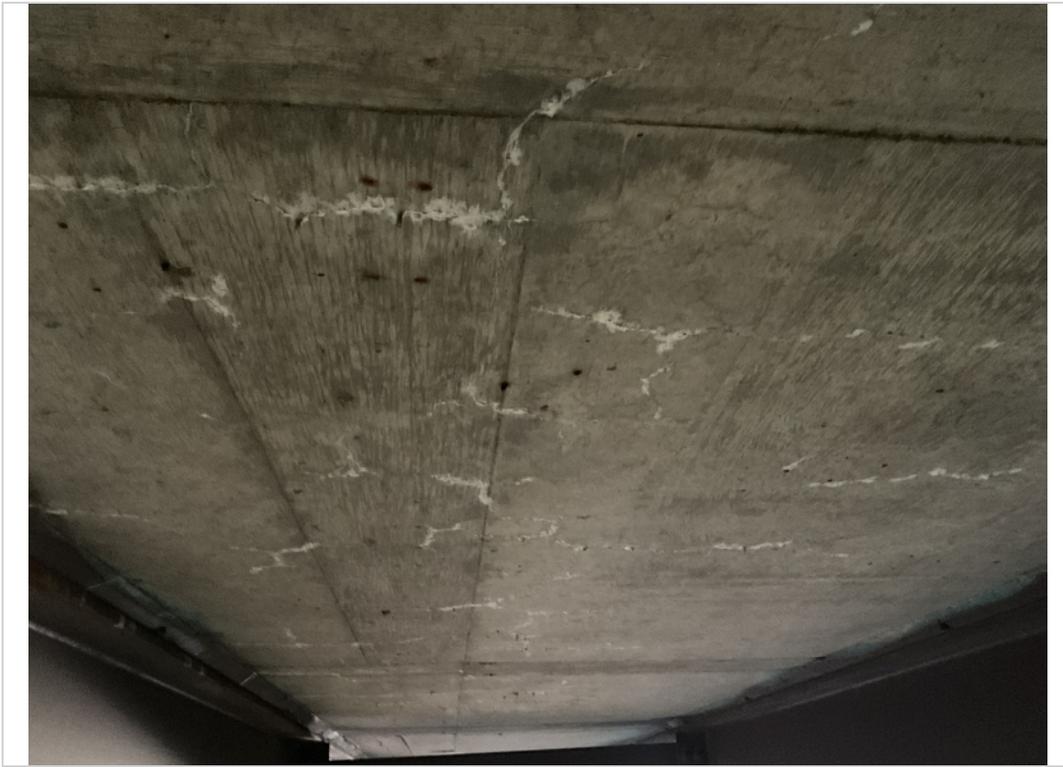
Span 4 Bay E patch

Span 4 bay D map cracks with eff

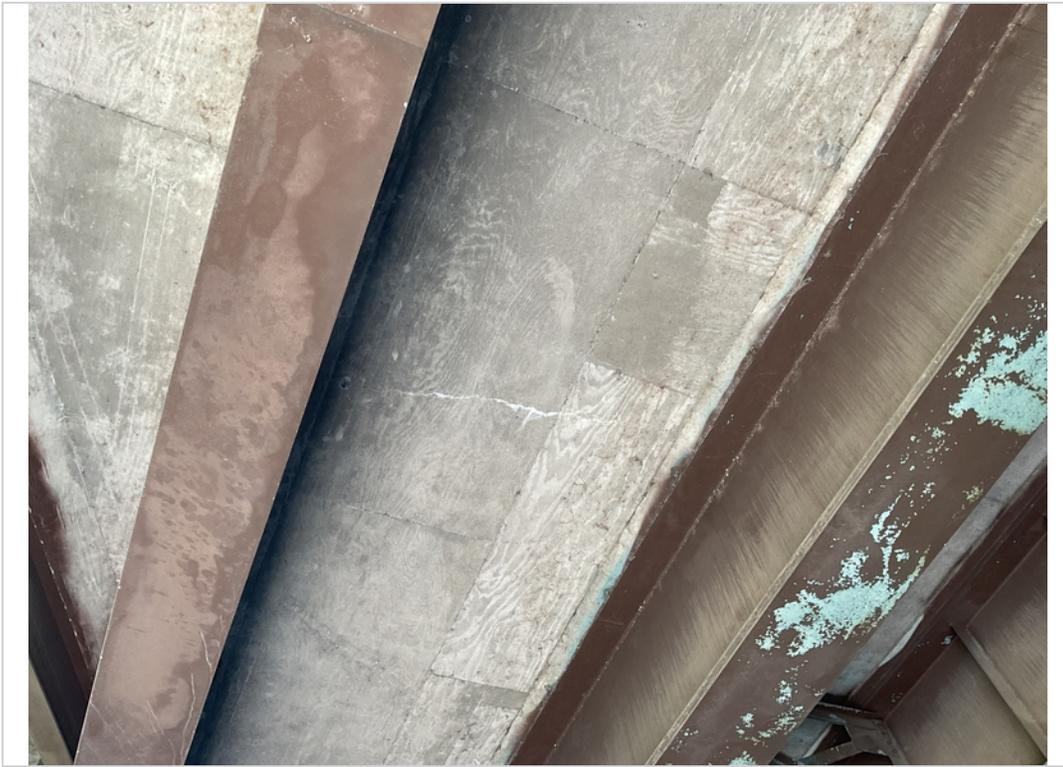
Span 3 bay E spall with exp steel

Span 3 bay B trans crack with eff

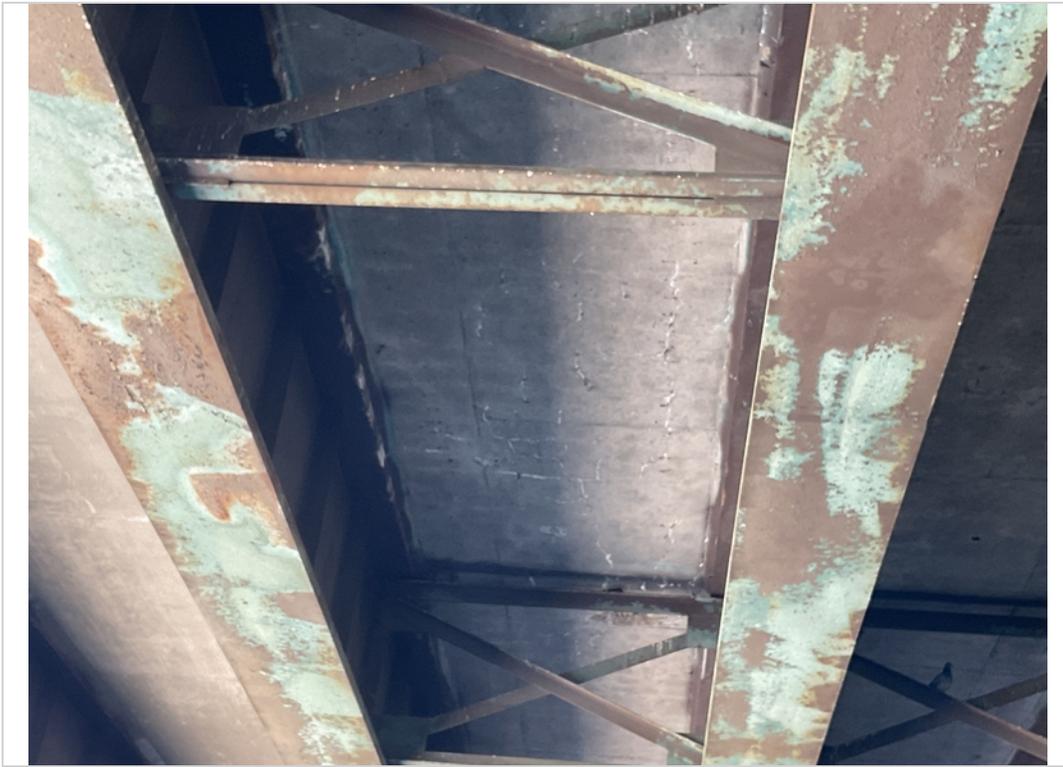
Span 3 bay C spall with exp steel

Span 3 bay C map cracks with eff

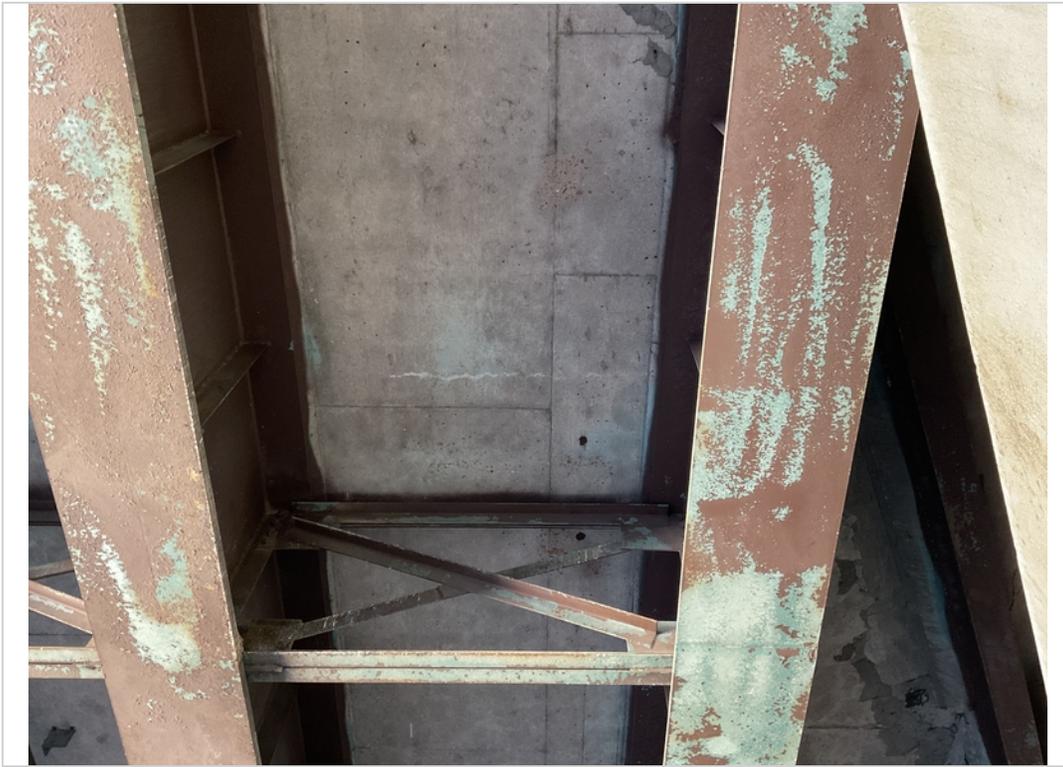
Span 3 bay D spall with exp steel

Span 3 bay E trans crack with eff

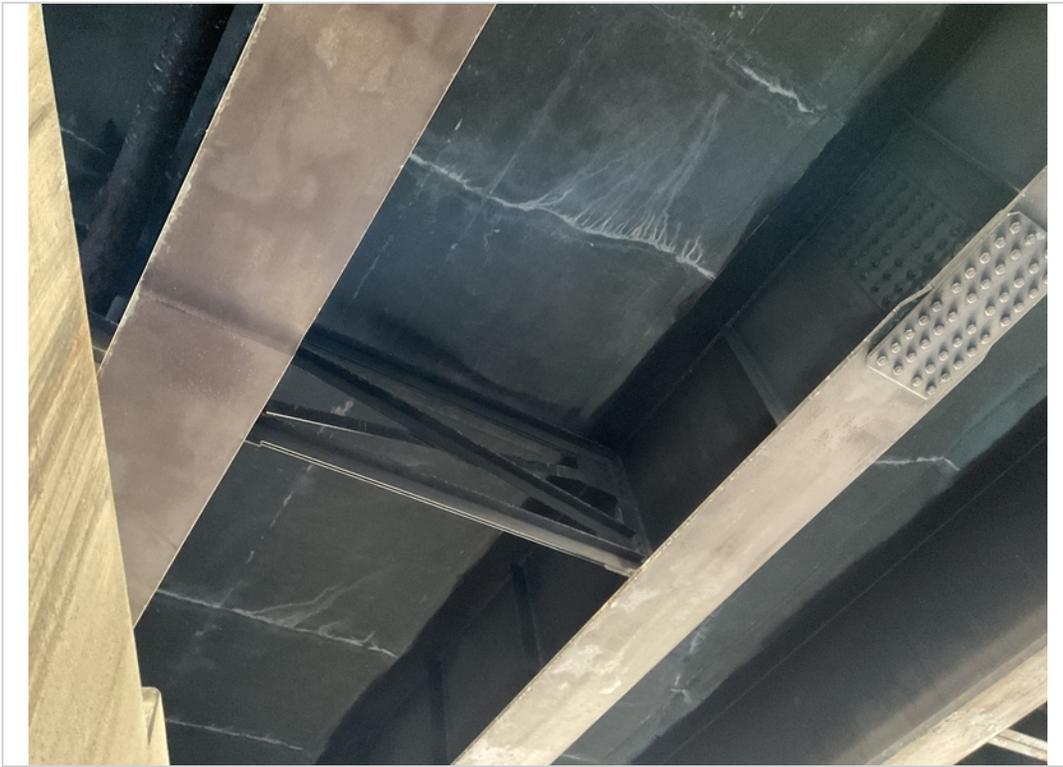
Span 3 bay G trans cracks with eff

Span 3 bay H trans cracks with eff

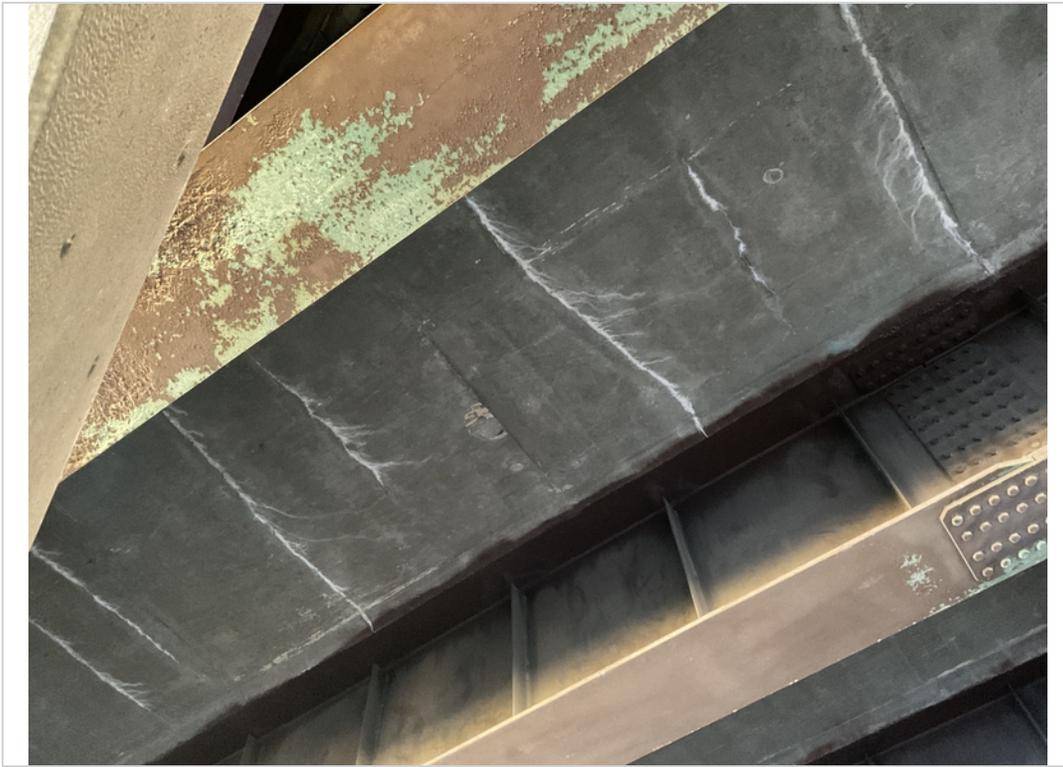
Span 3 bay I trans cracks with eff

Span 3 bay K trans cracks with eff

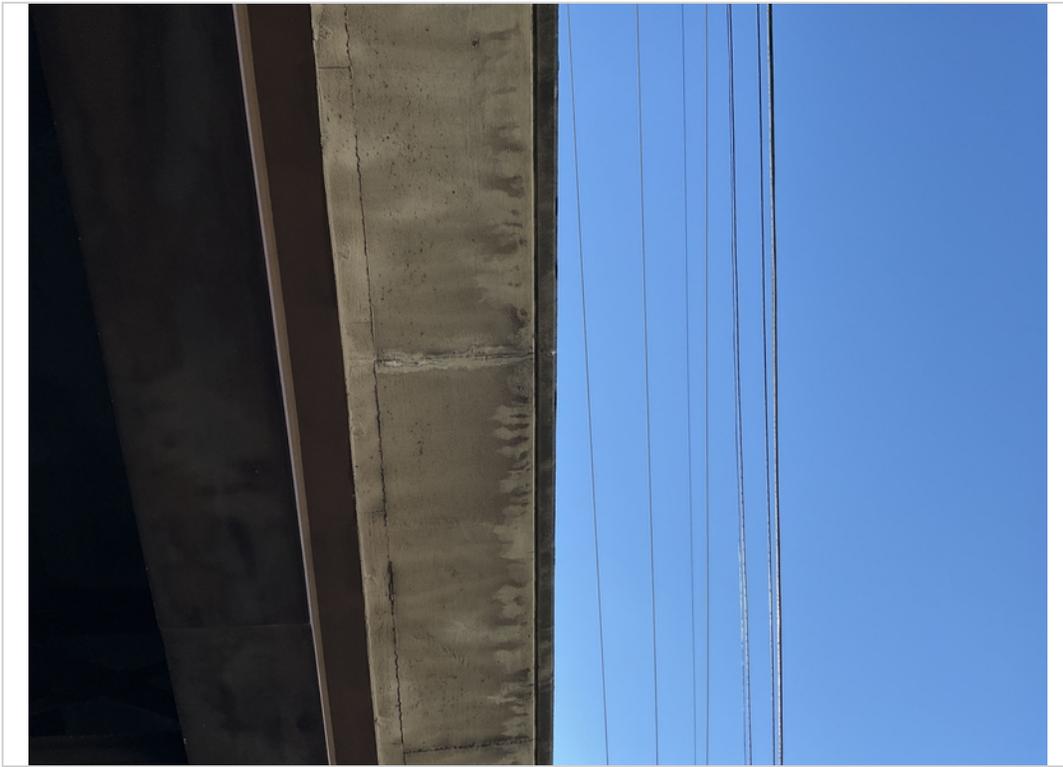
Span 3 bay J spall with exp steel

Overhang Span 3 right side trans crack with eff

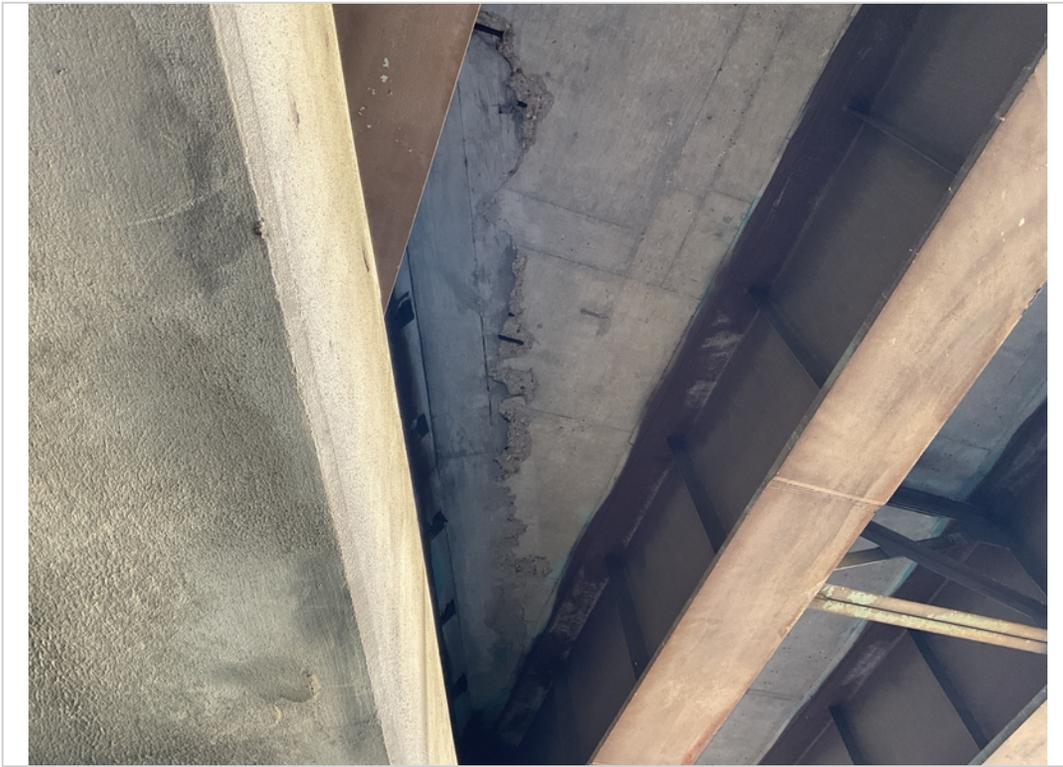
Span 2 bay N spall with exp steel

Span 2 bay M spall with exp steel

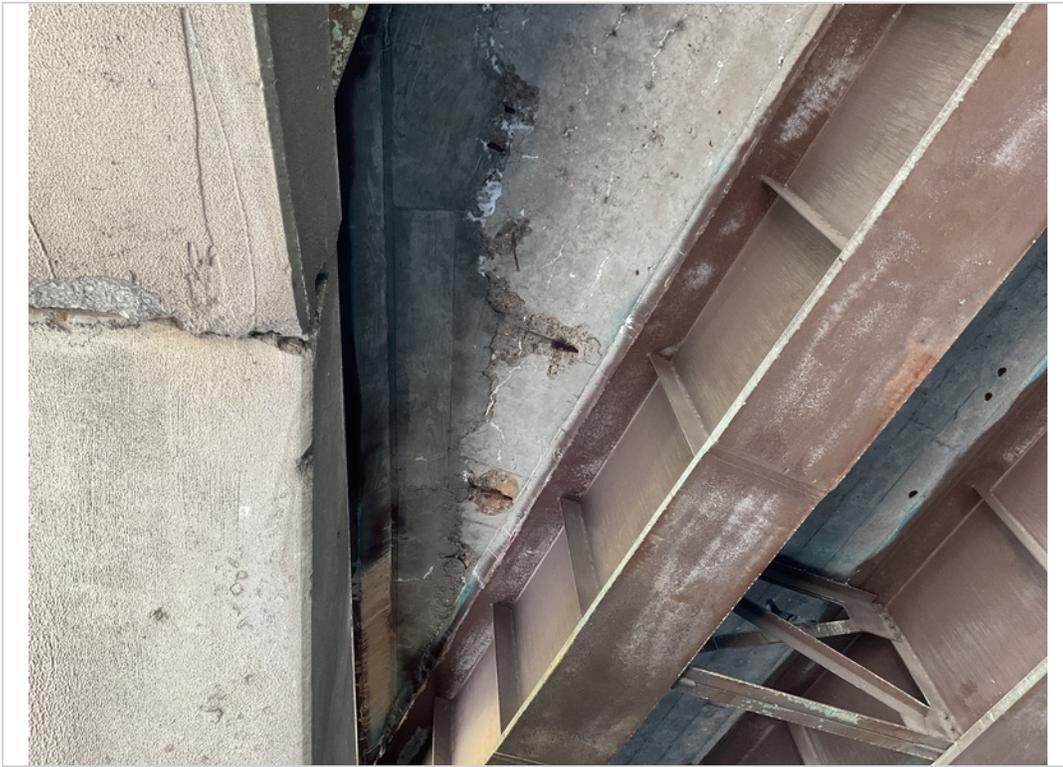
Span 2 bay D spalls with exp steel

Span 2 bay C spalls with exp steel

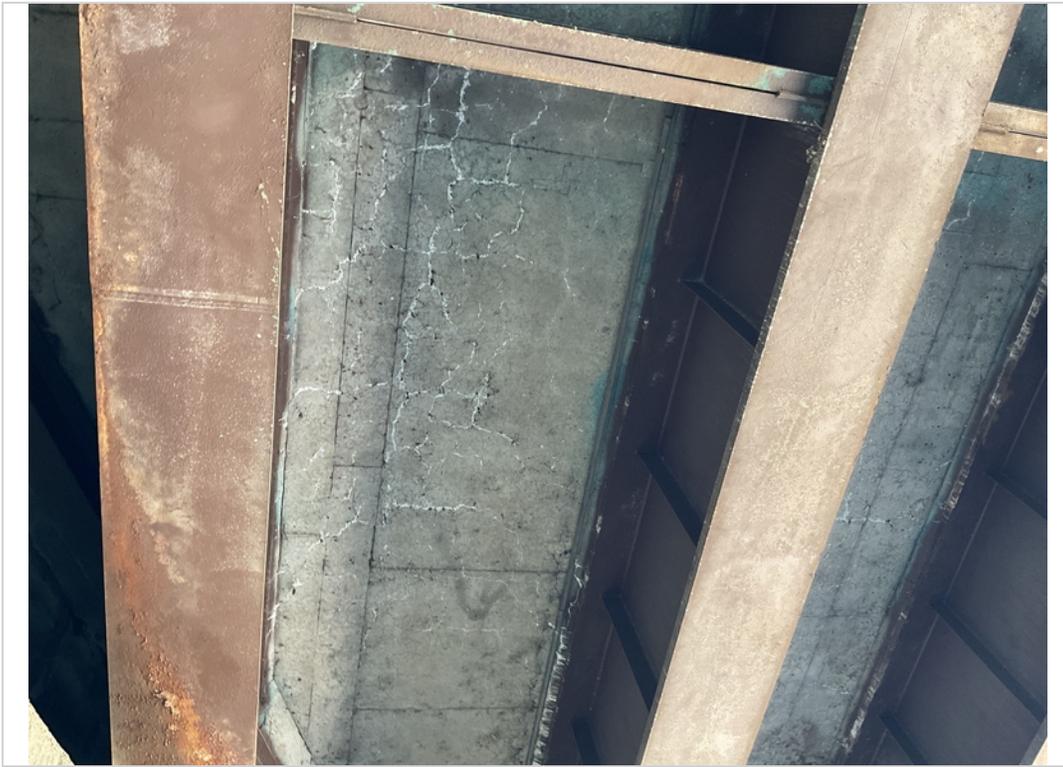
Span 2 bay C map cracks with eff

Span 2 bay D map cracks with eff

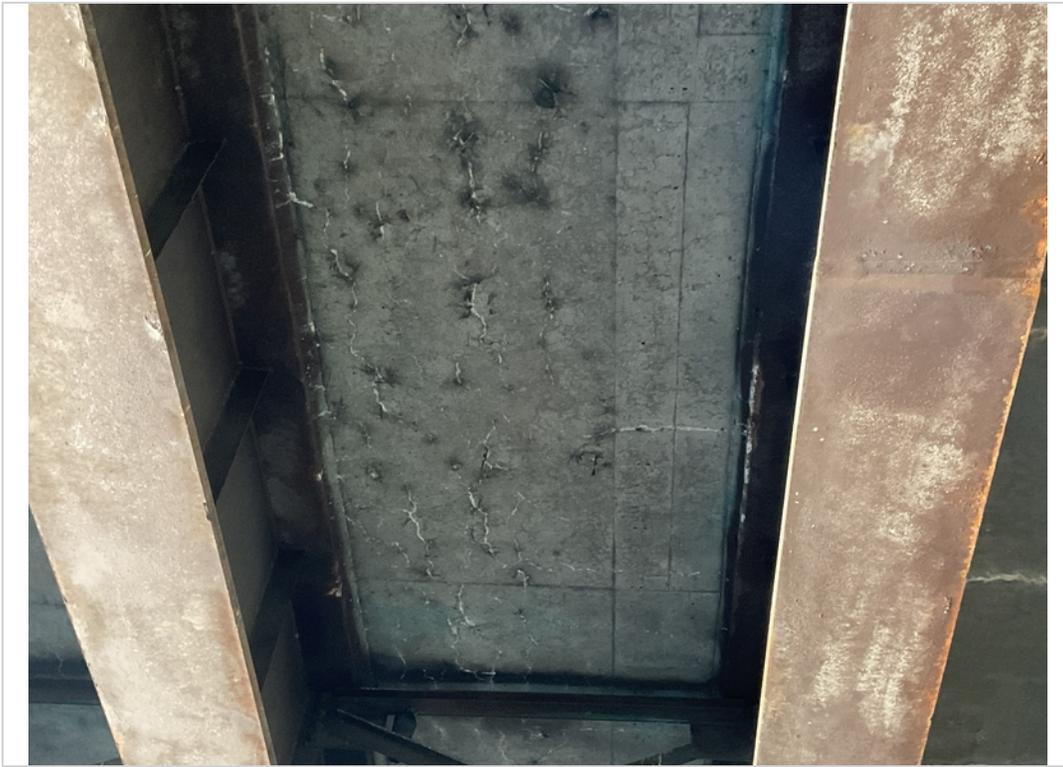
Span 2 bay E map cracks with eff

Span 2 bay F map cracks with eff

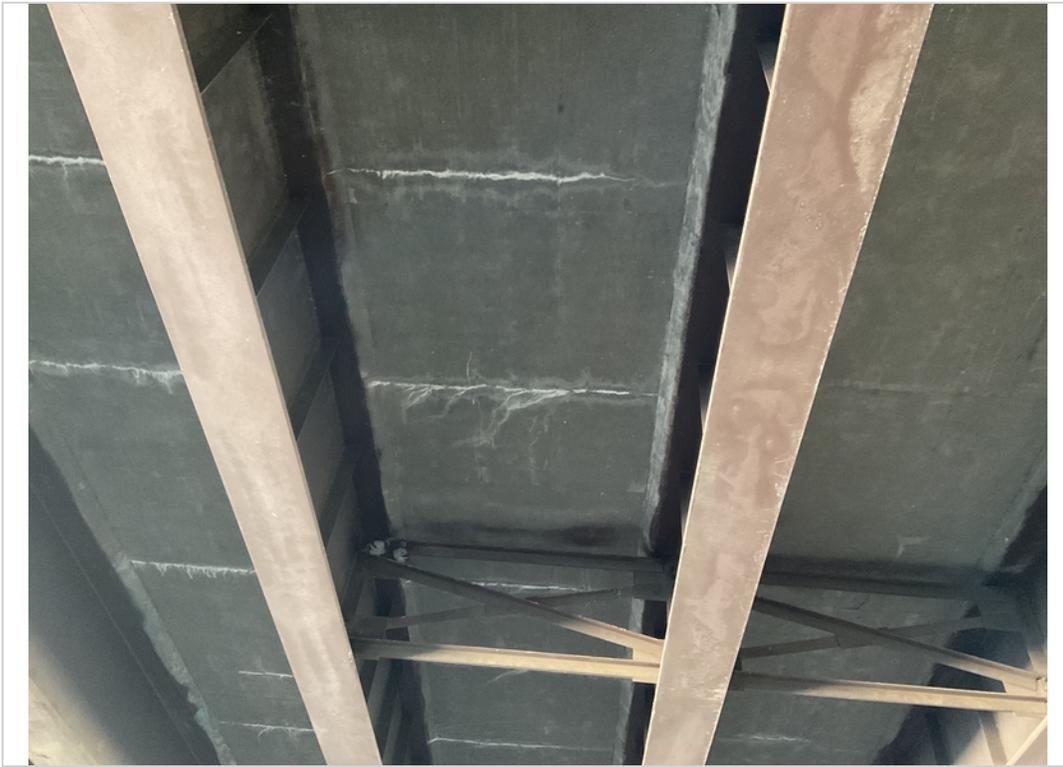
Span 2 bay G trans cracks with eff

Span 2 bay H trans crack with eff

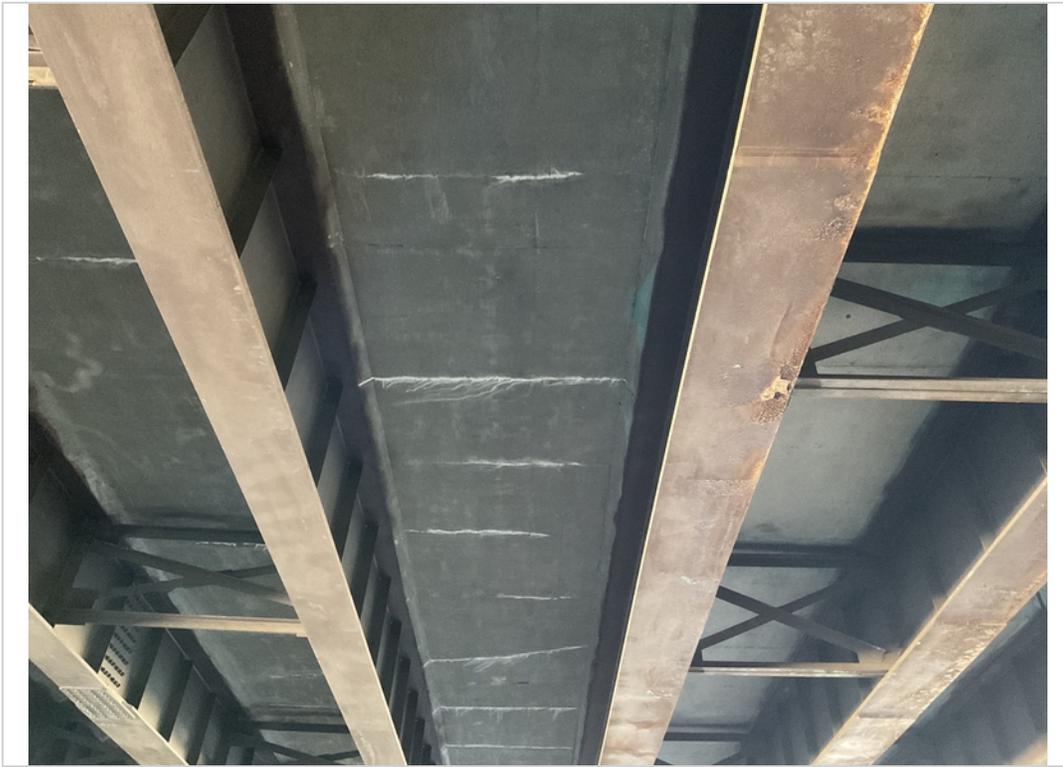
Span 2 bay I trans crack with eff

Span 2 bay J trans cracks with eff

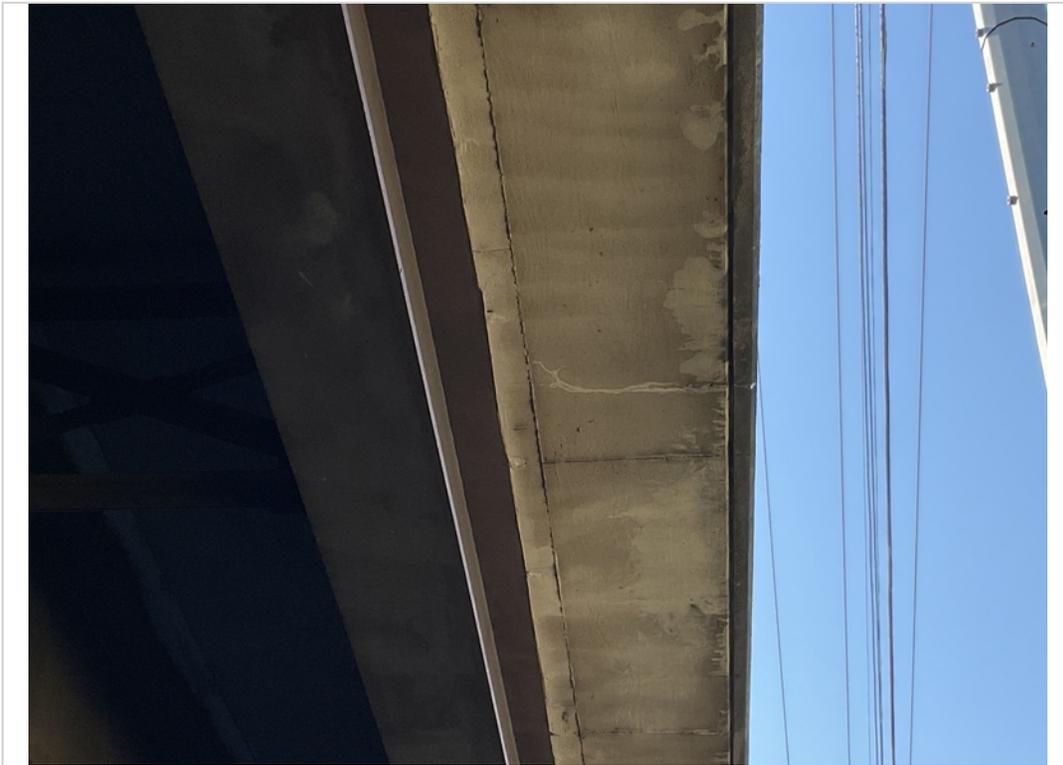
Span 2 bay N trans crack with eff

Overhang span 2 right side trans crack with eff

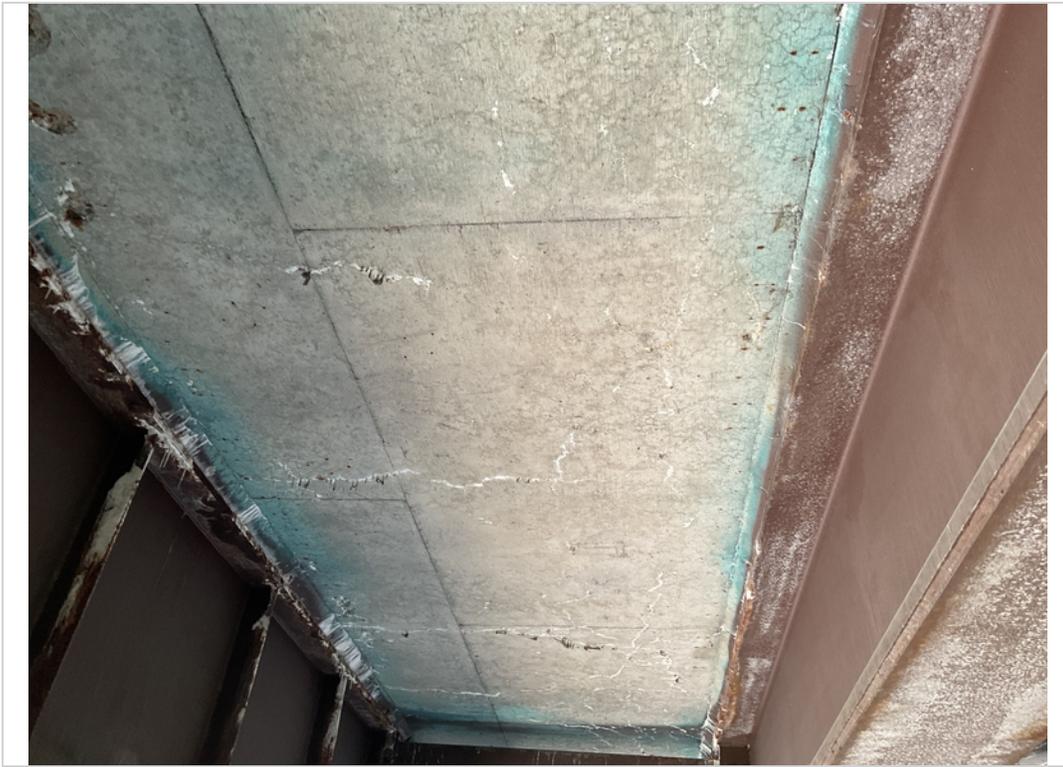
Span 1 bay A trans crack with eff

Span 1 bay C map cracks with eff

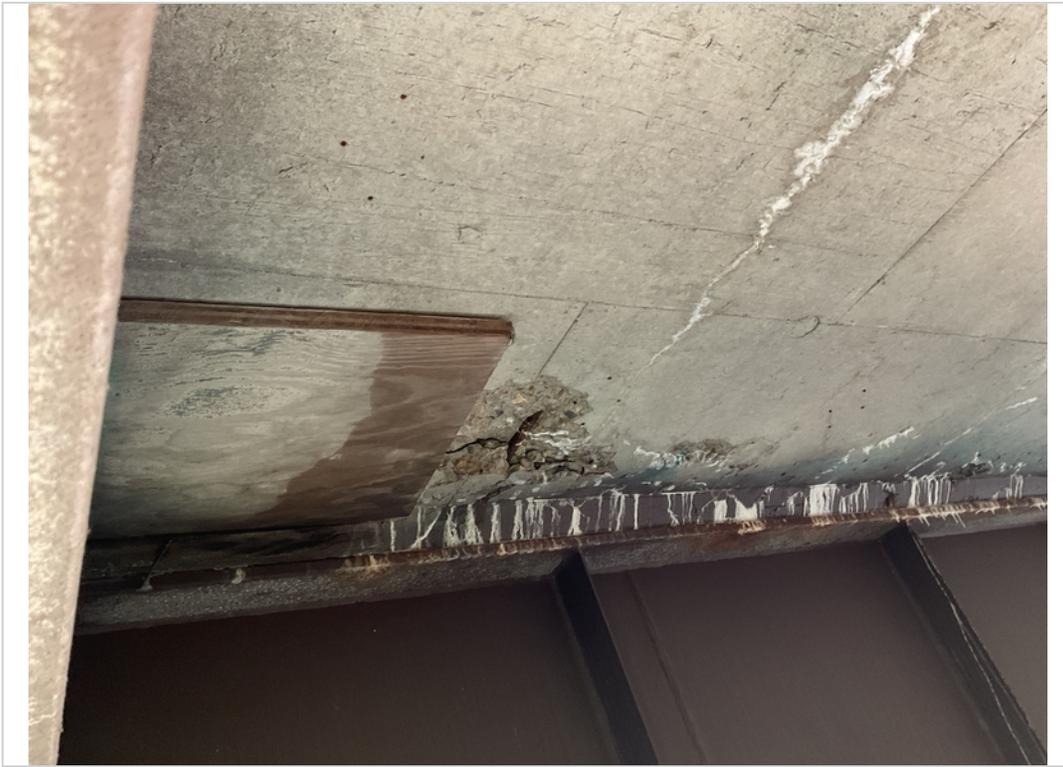
Span 1 bay C cracks with eff at top flange

Span 1 bay C spall with exp steel

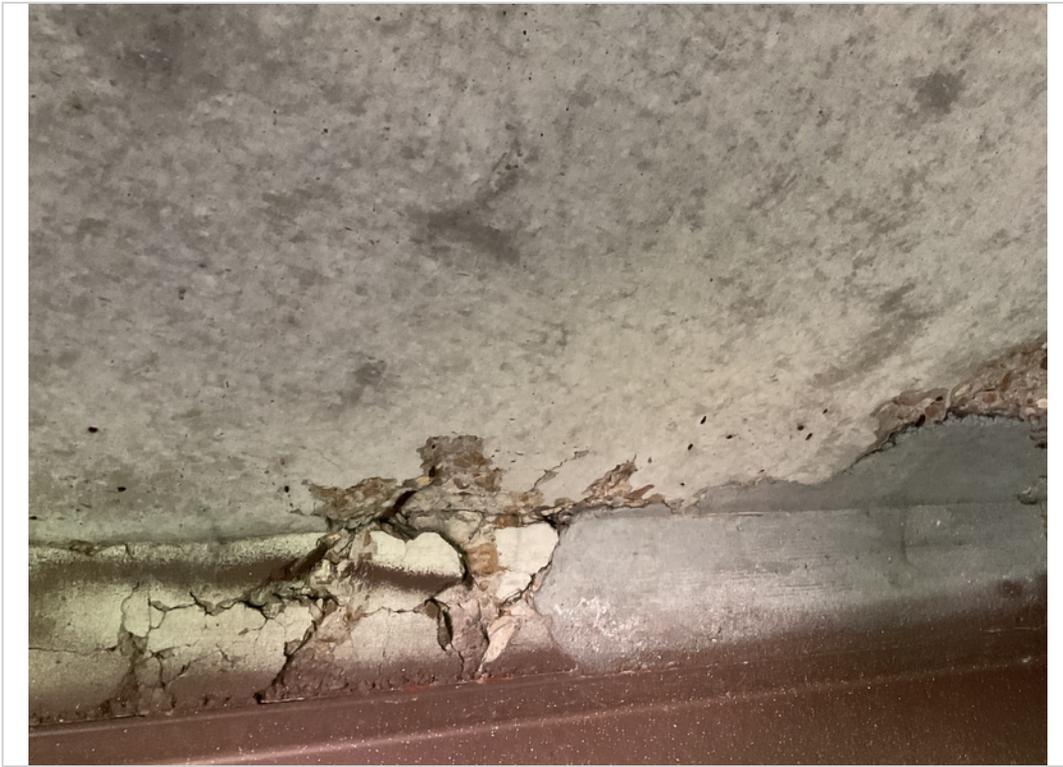
Span 1 bay C spall with exp steel

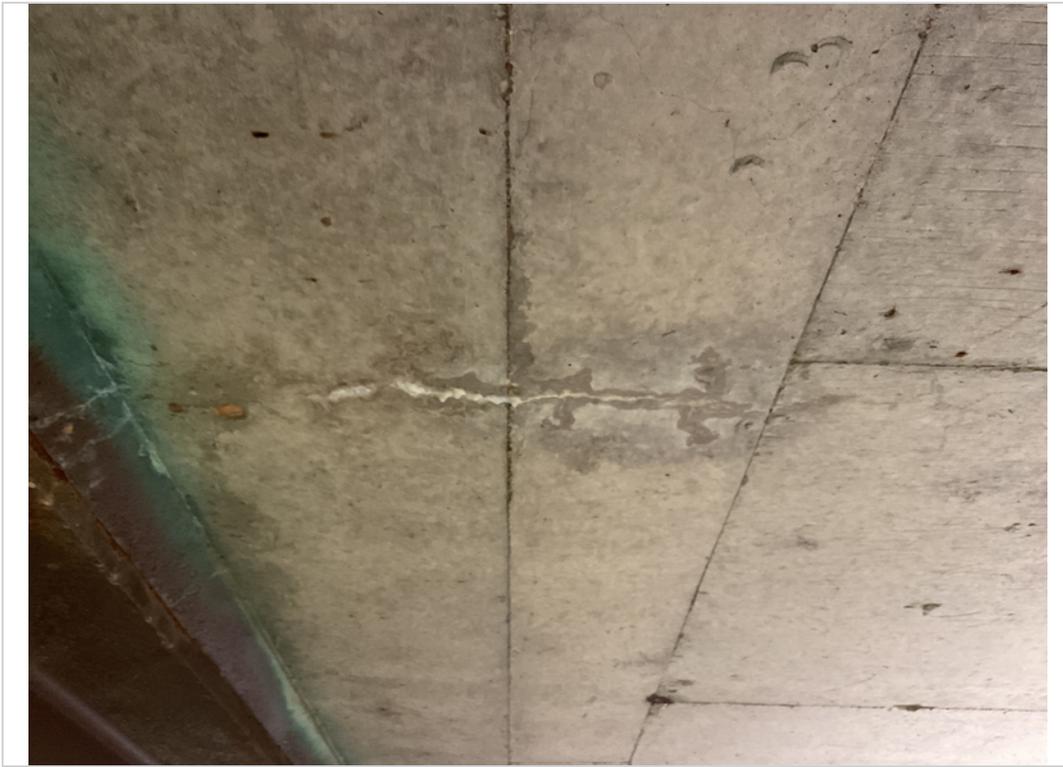
Span 1 bay D map cracks with eff

Span 1 bay D trans crack with eff

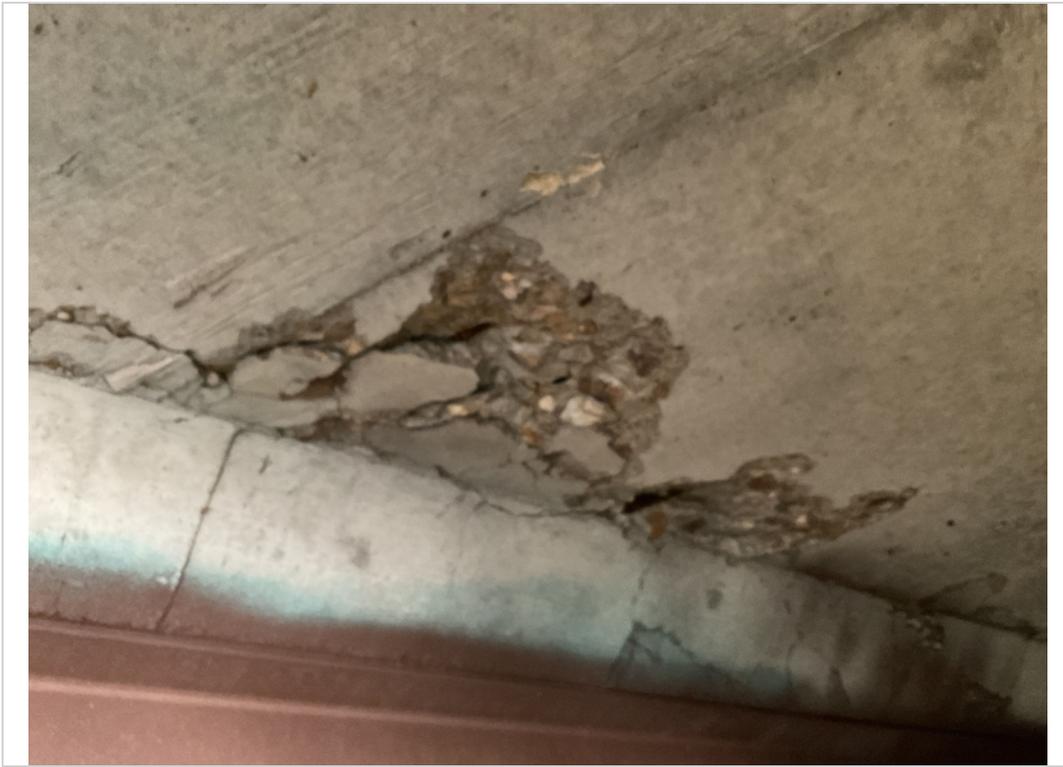
Span 1 bay E spall with exp steel

Span 1 bay D spall with exp steel

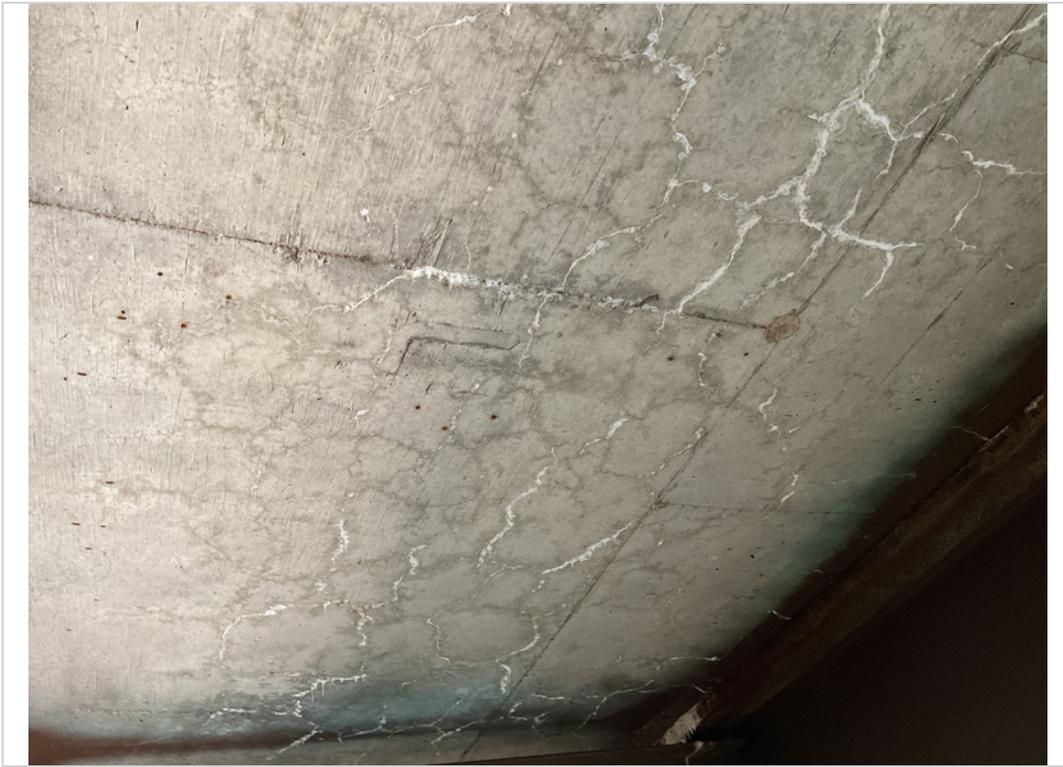
Span 1 bay F spall with exp steel

Span 1 bay E map cracks with eff

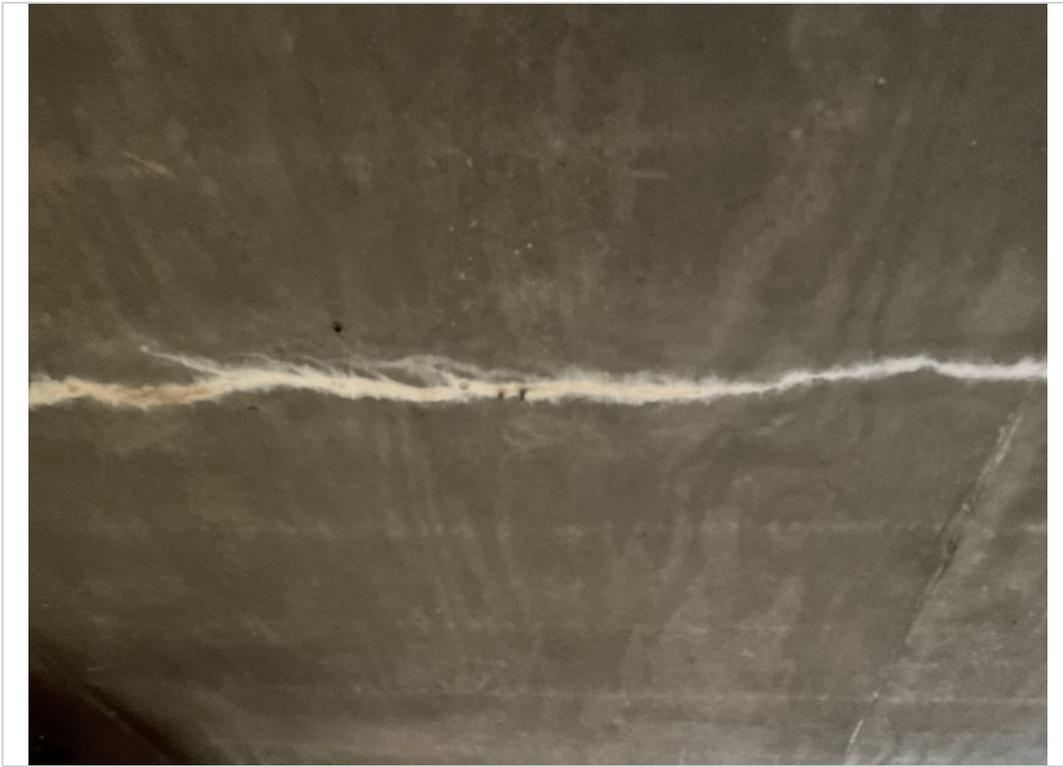
Span 1 bay G trans crack with eff

Span 1 bay H trans crack with eff

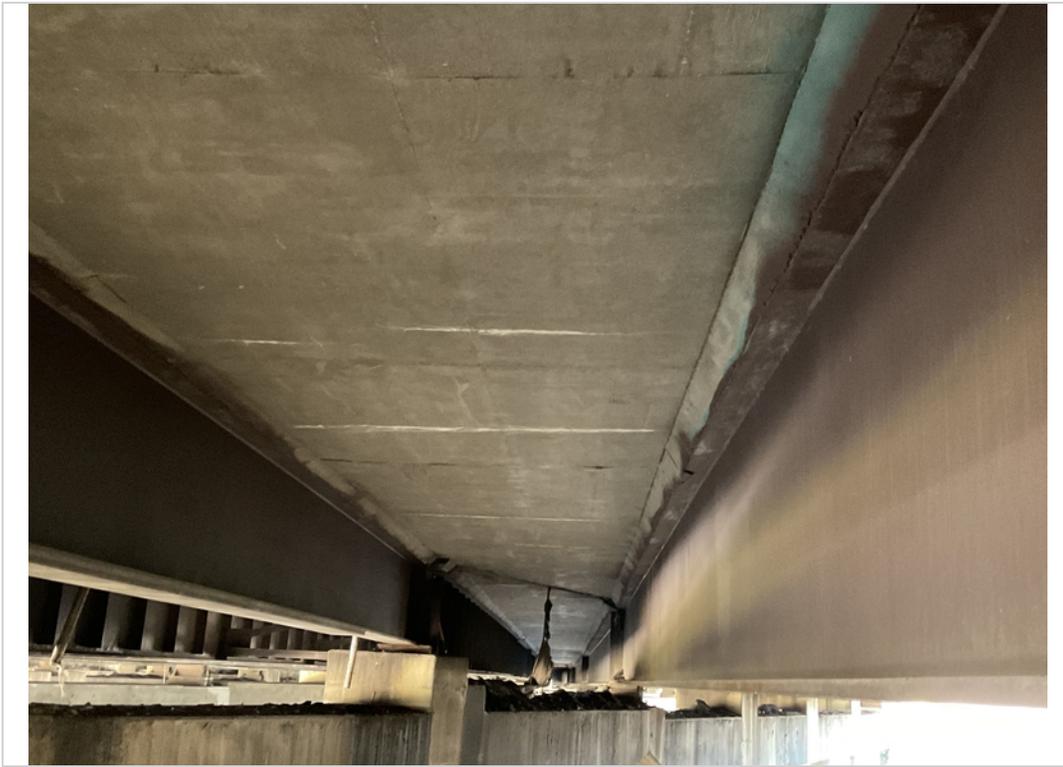
Span 1 bay I trans crack with eff

Span 1 bay J trans crack with eff

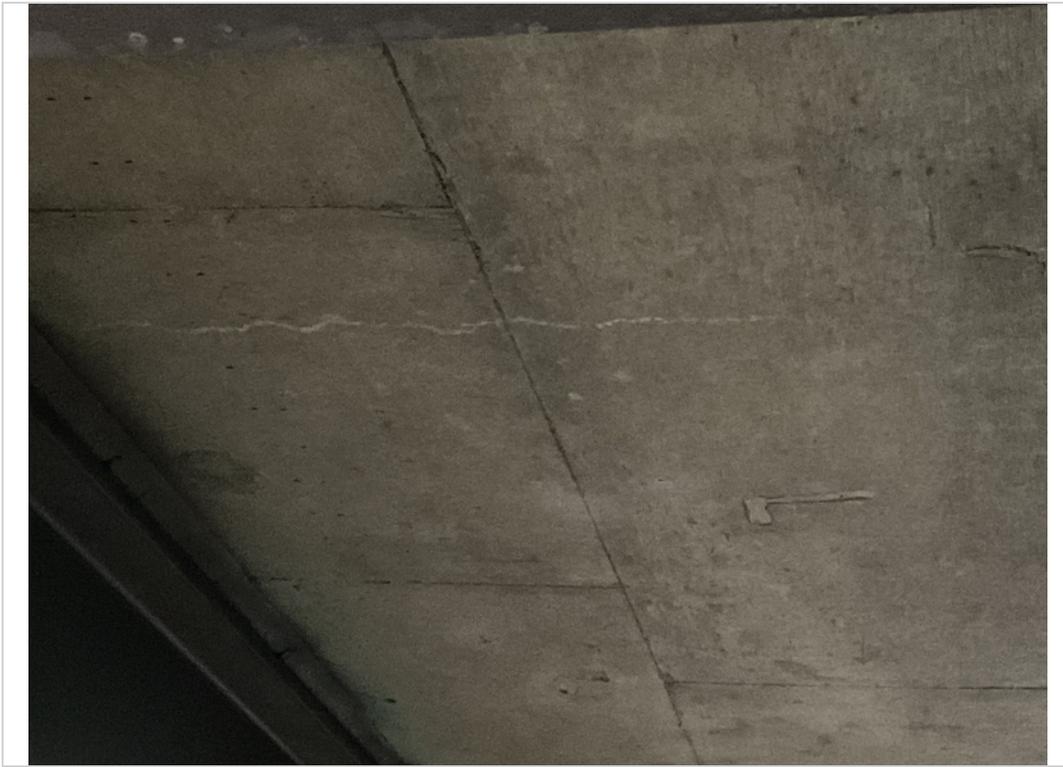
Span 1 bay J trans crack with eff

Span 1 bay M trans crack with eff
