I-24 Crossing I24 / NORTH FIRST ST

90 - LAST INSPECTION DATE 09/21/2021

IDENTIFICATION	
(1) State Names	47 - Tennessee
(8) Structure Number	19I00240107
(5) Inventory Route	1
(2) Highway Agency District	Region 3
(3) County Code	19 - Davidson

4 span Bridge / Cont. S.I.B
I-24 / North First Street

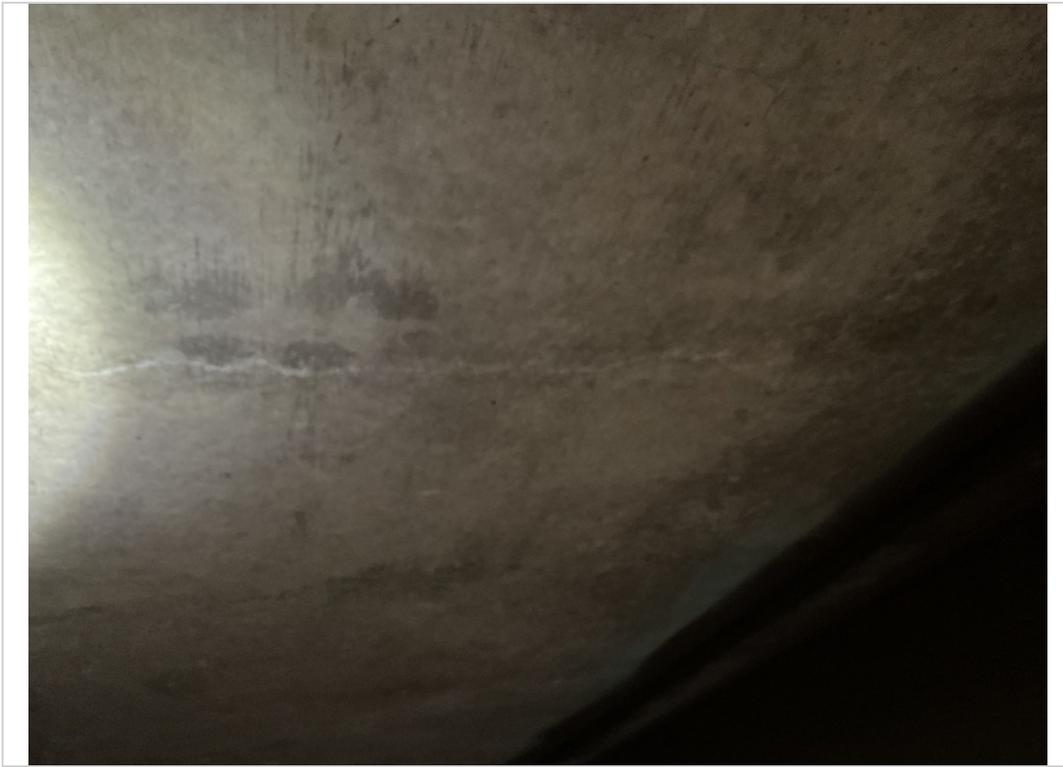
Span 1 bay N trans crack with eff

Span 1 bay O trans crack with eff

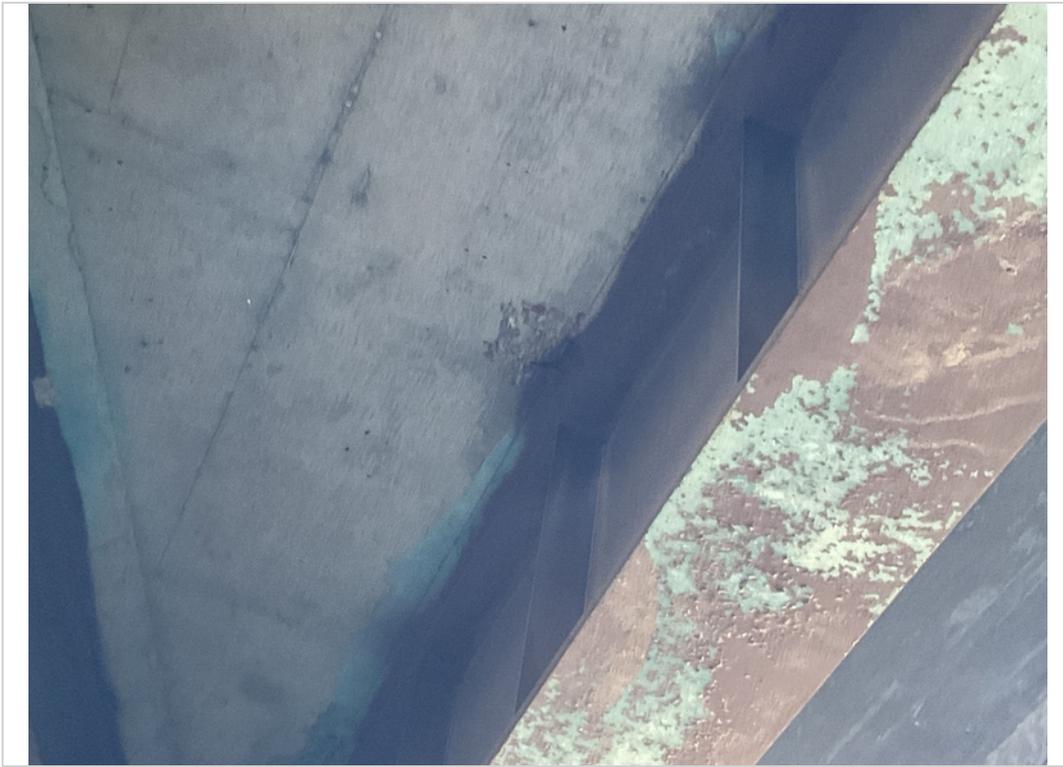
Span 1 bay O trans crack with eff

Span 1 bay O spall

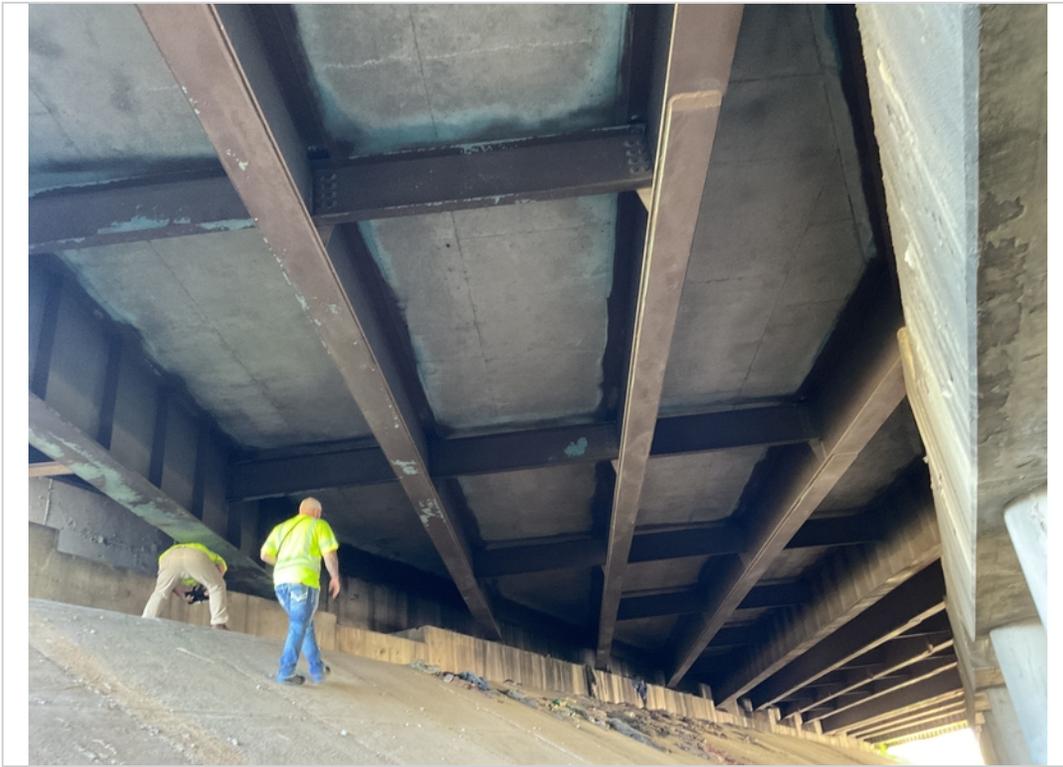
Span 1 diaphragm O spalling

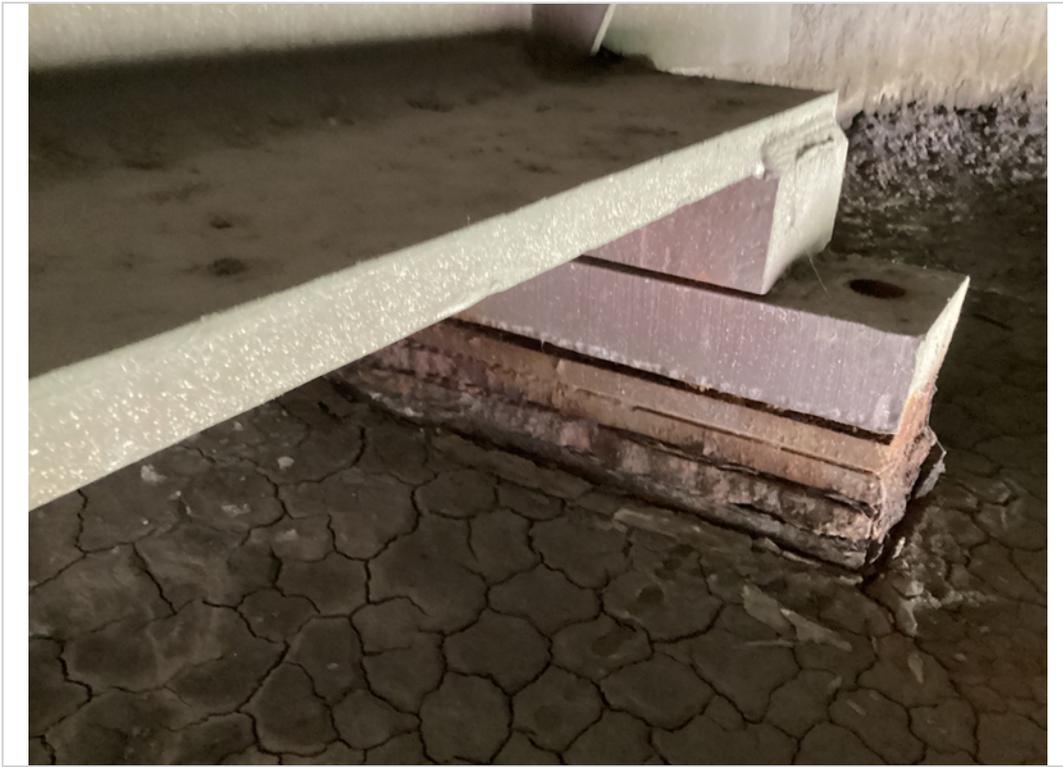
Bearing C missing bolt corrosion

Bearing D missing bolt

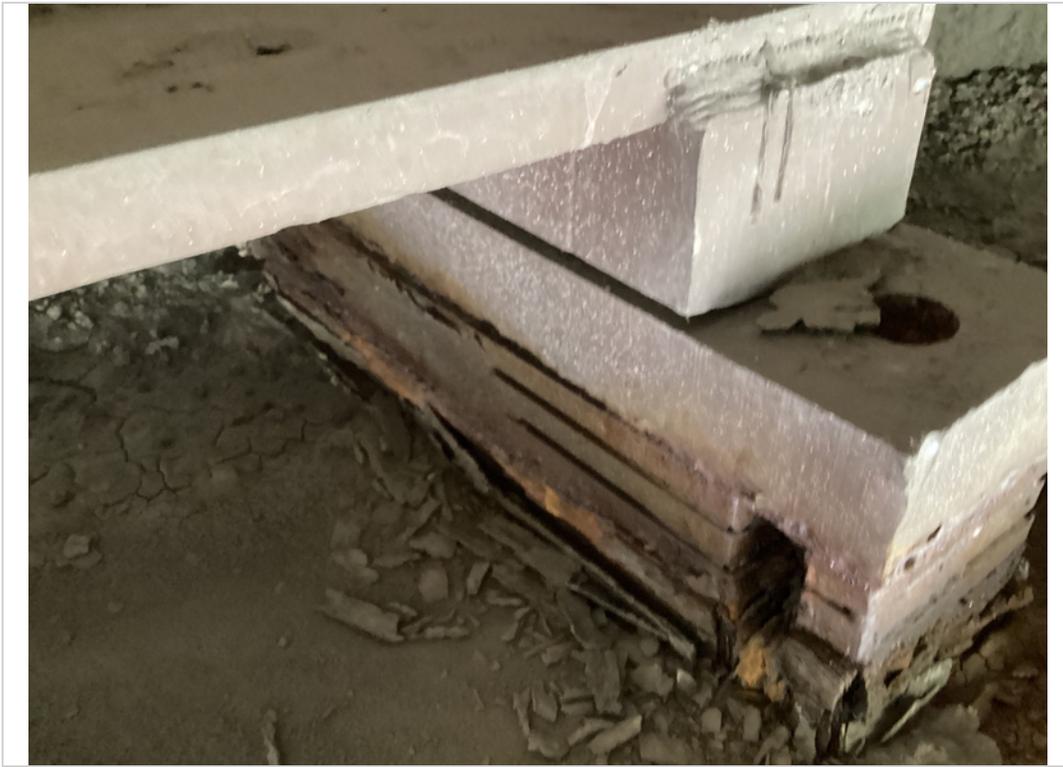
Bearing E missing bolts

Bearing F missing bolt

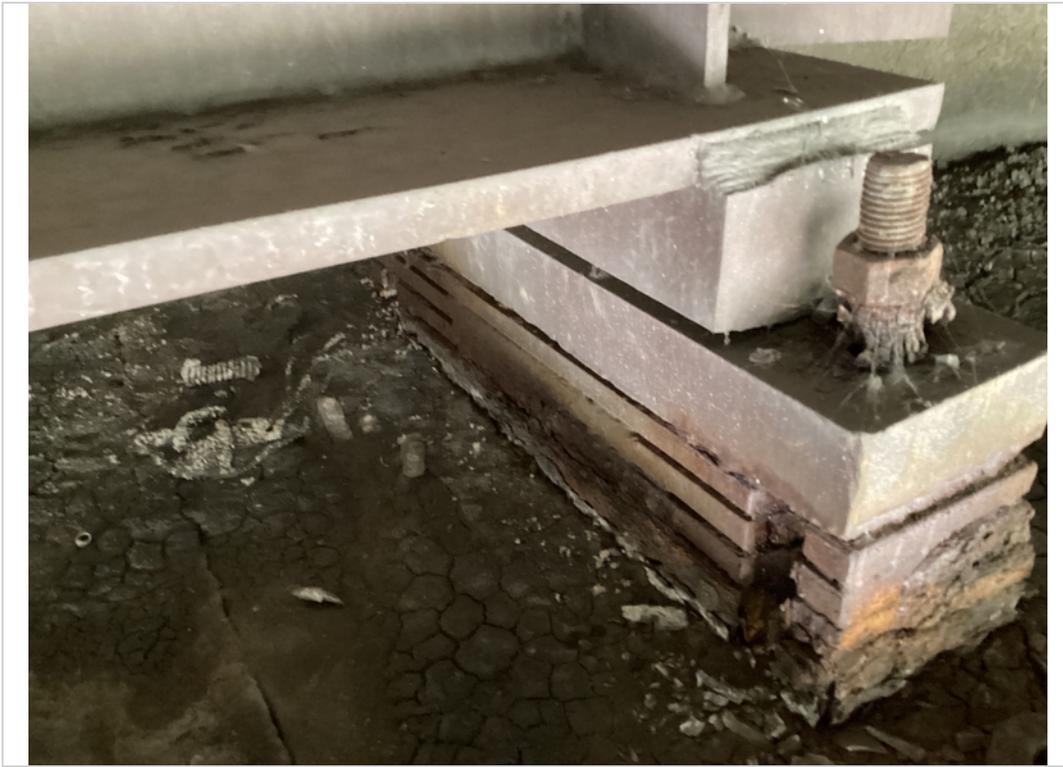
Bearing F bent bolt

Bearing G loose bolt corrosion

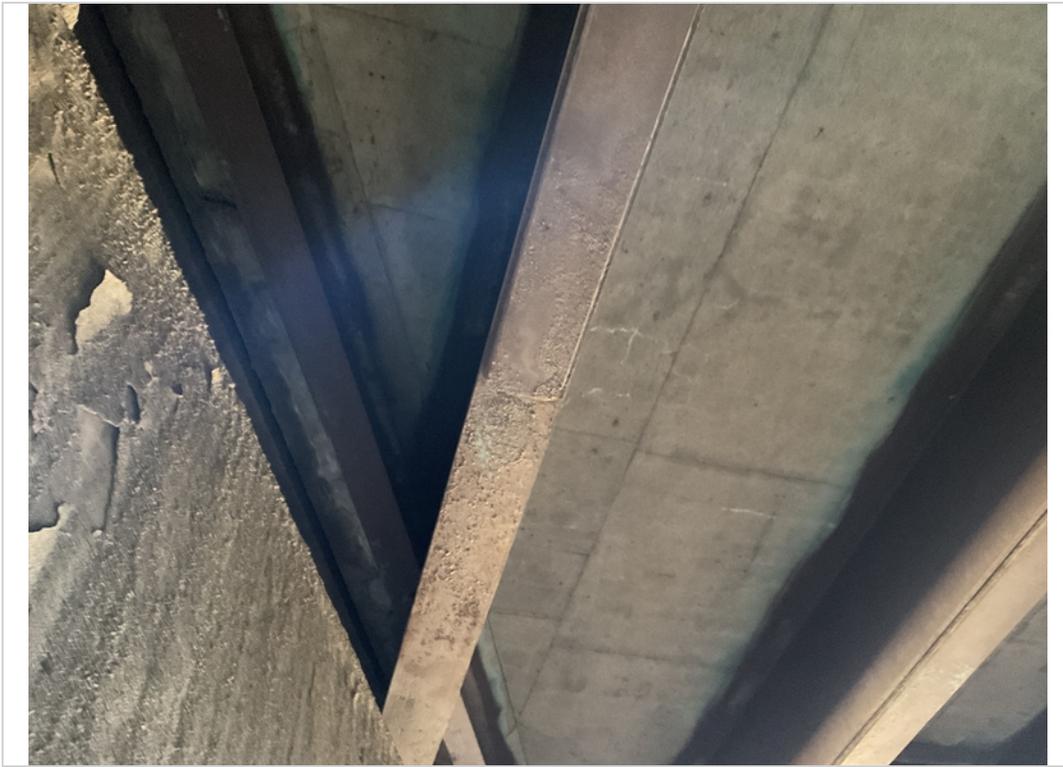
Bearing J loose nut corrosion

Span 4 Girder E corrosion

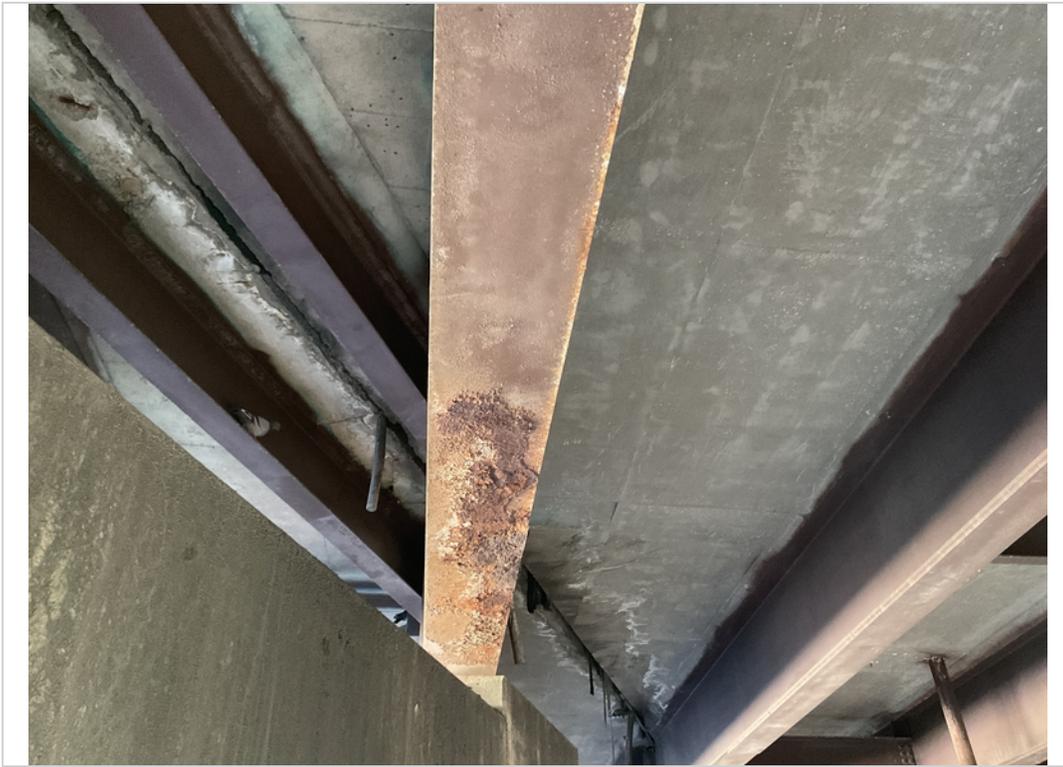
Span 4 Girder G corrosion with eff

Span 4 Girder K corrosion

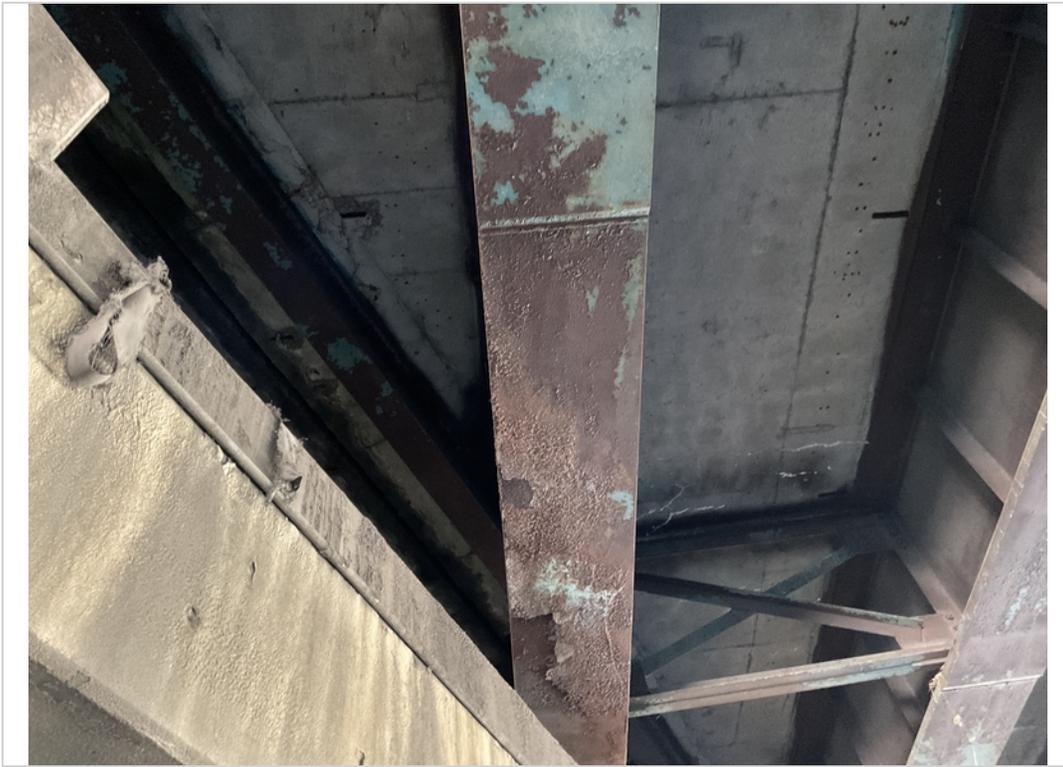
Span 4 Girder O corrosion

Span 3 Girder F corrosion

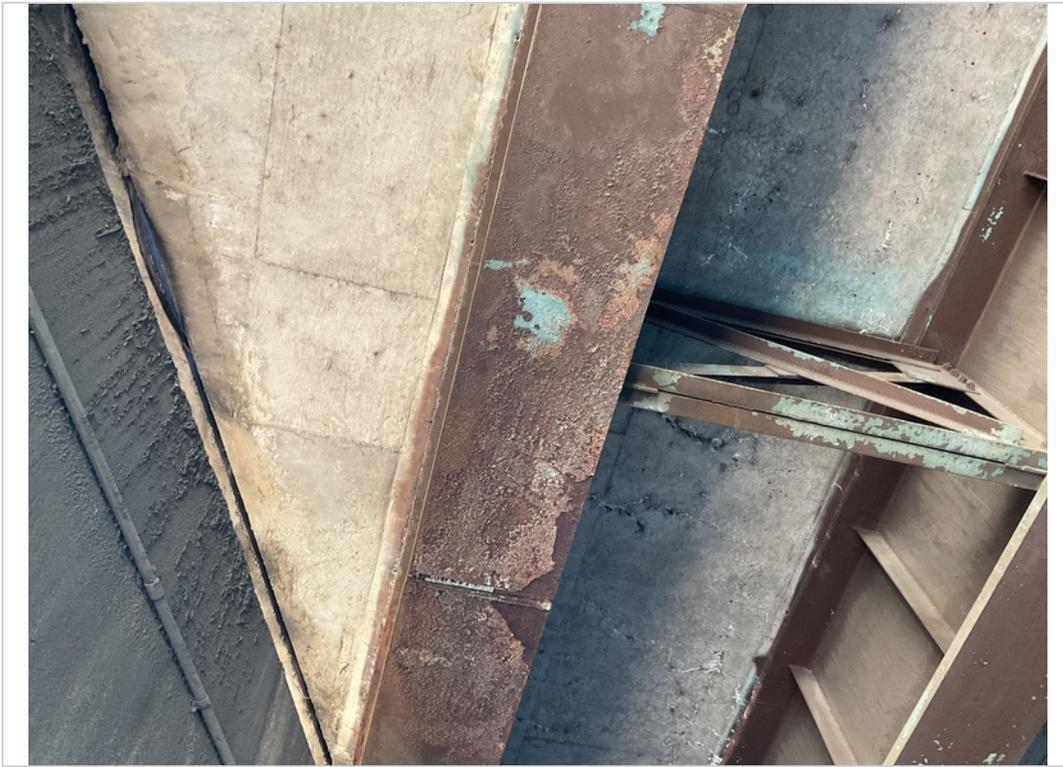
Span 3 Girder D corrosion

Span 3 Girder C corrosion

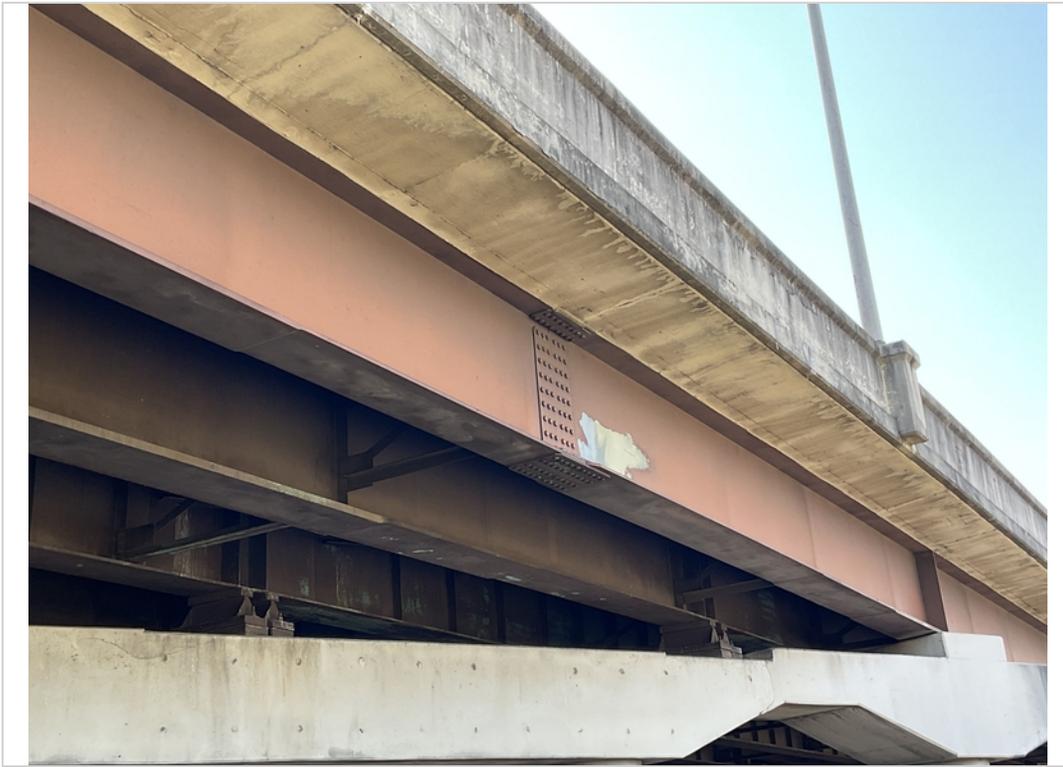
Span 2 Girder G corrosion

Span 2 Girder P paint peeling

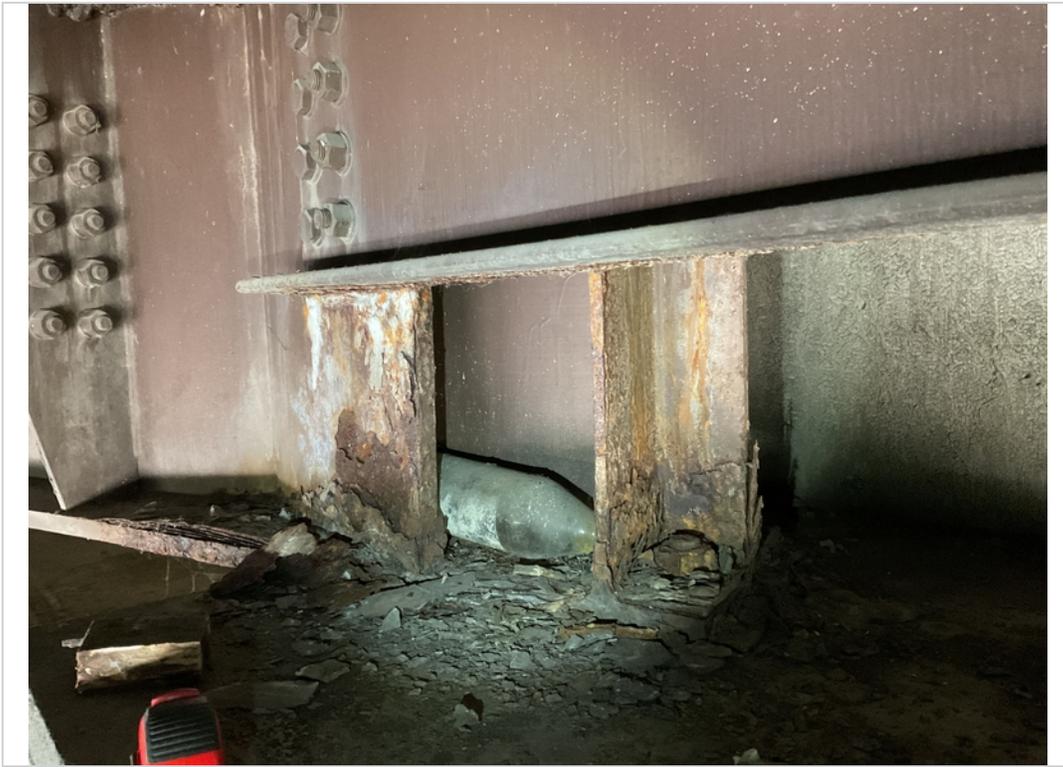
Span 1 Girder G corrosion

Span 1 Girder I heavy corrosion

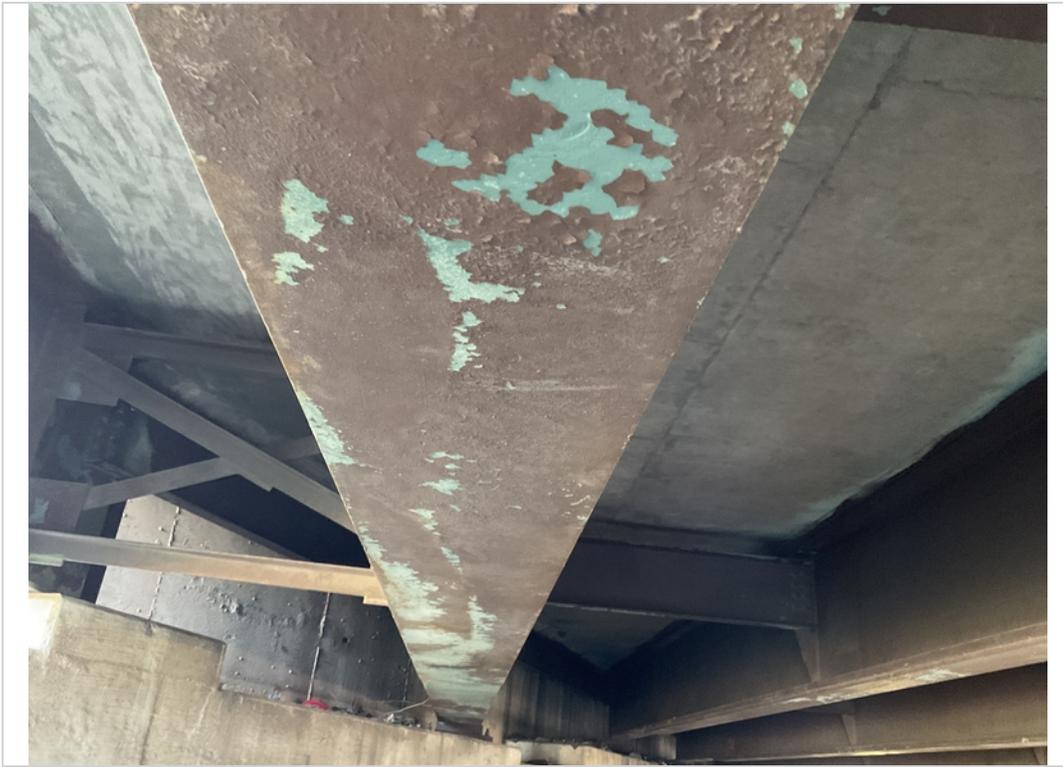
Span 1 Girder I heavy corrosion bottom flange

Span 1 Girder O paint peeling

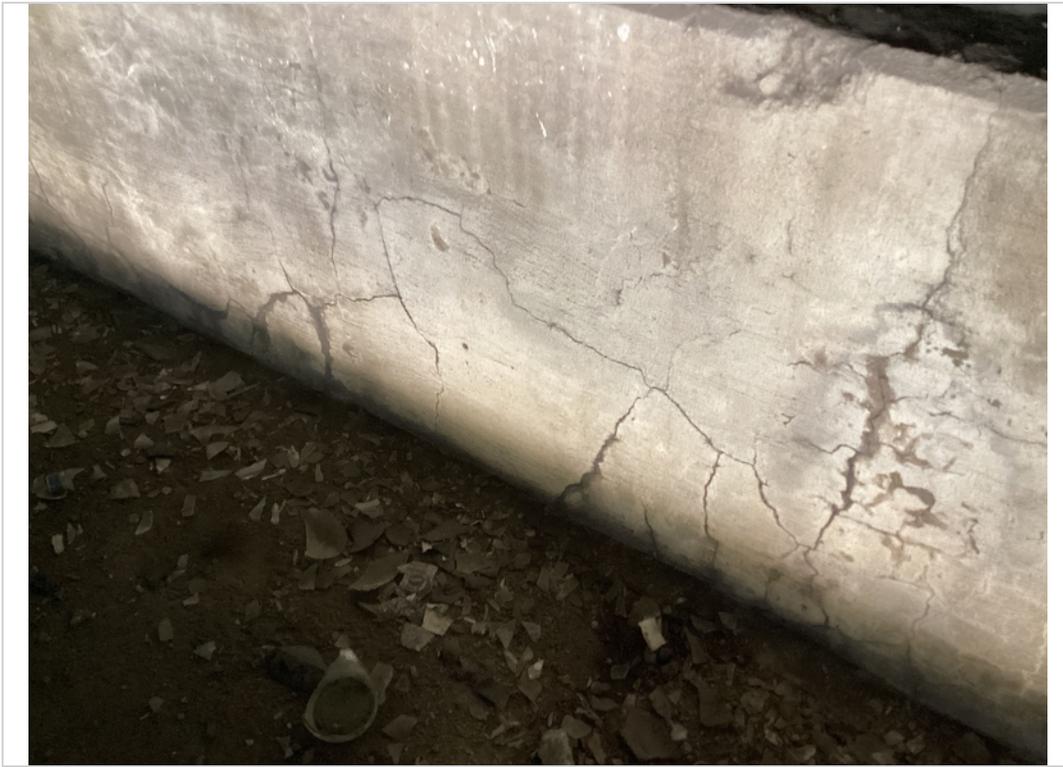
Span 1 bay M diaphragm M spalling

Abutment 2 cap map cracks

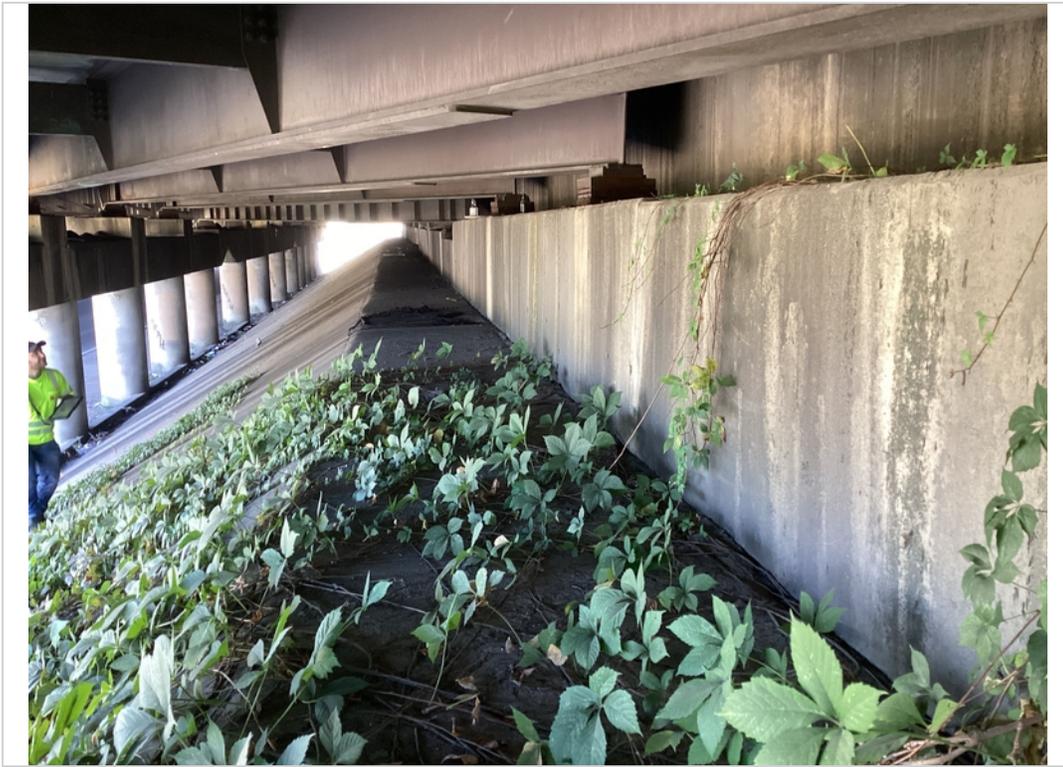
Abutment 2 cap spall with exposed steel

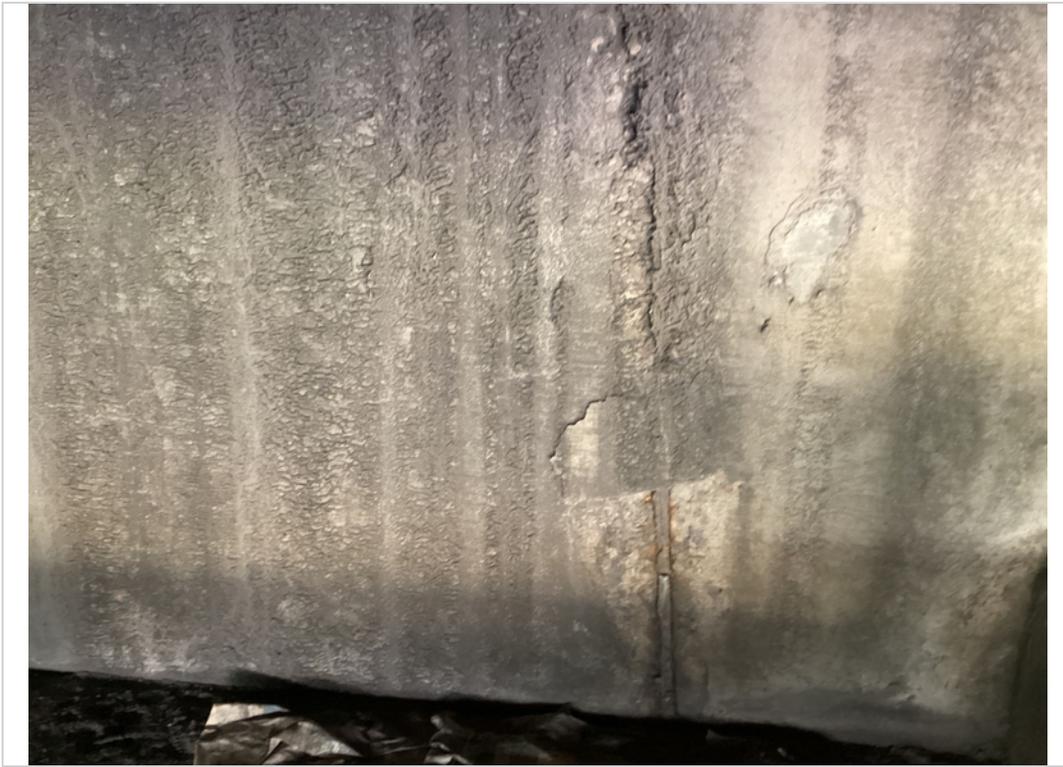
Abutment 2 backwall spall with exposed steel

Abutment 2 backwall scale

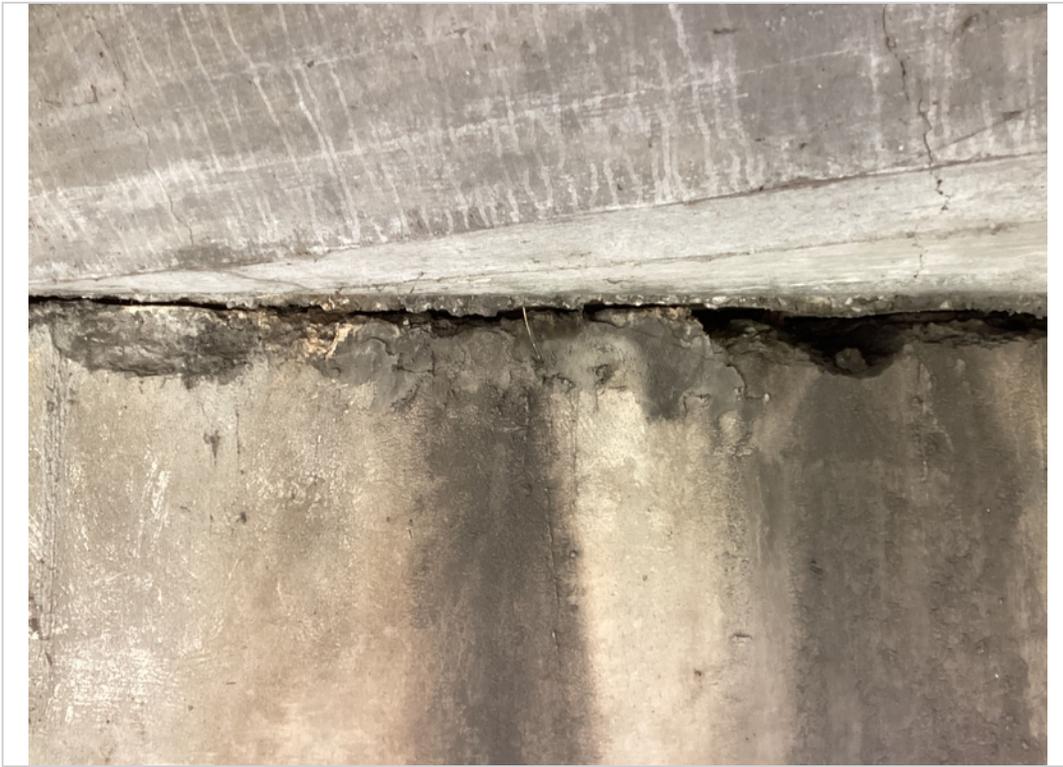
Abutment 2 backwall cracks with eff

Abutment 1 backwall scale

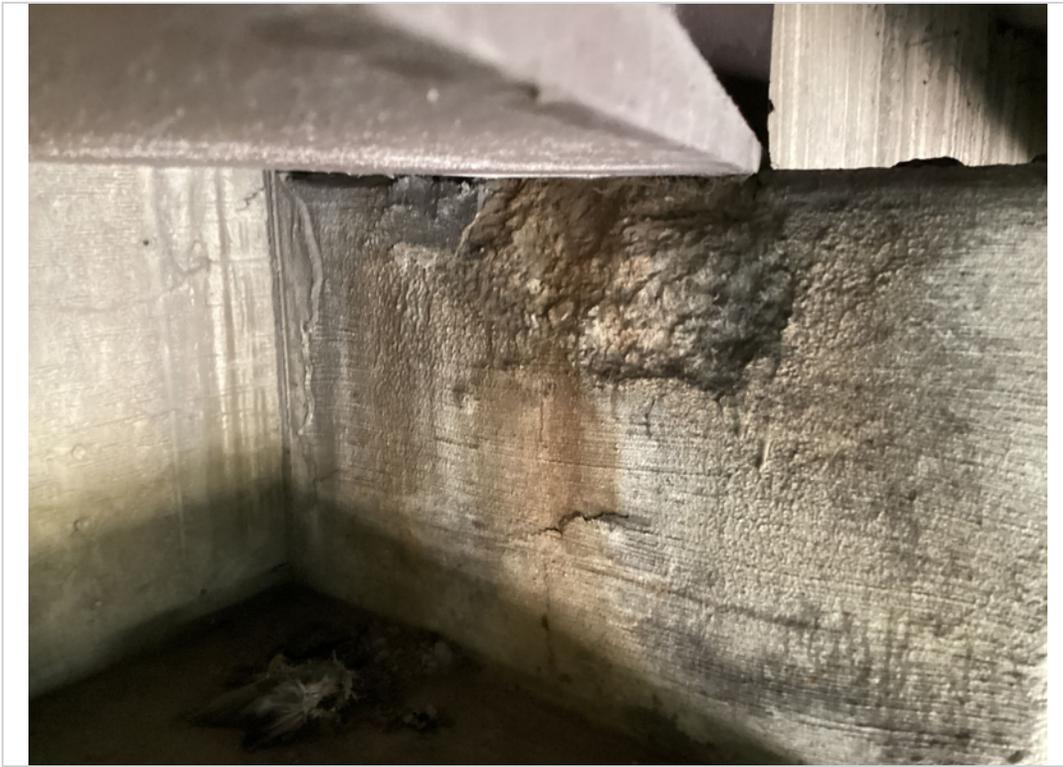
Abutment 2 bearings corrosion typical

Riser at Girder H spall

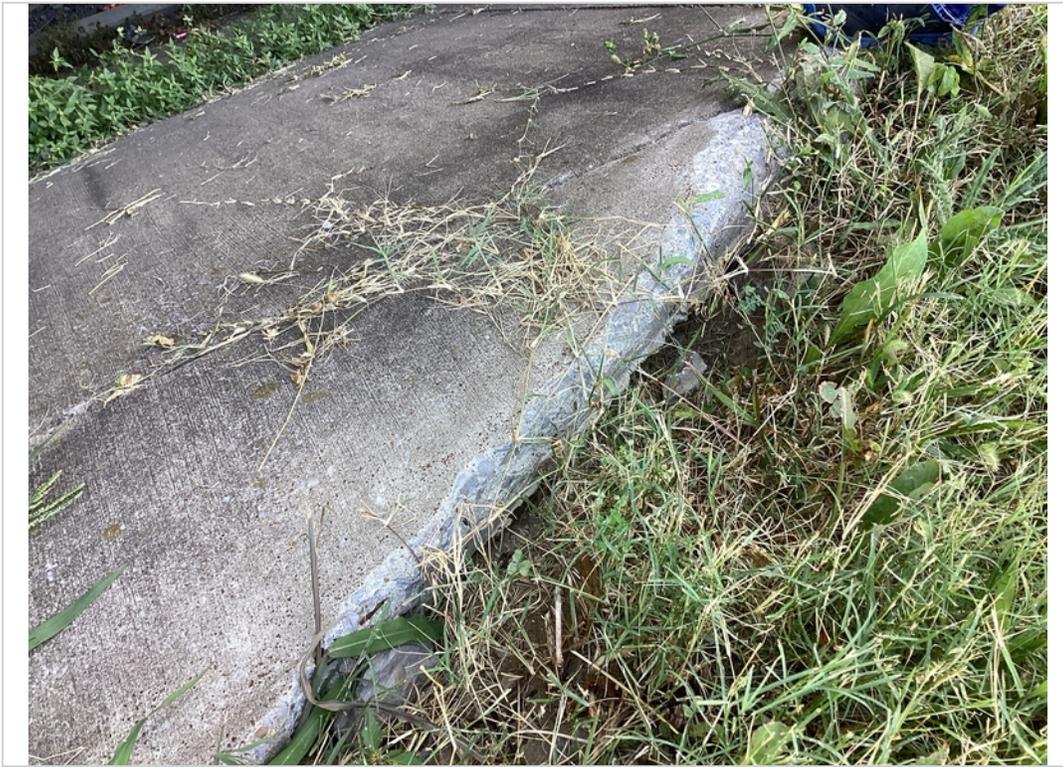
Riser K spall

Abutment 1 slope pavement erosion

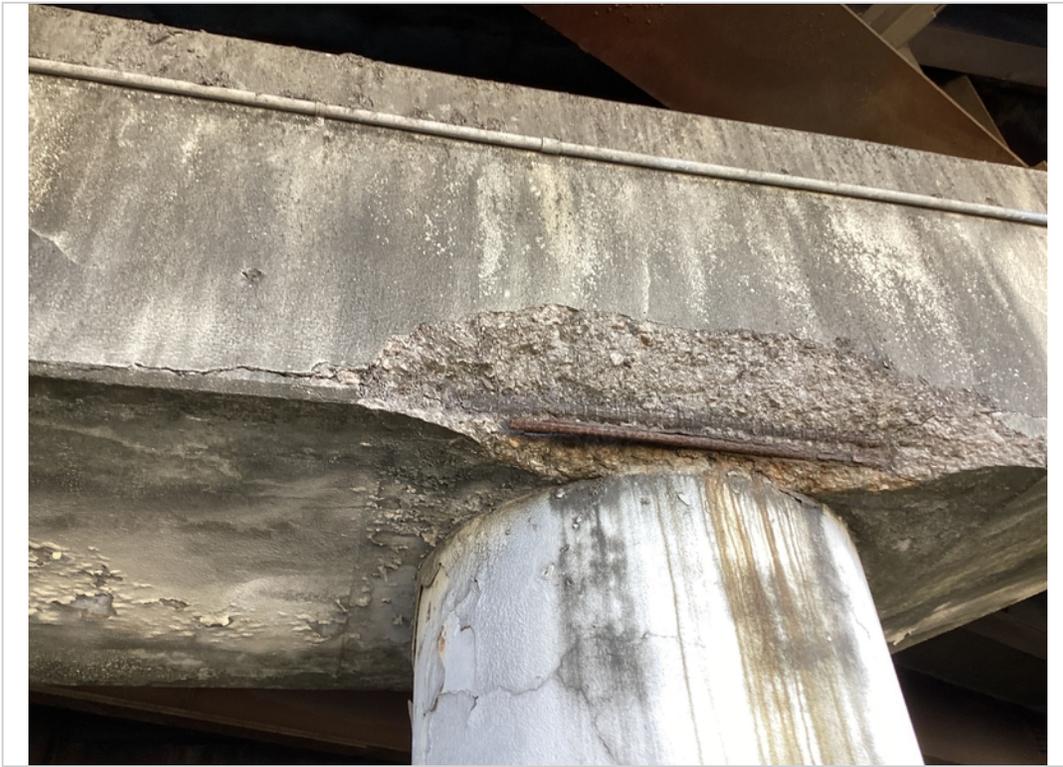
Bent 3 cap spall with exposed steel

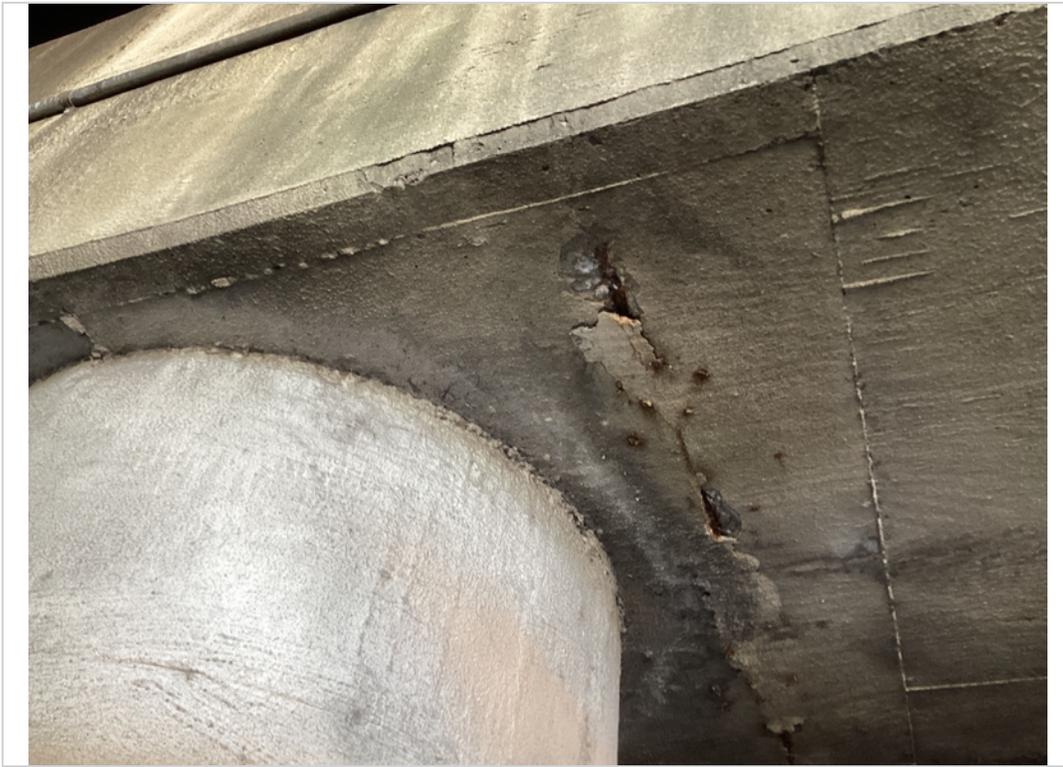
Bent 3 cap open crack

Bent 3 cap spall with exposed steel

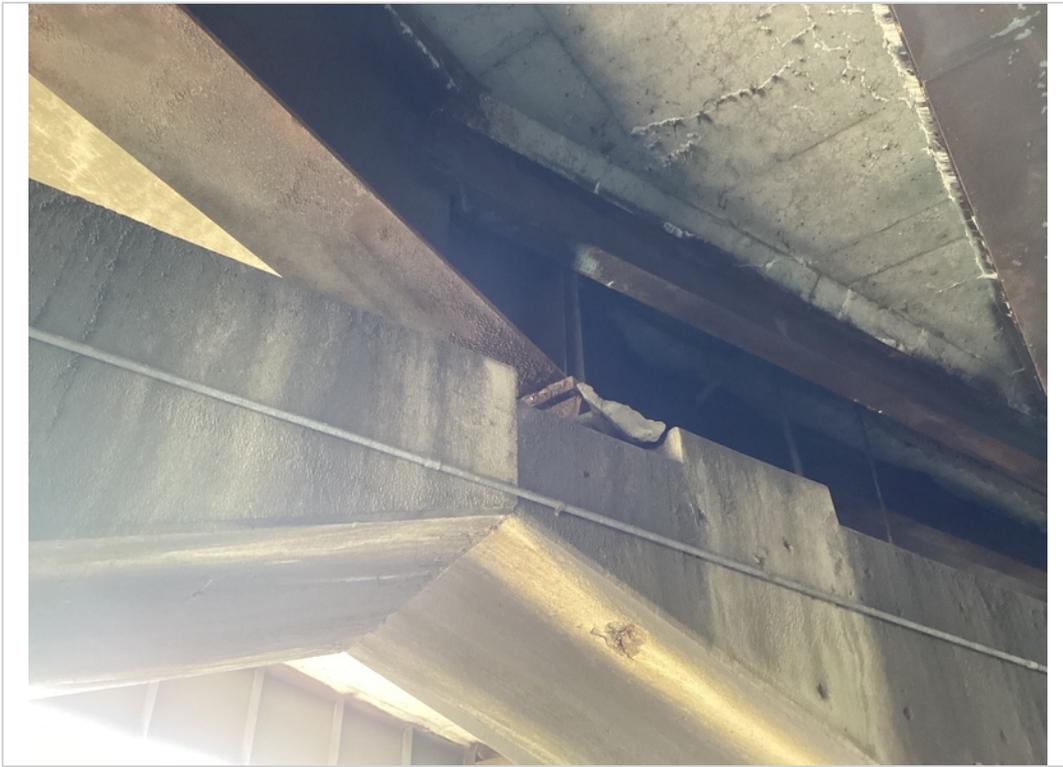
Bent 3 cap spall with exposed steel

Bent 3 loose concrete on cap

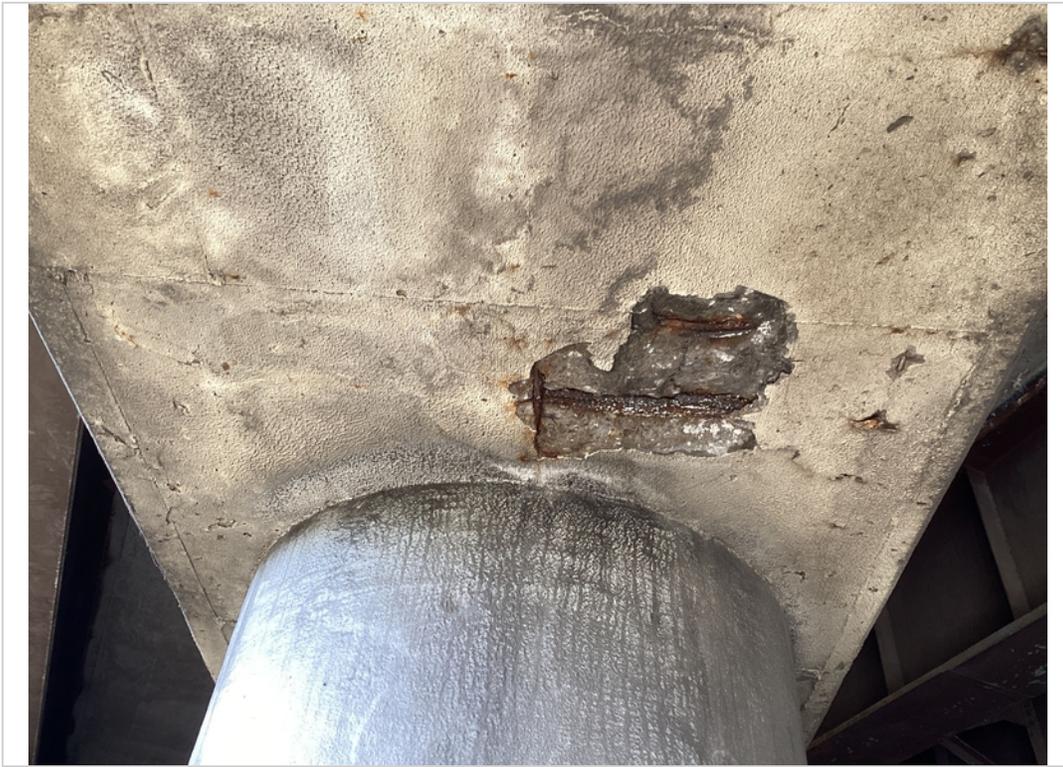
Bent 3 cap spall with exposed steel

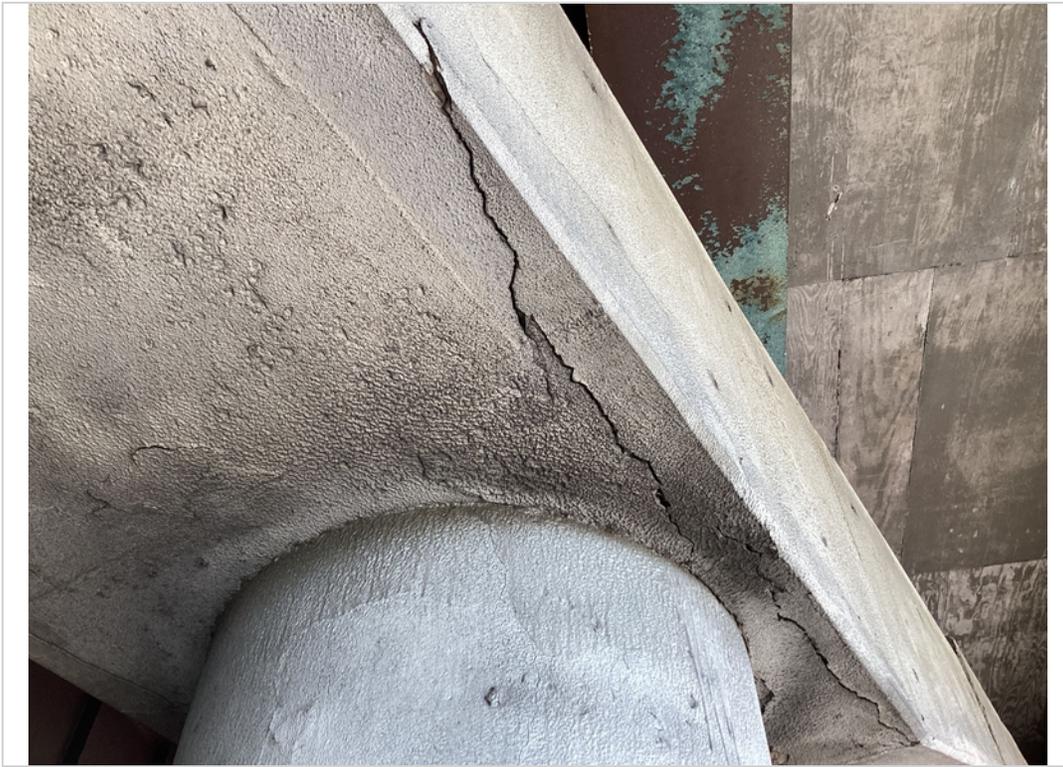
Bent 2 cap Inplace spalls scale

Bent 2 cap open crack

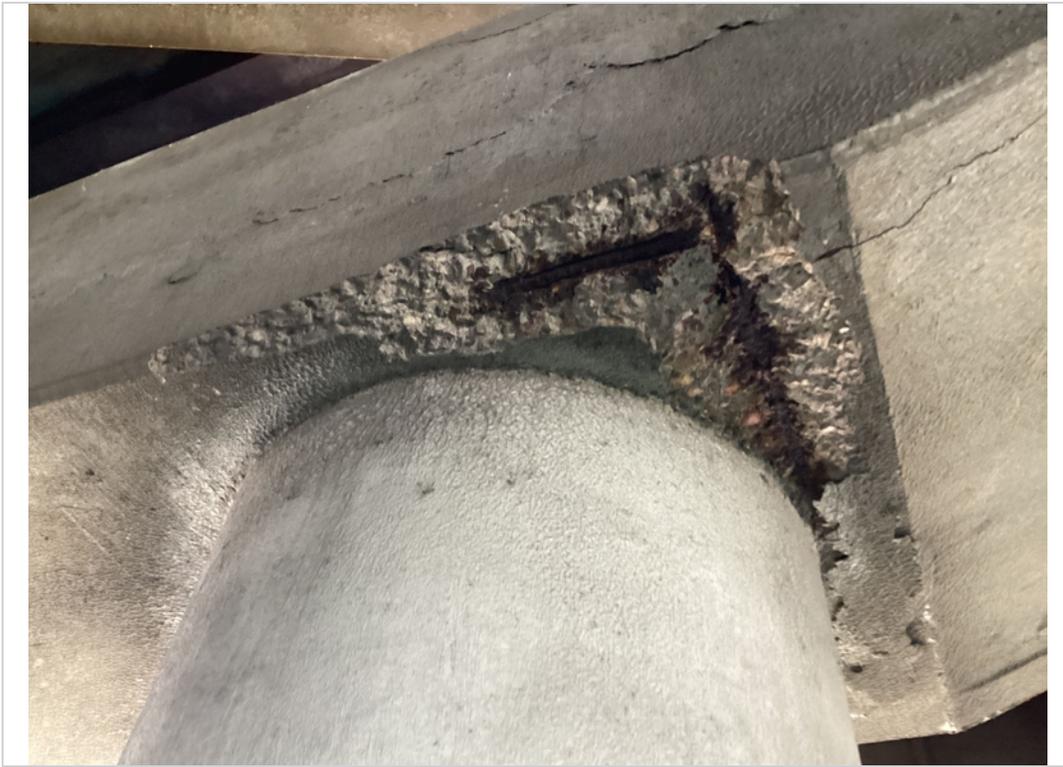
Bent 2 cap open crack

Bent 2 cap spall with exposed steel

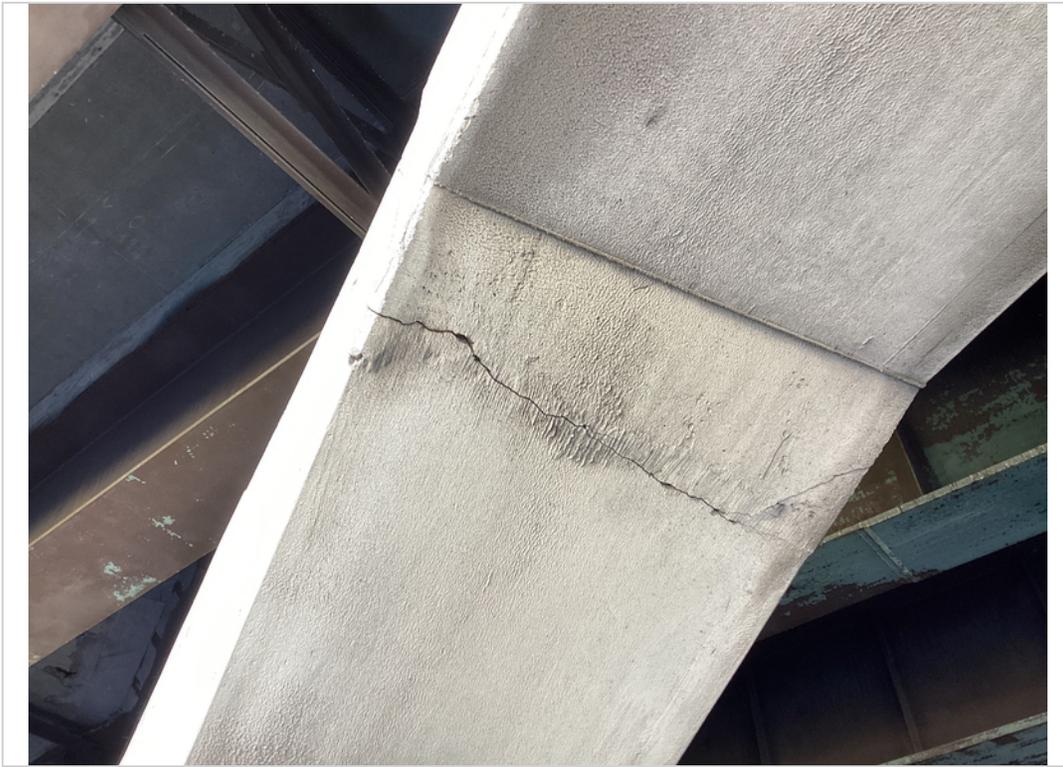
Bent 2 cap open crack at joint

Bent 2 cap crack

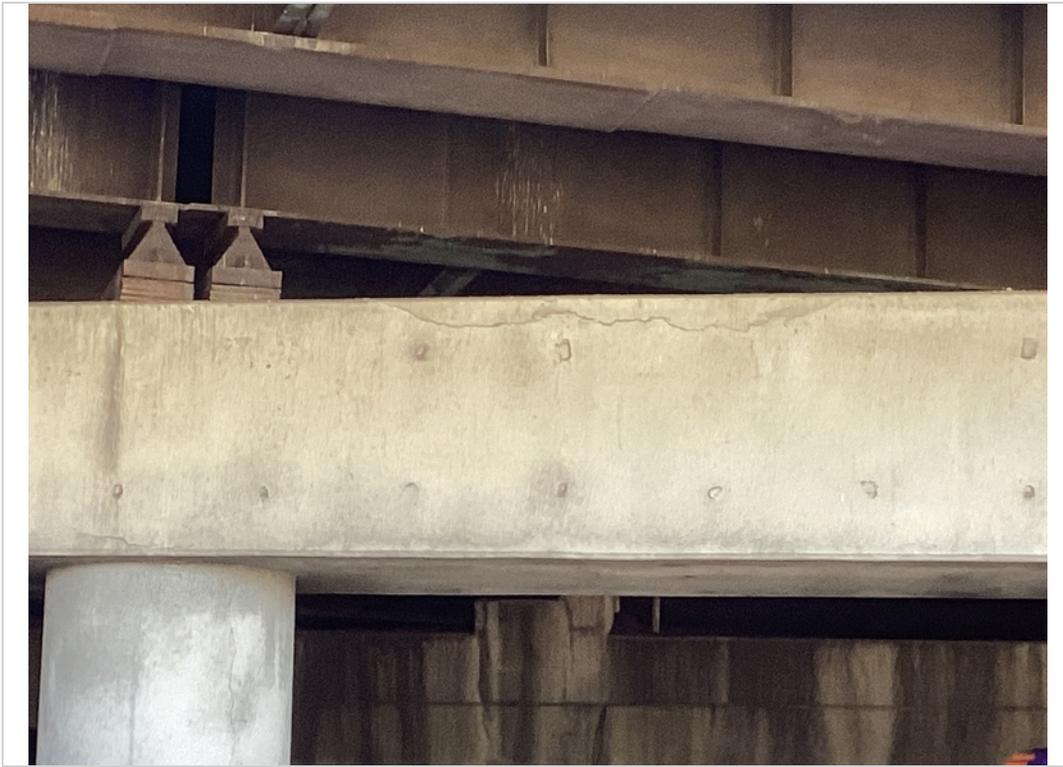
Bent 2 cap crack

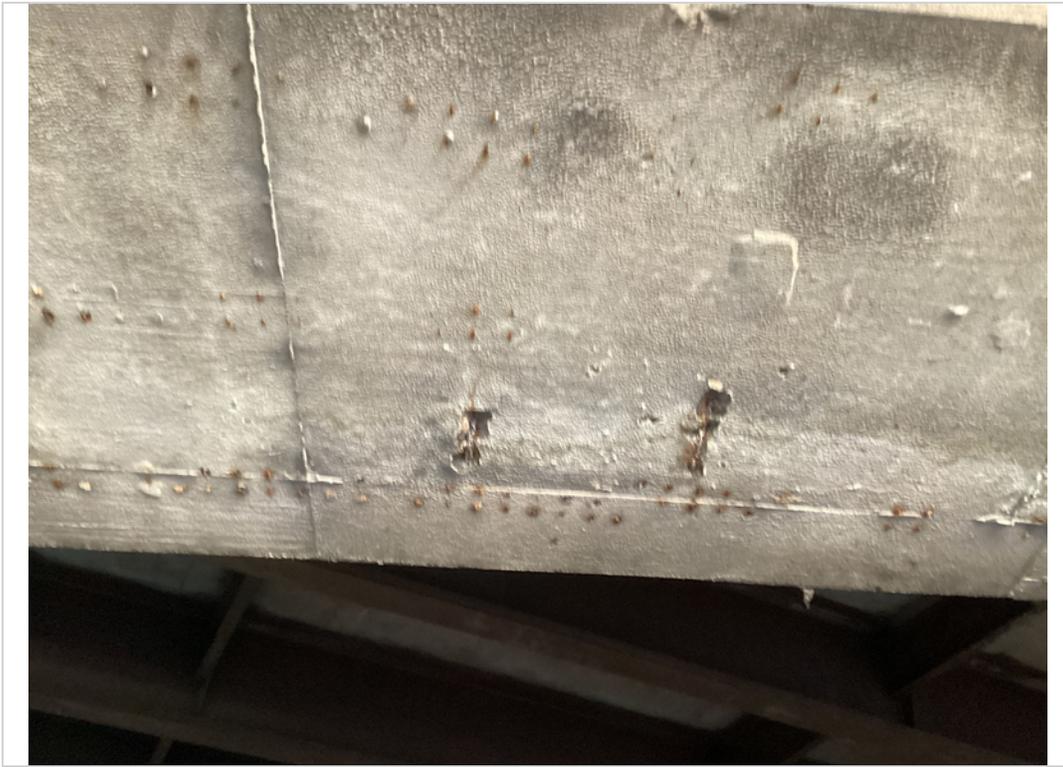
Bent 1 cap spalls with exposed steel

Bent 1 cap spall with exposed steel
