I-24 Crossing I24 / NORTH FIRST ST

90 - LAST INSPECTION DATE 09/21/2021

IDENTIFICATION	
(1) State Names	47 - Tennessee
(8) Structure Number	19I00240107
(5) Inventory Route	1
(2) Highway Agency District	Region 3
(3) County Code	19 - Davidson

4 span Bridge / Cont. S.I.B
I-24 / North First Street

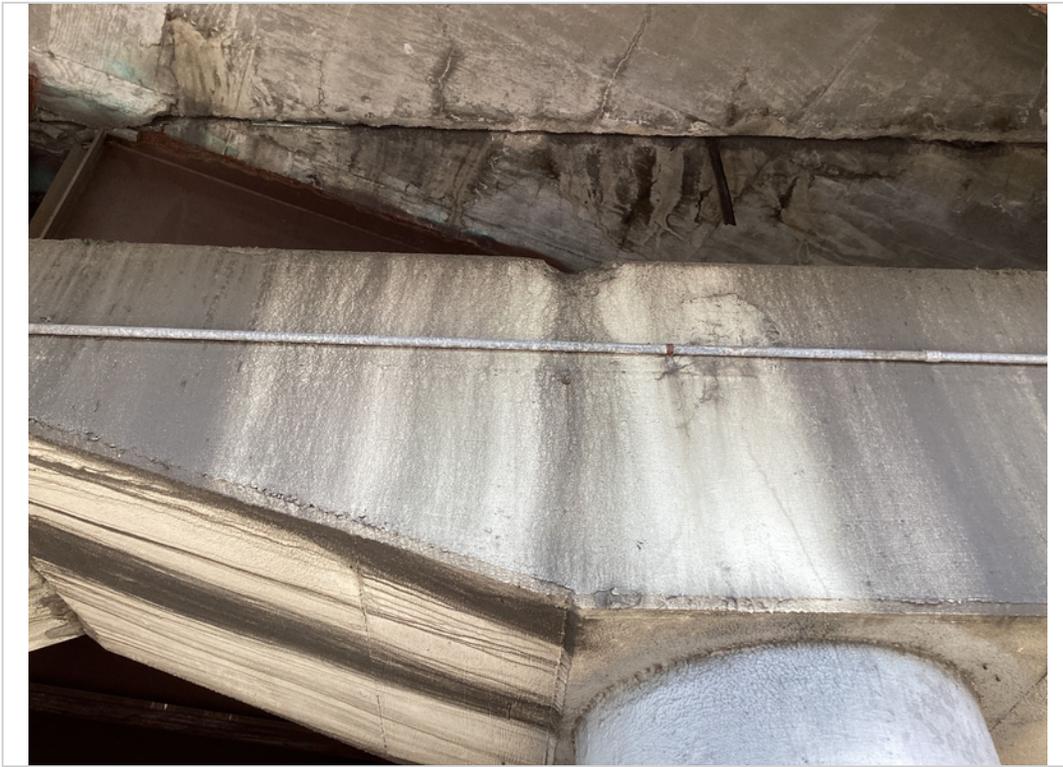
Bent 1 cap spall with exposed steel

Bent 1 cap spall

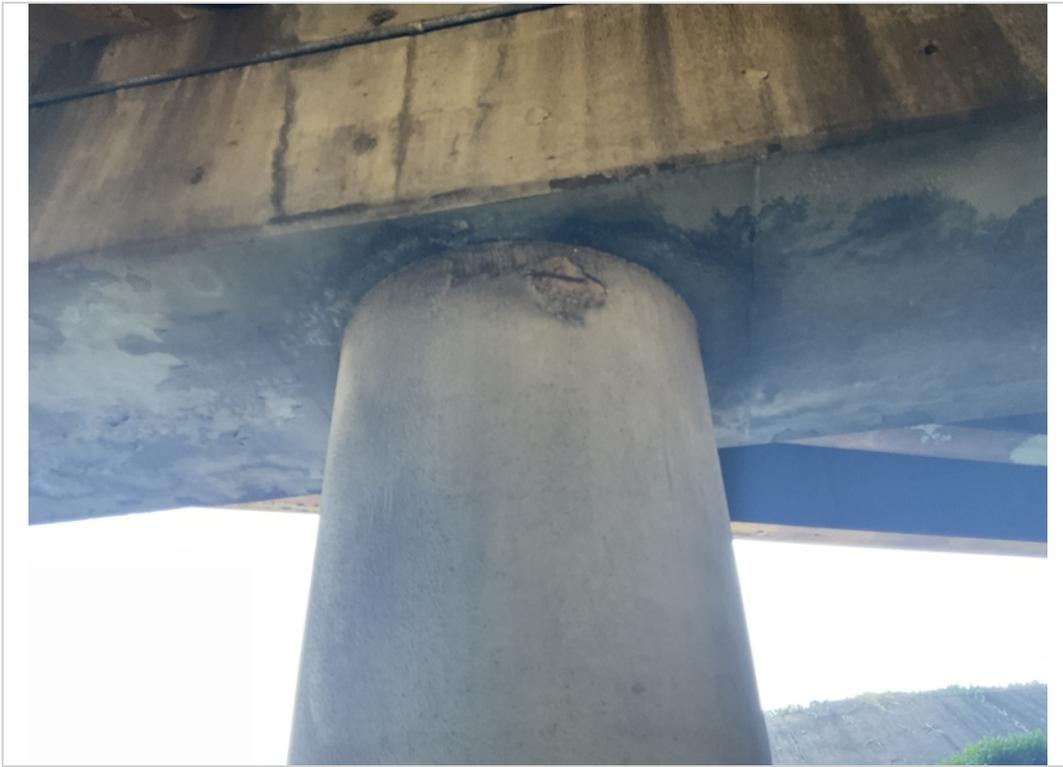
Bent 2 vert. H.C.

Bent 1 column C spall w/exp steel

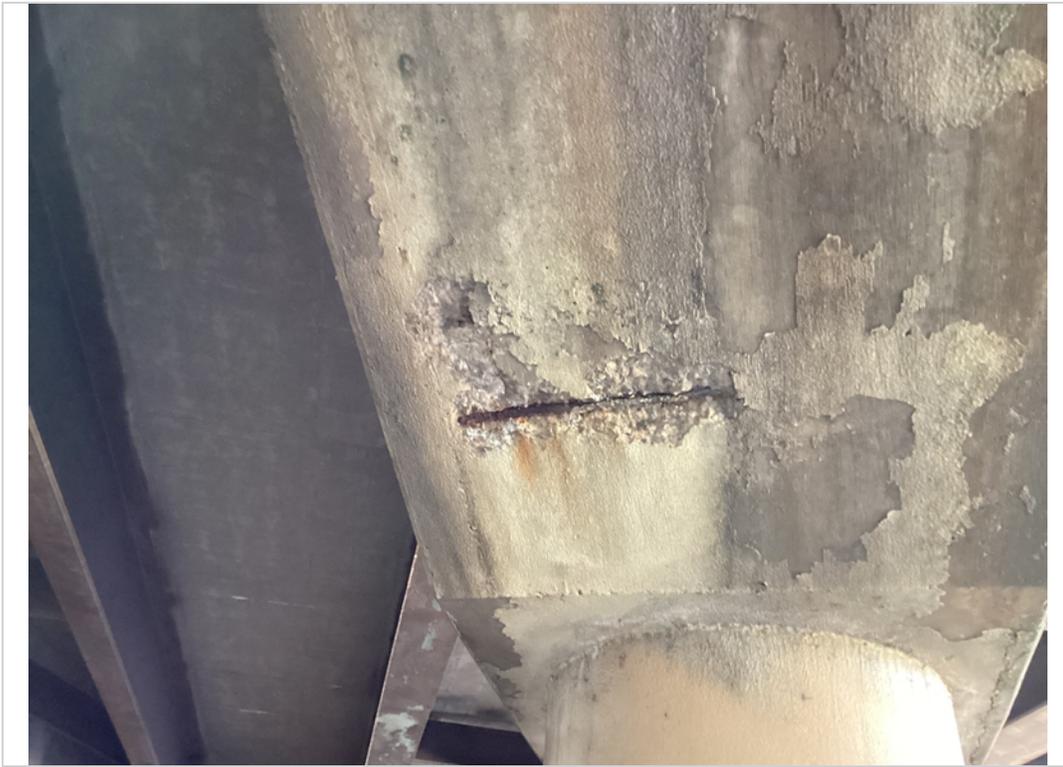
Bent 1 front map cracks

Bent 3 spall with exposed steel cap

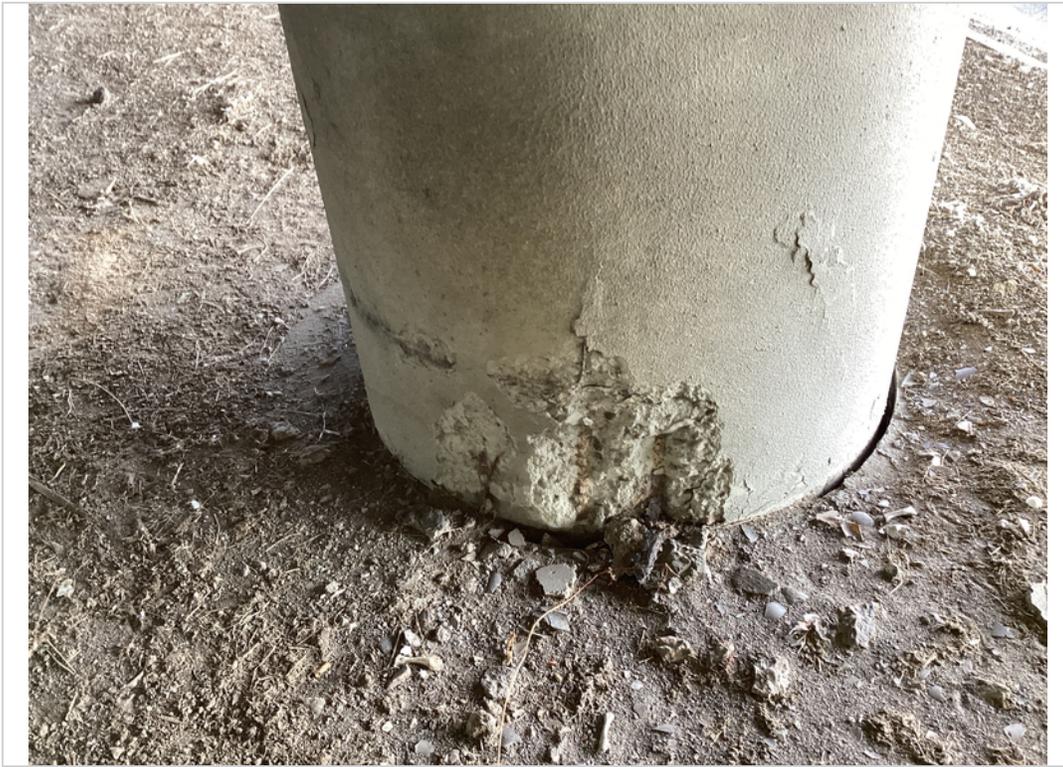
Bent 2 column D spall with exposed steel

Bent 2 column E spall with exposed steel

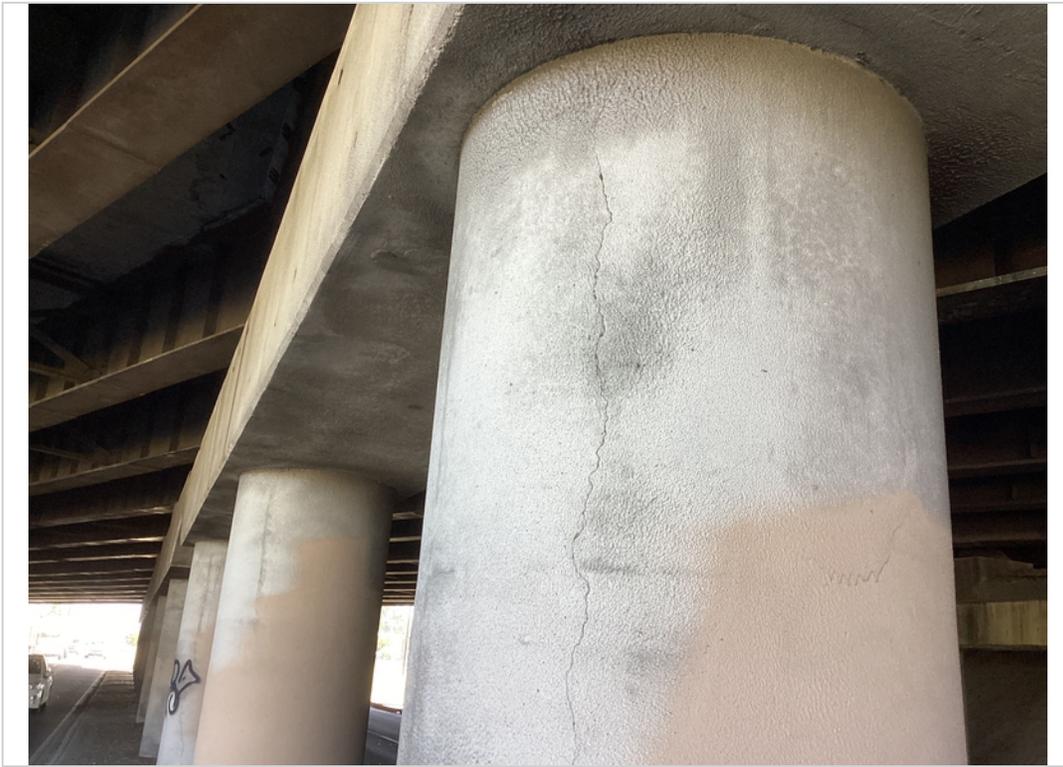
Bent 2 column M delamination

Bent 2 column N crack

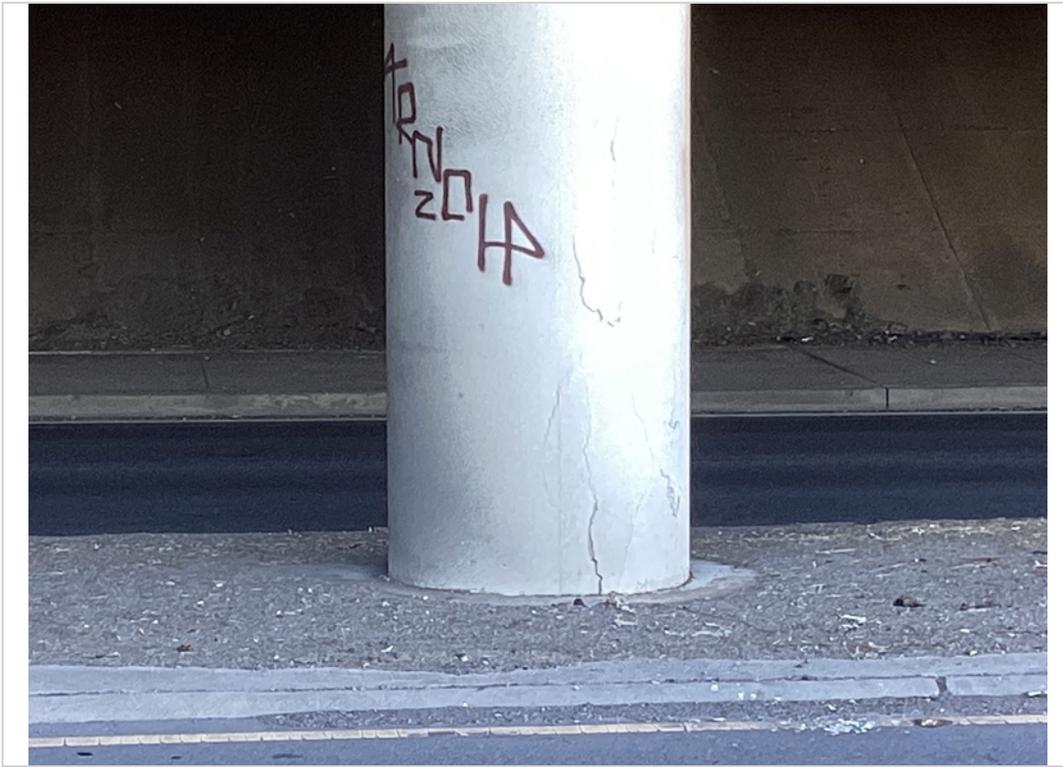
Bent 2 column P spalls with exposed steel

Bent 2 column O cracks

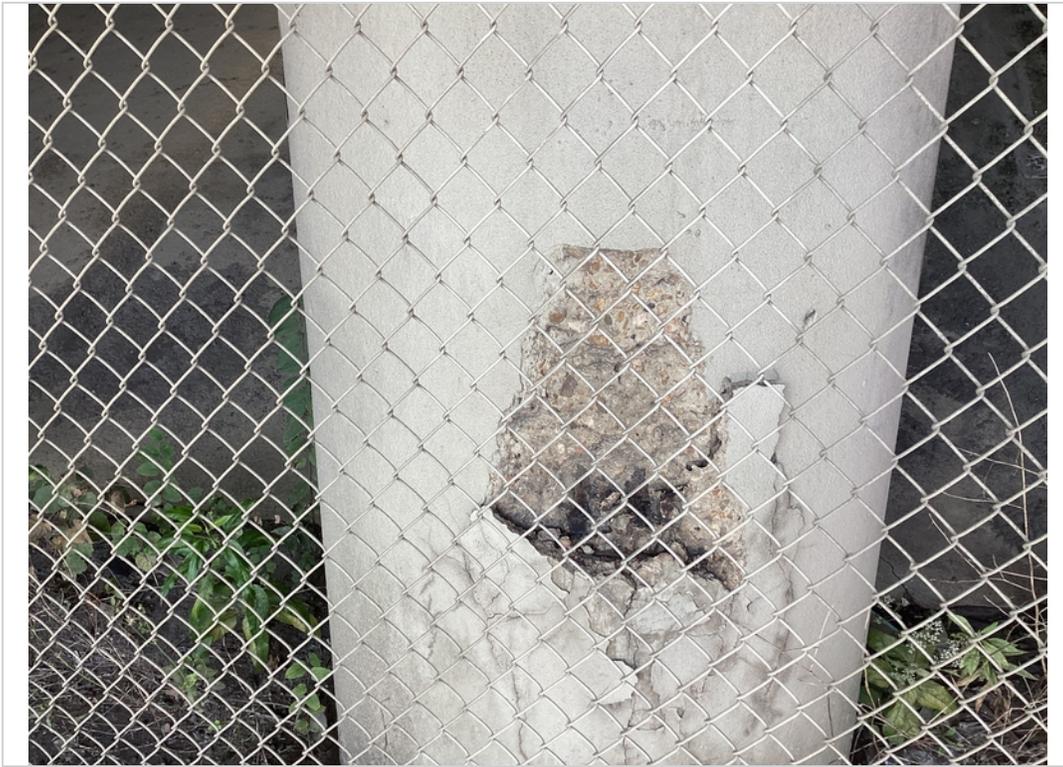
Bent 1 column D spall with exposed steel

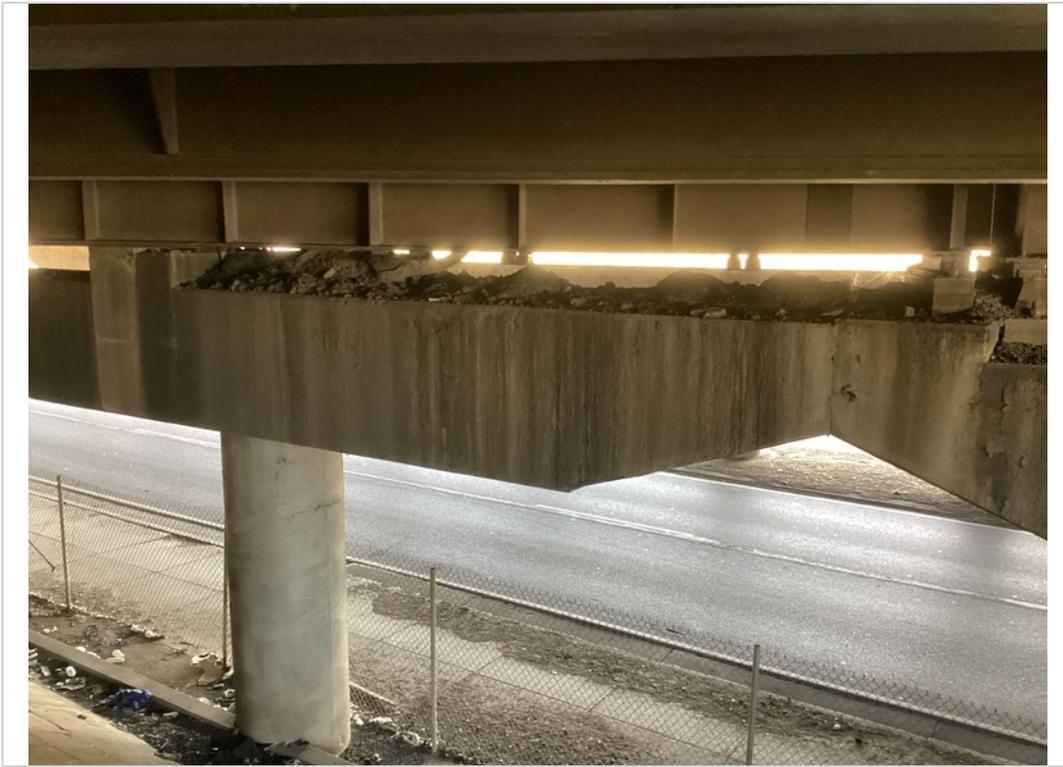
Bent 2 loose nuts on bearings typical

Bent 1 debris on cap

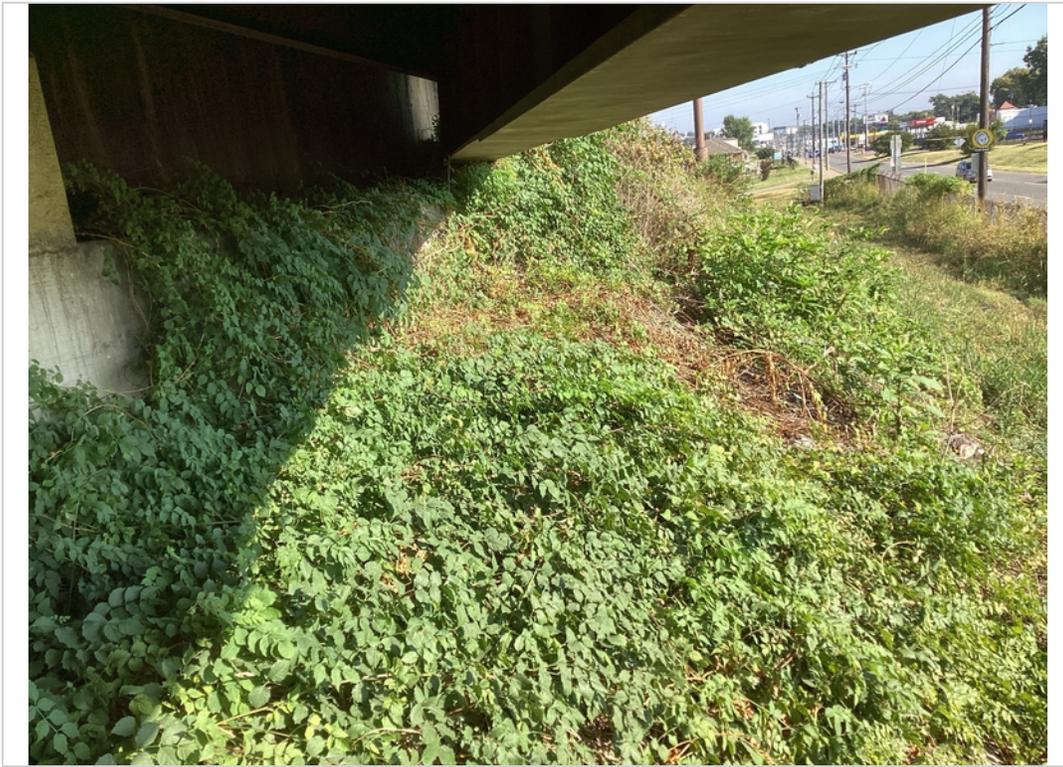
Abutment 1 trash

Abutment 1 left side heavy vegetation

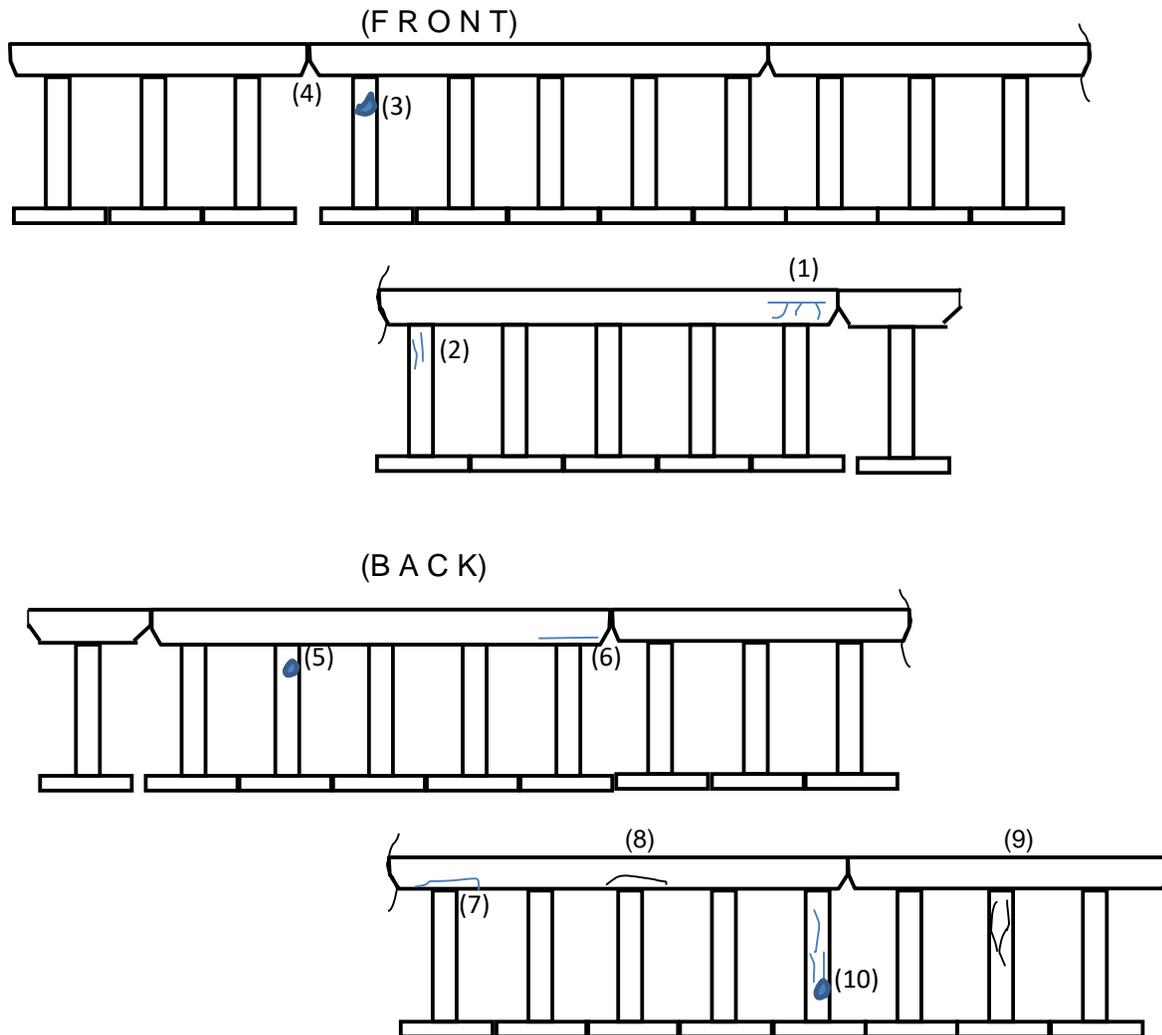
BENT # 2

CAP	GOOD	JOINTS--HCs W/ TEX COAT PEELING, DEBRIS ON TOP; TYPICAL--HVY WATER STAINS; (1) MAP CRACKS W/EFF COL 'G'--FAIR--RDM HORIZ HCs UP TO 3'L; COL 'L&I'--SPALL W/EXP STL 2'L X 8"W X 1.5"D; UNDER CAP--SPALLS W/EXP STL;
COLUMNS	FAIR	(3) I.P.B.O. 3' H X 2' W (2) VERT. 1/8" OPEN CRACKS & DELAM. (4) SPALL 1.5' L X 4" W X 1/2" DP (5) I.P.B.O. 6" DIA. (6) LONGIT. CRACK & I.P.B.O. (7) SPALL W/EXP. STL. 8" DP. (8) I.P.B.O. 3'L X 1'W, VERT CRACKS UPTO 3'L, (9) VERT CRACKS 3'L, (10) I.P.B.O. 4'L X 1'H; RDM TEX COAT PEELING
BEARINGS	FAIR	MOD CORR

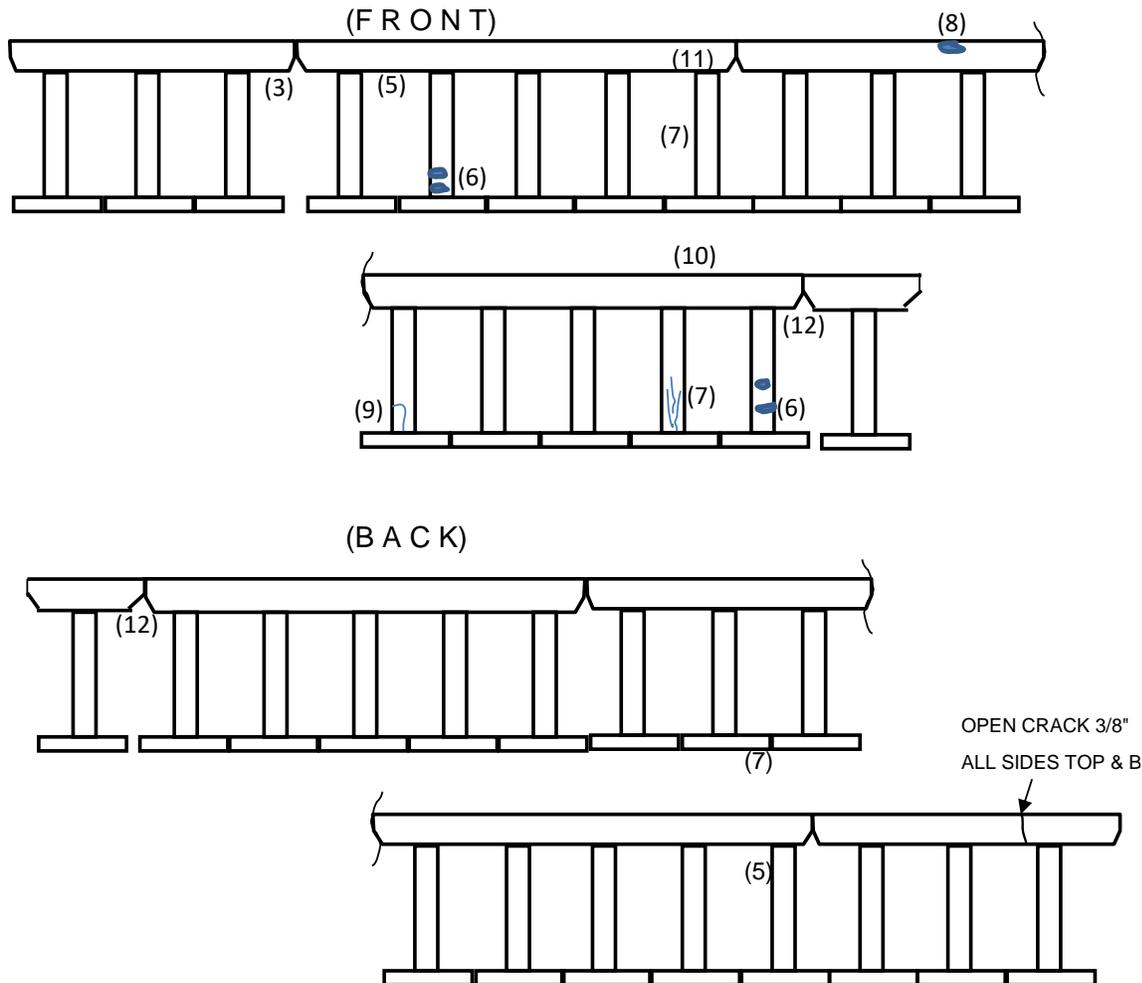
BENT # 3

CAP	POOR	(5) HORIZ. CRACKS UP TO 1/2" OPEN X 20'L W/SPALL W/EXP. STL. 2'L X 1'W X 1"DP, CRACKS UP TO 3" OPEN @ JOINT AREAS (8) SPALL 1' L X 4" H X 1" DP, (10) LONGIT. CRACK 3'L (3) SPALL 1.5' X 4"W X 1/2" DP, (12) 1/4" CRACK, (4) I.P.B.O. 1' DIA. (11) SPALL 2'L x 2'W x 2" DP; RDM IP SPALLS UP TO 2'L X 1'W
COLUMNS	FAIR	(9) I.P.B.O. 2'H X 2'W & DELAM; HVY GUANO BASE OF COLUMNS (6) SPALLS UPTO 1' L X 1' H X 1/2" DP W/ EXP. STL. (7) VERT. CRACKS 5' L , VERT CRACKS U TO 1./16" OPEN
BEARINGS	FAIR	LGH-MOD CORR; LOOSE NUTS--BRGs 'P,O,L'
