Region 04, 39 - Henderson County

NATCHEZ TRACE RD. Crossing SR-114 / I-40 EBL

90 - LAST INSPECTION DATE 06/03/2024

| IDENTIFICATION | |
|---|---|
| (8) Structure Number | 39I00400031 |

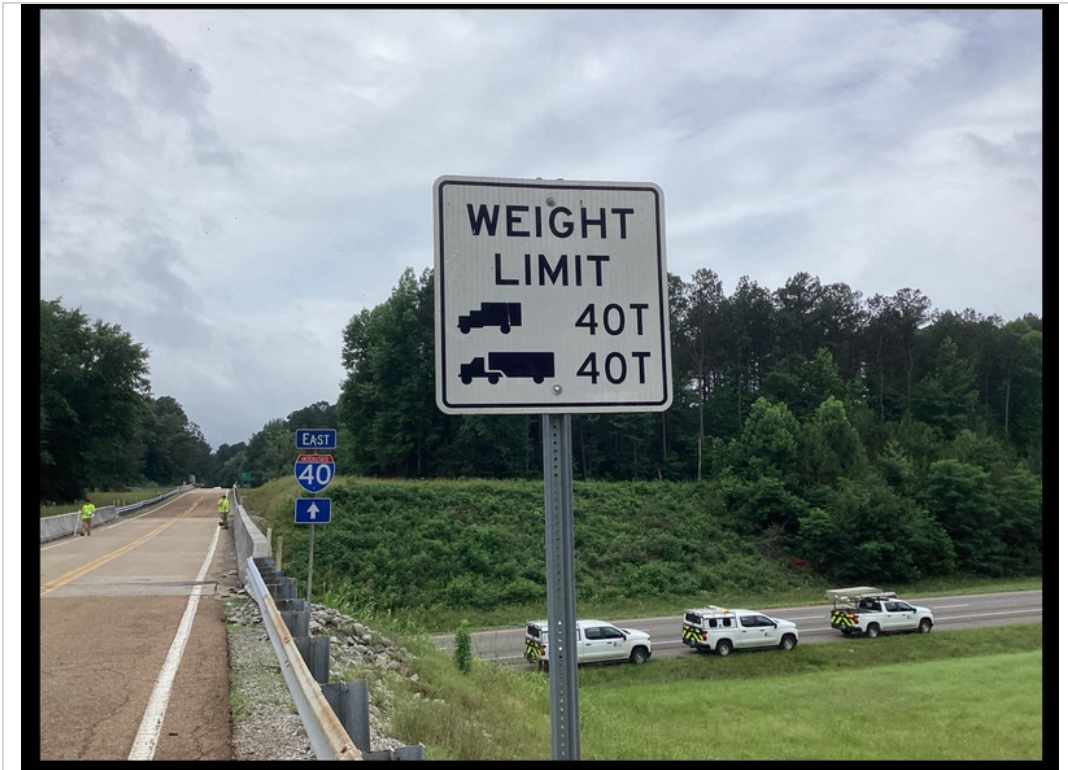
Approach 2 weight limit sign @ 26.48 bridge

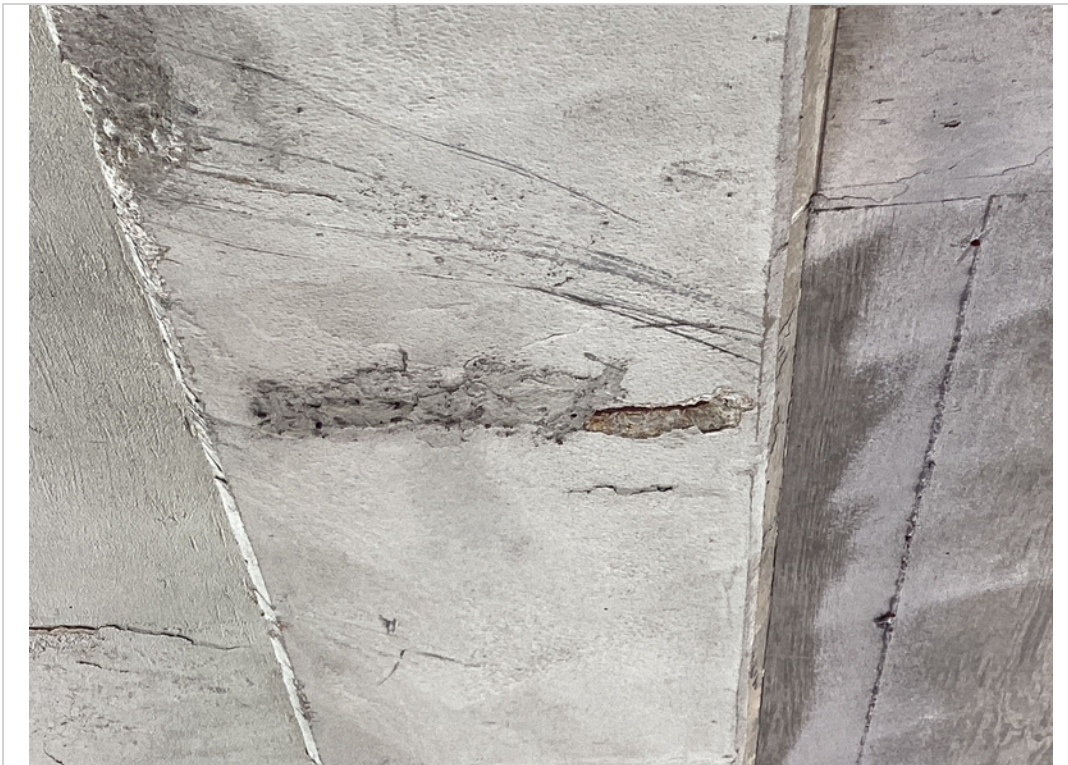
Span 1 beam A spall to steel

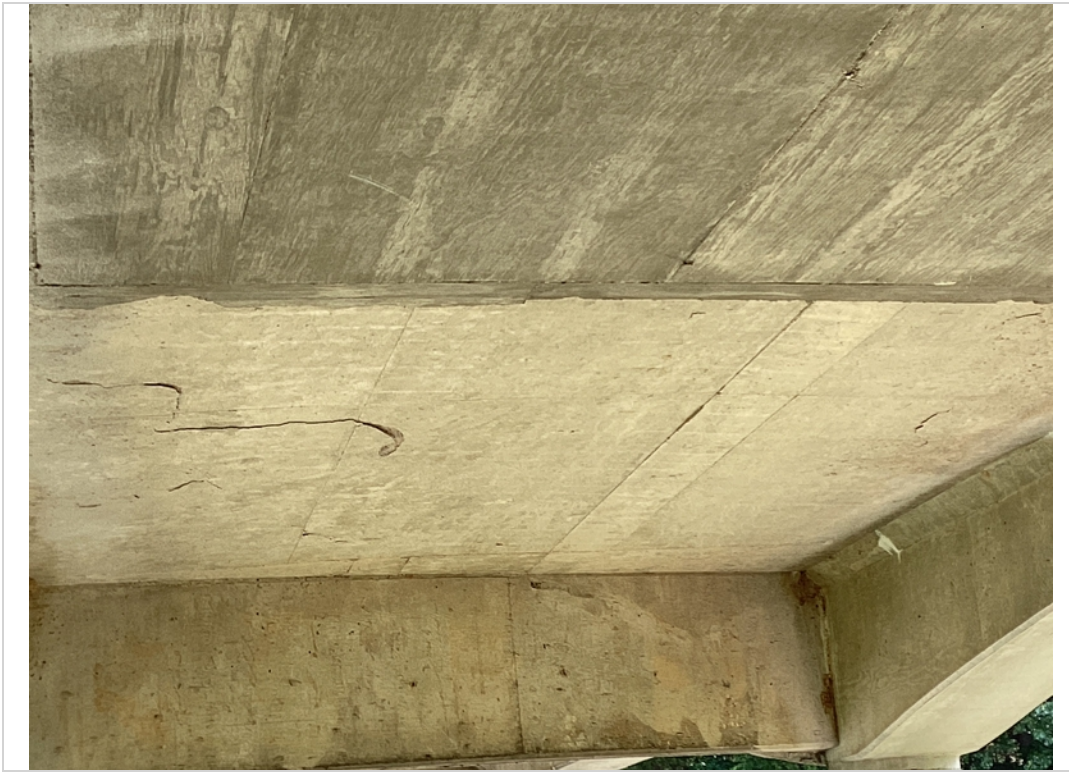
Span 1 bottom deck impending spall typical

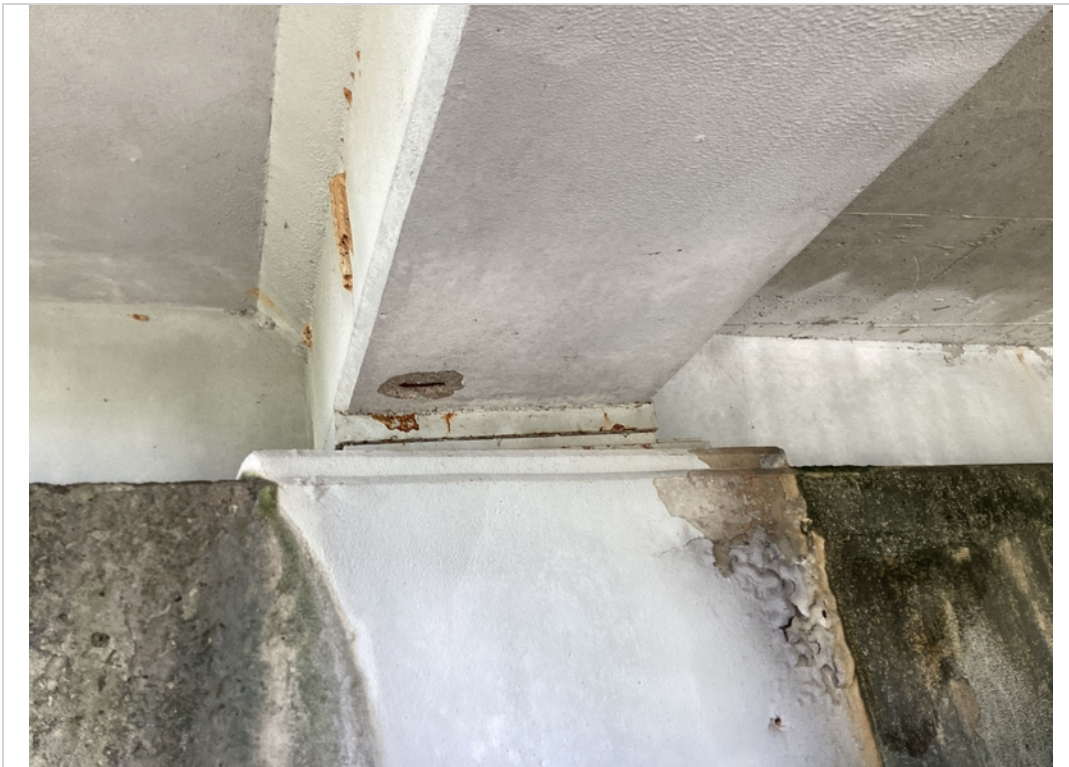
Span 1 beam B spall to steel

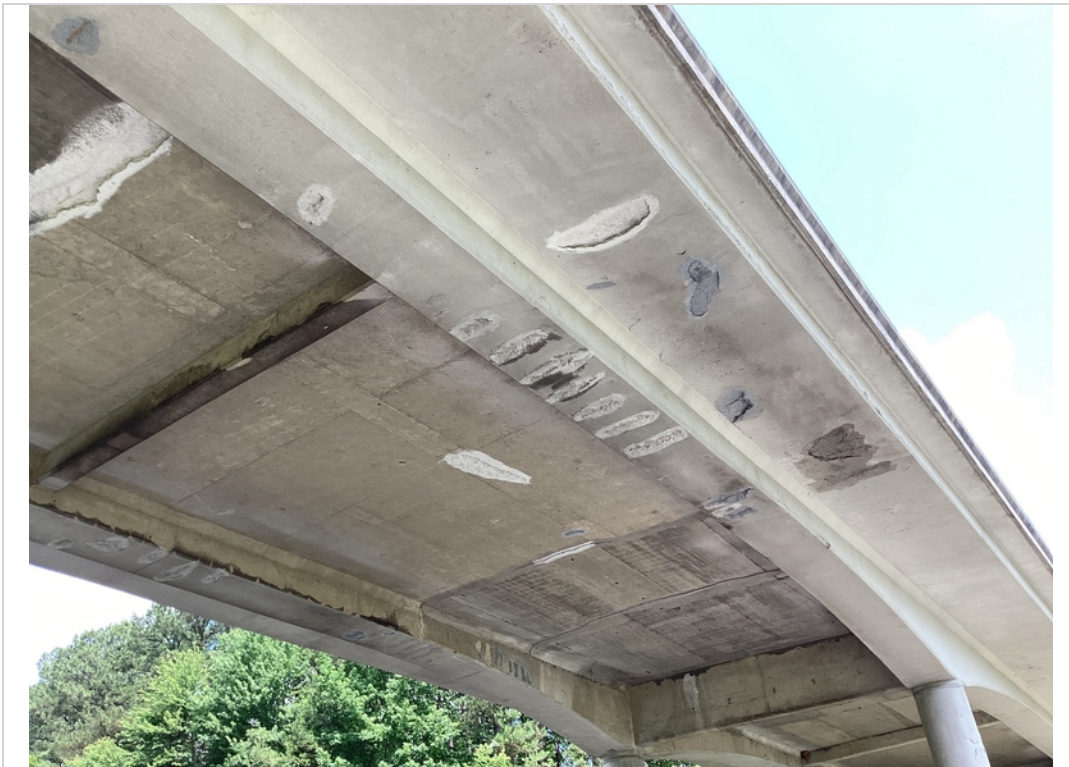
Bottom deck span 2 spall to steel

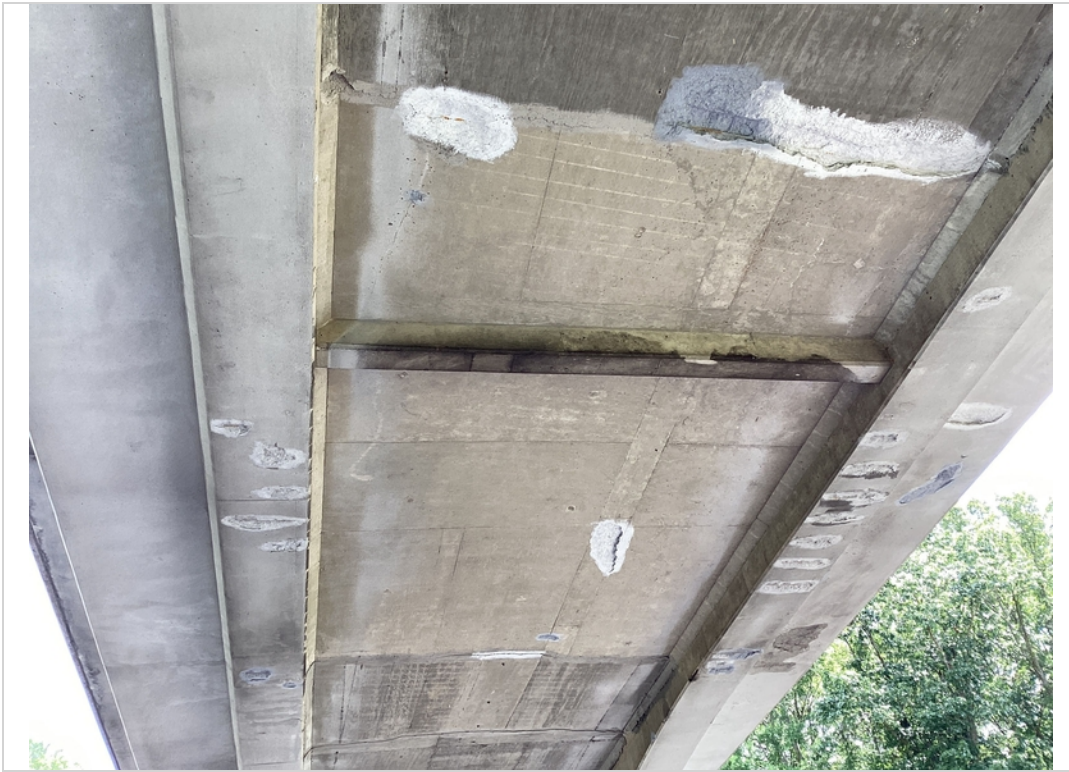
Bottom deck span 2 typical with spall to steel in deck and girders

| Date Added | Recommendation | Priority |
|---|---|---|
| 04/08/2022 | REPAIR CONCRETE GIRDER "B" IN SPAN NO.2 | |

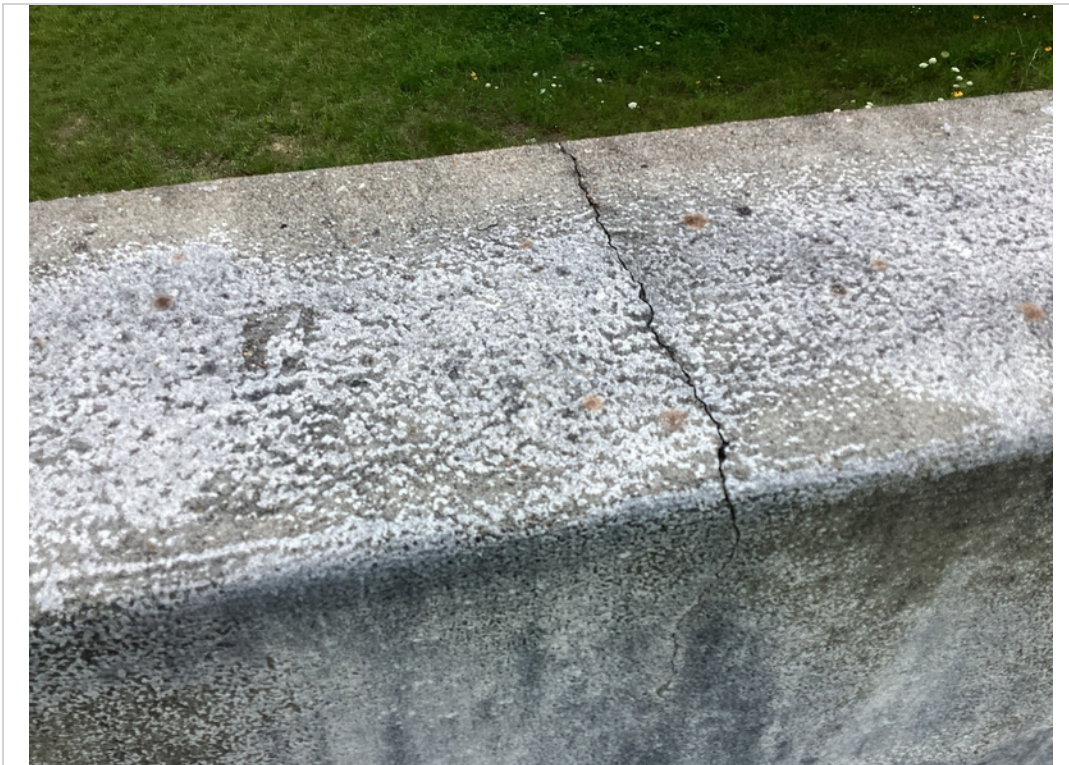
| Wearing Surface Type | | Concrete | Wearing Surface Depth |
|---|---|---|---|
| Parapet | (Fair) | Up to 1/16" cracks and spall to steel | |

Parapet crack typical

| Date Added | Recommendation | Priority |
|---|---|---|
| 06/03/2024 | Repair texture coat on concrete parapets. | |

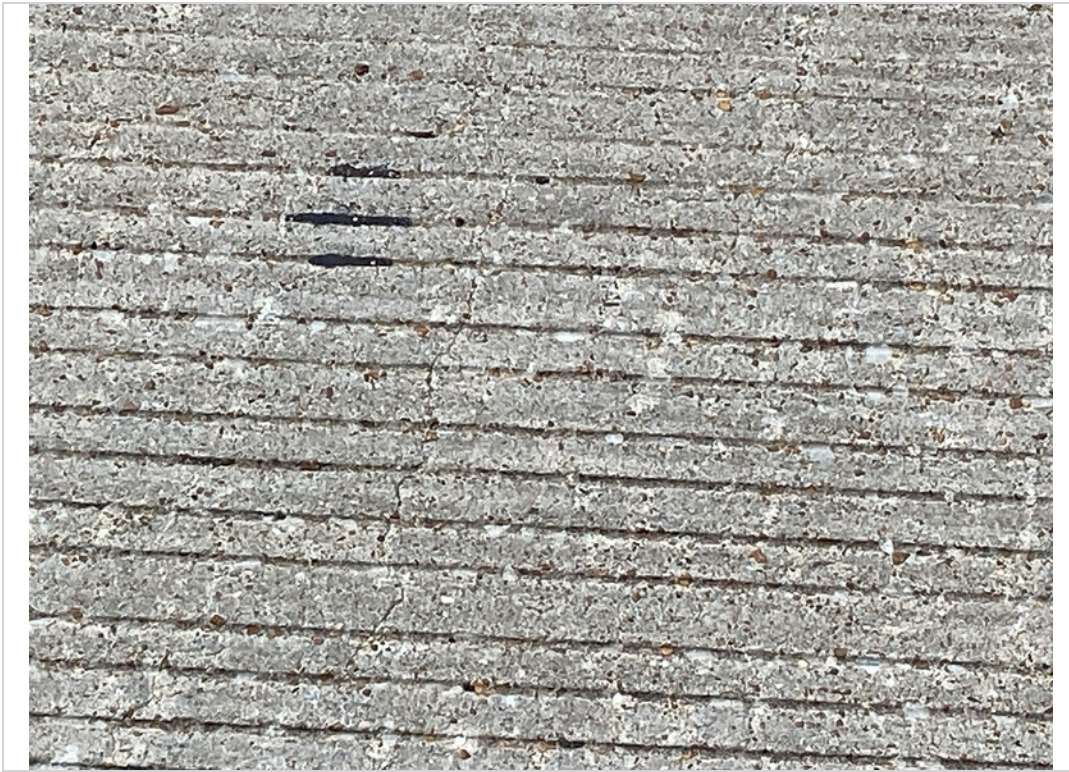
Span 3 crack

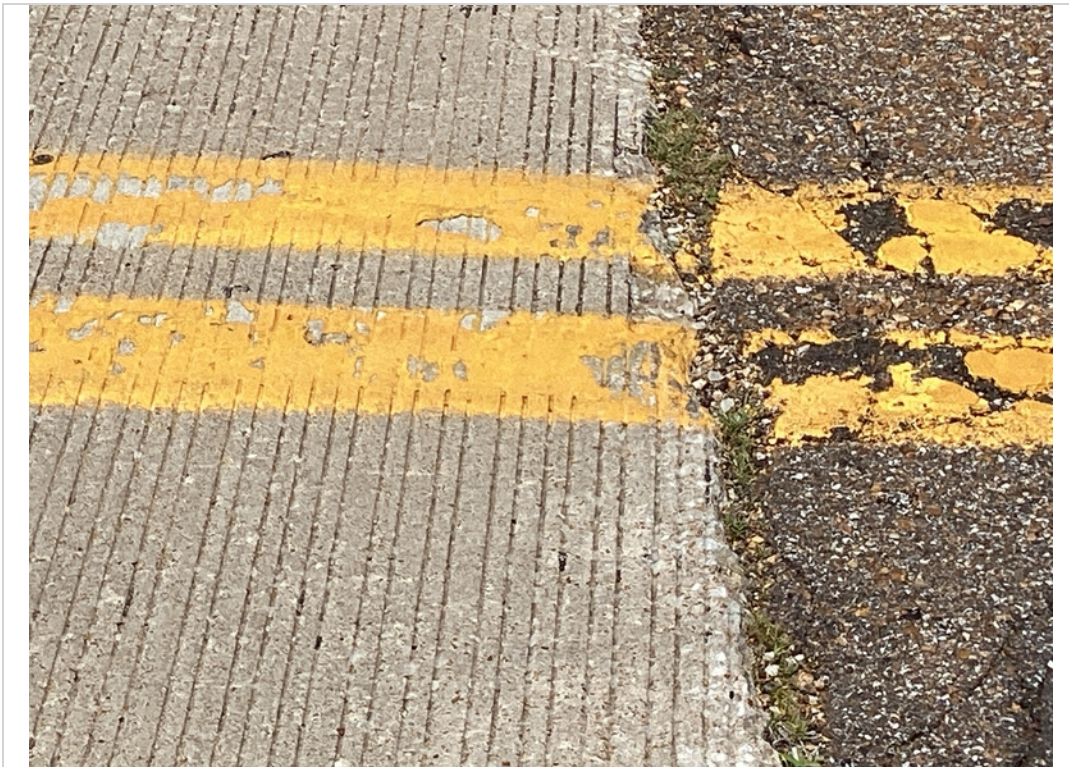
Span 3 spall

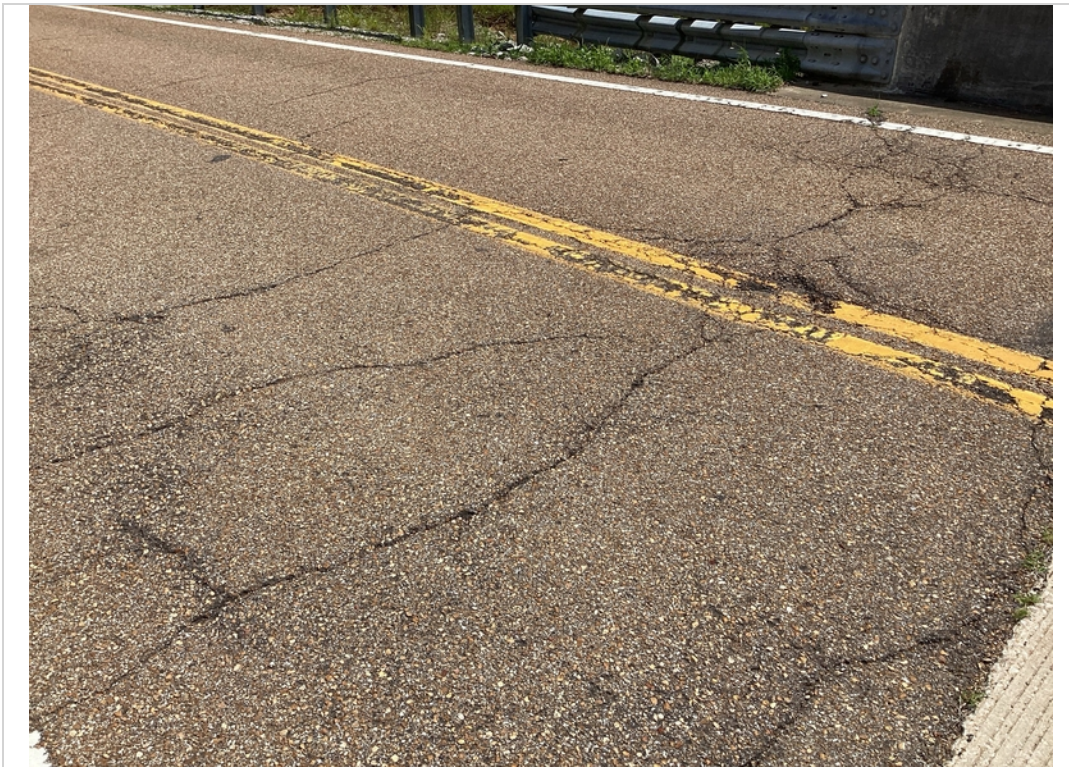
Approach 2 asphalt

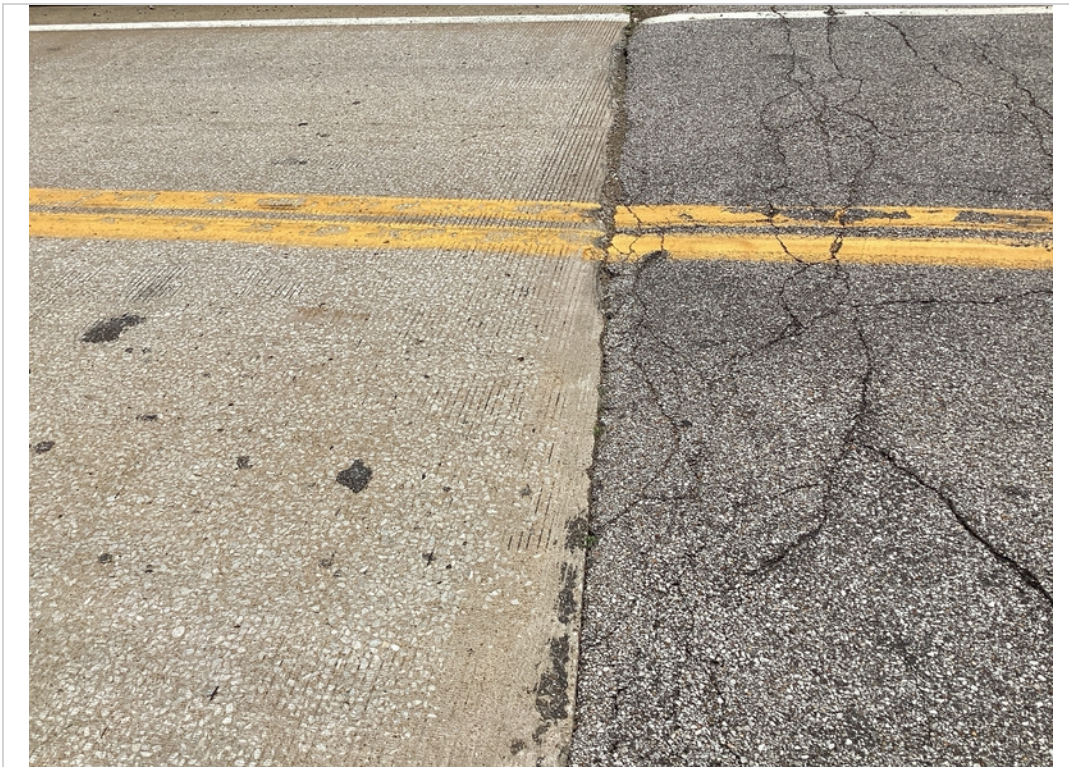
Span 1 spall

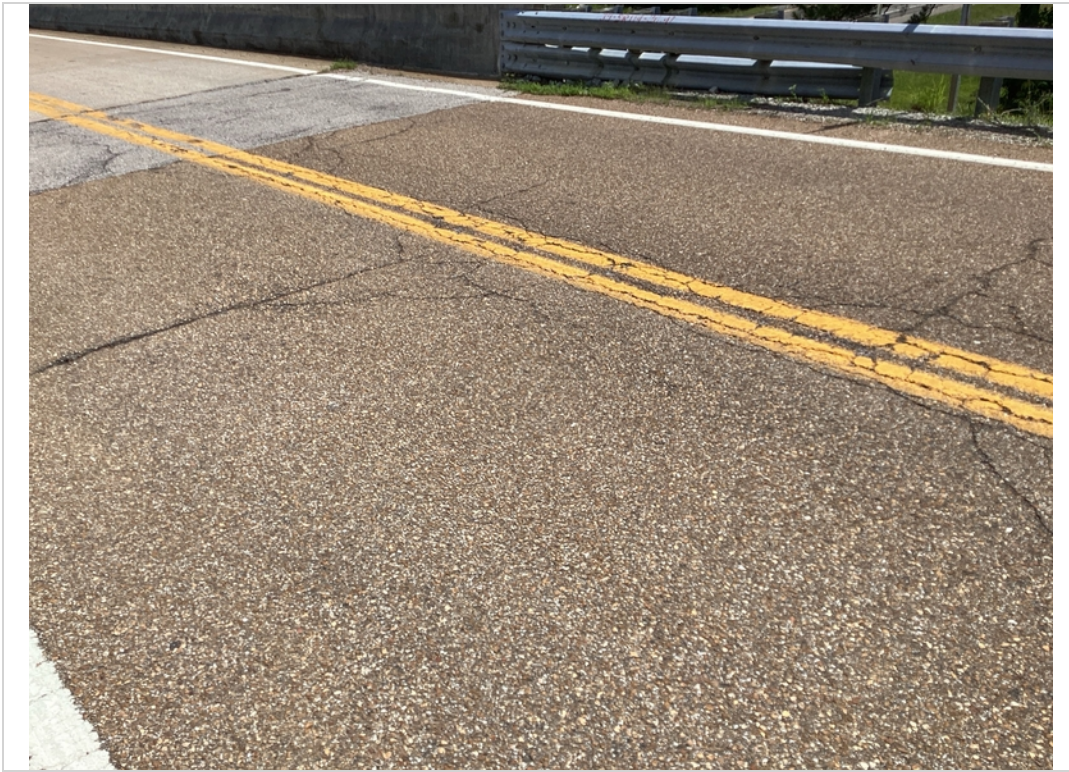
Pavement (Fair) 1/8" cracks and pothole

Approach 1 asphalt

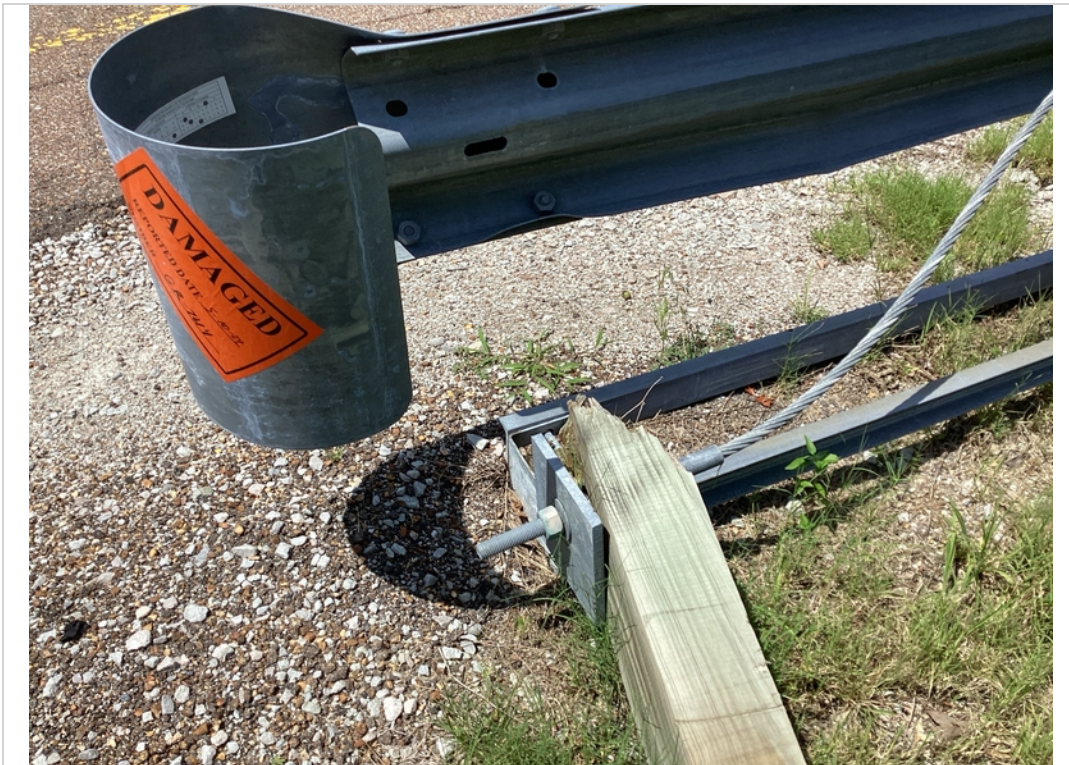
Guardrail Terminal Rating (Poor) Approach 1 right - broken post

Approach 1 right terminal damage

| Date Added | Recommendation | Priority |
|---|---|---|
| 06/03/2024 | Repair approach 1 right guardrail terminal | |

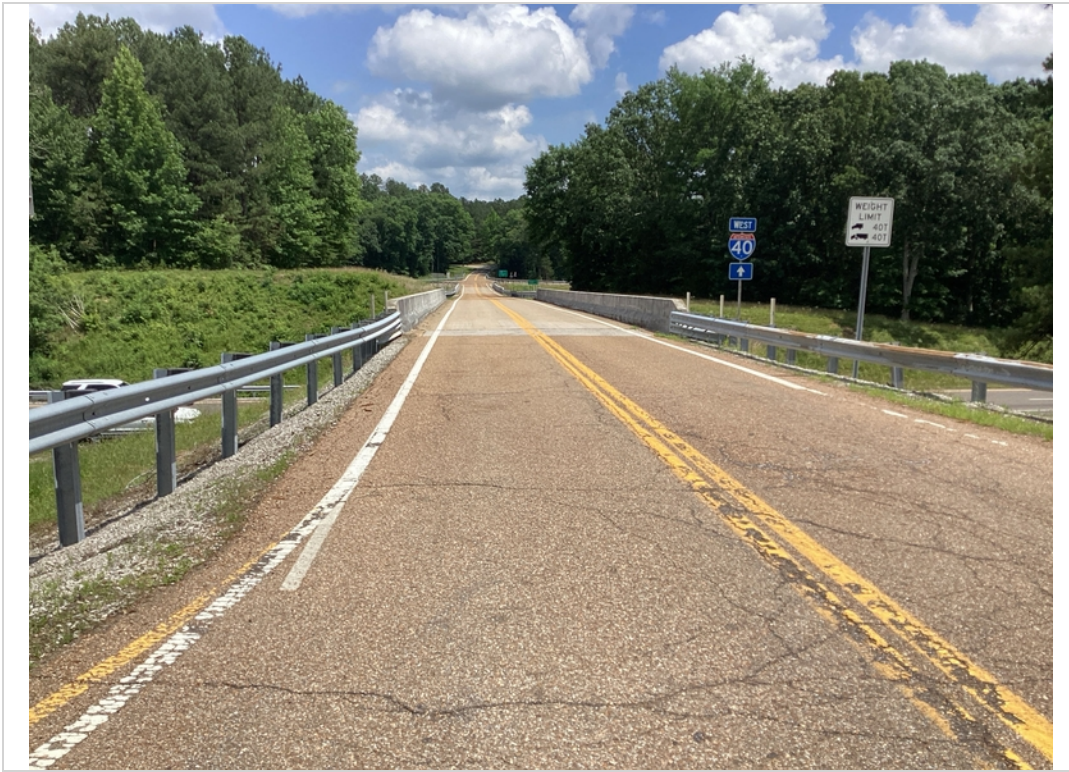
Direction of route approach 1 weight limit sign

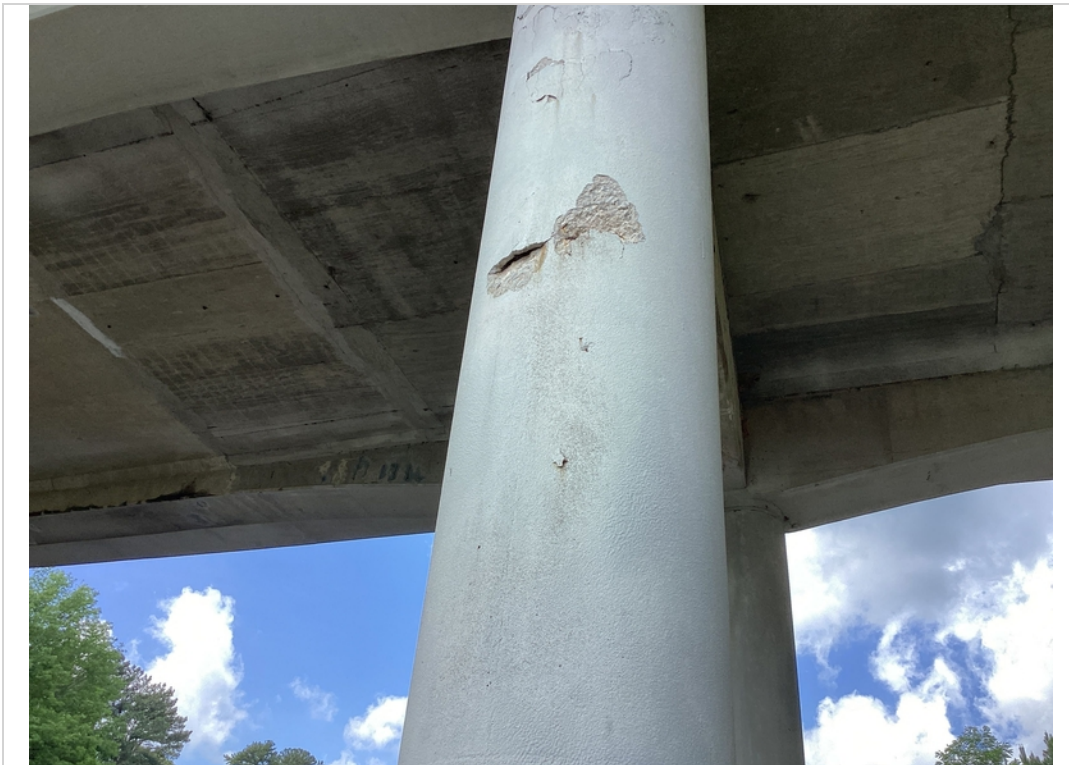
| <b>Bent Columns</b> | (Poor) | Spalling & 1/8" crack<br>Bent 1 B - poor - large spall to rebar |

Spall steel bent 1 column b

| Date Added | Recommendation | Priority |
|---|---|---|
| 06/03/2024 | REPAIR BENT #1 COLUMN "B" | 2 |

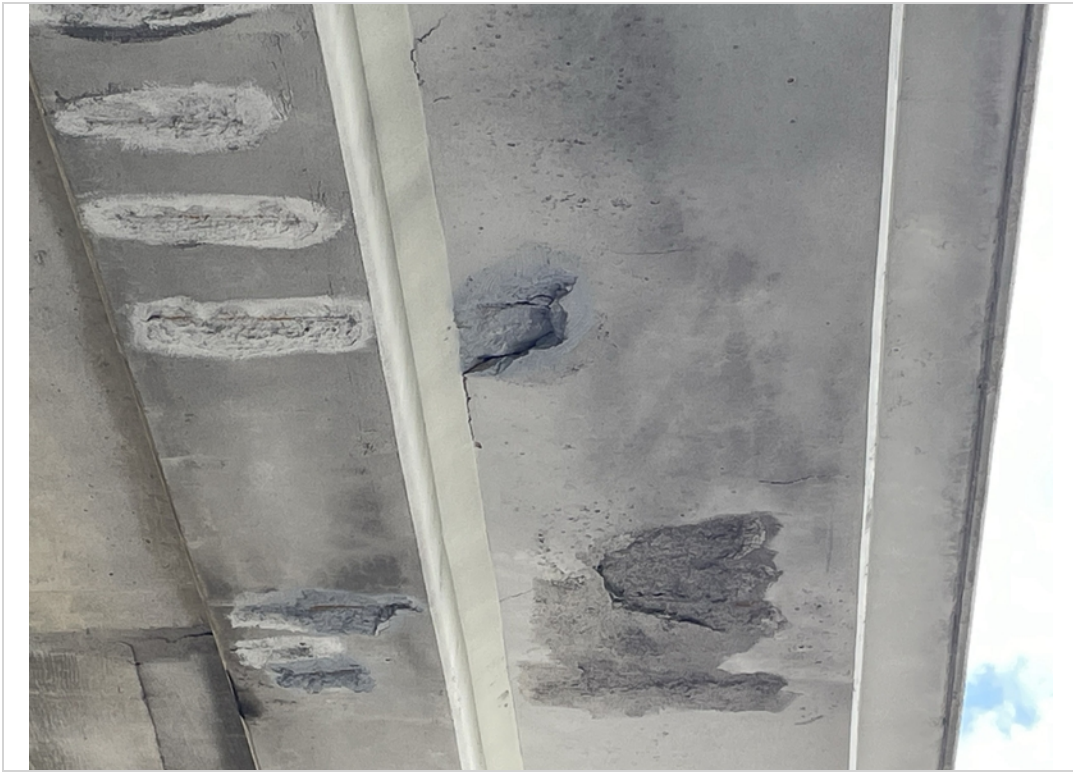
Span 2 right overhang impending spall

Span # R&E overhang impending spalling

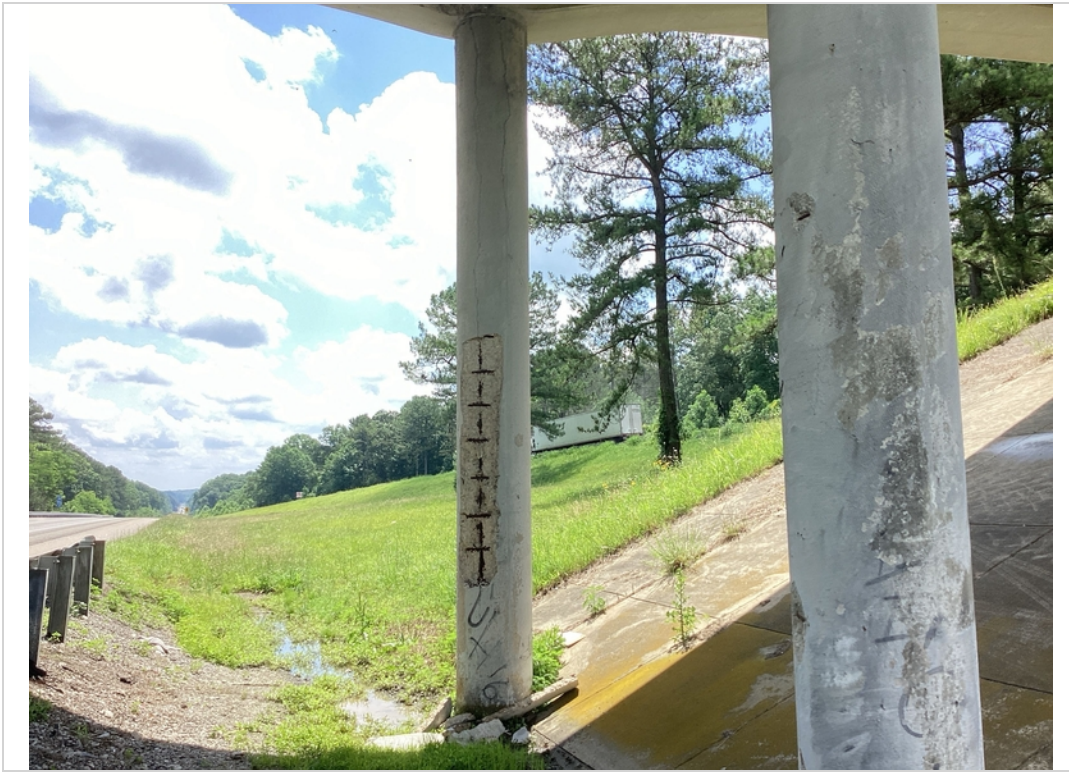
Bent #1 column B spalling

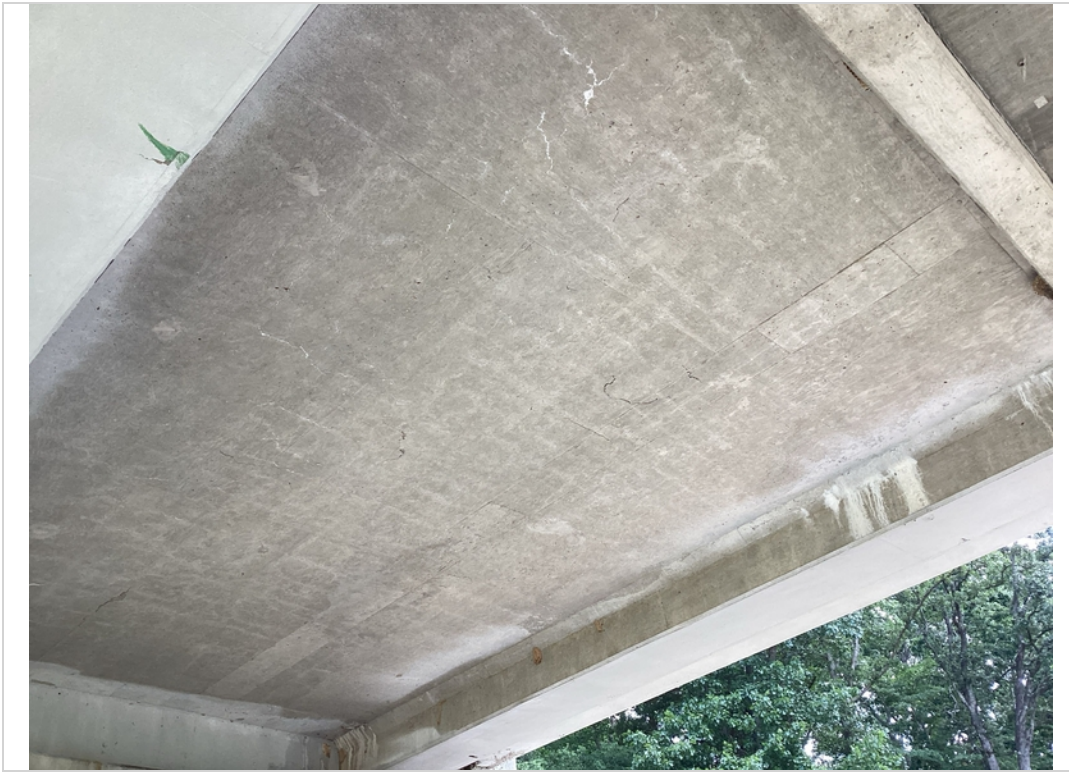
Impending spall on bottom deck of span #3

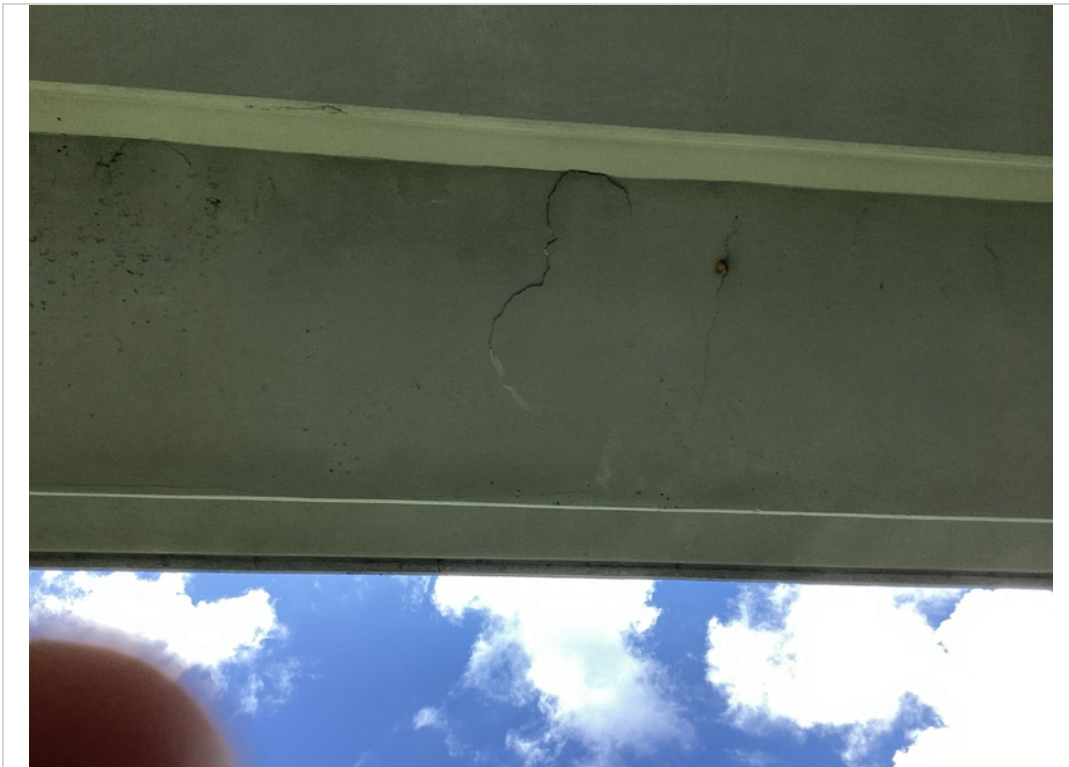
Impending spall on bottom deck of span #3

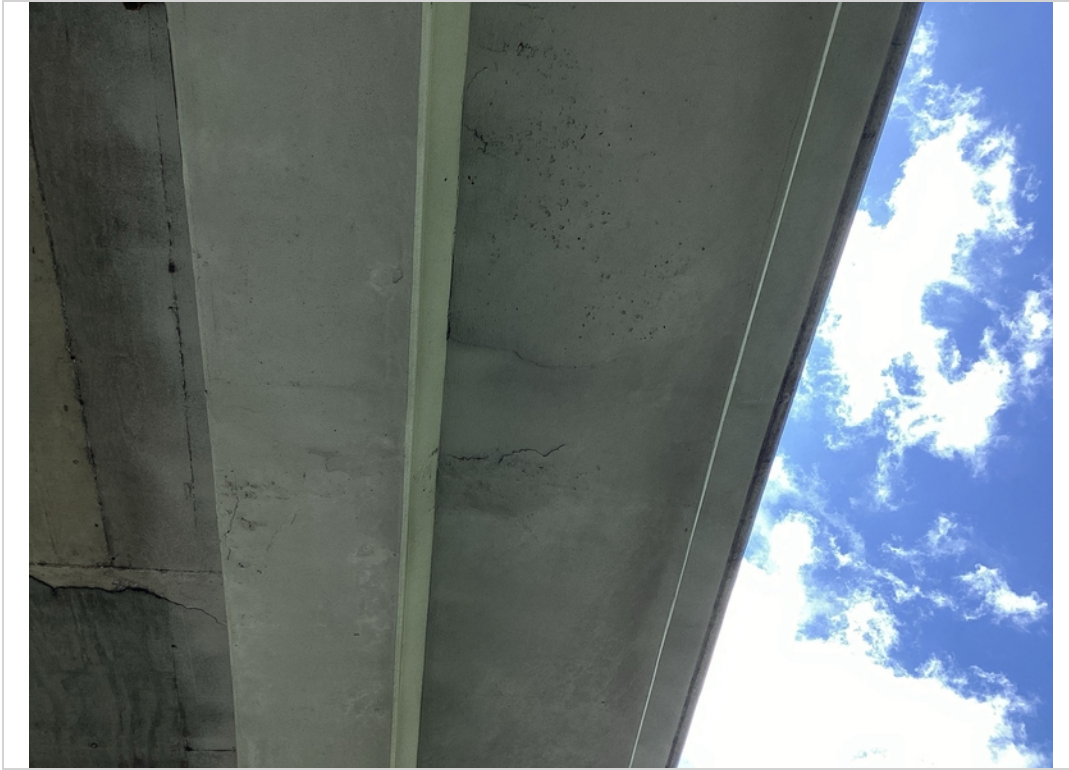
Impending spall on bottom deck of span #3

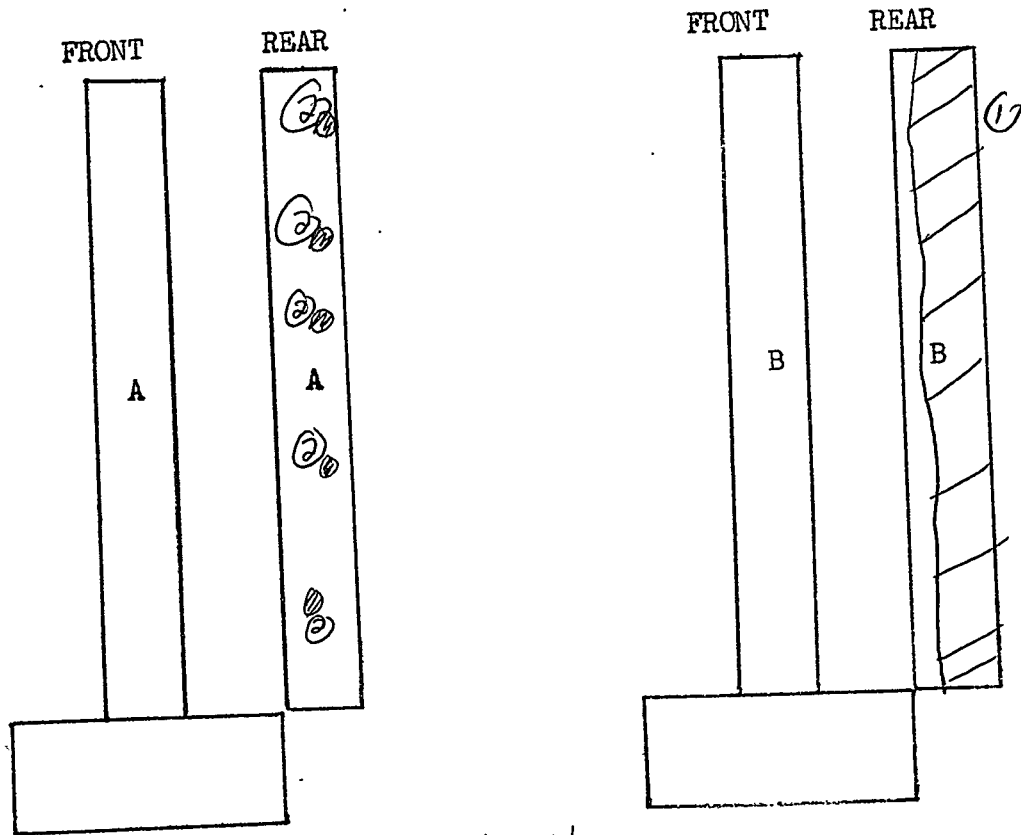
BR. NO. 39 7114 264BENT NO. 1

① imp spall/spall to steel 20'tall 24"wide 3'deep  
② spall to steel 18'dia 1'deep

| ELEMENT | | RATING | COMMENT |
|---|---|---|---|
| COLUMN | A | G F P C | ② |
| COLUMN | B | G F P C | ① |

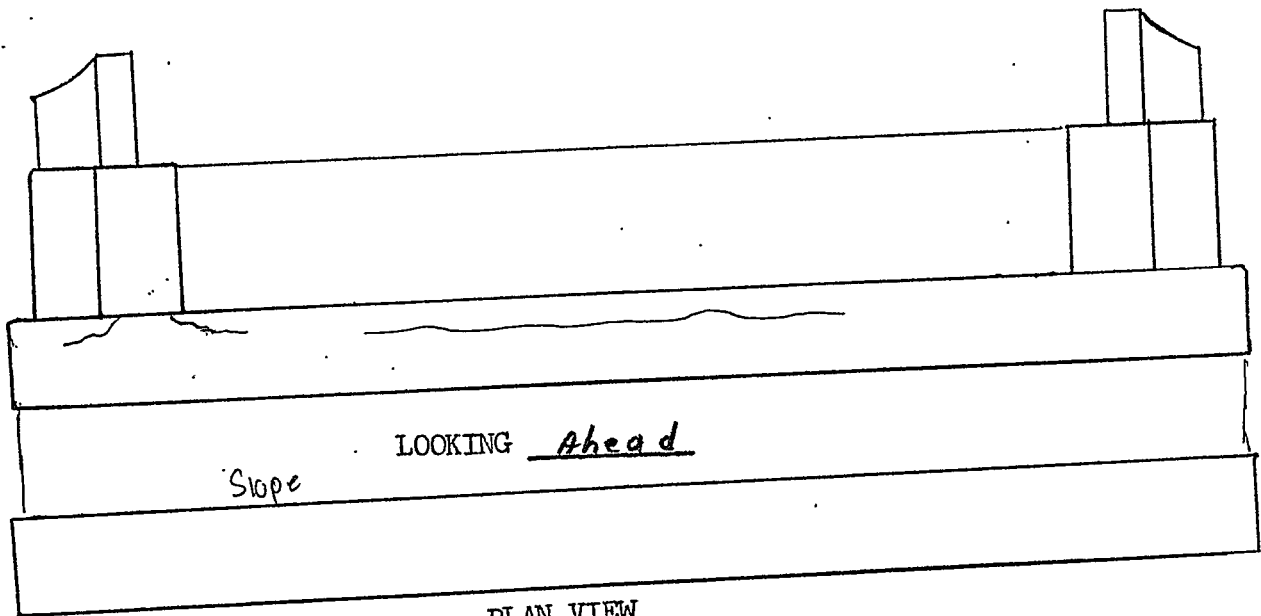
BR. NO. 37 ~~114~~ 2647ABUT. NO. 2

| ELEMENT | RATING | COMMENT |
|---|---|---|
| CAP | G (F) P C | 1/32" cracks |
