Region 04, 39 - Henderson County

NATCHEZ TRACE RD. Crossing SR-114 / I-40 WBL

90 - LAST INSPECTION DATE 06/04/2024

| IDENTIFICATION | |
|---|---|
| (8) Structure Number | 39I00400041 |

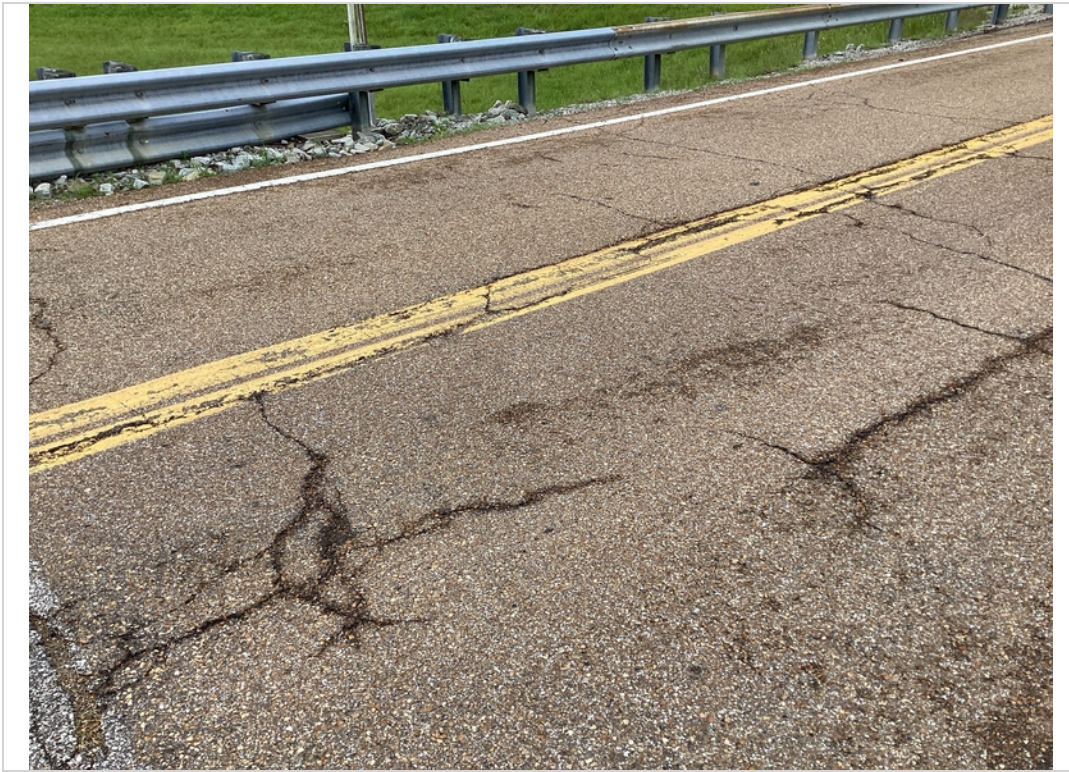
Approach 2 asphalt

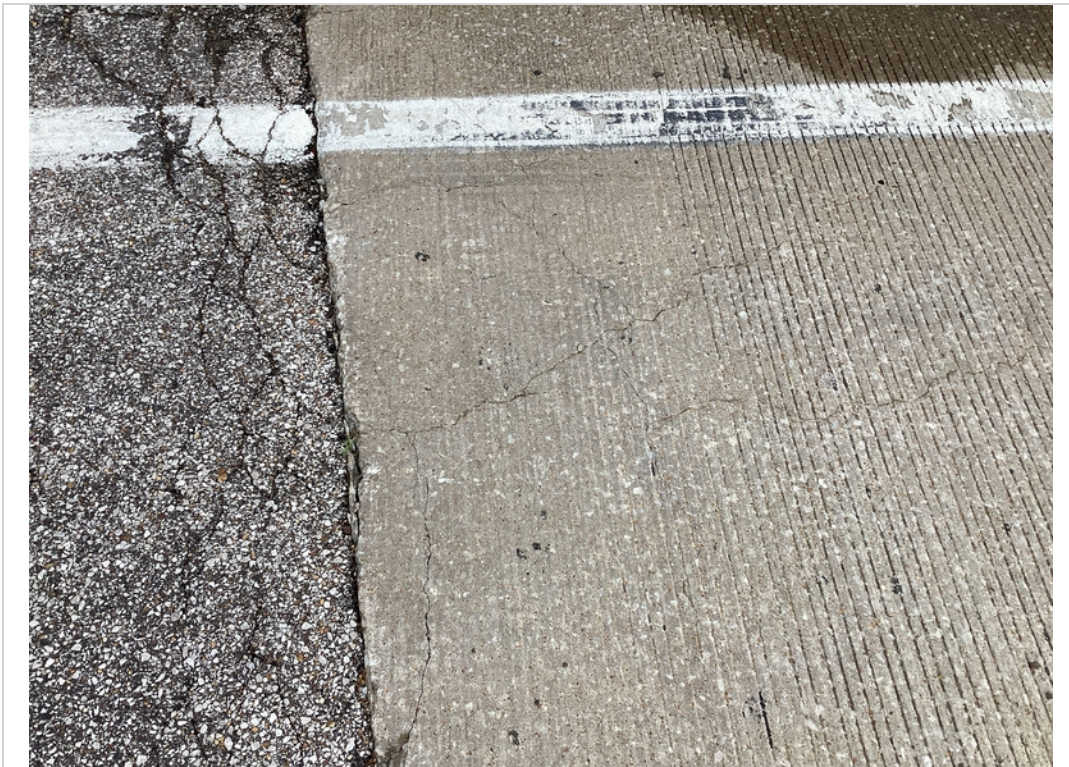
Span 3 cracks

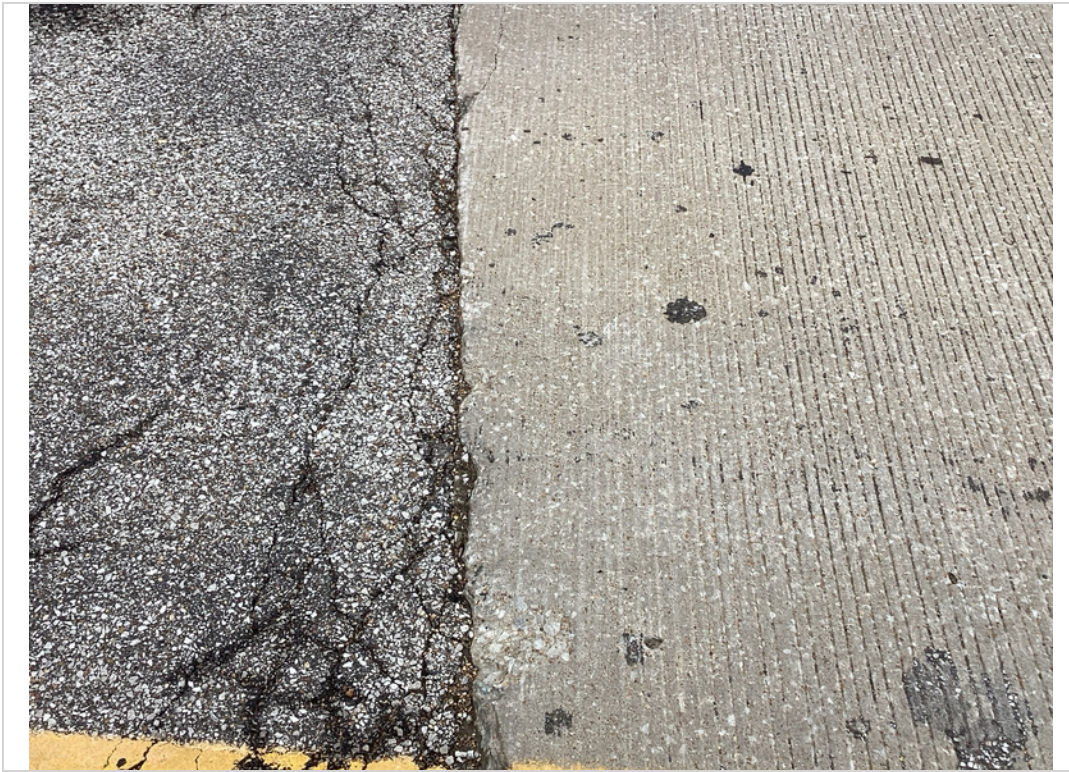
Span 3 spall

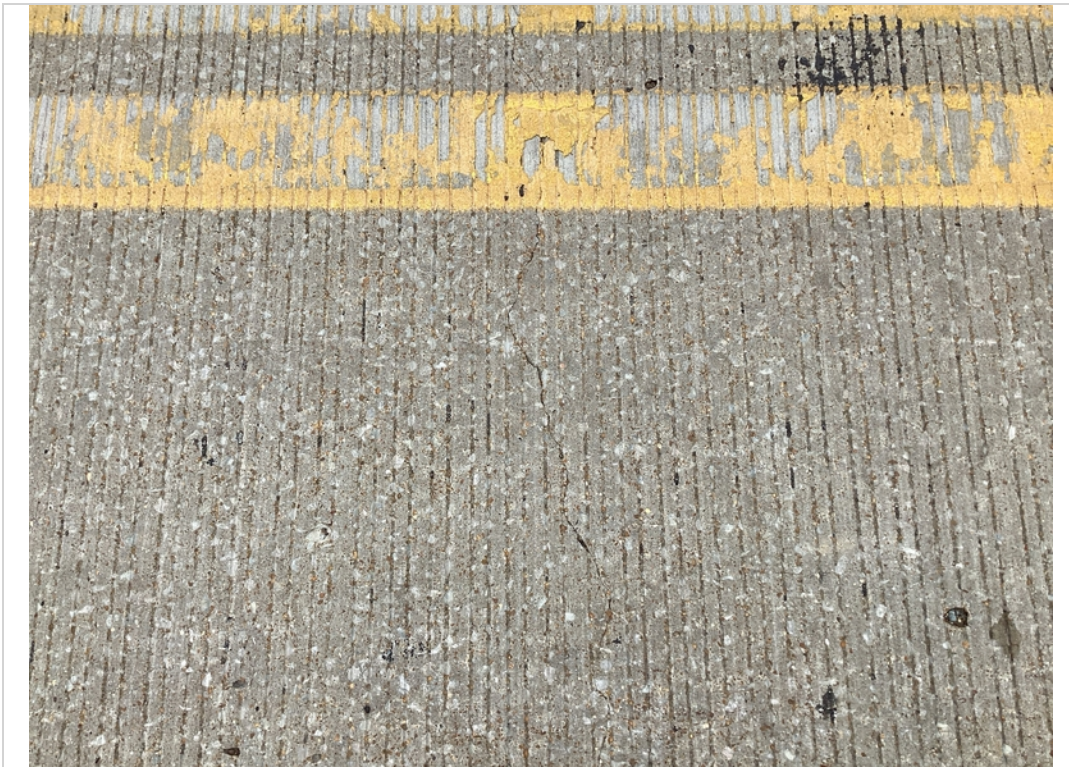
Span 2 crack

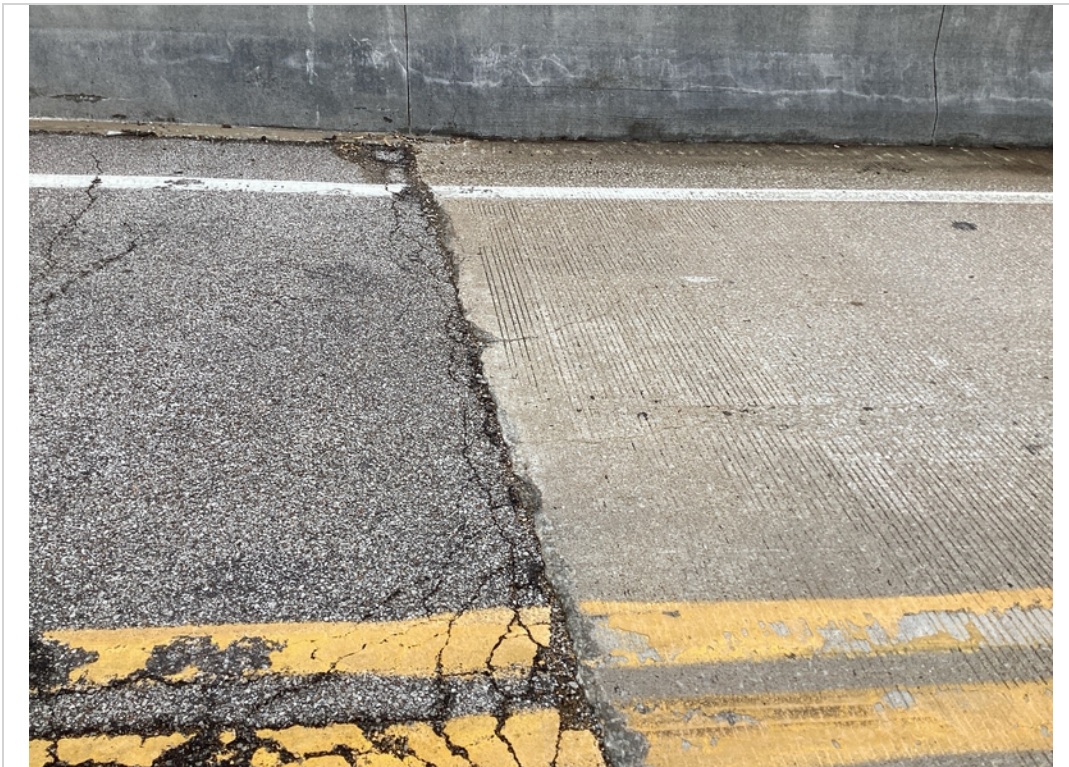
Span 1 spall

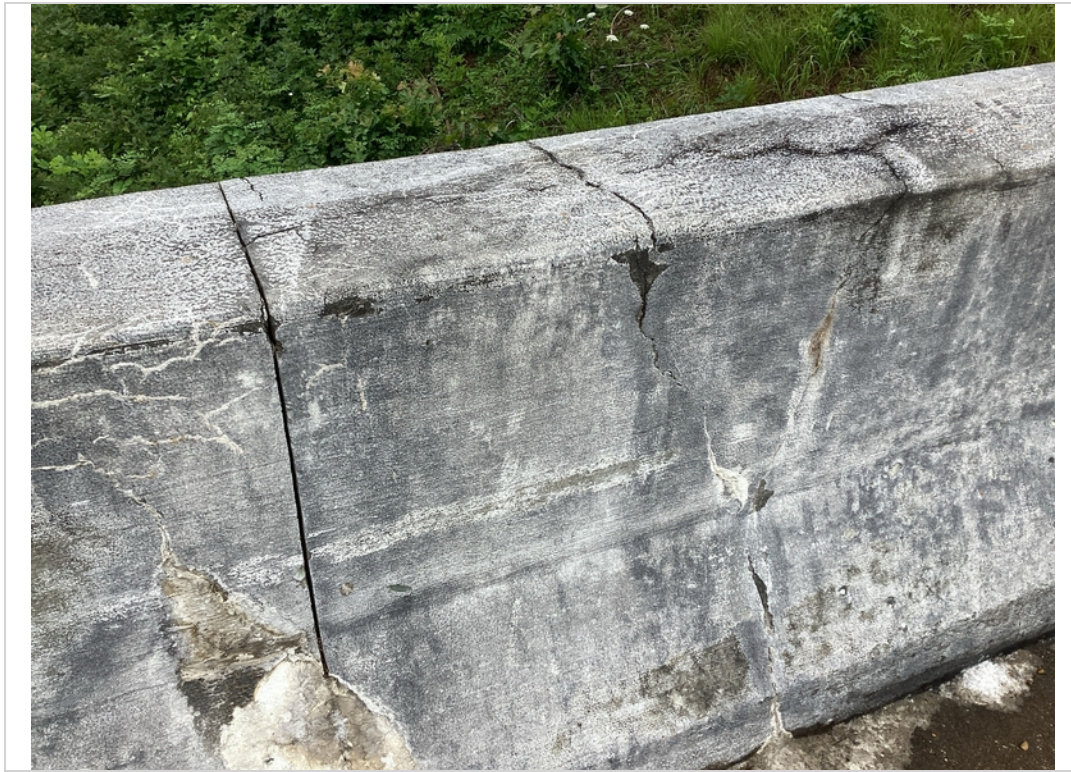
Span 1 parapet crack

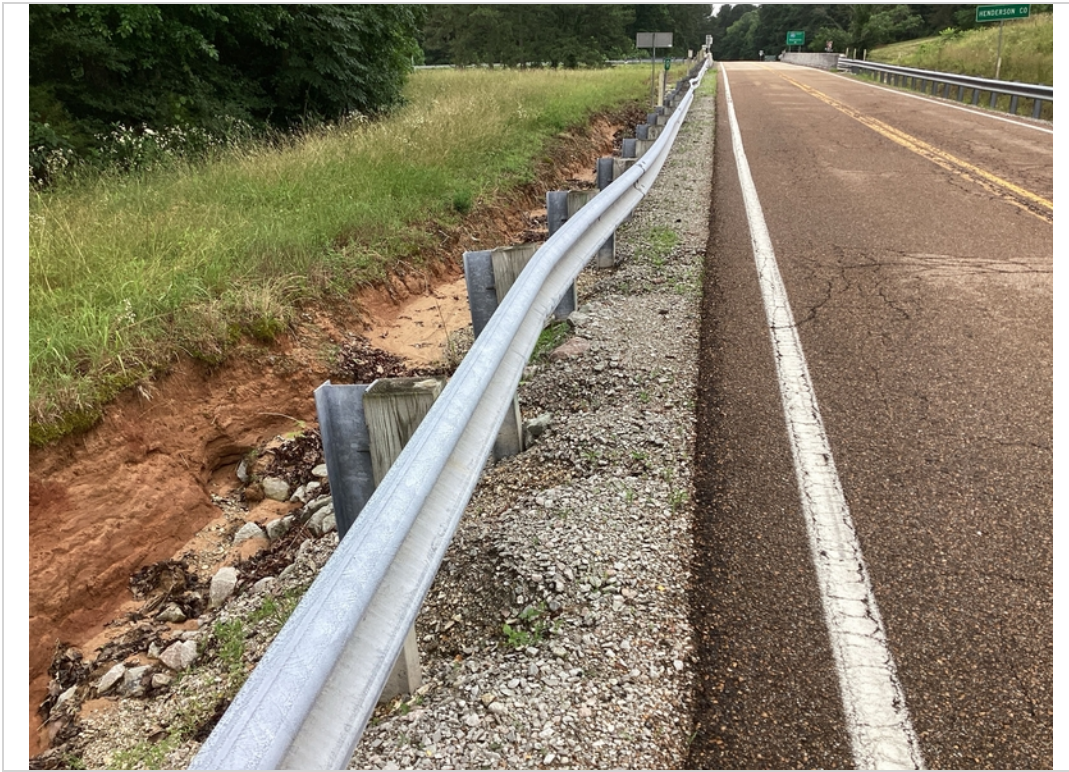
Light damage at approach 1 right

Approach 1 right guardrail damage

| Date Added | Recommendation | Priority |
|---|---|---|
| 11/19/2001 | APPROACH GUARDRAILS ARE SUBSTANDARD | |

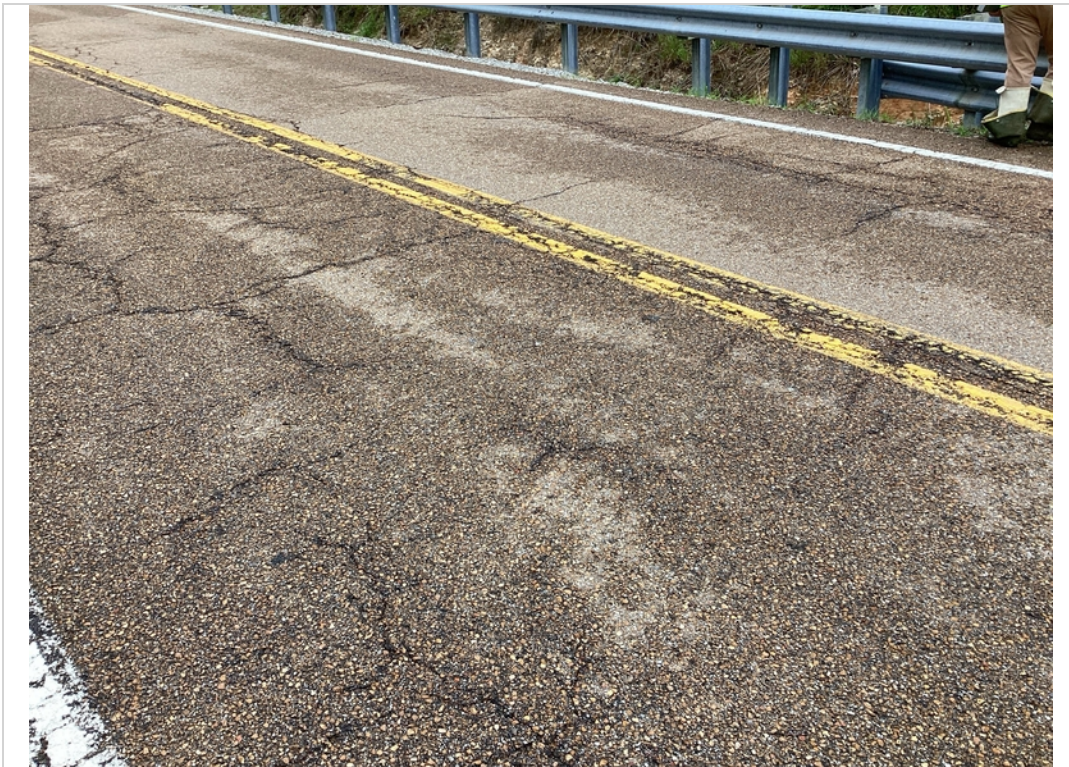
Approach 1 asphalt

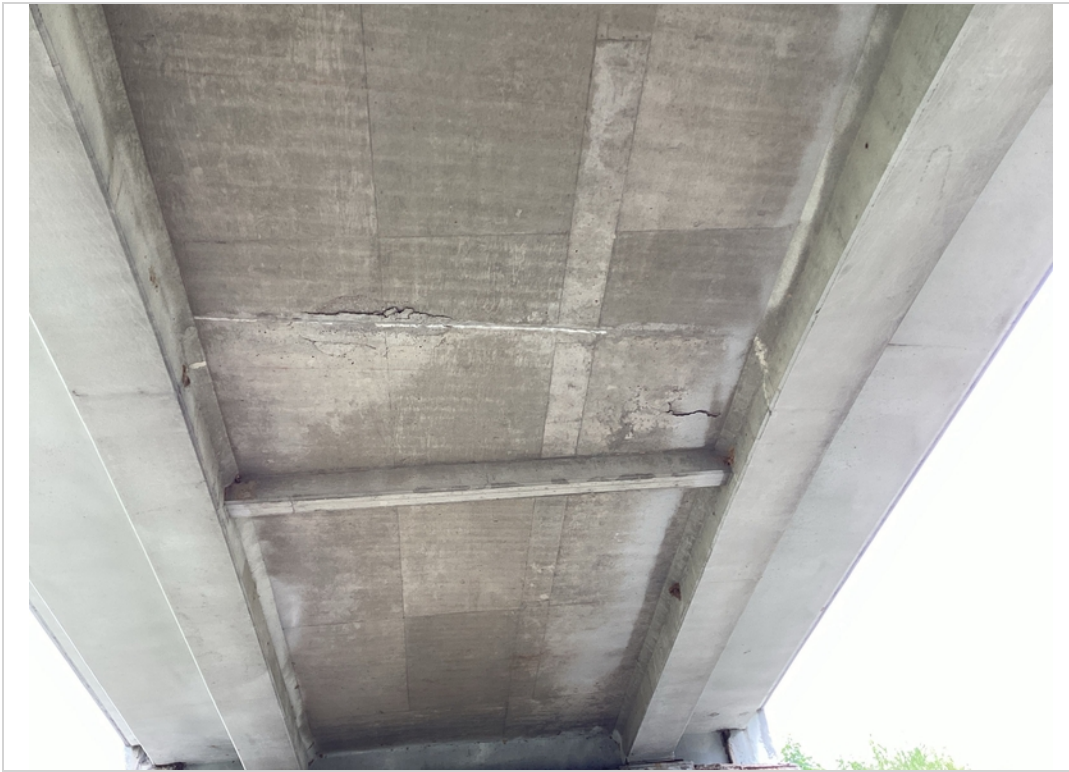
Impending spall on bottom deck of span #3

| Date Added | Recommendation | Priority |
|---|---|---|
| 06/04/2024 | PATCH BOTTOM OF DECK IN ALL SPANS | |

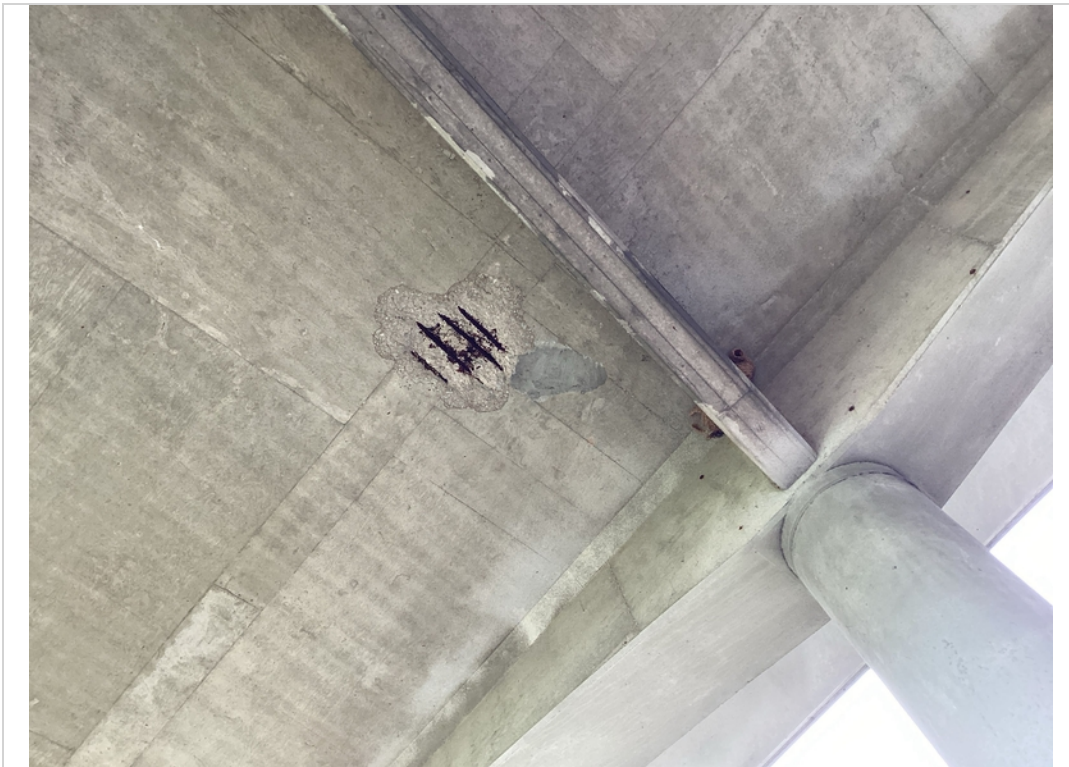
Spall to steel on bottom deck of span #3

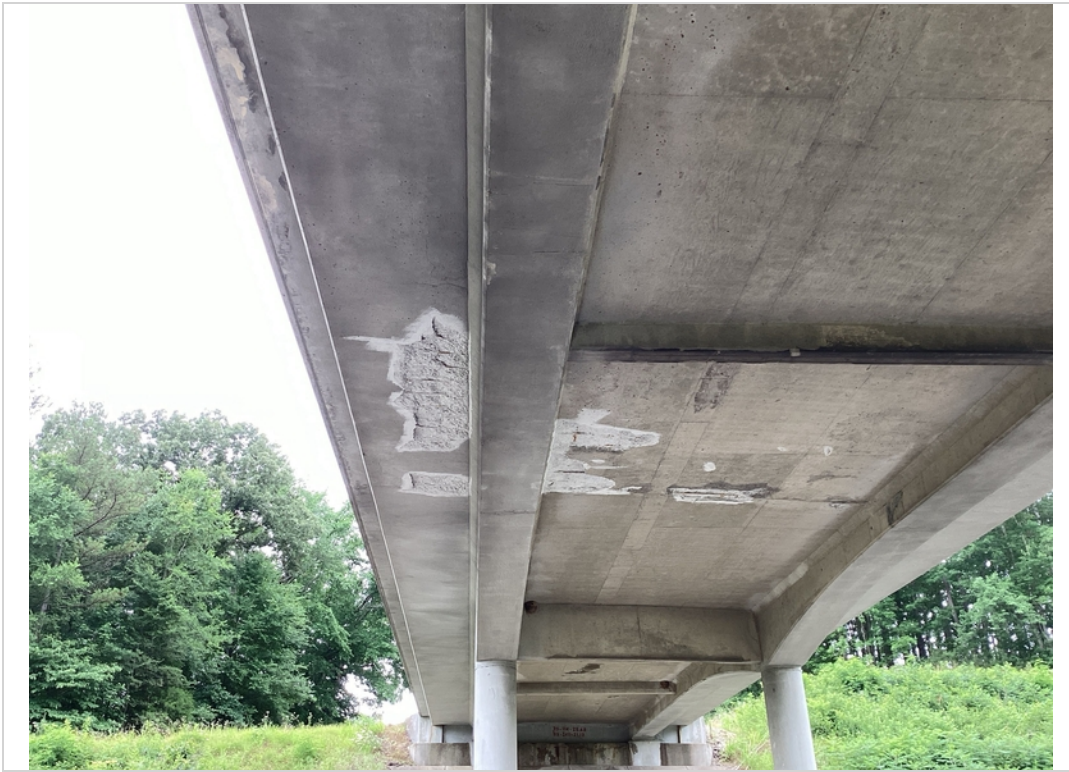
Spall to steel on bottom deck of span #2

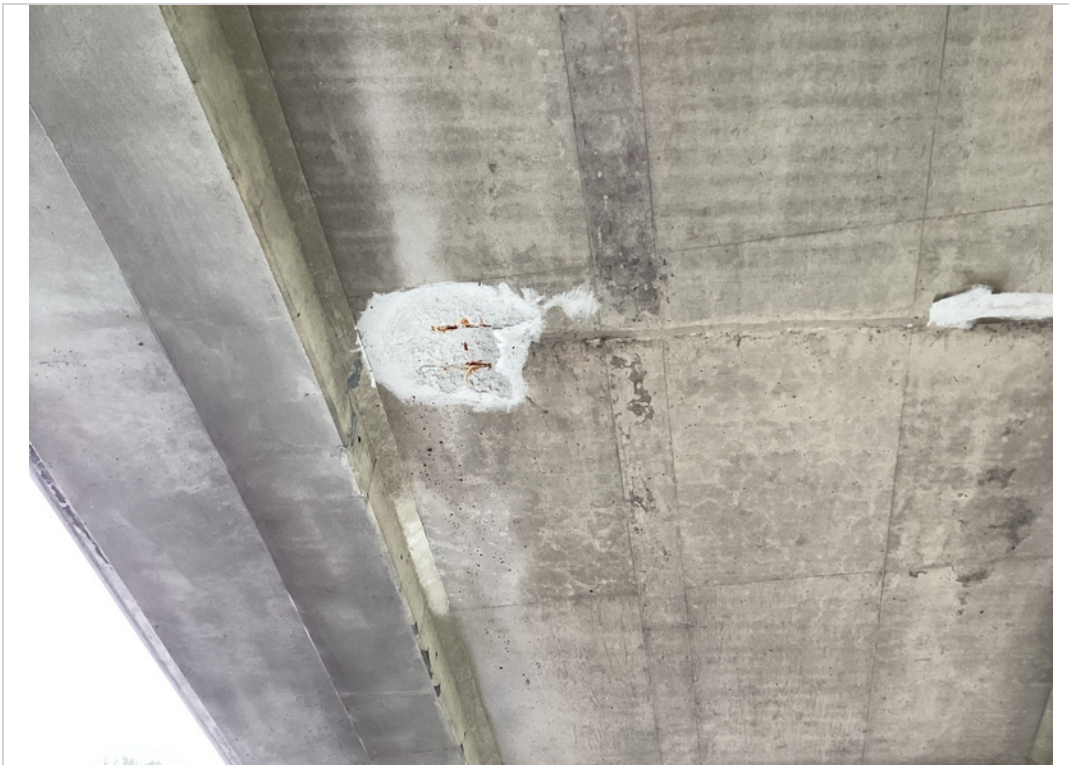
Spall to steel on bottom deck of span #2

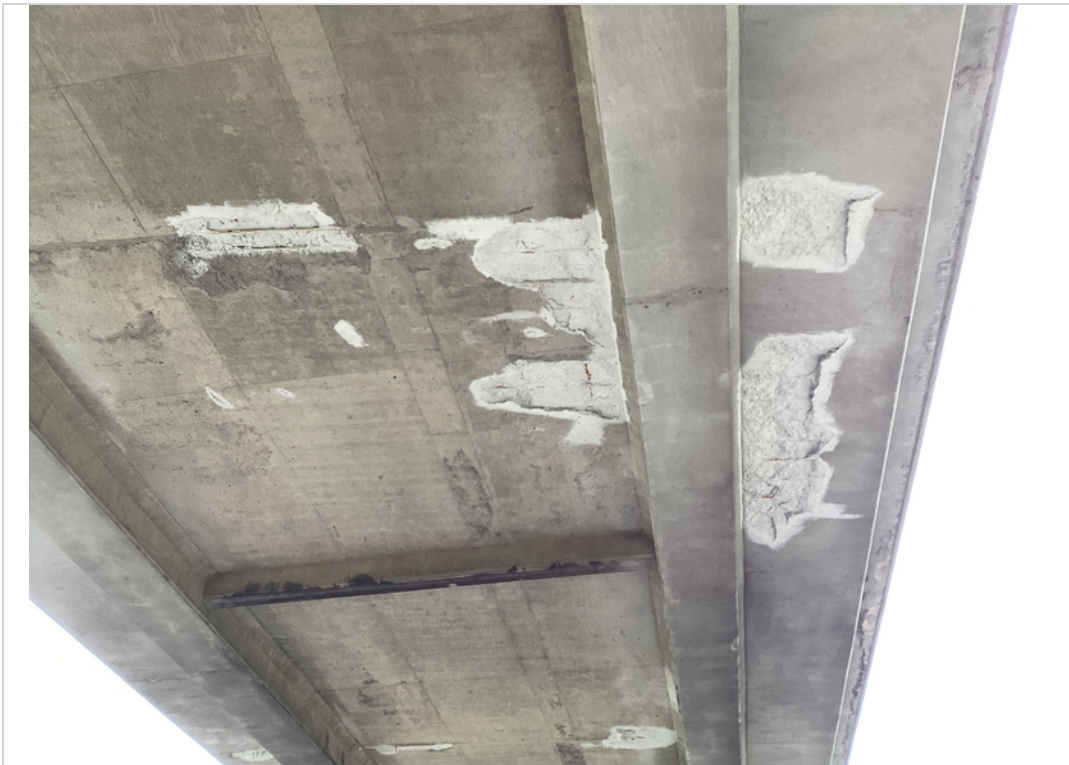
Span 2 bottom deck spall to steel

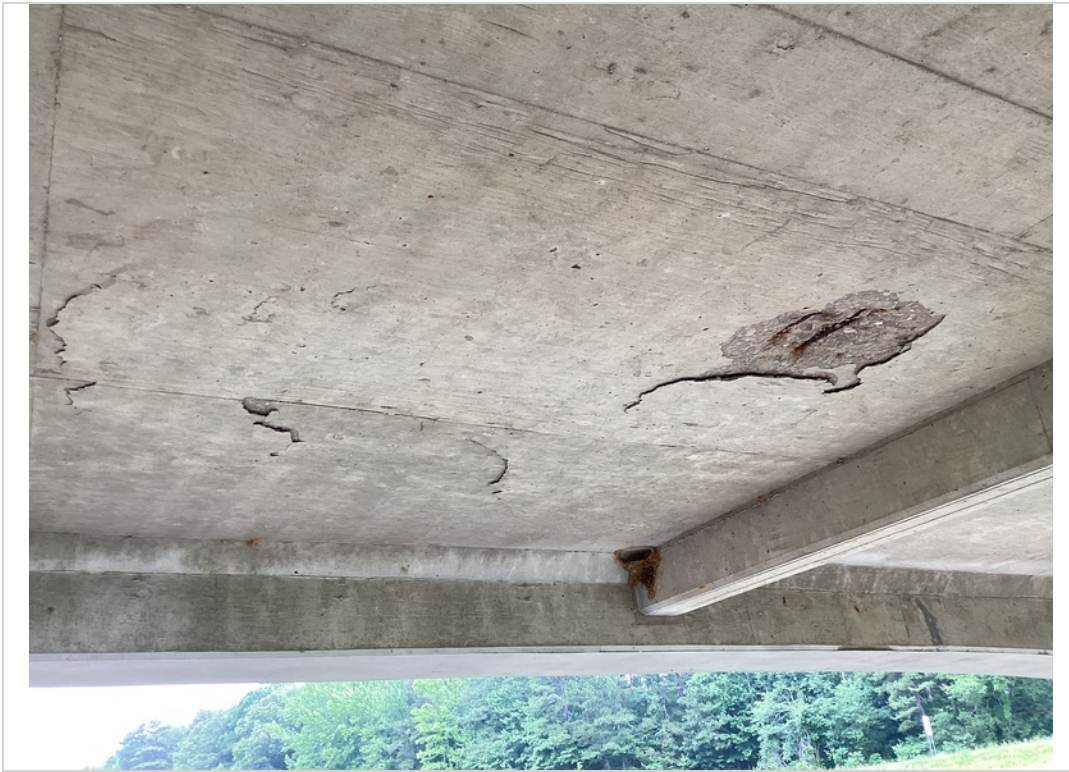
Span 1 bottom deck impending spalls and spall to steel

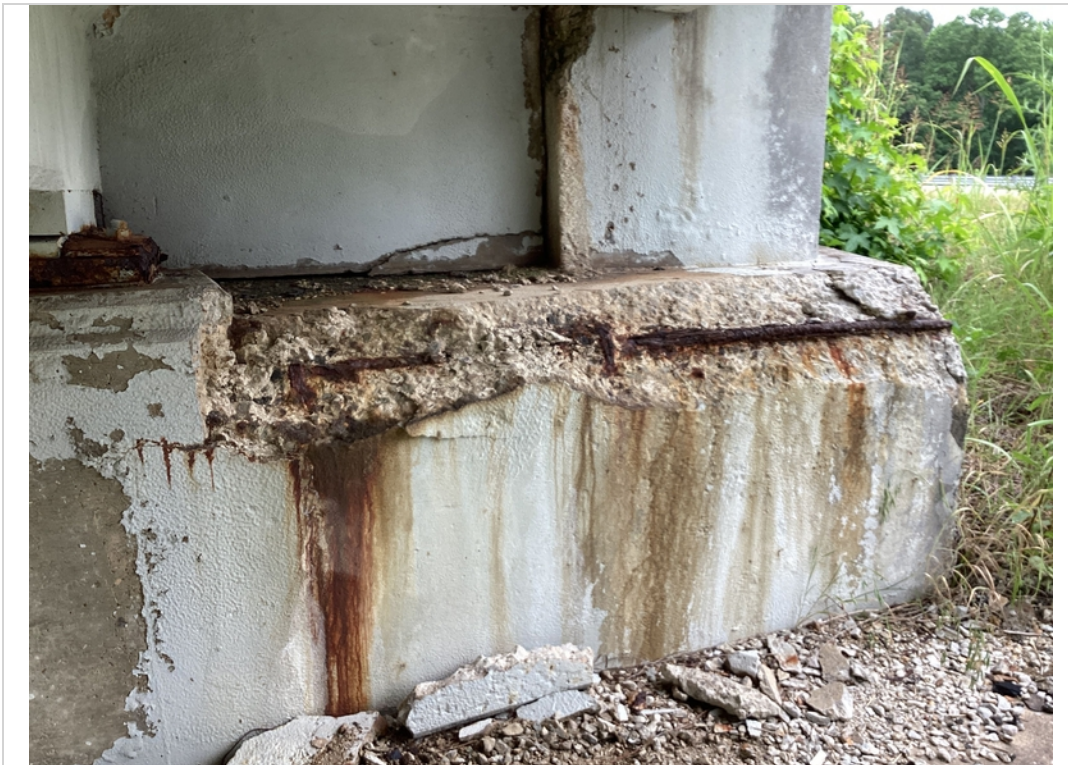
Spall steel abut 2

| Date Added | Recommendation | Priority |
|---|---|---|
| 06/04/2024 | REPAIR BOTH ABUTMENT CAPS | |

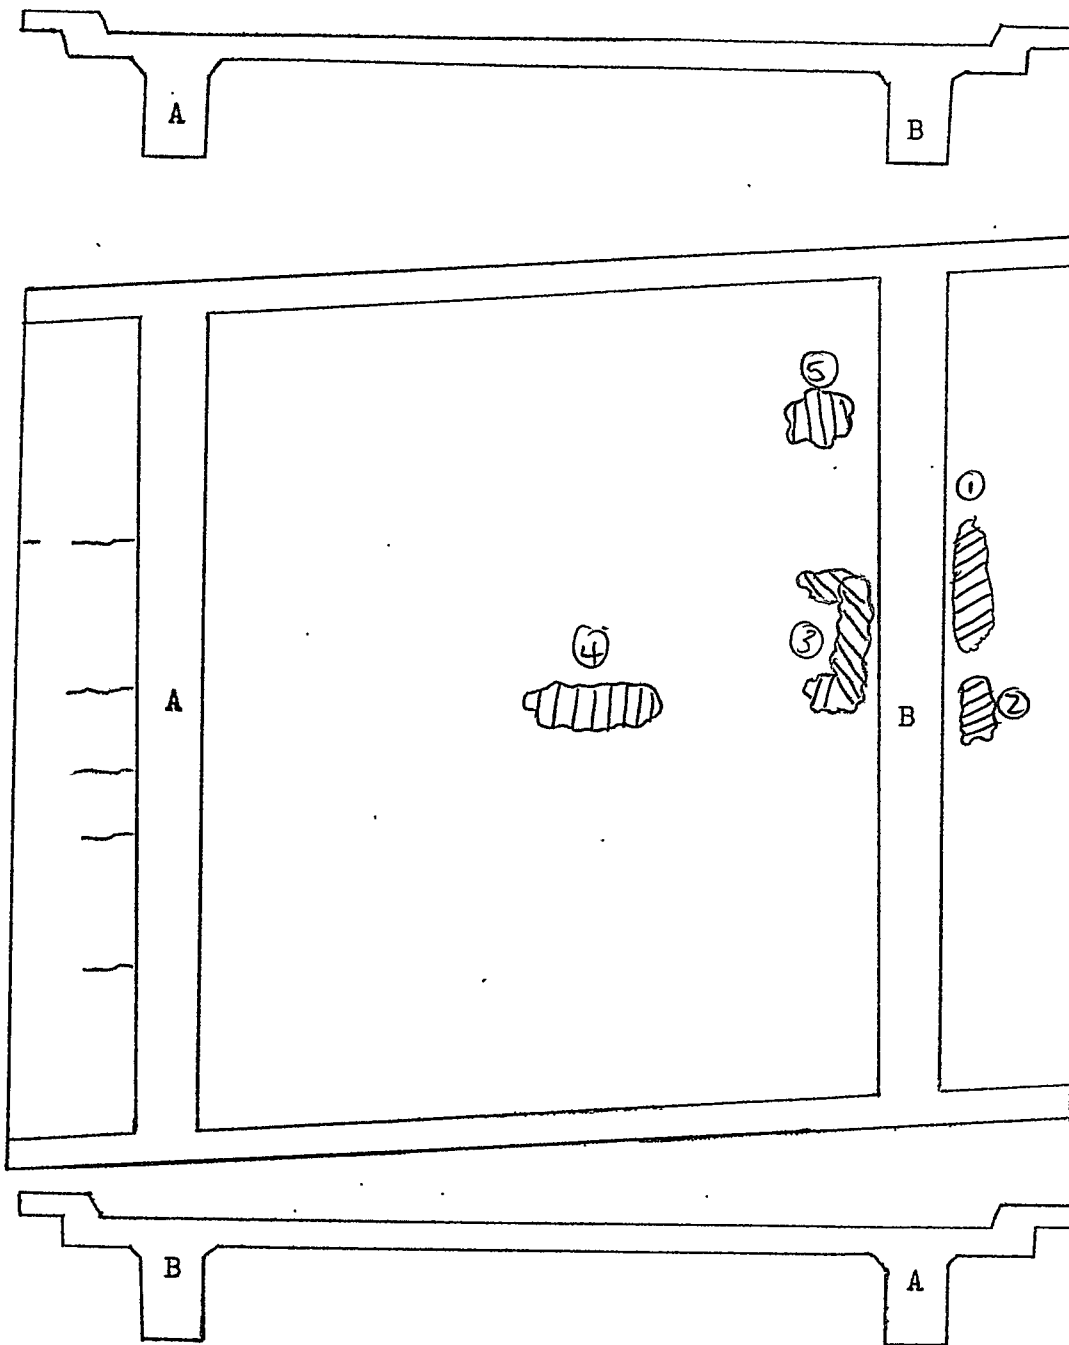
| ELEMENT | RATING | COMMENT |
|---|---|---|
| BOTTOM DECK | G (F) P C | hairline cracks w/eff, see 1-5 |
| | | ① 4' L x 2' W x 1 1/2" D<br>Spall to steel |
| | | ② 2' in dia x 1 1/2" D<br>Spall to steel |
| | | ③ 5' L x 2' W x 1 1/2" D<br>Spall to steel |
| | | ④ 3' L x 1 1/2" D<br>Spall to steel |
| | | ⑤ 3' in dia x 1 1/2" D<br>Spall to steel |

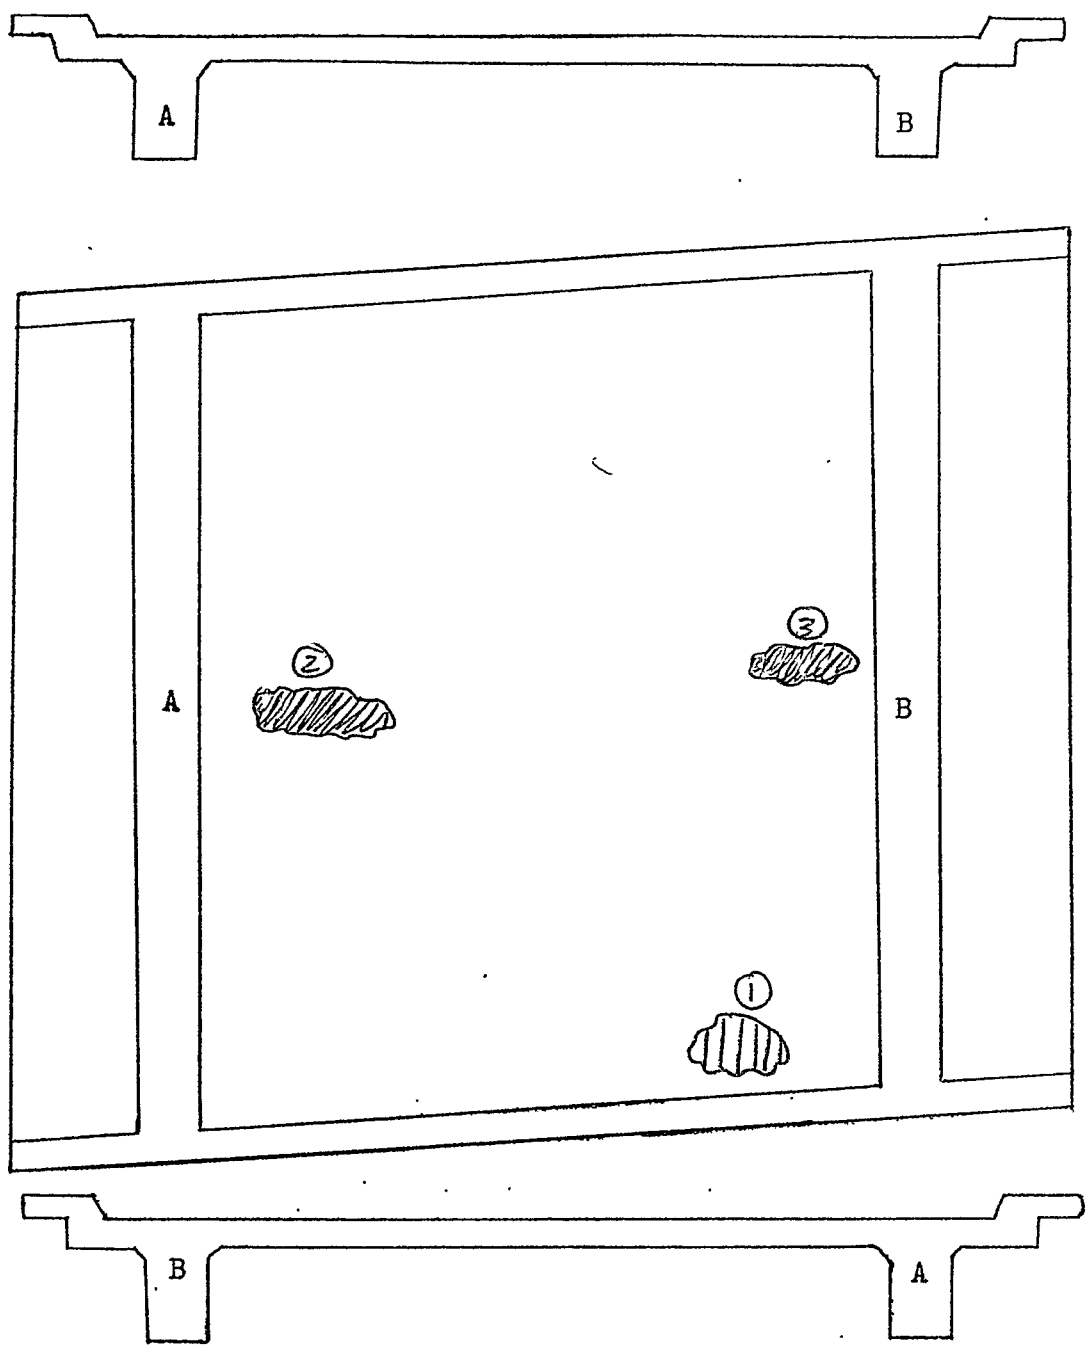
| ELEMENT | | RATING | COMMENT |
|---|---|---|---|
| BOTTOM DECK | | G (F) P C | See 1-3 |

- ① 2 1/2' in dia x 1 1/2" D  
Spall to Steel
- ② 3 1/2' w x 1 1/2' L x ? D  
Impending Spall
- ③ 2' L x 2 1/2' w x ? D  
Impending Spall

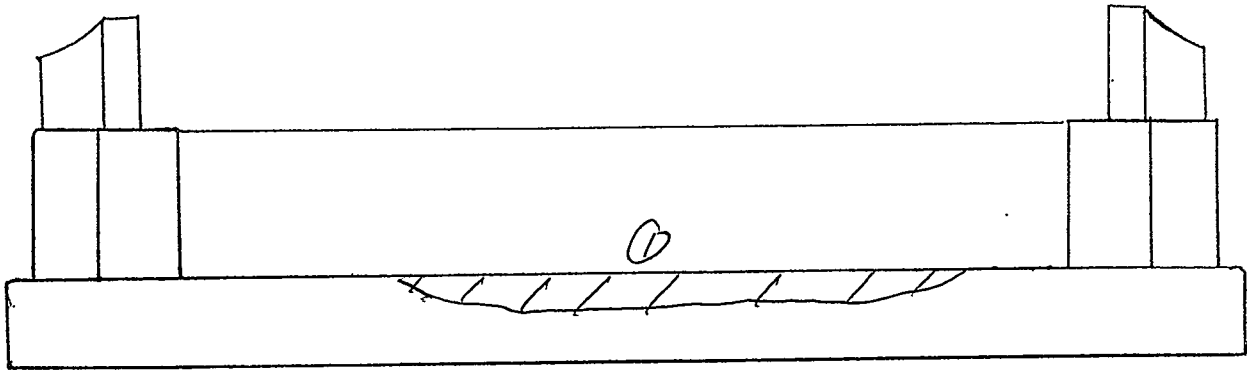
BR. NO. 3911.42648ABUT. NO. 1

| ELEMENT | RATING | COMMENT |
|---|---|---|
| BEARINGS | G F P C | ① imp spill 11' wide<br>8' tall 14' long |

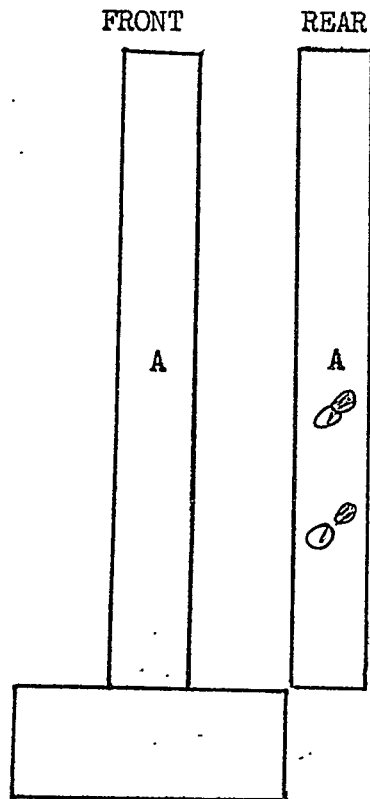
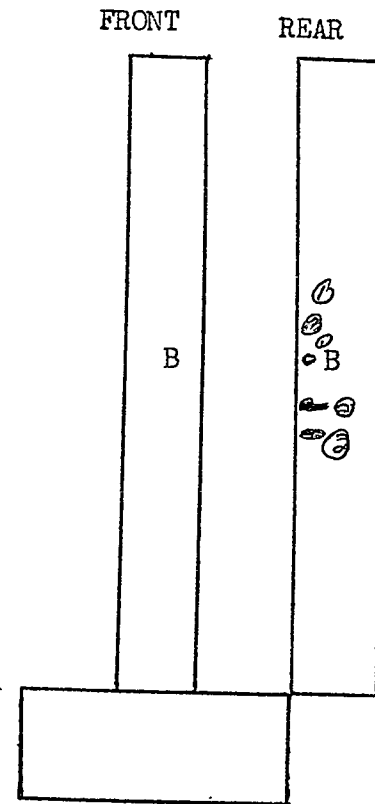
① Spall to steel 6" dia  
1/2" deep  
② Spall to steel  
16" wide 1/2" deep

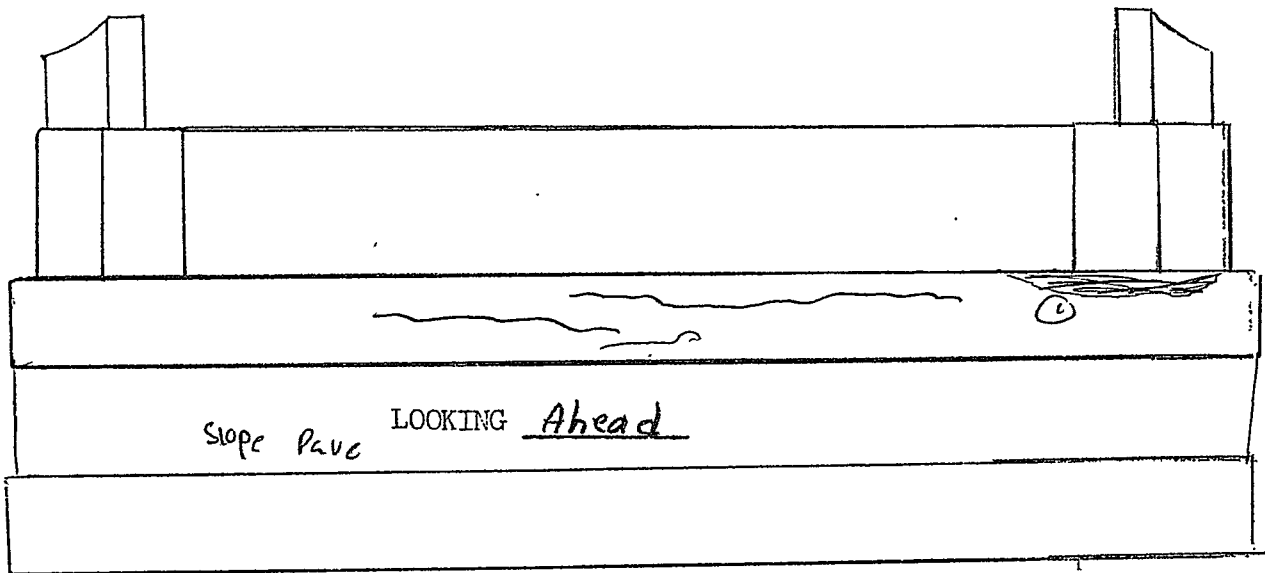
| ELEMENT | RATING | COMMENT |
|---|---|---|
| BEARINGS | G $\textcircled{F}$ P C | rust |
| CAP | G $\textcircled{F}$ P C | see $\textcircled{1}$ $\frac{1}{32}$ " cracks |

| Date Added | Recommendation | Priority |
|---|---|---|
| 04/08/2022 | CLEAN AND PAINT BEARINGS AT ABUTMENT NO.2 | |
