# TENNESSEE DEPARTMENT OF TRANSPORTATION

## ASBESTOS INSPECTION REPORT

Bridge Number 39I00400031  
SR-114 over I-40 EB LM 26.47  
PIN: 136173.00; PE-N: 39S114-FO-002  
Henderson County, Tennessee

624 Grassmere Park, Suite 14  
Nashville, Tennessee 37211  
TTL Project No. 250800975.00  
June 11, 2025

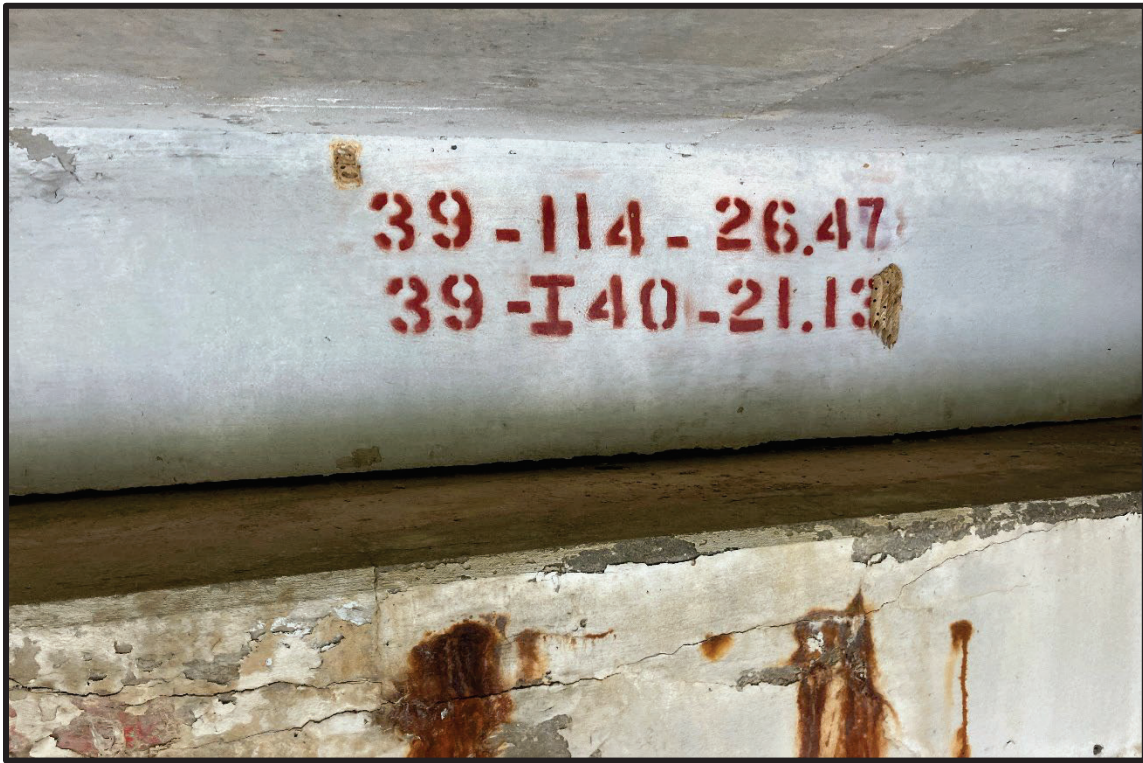
Photo 1: View of the bridge number.

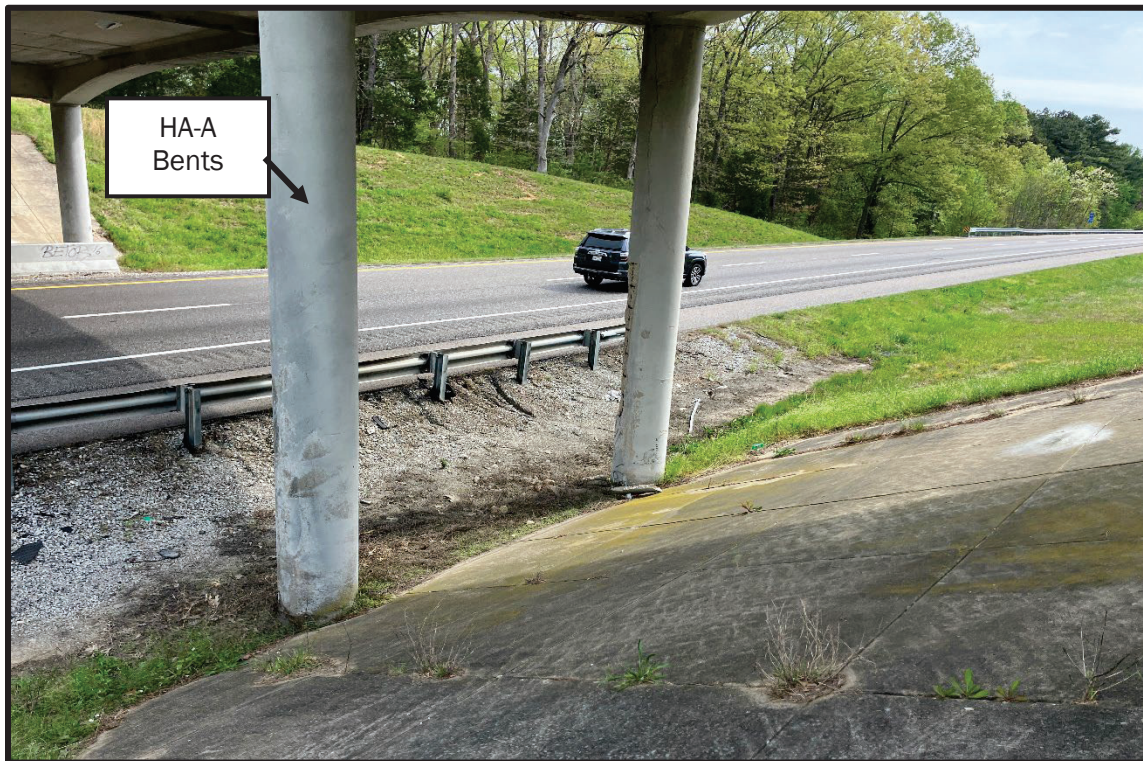
Three bulk samples of concrete were collected from the bents.

Photo 2: View of HA-A from the southern portion of the bridge.

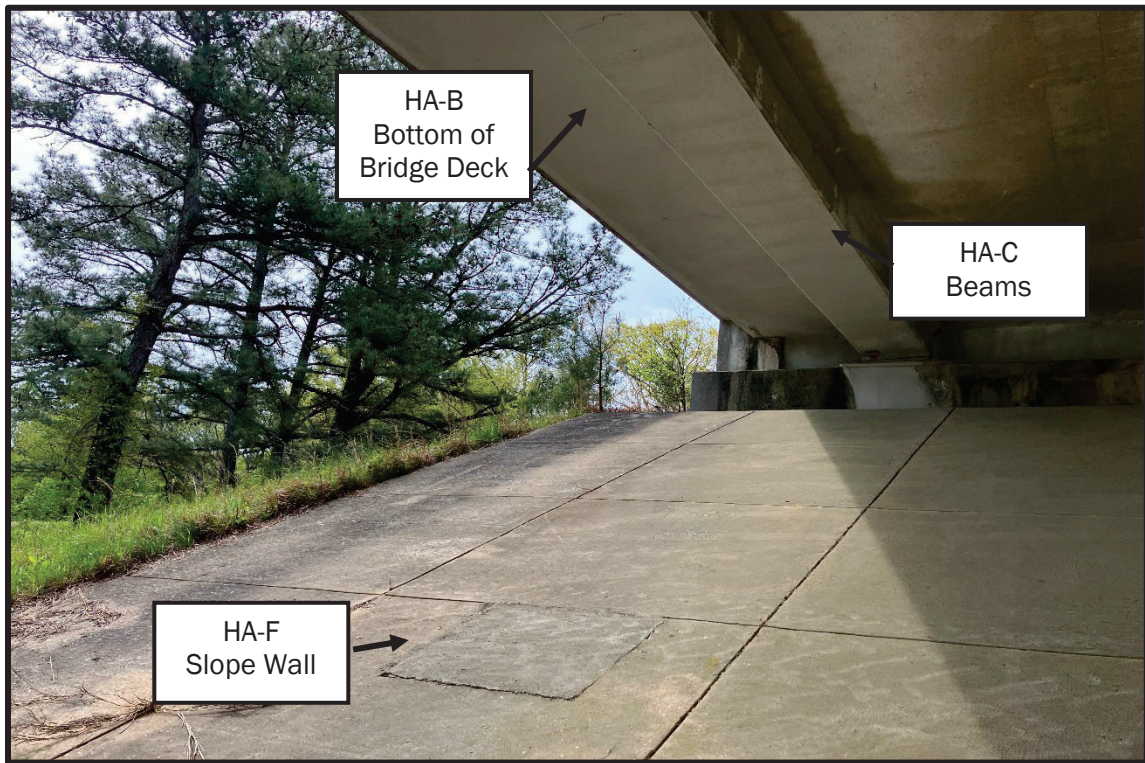
**Photo 3:** View of HA-B, HA-C, and HA-F from the south side of the bridge.

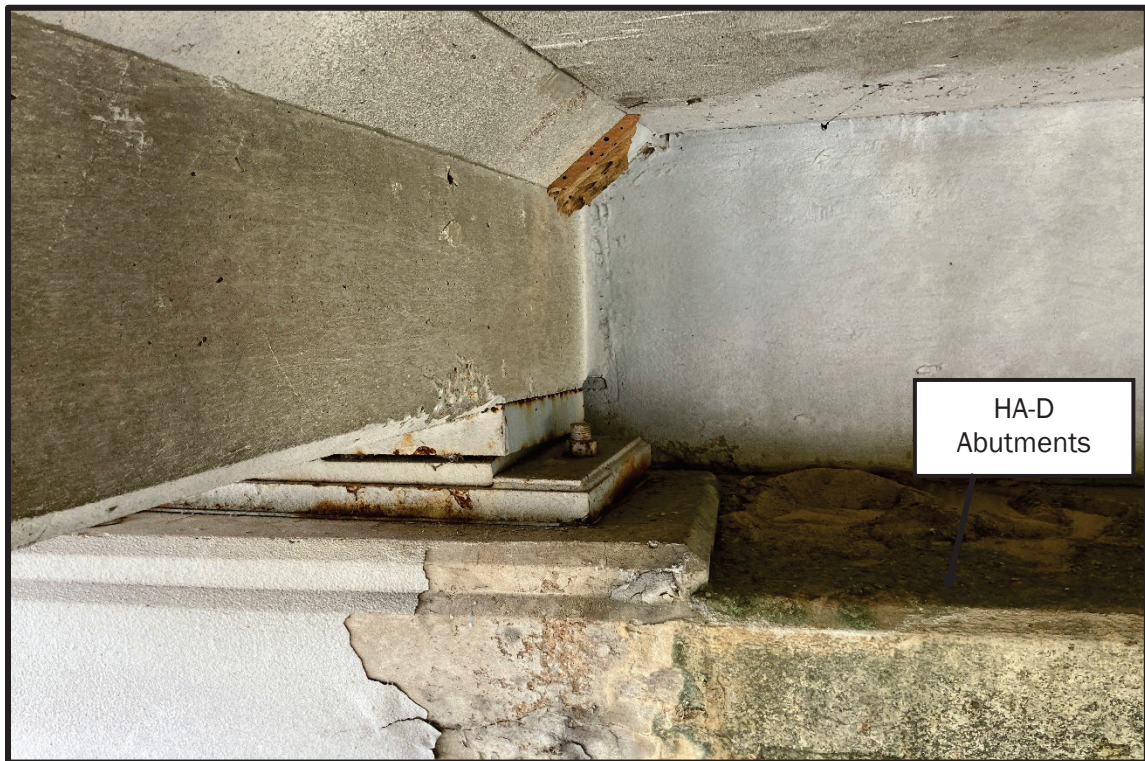
Three bulk samples of concrete were collected from the abutments.

**Photo 4:** View of HA-D under the north end of the bridge.

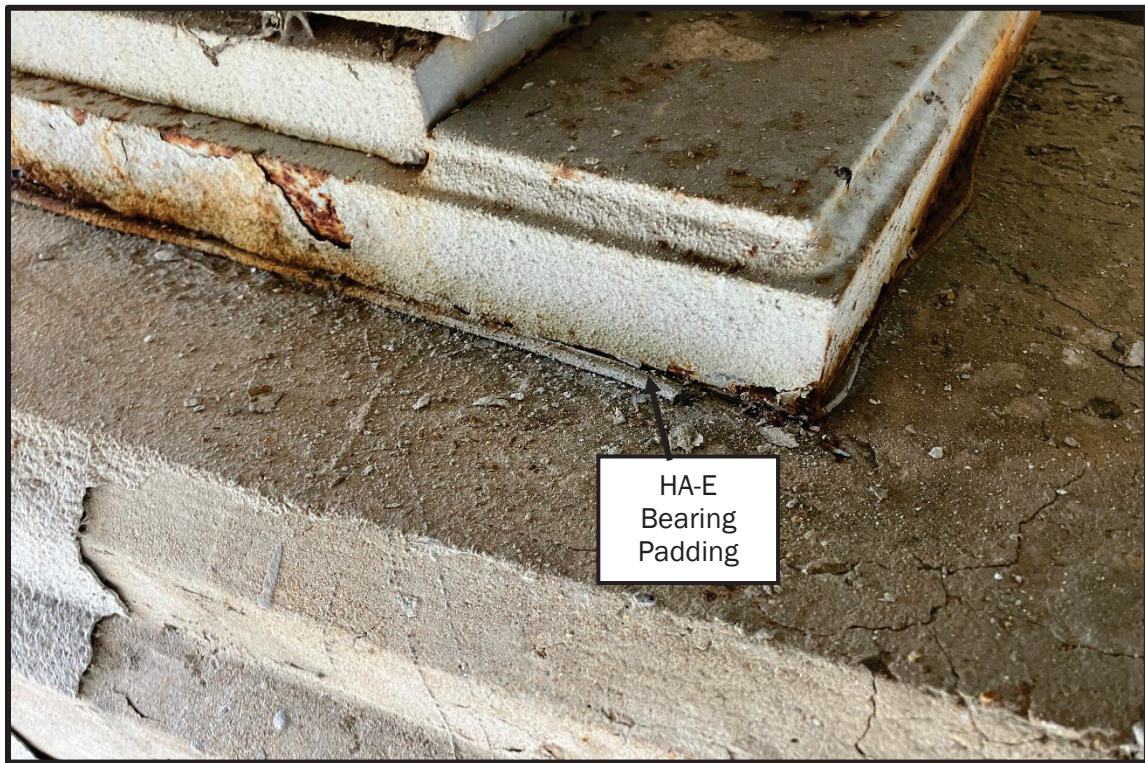
Three bulk samples of bearing padding were collected from between the bearings.

**Photo 5:** View of HA-E from under the north end of the bridge.

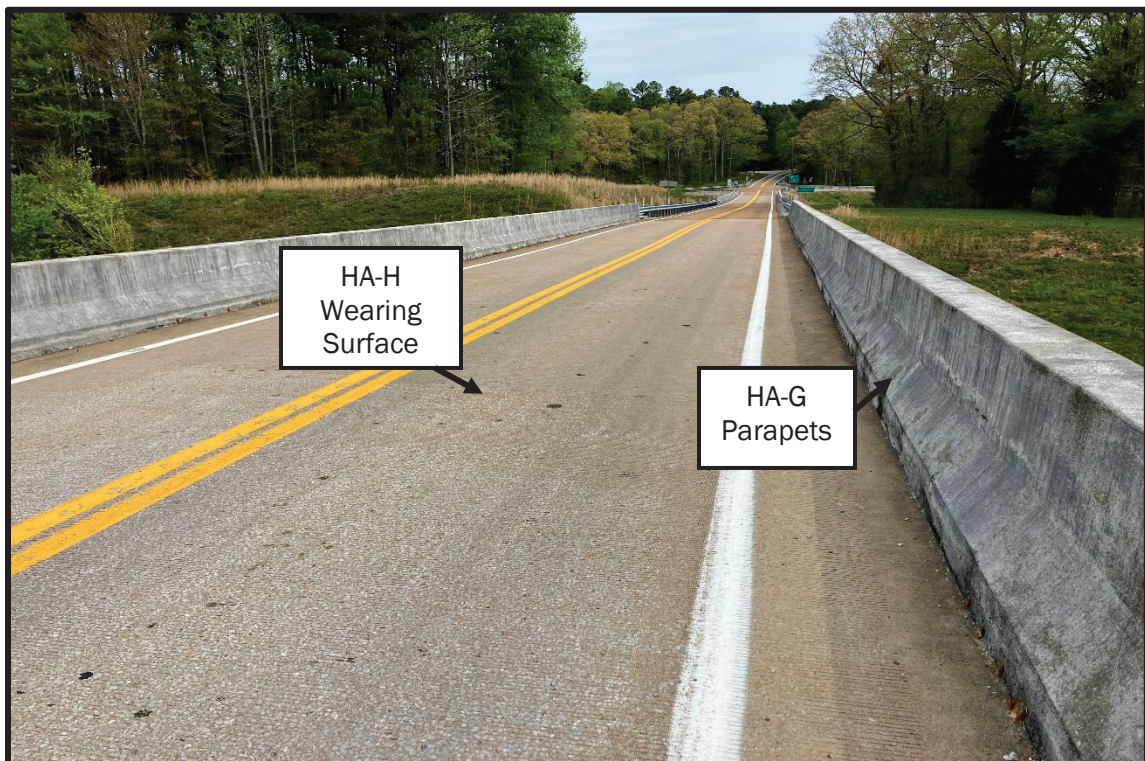
**Photo 6:** View of HA-G and HA-H from the south end of the bridge.
