## ASBESTOS INSPECTION REPORT

Bridge Number 39I00400041

SR-114 over I-40 WB

June 11, 2025

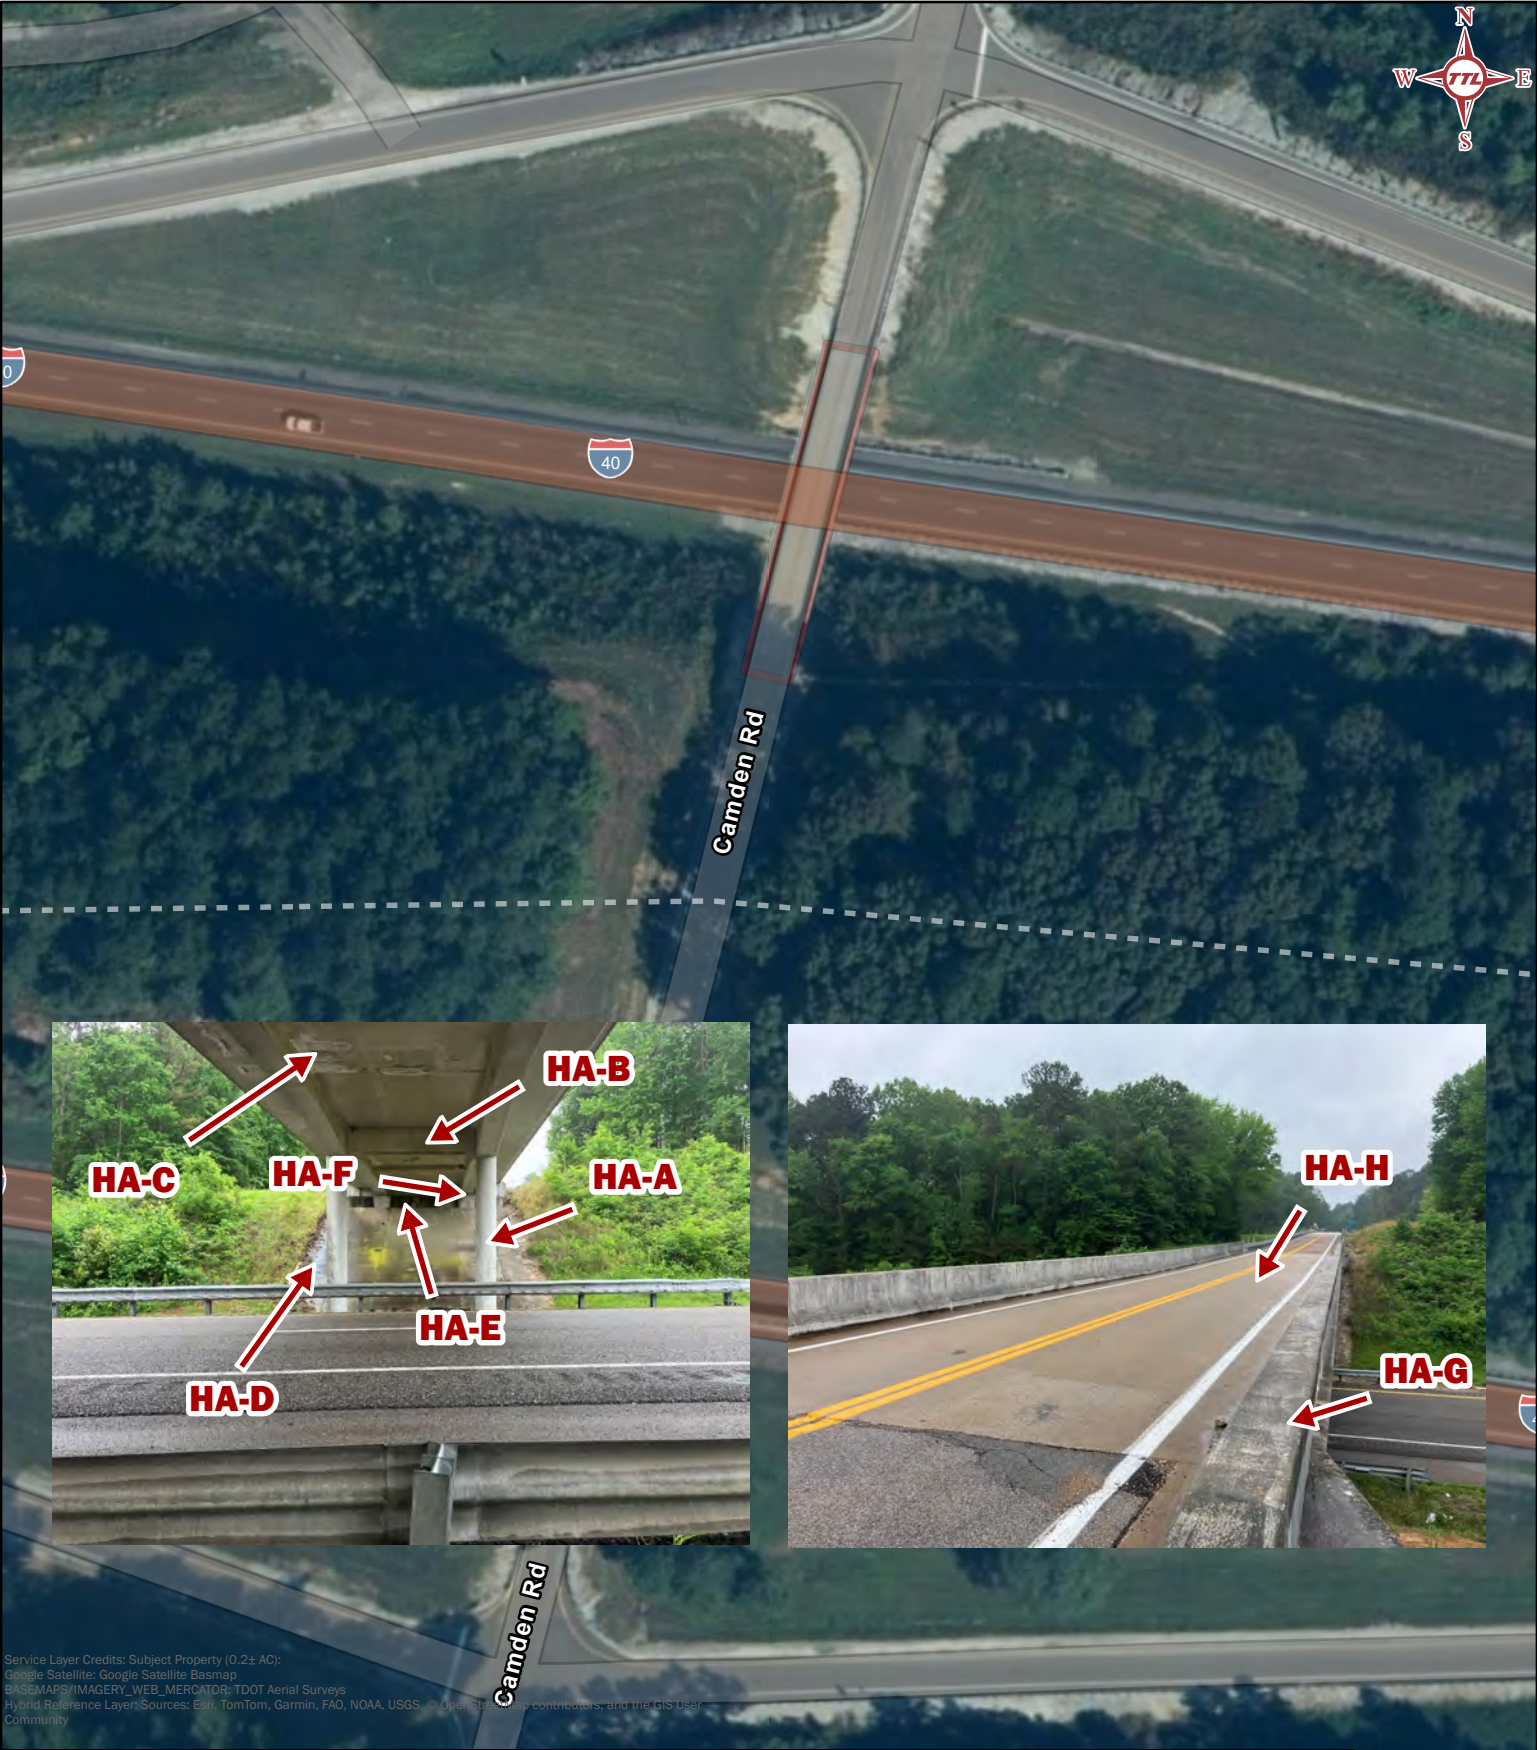
**FIGURE 2: SAMPLE LOCATION (AERIAL PHOTOGRAPH)**

Asbestos was not identified in the samples collected from the bridge. The laboratory report for the samples collected from the bridge, along with the chain-of-custody records, are included in **Appendix D**.

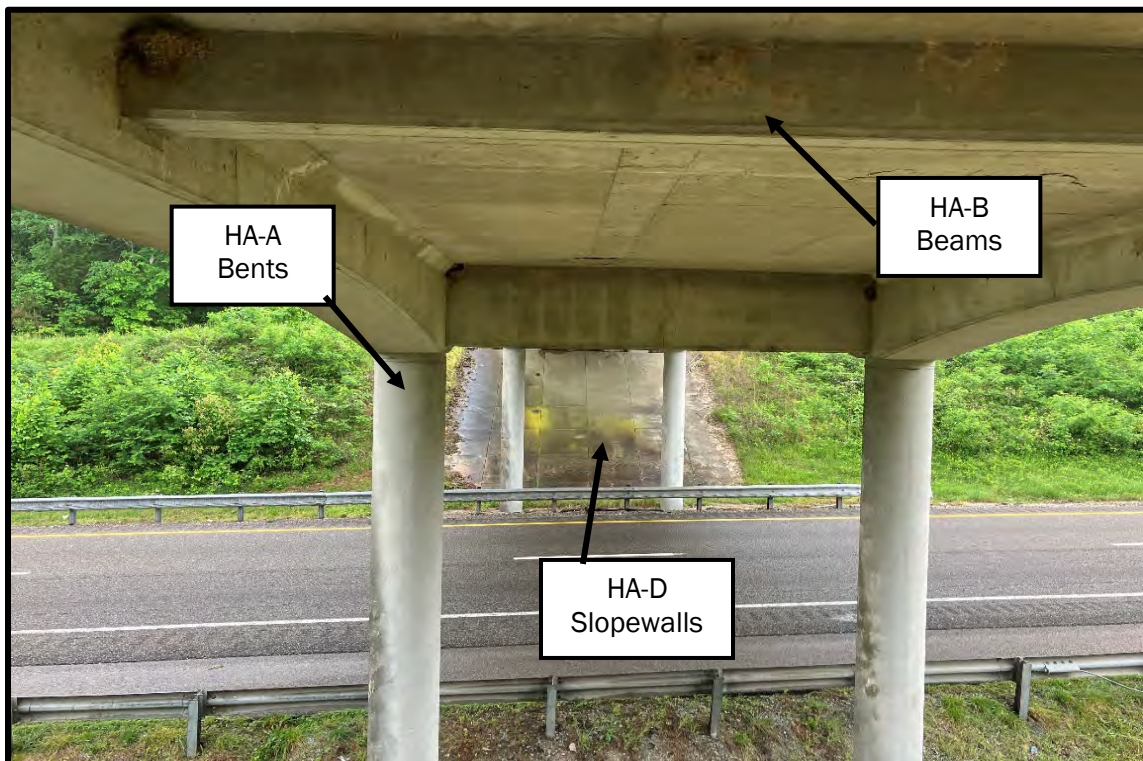
Three bulk samples of concrete were collected from the bents.

Three bulk samples of concrete were collected from the beams.

Three bulk samples of concrete were collected from the slope wall.

**Photo 2:** View of HA-A, HA-B, and HA-D from the southern end of the bridge.

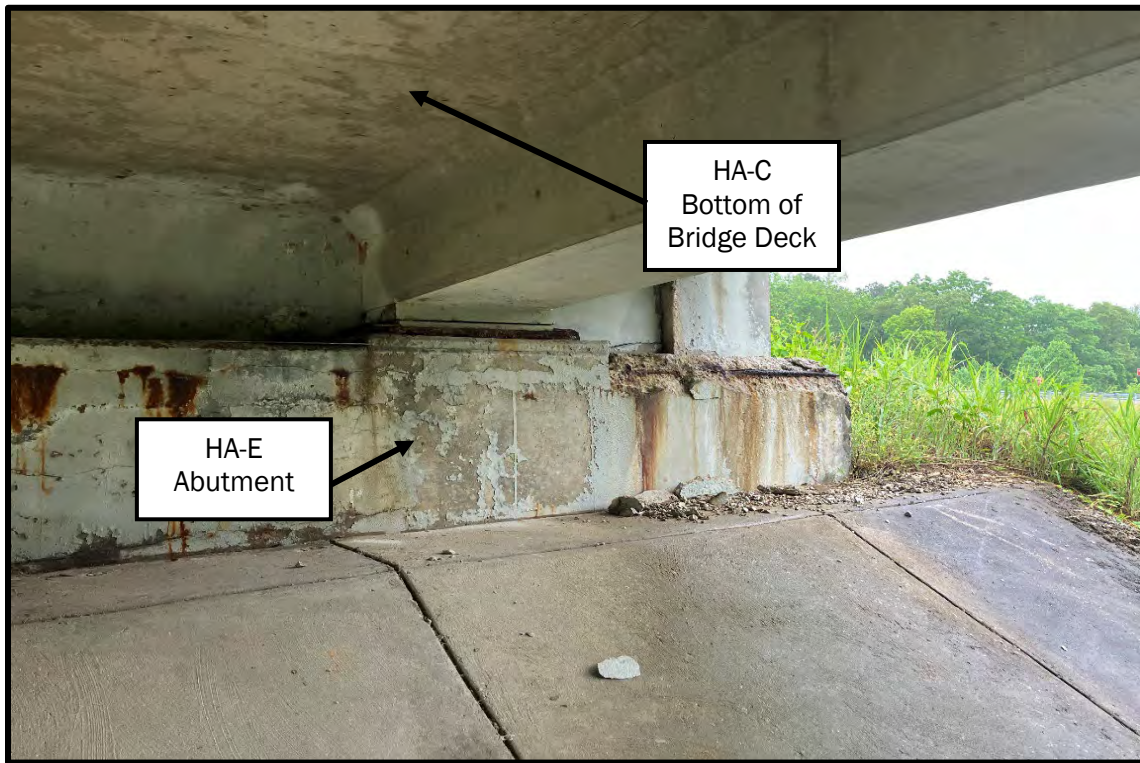
Three bulk samples of concrete were collected from the bottom of the bridge deck.

Three bulk samples of concrete were collected from the abutment.

**Photo 3:** View of HA-E and HA-C from the north end of the bridge.

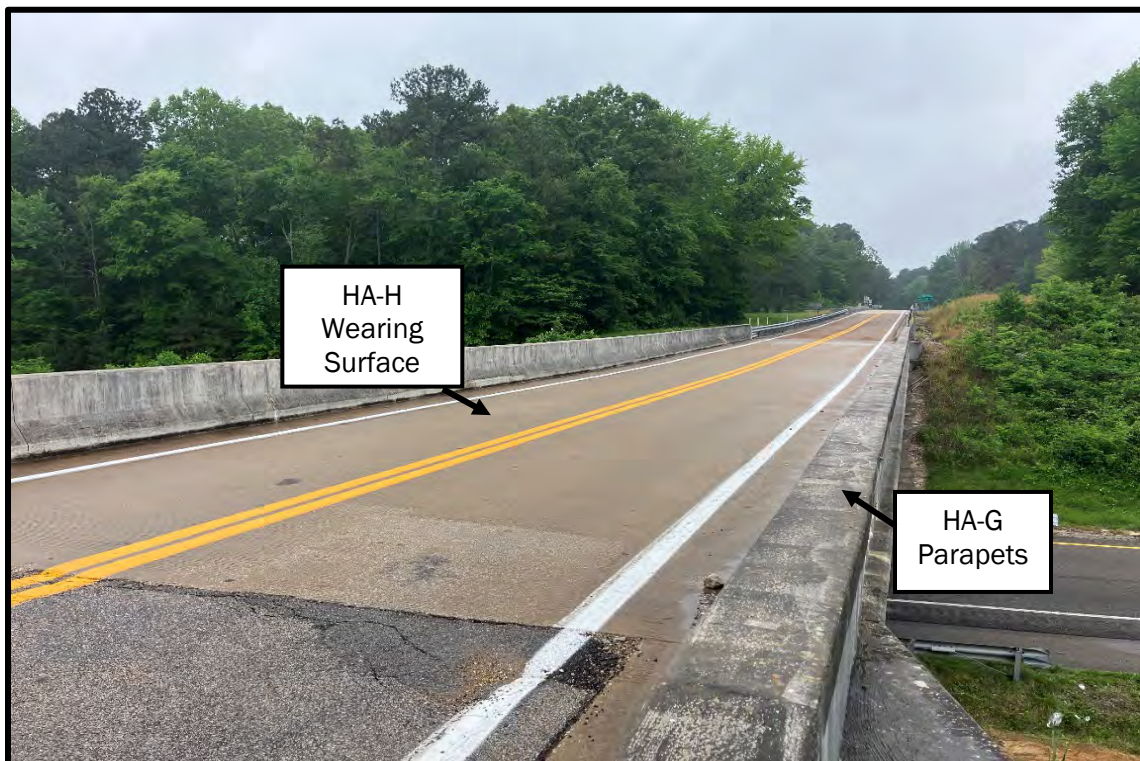
Three bulk samples of concrete were collected from the parapet.

Three bulk samples of concrete were collected from the wearing surface.

**Photo 4:** View of HA-G and HA-H from the north end of the bridge facing south.

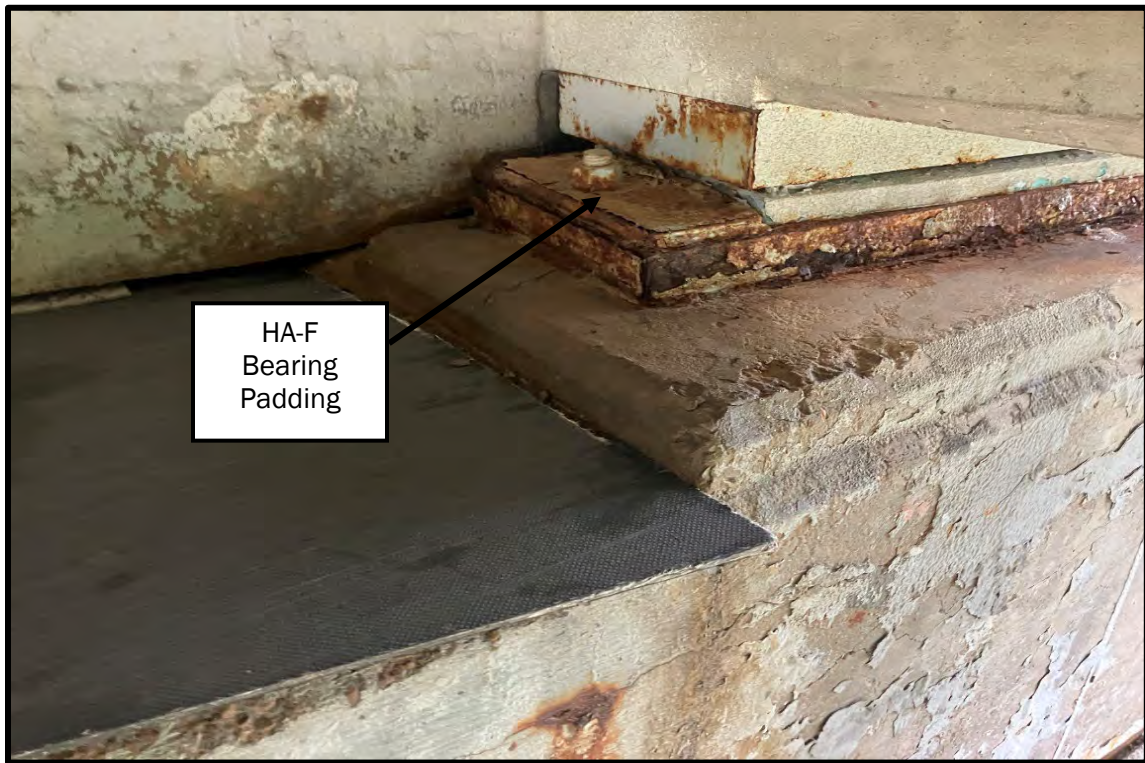
Three bulk samples of padding were collected from the bearing padding located between the beams.

**Photo 5:** View HA-F from the north end of the bridge.

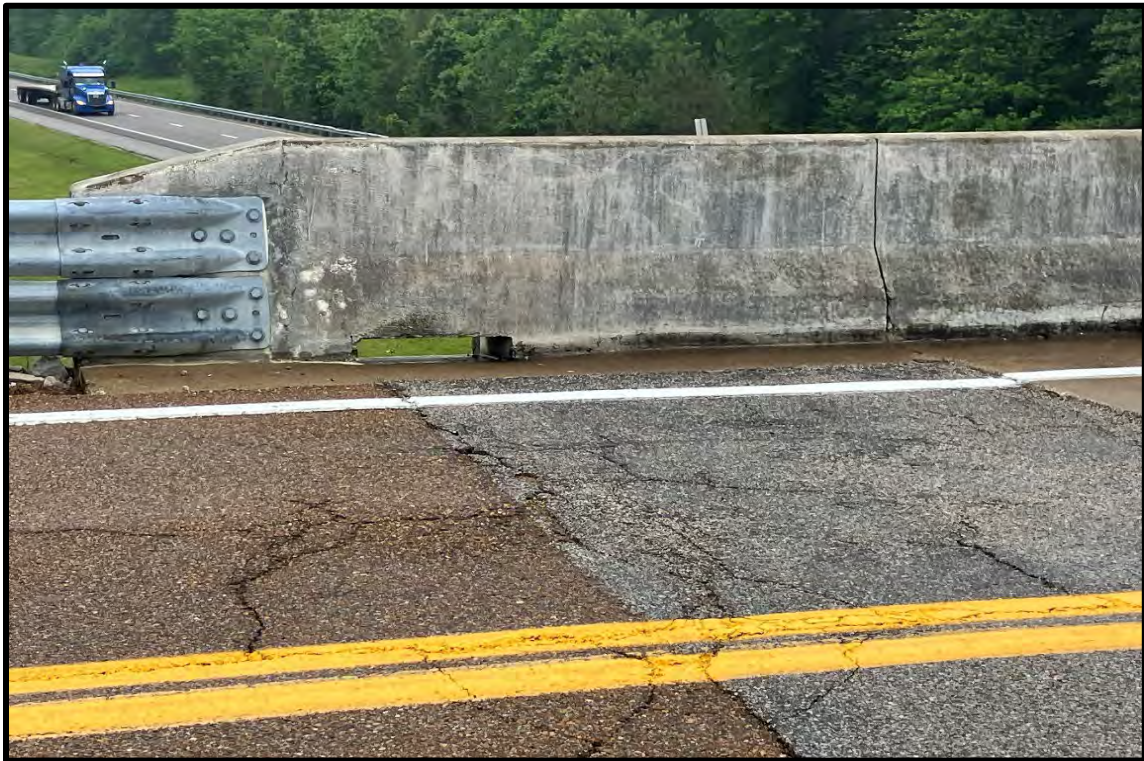
The bridge drainage system is comprised of concrete. No suspect materials related to the bridge drainage system were observed during the site visit.

**Photo 6:** View of bridge draining system from the east side of the bridge.
