# Bridge Maintenance Recommendations

Bridge Location No.: 80 - I0040 - 14.92 R

Crossing: BETTYS BEND RD (A138)\*

Inspection Date: 4/25/2003

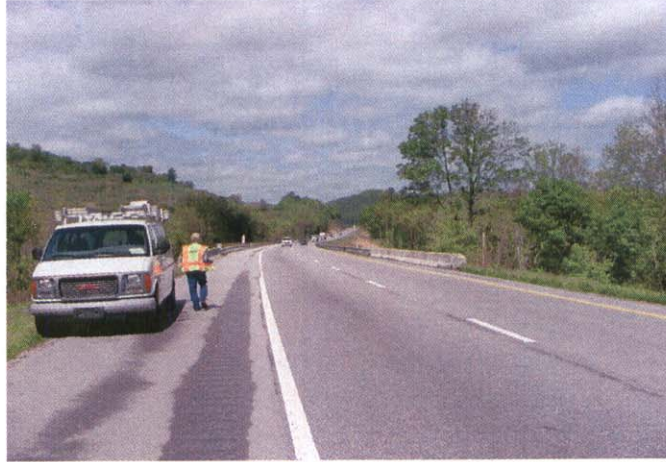
PIC1

VIEW ACROSS DECK FROM B-APPR

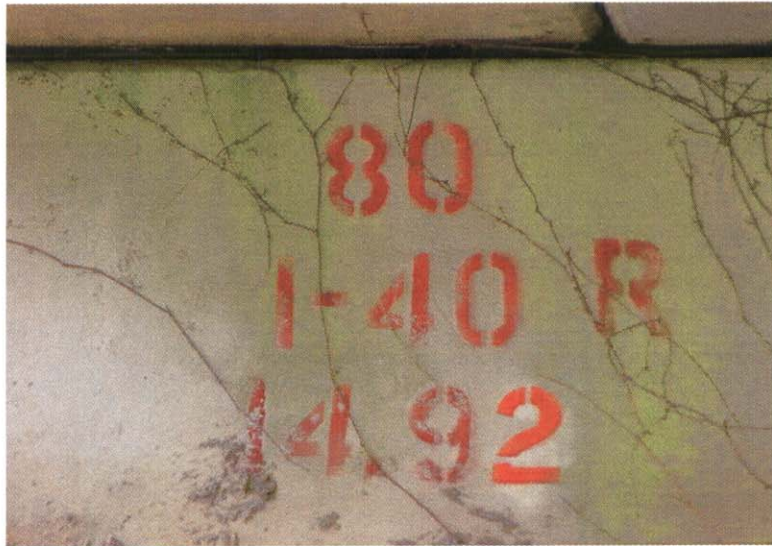
PIC2

BRIDGE NO. AT ABUTMENT # 1

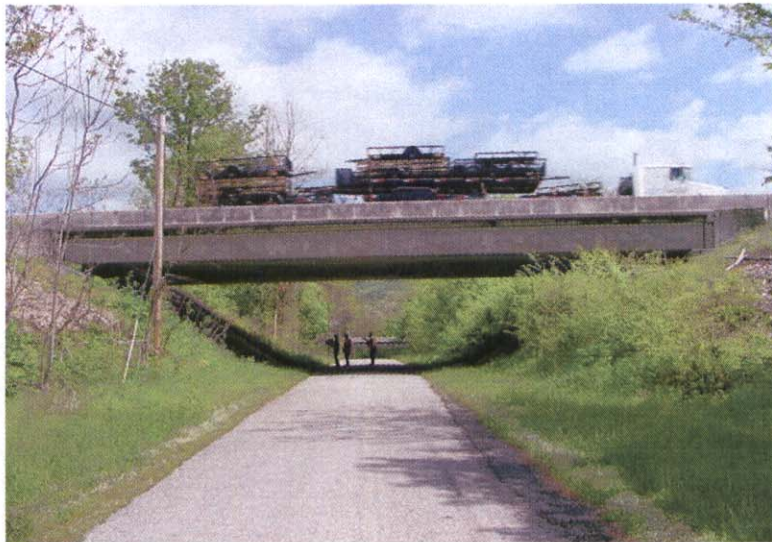
PIC3

RIGHT SIDE VIEW

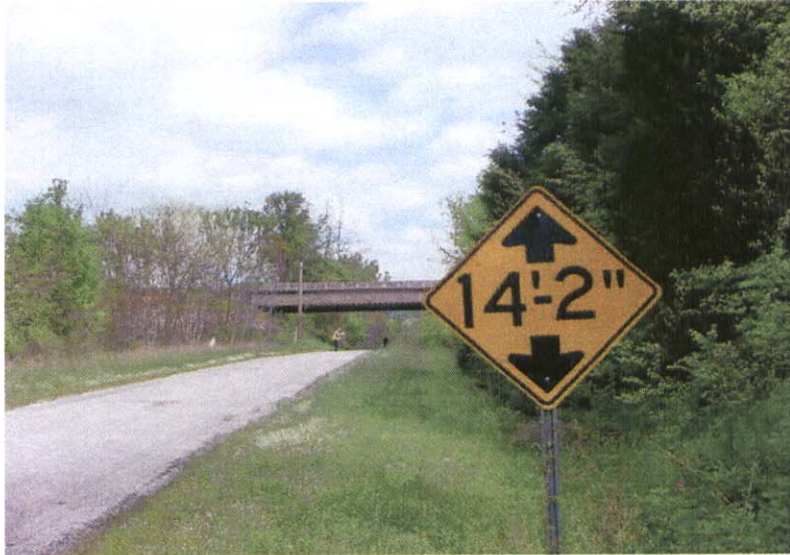
PIC4

CLEARANCE SIGN (14'2" @ R.S. APPR

This bridge was inspected and found to be in **good** condition. The approaches are good. The vertical clearance is posted for 14' 2" The parapet and approach rail are standard type and in good condition. The parapet on left side 'A' has collision damage and has a 1/2" separation crack. There are no paddleboards.

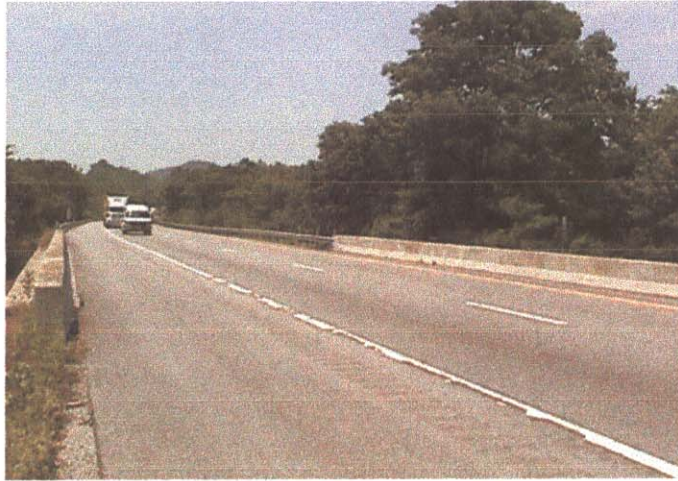
PIC1

VIEW ACROSS DECK

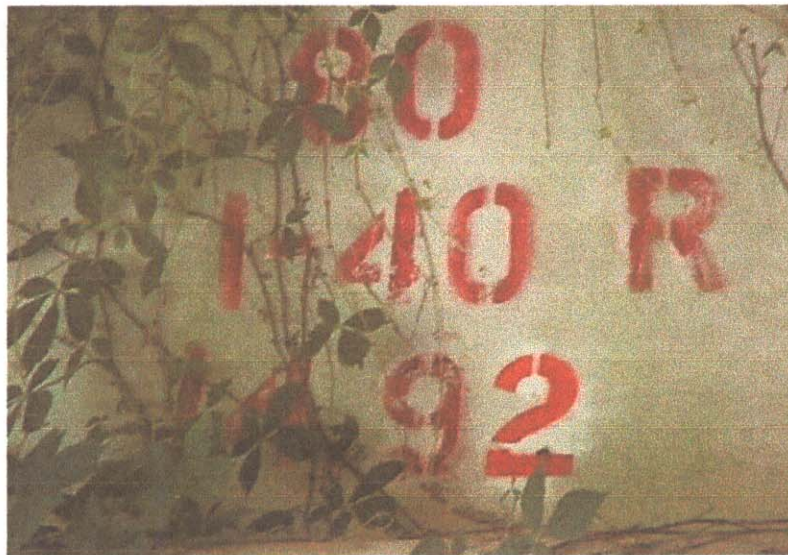
PIC2

BRIDGE NO. AT ABUTMENT # 1

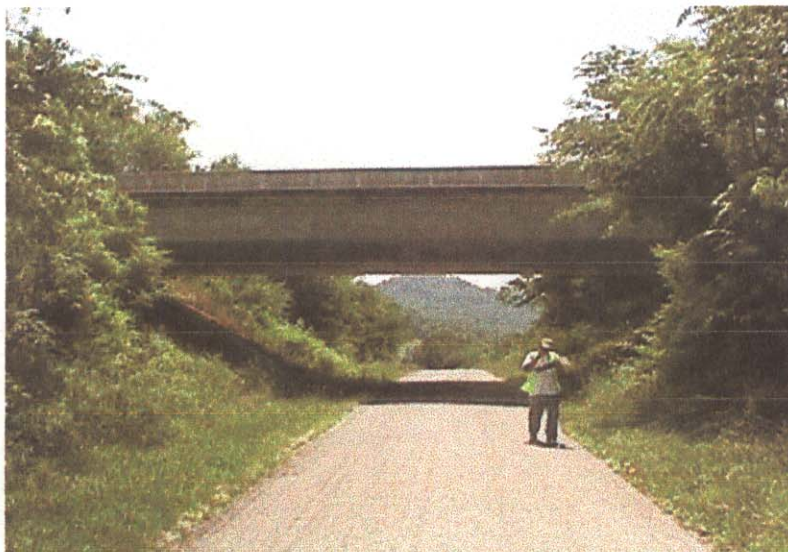
PIC3

LEFT SIDE VIEW

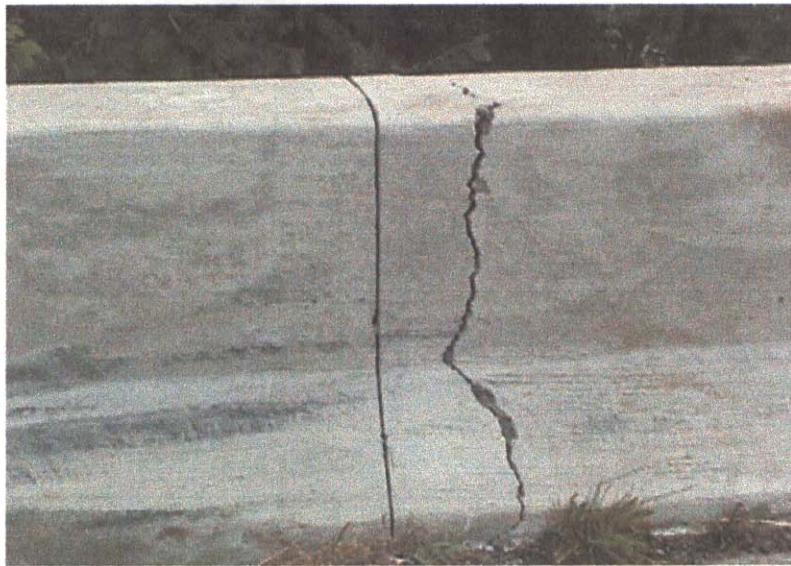
PIC4

DAMAGED (CRACK) APPROACH 'A' LEFT SIDE PARAPET

| PARAPET | G | (F) | P | C | col damage 1/2" open sep crack Lt. side. A' exc |

This bridge was inspected and found to be in good condition. The approaches have settled 1" - 2" at the ends of the bridge. The parapet and approach rail are standard type and in good condition. The parapet on left side 'A' has collision damage and has a  $\frac{1}{2}$ " separation crack. There are no paddleboards.

REPAIR COLLISION DAMAGE LEFT SIDE 'A' END.

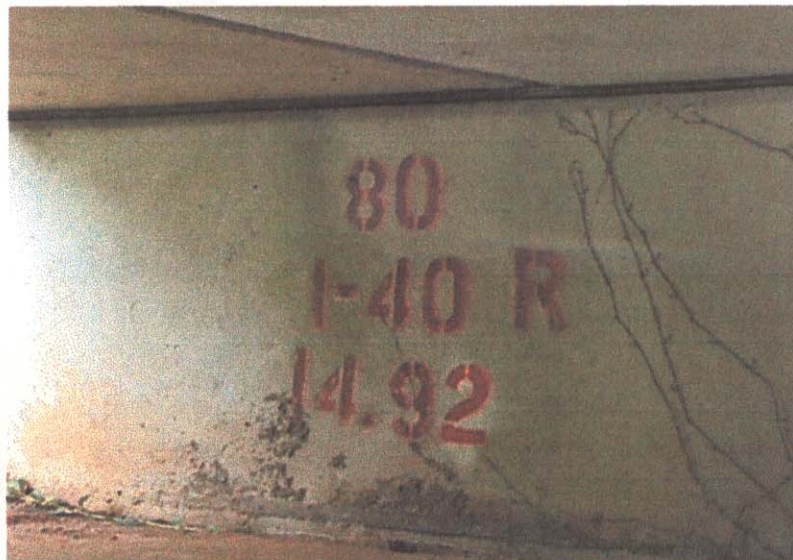
PIC5

BRIDGE NO. AT ABUTMENT # 1

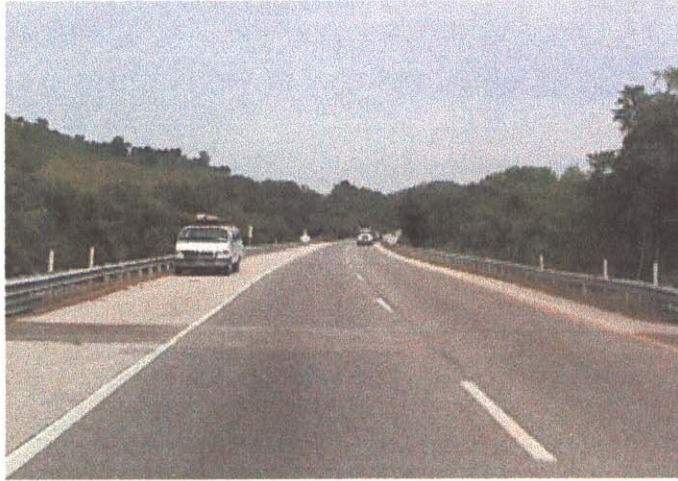
PIC1

APPROACH #1

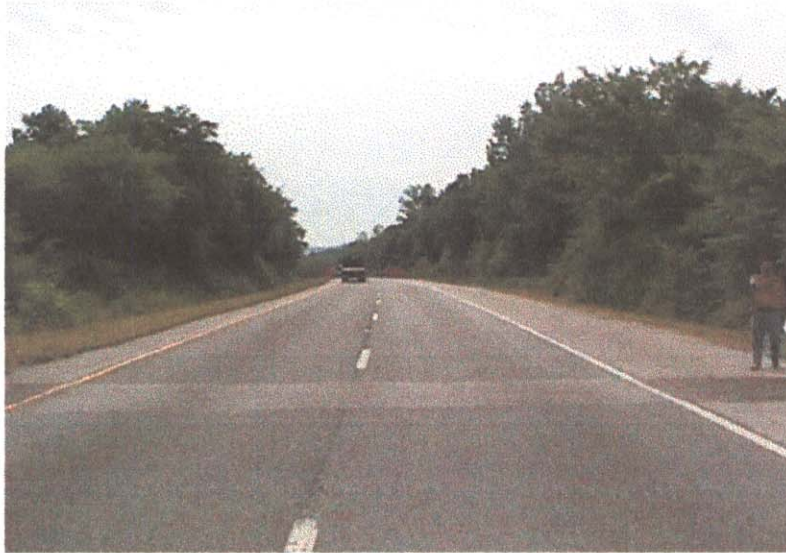
PIC2

APPROACH #2

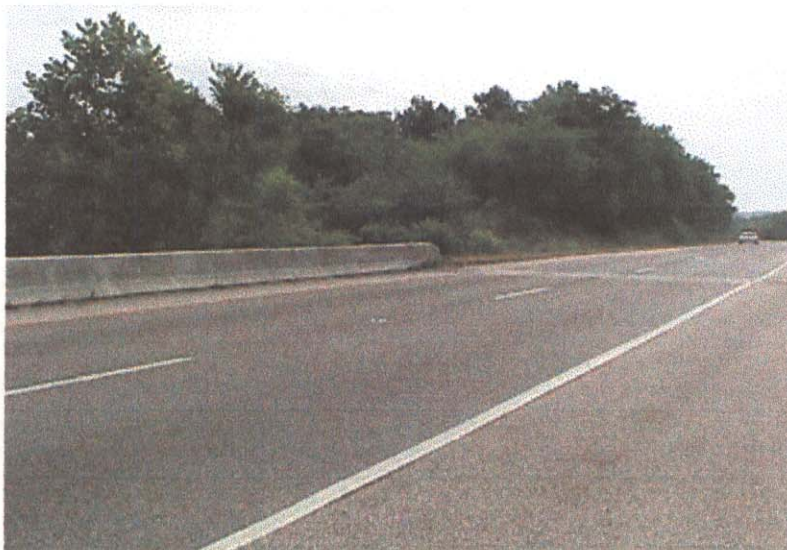
PIC3

ACROSS TOP OF DECK

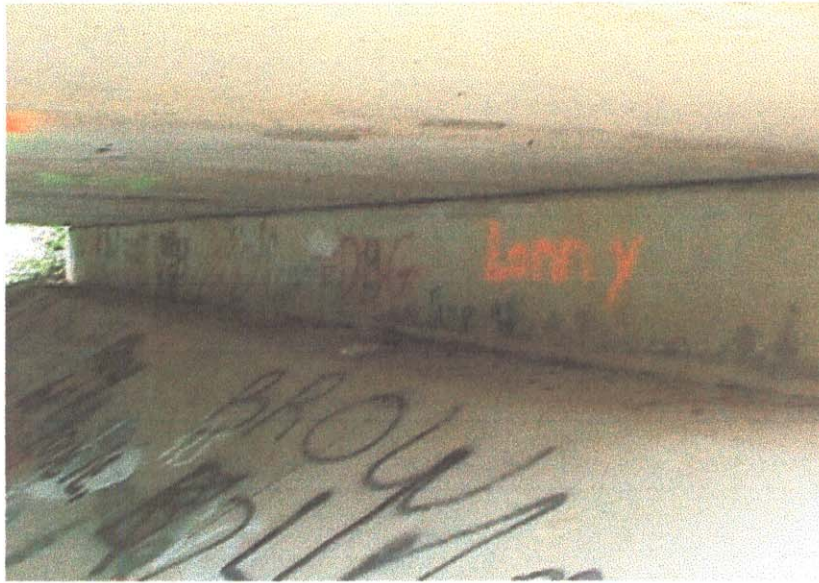
PIC6

ABUTMENT TYPICAL

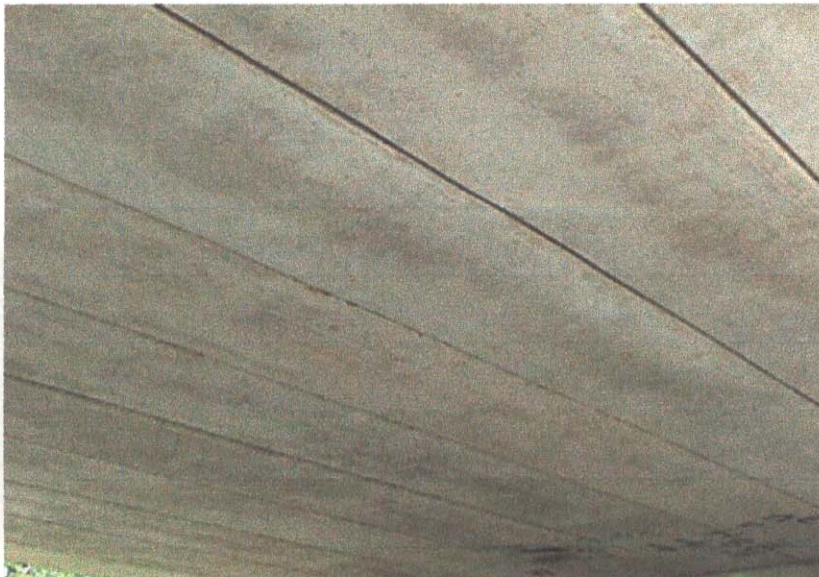
PIC7

BOTTOM OF DECK

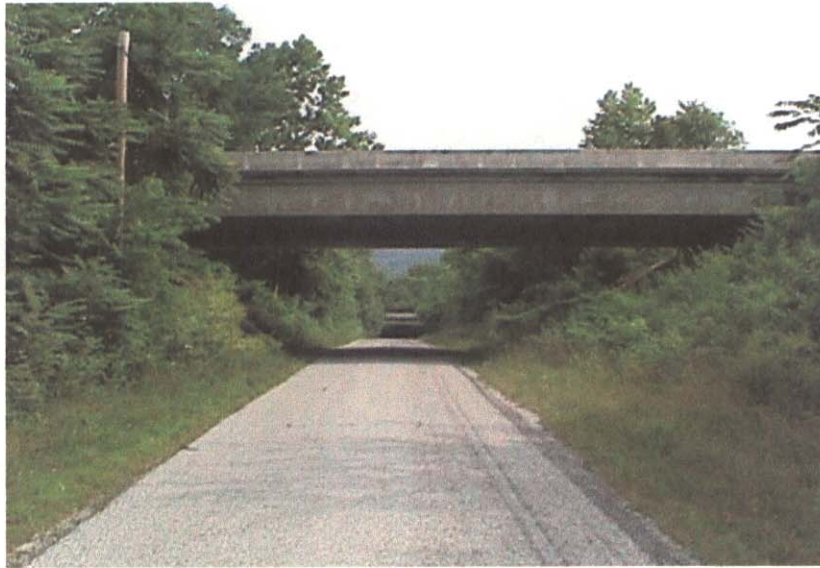
PIC8

RIGHT SIDE ELEVATION

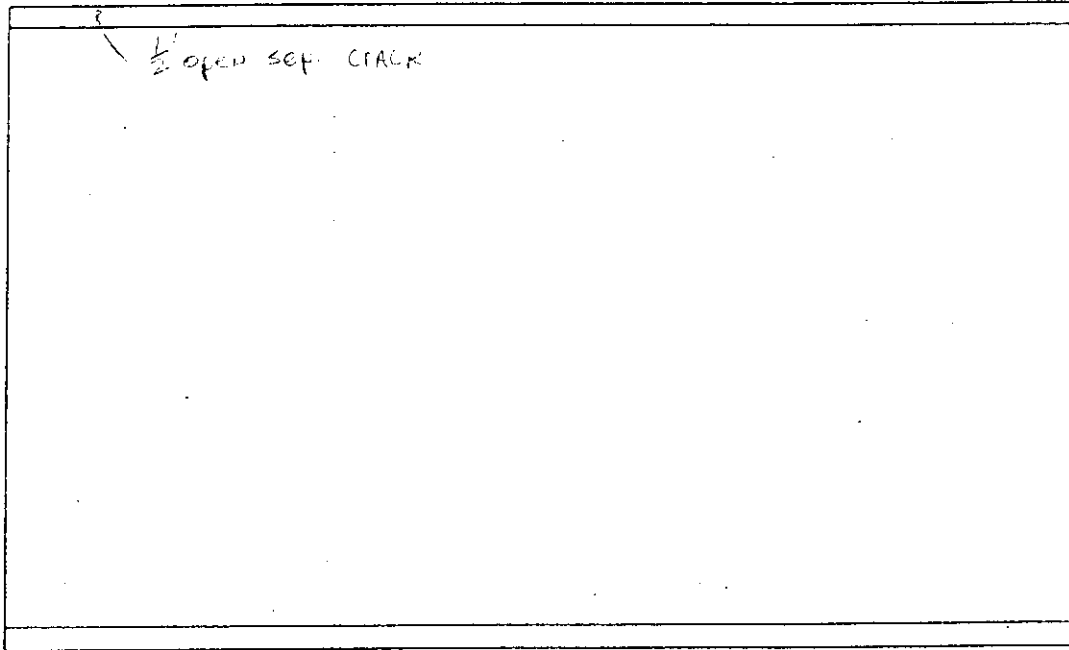
TOP SLAB #

| Parapet | F | Rel drainage LT side parapet wall 1/2" open sep crack |
