Region 04, 57 - Madison County

LOWER BROWNSVILLE RD. Crossing I40

Inspection Date(s): 04/09/2025 - 04/09/2025

Structure 57I00400011 is in poor condition with the substructure being the limiting component. The structure consists of a simply supported, four span, multi-beam superstructure consisting of a cross section containing five prestressed concrete I-Beams of varying depths.

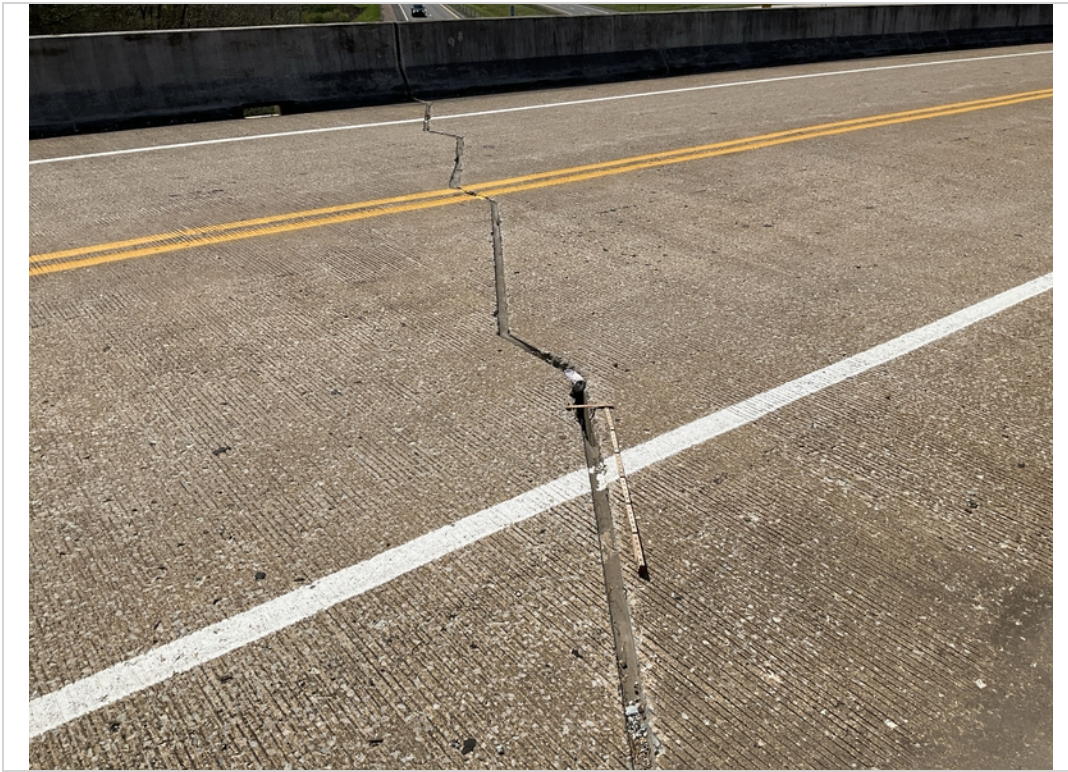
Joint over Bent 1 with sections of failed poured sealant allowing water to drain directly onto beam ends and substructure

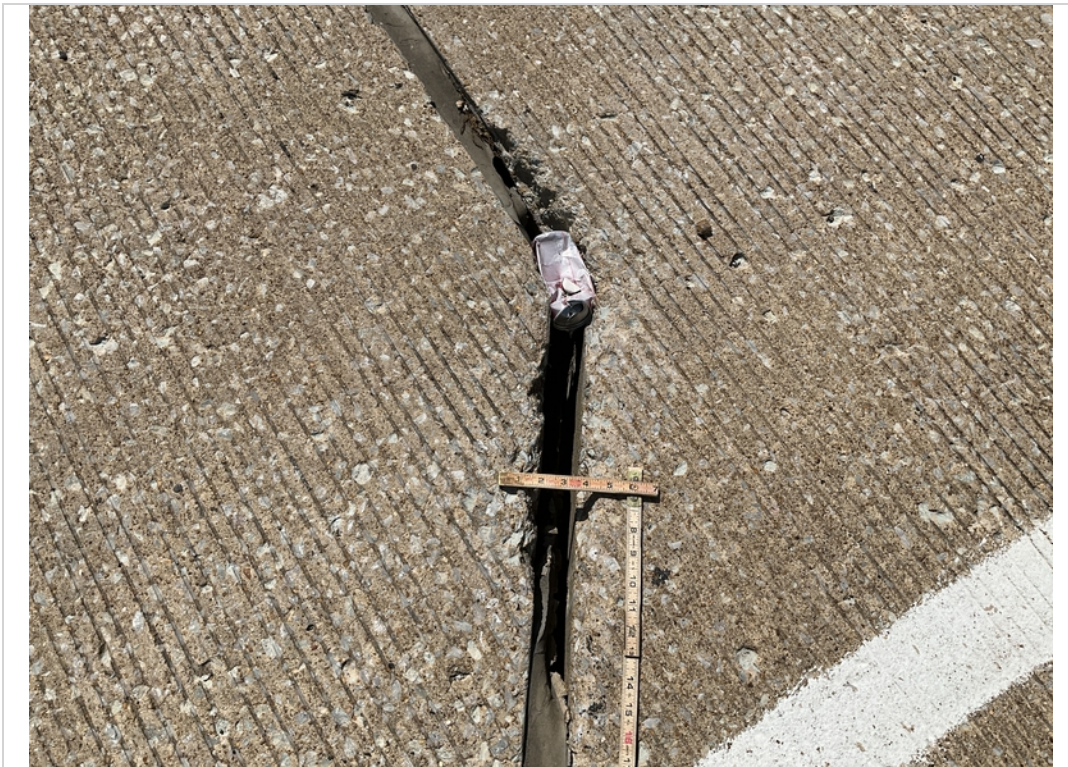
Joint over Bent 1 with sections of failed poured sealant allowing water to drain directly onto beam ends and substructure

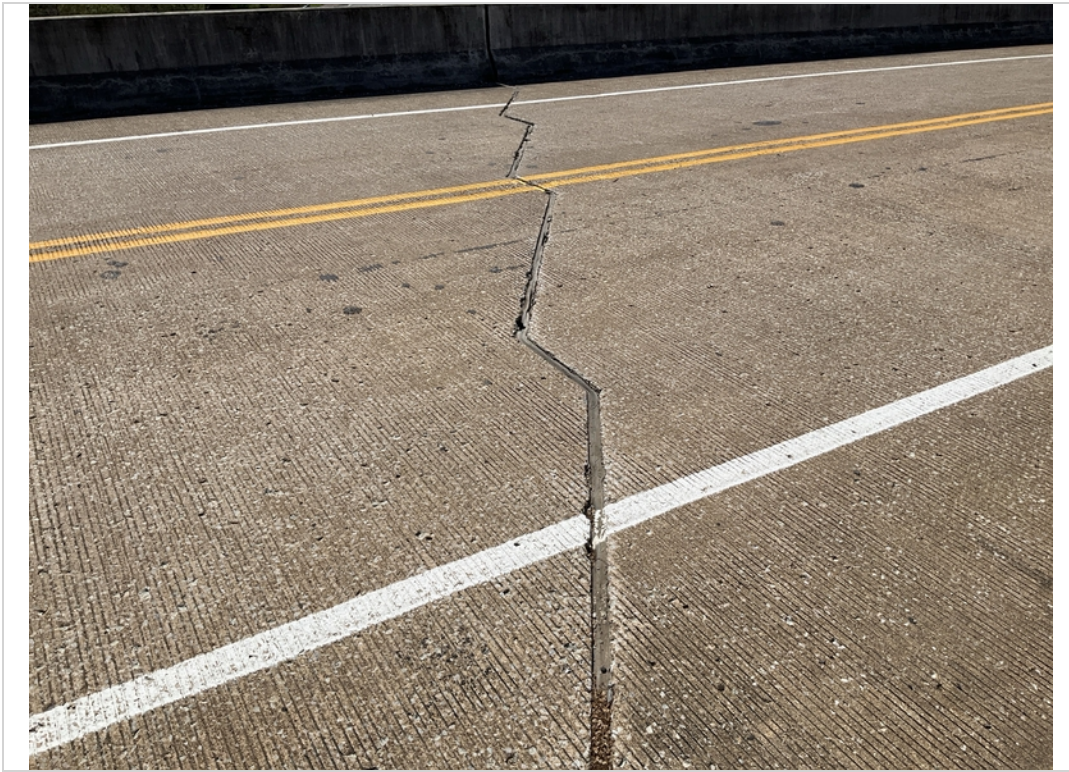
Joint over Bent 2 with failed sections of poured sealant allowing water to drain onto superstructure and substructure

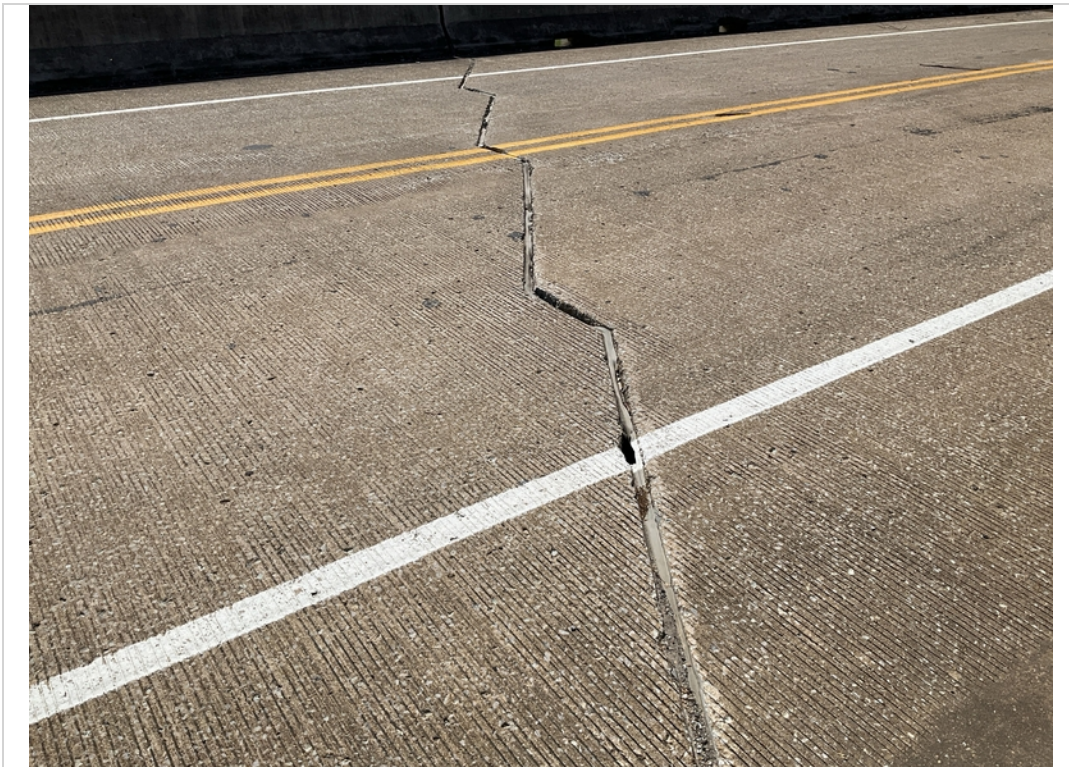
Joint over Bent 3 with failed sections of poured sealant allowing water to drain into the superstructure and substructure

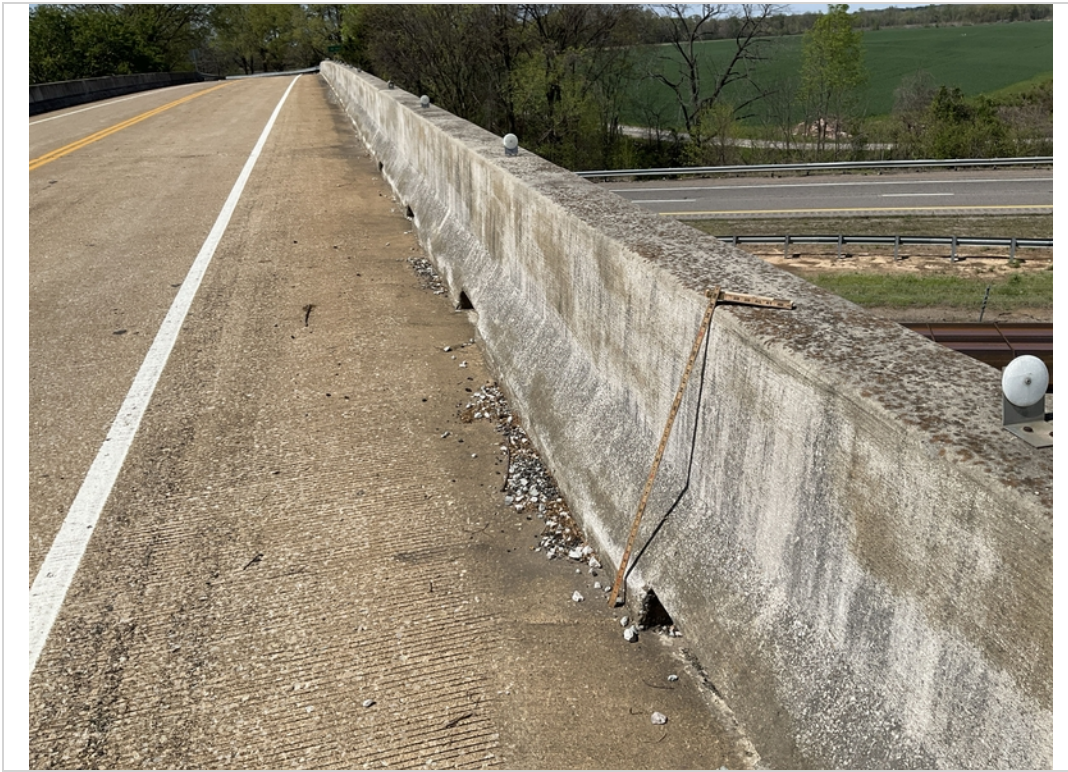
Span 1, right bridge rail, concrete safety shape. Spans 1 and 4 have drains through barrier bases

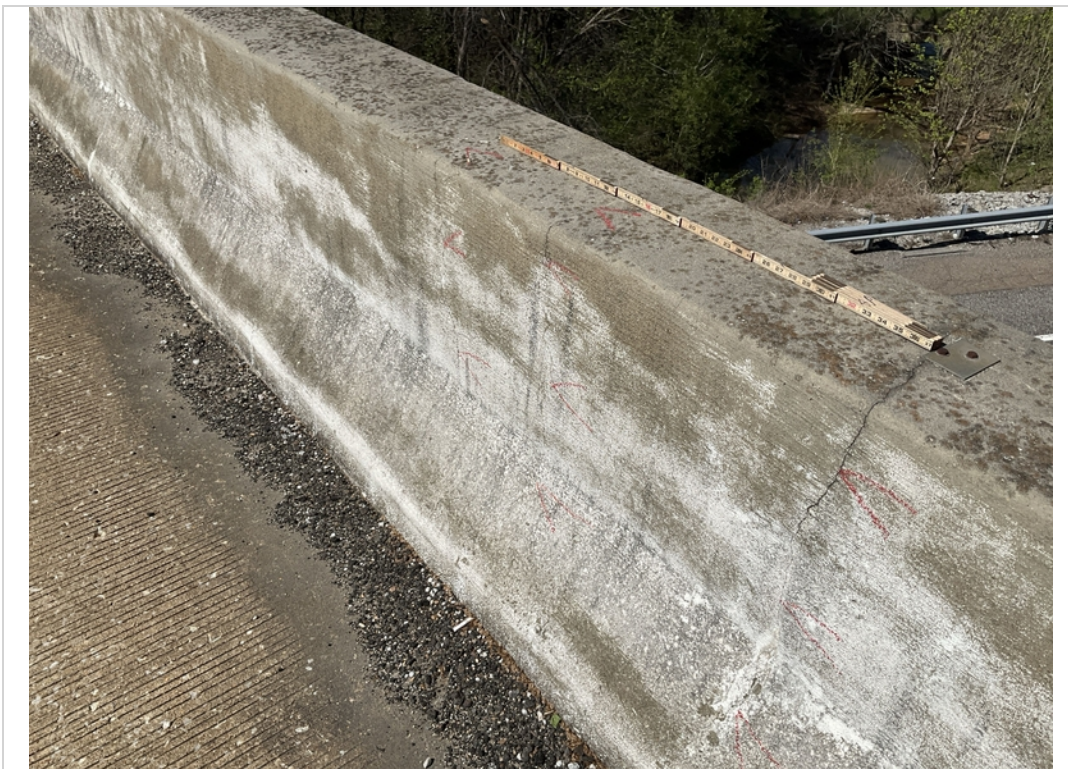
Right rail, span 3, vertical cracks (1/32" x full height), typical throughout all spans

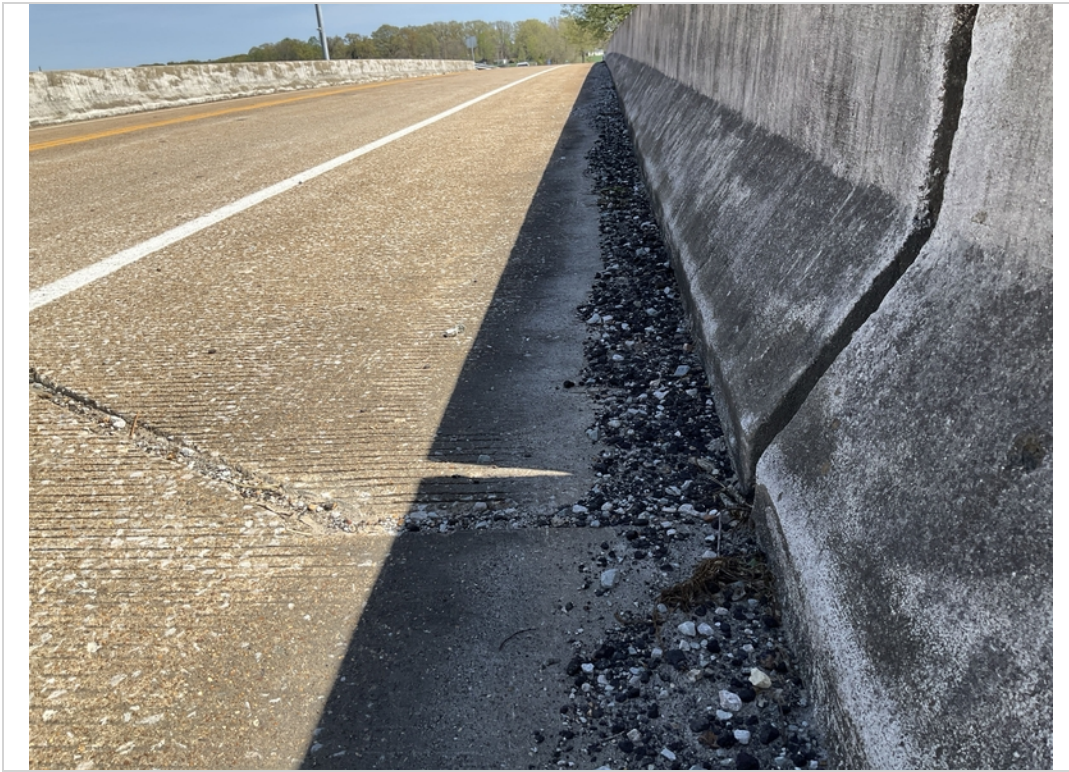
Left gutter line with minor debris

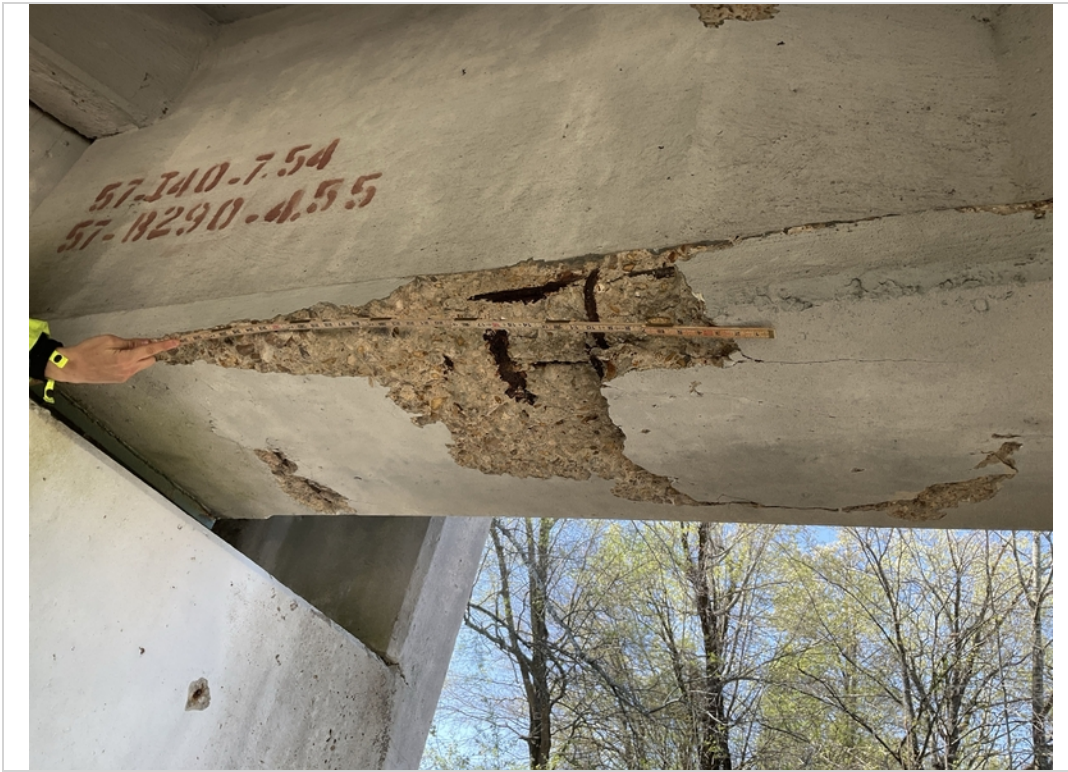
Span 1, Beam A, Abutment 1, isolated major spalling with exposing (2) P/S strands and (3) stirrups. There is longitudinal cracking along the bottom flange and delaminated areas in the beam underside and left bottom flange vertical face. Exposed P/S strand and stirrups exhibit active corrosion with minor section loss.

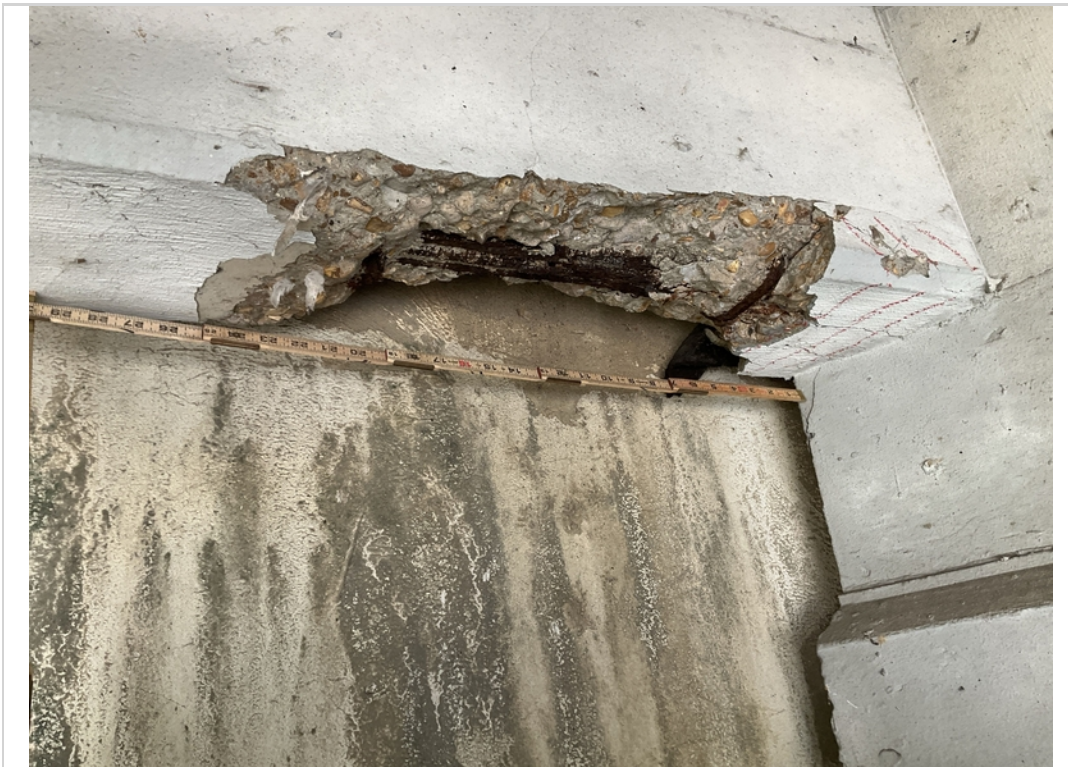
Span 1, End diaphragm Bay B at Beam B right side, Abutment 1, spall (26" x full width x 3" deep) with exposed corroded rebar.

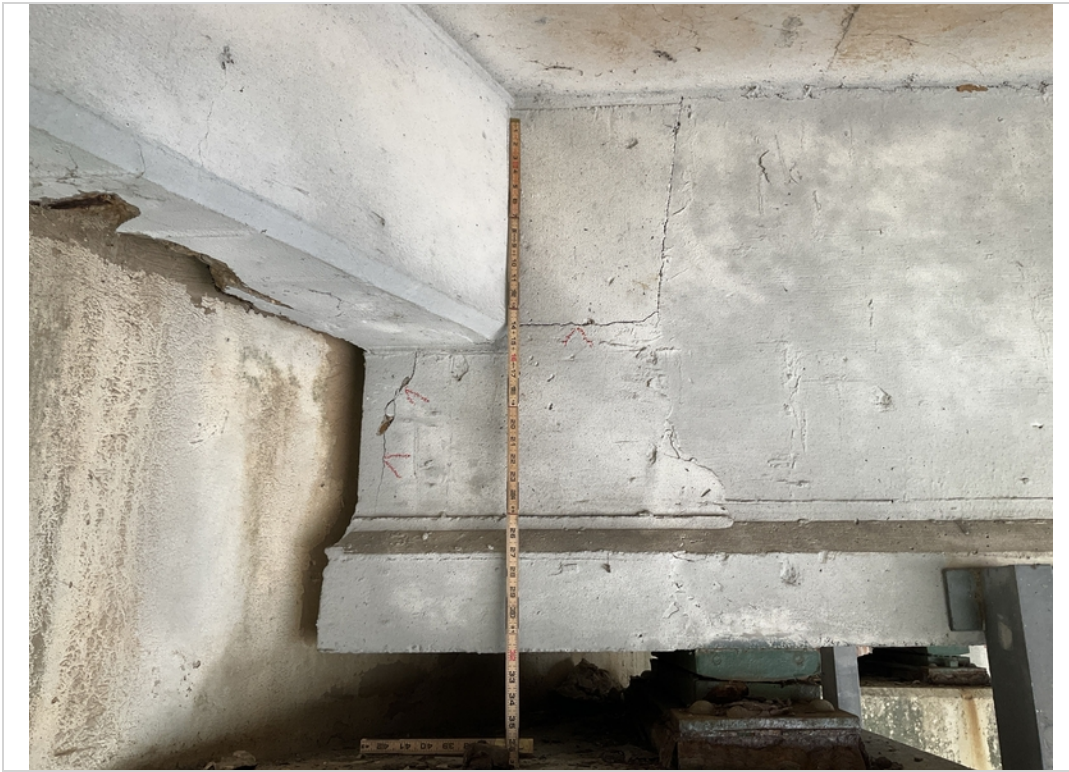
Span 1, Beam C, right side, abutment 1, minor beam end cracks with sound concrete adjacent to the end diaphragm

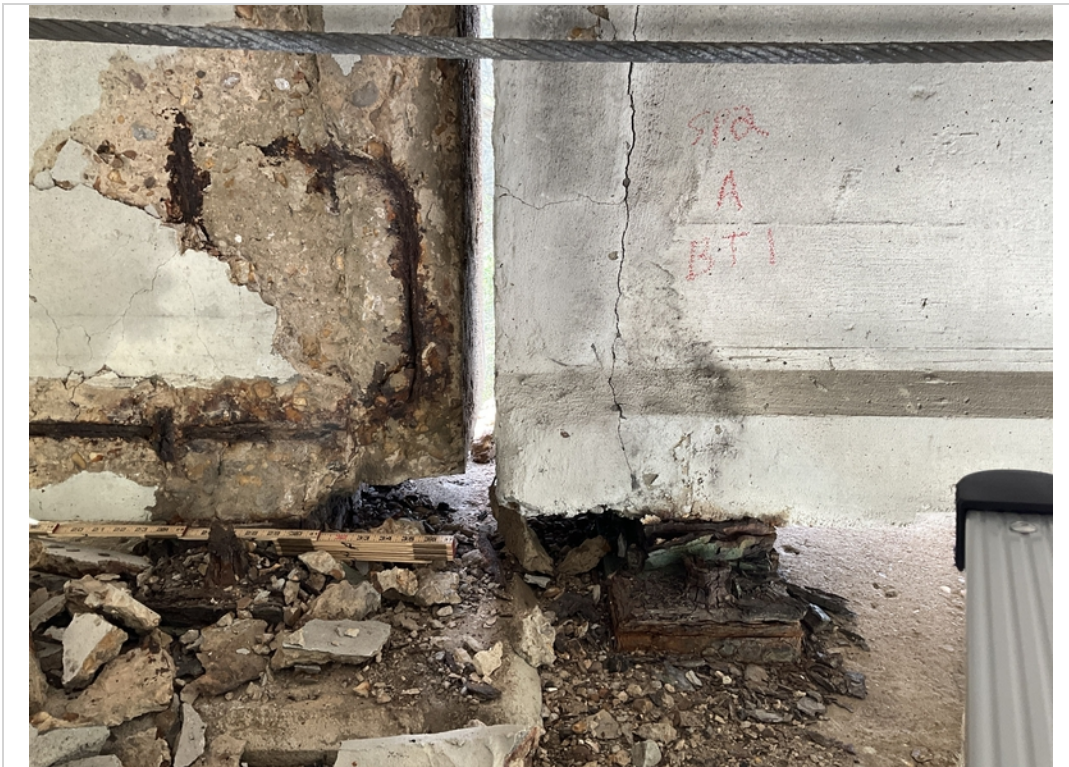
Beam A, spans 1 and 2 over bent 1, typical beam end cracking and spalling. Note corroded condition of the bearings.

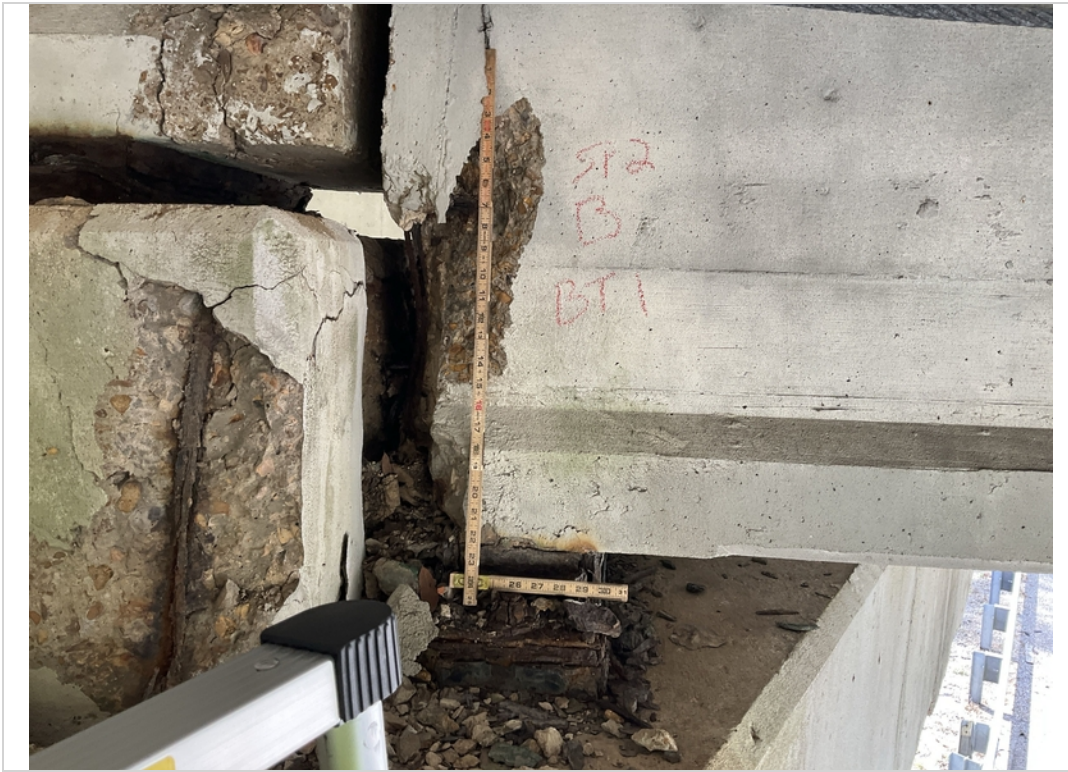
Beam B, Span 2, Bent 1, beam end spalls past bearing exposing stirrups and ends of P/S strands.  
Spalling with exposed and corroded rebar at the span 1 girder pedestal (left side of photo).

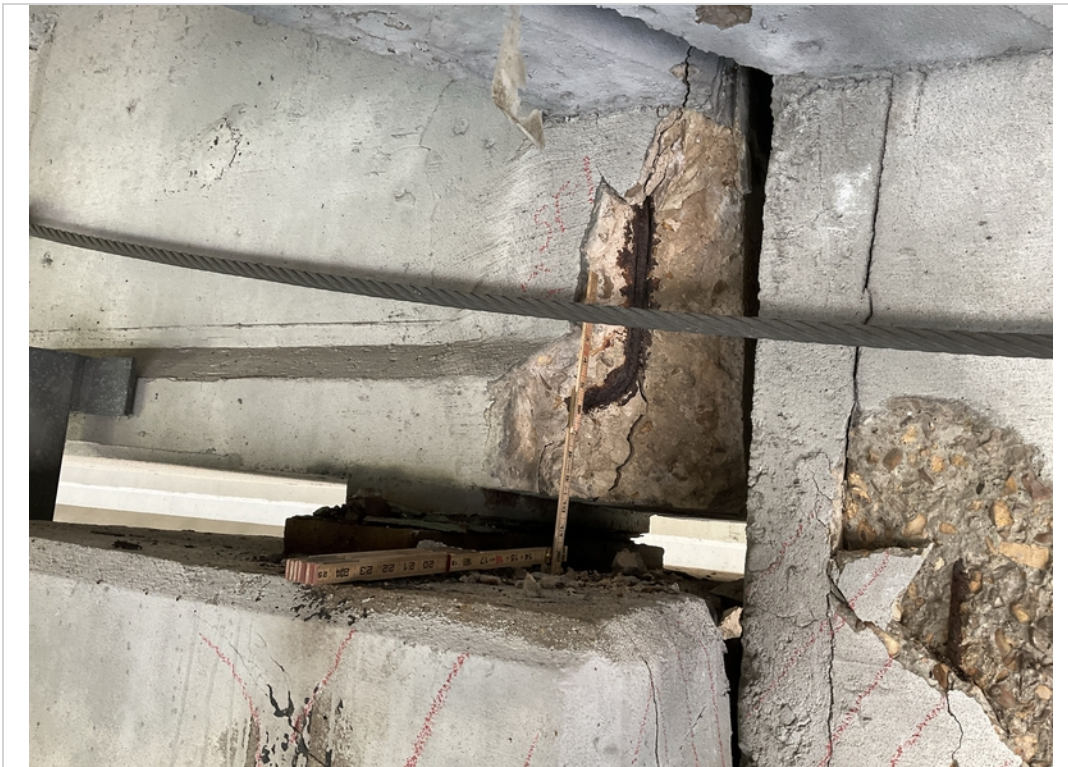
Beam C, Span 1, Bent 1, beam end spalls with exposed rebar and open cracking.

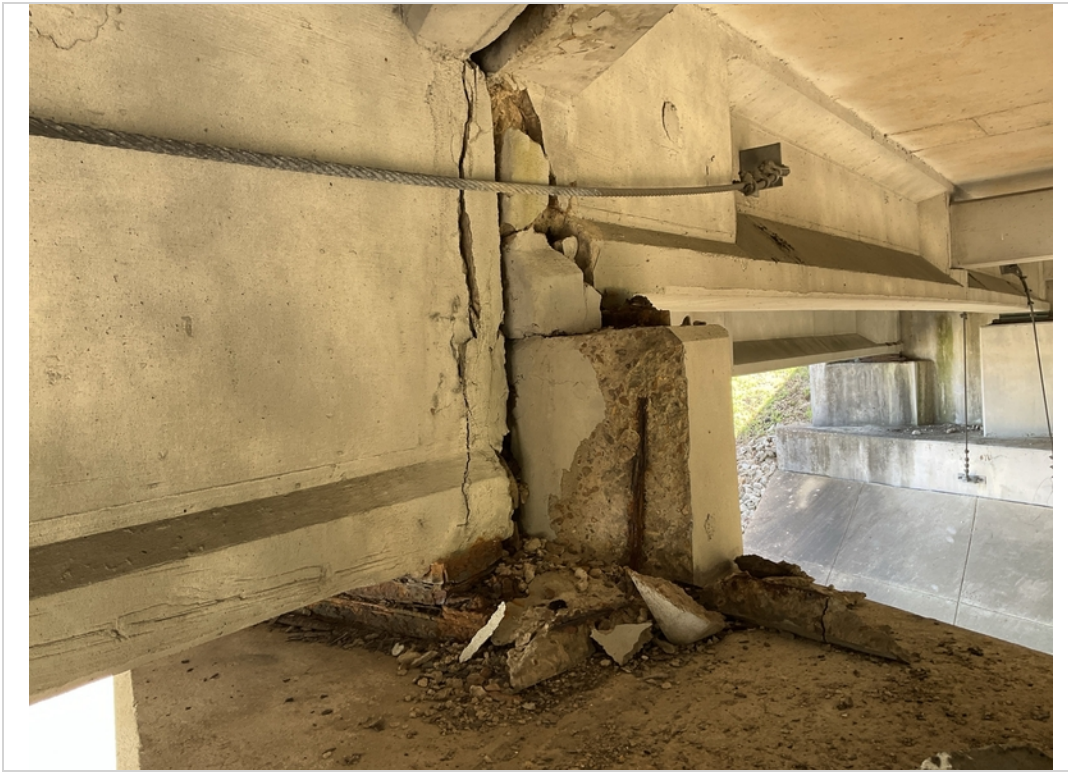
Beam D, Bent 1, spans 1 and 2, beam end delaminated areas and spalls. Pedestal spall with exposed corroded rebar.

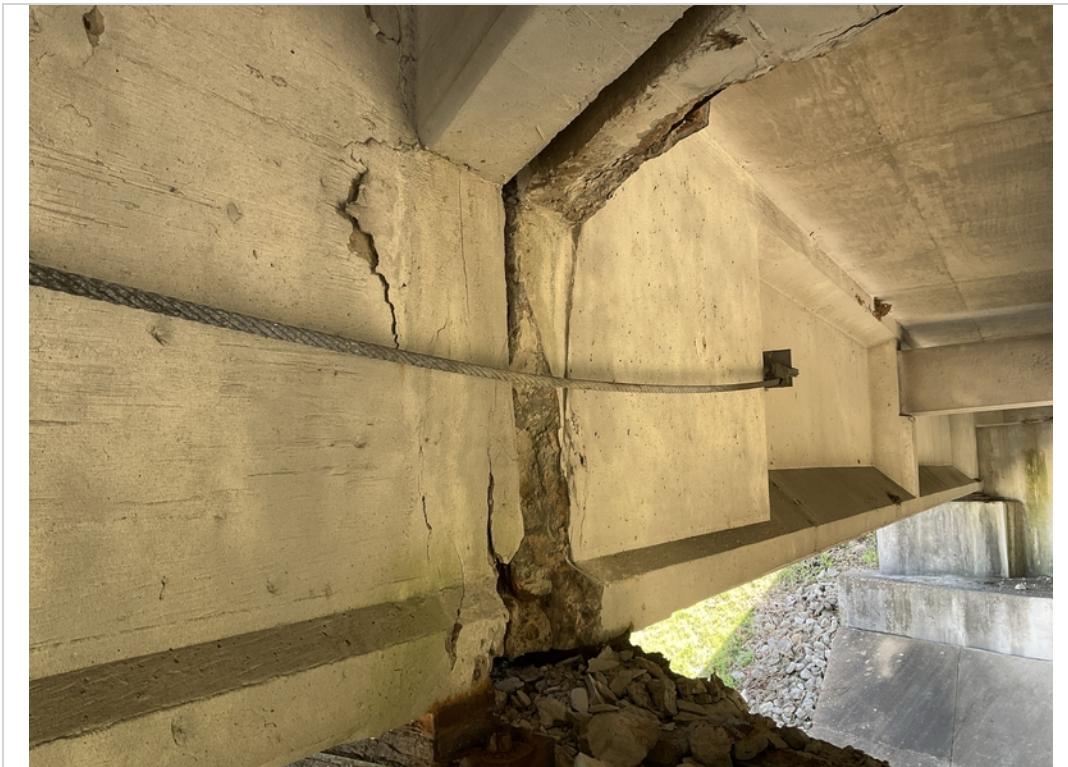
Beam E, Span 2 and 1 over Bent 1, typical beam end delamination and spalls.

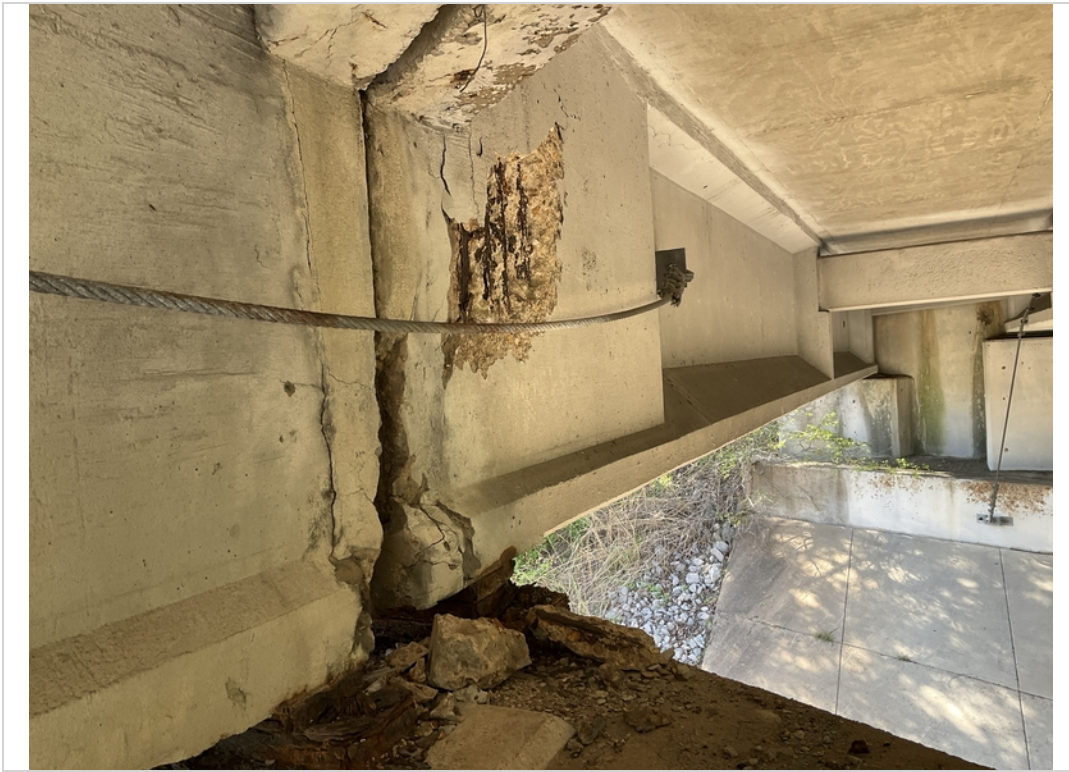
Beam A, over Bent 3, heavy spalling to web

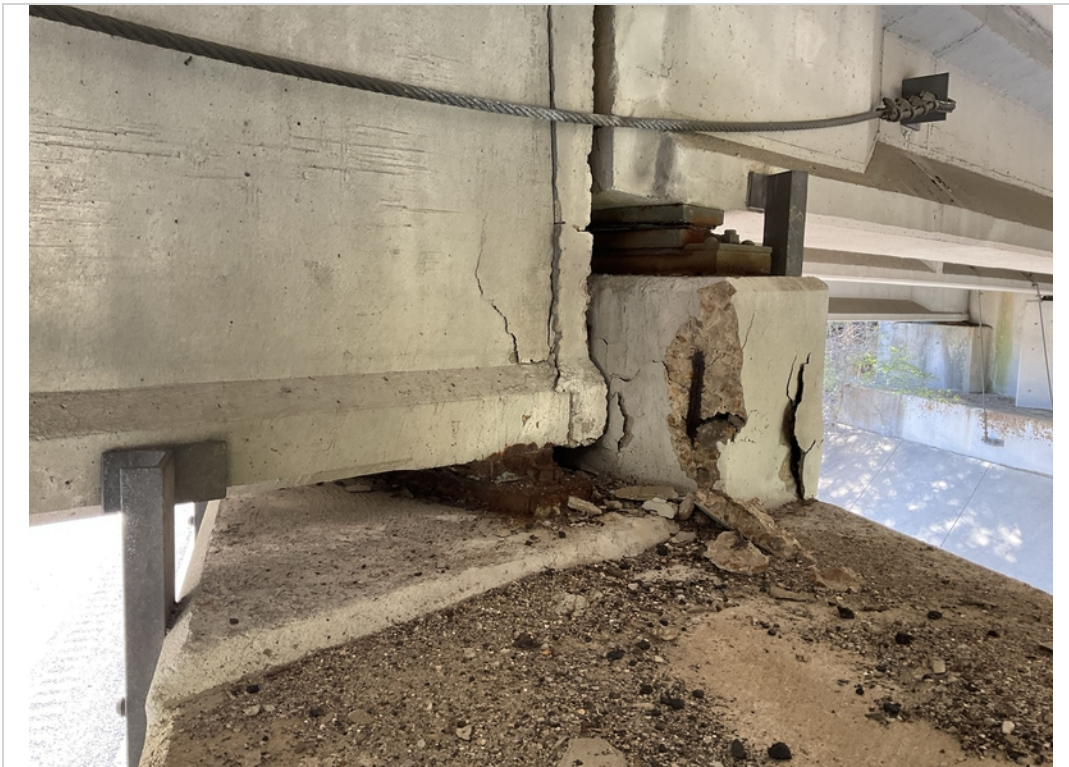
Beam C left face, Span 3 and 4 over Bent 3, spalling to the pedestal. Delaminated beam ends

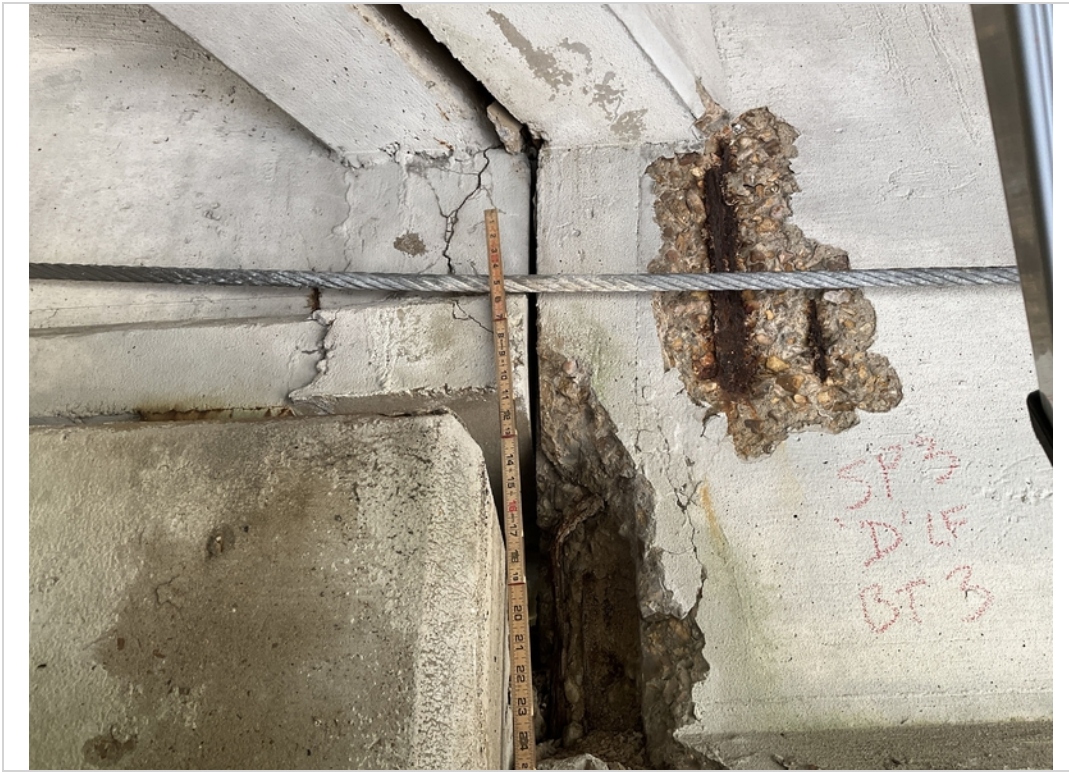
Beam D, Span 3, Bent 3, spalled beam end with exposed strand ends (right side of photo)

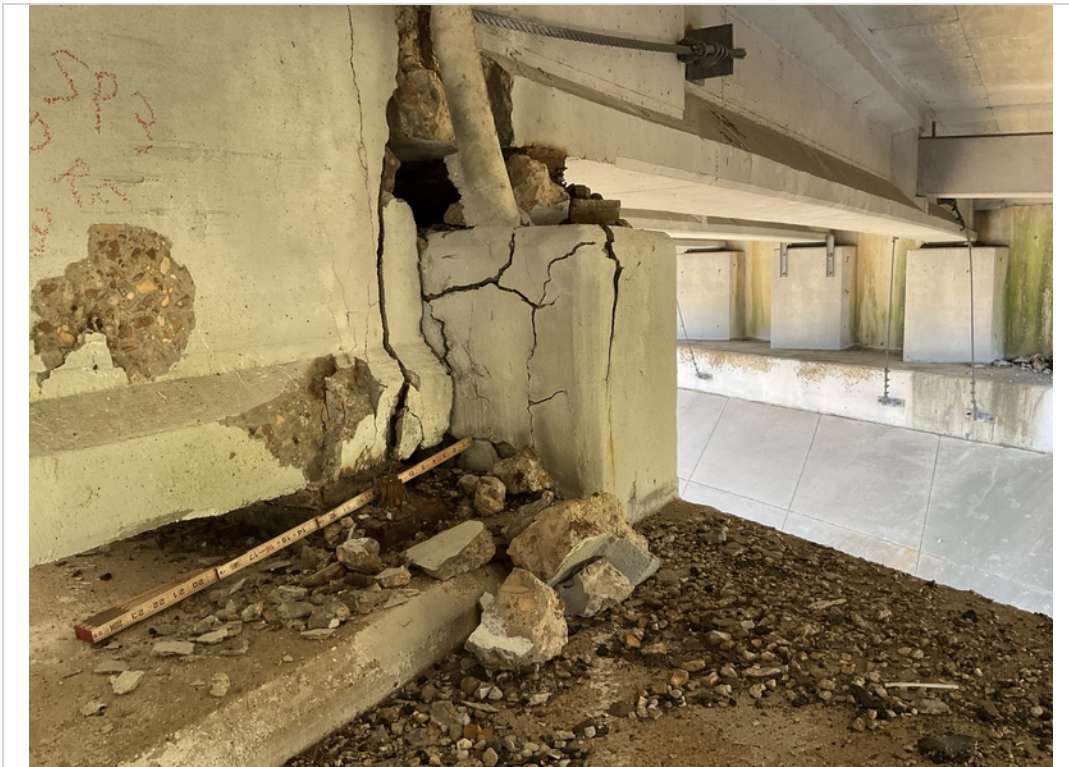
Beam D, Span 3, Bent 3, right face, beam end web spall with spalled and broken concrete and the beam end. Delaminated beam end, Span 4 pedestal with delaminated areas with wide cracking.

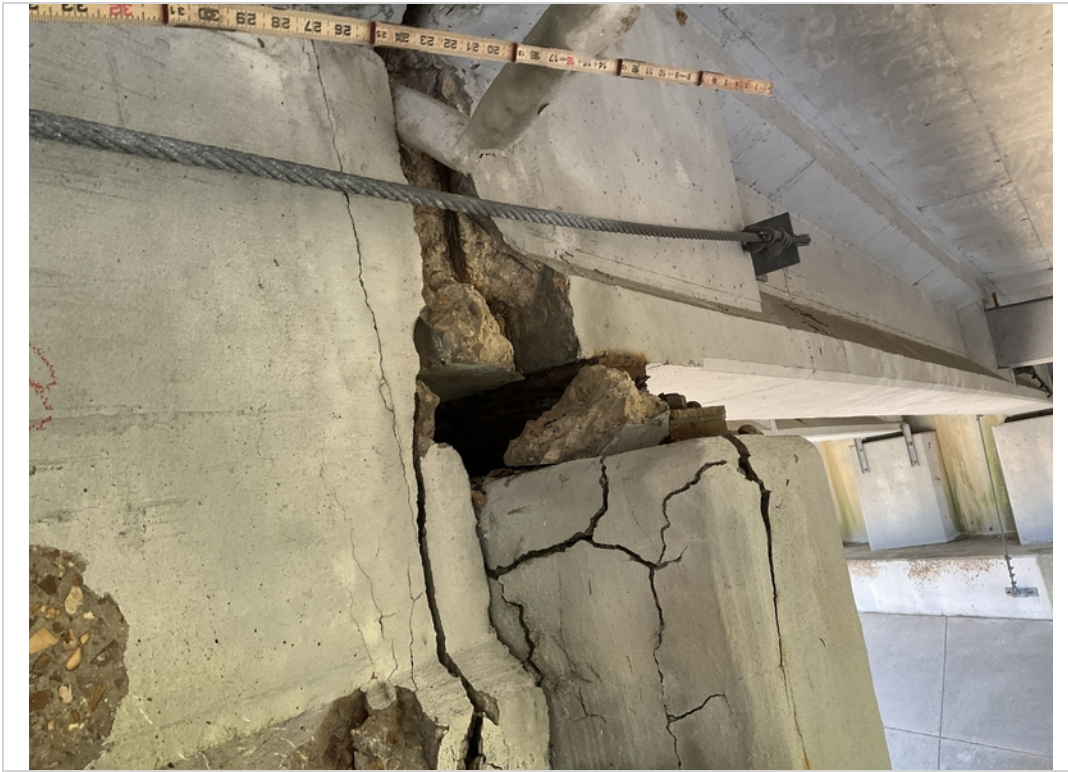
Beam D, Span 4, Bent 3, right face, beam end spall (right side of photo). Note the delaminated and heavily cracked pedestal.

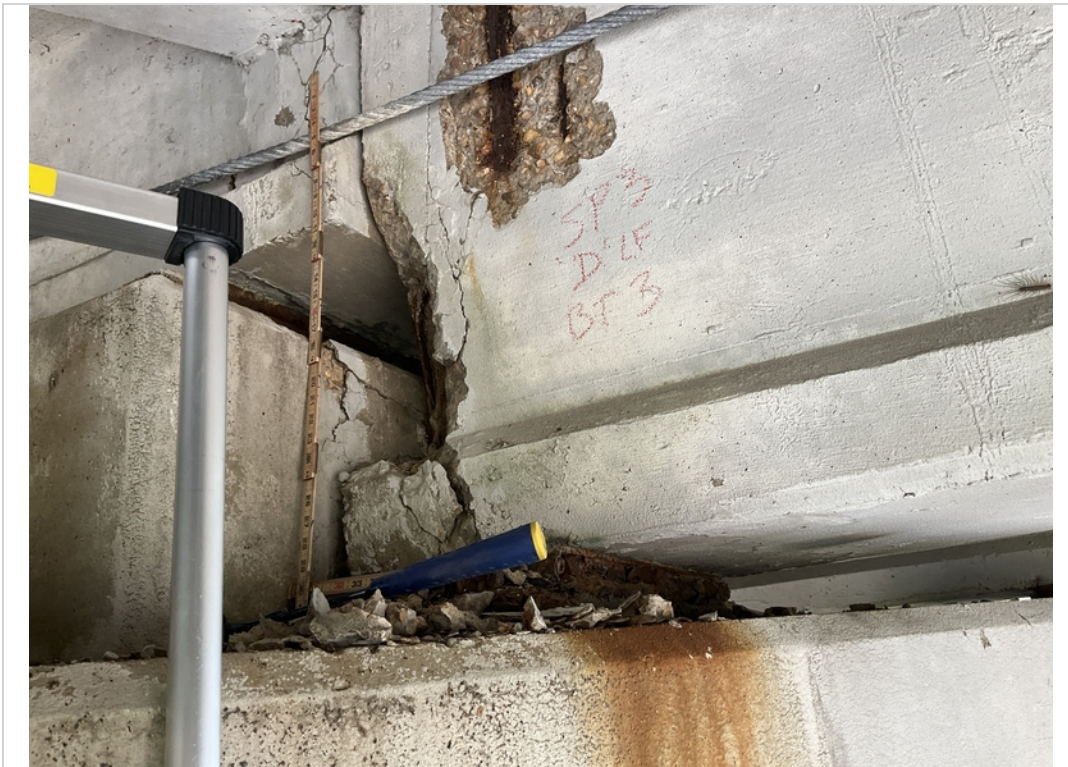
Beam D, Span 3, Bent 3, spalled beam end with exposed strand ends.

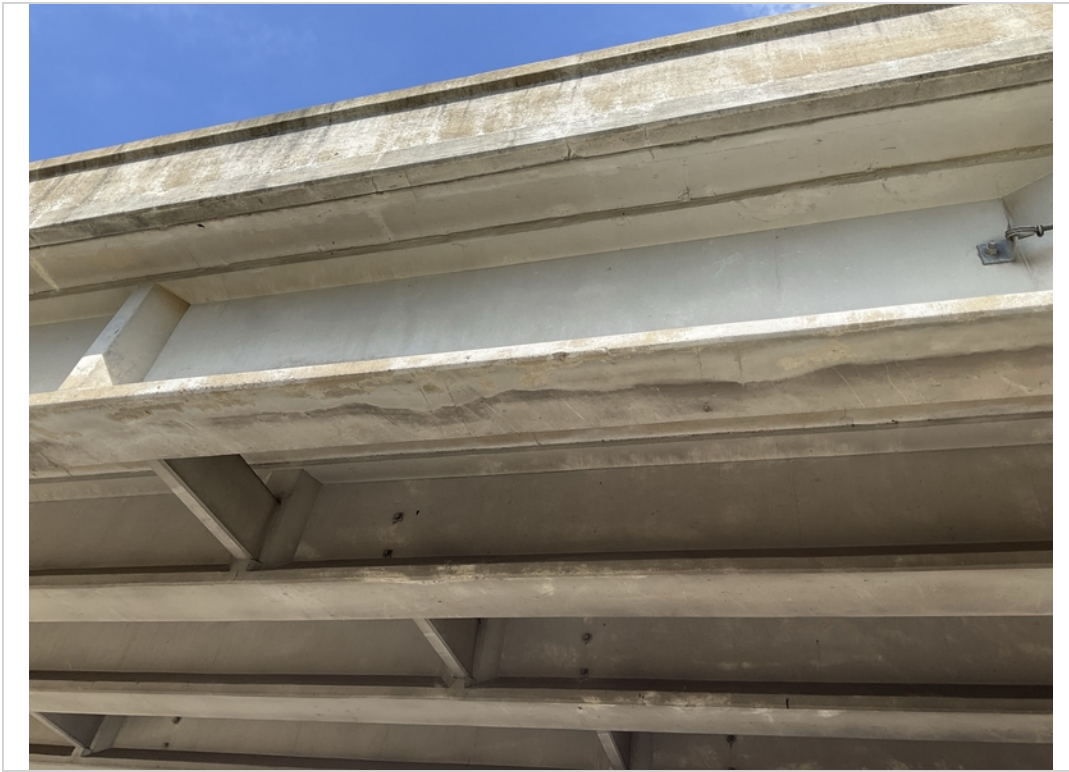
Beam A, Span 2, left corner over right travel lane, isolated minor impact spall on bottom flange corner with surface scrapes marks on underside

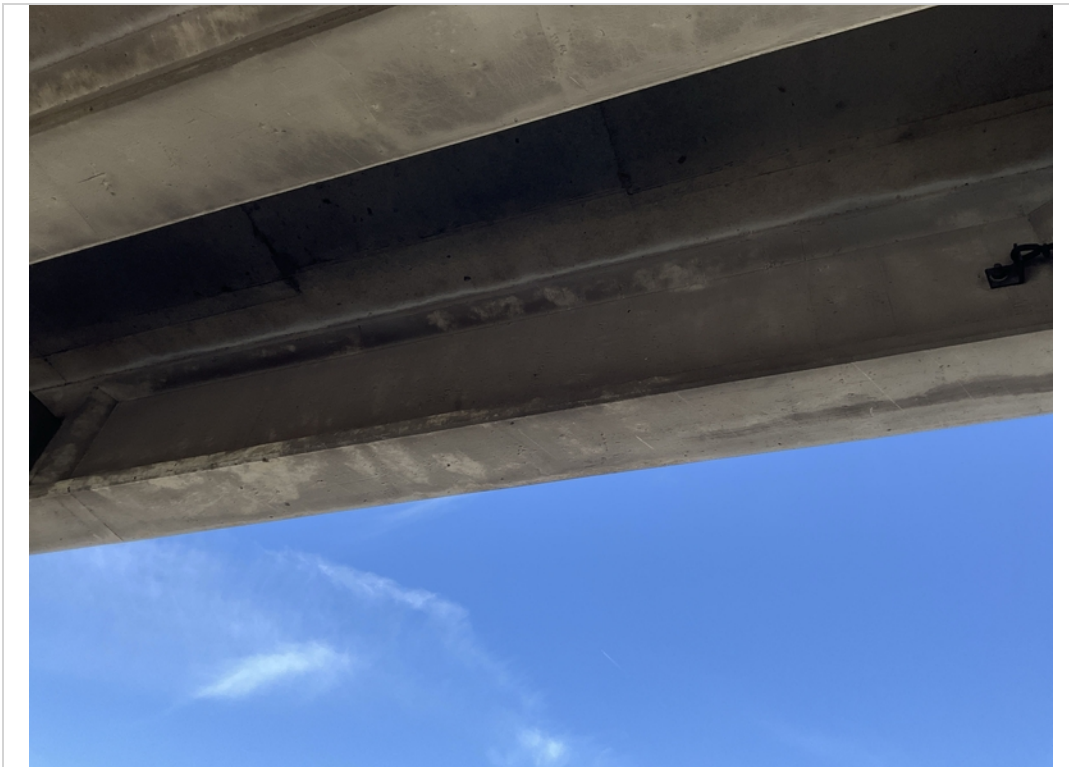
Beam E in Span 2, near Bent 1, minor surface scrapes on beam underside over right travel lane

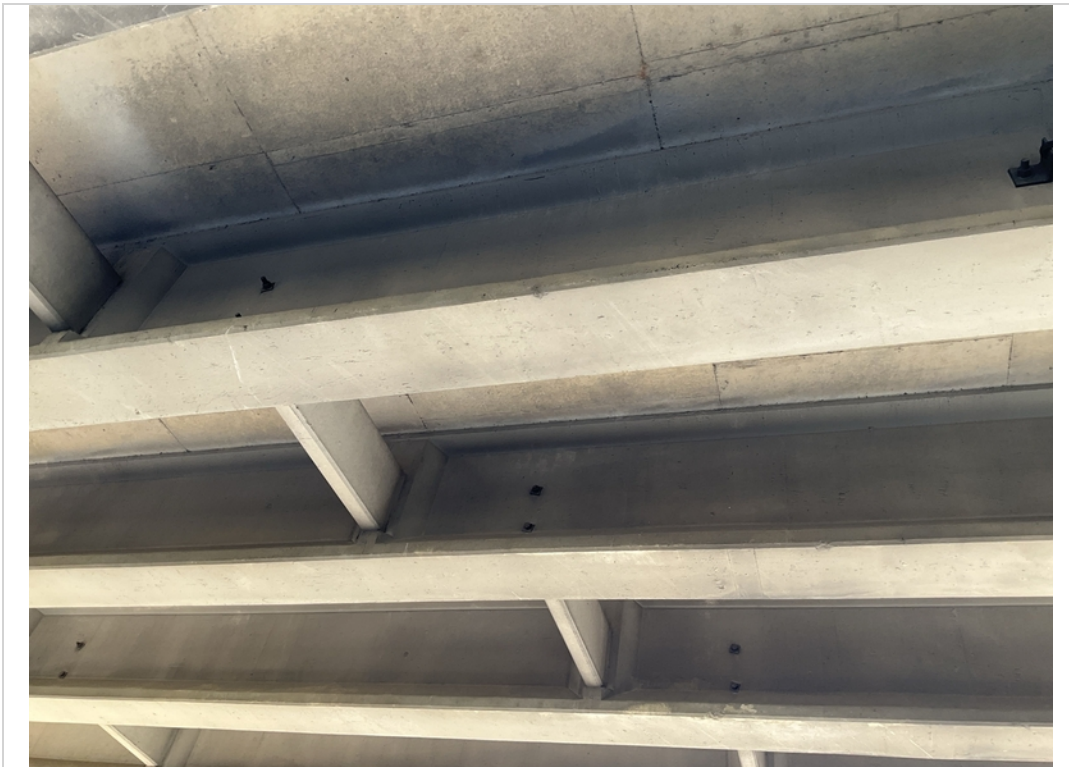
Beam D, Span 3, over right travel lane, minor bottom flange (right side) spall

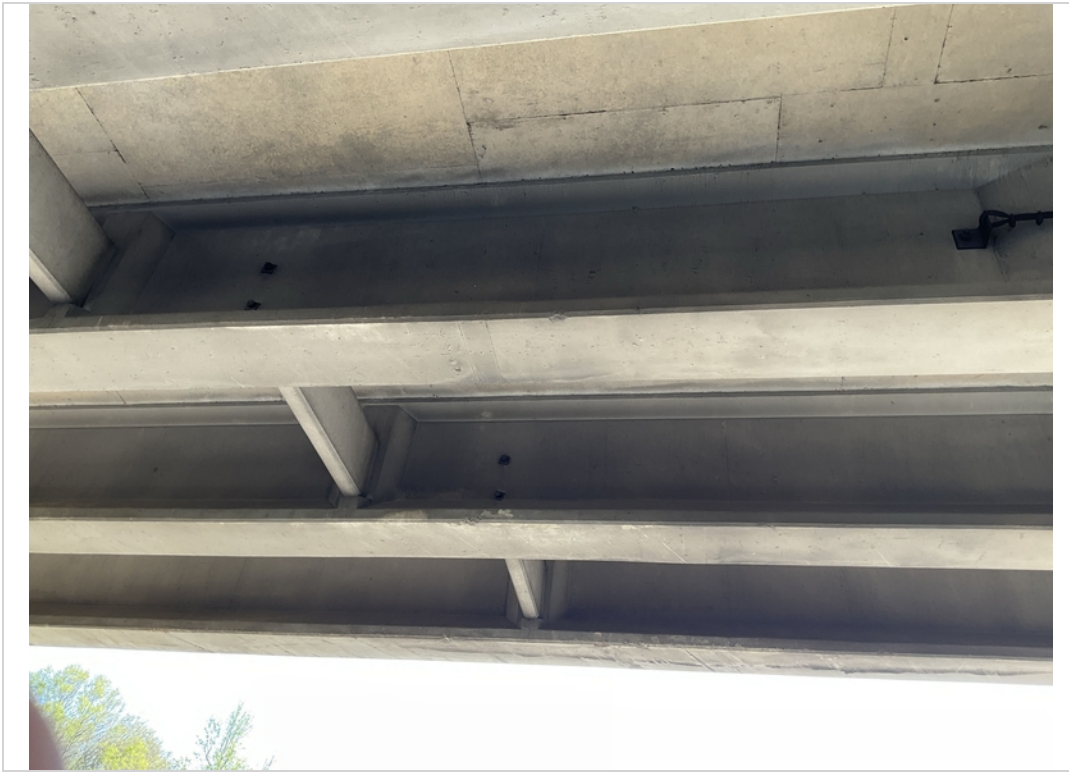
Beam C, Span 3, over right travel lane, minor bottom flange (right side) spall

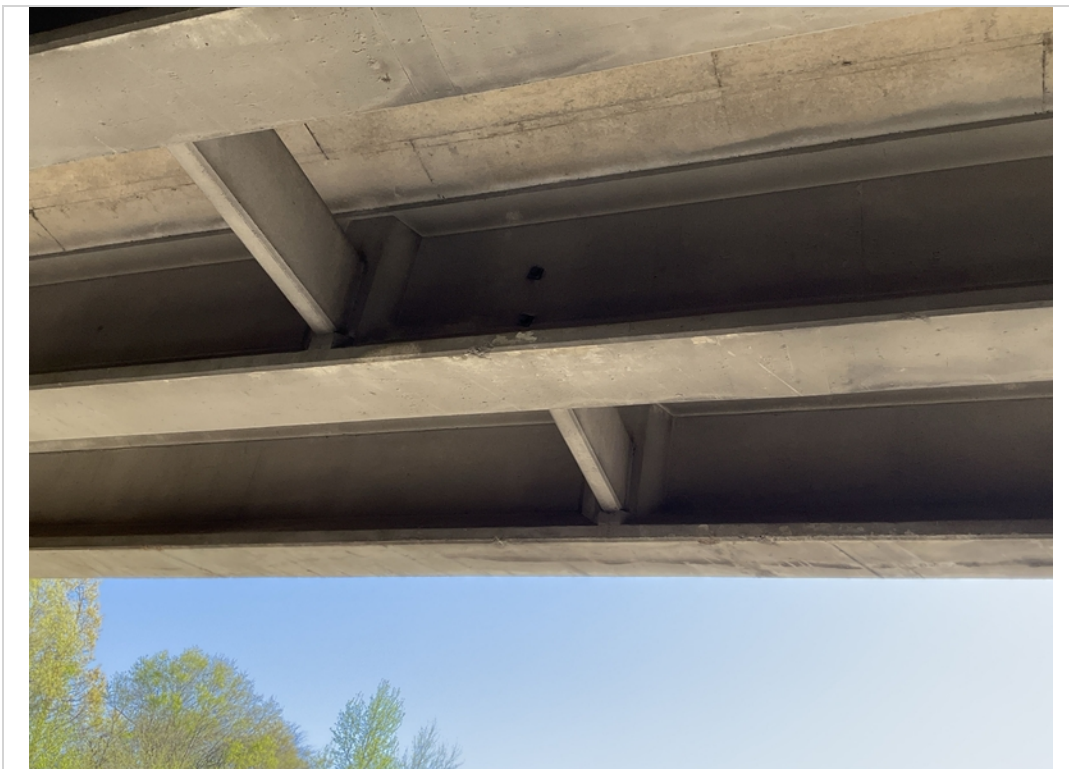
Beam B, Span 3, over right travel lane, minor bottom flange (right side) spall

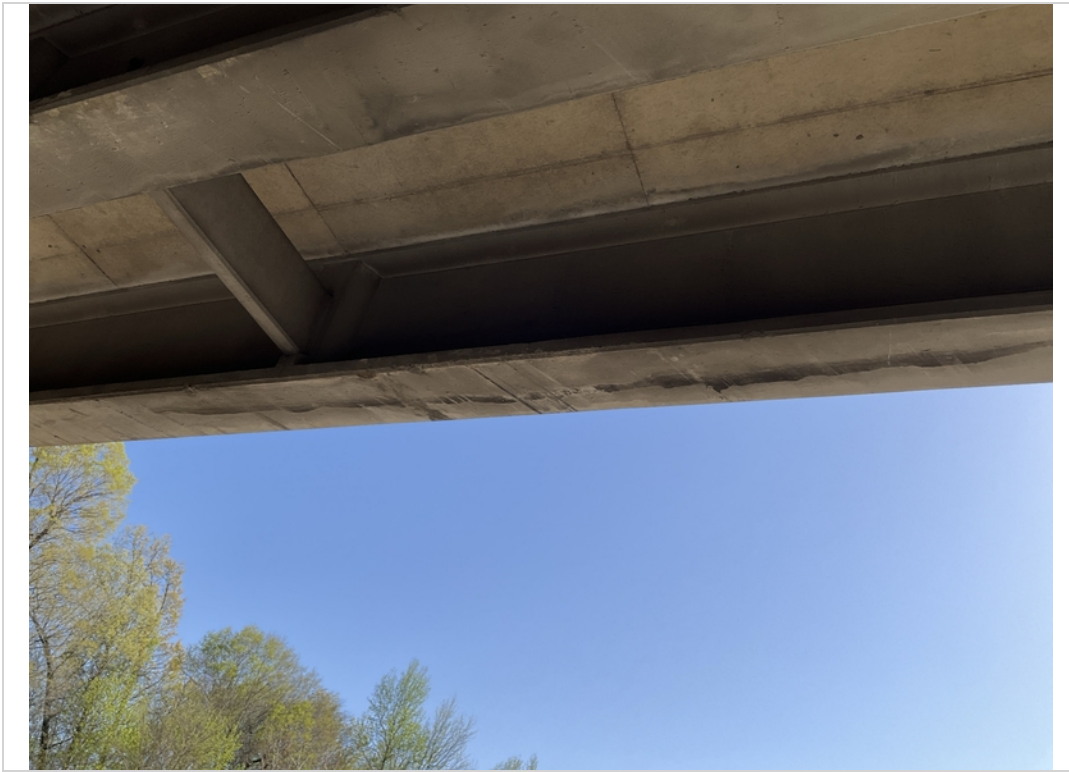
Beam A, Span 3, right bottom flange over right travel lane, impact spalls to bottom flange corner with multiple scrape marks (some appear to be up to 1/8" deep)
