Region 04, 57 - Madison County

LOWER BROWNSVILLE RD. Crossing I40

Inspection Date(s): 04/09/2025 - 04/09/2025

Structure 57I00400011 is in poor condition with the substructure being the limiting component. The structure consists of a simply supported, four span, multi-beam superstructure consisting of a cross section containing five prestressed concrete I-Beams of varying depths.

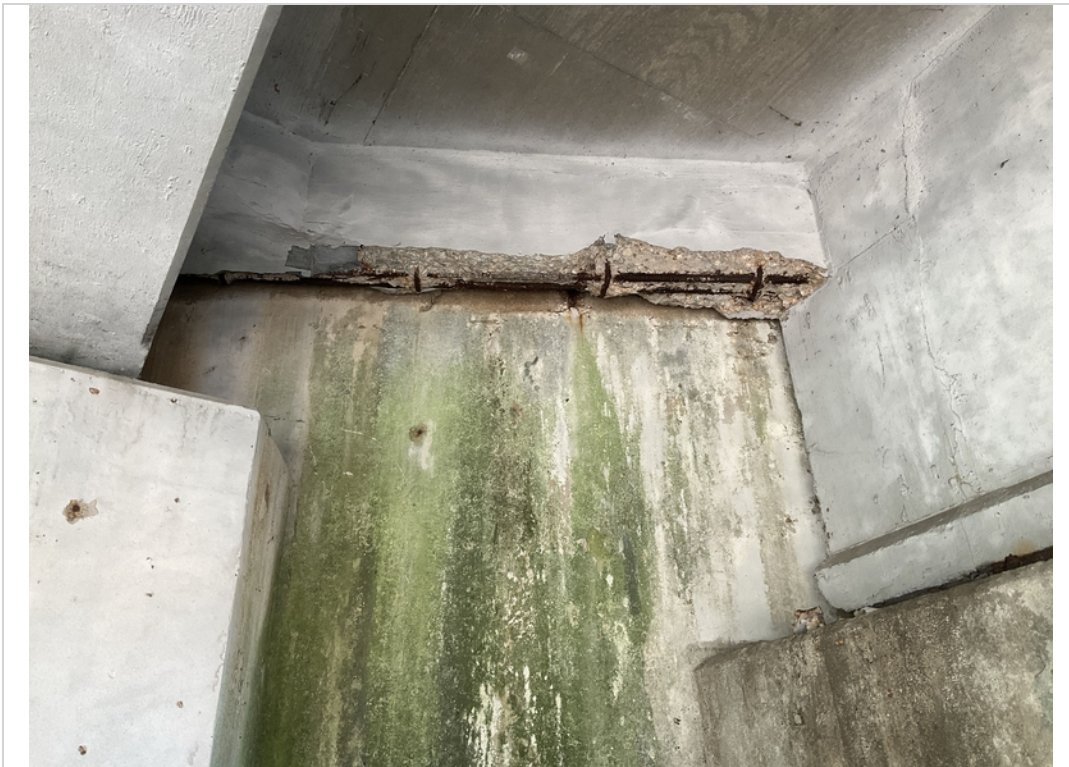
End diaphragm between Beams D/E at Abutment 2 with spalling throughout and exposed rebar with active corrosion

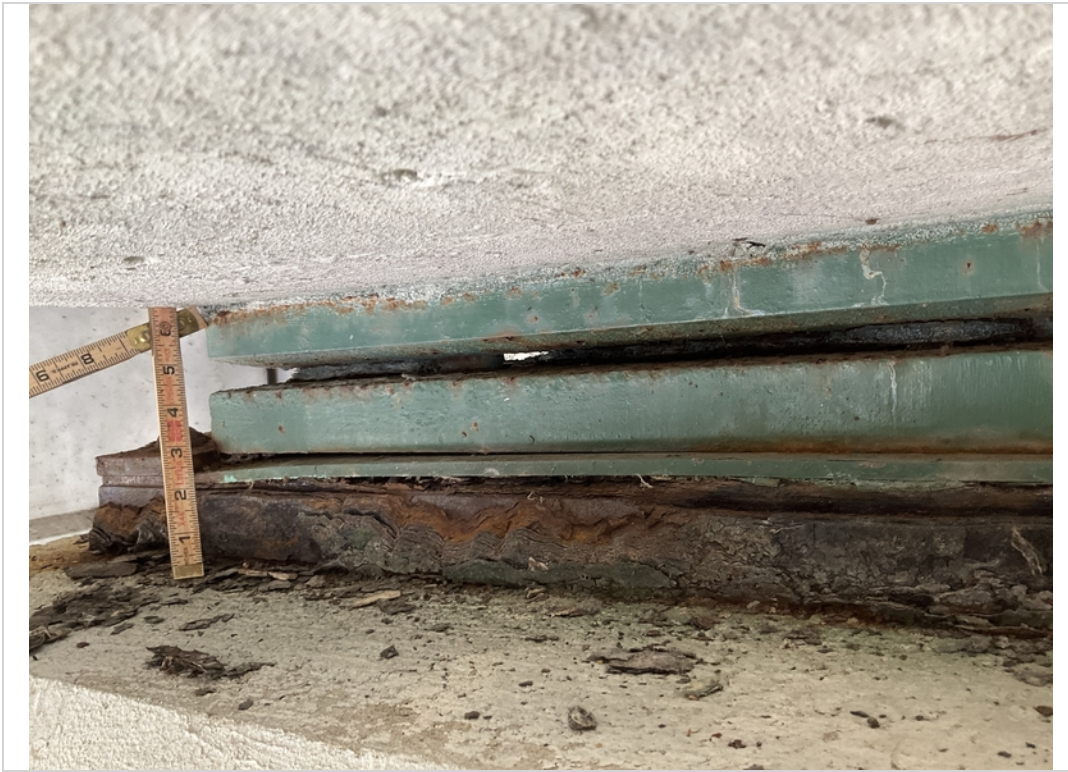
Abutment 1, Bearing D, pack rusting lifting the bearing and causing non-uniform bearing. Pack rust is 1/2" thick between sole plate and bearing plate with laminar rust along masonry plate. Missing anchor bolt at both sides.

| Date Added | Recommendation | Priority |
|---|---|---|
| 04/17/2023 | REPLACE MISSING BOLTS IN BEARINGS ABUTMENT NO.1 & 2 | |

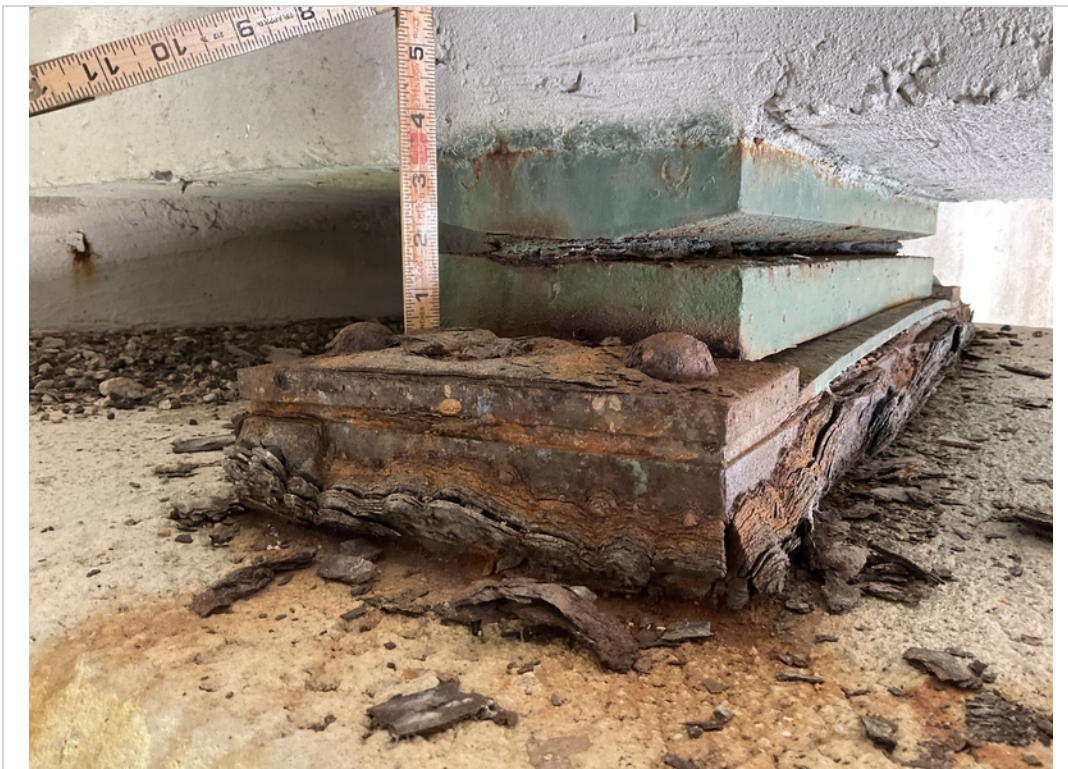
Abutment 1, Bearing D, pack rusting lifting the bearing and causing non-uniform bearing. Pack rust is 1/2" thick between sole plate and bearing plate with laminar rust along masonry plate. Missing anchor bolt at both sides.

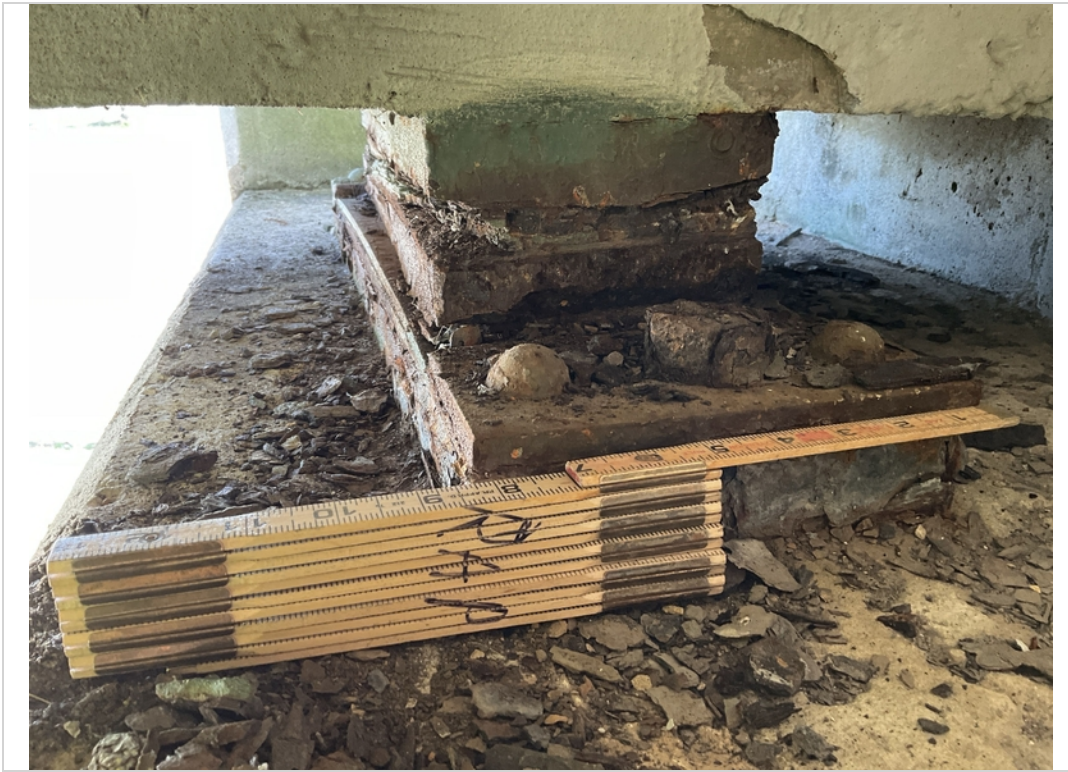
Abutment 1, Bearing E, severe corrosion with pack rust and section loss. Bearing is lifting due to pack rust.

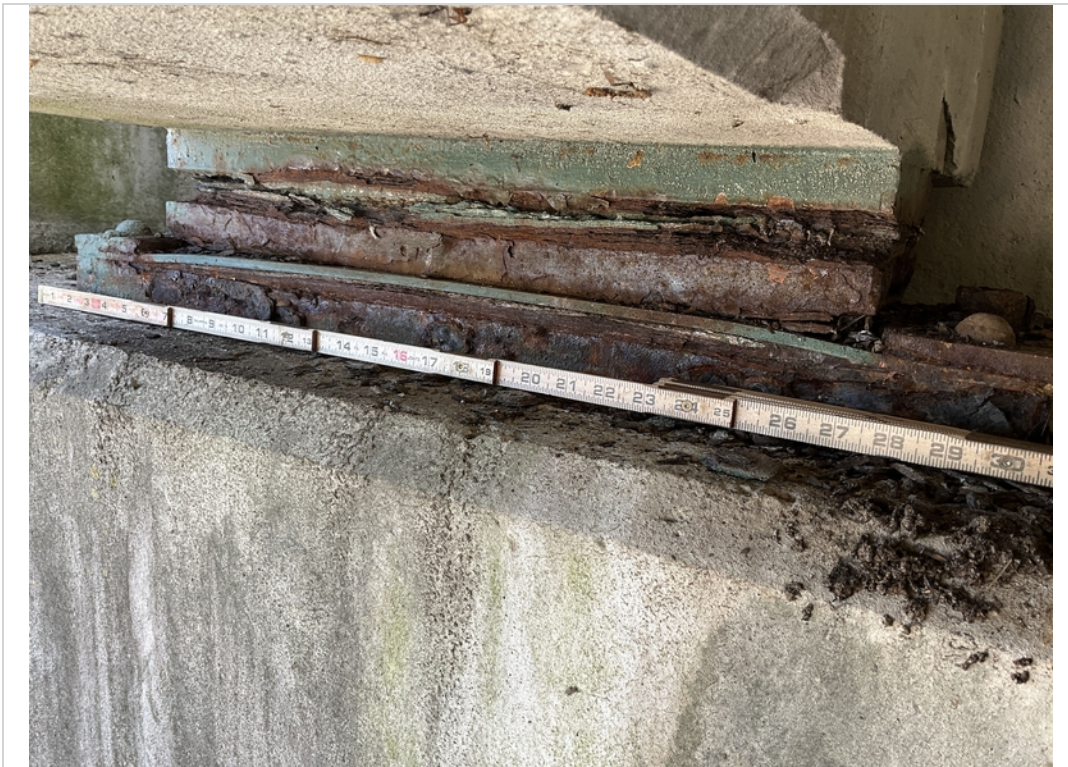
Abutment 1, Bearing E, severe corrosion with pack rust and section loss. Bearing is lifting due to pack rust.

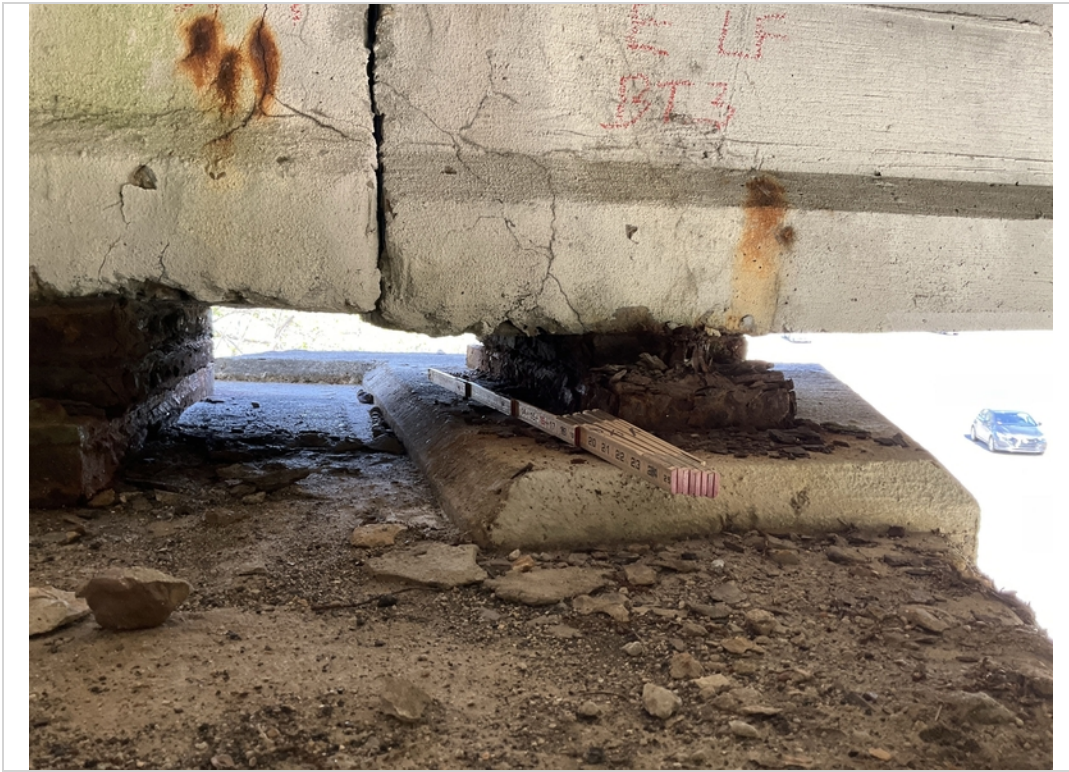
Bearing E, Span 3, Bent 3, typical corrosion with laminar rust and section loss

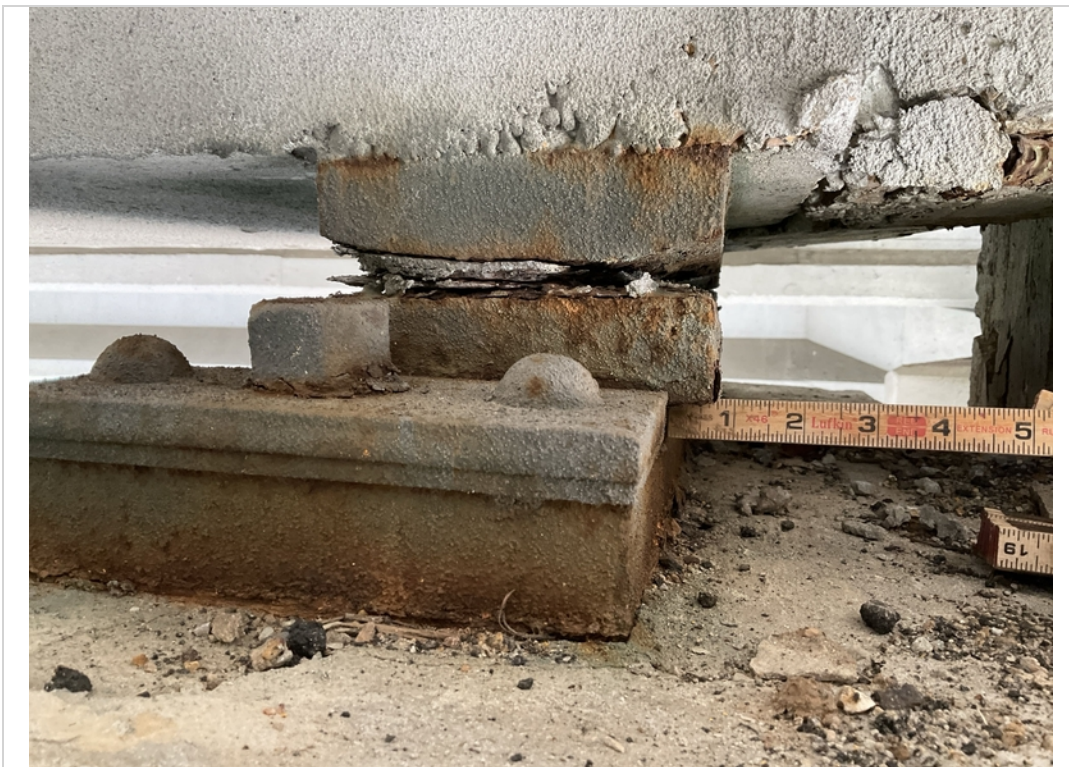
Bearing C, Span 4, Bent 3, over-expanded and heavily rusted with pack rust lifting the bearing

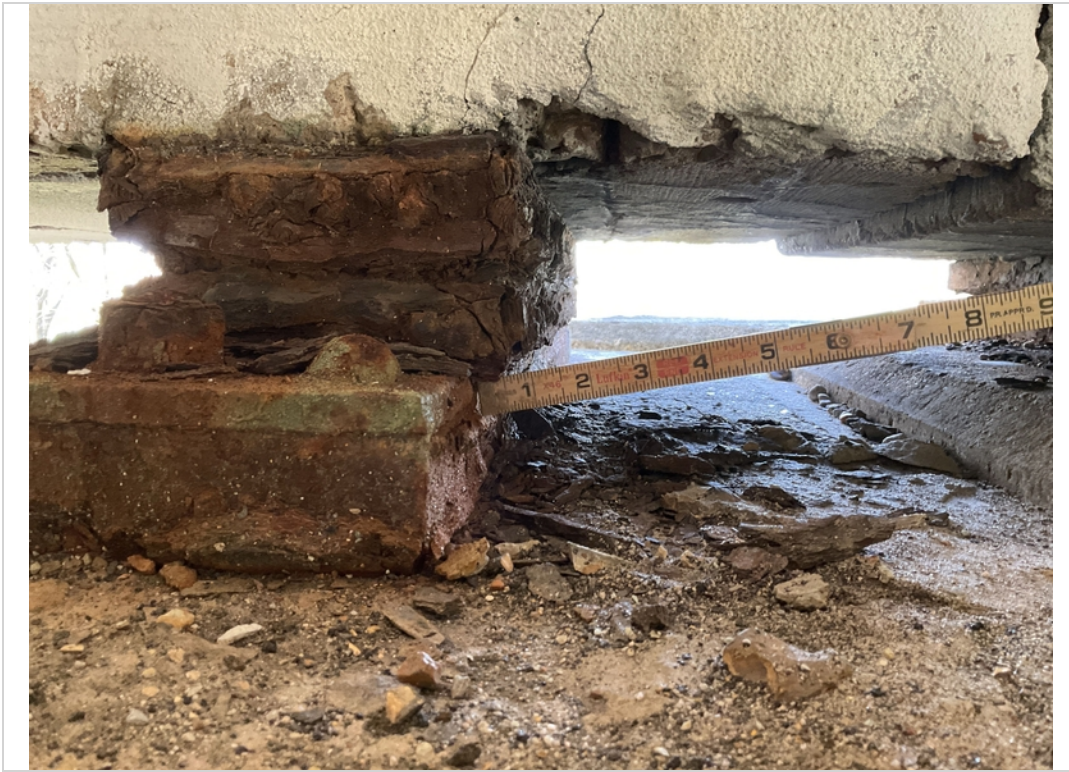
Bearing E, Span 4, Bent 3, over-expanded with major corrosion.

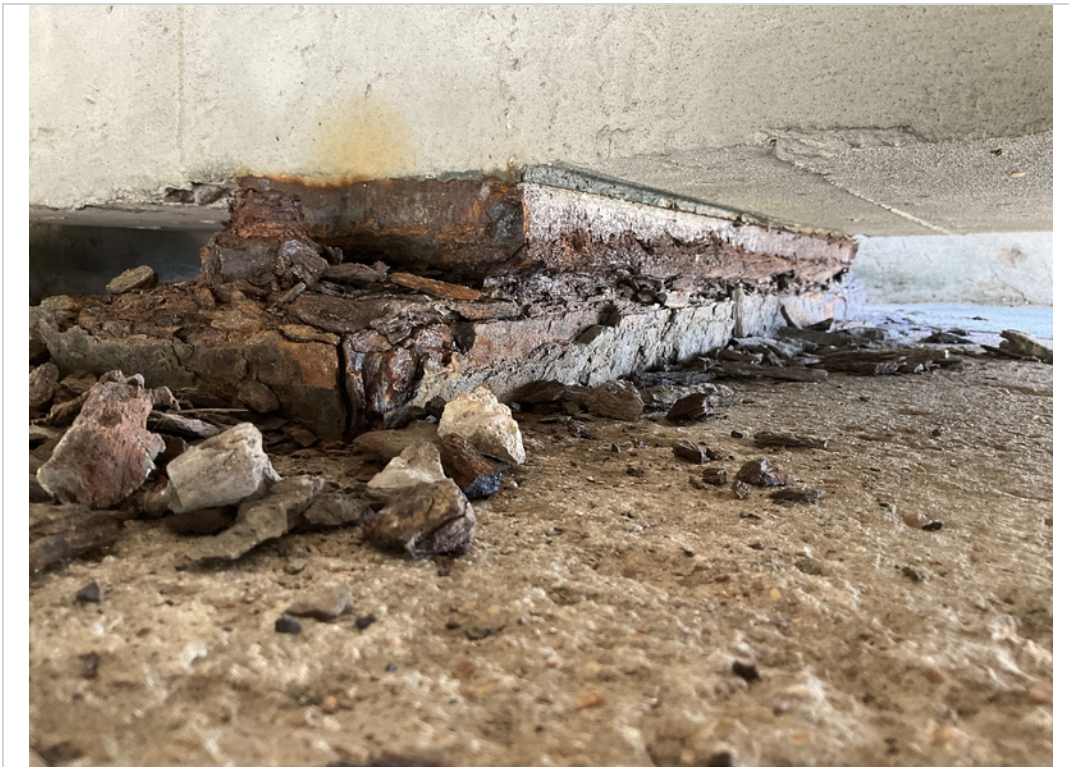
Bearing E at Abutment 2, Span 4, heavy corrosion with pack rust and section loss

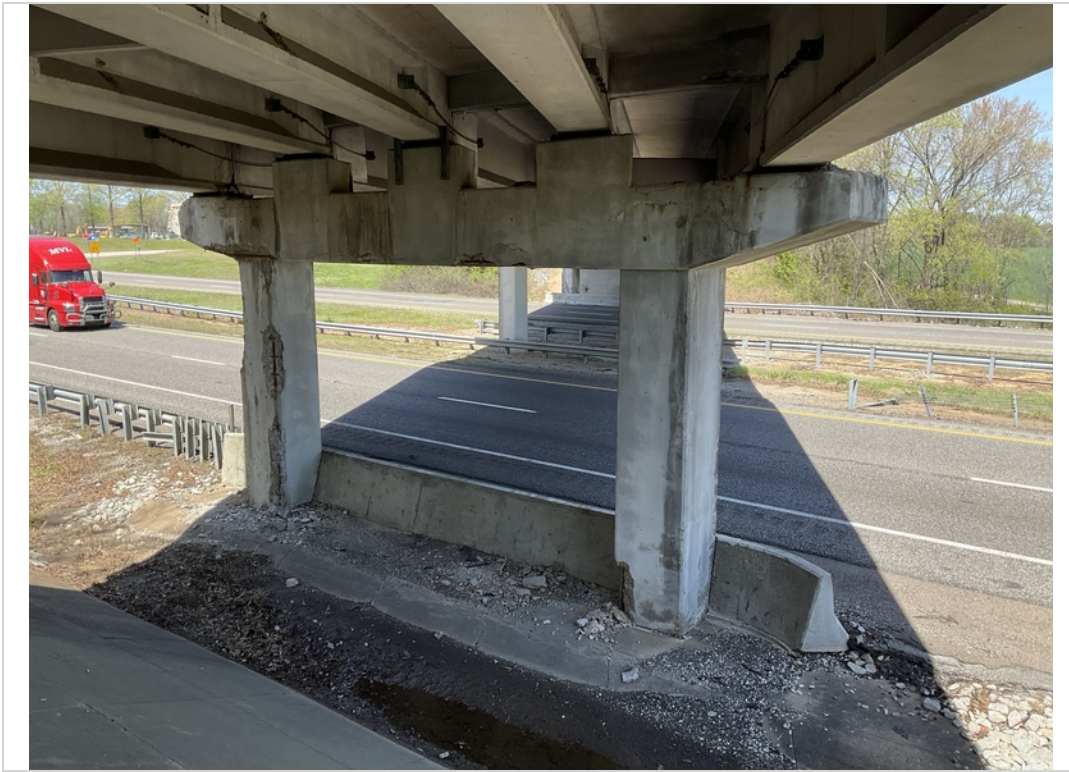
Bent 1, front face with significant spalling and delaminated areas throughout the columns and cap

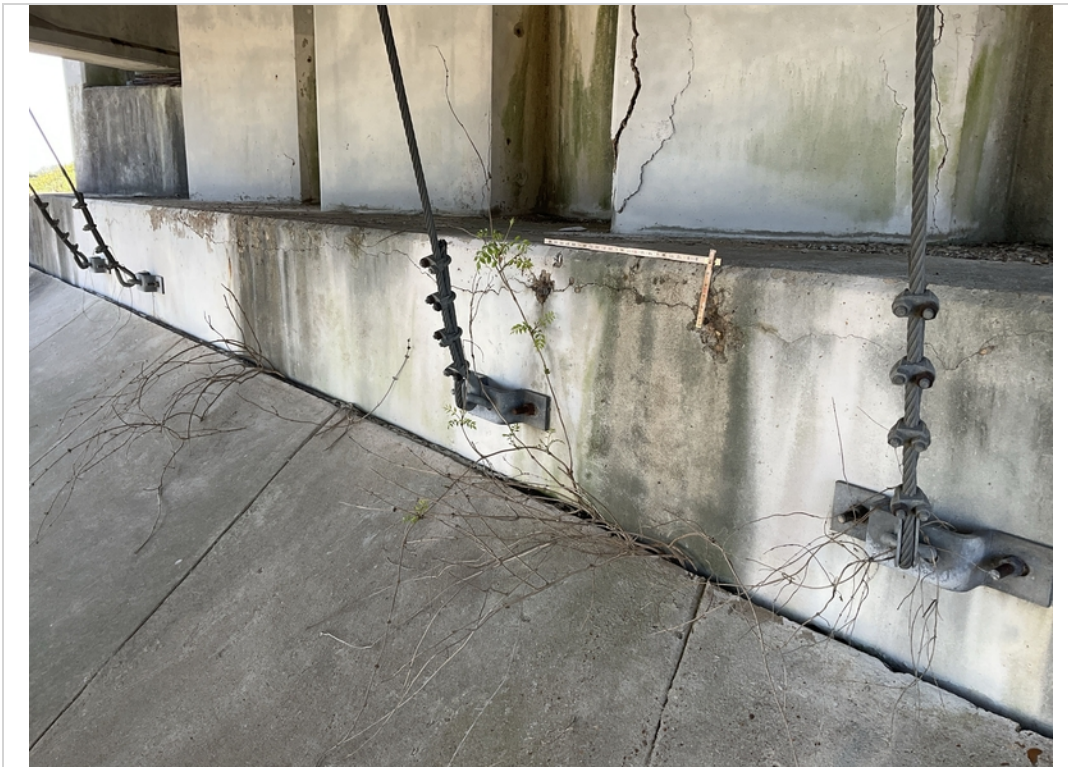
Abutment 1 cap with horizontal crack along top of cap (20' x 1/8" wide)

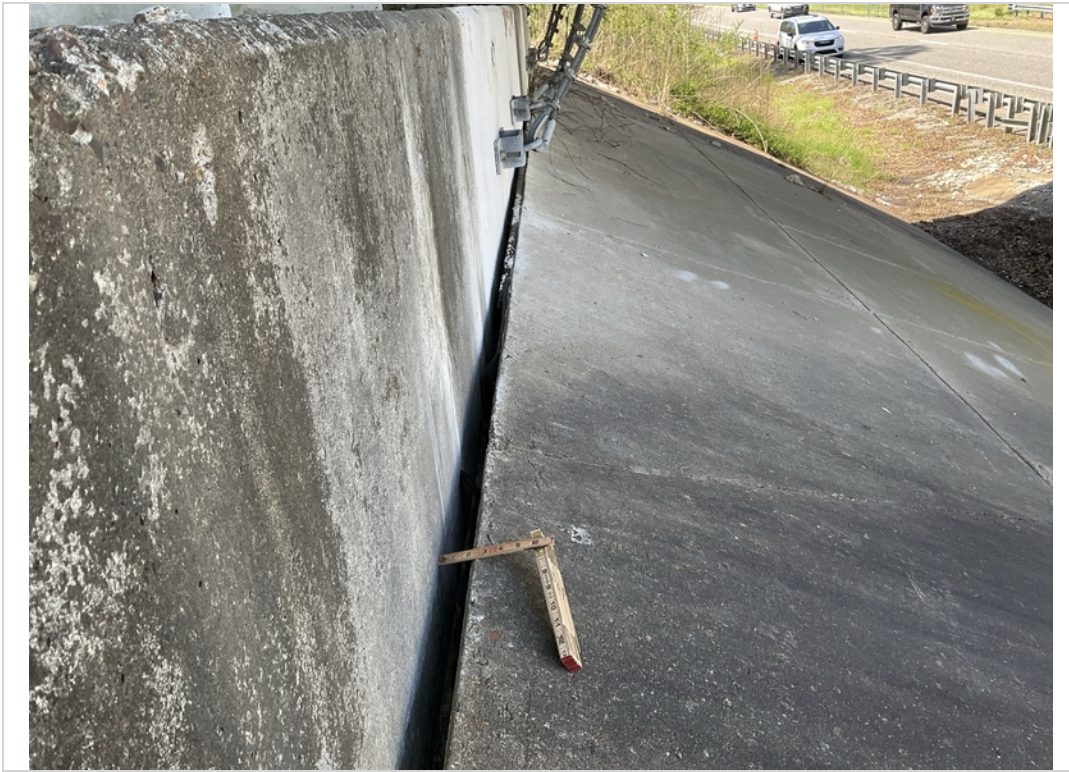
Abutment 1 slope protection looking left, separating from the stem face

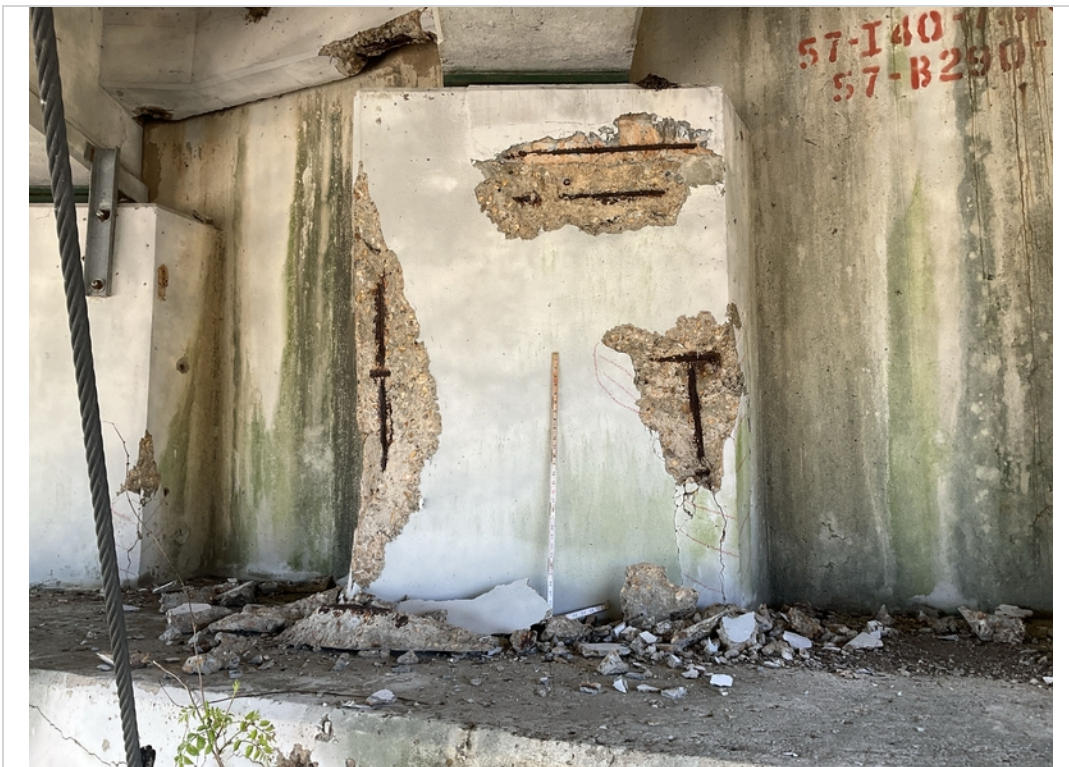
Abutment 1, pedestal B with spalling and exposed rebar throughout.

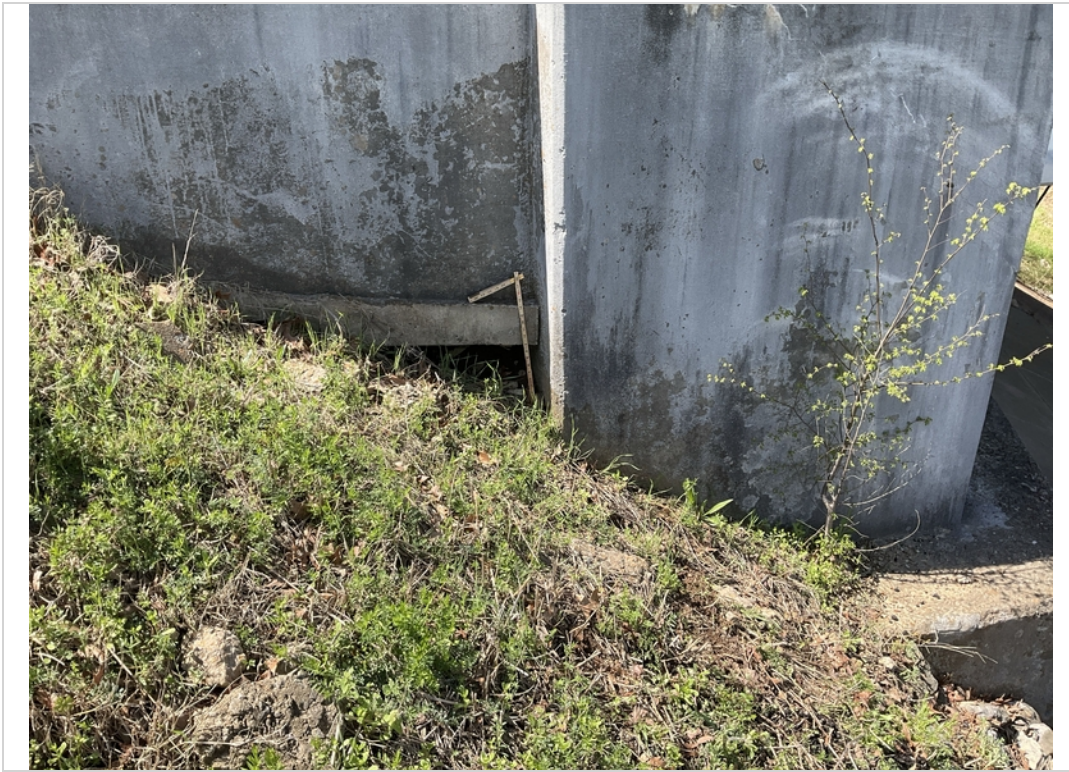
Abutment 1, right wing wall, localized undermining behind backwall

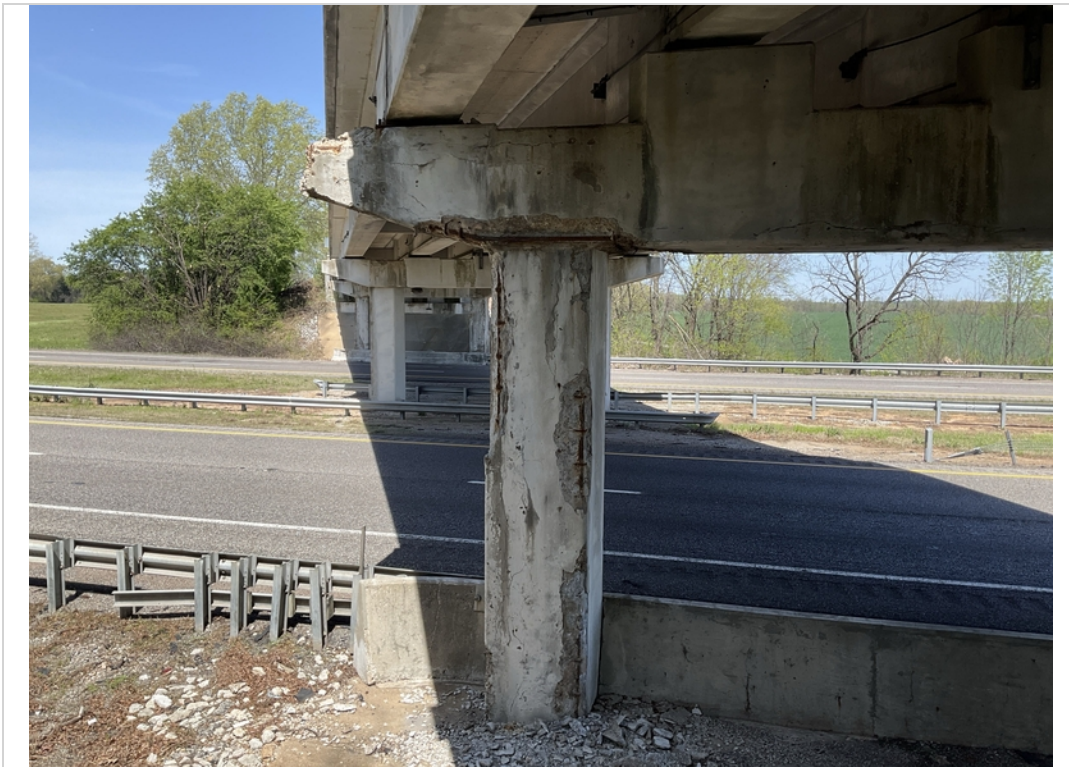
Bent 1, front face, left side cap and left overhang, widespread cracking with delaminated areas and spalls exposing rusted rebar

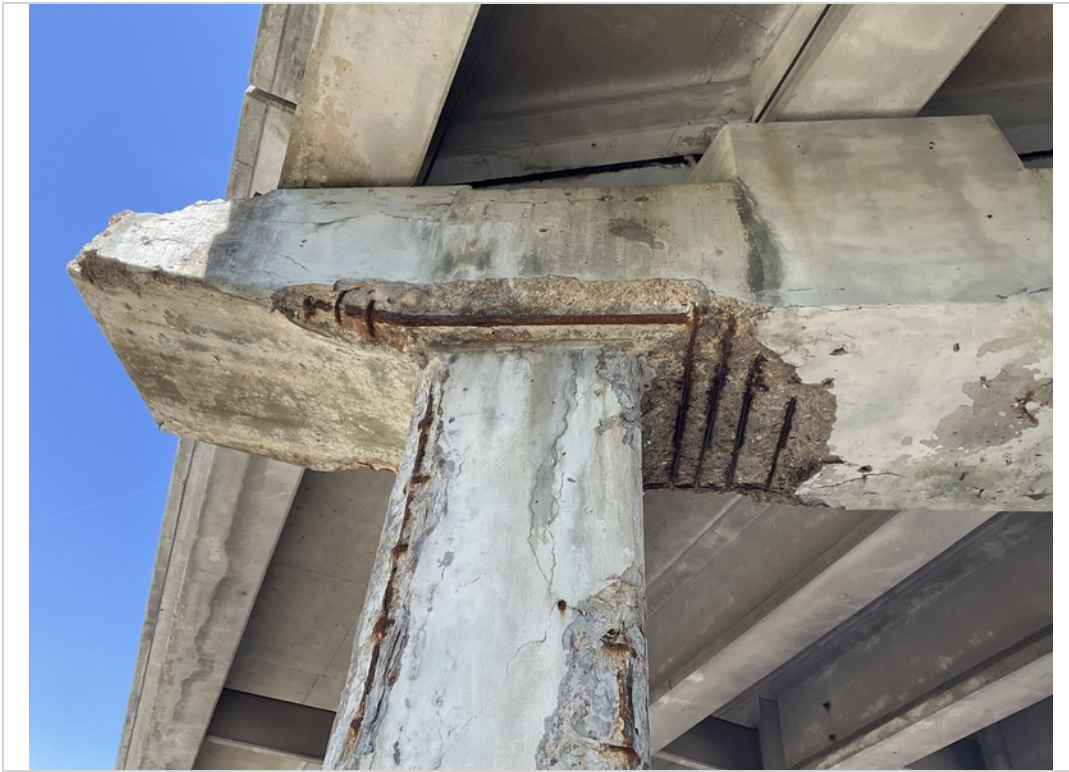
Bent 1, cap underside left end and under Bay A, serious spalling with exposed and debonded rebar

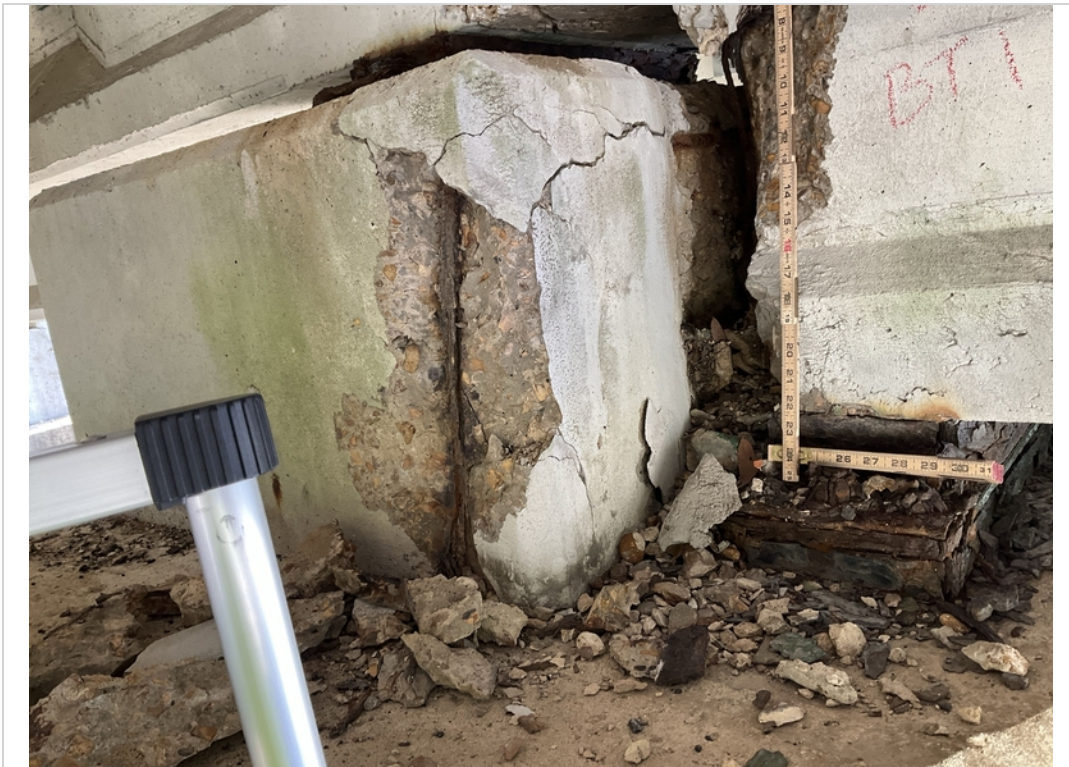
Span 1 Beam B pedestal over Bent 1, typical spall with exposed rebar. Beam end spall and heavily corroded bearing.

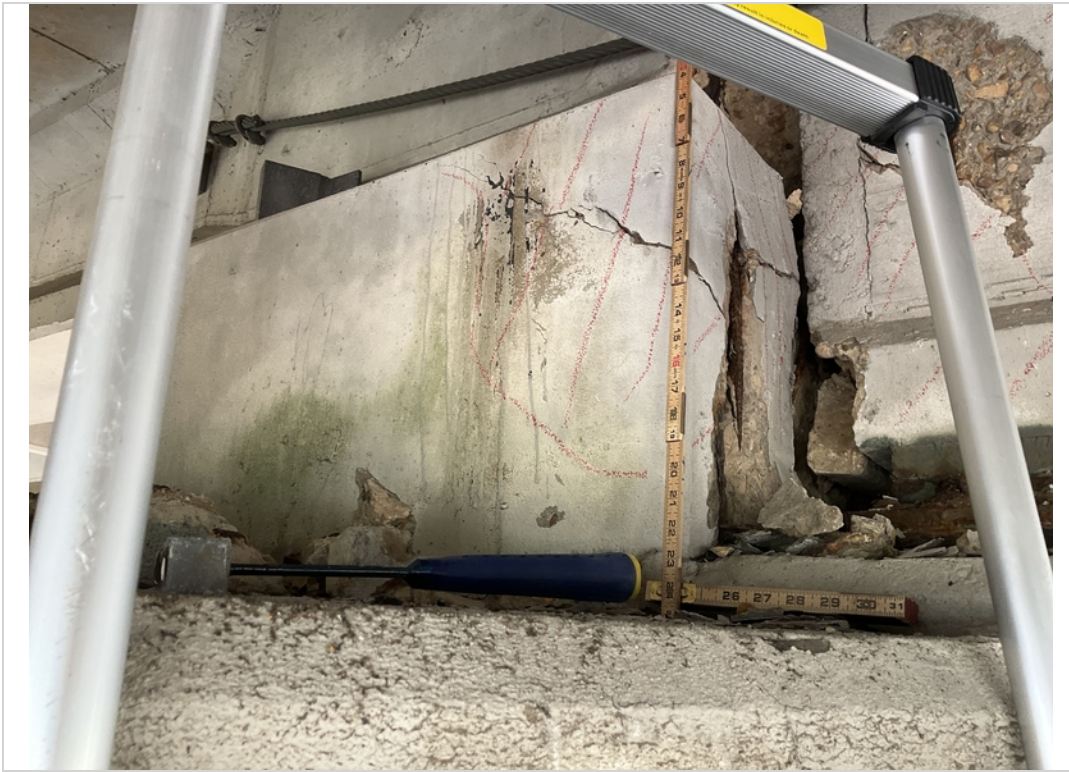
Pedestal for Beam C at Bent 1, delamination with adjacent spalling with exposed rebar.

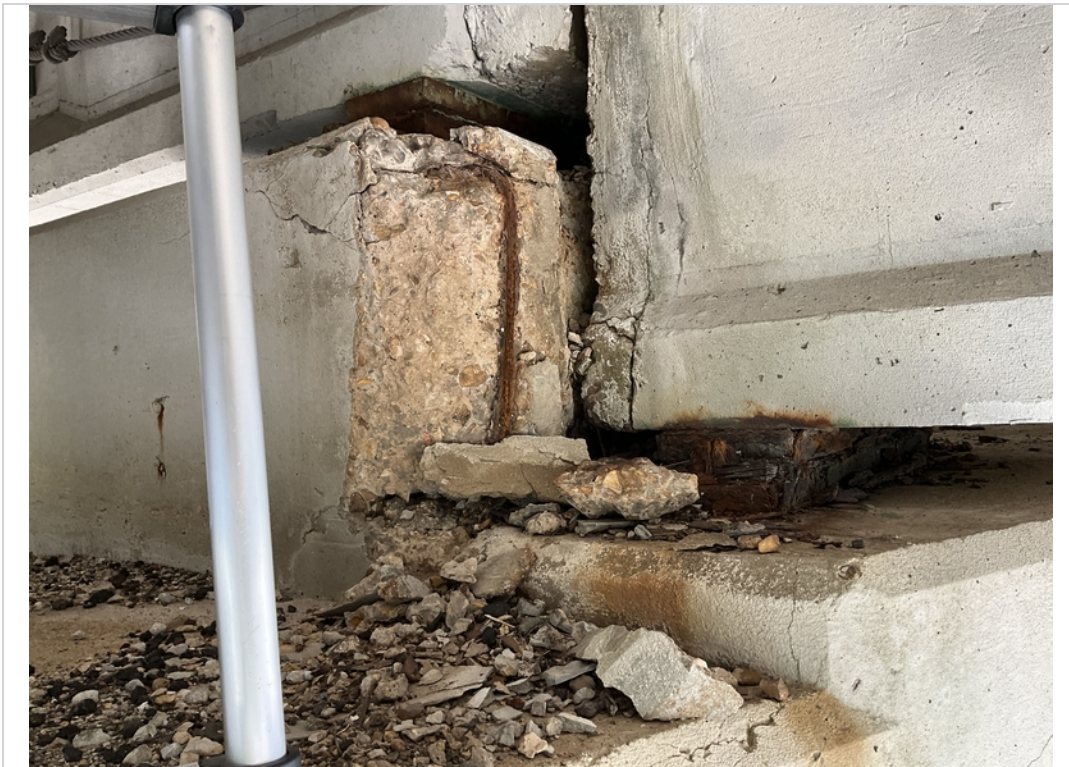
Pedestal for Beam B, Span 4, Bent 3, typical spall with exposed rebar

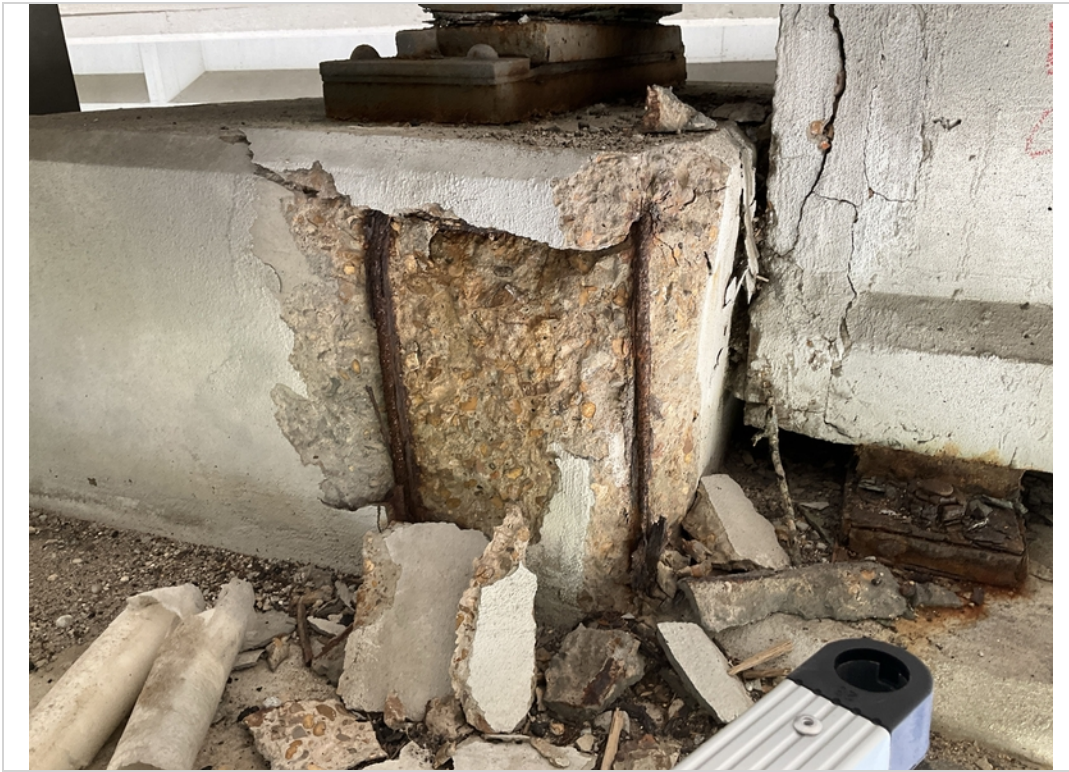
Pedestal for Beam C, Span 4, Bent 3, typical spall with exposed rebar

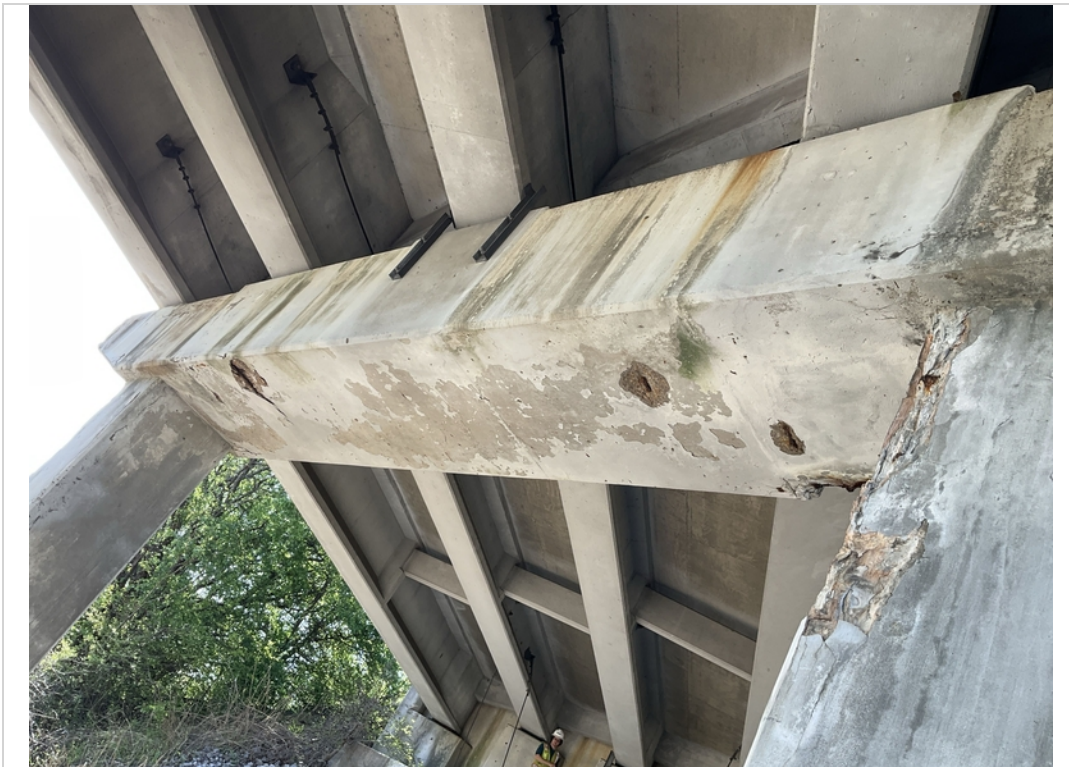
Bent 3 cap underside with multiple delaminated areas and spalls

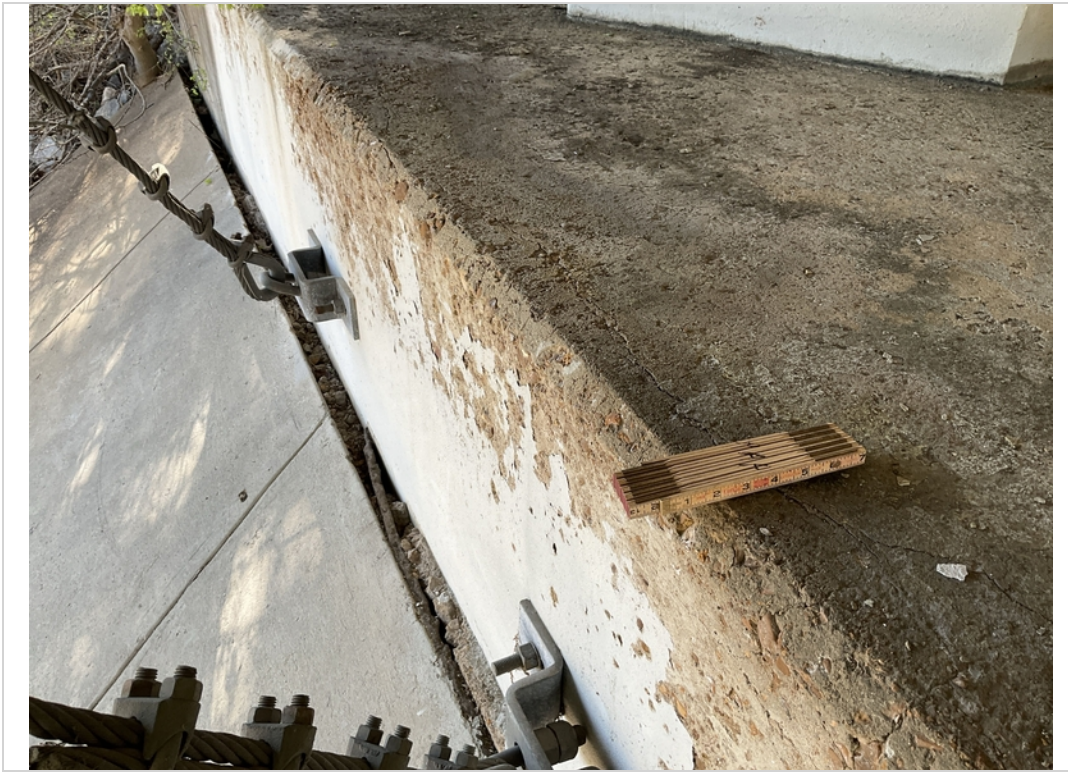
Abutment 2 cap with cracks in the top face adjacent to corner

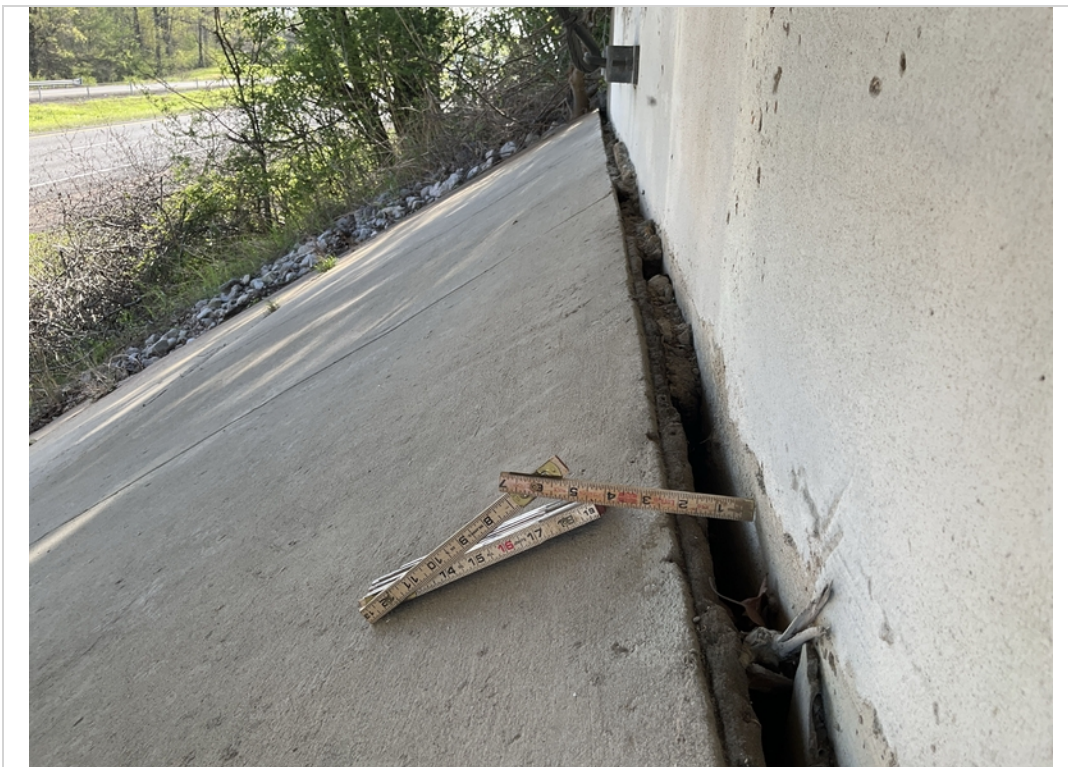
Abutment 2 slope protection pulling away from stem

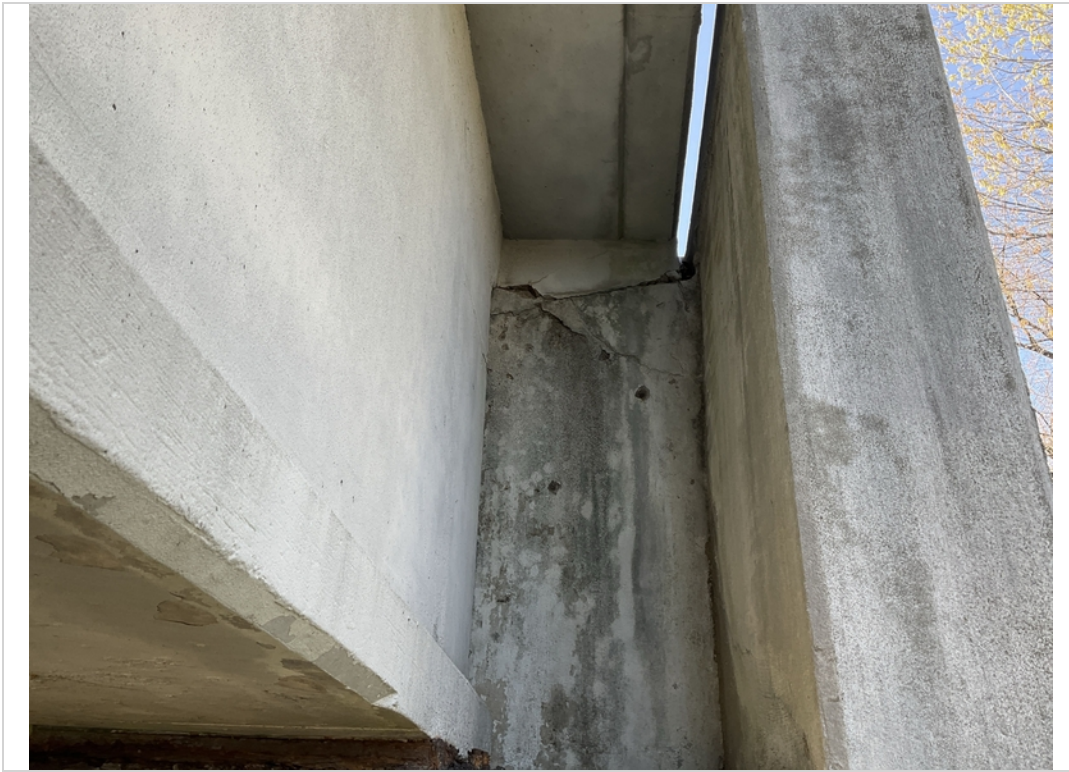
Abutment 2 backwall under right deck overhang, delamination with minor spall.

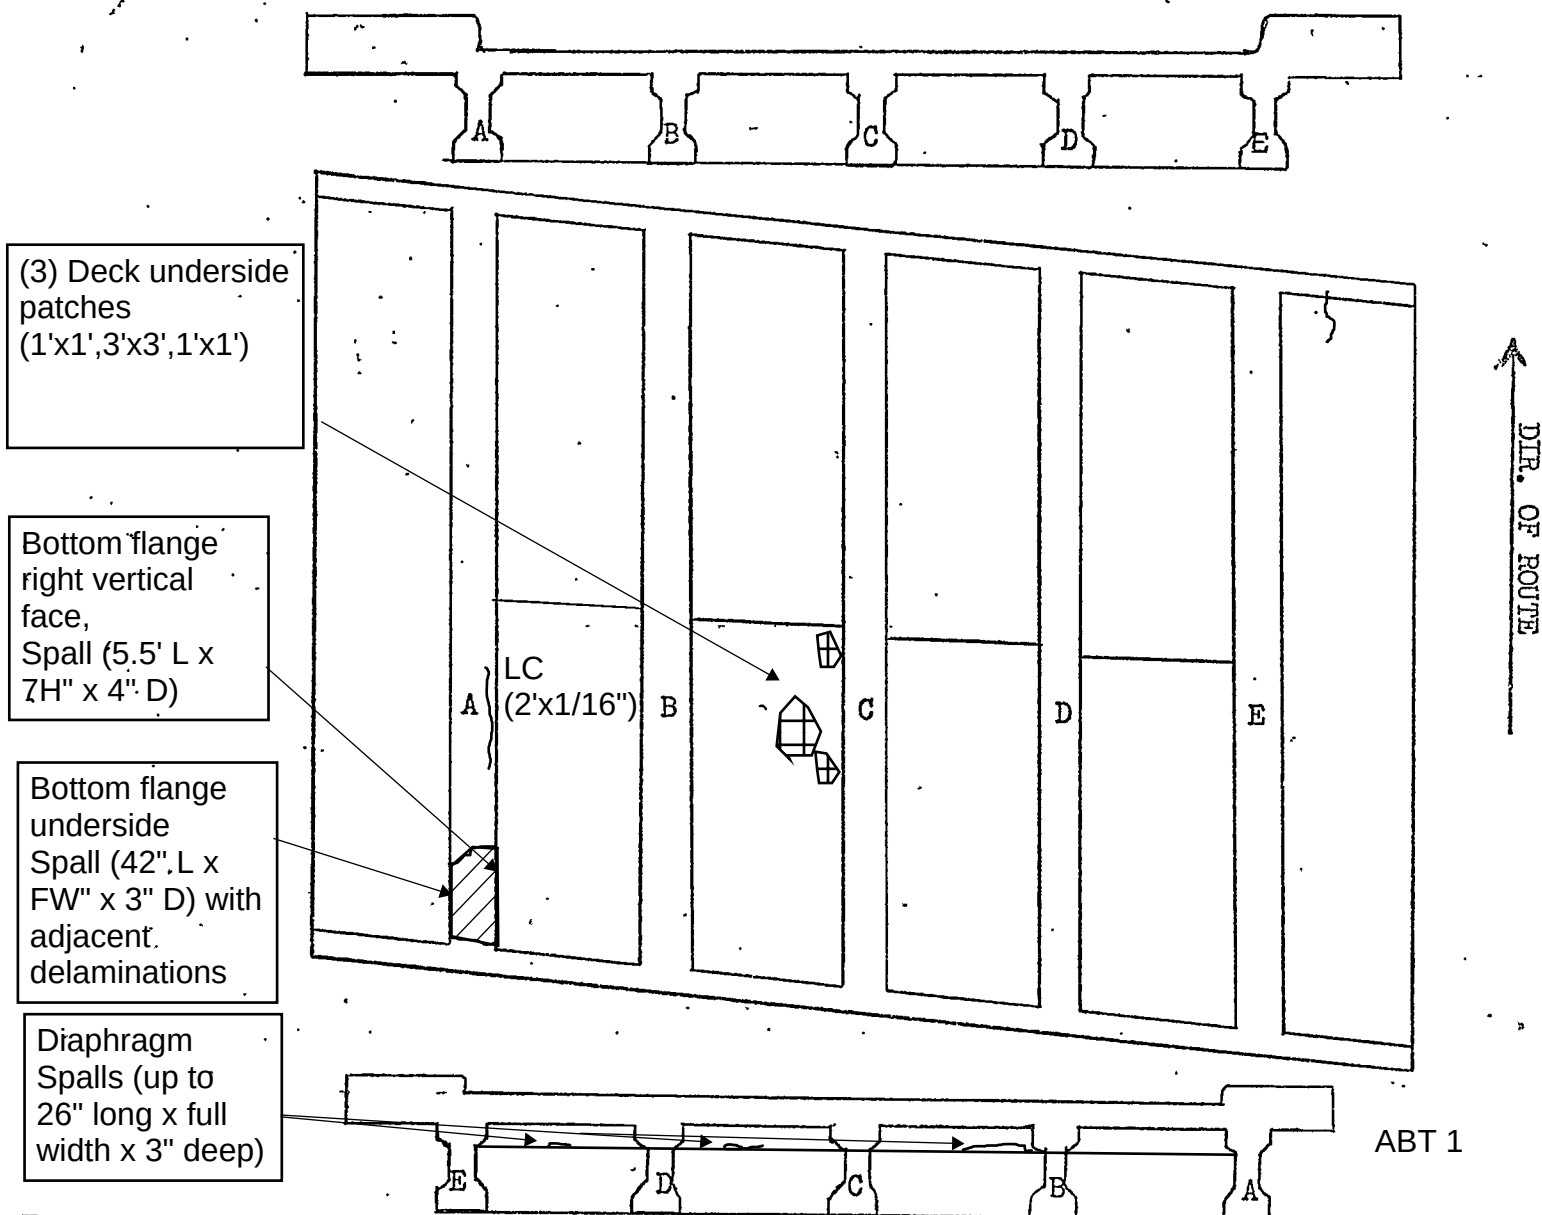
BR. NO. 57 140 7.54SK. 62° LT.SPAN NO. 1

Abutment End Diaphragms show spalling to undersides (with exposed rebar) Intermediate Diaphragms typically in good condition
