Region 04, 57 - Madison County

LOWER BROWNSVILLE RD. Crossing I40

Inspection Date(s): 04/09/2025 - 04/09/2025

Structure 57I00400011 is in poor condition with the substructure being the limiting component. The structure consists of a simply supported, four span, multi-beam superstructure consisting of a cross section containing five prestressed concrete I-Beams of varying depths.

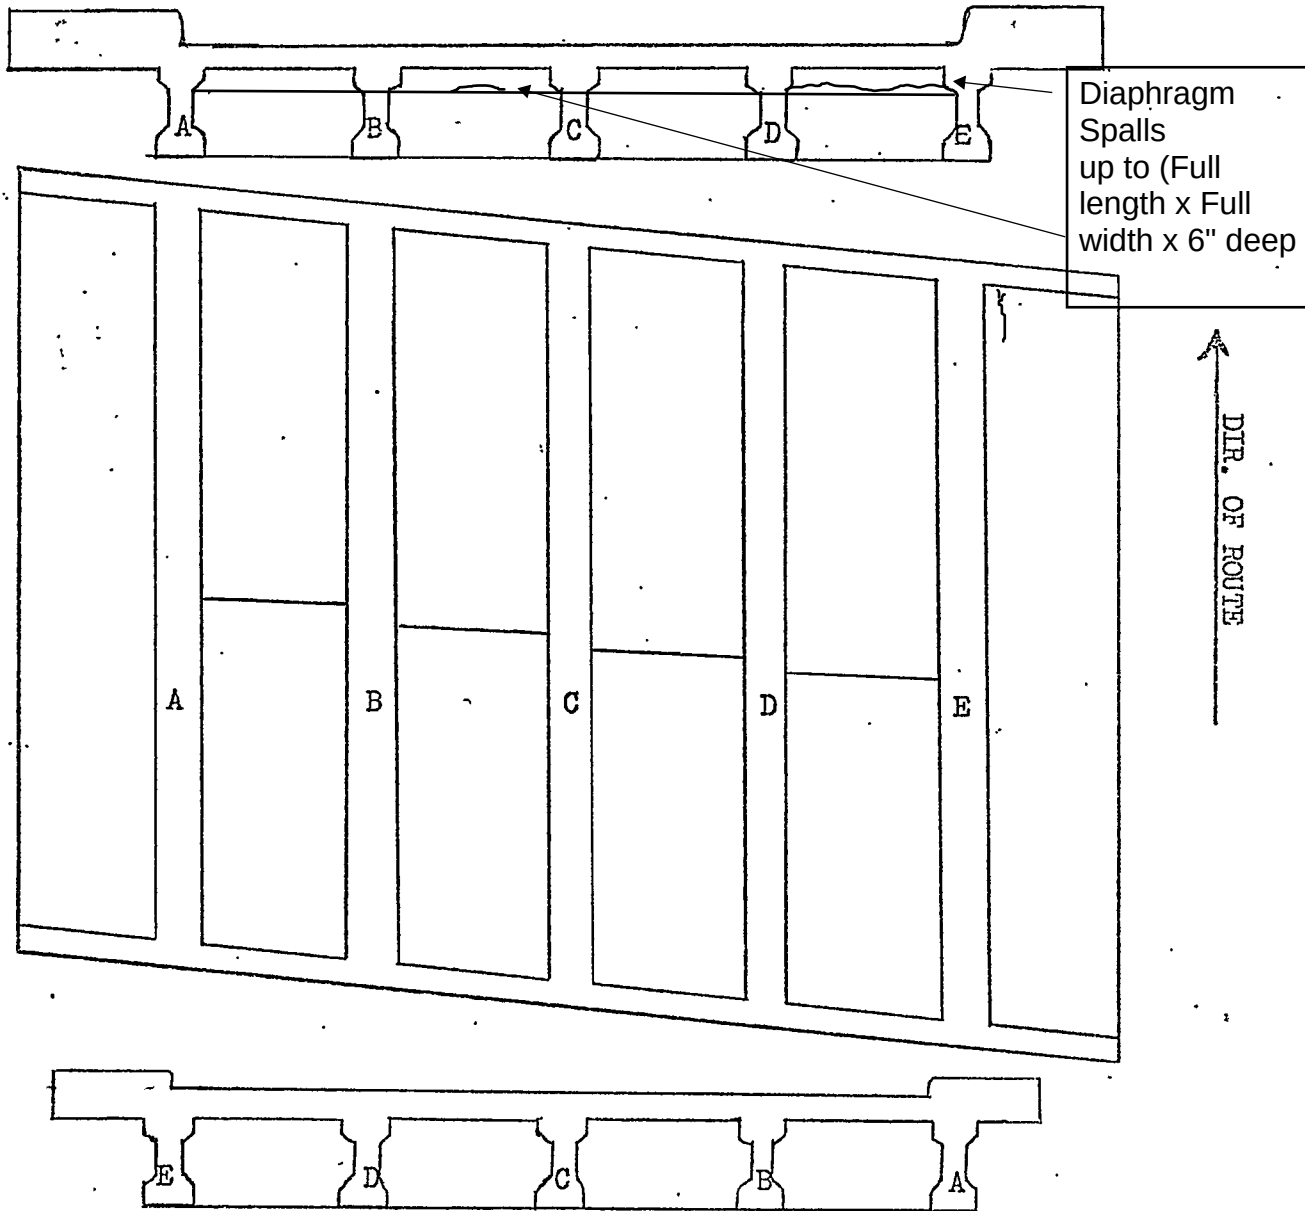
BR. NO. 57 I-40 7.54 SK. 62° LT. SPAN NO. 4

Abutment End Diaphragms typically show minor to moderate spalling to undersides (with exposed rebar)  
Bay D major spall (Full length x Full width x up to 6" D) with exposed corroded rebar
