Region 01, 53 - Loudon County

I-75 Crossing NFA 1247 KINGSTON ST

90 - LAST INSPECTION DATE 09/11/2024

| IDENTIFICATION | |
|---|---|
| (8) Structure Number | 53I00750034 |

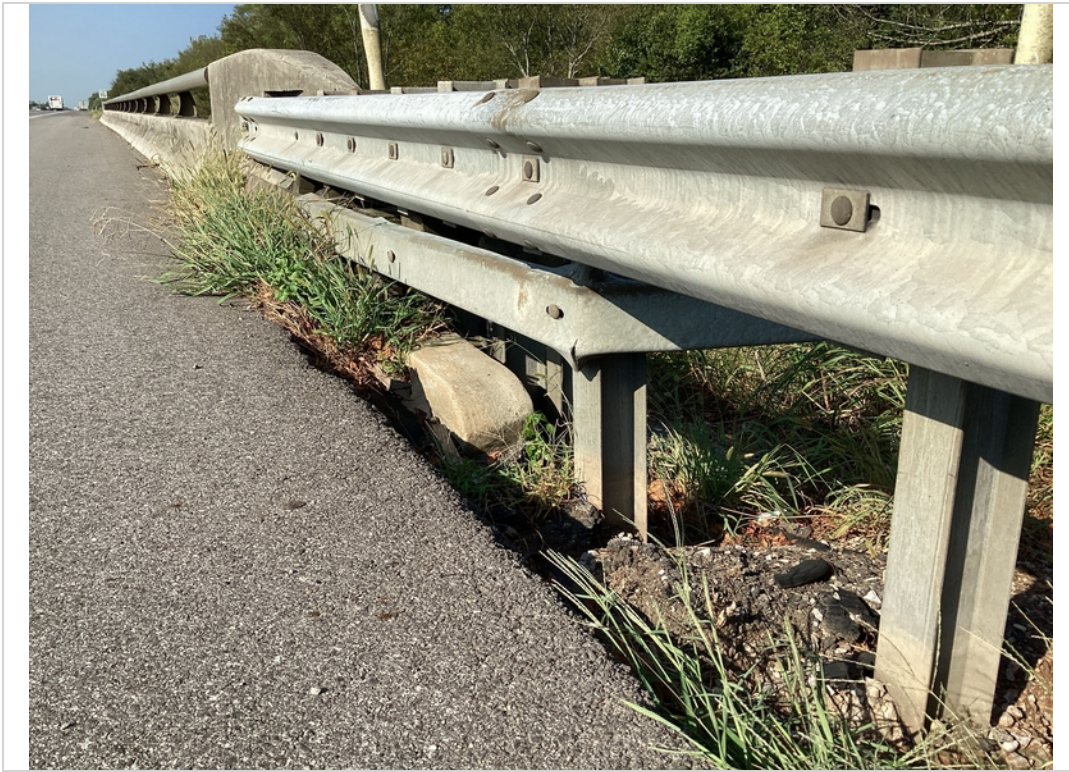
Transitions Rating (Fair) SUBSTANDARD, collision damage to rub rail at approach 2 left

Approach 2 left transition rub rail - collision damage

| Date Added | Recommendation | Priority |
|---|---|---|
| 09/11/2024 | REPAIR APPROACH 2 LEFT RUB RAIL | |

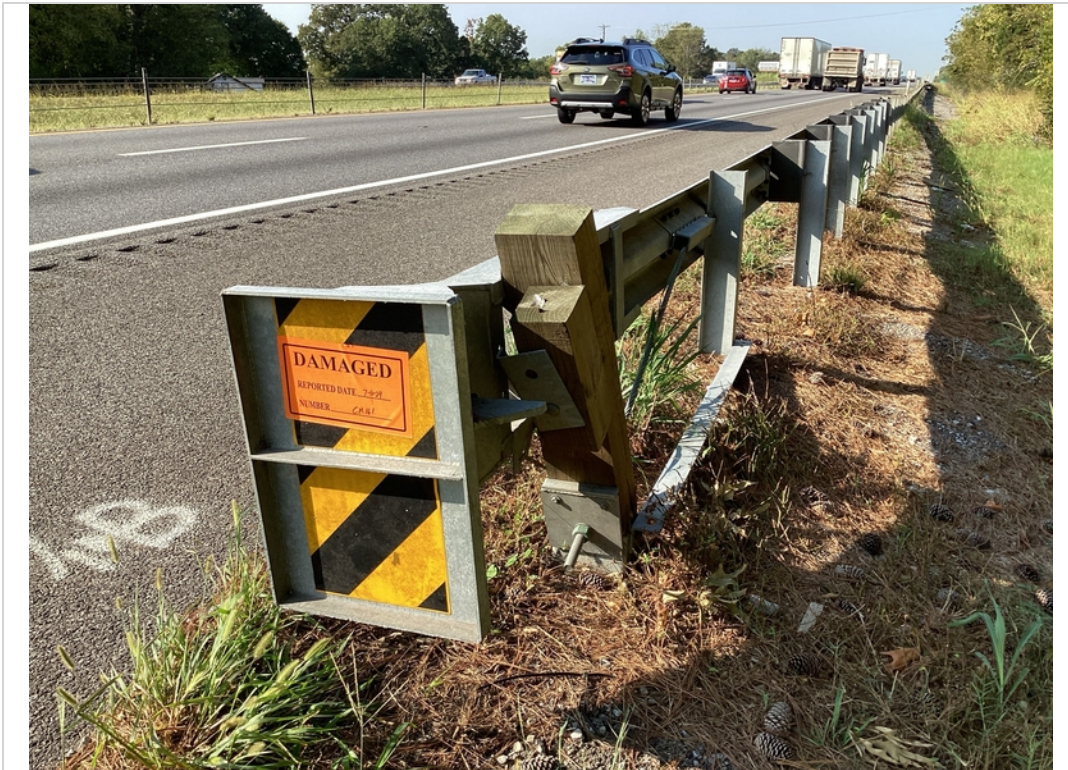
Guardrail Terminal Rating (Poor) STANDARD, collision damage approach 2 left

Approach 2 left rail - collision damage

| Date Added | Recommendation | Priority |
|---|---|---|
| 09/11/2024 | REPAIR APPROACH 2 LEFT TERMINAL | |

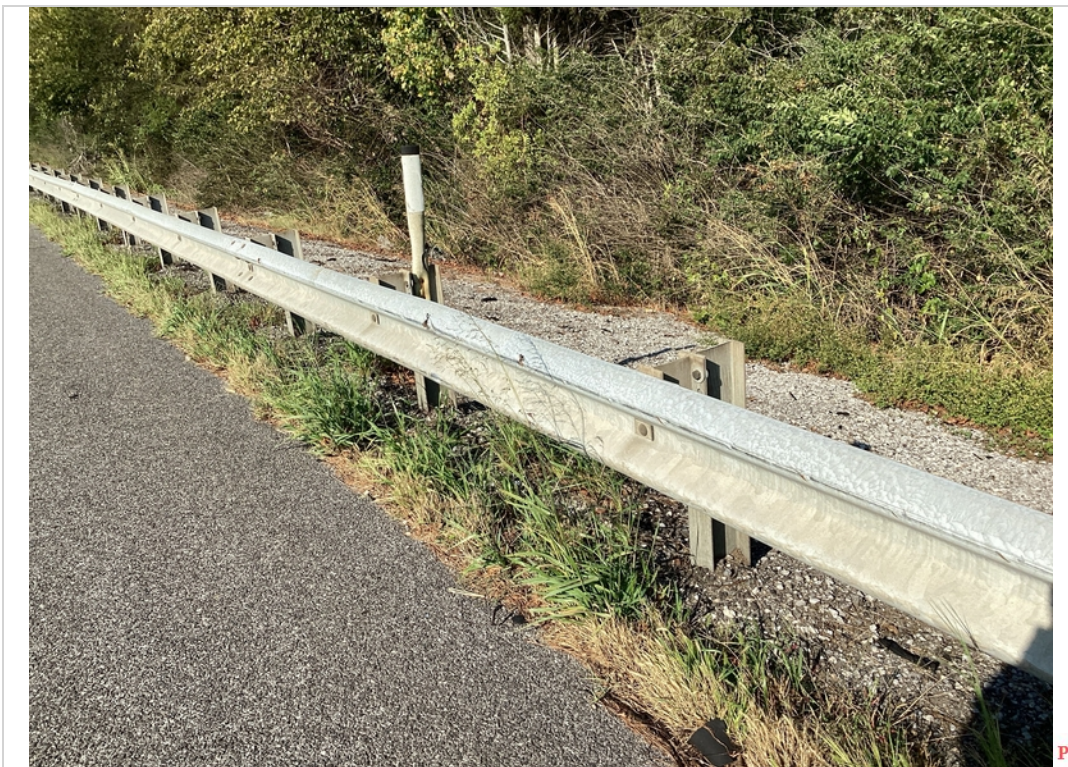
Approach 2 left rail - collision scrapes

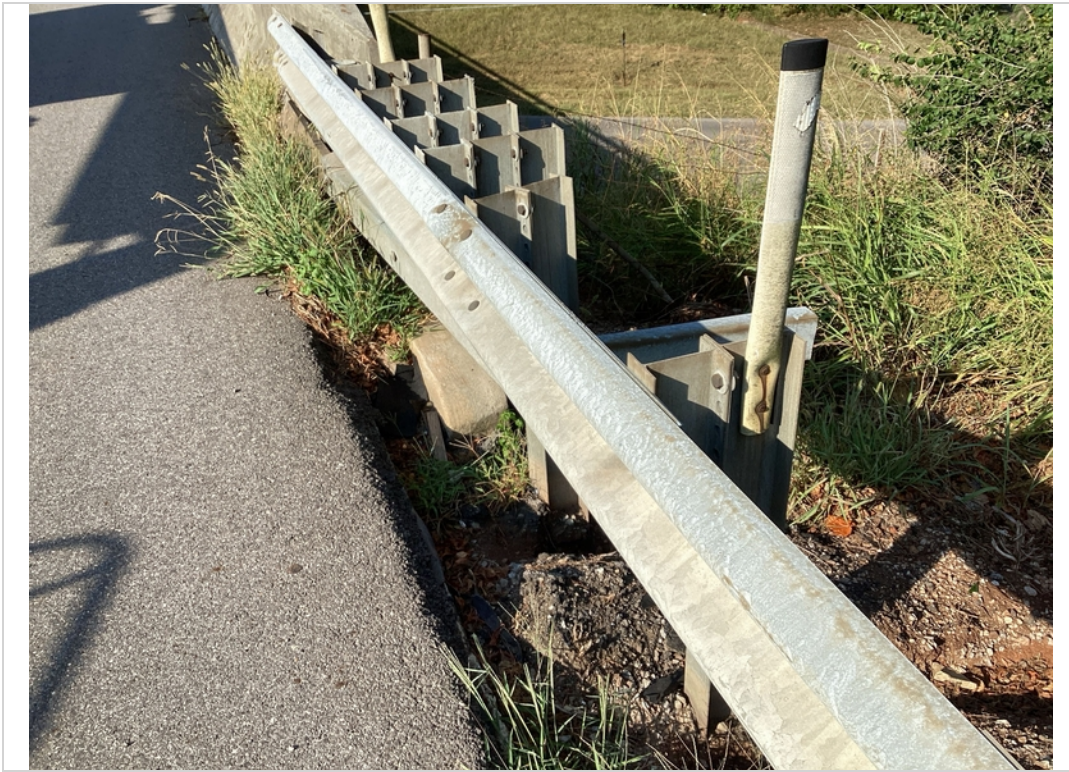
Moderate erosion ditches at approach 2 left

Approach 2 left embankment - moderate erosion ditches

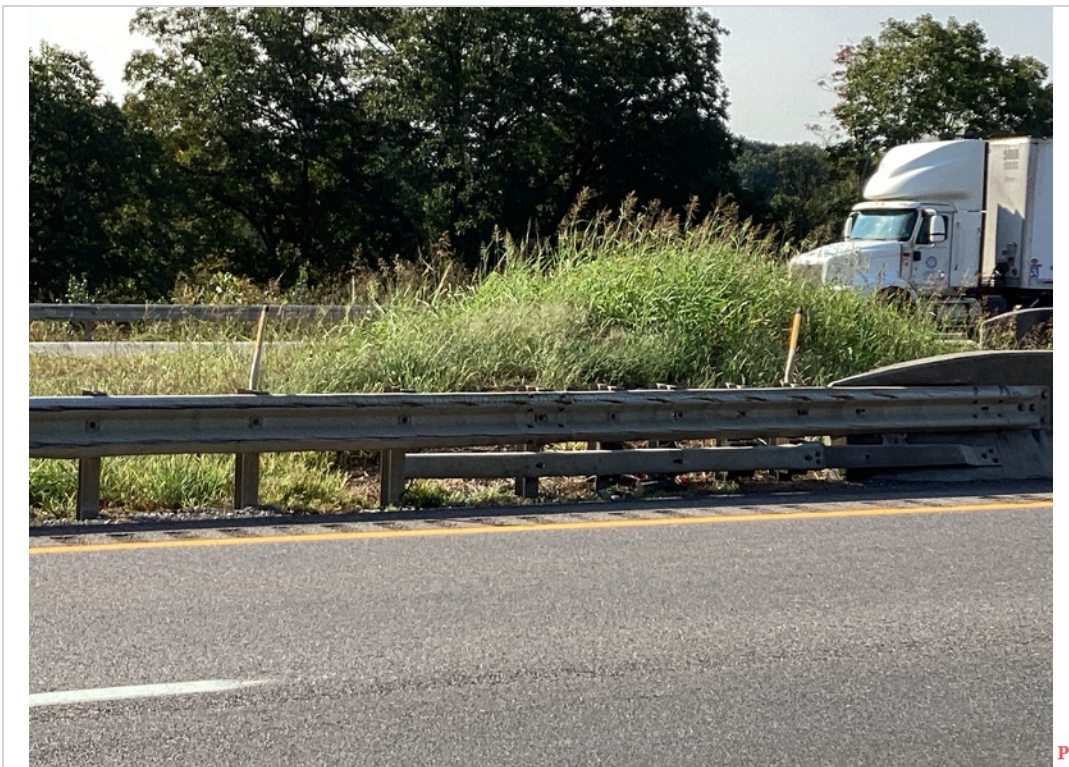
Approach 2 right rail - tire marks

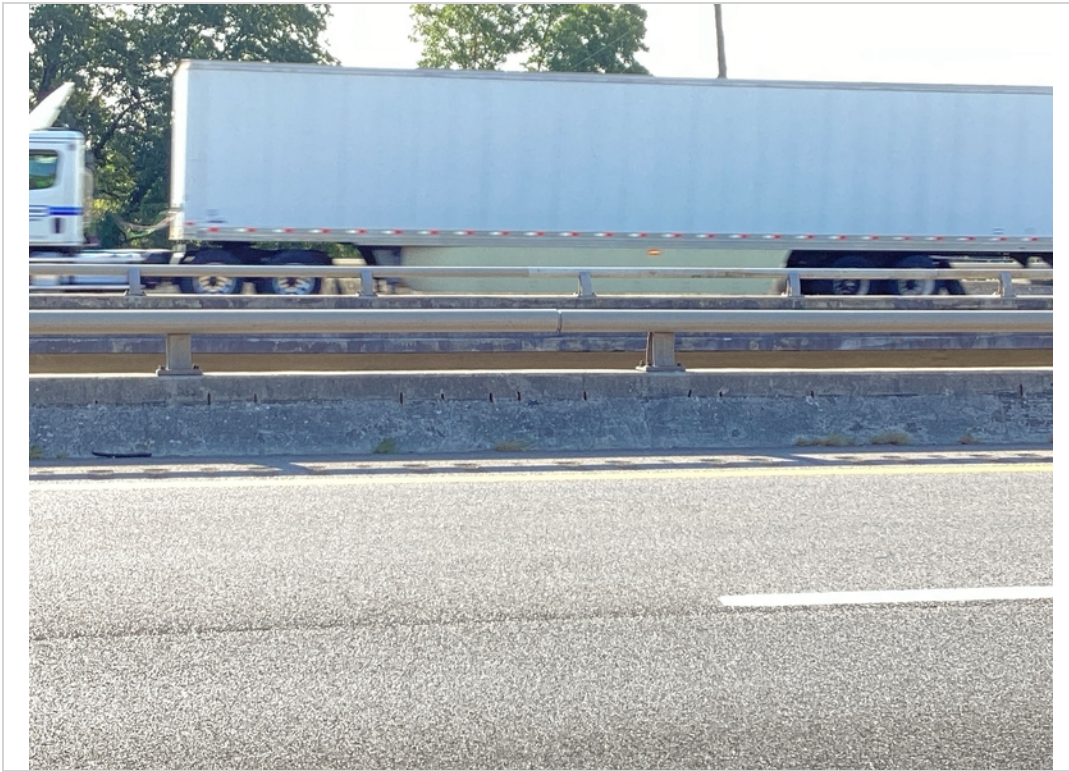
Deck wearing surface is good, asphalt overlay. Bridgerails are good, substandard, popouts, and scrapes.

Deck 1 right rail - popouts

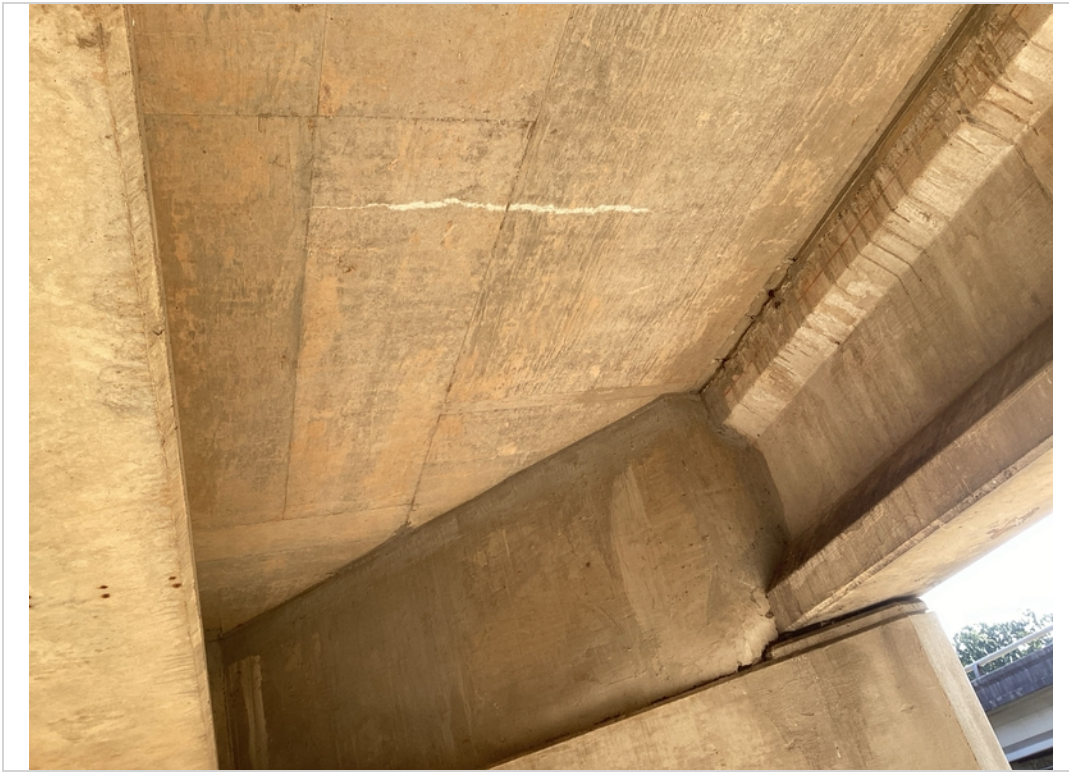
| Wearing Surface Type | | Asphalt | Wearing Surface Depth | 6 |
|---|---|---|---|---|
| Deck - Structural Condition | (Good) | Bottom deck span 1 - Hairline cracks w/ leaching | | |

Bottom deck span 1 - Hairline cracks w/ leaching

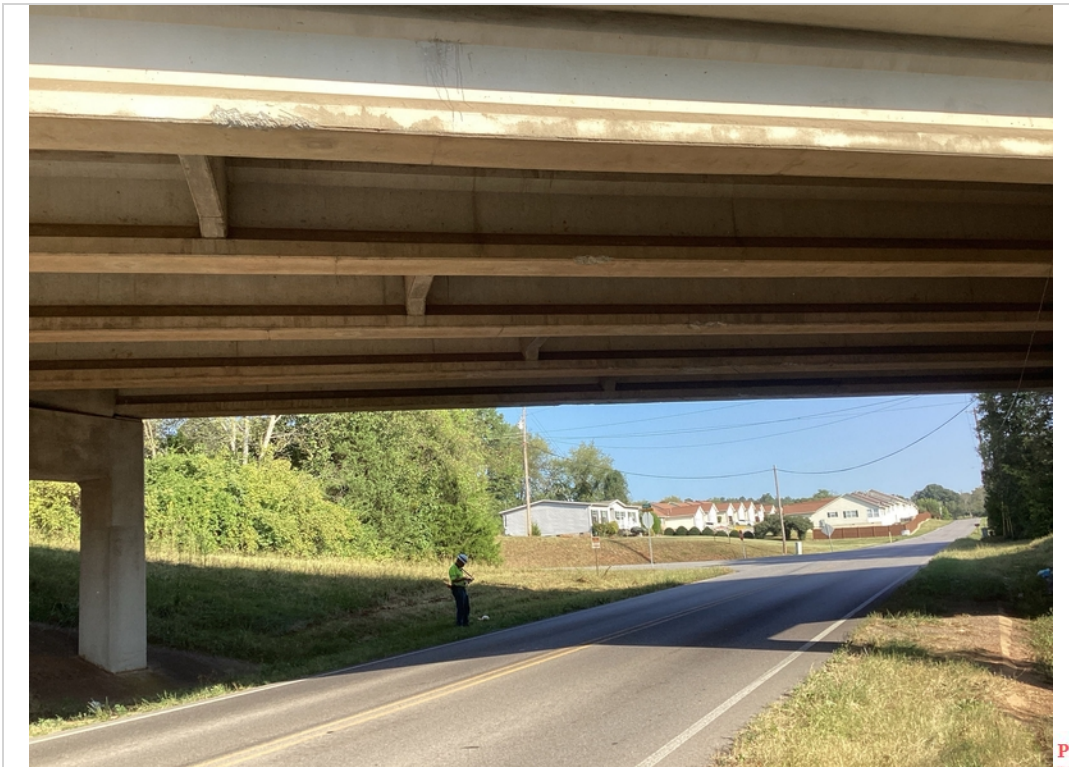
| Beams | (Fair) | Span 2 beams with areas of collision damage- scrapes, spalls up to 2' long and 1" deep; Span 2 beam A left side has area of recent collision damage to a previously repaired area with 2' long spall up to 1" deep, hairline crack on left side of lower flange, and scrapes. All beams span 1&3 filler - Hairline cracks | | |

Beam A thru E right span 2 - Collision damage w/ scrapes & spalls up to 2' long 1" deep

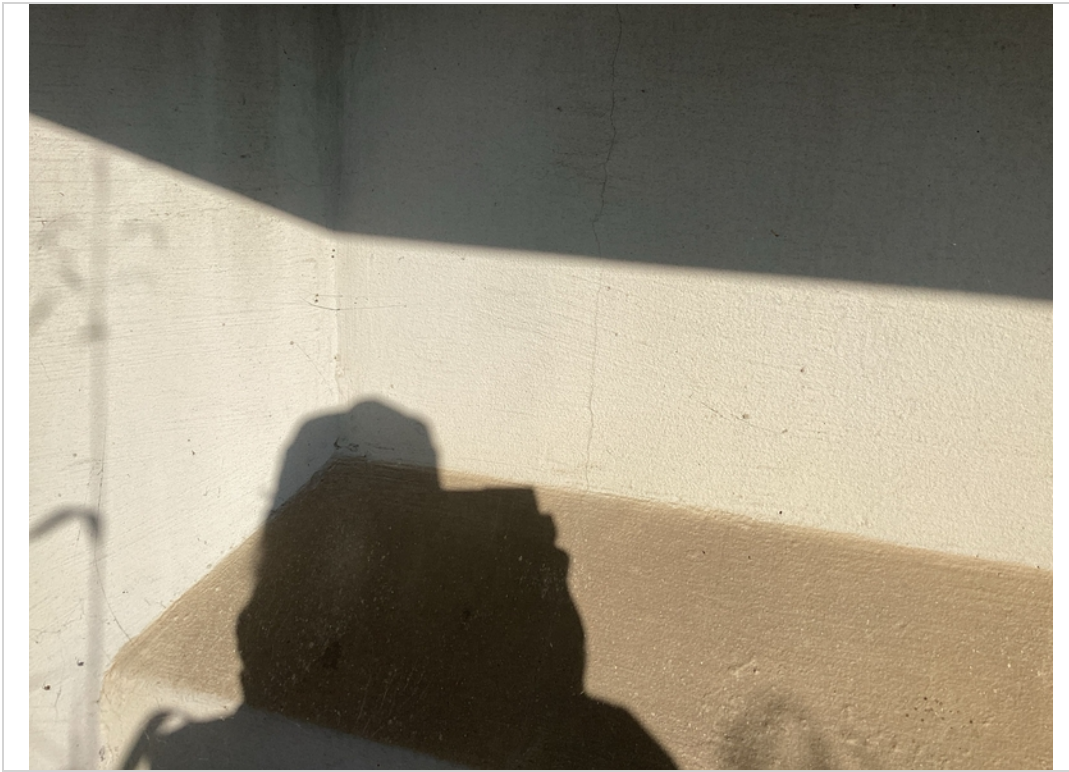
Beam E filler span 1 - Hairline crack (Typical all beams span 1&3)

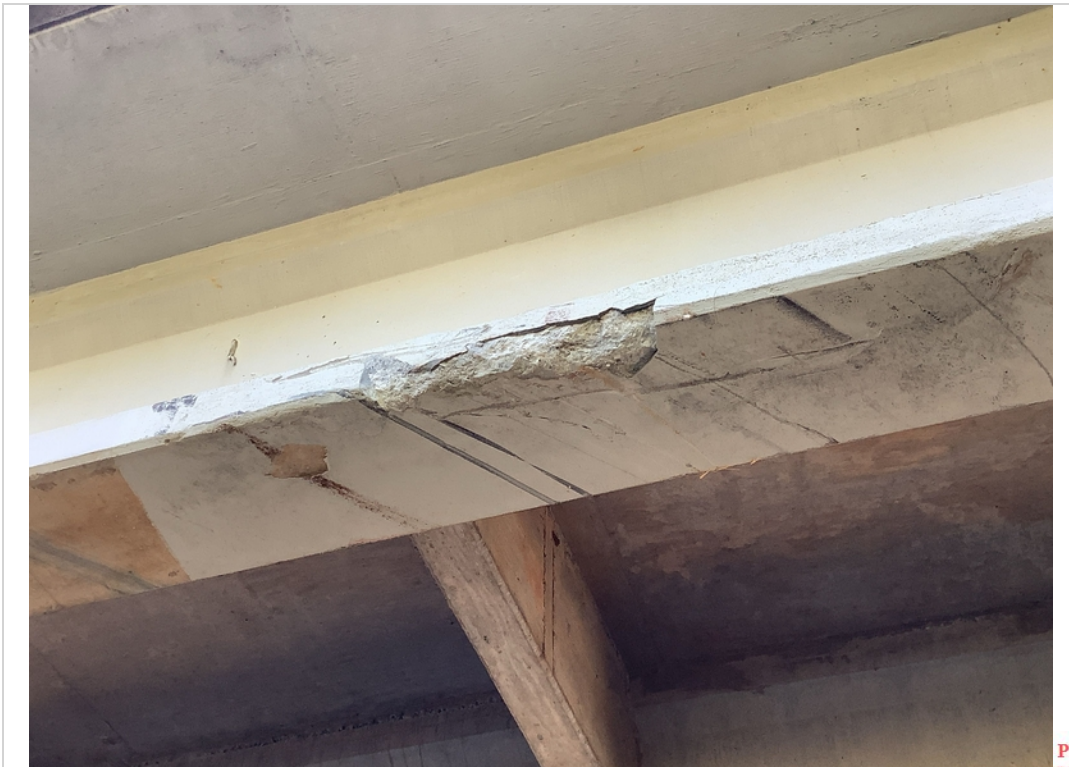
Span 2 beam A left side - spall (2' l x 6" w x 1" deep)

| Date Added | Recommendation | Priority |
|---|---|---|
| 03/02/2023 | Repair span 2 beam A lower flange | |

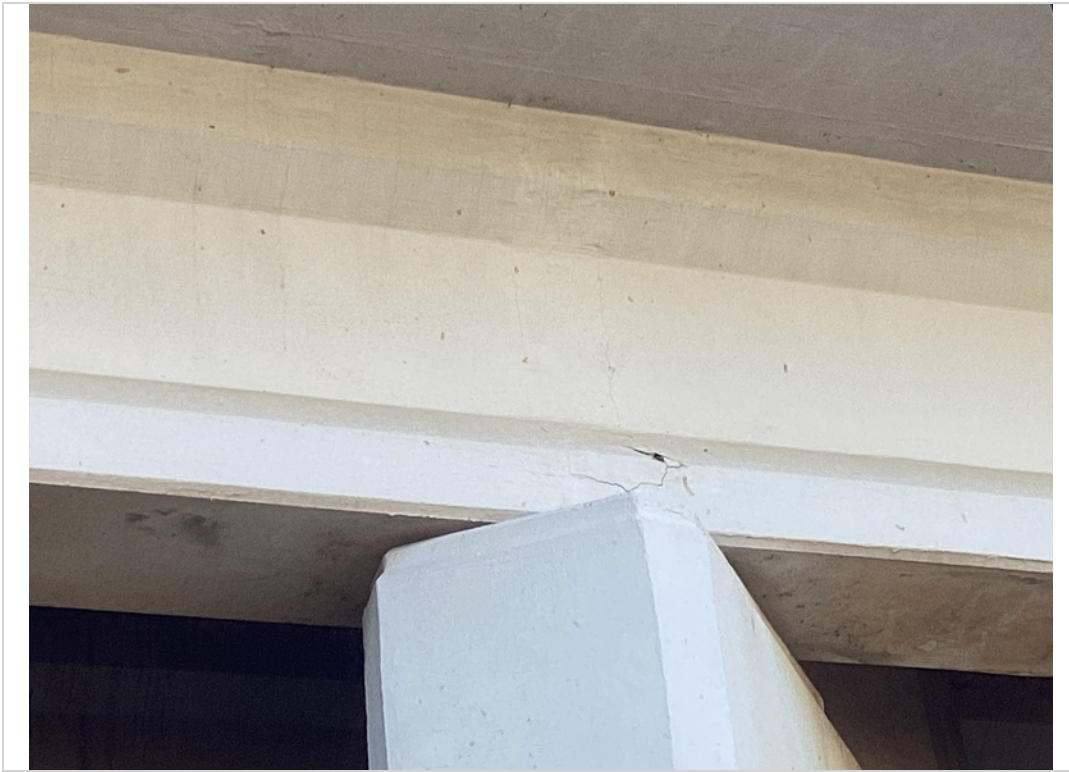
| Diaphragms | (Good) | Filler over bents - Hairline cracks | | |

Beam A over bent 2 diaphragm filler - Hairline cracks (Typical other diaphragms over bents)

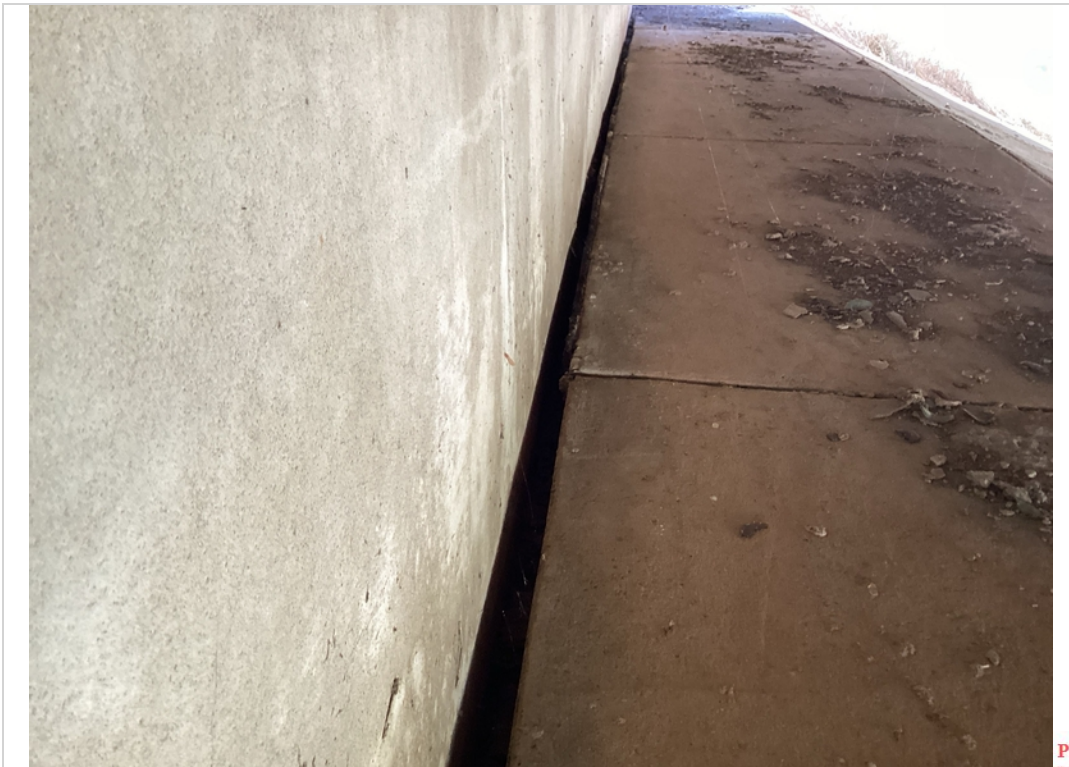
| Abutment Slope Paving | (Good) | 2" separation at berm |

Abutment 2 slope pavement - " separation (typical)

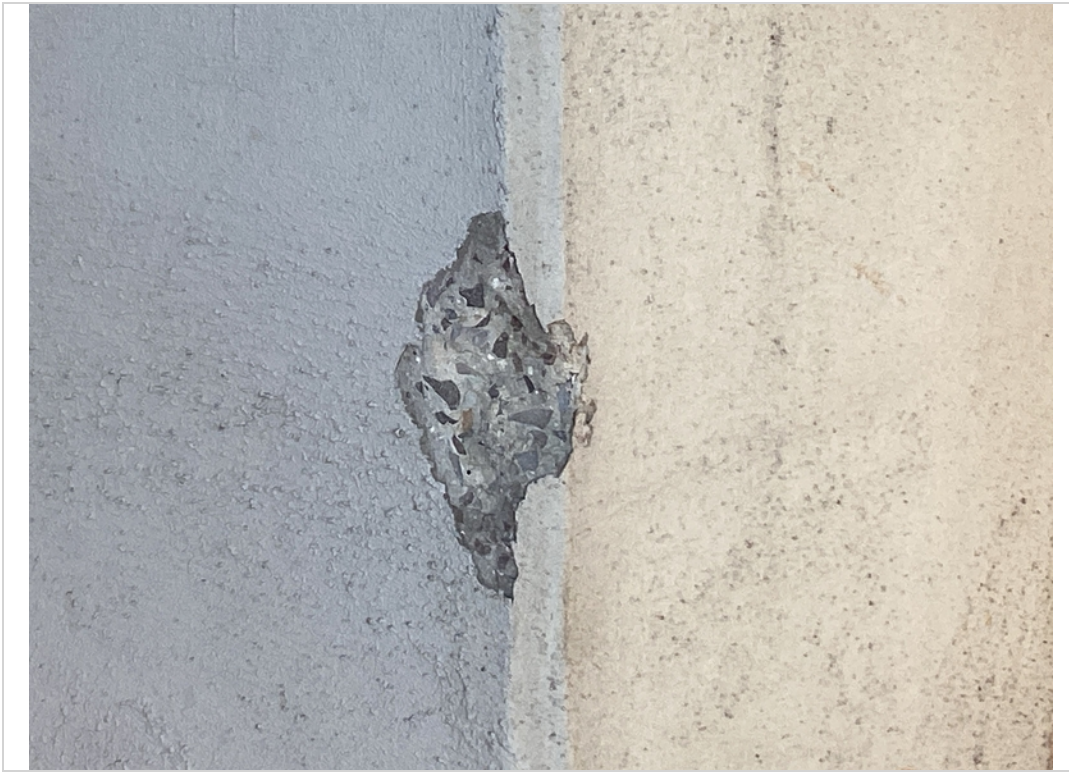
| Bent Columns | (Good) | Bent 2 - column B - minor spall |

Bent 2 column B front - spall (6" diameter x 2"Dp)

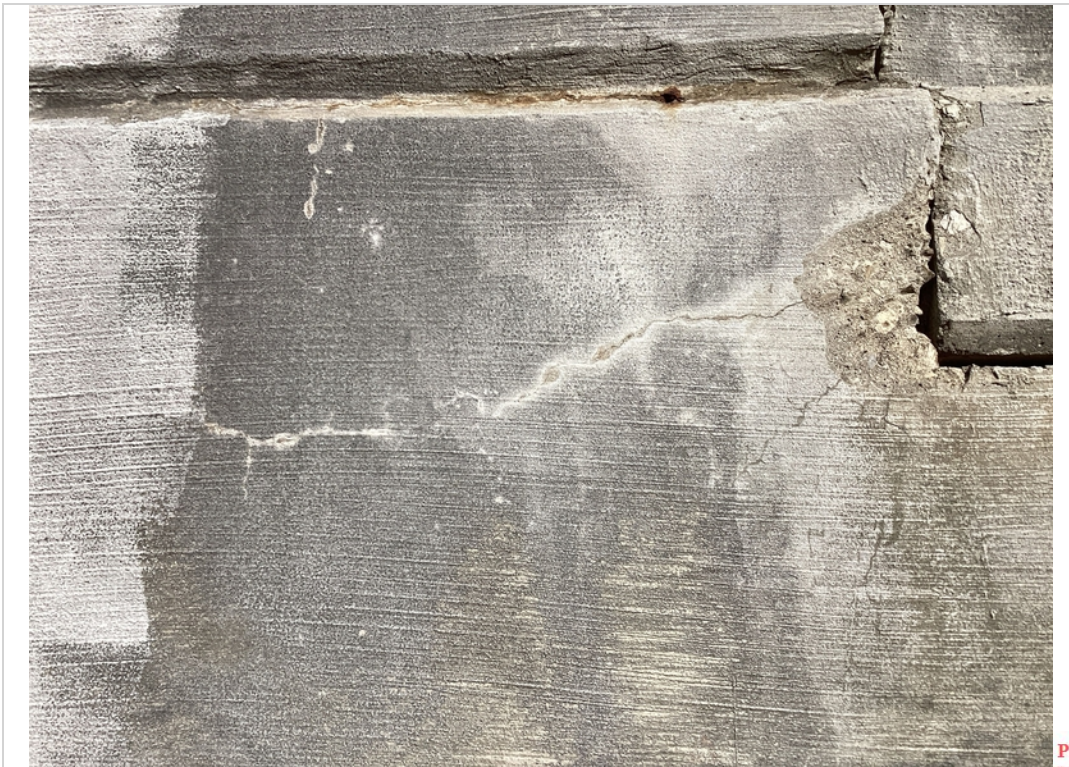
| Abutment Wings | (Good) | Hairline cracks with leaching ; minor spall |

Wing 1 right - Hairline cracks with leaching - spall ( 4" diameter x 1/2" Dp)

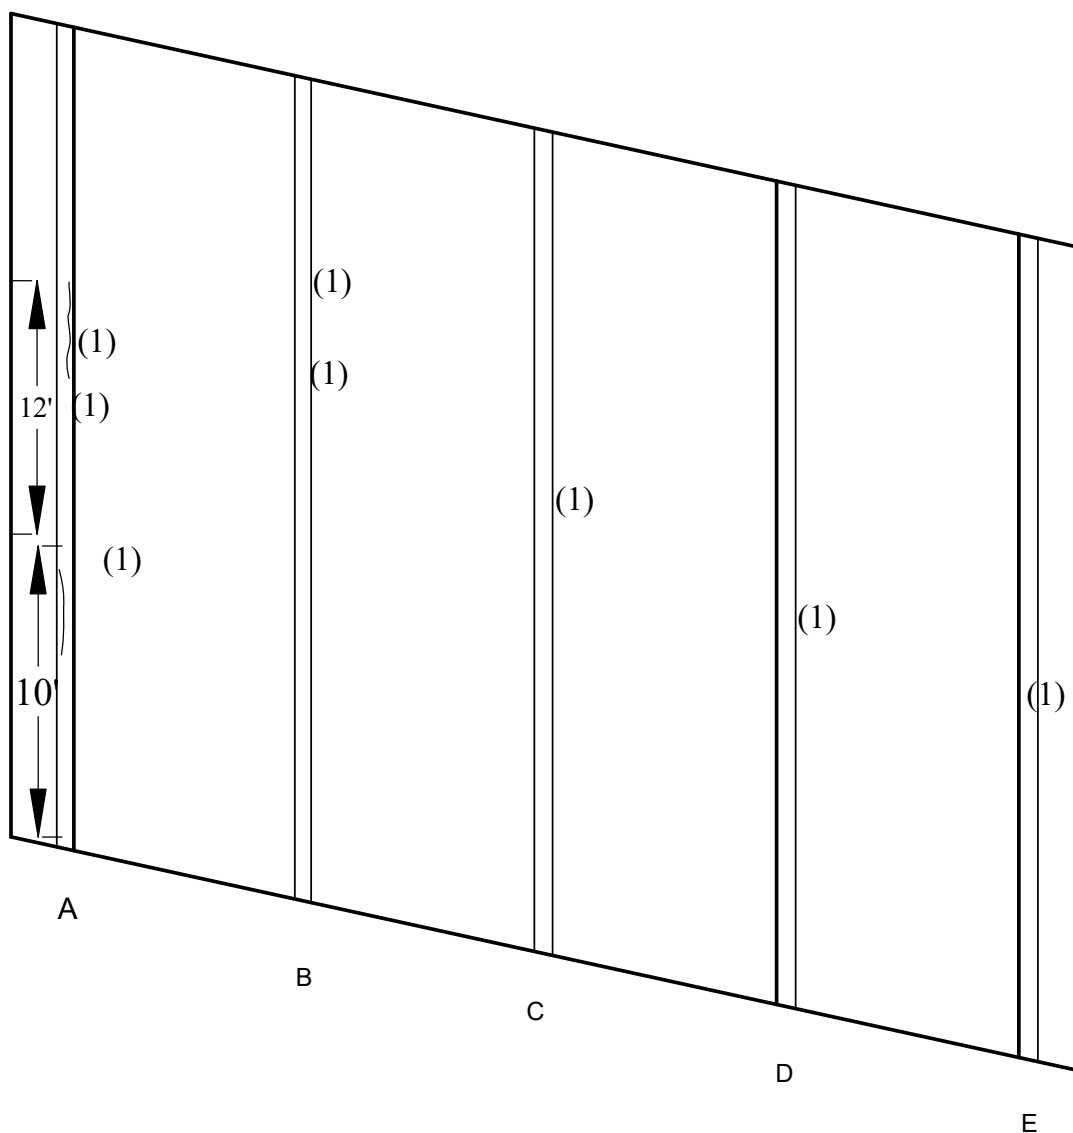
SPAN 2

| Beams | G | (1) BEAMS A-E - COLLISION DAMAGE UP TO 2' LONG x 1" DEEP |
| Diaphragms | G | HAIRLINE CRACKS IN FILLER |
