US-321 Crossing SR 73 RL / I75

90 - LAST INSPECTION DATE 09/11/2024

| IDENTIFICATION | |
|---|---|
| (8) Structure Number | 53100750035 |
| (6) Features Intersected | SR 73 RL / I75 |

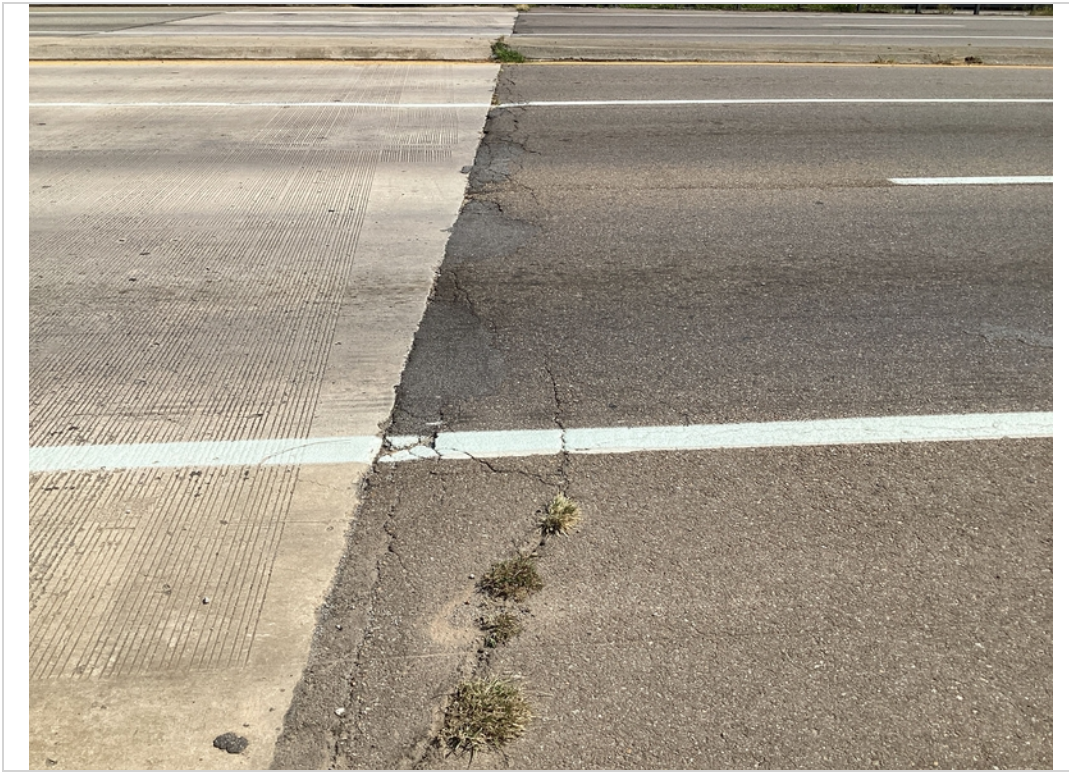
Approach 2 right lane wearing surface - patches, cracks to 1/8", areas ready to spall

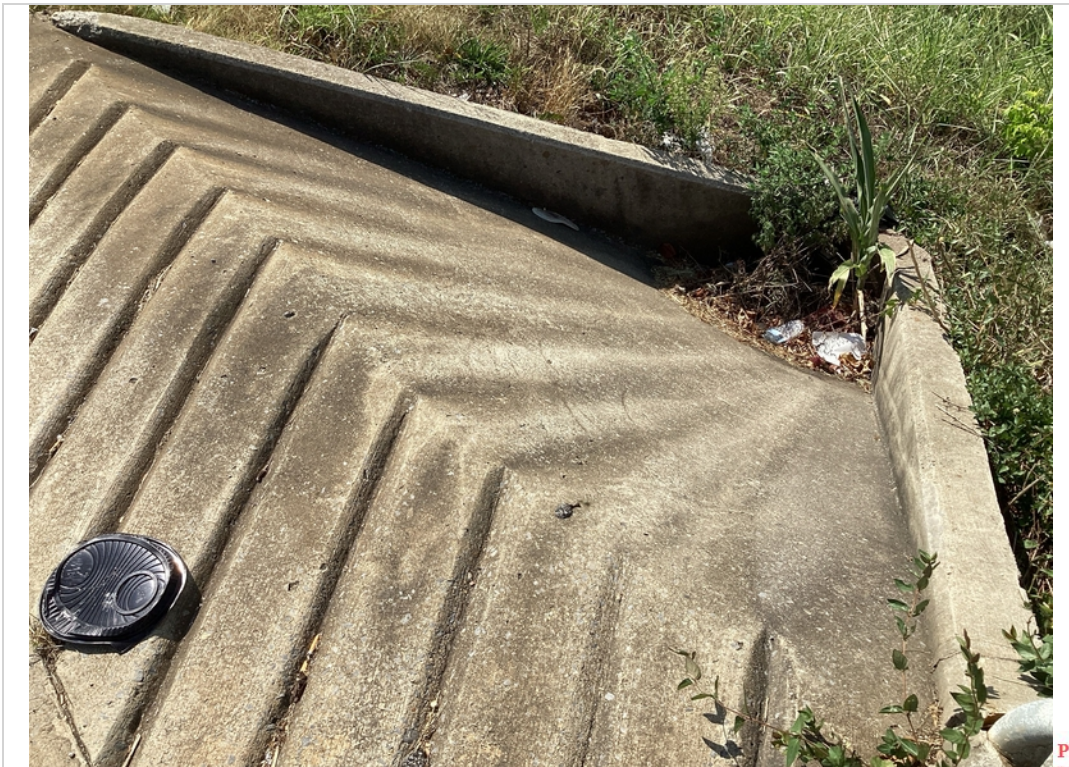
Approach 2 right drain - plugged

| Date Added | Recommendation | Priority |
|---|---|---|
| 08/30/2006 | CLEAN APPROACH 2 RIGHT DRAIN | |

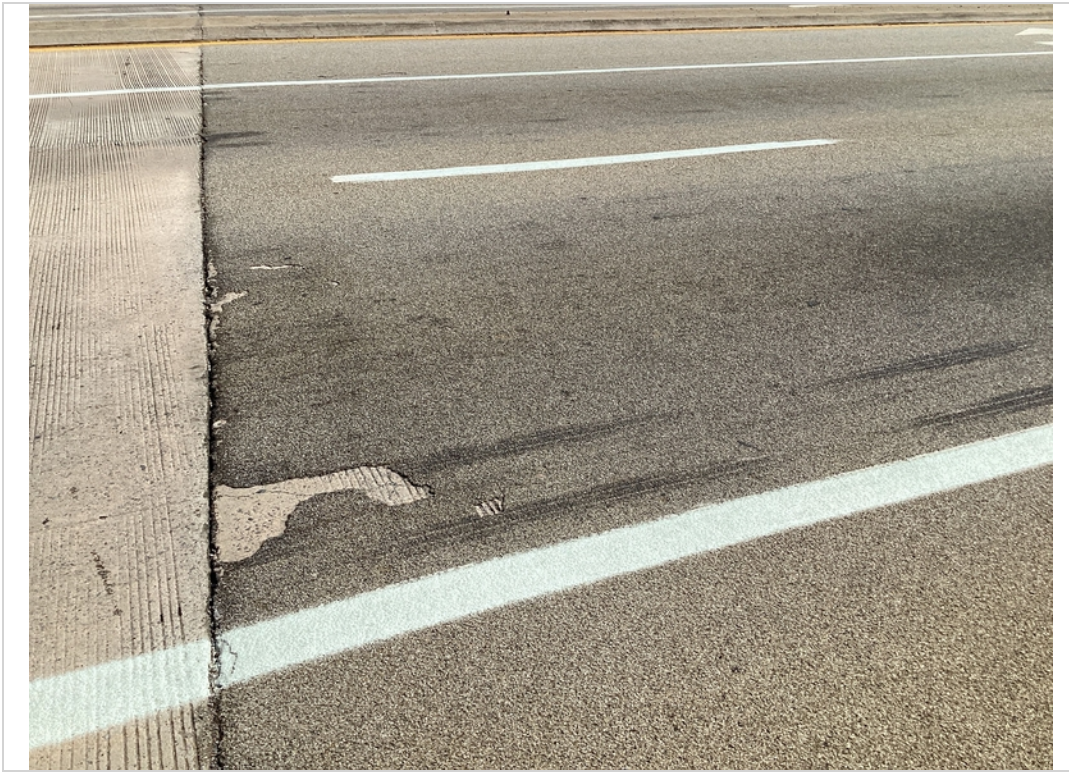
Deck 1 right lane - epoxy wearing surface scaled off

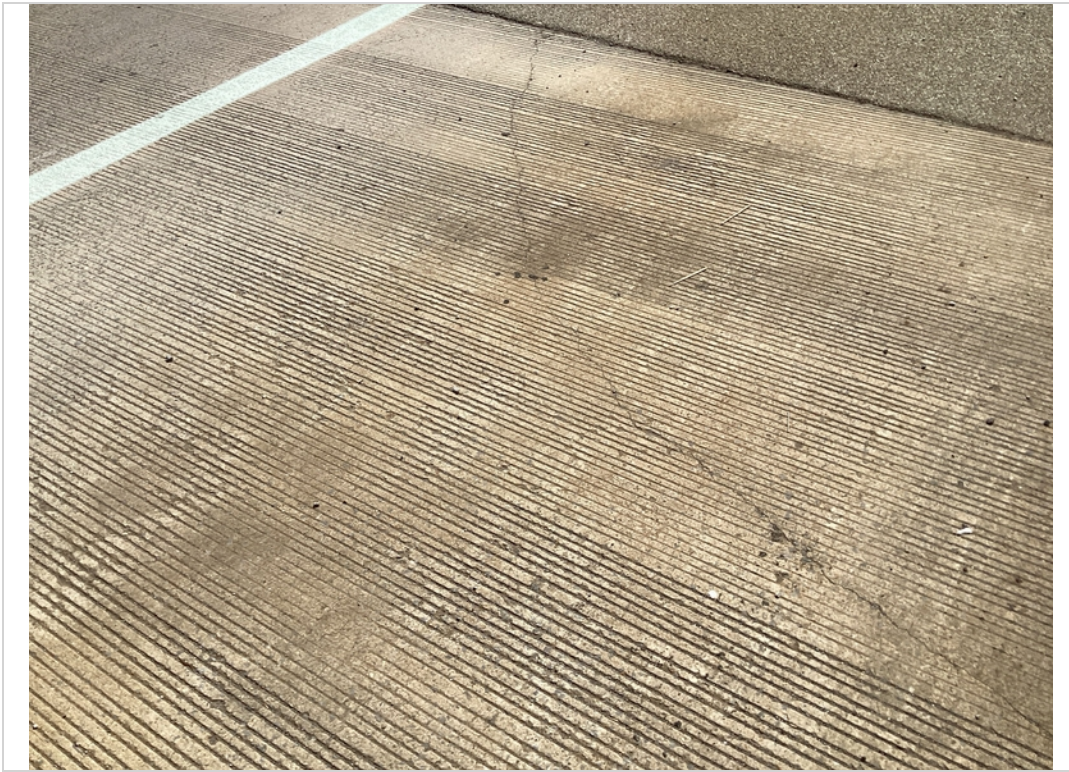
Approach 1 slab right lane - hairline crack

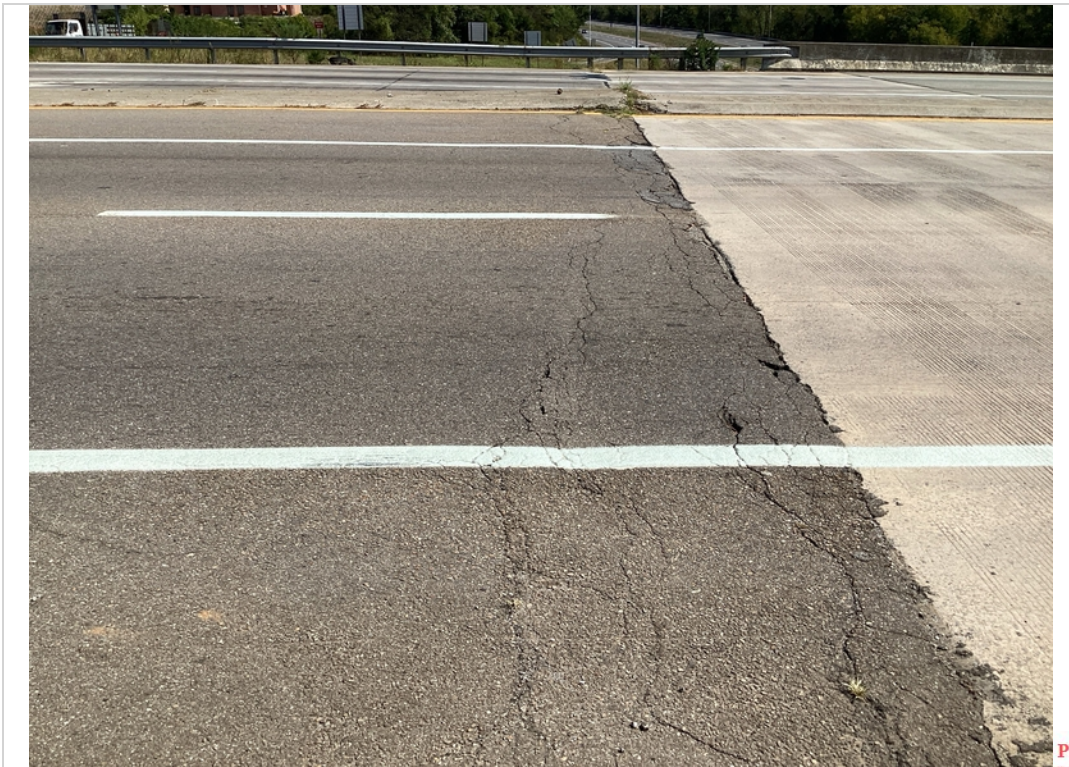
Approach 1 right lane wearing surface - patches, cracks to 1/8", areas ready to spall

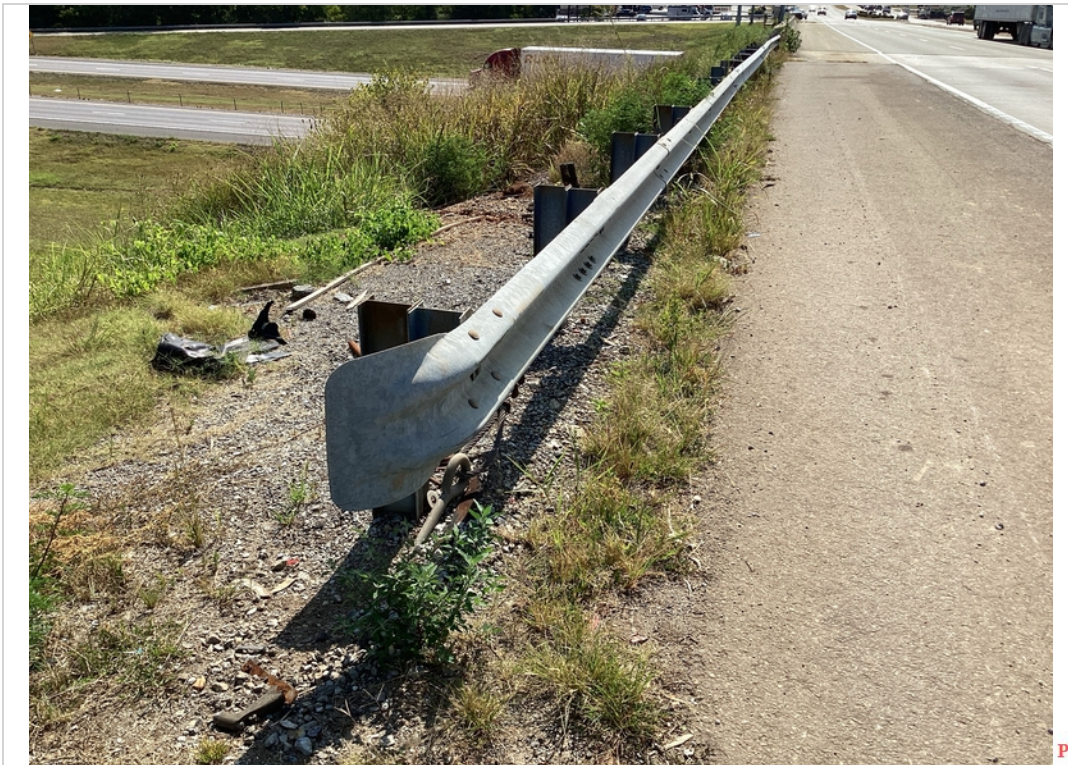
Approach 1 left rail terminal- substandard

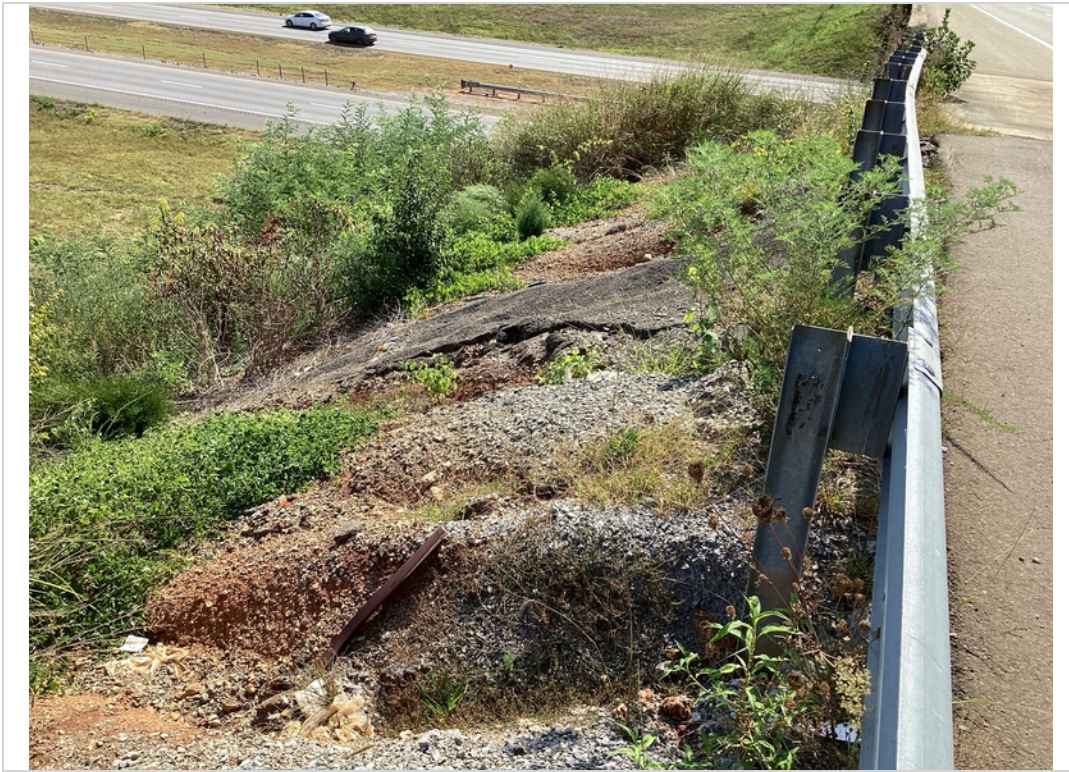
Embankment (Poor) EROSION DITCHES AT APPROACH 1 LEFT AND RIGHT AND APPROACH 2 LEFT, FEW DITCHES WITH ASPHALT ADDED

Approach 1 left embankment - erosion ditches, some with asphalt added

| Date Added | Recommendation | Priority |
|---|---|---|
| 09/23/2022 | REPAIR EROSION AT APPROACH 1 RIGHT AND LEFT EMBANKMENTS | |

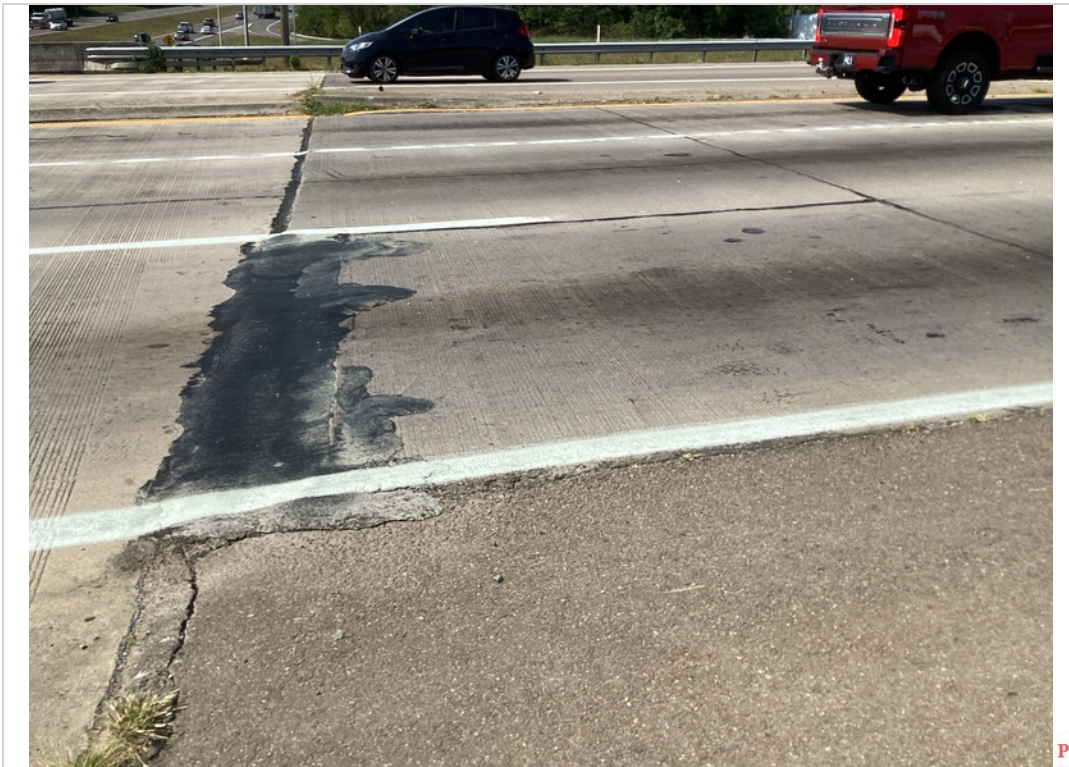
Approach 1 slab left lane - patched area

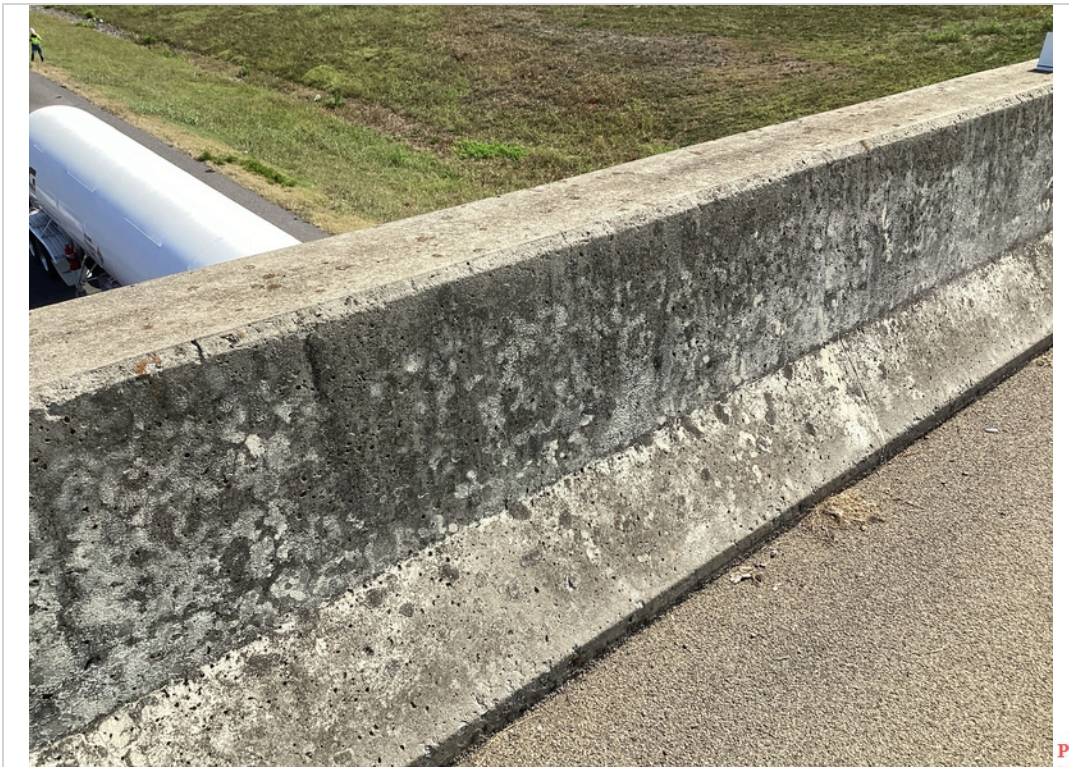
Deck 3 left rail - hairline cracks, aggregate voids (typical all)

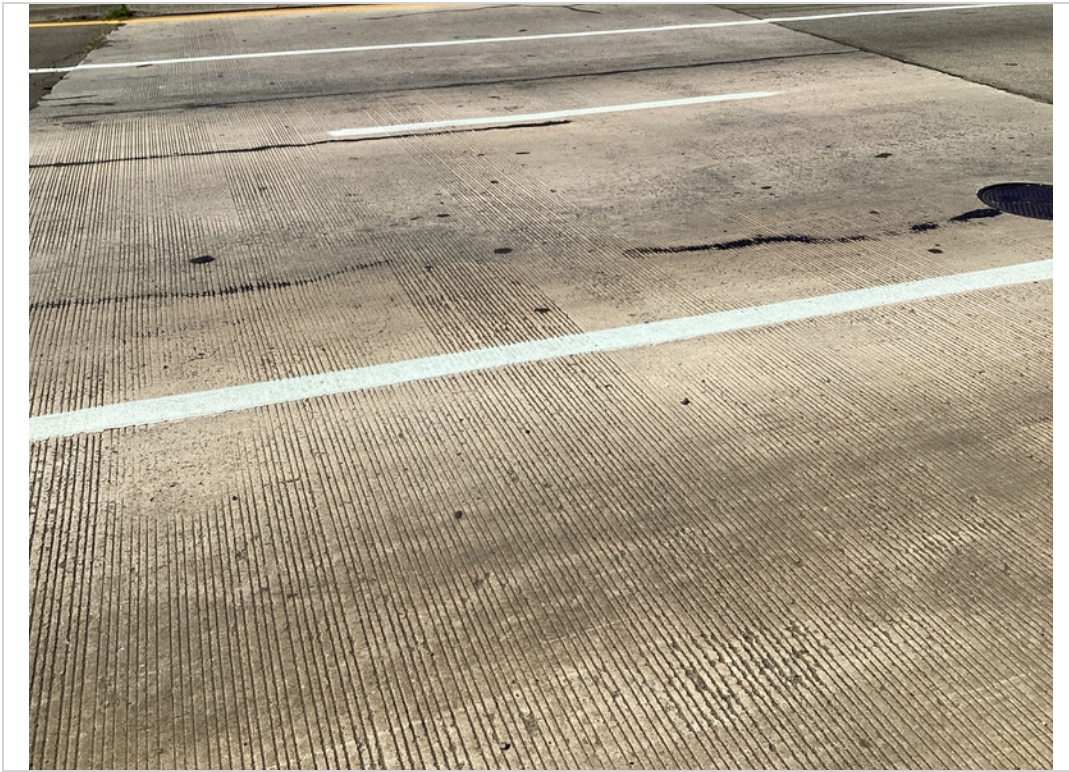
Approach 2 slab left lane - hairline cracks sealed

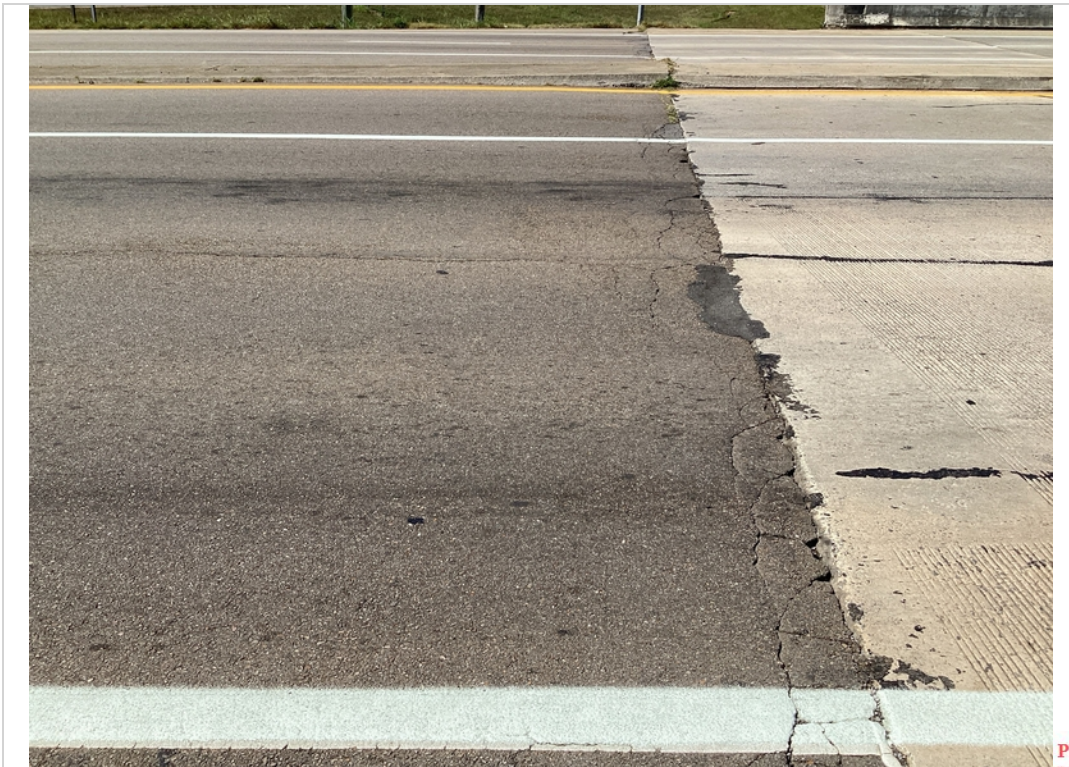
Approach 2 left lane wearing surface - patches, cracks to 1/8", areas ready to spall

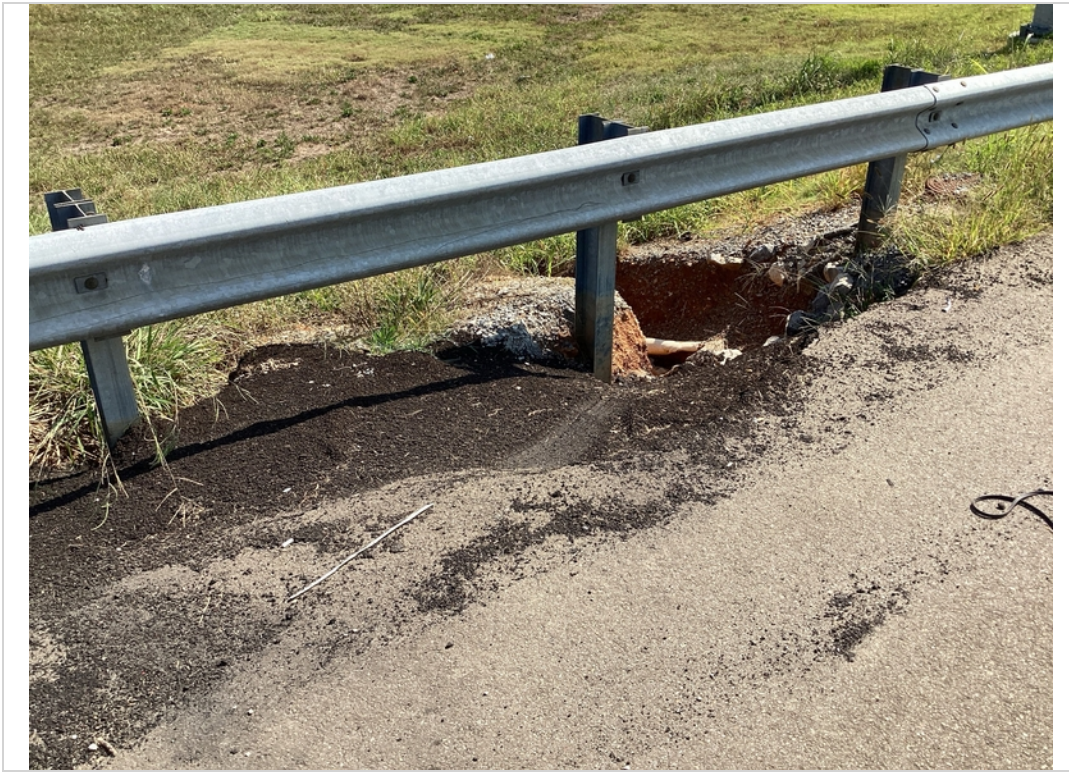
Approach 2 left embankment - erosion ditches with asphalt patch

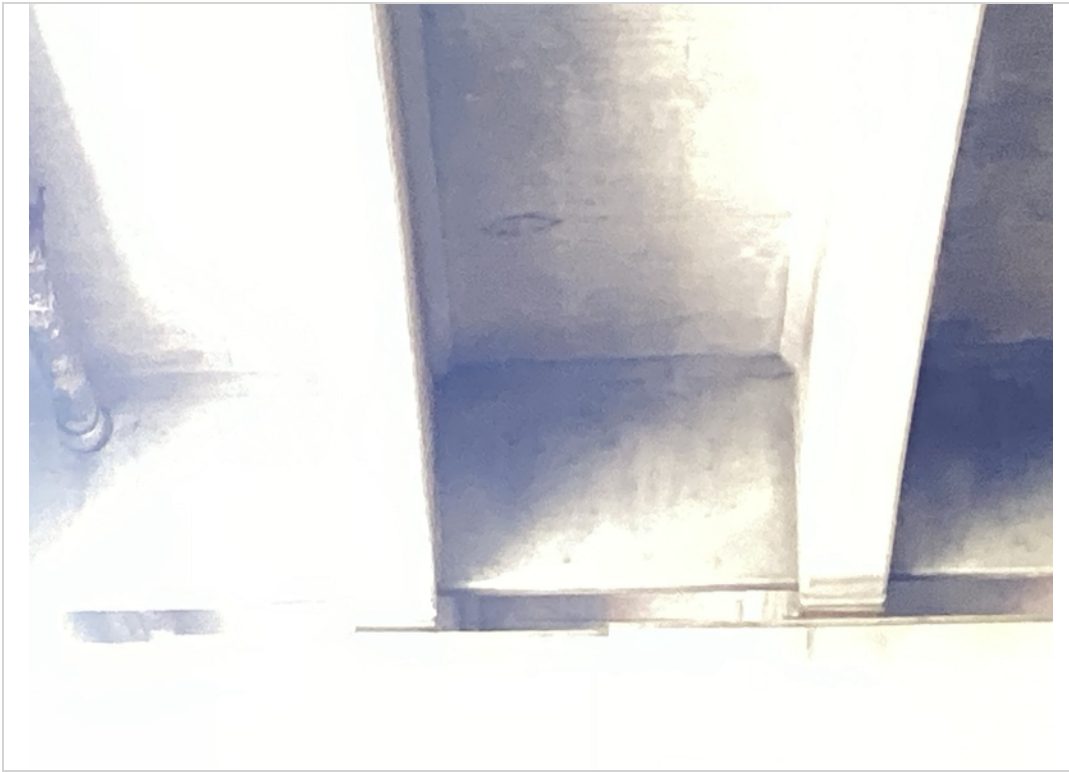
Bottom deck span 2 between beams C/D - In place spall (1' diameter)

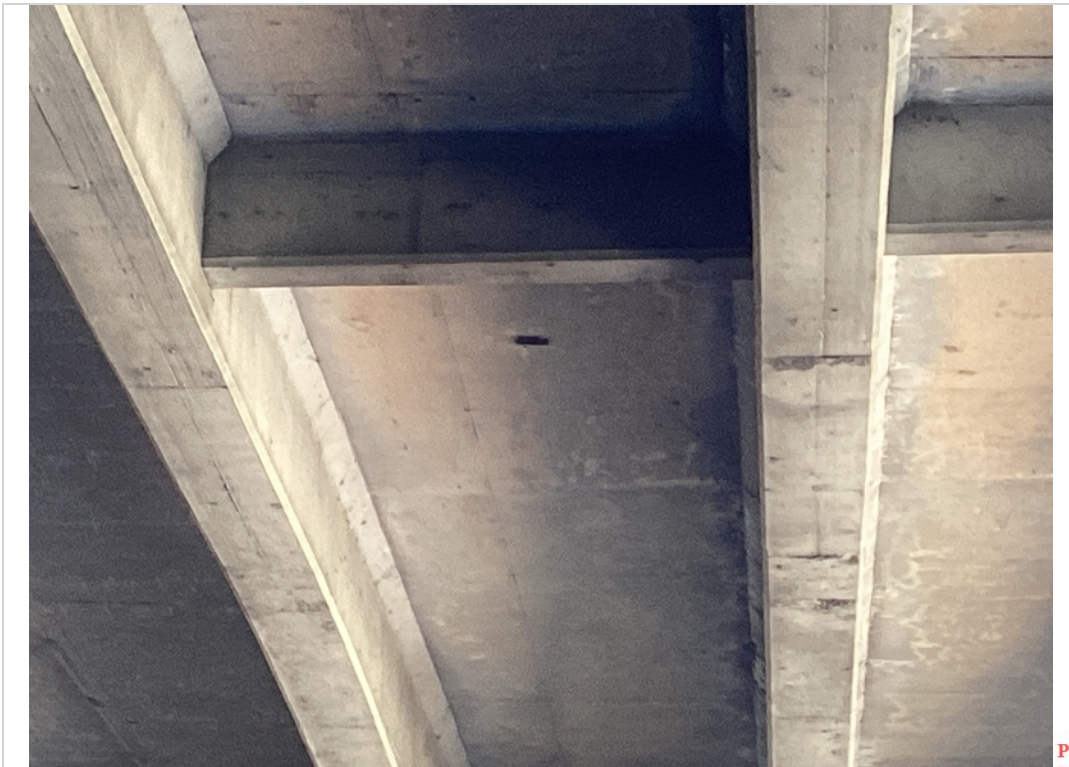
Bottom deck span 3 between beams D/E - Popout

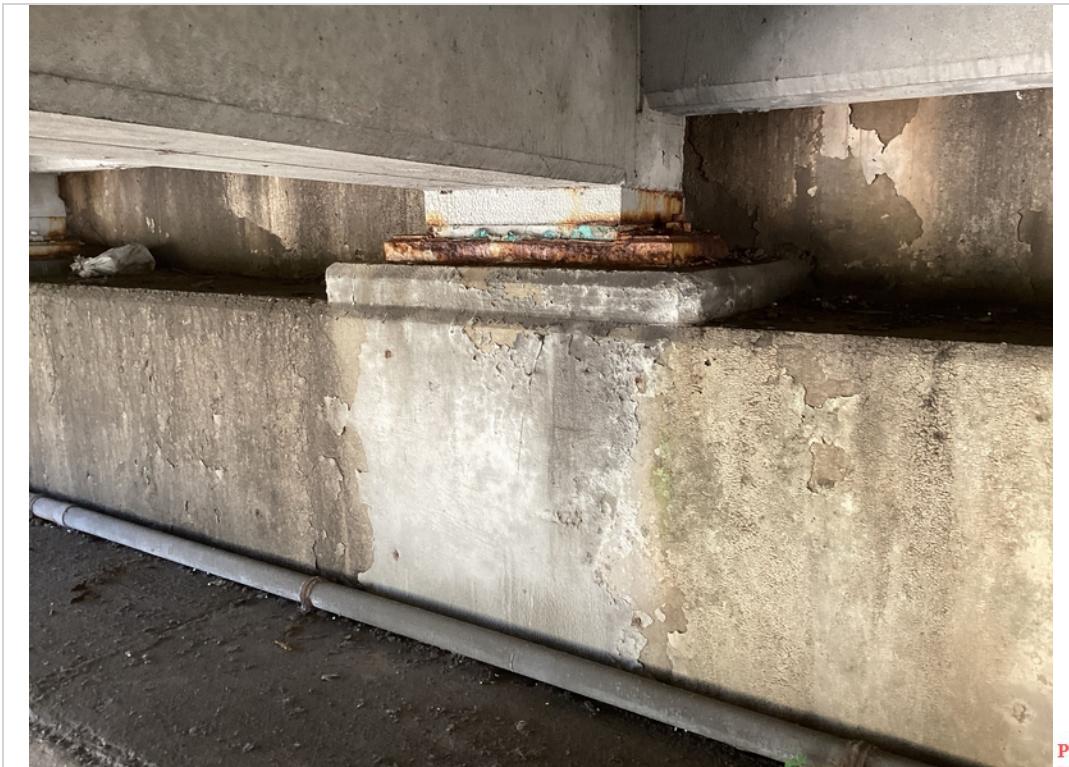
Bearing C abutment 2 - Moderate corrosion (Typical other bearings both abutments)

| Date Added | Recommendation | Priority |
|---|---|---|
| 09/11/2024 | CLEAN AND PAINT ABUTMENT BEARINGS | |

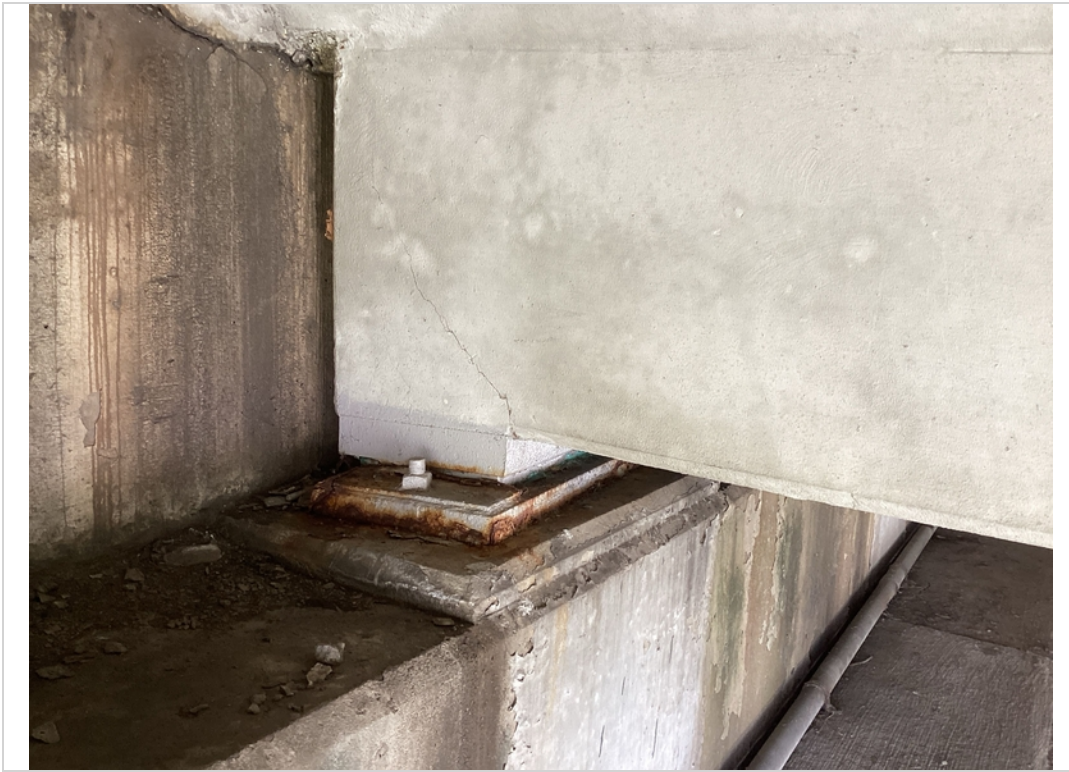
Span 1 Beam K right at abutment 1 - Diagonal hairline crack

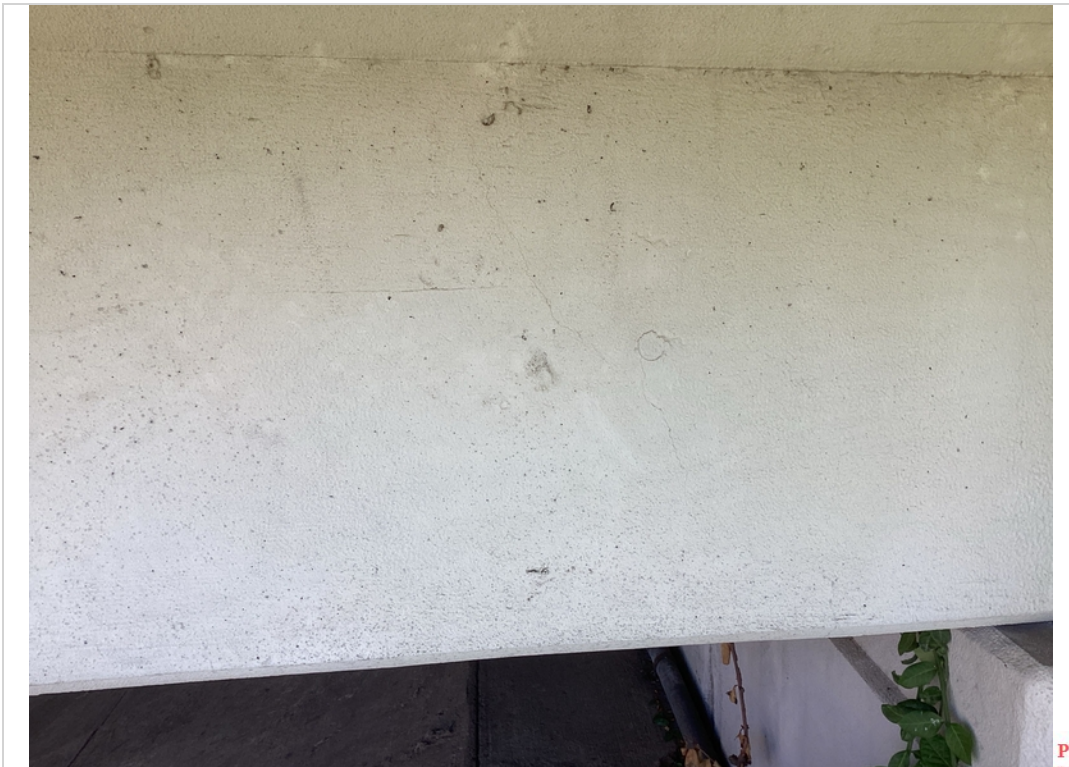
Span 4 Beam L right at abutment 2 - Diagonal hairline crack (Typical beam A left & beam L right abutment 1)

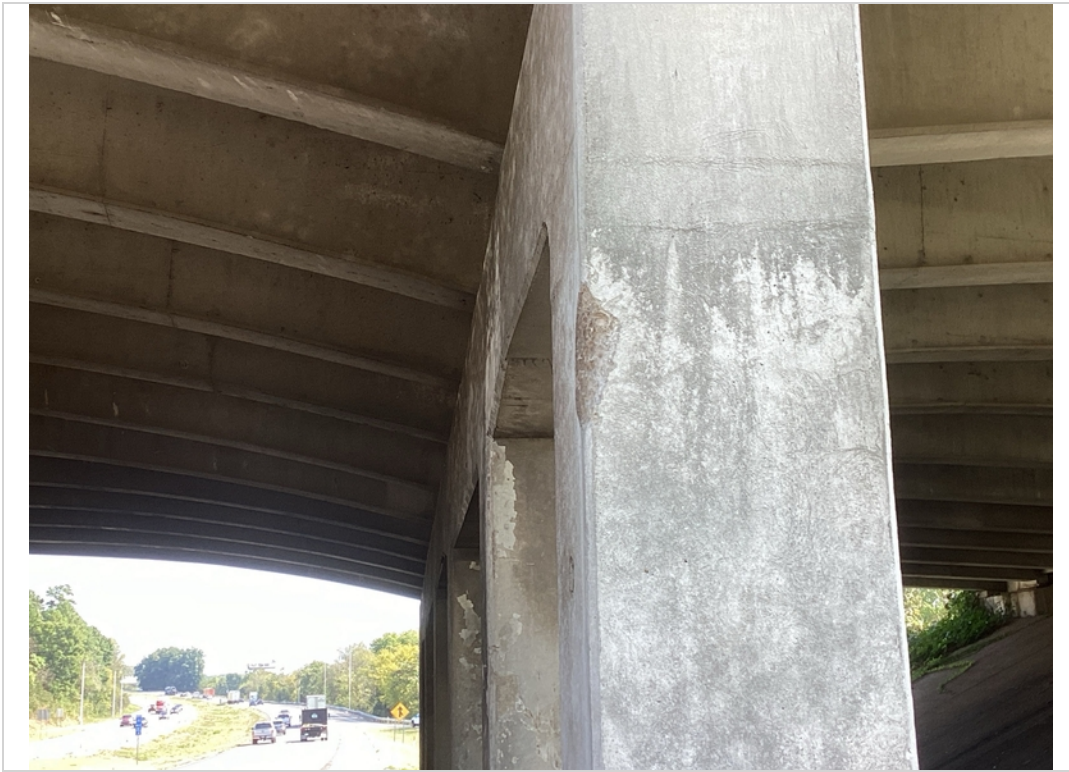
| Bent Columns | (Good) | 15"H x 8"W x 3"Dp SPALL COLUMN G BENT 3, POPOUTS |

Bent 3 column G front/right - (15"Hx8"Wx3"D)

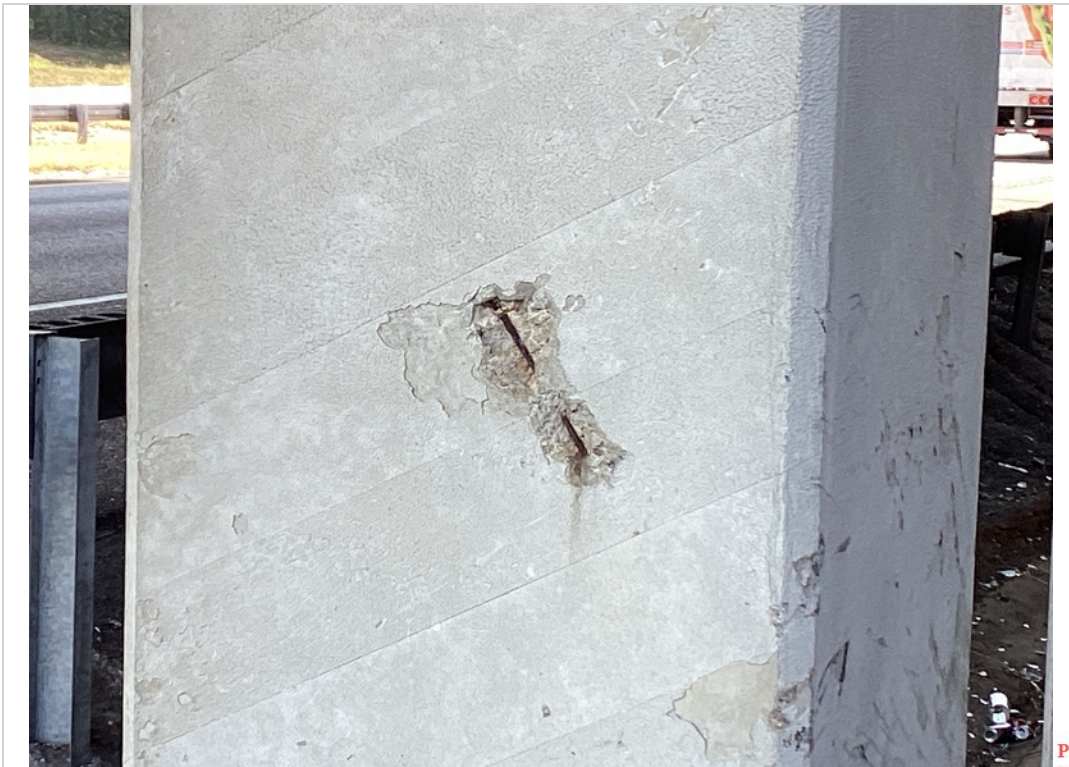
Bent1 = Column B left - popouts

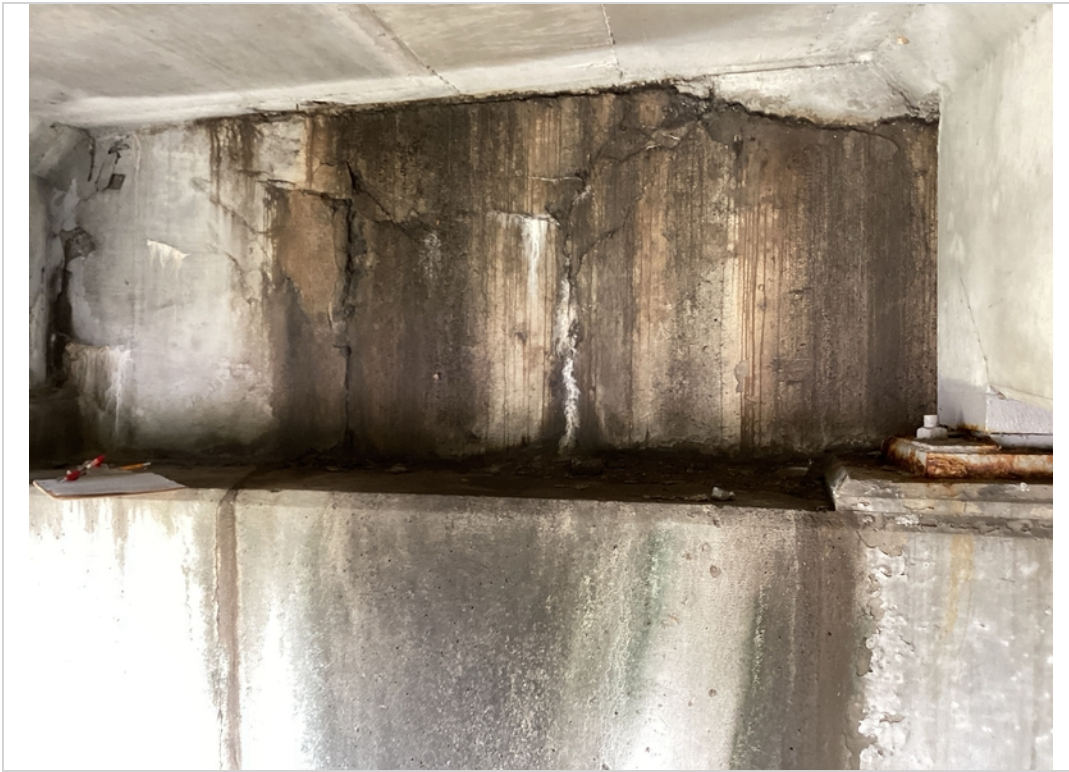
Abutment 1 back wall between beams K & L - Hairline cracks with leaching

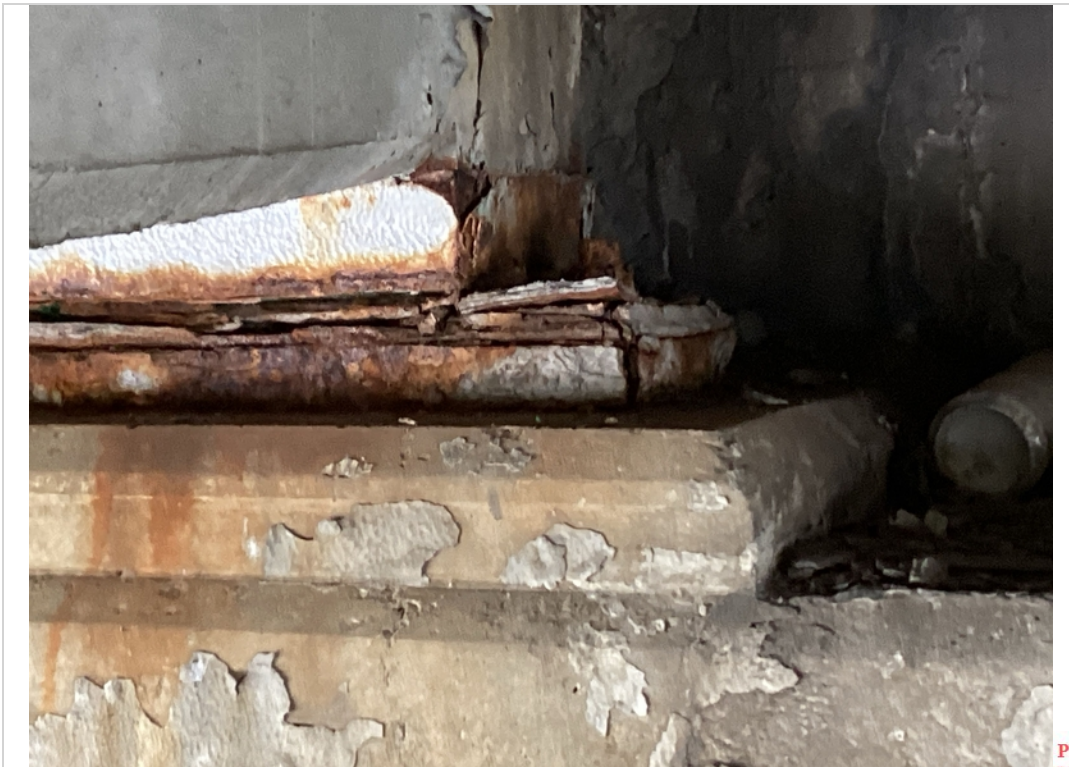
Abutment 1 Bearing I - Heavy corrosion and flaking

| <b>BEARINGS</b> | F | ABUTMENT 1 H & I - HEAVY CORROSION, MODERATE CORROSION | |

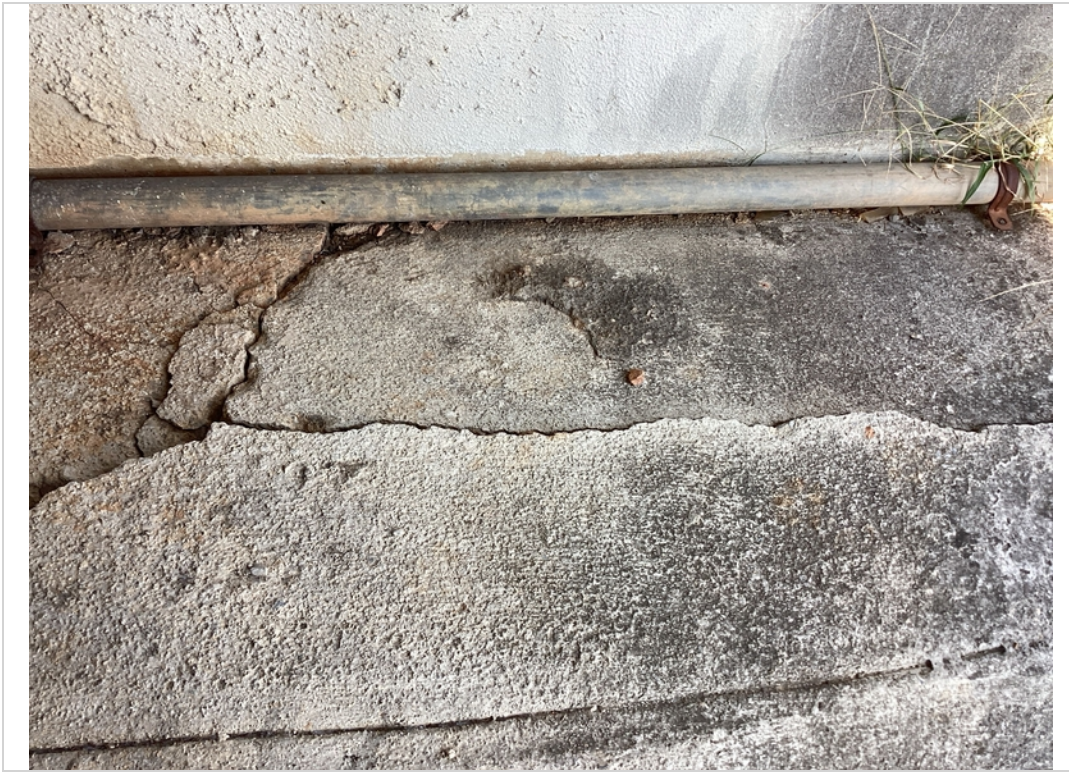
| Abutment Slope Paving | (Good) | CRACK AND SETTLEMENT ABUTMENT 1 LEFT |

Abutment 1 left - concrete slope - Cracking up to 1/4"

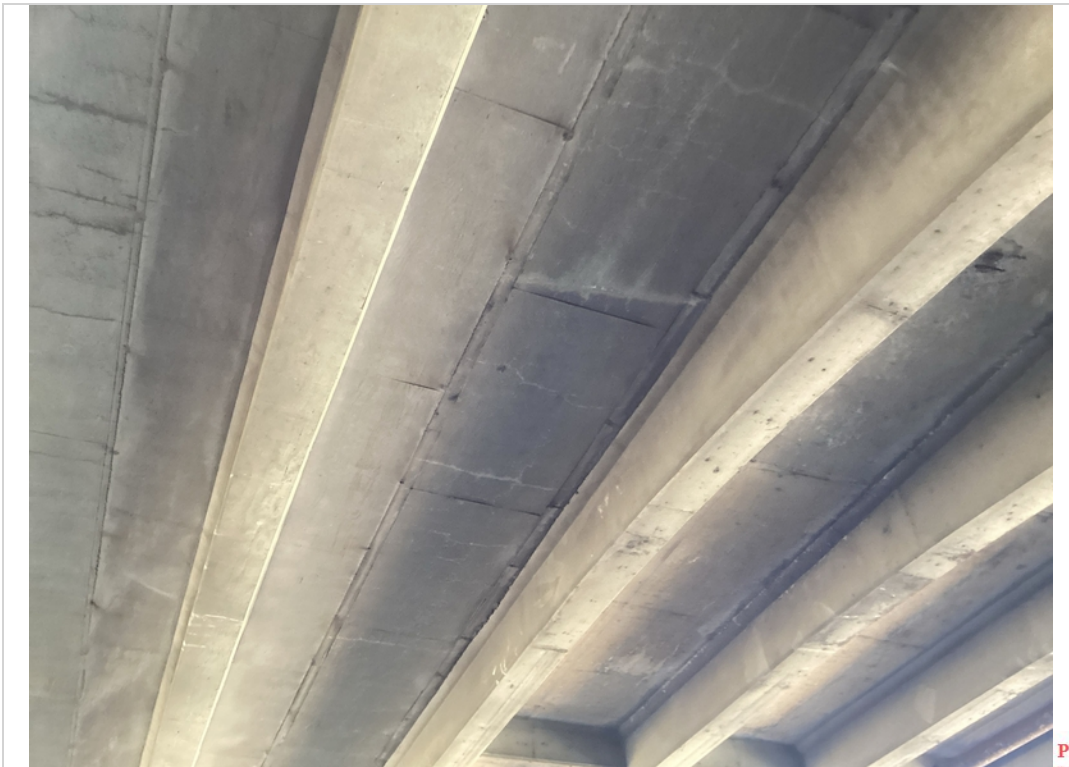
Span 2 bottom deck between beams E & F - Hairline cracks with leaching (typical)

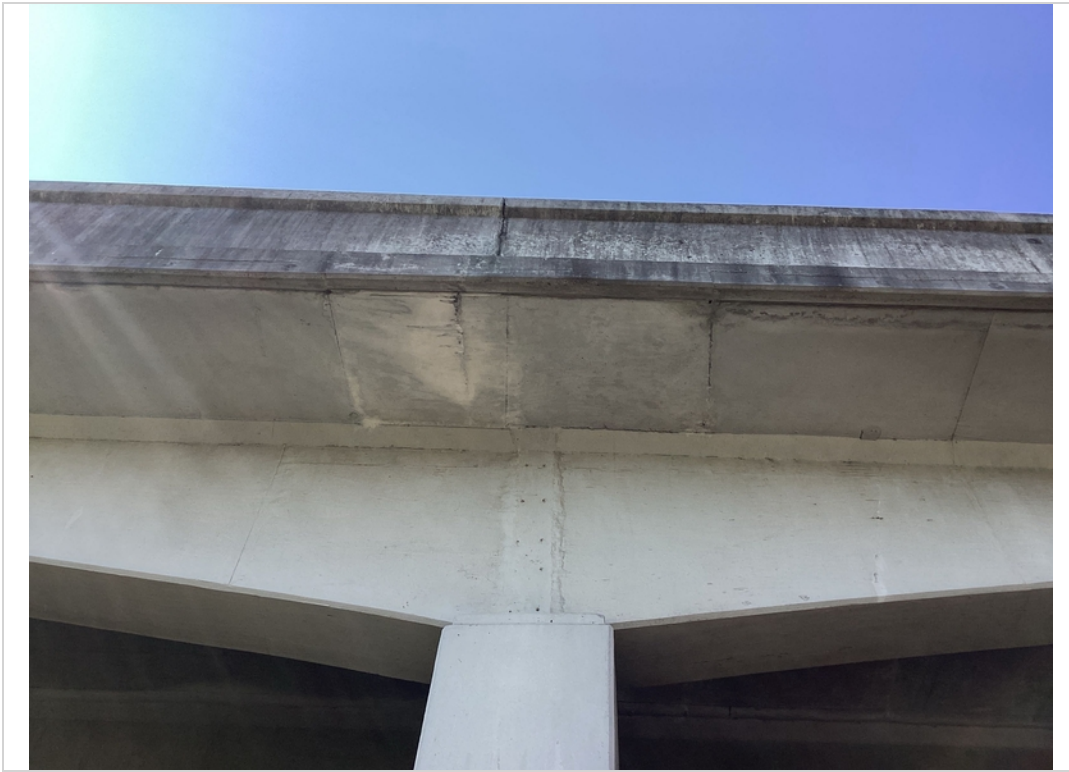
Bent 2 left overhang - Hairline cracks with leaching (typical )

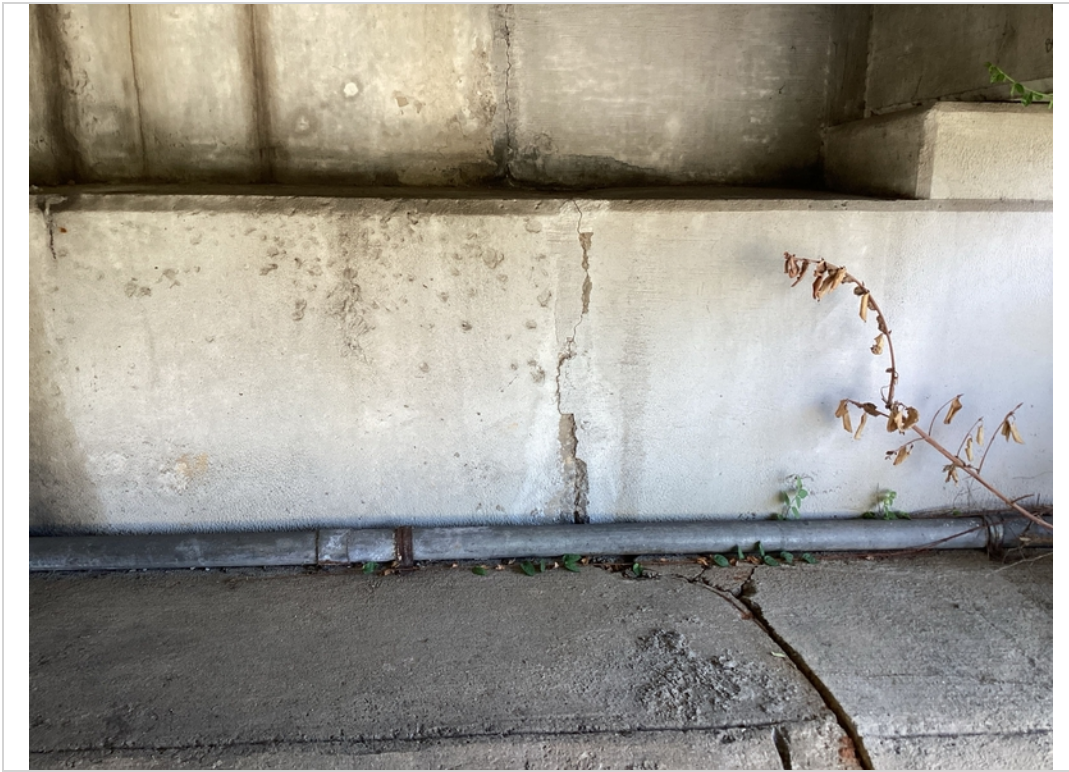
Abutment 2 cap between beams K & L - Cracking up to 1/16"

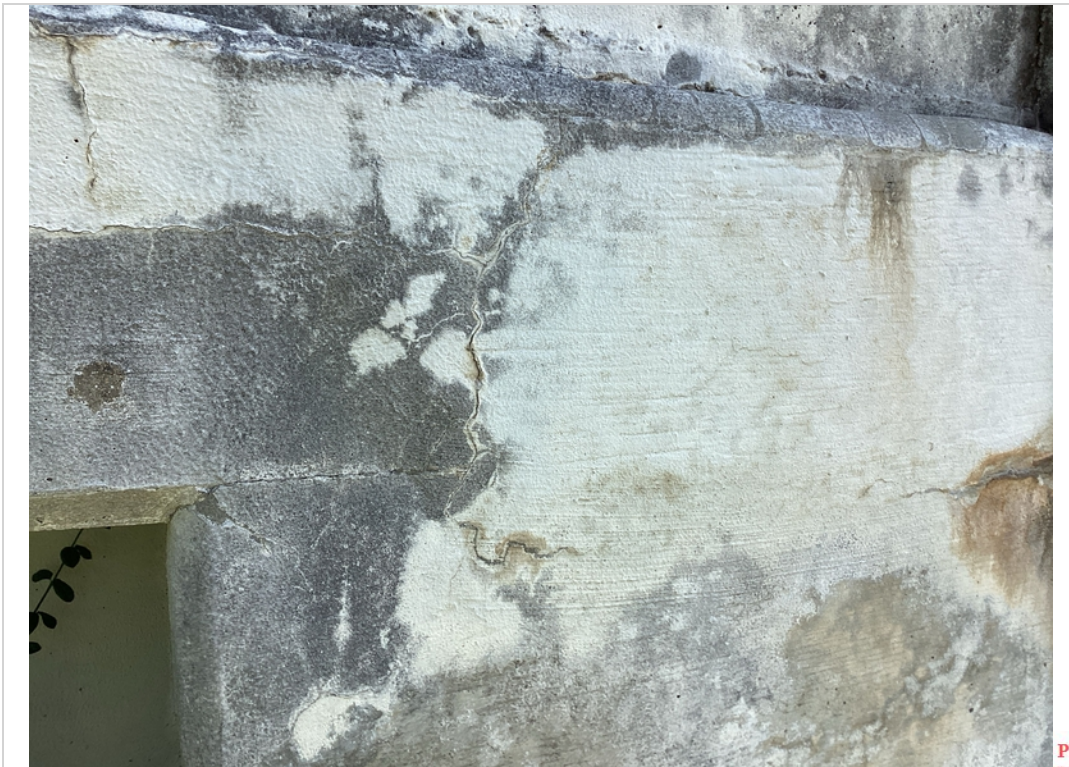
Wing 2 right - Hairline cracks with leaching

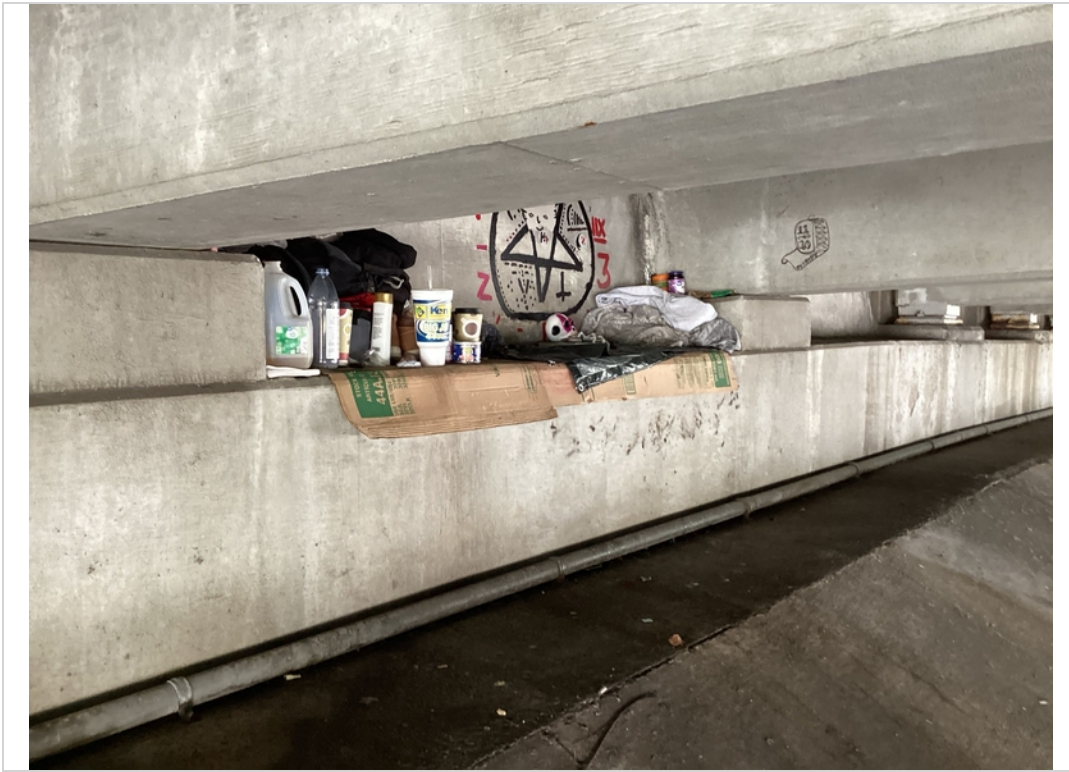
Evidence of Biohazards under abutment 2

Abutment 2 - biohazard
