US-321 Crossing SR 73 RL / I75

90 - LAST INSPECTION DATE 09/11/2024

| IDENTIFICATION | |
|---|---|
| (8) Structure Number | 53100750035 |
| (6) Features Intersected | SR 73 RL / I75 |

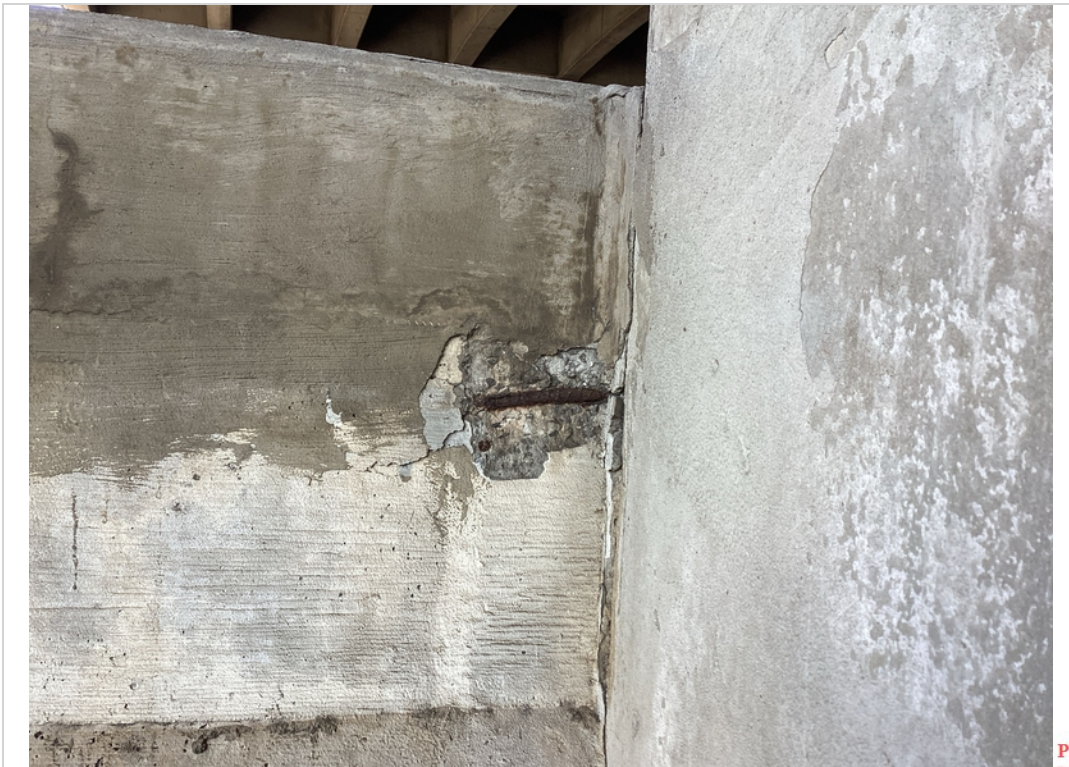
I - 75 East - U.P. Bridge rail in front of columns F & G - popouts

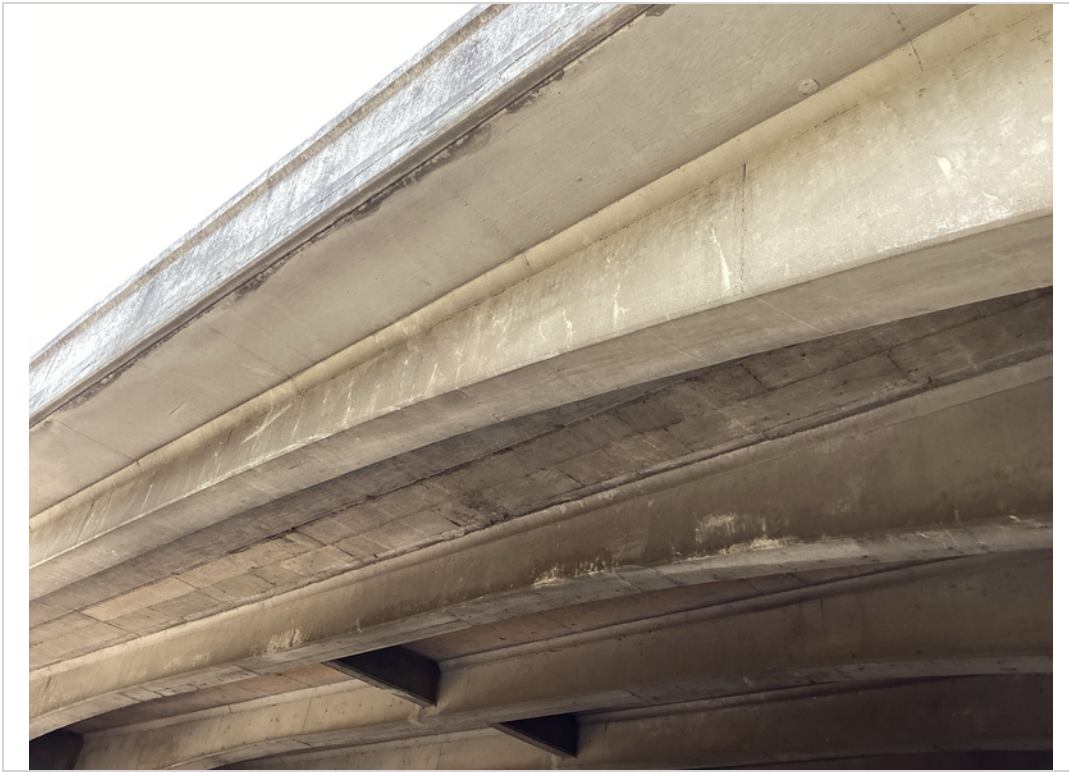
Span 2 beam L - Hairline cracks with leaching (typical )

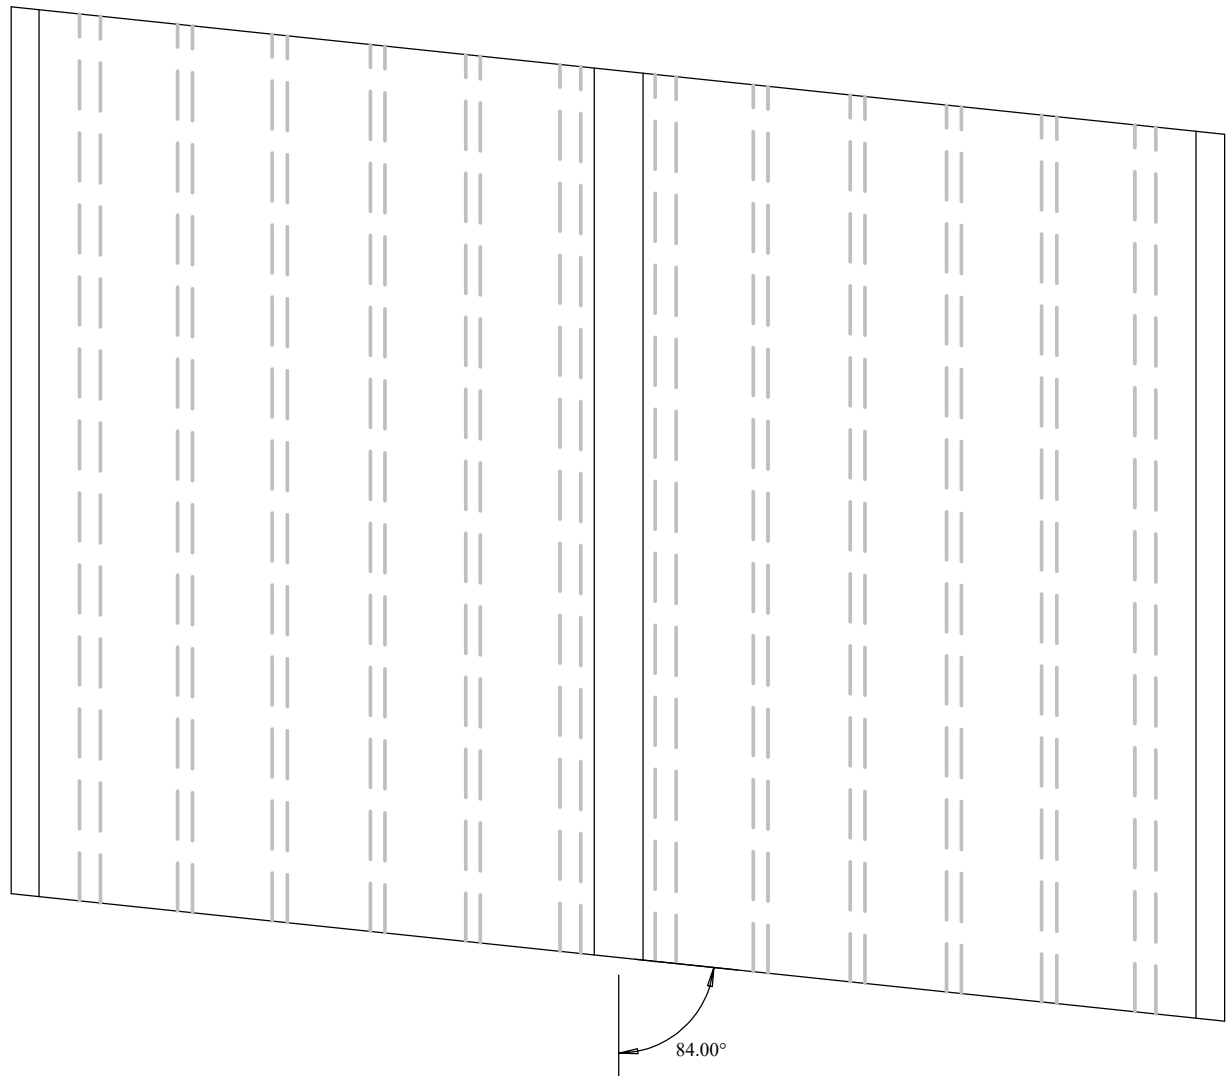
LOC. 53-SR073-4.68                      09-11-24 AB                      TOP DECK SPAN 1-4

| <b>WEARING SURFACE</b> | G | EPOXY OVERLAY |
| <b>BRIDGE RAIL</b> | G | HAIRLINE CRACKS, ROUGH TEXTURE WITH SMALL VOIDS |
| <b>MEDIAN</b> | G | RAISED CONCRETE, HAIRLINE CRACKS |
| <b>APPROACH SLABS</b> | G | GROOVED CONCRETE, HAIRLINE CRACKS, TAR SEALED CRACKS |
| | | APPROACH 1 - PATCHED AREA 12' x 2' |

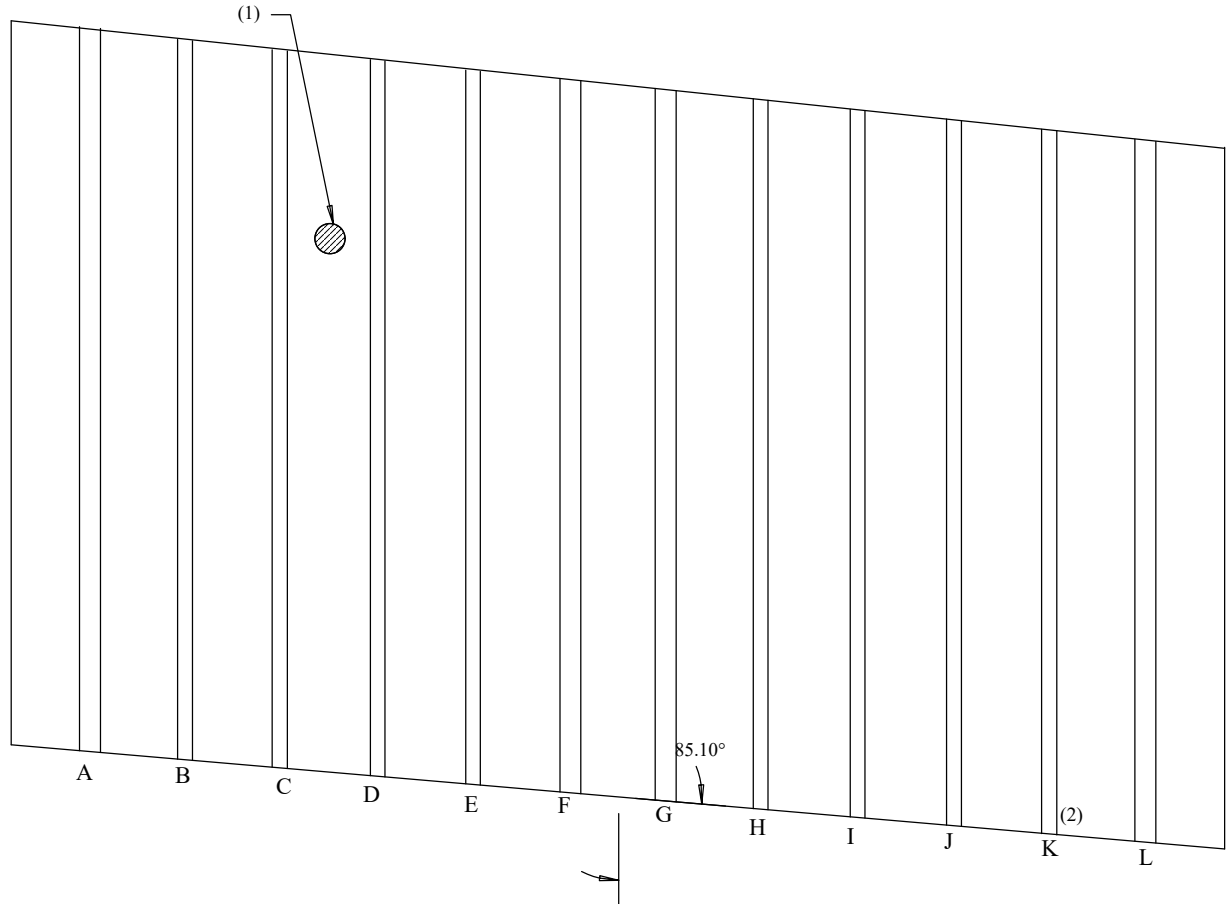
| LOC. 53-SR073-4.68 | | 09-11-24 AS | BOTTOM DECK SPAN 1-4 |

| <b>BOTTOM DECK</b> | G | (1) SPAN 2: 1' DIAMETER IN-PLACE SPALL | HAIRLINE CRACKS W/LEACHING |
| | | SPAN 3 BETWEEN BEAMS D & E - POPOUT | |
| <b>BEAMS</b> | G | HAIRLINE CRACKS WITH LEACHING, (2) ABUTMENT 1 BEAM K - DIAGONAL CRACK | |
| | | ABUTMENT 2 BEAM L RIGHT - DIAGONAL HAIRLINE CRACK | |
| | | ABUTMENT 1 BEAM A LEFT - DIAGONAL HAIRLINE CRACK | |
| | | ABUTMENT 1 BEAM L RIGHT - DIAGONAL HAIRLINE CRACK | |
| <b>BEARINGS</b> | F | ABUTMENT 1 H & I - HEAVY CORROSION, MODERATE CORROSION | |

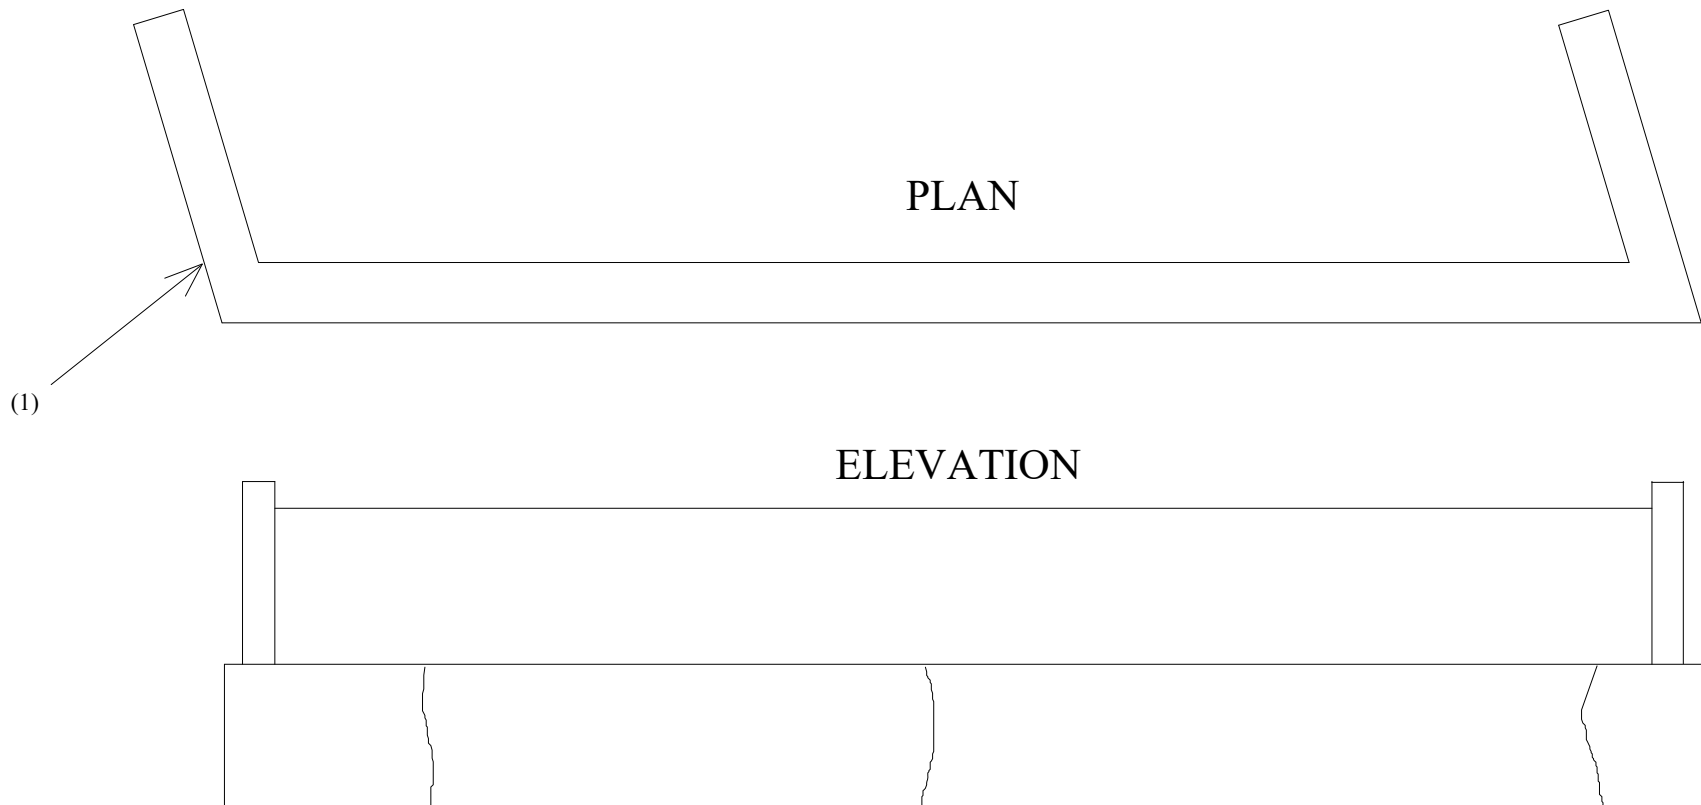
| CAP | G | CRACK UP TO 1/16" - BETWEEN BM'S A & B, E & F, G & H, K & L |
| | | MINOR SCALE, HAIRLINE CRACKS WITH LEACHING |
| BACKWALL | F | CRACKS AT WIDENING JOINTS - BETWEEN BM'S A & B, E & F, G & H, K & L |
| EMBANKMENT | G | (1) ABUTMENT 1 LEFT - MINOR SETTLEMENT WITH VOID UP TO 5' |

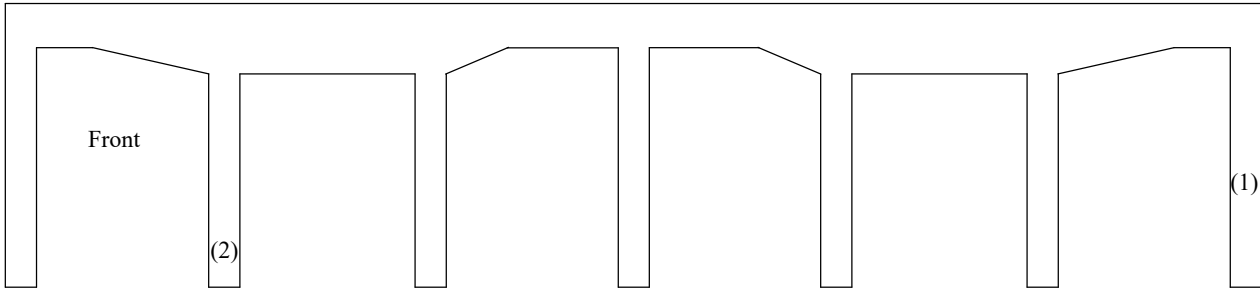
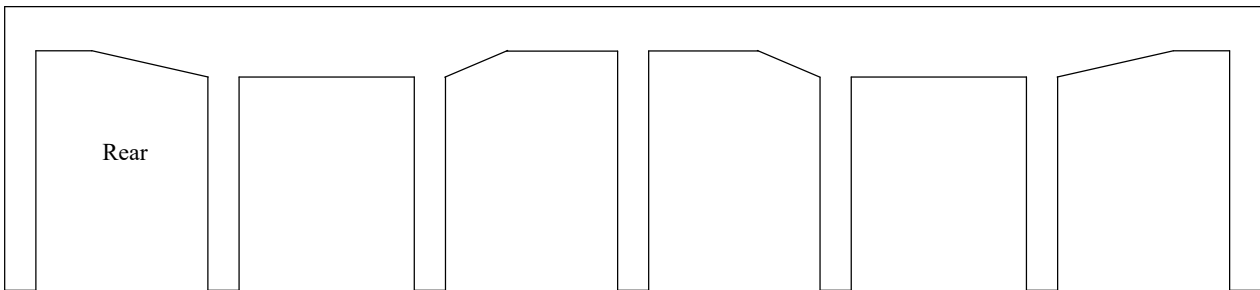
Bent No. 1-3

| Cap | G | VERTICAL HAIRLINE CRACKS |
| Columns | G | (1) BENT 3, COLUMN 'G' - MINOR 3" DEEP SPALL (15"H x 8"W x 3"DEEP) |
| | | (2) BENT 1 COLUMN B - POP-OUT |
