Region 01, 53 - Loudon County

HICKORY CREEK RD. Crossing I75

90 - LAST INSPECTION DATE 09/12/2024

| IDENTIFICATION | |
|---|---|
| (8) Structure Number | 53I00750037 |

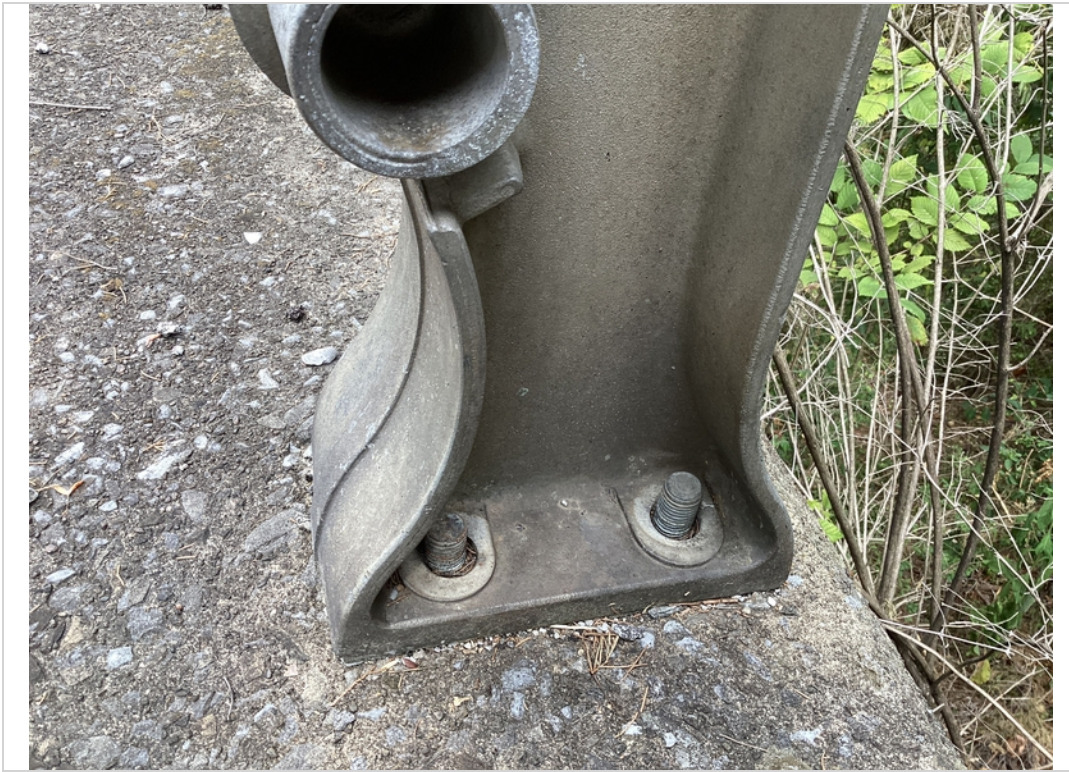
Deck 4 left bridge rail post back - missing nuts (also missing one on front)

| Date Added | Recommendation | Priority |
|---|---|---|
| 09/12/2024 | INSTALL NUTS WHERE MISSING ON BRIDGE RAIL POST ANCHORS | |

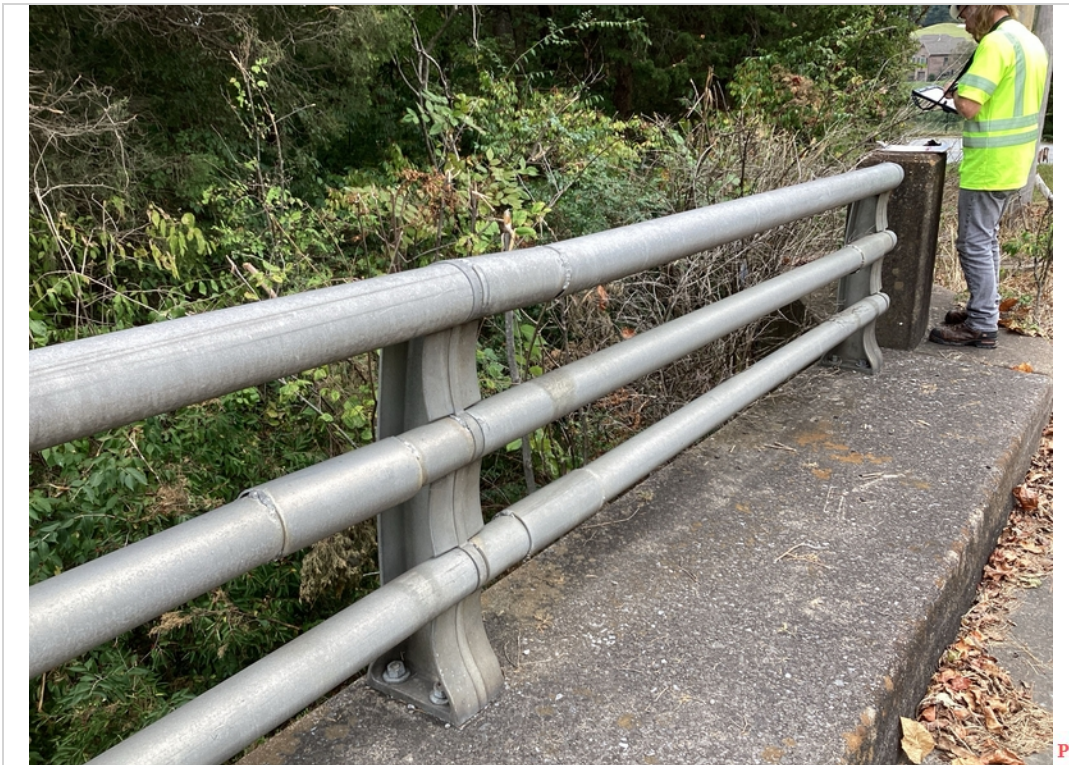
Deck 4 left bridge rail - loose

| Date Added | Recommendation | Priority |
|---|---|---|
| 09/12/2024 | REPAIR DECK 4 LEFT RAIL - LOOSE | |

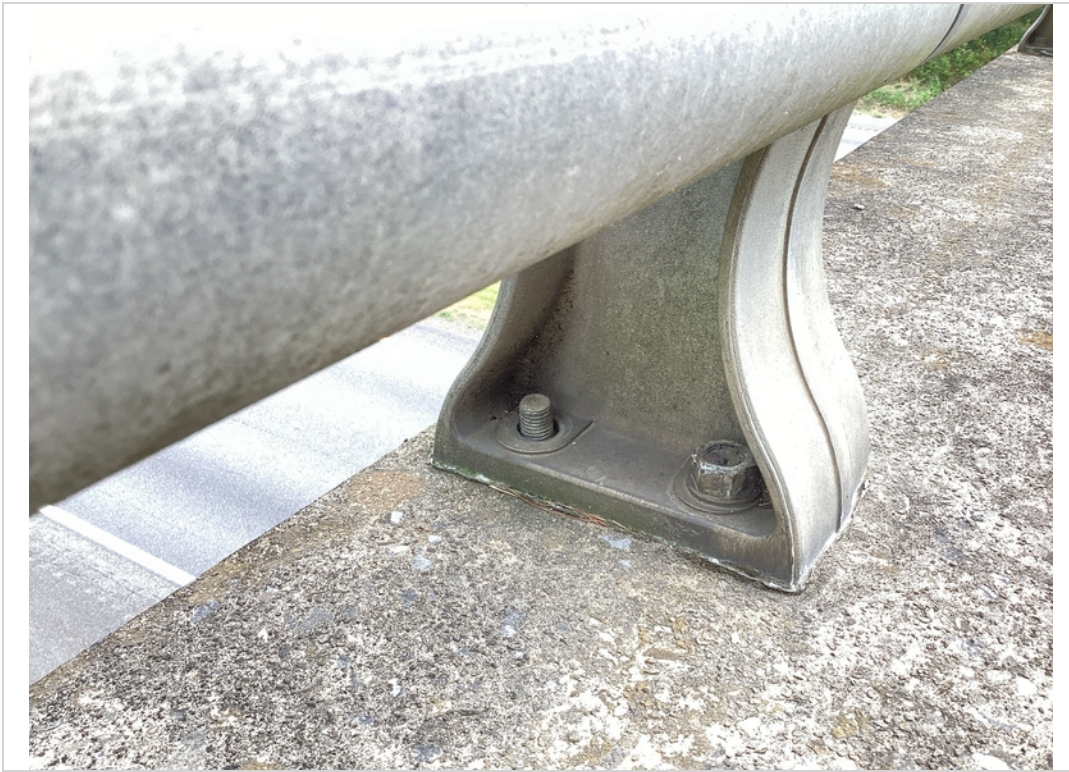
Deck 2 left rail post front- missing nut (also missing nut on back side)

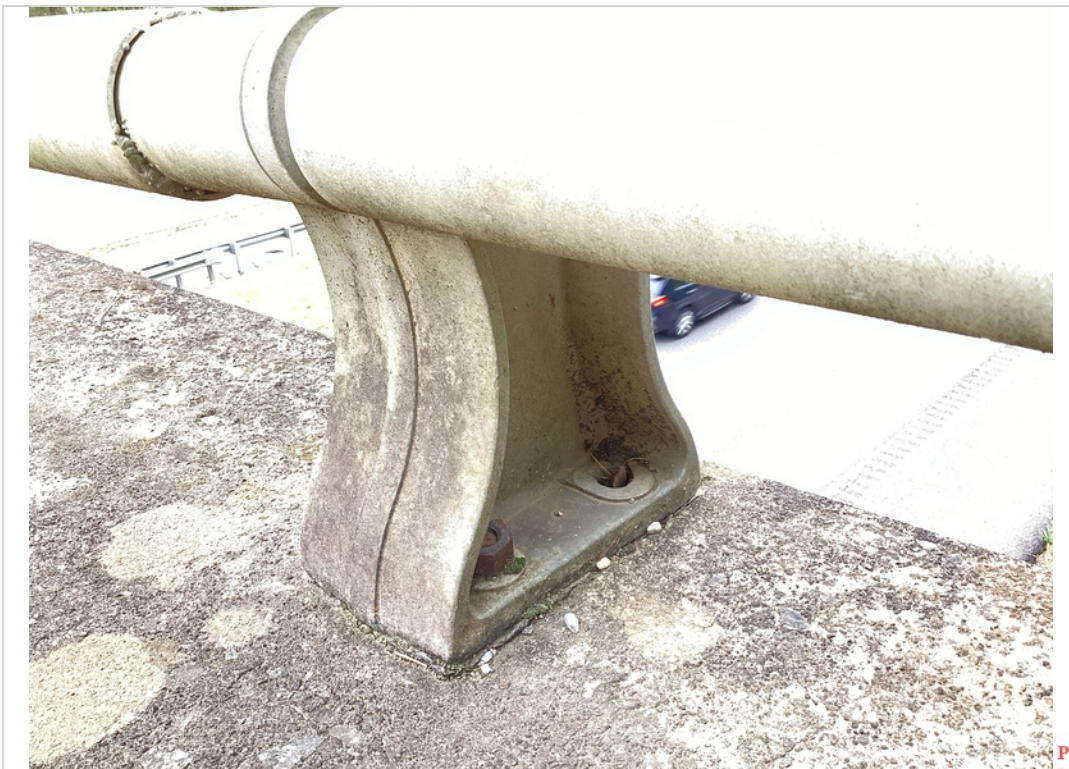
Deck 2 right rail post front- missing bolt ( also missing nut on back side)

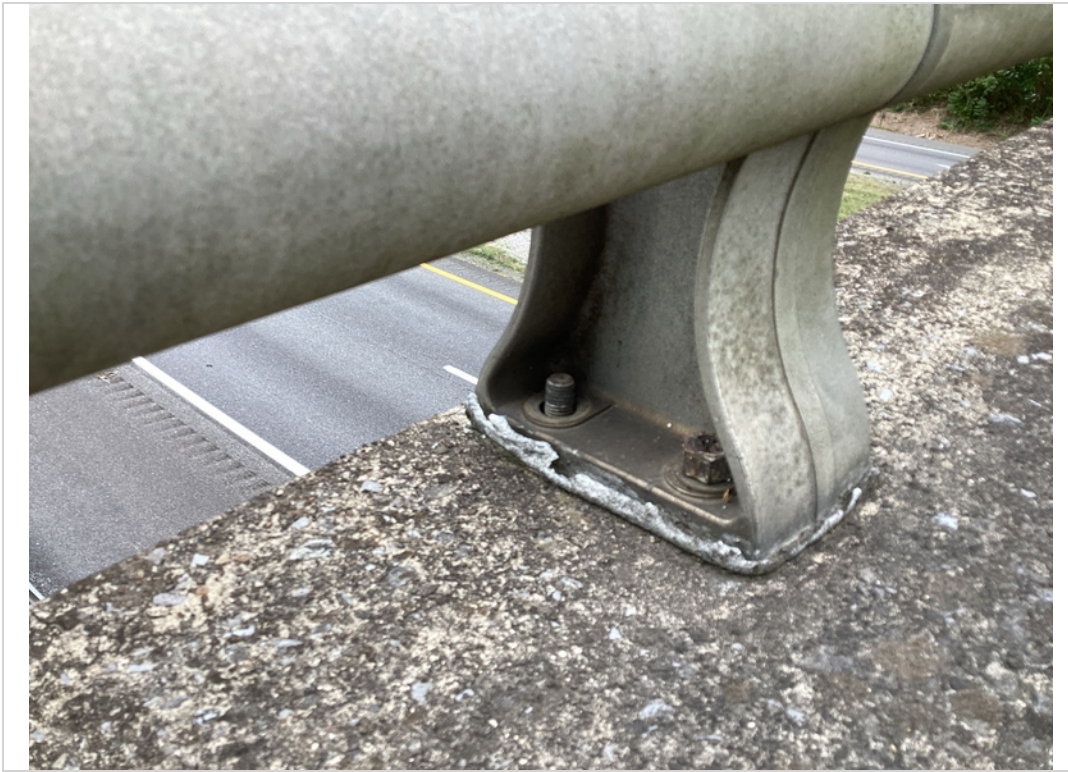
Deck 3 right rail post - missing nut

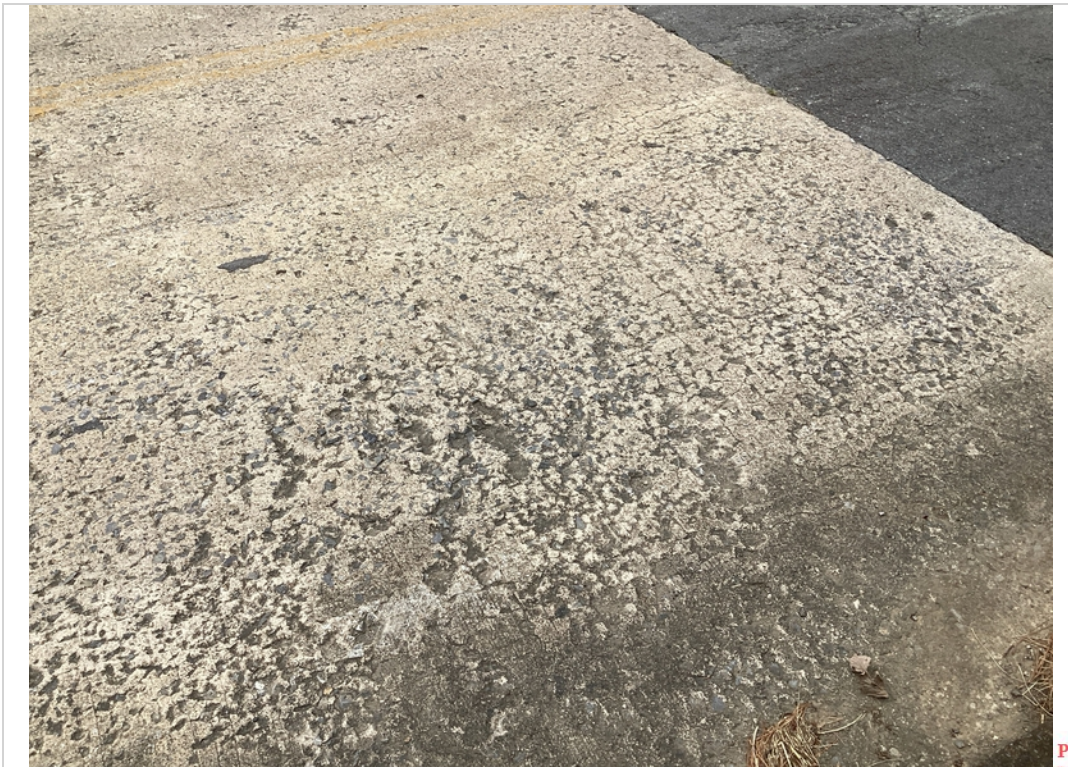
Deck 4 right at approach 2 - area moderate scale

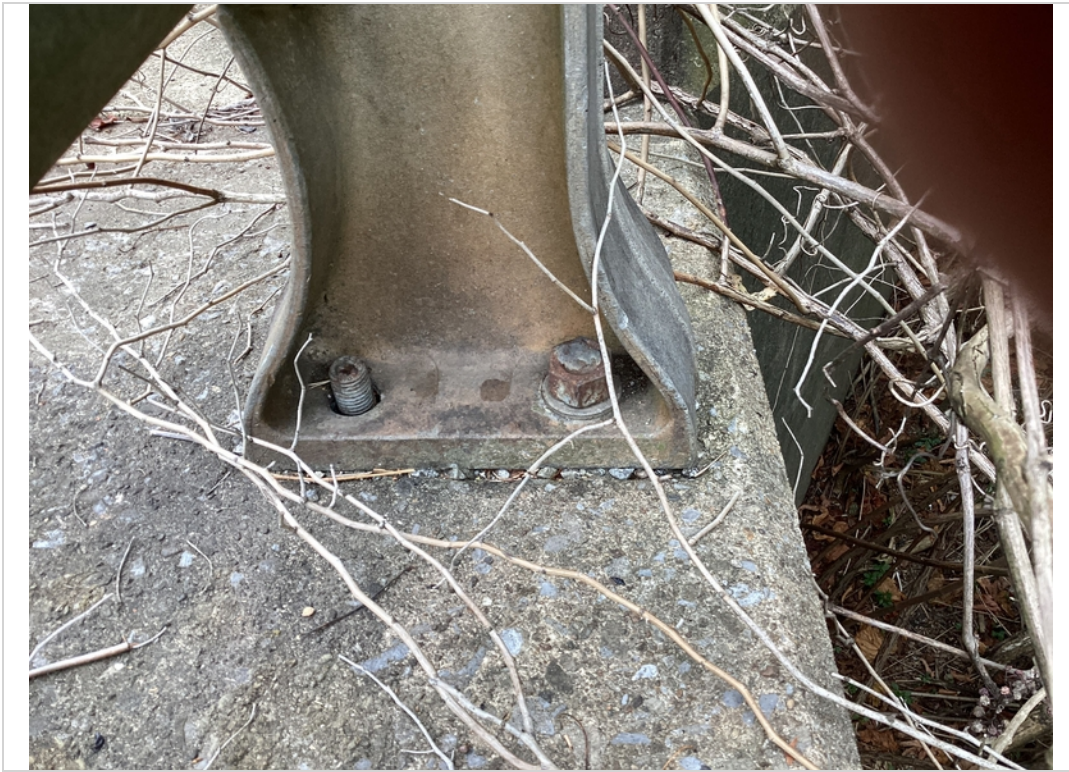
Deck 4 right bridge rail post - loose, missing nut

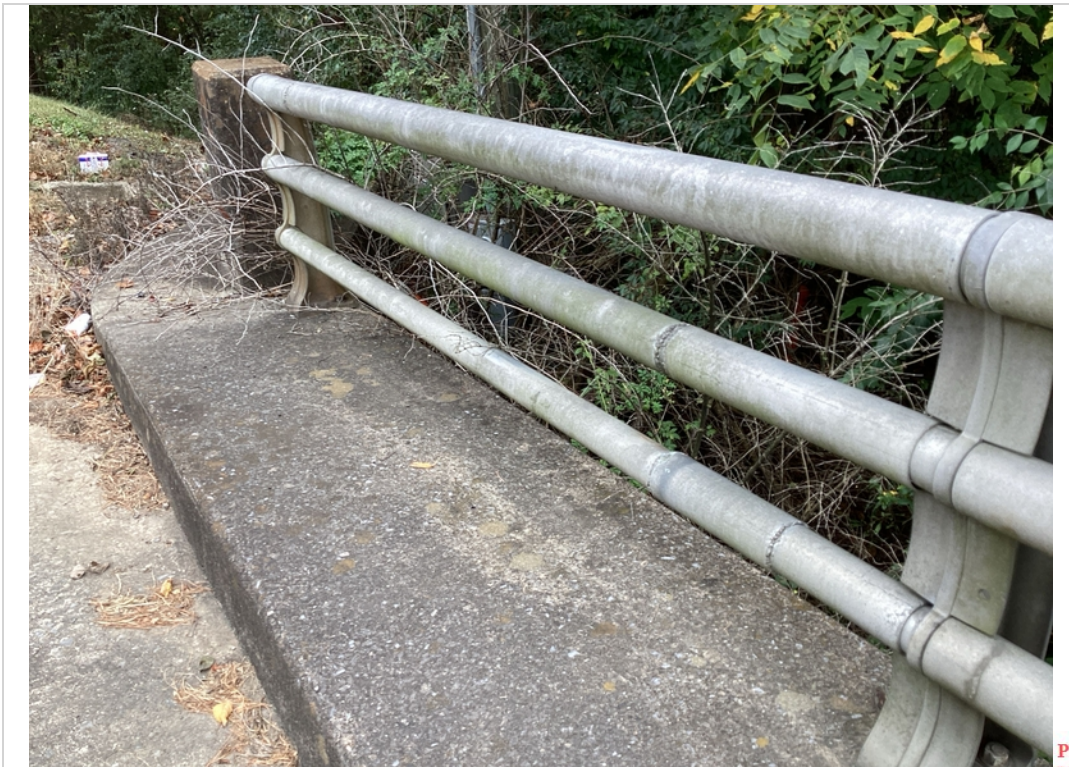
Deck 4 right bridge rail - loose

| Date Added | Recommendation | Priority |
|---|---|---|
| 09/12/2024 | REPAIR DECK 4 RIGHT RAIL - LOOSE | 3 |

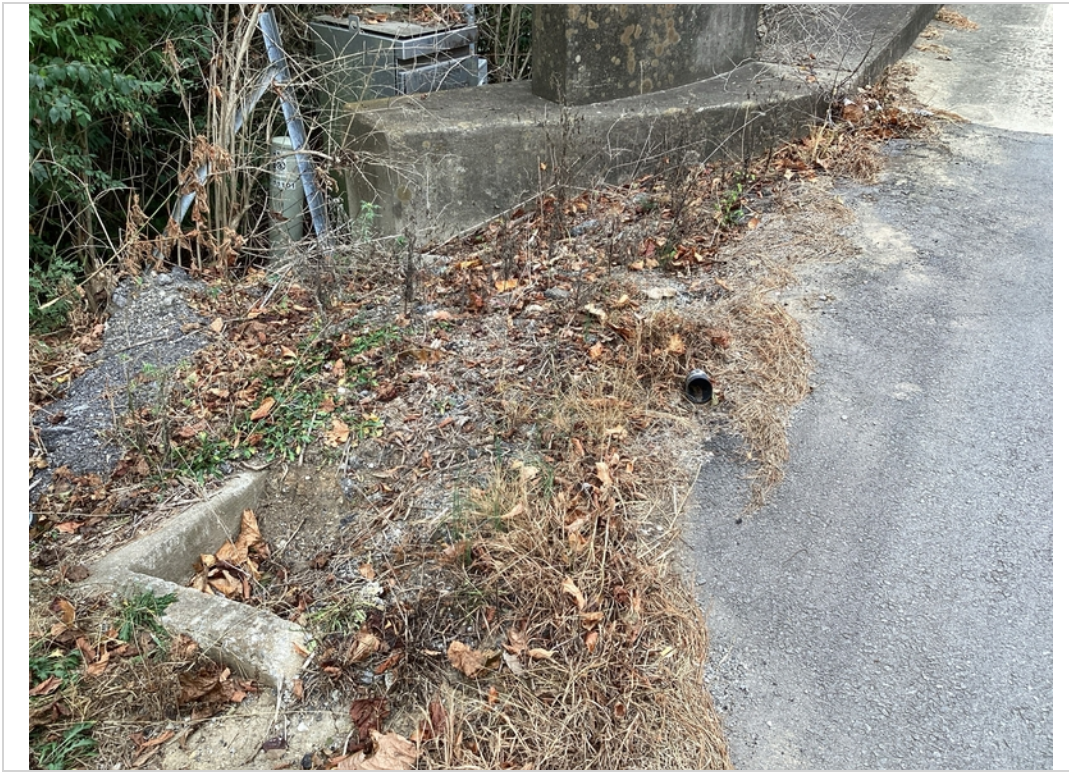
Approach 2 right drain - debris and plugged

| Date Added | Recommendation | Priority |
|---|---|---|
| 09/07/2006 | CLEAN APPROACH 2 DRAINS | |

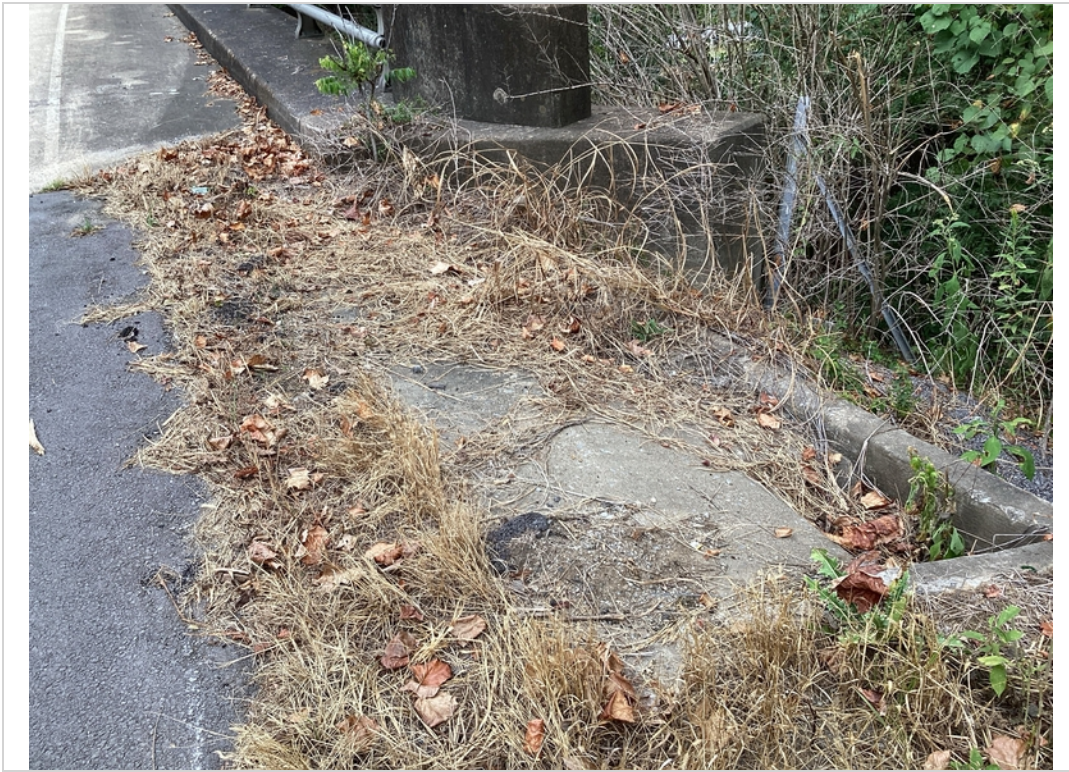
Approach 2 left drain - debris and plugged

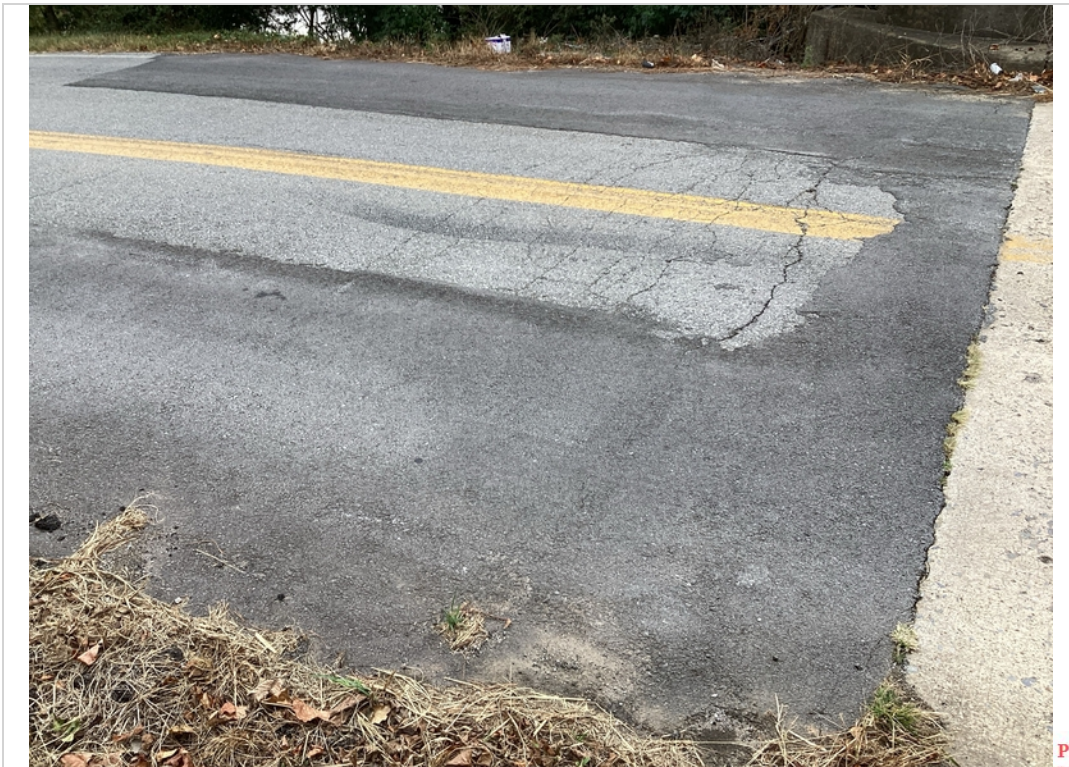
Approach 1 wearing surface - patches, cracks to 1/4"

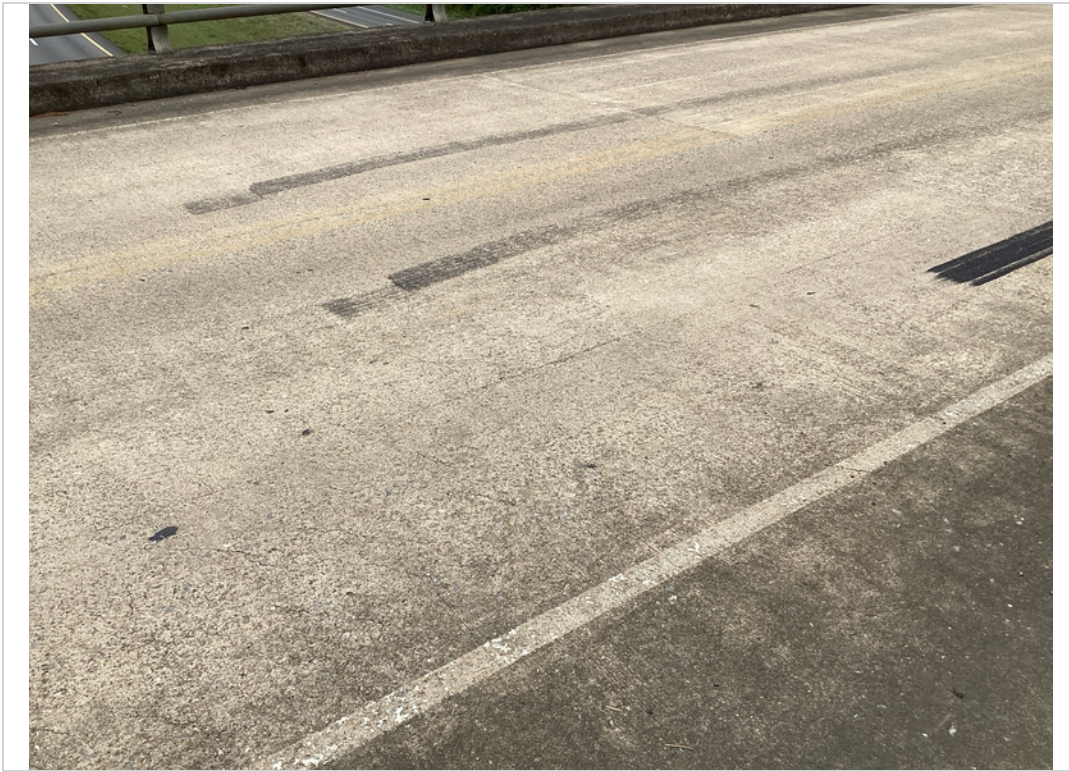
Deck 3 wearing surface - hairline to 1/16" map cracks, light scale, tire marks

| Date Added | Recommendation | Priority |
|---|---|---|
| 09/12/2024 | SEAL CRACKS IN CONCRETE WEARING SURFACE | |

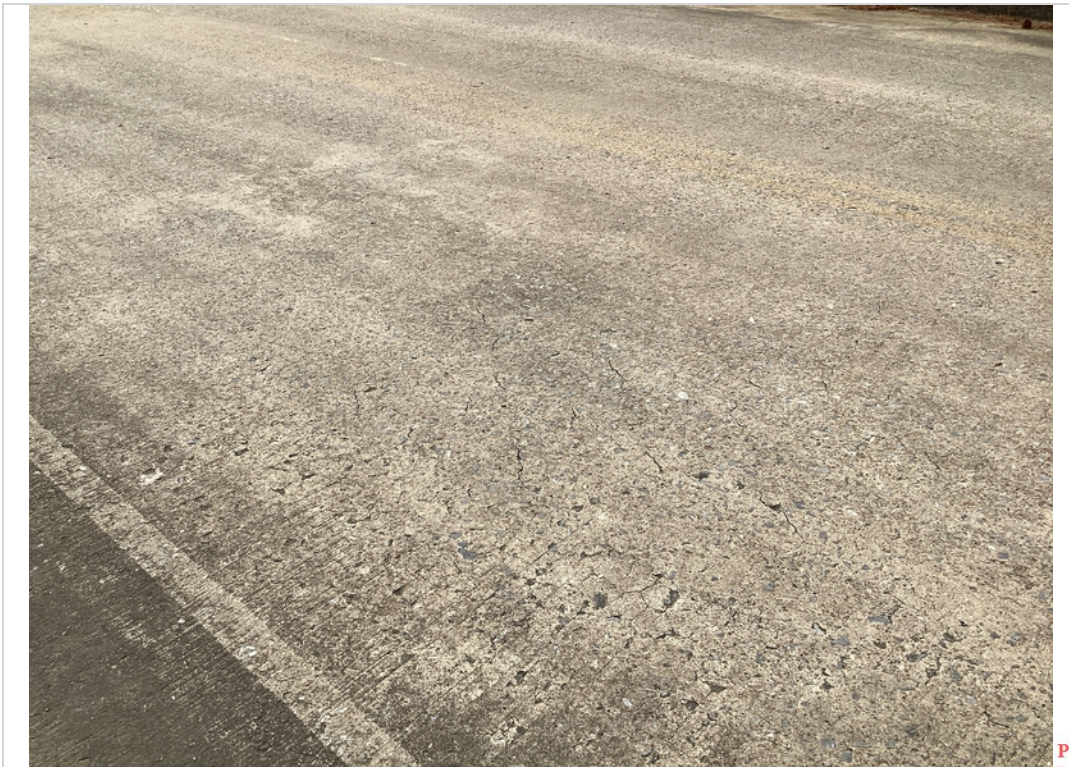
Deck 2 wearing surface - hairline to 1/16" map cracks, light scale, few aggregate voids

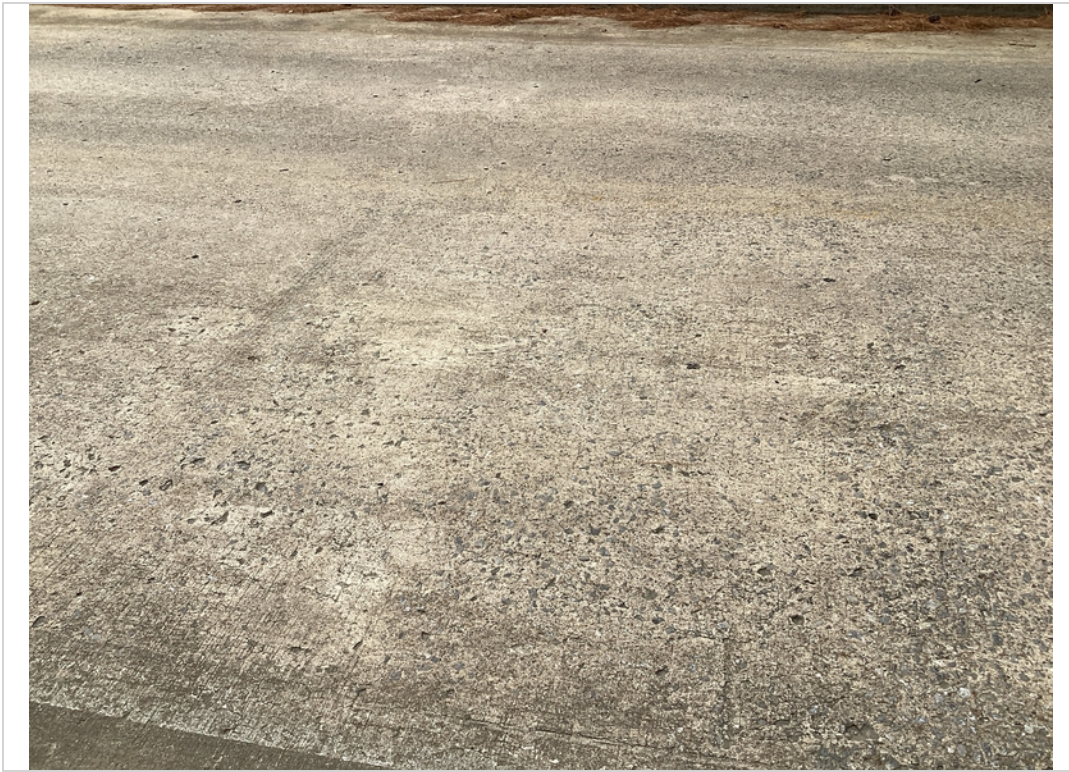
Deck 1 wearing surface - hairline map cracks, light scale, few aggregate voids

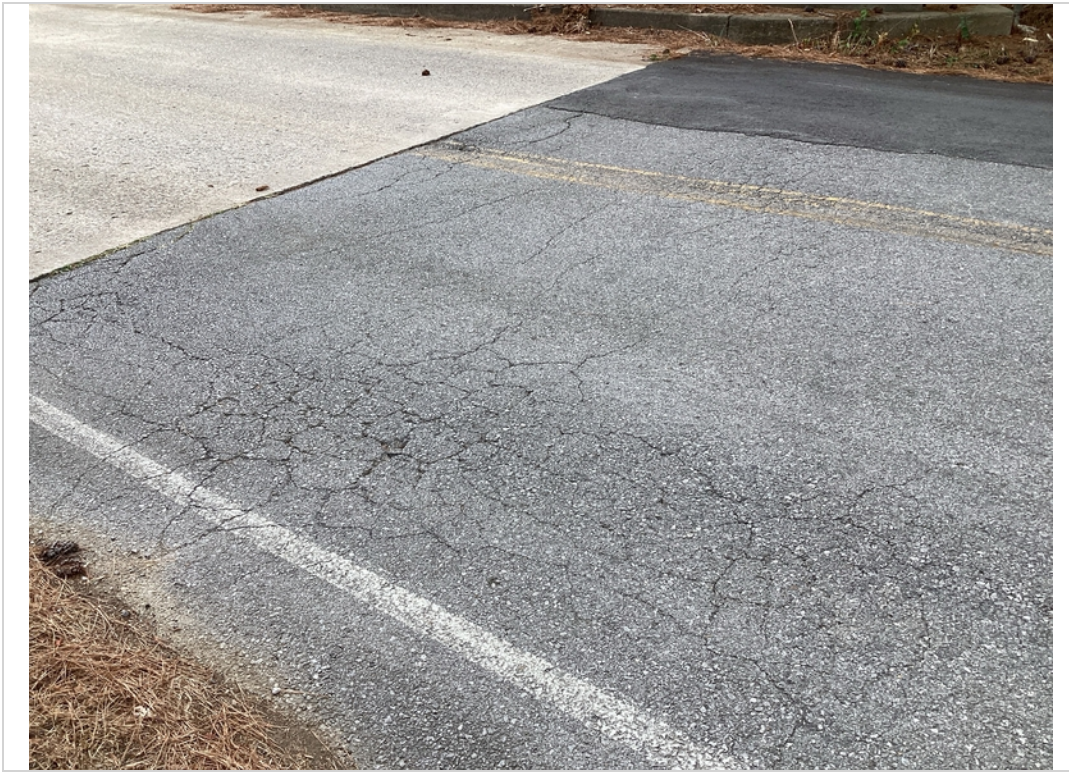
Approach 1 wearing surface - patch, cracks to 1/8"

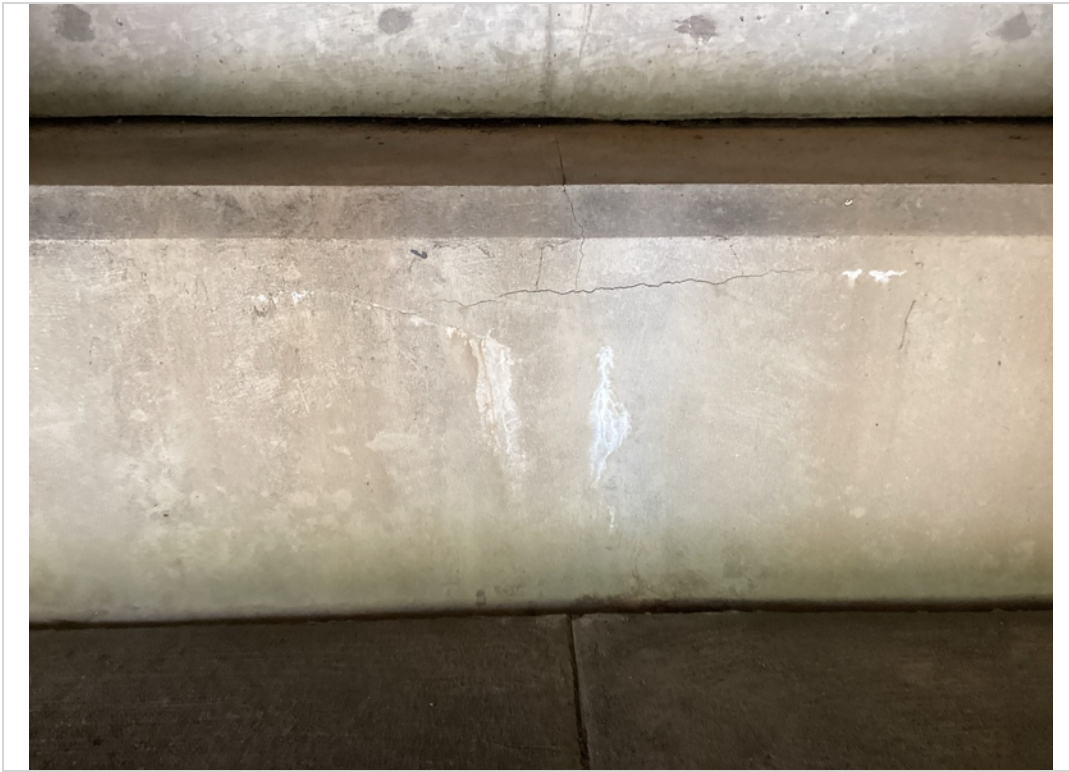
Abutment cap 2 - Cracks up to 1/16" & hairline cracks w/ leaching

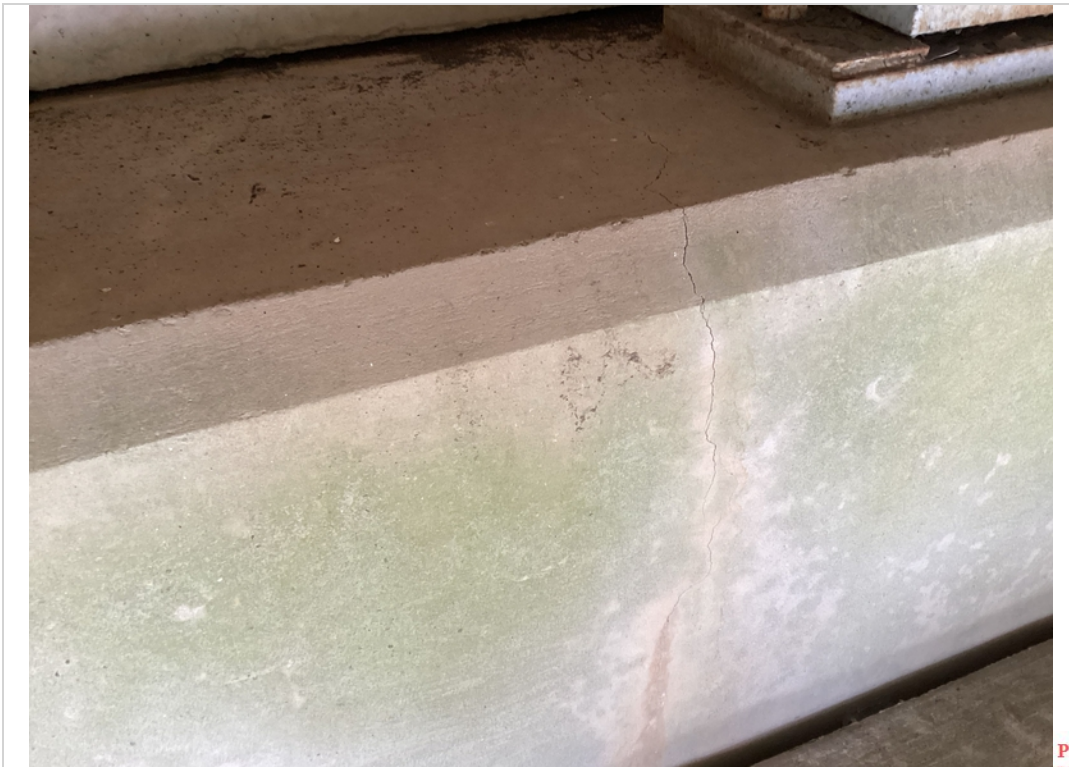
Abutment cap 1 - Hairline cracks (Typical abutment 2)

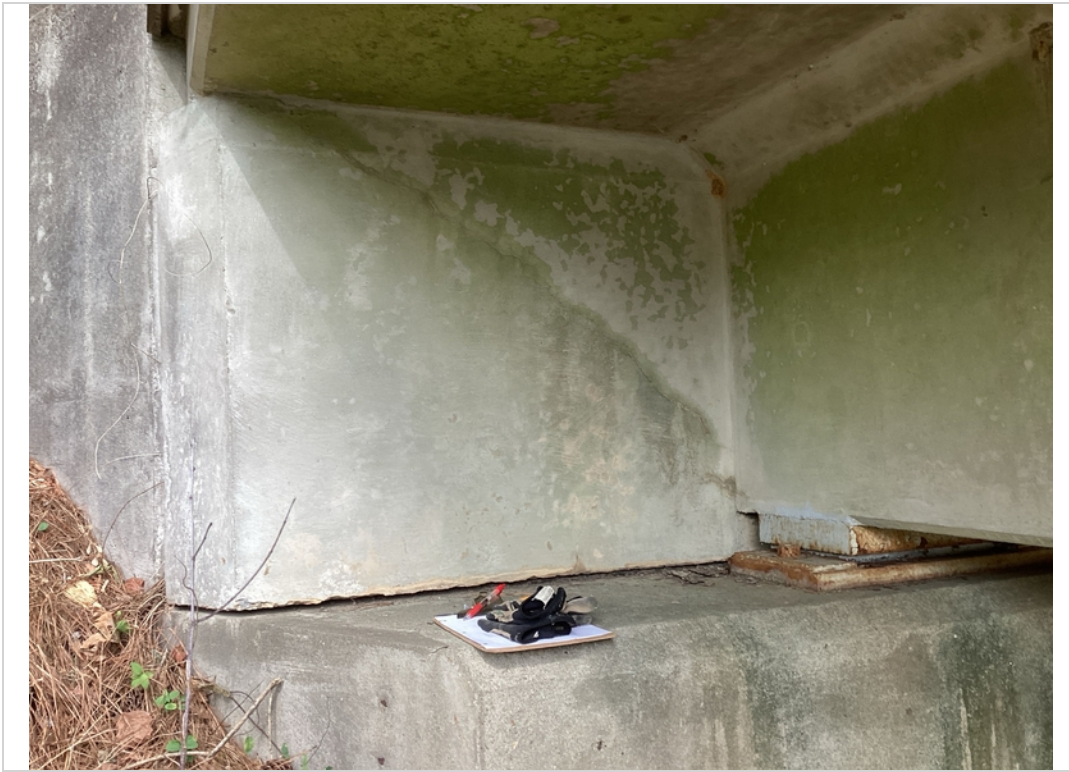
Backwall abutment 1 - Hairline cracks

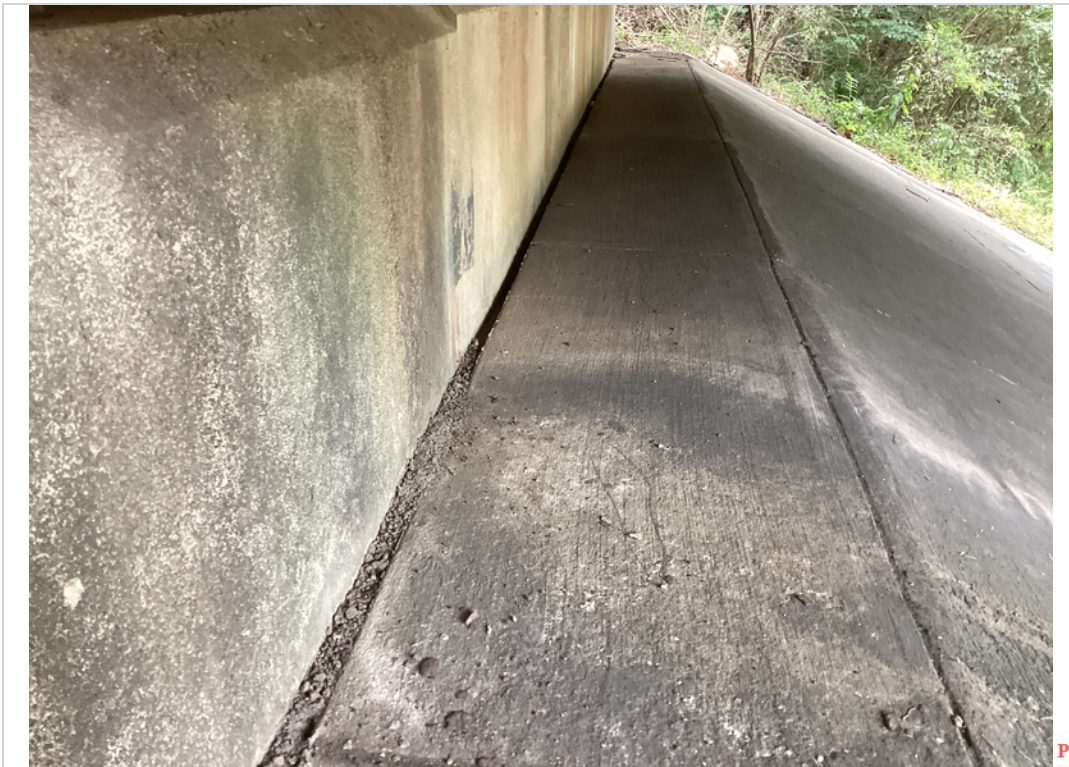
Slope paving abutment 2 - Separated from cap 1.25" (Typical abutment 1)

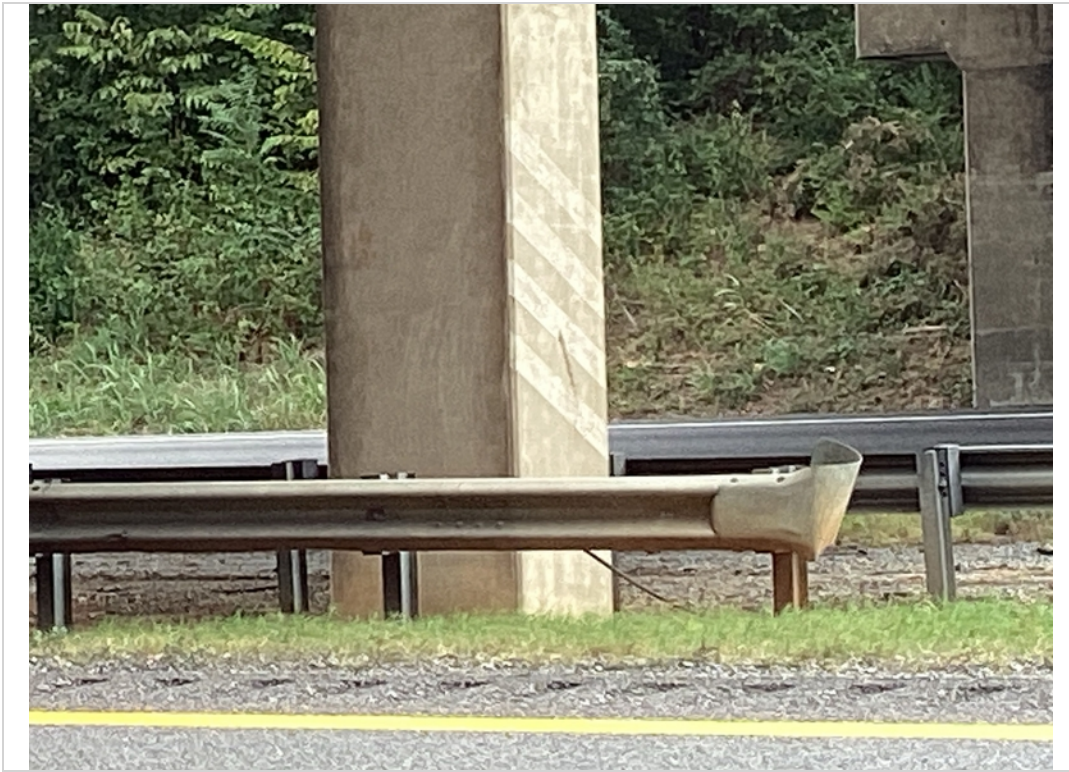
Column B right bent 2 - Popout

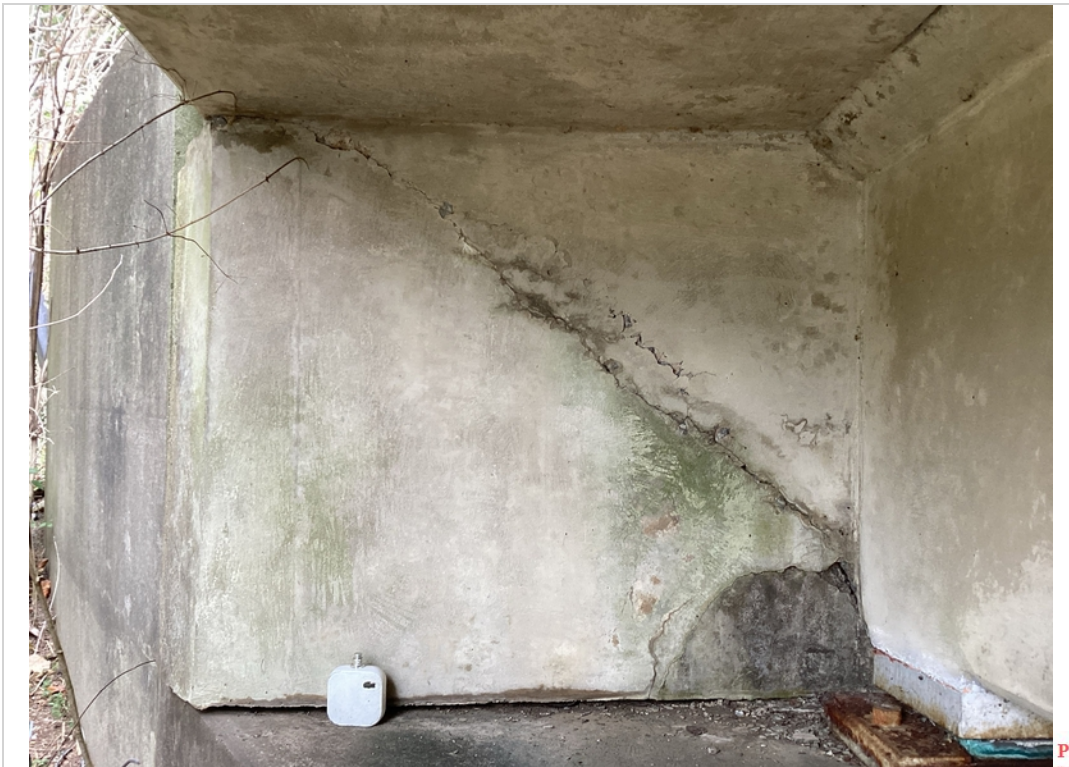
Abutment 2 left Backwall at beam A left - 1/16"

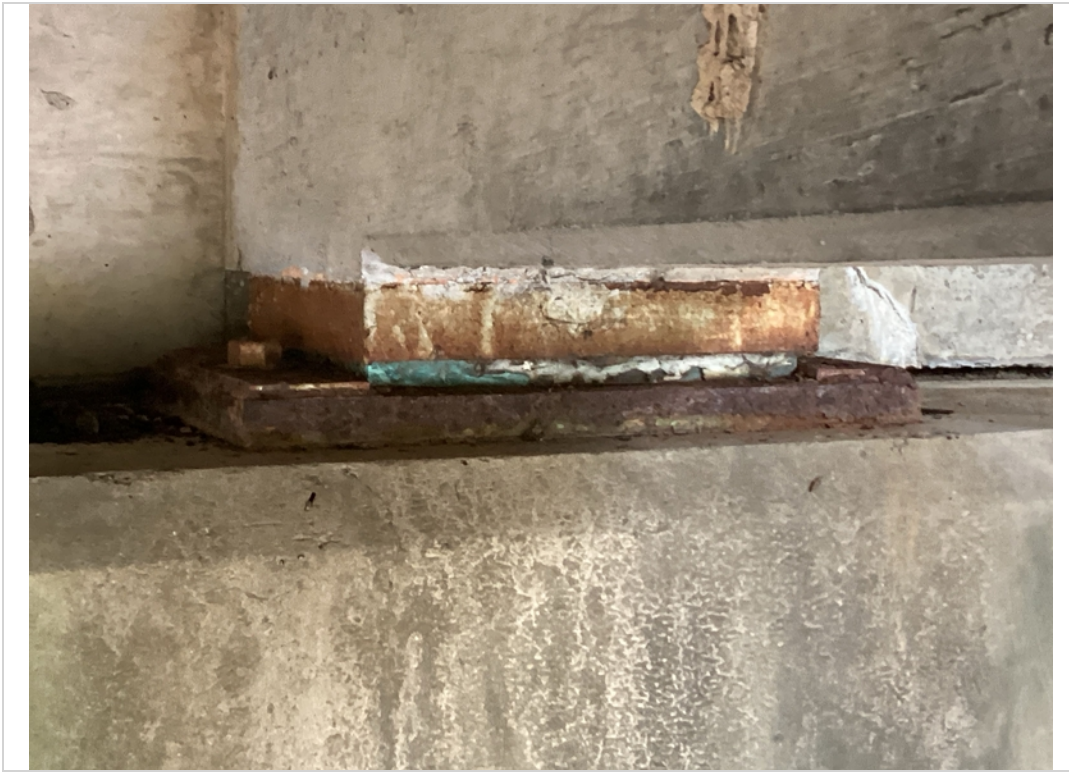
Abutment 2 - Bearings A & D - moderate corrosion

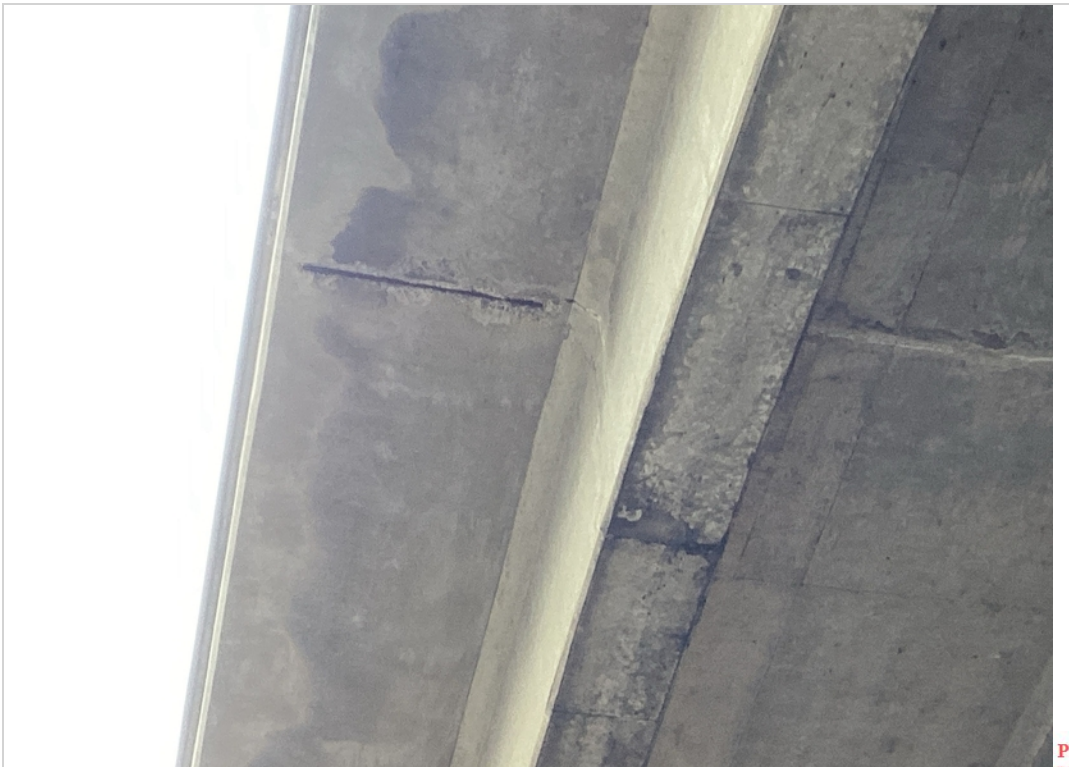
Span 2 left overhang - Popout and Hairline cracks with leaching

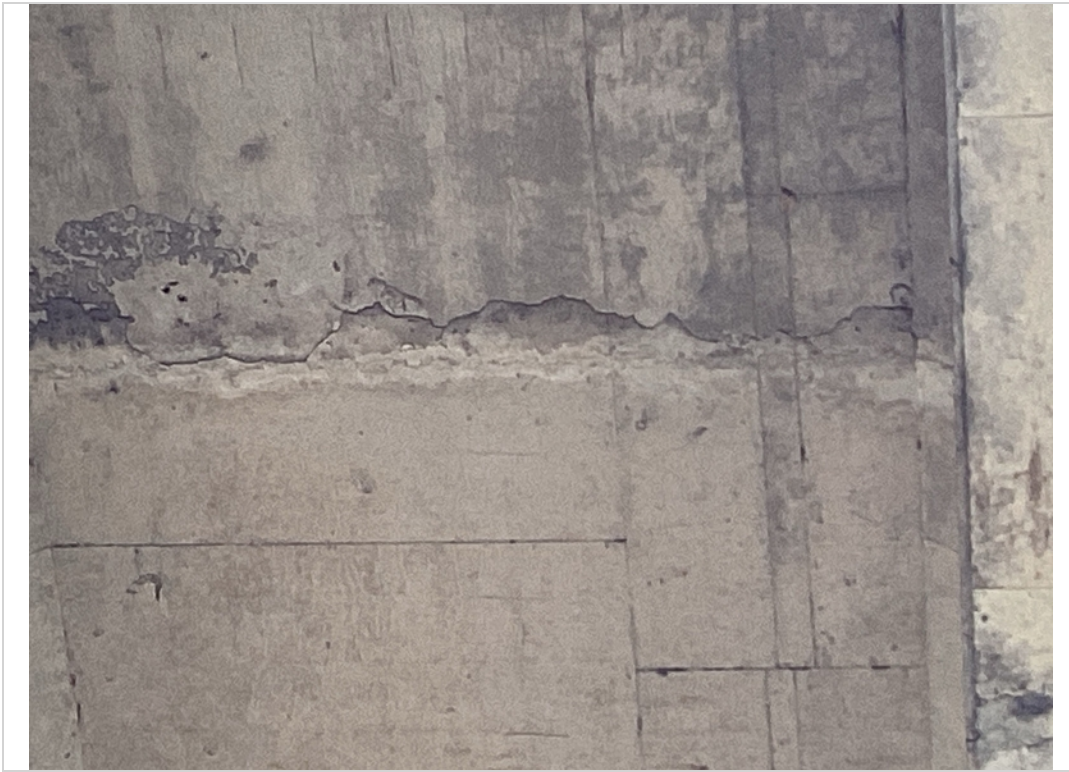
Span 1 bottom deck between beams A & B - Cracking up to 1/8" with leaching at the construction joints

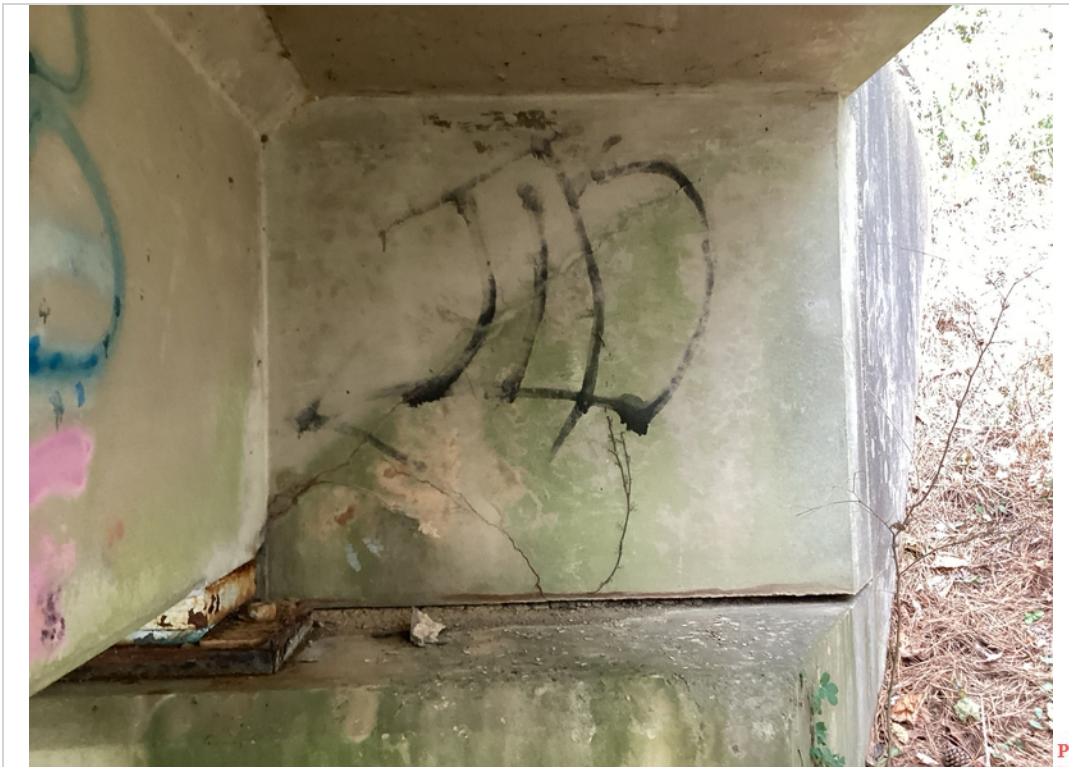
Abutment 1 back wall - Cracking up to 1/8"

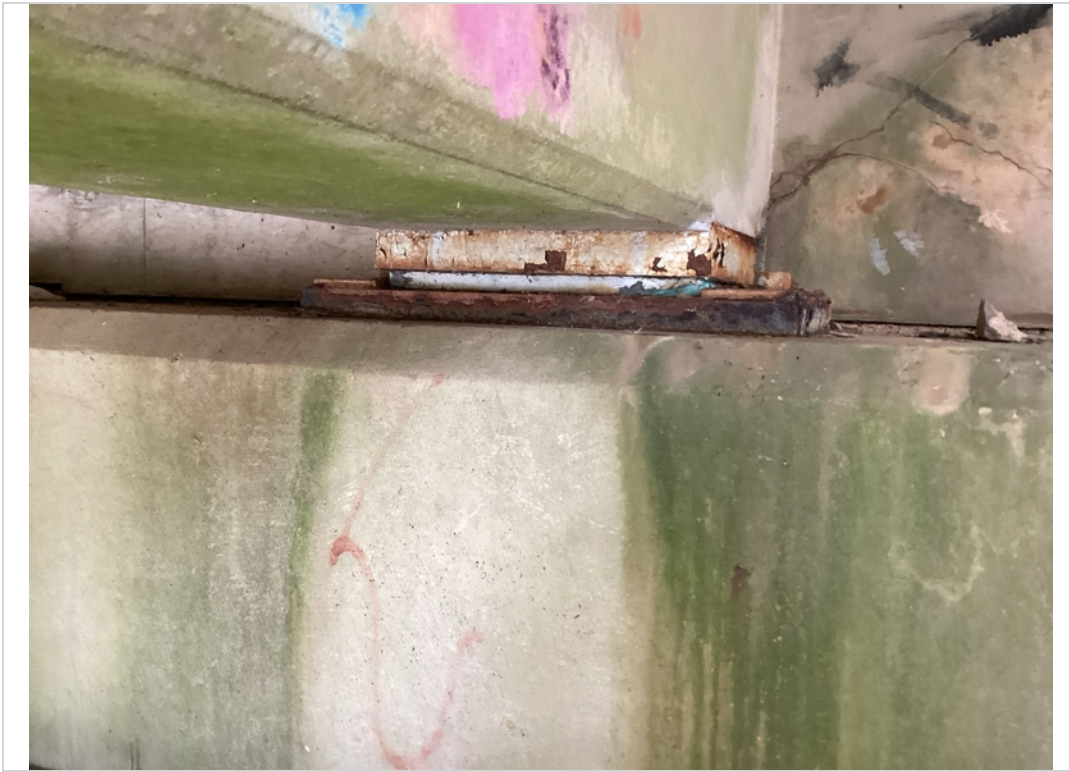
Abutment 1 - Bearing A - moderate corrosion

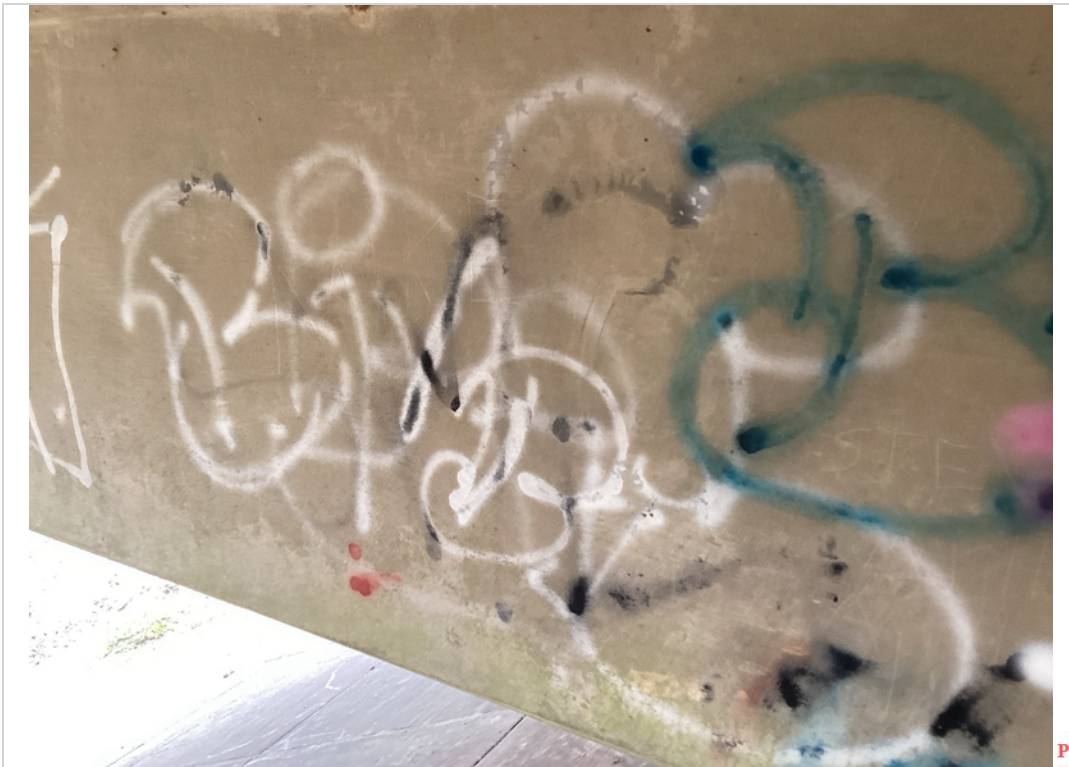
Beam A - abutment 1 - graffiti
