Region 01, 53 - Loudon County

I-75 Crossing SR 1

90 - LAST INSPECTION DATE 09/12/2024

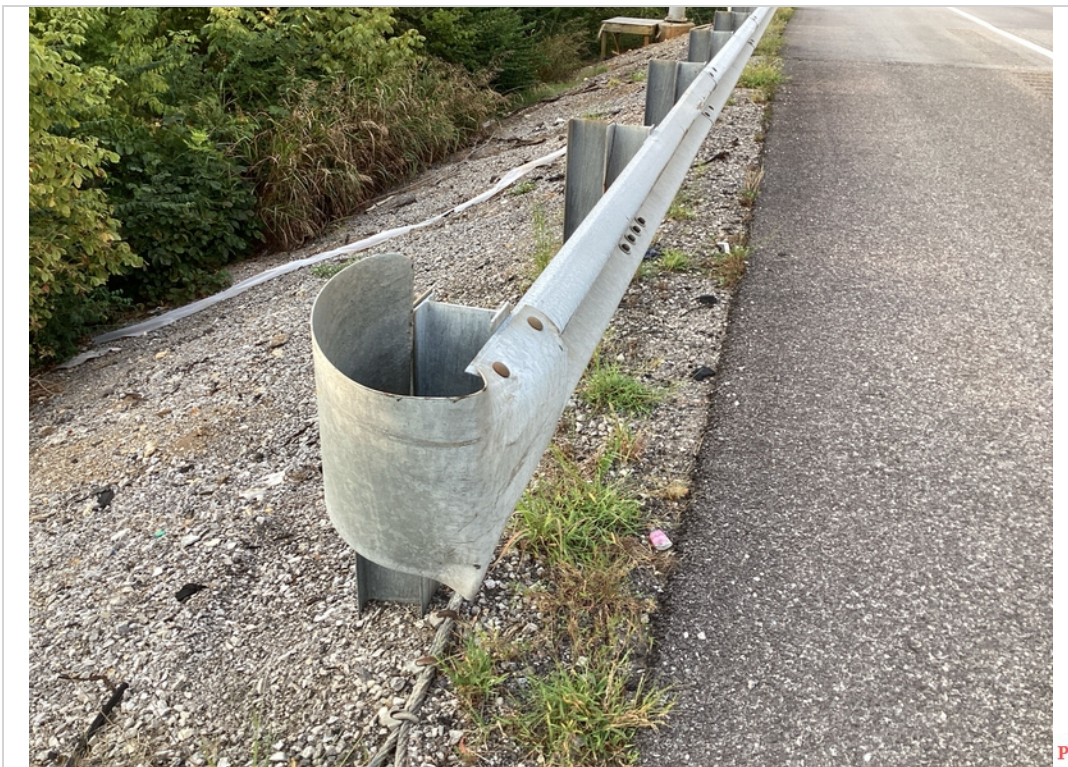
Approach 2 right terminal - minor collision damage

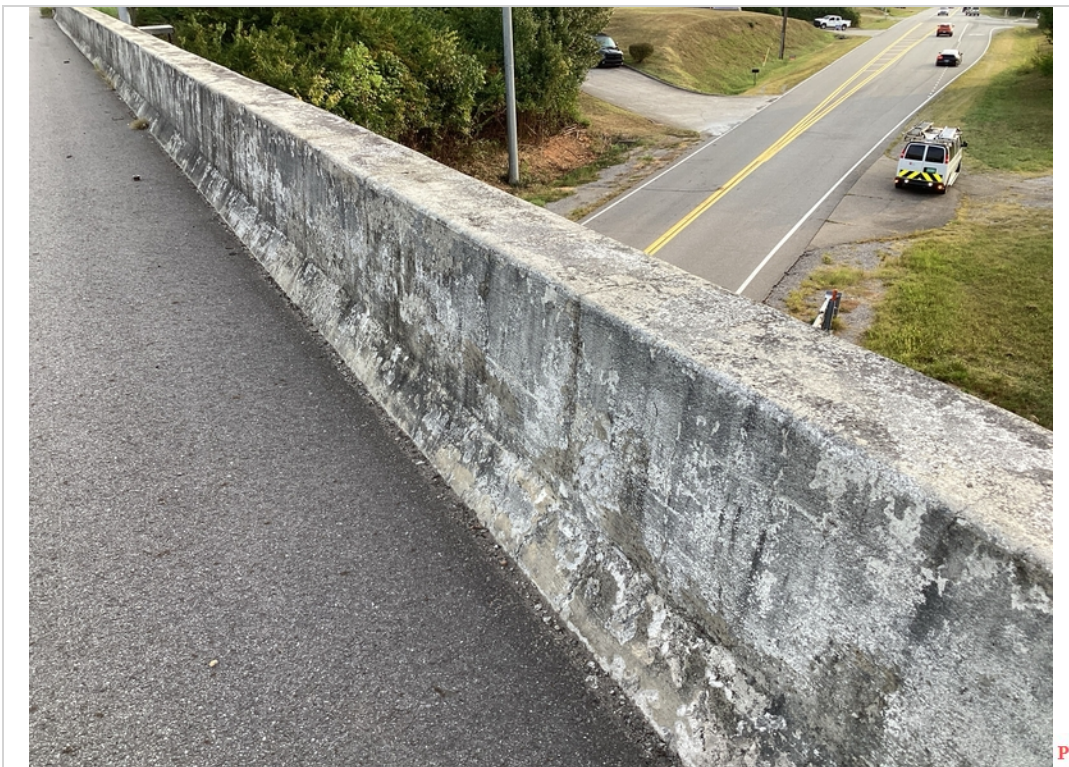
Deck 2 right rail - texture coat scaling (typical all)

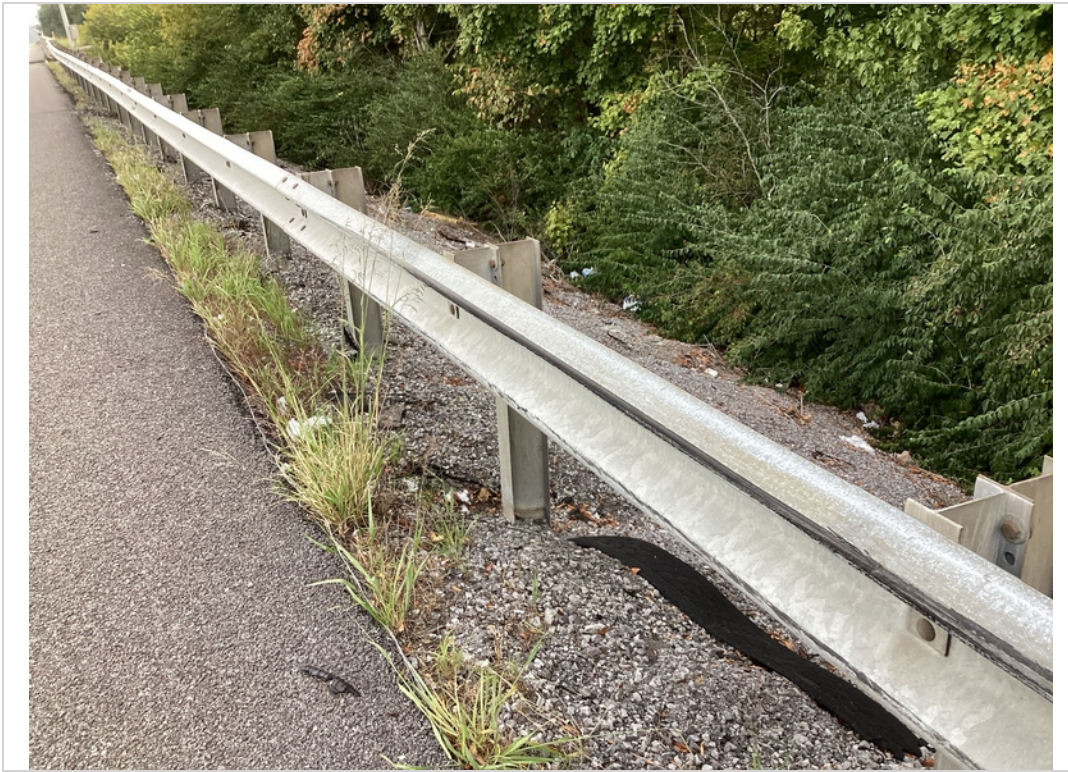
Approach 1 right rail - scrapes

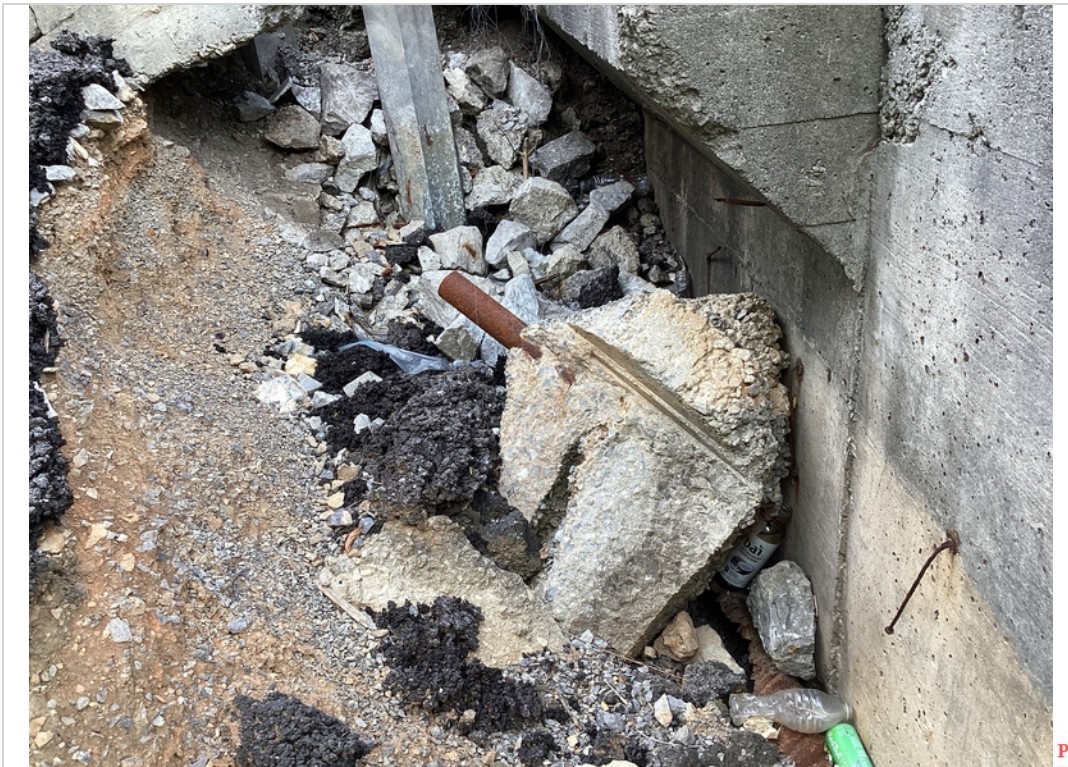
Approach 1 right drain pipe broken, eroding behind wing 1 right

Approach 1 right embankment and drain pipe - erosion

| Date Added | Recommendation | Priority |
|---|---|---|
| 09/12/2024 | REPAIR APPROACH 1 RIGHT DRAIN AND PIPE | |

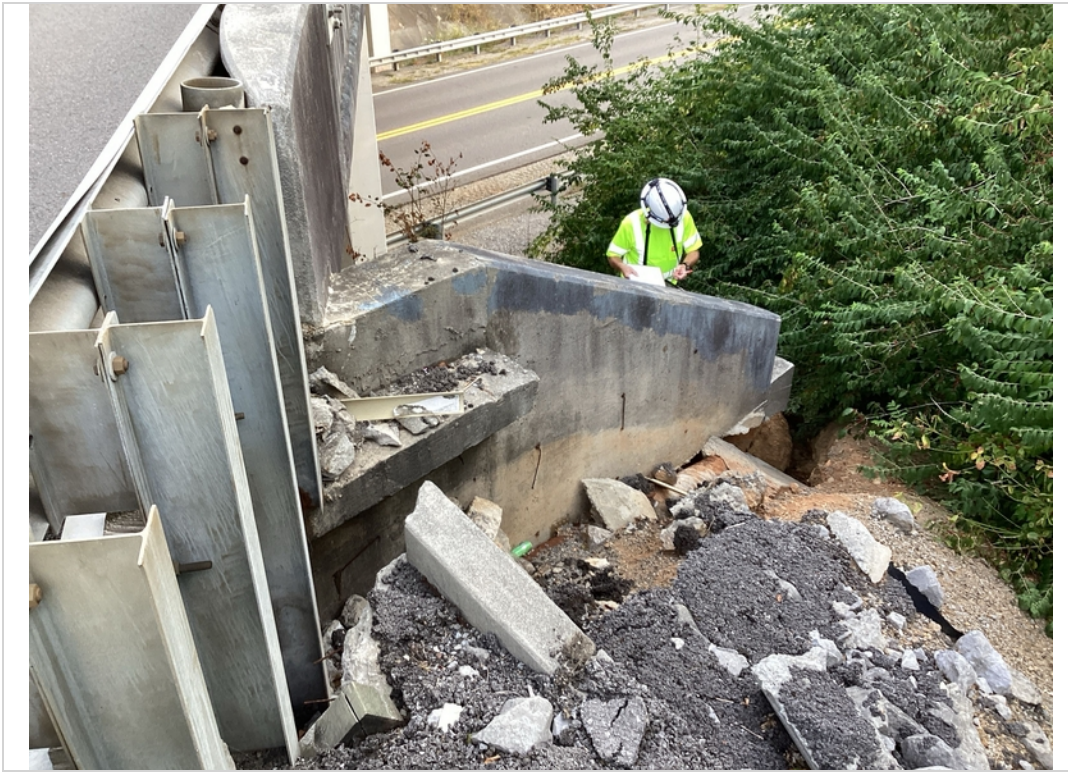
Steep with erosion rills, severe erosion at approach 1 right behind wing

Approach 1 right embankment - erosion

| Date Added | Recommendation | Priority |
|---|---|---|
| 09/23/2022 | REPAIR EROSION AT APROACH 1 RIGHT EMBANKMENT | 1 |

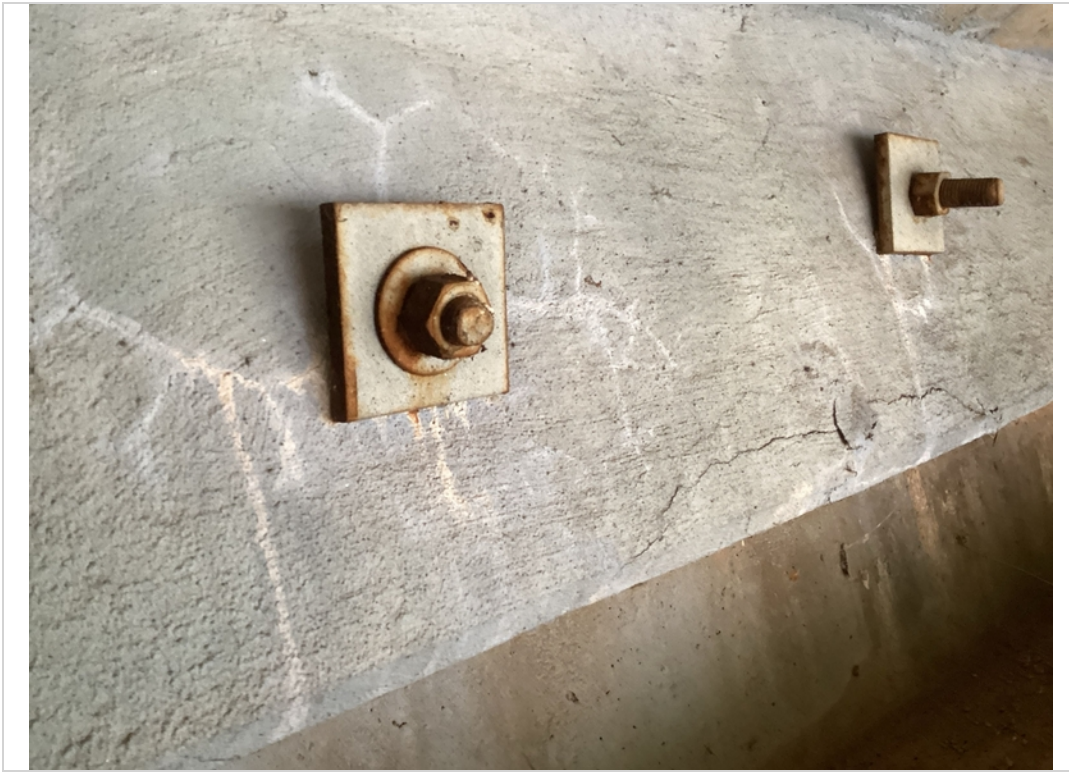
Diaphragm between beams B/C abutment 2 - Hairline map cracks (Typical abutment 1) & cracks up to 1/8"

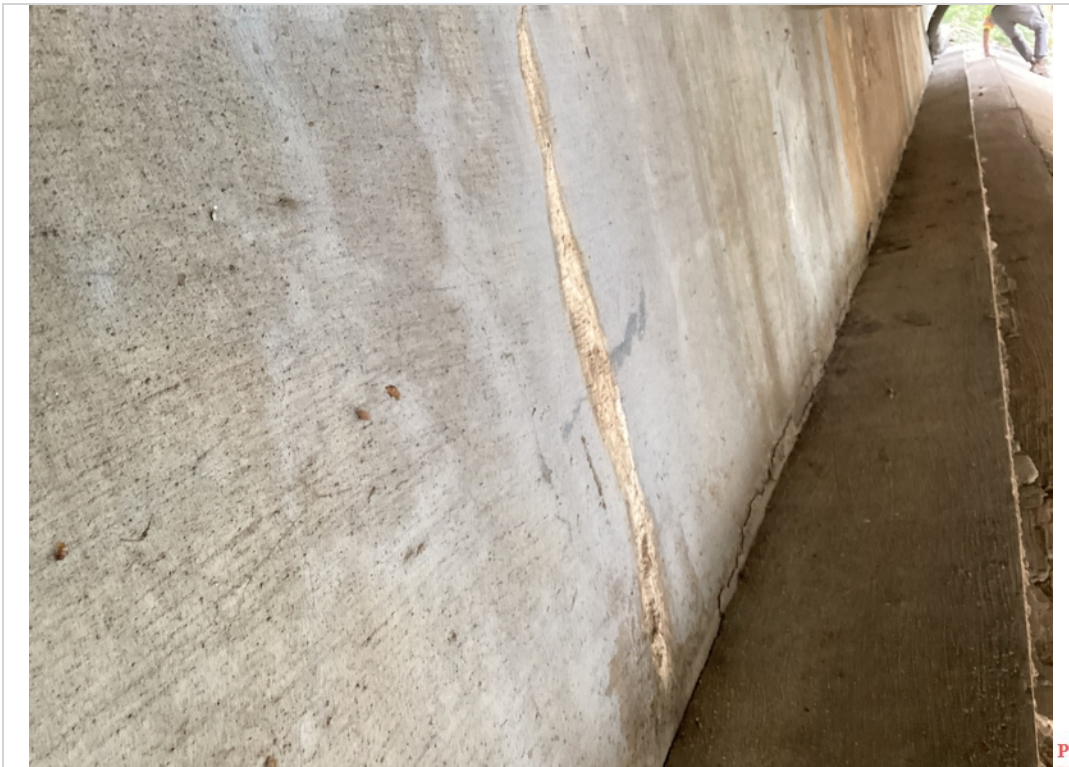
Abutment cap 1 Hairline cracks w/ leaching (Typical abutment 2)

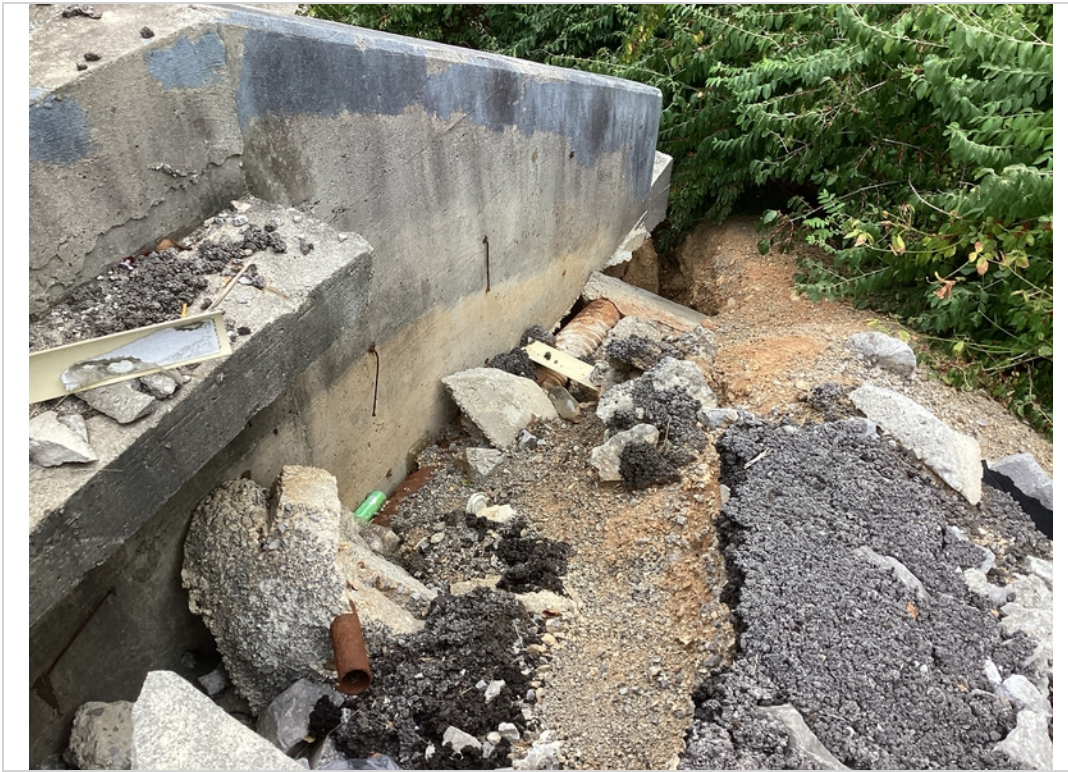
Behind wing 1 right - Heavy erosion (15'Lx4'Wx4'H)

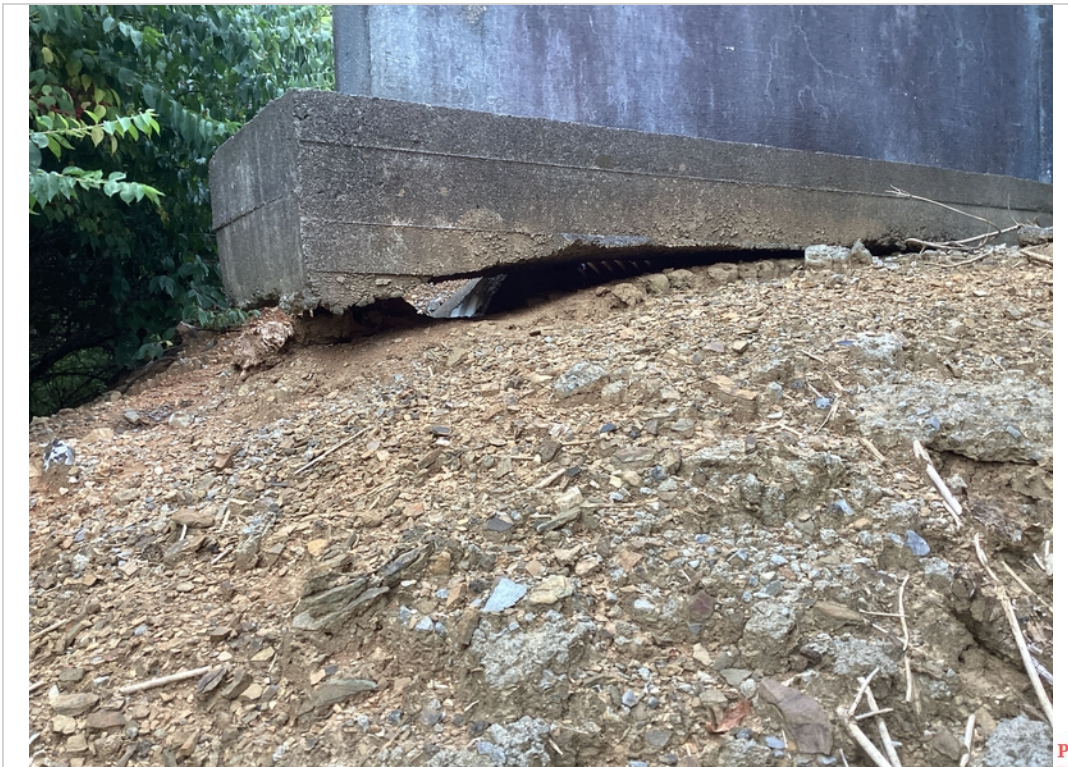
Wing 1 right - Undermining 8' long

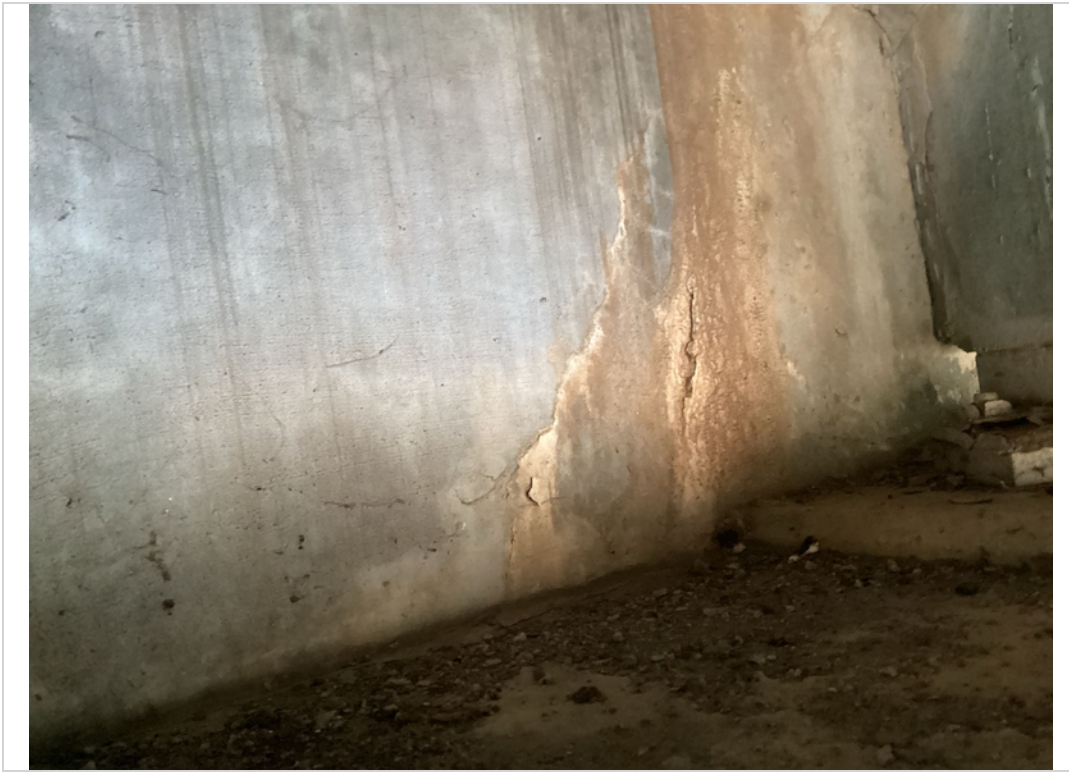
Backwall abutment 1 - Hairline cracks w/ leaching ((Typical abutment 2)

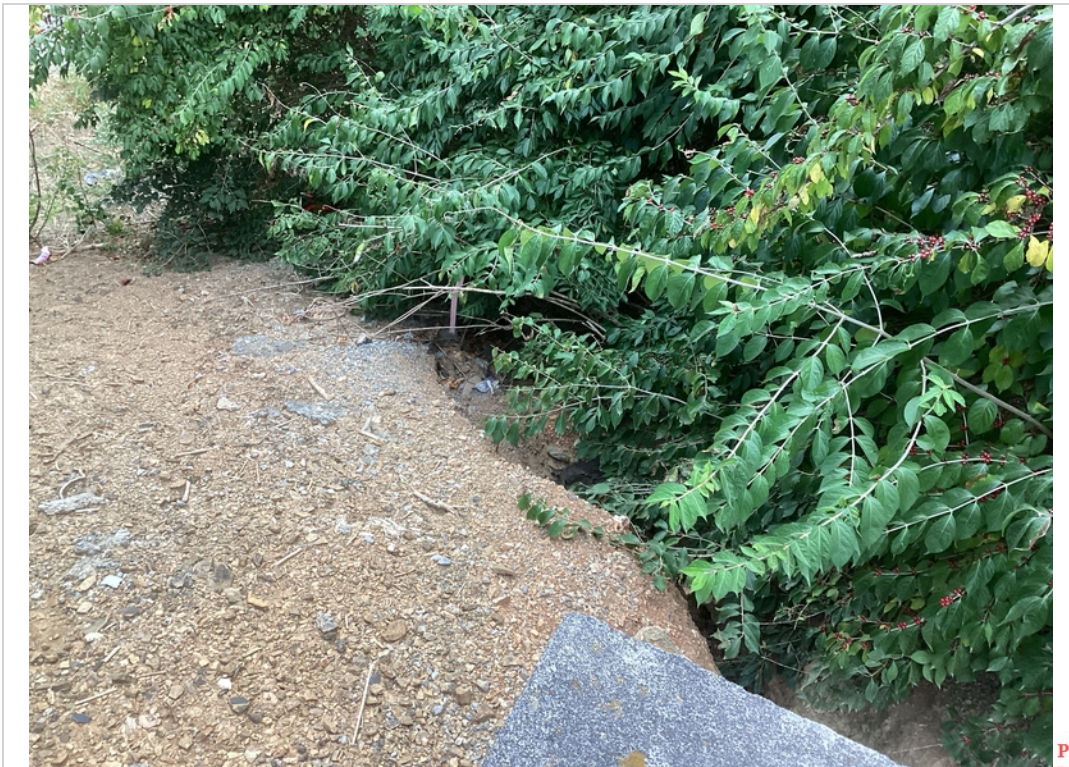
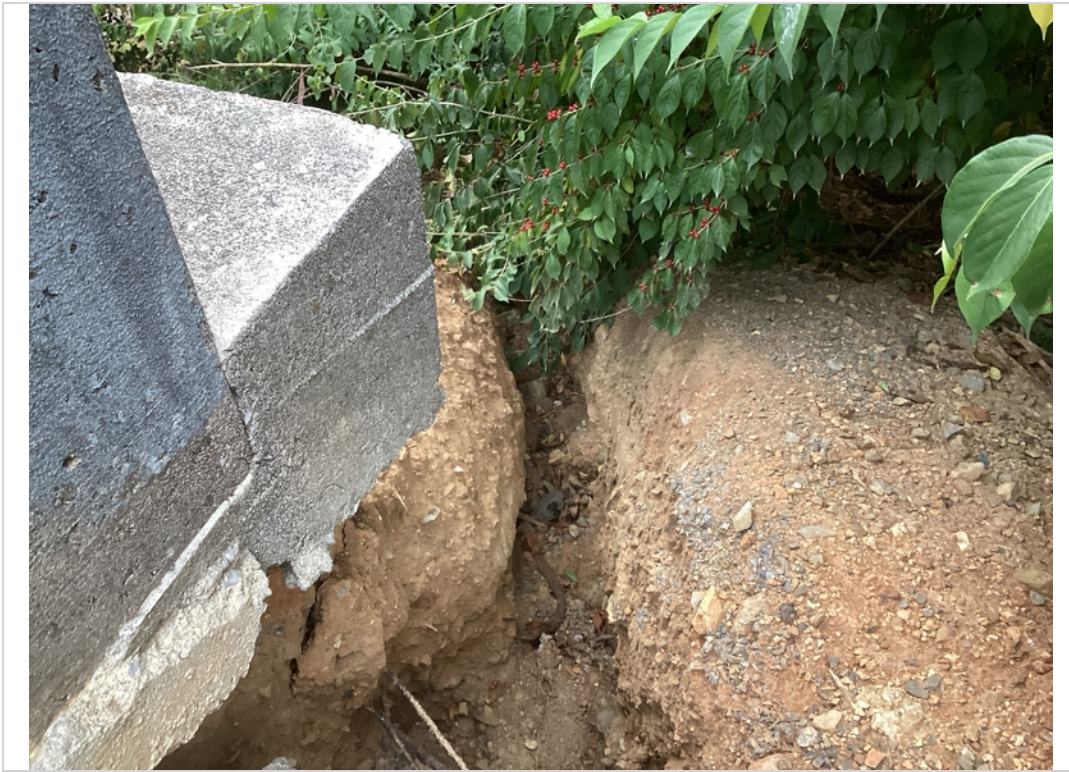
Embankment right - Erosion channel (10'Lx18"Wx3'D)

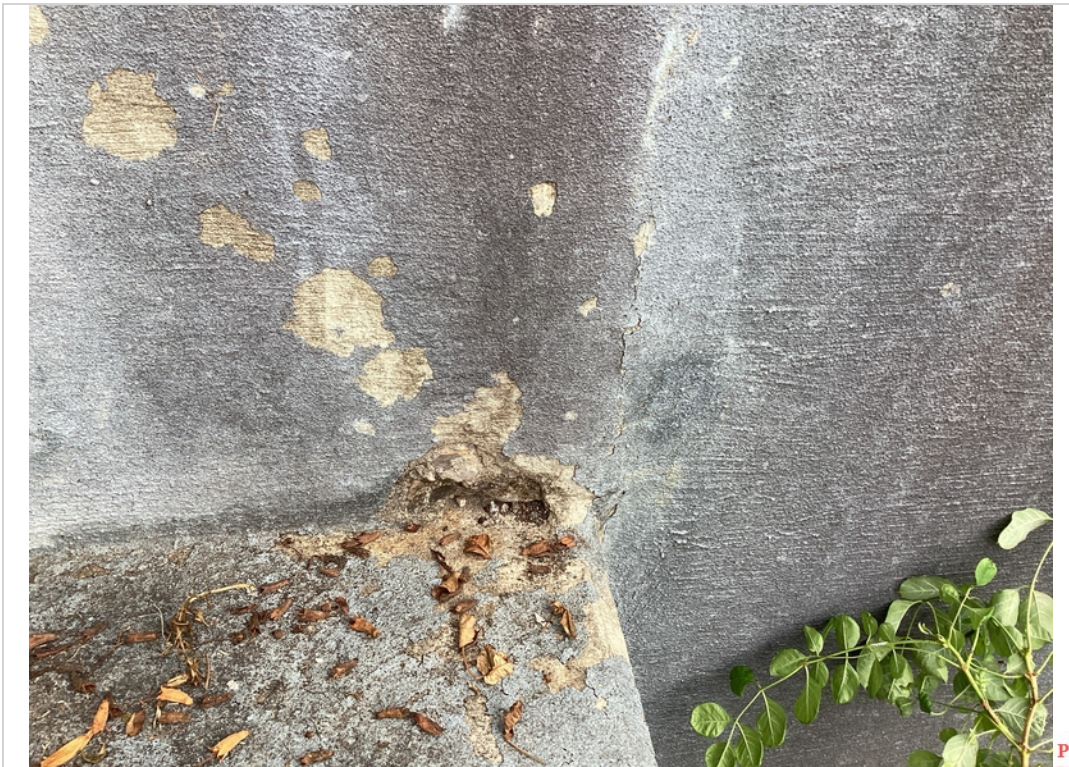
Wing 2 left - spall (4"diameter x 2"D)

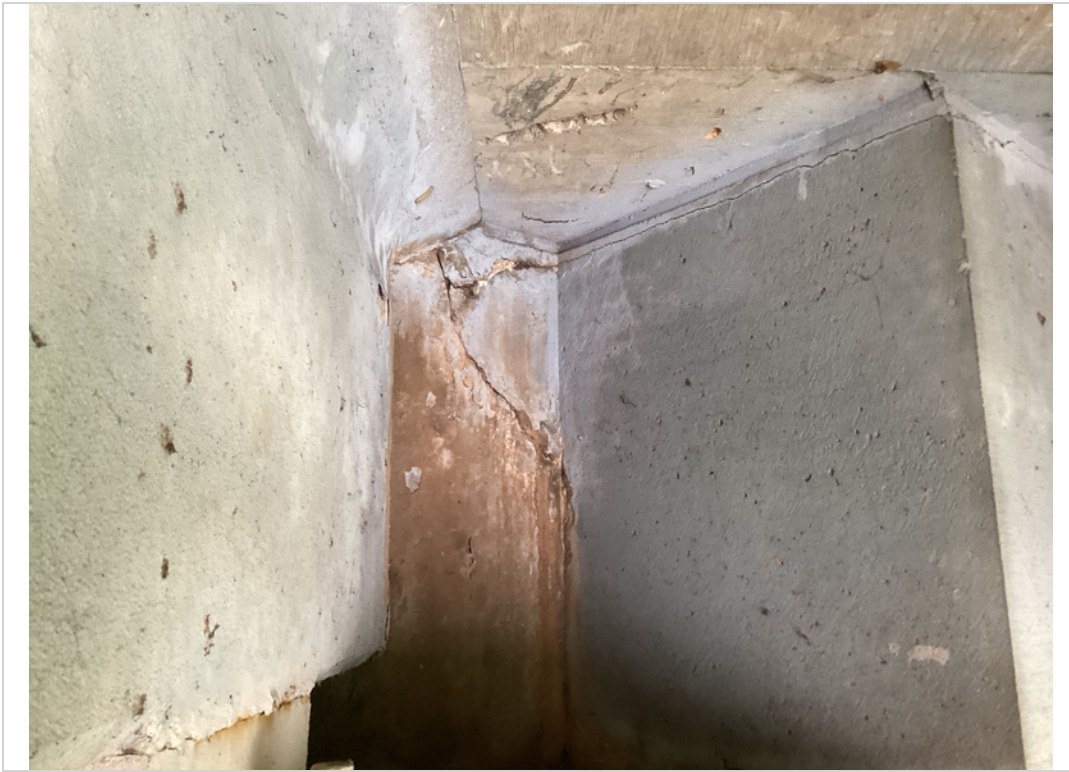
Abutment 2 backwall at Beam D right - cracks up to 1/8" with leaching

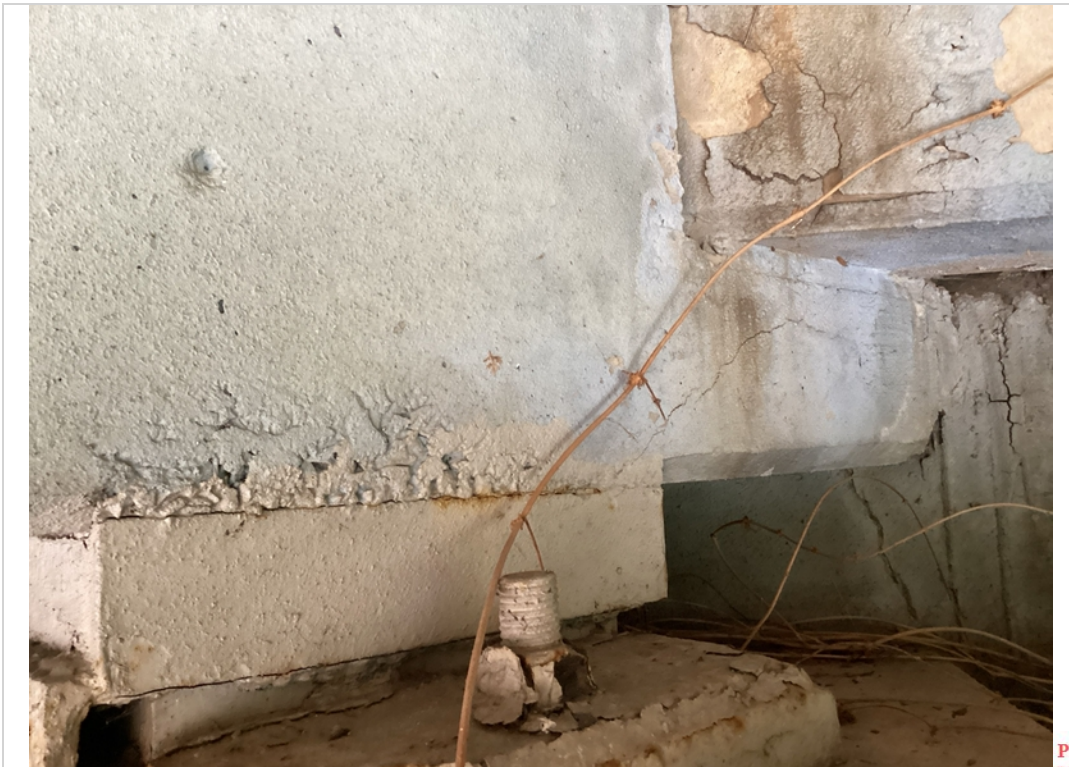
Span 3 Beam D behind bearing area - Hairline crack

| Date Added | Recommendation | Priority |
|---|---|---|
| 10/15/2008 | REPAIR ALL BEAMS BEHIND ABUTMENT BEARING AREAS | |

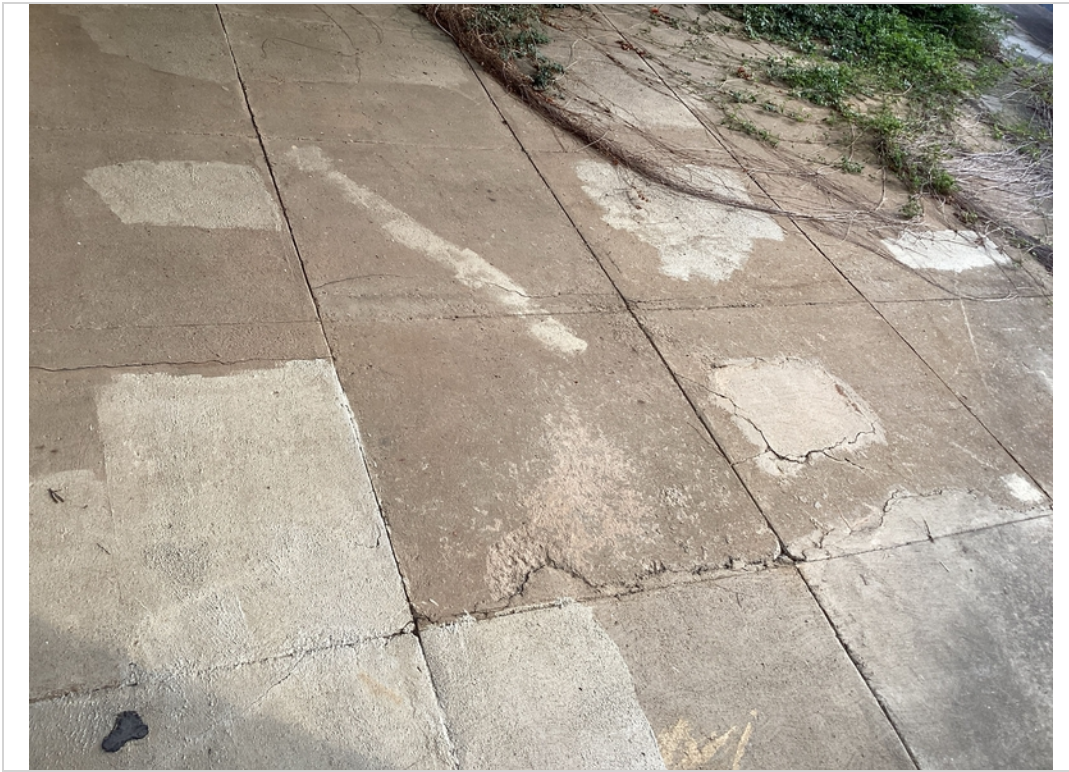
Abutment 2 concrete slope - Cracking up to 1/8"

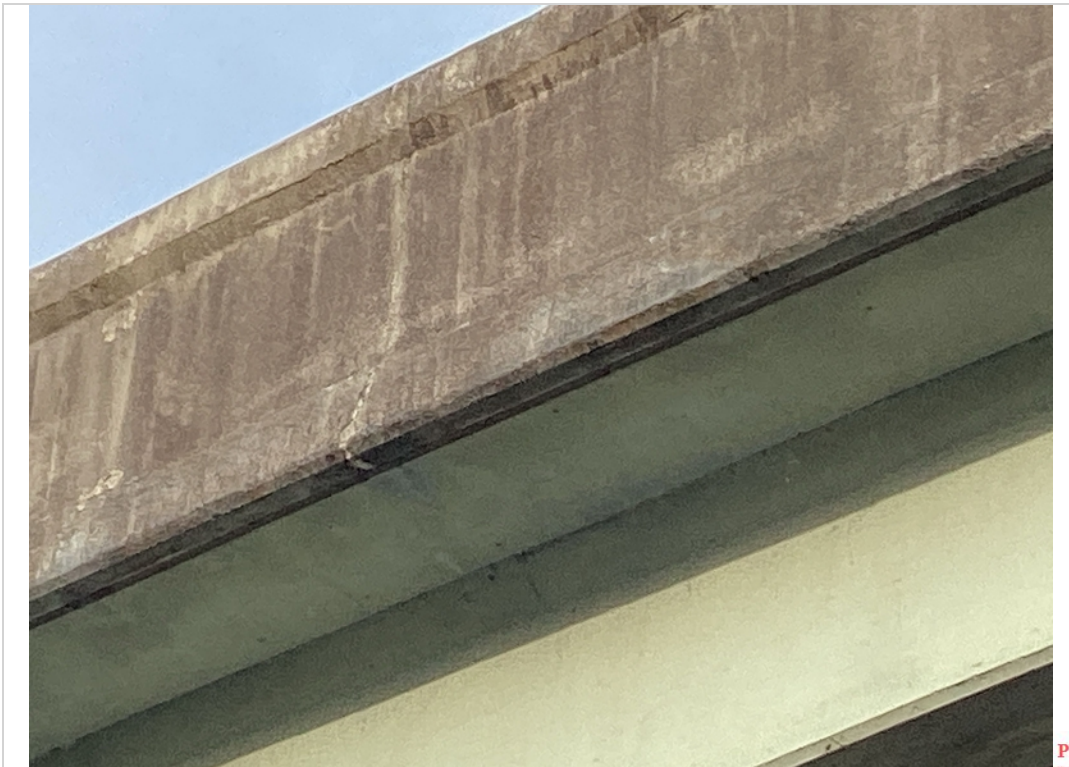
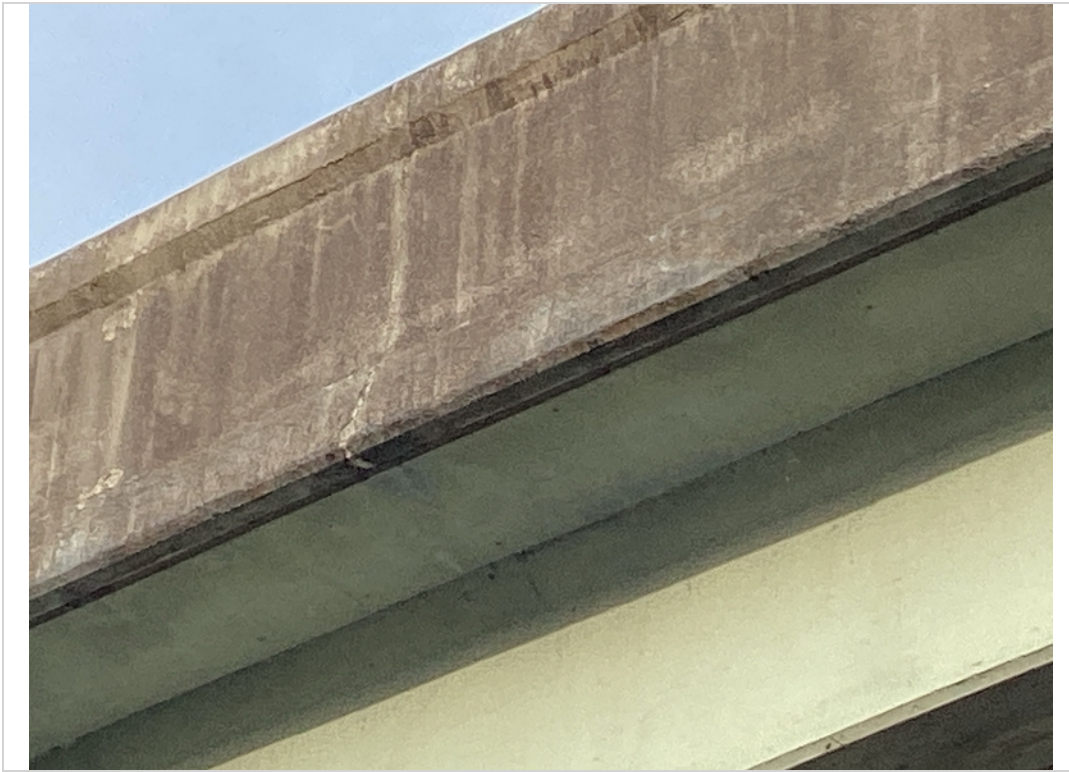
Span 2 Right bridge rail - Hairline cracks with leaching

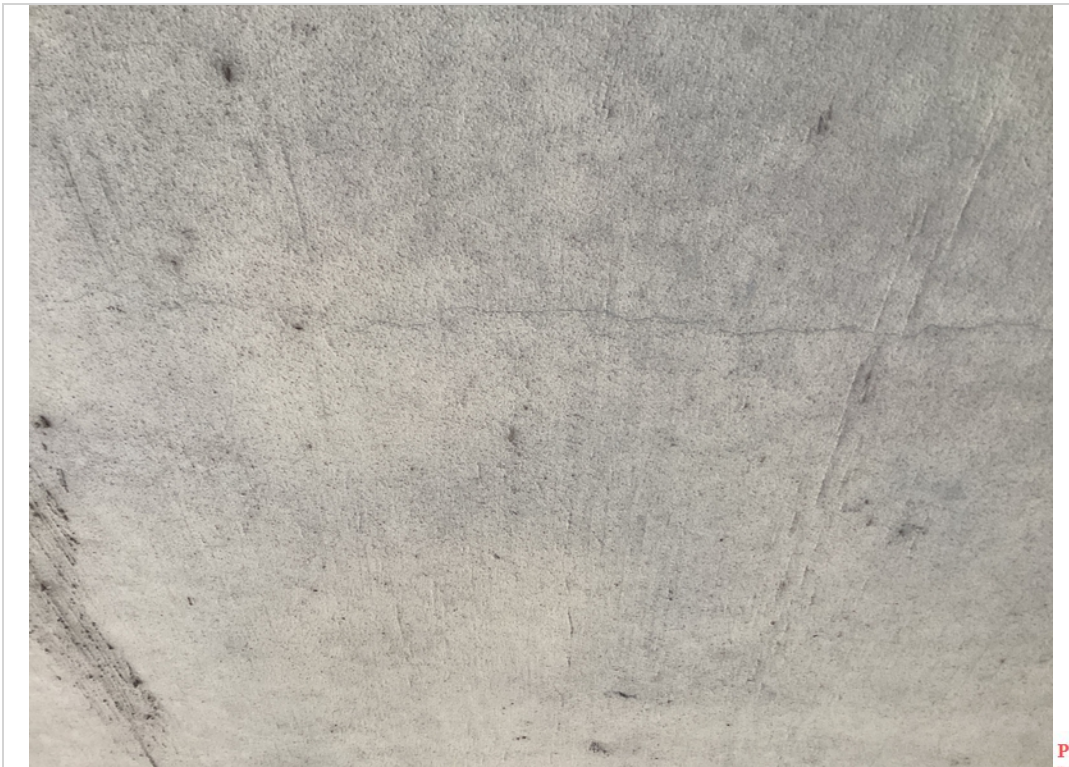
Span 1 left overhang - Hairline cracks

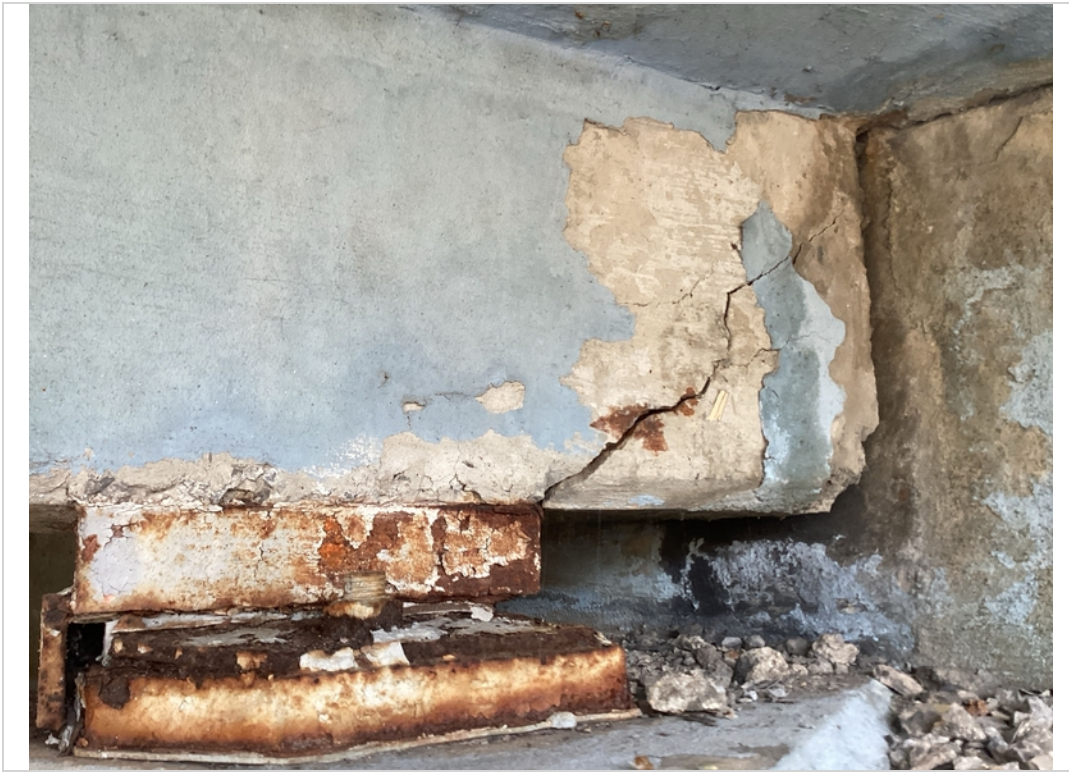
Span 1 Beam A - Spall in place behind bearing area (1'L x 1'H x 1"D)

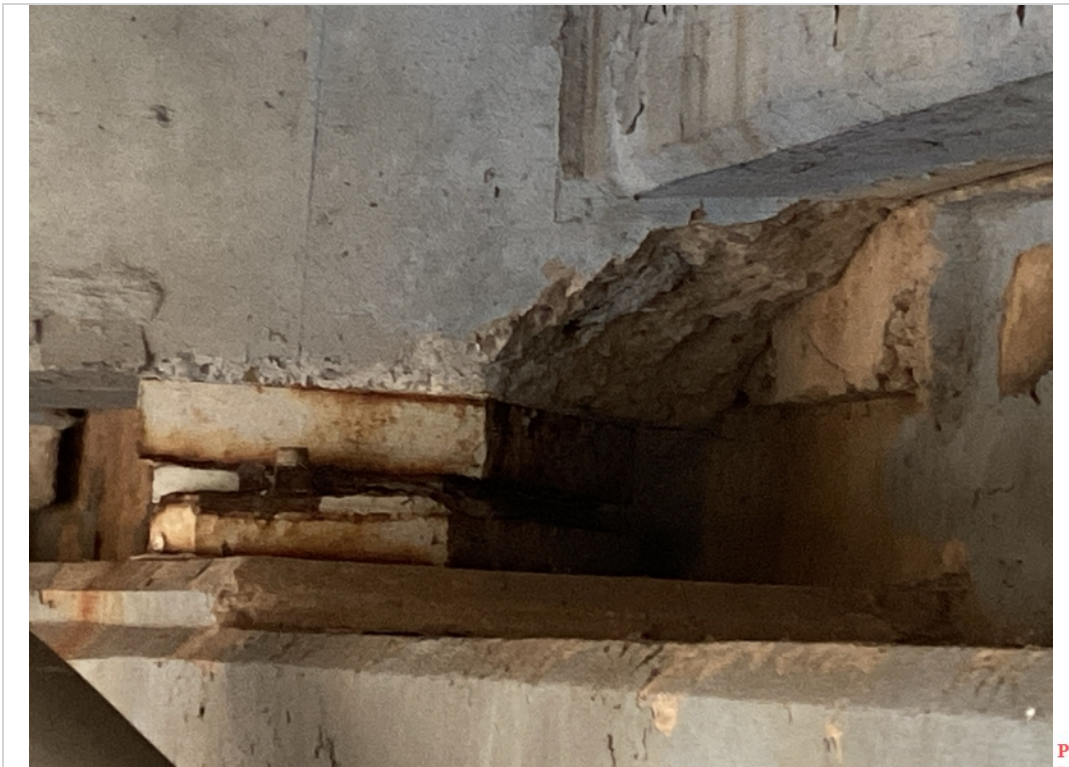
Span 1 Beam B - Spall behind bearing area (1'L x 1'H x 1"D)

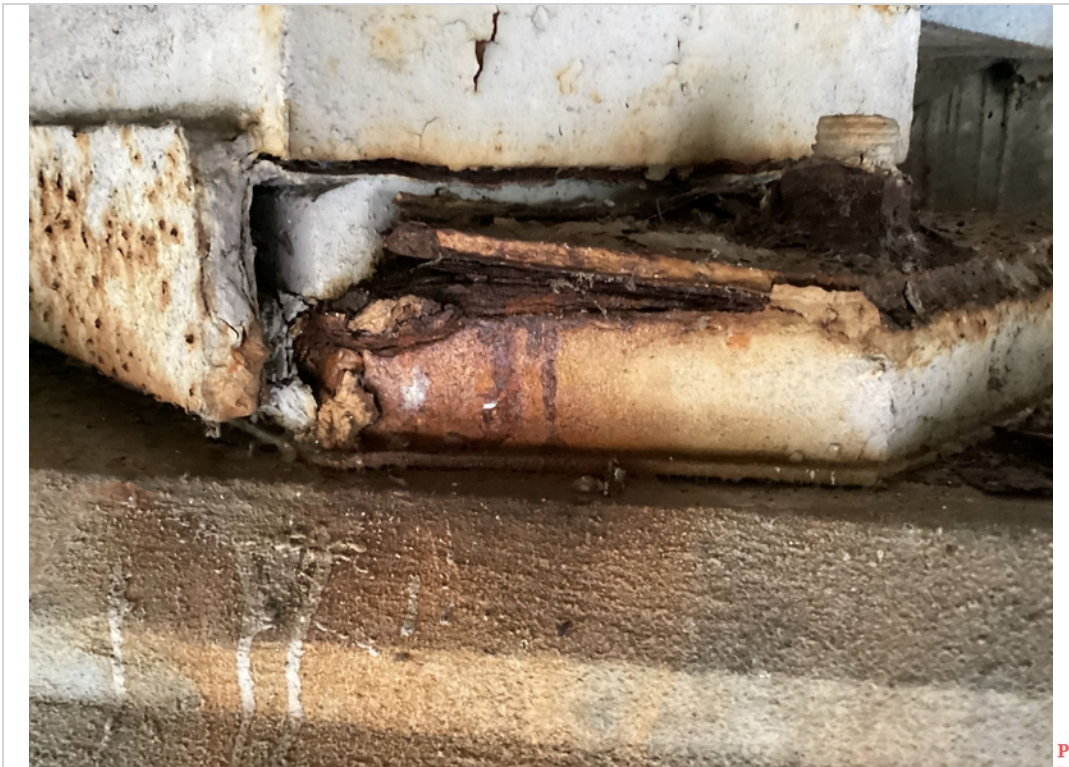
Span 1 Bearing D left - moderate corrosion (Typical A - D)

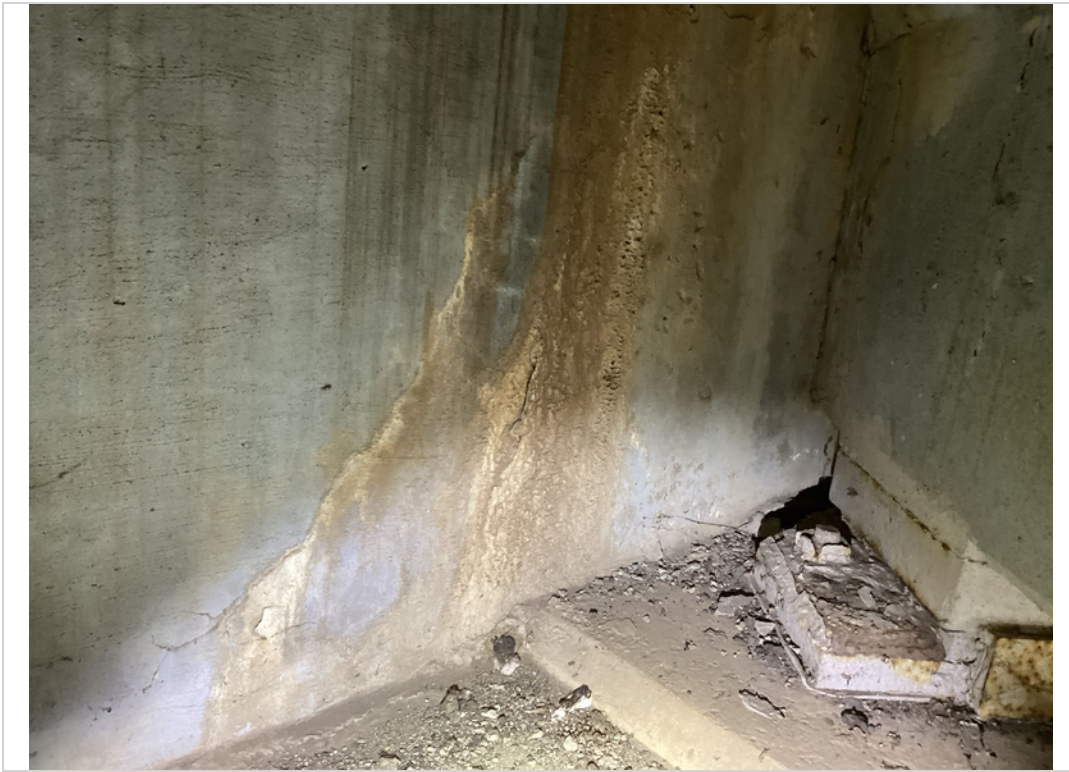
Span 1 Backwall at Beam D right - Hairline cracks with leaching

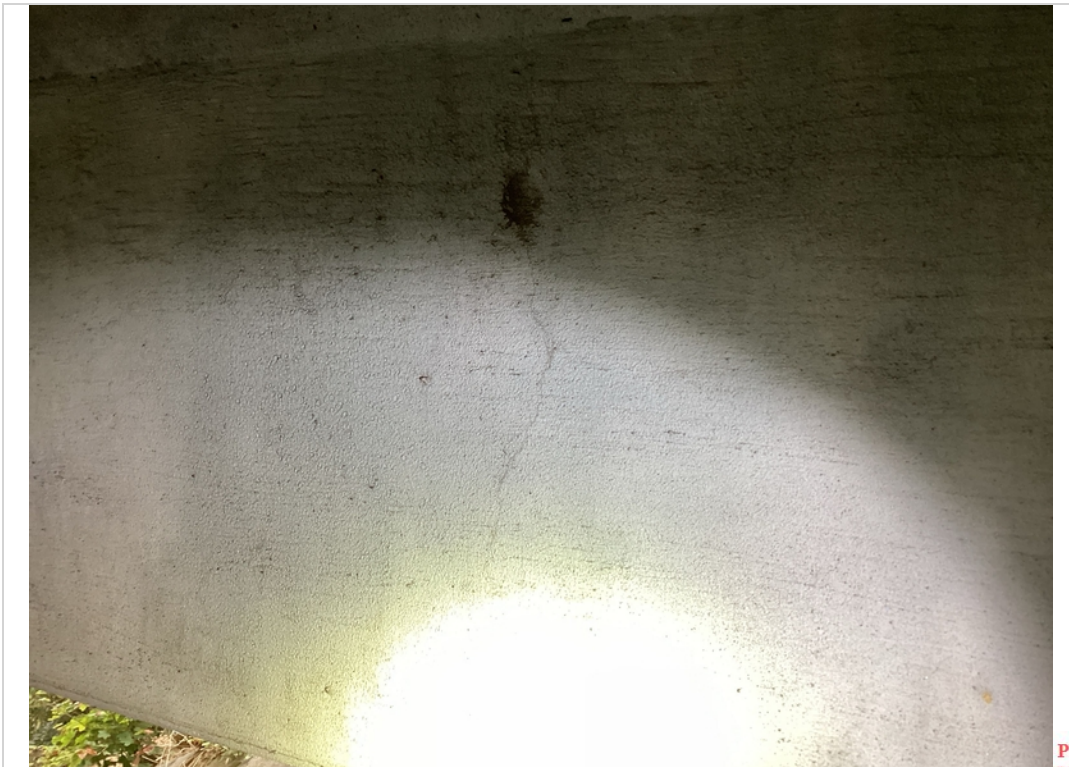
Span 1 Beam E - Hairline cracks (Typical )

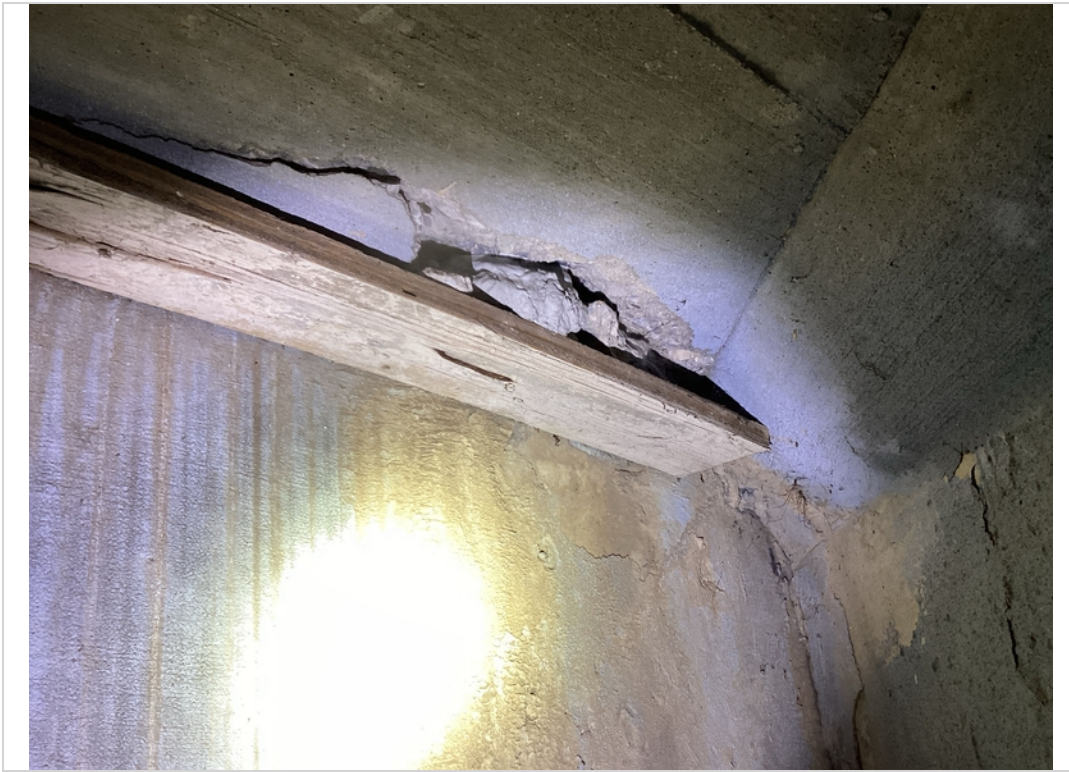
Span 1 Bottom deck at Beam D right - Spall with exposed rebar (1'W x 6"L x 3"Dp)
