Region 01, 53 - Loudon County

I-75 Crossing HOPE CREEK

90 - LAST INSPECTION DATE 09/16/2024

521 - OVERALL CONDITION 2 - Fair

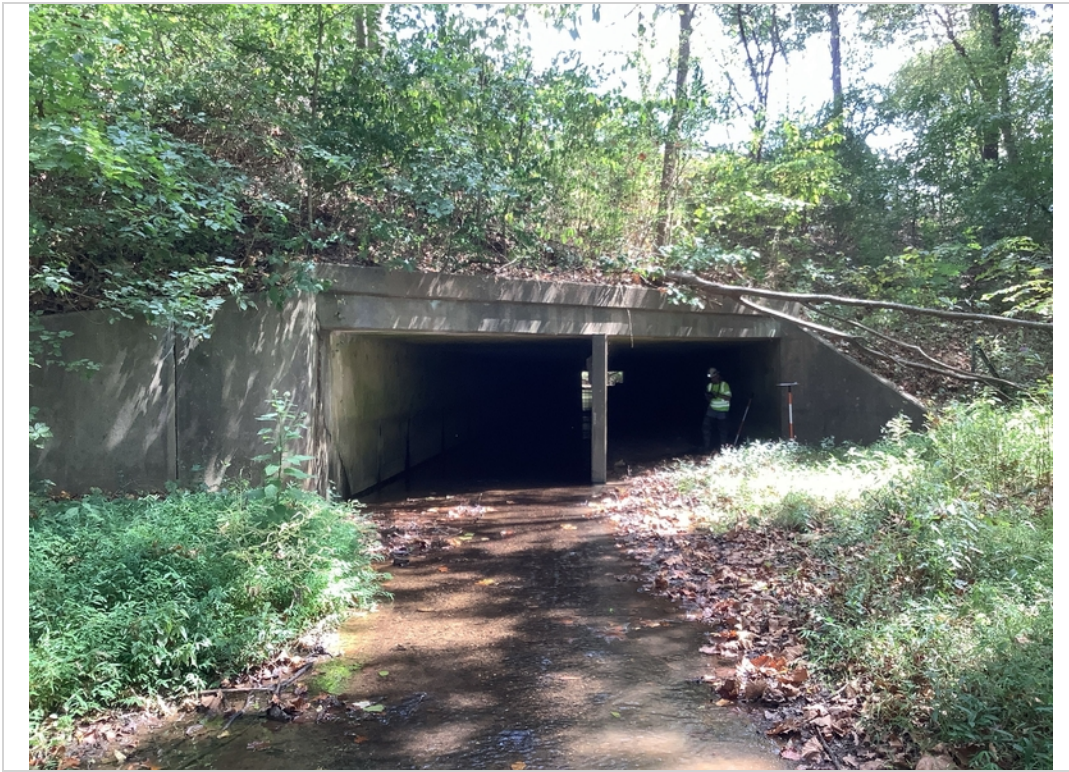
The channel is in good condition. There is up to 1' sediment in barrels. There is a fallen trees on outlet and inlet channels, and on wing 1 right.

Elevation left (note fallen tree)

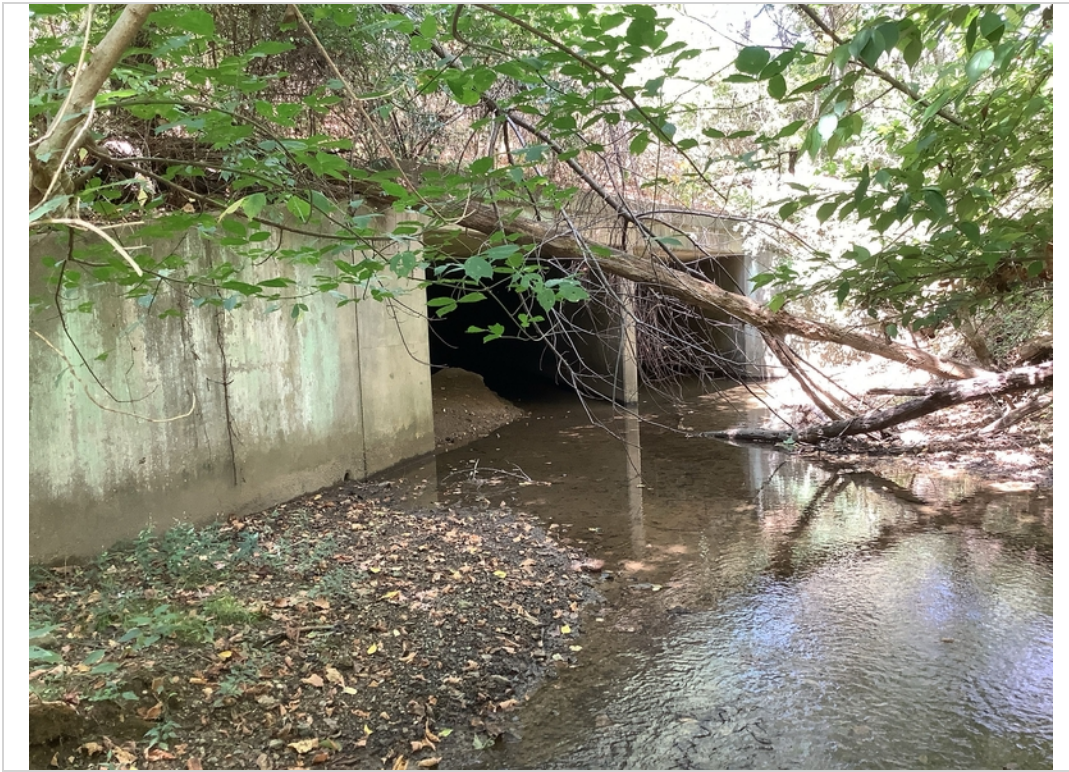
Elevation right (note fallen tree)

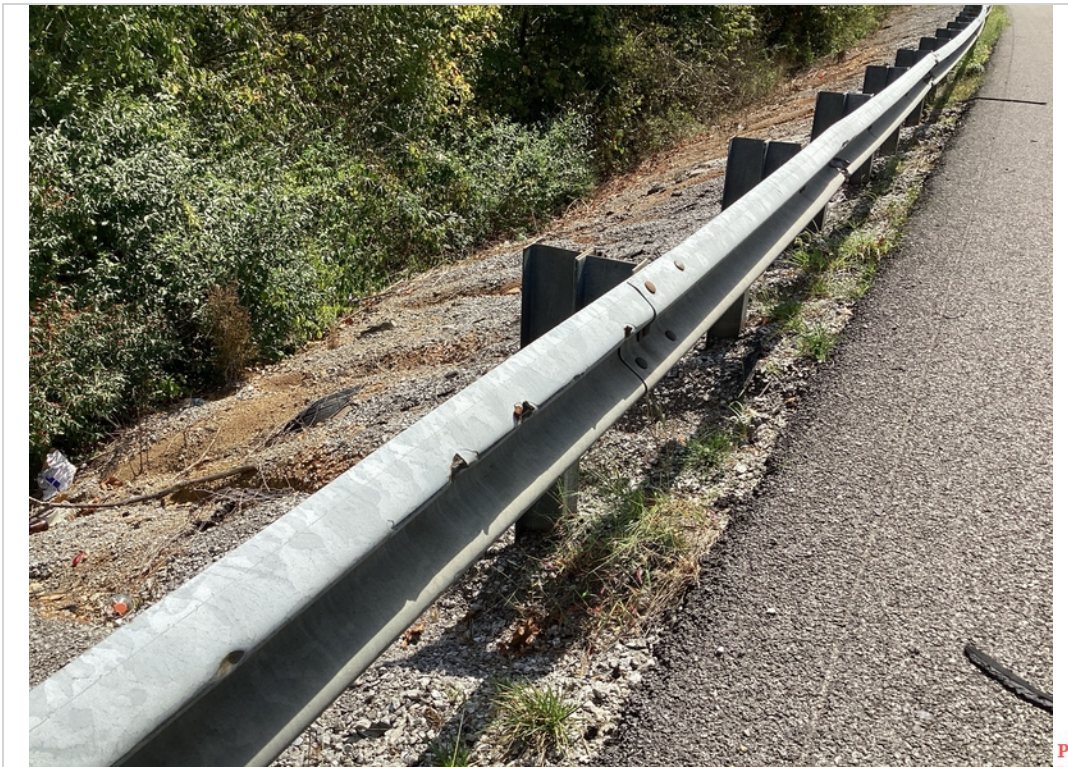
Approach roadway alignment is good. Approach and culvert wearing surface is good, asphalt overlay. Approach rails are good, substandard, and minor collision damage on right. Paddleboard decals are in place at rail terminals.

Right bridge rail - minor collision damage

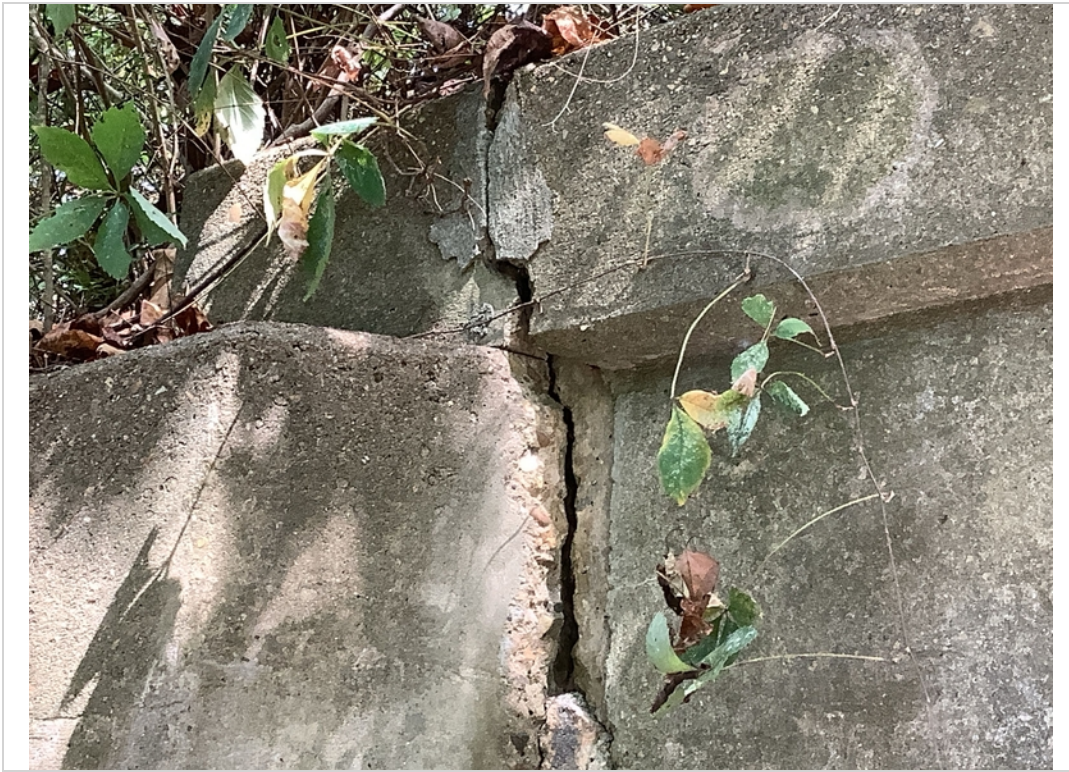
Wing 2 left abutment joint - cracks to 3/8", patch, minor spall

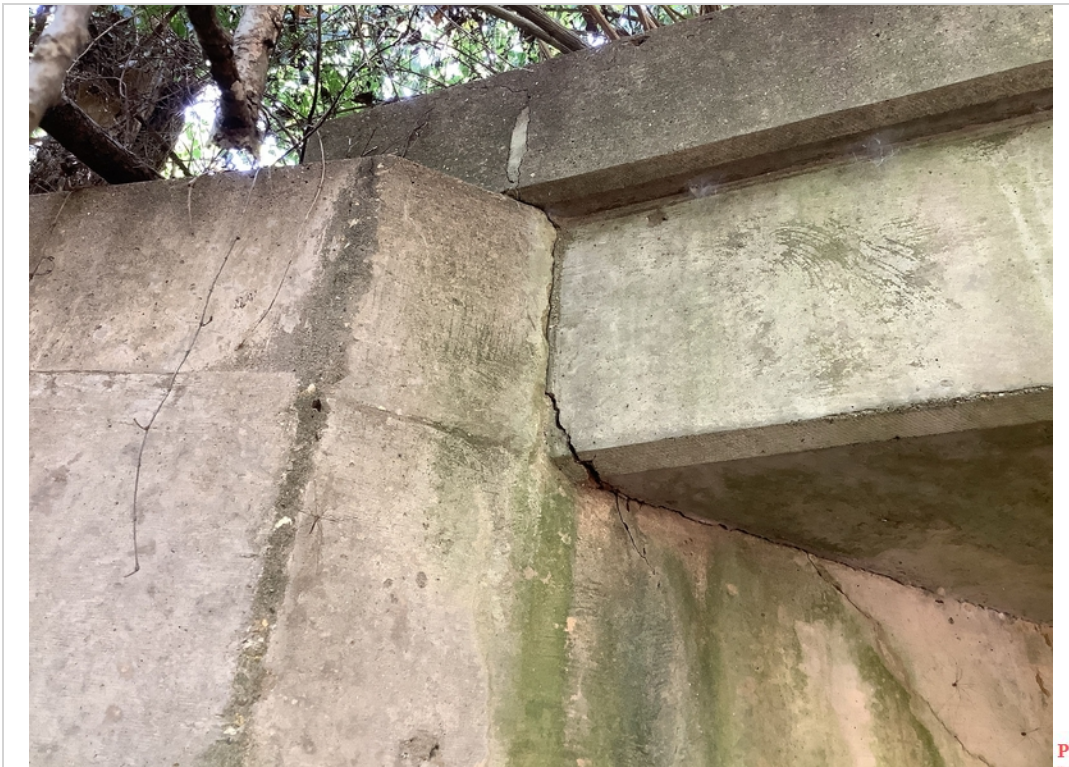
| Headwall/Curbs | (Good) | Inlet headwall - 1/8" crack; Outlet headwall - crack 3/8" w/ minor spalls, patch | | | |

Inlet headwall at barrel 1 - cracks to 1/8"

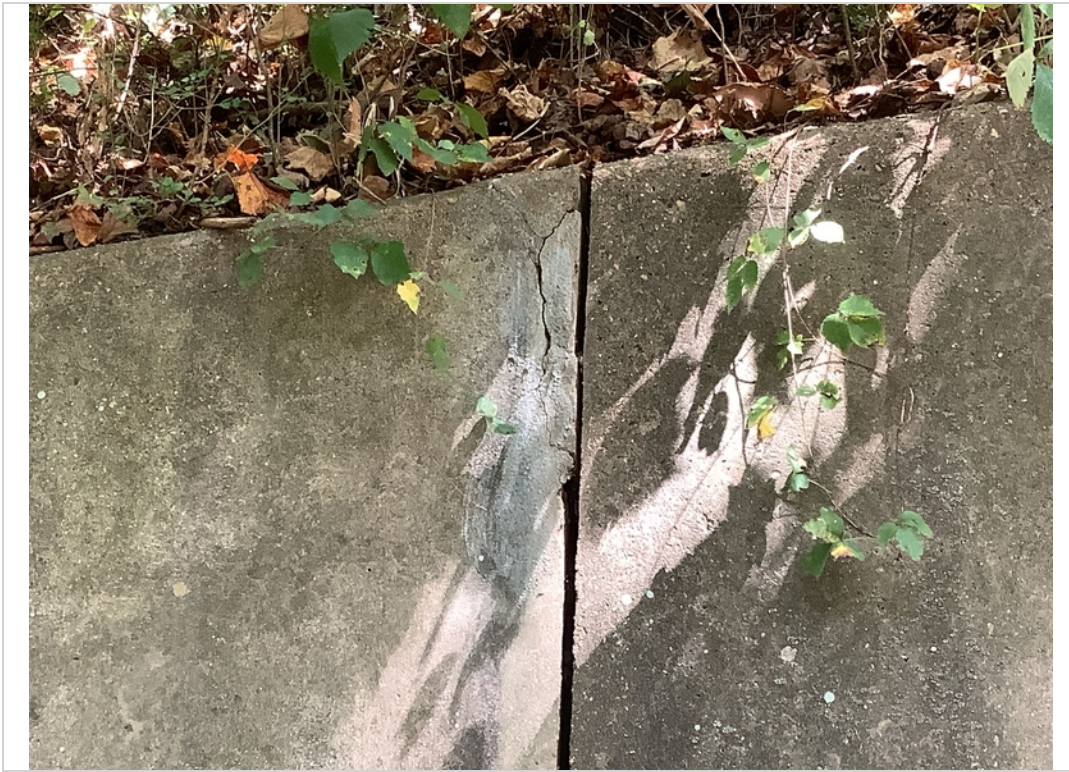
| Wingwall | (Good) | Wing 2 left - patch and spall in place 14" x 3", hairline cracks | | | |

Wing 2 left - patch and spall in place (14" x 3")

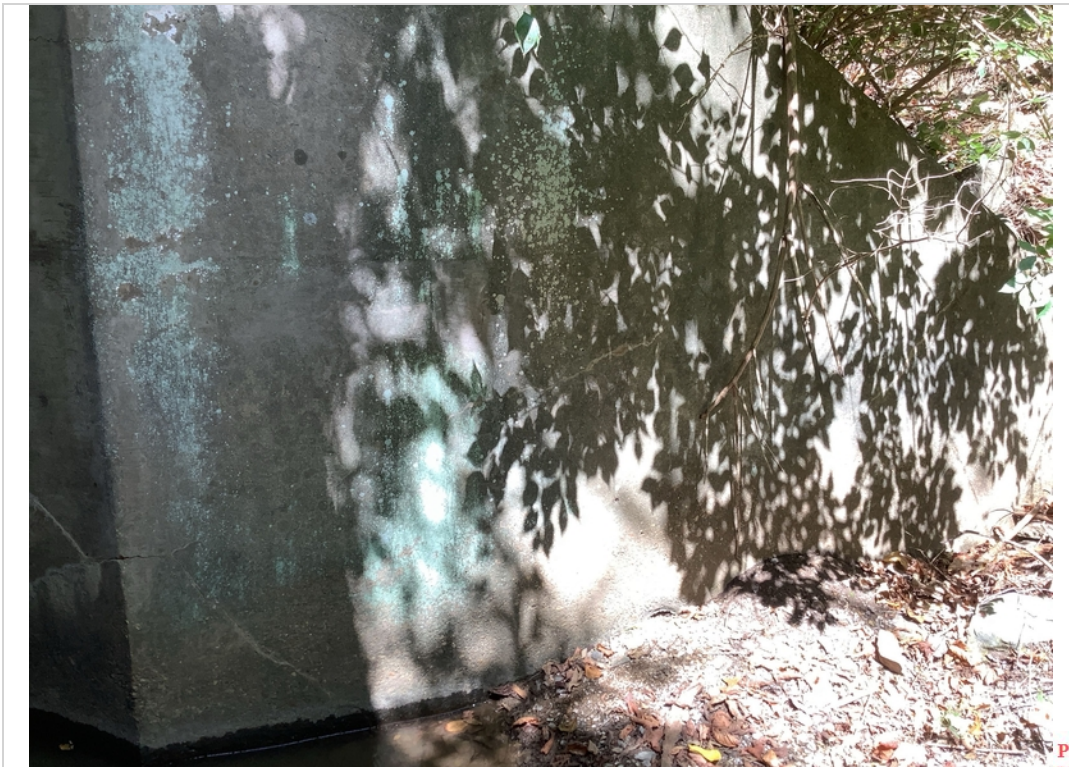
Wing 2 right - hairline cracks

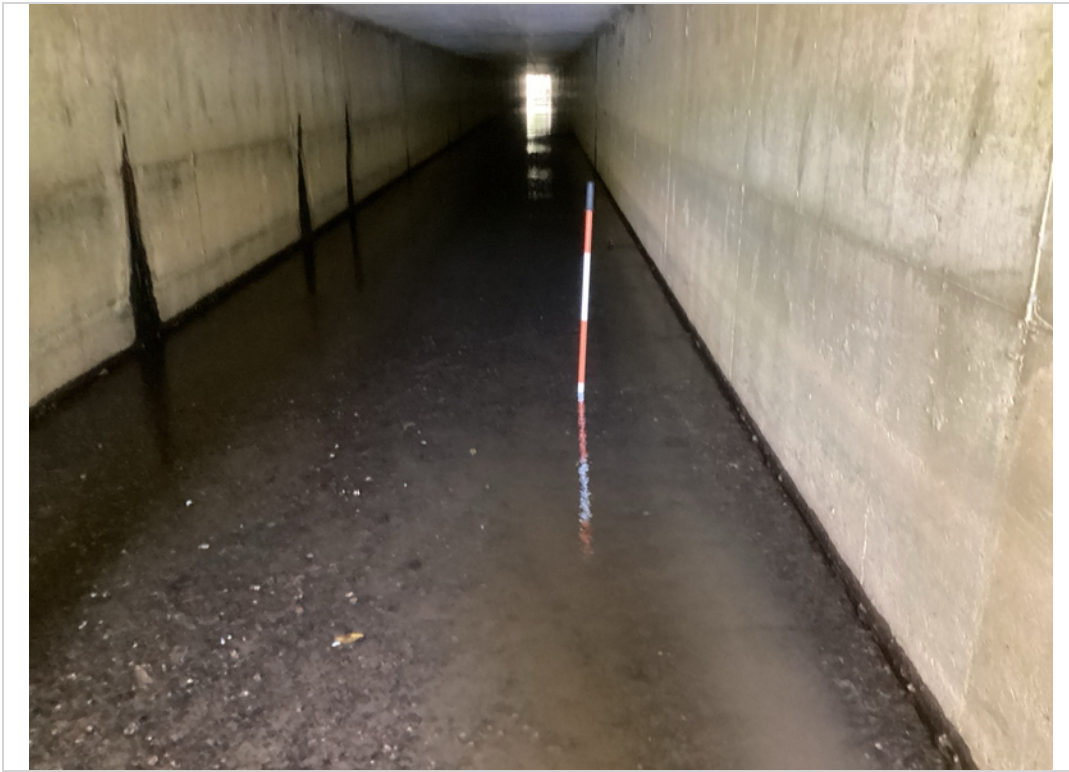
| Sediment | (Good) | Sediment up to 1' | | | |

Barrel 2 - Sediment up to 1' (Typical barrel 1)

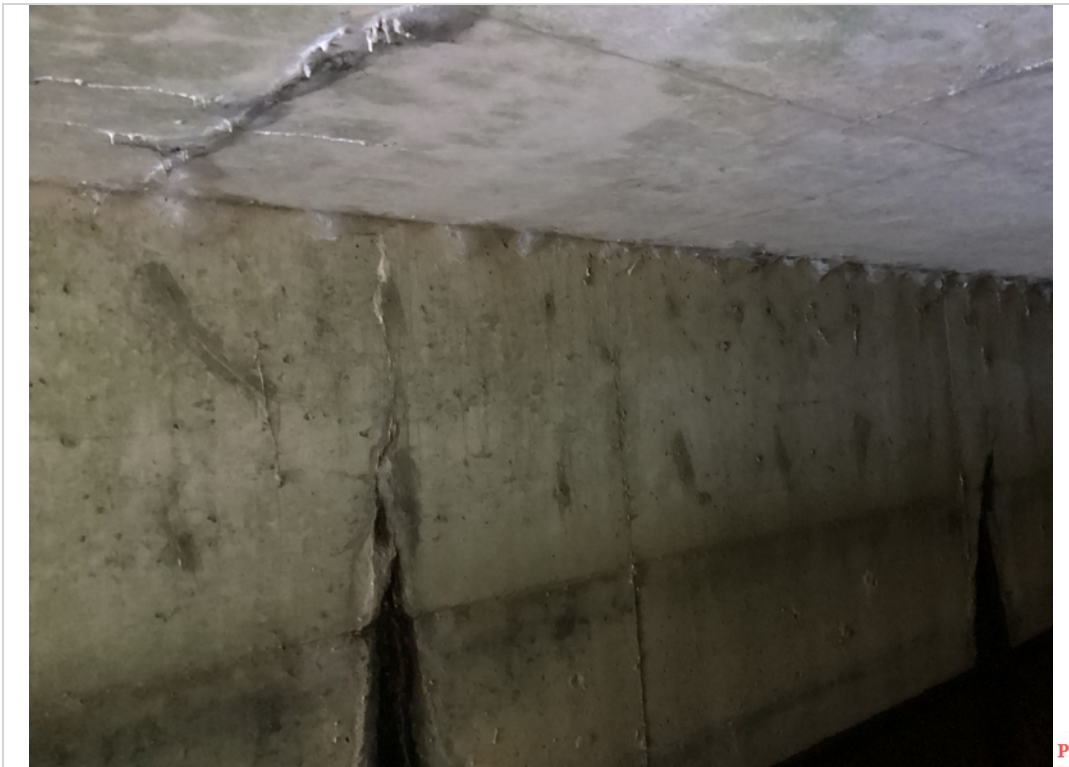
Barrel 2 - Hairline cracks w/ leaching (Typical barrel 1

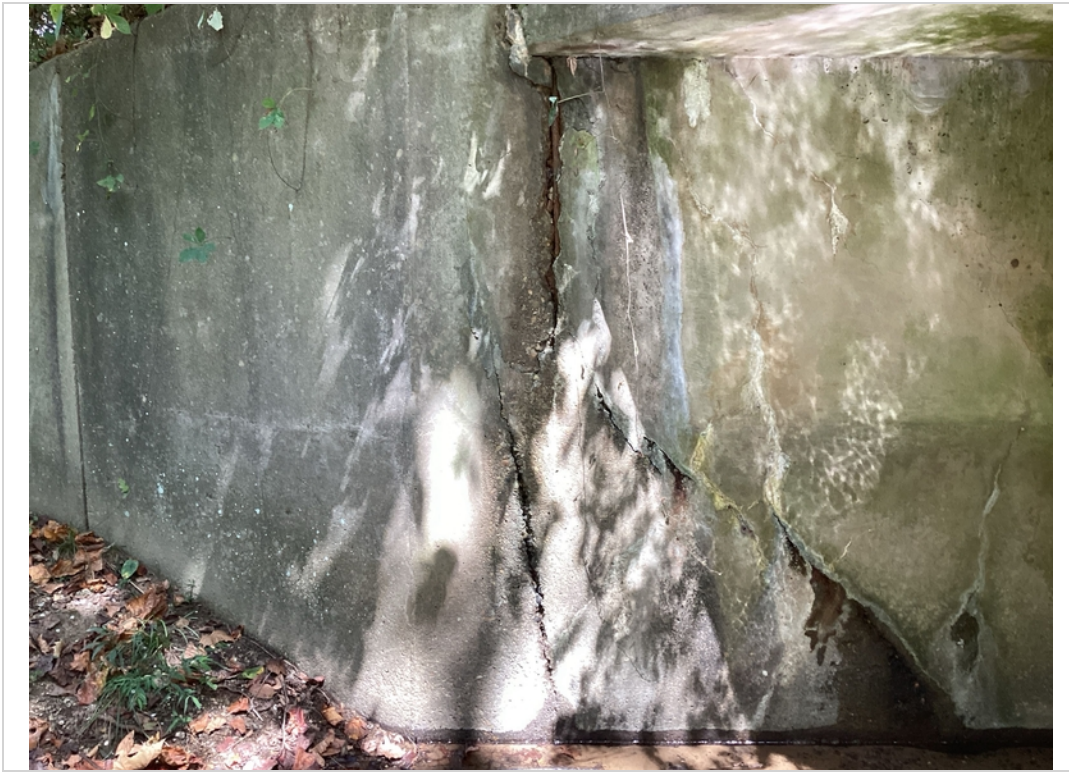
| Barrel Condition | (Fair) | Cracks up to 1/8" w/ leaching; Barrel 1 - Popout top at inlet; Barrel 1 wall 2 - 1/16" crack near top; Barrel 2 left - Spall w/ exposed rebar/in place spall (3'Hx3"Wx2"D) w/ crack up to 3/8"; Hairline cracks w/ leaching | | | |

Barrel 2 left - Spall w/ exposed rebar, in place spall (3'Hx3"Wx2"D) w/ crack up to 3/8"

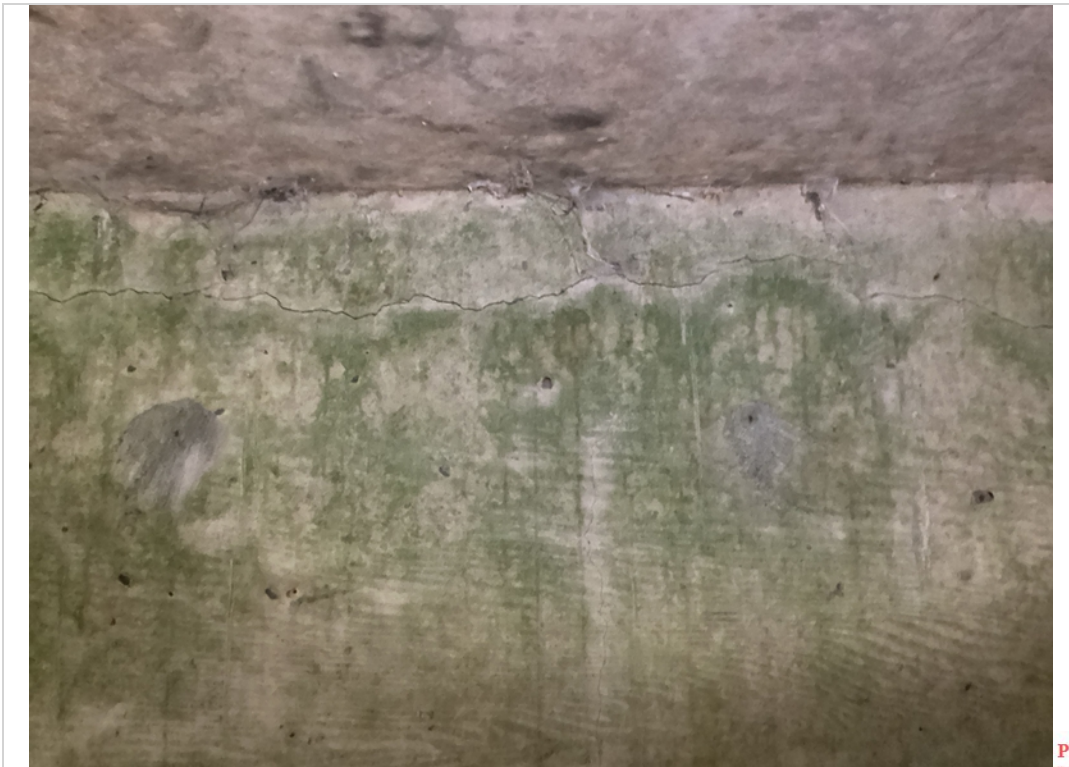
Barrels are fair, hairline cracks with leaching, a 1/16" crack 3" from top along barrel 1 wall 2, and spalls with rebar. Headwalls are good, hairline cracks, and a 3/8" crack. Wings are good, hairline cracks, and spalls, and patches.

Barrel 1 wall 2 - 1/16" crack about 3" from top

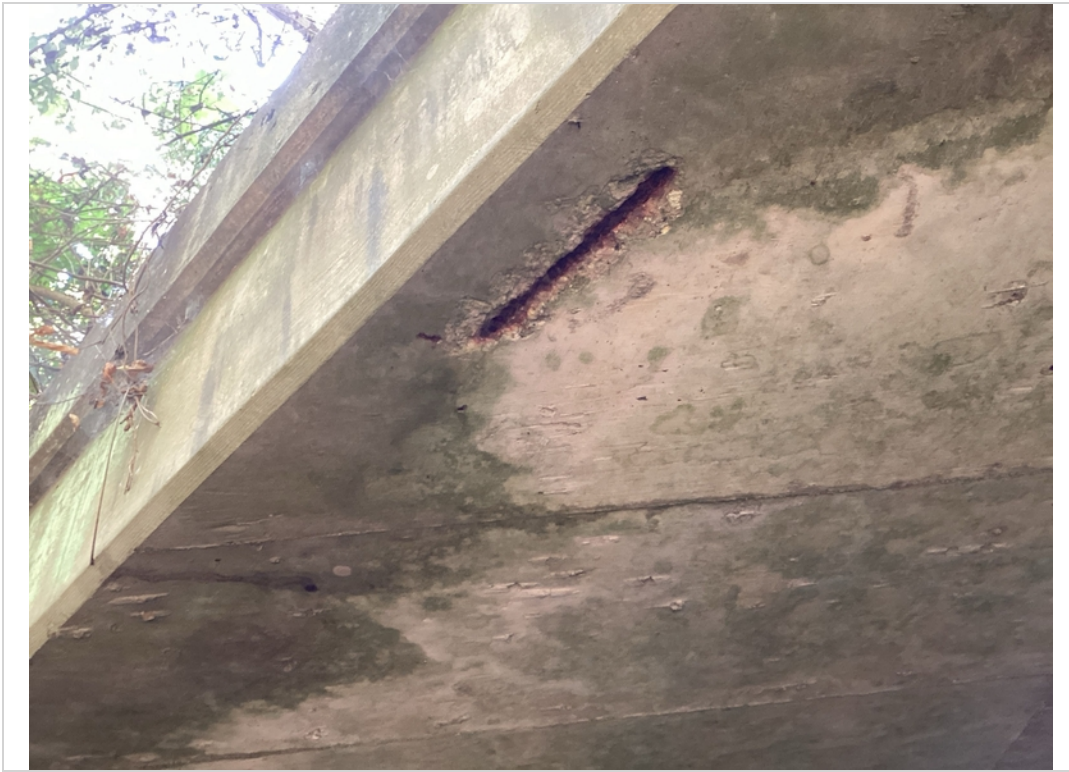
Barrel 1 - Popout top at inlet

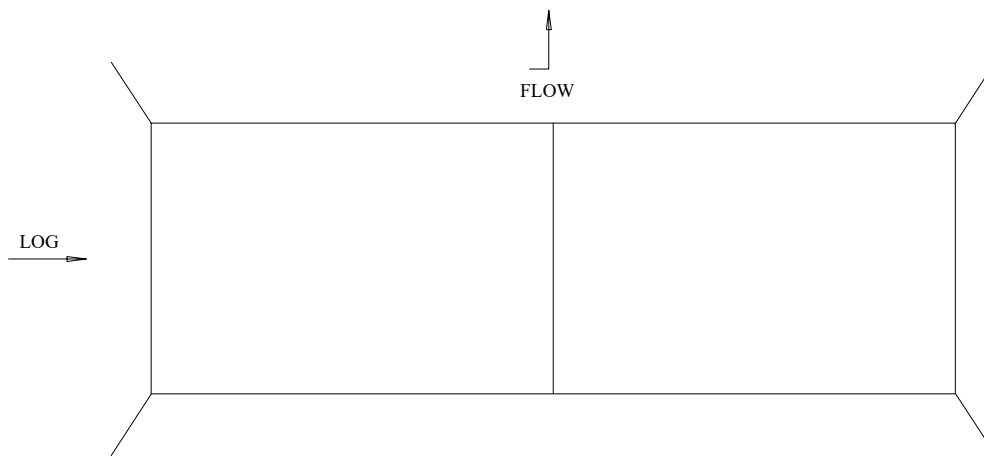
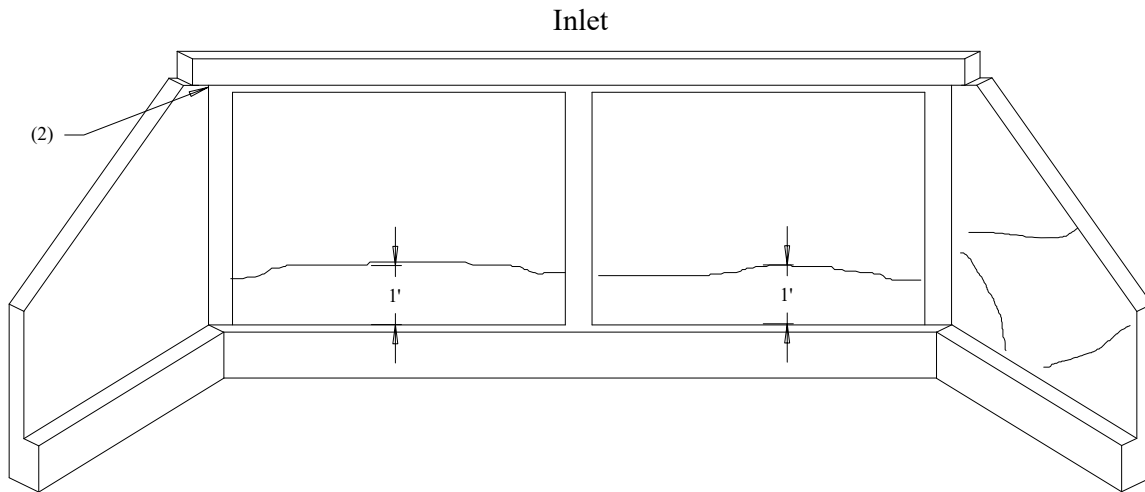
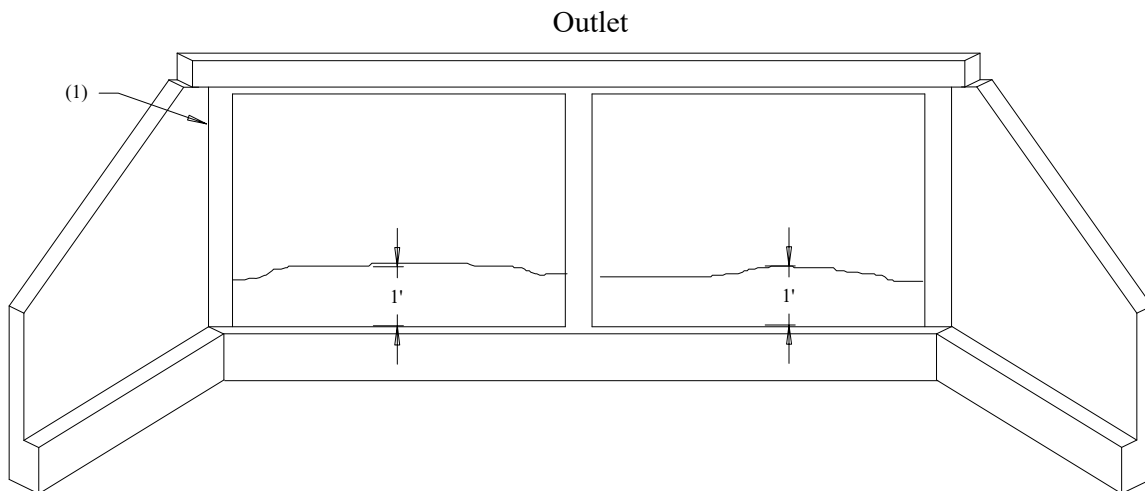
| LOC. 53-I-75-17.78 | | 09-16-24 RC | HEADWALLS |

| LOC. 53-I-75-17.78 | | 09-16-24 RC | HEADWALLS |
|---|---|---|---|
| INLET HDWALL | G | (2) 1/8" CRACK | |
| WINGS | G | WING 2 RIGHT - HAIRLINE CRACKS | |
| WINGS | G | (1) CRACK IN PATCH UP TO 3/8" WITH MINOR SPALLS | |

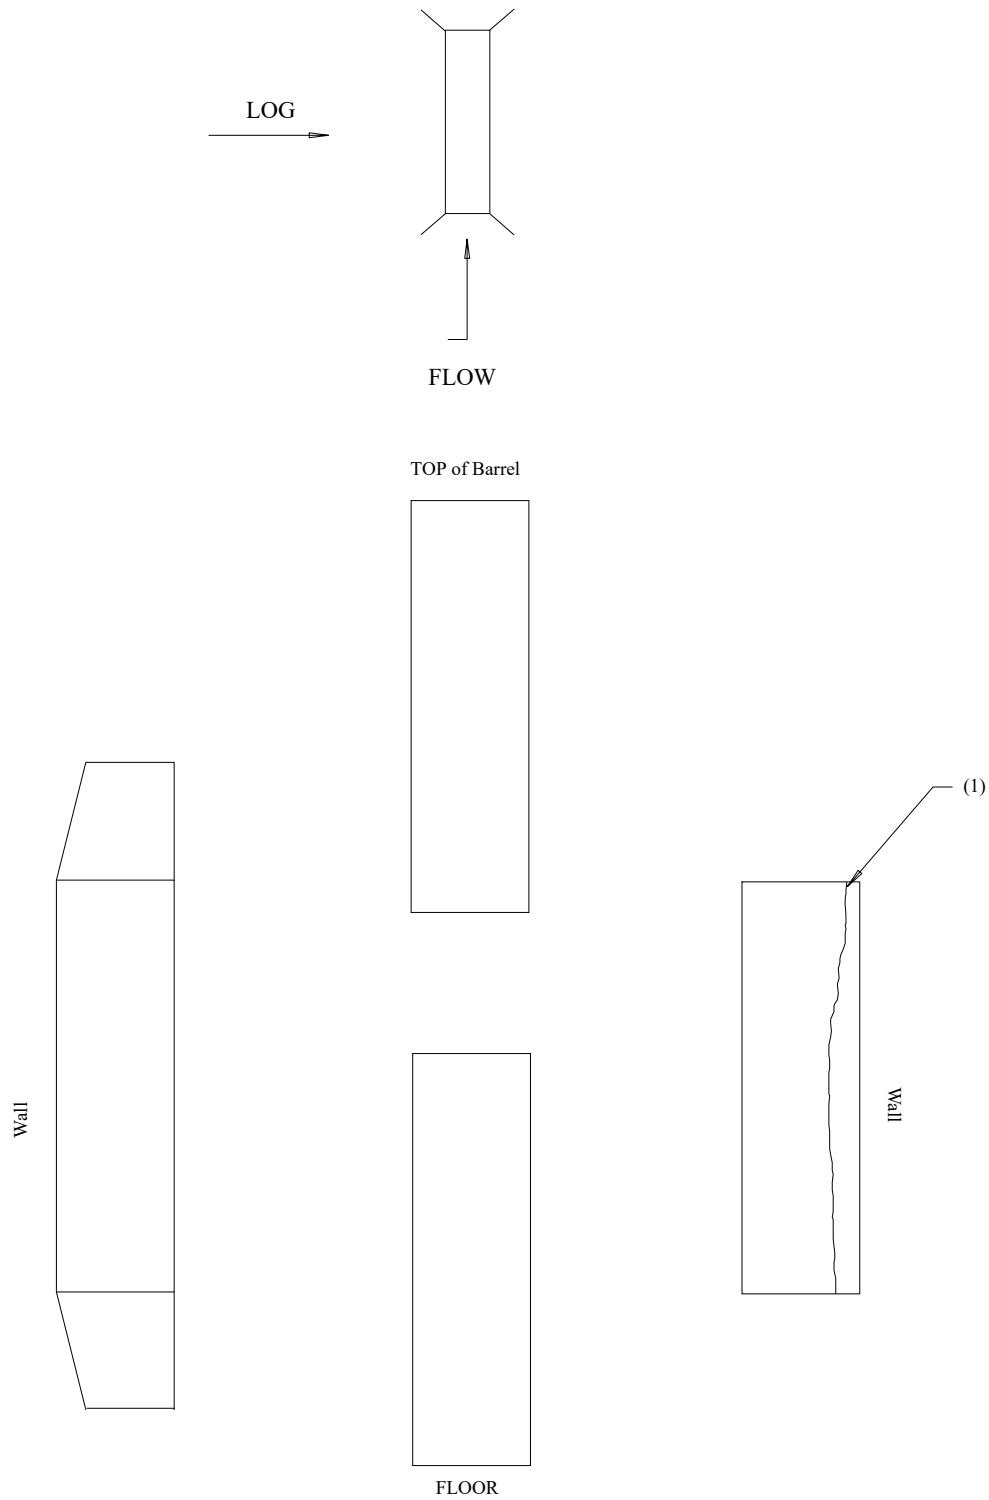
| LOC. 53-I-75-17.78 | | 09-16-24 AS | BARREL 1 |

| BARREL: | F | HAIRLINE CRACKS WITH LEACHING | |
| | | (1) 1/16" CRACK EXTENDS ENTIRE LENGTH OF WALL 2 ABOUT 3' FROM TOP | |
| | | INLET - POPOUT IN TOP | |
| | | SEDIMENT UP TO 1' | |

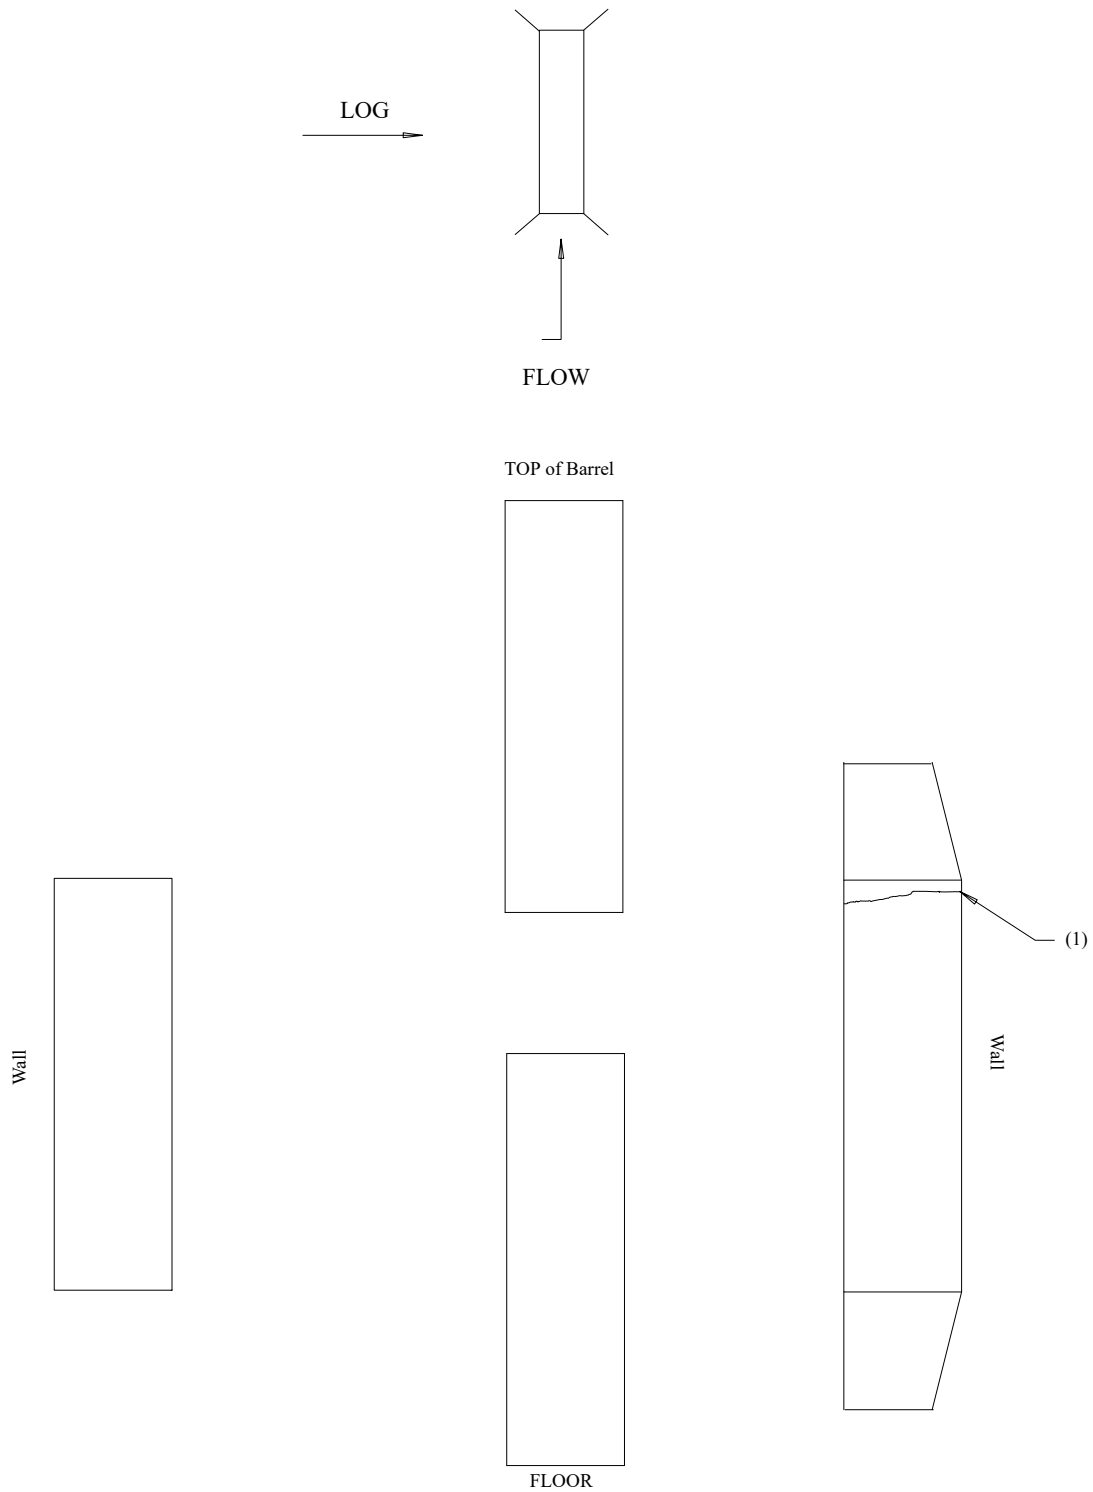
| LOC. 53-I-75-17.78 | | 09-16-24 AS | BARREL 2 |

| BARREL: | F | HAIRLINE CRACKS WITH LEACHING | |
| | | (1) BARREL 2 LEFT - SPALL WITH EXPOSED REBAR | |
| | | SPALL IN PLACE (3'H x 3"W x 2"D WITH CRACK UP TO 3/8" | |
| | | SEDIMENT UP TO 1' | |
